# **Troubleshooting Guide**

# **imageRUNNER ADVANCE**

# **8500 III/6500 III Series**

September, 2019  
OIP Field Quality Assurance Div.

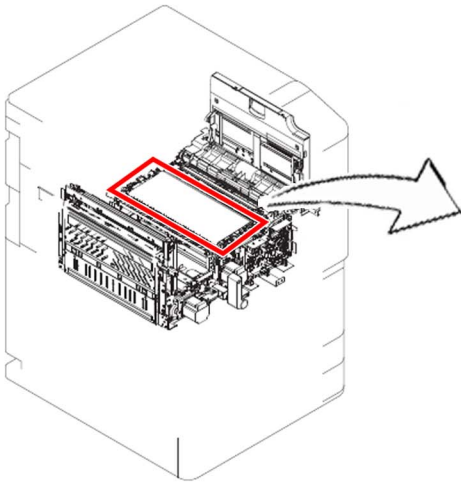
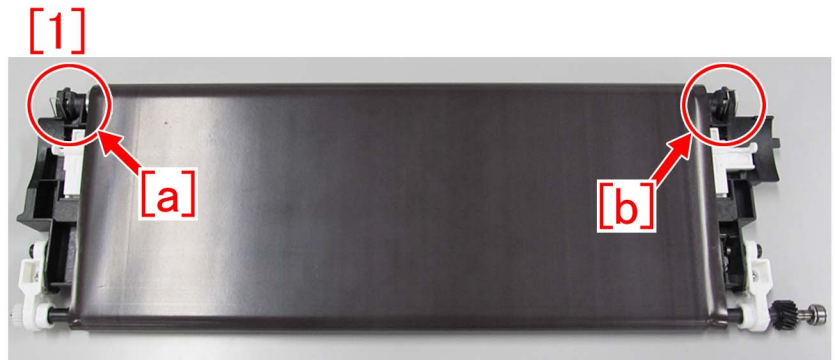
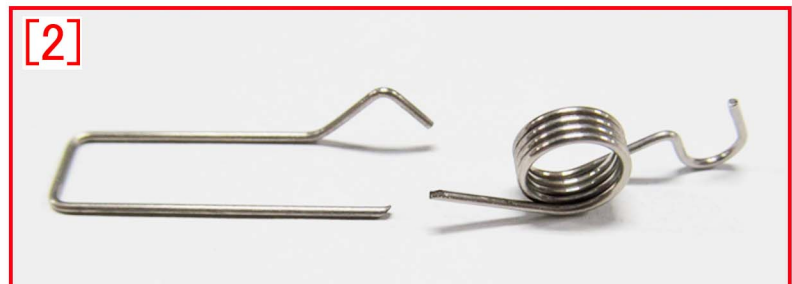
In the machines prior to the countermeasure cut-in serial number in factory described below, a stain seemingly caused by rubbing may occur on the leading edge of the image.

On the leading edge of the torsion spring on the rear side [a] and the front side [b] of the ETB unit [1], pressure is applied to the pre-transfer guide of the pre-transfer corona assembly to position the pre-transfer guide. After some endurance time, the torsion spring will not be able to slide well and a load will be applied, causing breakage.

This will lower the position of the pre-transfer guide and cause it to touch paper, resulting in the above-mentioned symptom. [2] shows the torsion spring broken on the front side [b].

If the above-mentioned symptom occurs, prepare the new-type torsion springs and replace them by referring to Service Manual "Removing the ETB Unit".

It is recommended replacing the torsion springs on both the front side and rear side at the same time even if the torsion spring only on one side is broken.

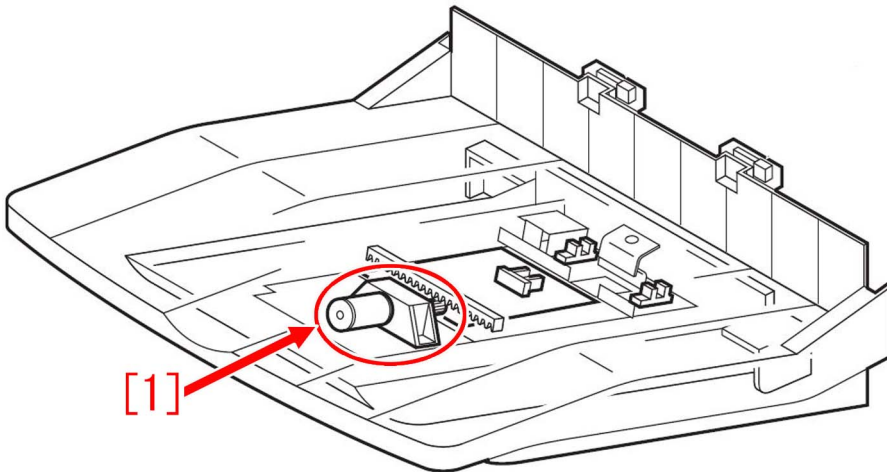
In the machine earlier than the following countermeasure cut-in serial numbers in factory, when using Shift Tray-F1, abnormal noise around the DC motor [1] or an operational failure such as not shifting may occur.

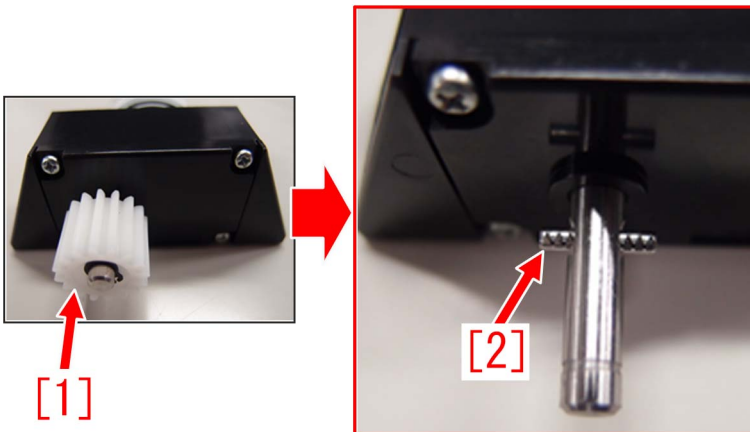
When DC motor have been used for a long time, a spring pin [2] of output gear [1] may break. For this reason, normal operation of the output gear [1] is prevented, and this leads to the afore-mentioned symptom.

When the above symptom occurs, prepare a new type of DC motor (FK3-3277-010) and follow the steps below to replace the part.

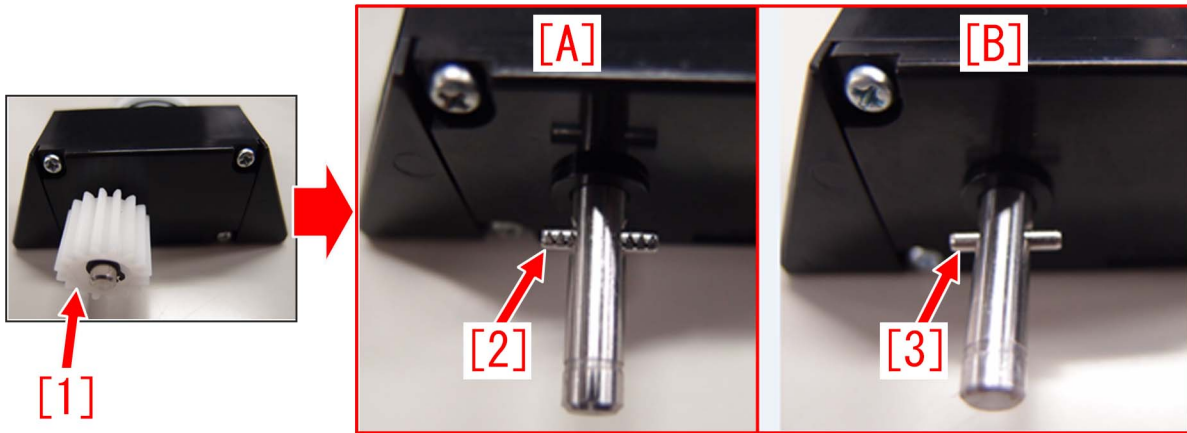
[Reference] Spring pin [2] used in the output gear [1] of the new type DC Motor [B] is changed to a dowel pin [3], for strengthening purpose. [A] is an old type.

3) If the output gear does rotate by hand, the spring pin is broken. Replace with a new type of DC Motor (FK3-3277-010), and assemble the parts by following the reverse order as removed.

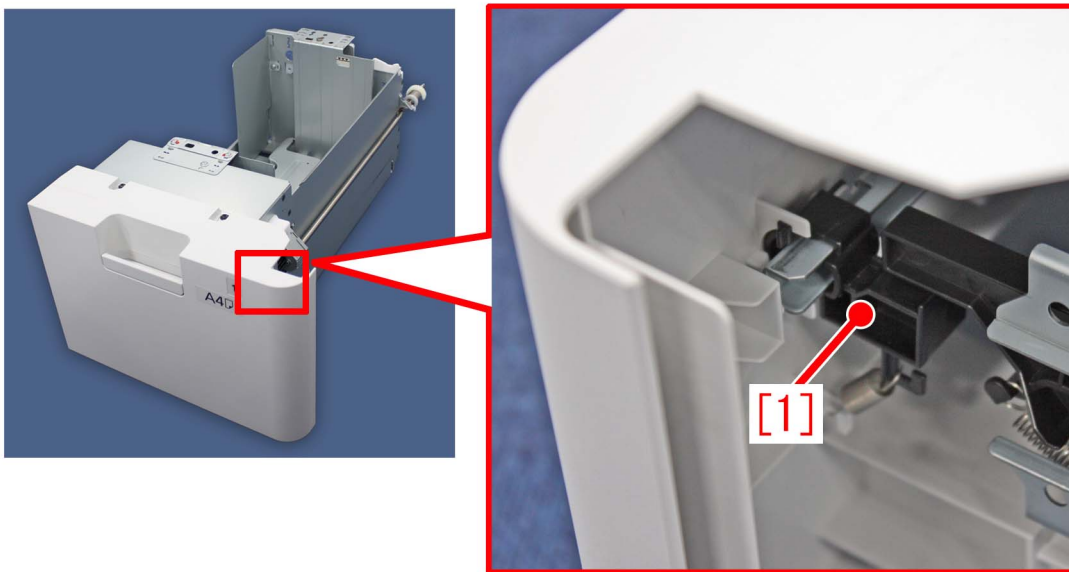
In the machines prior to the countermeasure cut-in serial number in factory described below, right pickup deck or left pickup deck of a main unit could not be pulled out.

Due to impact to either right pickup deck or left pickup deck when they were opened/closed, the deck lever [1], which is located near the handle, may break from its stress. With this damage, open/close lock could no more function to release, resulting in the above-mentioned symptom.

Photos below are showing the deck lever [1] on a right pickup deck of the iR-ADV 6500 Series machine.

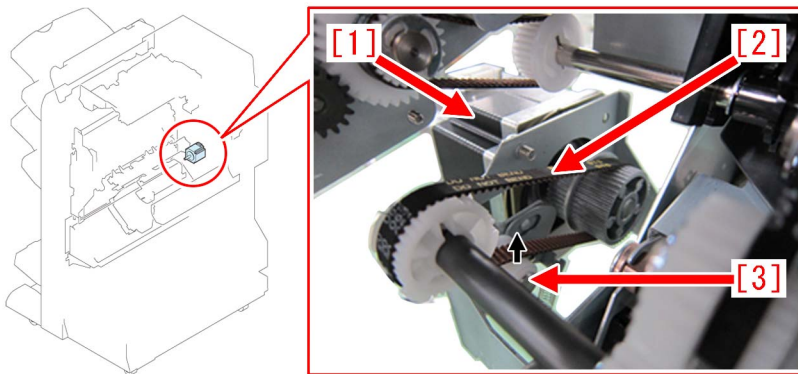
In the machine earlier than the following countermeasure cut-in serial numbers in factory, when printing using the finisher, 110F jam may occur.

The timing belt [2] in the operation feed motor (M26) [1] is designed to keep its tension and prevent from being loose by having the tensioner [3] pressed in the direction of the arrow. This tensioning method is "unfixed type". However, the pressing power of the tensioner [3] in the unfixed type is insufficient in some cases and when the operation feed motor (M26) [1] drives rapidly a meshing failure occurs on the timing belt because of power, resulting in the above symptom.

When the above symptom occurs, prepare and replace the paper delivery drive set (L) (4Y8-3156-000).

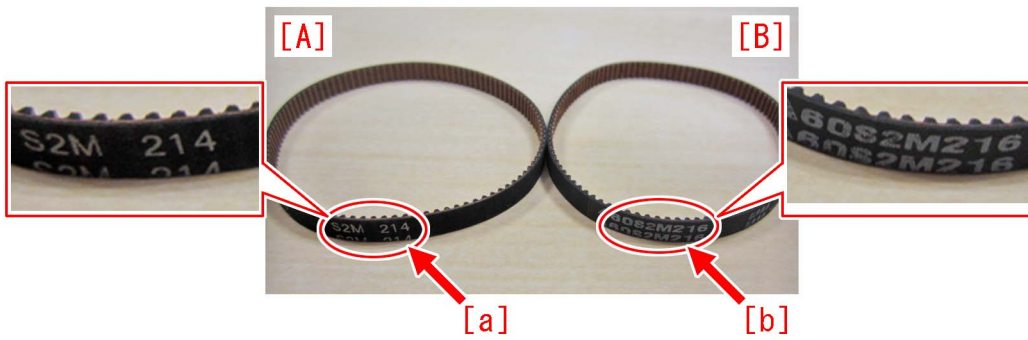
[Note] When replacing to the paper delivery drive assembly (L), be sure to also replace the timing belt [B] at the same time that is included in the set. 110F jam occurs when using the old type timing belt [A] as the number of teeth of the new type is different from the old type originally attached to the engine.

The old type [A] has "S2M 214" [a] printed on it. The new type [B] has "60S2M216" [b] printed on it.

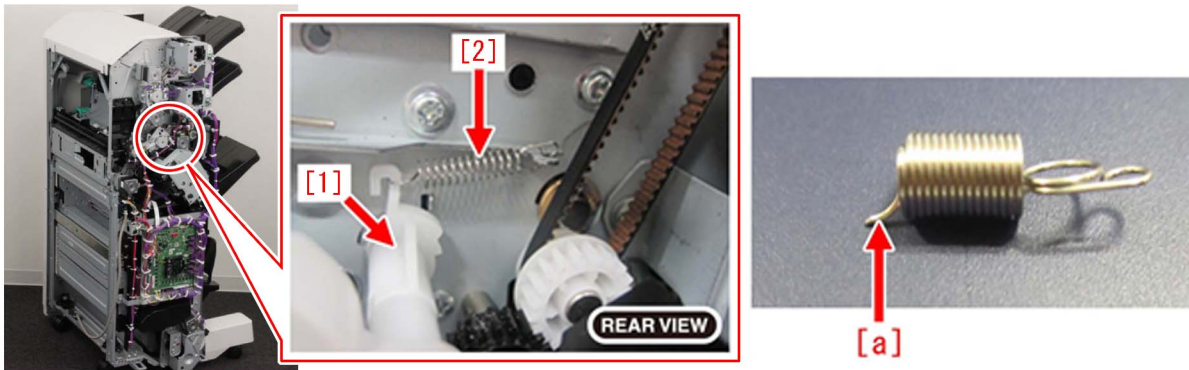
When the tension spring (FE3-8986-000) [2], which has the role to retain the home position of the Buffer/Saddle Inlet Flapper[1] is attached in a twisted condition, it may break [a] during operation. If this tension spring breaks, it may lead to 1002 jam.

When attaching the tension spring of the Buffer/Saddle Inlet Flapper, do not twist its hook.

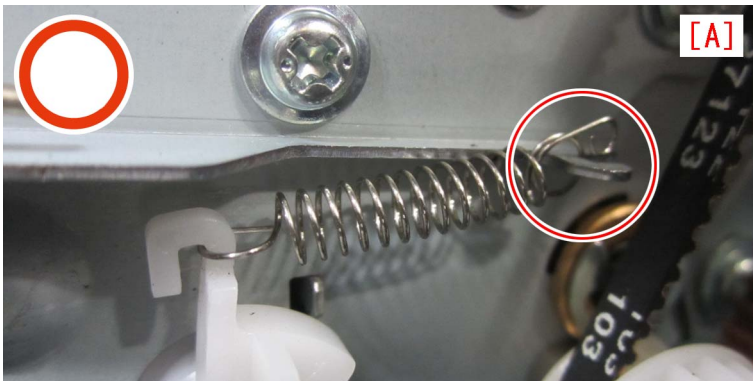
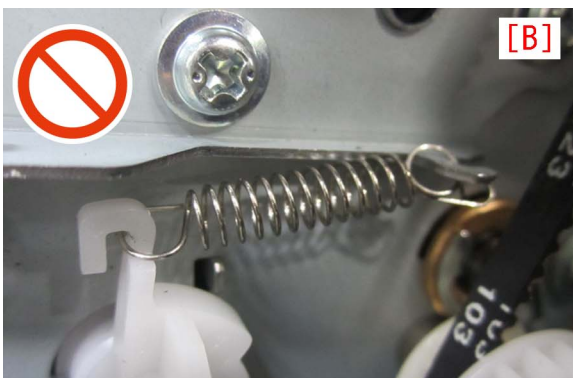
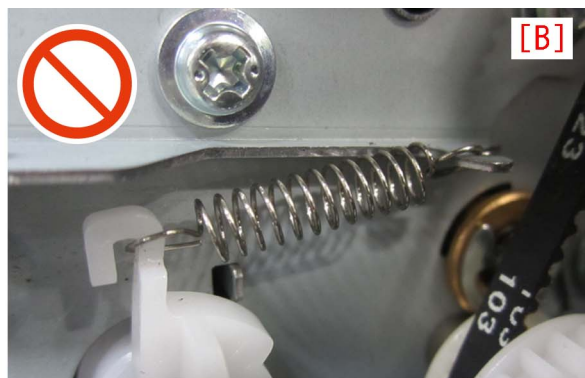
Below, photo [A] is showing the normal condition. The spring is attached correctly. Photo [B] is showing the incorrect status.
