# Service Bulletin

Ref. No. **COM-0218 (B056)**

<b>Subject</b>	<b>Note when releasing the paper jam/maintaining the machine (Prohibition of use of the flammable sprays and liquids)</b>
<b>Model</b>	All models

<b>Subject</b>	<b>Mac OS 10.7 Lion: Alternative Scan Function since Scan to SMB is NO LONGER supported in the Latest Mac OS Version</b>
<b>Model</b>	<b>All MFP Models</b>

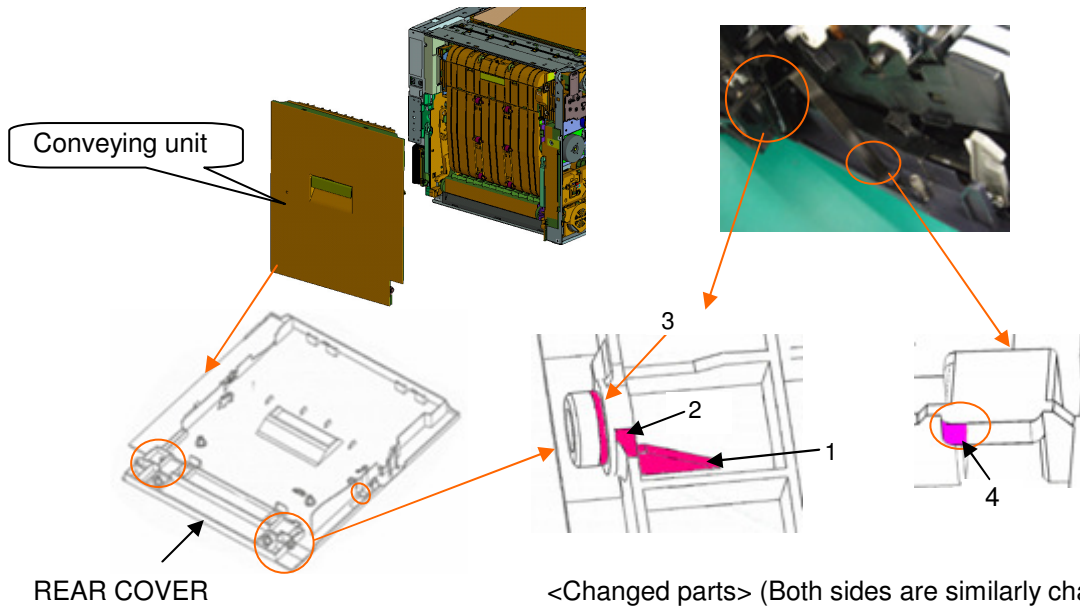
REAR COVER is changed as below for improving the margin of opening/closing the conveying unit at the machine rear side.

Thickness is added to 1, 2, 3 and 4 in encircled parts of REAR COVER.

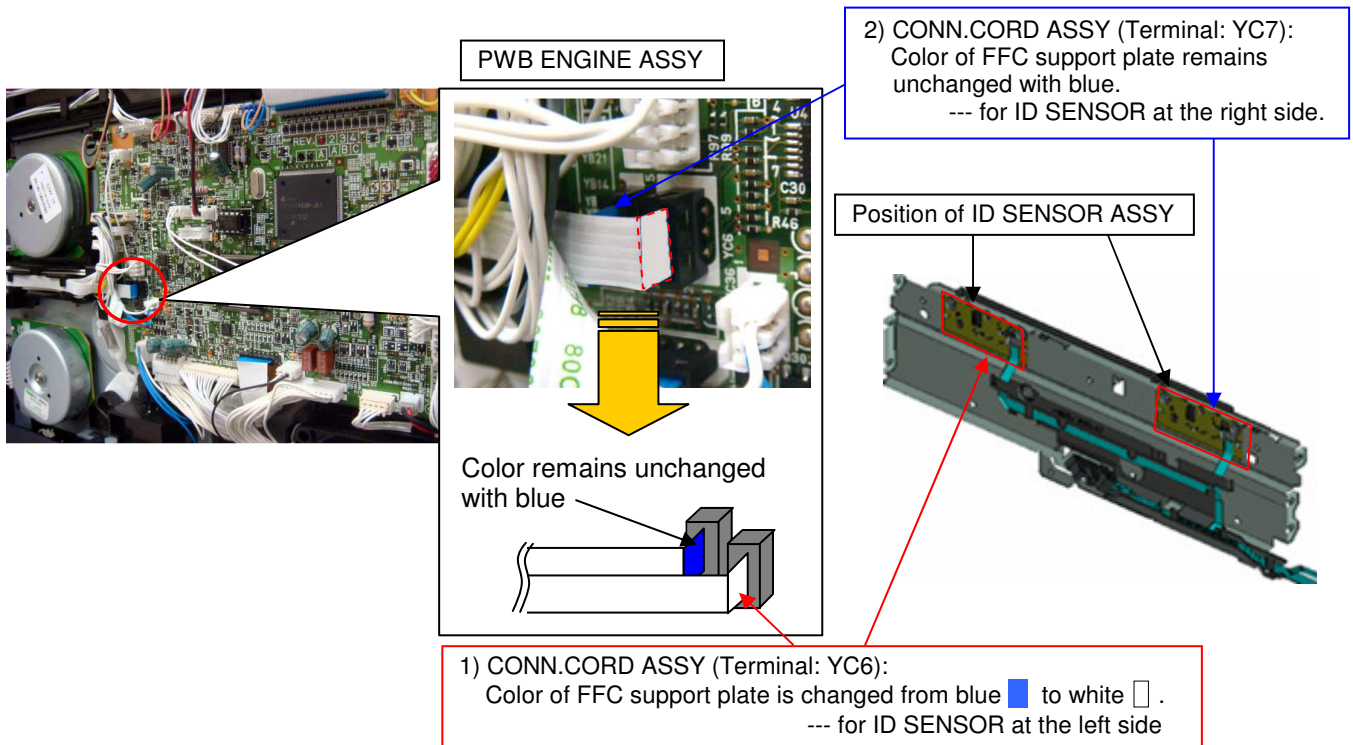
For preventing the misalignment of FFC against the engine board, color of the harness support plate of the right terminal (YC6) on the engine board is changed from blue to white.

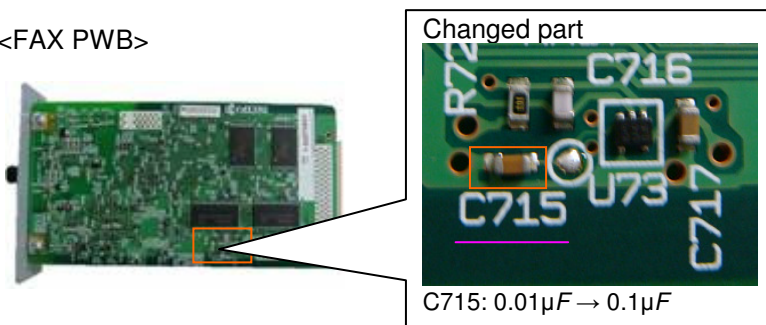
<FAX PWB>

Constant of the capacitor (C715) on FAX PWB is changed from 0.01μF to 0.1μF for improving against the FAX recognition failure.

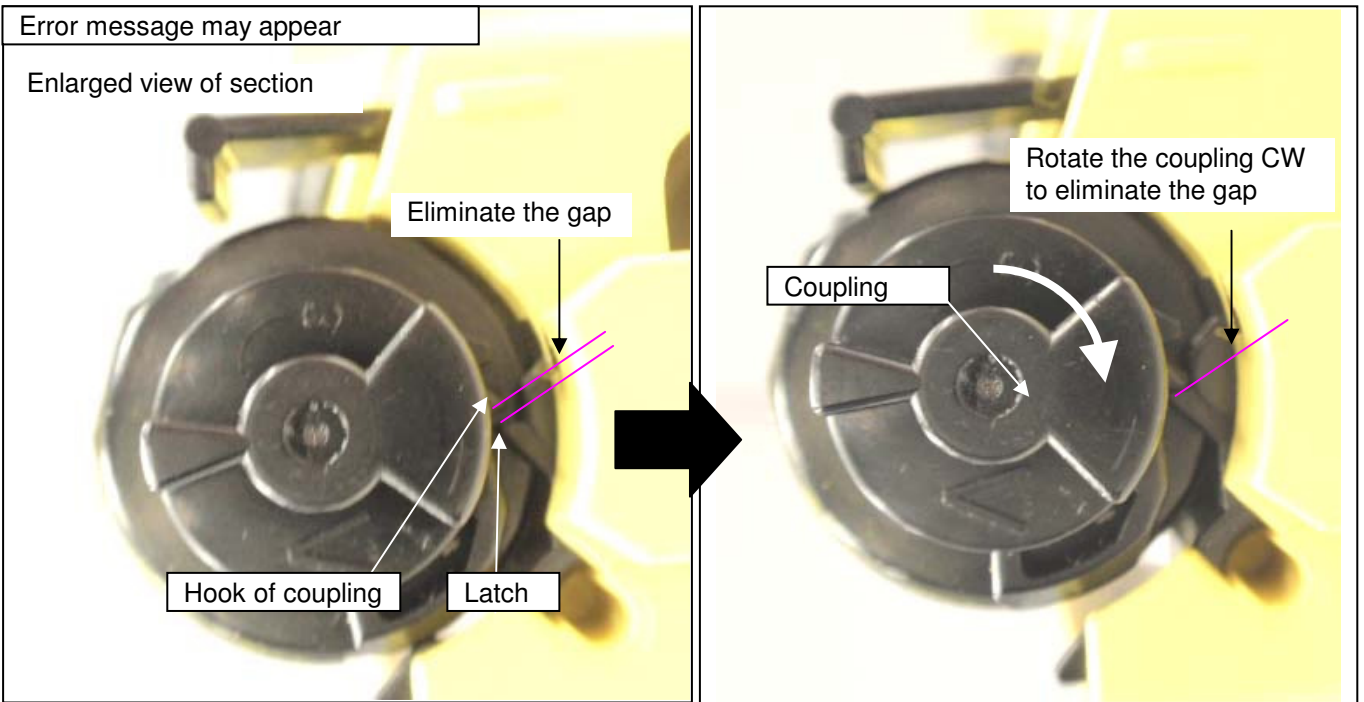
Message displayed                      MFP : The toner container is improperly installed

Once take out the toner container from the machine. Rotate the coupling at the right side of the toner container clockwise to eliminate the gap between the hook of the coupling and the latch. Then, reinstall it in the machine.

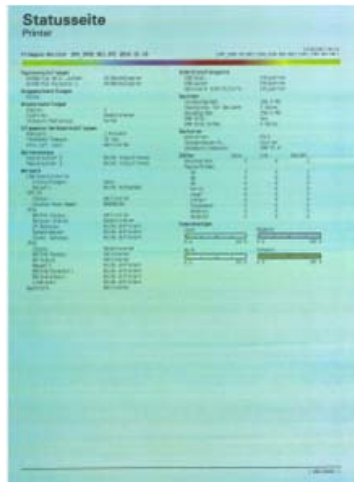
Full-page solid image

If the full-page solid image or leak image as shown in the example below is observed, the main charge may not be impressed or there may be a leak in between the drum and the developer sleeve.

Please check if there is contact failure on the high voltage board.

Cyan high voltage contact failure

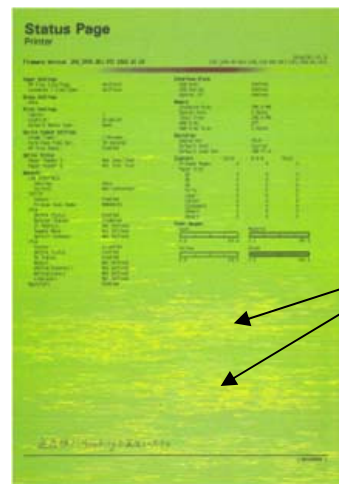
Developer leak image

Cyan and yellow high voltage contact failure

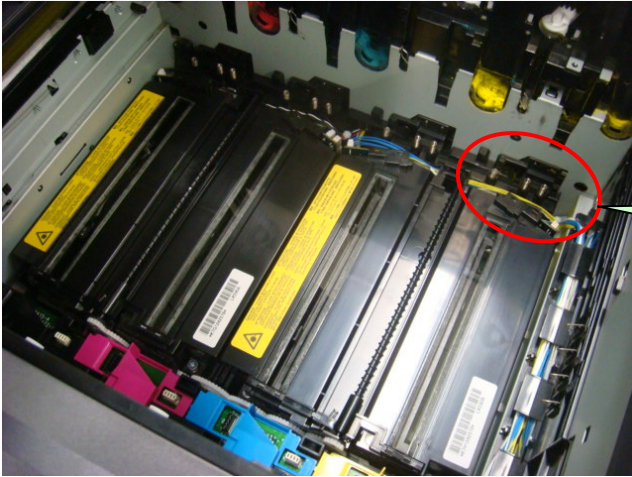
**NG** The leading edge of the spring is caught up with the plastic wall

In case NG condition is observed, release the leading edge of the spring caught up using a flat-blade screw driver and correct it to enter the hole

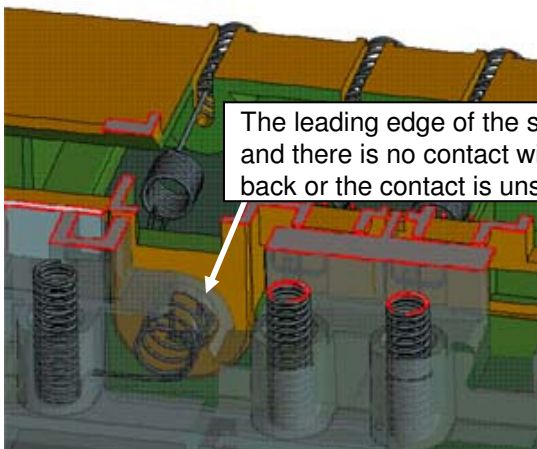
The leading edge of the spring is caught by the wall and there is no contact with the contact point at the back or the contact is unstable.

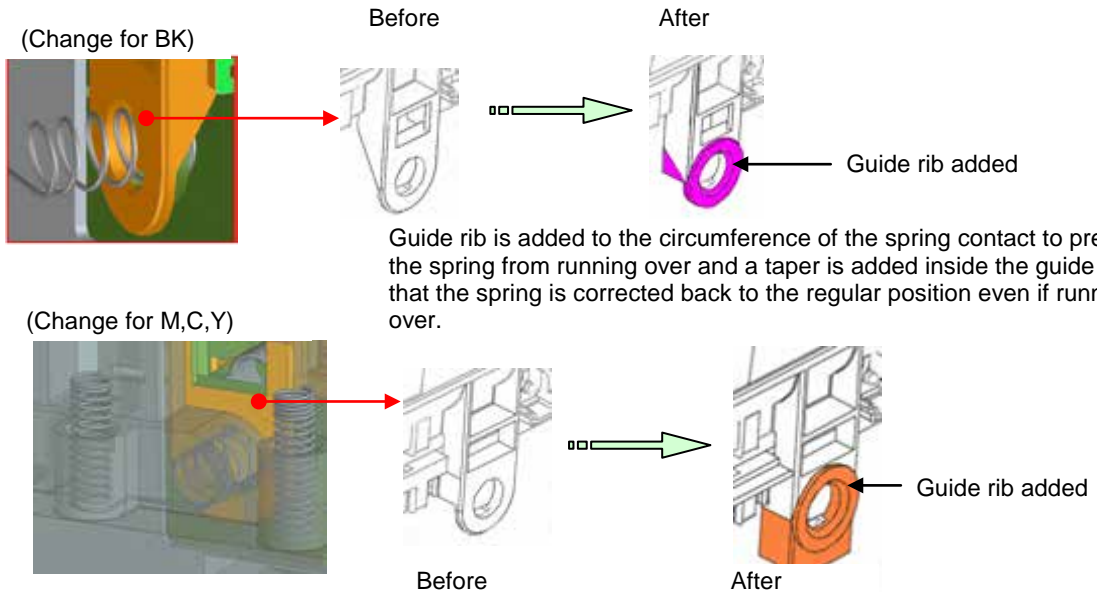
1. Corrective measures for the contact failure of the drum high-voltage board

A guide rib is added so that the spring does not run over the circumference of the hole.

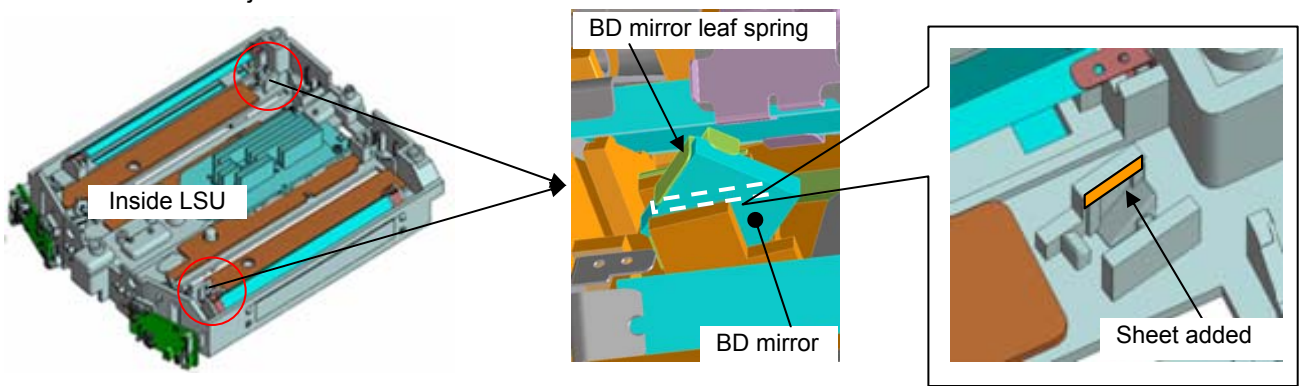
The BD mirror inside the LSU may be dislocated and an error may appear. Therefore, a sheet is added to the of the BD mirror to adjust.

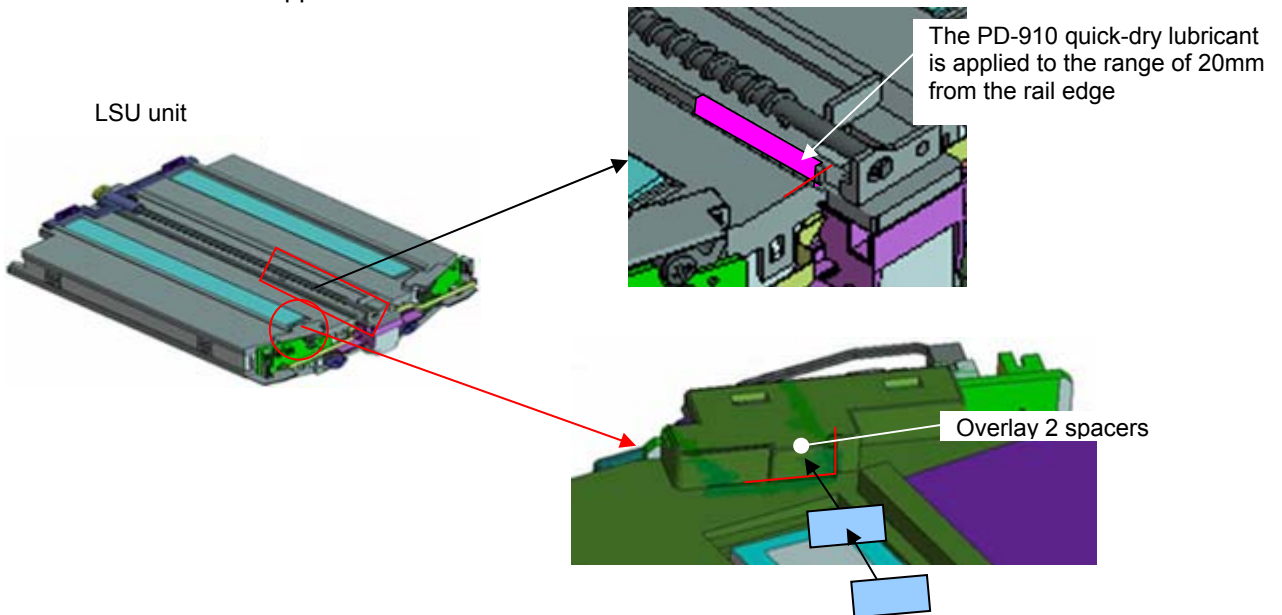
The motion failure may occur if the cleaning holder tilts when the LSU cleaner move. Therefore, a spacer is added and lubricant is applied to the rail.

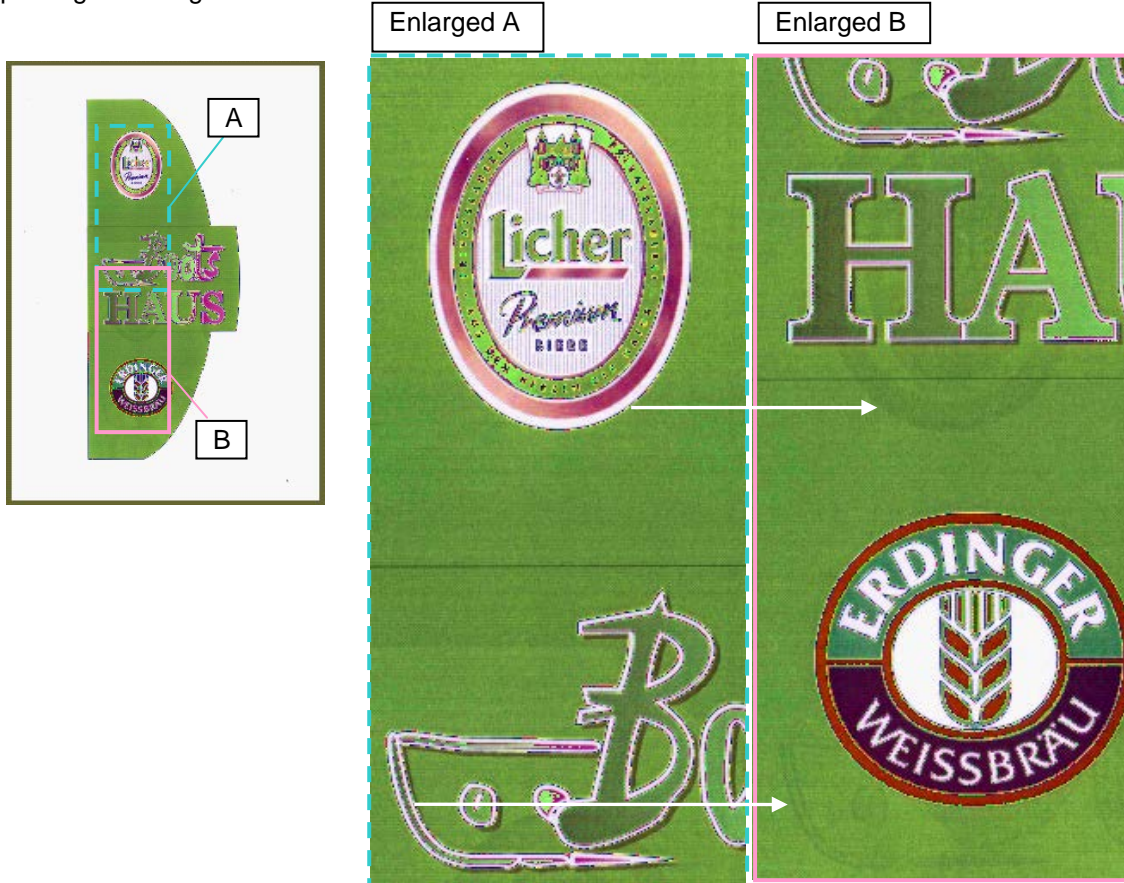
<Sample of ghost images>

The part A appears on the part B like shadow.

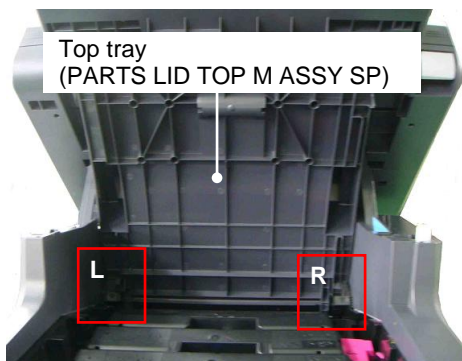
HINGE LID R or HINGE LID L may be damaged if forcibly pushing up the top tray because the machines with the serial number indicated in the table in page 4 are before change of the material as the corrective measures 2). If damaged, please replace them with the new parts (302KV0254\_/302KV0253\_). As for the distinction of the new and old HINGE LID R/L, please check the material indication engraving on the HINGE's side.
