FS-C2026MFP(+)-C2126MFP(+), FS-C2526MFP-C2626MFP, FS-C5150DN, FS-C5250DN

TROUBLESHOOTING GUIDE

KDE PRODUCT ENGINEERING

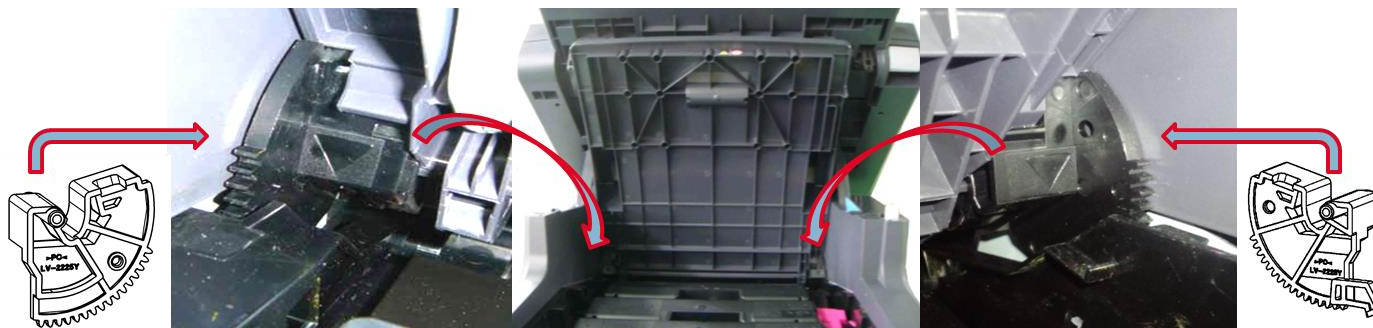
By frequent repeated opening / closing of the top cover the hinge left / right might be broken.
 From October 2010 on the material of these hinges have been changed from ABS to more stable POLYCARBONATE.
 In the event of such cases, please replace the hinges with the modified parts **302KV02532, HINGE LID L** and **302KV02542, HINGE LID R**.

We also recommend to change the RATCHET SHUTTER (302KV02501)
 These measures are described in SB-2KT-0007-B380, SB-2KT-0020-D014 and are a part of the modification kit [\(2KT-0019-D012\)](#)

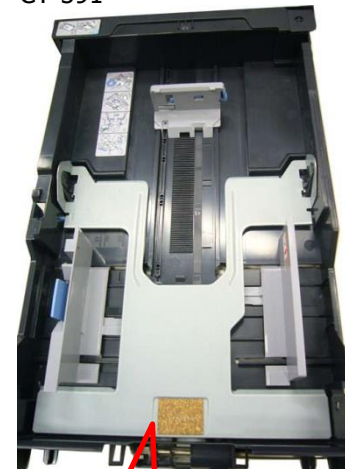
Location of the STOPPER HOOK

In some cases the jam code JAM0501 can occur in the mentioned models. In this case the STOPPER HOOK might not work correctly. Therefore the STOPPER HOOK was changed and a SPRING was added.

A detailed description how to attach the new parts you can find in the SB [2KT-0022 \(D027\)](#).

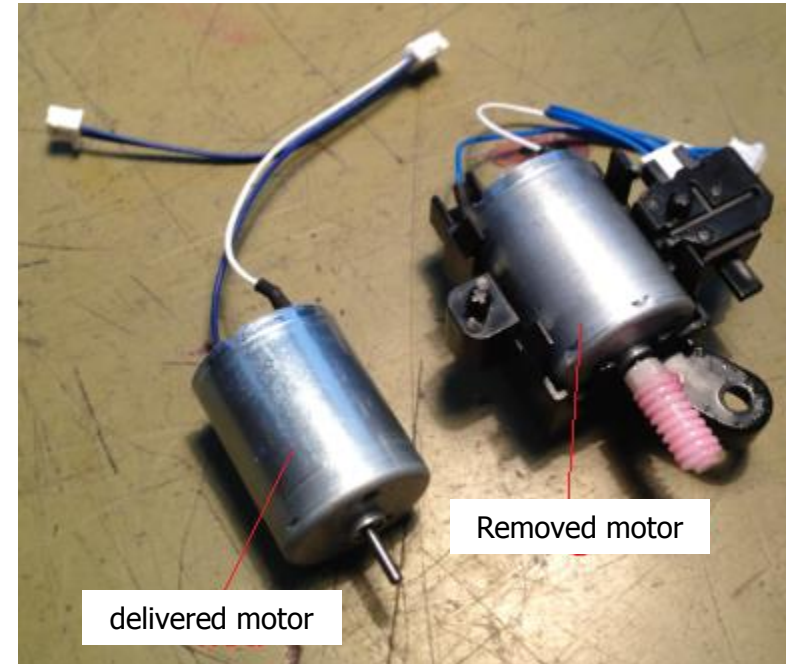
If the error C2740 occurs, the service manual recommends to change the developing release motor.

In most cases the motor is not the cause of the error. Usually it is caused by a mechanical failure or a contact problem. Furthermore, the motor will be delivered without any bracket and worm gear.

Therefore we recommend to exchange the hold drive unit

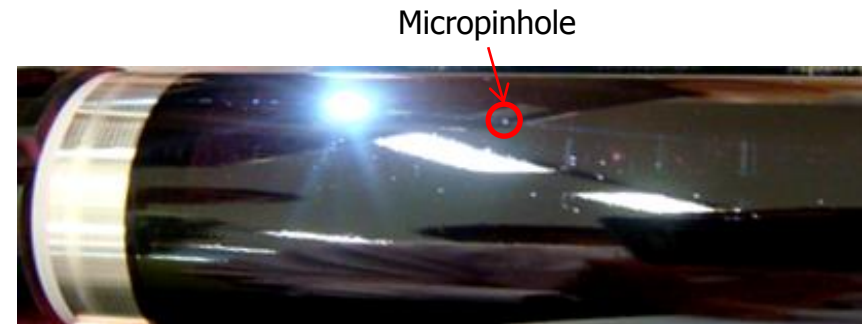
Dots appear on the output image caused by the micropinhole in the layer of the Drum. The phenomenon is occurring in high humidity environment, but occurs even in normal temperatures.

Since firmware version 2KT_1000.004.003 for printers and 2KW_1000.009.003 for MFP's some control mechanism were changed. If an update doesn't solve this issue, please change the drum unit.

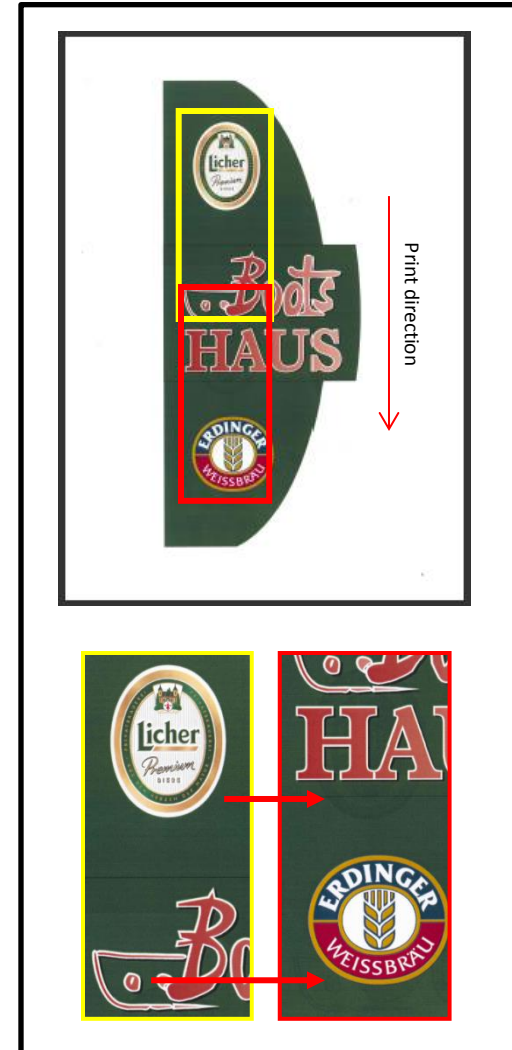
Picture1

A ghost image (picture1) might appear during full page color printing because the primary transfer bias is not erased completely before one complete rotation.

Since firmware version 2KT/2KV_1000.005.002 for printers and 2KW_1000.010.003 for MFP's the primary transfer current is adjusted in conjunction with the MC setting of 1 to 5 in the service menu. If an update doesn't solve this issue, please change the drum unit.

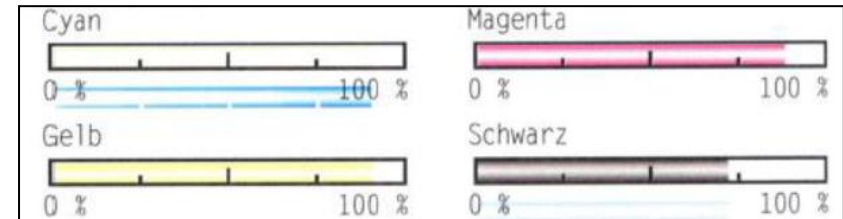
Picture 1

Reoccurrence of misalignment in the color registration (picture 1). Different reasons have to be considered. Therefore, perform the following steps.

Step 1: Check the Service Statuspage (printer) or the Maintenance Report (MFP)

Step 2: Check belt drift or misalignment of the transfer belt and the ID-Sensor (see description below)

Step 3: Firmware Update (referring to [SB C132](#)) (see description below)

Step 4: Exchange Engine PWB, as last technical measure.

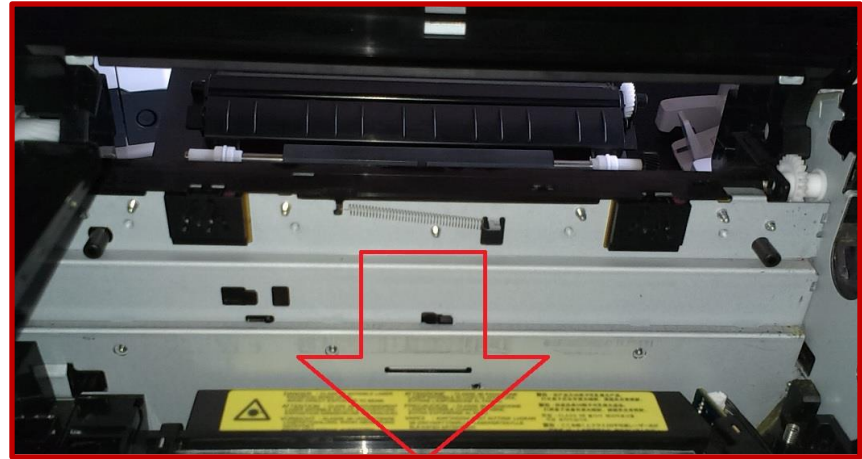
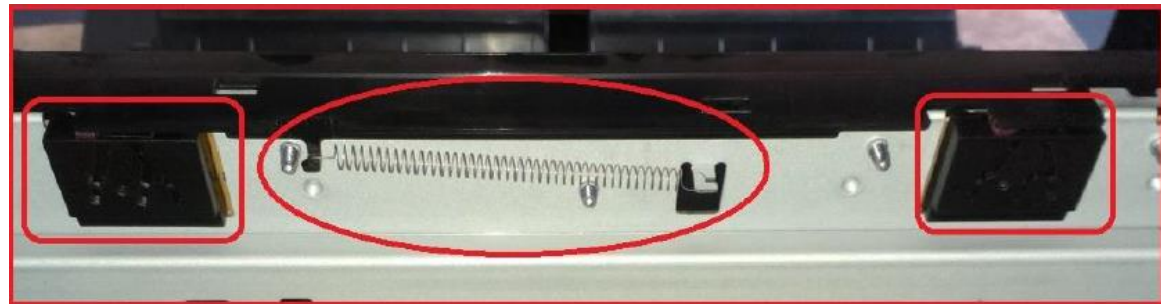
If the first 2 digits are other than „00“, the ID-Sensors have to be checked.

In particular, the cover and cover mechanism itself should be checked also.

Check the inner frame as seen on the pictures.

Please ensure, that with opening/closing the top cover, these covers slide in left/right direction.

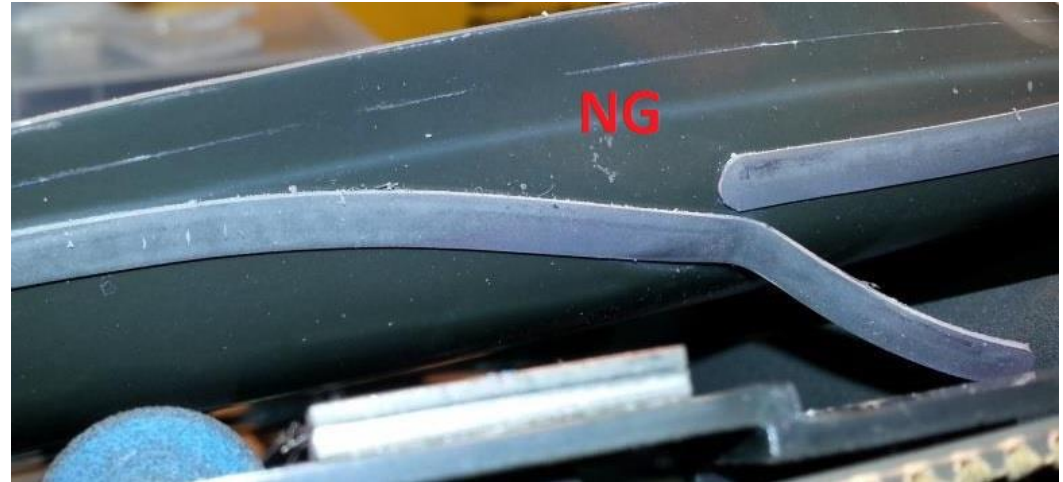
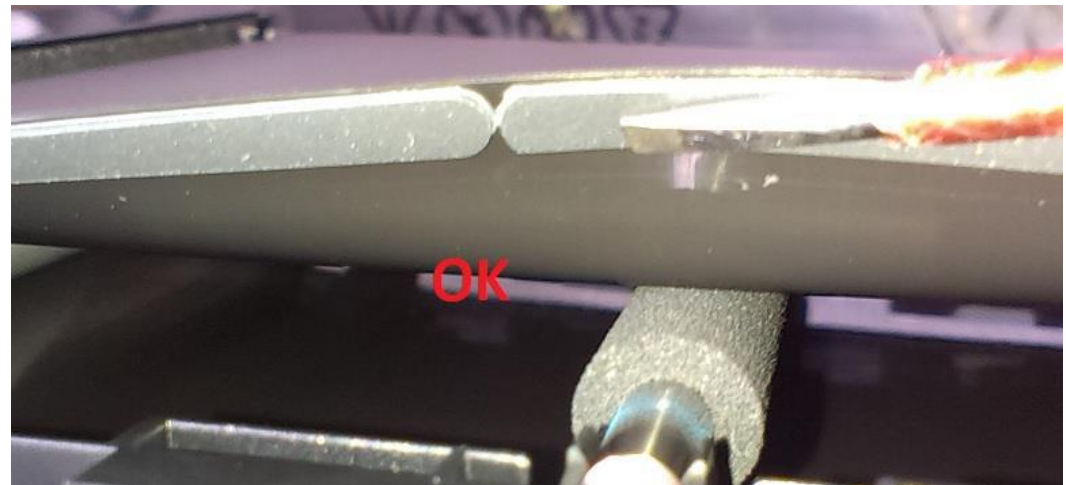
Step 2:
Drift or misalignment of the transfer belt.
