Service Bulletin

Ref. No. **COM-0218 (B056)**

Subject	Note when releasing the paper jam/maintaining the machine (Prohibition of use of the flammable sprays and liquids)
Model	All models

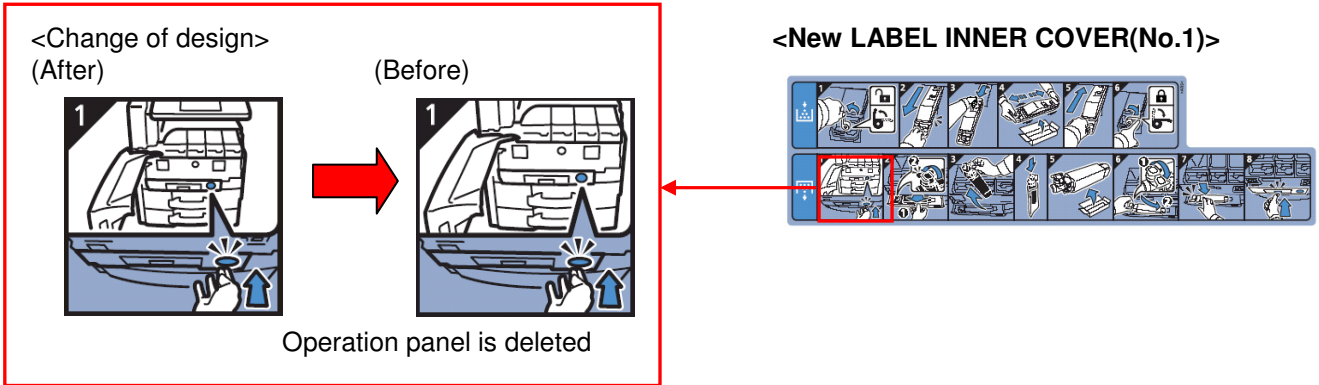
Design of LABEL (No.1) is changed for common use with other models as follows.

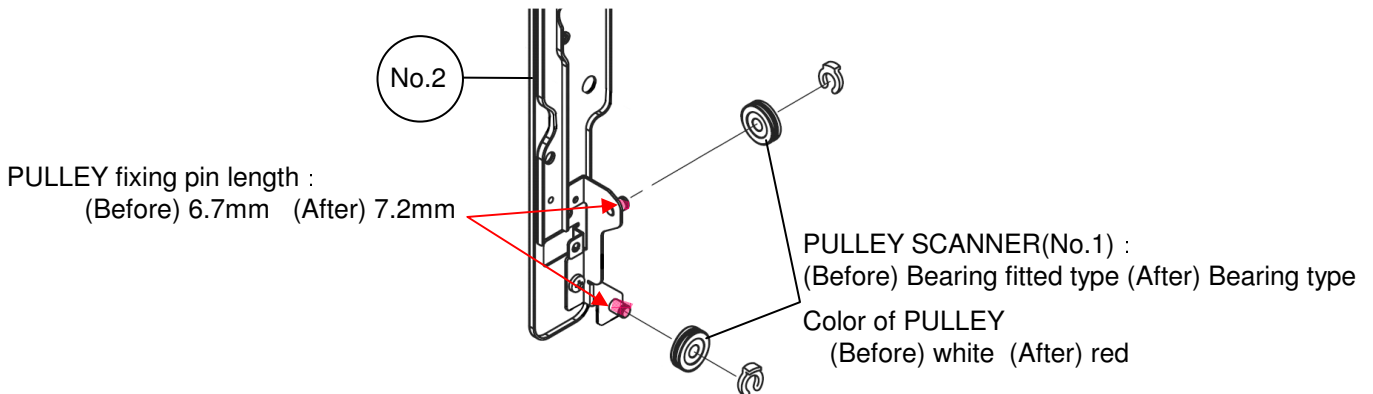
PULLEY fixing pin length for PLATE LEFT COVER ASSY(No2) is extended by 0.5mm to secure the fixing margin.

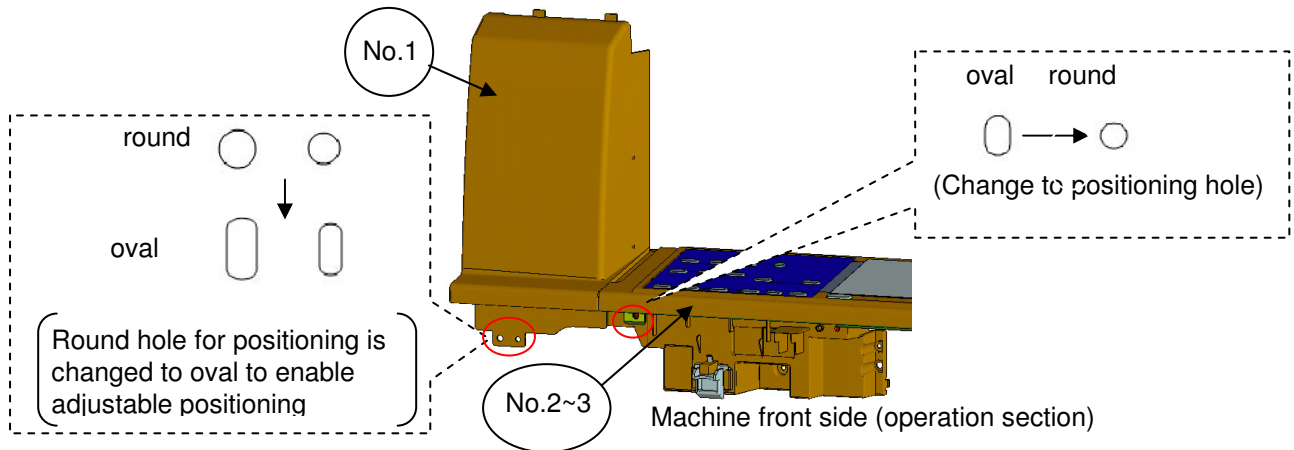
COVER FRONT TOP(No.1) and COVER OPERATION(No.2) at the operation section are changed to improve assembly process as follows

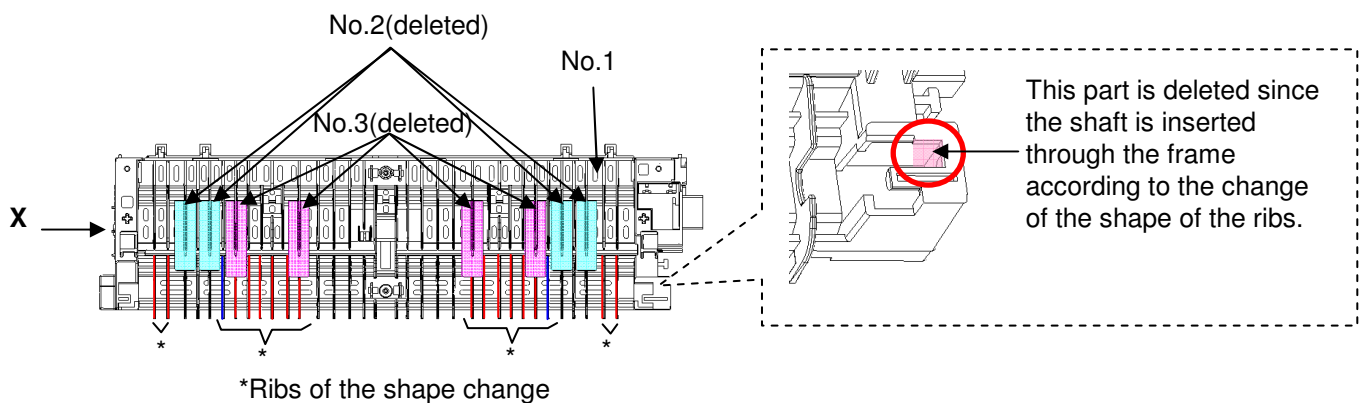
- 1) Shape of the ribs are changed (added or cut) to prevent the dog ear generated at the gap between the roller shaft and the rib.
- 2) SHEET EXIT(No.1) and SHEET EXIT B(No.2) are deleted according to the change.

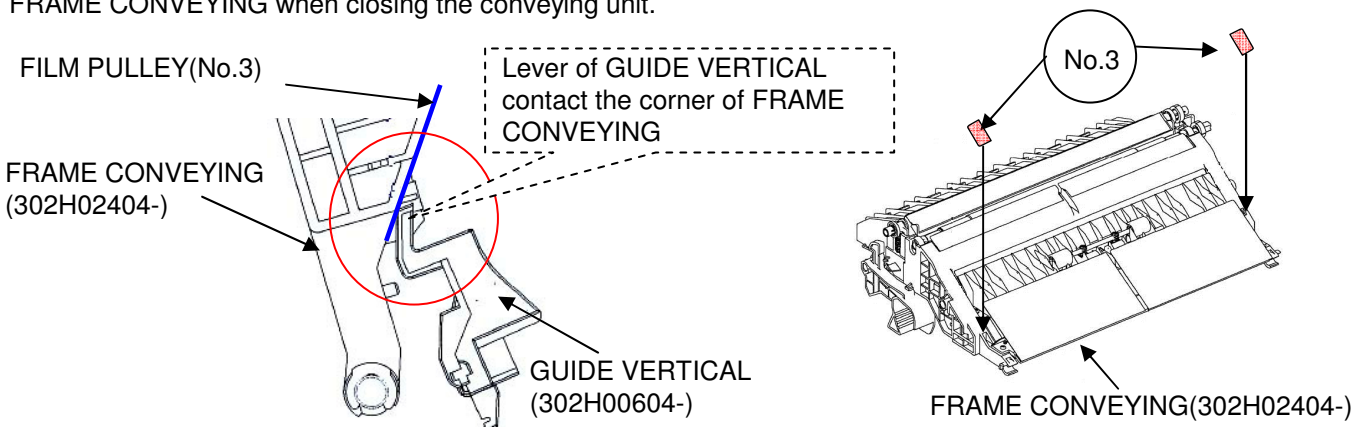
FILM PULLEY(No.3) is added to the point where the lever of GUIDE VERTICAL may contact the corner of FRAME CONVEYING when closing the conveying unit.

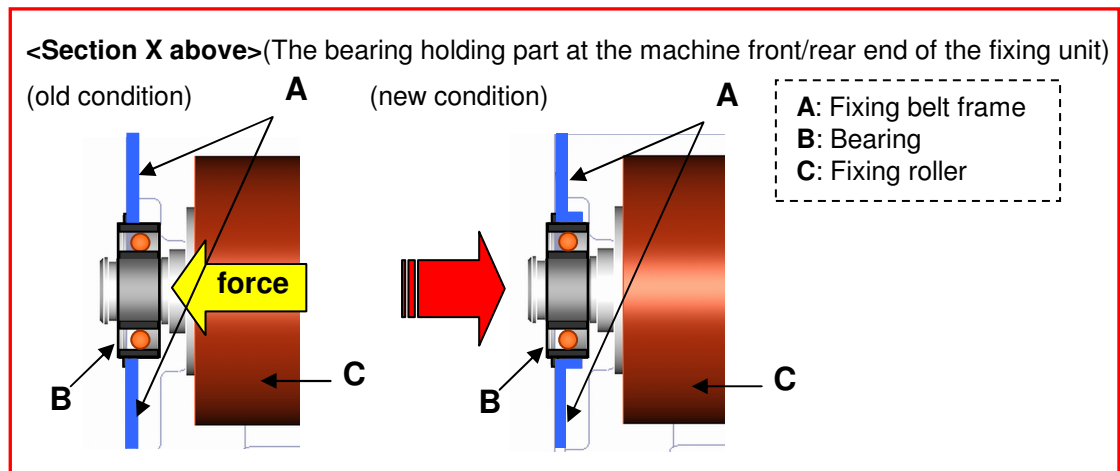
If the drive continues with the leaned bearings, the abnormal noise may be heard from the friction between the fixing roller shaft and the inner part of the bearing, or the bearing may be broken to cause the SC2300 error or jam. Therefore, following are changed.

The grease that is applied to the inner part of the bearing to reduce the friction between the fixing roller shaft and the inner part of the bearing is changed to heat resistant type to avoid deterioration by the fixing heat and (applied since August 2009 production)

Field Measure: Please replace with the fixing unit of the permanent measures in case the above phenomenon arises. (the fixing unit with the serial number listed in the <Permanent measures: change of the fixing belt frame> in the next page*)

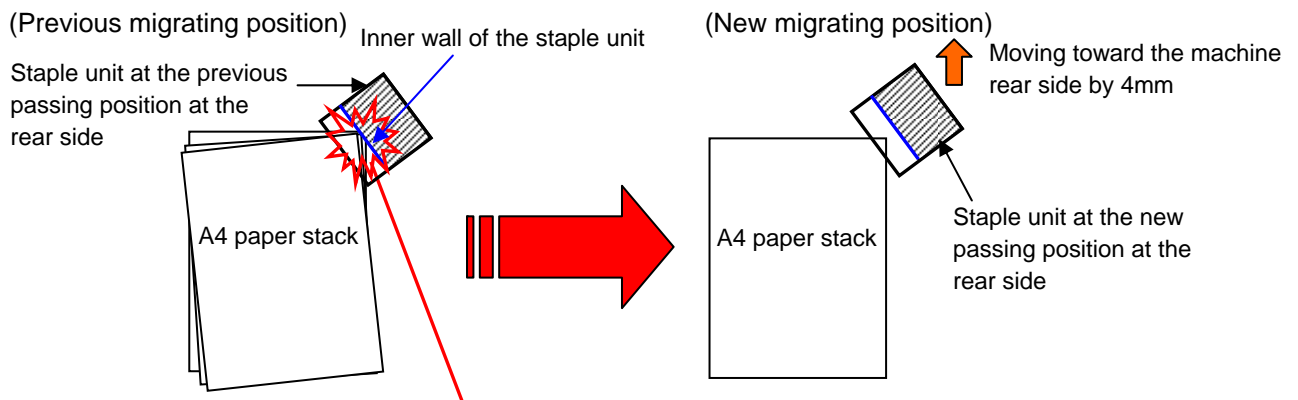
<Simplified figure when stapling the rear side of the A4 paper stack> (Below is view from upper)

The paper stack adjustment failure may occur in case the right corner of the rear edge of the A4 paper stack is hit by the inner wall of the staple unit, and the rear stapling may be executed in that state.

The paper stack adjustment failure does not occur if the center of the paper stack in the cassette is within the reference range. Please correct the center position of the paper stack.

1. Print the test pattern in the U402 and compare it with the center position on the paper .
2. If the center position is shifted toward the rear side of the machine, loosen 3 of the screws A and rotate the adjuster screw B clockwise and move the adjuster plate C toward the rear side of the machine. Then, tighten the 3 of the screws.
3. Adjust the center line for the image forming in the U034.

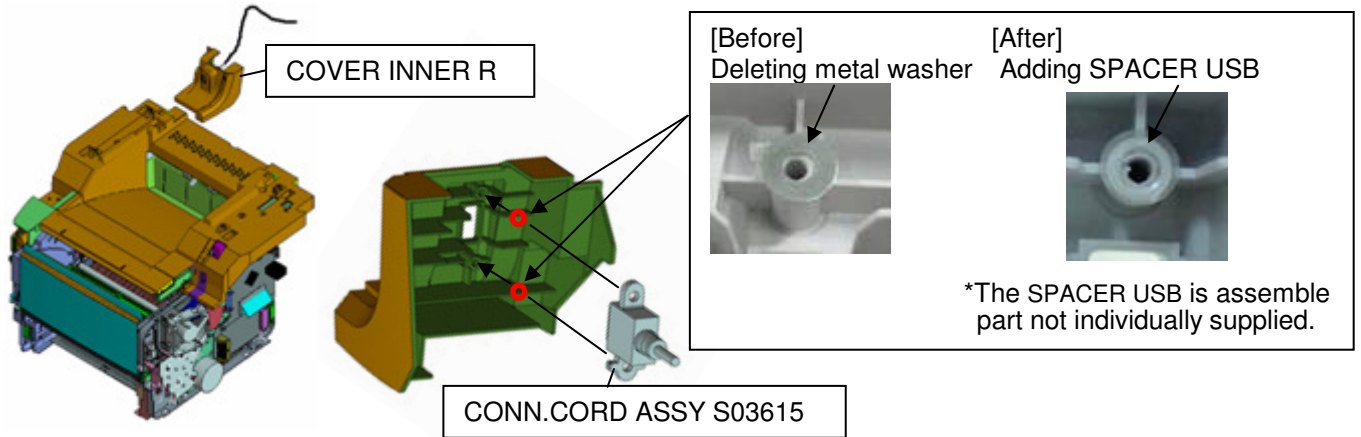
The boss on COVER INNER R may be broken where CONN.CORD ASSY S03615 contact.
For strengthening COVER INNER R, 2 pcs of SPASER USB are added.
According to this change, the part code remains unchanged.

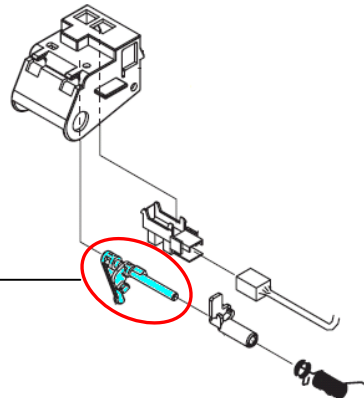
Paper empty may be mis-sensed with motion failure of the actuator that senses paper when paper is installed in the cassette. In order to improve the motional margin of the actuator, the material is changed. According to this, the shape remains unchanged.

Change the material of ACTUATOR EMPTY A
[Before] ABS (P2H-AT)
[After] PC (LV-2225Y)

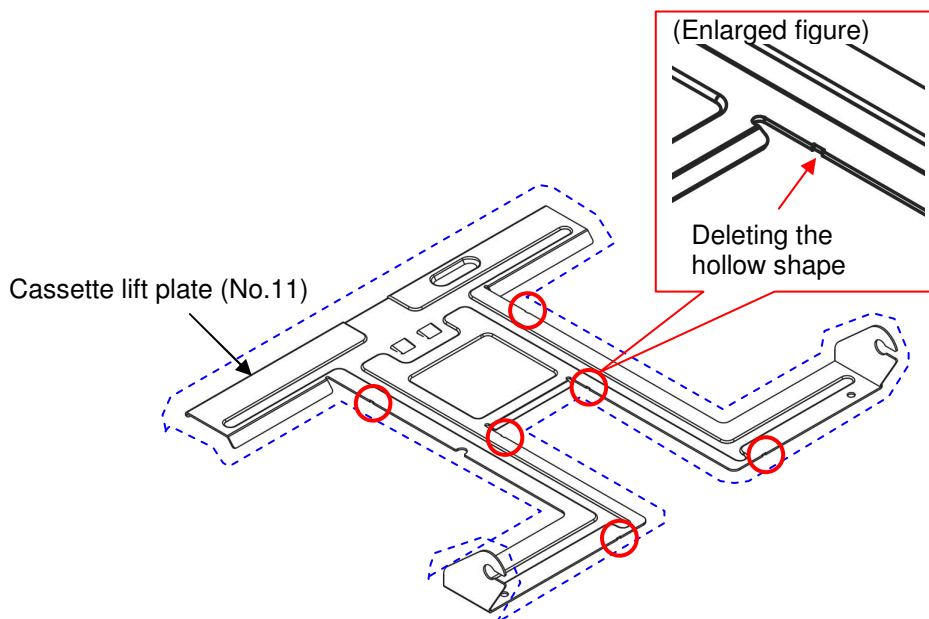
- The outside edge of the cassette lift plate is chamfered.
- Hollow shape at the outside edge is deleted. (Encircled part in red line: Total 6 sections)

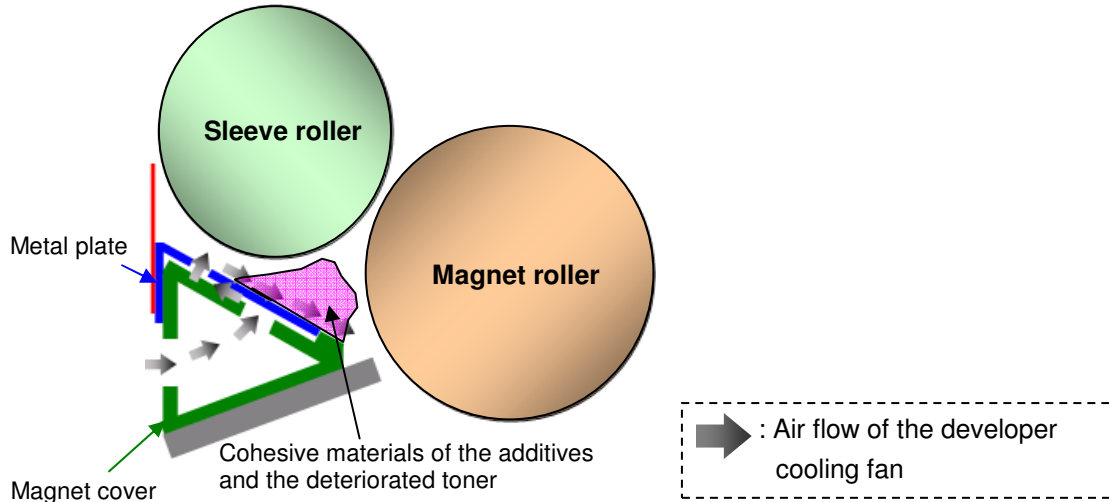
Normally, air flow from the developer cooling fan removes the additives and the deteriorated toner that are accumulated on the magnet cover by passing through the cut-out of the magnet cover. However, the remaining materials may be condensed depending on the operating condition that increases the deteriorated toner and it may interrupt the air flow of the developer cooling fan above the magnet cover. In that case, the deteriorated toner accumulating on the cohesive materials may adhere to the magnet roller or the sleeve roller and the Bk toner smudge may appear.

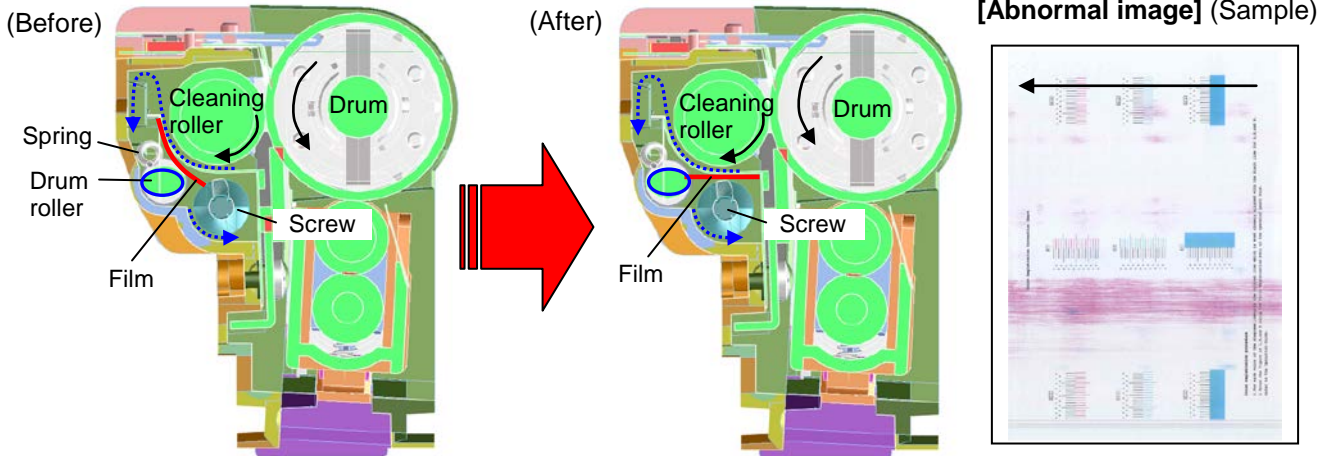
Due to contacting the middle part of the film to the drum roller, the cleaning of the toner adhered on the drum roller is difficult and so the toner accumulates. As the result, the toner conveying ability reduces and the cleaning failure occurs.
