Service Bulletin

Ref. No. **COM-0218 (B056)**

Subject	Note when releasing the paper jam/maintaining the machine (Prohibition of use of the flammable sprays and liquids)
Model	All models

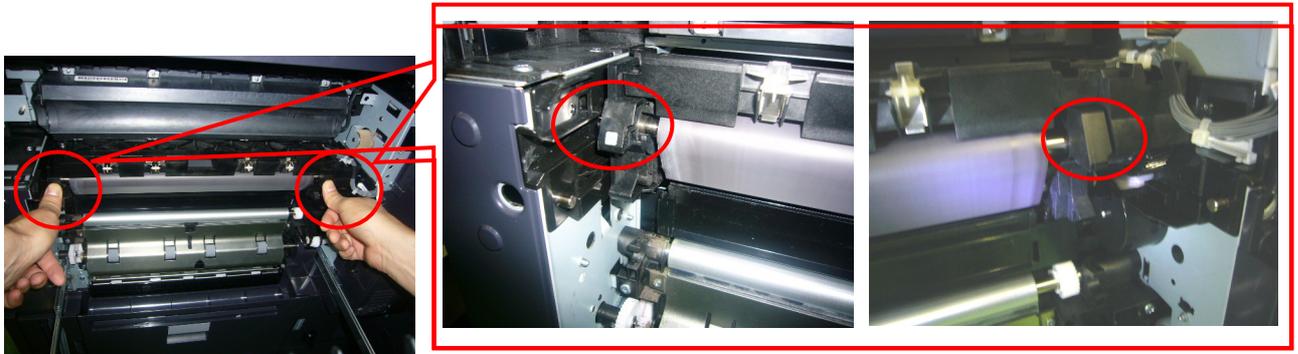
<How to insert the primary transfer belt unit>

If the primary transfer unit is strongly inserted along the rails, it may be installed while the waste toner vent at the cleaning section of the primary transfer unit covers the waste toner collection vent at the main machine side. If the machine is operated in this condition, the primary transfer belt may be distorted and skew that will cause SC2770 (Transfer skew error) after more or less than 50 pages of output.

Do not strongly insert the primary transfer unit from the machine left side, but insert gently until it reaches the above point and once it stops. Then, slowly set it while pushing the points above with fingers.

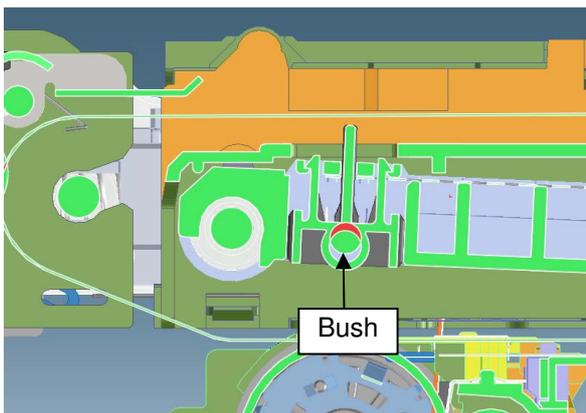
<Bush coming off>

The bush for the primary transfer roller for yellow in the primary transfer unit may come off by excess shake and impact in transit and it may cause the yellow image dropout. This was informed as per the service bulletin No.2LC-0006(B141).

The transfer roller do not contact the drum after the bush comes off by the impact in transit to cause the yellow image dropout

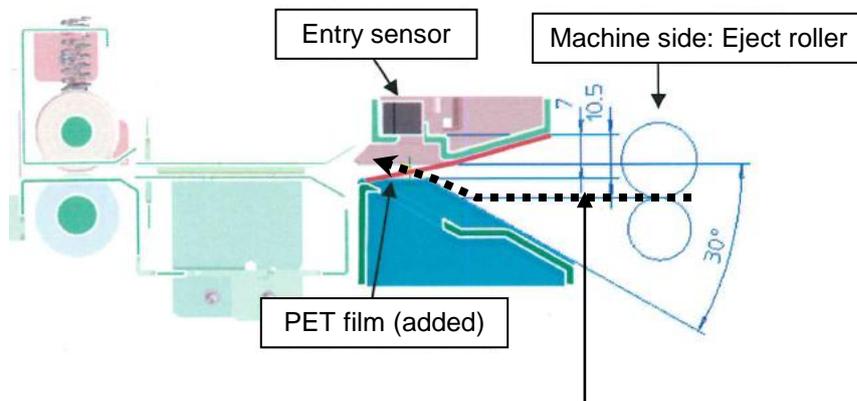
Dotted line: paper conveying path
 The bad condition is the angle of 30 degree with the sensor when entering

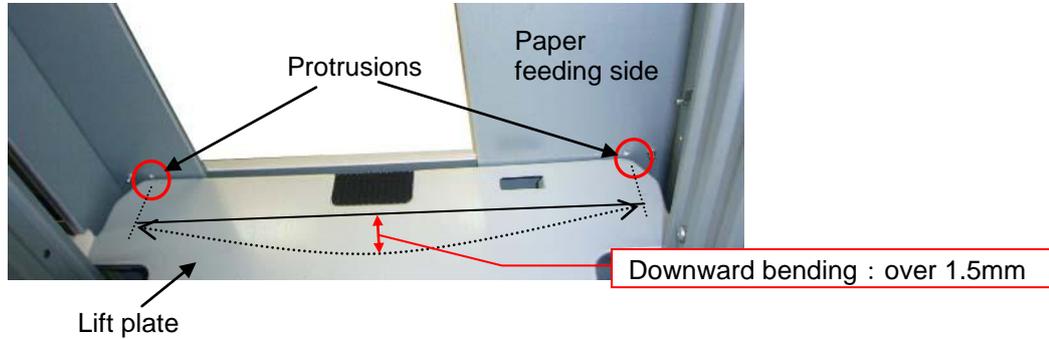
Please replace with the new paper deck unit (No.1 or No.2) if the below position of the lift plate is bent downwards over 1.5mm.

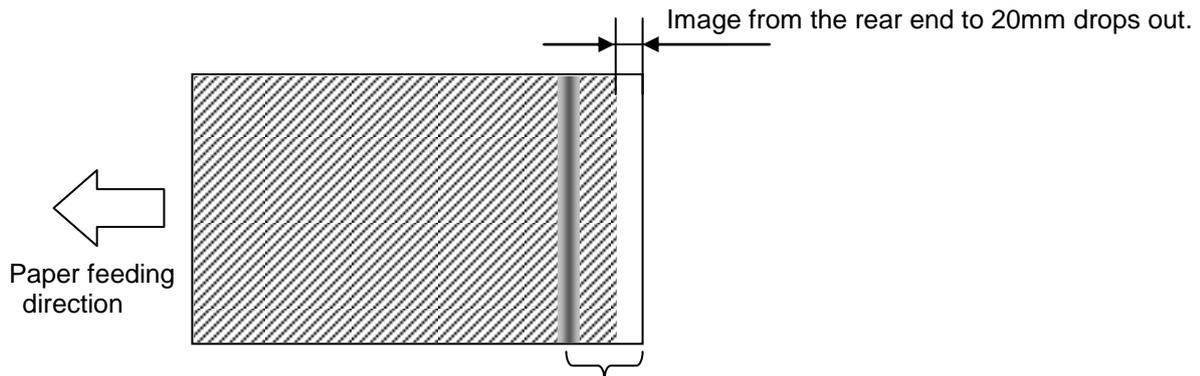
A black band appears on about 60mm positions from the rear end.
