Service Bulletin

Ref. No. **COM-0218 (B056)**

Subject	Note when releasing the paper jam/maintaining the machine (Prohibition of use of the flammable sprays and liquids)
Model	All models

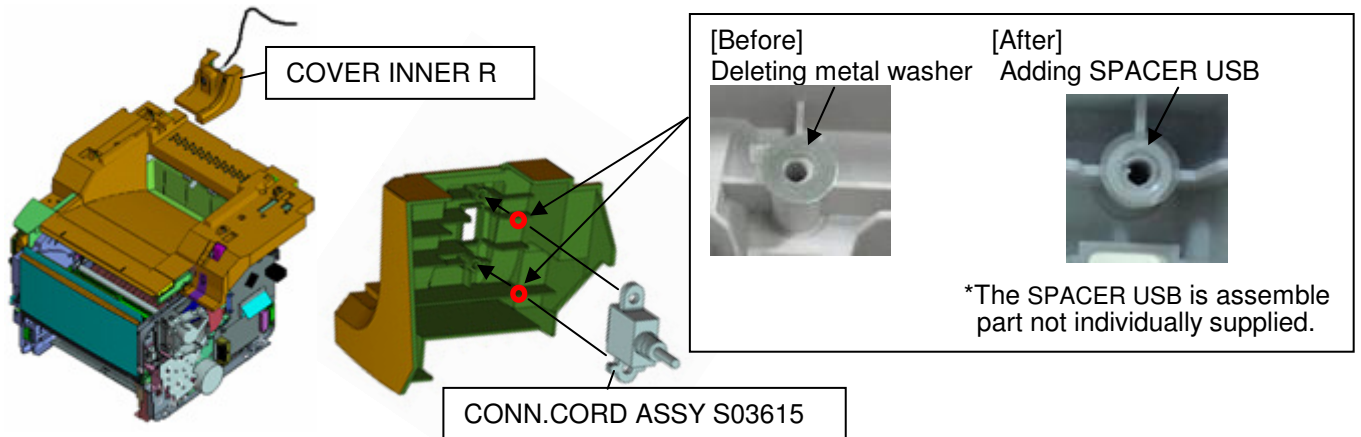
The boss on COVER INNER R may be broken where CONN.CORD ASSY S03615 contact.
For strengthening COVER INNER R, 2 pcs of SPASER USB are added.
According to this change, the part code remains unchanged.

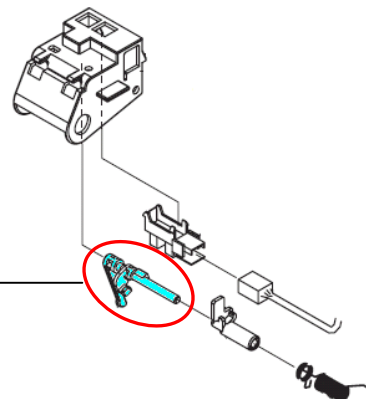
Paper empty may be mis-sensed with motion failure of the actuator that senses paper when paper is installed in the cassette. In order to improve the motional margin of the actuator, the material is changed. According to this, the shape remains unchanged.

Change the material of ACTUATOR EMPTY A
[Before] ABS (P2H-AT)
[After] PC (LV-2225Y)

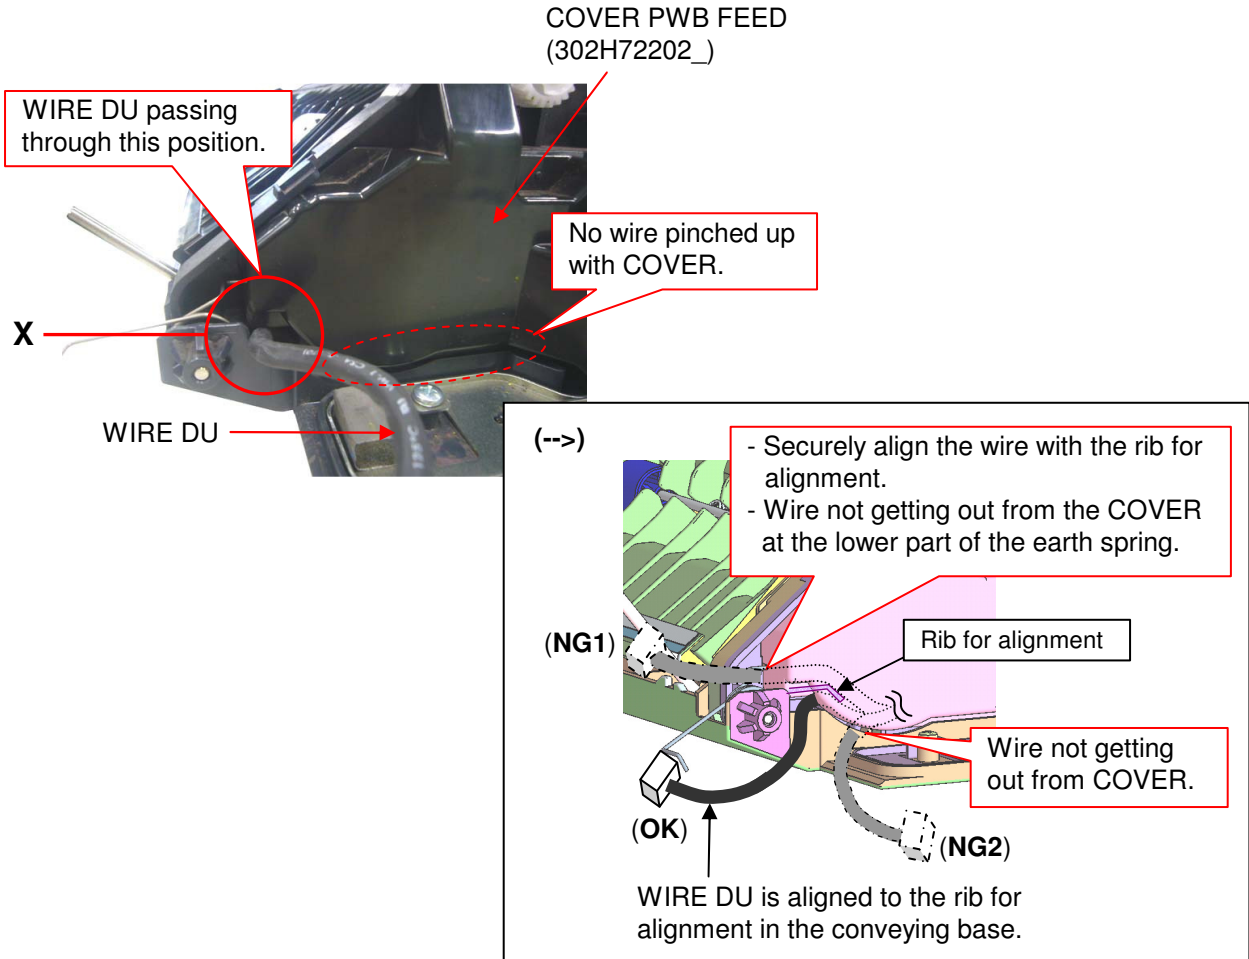
3) (-->) When reassembling the conveying unit, check if WIRE DU is passed through the position marked **X** in the figure below when refitting COVER PWB FEED to the machine rear side of the conveying unit.

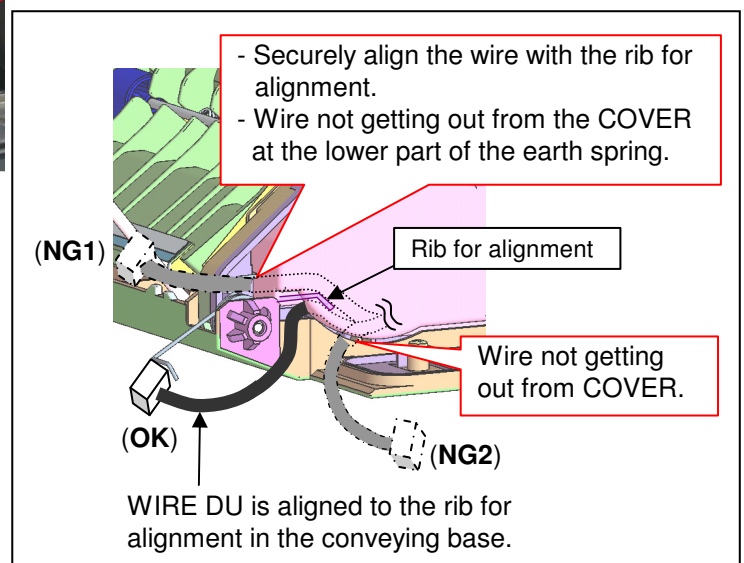
(*) When the short circuit occurs by damaging the wire coating of WIRE DU due to the wire alignment mistake, the excessive current may be impressed from the engine PWB and it may become the cause of the operation failure as the result.

When reassembling the conveying unit, check if WIRE DU passes through the position marked X in the figure below when refitting COVER PWB FEED to the machine rear side of the conveying unit.

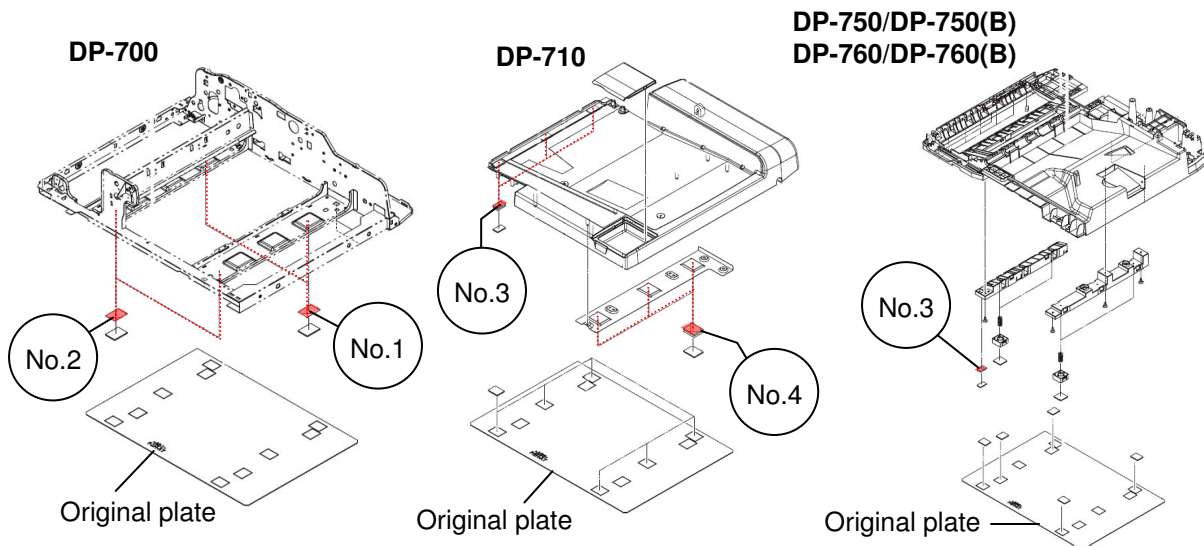
Sponge used to the original plate may deteriorate by hydrolysis. As the result, the sponge may peel off, or the original plate may come off because the sponge cannot keep the original plate. Therefore, the material of the sponge is changed as below.

Material: (Before) SM-55 (Esters) --> (After) F-2G (Ethers)

* Please replace all q'ty to use of No.1-4 with the new one when replacing the parts.

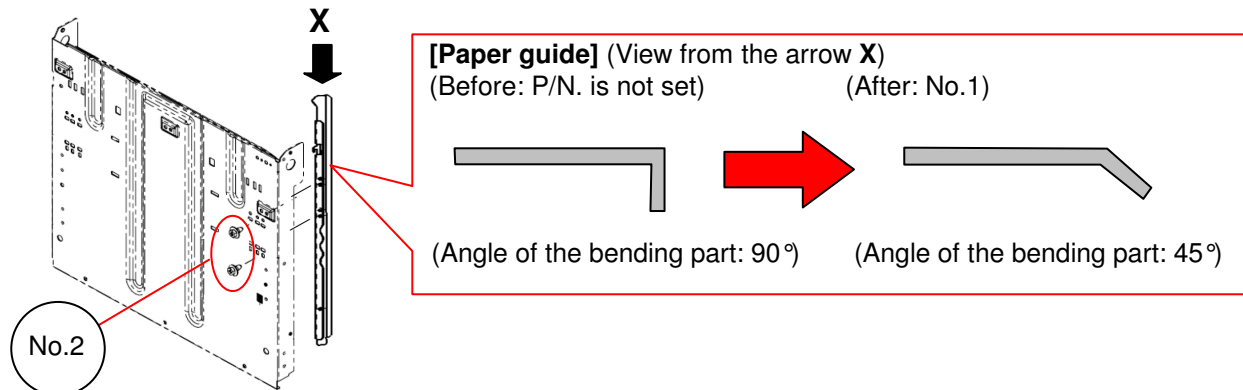
Angle of the bending part of the paper guide (No.1) in left front side of the tray is changed from 90° to 45° for improving paper guide for supplying paper to the large capacity paper deck (PF-800). Accordingly, the new paper guide (No.1) and the screw (No.2) for fixing the new paper guide are supplied.

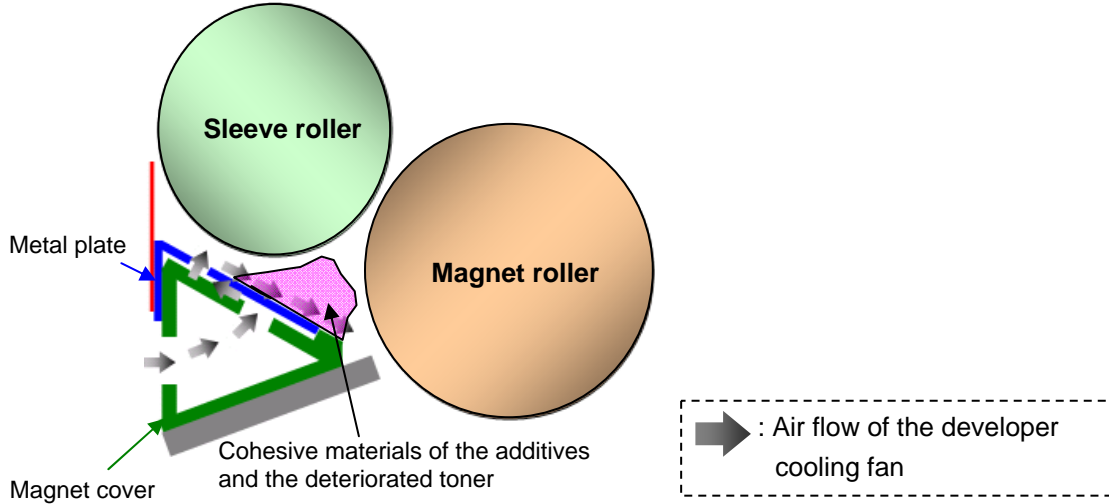
<Normal Bk developer unit> (Below is the cross section figure of the magnet roller/sleeve roller section that is viewed from the machine front side)

Depending on the operating environment (*), the cohesive materials of the deteriorated toner and the additives peeled off from the toner may accumulate on the topside of the Bk developer magnet cover and it may interrupt air flow of the developer cooling fan. If the deteriorated toner accumulates on the cohesive materials and adheres to the magnet/sleeve roller, Bk toner smudge may appear. Therefore, following are changed.

Normally, air flow from the developer cooling fan removes the additives and the deteriorated toner that are accumulated on the magnet cover by passing through the cut-out of the magnet cover. However, the remaining materials may be condensed depending on the operating condition that increases the deteriorated toner and it may interrupt the air flow of the developer cooling fan above the magnet cover. In that case, the deteriorated toner accumulating on the cohesive materials may adhere to the magnet roller or the sleeve roller and the Bk toner smudge may appear.

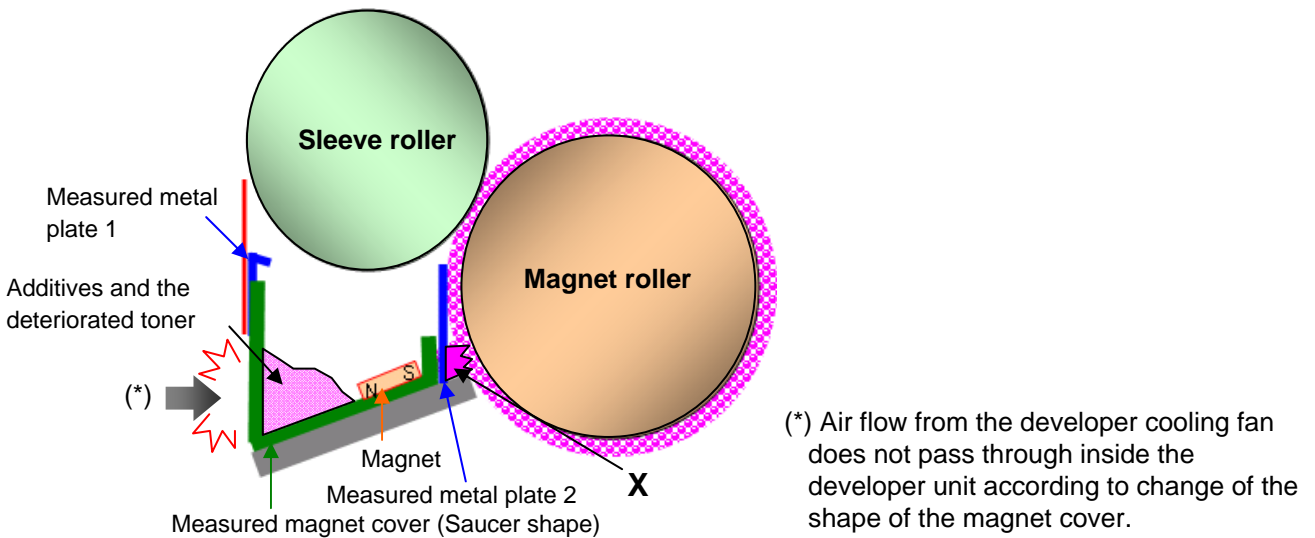
<Bk developer unit for preventing the toner smudge>

<Changed point 1>
 Measured magnet cover/measured metal plate 1:
 Changing to the saucer shape to collect the deteriorated toner and the additives in the position where is not close to the magnet roller so that the service person periodically cleans it.
