How to adjust the ADF Top Cover assembly to stop the gear grinding noise on the MB760/770 – MC770/780 – MPS 5502 – MPS3537 – MPS4242

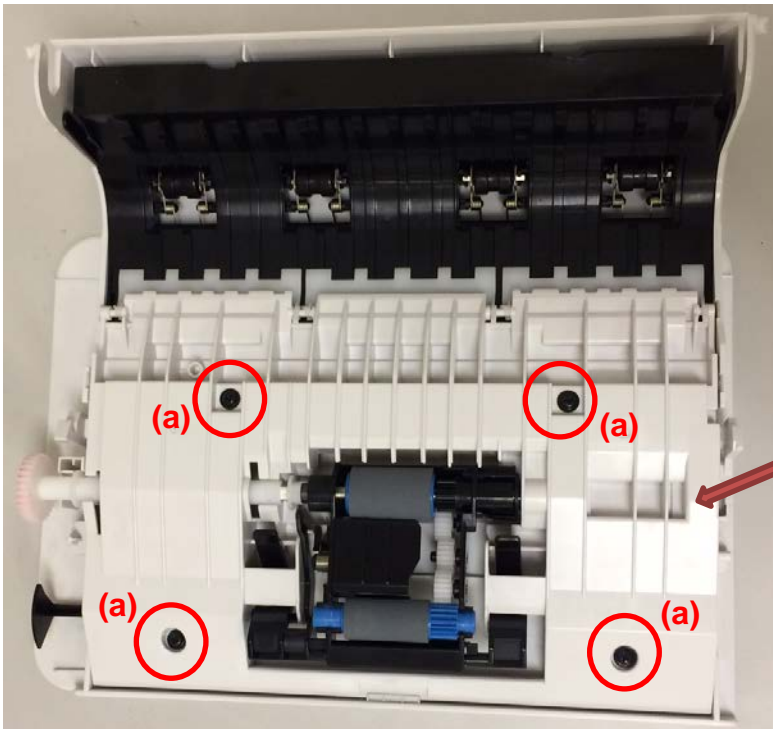
Top Guide Assembly

11. Loosen the 4 mounting screws (a) of the "Top Guide Assy."

Once all four screws are loose there should now be play on "Top Guide Assembly."

Note: If the gear noise does not stop after the above procedure has been made, please replace the "ADF Top Cover Assembly" (P/N 45059201) with a new one.
