Process improvement for UCOS feeder.

Important Technical Information

<u>UCOS Feeder</u>	Specifications	
	Firmware	
	General Recommendations	
	Resources	
<u>Technical Issues</u>	<u>Wedge Lever Damage</u>	
	<u>Feed Belts Damage</u>	
	<u>Discharge Belt Damage</u>	
	<u>Paper Guides Mechanical Alignment</u>	
	<u>Paper Guides Damage</u>	
	<u>Prepared lever is Loosen</u>	
	<u>Black Envelope Detection</u>	
<u>Troubleshooting</u>	<u>Envelope Jamming, misfeeding</u>	
	<u>Print position offset</u>	
	<u>Spring Pinch Damage</u>	
	<u>Prepared Lever</u>	
	<u>Not Feeding Envelopes</u>	
	<u>Power</u>	
	<u>Magnetic Catch</u>	
<u>RSPL</u>	<u>Recently added</u>	
	<u>Lock-Parts, Rollers-Catches-Bracket</u>	
	<u>Fuser-Drive Assy, p/n: 45192101</u>	
	<u>RSPL</u>	
<u>Troubleshooting</u>	<u>Envelope Jamming, misfeeding</u>	
	<u>Spring Pinch Damage</u>

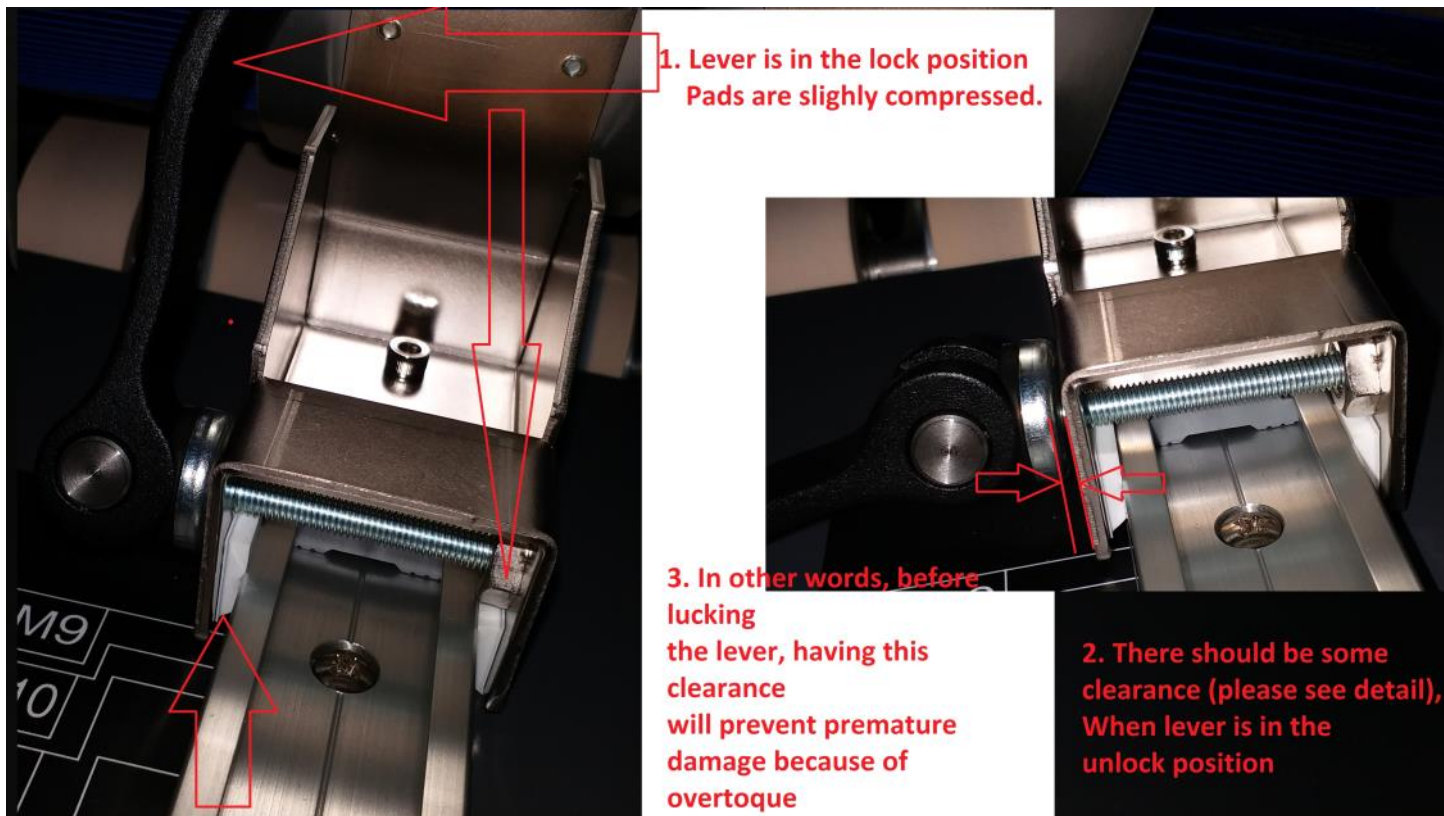
Wedge Lever Damage

Lever torque and Clamping force can be adjusted depending on the distance from the lever metal spacer to the bracket (C-shaped section). If lever is screwed too far in, then the clamping force may become excessive.

-There is no mechanical stopper or limit on the distance with respect to its mounting bracket. If lever is screwed too far in (no gap), an excessive force has to be applied in order to lock it, but this compresses the pads, eventually the white rubber pads may break apart.

There is potential of permanent damage to Wedge Lever mechanism if lever distance is not properly set.

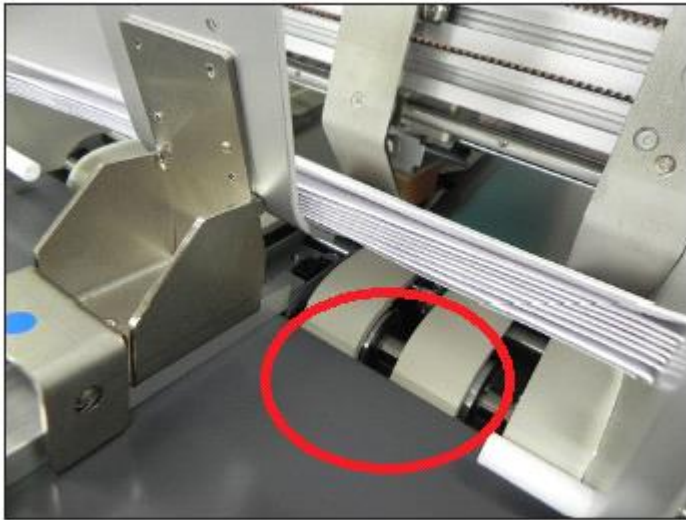
Feed Belts Damage

When feeder is not attached to printer, the platen is pulled to the highest point by the spring mechanism. This causes the feed belts to get in contact with the edge of the plate. The edge of the plate rubs on the feed belts when envelopes are fed as per the setup procedure. This wears down the belts surface prematurely. The production feeder comes with different belts, but there is potential of premature damage too.

In order to test feeder functionality, never operate feeder with feeding table at its highest position. Also, setup Procedure described in the handbook applies to the old style feeder.

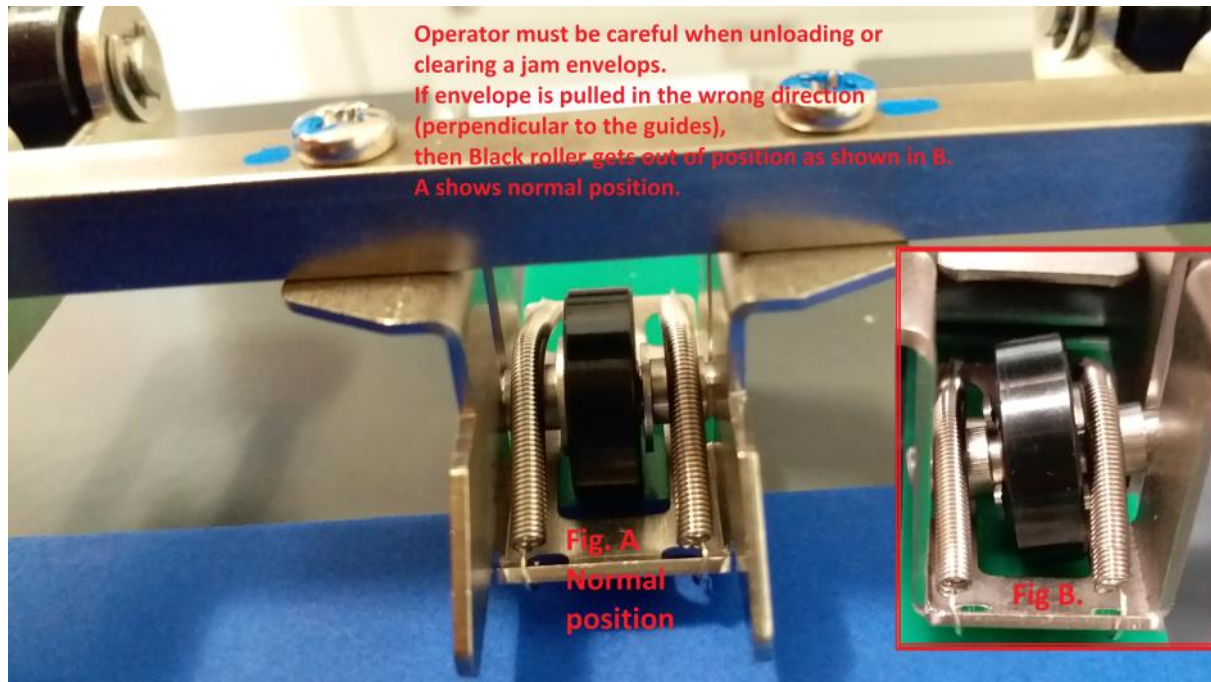
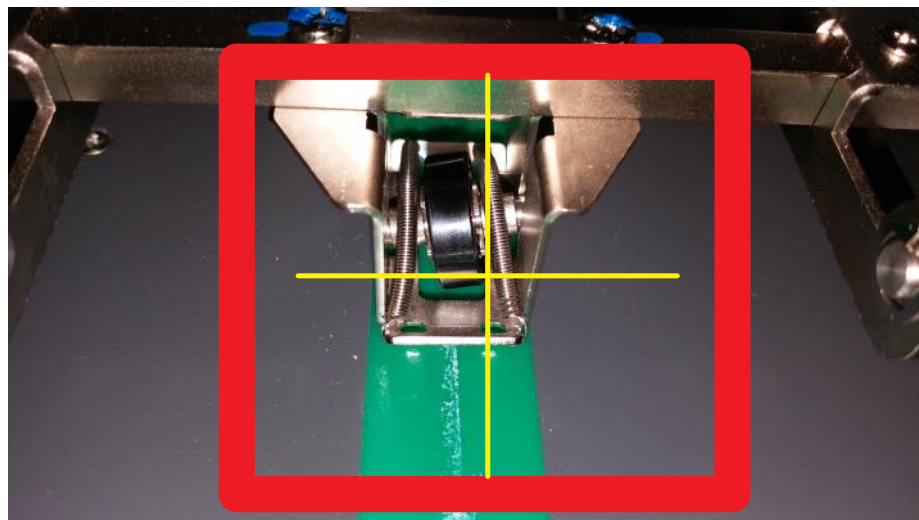
Discharge Belt Damage

- Roller get out of position when envelopes are not removed in the feeding direction. This roller then stops rotating freely and starts rubbing on the discharge belt (green belt on the platen).

After pinch roller is dislodged, roller will not roll flat on the discharge belt. Permanente damage to both pinch roller and discharge belt will happen if feeder is run under this condition. Correct pinch roller to its normal position immediately.

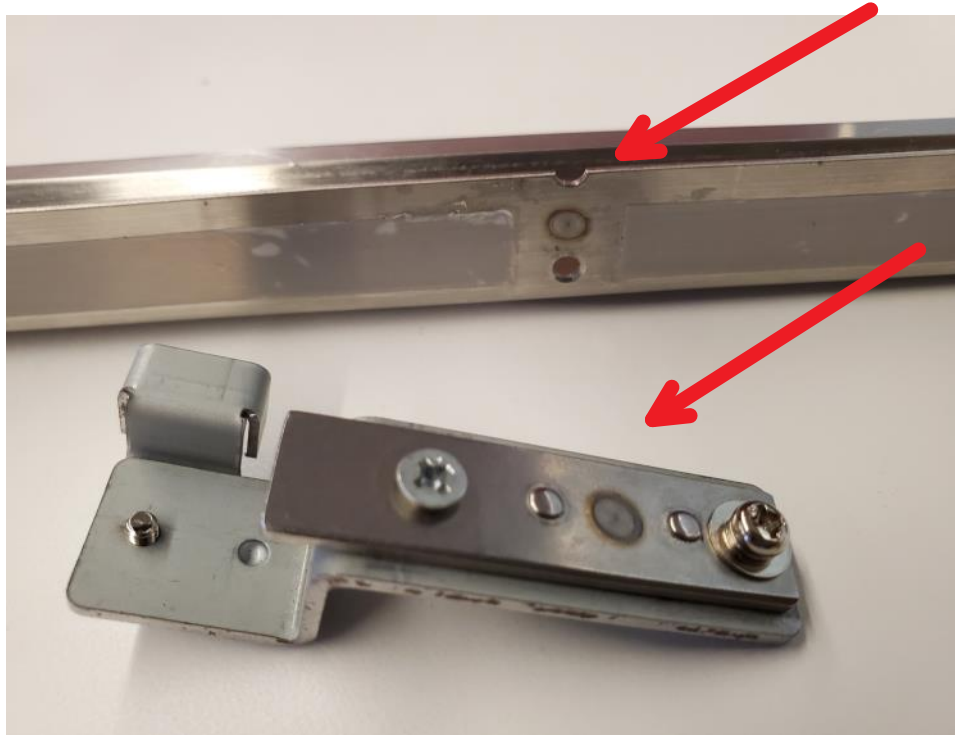
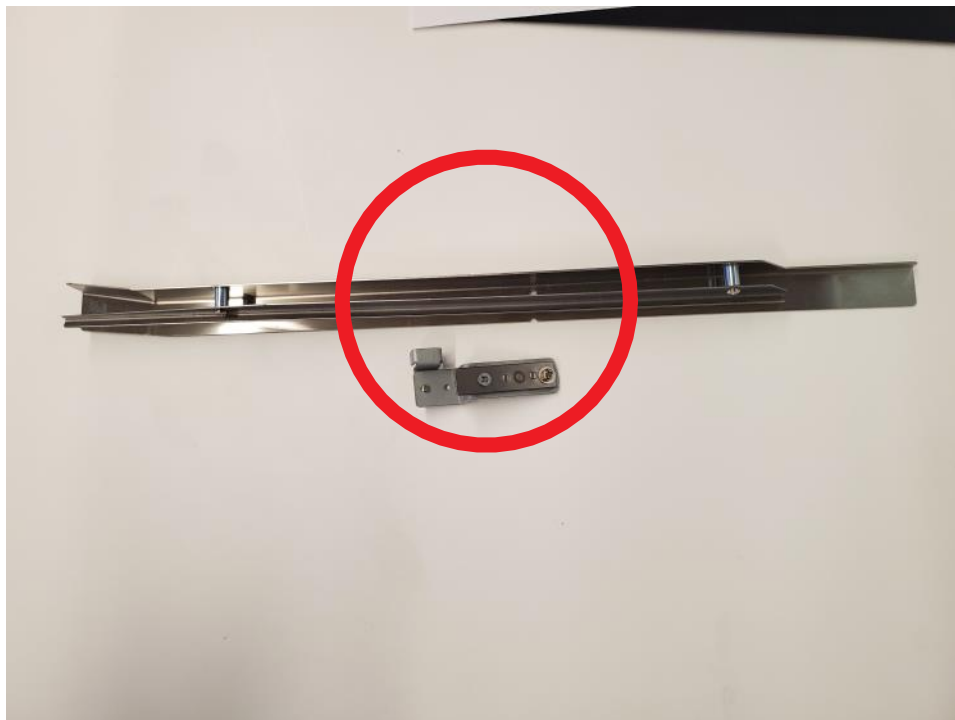
Paper Guides Damage

Risk of permanent damage if guide are not handled from the middle, near the slider.

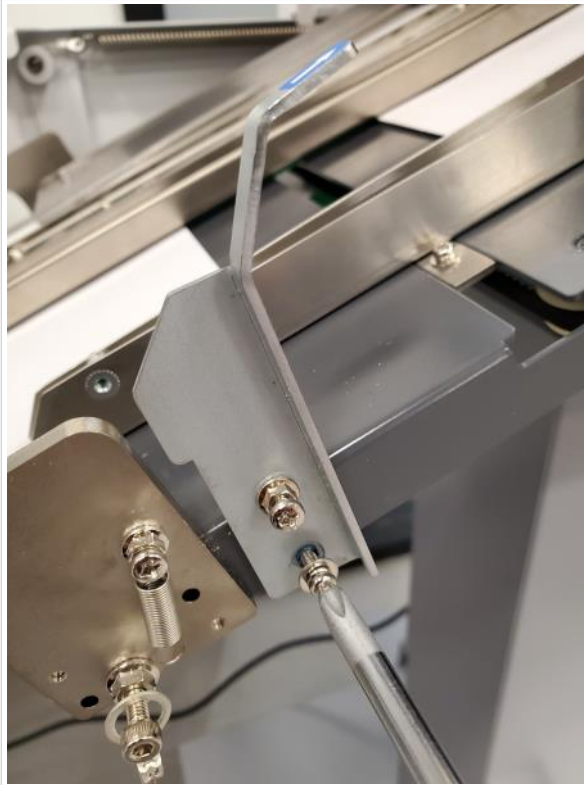
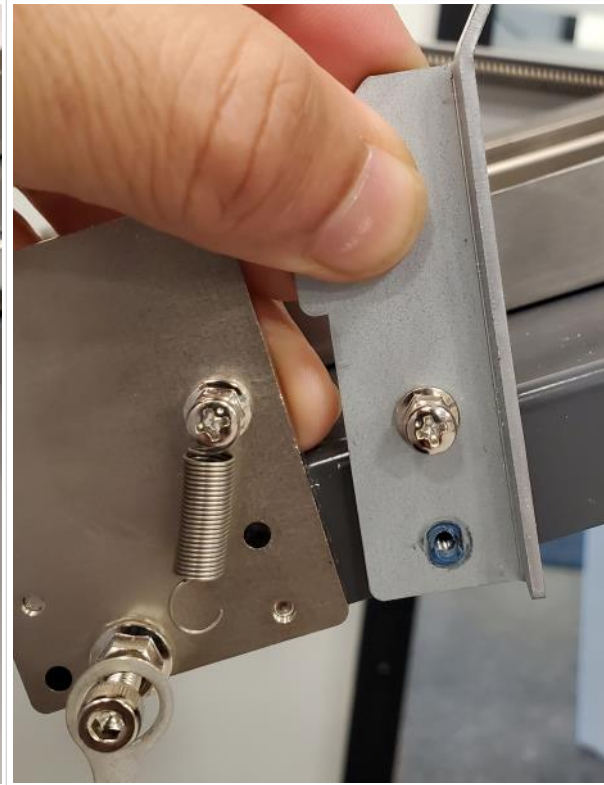
Ready Lever and pivot screw

Problem:
Incorrect operation of Prepared lever

Symptom: Prepared lever becomes loosen. Pivot screw loosens

Solution:
Apply Loctite Thread locker 242 or 243 (Item Number 24205, 0.5 ml Capsule, blue) on the screw's threads and retighten

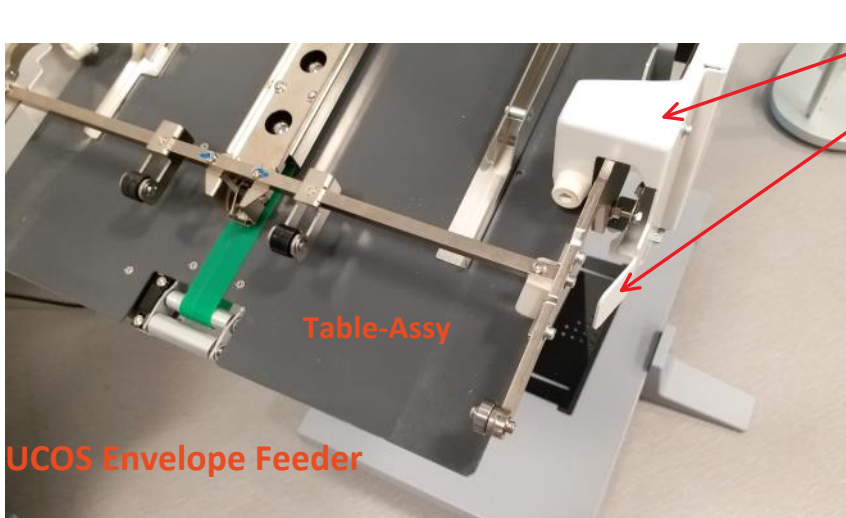
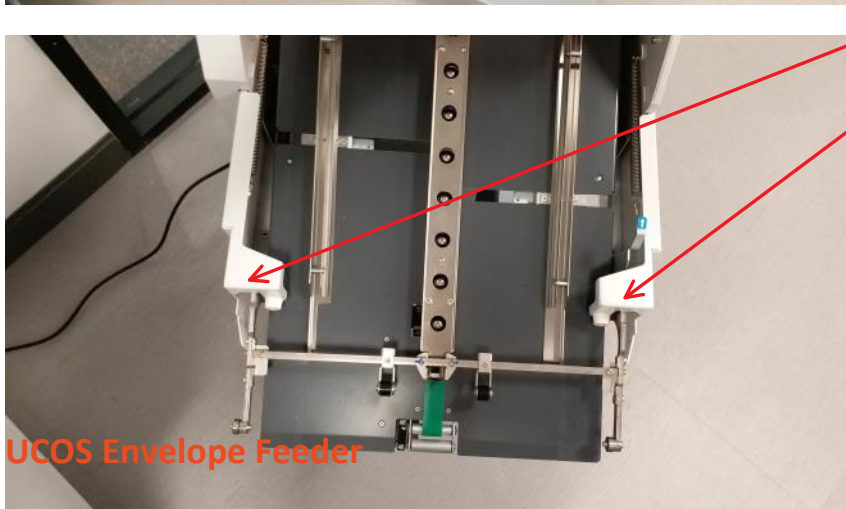
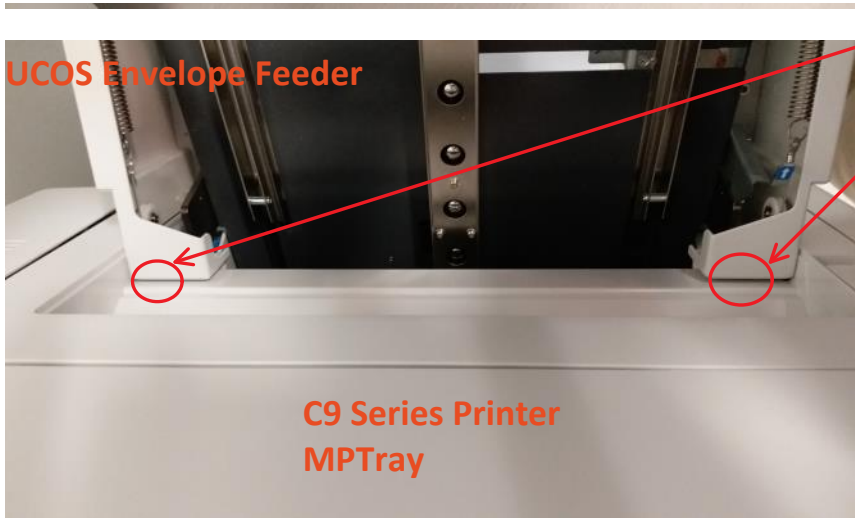
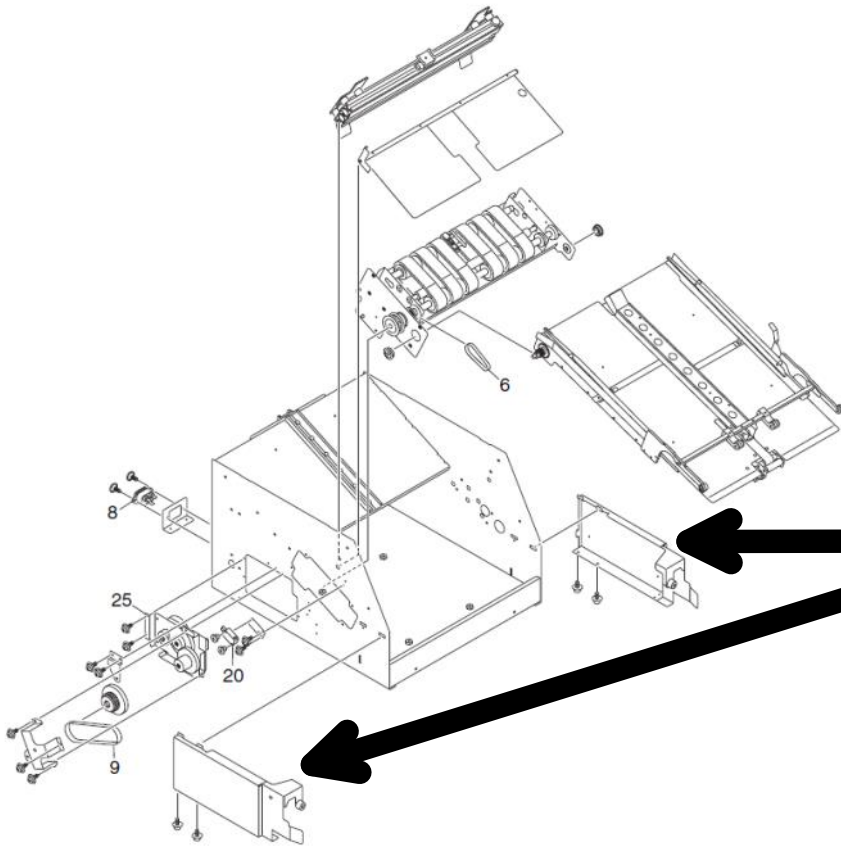
a) Because user abuse, the Arm-R and Arm-F Assemblies get slightly bent and out of alignment because users handle feeder by grabbing and pulling from them. Eventually this affects the positioning and location of the feeder with respect to the MPTray. This issue is experienced in lesser degree with recent feeders, because the plates were modified.

<=1/16" Clearance Max.

Note: The Arms (R and F arms). There is no alignment or adjustment, but make sure the position of the arms keeps the edge of the envelope feeder table horizontal to the MPTray (and the feeding path is straight) when hooked to printer.

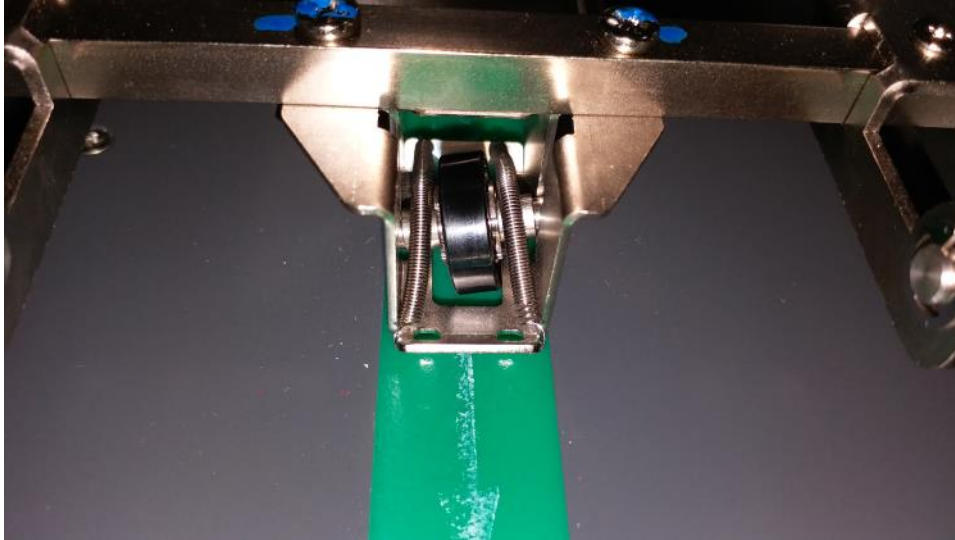
46564342 Spring-Pinch
(Somehow, the part name on the RSPL is "Feeder Spare Parts Purchase Spec".)

Roller is dislodged when envelopes are not pulled in the feeding direction when unloading or clearing a paper jam condition.

Unload or remove envelopes pulling in the feeding direction. Avoid pulling envelopes upwards or across the feeding direction.

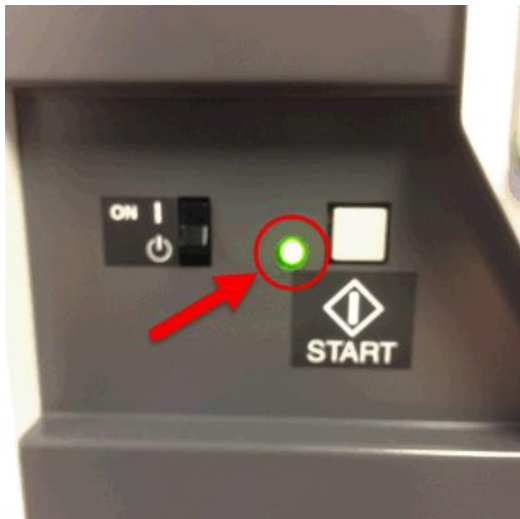
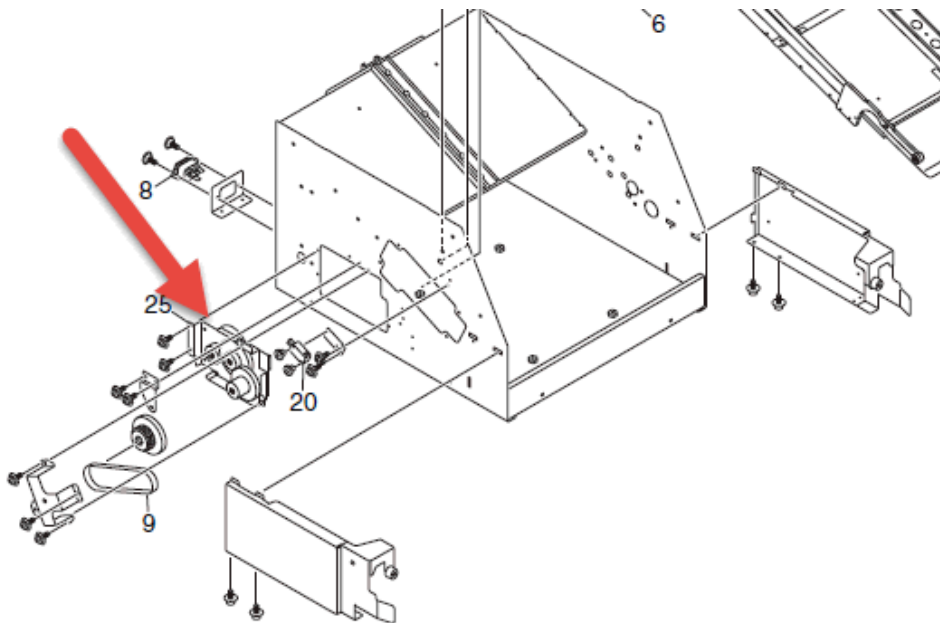
Fuser-Drive-Assy.

If there is no feeding belt movement after pressing START button and LED green light flashes rapidly, then the Fuser-Drive Assy is bad.

Replace the Fuser-Drive Assy (p/n: 45192101) OKIDOC 92928

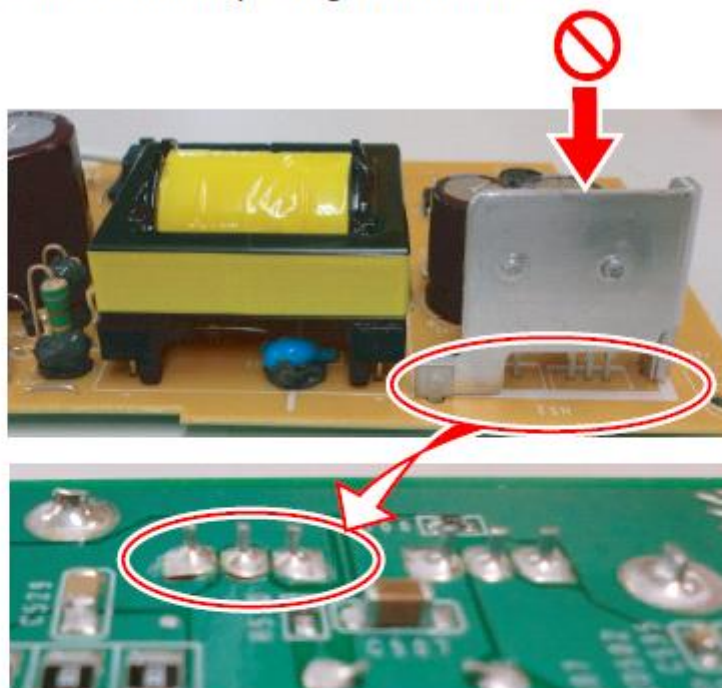
3. Pushing parts causes terminal peeling on the back side.

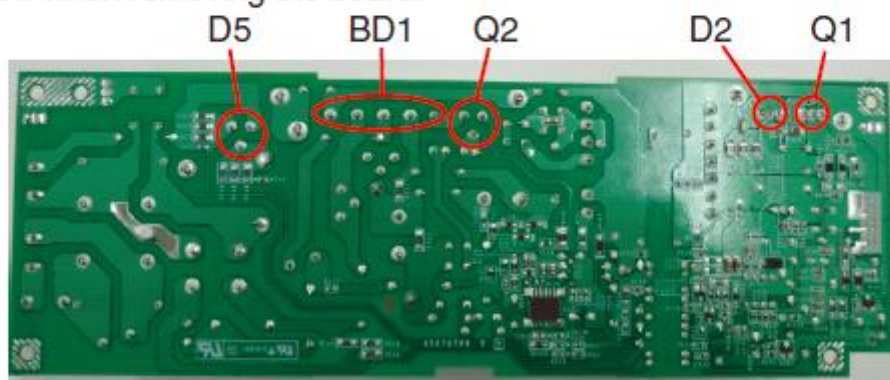
4. Especially check whether the following D5, BD1, Q2, D2 and Q1 terminals are peeling off when removing the board.

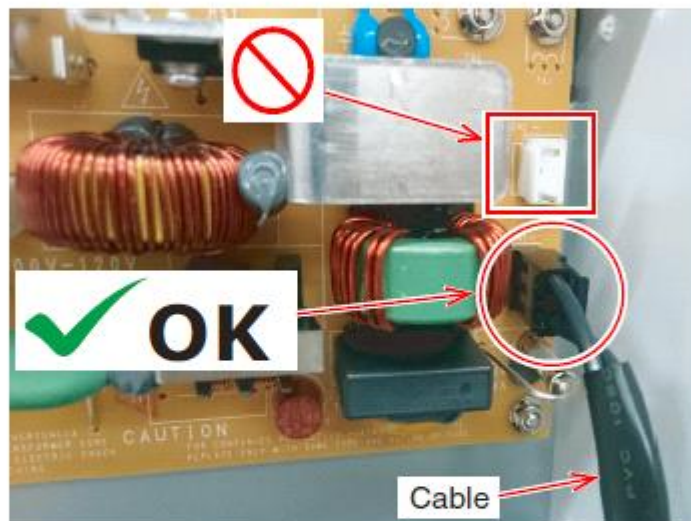
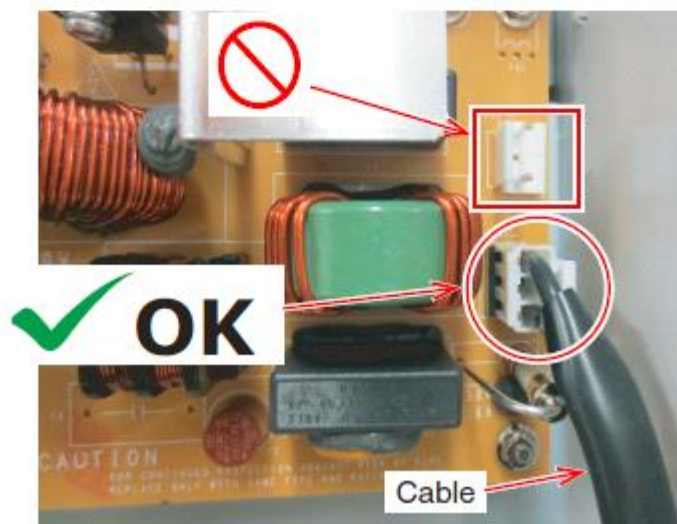
For the production before Oct. / 2016, the colors are mismatched between a cable connector and a socket on OR-Board-30L ④ .

Cable color: white

Socket color: black

So, be careful for to do not connecting to the other wrong connector.
