Troubleshooting Guide

imageRUNNER ADVANCE

C5560 III Series

New Arrival Information

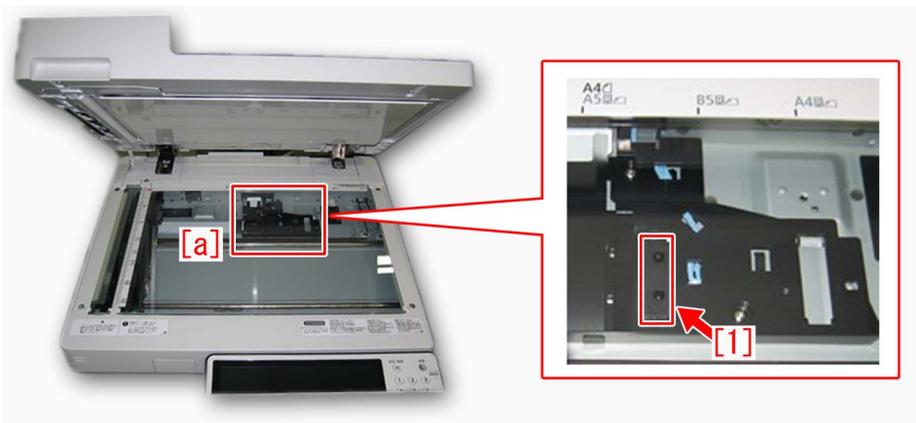
When placing a document on the copyboard for copy, the document size may be detected incorrectly, as a larger size than the original.

The document size is detected by the document size photo sensor (FK4-4384) [1], which is located on the reader assembly. When reading, if the copyboard glass above the document size photo sensor [a] is dirty, the document size photo sensor may detect this dirt as a document, resulting in the above mentioned symptom.

1) Refer to the service manual to remove the copyboard glass [1], and wipe off any dirt on both side of the platen glass, using the equipped cleaning cloth (FE3-4473) [2]. Check and confirm that [a] part of the copyboard glass is clean.

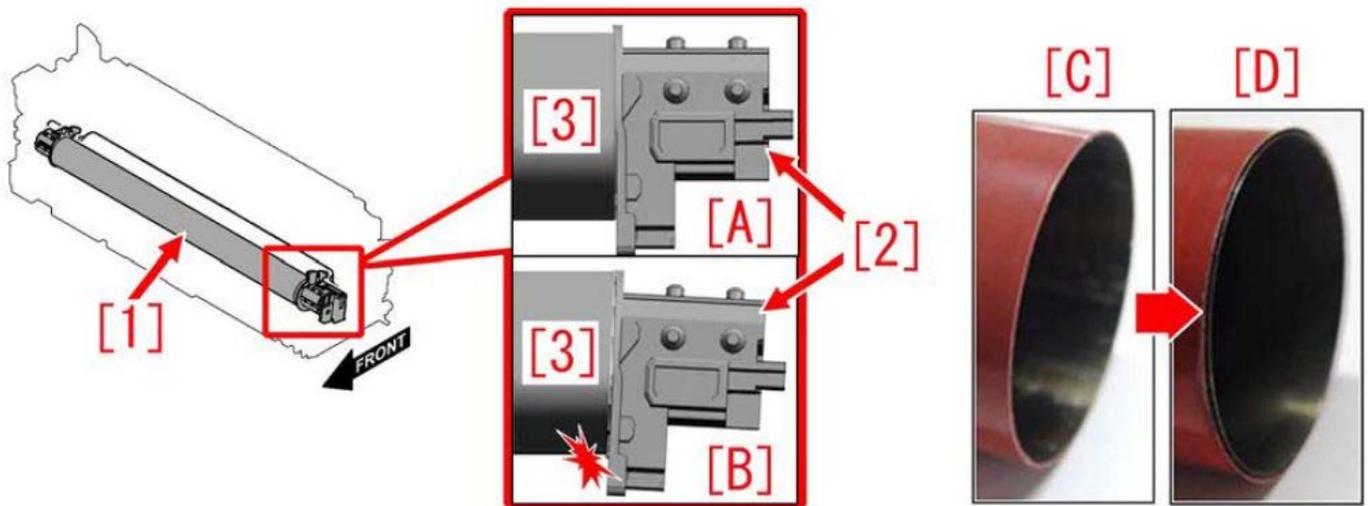
On the film assembly [1], the flange [2] may become slanted [B] if it is pressurized. This pressurization makes the fixing film slanted, causing the flange and the fixing film [3] to become chipped [D]. This results in a noise being produced.

[A] shows the correct position of the flange [2].
[B] shows the incorrect position of the flange [2].

If this noise continues, prepare a new Film Assembly (FM1-N253-010) to prevent downtime and/or customer dissatisfaction.

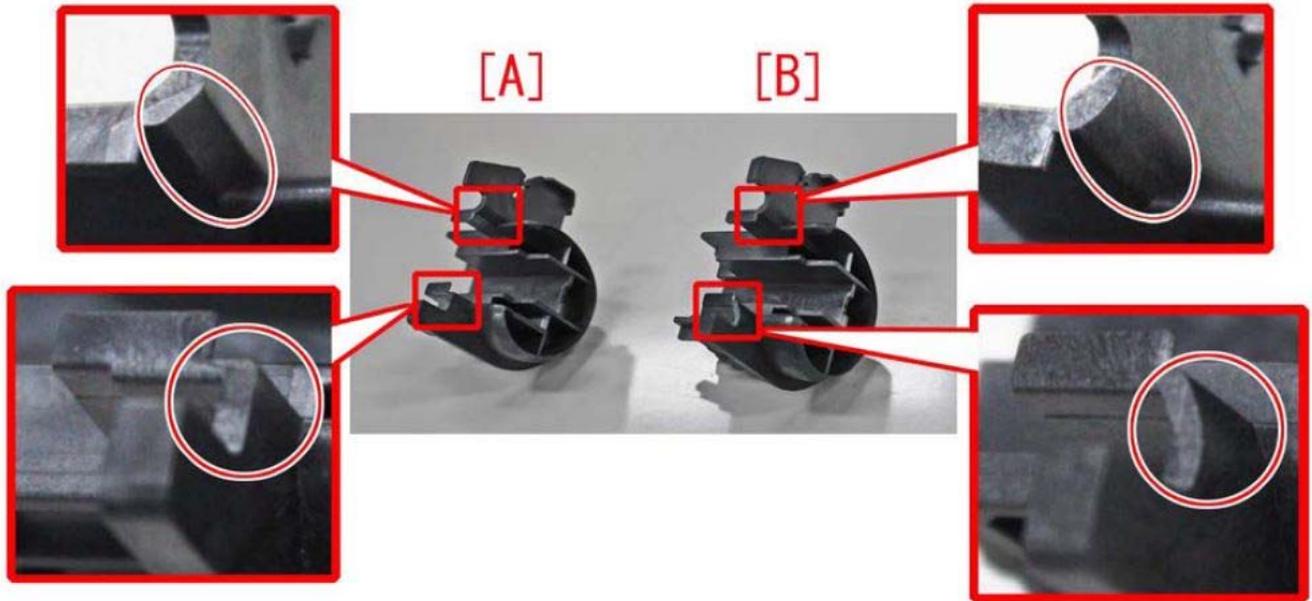
The new type Film Assembly (FM1-N253-010) flange shape has been changed to reduce the chance of chipping.

[A] shows the old type flange.
[B] shows the new type flange.

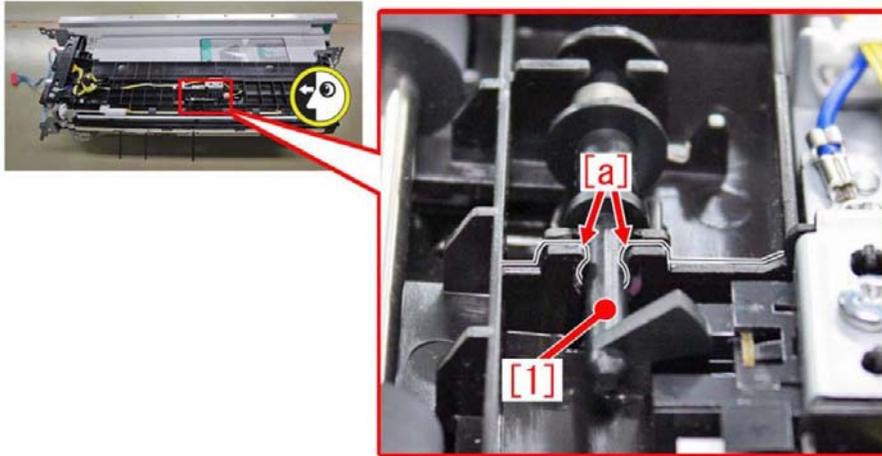
When the overlap amount of the shaft of the reverse sensor flag and the retaining claw [a] of the 2nd / 3rd Paper Delivery up stay is small, the force to retain the reverse sensor flag [1] decreases.

This causes the reverse sensor flag to dislodge when clearing jams in the reversing area.

The result is 010A/020A jam codes.

When this symptom occurs, prepare the Flag Limit Sheet (FL4-2314-000) to be attached to the 2nd / 3rd Paper Delivery Assembly using the instructions in the **SERVICING PROCEDURE** section.

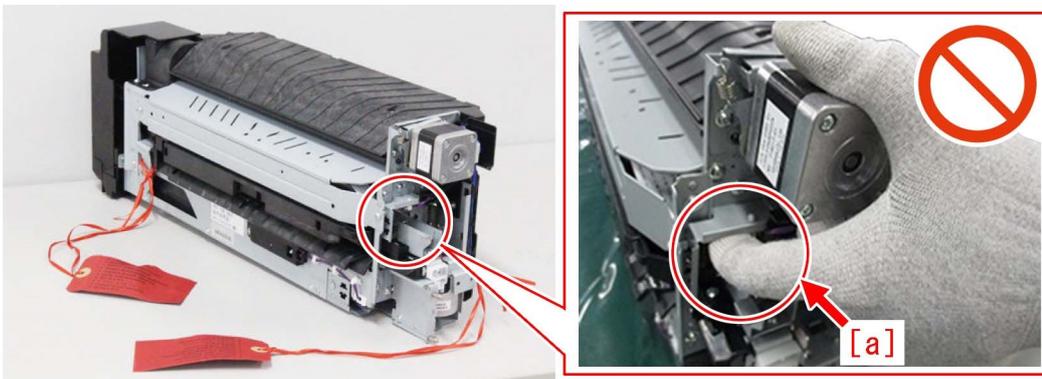
E593-0001/E593-0002 error may occur after installing Inner Puncher-B1/C1.

The above symptom occurs if the rear sensor [a] is touched by a finger when lifting Inner Puncher-B1/C1 and the connector of the sensor is unplugged.

To prevent the above, hold Inner Puncher-B1/C1 without touching the sensor [a] with a finger.

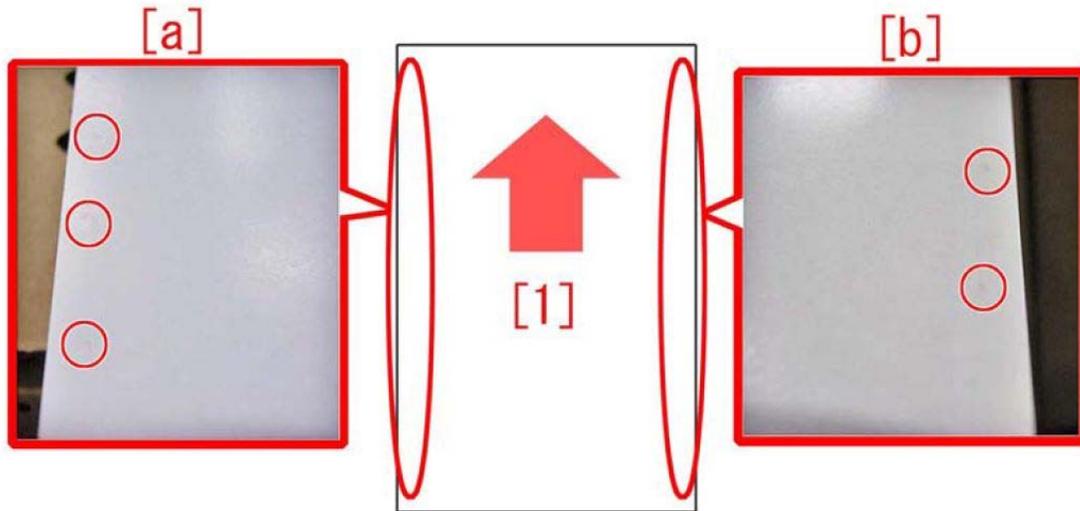
When printing on paper wider than 305mm (12 inches), streaks may occur on the front [a] and rear [b] margins of the paper. For reference, the arrow [1] is the paper feed direction.

This issue is caused by a buildup of developer material on the outer edges of the developer roller. This buildup is what creates the streaks on the front and rear margins of paper wider than 305mm (12 inches).

To prevent this issue from happening, order the newly setup Side End Seal (FL4-1311-000) and follow the procedure in the **SERVICING PROCEDURE** section.

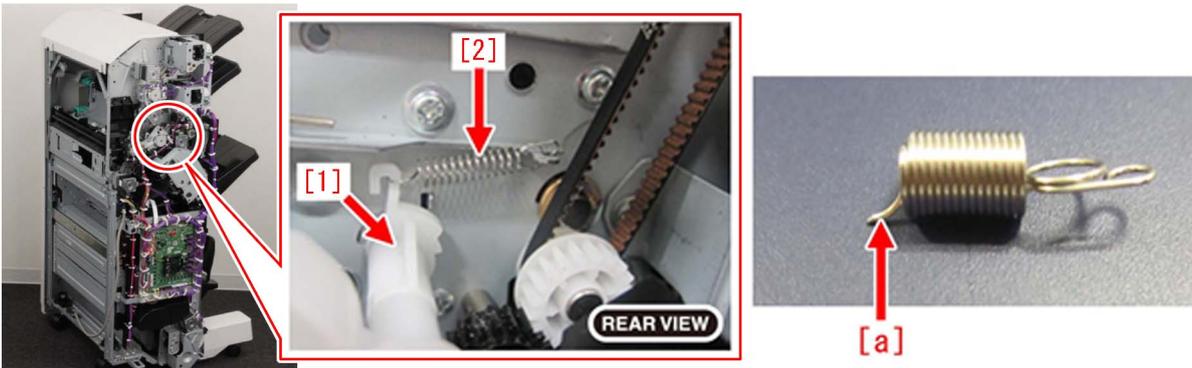
When the tension spring (FE3-8986-000) [2], which has the role to retain the home position of the Buffer/Saddle Inlet Flapper[1] is attached in a twisted condition, it may break [a] during operation. If this tension spring breaks, it may lead to 1002 jam.
- 1002 : Delivery sensor (PS102) delay jam

When attaching the tension spring of the Buffer/Saddle Inlet Flapper, do not twist its hook. Below, photo [A] is showing the normal condition. The spring is attached correctly. Photo [B] is showing the incorrect status.
