# Troubleshooting Guide

## imagePRESS C800 Series

July 16, 2019  
Canon U.S.A., Inc.

# New Arrival Information

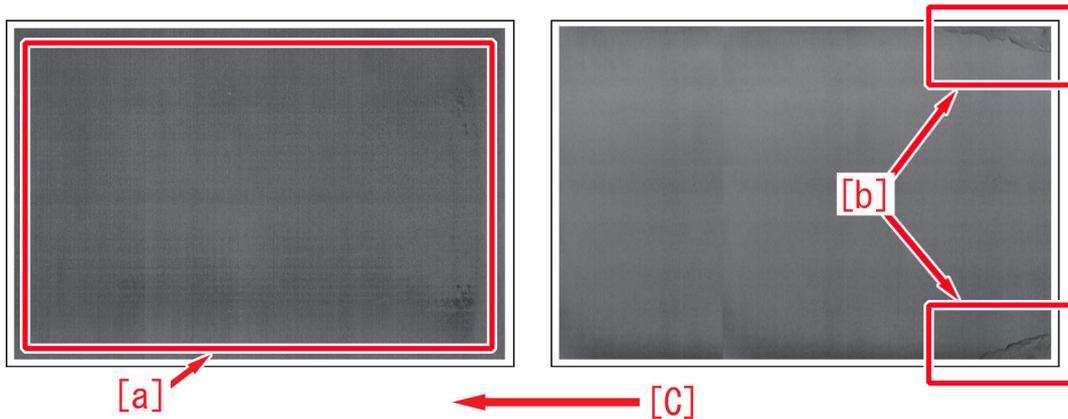
If a coated paper 150gsm or less or a plain paper 100gsm or less that had been left in a low humidity environment is used, uneven density [a] as if scratched in the center of a Bk halftoned image or disordered image [b] on the front and rear edges near the trailing edge of the sheet may occur.

The arrow [c] indicates the feed direction.

A sheaf of paper that had been left in a low humidity environment is dried unevenly and the paper deforms.

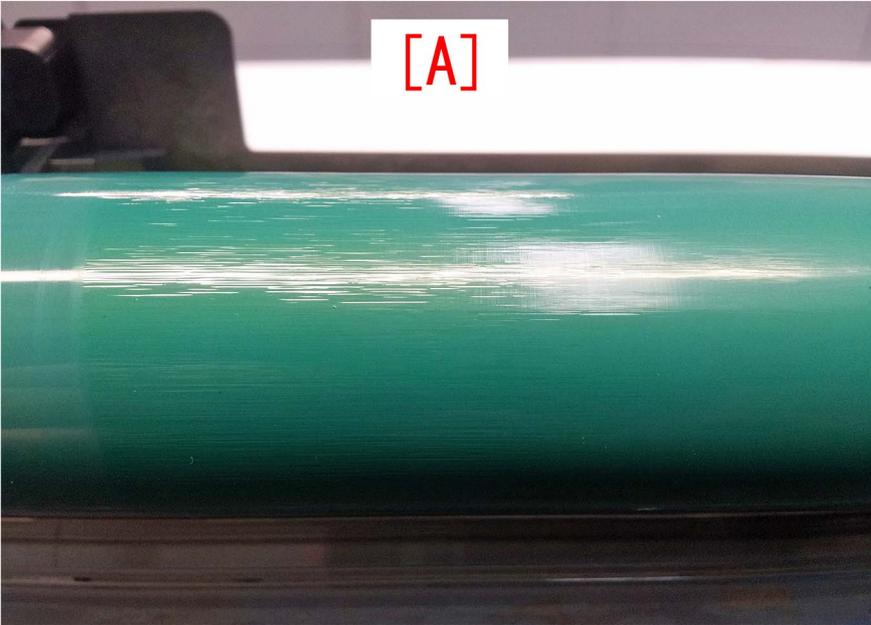
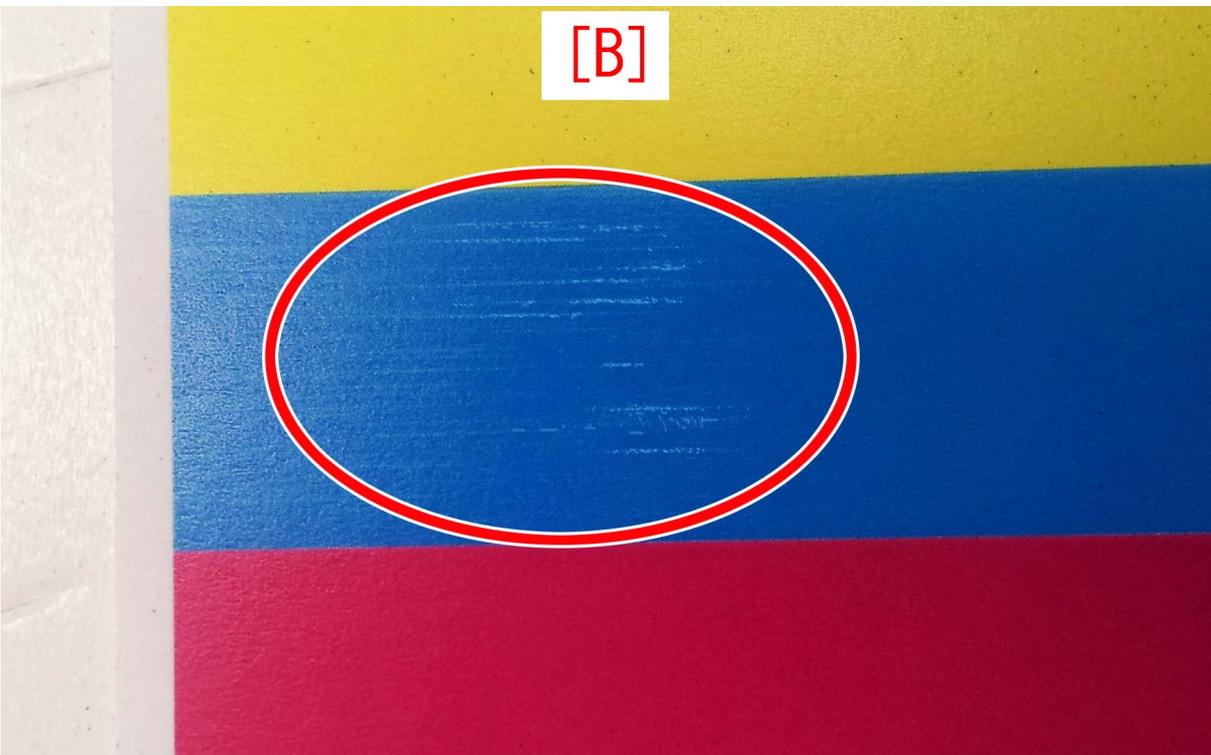
Depending on the operating environment, scratches [A] may appear in the main scanning direction on the front/rear of a color drum. This may cause an image having fine lines [B] or an image having lines that appear at intervals of drum circumference (96mm).

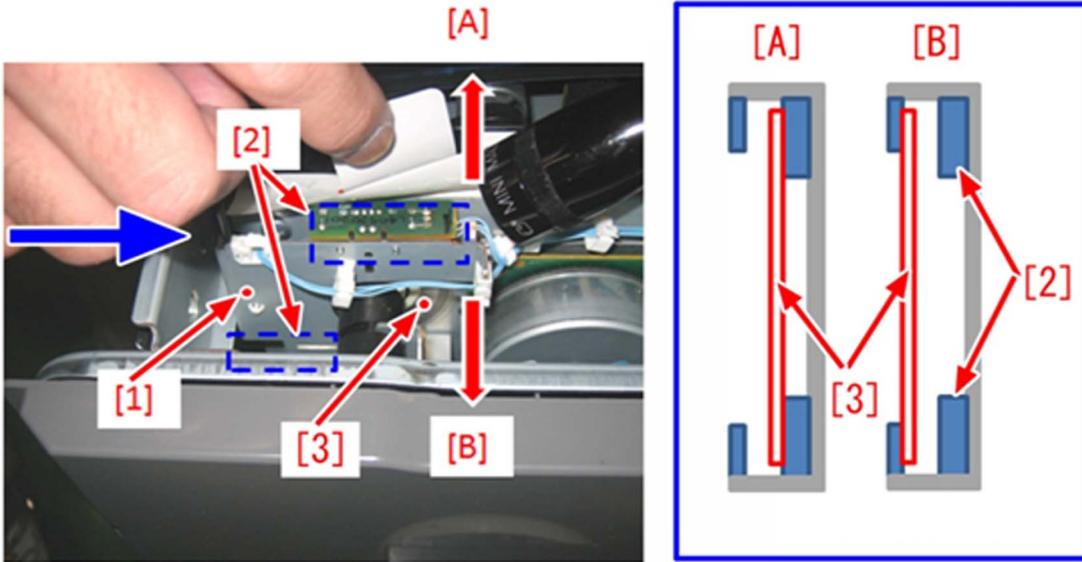
When encoder support plate [1] for ITB unit is deformed to the direction of arrows [A] or [B], the encoder sensors [2] attached the encoder support plate may come into contact with encoder [3]. The encoder shaves the surface of the encoder sensors due to this contact, and the accumulation of shaving chips in the slit of the encode sensors causes detective failure and then it results in the above symptom.

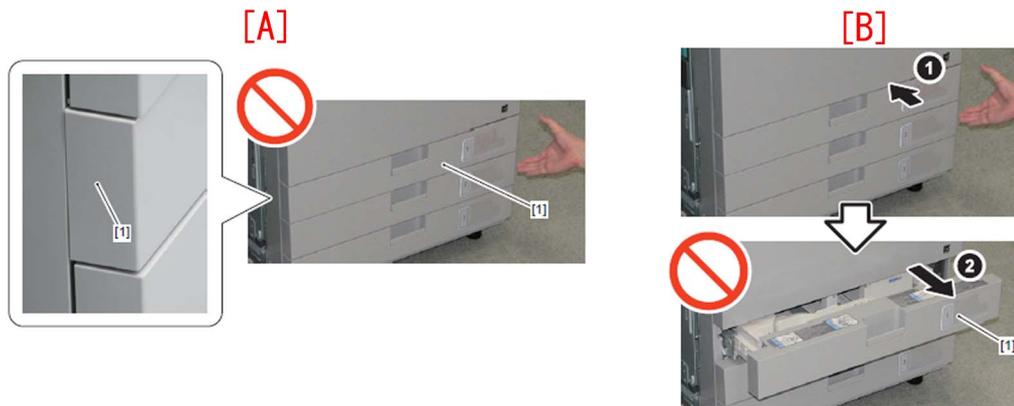
- Semi-closed [A]: The cassette [1] has been excessively pulled in. The gap from other external covers is eliminated by further pushing the cassette in this situation, but adjustment is needed from a functional point of view.
- Latch not locking [B]: The cassette has not been pulled in enough. The cassette [1] is not latched and comes out. Adjustment is needed.

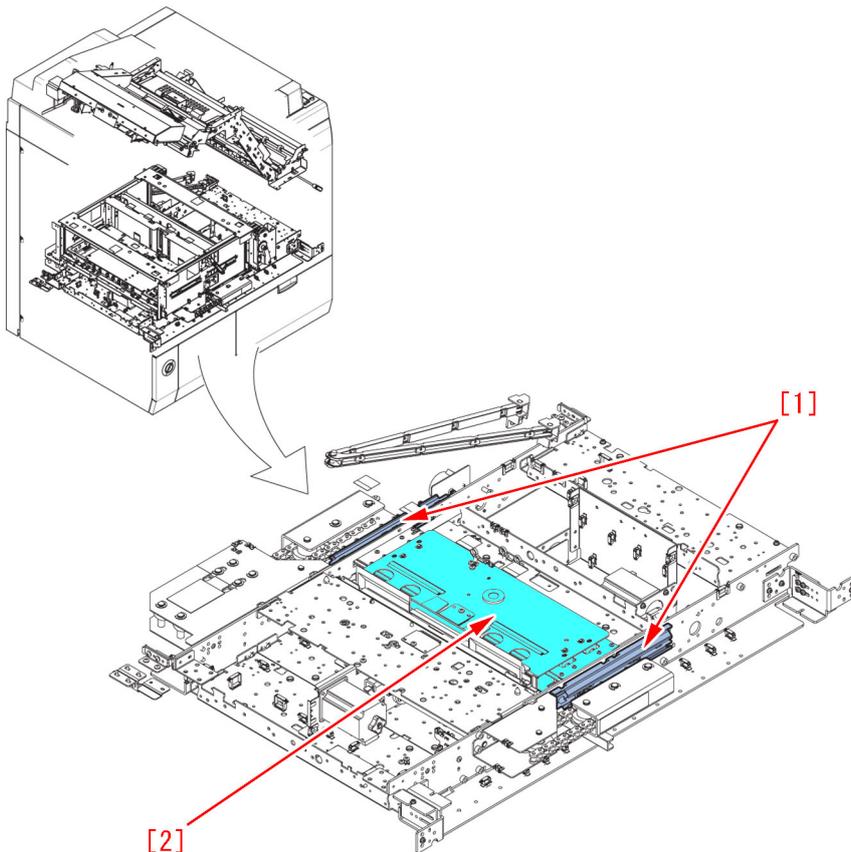
In the machine after the heavy usage of the trimming, the pressing plate sliding part [1] of the trimming assembly is deformed or chipped off to cause the pressing plate [2] of the trimming assembly to be lowered than the normal position.

If the stack of sheets are trimmed in a state where the pressing plate [2] is lowered, the trimming blade [3] contacts with the pressing plate [2] [a], and the nicked trimming blade [4] occurs. As a result, the above-mentioned symptom occurs.

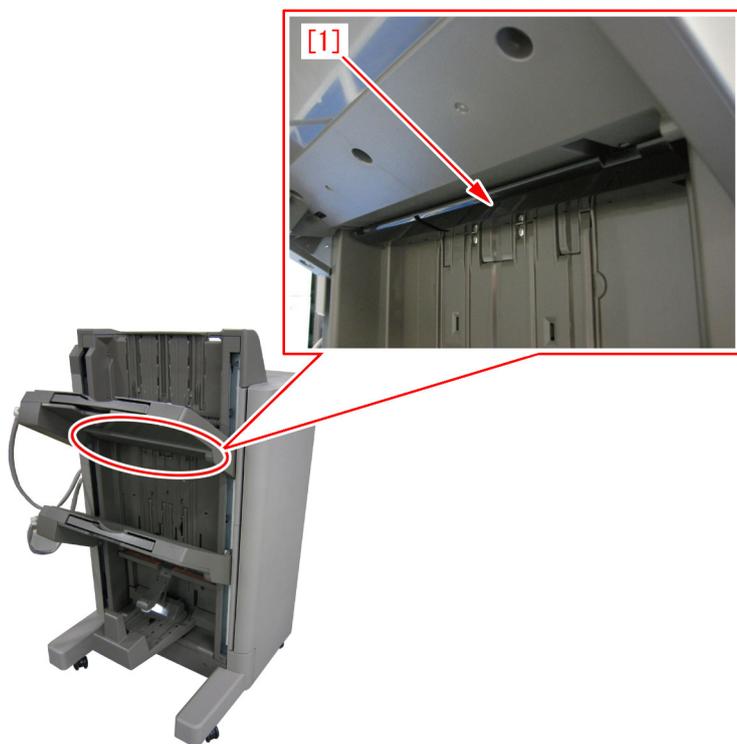
On the main bodies earlier than the following countermeasure cut-in serial numbers in factory, the safety cover [1] may come off of Tray 1.

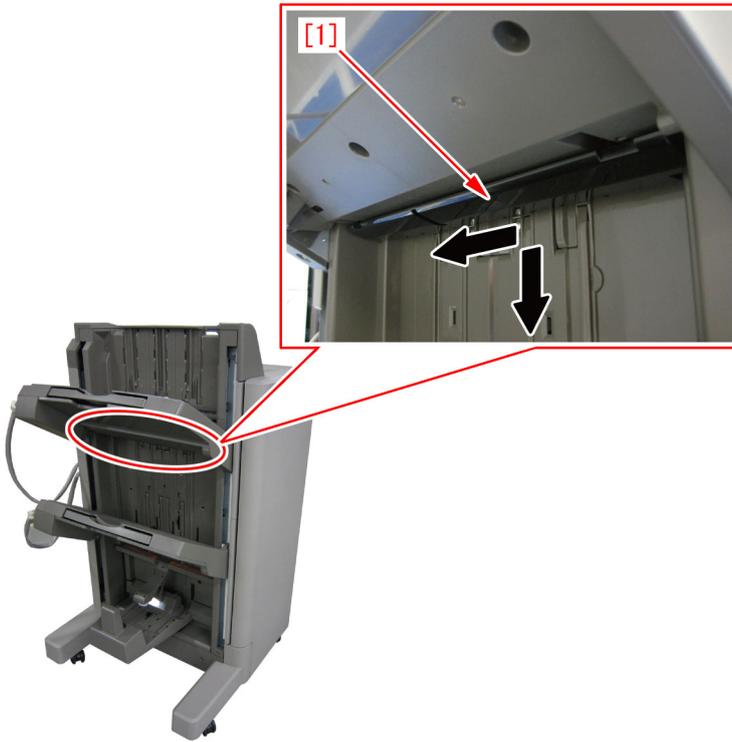
When the safety cover [1] is pressed hard to the direction of the arrow (rear side or downward), the above symptom occurs.

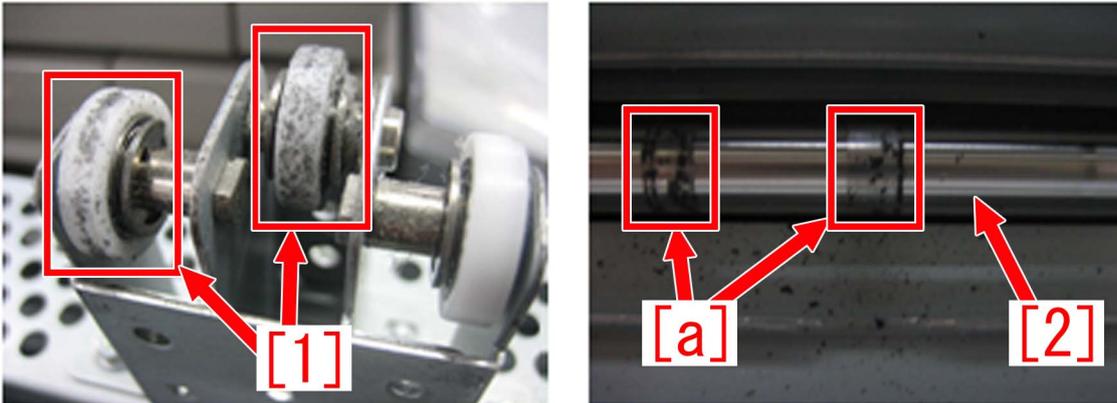
In upstream and downstream of the decurler path assembly, if the back-up roller [1] is abraded or shaved after some endurance time has elapsed, vibration may be generated between the back-up roller and the contacting [a] shaft [2]. The frame assembly resonates with this vibration and results in an abnormal noise.

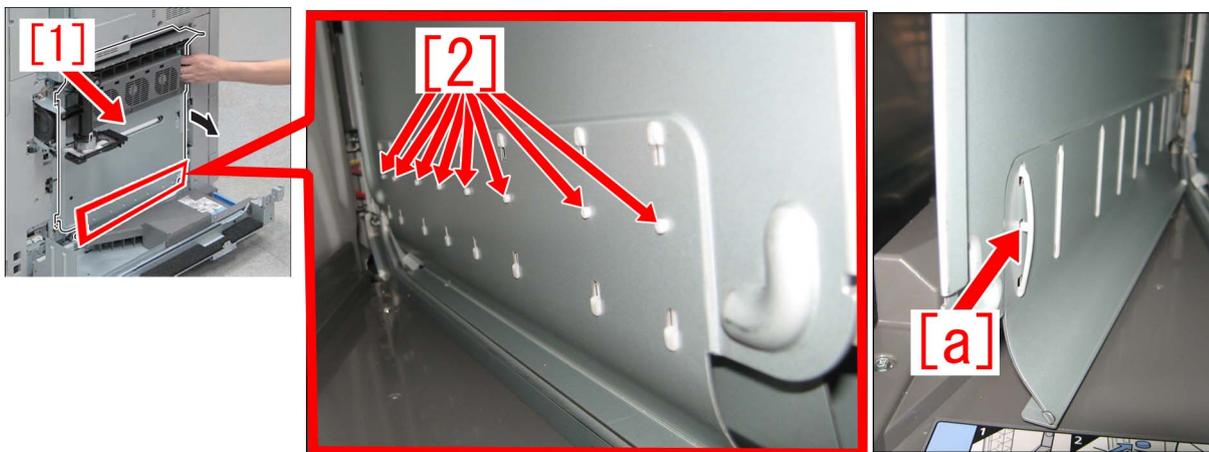
The reverse guide rib would not come off from the reverse delivery door assembly [1] in normal paper feed operations. However if a hand or the like comes in contact with the boss [2] of a reverse guide rib, the reverse guide rib may be half-coupled. If paper is fed with the reverse guide rib half-coupled [a], the reverse guide rib comes off and drops in the paper path area, and resulted in the above symptom.

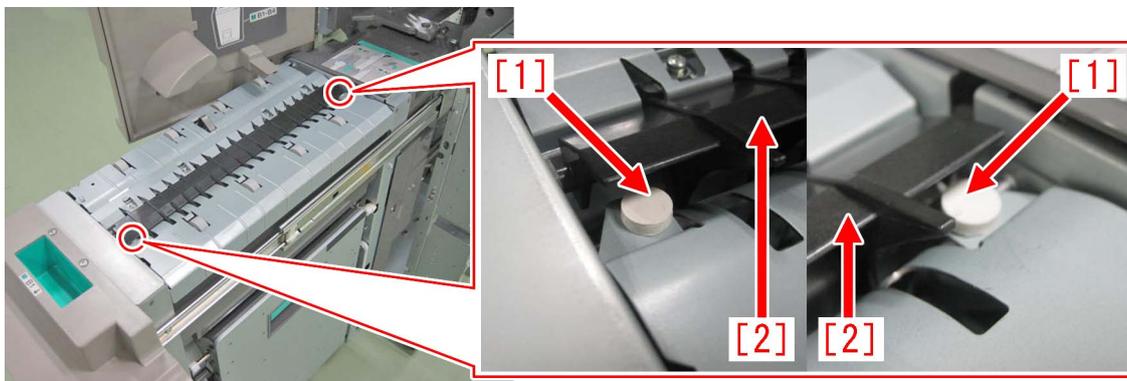
As the spacer [1] gets softened and its surface gets sticky, the folding/straight flapper [2] sticks to it, causing the above symptom to occur.

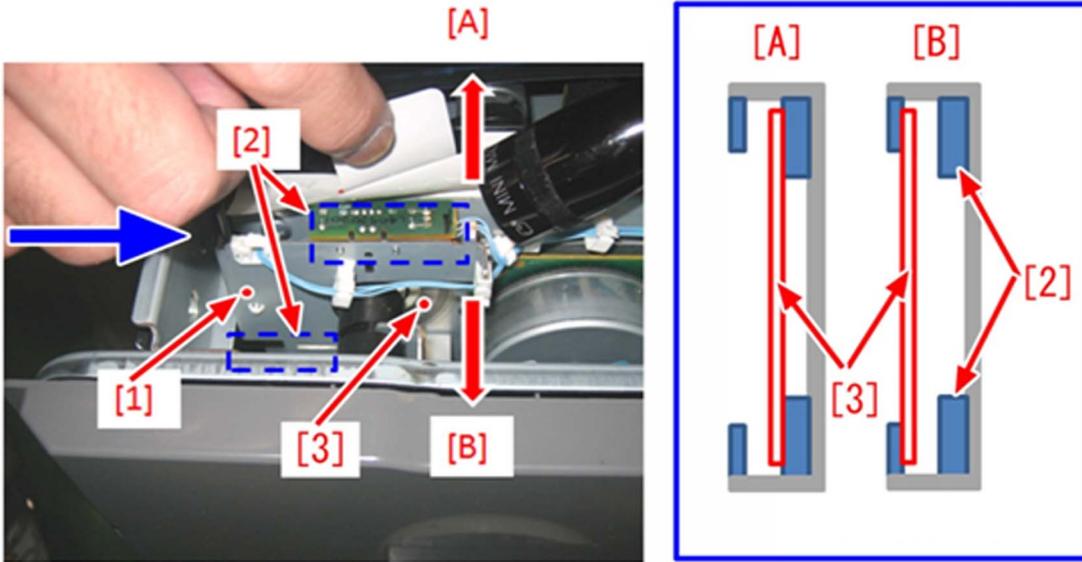
When encoder support plate [1] for ITB unit is deformed to the direction of arrows [A] or [B], the encoder sensors [2] attached the encoder support plate may come into contact with encoder [3]. The encoder shaves the surface of the encoder sensors due to this contact, and the accumulation of shaving chips in the slit of the encode sensors causes detective failure and then it results in the above symptom.

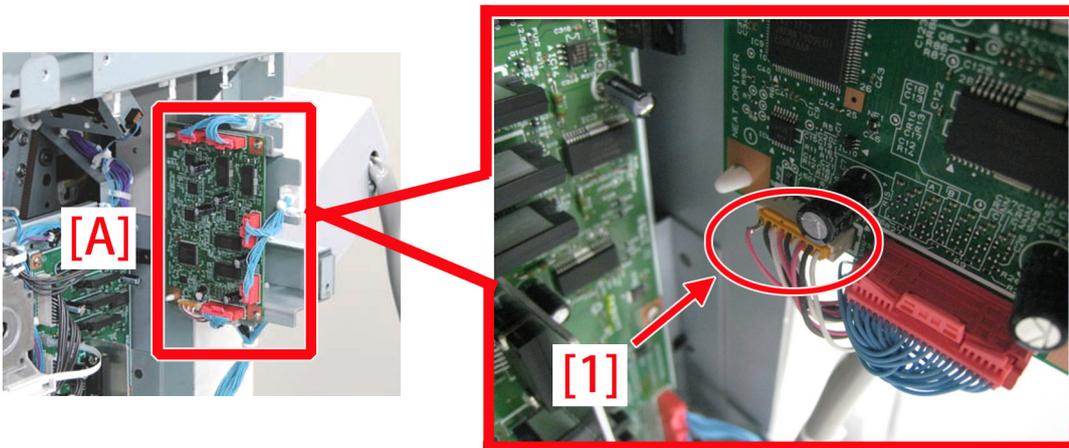
When the connector pins [1] of Neat Driver PCB [A] J501 for Finisher-AM1/Saddle Finisher-AM2 come off, the above mentioned symptom occurs.

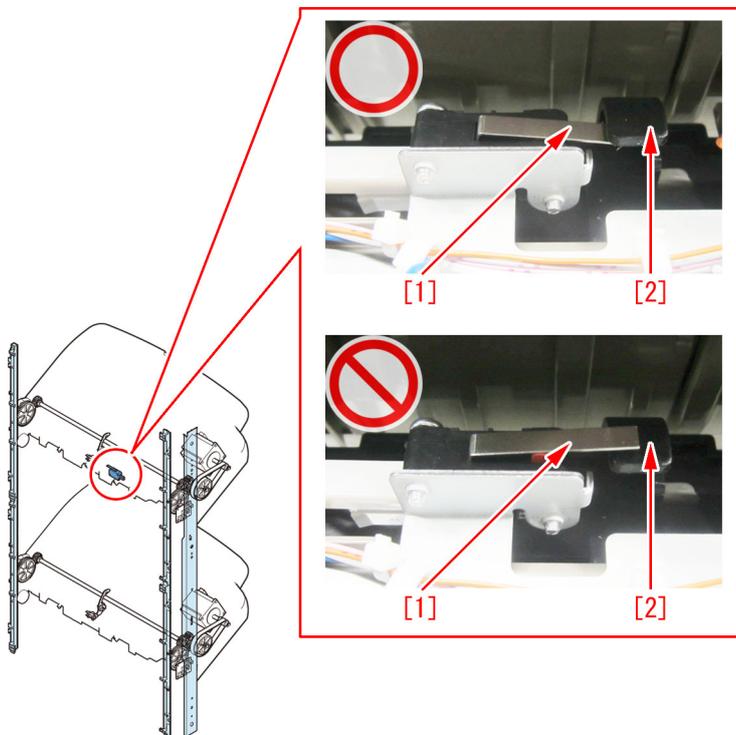
The lever [1] of tray 1 switch becomes in the state of being on the flag [2] of safety cover for the tray 1 due to applying improper force to the tray during initial motion. That results in the 2 errors.
