# Troubleshooting Guide

## imagePRESS C850 Series

July 16, 2019  
Canon U.S.A., Inc.

Please be advised of the release of Troubleshooting Guide for imagePRESS C850 Series.  
Troubleshooting Guide is a booklet compiled from FAQs issued by Canon Inc.

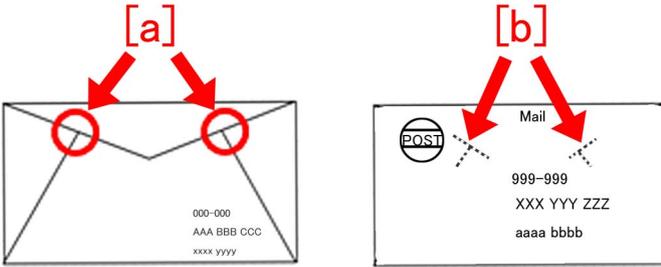
When envelopes pass the fixing assembly, the load is centralized on the overlapping points [a] on the reverse side of envelop. Therefore an image having partial white spots may be output due to the occurrence of worn-out fixing belt surface or shaved rubber of fixing roller surface. If the fixing pressure is greater, the overlapping points [a] may make impresses [b] on the front of envelop depending of the type of envelop.

Adjust Fixing Pressure	Recommended conditions of use	Degree of improvement for the impress
-1	Image with small amount of toner deposit. (Image with small amount of solid parts)	Slightly improved
-2	Image with small amount of toner deposit. (Image with small amount of solid parts)	Almost no impress
-3	Text image	No impress

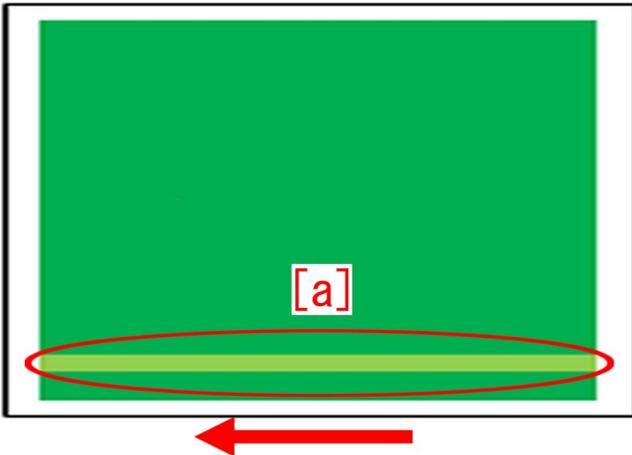
On the main body whose Countermeasure Cut-in Serial Numbers in Factory is earlier than the following number, non-glossy streaks [a] image may occur with high gloss media or heavy media (200g or more). The arrow indicates the paper feed direction.

As a countermeasure against the aforementioned symptom, replace the separation plate with the thinner type that reduces scuffing of the tape even when a high gloss or heavy media is passed through.

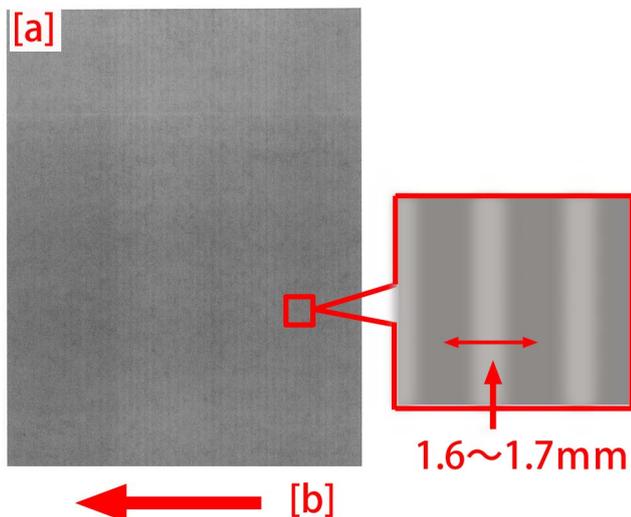
From 1.6mm to 1.7mm pitch uneven density [a] may appear in main scanning direction on the second sheet or later when coated sheets whose basis weight is 200gsm or more are continuously output. The symptom is prominently seen on a black halftone image. The arrow [b] indicates the direction of feeding.

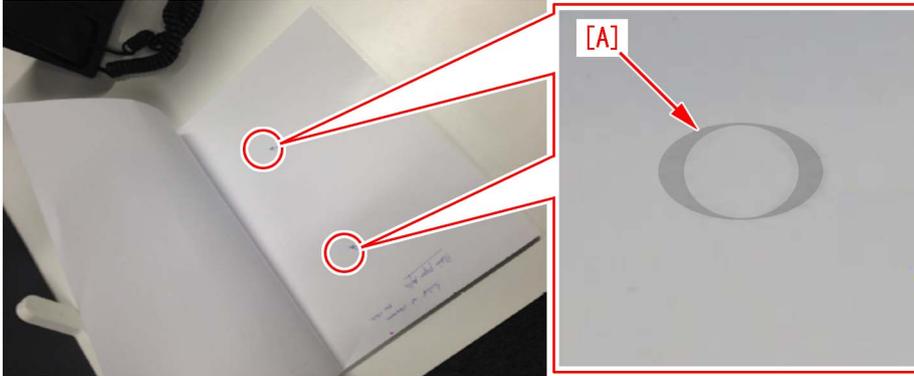
The marks caused by friction [A] may appear on the first and last pages of glued stacked of sheets during printing.

[Reference] This symptom remarkably occurs on glossy paper such as coated paper.

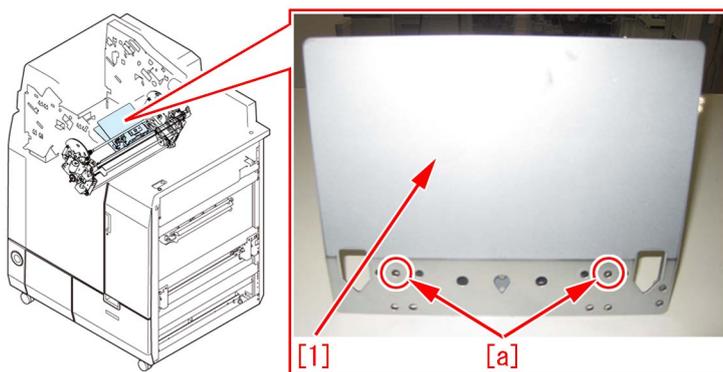
The stack of sheets loaded on the height tray assembly is fed by sub gripper assembly and then transferred to the main gripper assembly. The marks caused by friction are put on the first and last pages of glued stacked of sheets due to the edges of round holes [a] of mini gripper [1] being located at the upper and lower sides of main gripper assembly when transferring.

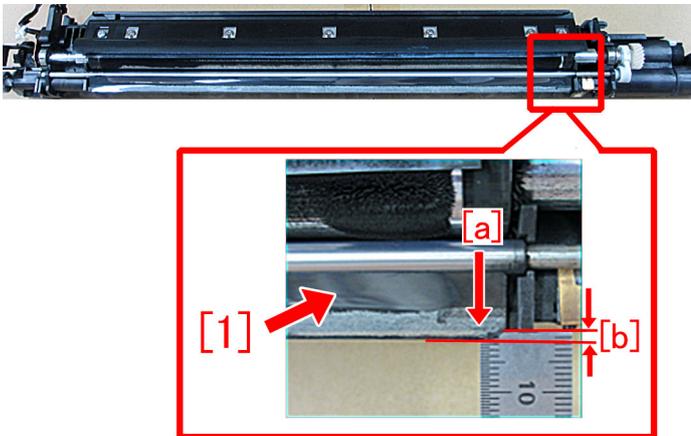
The double-sided tape that secures the scraper [1] which collects waste toner has a shape where the edge of the glued portion is narrower than the center of the glued portion. Thus depending on the force to affix the scraper [1] or the displacement of the affixing position, in a high temperature/high humidity environment, the position of the edge may be displaced [b] depending on the force loaded in the direction of the arrow [a]. The above symptom occurs because toner cannot be collected in the area where the sheet is displaced.

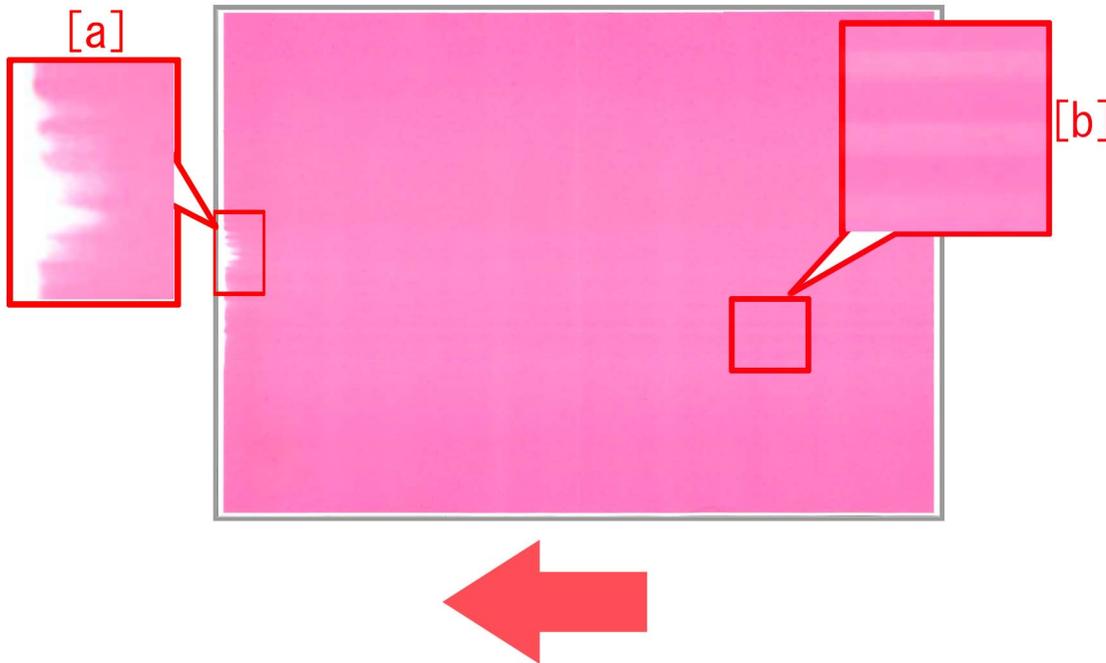
In the machine earlier than the following countermeasure cut-in serial numbers in factory, when printing in Y/M/C colors, white spots [a] may be observed in the center of the leading edge on feed direction, or streaks [b] may be seen on images. Arrow shown below is the feed direction.

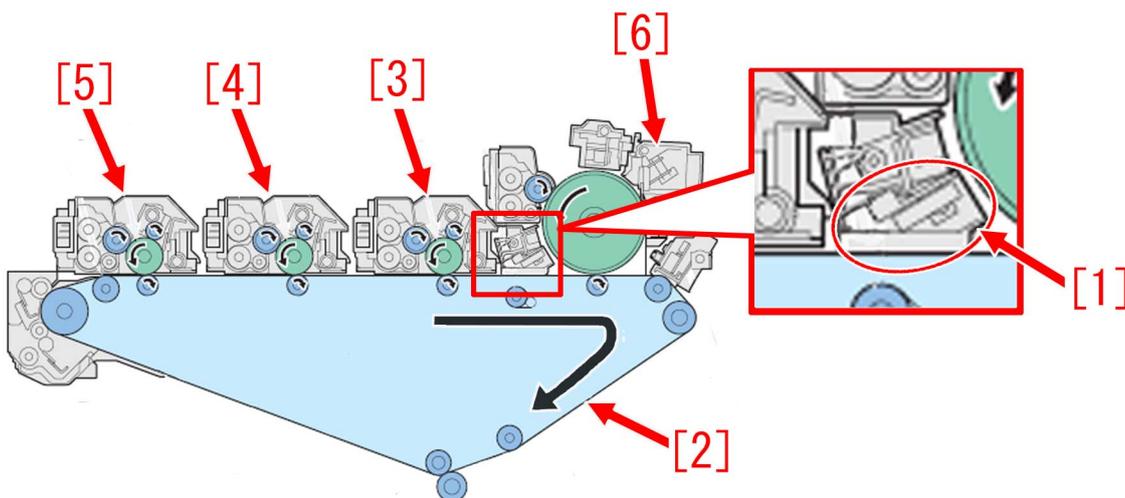
When a sensor holder of a black patch sensor unit [1] is deformed by heat, it touches the central part of ITB belt [2] to cause toner friction, resulting in the above-mentioned symptom. Since the toners C[3], M[4] and Y[5] exist at the upper stream side of the black patch sensor unit [1], the above symptom occurs with all colors except Bk[6].

When the above symptom is seen, prepare a new type of black patch sensor unit (FM0-4955-010) and replace it by referring the service manual "4. Parts Replacement and Cleaning" > "Image Formation System" > "Removing the Drum Patch Sensor Unit (Bk)" to replace the part.

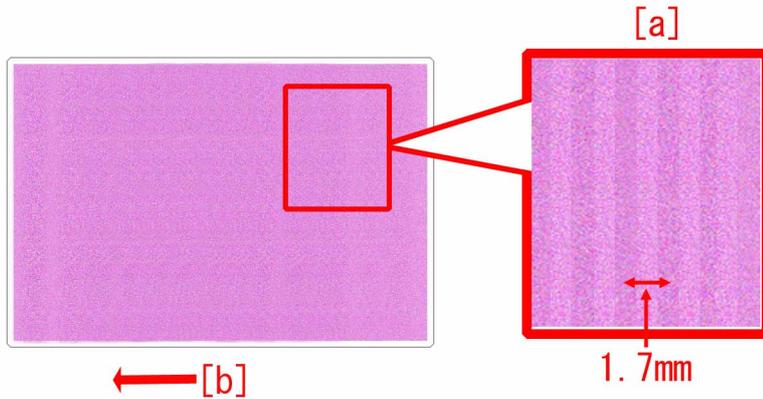
When continuous color printing is made in the paper settings listed below, uneven density at 1.7mm pitch [a] may occur, in the printout of the second sheet and later [b] is the feeding direction.

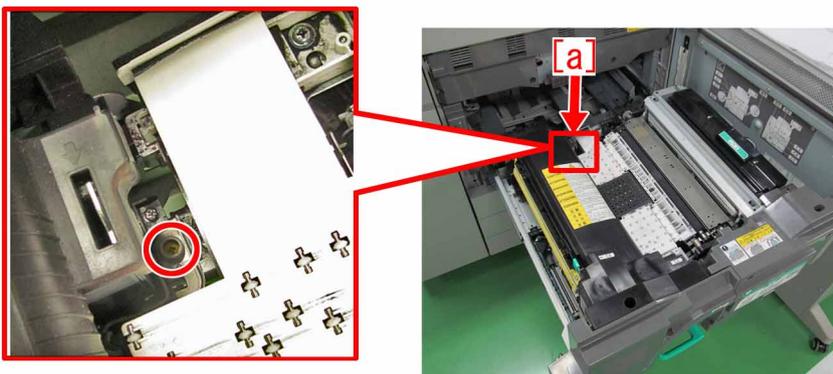
When installing a fixing assembly to a fixing feed unit, 3 screws are to be used and the first screw has to be fixed on the positioning hole [a] before installing other screws. When screws are not installed in this order, a fixing assembly may be not installed in correct position. In such case, the gear mesh between a fixing drive idler gear and a fixing idler gear become insufficient. As a result, gear vibration increases to cause aforementioned symptom.

- 1) Refer to the service manual to open the front cover and draw out a fixing feed unit.
- 2) Loosen the 3 pcs of yellow screws [a] [b] [c], which are fixing a Fixing Assembly. Then install the screws again, in the order of [a] (screw this on first), [b] and [c], firmly

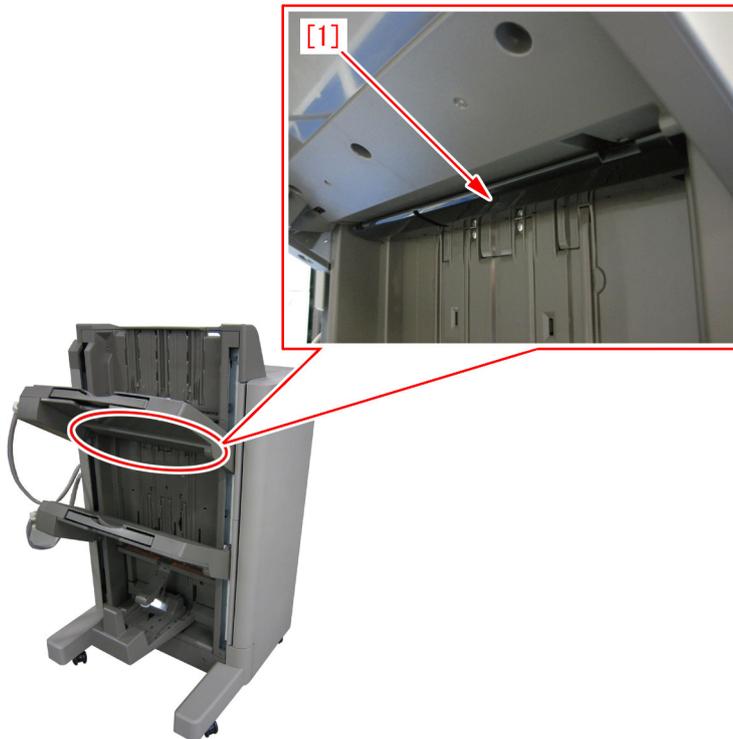
On the main bodies earlier than the following countermeasure cut-in serial numbers in factory, the safety cover [1] may come off of Tray 1.

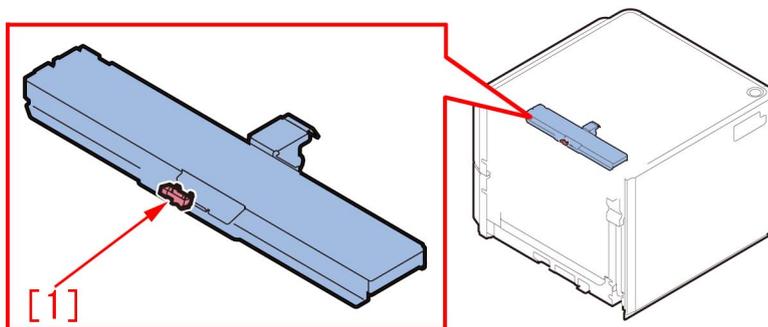
The deck pull-out sensor [1] of the pickup unit may incorrectly detect the reflected light of the adjacent deck pull-out roller feeder guide as paper, resulting in the above-mentioned symptom.

When the aforementioned symptom has occurred, prepare and replace with the lower feed guide [2] (FL0-2918-000) to which the black sheet [1] is affixed following the procedure below.

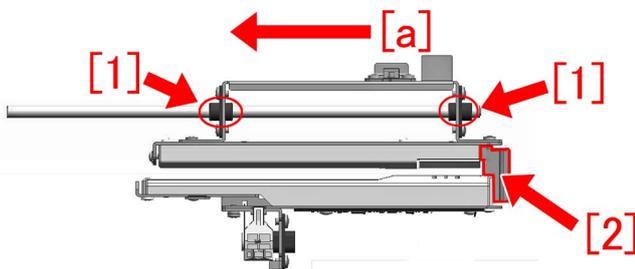
When the sliding load from the sliding part [1] inside the side registration sensor assembly is great, the side registration sensor assembly drive motor steps out and the position of the support [2] is displaced towards the front side of the product [a]. In the said condition, the paper contacts the support [2], would be skewed in delivery and may result in the aforementioned symptom.

When the above mentioned symptom frequents, prepare and replace with the new type side registration sensor assembly for each product referring to the service manual.

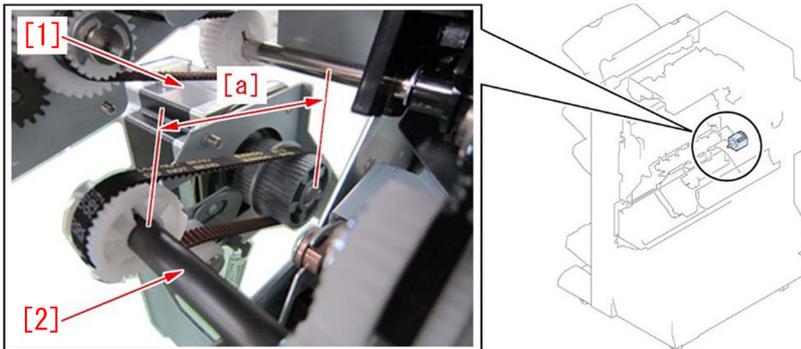
When the belt roller [2] of the process upper guide tilts to the processing feed motor (M26) [1] side, the distance between the shafts [a] becomes smaller and makes it easier for the timing belt to get loose. When the timing belt gets loose, a meshing failure occurs between the timing belt and the gears, resulting in the above symptom.

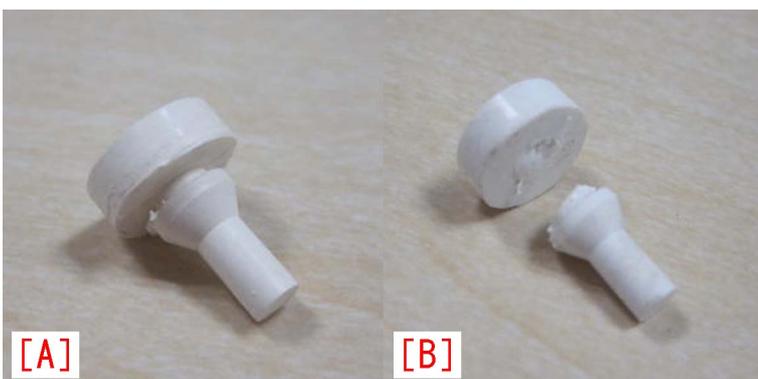
[Note] When removing the spacers, be sure not to break it as when the spacer breaks and falls inside the machine, jam and error may occur.

The photo below shows the normal spacer [A] and the broken spacer [B].

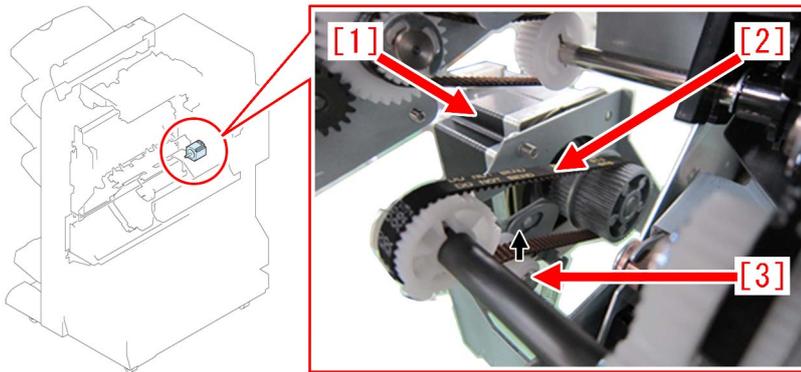
The timing belt [2] in the operation feed motor (M26) [1] is designed to keep its tension and prevent from being loose by having the tensioner [3] pressed in the direction of the arrow. This tensioning method is "unfixed type". However, the pressing power of the tensioner [3] in the unfixed type is insufficient in some cases and when the operation feed motor (M26) [1] drives rapidly a meshing failure occurs on the timing belt because of power, resulting in the above symptom.

When the above symptom occurs, prepare and replace the paper delivery drive set (L) (4Y8-3156-000).

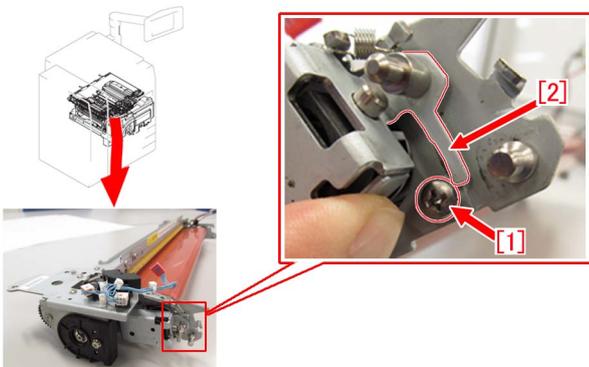
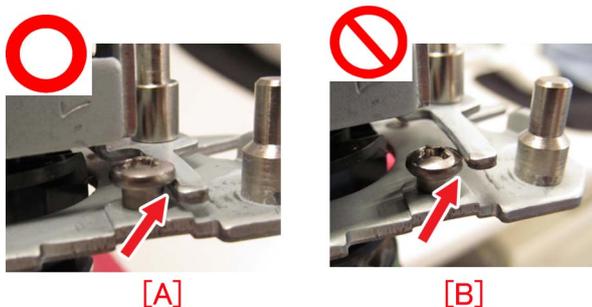
Due to looseness of the front tension arm unit (FM0-1379-000), its arm [2] may go onto the head of the stepped screw (FU1-9010-020) [1].

Photo [A] is showing the normal status, with the arm located below the head of stepped screw.

Photo [B] is showing the abnormal position of the arm, which is causing errors. Here, a scratch mark is observed on the head of the stepped screw.

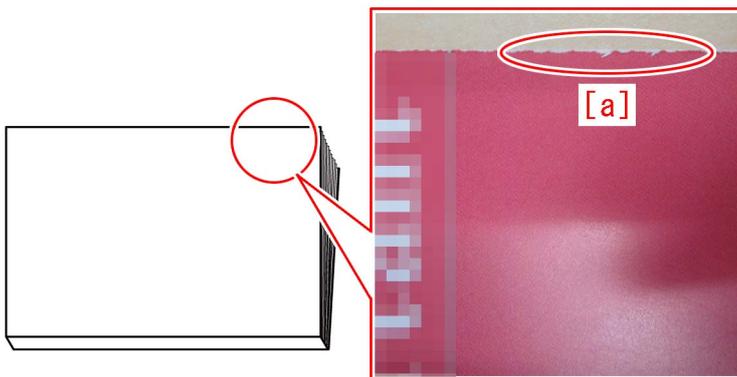
Trimming performance of the trimming blade goes down and trimming failure [a] occurs.

Replace the trimming blade and the heater (Glue vat unit) in accordance with the designated work interval described in Service Manual.

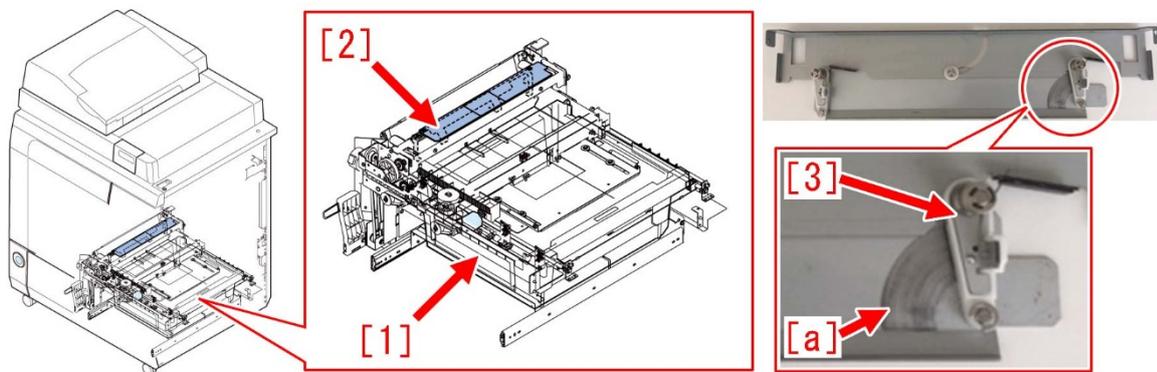
As the life of the dust buffer [2] in dust collecting area [1] advances, the surface [a] that comes in contact with the arm [3] gets shaved. This causes sliding failure of the dust buffer, resulting in the above symptom.
