Knowledge Base

Product : DR 2080C

Title : How to install a DR 2080C scanner on an XP PC via a SCSI port.

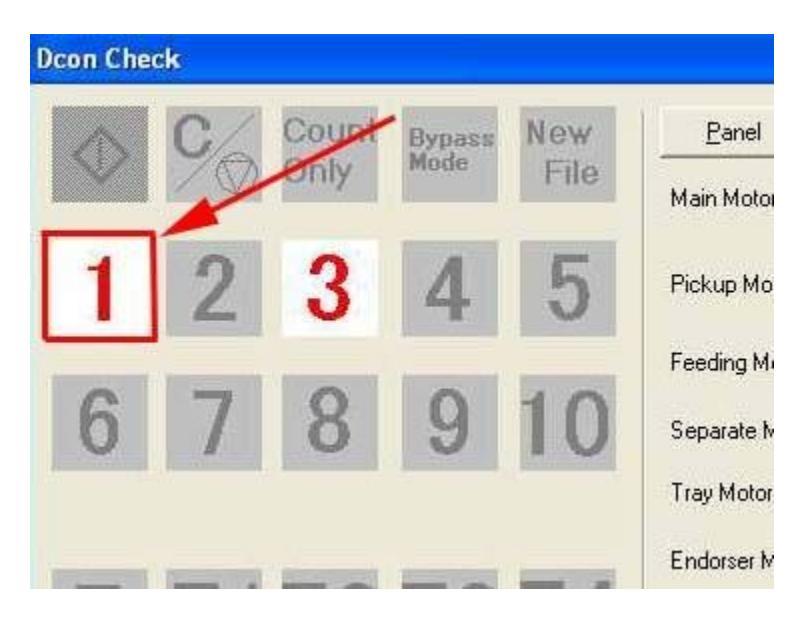
First, check the sensor with the service tool. The number "1" will be highlighted if the sensor is being actuated.

If the number "1" is not lit, check the PS1 actuator under the Document Tray Assembly or replace PS1 if necessary.

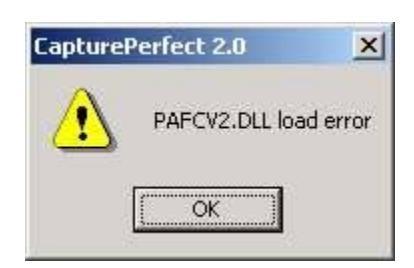
A Capture Perfect 2.0 error is displayed, after trying to scan a batch to file while saving it as a .pdf. The error appears on the screen as shown below.

Workaround :

This error is caused by a missing or corrupt file within Capture Perfect. Reload the Capture Perfect software.

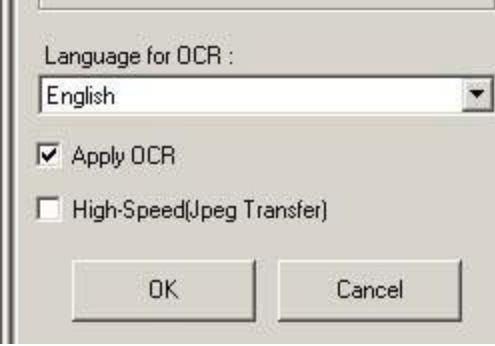
The error seems to be related to the user rights, permissions or free hard drive disk space but all have been checked and found to be correct.

The only solution found was to install Capture Perfect 3.0. After the 3.0 software was installed the same setting were configured and the system was able to scan all of the customer's documents.

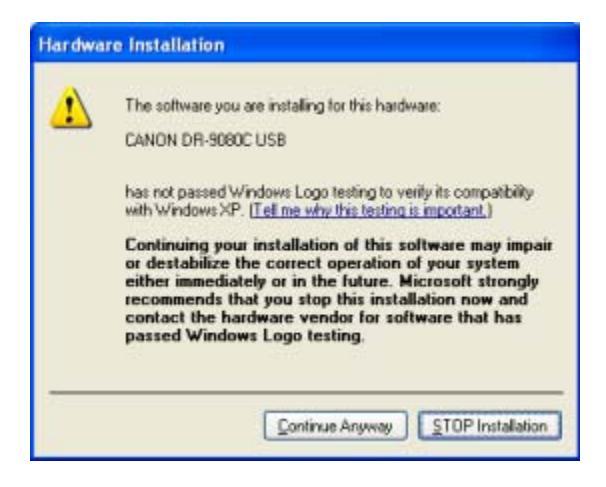
Error : "Digital Signature Not Found" message appears during scanner driver installation.

This message appears during the driver installation because a Windows Digital Signature is not included as part of the driver. To install the scanner driver, click the "Continue Anyway" button. The DR-2050C / 2580C / 2080C / 3080CII / 5010C / 6080 / 7080C / 7580 / 9080C drivers are compatible with Microsoft Windows XP.

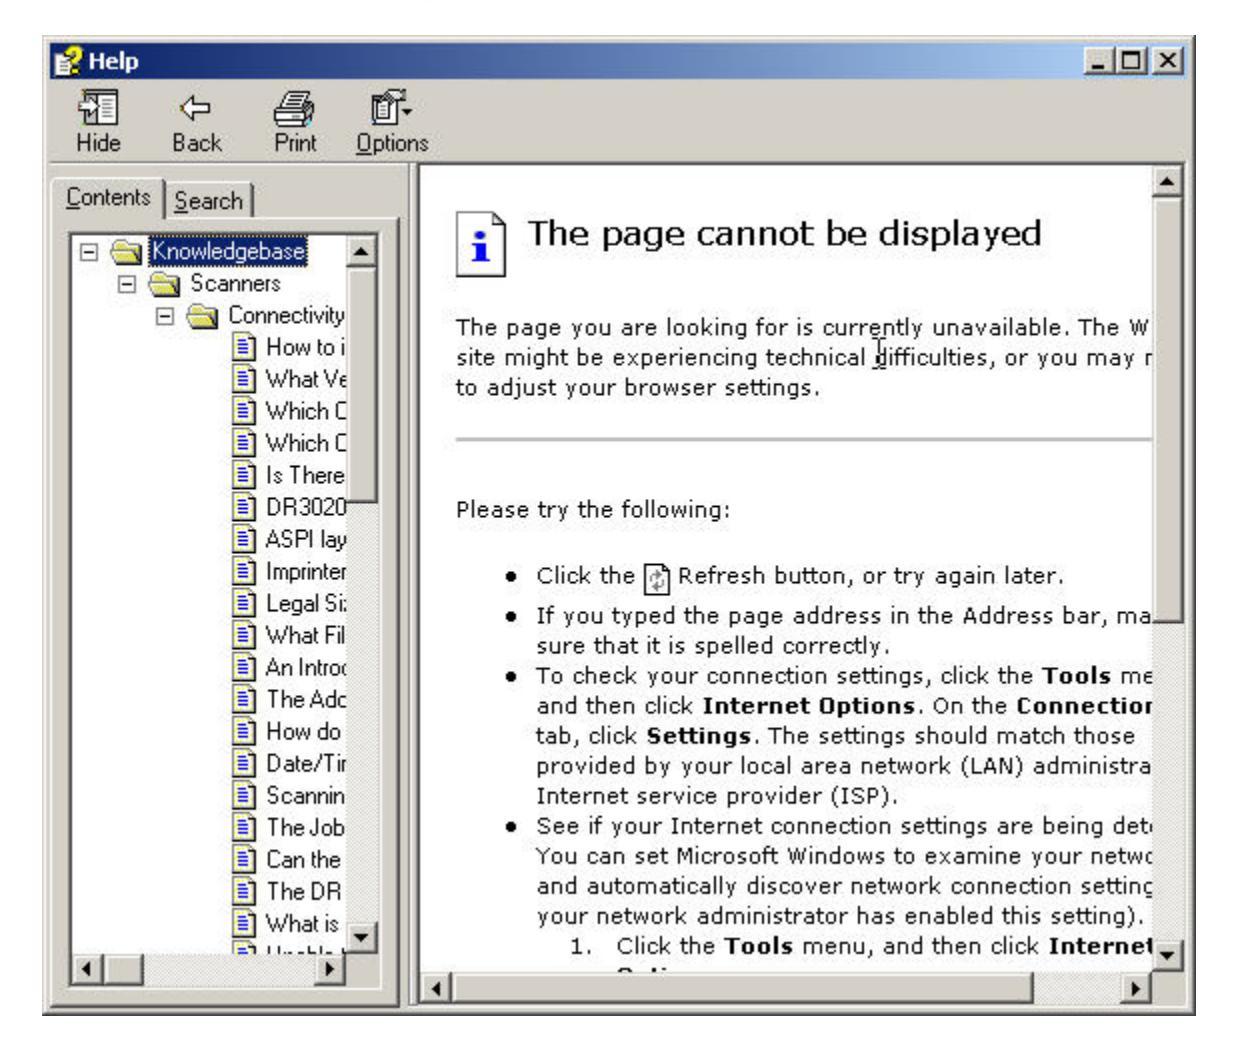
When I try to open the Downloadable KnowledgePAK, a 'The page cannot be displayed' error appears. I cannot view any Knowledgebase articles.

By default, Windows XP/ Server 2003 will block Compiled HTML Help (chm) files which come from other computers. To unblock it, perform the following steps:

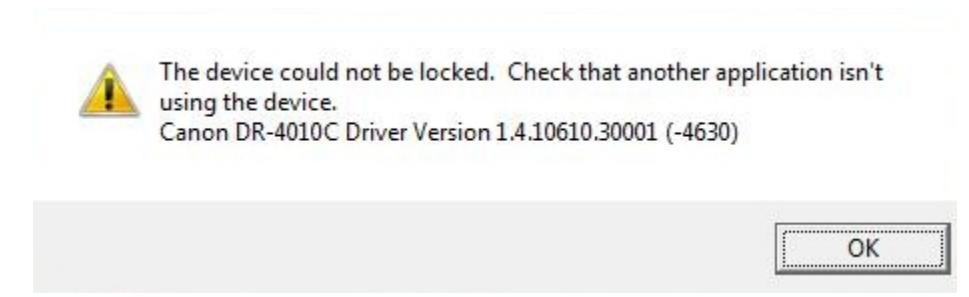
When trying to scan or change the scanner settings, the error message, "Device cannot be locked", is displayed on the computer.

This error may be caused by a communication interruption between the scanner and the PC. First try rebooting the scanner and the PC.

If rebooting fails, enter Device Manager on the PC and reload the INF file.

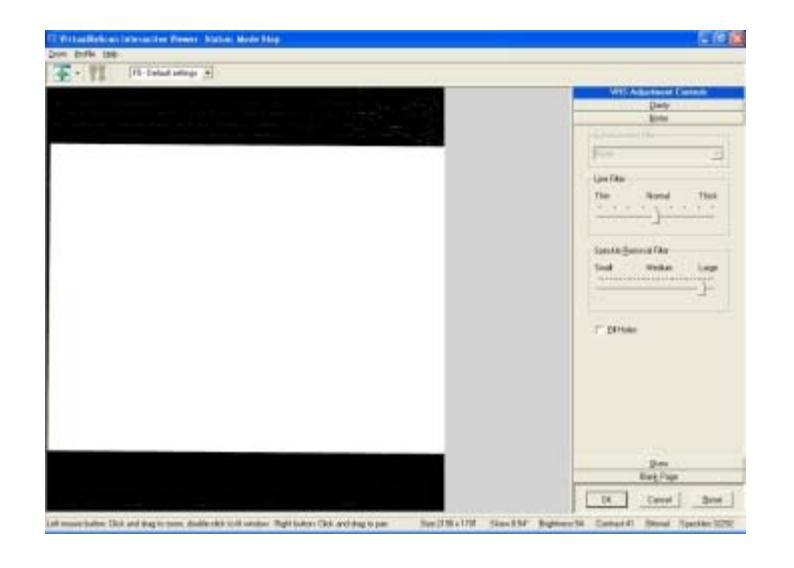
The Kofax VRS Interactive Viewer appears after each page is scanned.
