3500i/4500i/5500i/6500i/8000i Troubleshooting Guide

2013.11.18 3rd Edition

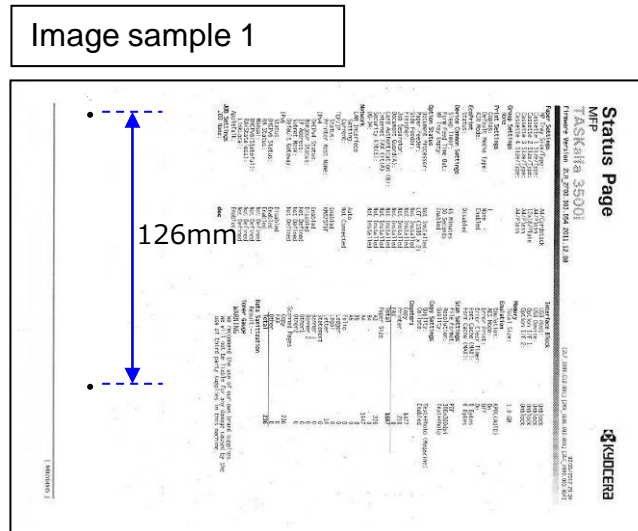
(Image sample 1)

1. 126mm interval Black Dots (drum)

If one of several 126mm interval black dots appears randomly at sub scanning direction, take the following measure.

(*there is the case that the black dots appearance becomes vertical line.)

a. Replace the DRUM ASSY (DK-6305/6705).

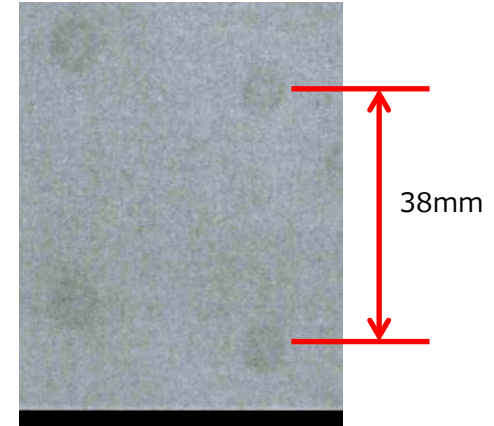
1. 38mm interval black dots, black marks (Charger roller)

Take the following measure if the 38mm interval black dots or marks appear at the image in the sub scanning direction.

- Check the 38mm interval to print out the test sample by U089 Mono4.
- Replace the MC-6705 after confirming the dots appears 38mm interval.
- Execute U930 charger roller counter reset after replacing MC-6705.

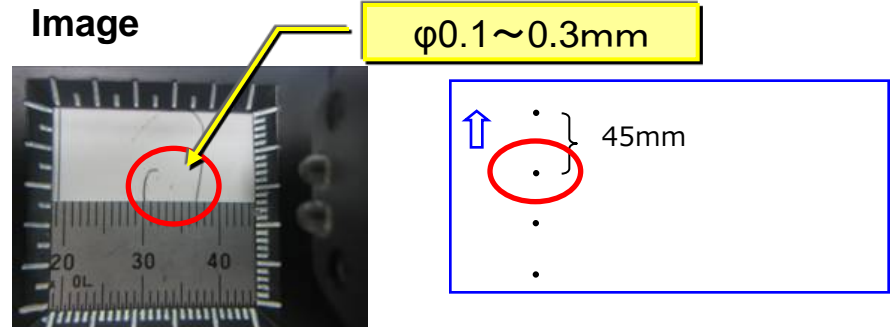
2. 45mm interval Black dots

If 45mm interval paper appears at image in the sub scanning direction, take the following measure.

Above is to check the black dots on the paper by the Magnifying glass.

- Check whether the foreign substance are attached on the developing roller surface.
- If the foreign substance attached, wipe off by the clean cloth.
- If no foreign substance attached or it will not be disappeared after wiping off, replace the developing unit.

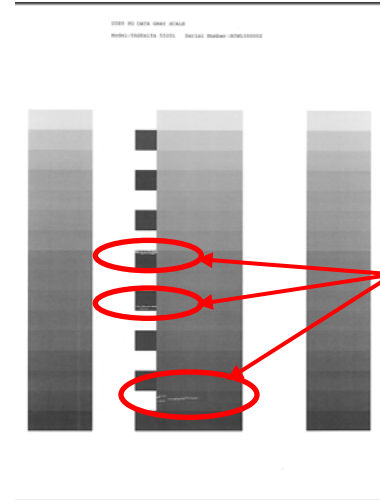
Image sample 1

- ◇ Leak at the solid part
Void image appear at the solid part.

U89 Sample set
Void image at
Solid part

- If the void image appear at solid part of prints out on U089 Color Belt, refer to below “b” * If the vertical streak image appears at the halftone, replace the developing unit.
- Execute U140 → AC Calib→ High Altitude
- Select “Altitude” and find the setting which the leak image does not appear. * Avoid the setting far from the actual altitude.
- If the image will not be recovered, replace the developing unit.

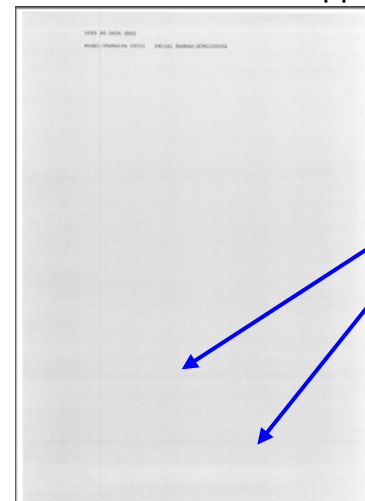
Image sample 2

- ◇ Leak at the halftone part
Horizontal streaks appear at Halftone image.

U89 Sample set
Horizontal streaks
at halftone image

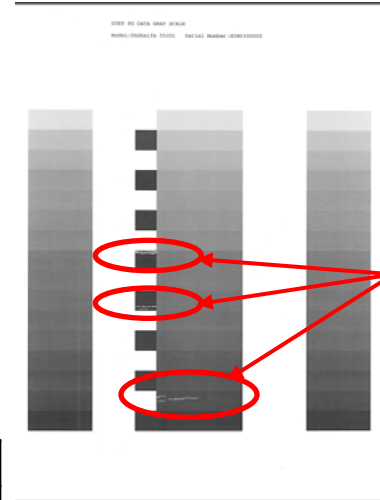
Image sample 1

- ◇ Leak at the solid part
Void image appear at the solid part.

U89 Sample set
Void image at
Solid part

- If the void image appear at solid part of prints out on U089 Color Belt, refer to below “b” * If the vertical streak image appears at the halftone, replace the developing unit.
- Check the value of U140 Sleeve AC (1)
- U140 → Execute AC Calib (2) → Set “K” Off to On (3) → Execute (4) → Start
- Check whether the value of U140 Sleeve AC (3) becomes lower and the image is recovered.
- If the image will not be recovered, replace the developing unit.

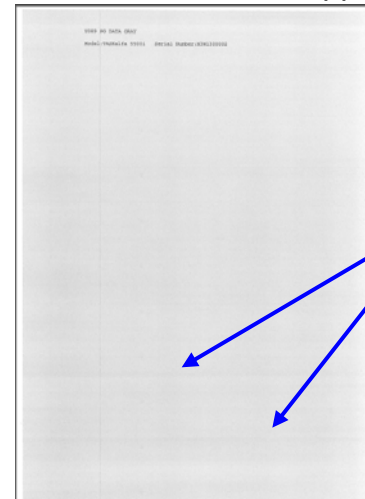
Image sample 2

- ◇ Leak at the halftone part
Horizontal streaks appear at Halftone image.

U89 Sample set
Horizontal streaks
at halftone image

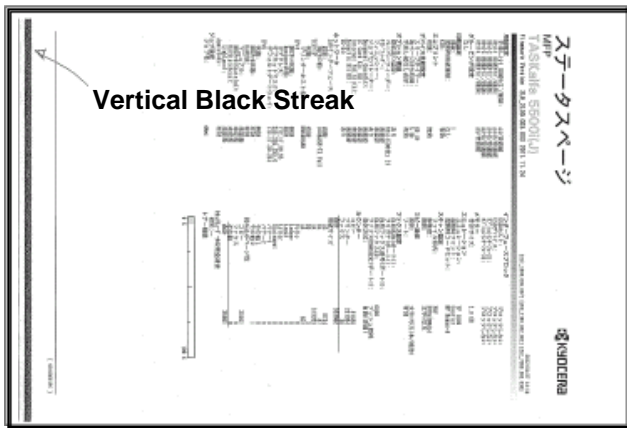
Image sample 1

1. Vertical Black streaks (Image sample 1)

Please remove the transfer belt unit and check whether the transfer belt is cracked.

1. When the transfer belt is torn or cracked, please replace the drum unit and the transfer belt unit.
2. Check the firmware version (U019) and upgrade it higher than Upgrade Pack Ver. V4.00

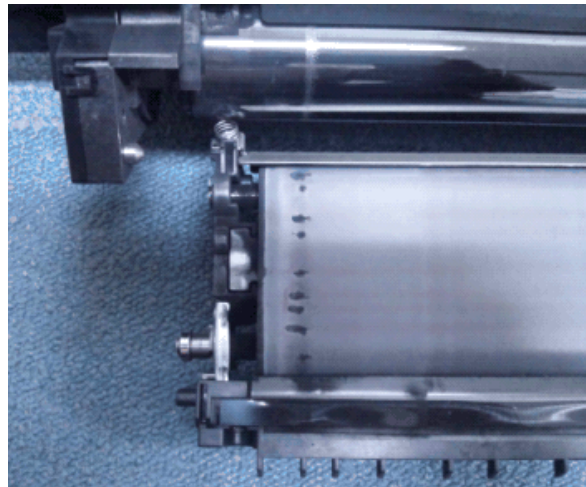
Condition of tear or crack on the transfer belt

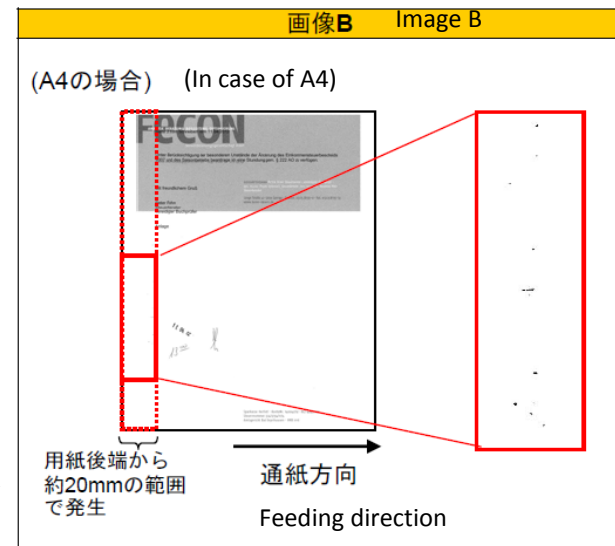
2. When toner stain occurs at about 20mm position from paper bottom edge, please take the following measure. (image sample B)

It occurs in the range of about 20mm from paper bottom edge.

a. Replace the DV unit. (DV-6305/6705:
302LH93034/302LF93034)

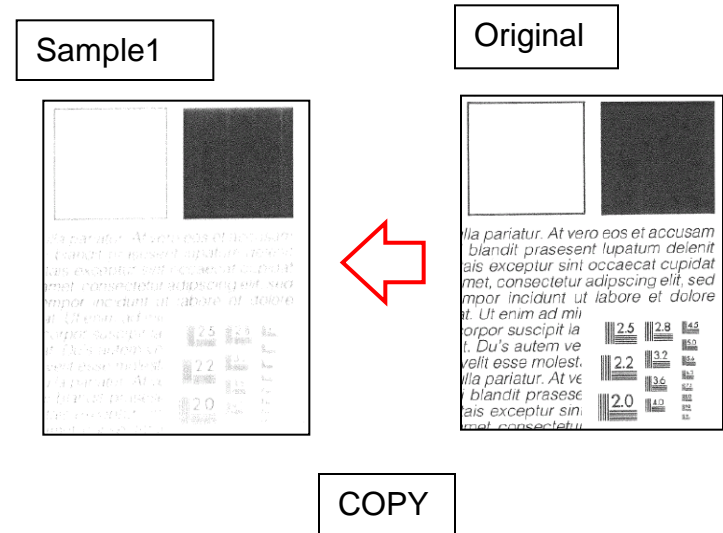
If the copy image becomes out of focus, take the following measure in order. (Sample1)

1. Replace the ISU_LENS UNIT (PARTS IMAGE SCANNER L SP : 302K993082)
2. Execute the scanner auto adjustment.
 - 2-1. Place the designated adjustment original (Part No.: 7505000005) on the contact glass.
 - 2-2. Select "Target" on U411 Scanner Auto Adjustment
 - 2-3. Select "Auto" and press the start key.
 - 2-4. Select "Table (Chart1)".
 - 2-5. Select "ALL" for items to be executed.
 - 2-6. Press the start key and start the auto adjustment.

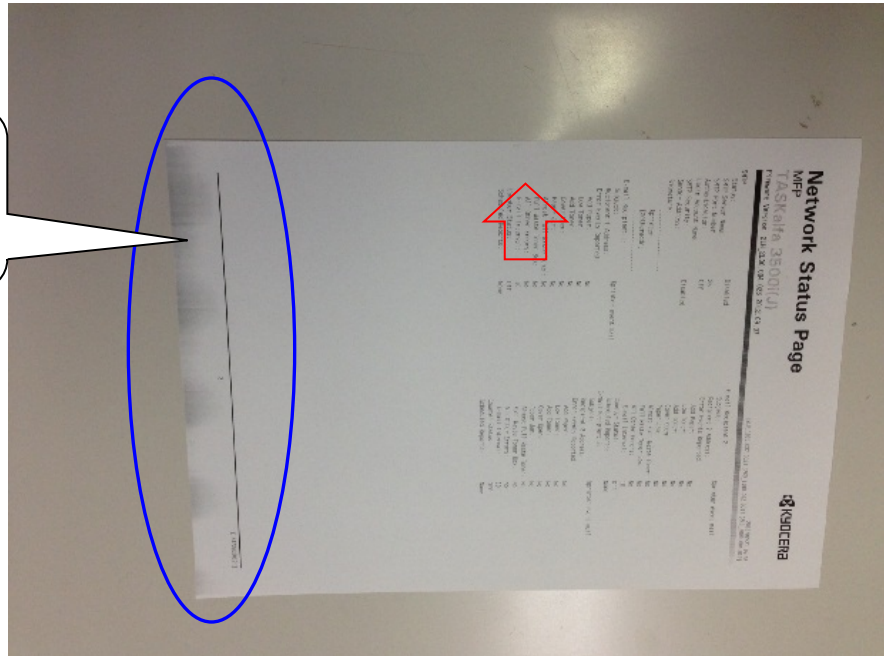
Sample 1 : Case of failure (Monochrome Machine)

End Background occurs in the magnetic roller pitch

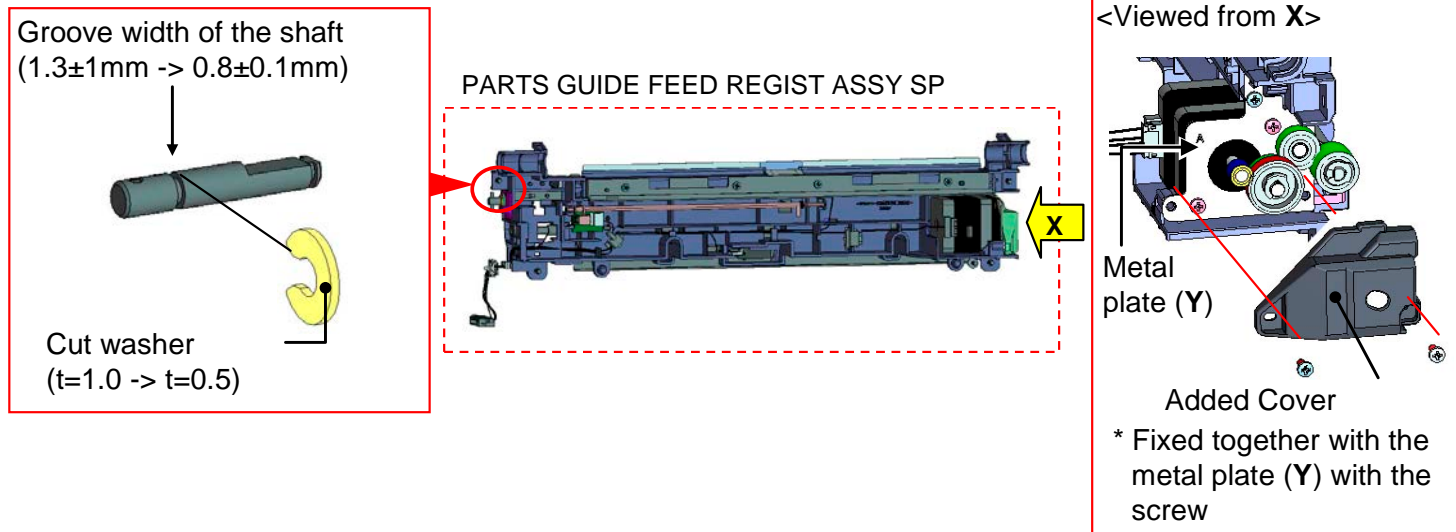
The abnormal noise may be heard or the Jam (J42XX / J40XX) may occur if the gear of the middle roller drive motor is worn with toner spillage.

The cover (302N724020 : COVER MOTOR MIDDLE) is added to prevent the gear wear.

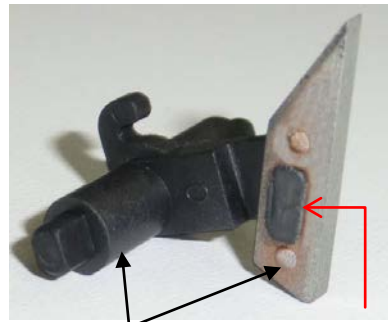
(Before)

The claw and holder are joined

The claw may crack or come off from the joint part

If the claw is broken in half, please change to the new claw (claw that is integrated).

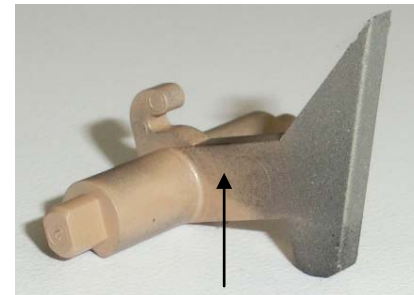
(After)

Unifying the claw and hold prevents the crack at the joint part

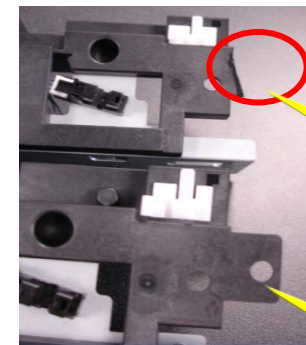
2. Check whether the positioning hole of the bridge drive unit is damaged.

Broken

→ If it is damaged, replace the AK drive unit (following item number.)

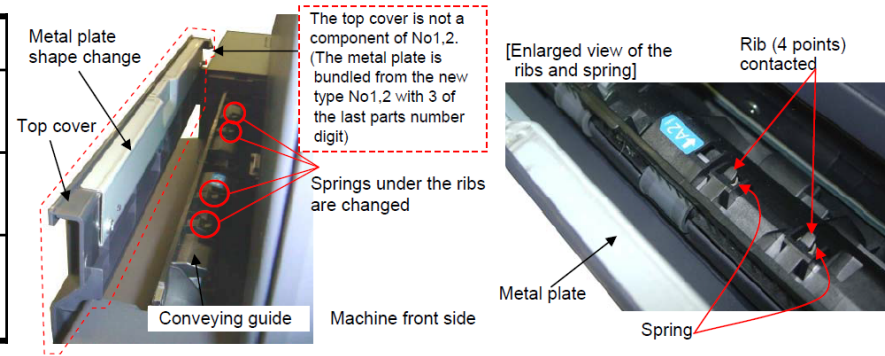
10. Check whether the rib (blue color round mark on the right fig) of the conveying guide of the bridge exit unit is broken or not.

→ In case of breakage, replace the below part No.1 to 3 as referring to the service bulletin "2LC-0068(C076)

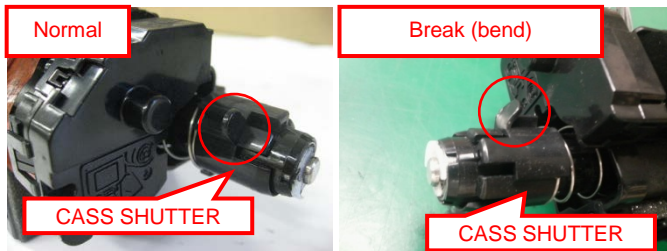
Fig.1

2. In case of no abnormal sound (developing drive possible)
 - a. Remove the INNER UNIT.
 - b. Check the CASS SHUTTER of the DLP UNIT.
 - c. If the parts is broken, replace the DLP UNIT.(Fig.1)
 - d. Re-assemble it as referring to below attention 1.

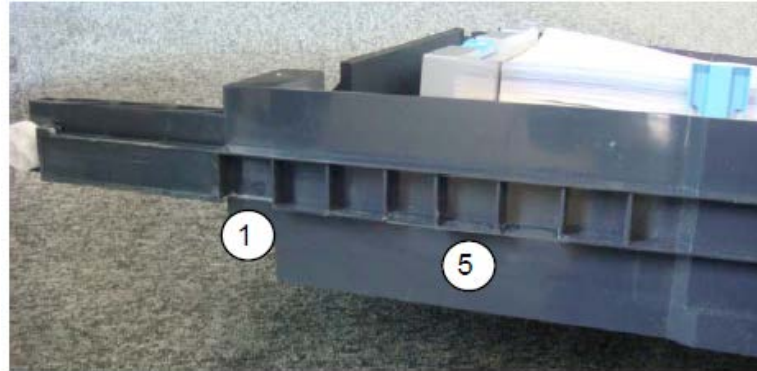
<Cassette rail damage position> 1 and 5 are mostly damaged in the figure below.

- ①: may contact the pulley A in the figure left and may be broken if pulled out just before full open and the downward force is applied to the cassette.
- ②: may contact the pulley B in the figure left and may be broken if repeatedly pulled out with paper fully loaded in the cassette.
- ※Others than 1 and 5 above may be damaged depending on the position where the cassette is pulled out
- Note the parts to use and the direction to install differ between before and after the damage.

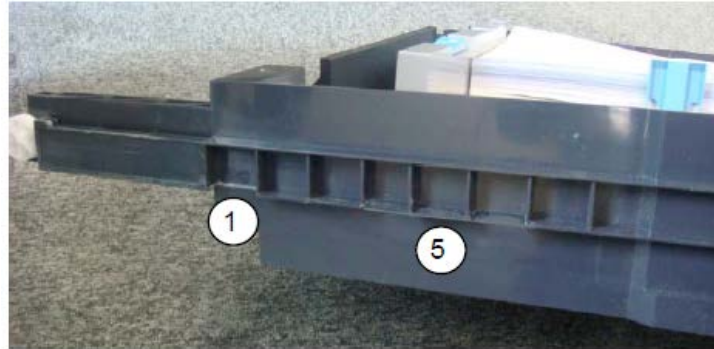
1 and 5 are mostly damaged in the figure below.

1st rib: may contact the pulley A in the figure left and may be broken if pulled out just before full open and the downward force is applied to the cassette.
