Document Solutions

TASKalfa 3550ci Trouble Shooting Guide

Revision 2

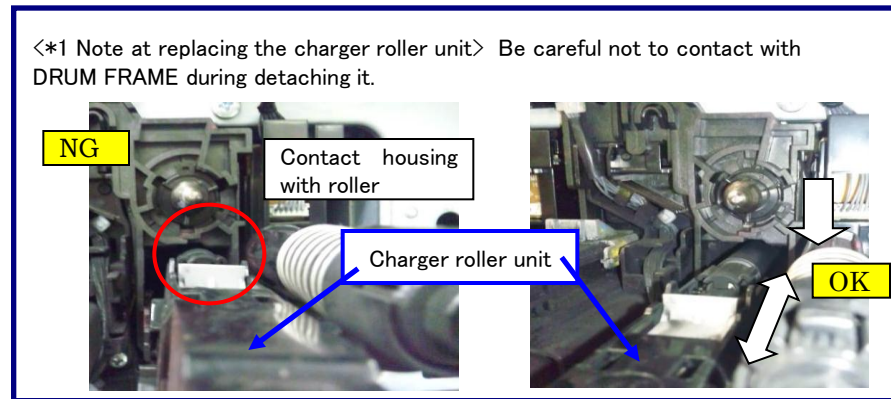
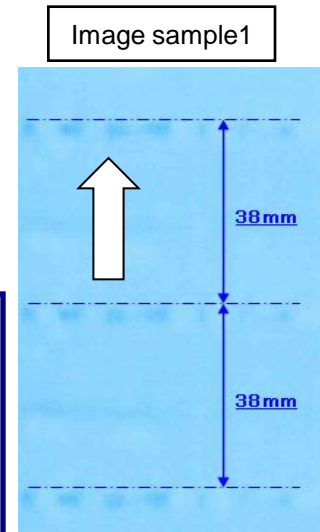
1. 38mm interval color dots (Charger roller)

Take the following measure when the 38mm interval color dots or marks appear vertical direction at image.

- Check the 38mm interval to print out the test sample by U089 Gray image.
- Replace the MC-8705 after confirming the dots appears 38mm interval. (*1)
- Execute U930 charger roller counter reset when dots disappear after replacing MC-8705.
If still dots on the image, replace the developing unit.

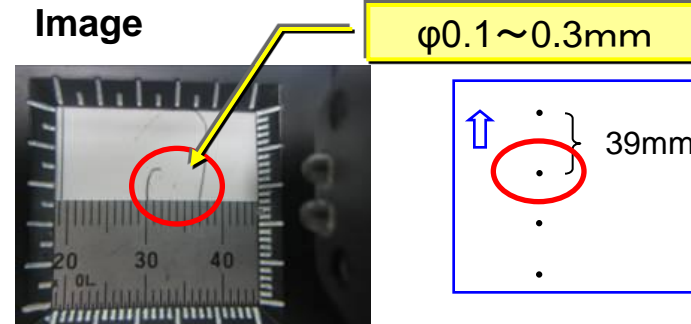
2. 39mm interval color dots (developing roller)

It appears at image 39mm interval paper in the conveying direction.

Above is to check the color dots on the paper by the Magnifying glass.

- Check whether the foreign substance are attached on the developing roller surface.
- If the foreign substance attached, wipe off by the clean cloth.
- If no foreign substance attached or it will not be disappeared after wiping off, replace the developing unit.

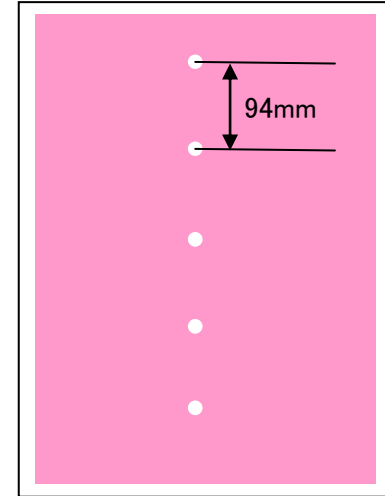
1. White dot / Void areas

Take the below action if 94mm interval white dots / Void areas appear at image toward vertical direction.

- a. Check whether the interval of appearance is 94mm after printing out the half image by U089 for the relevant color.
- b. After confirming 94mm interval, clean the drum surface with clean cloth.
- c. If appearance can not be eliminated by cleaning, replace DK-8505.
- d. Check the most updated firmware version and version up the firmware.

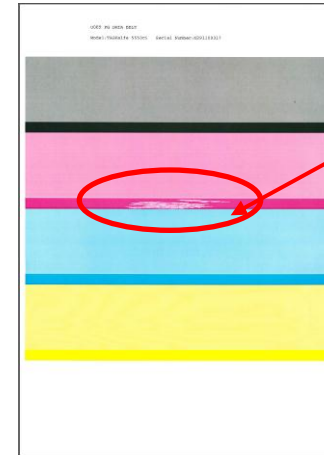
Image sample 1

- ◇ Leak at the solid part of image
Void image appears at the solid part.

U89 Color Belt
Void image at
Solid part

1. If the solid part of image become void after printing U089 Color belt, go to next 2. *** If the horizontal line appears at the Halftone image part, replace the developing unit.**
2. Execute U140 → AC Calib → High Altitude
3. Select the high Altitude and find out the point which leak image does not appear.
*Avoid the setting far from actual altitude .
4. If the image will not be recovered, replace the developing unit.
5. Install the new firmware (**Plan to release at 2012 March**).

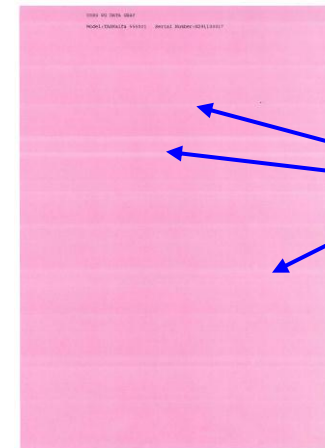
Image sample 2

- ◇ Halftone image leak
Horizontal streaks occur on halftone image

U89 Gray M
Horizontal
streaks on
Halftone image

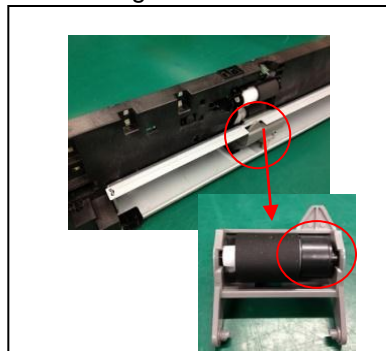
Fig.4 Check the installing direction of Pulley Retard

•As referring to Fig.5, check the installation condition of the Spring Retard whether it is misplaced or not.

h. If the problem is still not solved after performing above "g", replace the Primary Feed Unit.

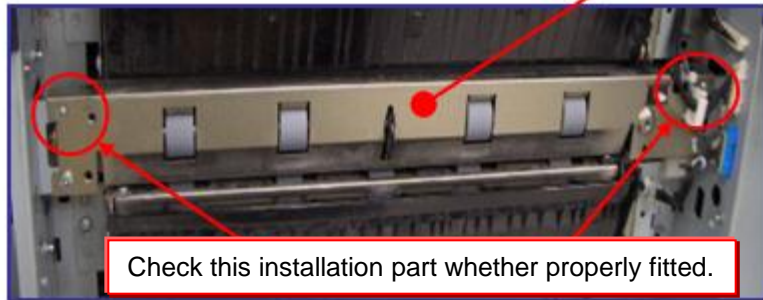
Check this installation part whether properly fitted.

- a. Check whether installing 302K994130 PARTS GUIDE FEED MIDDLE ASSY SP is proper.
→ The unit is not set properly, reinstall it.
- b. Check whether 302K994430 PARTS ROLLER FEED LOW SP is rotating without power on the clutch.
* refer to the procedure-1
→ If the clutch is rotating, change the clutch cable wiring treatment. * refer to the procedure-2
- c. If JAM is not solved after changing the clutch cable wiring, replace the 302K994130 PARTS GUIDE FEED MIDDLE ASSY SP unit.

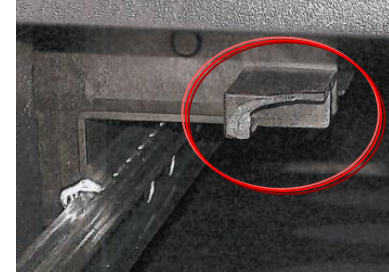
6. Check there is any breakage at the hook hang part of the bridge relay exit unit. (Right fig.)

→ If it is broken, replace the relay exit unit.

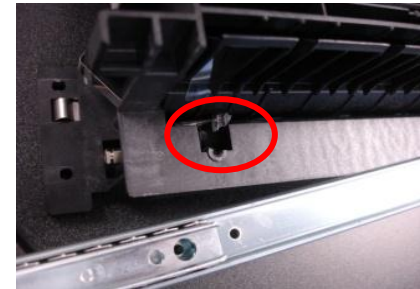
7. Check whether the screw fixed boss, positioning boss of the Rail installing section at the bridge relay exit unit is broken. → If it is broken, replace the relay exit unit.

No.	Old	New Parts No	Parts name	Q'ty
1		303NB94174 3NB94174	PARTS RELAY EXIT SP	1

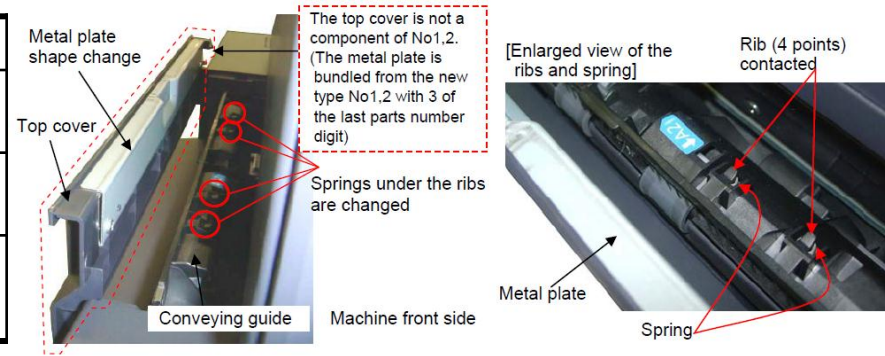
10. Check whether the rib (blue color round mark on the right fig) of the conveying guide of the bridge exit unit is broken or not.

→ In case of breakage, replace the below part No.1 to 3 as referring to the service bulletin "2LC-0068(C076)

No.	Old	New Parts No	Parts name	Q'ty
1		303NB94174 3NB94174	PARTS RELAY EXIT SP	1
2		302LF28621 2LF28621	+PLATE REINFORCEMENT EXIT	1
3		302LF28840 2LF28840	+SPRING-COMPRESSION RELAY EXIT	4

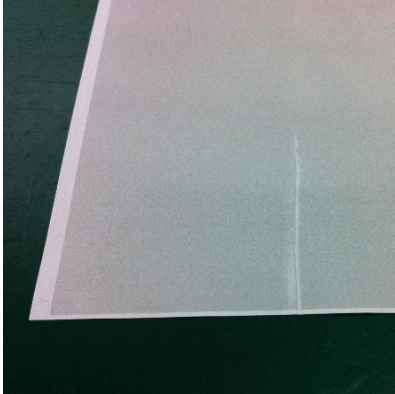
<Check the image sample>
On the image sample of creased paper, spread out the creased part and check if toner is not transferred to the creased

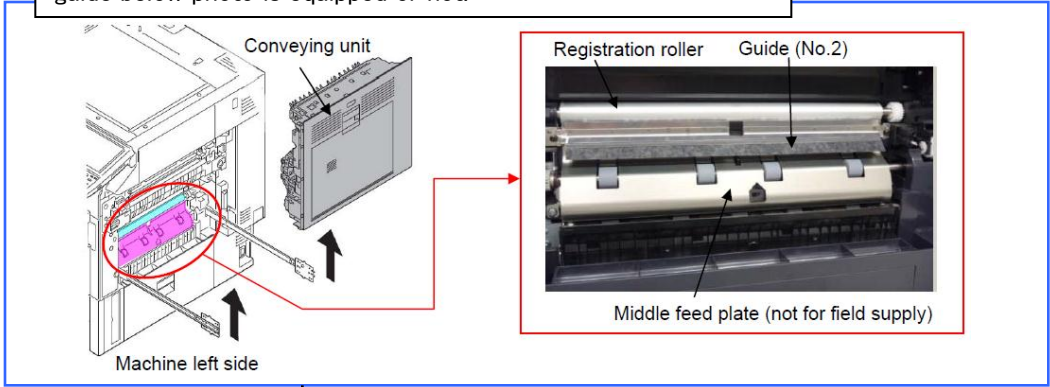
Ref.No. 2LC-0013(B213)

If the paper is above creasing condition, check whether modified guide below photo is equipped or not.

YES
Perform above service bulletin measurement contents.

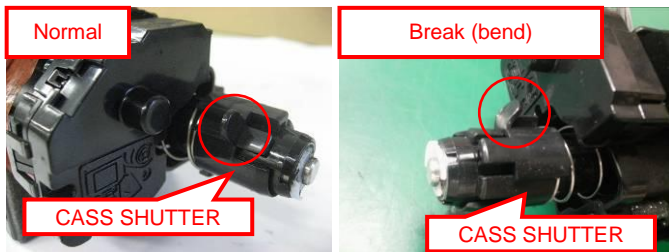
Fig.1

There is a possibility that DLP is LOCKing by jam in the developing powder outlet etc.
(It may be accompanied by the unusual rattling sound like no engagement of gears and C7101)

2. In case of no abnormal sound (developing drive possible)
 - a. Remove the INNER UNIT.
 - b. Check the CASS SHUTTER of the DLP UNIT.
 - c. If the parts is broken, replace the DLP UNIT.(Fig.1)
 - d. Re-assemble it as referring to below attention 1.

1. In case of abnormal sound occurs
 - a. Replace the DLP UNIT .
 - b. Re-assemble it as referring to below attention 1.

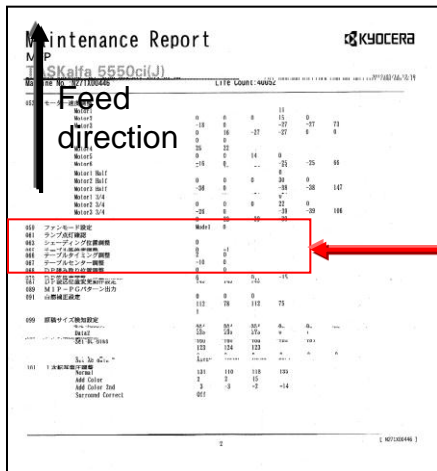
[Image block dropout] (example)

Content of failure	SATA cable to replace			
	No	Parts No.	Parts name	Affected model
- C9500 error - C9510 error - C9520 error - C0630 error - Scanned image block dropout (Refer to below for the image sample)	1	302K946700*	WIRE CCD DATA	5550ci/4550ci/3550ci/3050ci 5500i/4500i/3500i 7550ci/6550ci 8000i/6500i
	2	303M446020	WIRE INTERFACE VIDEO	7550ci/6550ci, 8000i/6500i DP-771
- C0640 error - F245 error	3	302K946A20*	WIRE HDD DATA1	5550ci/4550ci/3550ci/3050ci 5500i/4500i/3500i 7550ci/6550ci 8000i/6500i
	4	302K946A30*	WIRE HDD DATA2	5550ci/4550ci 7550ci/6550ci 8000i/6500i
