TASKalfa 6550ci/7550ci Trouble Shooting Guide

Revision 2

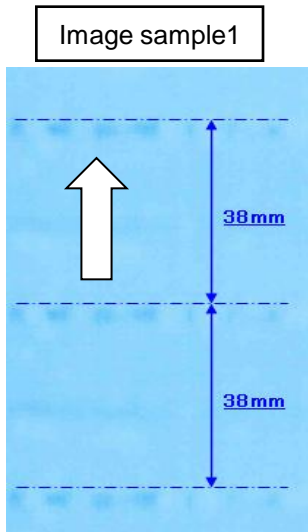
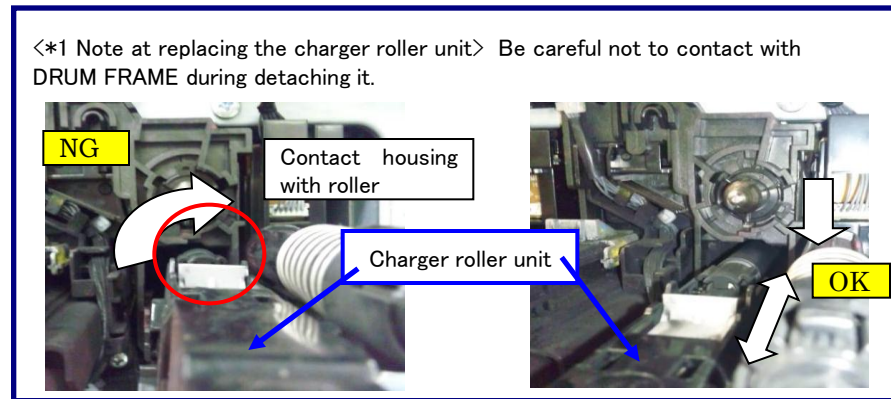
1. 38mm interval color dots (Charger roller)

Take the following measure when the 38mm interval color dots or marks appear vertical direction at image.

- Check the 38mm interval to print out the test sample by U089 Gray image.
- Replace the MC-8705 after confirming the dots appears 38mm interval. (*1)
- Execute U930 charger roller counter reset when dots disappear after replacing MC-8705.
If still dots on the image, replace the developing unit.

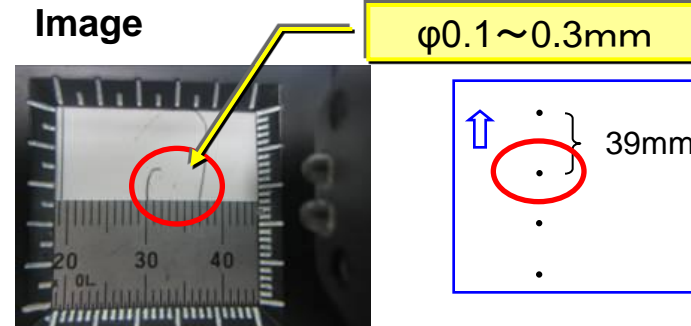
2. 39mm interval color dots (developing roller)

It appears at image 39mm interval paper in the conveying direction.

Above is to check the color dots on the paper by the Magnifying glass.

- Check whether the foreign substance are attached on the developing roller surface.
- If the foreign substance attached, wipe off by the clean cloth.
- If no foreign substance attached or it will not be disappeared after wiping off, replace the developing unit.

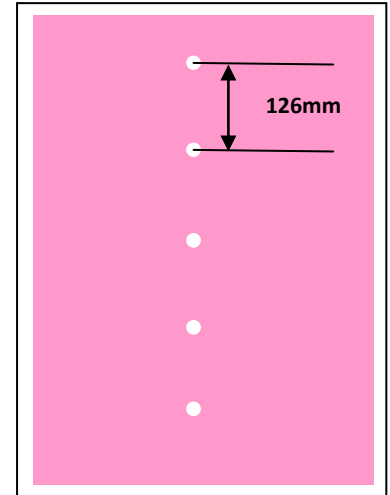
1. White dot / Void areas

Take the below action if 126mm interval white dots / Void areas appear at image toward vertical direction.

- a. Check whether the interval of appearance is 126mm after printing out the half image by U089 for the relevant color.
- b. After confirming 126mm interval, clean the drum surface with clean cloth.
- c. If appearance can not be eliminated by cleaning, replace DK-8505.
- d. Check the most updated firmware version and version up the firmware.

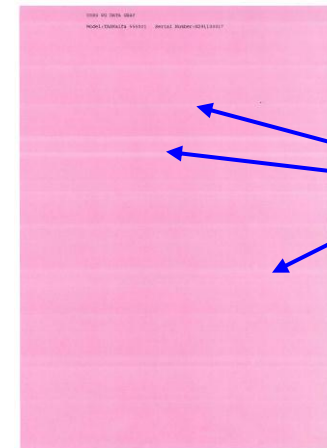
Image sample 2

- ◇ Halftone image leak
Horizontal streaks occur on
halftone image

U89 Gray M
Horizontal
streaks on
Halftone image

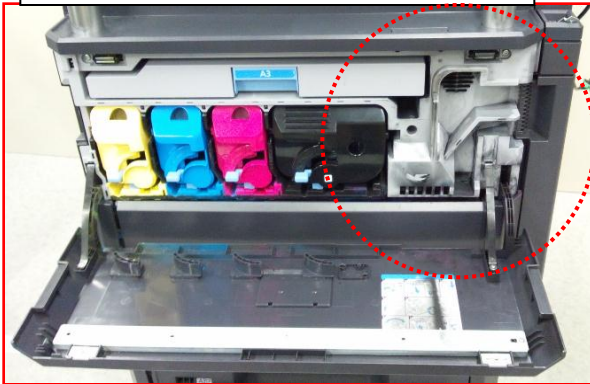
Toner stain on the inside of front cover.

→ Perform “2.Clean toner stain at inside of machine”.

→ Please use the PARTS SEAL SET SP, and replace the New Inner Unit.

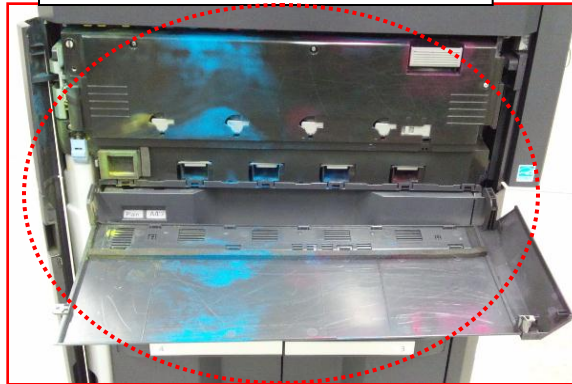
Toner stain on the inner unit cover.

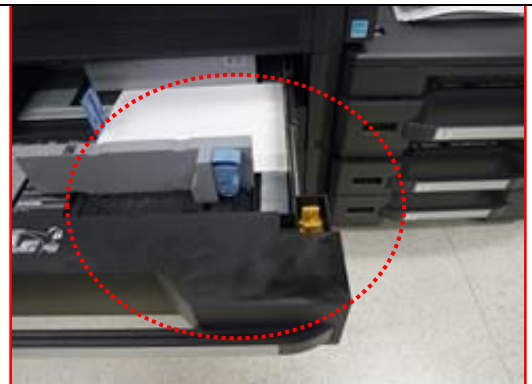
Toner stain at the first cassette (cover, cursor)

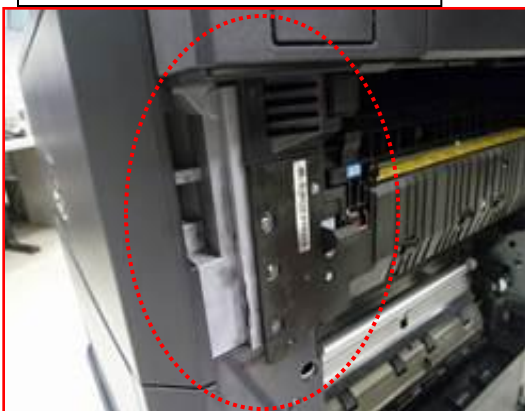
Toner stain on the inner cover.

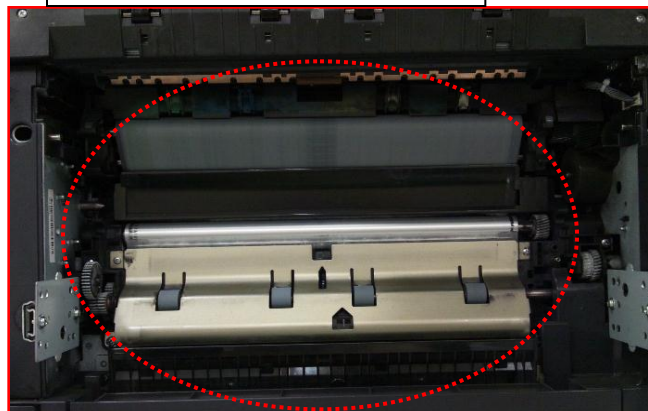
Toner stain on the conveying guide.

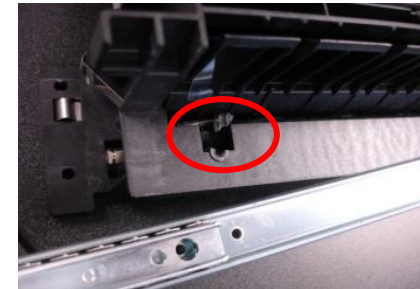
4. Check whether the screw fixed boss, positioning boss of the Rail installing section at the bridge relay exit unit is broken. → If it is broken, replace the relay exit unit.

Refer to the service bulletin : 2LC-0034(B395)

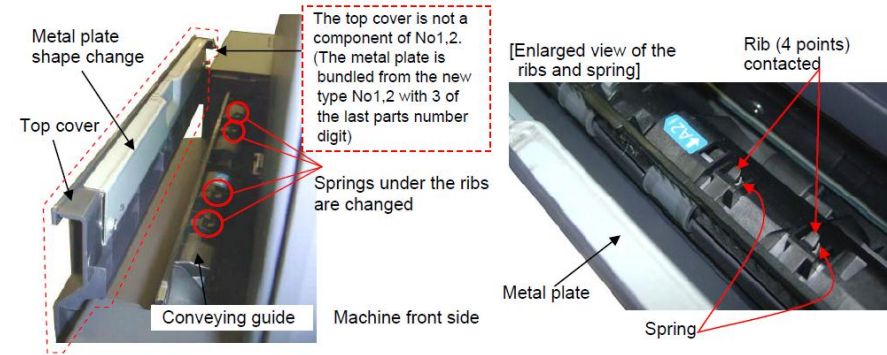
5. Check whether the rib (blue color round mark on the right fig) of the conveying guide of the bridge exit unit is broken or not.

→ In case of breakage, replace the below part No.1 to 3 as referring to the service bulletin "2LC-0068(C076)

Refer to the service bulletin: 2LC-0068(C076)

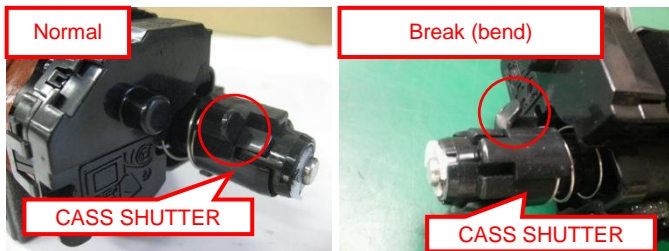
Fig.1

2. In case of no abnormal sound (developing drive possible)
 - a. Remove the INNER UNIT.
 - b. Check the CASS SHUTTER of the DLP UNIT.
 - c. If the parts is broken, replace the DLP UNIT.(Fig.1)
 - d. Re-assemble it as referring to below attention 1.
