# Service Bulletin

Ref. No. **COM-0218 (B056)**

<b>Subject</b>	<b>Note when releasing the paper jam/maintaining the machine (Prohibition of use of the flammable sprays and liquids)</b>
<b>Model</b>	All models

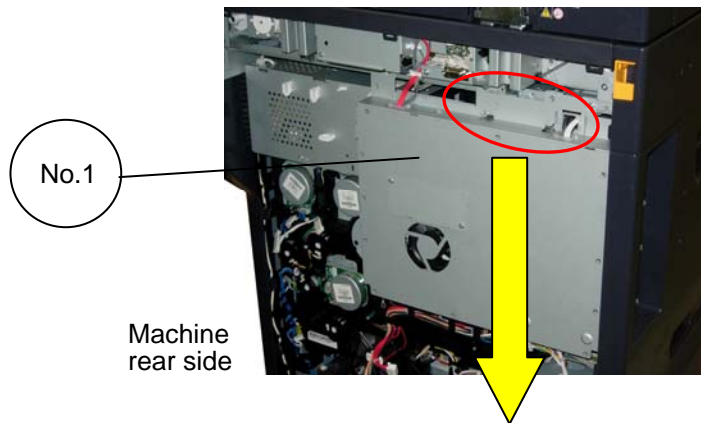
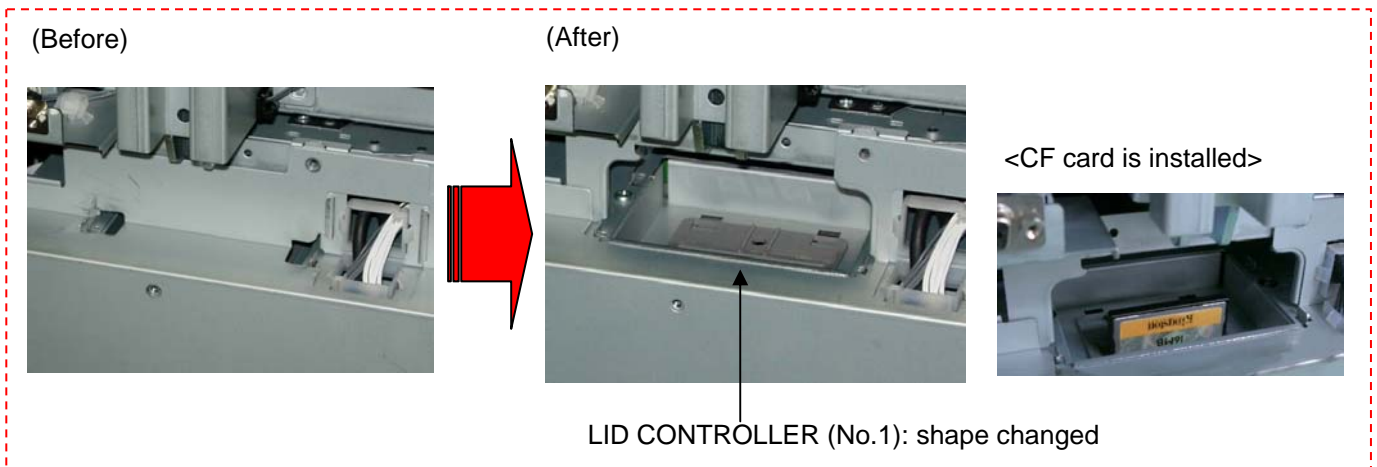
The shape of LID CONTROLLER (No.1) on the controller box is changed as follows to make it easy to attach and detach a CF card. The CF card can be attached and detached without removing LID CONTROLLER (No.1) after this change.

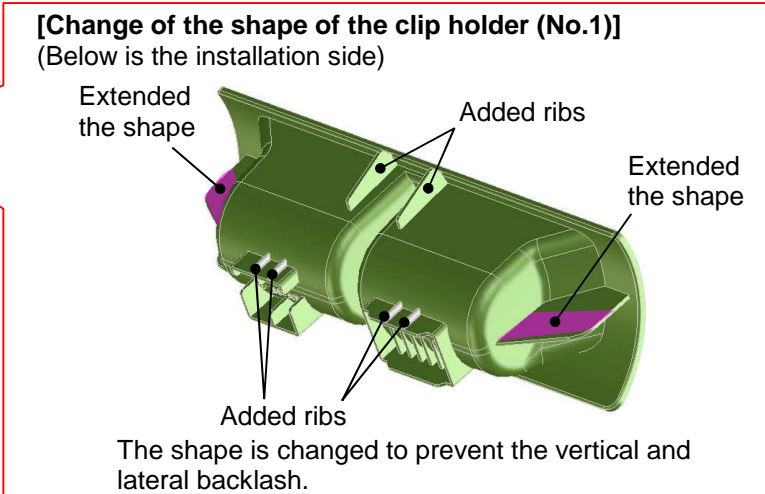
This convex part prevents the clip holder (No.1) from coming off before this change.

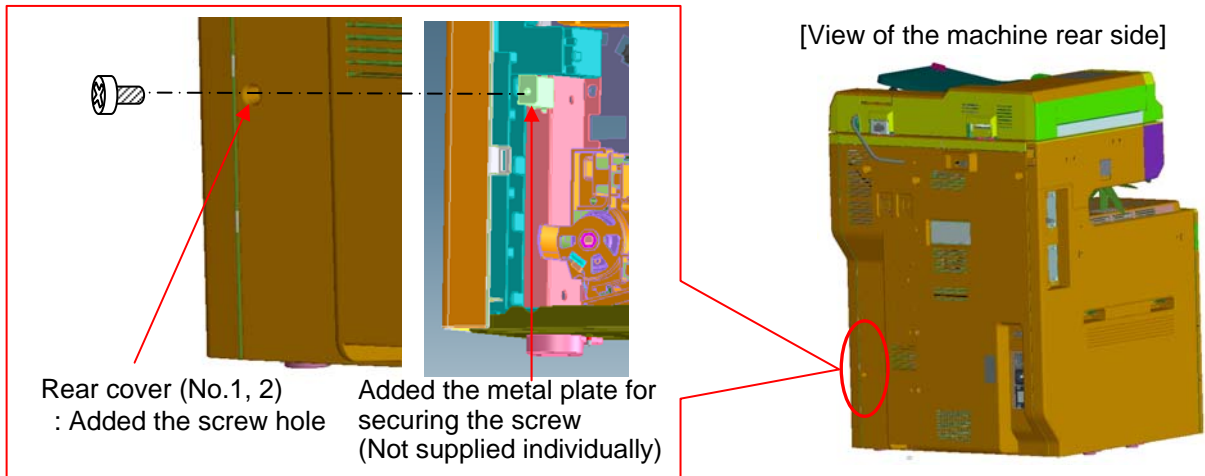
An attention is required when replacing the rear cover according to this change, and refer to [Field Measure].

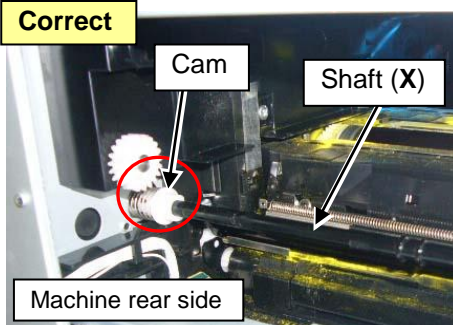
If the shaft (X) comes off, the abnormal noise from the intermediate transfer unit may be heard or the toner may leak from the retainer section. (Please refer to the next page for the detailed occurrence mechanism.)

<p>Machine rear side</p> <p>The shaft (X) is inserted into the cam of the drive unit.</p>

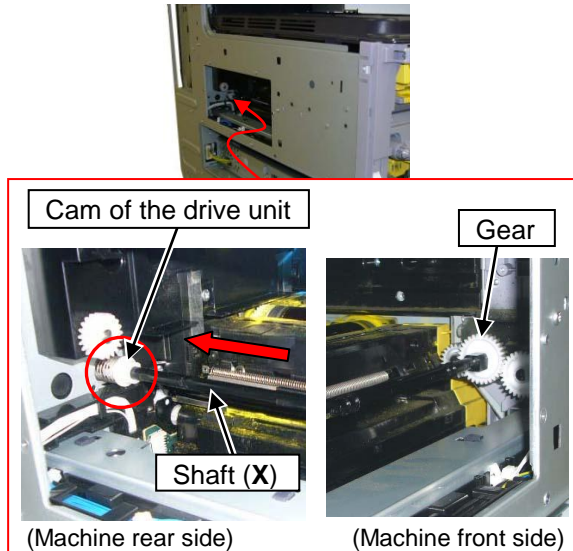
<p>Cam of the drive unit</p> <p>Gear</p> <p>Shaft (X)</p> <p>(Machine rear side)</p> <p>(Machine front side)</p>
<p>Refit the drive unit (*).</p> <p>* DR-895 (302K09312_)</p>	<p>Remove the left lower cover, the main PWB and the intermediate transfer unit. This is to insert the shaft (X) into the cam of the drive unit from the aperture of the metal plate behind the main PWB.</p>	<p>Insert the shaft (X) into the cam of the drive unit.</p> <p>(Note) At this time, confirm the front end of the shaft (X) is inserted into the gear at the machine front side.</p>
