HP CM8060/CM8050 Color MFP with Edgeline Technology

Service Manual

Edition 5.0, 2/2009

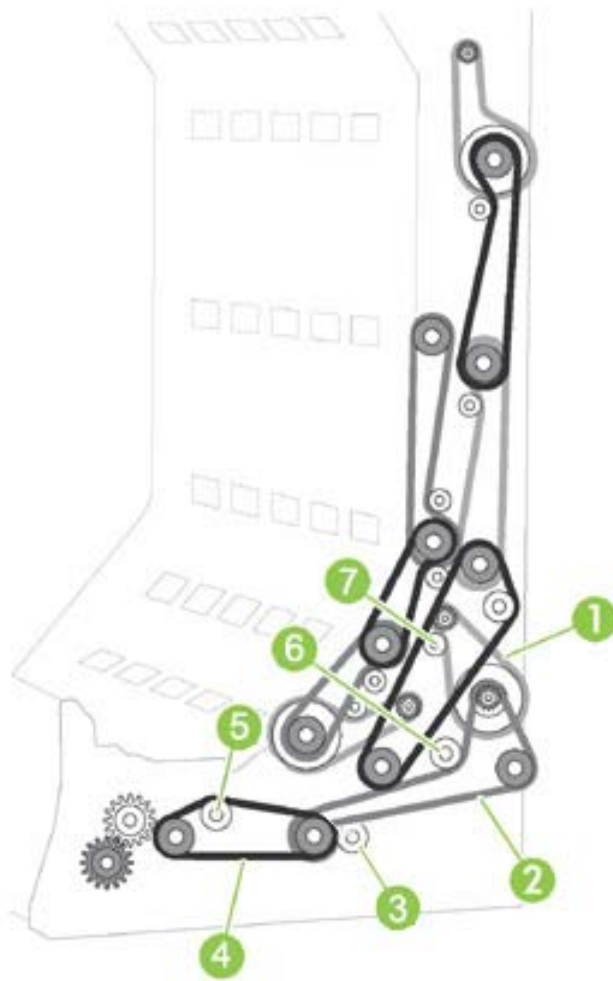
1. Remove the IDO RM.
[IDO removable module \(IDO RM\) on page 400](#)
2. Replace the IDO curler output transmission belts and pulley assemblies included with the PM kit.

1	Belt-71T
2	Belt-162T
3	Short flanged tensioner
4	Belt-97T
5	Mid flanged tensioner
6	Idler pulley 14mm assembly
7	Idler pulley (flangeless) assembly

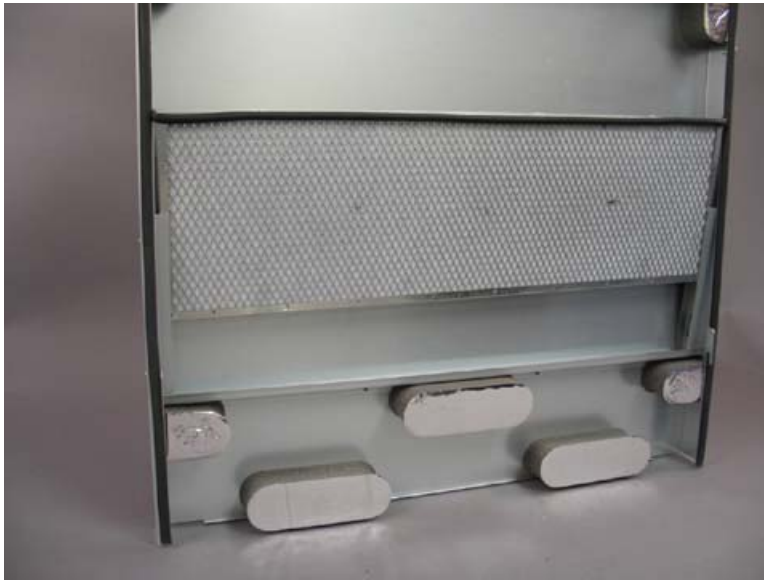
Replace the charcoal filter at the scheduled preventive maintenance interval. The filter is located inside the muffler case part.

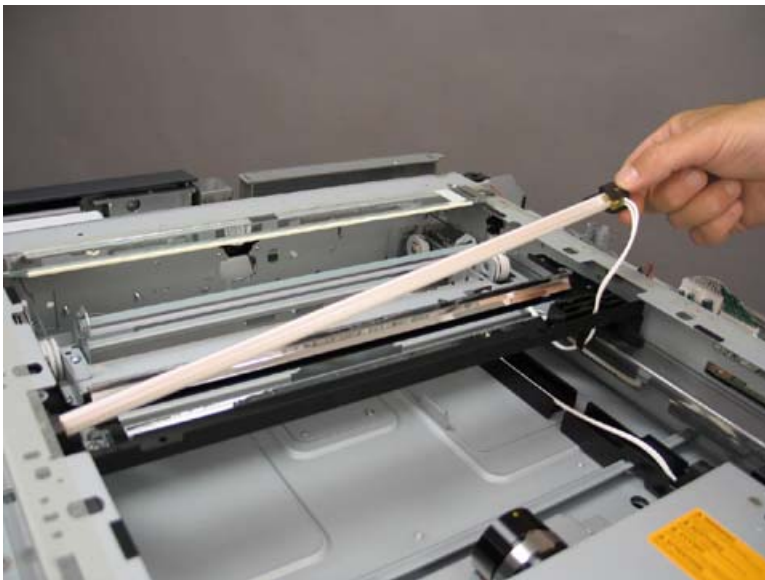
5. Lift out the lamp and cord.

📄 **NOTE:** The scanner exposure lamp is a preventive maintenance item and is replaced at scheduled intervals. See [Service intervals on page 79](#).

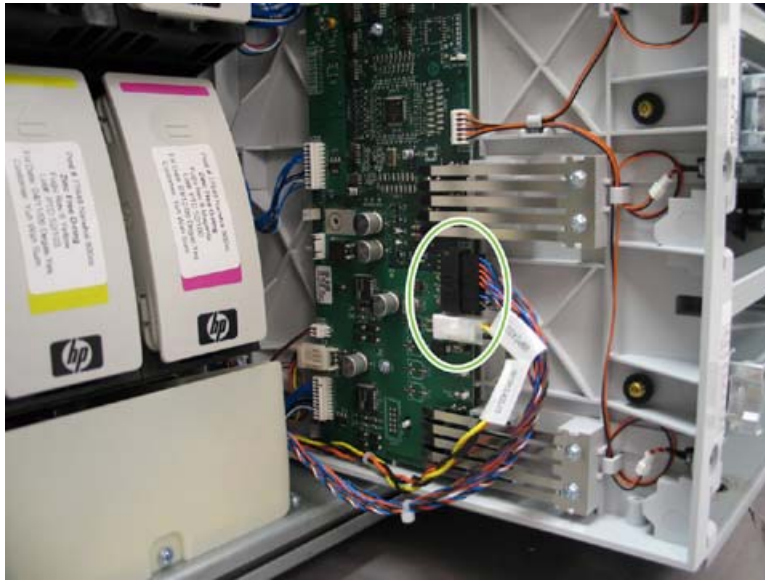
6. On the left side of the Trays 2, 3, and 4 assembly, disconnect the two wire connectors.
 - W11P13-A23J13
 - W9P9-A23CN12

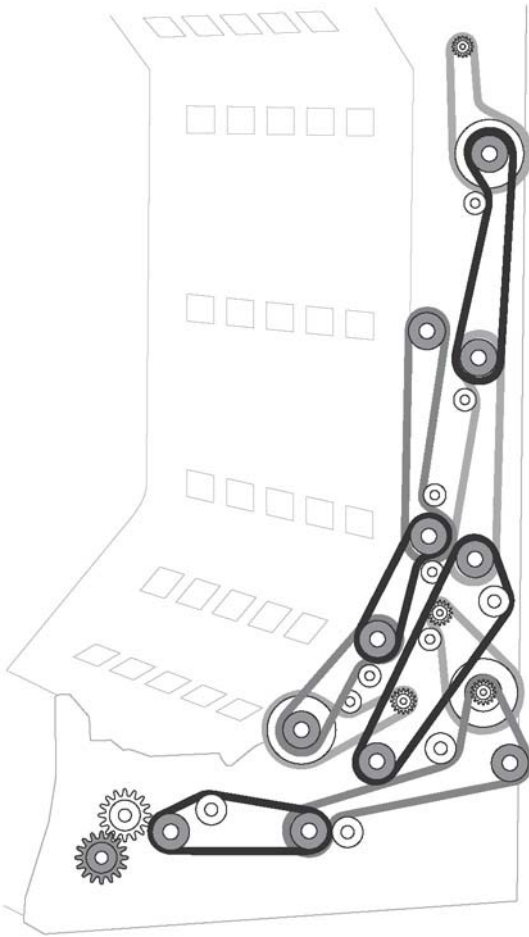
Use the following illustration as a guide for belt locations on the IDO.

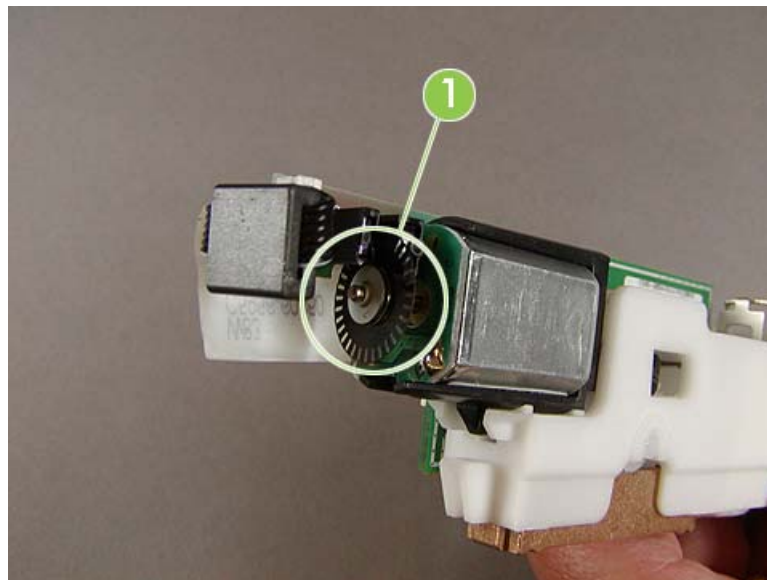
- If the hole is not already underneath the sensor, gently turn the encoder wheel (callout 1) until the hole in the sensor disk is underneath the sensor.

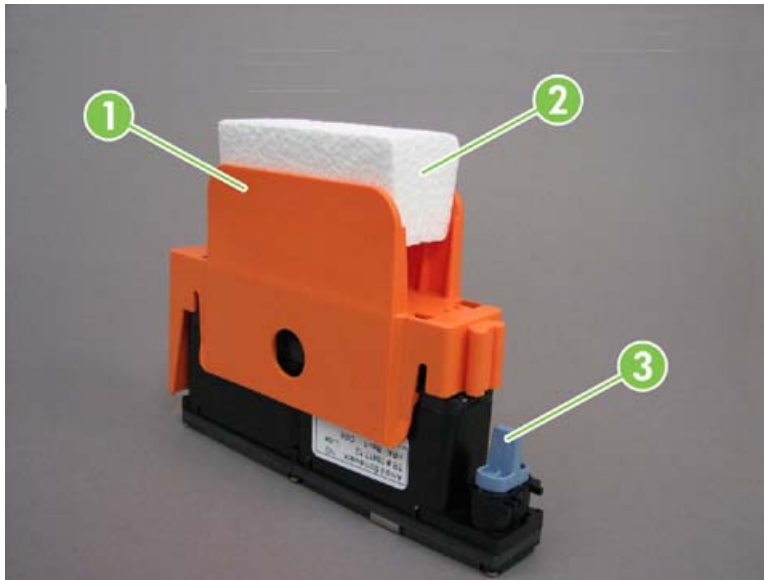
⚠ **CAUTION:** The pen contacts are sensitive to electrostatic discharge (ESD). Do not touch the exposed side or bottom contacts on the pen after removing the cap.

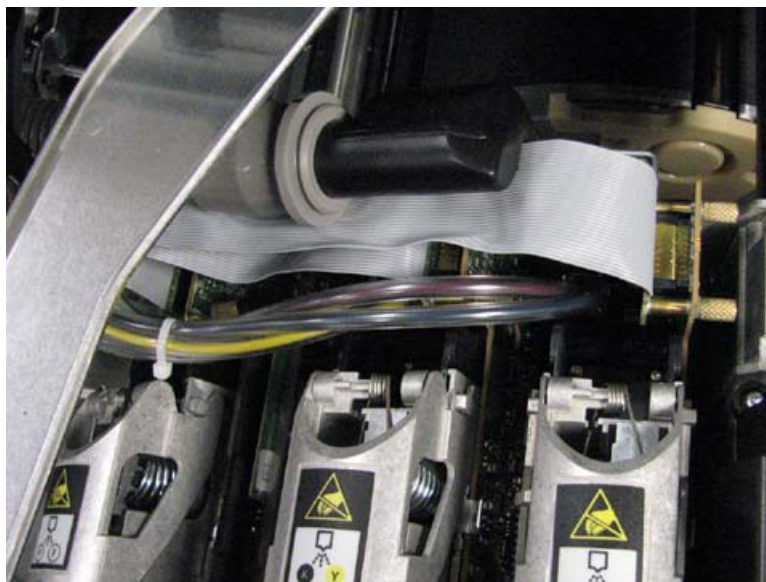
💡 **Reinstallation tip** Ensure the ink tubes are routed **in front** of the trailing cables.

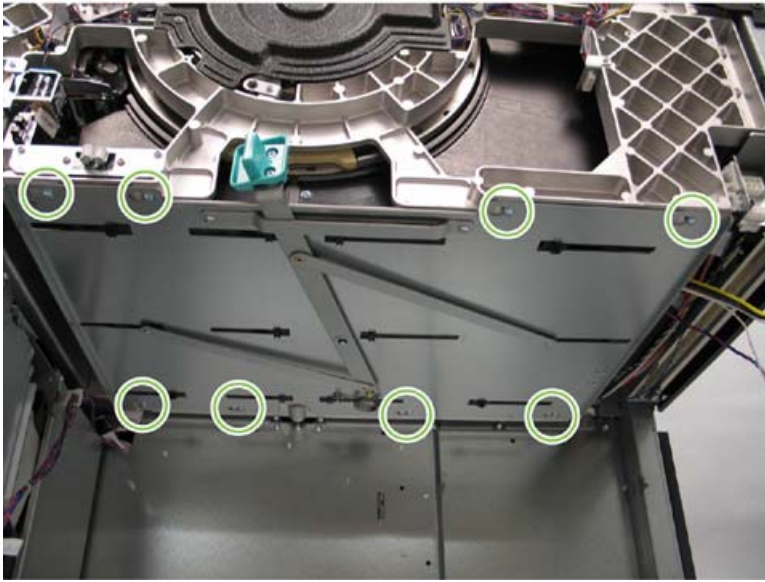
5. Loosen eight screws underneath the dryer plate far enough that the dryer plate falls below the line-up pins.

- 💡 **Reinstallation tip** Tighten the front-left corner screw first. There is a locating pin in that corner to help with alignment of the dryer.

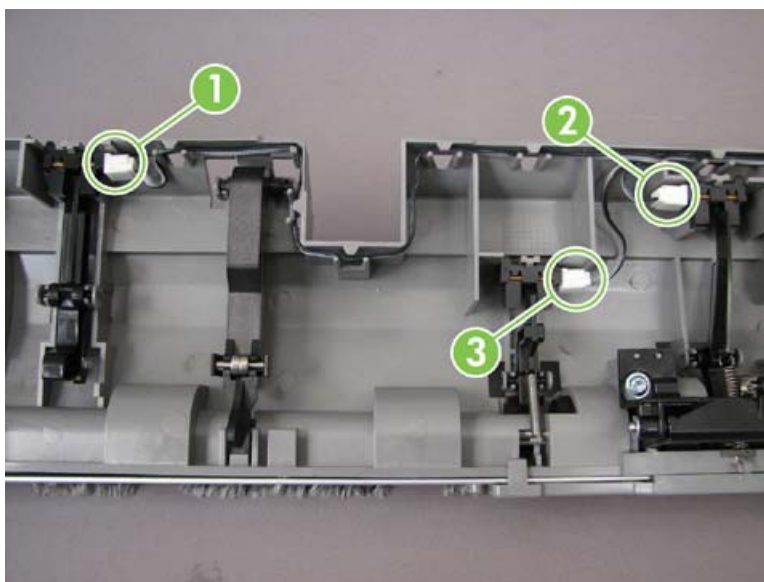
1	Accumulator Job Height sensor (SN240)
2	Accumulator Wheel sensor (SN241)
3	Accumulator Exit sensor (SN242)

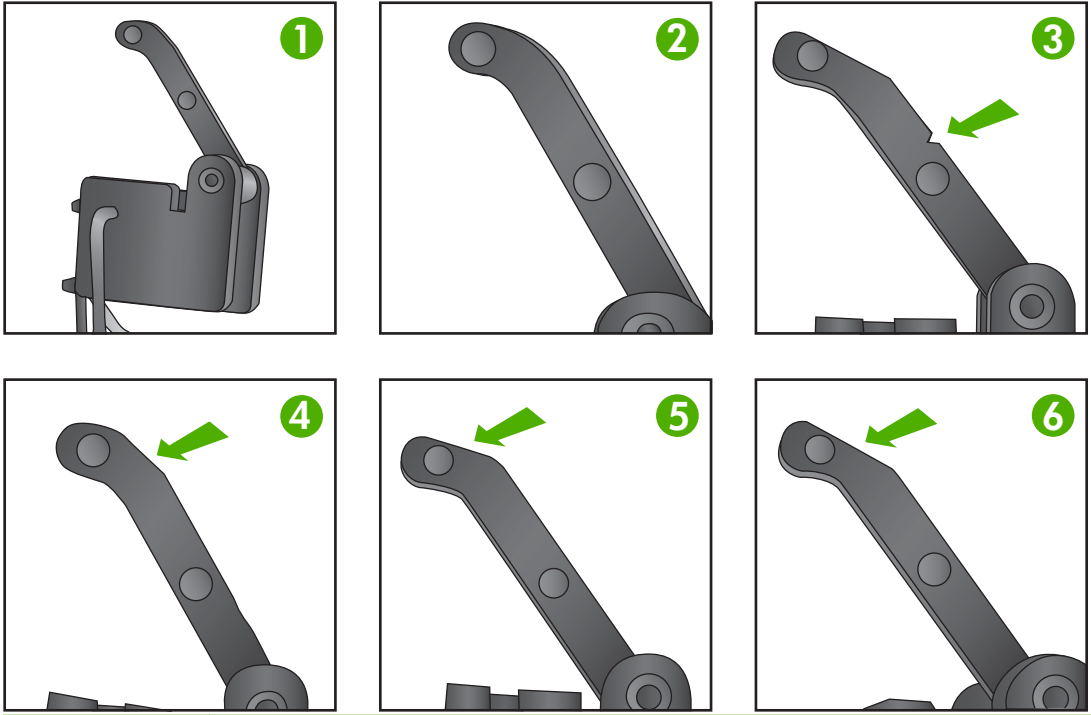
1	Good actuator
2	Close-up of good arm
3	Worn arm (nick on arm)
4	Worn arm (flat spot —variation 1)
5	Worn arm (flat spot —variation 2)
6	Worn arm (flat spot —variation 3)

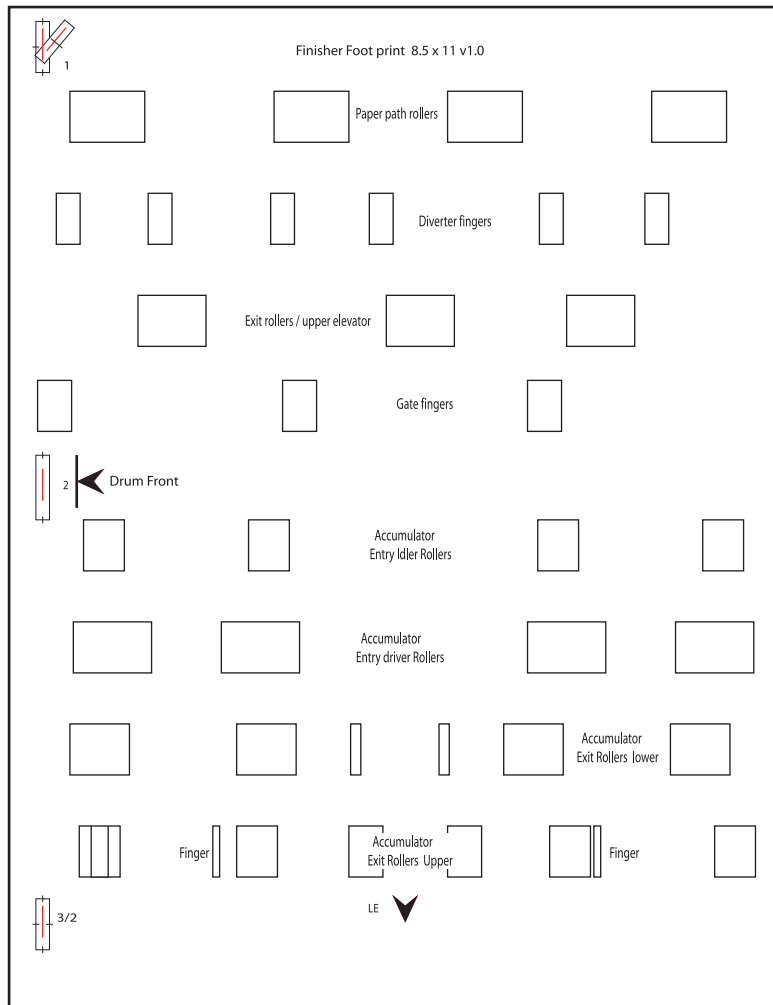
Use the Finisher Footprint test page to determine whether rollers or diverter fingers in the finisher paper path are marking, damaging, or contaminating the prints. This test page shows where the finisher rollers make contact with the paper. Check the roller that corresponds to the area of the test page that was damaged or contaminated. Look for smudges, damage, roller tracking marks, nicks, or dents where the diverter fingers contact the page.
