Knowledge Base

Product : DR 2080C

Title : How to install a DR 2080C scanner on an XP PC via a SCSI port.

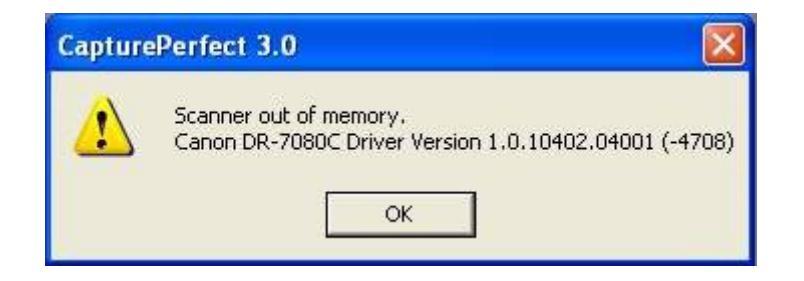
A "Scanner out of Memory" message appears when scanning documents larger than A3 in 24-bit Color or 256-level Gray.

The long document mode used to scan documents larger than A3 does not support the 24-bit Color or the 256-level Gray scan mode. Documents larger than A3 can only be scanned using the Black and White scan mode.

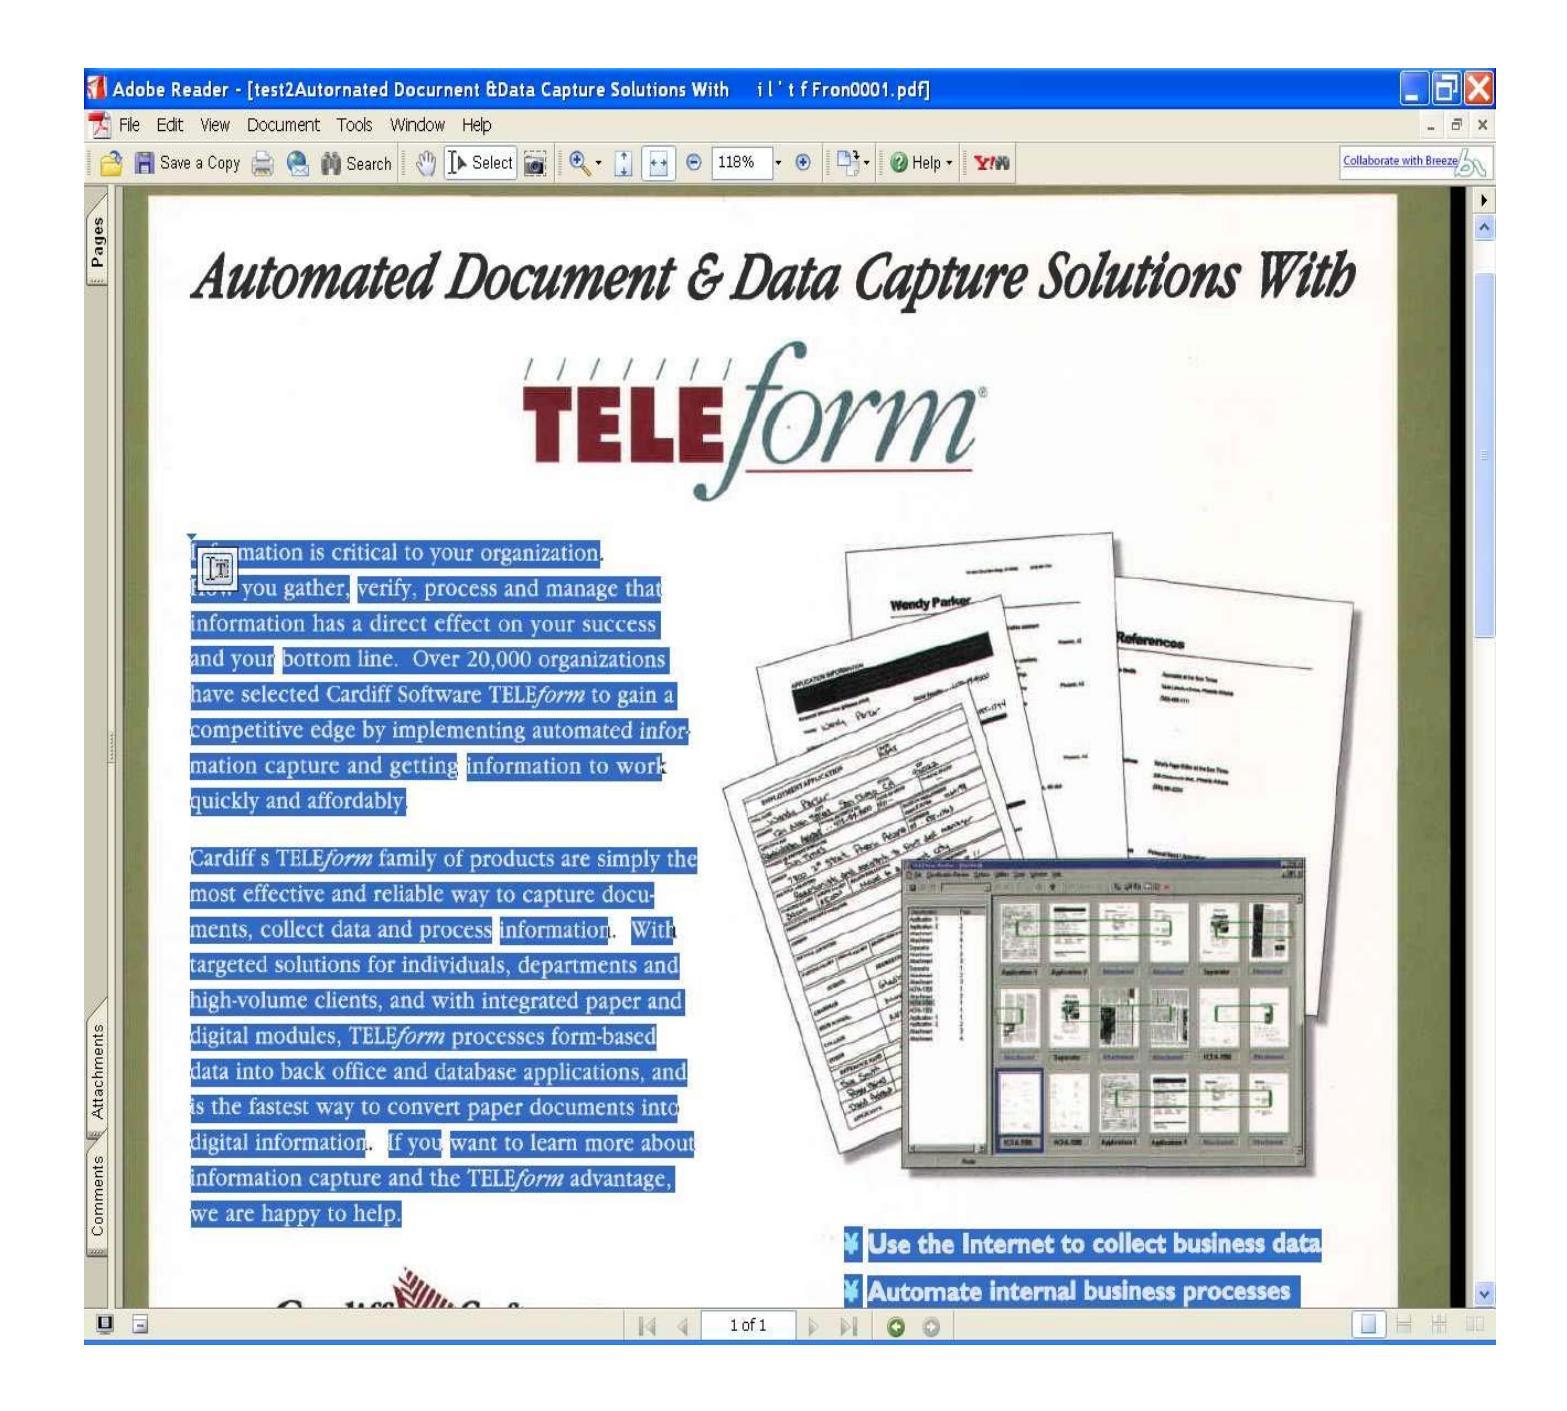
The Notepad will then display the words of the document how they were interpreted by the software. Below is the cut and paste version of how the software read the document, as you can see the work "capture" was not correctly read. If you did a word search on the work "capture" it would not show up.

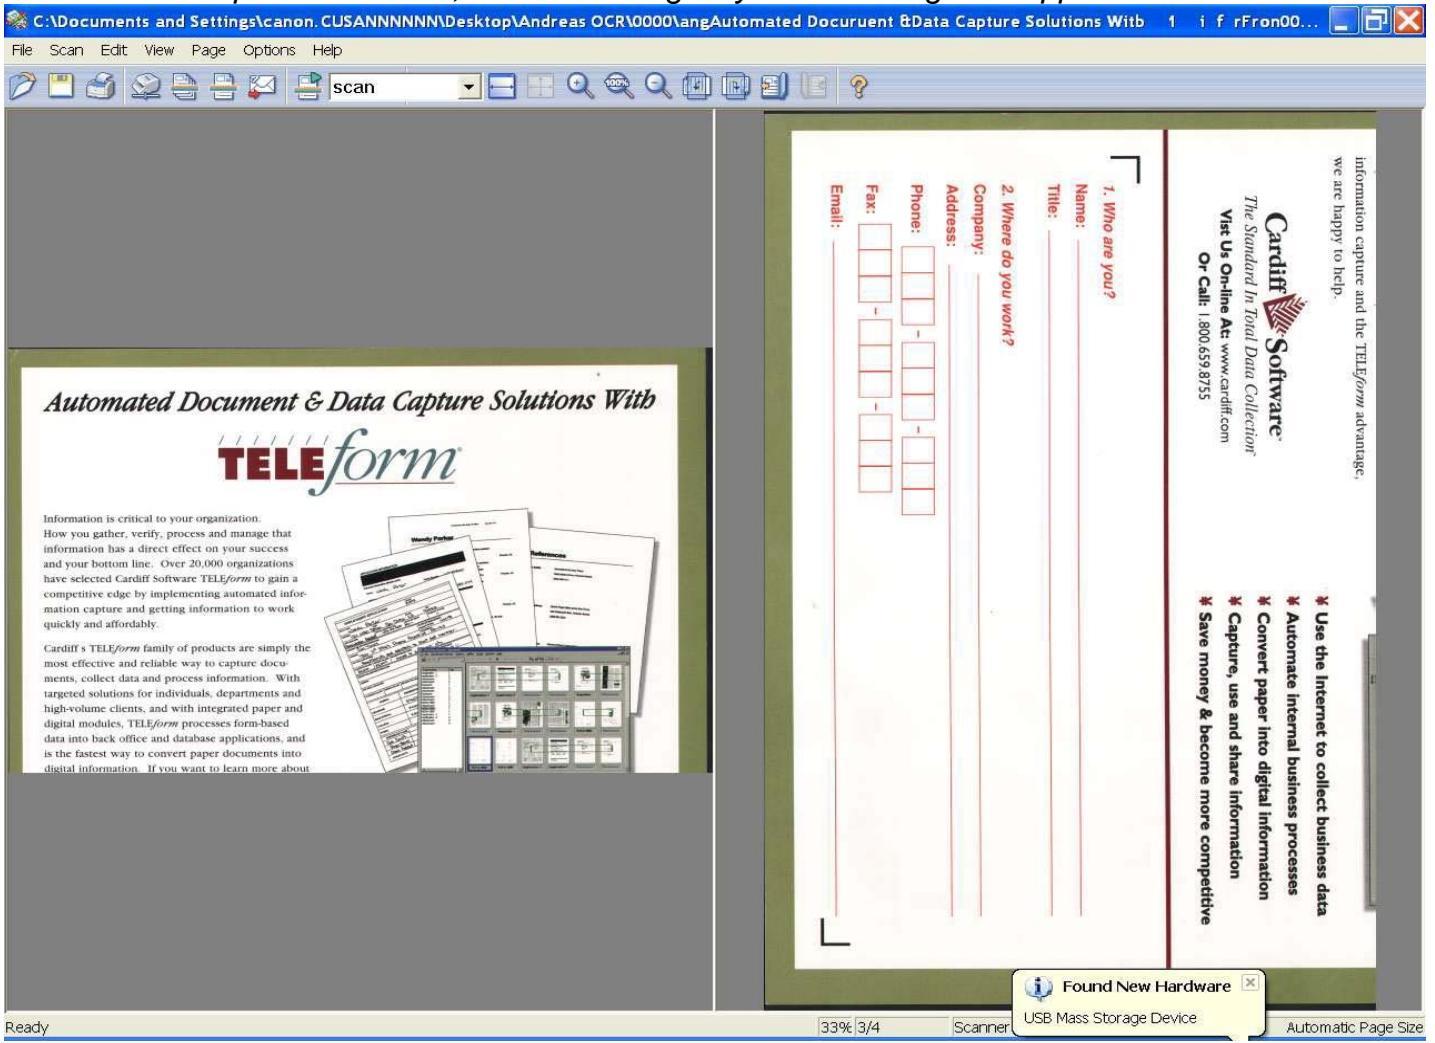
When scanning a batch the image shows as two half images on the Computer Display. Looking as if the page was cut in half. .

Note: This is a split screen view, when scanning only half the image will appear.

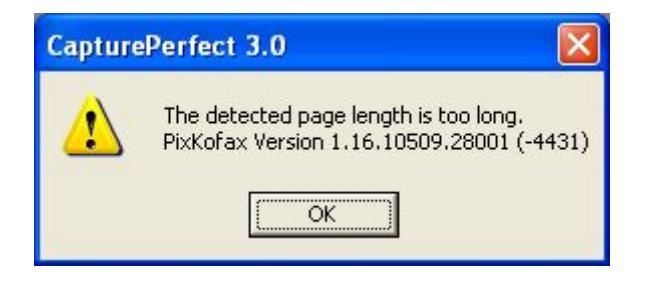
The message "The detected page length is too long" occurs when scanning documents longer than 17" with the Kofax VRS driver into Capture Perfect 3.0.

Scanning documents longer than 17" with the Kofax VRS driver is not supported by Capture Perfect 3.0. Capture Perfect 3.0 only supports scanning documents longer than 17" with the Canon ISIS Driver.
