# **Troubleshooting Guide**

# **imageRUNNER ADVANCE**

# **8500 III/6500 III Series**

September, 2019  
OIP Field Quality Assurance Div.

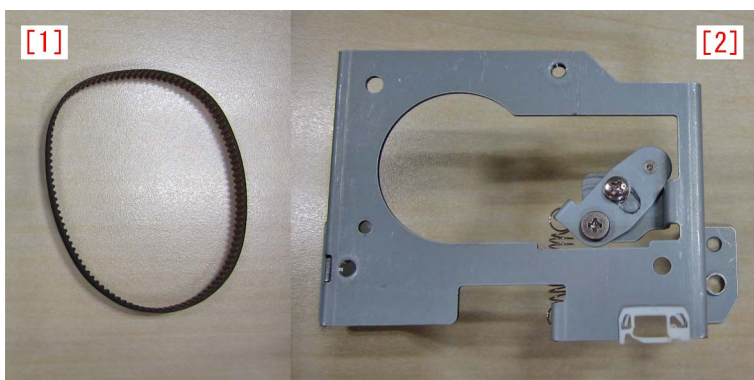
The timing belt [2] in the operation feed motor (M26) [1] is designed to keep its tension and prevent from being loose by having the tensioner [3] pressed in the direction of the arrow. This tensioning method is "unfixed type". However, the pressing power of the tensioner [3] in the unfixed type is insufficient in some cases and when the operation feed motor (M26) [1] drives rapidly a meshing failure occurs on the timing belt because of power, resulting in the above symptom.

When the above symptom occurs, prepare and replace the paper delivery drive set (L) (4Y8-3156-000).

The paper delivery drive set (L) (4Y8-3156-000) contains the following 2 items.

- Timing belt [1]
- Paper delivery drive assembly (L) [2]

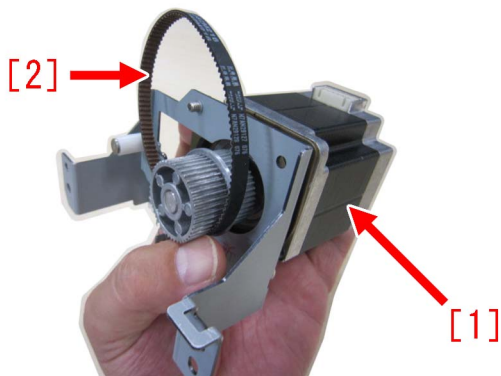
[Note] When replacing to the paper delivery drive assembly (L), be sure to also replace the timing belt [B] at the same time that is included in the set. 110F jam occurs when using the old type timing belt [A] as the number of teeth of the new type is different from the old type originally attached to the engine.

4) After attaching the timing belt [2] that is included in the set to the paper delivery drive assembly (L) [1] with the motor attached, attach the whole thing to the machine using the 2 screws removed in the step 2).
