3500i/4500i/5500i/6500i/8000i Troubleshooting Guide

2013.11.18 3rd Edition

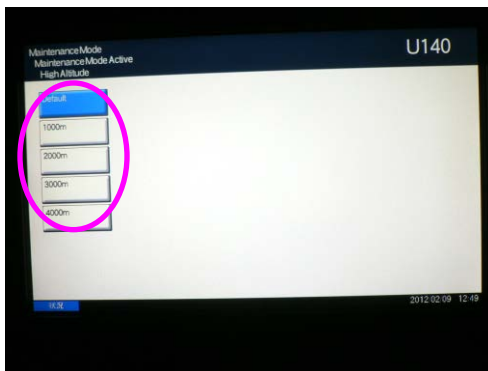
Image sample 1

1. Leak Image 1 (3500i, 4500i)

- ◇ Leak at the solid part
Void image appear at the solid part.

- If the void image appear at solid part of prints out on U089 Color Belt, refer to below “b” * If the vertical streak image appears at the halftone, replace the developing unit.
- Execute U140 → AC Calib→ High Altitude
- Select “Altitude” and find the setting which the leak image does not appear. * Avoid the setting far from the actual altitude.
- If the image will not be recovered, replace the developing unit.

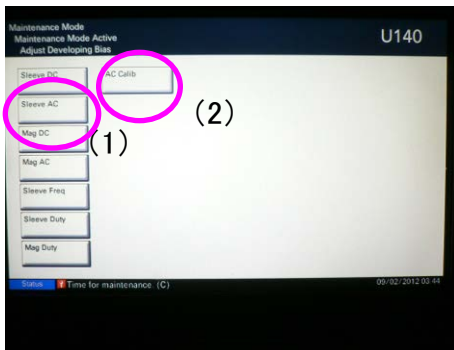
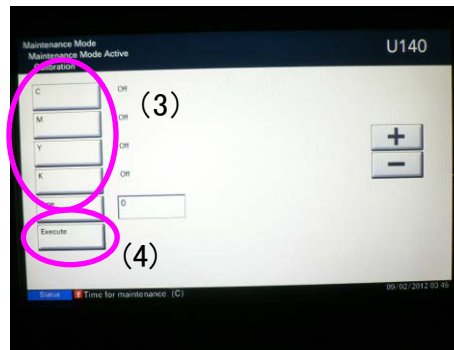
U89 Sample set
Horizontal streaks
at halftone image

- If the void image appear at solid part of prints out on U089 Color Belt, refer to below “b” * If the vertical streak image appears at the halftone, replace the developing unit.
- Check the value of U140 Sleeve AC (1)
- U140 → Execute AC Calib (2) → Set “K” Off to On (3) → Execute (4) → Start
- Check whether the value of U140 Sleeve AC (3) becomes lower and the image is recovered.
- If the image will not be recovered, replace the developing unit.

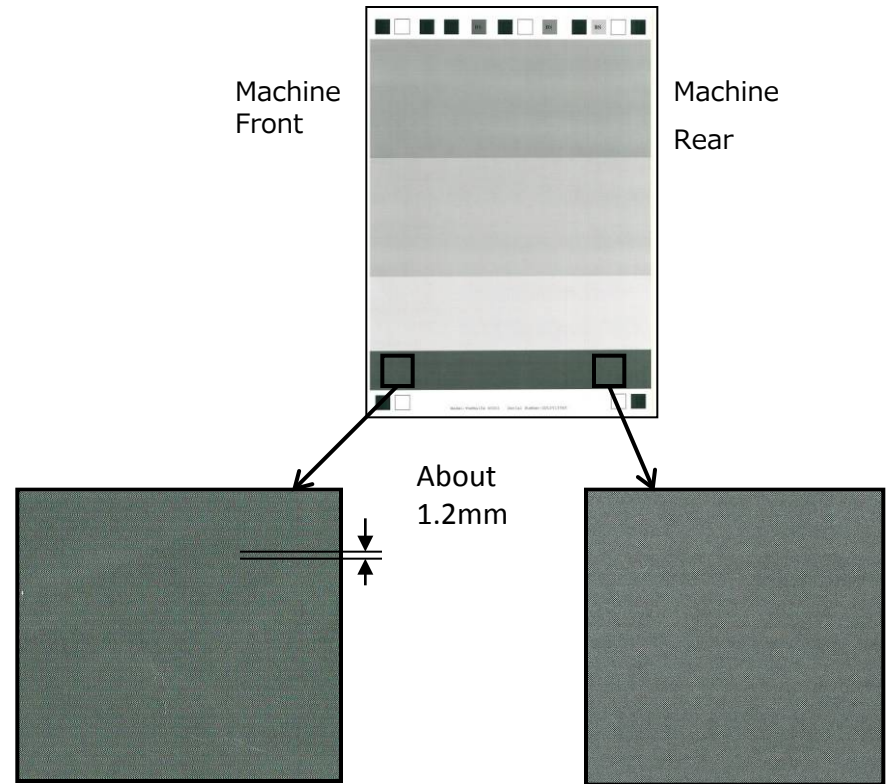
Image sample 1

If 1.2mm interval horizontal streaks occur at the gray image in the main scanning direction, take the following measure. *In case of this appearance at the machine's rear side is more noticeable than at front.

a. Replace the LSU.

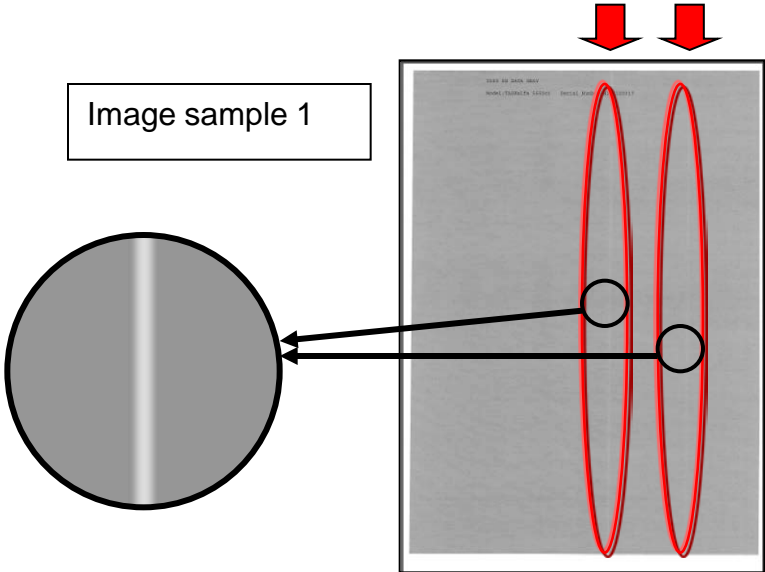
Vertical white streaks

If vertical white streaks appears continuously and linearly in the sub scanning direction, take the following measure.

- a. Clean the cover glass on the LSU.

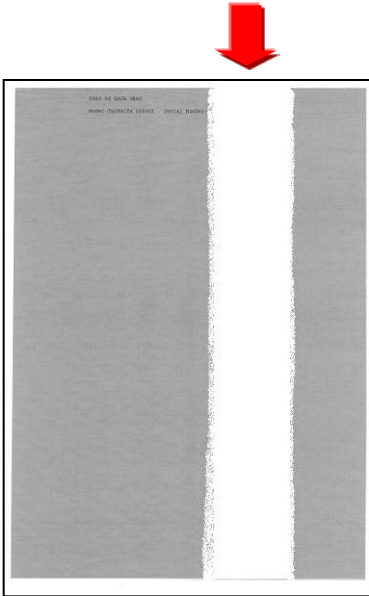
Image sample 2

If the void image appears by wide width in the sub scanning direction, take the following measure.

- a. Replace the LSU. (In case of the machine is produced before 2011 Oct.)

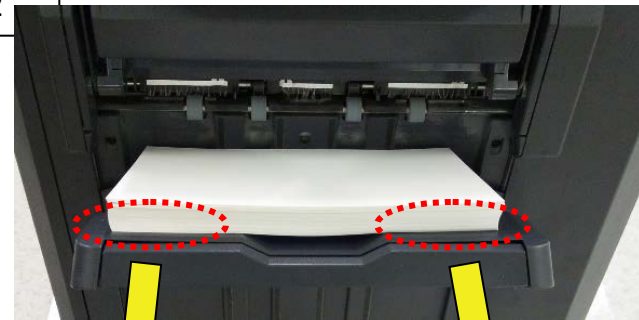
Image sample 2

The smudges appears at the leading edge of ejected paper.

View from bottom part of ejected paper

Refer to "3.Cleaning Procedure" for cleaning.

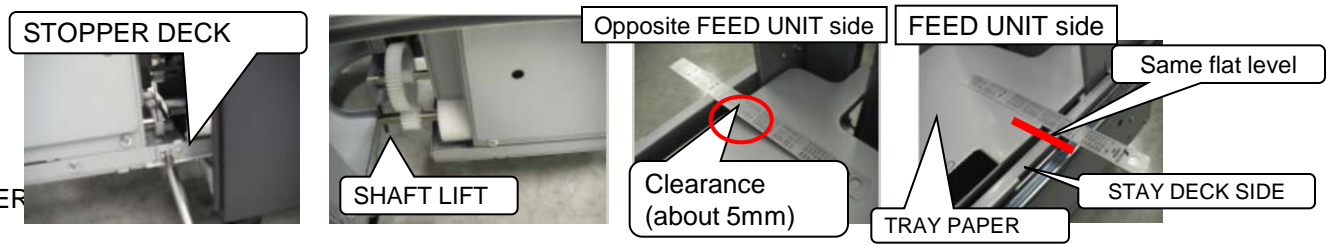
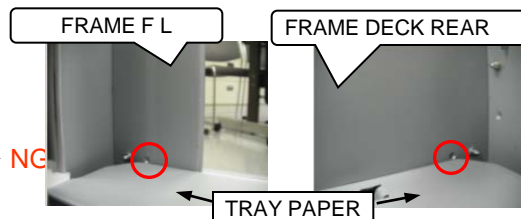
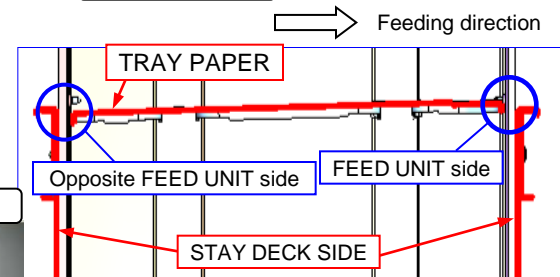
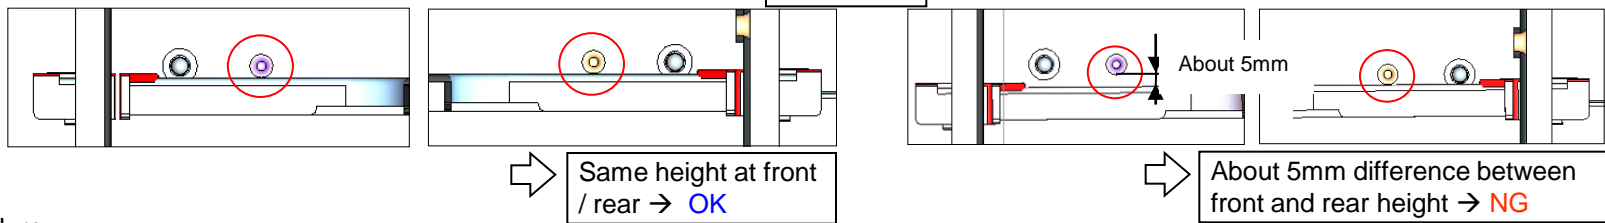
- d. If the TRAY PAPER for paper loading was assembled by slanting condition, there is possibility of JAM0545 occurring. In case of the problem, check it according to the next page "Inclination check and recovering procedure of PF-770 TRAY PAPER" and corrected.
(There is a possibility that J0545/0555/1305/1315 may occur.)

Turn the SHAFT LIFT and adjust the top part of STAY DECK SIDE becomes the same flat surface level with the TRAY PAPER at the FEED UNIT side.

In that height position, check that the TRAY PAPER surface of the opposite FEED UNIT side is lower than the STAY DECK SIDE top part. In addition, the height of STAY DECK SIDE is the same height at the FEED UNIT side and opposite FEED UNIT side.

- 1) Same flat height level at front and rear → OK
- 2) If it has about 5mm difference height between front and rear → NG

If above item 2 and 3 is NG, the following re-assembling is necessary.

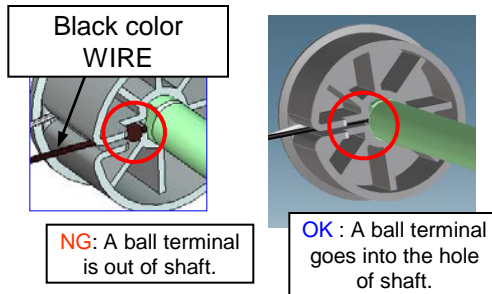
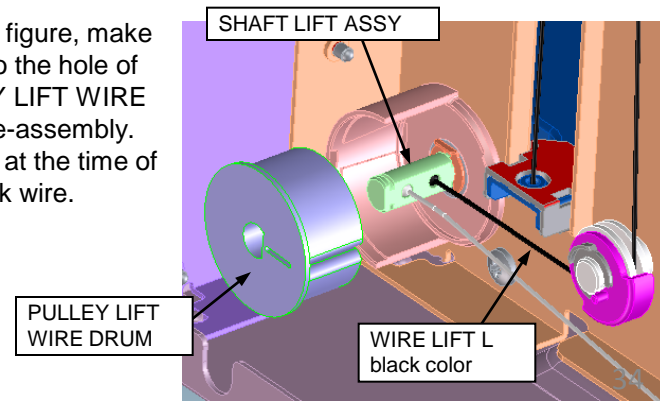
normal, it has a possibility that the ball is out of position as shown in the NG figure, re-assembly of the wire is necessary.

In the case of NG above item 2, it has a possibility that the ball is out of position at both of front and rear, re-assembly of a front and rear wire is necessary.

* As shown in the right figure, make it a ball terminal go into the hole of SHAFT within PULLEY LIFT WIRE DRUM at the time of re-assembly. Be cautions especially at the time of the assembly of a black wire.

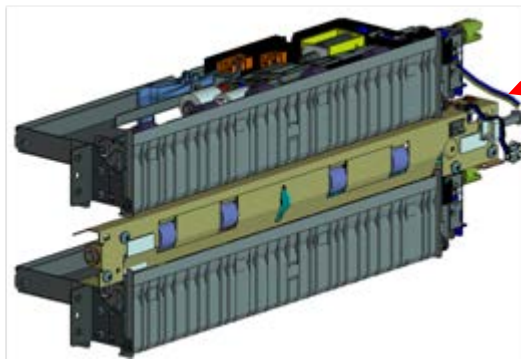
Paper conveying sensor (PCS/PFPCS2)

The paper conveying actuator is scraped for a long usage, J1904 and J150X occurs due to sensor detection failure depending on the paper.

Width of the protrusion of the paper detection parts to paper path is 0.85mm. The protrusion is frictionally worn down due to the contact with paper and the paper detection margin decreases.

Replace the actuator (ACTUATOR FEED LOW 302N706500) when the problem occurred.

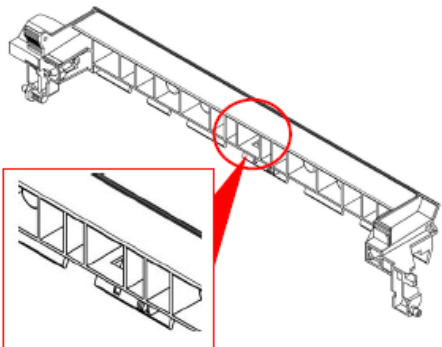
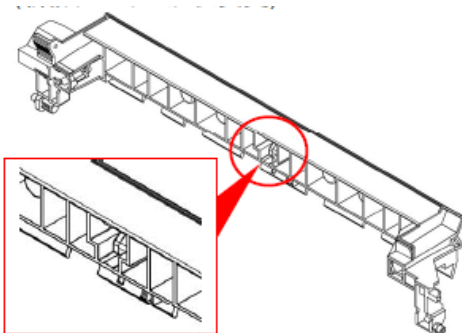
In the case of J421X occurs, check the fuser guide shape of the fixing, it will be required the following.

<p>Added 2 cut washers to the fulcrum of the fuser exit guide.</p> <ul style="list-style-type: none"> •Machine front fulcrum:1pc •Machine back fulcrum:2pcs

<p>Please add to the fulcrum below the cut washer.</p> <ul style="list-style-type: none"> •Machine back fulcrum:2pcs

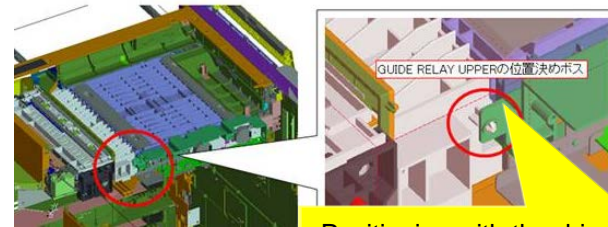
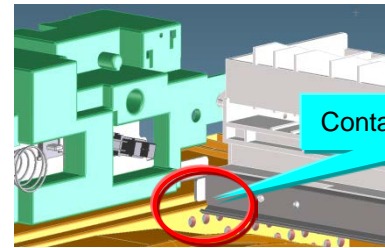
Positioning with the drive unit

→ If it is not inserted into the positioning hole.

a. While being careful not to contact with the tray in following fig, insert the positioning boss of AK conveying-in unit into the positioning hole of the drive unit.

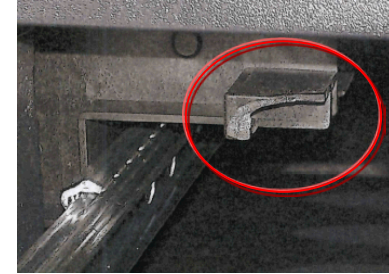
6. Check there is any breakage at the hook hang part of the bridge relay exit unit. (Right fig.)

→ If it is broken, replace the relay exit unit.

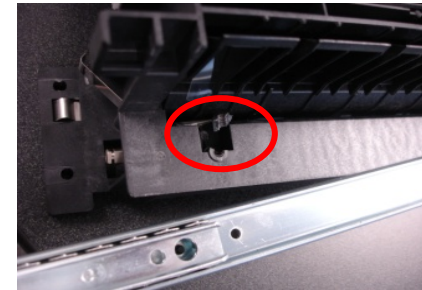
7. Check whether the screw fixed boss, positioning boss of the Rail installing section at the bridge relay exit unit is broken. → If it is broken, replace the relay exit unit.

No.	Old	New Parts No	Parts name	Q'ty
1		303NB94174 3NB94174	PARTS RELAY EXIT SP	1

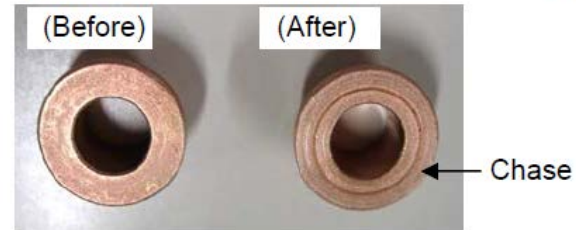
Fig 1

8. Check the bushing of the Bridge Exit Unit (Fig.1)

→ If it is old type shown in right fig, replace the bushing according to the replacement procedure (refer to the next page).

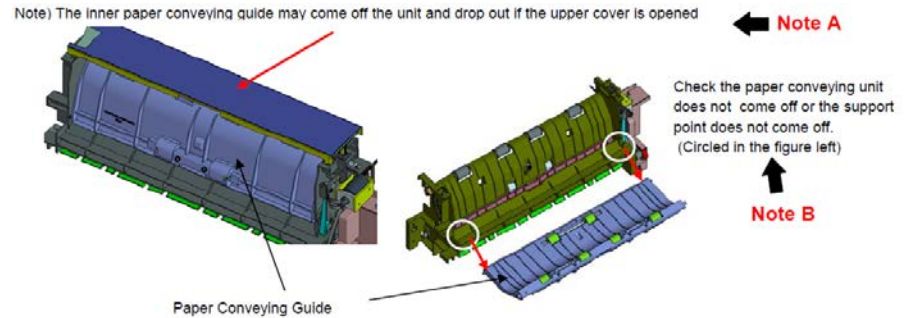
Fig 1

9. Check whether the check whether the paper conveying guide fulcrum for the bridge exit unit has separated or not. (fig.1).

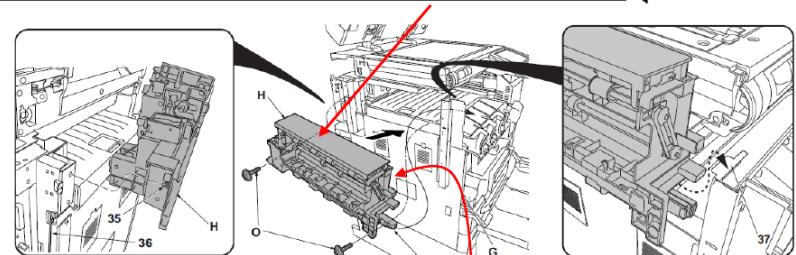
Fig 2

Check the paper conveying unit does not come off or the support point does not come off.

18. Position the eject unit (H) so that its rail section (34) is inside the MFP, insert the projection (35) on the rear into the hole in the side plate and then place the front end onto the plate section (37) on the front left stay (G).

Install the eject unit along the front and rear stay of the unit while holding the upper cover.

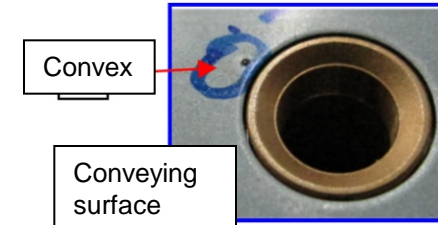
Paper is caught by the convex of welding part at the Punch unit upper guide conveying surface.

b. If the serial number of unit is before below number, replace the Punch Unit.

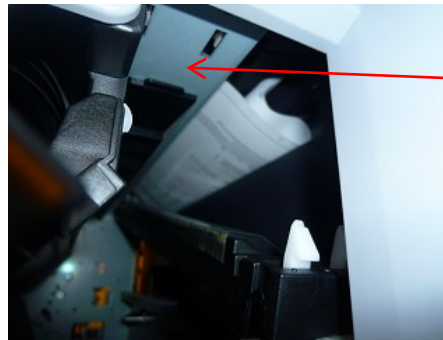
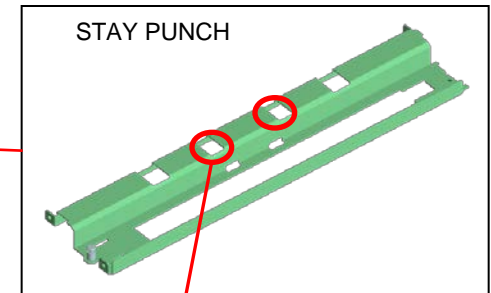
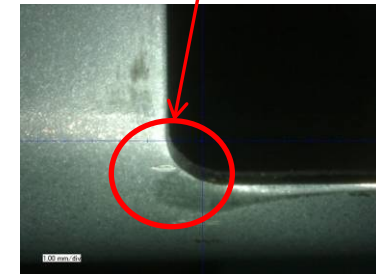
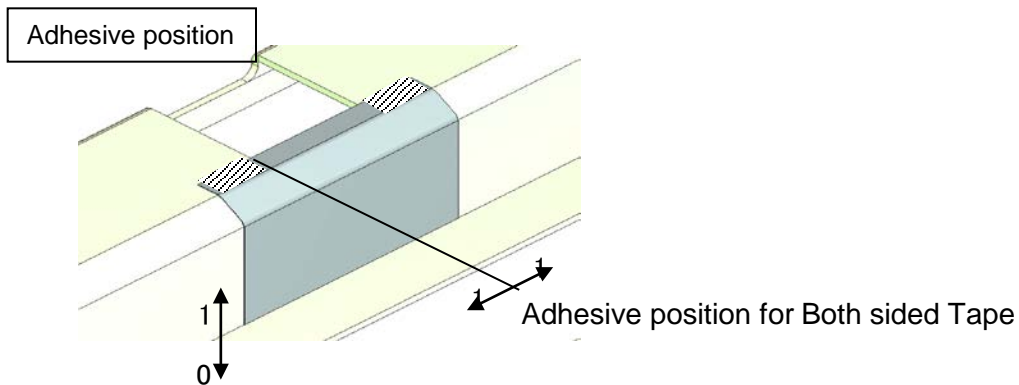
4. If the paper stop before the conveying-in roller and there is no damage on paper, check whether the paper is caught by the STAY PUNCH.

a. Add the PET Films on the middle part of cutout of the STAY PUNCH.

No	Old Parts Item	New Parts Items	Parts Name	Q'ty
1	303NB07140		SHEET ROLLER FEED	2

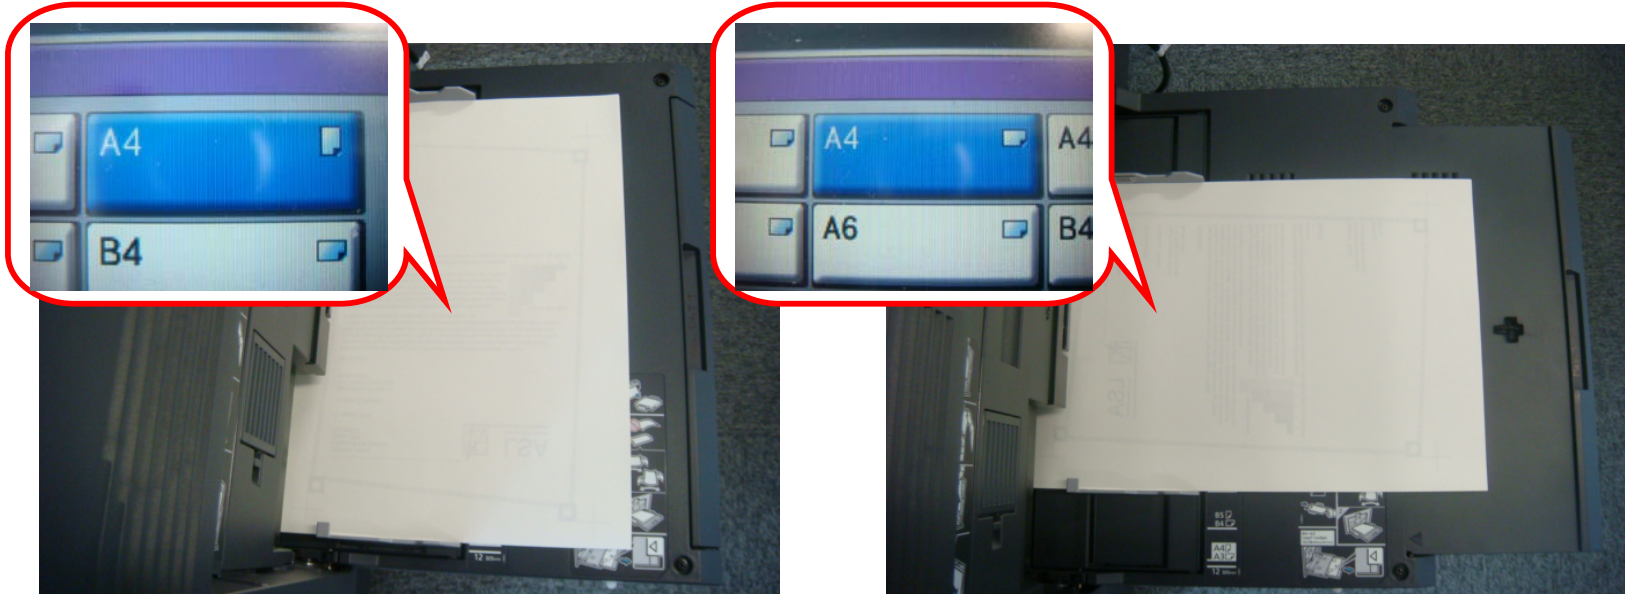
If the actual direction of A4(Letter)size paper set on the manual bypass tray is not same as setting the direction by the operation panel, JAM6110 may occur after feeding is started . Therefore, please instruct user about the setting method of manual bypass size.

5. When select A4 paper size at the manual bypass tray, be careful below item.

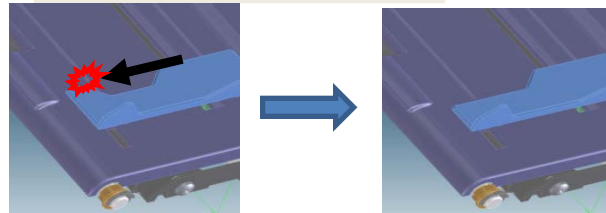
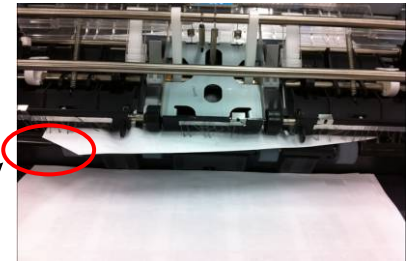
1. Corner folding at paper leading edge or curling JAM (Image sample 1)

- (a) Replace the cursor
 303NB36031
 CURSOR L MIDDLE TRAY
 303NB36041
 CURSOR R MIDDLE TRAY
 Affected from : 2012 Jan production

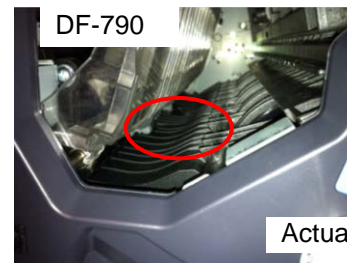
DF-790

d. Check whether the Actuator (DF middle sensor) is operating smoothly without any problem.

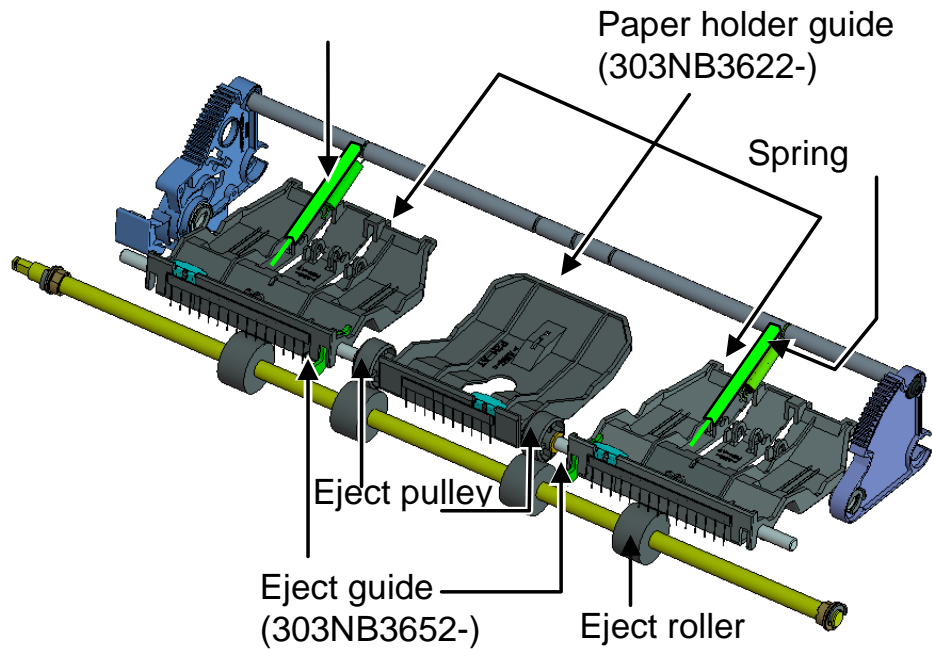
Before	After
Drawing length	40.86mm	50mm
Spring constant	0.04 N/mm	0.078 N/mm
Initial tension	0.29 N	0.524 N
Tension	1.92 N	2.7 N
Color	Silver	Black

The tension of the spring is increased that pulls up the paper holder guide.

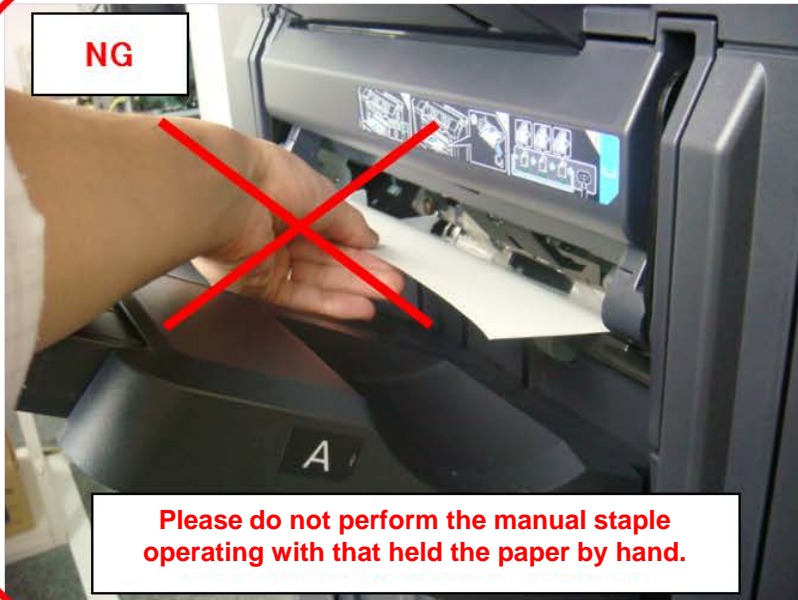
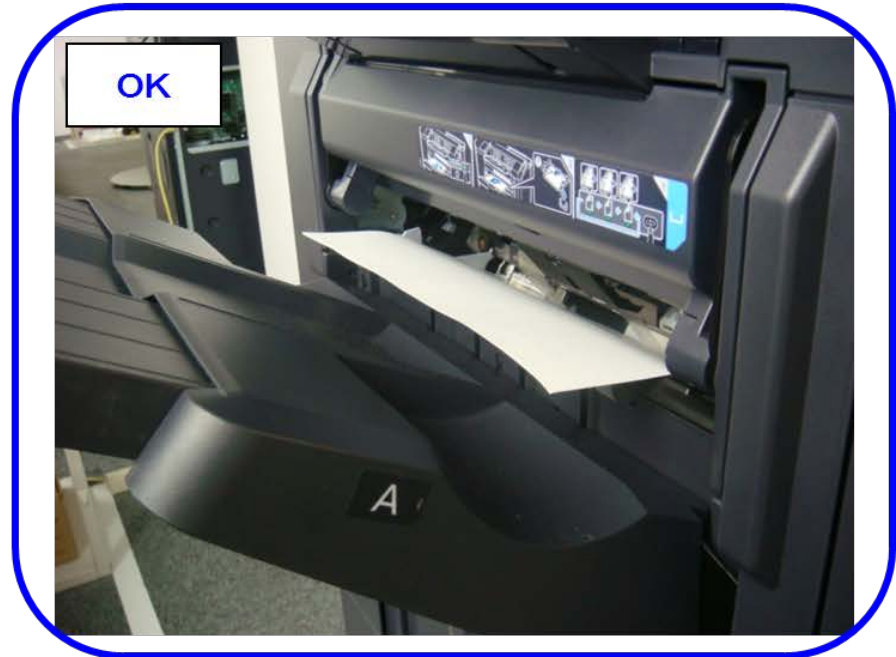
When you perform the manual staple operations when they hold the paper by hand, paper jam (J6510) will occur.

When inserting the paper, please make sure that the paper hold hand is away from the paper during staple operation.

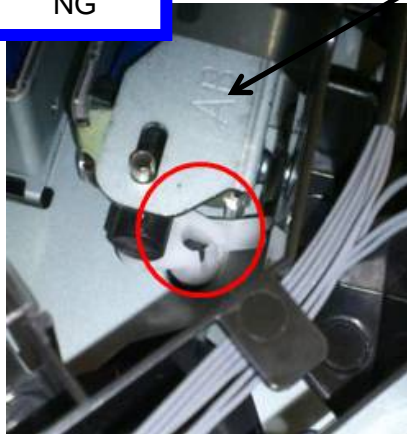
NG

Check the shaft of Feedshift guide 1 is firmly inserted into the lever of DF feedshift solenoid 1. In case of out of location, insert the shaft into level as shown in below photo.

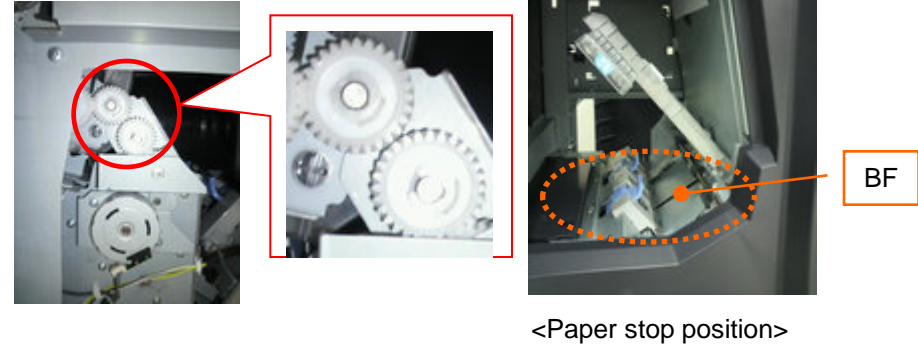
b. Check whether the mesh of gears is not engaged or not after setting the BF into the DF.

→ If the gears are not engaged, replace the fulcrum pin (1) of BF lock lever, DF hook pin (2).

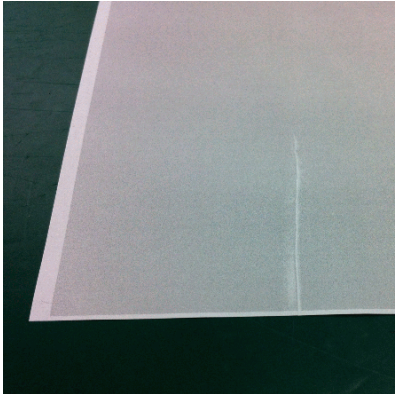
If the paper creasing like a below image occurs frequently, check as referring to below procedure.

<Check the image sample>
On the image sample of creased paper, spread out the creased part and check if toner is not transferred to the creased

If the paper is above creasing condition, check whether modified guide below photo is equipped or not.

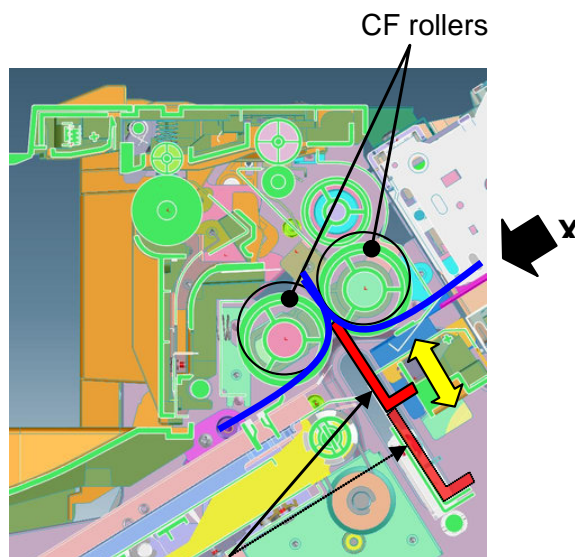
When center-folding or tri-folding one sheet of paper with the downward bending (toward the CF blade side) at its central part, the paper center part of paper may be creased or damaged due to the paper's bent part pinched up by the CF rollers and the CF blade.

CF blade (No.1):
CF blade lifts up to fold the paper (indicated with the blue line in the above figure) when center-folding or tri-folding the paper.

- 1 . Set the positions of the paper length guide and the paper width guides in the paper cassette in order to properly fit the paper size.
- 2 . Turn the papers in the paper cassette over and reinstall it. (The grade of the paper's bending may be slightly improved)
- 3 . Replace the CF blade (303J124142 : BLADE MID PRESSING) with the new one.

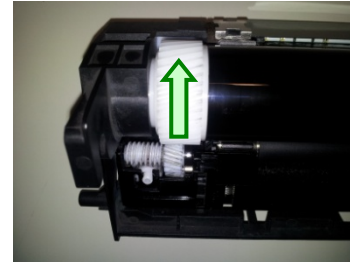
<Fig1 Check Drum Rotation>
Turn it below direction.

- a. Remove the DRUM unit from machine.
- b. Check the drum rotation (refer to Fig1)
In case of no rotation, replace the drum unit
- c. Check rotation of the drum spiral roller (refer to Fig2)
In case of no rotation, replace the drum unit.
- d. Check the poor connection of cleaning lamp connector.
- e. Replace the HVT PCB.
- f. Replace the engine PCB.

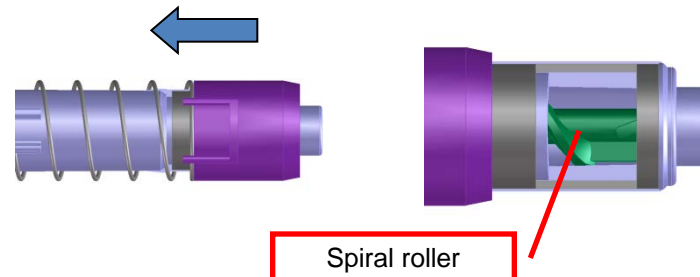
<Fig2 Check Spiral Roller Rotation

Check whether the spiral roller is rotating when turning the drum manually.

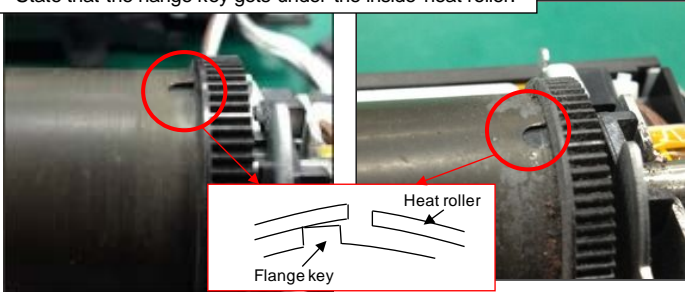
</div> <div style="width: 45%;"> <p>State that the flange key gets under the inside heat roller.</p>

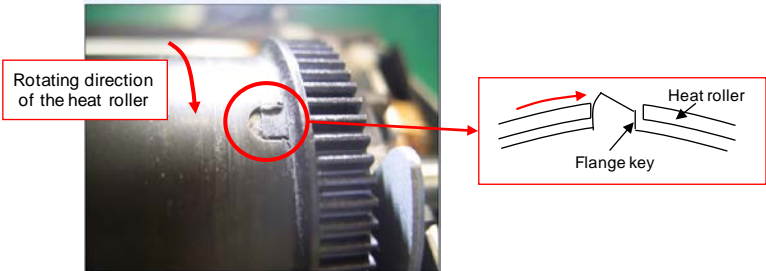
</div> </div> <div style="display: flex; justify-content: center; margin-top: 20px;"> <div style="width: 45%;"> <p>State that the flange key is raised due to being pressed by the heat roller.</p>

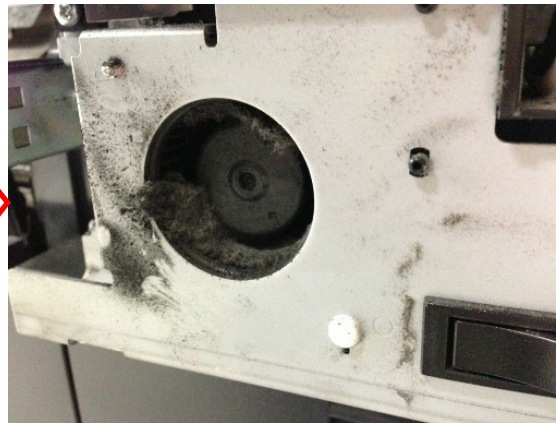
Before (With clogging)

Clean the cooling fan with a vacuum cleaner.

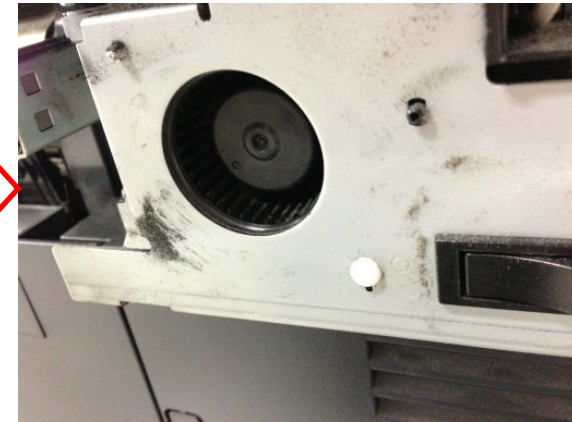
After

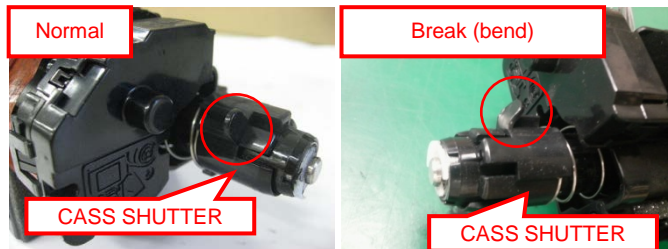
Fig.1

When pushing in the CASS LOCK release LEVER at the INNER UNIT, there is a case not to push in smoothly.
In that case, without pushing in by force, re-install the INNER UNIT while shifting it by right-hand side and fix.
If it pushes into INNER UNIT forcefully, the lock release cannot be done normally, C2101, C7101, and unusual sound occur again and DLP UNIT may damage.

- a. Remove the INNER UNIT.
- b. Check the CASS SHUTTER of the DLP UNIT.
- c. If the parts is broken, replace the DLP UNIT. (Fig.1)
- d. Re-assemble it as referring to below attention 1.

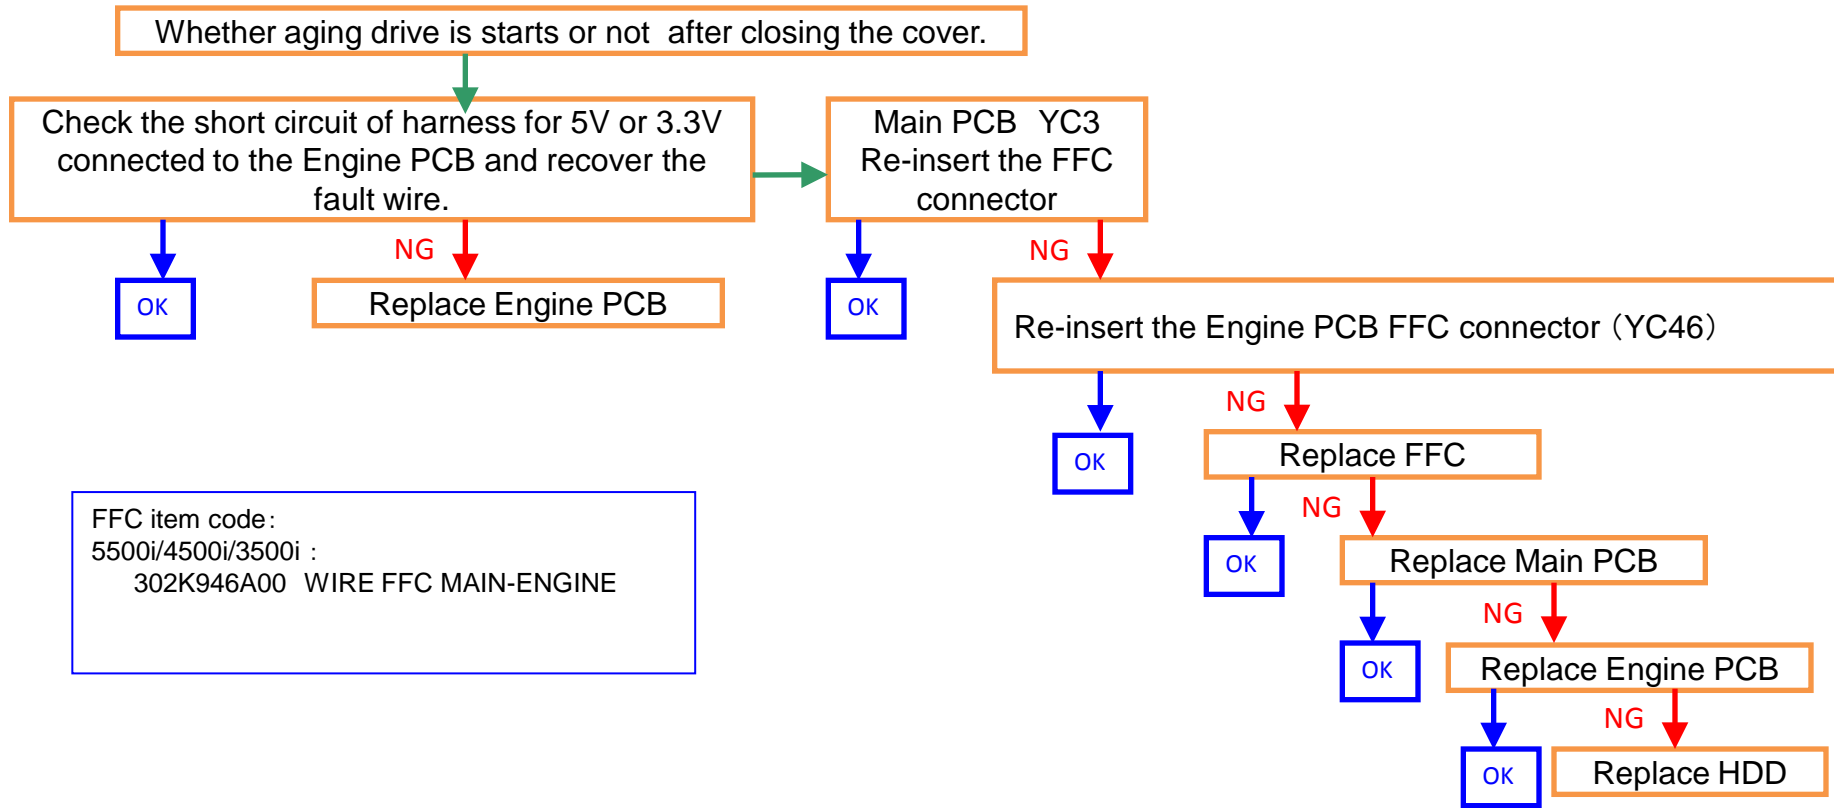
CF040 (Communication Error between the Main PCB and Engine PCB)

If CF040 occurs, take the following measure.

Product	3500i/4500i/5500i		6500i/8000i	
	Item Name	Item Number	Item Name	Item Number
MAIN PCB	PARTS PWB MAIN ASSY SP	302LH9414*	PARTS PWB MAIN ASSY SP	302LF9417*
	PARTS PWB MAIN ASSY SP EU	302LH9415*	PARTS PWB MAIN ASSY SP EU	302LF9418*
ENGINE PCB	PARTS PWB ENGINE ASSY SP	302LH9417*	PARTS PWB ENGINE ASSY SP	302LF9420*
HDD	PARTS STORAGE DEVICE SP	302LH9307*	PARTS STORAGE DEVICE SP	302LC9316*

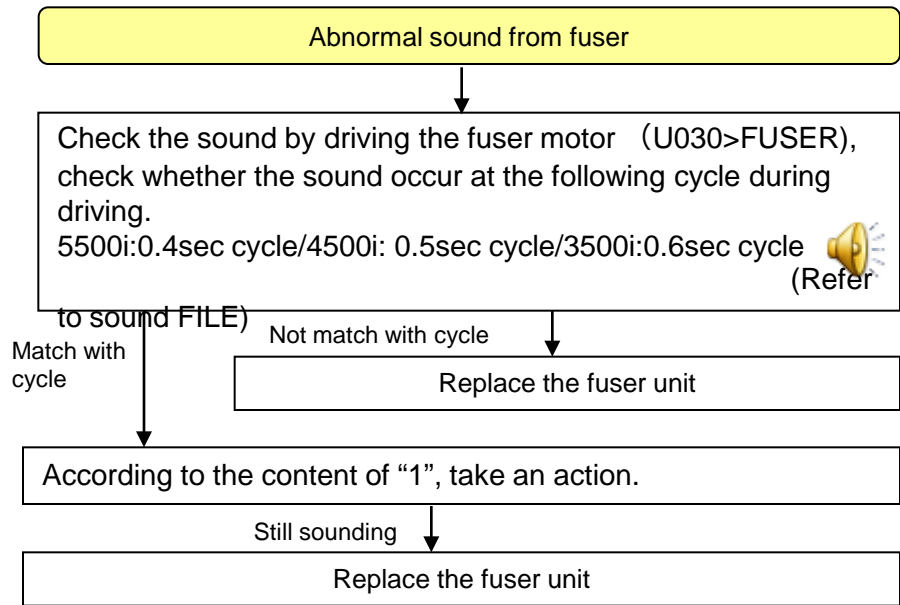
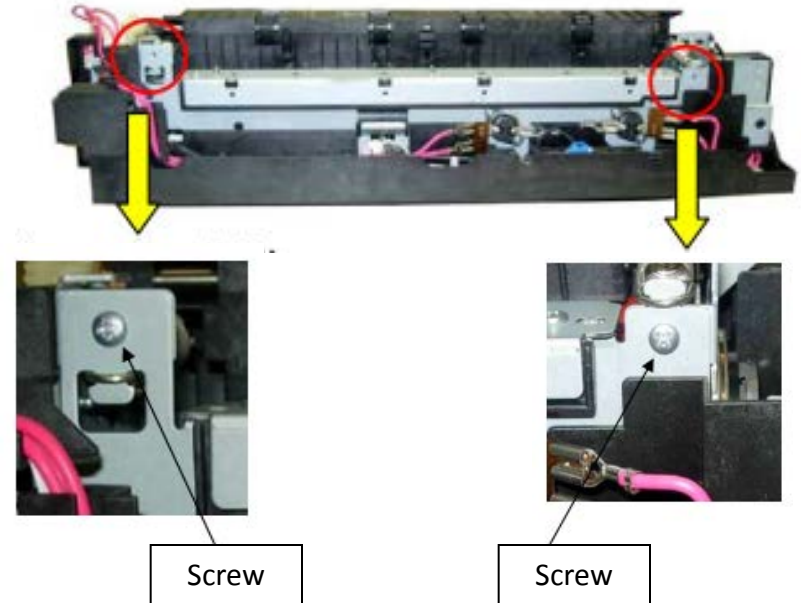
■ Screws adding position

Take the measure after checking the following contents and phenomenon.

1, Add the following 2 screws as referring to next page.

No.	Old	New	Parts Item	Q'ty
1		7BB700308H BB105600	+BIND T.T S SCREW 3X8 SR	2

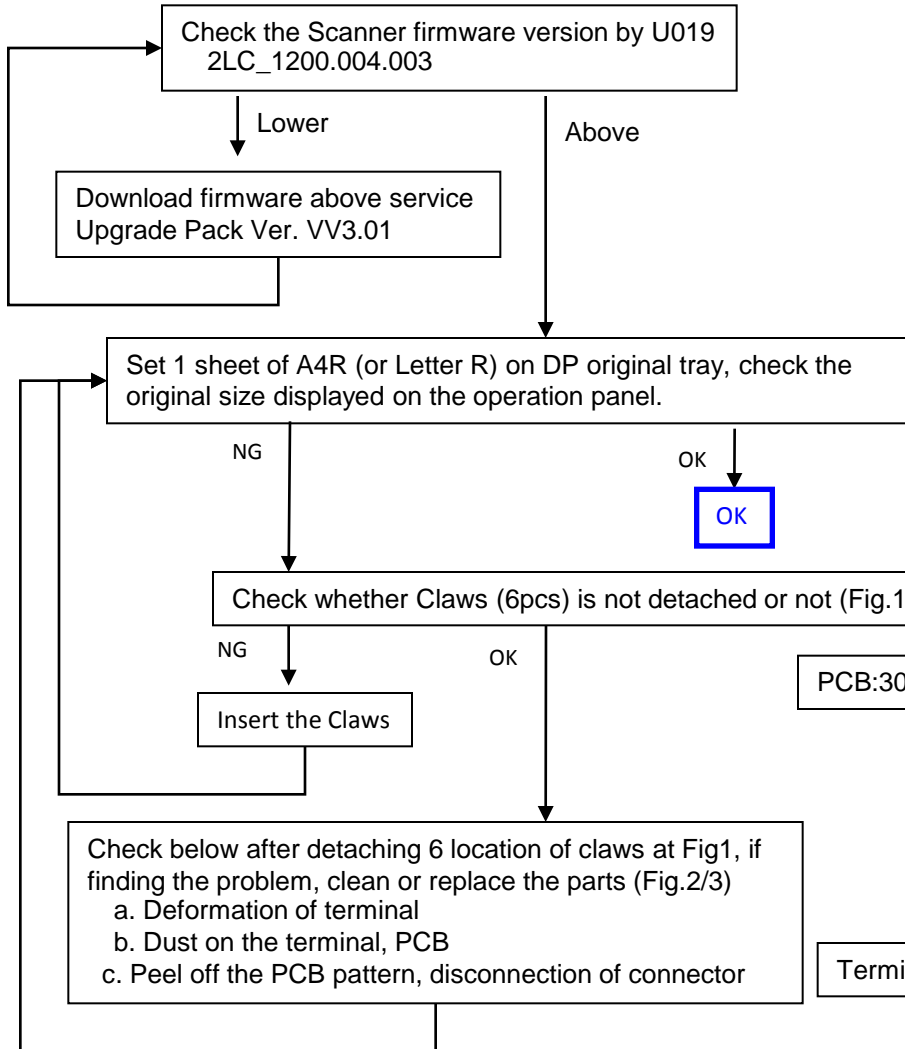
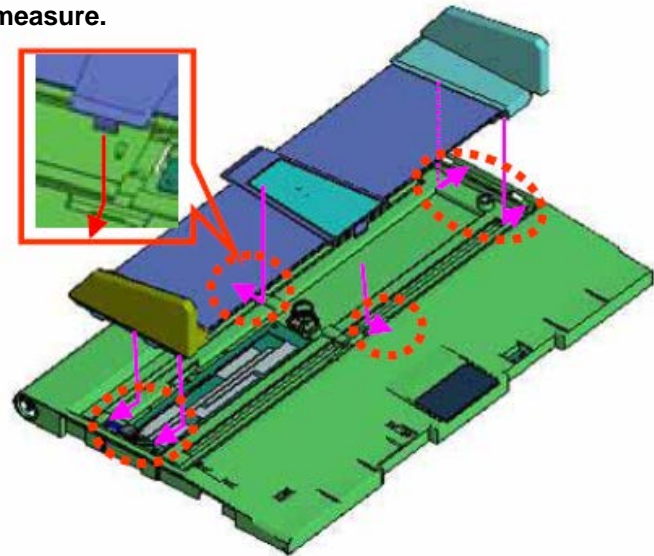
DP Size Detection Error

When the size detection error occurs at DP, check below item and take measure.

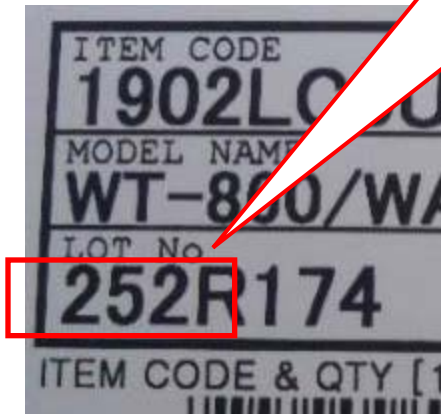
Fig.A

1st digit: production year
2nd digit: production
In this case, 2012 May. production

- a. When Lot No. of the waste toner bottle is "25" (refer to fig. A) and before, check it as referring to the fig. B.
- b. When there are any faults such as peeling and poor adhesion, replace with another waste toner bottle.

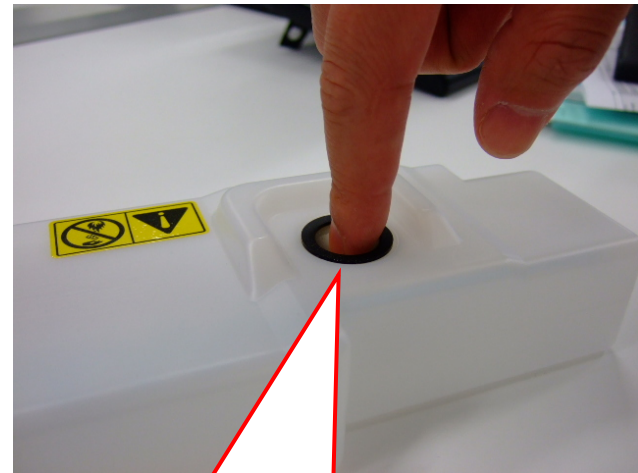
Fig.B

Push it lightly by a fingertip and check peeling and adhesion.

* In case of the top 2digits is "25" (2012 May. production) or before, perform the checking mentioning at right.

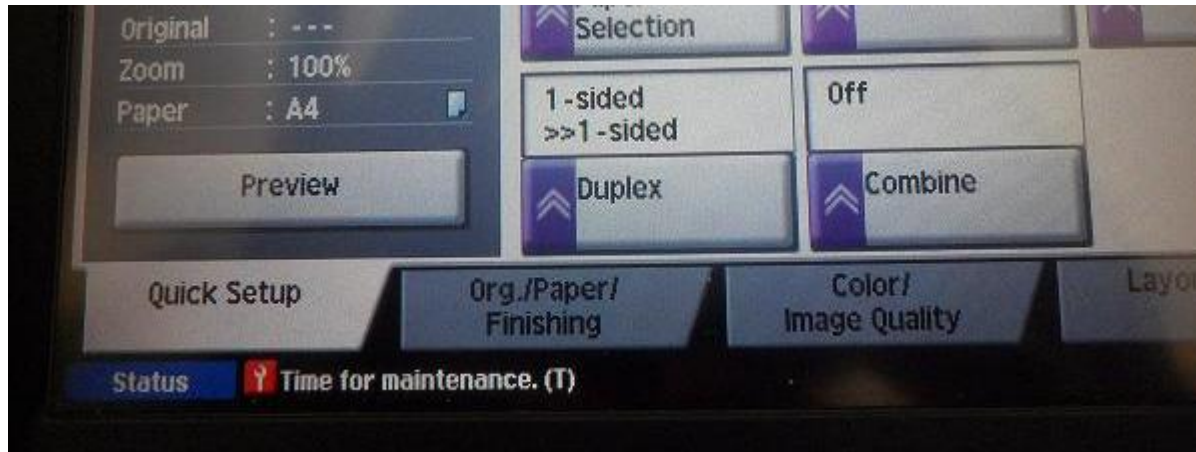
When "Time for maintenance.(T)" was displayed on a status bar (refer to attachment picture), please take the following measure.

- a. Performs resetting partial operation control in Sim.906.
- b. Set up the present time from a system menu.
- c. When can not canceled above, please exchange Main PCB.

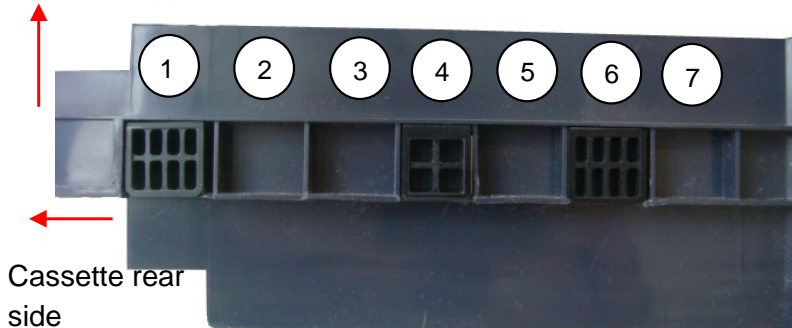
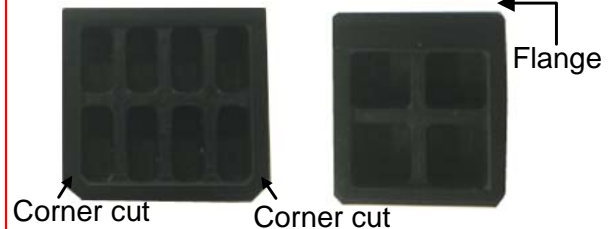
The Cassette Rails Damage (1/2)

<Cassette rail damage position> 1 and 5 are mostly damaged in the figure below.

- ①: may contact the pulley A in the figure left and may be broken if pulled out just before full open and the downward force is applied to the cassette.
- ②: may contact the pulley B in the figure left and may be broken if repeatedly pulled out with paper fully loaded in the cassette.
- ※Others than 1 and 5 above may be damaged depending on the position where the cassette is pulled out
- Note the parts to use and the direction to install differ between before and after the damage.

For repairing the broken rail--- apply to damaged rail

- Apply to other than ④ in the figure left
- Install with the corner cut facing down
- Apply to ④ in the figure left
- Install with the flange facing up

(Note) The reinforcing parts can not be installed depending on the cassette rail damage. In this case, cut the bottom of the damaged part in the cassette rail where interferes the reinforcing parts by using a nippers.

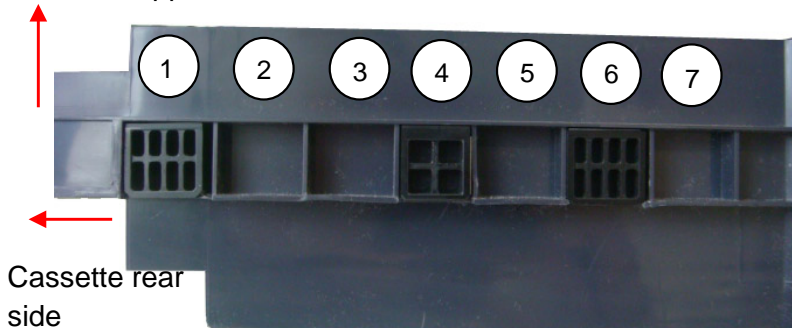
The Cassette Rails Damage (1/2)

1 and 5 are mostly damaged in the figure below.

1st rib: may contact the pulley A in the figure left and may be broken if pulled out just before full open and the downward force is applied to the cassette.

5th rib: may contact the pulley B in the figure left and may be broken if repeatedly pulled out with paper fully loaded in the cassette.

※Others than 1 and 5 above may be damaged depending on the position where the cassette is pulled out

For repairing the broken rail--- apply to damaged rail

(Note) The reinforcing parts can not be installed depending on the cassette rail damage. In this case, cut the bottom of the damaged part in the cassette rail where interferes the reinforcing parts by using a nippers.

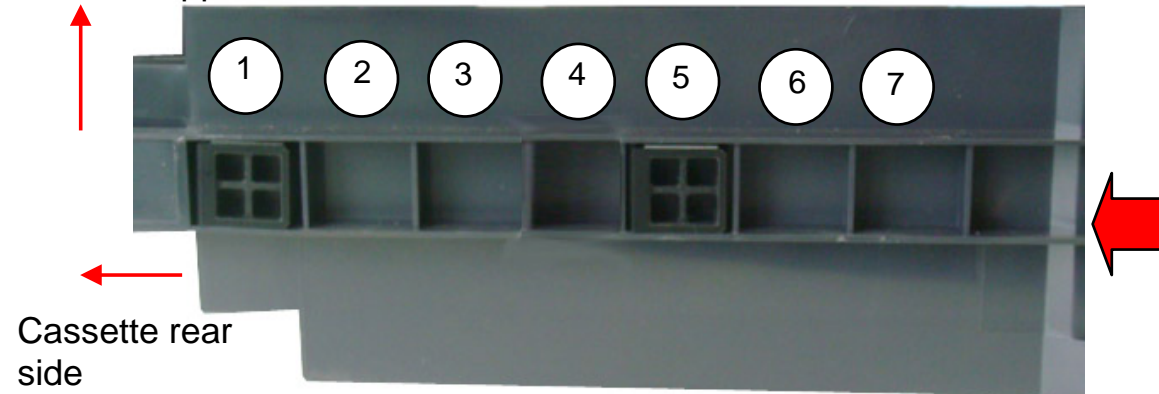
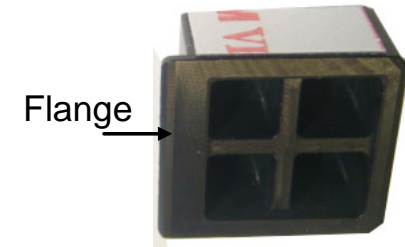
The Cassette Rails Damage (2/2)

- For Strengthening the rail (Before the damage, the resin portion and deformation is whitening rail section.)

(1 and 5 are mostly damaged)

---install before broken and where is deformed or whitened at the rail resin

- Apply to 1 - 7 in the figure left
