# Service Bulletin

Ref. No. **COM-0218 (B056)**

<b>Subject</b>	<b>Note when releasing the paper jam/maintaining the machine (Prohibition of use of the flammable sprays and liquids)</b>
<b>Model</b>	All models

<b>Subject</b>	<b>Mac OS 10.7 Lion: Alternative Scan Function since Scan to SMB is NO LONGER supported in the Latest Mac OS Version</b>
<b>Model</b>	<b>All MFP Models</b>

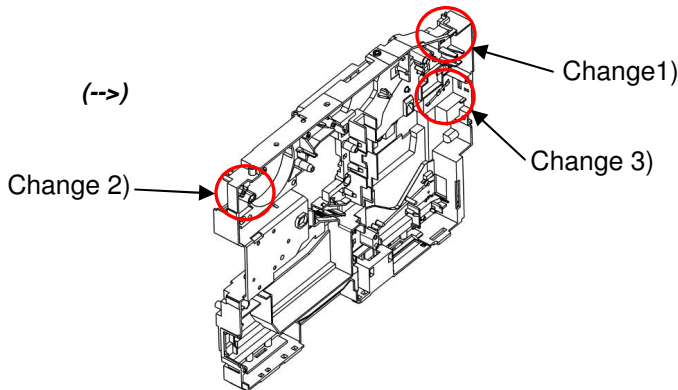
The shape of the following parts is changed for common use of FRAME LEFT with other models.

(-->)Change 1) FRAME LEFT (No.1) is changed as below.  
Rib at the section for inserting LOCK COVE TOP L is cut.

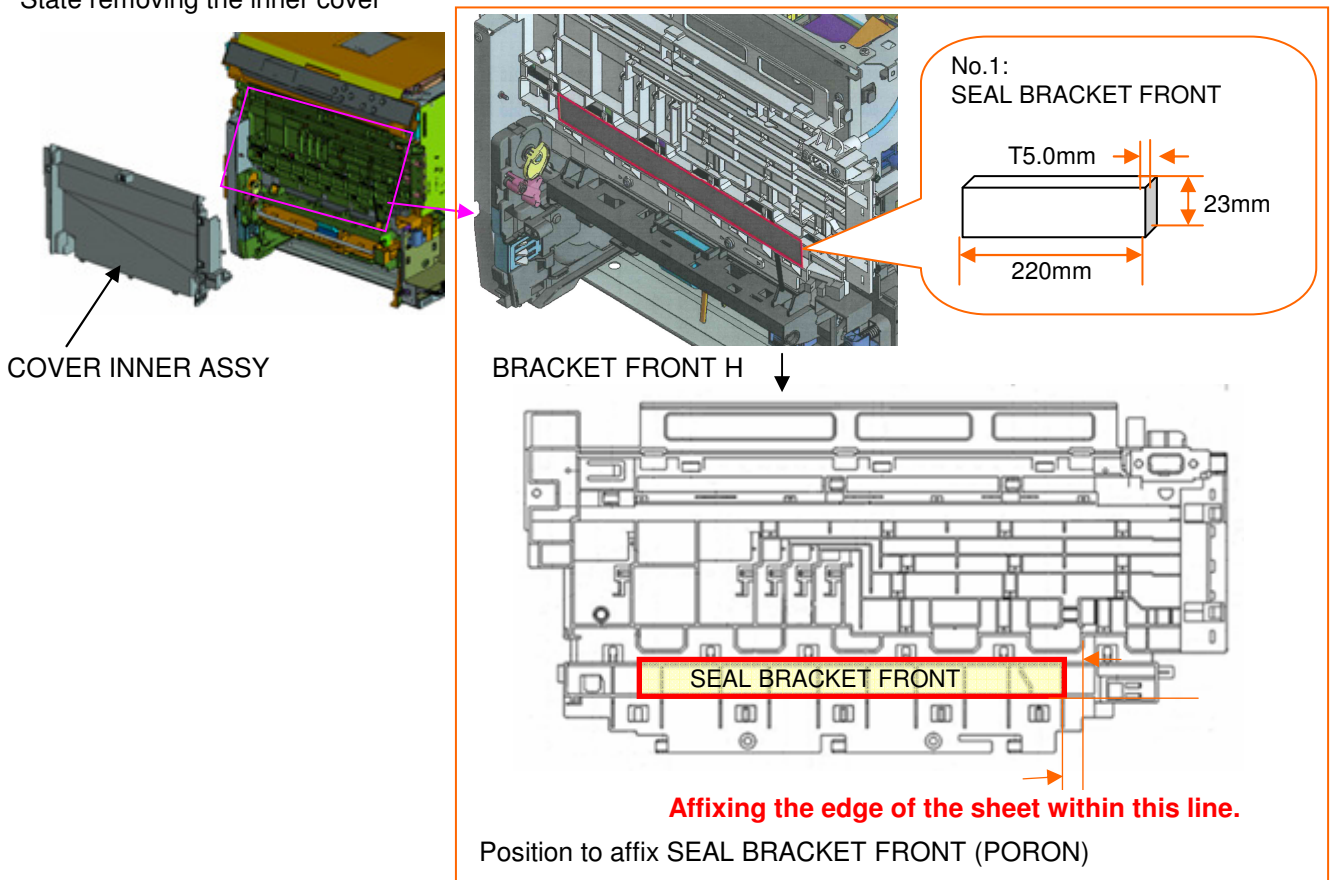
\* Part to affix PORON sheet  
State removing the inner cover

For improving the abnormal noise due to vibration that occurs when driving the main machine, the PRON sheet (No.1) for reducing vibration is affixed on the mounting plate (BRACKET FRONT HV) at the inner cover (COVER INNER ASSY) backside.

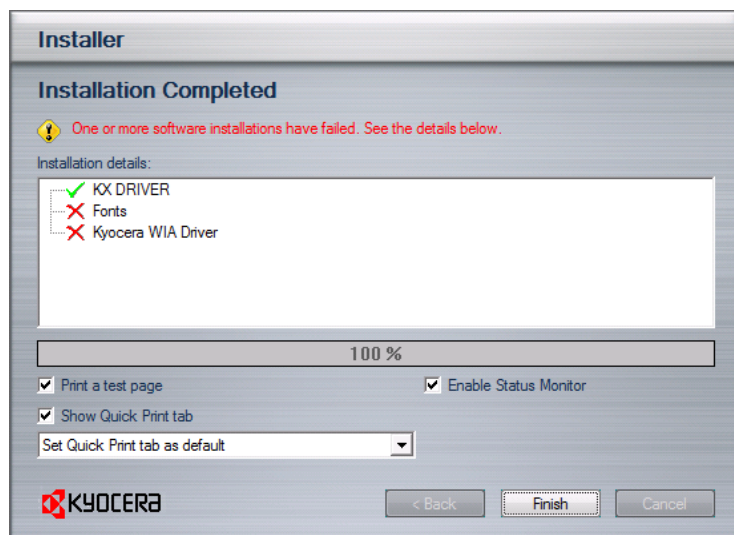
The combination with the new CD (Ver.1.1) and the old system firmware was partly shipped for KMA, KMAUS. The following screen is displayed at this combination when installing the driver from Express Mode by connecting with the USB memory.

Please finish by pressing "Finish" button because the KX driver is installed without the problem.

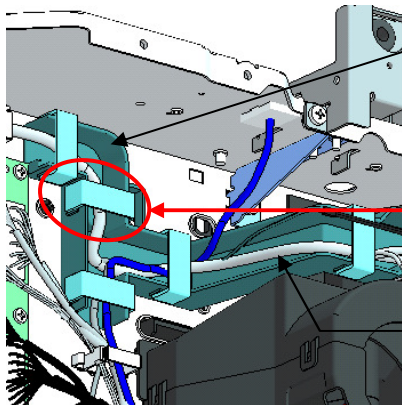
Deleting 1 pce of HOLDER WIRE A (No.1)  
(Parts List: Fig.28-28)

For improving the assembly process, 1pce of HOLDER WIRE A (No.1) that aligns WIRE TRANSFER JOINT/WIRE TRANSFER EXIT is deleted.

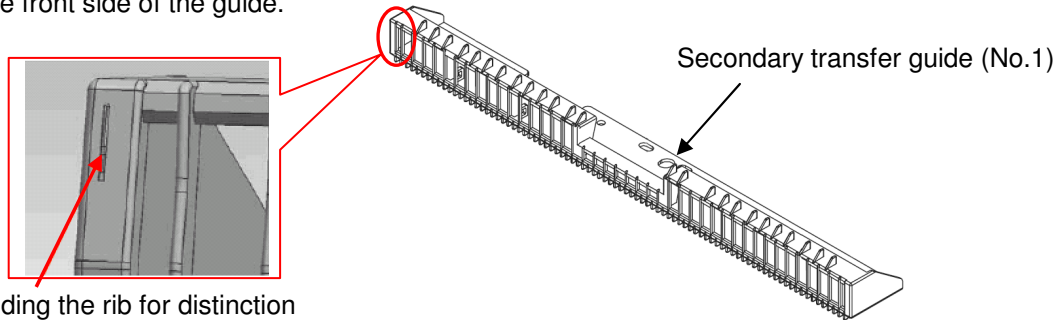
The rib on the secondary transfer guide (No.1) is thickened for common use of the parts. The parts number remains unchanged according to this change. However, the rib for distinction is added to the machine front side of the guide.

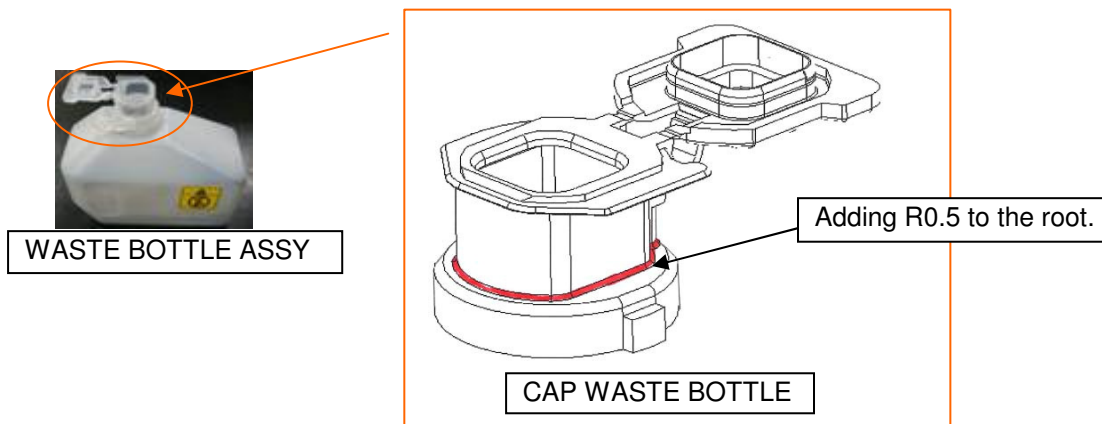
Shape of CAP WASTE TONER BOTTLE is changed as below to improve the quality.

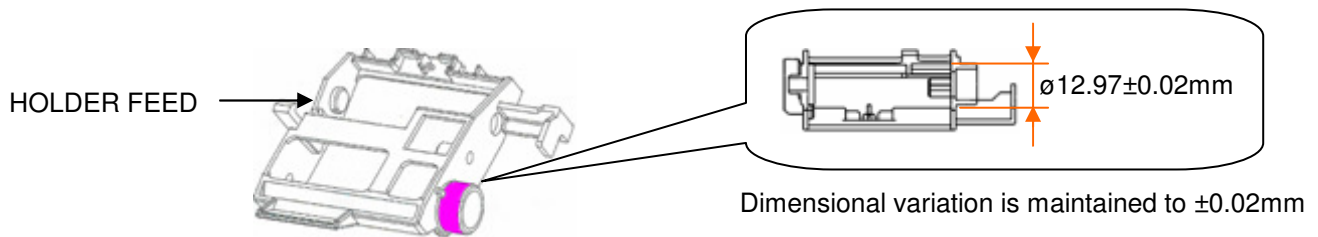
Dimensional variation of HOLDER FEED is maintained to prevent the operation failure when fitting HOLDER FEED ASSY to GUIDE PICK HOLDER.

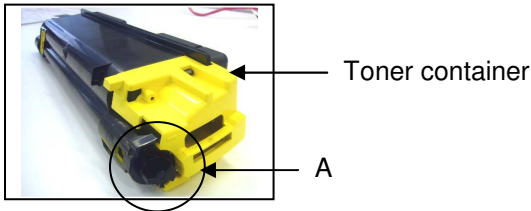
Message displayed                      MFP : The toner container is improperly installed

Once take out the toner container from the machine. Rotate the coupling at the right side of the toner container clockwise to eliminate the gap between the hook of the coupling and the latch. Then, reinstall it in the machine.

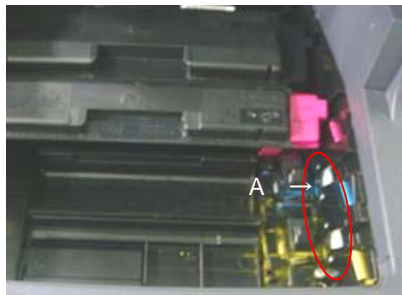
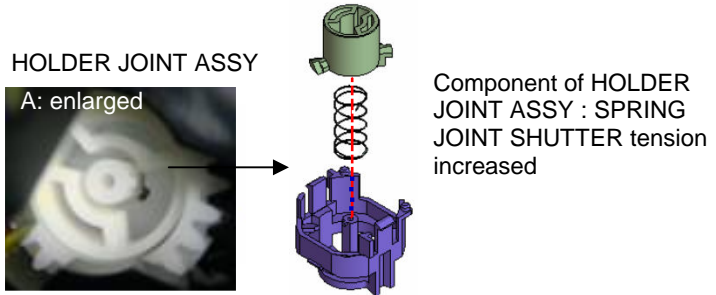
- Change of the toner container holder section at the main machine side  
Tension of SPRING JOINT SHUTTER is increased that is a component of HOLDER JOINT ASSY in order to increase interlocking force for the joint between the toner container and HOLDER JOINT at the main machine side.

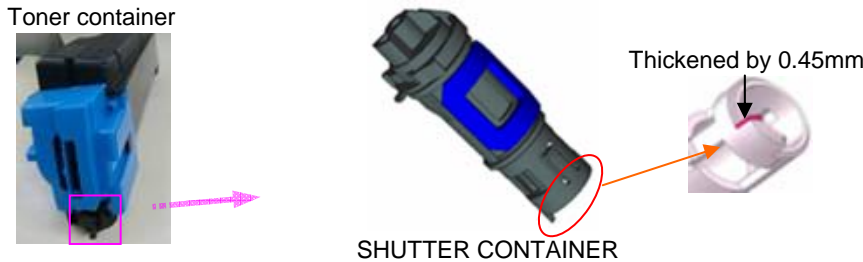
- Change of the toner container shutter  
Shape of SHUTTER CONTAINER is changed to reduce backlash at the joint of SHUTTER CONTAINER and secure the margin for opening and closing capabilities for the toner container shutter

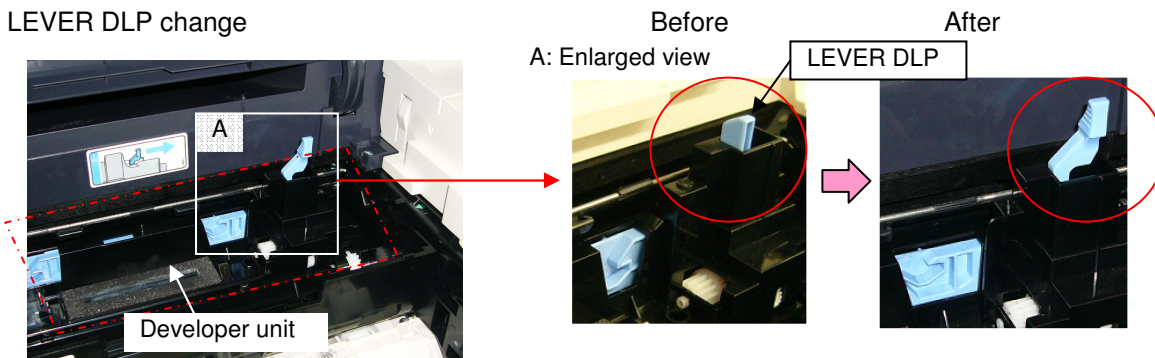
LEVER DLP change

The following parts numbers are changed for common use and "B" is added to the parts names.  
 The shape of LEVER DLP is changed after the change.

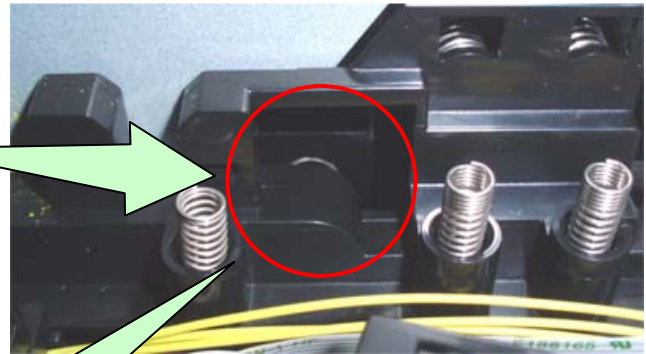
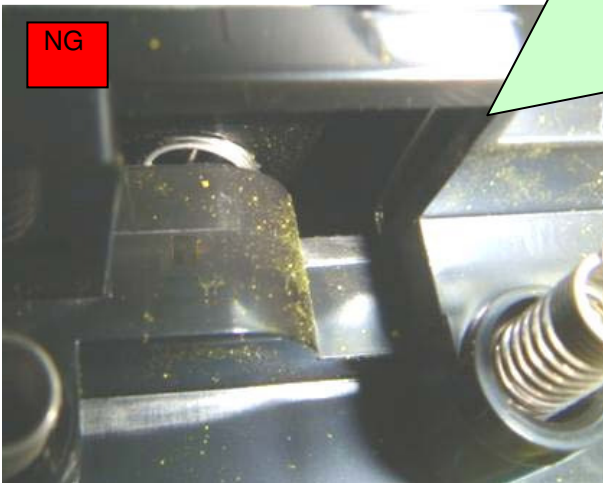
**NG** The leading edge of the spring is caught up with the plastic wall

**OK** The leading edge of the spring is not caught up but it enters into the hole

In case NG condition is observed, release the leading edge of the spring caught up using a flat-blade screw driver and correct it to enter the hole

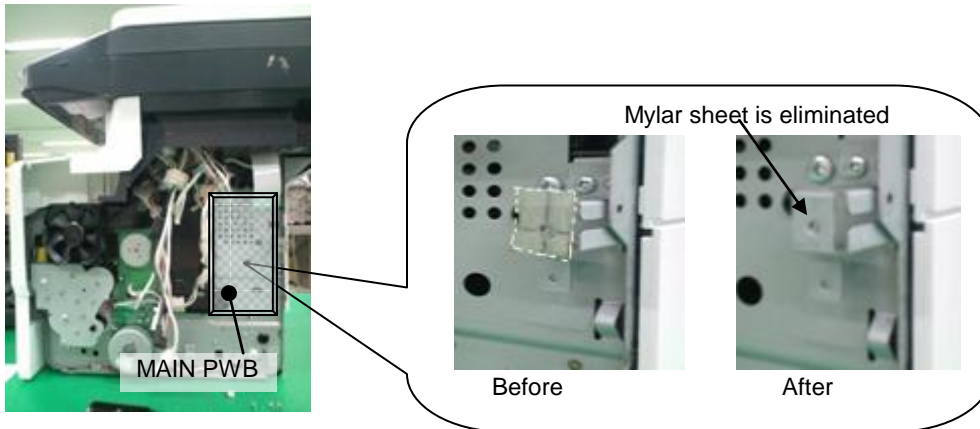
A Mylar sheet is affixed in between the main machine's metal frame and the main board for insulation. After the main board circuit pattern is changed to secure the insulation, the Mylar sheet is eliminated.

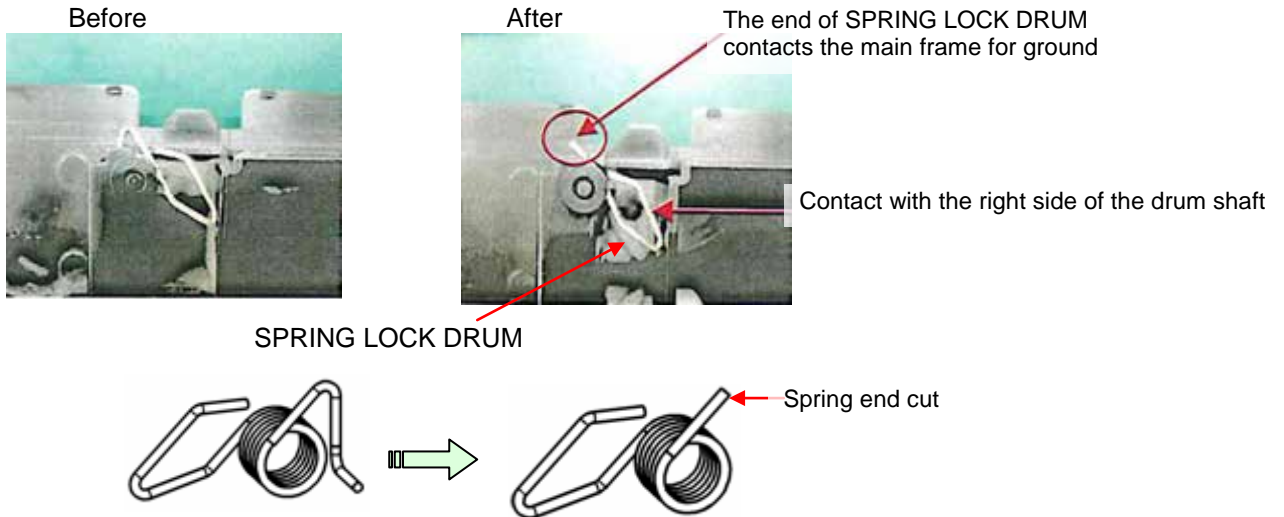
The abnormal full-page solid image or leak image may appear due to the drum high-voltage contact failure and the drum ground failure. Therefore, the following are changed. (Refer to the service bulletin No. 2KV-0002(B157)  
Checkpoint when the full-page solid image or leak image appears)

The shape of the drum lock spring (SPRING LOCK DRUM) is changed.

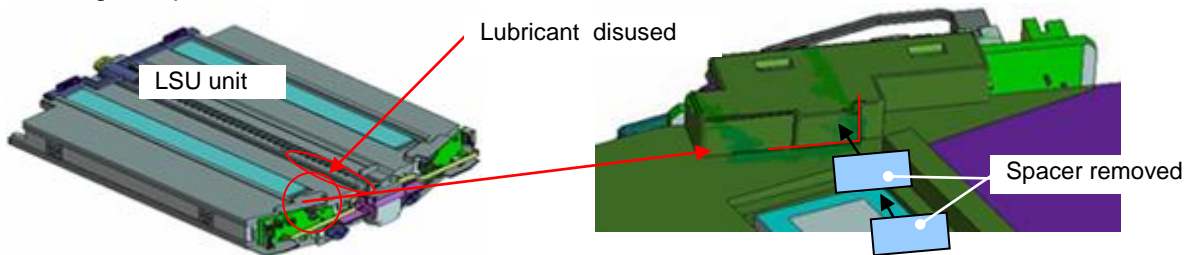
1. Disusing the spacer and lubricant

\*Spacers to prevent the cleaning holder tilt and lubricant for sound proofing were applied as the temporary measures. The spacers and lubricant are disused after the permanent measures.

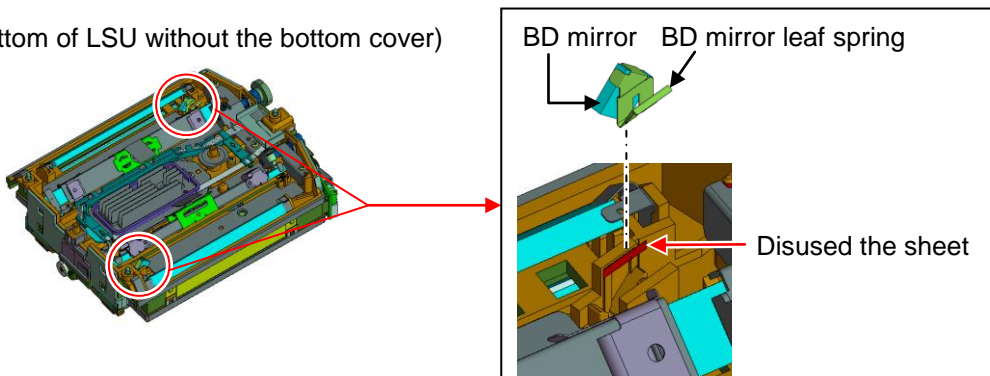
(Bottom of LSU without the bottom cover)

The BD sensors (U1 on the PWBs inside LSU) are relocated.

\*The sheet is disused according to the permanent measures while the sheet had been affixed to the seat of the BD mirror at temporary measures (2KT-0006(B360)) to prevent the BD mirror from shifting .

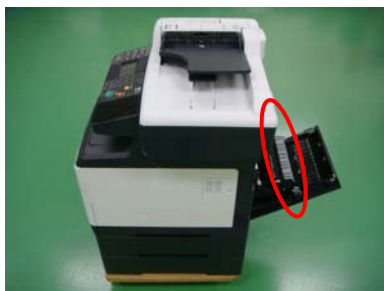
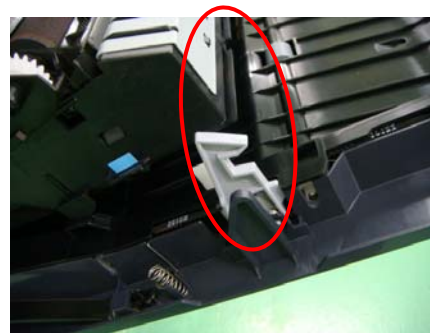
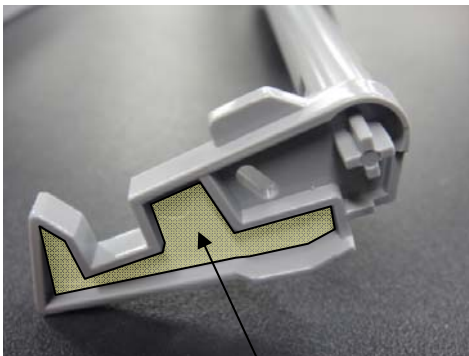
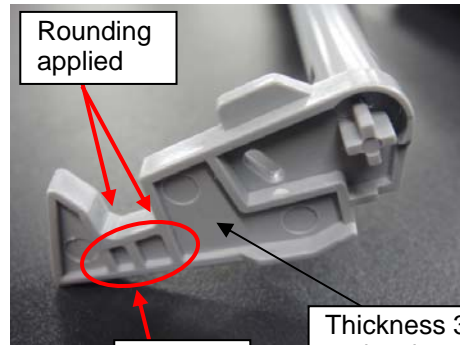
Rounding is applied, ribs are added to the hook part of HOOK DU RELEASE, and the part is thickened by 1mm.

Thickness 2mm

Ribs added

Thickness 3mm (+1mm)  
colored part as shown in  
the part before change

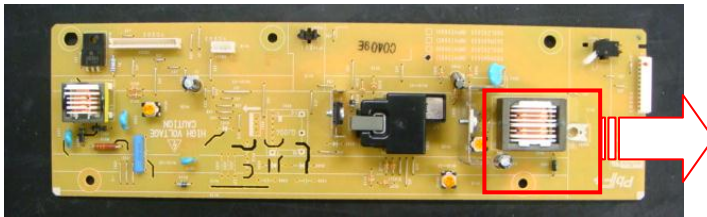
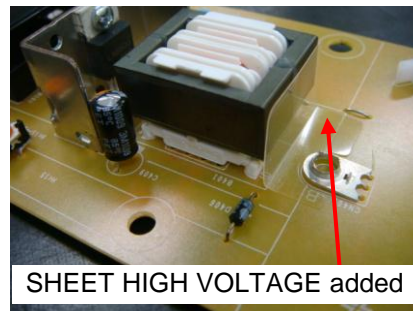
HIGH VOLTAGE UNIT Change

SHEET HIGH VOLTAGE is added to the assembly process improvement to attach the high voltage board.  
 (-->) Accordingly, the packing for the high voltage board (No.4) is changed to suit the drop shock and vibration in transit.

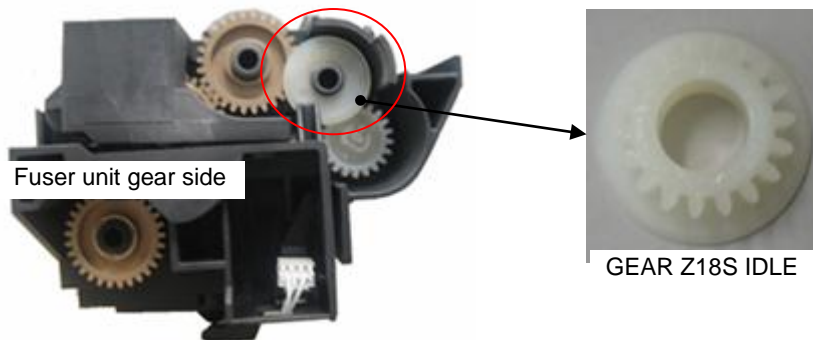
The material of GEAR Z18S IDLE is changed to improve the heat resistance margin.

Material Change: Asahi Kasei Chemicals LEONA 1300S → LEONA 1402S

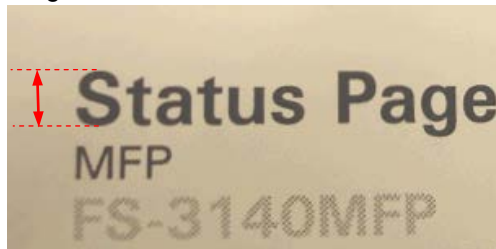
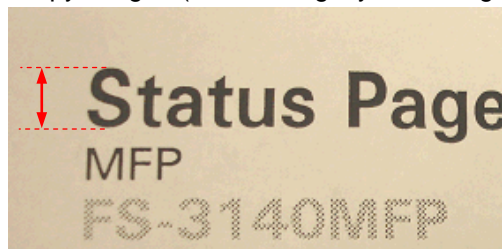
The image at the leading edge of the original may be slightly extended when scanning the original from the DP.

<Copy image> (State of slightly extending toward the paper feeding direction)

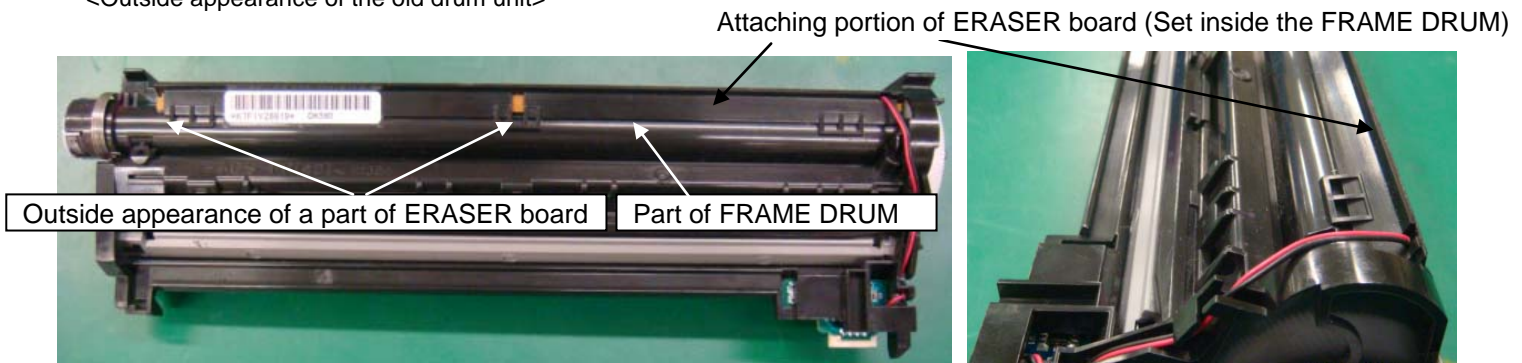
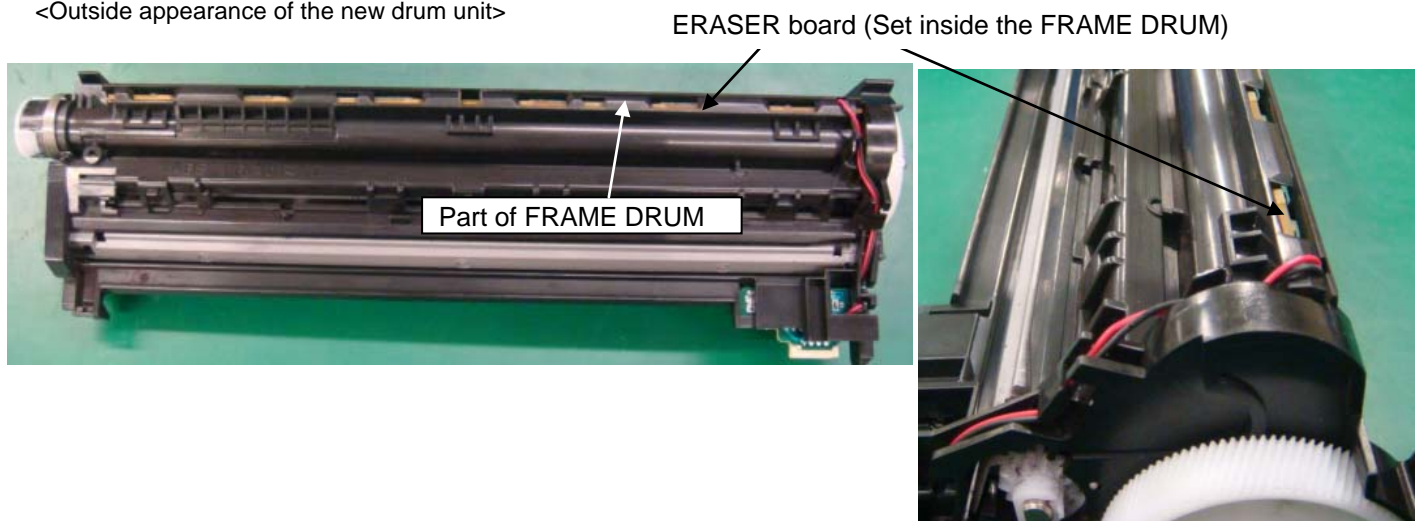
\*3: If replacing the drum unit as a corrective measure for ghost image, please change the drums for all the color (4 colors) at the same time. There is no problem to change a single drum for other factors.

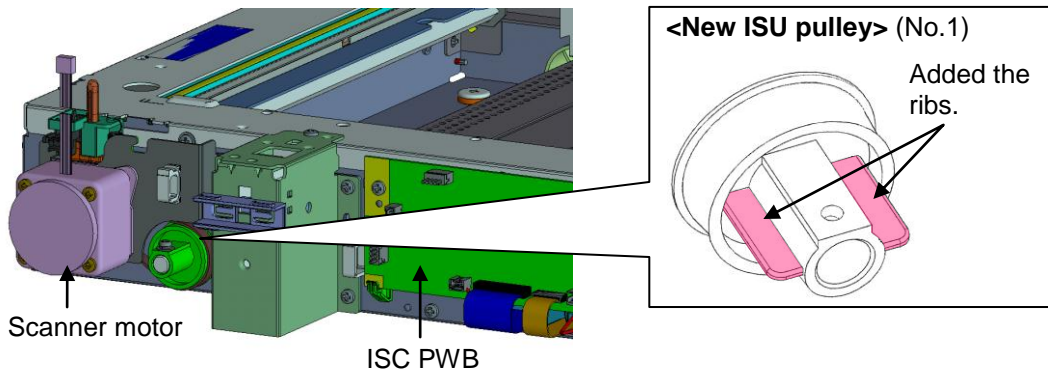
The shape of the ISU pulley (No.1) beside the scanner motor is changed as below for common use of the parts.  
 (Below is the old ISU unit viewed from the machine rear side.)

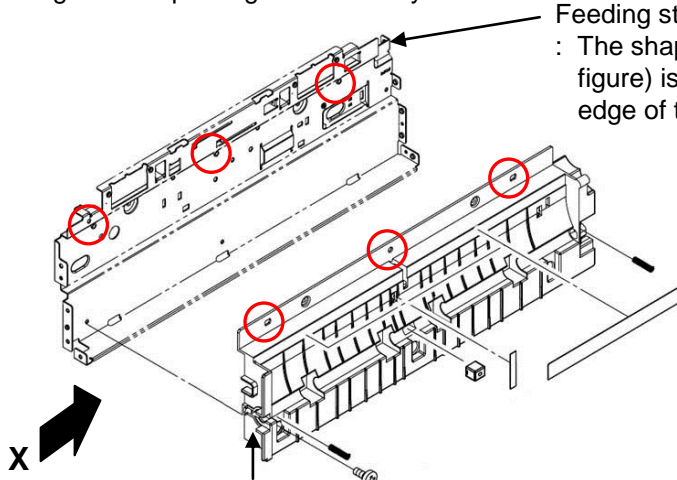
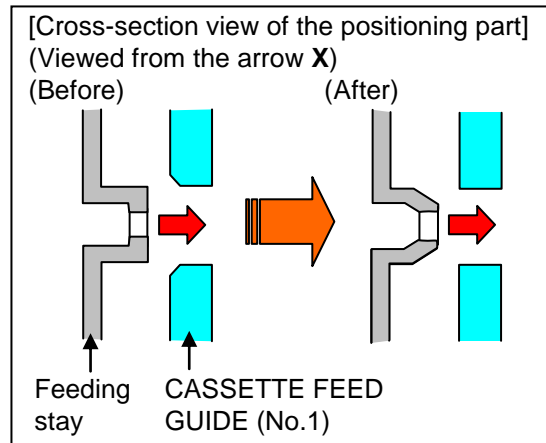
The positioning shape of CASSETTE FEED GUIDE (No.1) and the feeding stay (not supplied individually) is changed for improving the assembly work.

: The shape of the 3 positioning burring (circled in the below figure) is tapered off according to deleting the chamfer at the edge of the positioning hole of CASSETTE FEED GUIDE.

**CASSETTE FEED GUIDE (No.1)**  
: The chamfers at the edge beside the feeding stay of the 3 positioning holes (circled in the figure.) are deleted.

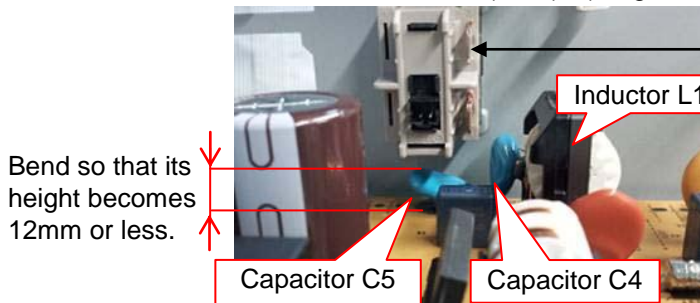
<Power source PWB (No.1)> (Neighborhood of where the main switch is attached.)

The main switch in the left photo is the one for conforming to the ErP Lot6.

These changes are performed this time because the main switch for conforming to the ErP Lot6 that is widened in sidewise compared with the normal main switch may contact the applied capacitors. No particular problems are expected even if the old power source PWB is used in the models that do not conform to the ErP Lot6.

- C4: Bent toward the inductor L1 and then fix to the side of the inductor L1 with adhesive.
- C5: Bent toward the reverse side of the capacitor C4 and fix to the mounted side of the PWB with adhesive.

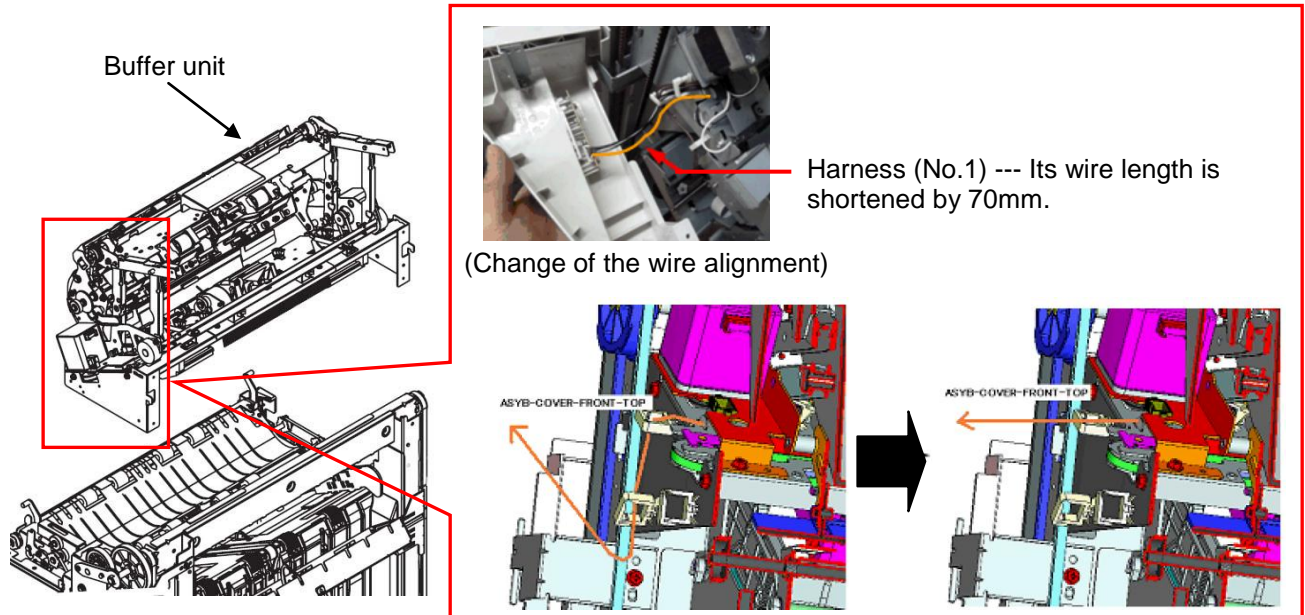
The wire length of the harness connecting between the FIN board in the buffer unit and the control panel is shortened by 70mm for common use of the parts at the vendor and then its wire alignment is changed.

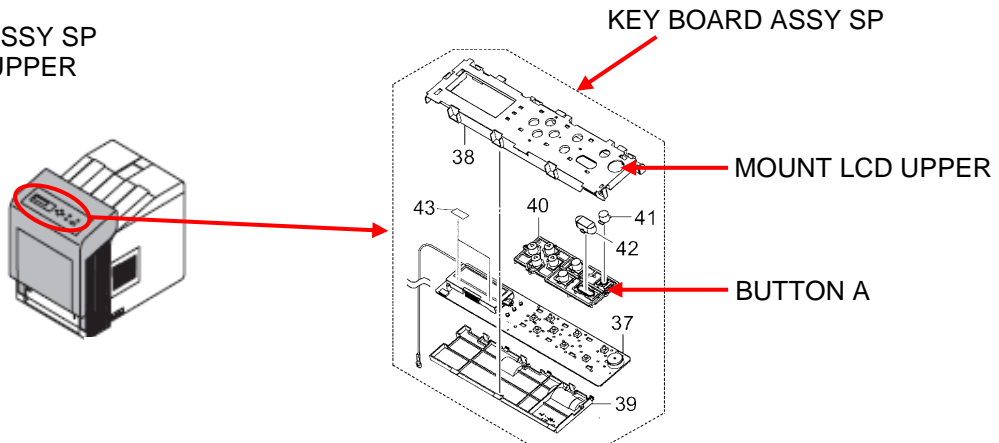
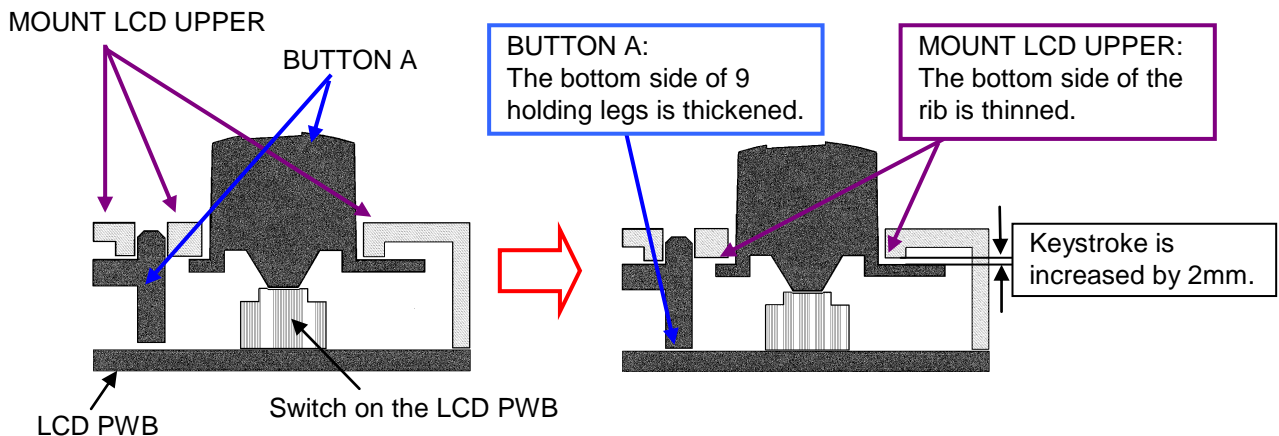
The keystroke of the keyboard is increased by 0.2mm by changing the shape of MOUNT LCD UPPER (No.2) and BUTTON A (No.3) in order to smooth the keystroke in the operation unit.

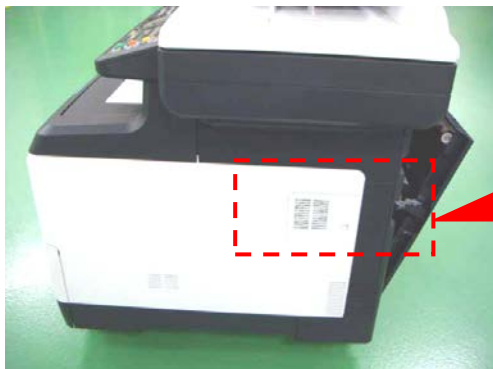
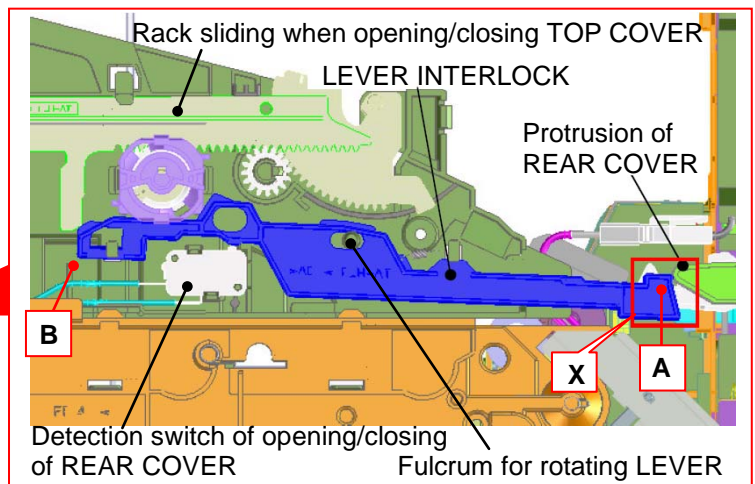
Depending on the location (X in the below figure) of the rear edge (A) of LEVER INTERLOCK against the protrusion of REAR COVER and on how to close TOP COVER, the rear edge (A) may get under the protrusion of REAR COVER, and as a result, the front side (B) cannot press down the detection switch of REAR COVER opening/closing due to the upward rotation failure of LEVER.

At this time, normally, the rear edge (A) is rotated upwards and located at the upper side than the protrusion, but, in rare case, the rear edge (A) may get under the protrusion, and as the result, the detection switch is turned off (REAR COVER OPEN detection) by the failure that the front edge (B) cannot press down the detection switch.

If the rear edge (A) of LEVER gets under the protrusion of REAR COVER, the front edge (B) of LEVER does not press down the detection switch due to the rotation failure and "The cover is opened" is displayed mistakenly.

Thus, the rib is added to the rear edge (A) of LEVER for securing the margin against its inroad.

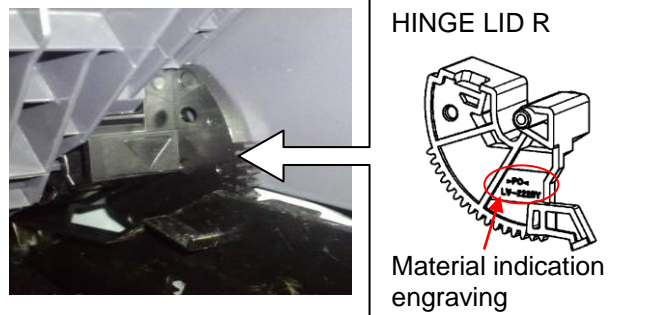
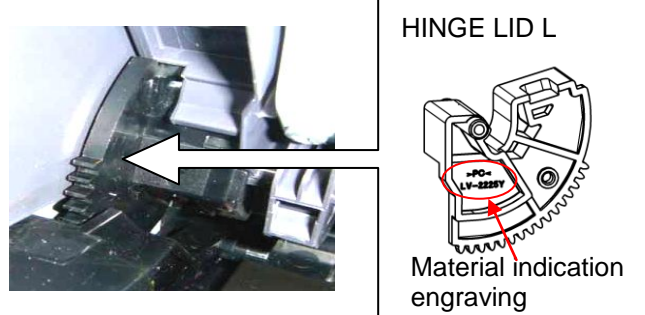
HINGE LID R or HINGE LID L may be damaged if forcibly pushing up the top tray because the machines with the serial number indicated in the table in page 4 are before change of the material as the corrective measures 2). If damaged, please replace them with the new parts (302KV0254\_/302KV0253\_). As for the distinction of the new and old HINGE LID R/L, please check the material indication engraving on the HINGE's side.

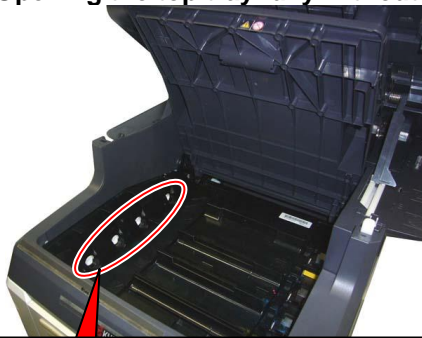
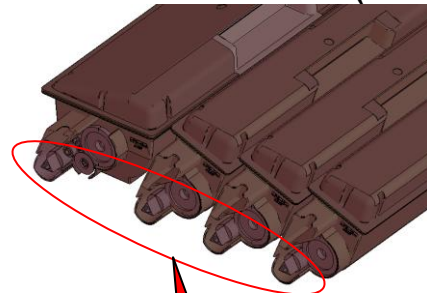
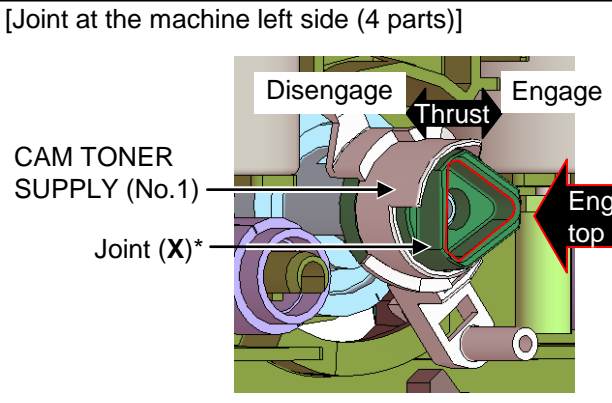
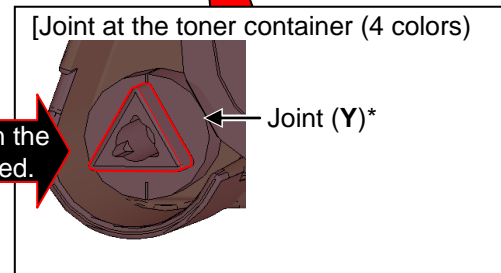
When the joint (X) at the machine left side insufficiently engages the joint (Y) at the toner container due to dimensional variation of the parts or the assembly, the machine drive may not be transmitted to the toner container and the toner supply may fail. And, the toner replacement message may frequently appear even if the toner container is replaced with the new one. Thus, the following is changed.

Engaged when the top tray is closed.

The shape of CAM TONER SUPPLY (No.1), that thrusts the joint at the main machine in the engaging and disengaging directions, is changed to facilitate the joints engagement of the main machine and the toner container. (Please refer to the next page for the detailed content of change.)

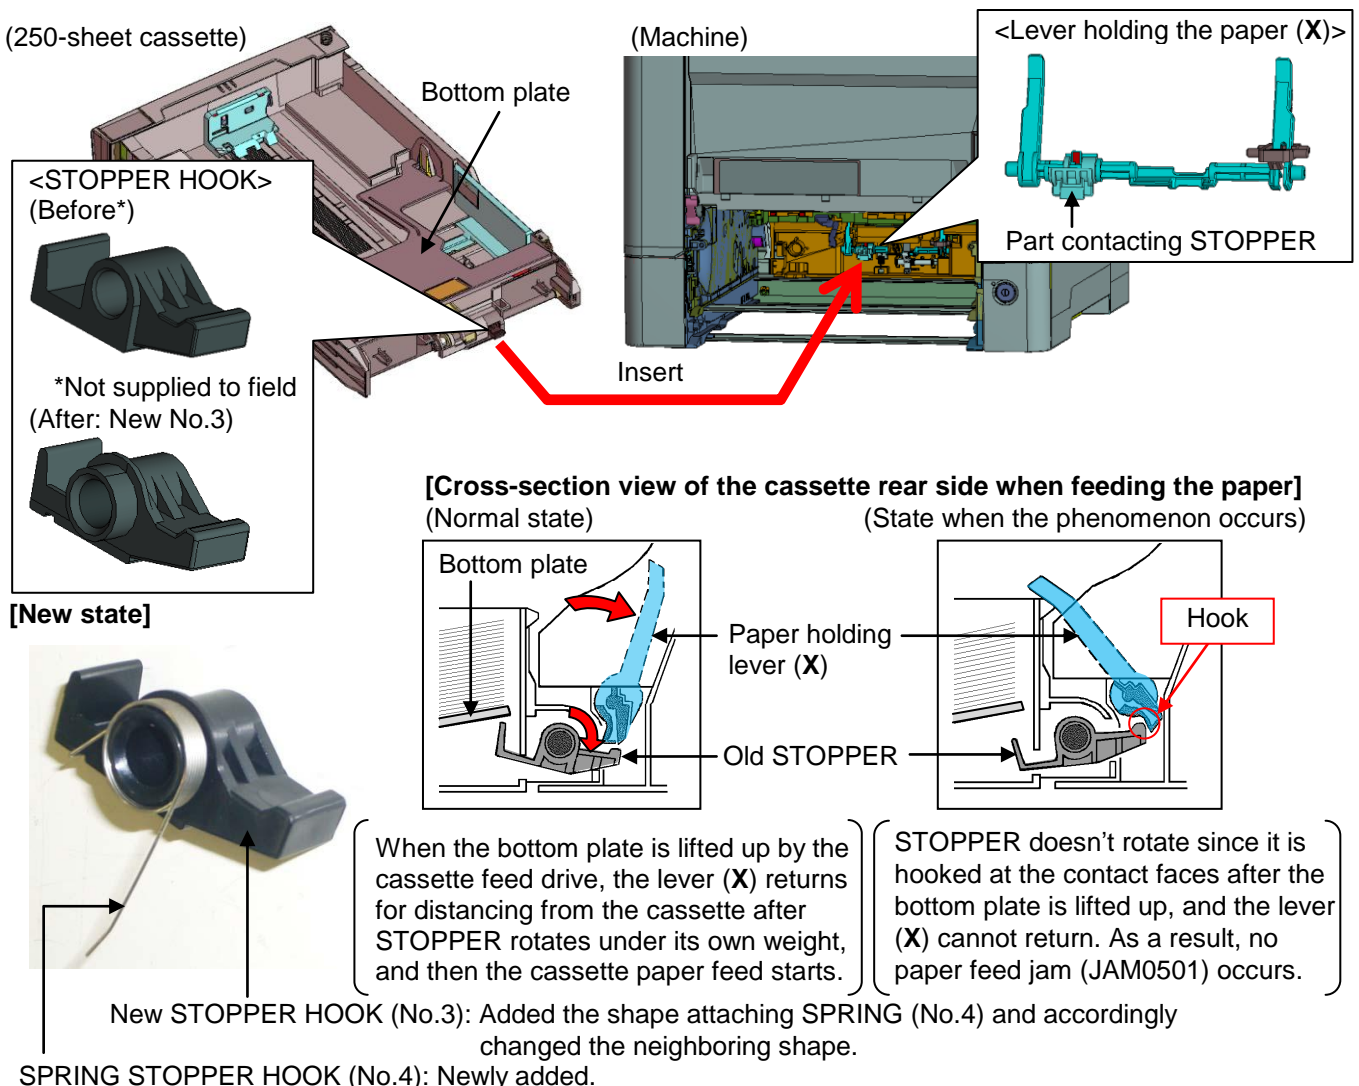
The shape of STOPPER HOOK (No.3) is changed and SPRING STOPPER HOOK (N) is added to improve the operability of STOPPER HOOK when feeding the paper from the cassette with the bottom plate lifted up.

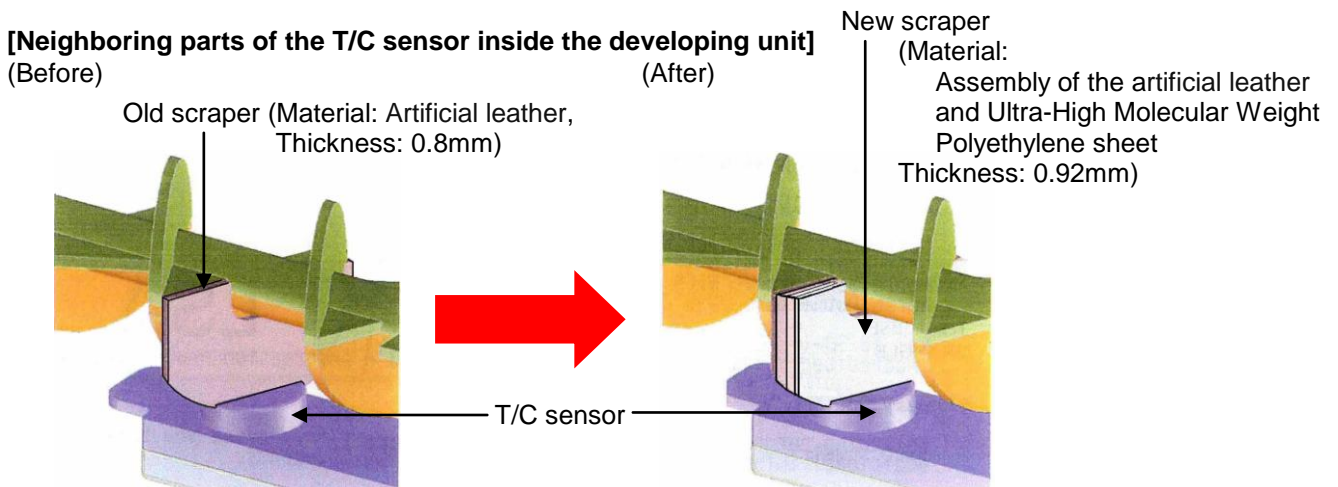
The material of the T/C sensor cleaning scraper inside the developing unit is changed for improving the durability.

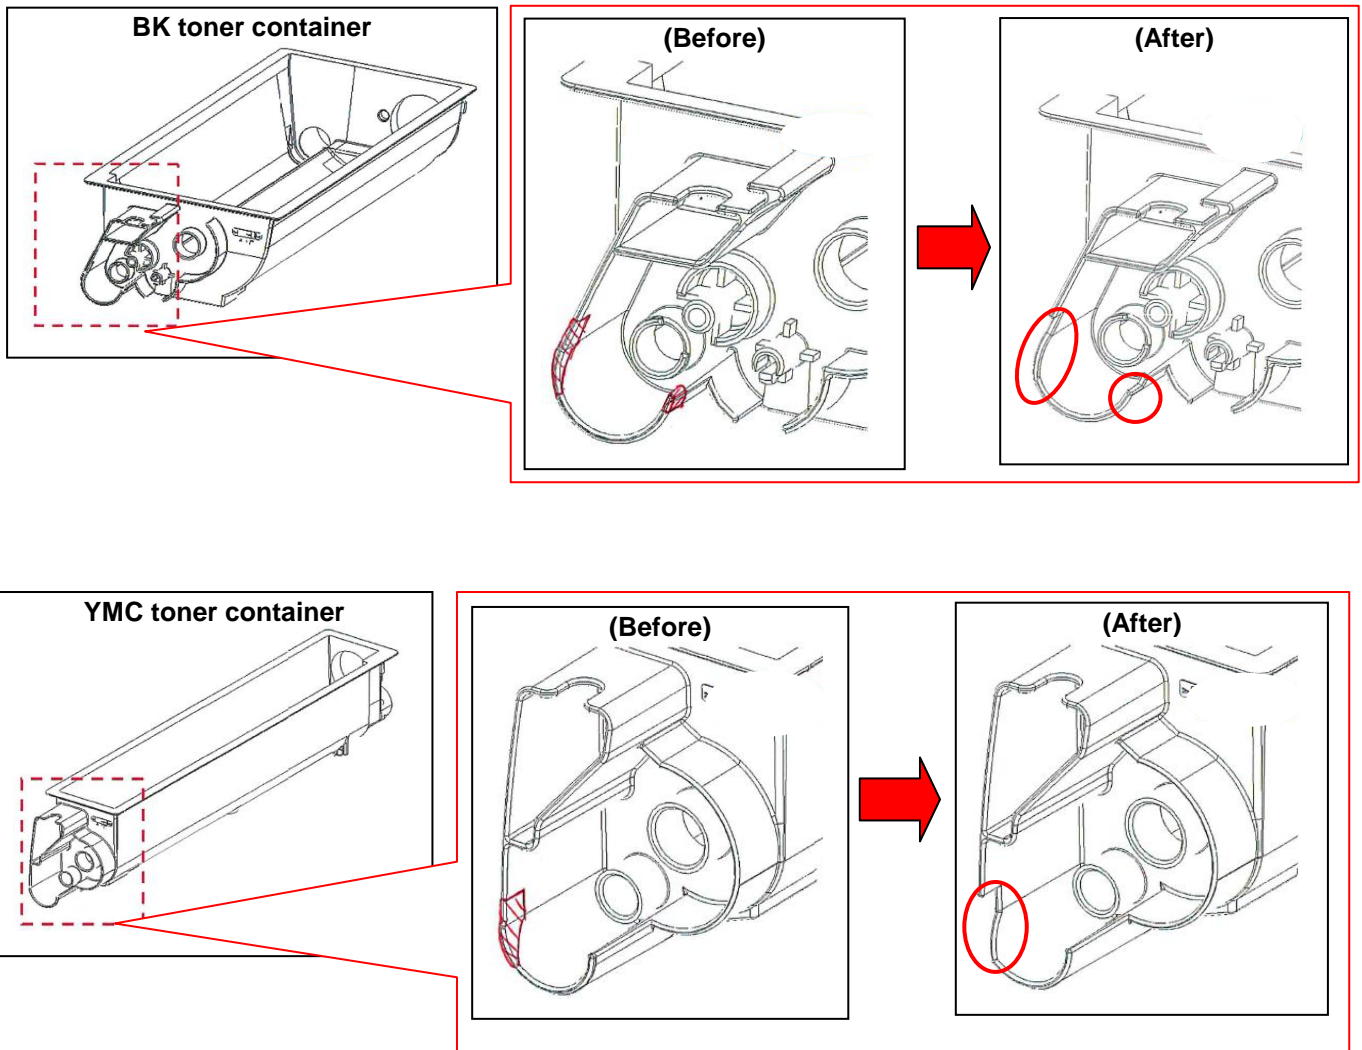
The shape of the toner container is changed to secure the margin for the clearance with the toner container driving parts at the main machine side.

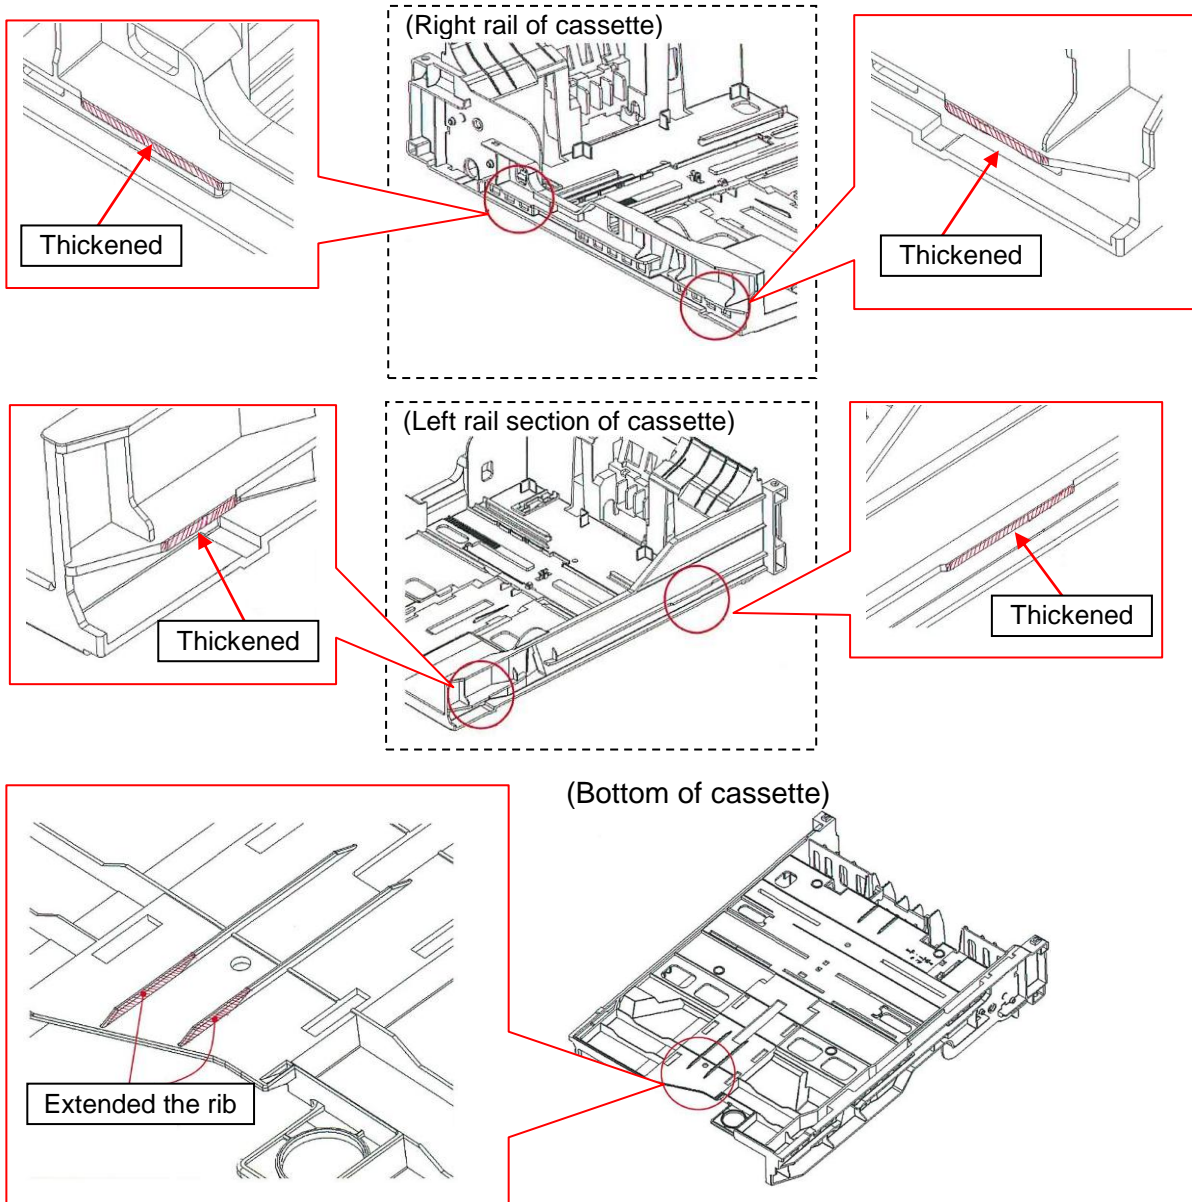
The shape of the cassette is changed as follows.

- 1) The left and right rails of the cassette are partially thickened to improve the margin for sensing the cassette (improving the side-to-side backlash of the cassette). (total 4 points)
- 2) The ribs at the bottom of the cassette are extended to improve the margin for the clearance to install the cassette.

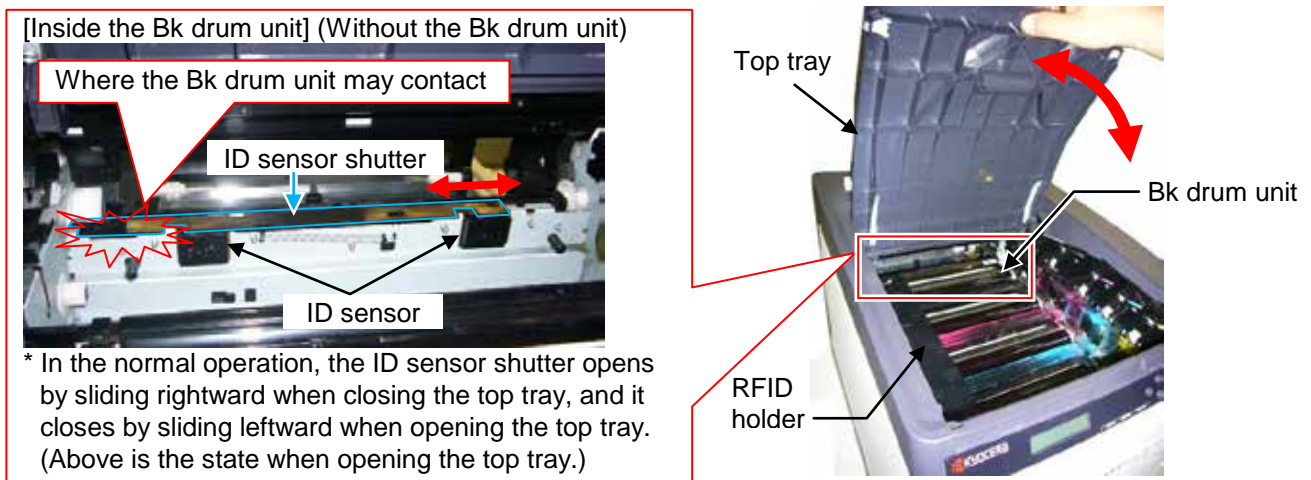
Please note the following when detaching the Bk drum unit because the ID sensor shutter may come off depending on the way to detach the Bk drum unit (Note 1). In a rare case, it causes the color registration drift if the main machine continues drive while the ID sensor shutter comes off.

If the ID sensor shutter comes off and cannot slide, it covers the ID sensor even if the top tray is closed. Then, acquiring the correction fails because the ID sensor covered cannot scan patch patterns drawn on the transfer belt at the color registration executed when turning on the main power, etc. (Note 2) As a result, the color registration is executed based on the correction that was normally acquired last time, the difference with the actual state of the machine is widened per the execution of the color registration and the color registration drift gradually appears.

**When detaching the Bk drum unit, please hold the both sides of that unit, and pull it forward along the guide rails inside the machine.**

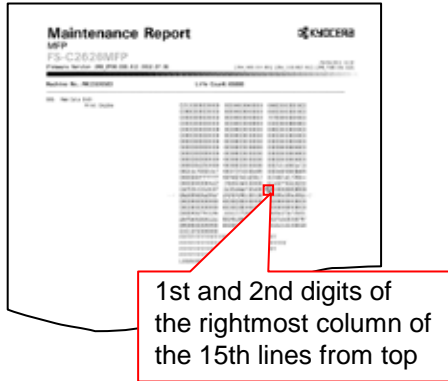
(2nd page of the maintenance report for MFP)

(Note 2) If acquiring the correction fails when executing the color registration, the error message does not appear. While the failure or success of the acquirement can be checked by referring to the numeric (Refer to the figures in the next page) of the calibration result on the 2nd page of the maintenance report (for MFP) or the service status page (for Printer). ("00" means the success and other numeric means the failure.)

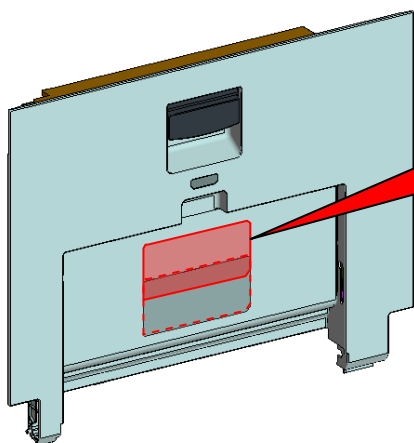
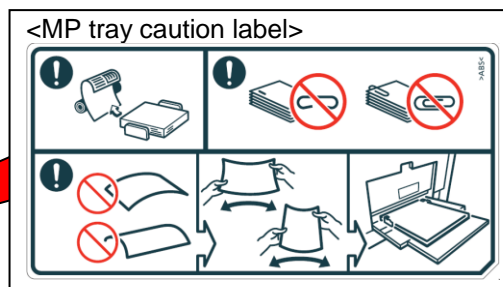
**<PARTS RIGHT COVER UNIT (No.1)>**

The MP tray caution label on the exterior of PARTS RIGHT COVER UNIT (No.1) is relocated for common use of the parts.
