# Service Bulletin

Ref. No. **COM-0218 (B056)**

<b>Subject</b>	<b>Note when releasing the paper jam/maintaining the machine (Prohibition of use of the flammable sprays and liquids)</b>
<b>Model</b>	All models

<b>Subject</b>	<b>Mac OS 10.7 Lion: Alternative Scan Function since Scan to SMB is NO LONGER supported in the Latest Mac OS Version</b>
<b>Model</b>	<b>All MFP Models</b>

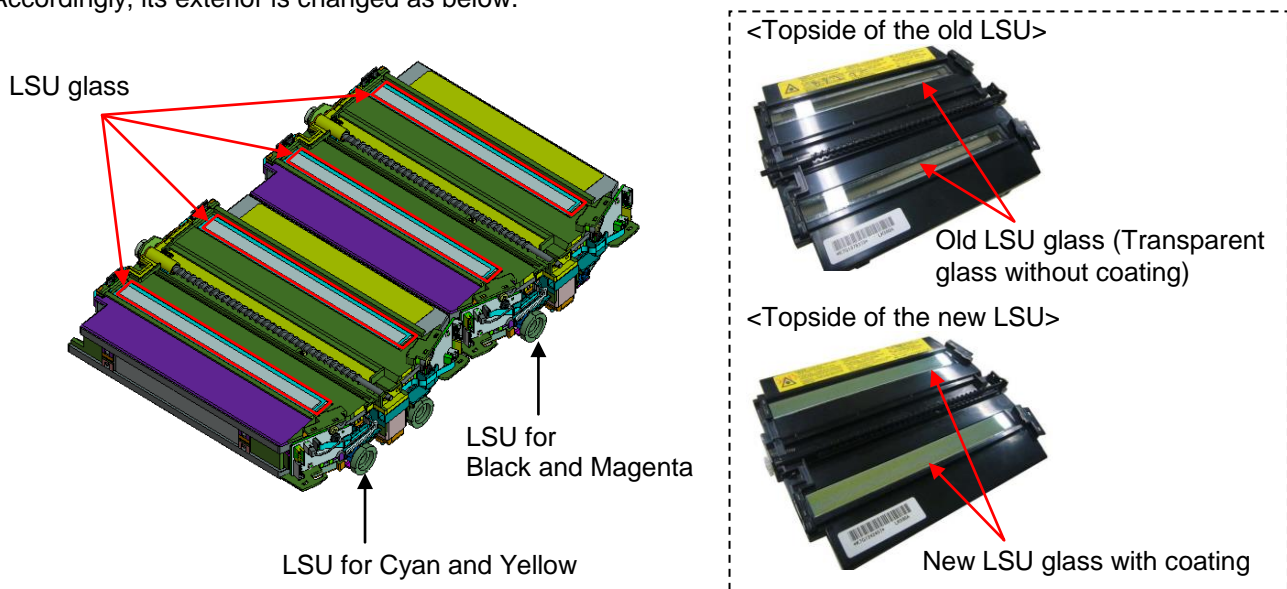
The coating is applied to the surface of the LSU glass for common use of the parts.  
 Accordingly, its exterior is changed as below.
