FS-C2026MFP(+)-C2126MFP(+), FS-C2526MFP-C2626MFP, FS-C5150DN, FS-C5250DN

TROUBLESHOOTING GUIDE

KDE PRODUCT ENGINEERING

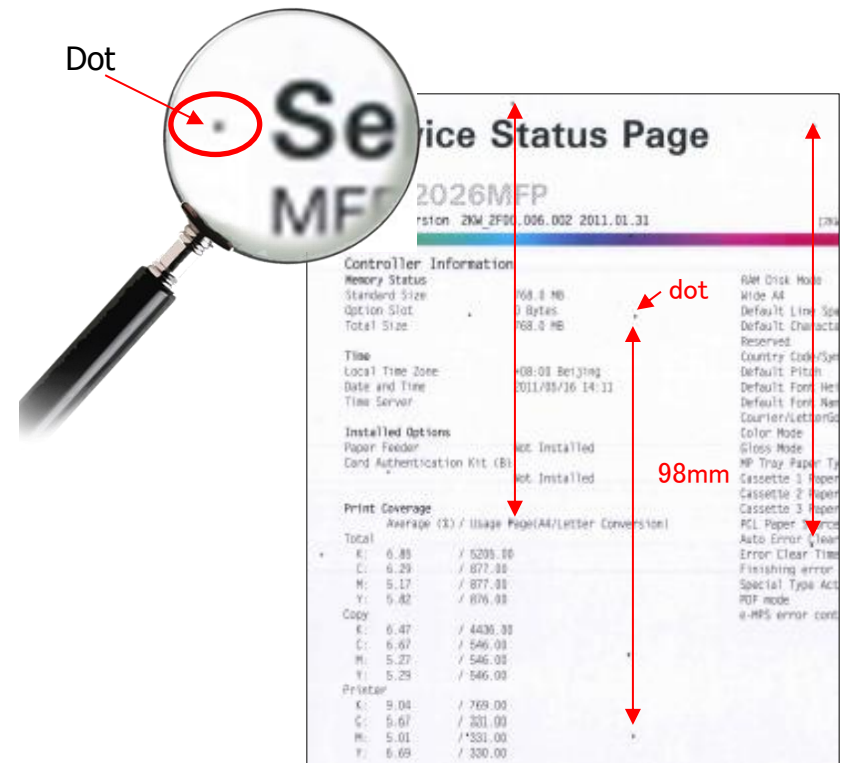
Dots appear on the output image caused by the micropinhole in the layer of the Drum. The phenomenon is occurring in high humidity environment, but occurs even in normal temperatures.

Part information:

DK-591 - 302KT93014 or newer (FS-5150DN)
 DK-590 - 302KV93014 or newer (FS-C5250DN, FS-C2026MFP,
 FS-C2126MFP, FS-C2526MFP, FS-C2626MFP, FS-C2026MFP+, FS-
 C2126MFP+)
