Service Bulletin

Ref. No. **COM-0218 (B056)**

Subject	Note when releasing the paper jam/maintaining the machine (Prohibition of use of the flammable sprays and liquids)
Model	All models

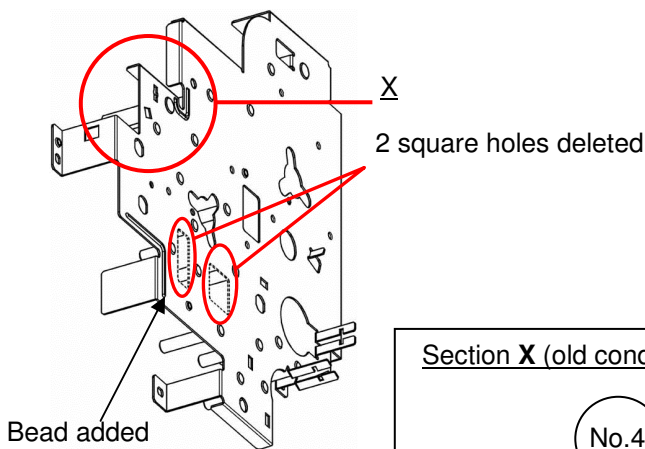
<PLATE DRIVE A (No.1)>

- PLATE MAIN DRIVE A(No.1) : 2 square holes deleted, bead added
- PLATE MAIN DRIVE C(No.2) : 1 square hole deleted, hole diameter change (from 18mm to 14mm), top of bent 5mm cut-off (3 portions)

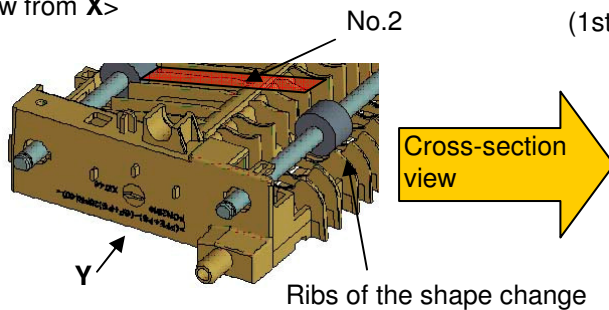
<View from X>

Ribs extended to reduce gap between the shaft and the ribs (1st,2nd,6th to 12th rib from right/left respectively)

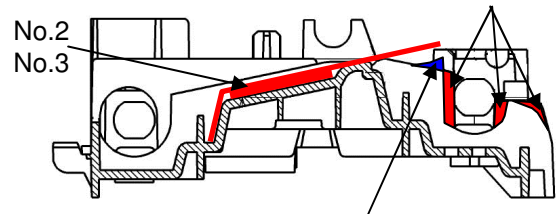
Cut off (1st,2nd,7th to 12th rib from right/left respectively) (6th rib is not cut off)

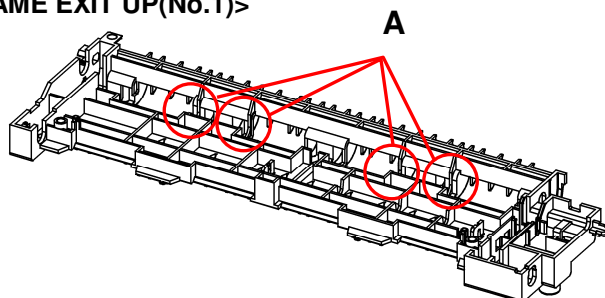
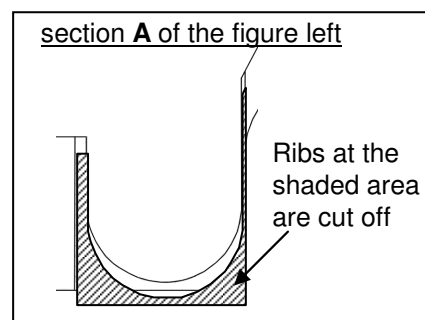
<FRAME EXIT UP(No.1)>

The ribs on FRAME EXIT UP (No.1) are cut off for common use with other models.

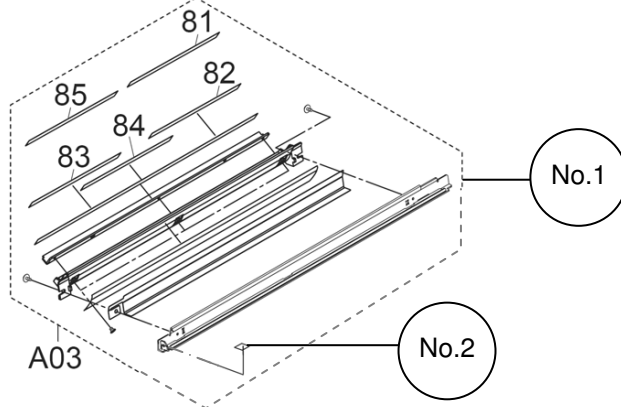
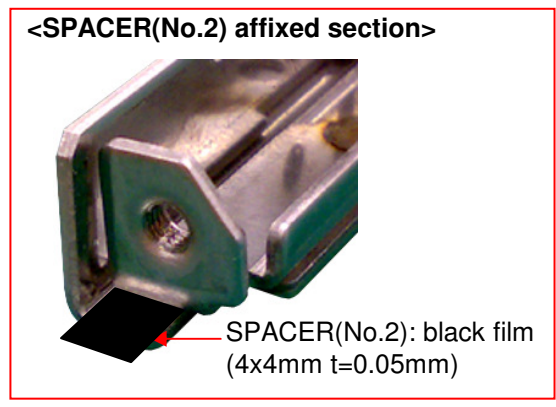
The spacer (No.1) is added to the machine front side of the transfer guide to stabilize the image quality.

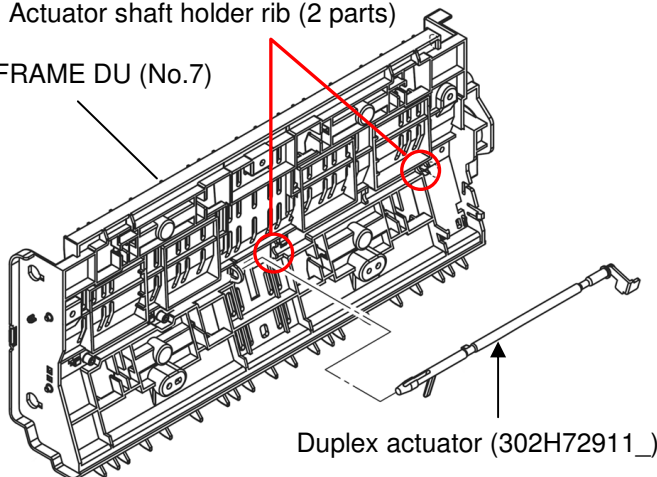
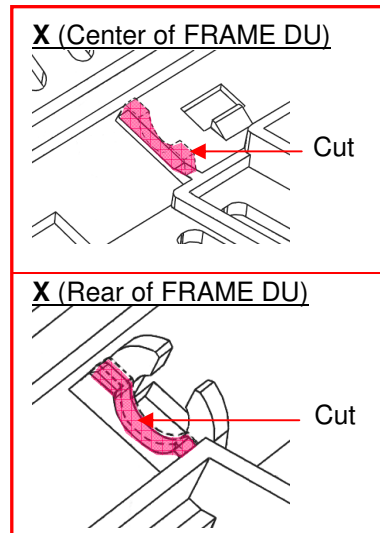
When the paper is transported into the duplex section in case of duplex printing, the shaft of the duplex actuator may be interfered by the actuator shaft holder rib (X below) on FRAME DU (No.7) due to dimensional variation of the part and it may cause JAM60 of the duplex feed 1 jam. Therefore, following is changed.

X: Actuator shaft holder rib (2 parts)

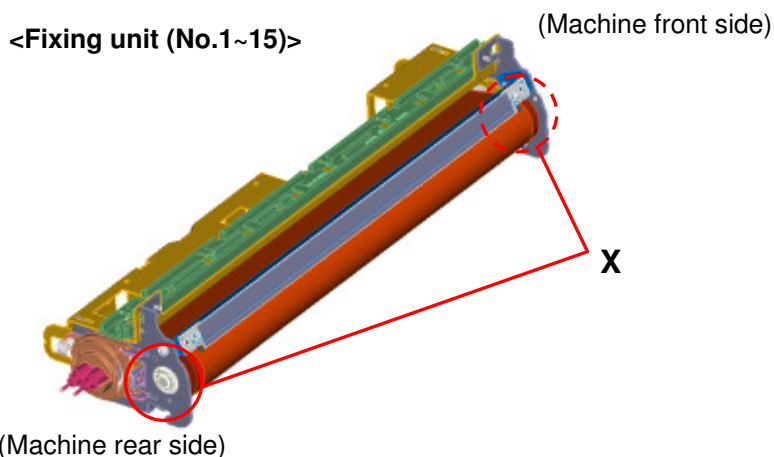
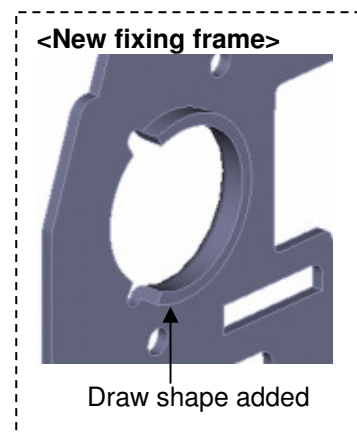
If the drive continues with the leaned bearings, the abnormal noise may be heard from the friction between the fixing roller shaft and the inner part of the bearing, or the bearing may be broken to cause the SC2300 error or jam. Therefore, following are changed.

The grease that is applied to the inner part of the bearing to reduce the friction between the fixing roller shaft and the inner part of the bearing is changed to heat resistant type to avoid deterioration by the fixing heat and (applied since August 2009 production)

Draw shape is applied to the part to hold the bearing on the fixing belt frame to improve holding of the bearing. (planned in November 2009 production)

Field Measure: Please replace with the fixing unit of the permanent measures in case the above phenomenon arises. (the fixing unit with the serial number listed in the <Permanent measures: change of the fixing belt frame> in the next page*)

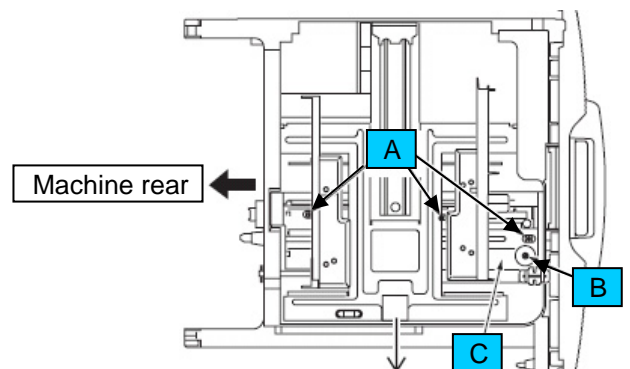
The paper stack adjustment failure may occur in case the right corner of the rear edge of the A4 paper stack is hit by the inner wall of the staple unit, and the rear stapling may be executed in that state.

The paper stack adjustment failure does not occur if the center of the paper stack in the cassette is within the reference range. Please correct the center position of the paper stack.

1. Print the test pattern in the U402 and compare it with the center position on the paper .
2. If the center position is shifted toward the rear side of the machine, loosen 3 of the screws A and rotate the adjuster screw B clockwise and move the adjuster plate C toward the rear side of the machine. Then, tighten the 3 of the screws.
3. Adjust the center line for the image forming in the U034.

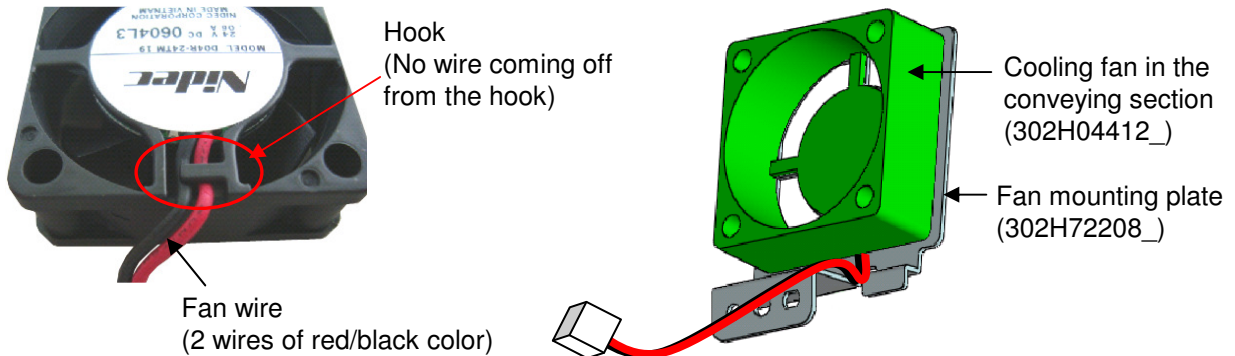
(Photo in below is the fitting side to the fan mounting plate of the cooling fan)

- 1) Check if the wire (2 wires of red/black color) of the cooling fan stays at the hook inside and is not pinched up between the cooling fan and the cooling fan mounting plate.

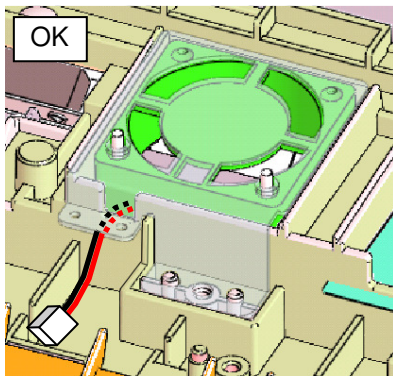
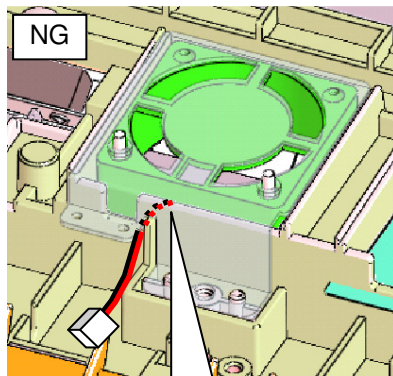
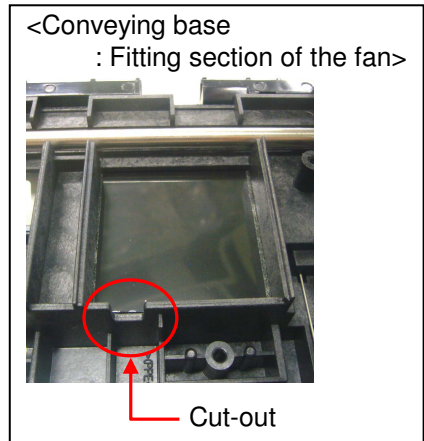
Above is the state that the fan wire is pinched up between the rib of the conveying base and the fan mounting plate.

- 2) Check if the fan wire passes through the cut-out of the conveying base when refitting the assembly of the cooling fan to the conveying base.

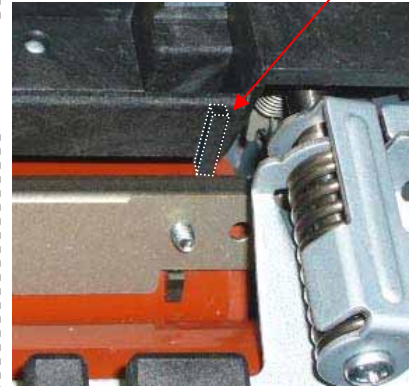
<(New) Fuser guide> Adding the rib

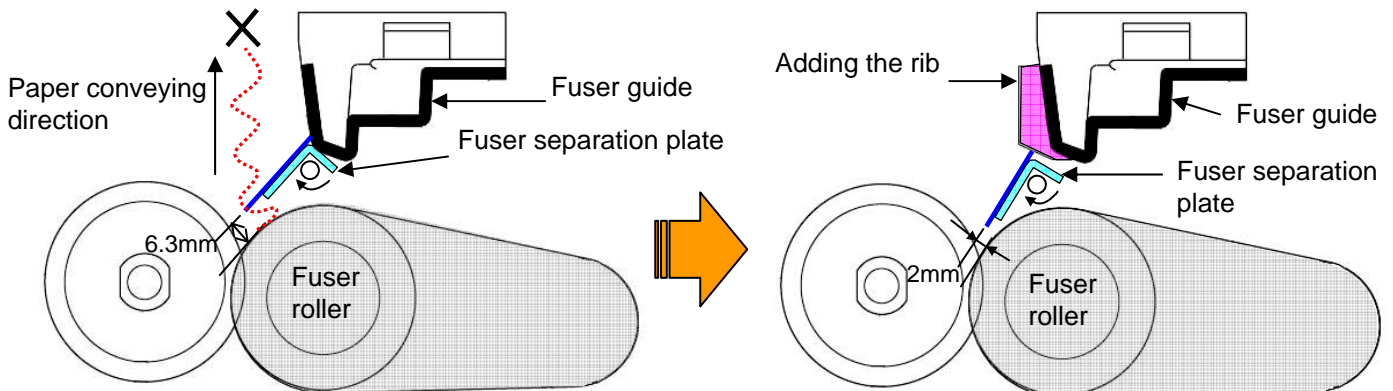
<State with the old fuser guide (Cross-section view)>
(Before)

<State with the fuser guide adding the rib (Cross-section view)>
(After)

Pleated paper like the accordion shape by bumping to the previous paper may push up the fuser separation plate and the rear end of the paper may be wrapped around the fuser roller from the gap because the motion range of the fuser separation plate is wide. If the paper is perfectly wrapped, the service code of fuser problems (C6000 thru C6400) appears.

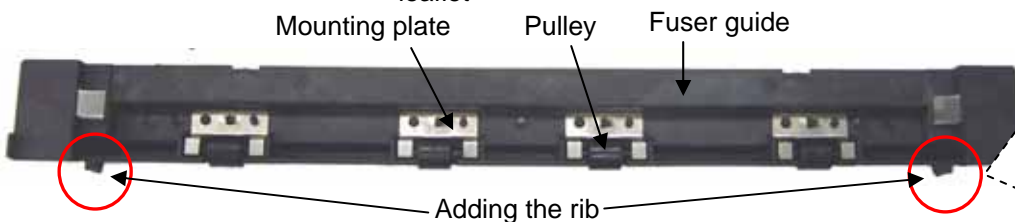
<Change of the fuser guide (Adding the rib)>

(After) Fuser guide } Assembly parts for service (No.13)
Pulley } (-->)+bundling the washer (No.14) and adding the caution
Mounting plate } leaflet

Adding the rib

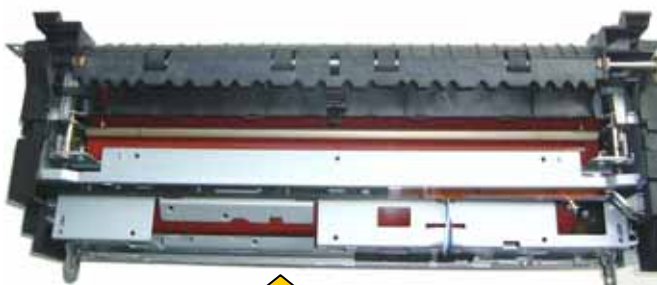
4. Check if there is paper.

(It is possible to check if the paper is wrapped around the fuser roller by viewing from X in the figure below.)
If the paper can be removed, securely remove so that the paper piece does not remain.

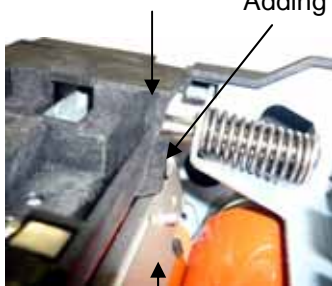
Fuser guide (No.13)

Fuser separation plate

Please confirm the gap in the method described in the left

1. Fit the new fuser guide (No.13) and fix 3 places of former page procedure 3 with 3 screws.
2. Confirm that there are the gap between the fuser separation plate and the 2 ribs added to the fuser guide after fitting the new fuser guide (No.13).
3. In case there is no gap in the above confirmation, please add the washer (No.14).

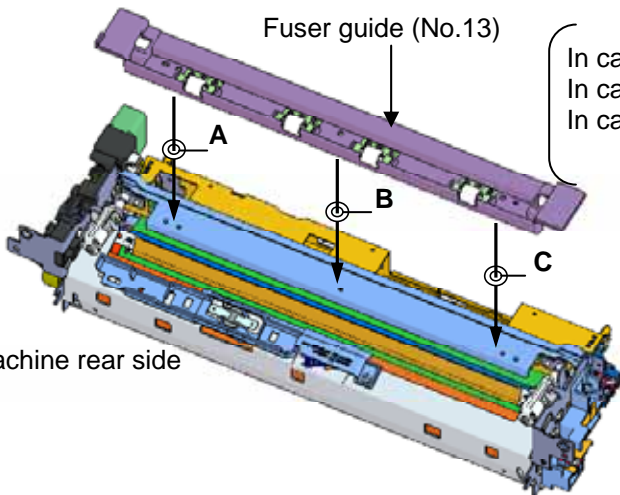
<Position to add the washer (No.14)>

Machine rear side

machine front side

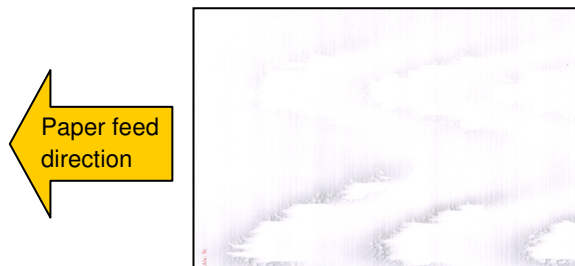
<Image sample> (Below is the eminent example)

Bk background image like the following image sample from the uneven Bk toner layer may be rarely printed in the high humidity environment. Therefore, the following is changed.

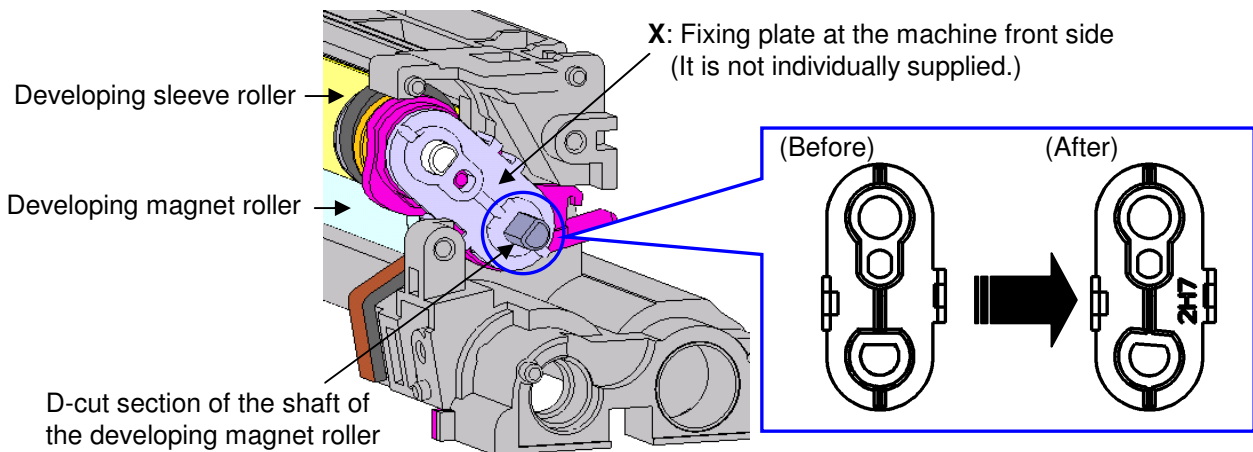
[Machine front side of the Bk developing unit]

To suit the position of the developing sleeve roller and the developing magnet roller, angle of the D-cut hole in the fixing plate (X in the figure below) at the machine front side that secures the attachment angle of the developing magnet roller is changed so that the image failure in the high humidity environment is improved.

KMC's Classification	<input type="checkbox"/> Entire Stock Rework <input checked="" type="checkbox"/> In-Field modification by case	<input type="checkbox"/> In-Field modification at next visit <input type="checkbox"/> No modification necessary
Field Measure:	Please execute [Developer Refresh] from [Adjustment/Maintenance] in [System Menu] when the above phenomenon occurs. If the image is not improved after Developer Refresh, please replace the Bk developing unit (No.1, 2) to the new one.

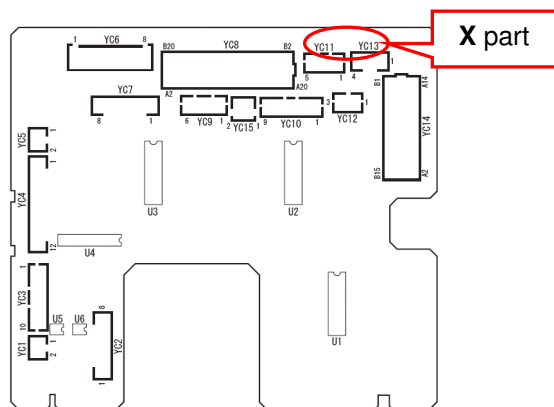
<Feed PWB (No.4)>

(*) When the short circuit occurs by damaging the wire coating of WIRE DU due to the wire alignment mistake, the excessive current may be impressed from the engine PWB and it may become the cause of the operation failure as the result.

- Feed PWB (No.4) for TASKalfa500ci/400ci, TASKalfa552ci and FS-C8500DN:
(Before) X part: A0280DCZ+GH/A0280-D --> (After) X part: A0280ECZ+GH/A0280-E
- Feed PWB (No.8, 10) for TASKalfa300ci/250ci:
(Before) Y part: A0333-C/Z part: A0333CCZ+GH --> (After) Y part: A0333-D/Z part: A0333DCZ+GH

KMC's Classification	<input type="checkbox"/> Entire Stock Rework	<input type="checkbox"/> In-Field modification at next visit
	<input checked="" type="checkbox"/> In-Field modification by case	<input type="checkbox"/> No modification necessary
Field Measure:		
Please check the state of the wire alignment/wire coating of WIRE DU at the machine front side for the machine with the record of disassembling and reassembling the conveying unit. If the wire coating is damaged, please wrap the insulation tape to the damaged part or replace WIRE DU to the new parts according to the state of the wire and correct the wire alignment to the normal state. (Please refer to the next page for the parts number of WIRE DU and the wire alignment.)

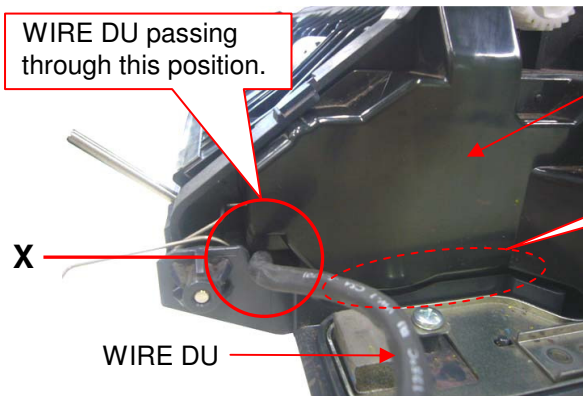
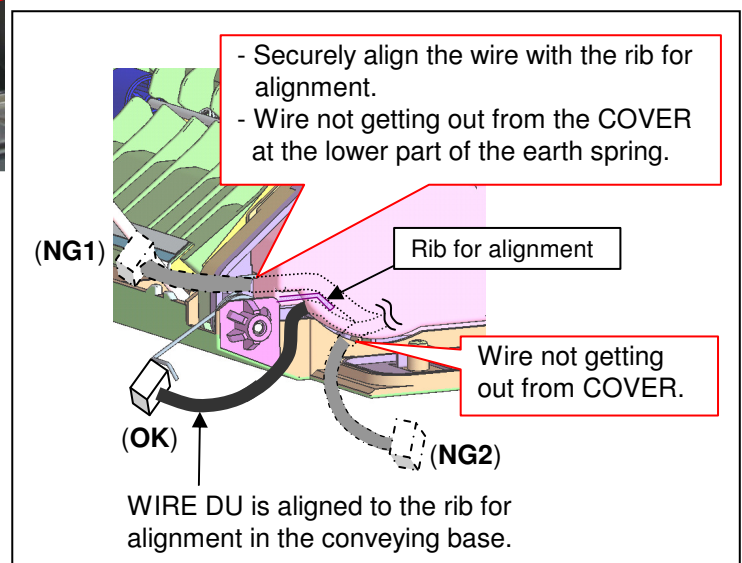
<Wire alignment of WIRE DU>

When reassembling the conveying unit, check if WIRE DU passes through the position marked X in the figure below when refitting COVER PWB FEED to the machine rear side of the conveying unit.

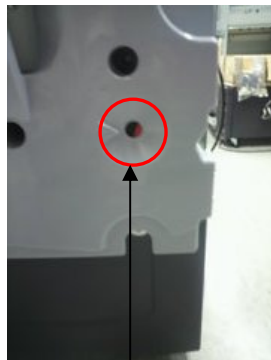
Red color is partly visible.

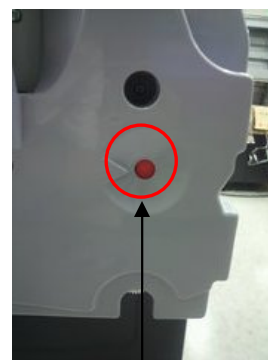
All of red color is visible

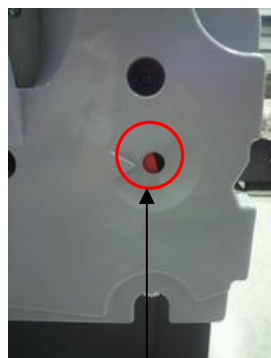
Red color is partly visible.

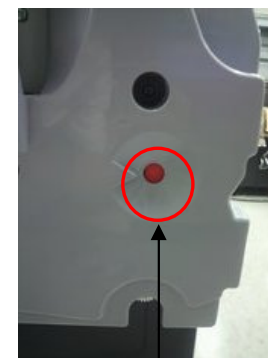
All of red color is visible

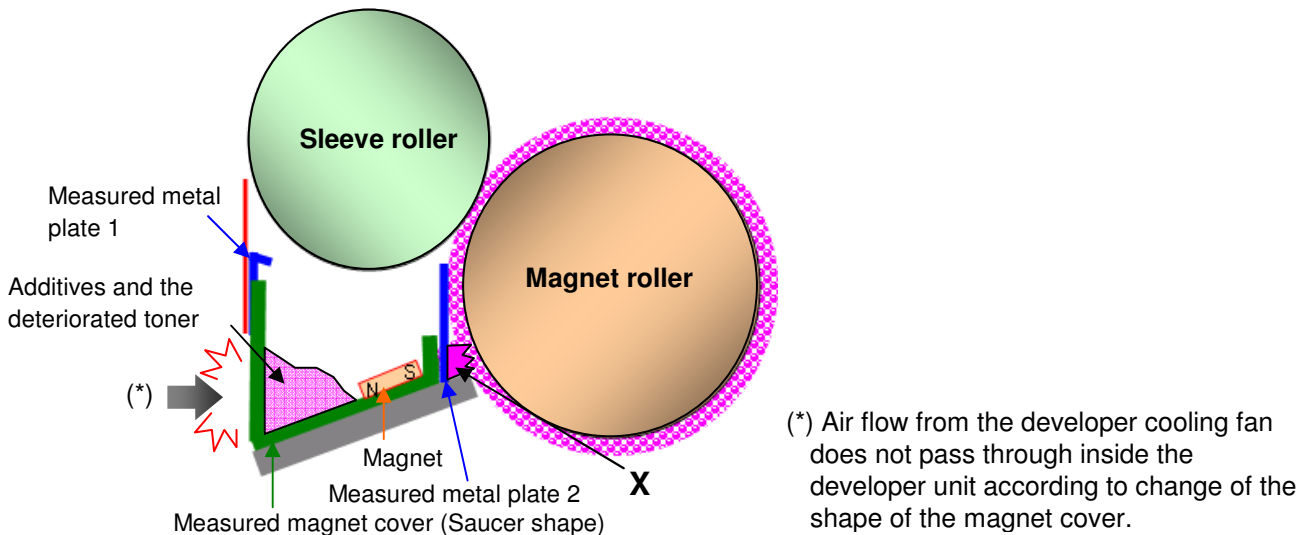
<Bk developer unit for preventing the toner smudge>

Normally, air flow from the developer cooling fan removes the additives and the deteriorated toner that are accumulated on the magnet cover by passing through the cut-out of the magnet cover. However, the remaining materials may be condensed depending on the operating condition that increases the deteriorated toner and it may interrupt the air flow of the developer cooling fan above the magnet cover. In that case, the deteriorated toner accumulating on the cohesive materials may adhere to the magnet roller or the sleeve roller and the Bk toner smudge may appear.

Measured magnet cover/measured metal plate 1:

Changing to the saucer shape to collect the deteriorated toner and the additives in the position where is not close to the magnet roller so that the service person periodically cleans it.

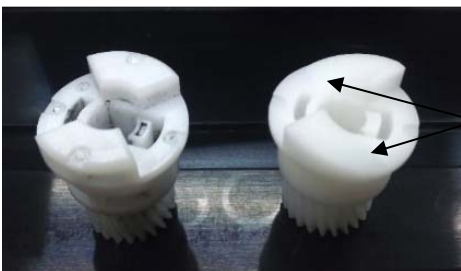
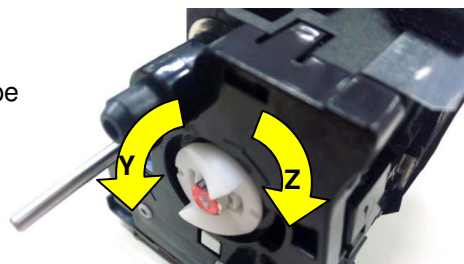
(Machine rear side of the Bk developer unit for preventing the toner smudge)

--> Operation that the gear is came off from the coupling at the main machine drive side and mesh again can be repeated when reversely rotating according to the above change. The deteriorated toner adhering to the upper side of the measured metal plate 2 that is added in <Changed point 2-2> can be shaken off and removed by giving the vibration to the developer unit when meshing with the coupling.

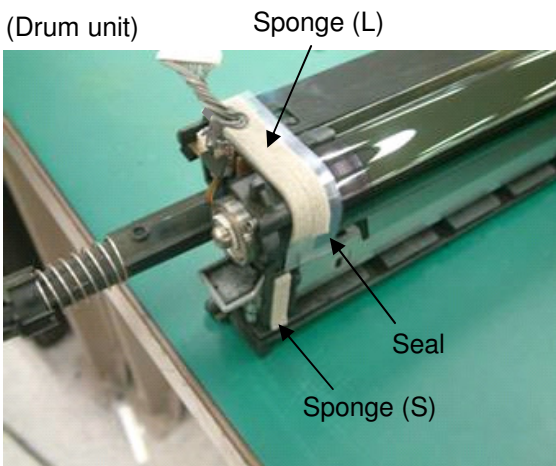
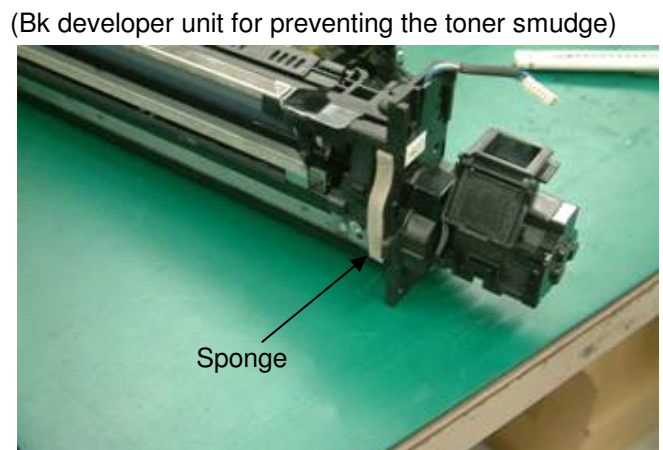
Air flow from the developer cooling fan normally enters into inside the developer unit from the cut-out of the developer magnet cover. However, air flow, due to deleting the cut-out of the developer magnet cover, is led to pass between the developer/drum unit and it blows to rise to the topside of the unit with the toner scattered from the developer unit. To interrupt this air flow, affixing the sponges and seal to the side facing the drum unit/developer unit. (Below in the photo below is prototype. Color of the actual sponge is dark gray.)

- Developer unit: Affixing the sponge to the side facing the developer unit for preventing the toner smudge.
- Drum unit: Bundling the sponge (L), (S), seal and affixing procedure leaflet (refer to the attached leaflet) in the Bk developer unit for preventing the toner smudge to affix to the drum unit when installing the developer unit.

(*) The above sponge and seal are not affixed or bundled in the drum unit. Please separately order the seal kit (No.5) and affix the sponge and seal to the new drum unit when replacing the drum unit in the machine that installs the Bk developer unit for preventing the toner smudge.

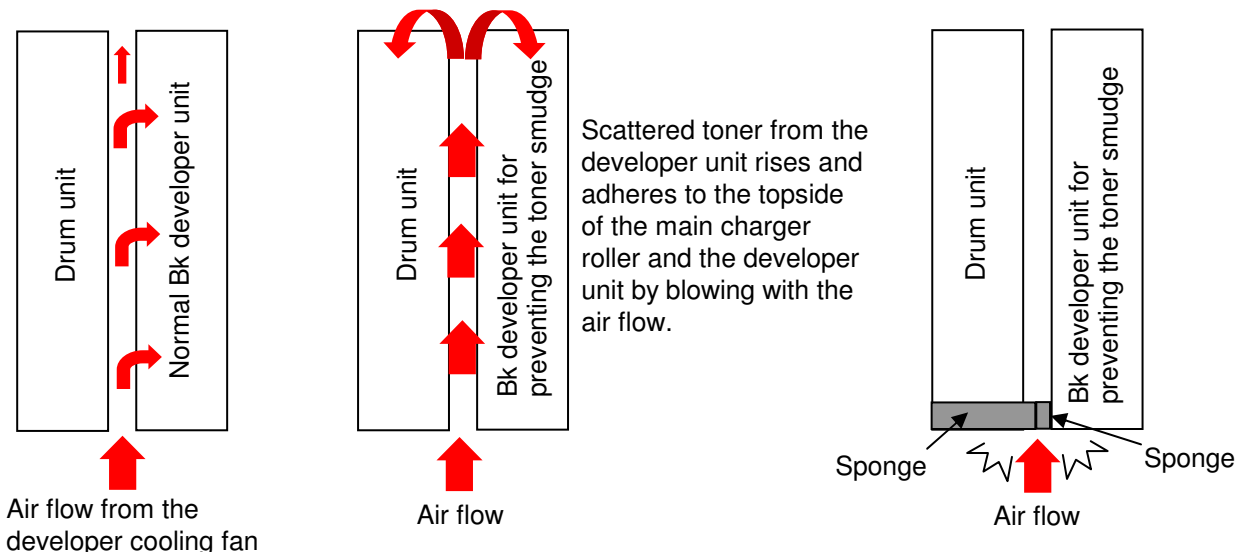
[Normal air flow of the developer cooling fan]

[Air flow when using the measured magnet cover (without sponge)]

[Air flow when using the measured magnet cover and affixing the sponge]

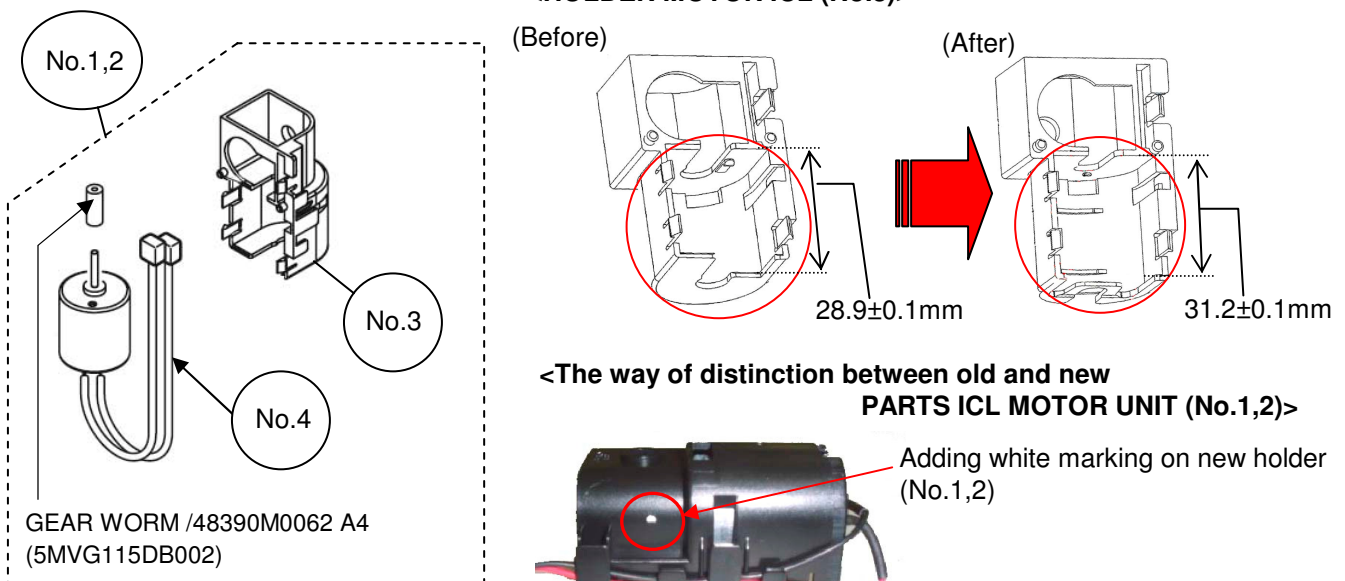
<HOLDER MOTOR ICL (No.3)>

When excessive electrical current is impressed by the short circuit in the waste toner motor, the engine PWB may be damaged or C2810 (waste toner motor error) may appear. Therefore, following are changed. Accordingly, an attention is required when replacing the parts. Please refer to <Field Measure> as below.

- 1) Margin for frictional wear of the brush is improved by changing the motor from different vender.
- 2) According to the above change, the shape of the holder of the motor is changed.
- 3) According to the above change, the wire alignment of the motor is changed. (Please refer to the next page)

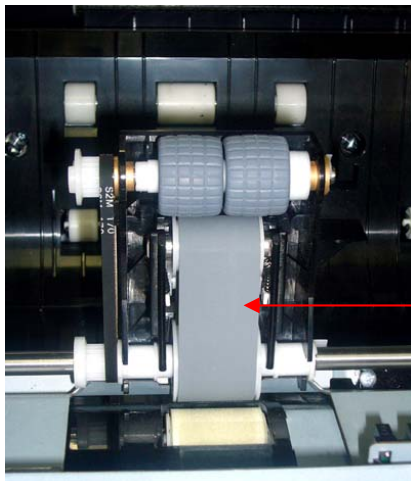
DP original feed belt (No.2)

As the result, the DP original feed belt may rarely drift when feeding the original at DP depending on the variation of the parts, and it may cause the paper jam (JAM70/71/72). Therefore, following are changed.

(*) The DP original feed belt (3H607010) that was normally used before is used for the period from the production in January, 2011 to this change (New No.2) as the temporary measure for TASKalfa620/820, the MK kit for TASKalfa620/820 and KM-6030//8030 only.

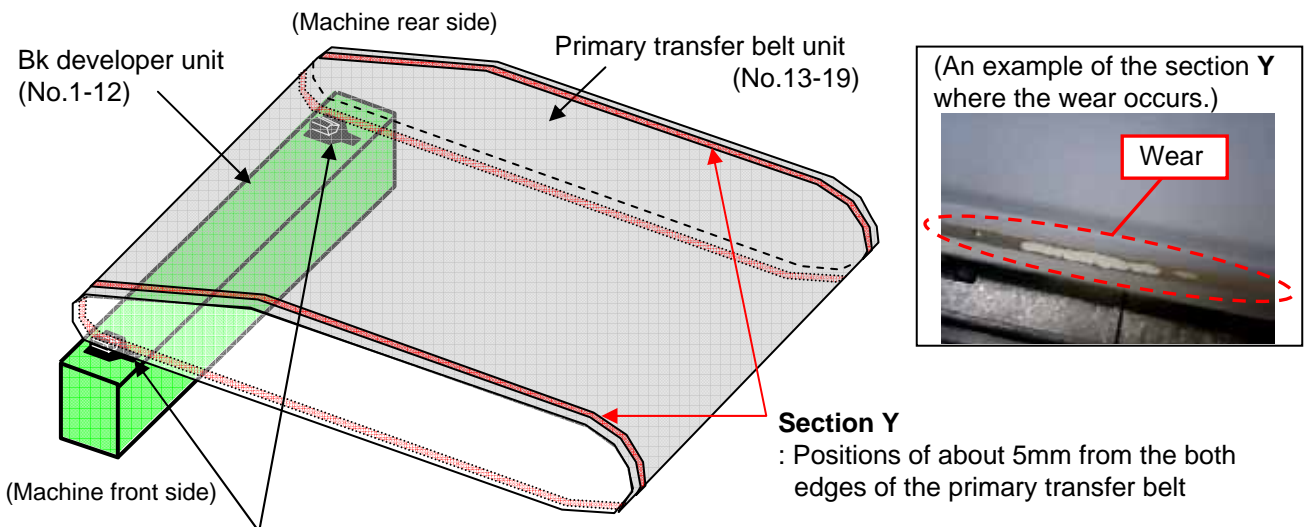
The affixing position of the seal (X in the figure below: No. 20) on the topside of the Bk developer unit was changed before (Note 1) as the countermeasure against the primary transfer belt side scratches. (*1)
Following is changed to reduce the wear at the positions (Section Y) of about 5 mm from the both edges of the primary transfer belt.

(*1) When the section Y at the primary transfer belt is worn down due to increase of the friction resistance between the primary transfer belt and the seal under the influence of the operation environment (high temperature/high humidity), the following phenomena may occur.

- White steaks or black streaks from the cleaning failure because of the scratched dust getting into the developer unit and the drum unit.
- Image failure from tear of the primary transfer belt because of the scratches going further to tear.

Material of the seal (X: No.20) on the topside of the Bk developer unit is changed to the one with lower friction resistance than before to reduce the wear of the section Y of the primary transfer belt.

Material of the seal: (Before) Seal planted nylon fiber (Black) --> (After) Fujiron (Teflon felt) (Dark brown)

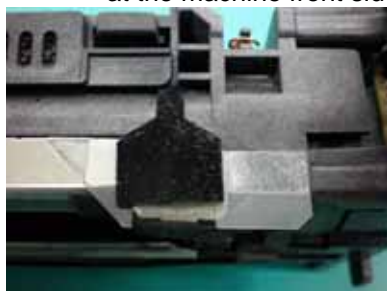
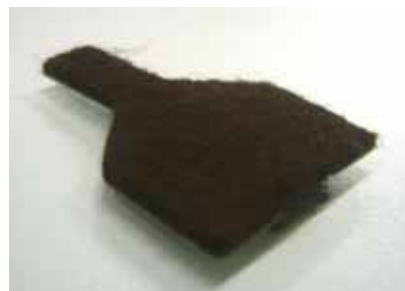
<Seal (X: 20) on the topside of the Bk developer unit>

Material/Color: Seal planted nylon fiber/Black

Material/Color: Fujiron (Teflon felt) (Dark)

1. Peel off the seal (**X**) on the topside of the Bk developer unit (Old No.1-12), and affix the new seals (**X**: New No.20) to the machine front/rear side of the Bk developer unit after cleaning the affixing part with alcohol. (Please refer to the attached leaflet for the alignment.)
2. Replace with the new primary transfer belt (No.13-19).
(New seals (**X**) in the above 1 should not be separately procured because the new primary transfer belt unit bundles 2 pcs of the new seal (**X**.)

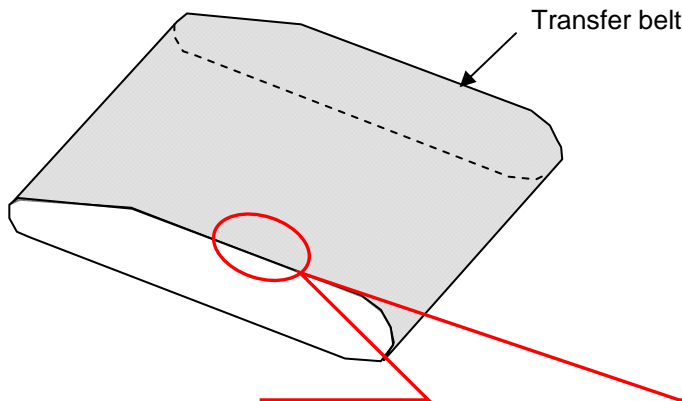
<Where to affix the stopper rubber (X)>

Following phenomena may occur with peel-off of the stopper rubber for the primary transfer belt side slipping during the machine drive from the seam in case adhesive force of the double-side tape comes to weak that affixes the stopper rubber (marked **X** in the figure below) at the inner side edge of the primary transfer belt depending on the operating environment of high temperature and high humidity.

- Image failure with tear of the transfer belt after the rubber runs over the edge of the drive roller
- Abnormal noise and jam (JAM31) with lock-up of the transfer belt drive after the rubber rolls up along the driver roller and gear

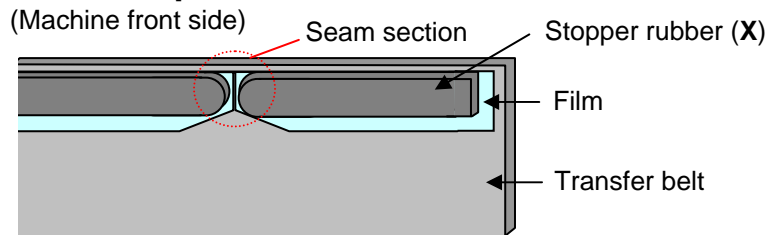
[View from inside the transfer belt edge at the machine front side as marking the red circle above]

*The stopper rubber is first affixed on the film with the double-side tape and then they are affixed on the inner edge of the primary transfer belt. In case adhesive force of the double-side tape in between the film and rubber comes to weak, the stopper rubber may peel off at the seam section. Then, seam section of the stopper rubber is fixed with glue to the film to prevent it from peeling off. (The transfer belt edge at the machine rear side has also the stopper rubber and film as in the above figure)

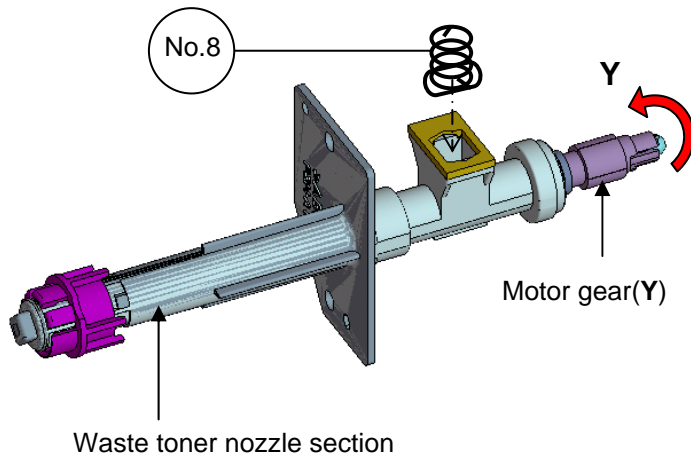
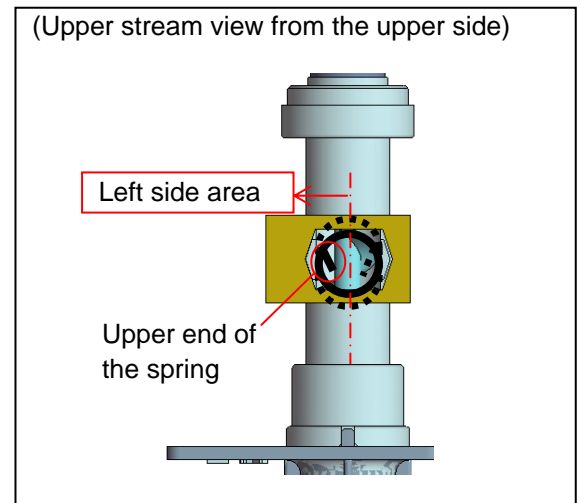
<Check2> The motor gear (D) that is at rear of the waste toner nozzle section can rotate toward the arrow Y without caught up.

* The lower end of the spring may be caught up in the mixer screw inside the waste toner nozzle if the upper end of the spring is in the right side area.

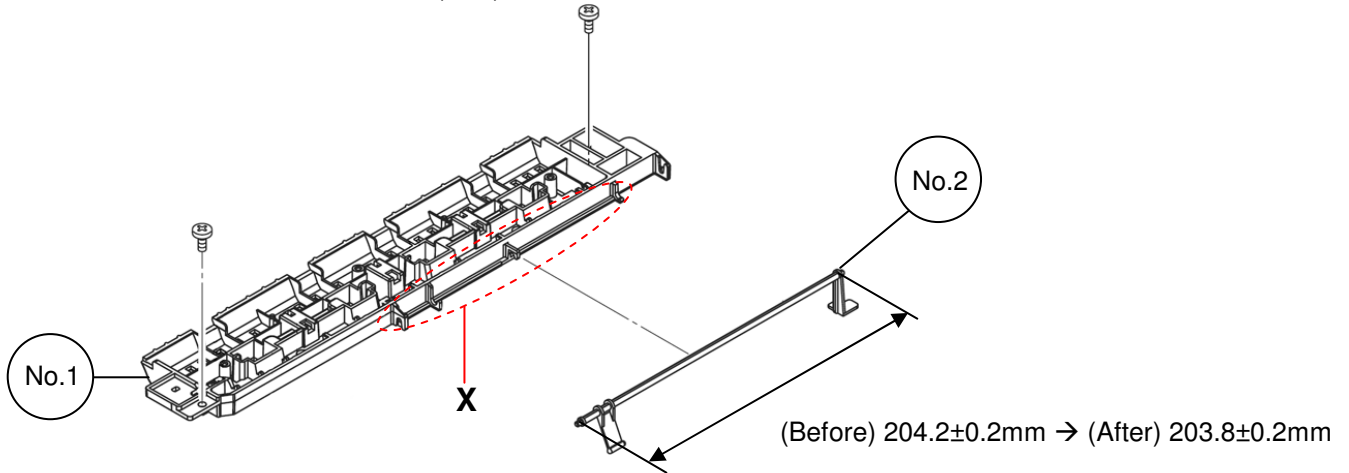
+/-0.3mm tolerance is added to the size of the exit sensor actuator fitting section (marked X below) on the upper exit frame (No1) and total length of the exit sensor actuator (No2) is shortened by 0.4mm to secure the margin for motion of the exit sensor actuator (No2).

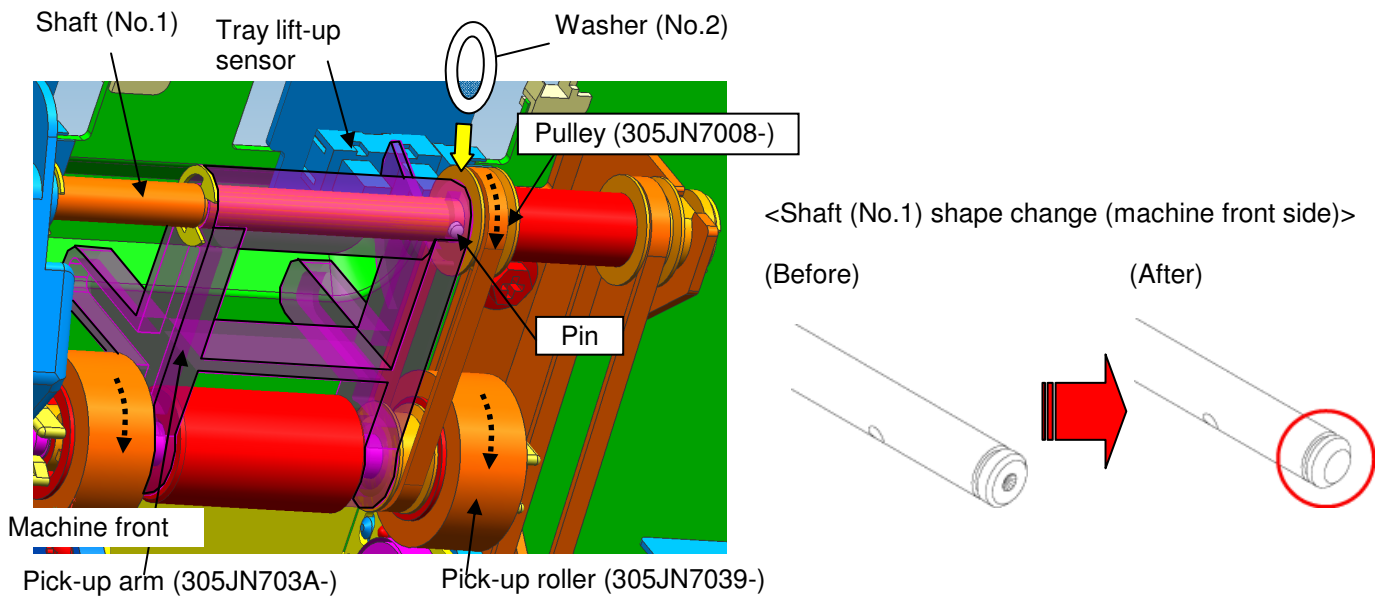
- 1) Pin hole angle on the shaft (No.1) is changed to prevent backlash of the shaft (No.1) and pick-up arm when the pick-up roller rotates
- 2) Shape of the shaft (No.1) is changed for distinction of the old and new shaft according to the above change.
- 3) Washer (No.2) is added in between the pick-up arm and pulley to reduce load to the pick-up arm and shaft (No.1) when the pulley rotates

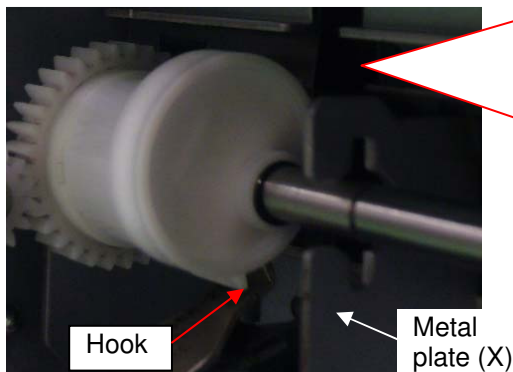
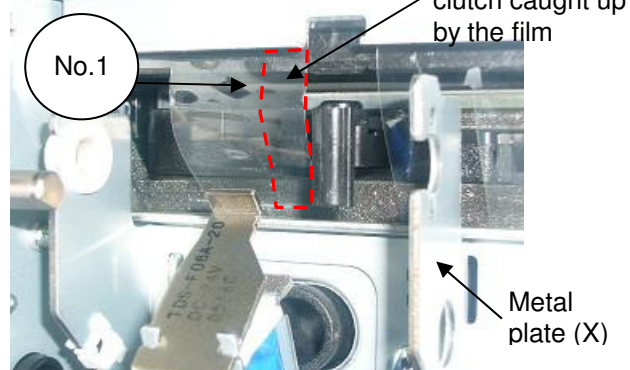
The shape of the film (No.2) is changed as follows in order to prevent the LSU cleaning blade motion failure from the hook of the drive clutch caught up by the film (No.2).

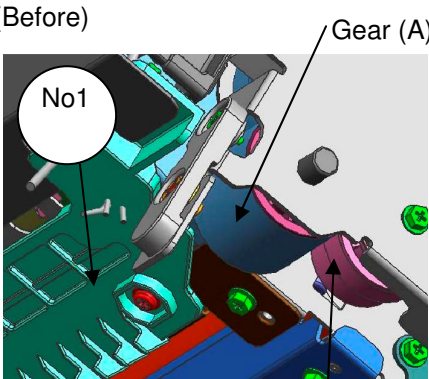
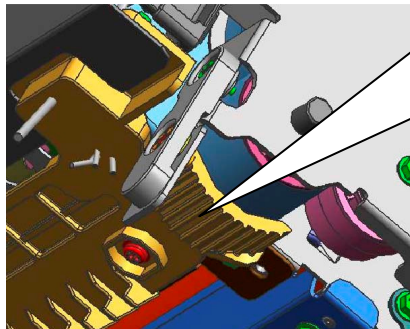
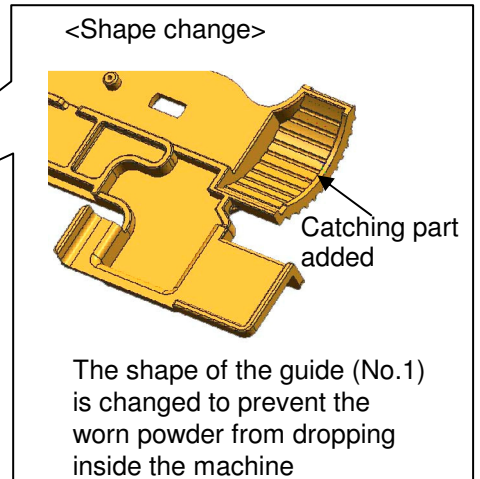
Change of the gear was informed per the service bulletin No.5JN-0030(A208) to improve the abrasion resistance of the fuser drive gear and the shape of the guide (No.1) is changed for further improvement to prevent the worn powder from dropping inside the machine. Adhesion of the worn powder to other units does not affect the image failure and abnormal sound, etc.

When GEAR-8H30-8(305JN7218-) is worn, the worn powder is brought to the gear (A) to prevent it from dropping inside the machine

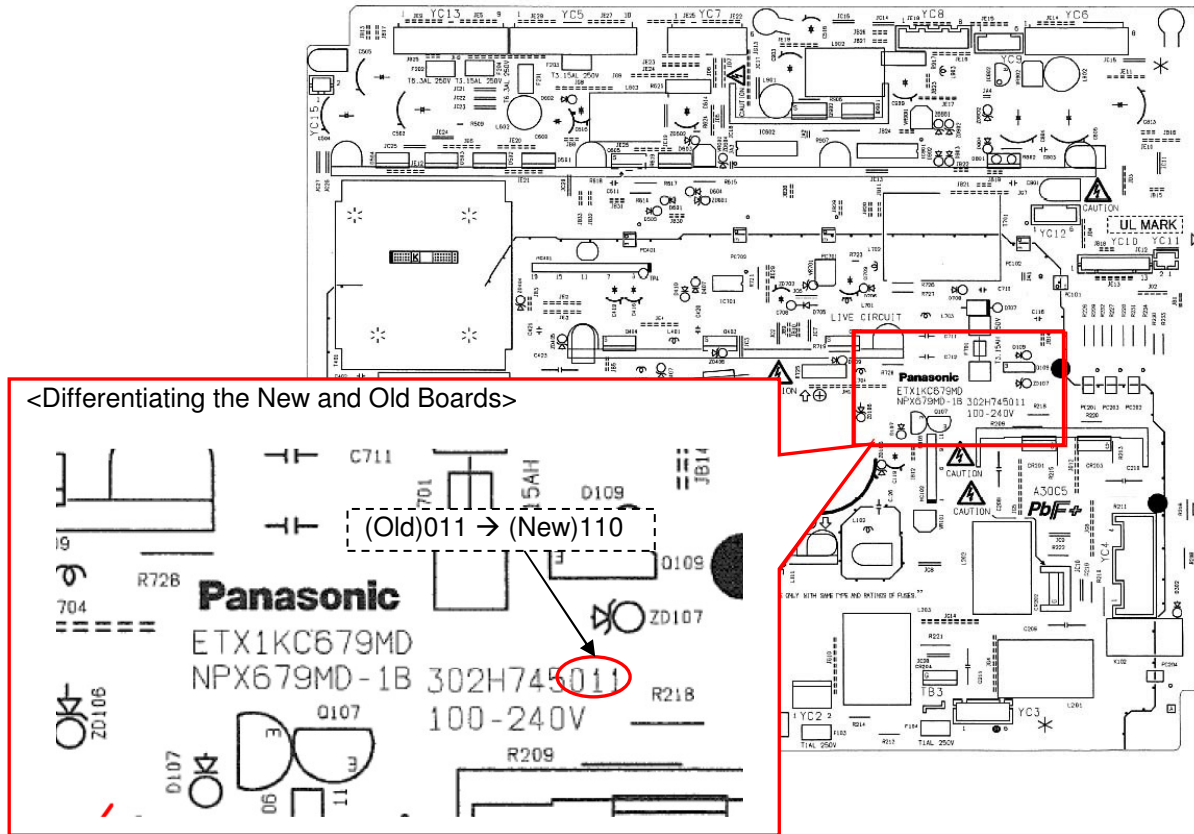
<PARTS UNIT LOW VOLTAGE 200 SP(No.1)>

1) In order to increase the margin for the Zero Cross Pulse, the resistance of Board(No.1) has been changed from 100kΩ to 12kΩ.

KMC's Classification	<input type="checkbox"/> Entire Stock Rework <input checked="" type="checkbox"/> In-Field modification by case	<input type="checkbox"/> In-Field modification at next visit <input type="checkbox"/> No modification necessary
Field Measure:	If the phenomenon mentioned above occurs, please replace the No.1 board with the new one.	
Serial Nos. of Affected Machine:	From the production in June, 2011 on*	
	* The above is the plan at the present moment.	
	Please note that there is a possibility of change after giving this information.

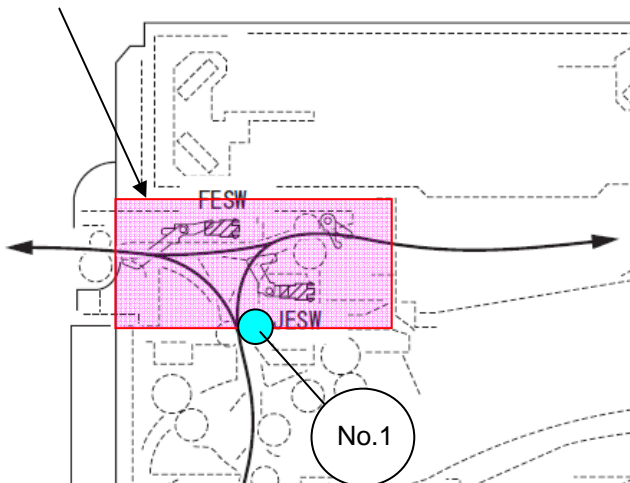
JS-720/JS-720(B)

If the roller (No.1) of PARTS ROLLER JS LOWER in the job separator reaches high temperature, the rubber roller is swelled due to the wax content of the toner and the inner diameter of the roller is expanded. Then, the rubber roller spins around against the shaft to cause the J51 jam (Misfeed in job separator eject section). Therefore, the following is changed.

The material of the rubber roller of PARTS ROLLER JS LOWER(No.1) is changed.
 [EPDM(Gray) → Silicon rubber (Black)]

Field Measure: Please replace with the new parts when the above phenomenon arises.

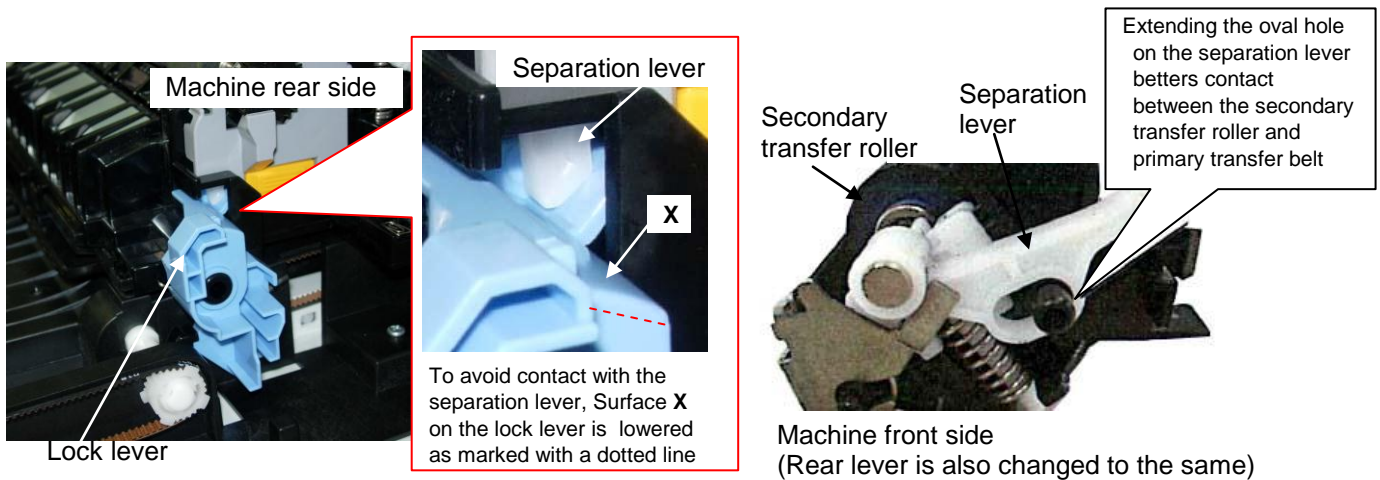
- 1) The shape of the lock lever is changed to avoid the contact between the lock lever at the conveying unit and the separation lever when opening/closing the right cover.
- 2) The shape of the oval hole on the separation lever is changed to secure the margin for contact between the secondary transfer roller and the primary transfer belt.

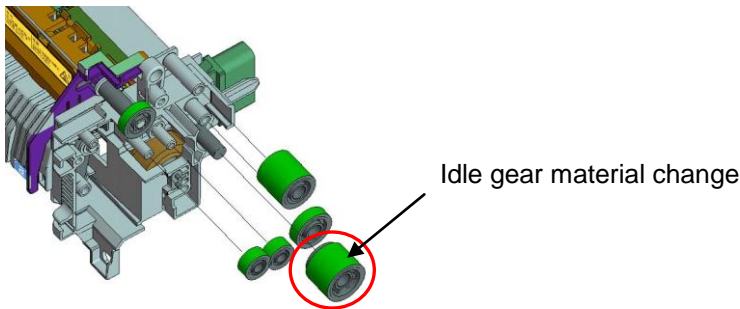
[Fuser unit (No.1~5)]

The material of the fuser idle gear is changed to improve the abrasion resistance.

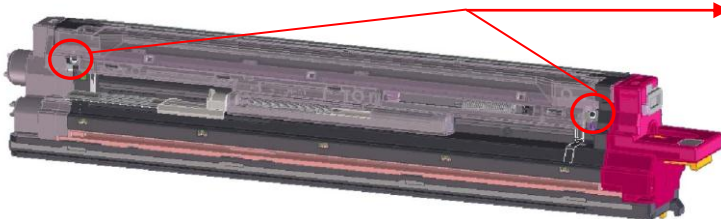
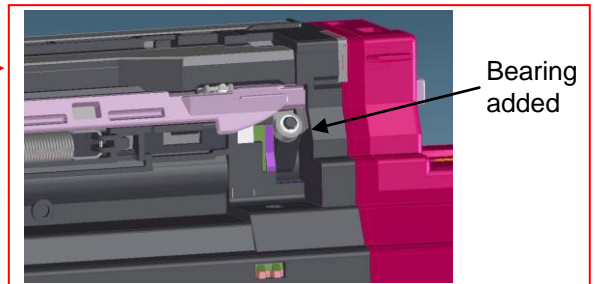
A bearing is added to the lever of the developer unit to reduce the load impressed to it.
