Service Bulletin

Ref. No. **COM-0218 (B056)**

Subject	Note when releasing the paper jam/maintaining the machine (Prohibition of use of the flammable sprays and liquids)
Model	All models

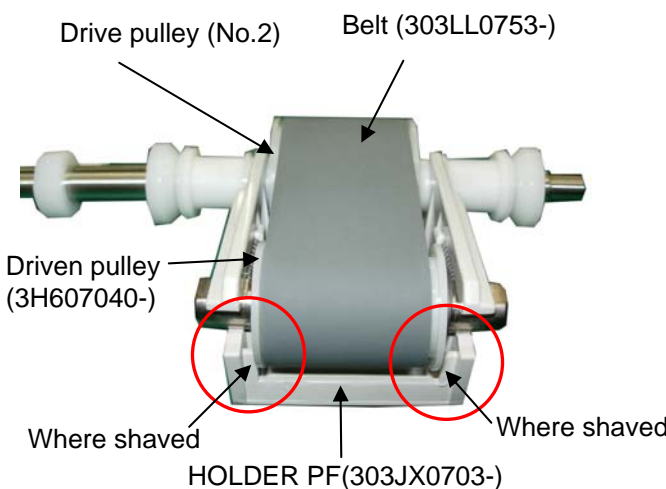
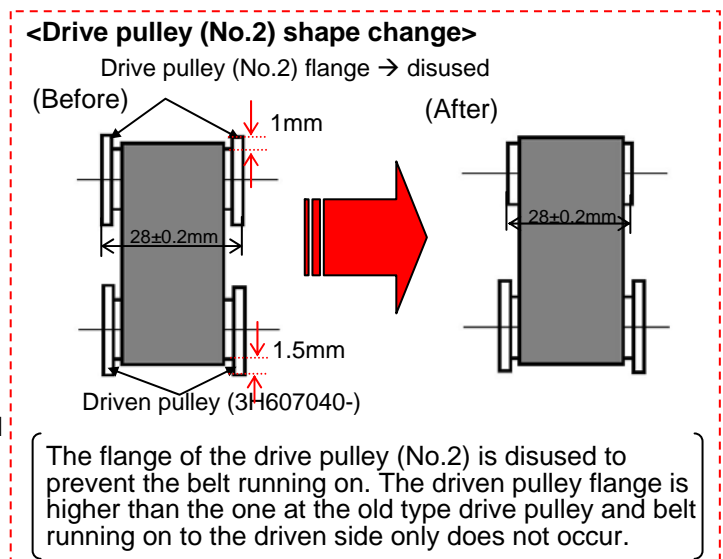
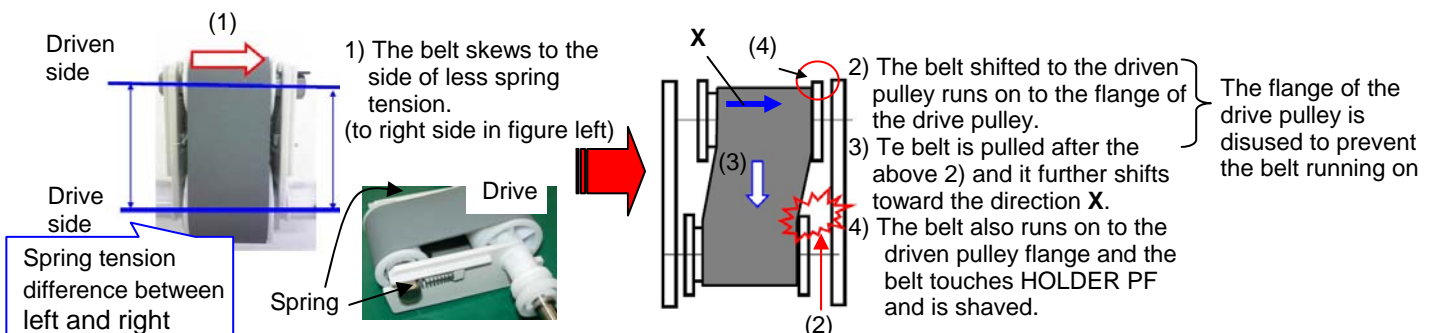
If the DP feed belt runs on to the flange at the edge of the drive pulley depending on the variation of the spring tension and parts dimension, it may further run on to the flange of the driven pulley later. Then, the belt edge may touch HOLDER PF(303JX0703-) and may be shaved to cause the J96xx jam. Therefore, the following is changed.

The shape of the drive pulley (No.2) is changed so that the belt does not run on to the flange at the edge of the drive pulley.

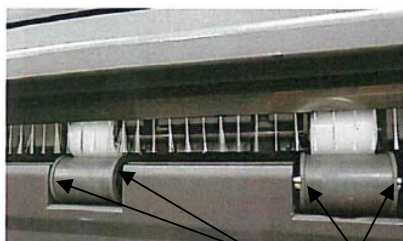
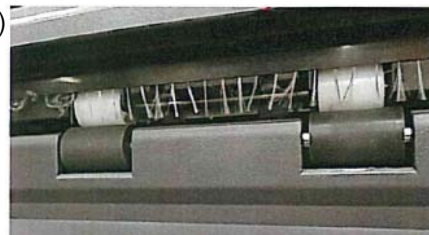
The shape of the eject pulley is changed to the one without flange to reduce the marks of the AK (bridge) pulleys. The material of the pulley is changed from EPDM to Silicon rubber as the lateral spread from other rollers to prevent the swelling by toner.

Flange disused

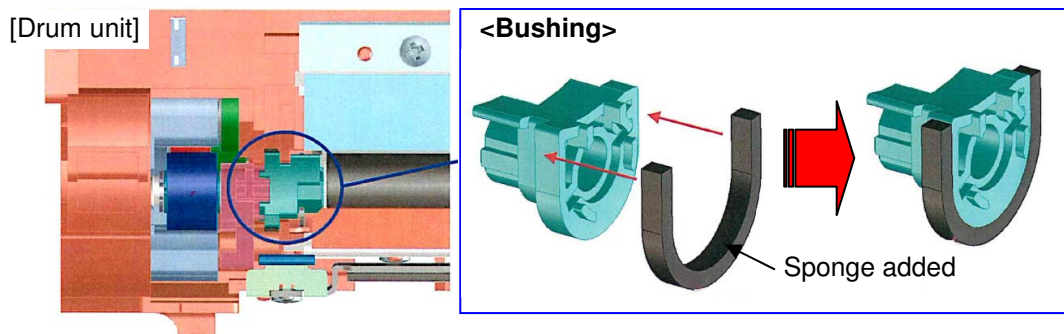
A sponge is added to the external circle of the bushing before and after the cleaning roller in the drum unit

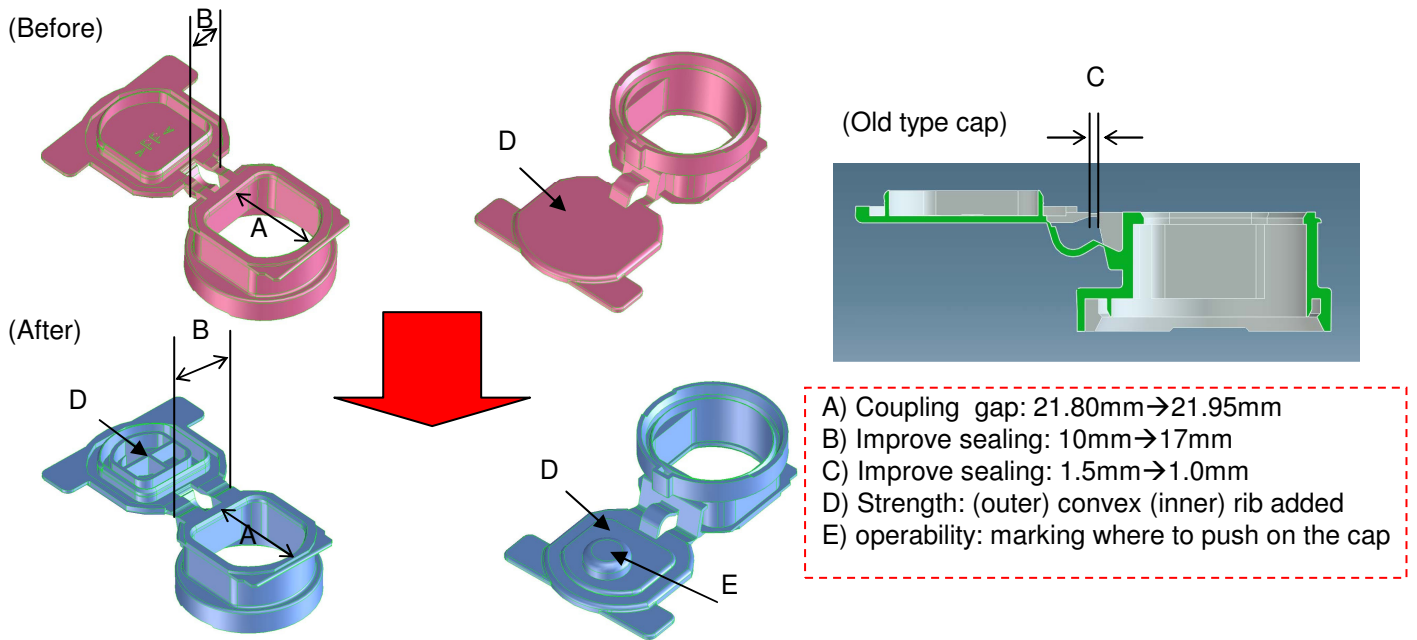
The following are changed to improve the waste toner box cap sealing and the hinge strength.

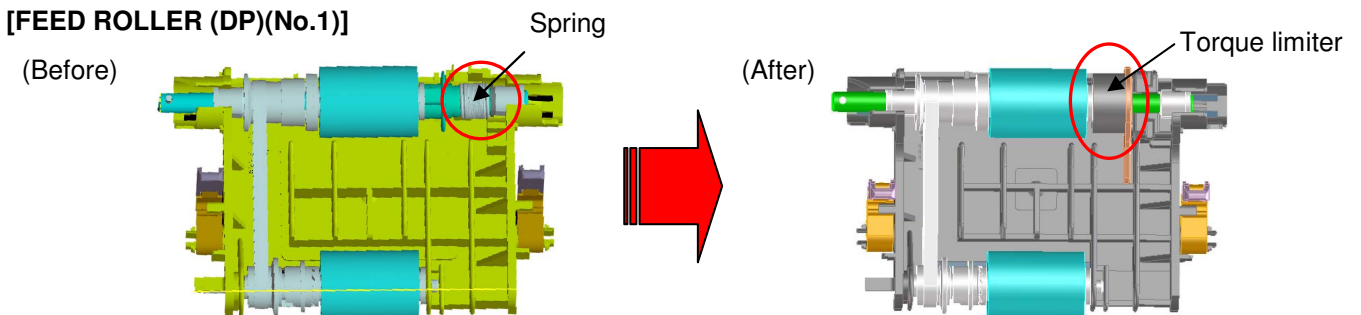
[FEED ROLLER (DP)(No.1)]

The spring is changed to the torque limiter to improve the margin for the DP pick-up holder elevation motion.

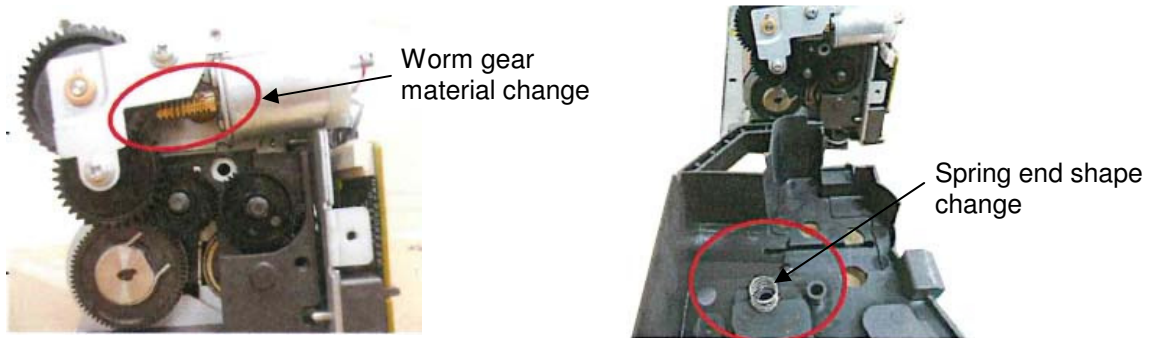
The fuser unit (No.1,2) is changed as follows for common use of parts with other models.

- 1) The material of the worm gear is changed from the PA66 resin to brass and the grease applied to the gear is changed from HP-500 to EM-50LP.
- 2) The shape of the spring end is changed to improve the margin to fix the spring

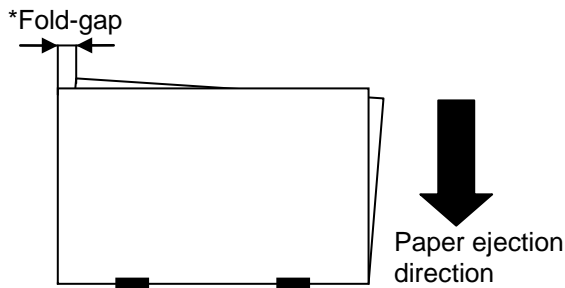
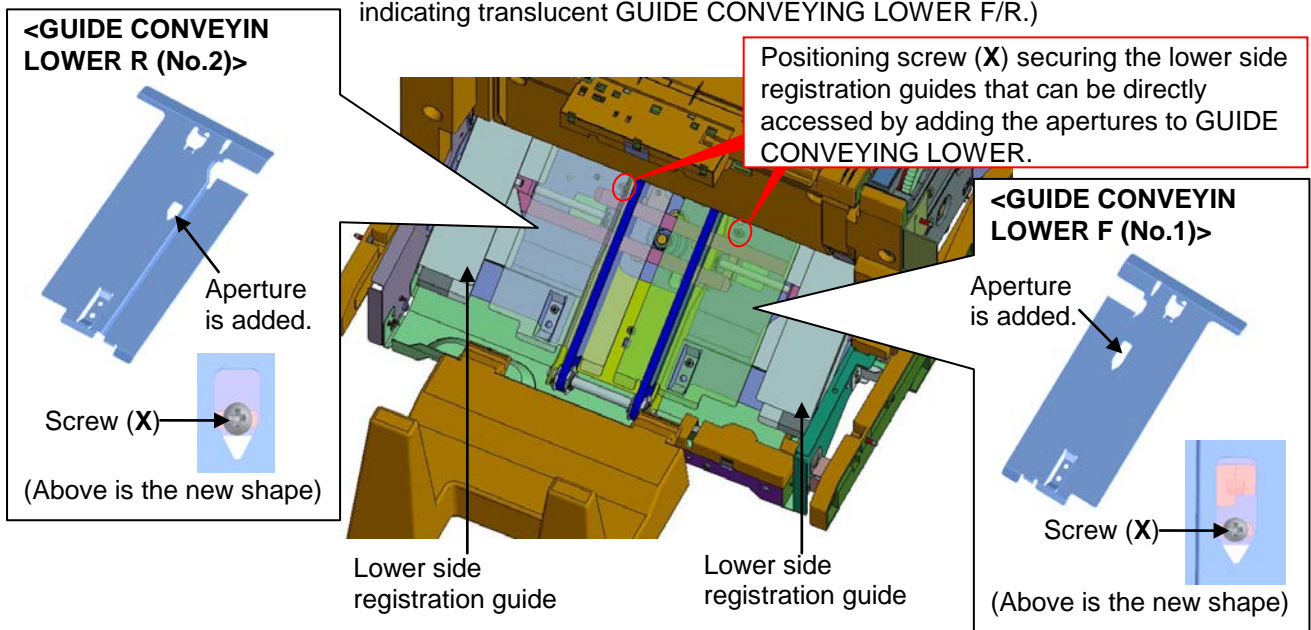
If the gap (*) of the half-folded paper is large at the center-folding unit, the adjustment of the center position of the lower side registration guide in the horizontal direction will reduce the gap.
 Please refer to page 3 and after for the adjusting procedure.

Currently, GUIDE CONVEYING LOWER (No.1, 2) needs to be removed for loosening the positioning screw (X) securing the lower side registration guide when adjusting. At this time, its work becomes unnecessary by adding the apertures to GUIDE CONVEYING LOWER (No.1, 2) in order to directly access the screw.

KDC's Classification	<input type="checkbox"/> Entire Stock Rework	<input type="checkbox"/> In-Field modification at next visit
	<input checked="" type="checkbox"/> In-Field modification by case	<input type="checkbox"/> No modification necessary
Field Measure: If the gap of the half-folded paper is large, please adjust the center position of the lower side registration guide according to the adjusting procedure in page 3 and after.

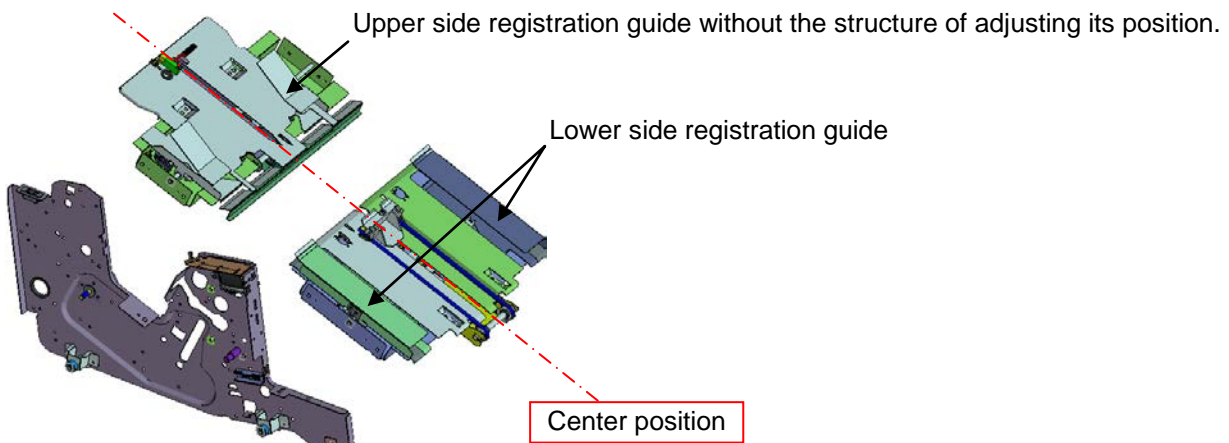
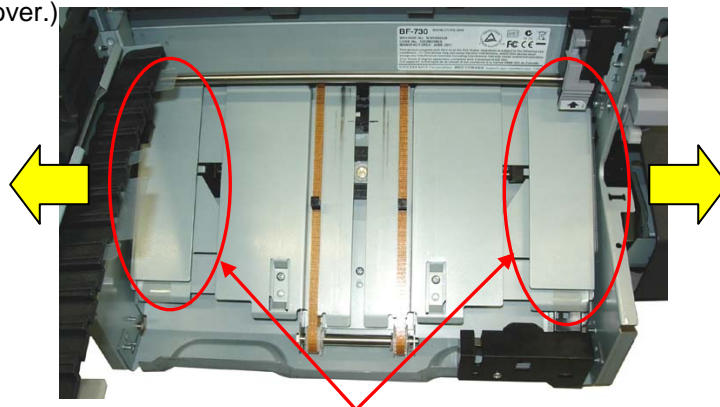
If the center position between the upper side registration guide and the lower guide shifts, the gap of the half-folded paper may be larger. In that case, please adjust the center position of the lower side registration guide in the horizontal direction according to the procedure in the next page and after for aligning it to the center position of the upper side registration guide.

Lower side registration guide

(The whole structure* of the lower side registration guide is shifted by this adjustment.)

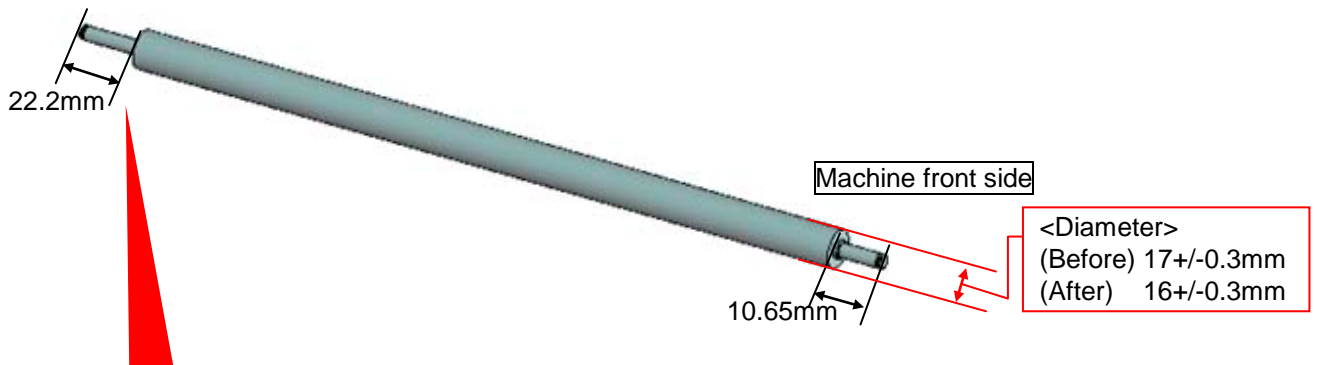
After the prolonged period of use of the machine, the abnormal image (offset image) may be printed out caused by the cleaning failure on the transfer belt due to the cleaning ability deterioration of the fur brush in the intermediate transfer belt unit. Thus, the following are changed.

- 1) Material change : (Before) UUN 6D → (After) SA-7
- 2) Diameter change: (Before) 17+/-0.3mm → (After) 16+/-0.3mm

Machine rear side (with D-cut shape)

10	<p>Replace with the new fur brush (No.1). (Note) When fitting the new fur brush, please don't touch the brush parts and hold the shaft.</p> <p>Reattach the removed parts and unit in the reverse procedures.</p>

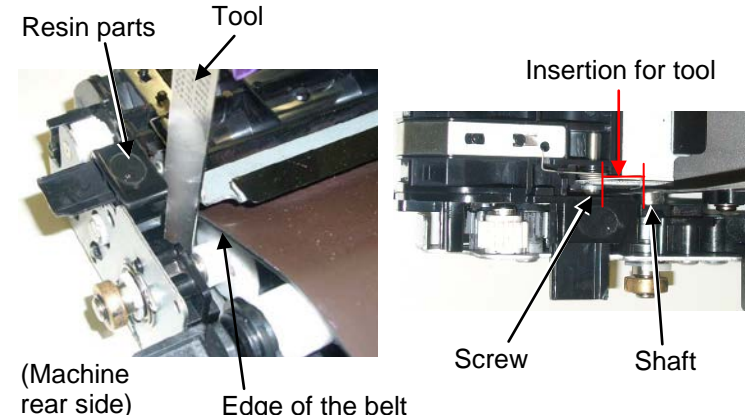
<p>(Machine rear side)</p>
4	Insert the tool such as a metal ruler into the gap (Insertion for tool in the right figure) between the screw and the shaft at the machine rear side. (This is because the edge of the belt is protected from the damage due to contacting the resin parts when detaching the cleaning unit.)

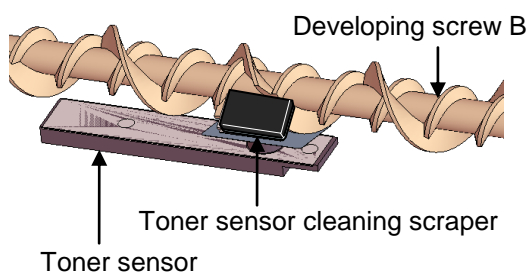
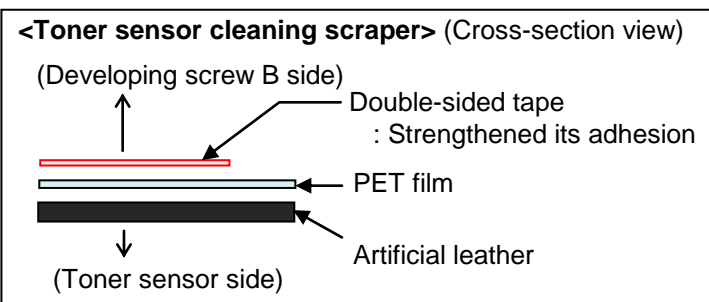
Adhesion of the double-sided tape of the toner sensor cleaning scraper inside the developing unit is strengthened to improve the durability.

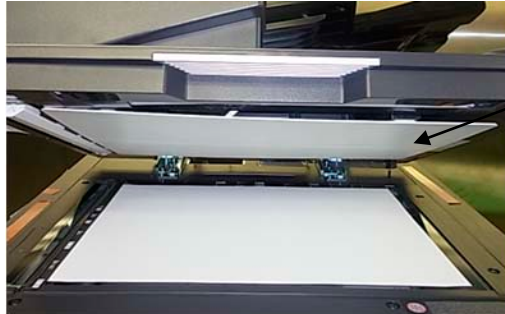
[Original mat]
 <OK>

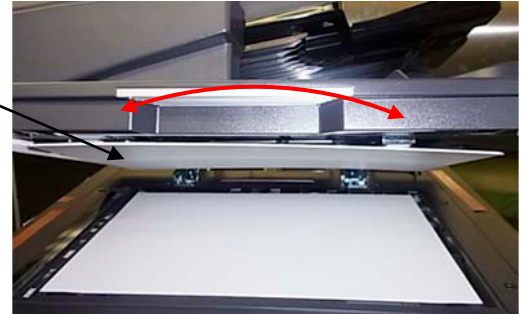
<NG> Center of the original mat is curved

KDC's Classification	<input type="checkbox"/> Entire Stock Rework	<input type="checkbox"/> In-Field modification at next visit
	<input checked="" type="checkbox"/> In-Field modification by case	<input type="checkbox"/> No modification necessary
Field Measure:	(Color models) Replace with the original mat with the regulation standard for the curve (new No.10) if the above phenomenon arises or affix the sponges (No.11-13) after cleaning the surface to affix them with alcohol. (Refer to Page 4, 5 for the alignment)	
	(BW models) No particular problems are expected.	
Serial Nos. of Affected Machine:	Refer to page 6-8.

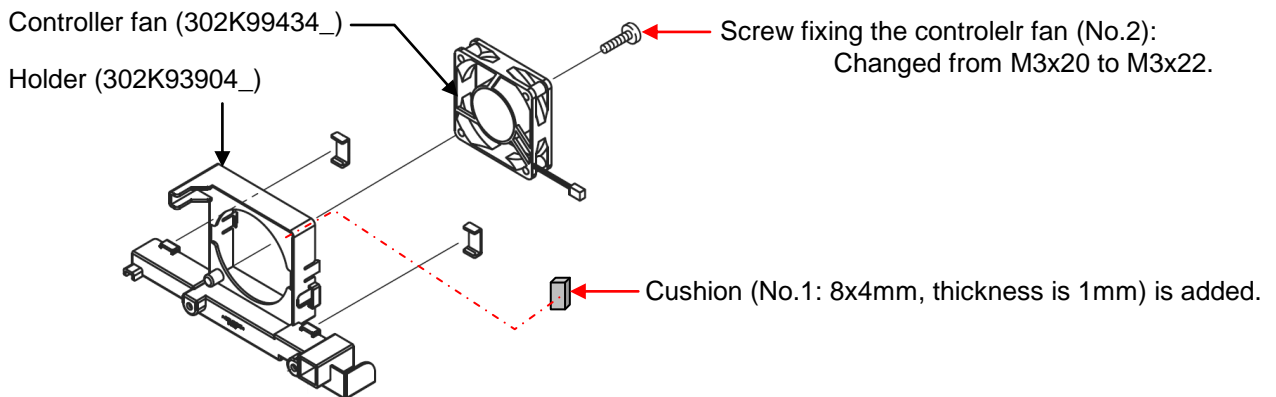
Followings are changed for improving the margin of fixation of the controller fan (302K99434_).

- 1) Added the cushion (No.1) to where the controller fan is fitted on the holder (302K93904_).
- 2) Changed the screw fixing the controller fan (No.2) from M3x20 to M3x22.

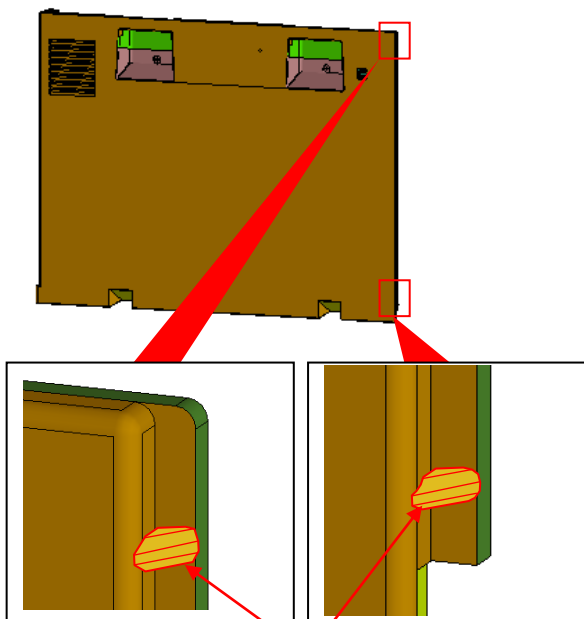
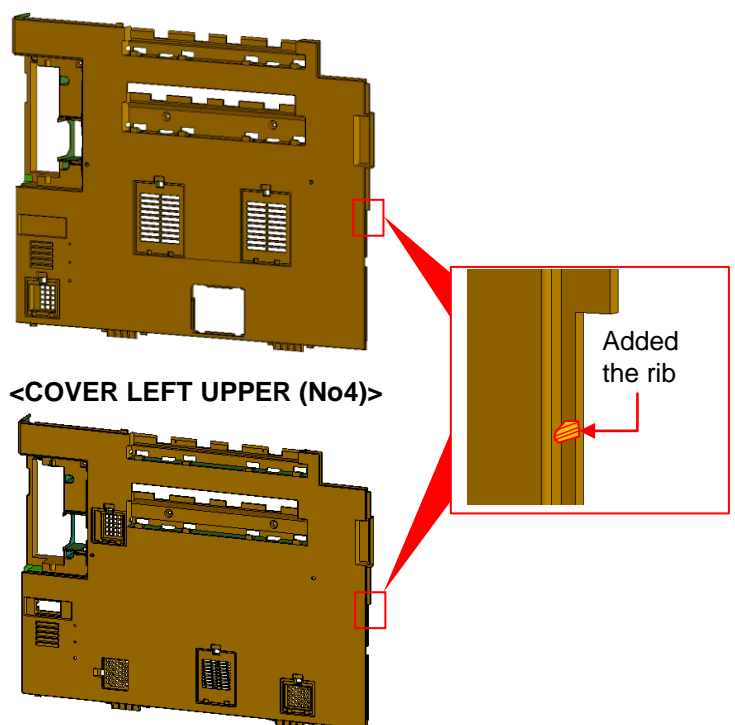
<COVER LEFT LOWER (No.2)>

Added the ribs

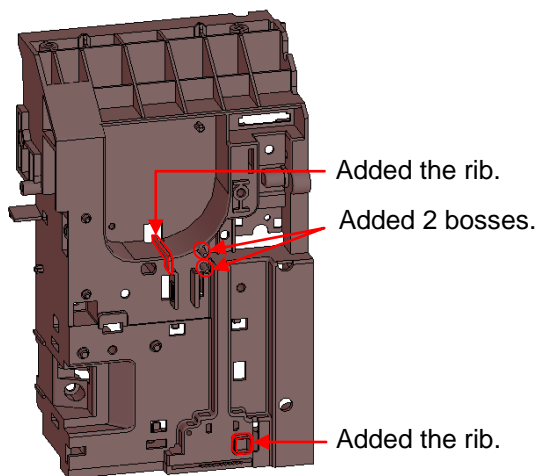
<New FRAME FRONT FUSER A (No.1)>

The shape of the following parts (No.1, 2) is changed for common use of the parts.

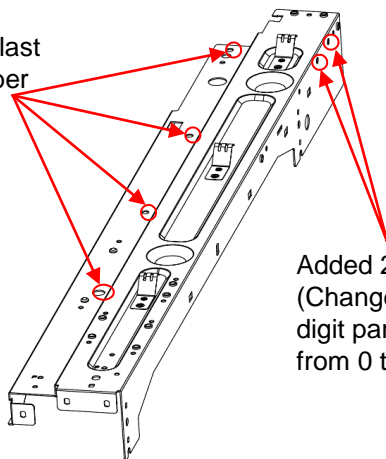
<New MOUNT SCANNER RIGHT (No.1)>

Added 4 holes
(Change of the last digit parts number from 1 to 2)

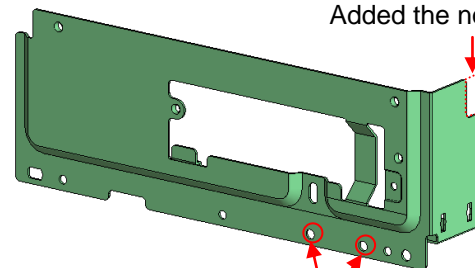
<New MOUNT OPTION(No.2)>

Added the notch

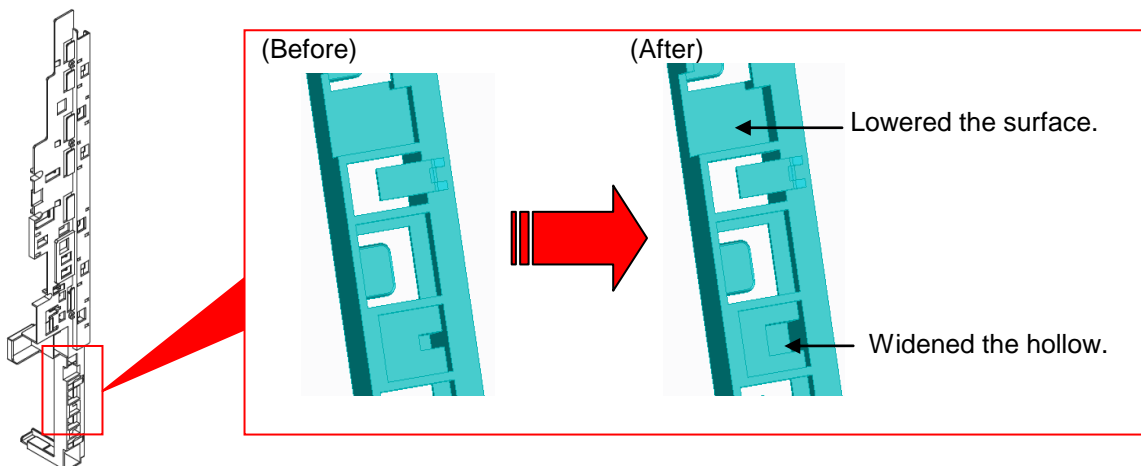
<HOLDER CORD RIGHT (No.1)>

The shape of HOLDER CORD RIGHT (No.1) is changed for common use of the parts.

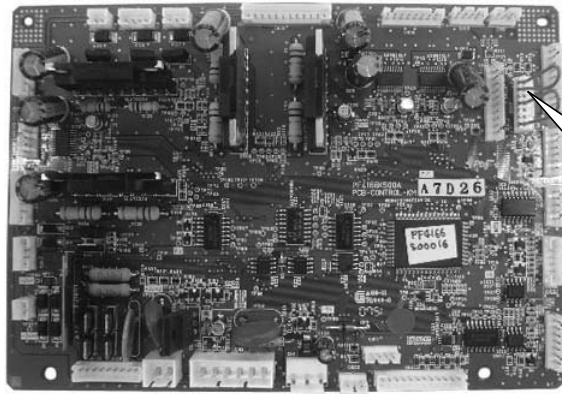
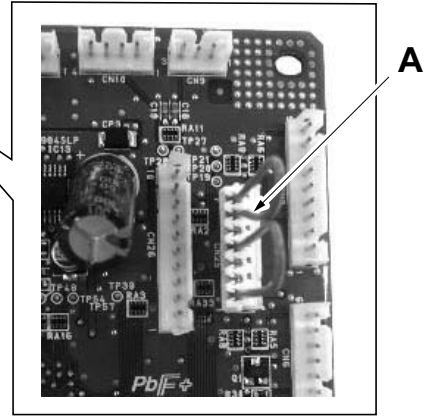
Notes for replacing parts

A short-circuiting connector (A) is not required on the new PWB if there was no short-circuiting connector (A) on the PWB being replaced.

Leaving the short-circuiting connector (A) attached will cause step-out of the staple motor and mispositioned stapling.
