Service Bulletin

Ref. No. **COM-0218 (B056)**

Subject	Note when releasing the paper jam/maintaining the machine (Prohibition of use of the flammable sprays and liquids)
Model	All models

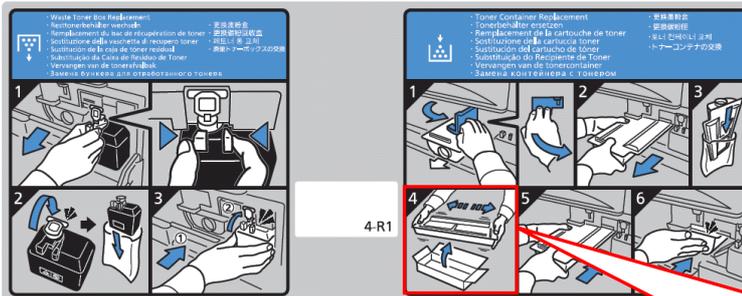
(Before)

The illustration of the procedure 4 (Correcting the unpacking direction of the case) on the sheet for replacement procedure of the toner container affixed on the front cover inside is changed to the one along with the actual parts.

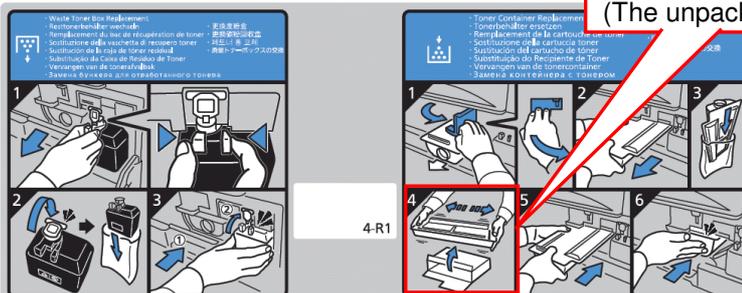
(After)

Corrected illustration
(The unpacking direction of the case)

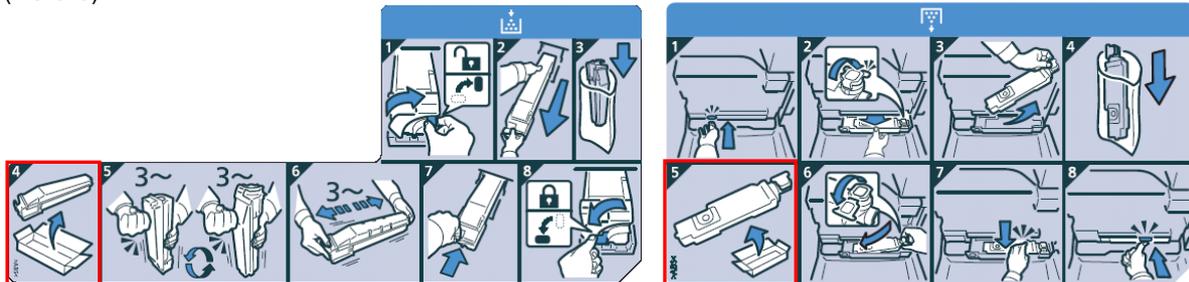
(Before)

The illustrations framed in the red line (Correcting the unpacking direction of the case) on the labels for replacement procedure of the toner container/waste toner box affixed on the machine front side of PARTS INNER UNIT SP (302LC9401_/302LK9401_) is changed to the one along with the actual parts.

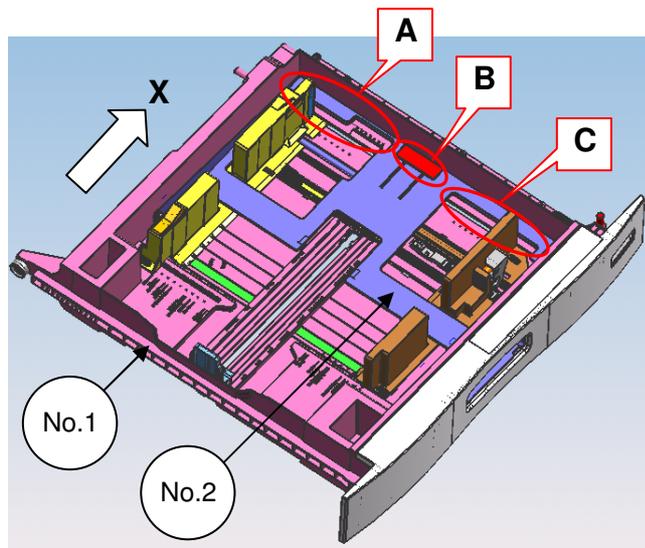
Shape of the cassette (No.1) and the lift plate (No.2: The parts number of the new parts is set this time) is changed as below for improving paper stack in the cassette so that the paper is not caught in these parts even if installing the paper toward the conveying direction (X direction in the figure below).

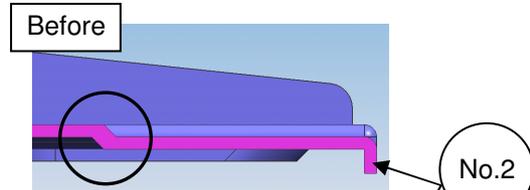
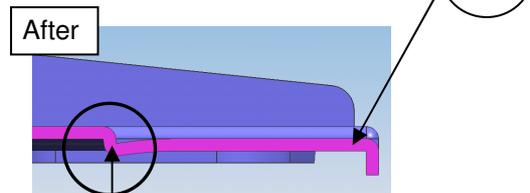
[Cross section view of section B in the above figure (Part for affixing the pad for preventing the multi-feed.)]

Lowering the paper installation side of the affixing part where the pad is affixed.

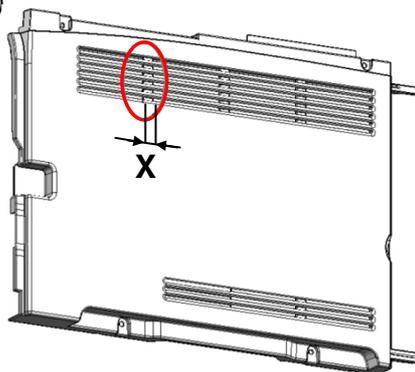
<Right cover (No.1)>
(Before)

Shape of the louver section of the right cover (No.1) is changed as below for common use of the parts.
(Width of the crosspiece (X) is changed from 10mm to 40mm.)

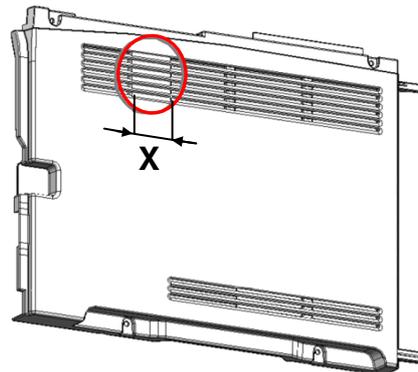
Width of the crosspiece (X): (Before) 10mm --> (After) 40mm
Height of the convex section of the crosspiece (X): (Before) 2.5mm --> (After) 0.5mm

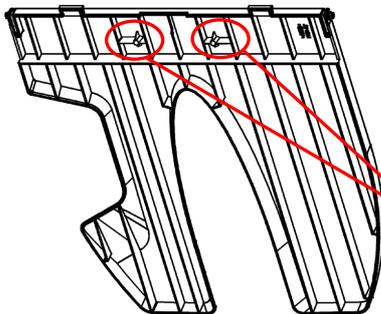
<New TRAY SUB (No.1)>

Each 2 sections of the bosses and rib are added to the backside of TRAY SUB (No.1) for common use of the parts.

Adding the bosses and the ribs (2 section each)

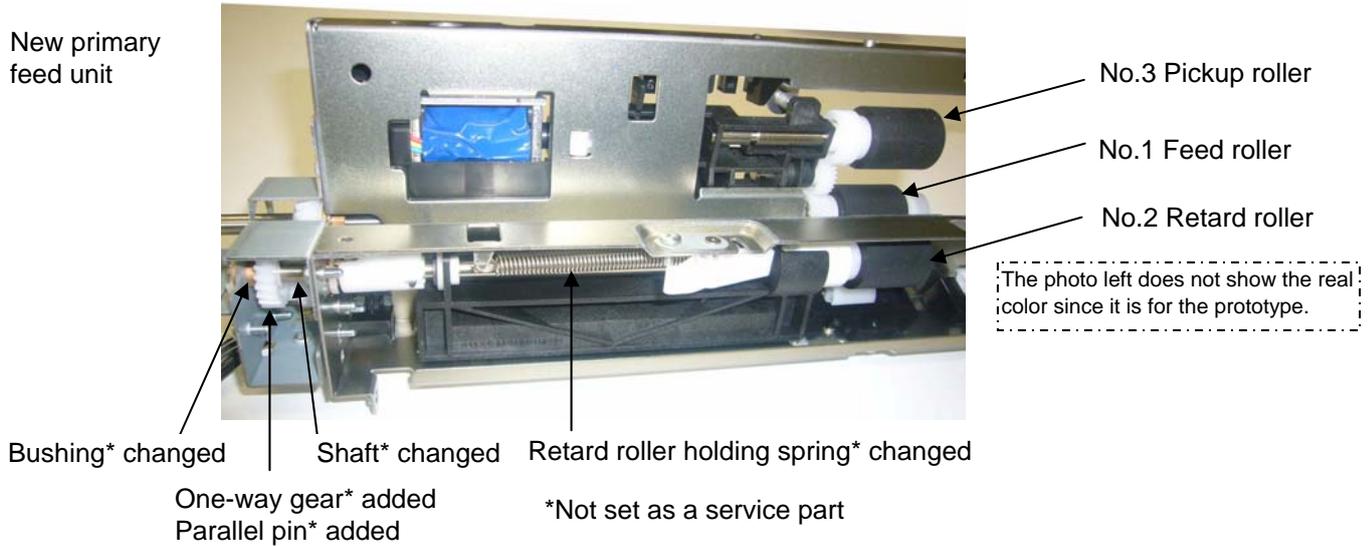
- Please note the following when replacing the pulleys in the primary feed unit.
 - The new rollers : can be used in either the old or new type primary feed unit (use the set of all the old or new parts)
 - The old rollers : can be used in the old type primary feed unit only.
 (Multi-ply feed jam may occur. (J051*) when using the them in the new type primary feed unit.
- *The old type parts (No.2,3) are not supplied. Use the new type roller set (No.4) when replacing the parts.
- The primary feed units are compatible and can be replaced without problem.
- Please distinguish the old and new rollers with color of the rubber part and collars.

<Distinction>	Rubber	Collar		Rubber	Collar
No.1 Feed roller	Gray	White	➔	Black	White
No.2 Retard roller*1	Gray	Black		Black	Black
No.3 Pickup roller*1	Gray	Black		Black	Gray

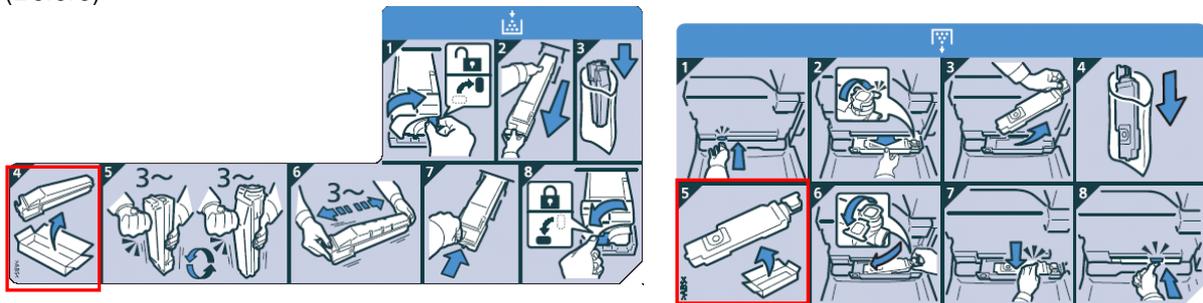
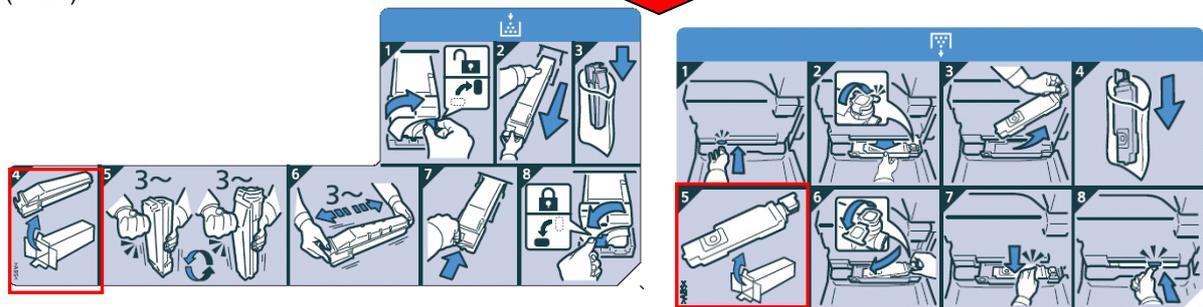
<Toner container/waste toner container replacement procedures label (not supplied to field)>

Illustration of the toner container/waste toner container replacement procedures label is changed that is affixed at the machine front side of PARTS INNER UNIT SP(302LC9401_/302LK9401_) As marked in red below, direction of unpacking the box is corrected to show the actual situation

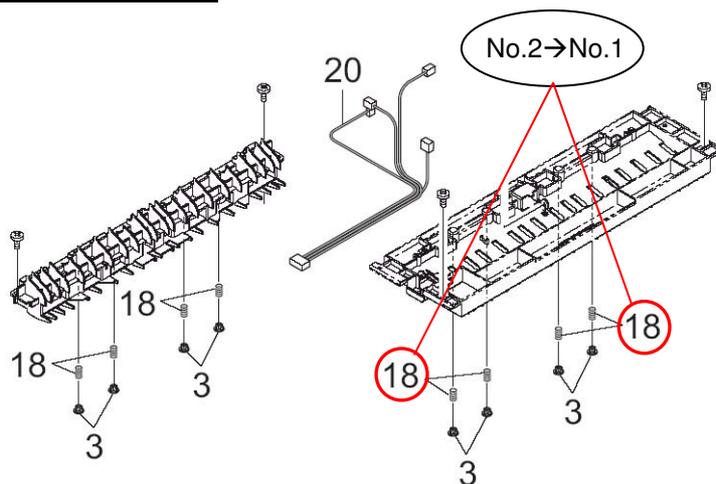
FIG. 19 Exit Section

The spring is changed to improve paper conveying at the duplex switch back section.

New (No.1)	Old (No.2)
Material	SWP-B	SUS304WPB
Material's diameter	Φ0.4mm	Φ0.29mm
Coil's average diameter	Φ5.0mm	Φ4.89mm
Coil's external diameter	Φ5.4mm	Φ5.18mm
Valid turns	5 turns	4 turns
Total coils	7 turns	6 turns
Spring constants	0.399N/mm	0.13N/mm

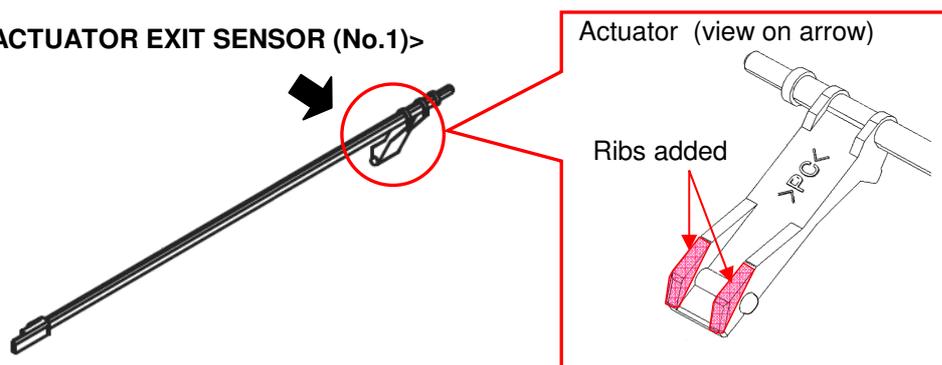
<ACTUATOR EXIT SENSOR (No.1)>

Ribs are added to the leading edge of ACTUATOR EXIT SENSOR(No.1) for common use of parts.

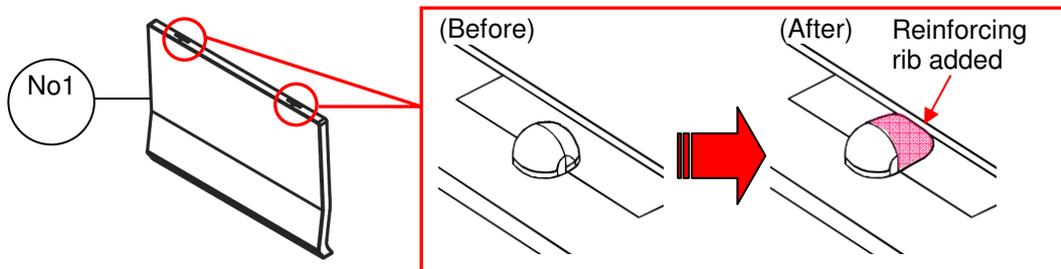
A reinforcing ribs are added to the latches of EMBLEM(No.1) to improve fitting margin

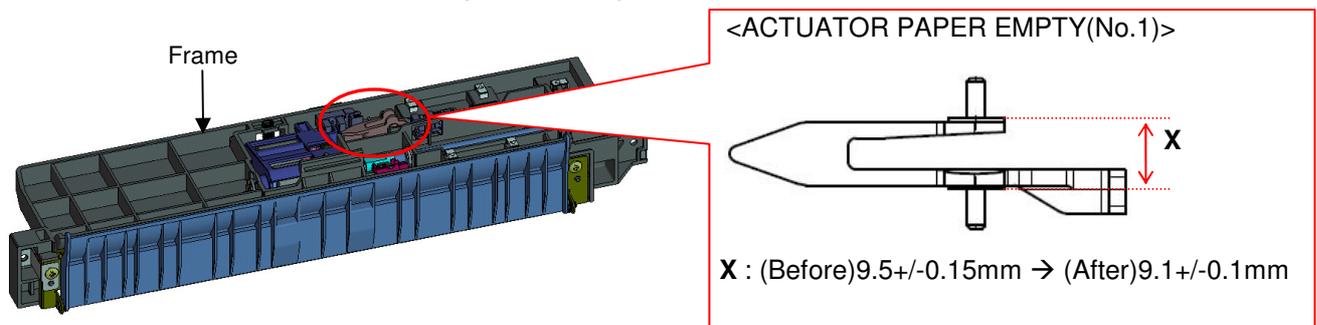
<PARTS PRIMARY FEED UNIT LOW SP(302LC9404-)>

ACTUATOR PAPER EMPTY(No.1) is changed as below to secure the clearance margin with the frame.

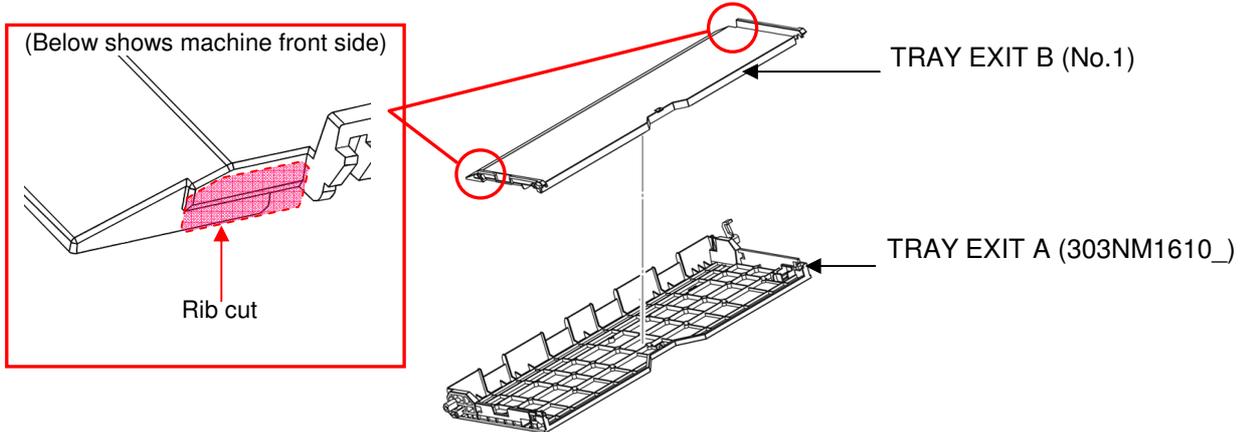
Ribs at the both ends of TRAY EXIT B (No.1) are cut to secure the clearance margin with TRAY EXIT A (303NM1610_)

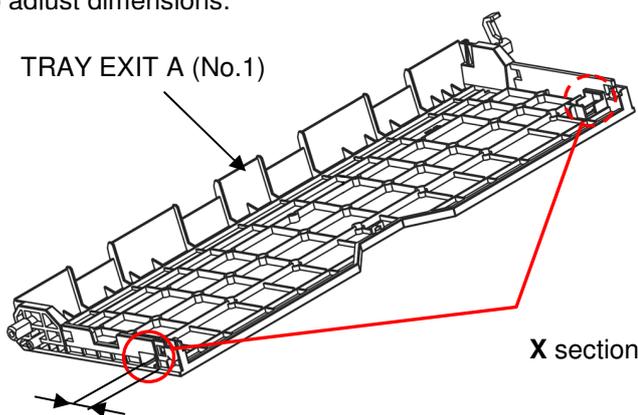
Width of the stopper fixing section (X section below) at the both ends of TRAY EXIT A(No.1) is extended by 0.3mm to adjust dimensions.

(Before) 12.0mm;/-0.1mm --> (After) 12.3mm+/-0.1mm

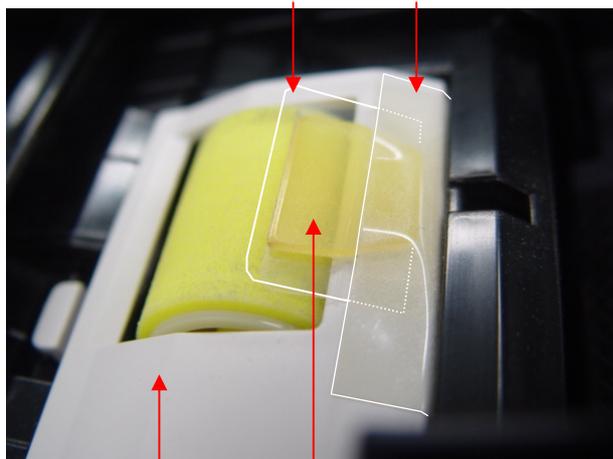
(Old state) Film B disused Film A disused

Shape of parts at the DP separation roller cover section is changed as follows to improve the original conveying. According to this change, an assembly of the DP separation roller cover, pad and film are supplied as service parts.

Old pad material : Urethane

Old DP separator cover : Depression to affix Film B disused

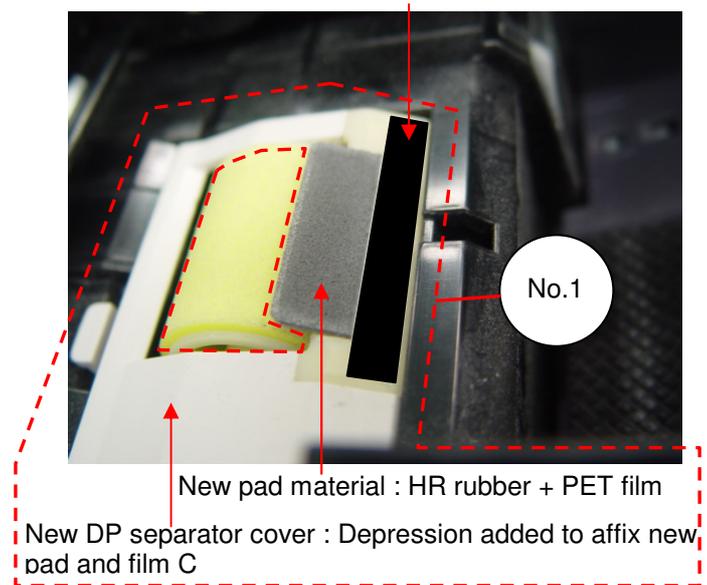
(New state) Film C added

New pad material : HR rubber + PET film

New DP separator cover : Depression added to affix new pad and film C

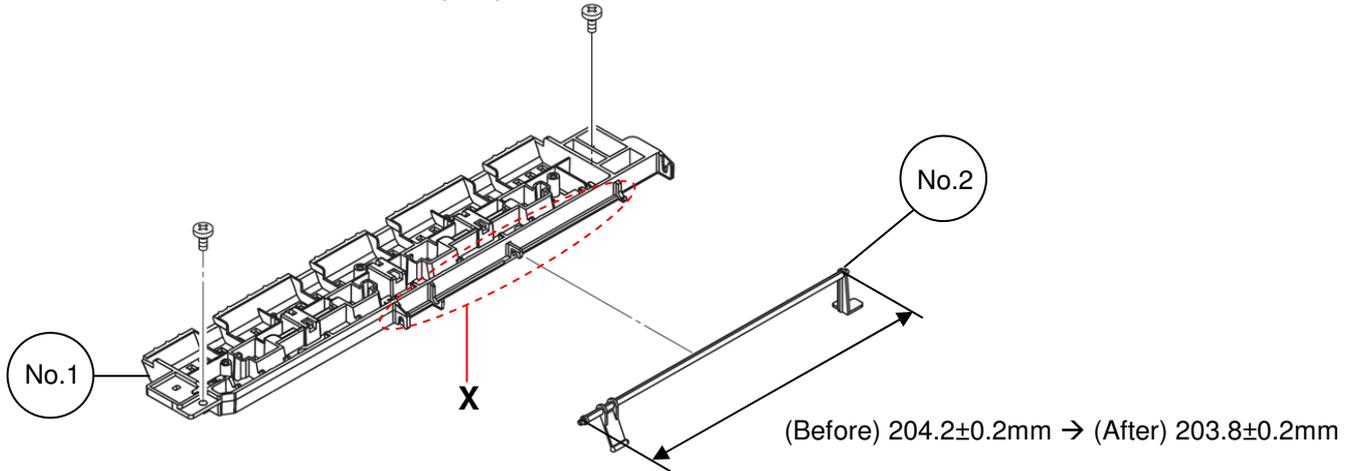
+/-0.3mm tolerance is added to the size of the exit sensor actuator fitting section (marked X below) on the upper exit frame (No1) and total length of the exit sensor actuator (No2) is shortened by 0.4mm to secure the margin for motion of the exit sensor actuator (No2).

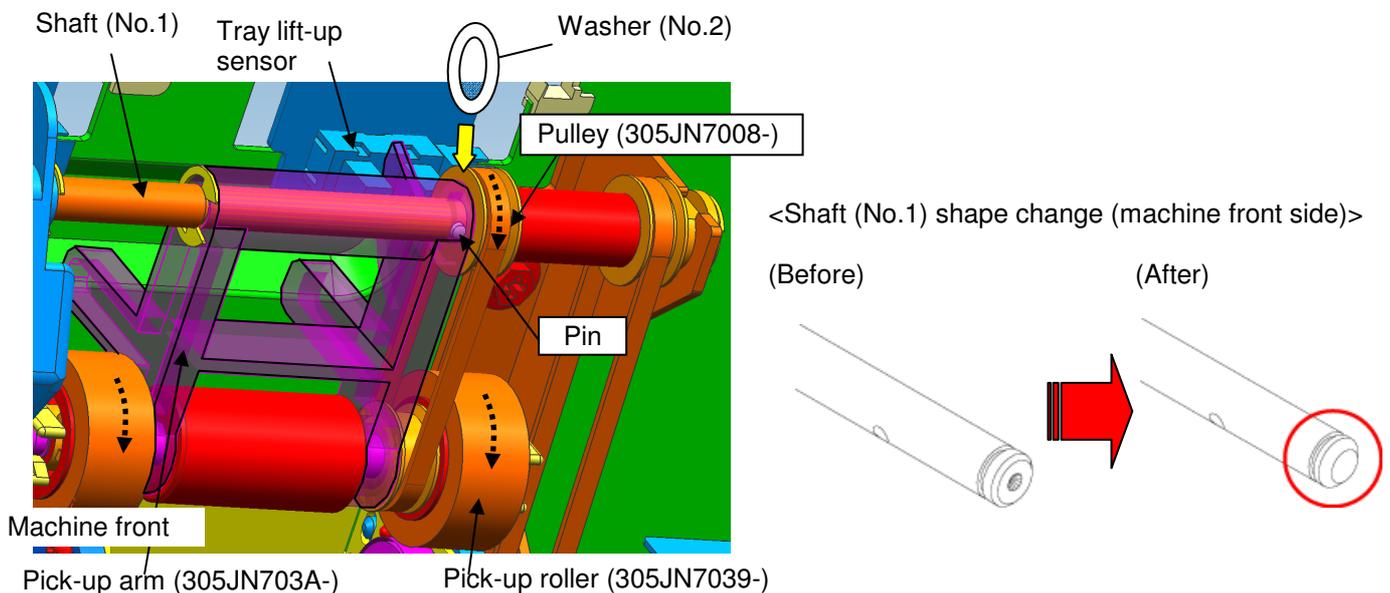
- 1) Pin hole angle on the shaft (No.1) is changed to prevent backlash of the shaft (No.1) and pick-up arm when the pick-up roller rotates
- 2) Shape of the shaft (No.1) is changed for distinction of the old and new shaft according to the above change.
- 3) Washer (No.2) is added in between the pick-up arm and pulley to reduce load to the pick-up arm and shaft (No.1) when the pulley rotates

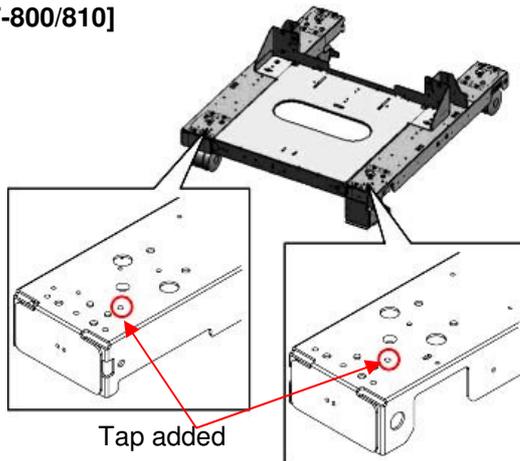
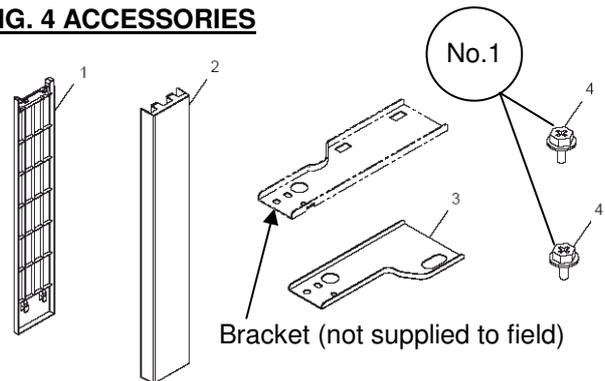
FIG. 4 ACCESSORIES

(PH-6) Screw (No.1) to fit the bracket is changed from tapping screw to no tap screw according to this change

Tap added

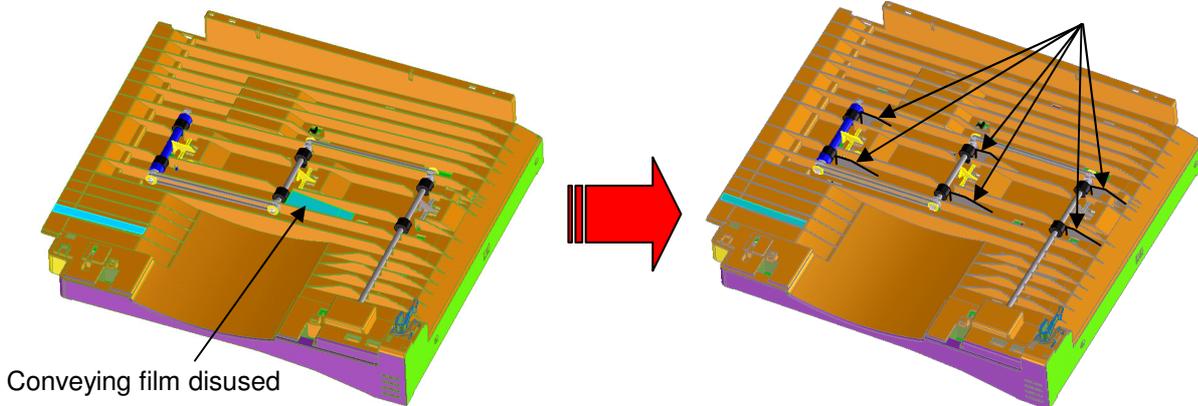
Conveying rib added (6 parts)

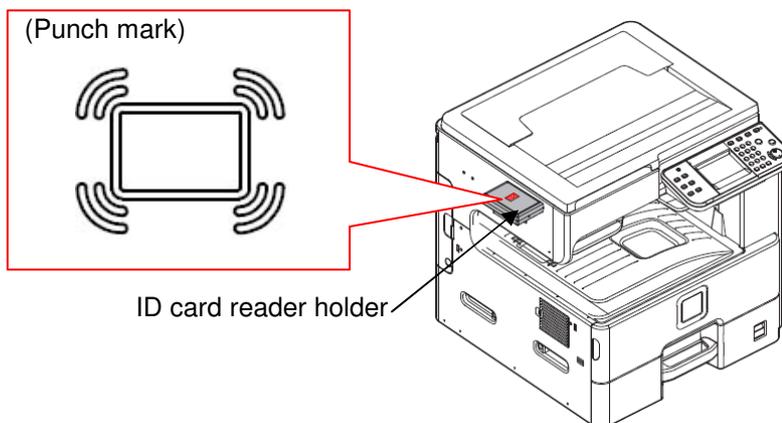
CARD READER HOLDER(B)

Punch mark is applied to the ID card reader holder to show where to swipe card for common use of parts with other models.

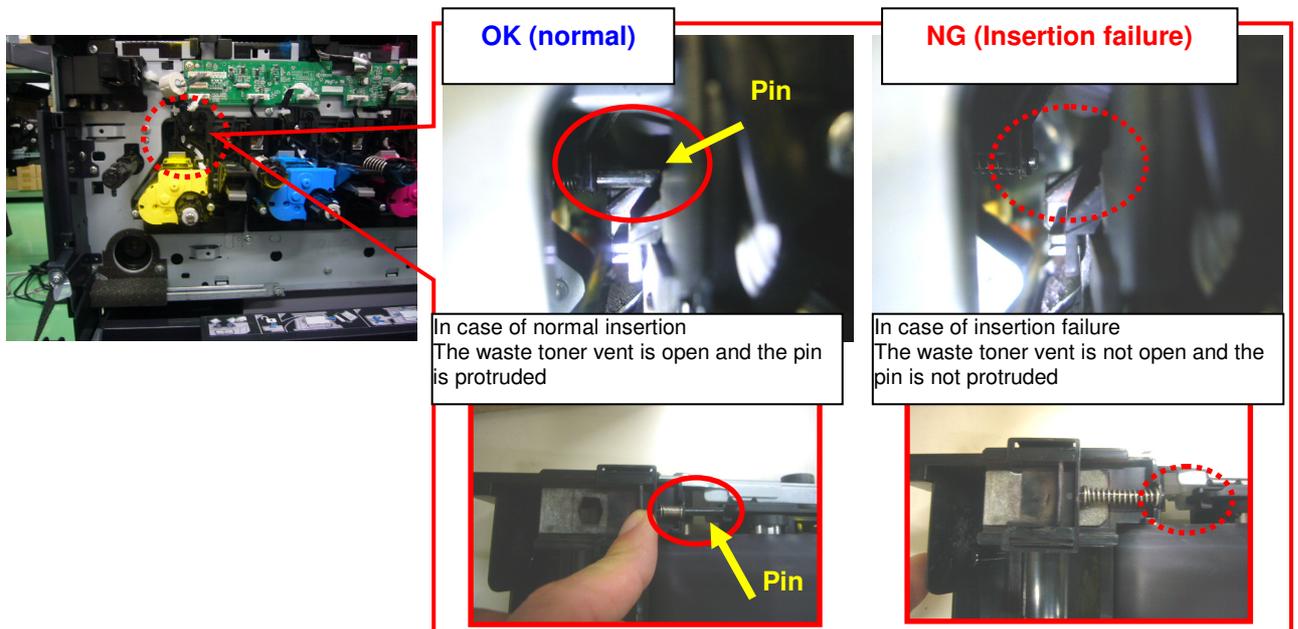
If the primary transfer unit is strongly inserted along the rails, it may be installed while the waste toner vent at the cleaning section of the primary transfer unit covers the waste toner collection vent at the main machine side. If the machine is operated in this condition, the primary transfer belt may be distorted and skew that will cause SC2770 (Transfer skew error) after more or less than 50 pages of output.

- OK (Normal) → The pin is protruded (Waste toner vent is open)
- NG (Insertion failure) → The pin is not protruded (Waste toner vent is not open)

Please remove the inner unit and check through the gap on the yellow developer unit as shown below if the primary transfer belt unit overlaps.

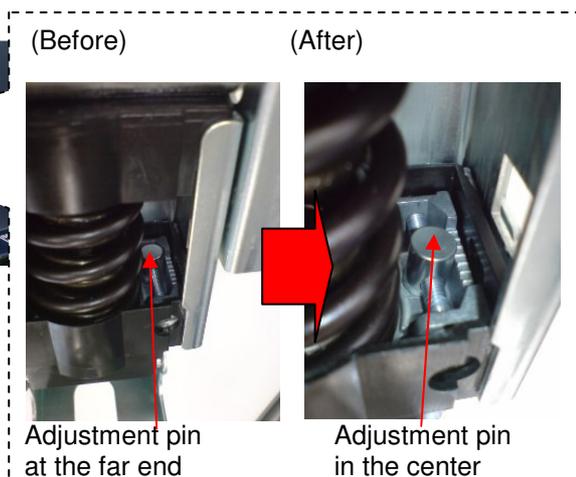
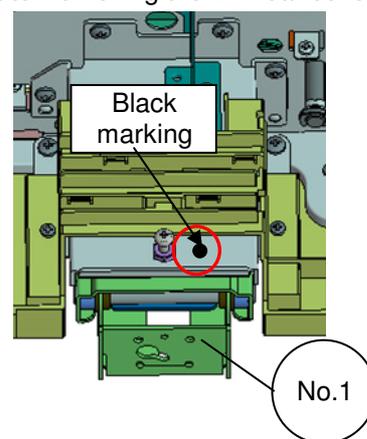
<(Temporary measures) Adjustment pin relocated>

[Distinction (temporary measure hinge)] View of HINGE LEFT (No1) from the machine rear side after removing the DP rear cover

[Permanent measures] It is planned to change the spring to improve the hinge torque.

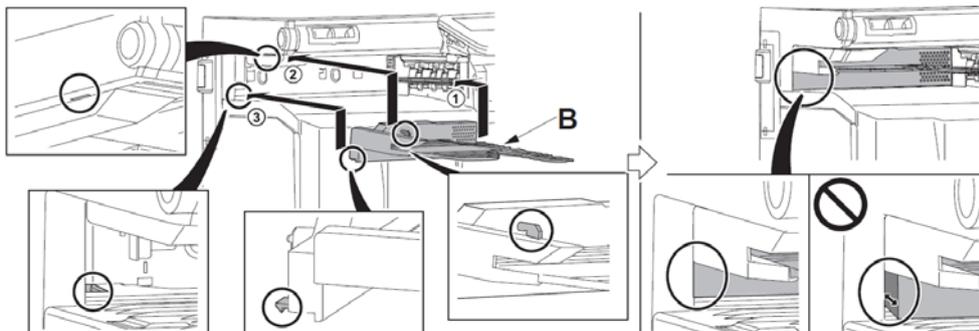
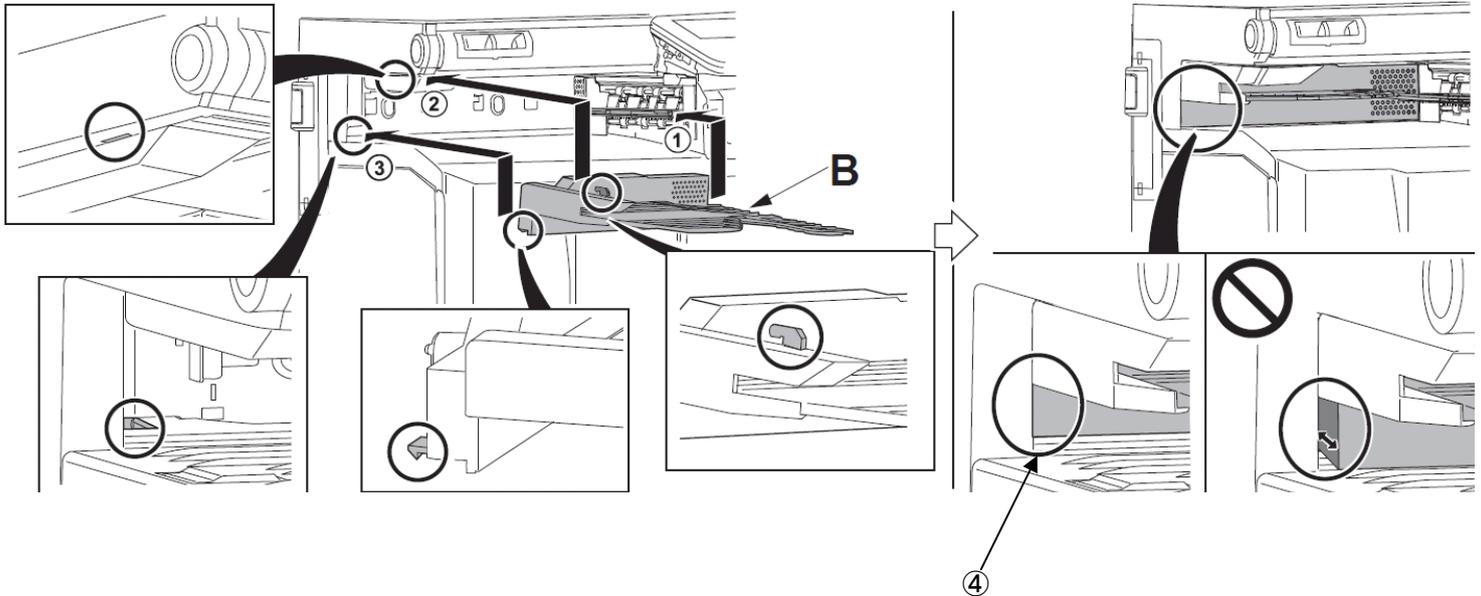
Step 19 Job separator Fitting TRAY (B)

Partially enlarged view added to step 19 (See next page for details)

- 1 Insert the right side of tray in the rail of the exit guide.
- 2 Insert the hook at the upper left of the tray in the cutout at the bottom of the upper left cover.
- 3 Insert the hook at the lower left of the tray in the cutout at the main machine left rear side while slightly lifting up the rear of tray.
- 4 Check if the tray is inserted until the rear of the tray and upper left cover are level.

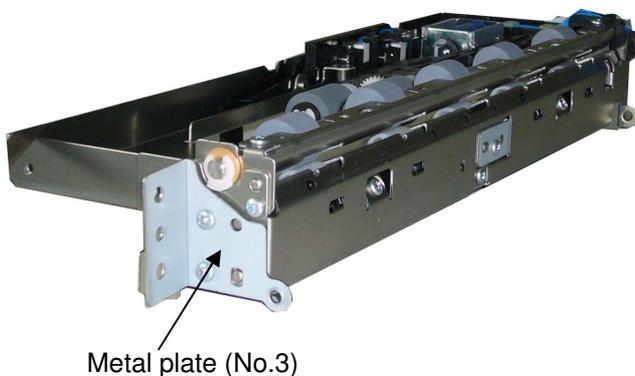
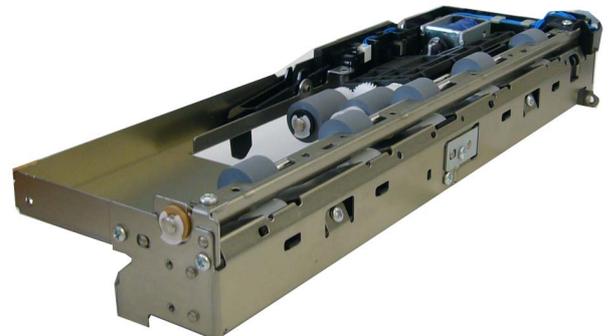
(*) The guide (Y) may be damaged when installing it with the metal plate (No.3) installed in the primary feed unit (No.1,2) depending on the way of installation. Therefore, the primary feed unit (No.1,2) are shipped without the metal plate (No.3) installed. (Refer to the next page for where to install the guide (Y))

(Before) Shipped with the metal plate (No.3) installed

(After) Shipped without the metal plate (No.3) installed (deleted from components)

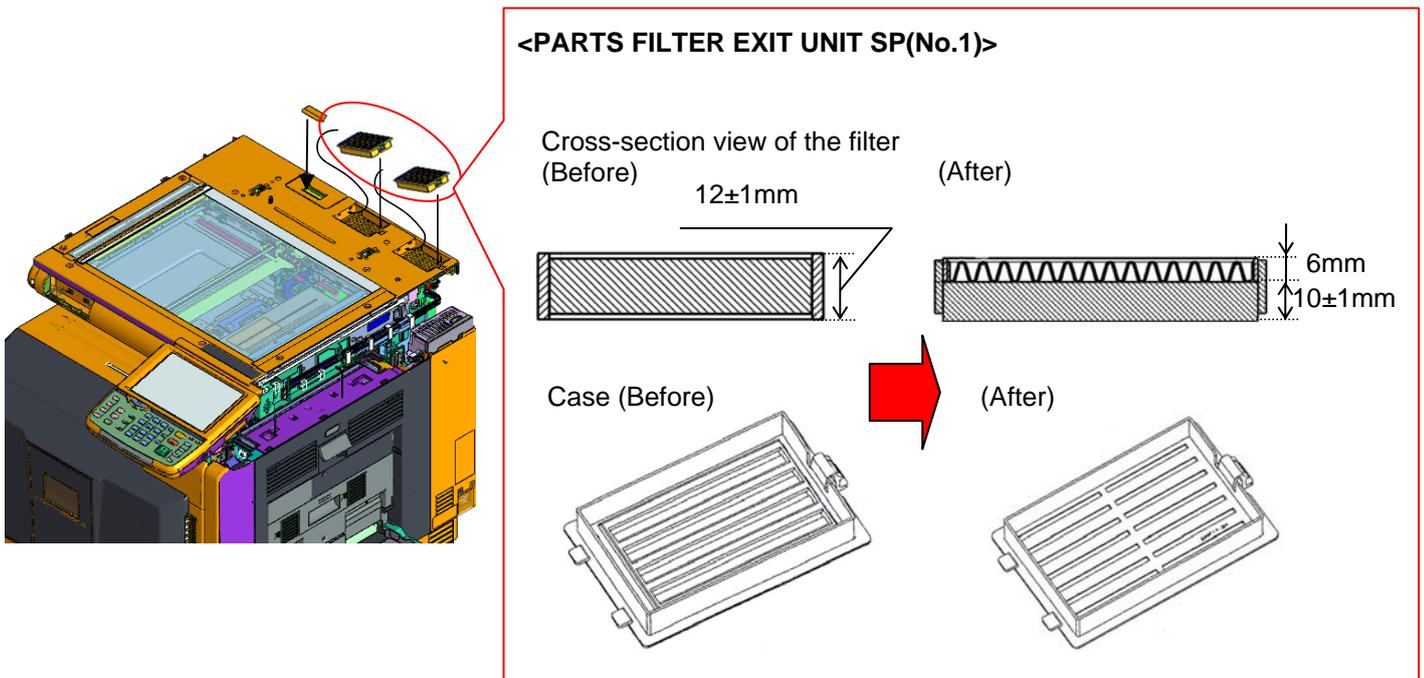
The shape of the filter and case at the eject section is changed as shown below in order to prevent the original from shifting because of the air-flow exhausted from the machine when scanning the thin original like news papers and leaflets on the contact glass. Accordingly, the filter as an individual part contained in the MK kit (MK-8505C/8305C) is changed to the assembly of the filter and case.

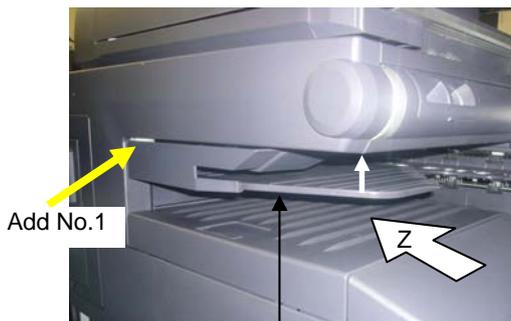
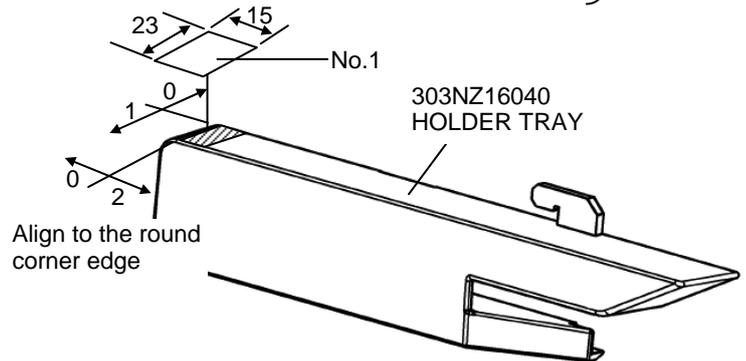
The JS-730 inner job separator tray may be slightly lifted up and the hook at the rear side of the machine may be taken off to cause the tray pulled out to the front side in case the operator's palm may contact the inner job separator tray when picking up the paper stuck in the inner tray. Therefore, the following are changed.

The JS-730 inner job separator tray is fixed with the hooks **A** and **B** while pushing to the direction **X** below in the machine. (The hook A is located at the rear side of the machine and B upper side of the inner job separator) When putting the hand under the JS-730 inner job separator tray as marked **Z** below, the palm may lift up the tray and the hook A may be taken off the main machine side.

A spacer (No.1) is added to HOLDER TTRAY filling the backlash and play in order to prevent the hook fixing the JS-730 inner job separator tray from taken off.

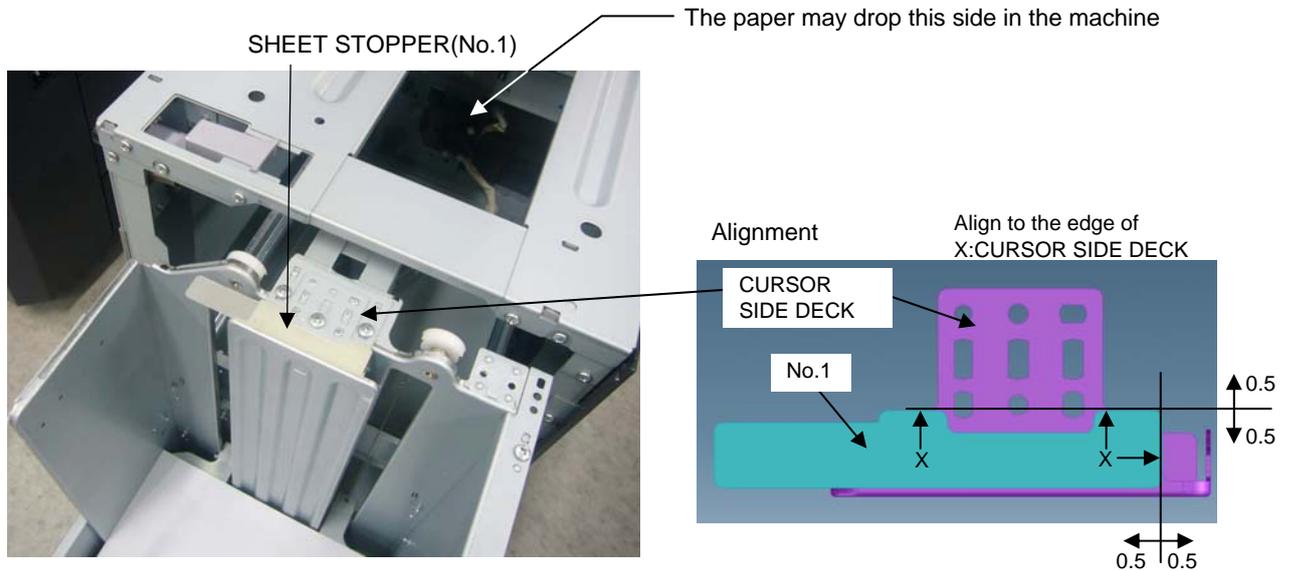
The paper on the paper deck may fall into the machine inside if strongly pulling out the paper deck while the paper is pinched by the feed roller and the retard roller. Therefore, a film is added to prevent it. Please take good care of the additional film not being damaged after this change when removing the cushion material at the machine set-up

The film (No.1: SHEET STOPPER) is added to the rear side of the machine.

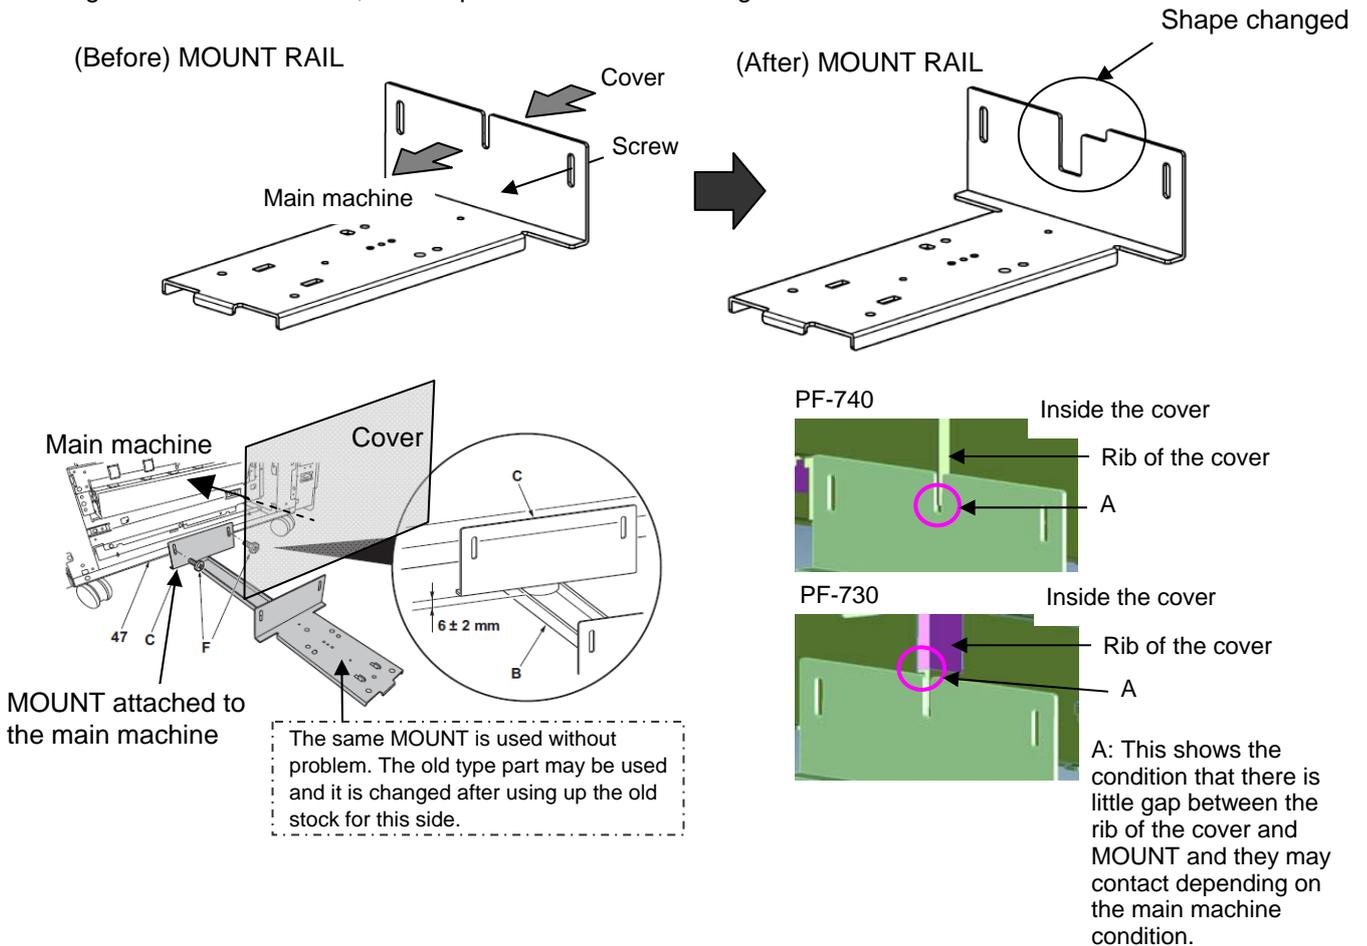
The shape of MOUNT RAIL(No.1) is changed to make tolerance for adjustment.

After attaching MOUNT RAIL to the main machine, a rib inside the cover may contact MOUNT RAIL when attaching the cover. Therefore, the shape of the cutout is changed to avoid the contact.

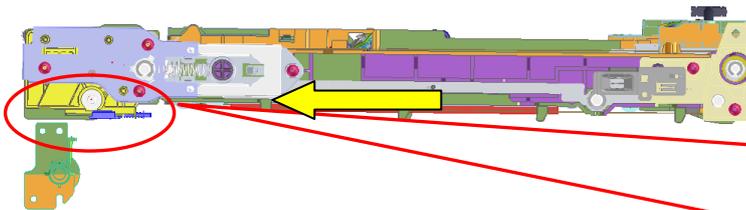
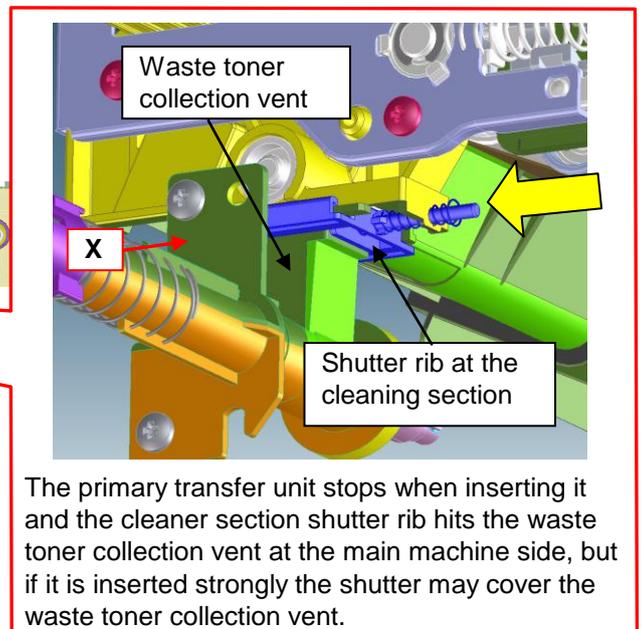
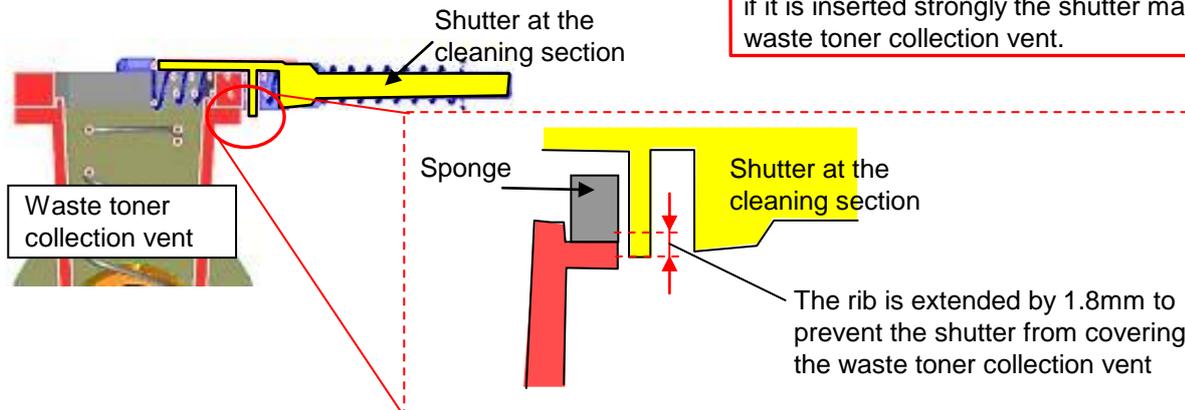
<Change the shape of the cleaning section shutter rib (Viewed from X)>

- 1) The shape of the shutter is changed.

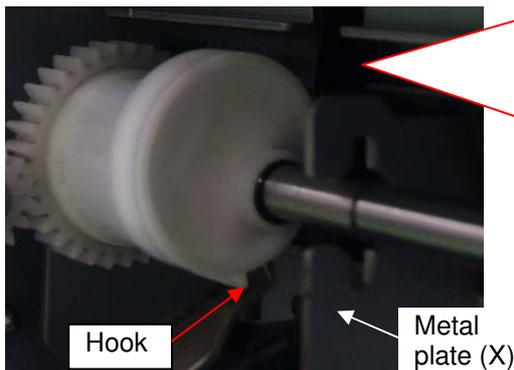
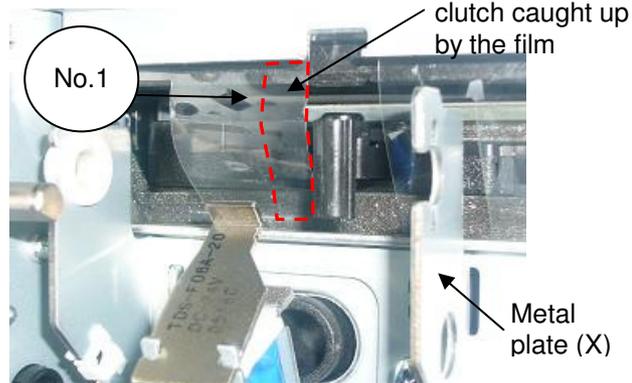
The shape of the film (No.2) is changed as follows in order to prevent the LSU cleaning blade motion failure from the hook of the drive clutch caught up by the film (No.2).

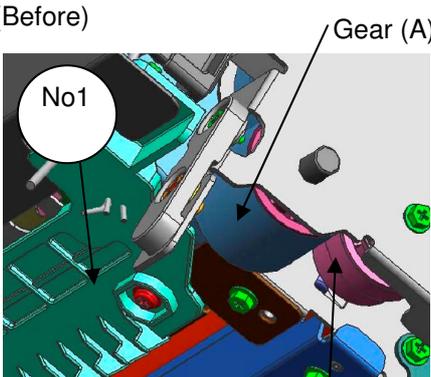
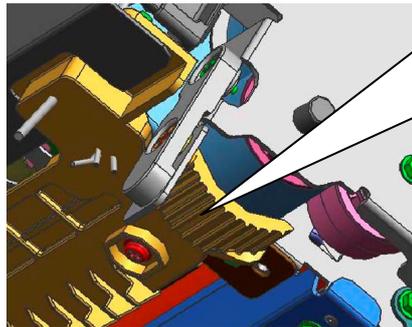
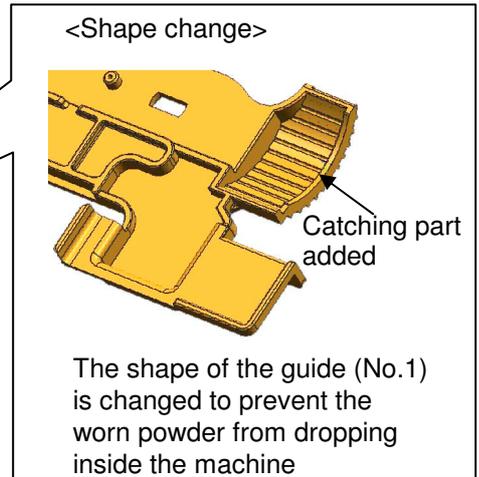
<Change of the Guide Shape>

Change of the gear was informed per the service bulletin No.5JN-0030(A208) to improve the abrasion resistance of the fuser drive gear and the shape of the guide (No.1) is changed for further improvement to prevent the worn powder from dropping inside the machine. Adhesion of the worn powder to other units does not affect the image failure and abnormal sound, etc.

When GEAR-8H30-8(305JN7218-) is worn, the worn powder is brought to the gear (A) to prevent it from dropping inside the machine

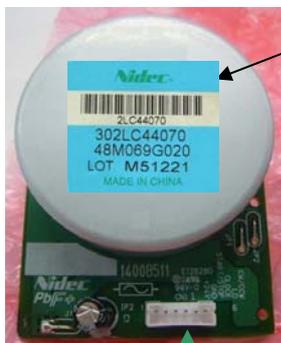
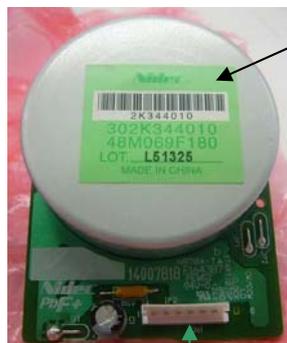
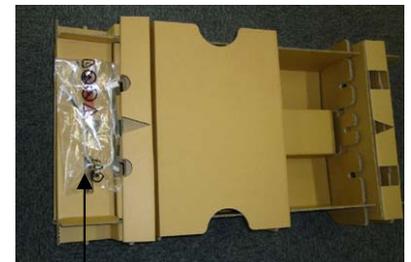
*1: In case of rotation failure due to insufficient torque: C2203 Drum motor M steady-state error] may appear

- Drum motor Rated torque 80mN·m -> 130mN·m (at 2300rpm)
The type of connector on the drum motor board is changed
- Wire drum motor *2..... Connector changed *2: Not for the field supply
- Set of the drum motor and wire drum motor (No.3)
- Wire drum motor bundled for the drive unit (No.1,2)

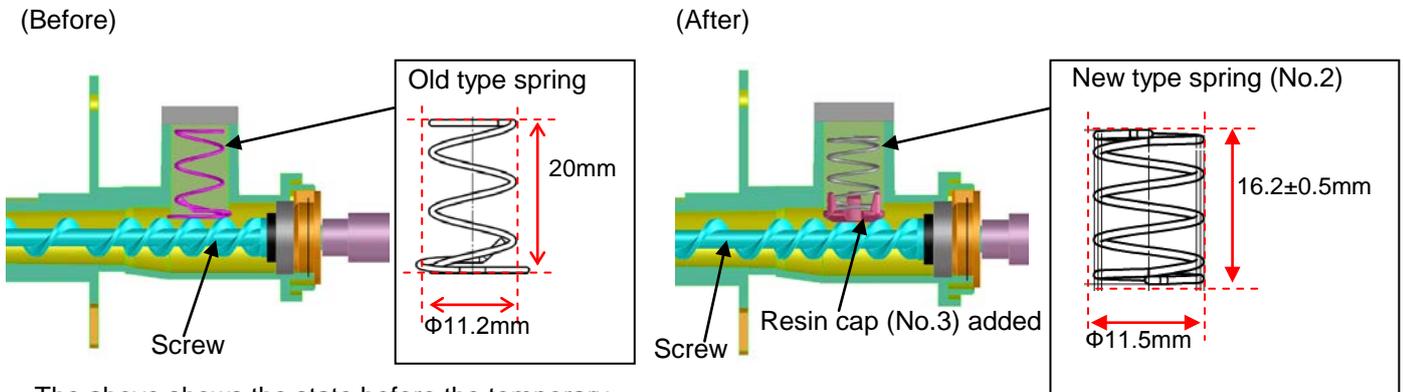
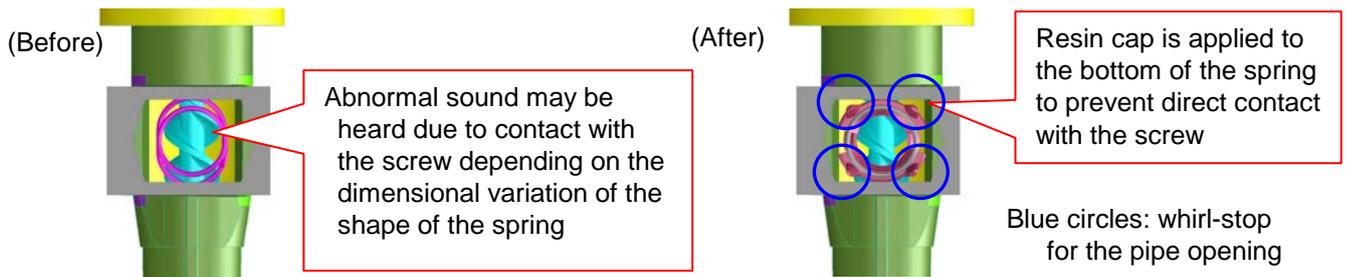
- 1) The shape of the spring is changed and a resin cap is applied to the bottom of the spring.
- 2) The spring (No.2) and resin cap that are not for field supply are set up for the service parts after the above change and the parts set (No.1) consisting of the spring (No.2) and resin cap (No.3) is set up.

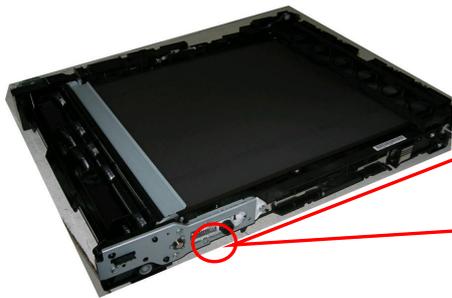
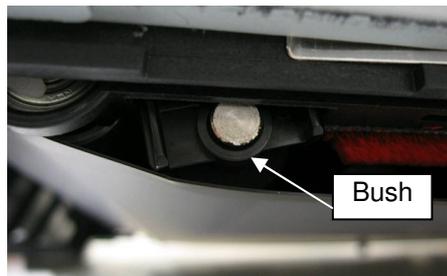
<The bush has come off>

The bush for the primary transfer roller for yellow in the primary transfer unit may come off by excess shake and impact in transit and it may cause the yellow image dropout. This was informed as per the service bulletin No.2LC-0006(B141).

The transfer roller do not contact the drum after the bush comes off by the impact in transit to cause the yellow image dropout

This time, the shape of the bush is changed for further improvement.

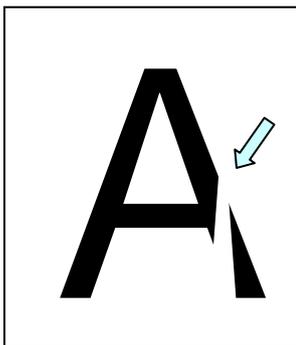
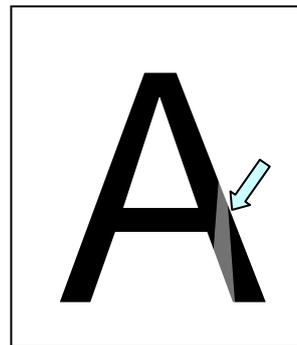
1) Crease at the registration roller
→ Toner is NOT transferred when spreading out the creased part

2) Crease at the fuser section
→ Toner is transferred when spreading out the creased part

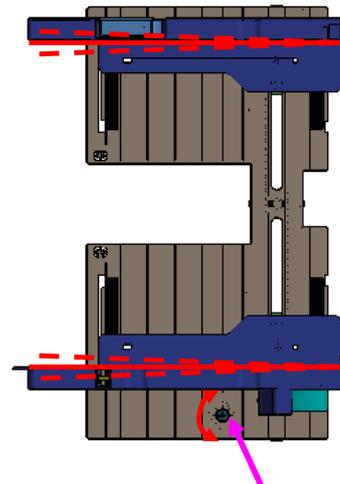
**B) Check/adjust the skew feed**

---Check paper skew when conveying the paper from the cassette causing the paper crease.

- (1) Reduce the paper loop at the registration roller with the maintenance mode U051(Adjust paper loop) to check the skew amount
 - *Print the maintenance report to check the values prior to the above.
 - a) Reduce the U051 value by 10bit for the target cassette
 - b) Print the test pattern by pressing the system menu.
- (2) It is OK if the skew amount (or lateral level) is within 1mm
- (3) If the skew amount (or lateral level) is over 1mm, adjust it by moving the cursor with the paper angle adjuster in the cassette
 - Loosen 4 screws and adjust the cursor angle with the paper skew adjusting screw.
- (4) Resume the paper loop at the registration roller with the U051.
