Service Bulletin

Ref. No. **COM-0218 (B056)**

Subject	Note when releasing the paper jam/maintaining the machine (Prohibition of use of the flammable sprays and liquids)
Model	All models

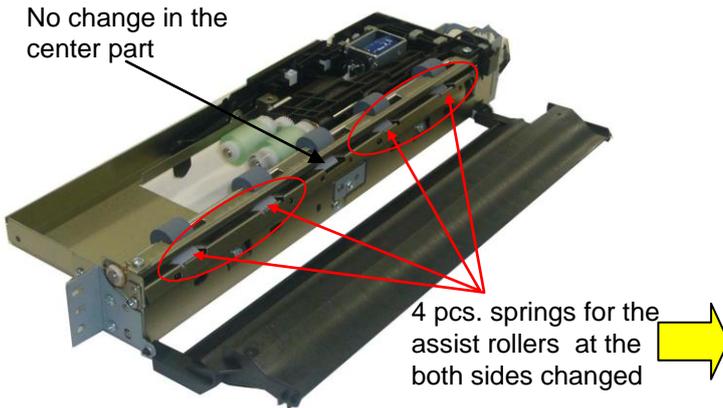
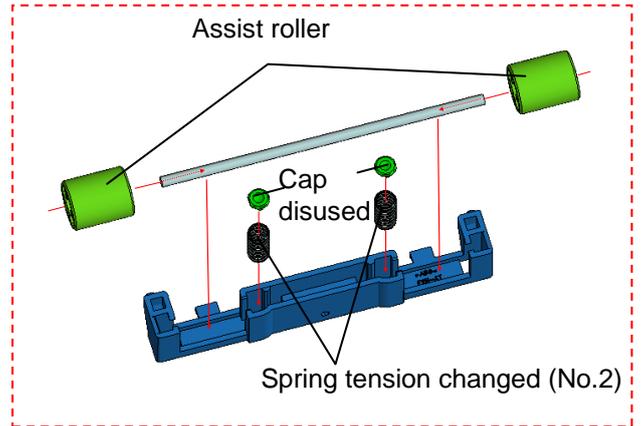
Primary feed unit (No.1) Change ---Main machine/PF-730/PF-780

Phenomenon		Change	Affected model	Parts changed
C	Crease Jam If paper is conveyed in skew to the assist roller, it remains and is conveyed to the feed roller. This may cause the paper crease or jam (J4***)	<Primary feed unit (No.1) Change> 1) Tension to the assist roller changed from 5N to 0.1N 2) The cap attached to the spring disused after the above change 3) The new type spring (No.2) is set up for field supply after the above change	Main machine** PF-730 PF-780	No.1 No.2
D	Crease if the paper is fed from the cassette 4, the crease may have appeared because the spring tension at the registration roller is too much.	<PF conveying unit (No.3) Change> 1) 2 out of 4 of spring/cap at the both ends of the registration roller are disused to reduce the tension at the both ends.	PF-730	No.3
E	None n/a	<Primary feed unit (No.4) Change> 1) Tension to the assist roller changed from 5N to 3N	PF-740	No.4 No.5

C) If it is not improved after implementing A) and B), replace with the new type primary feed unit (No.1) or modify it by referring to the next page··· for the main machine/PF-730/780

[Note] Do not implement in the PF-740, PF-770. If done, it may cause the jam, etc.

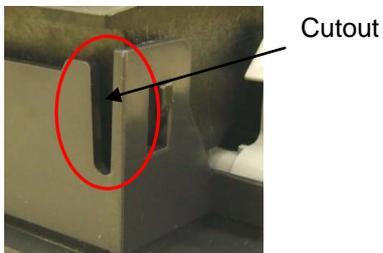
(Able to modify)

Cutout at the point Z of the outer cover
→ modification available

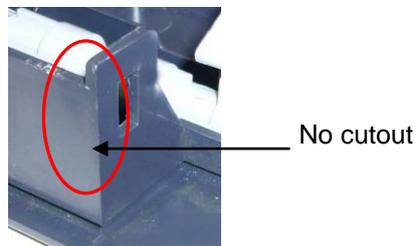
(Unable to modify)

No cutout at the point Z of the outer cover
→The point Z may be damaged when attempting to modify

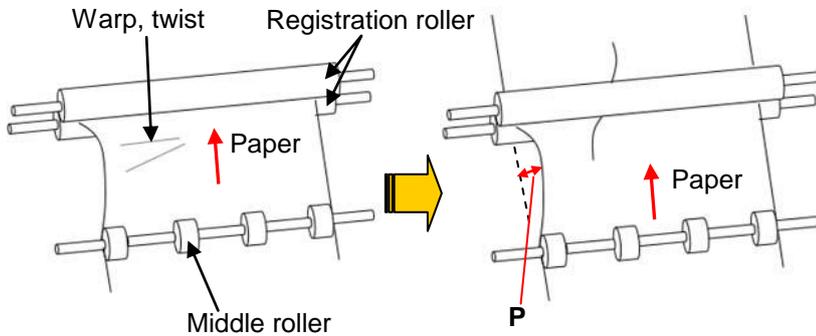
<Phenomenon (image of the crease)>

Paper may be warped or twisted at the registration section if it is conveyed while skewed. If the secondary feed starts in this condition, the paper crease may appear. Therefore, the following are changed.

(1) Paper warps and twists

(2) Because the paper conveying path width (P) is large as above, paper ripples after warp and twist. Paper crease appears after the secondary feed at the registration section.

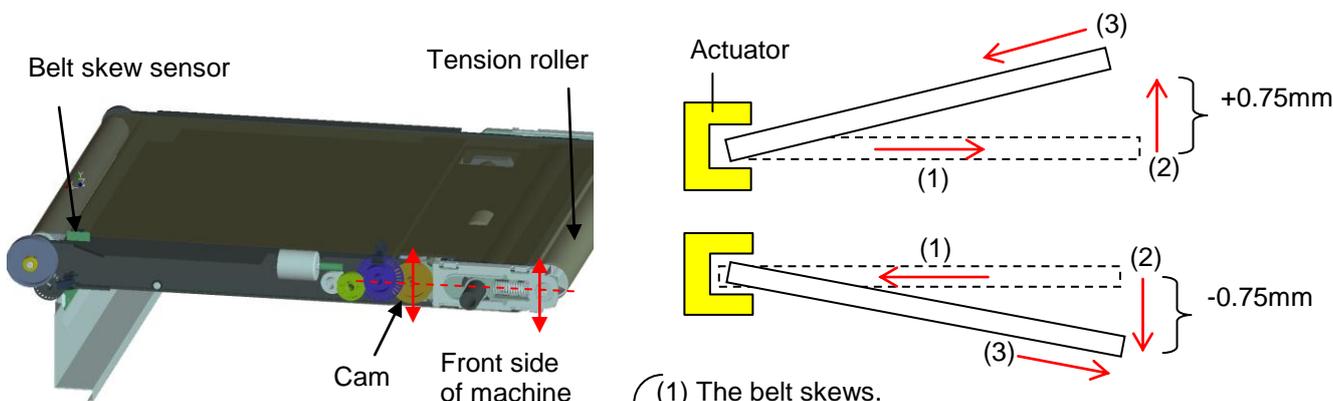
- (1) The belt skews.
 - (2) According to the cam's up/down motion, the tension roller also goes up/down to correct the belt skew.
 - (3) motion as the above (2) improve the belt correction range.
- Widening the motion range as in the above (2) after changing the shape of the cam, the belt skew from the tolerance of the belt is improved.

The shape of the adjusting cam is change to improve the belt skew correction.

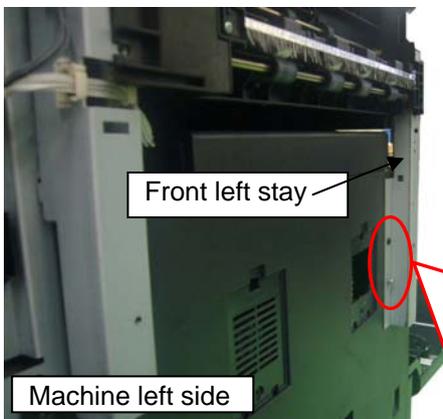
If the screw for the DF connecting plate (M4X30_silver) is mistakenly used to fix the front left stay of the AK-730, it is longer by 10mm and it may push the front side of the primary transfer cleaning unit to cause the C2770 error (Transfer skew error).

- 1) The screw for the DF connecting plate bundled in the DF is changed to the one same as for the front left stay of the AK-730 to avoid the above wrong use [M4X30(silver) → M4X20(black)]
- 2) A correction leaflet for the installation guide is bundled after this change.

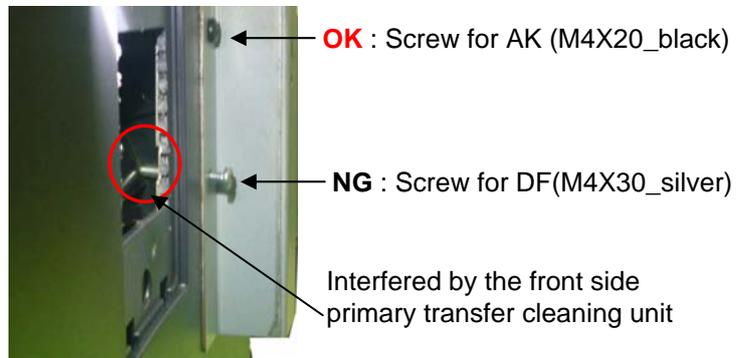
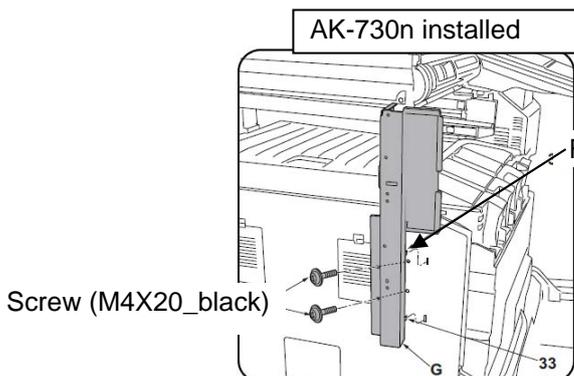
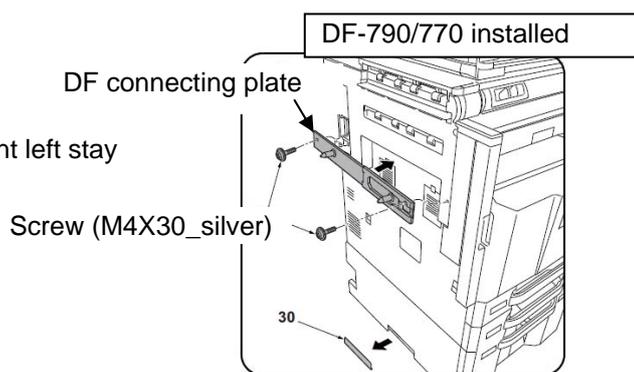
[Condition of fixing the AK front left stay]

Note 1) Both of 2 screws are usually M4X20(black) to fix.
 Note 2) The metal plate in the above figure is modified to show the length of the screws.

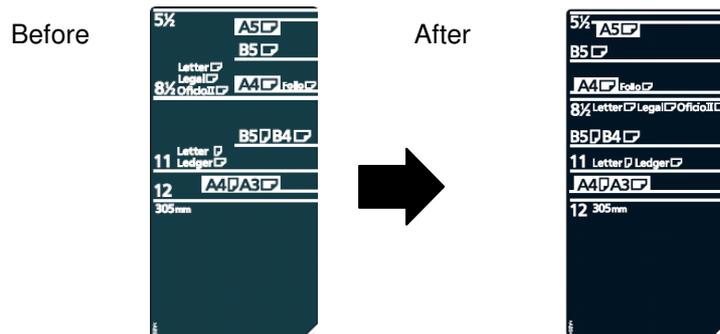
Design of the cassette size label is changed so that the size is visible when moving the size change lever.
 (The color remains unchanged)

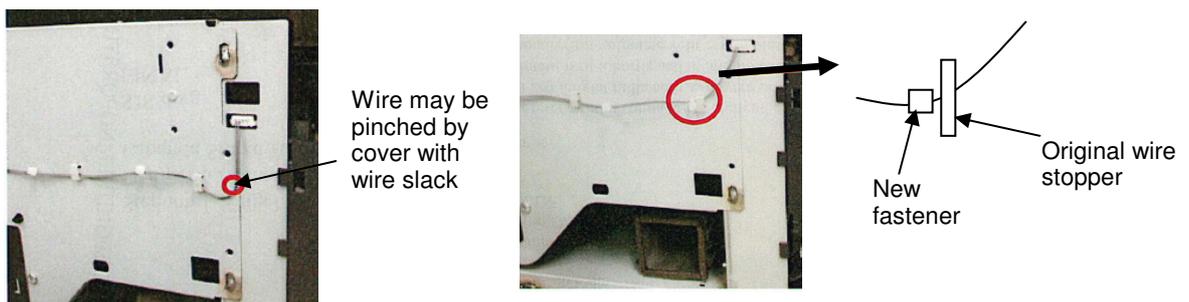
The wire may be pinched by the cover with wire slack after assembly process. A cable fastener is added to prevent it.

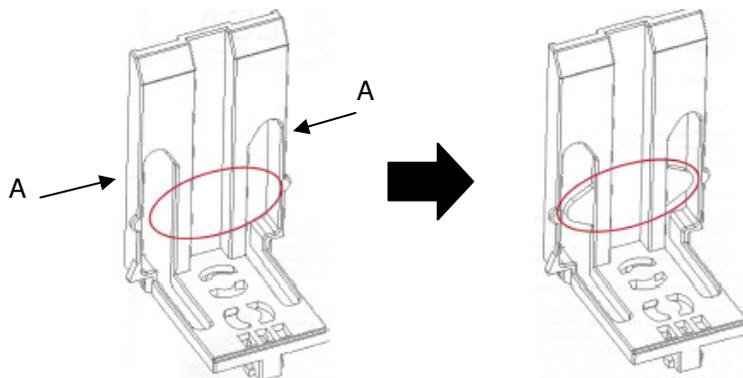
The shape of the cassette stopper is partially changed to regulate the flexure and prevent the stress whitening. This is to regulate the flexure around **A** that may be whitened if pinched too much.

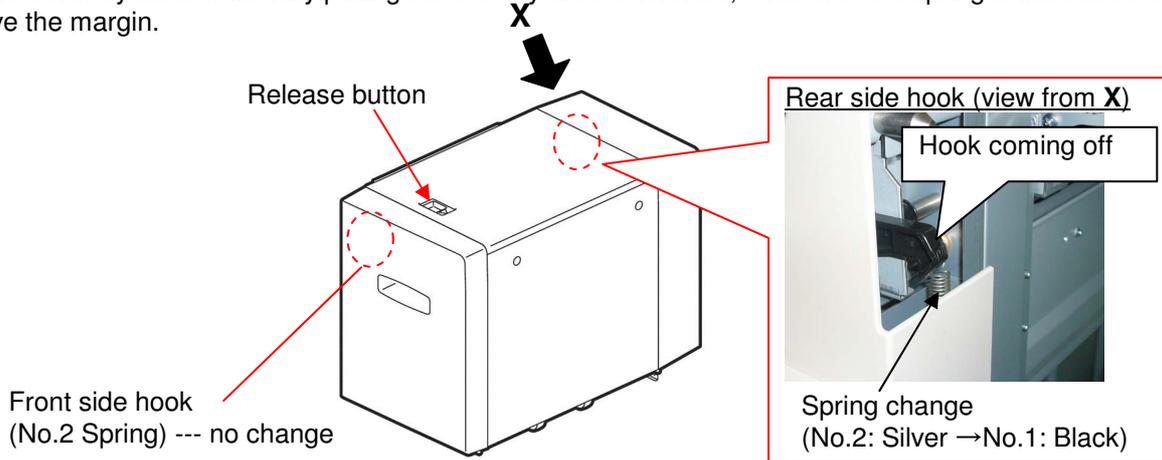
The PF-800's rear side latch may very rarely come off the machine when strongly pressing down the upper part of the front cover by hand while fully pulling out the tray unit. Therefore, tension of the spring is increased to improve the margin.

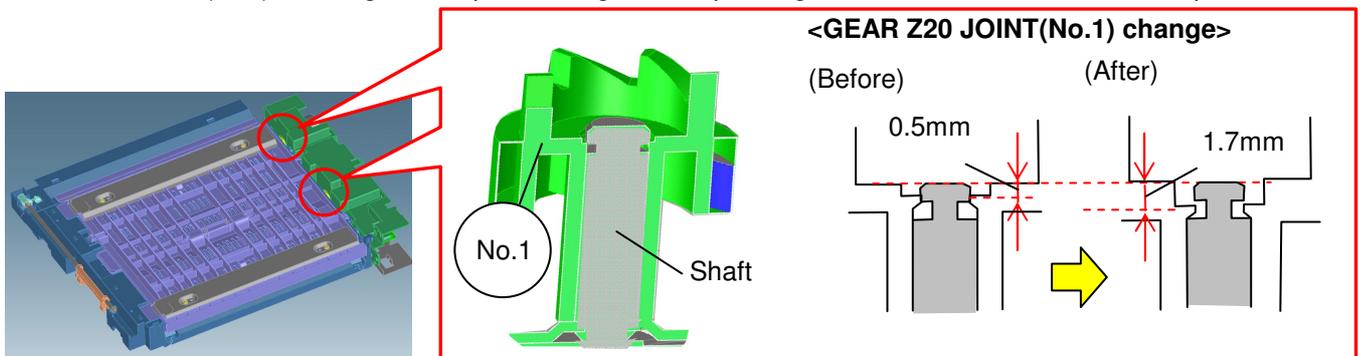
GEAR Z20 JOINT(No1) is changed to improve fitting ease depending on dimensional tolerance of the part.

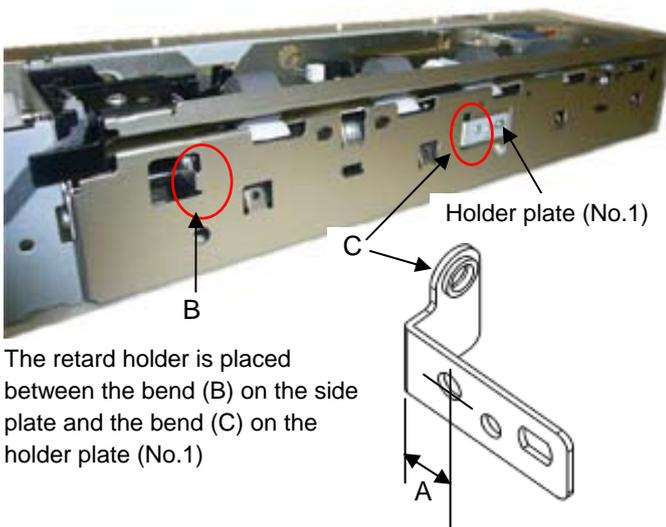
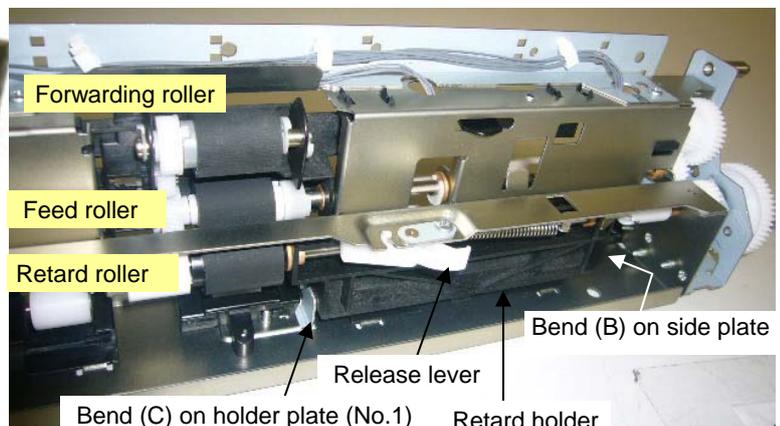
Paper feed failure (no feed jam, (-->) J0545) or paper edge turn-up (or damaged) at the leading edge of paper may occur when using the PF-770.

The hole on the holder plate is relocated and the fixing point of the holder plate (No.1) is shifted by 0.4mm in order to secure the gap margin for the retard holder

The retard holder is placed between the bend (B) on the side plate and the bend (C) on the holder plate (No.1)

A: 90mm → 89.6mm

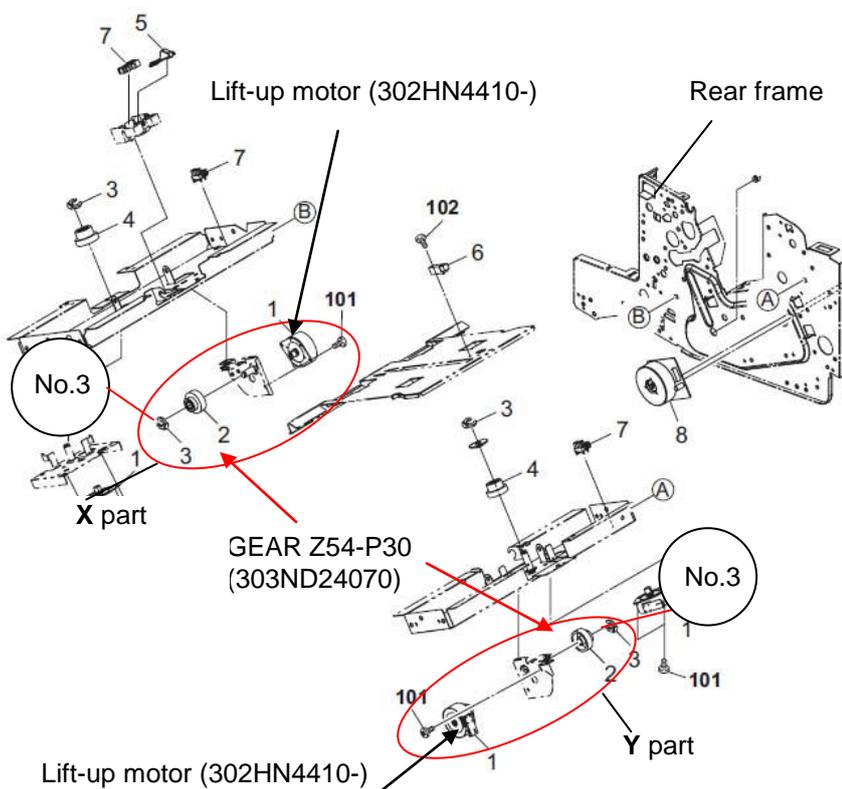
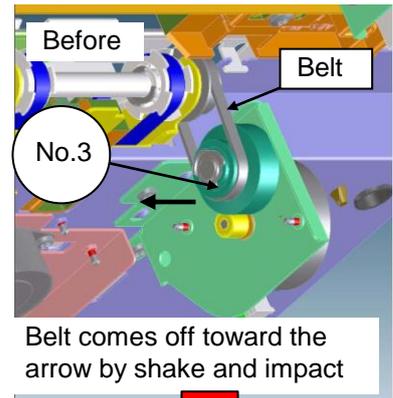
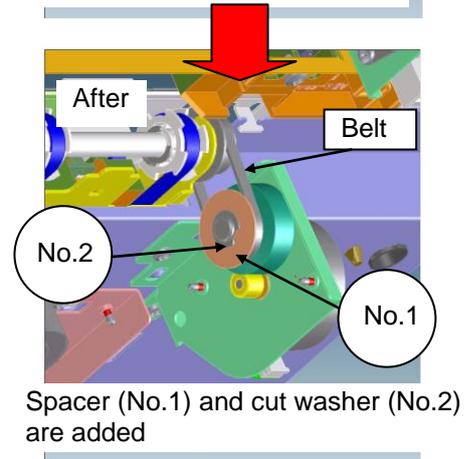
FIG. 1 Booklet Folder 1

- 1) The spacer (No.1) and cut washer (No.2) are added to prevent the belt from coming off.
 The stopper (No.3) is disused.

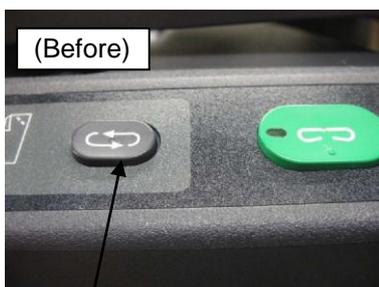
The manual staple is enabled if the switch is contacted.

- 1) The shape of MOUNT OPERATION (not for field supply) is changed so that the manual staple is not enabled when contacting the switch.
- 2) The shape of SHEET OPERATION(No.2) and COVER TOP(No.3) is changed after the above change.
- 3) The assembly (No.1) is set up for field replacing ease that consists of MOUNT OPERATION, SHEET OPERATION(No.2) and COVER TOP(No.3) and individual part supply of COVER TOP(No.2) is cancelled after the above change.

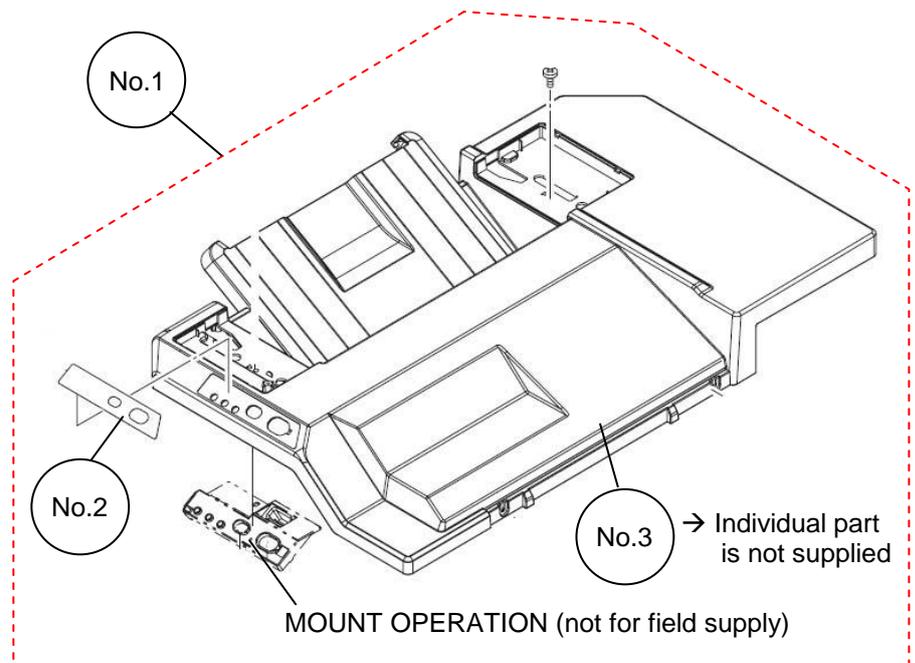
The shape is changed so that the manual staple is not enabled at contact

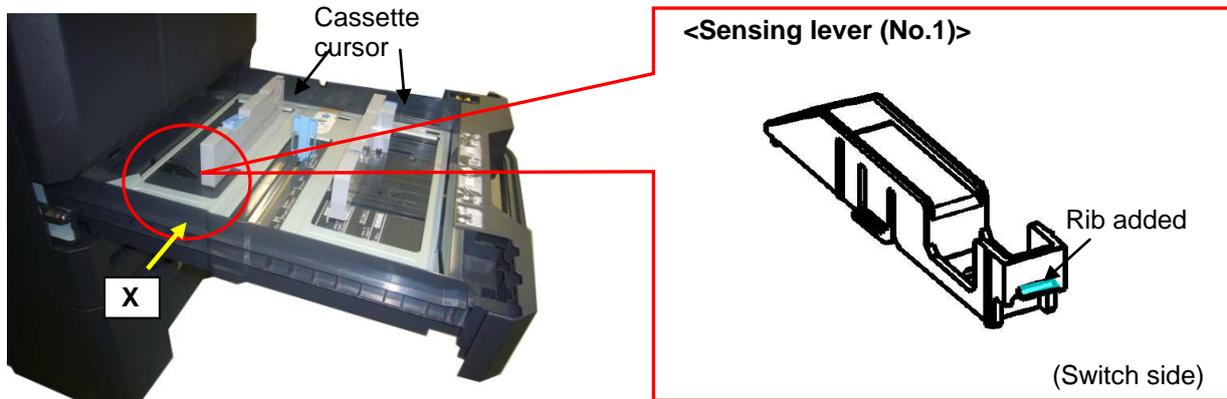
If a cassette with small a amount of stack of B4(L) or B5(W) is strongly installed, the paper width sensing lever (No.1) may come off from the switch at the main machine side and it may override the switch causing paper size sensing failure due to the impact at the installation. Therefore, the following are changed.

- 1) A rib is added to the sensing lever (No.1) to prevent it from coming off and overriding the switch.
- 2) The sensing lever is set up to the service part after the above change.

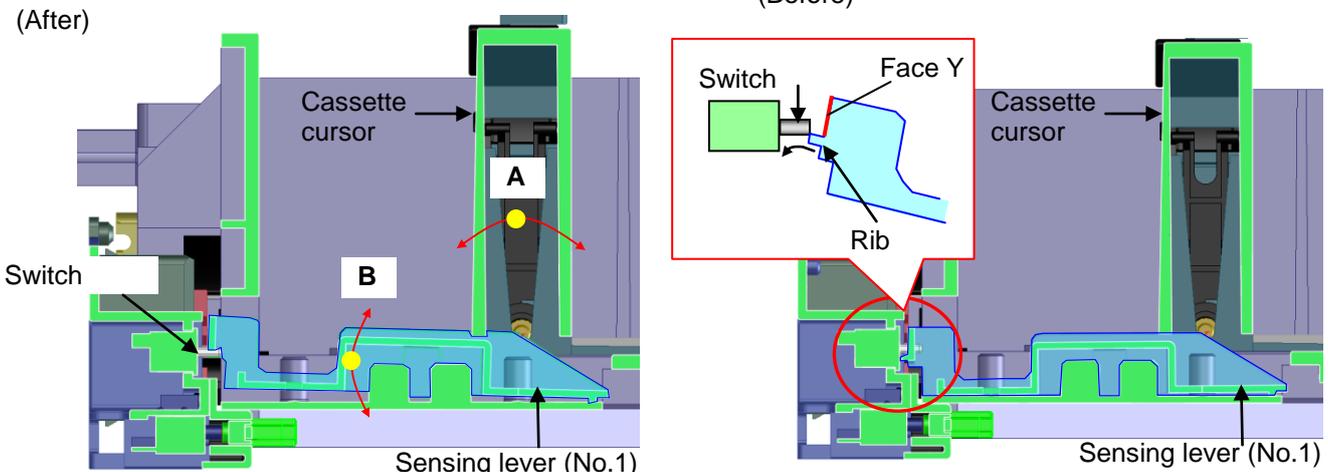
<Phenomenon (viewed from X above)>

(The cassette cursor is shaken toward the direction (A) if the cassette is strongly installed. Then, the sensing lever (No.1) is also shaken toward the direction (B) and it comes off the switch and it overrides.) (Even if the sensing lever (No.1) is shaken, it is taken back to the normal position with the rib added to securely push the switch at the face Y)

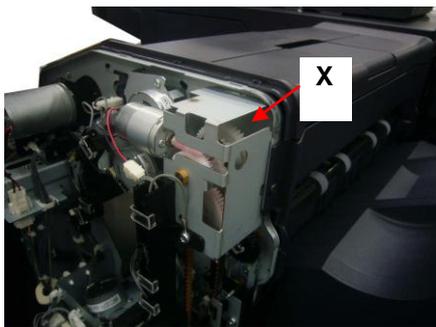
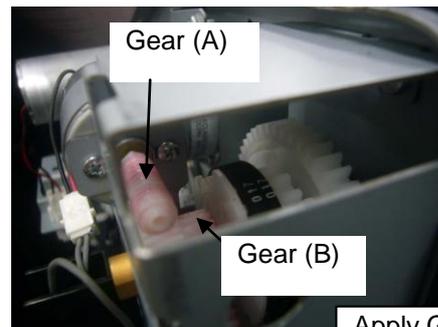
[Viewed from X]

*If the power is turned on without installing the eject tray, the C8140/8150/8160/8250 error (Tray elevation motor problem (document finisher)) may appear, or the gear may be worn, step out or the abnormal sound may be heard from the gear. (Apply grease(*1) when replacing the gear)

<DF-770> Gear (A,B) maybe worn.

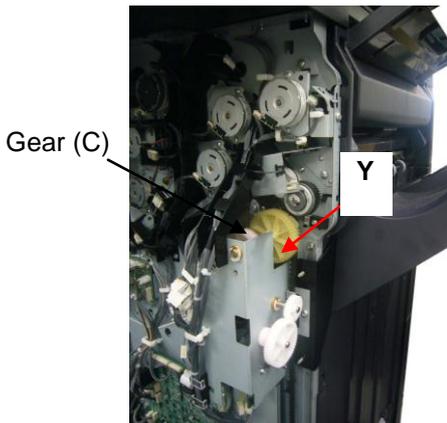
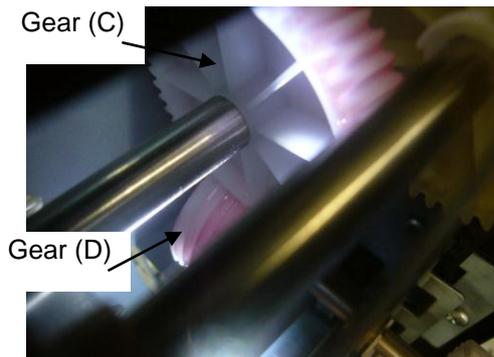
[Viewed from Y]

<DF-790> Gear (C,D) may be worn.

Apply GREASE MOLYKOTE EM-50LP 50G(7BG010009H) when replacing the gear

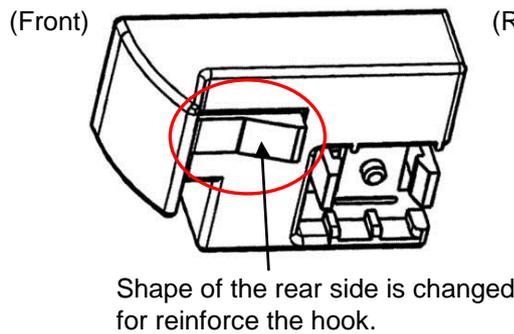
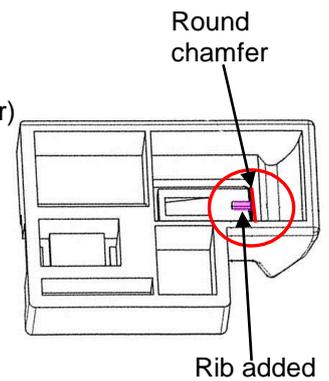
<Scanner lock lever shape change>

The scanner lock lever that is not the field supply parts is changed as follows to reinforce its hook.

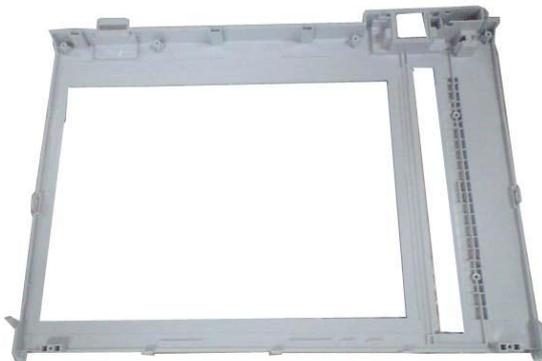
(Before)

Since the white shading tape affixed to the scanner top cover can not be replaced in the field, supply of the separate cover is changed to the assembly including the white tape (No.1). This is an assembly composed of the cover, white shading tape and contact glass. Supply of the separate cover is discontinued.

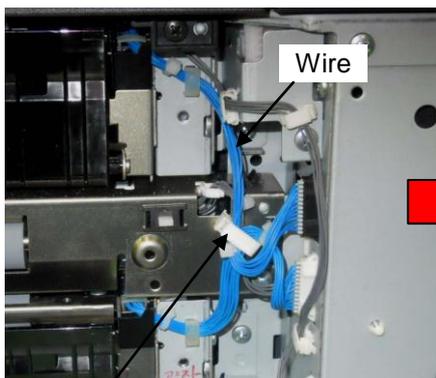
<Before>

Access saddle (A)

Pass the wire through the access saddle (A)

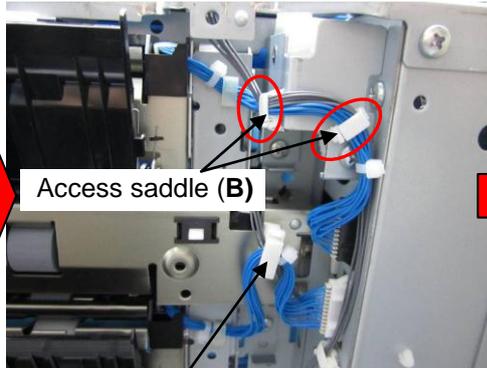
<Tentative measure>
Service Bulletin No.3NJ-0001

Access saddle (A)

Pass the wire through 2 points of the access saddle (B) not passing through the access saddle (A)

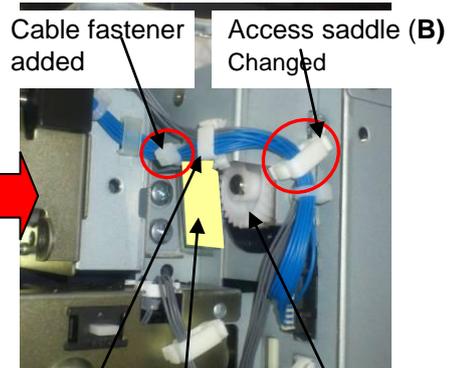
<(This time change)>
Permanent measure>

Access saddle (B)
No change

- 1) A cable fastener is added to prevent the wires spread.
- 2) The size of the access saddle is changed.
- 3) A film is added to prevent the wire from pinched by the gear if moving toward the right.

Film added
(size: 31X16.6mm, t=0.125mm)

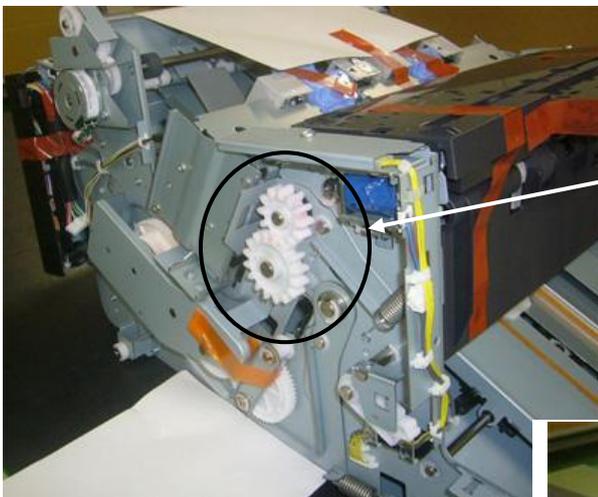
A sheet of copy paper is added to prevent the grease on the gear once adhering to the packing bag from again adhering other place in the assembly process at factory

Prevent grease on the gear from adhering other places via the packing bag

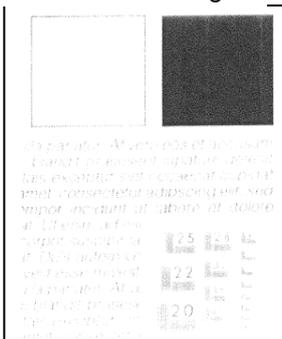
Focus failure image

When the focus failure image is observed as below at set-up on arrival, the plastic parts allocating MOUNT A/B of the ISU may have backlash or come off. Please replace with the new ISU in this case.

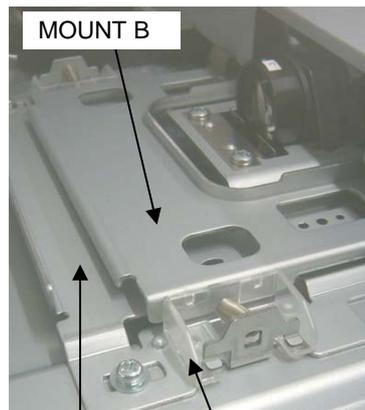
ISU section

MOUNT A Plastic parts (4 points)

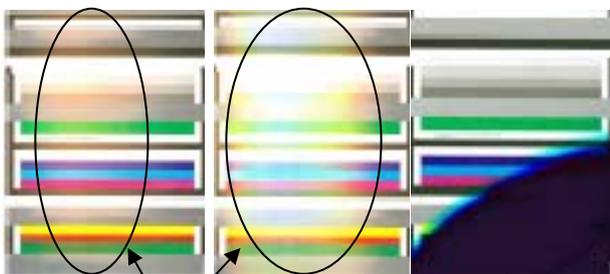
The abnormal image may appear as below or the error may occur at the U411 adjustment when installing the service parts ISU. Please check the images and add the height adjuster spacer. The spacer and leaflet are bundled in the service parts ISU.

Partly Whittish image from the leading edge of the image

Background appearing partly in midstream of the image

1. In case of the image of above A or B, insert the large spacer (16mm diameter, 0.5mm thickness). If the abnormal image is still there, check the image,
2. If the image of A or B appears again, insert the small spacer (12mm diameter, 0.2mm thickness) laying on the large spacer (16mm diameter, 0.5mm thickness)
3. If the image of C or D in the next page appears, insert the small spacer (12mm diameter, 0.2mm thickness)

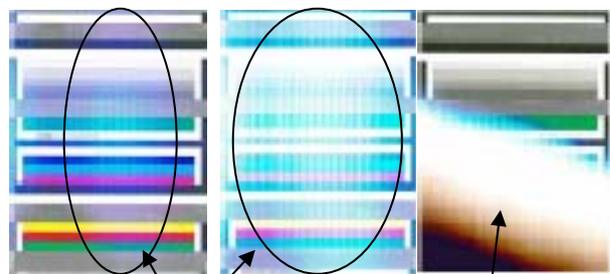
Vertical streaks from the leading edge of the image

Lateral white streaks appearing partly from midstream

1. In case of the image of C or D as above, insert the large spacer (16mm diameter, 0.5mm thickness)
 If the abnormal image is still there, check the image,
2. In case of the image of C or D again, insert the small spacer (12mm diameter, 0.2mm thickness) laying on the large spacer (16mm diameter, 0.5mm thickness)
3. In case of the image of A or B in the previous page, insert the small spacer (12mm diameter, 0.2mm thickness)

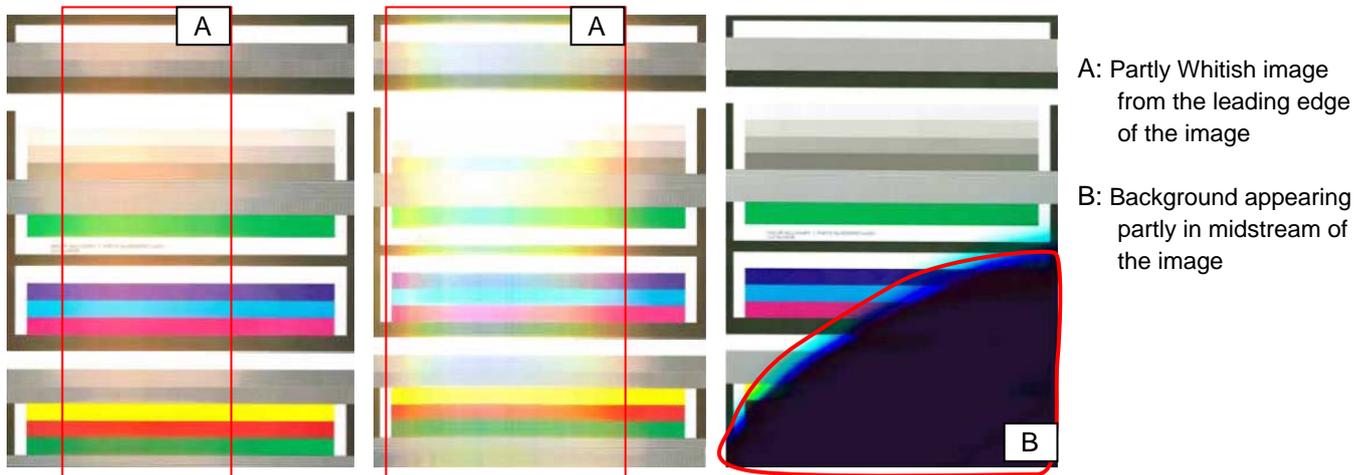
- Image check -

The height and warpage of the base to install the ISU are slightly different depending on the machine and the light beam path may be interrupted by the reflector plate with the shift of the axis or the LED lights directly enter if shifted to the light guide plate side.

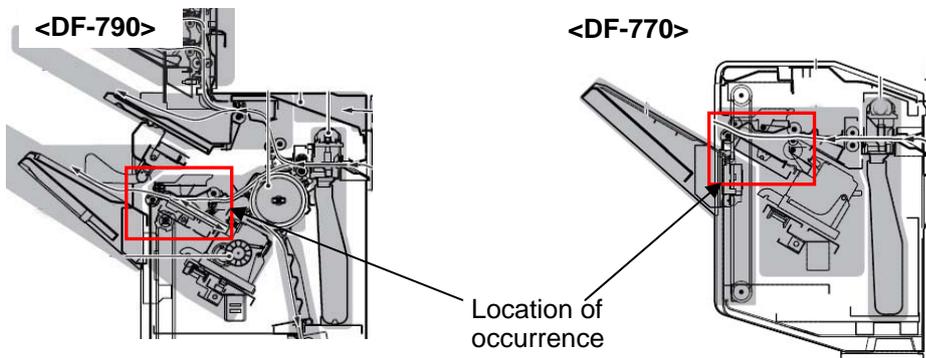
(-->)Please perform the following measures when J6310/J6510 (DF-790) and J6311/J6511 jam occurs.

1st sheet eject		2nd sheet and after eject	
Phenomenon	The paper is pulled in more and it is fold in two or accordion if the upper eject roller is not fully released due to narrow gap between the eject roller and upper eject roller when pulling paper back to the adjuster tray. Then, the paper conveying failure of the next sheet as indicated (-->)J631* or paper eject failure as (-->)J651* may occur.		The upper eject roller (as assist) is not fully released (=narrow gap between the eject roller and upper eject roller) Paper may hit the upper eject roller to cause paper conveying failure for next sheet as (-->)J631* and eject failure as (-->)J651*.	
	Normal behavior at paper bundle ejection	when the above occurs	Normal behavior at paper stack ejection	when the above occurs
Cause	(1) Paper conveyed (2) Paper pulled back to the adjuster tray starts while pinched between the eject roller and upper eject roller (3) During above, the upper eject roller released with the sensor rear side. Paper conveyed to the adjuster tray with the eject roller only (4) Paper ejected from the adjuster tray (Then, eject roller and upper eject roller again pinch paper) *Explaining the 2nd paper stack and after is omitted.	(1) same as left (2) same as left (3) During above, the upper eject roller may not be fully released due to tolerance of the sensor position to determine release volume (*1) when releasing the upper eject roller. <u>*1: Refer to [Field Measure] in the previous page</u> (4) Above phenomenon occurs if paper conveyed while the upper eject roller is not fully released (=narrow gap between the eject roller and upper eject roller)	(1') 2nd sheet conveyed (2') Ejected 2nd sheet pulled back to the adjuster tray by paddle and conveying guide (*2) (3') Ejected from the adjuster tray (Then, paper pinched by the conveying roller and upper eject roller) <u>*2: Eject roller and upper eject roller do not rotate</u> (upper eject roller : released) the paper conveying guide moves up and down when the paddle rotates	(1') same as left (2') If the upper eject roller released at 1st sheet is not fully released (=narrow gap between the eject roller and upper eject roller), 2nd sheet hits the upper eject roller and above phenomenon occurs.

Please adjust the position of the sensor to widen the nipping gap between the eject roller and upper eject roller.

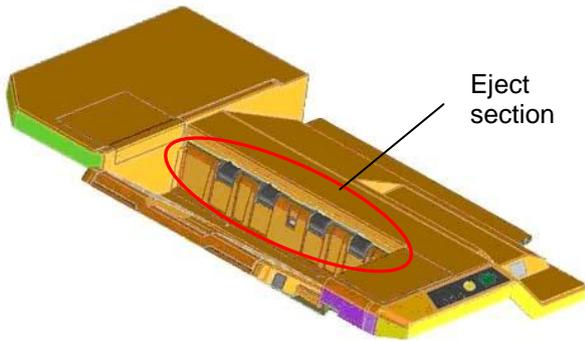
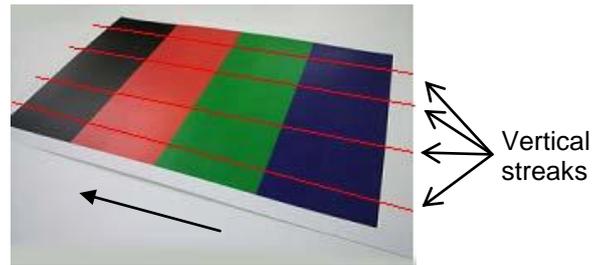
<Image with vertical streaks>

- 1) The shape of the POM pulley at the eject section is changed to prevent the marks of the pulleys.
- 2) The POM pulley (No.1) that used be not supply to field is changed to the service parts after the above change.

Field Measure: Please replace the POM pulley with the new parts (No.1) when the above phenomenon arises. (Refer to the next page and after for replacement procedures)
Serial Nos. of Affected Machine: (→)Please refer the affected machine serial number table on next page

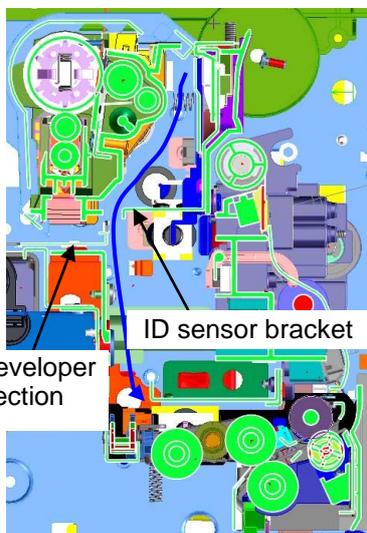
[Where to occur]

Toner may spill from the developer unit and may be put on the paper set in the cassette. Therefore, a film (No2) is added in between the ID sensor bracket and the BK developer unit rail where is a route of the toner spillage.

Toner passes through the gap between the ID sensor bracket and BK developer unit rail and drops around the primary feed pick-up roller pressing part via the side hole of the primary feed unit (figure above A) or directly onto the surface of the pick-up roller to adhere the paper when it is fed. (figure above B)

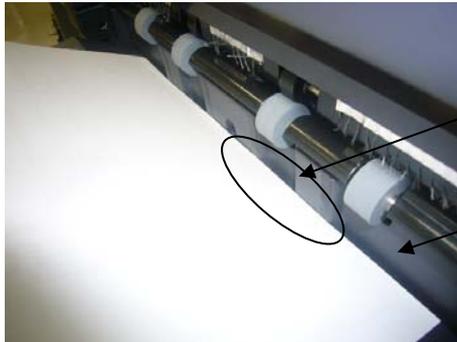
The trailing edge of paper may contact the cover (partition) to cause an abnormal sound

- The point on the cover (partition) is padded where FILM PARTITION is currently affixed.
- FILM PARTITION is additionally affixed to 2 points. (Total 4 pcs. → 6 pcs.)

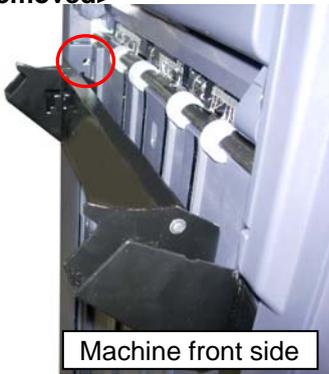
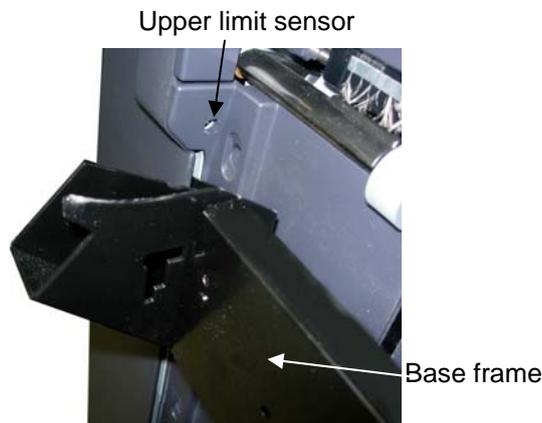
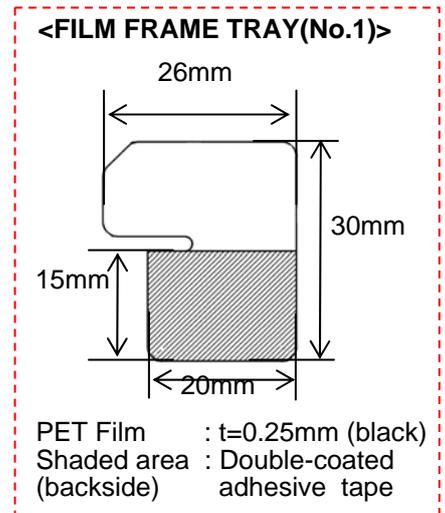
<The eject tray is removed>

The upper limit detection for the eject tray is not correctly function and the service call errors may appear or the gear may wear if the eject tray is not installed or is incompletely fitted. Therefore, a film (No.1) is added to improve the detection margin.

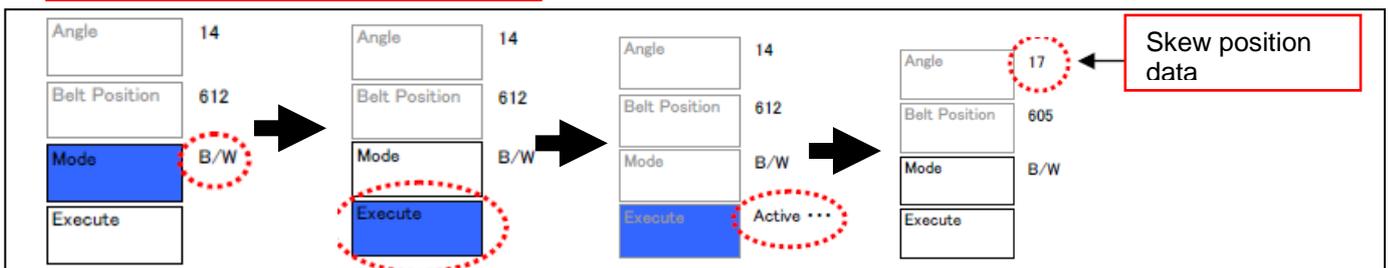
Angle: 6 to 26	=OK
Angle: 5 or less, 27or more	=NG

4. If the [Angle] value is NG, the waste toner shutter of the primary transfer belt unit may strand. **Once slowly pull out and push in the primary transfer belt unit.** again execute the U469(Belt Check) and check [Angle] value. (The shutter may strand from the excess shock in transportation)

5. Replace the primary transfer belt unit if the value is NG at checking in the above 4.

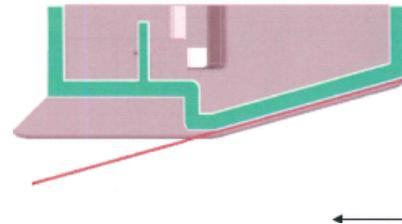
0-1mm

No protrusion at the right side of the above figure

Clean the part to affix with alcohol, etc. to eliminate dirt and affix the film

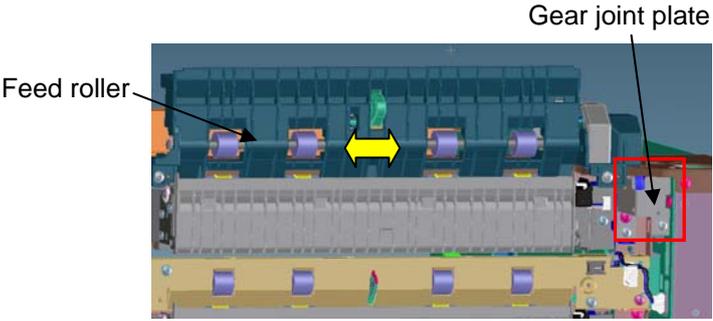
2	<p>After fitting the gear joint plate, check if the feed roller is lightly moved toward the thrust direction.</p> <p>*If there is a gap between the gear joint plate and frame, the feed roller is not moved toward the thrust direction.</p>

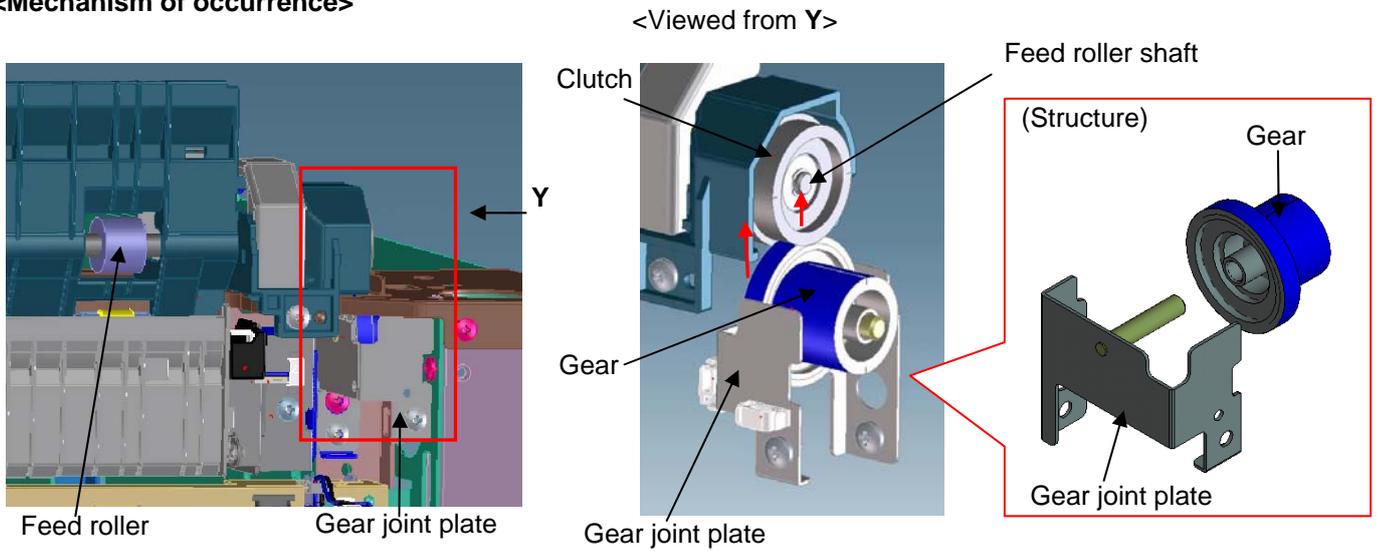
<Mechanism of occurrence>

The feed roller is not rotated since the drive from the gear spins around when the clutch is off.

The gear on the joint plate pushes up the clutch that contacts the feed roller shaft. Then, the clutch being turned off and spinning around may deliver drive to the feed roller.

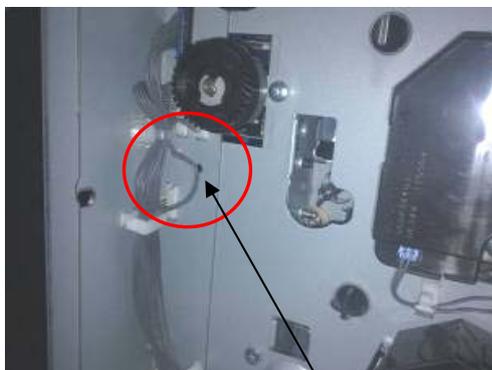
<Checkpoint A>

The wires are caught up by the drive unit and the wires are separated, the wires may be pinched at the boss of the drive unit.

[Checkpoint A] → A snap-fit cable fastener is added to the point X.

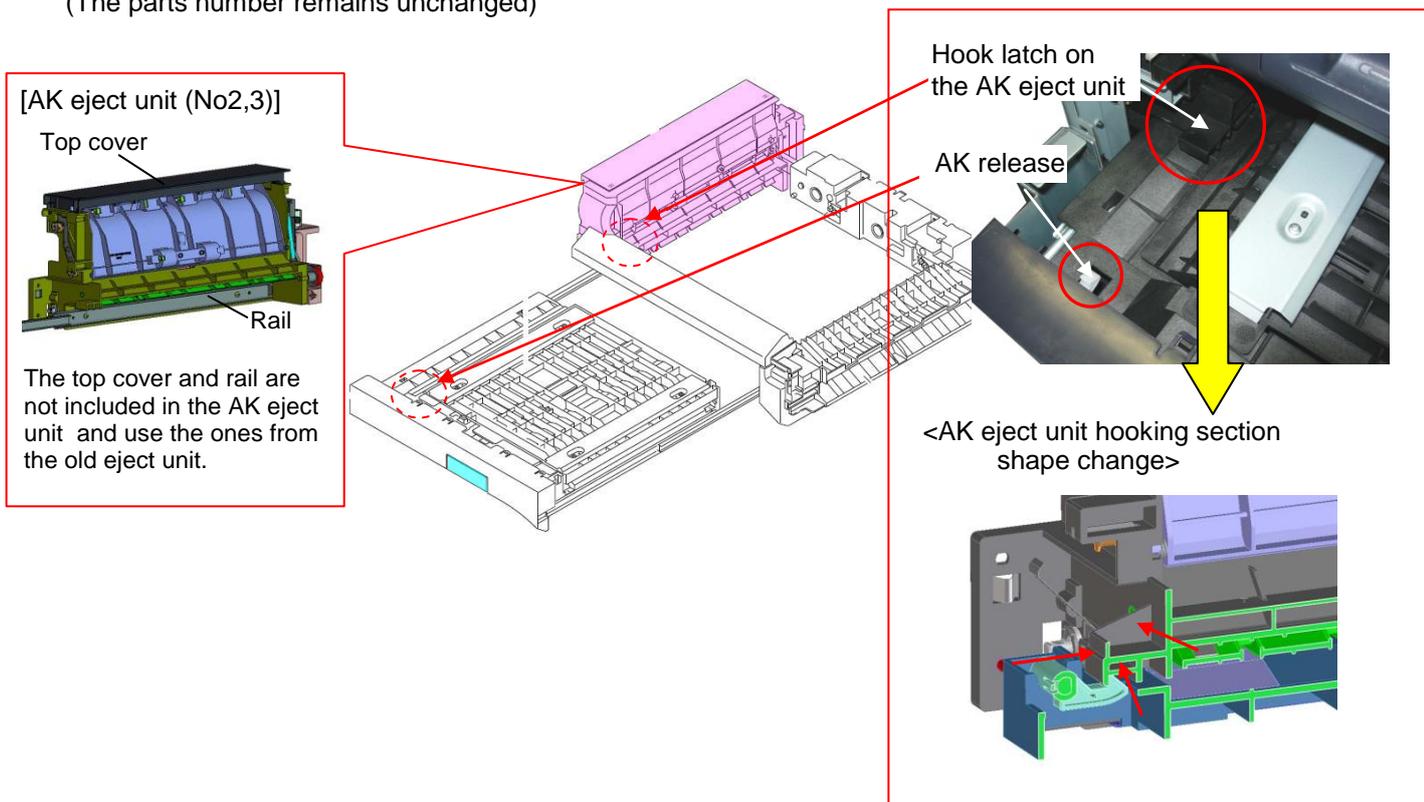
The AK can be pulled out by normally pulling the handle laterally (as in the figure **A** of normal operation (hereafter **A**) in the Table 1). However, if incorrectly pulling it up after once pulling it up (as in the figure **B** of incorrect operation (hereafter **B**) in the Table 1), the AK release hook is not unhooked from the hook latch at the main machine side. Then, the hook latch at the main machine side may be broken if attempting to forcibly pull it out in that state. Therefore, the following is changed.

Ribs added to the points marked by arrows

- 1) The shape of the handle is changed to improve the operation of the AK withdrawal. This is for the change of the way to pulling out the AK from pulling out the handle laterally (as in the figure **A** in the Table 1) to pulling it out after once pulling it up (as in the figure **B** in the Table 1).
- 2) The handle that is not for field supply is changed to the service parts after the above change. The AK eject unit for the TASKalfa 7550ci/6550ci/8000i/6500i is changed to the service parts as No3 while the AK-730 eject unit is set up for the service parts as No2. (The handle is not changed since it is mechanically incompatible between the one for the TASKalfa 7550ci/6550ci/8000i/6500i and for AK-730)
- 3) The shape of the AK eject unit hooking section is changed to reinforcing it.
(The parts number remains unchanged)

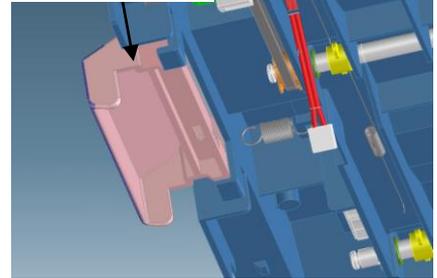
Handle (No.1)

The AK release lock is lightened after change of the shape of the handle and then the AK is smoothly pulled out in the motion X and then Y.

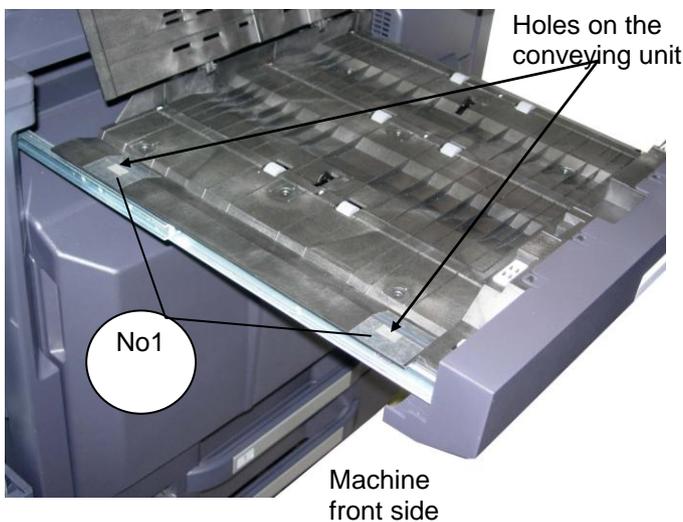
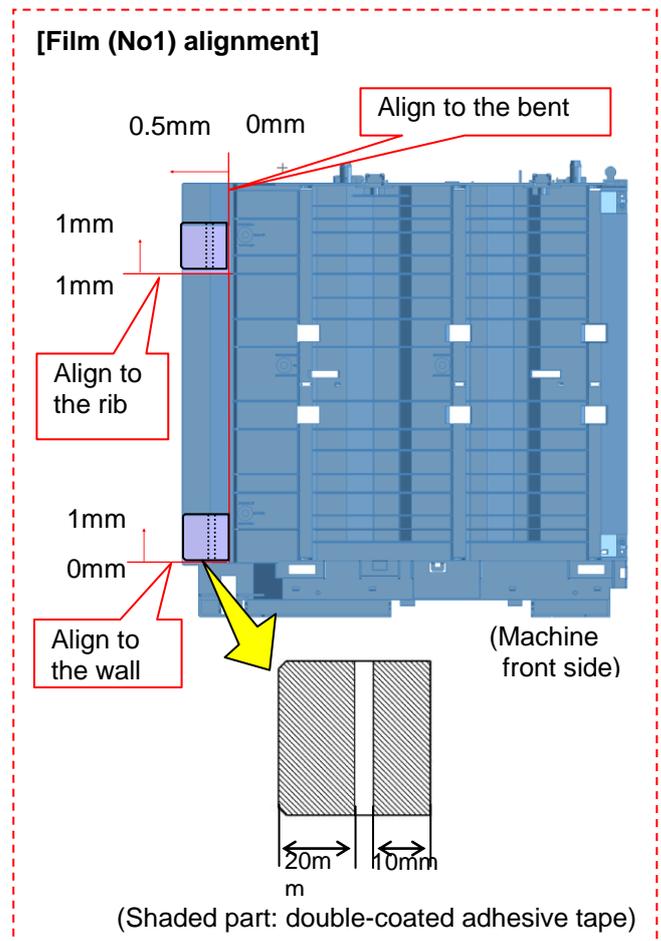
Depending on the paper condition like the downward curl, curled part of paper may be caught up by the hole on the AK conveying unit and the dog ear may be generated. Therefore, the following is changed. Meanwhile, J6110/6111* may occur at the DF conveying section due to the dog ear.

- 1) 2 pcs of film (No1) are added to the holes on the conveying unit to prevent paper from being caught up.

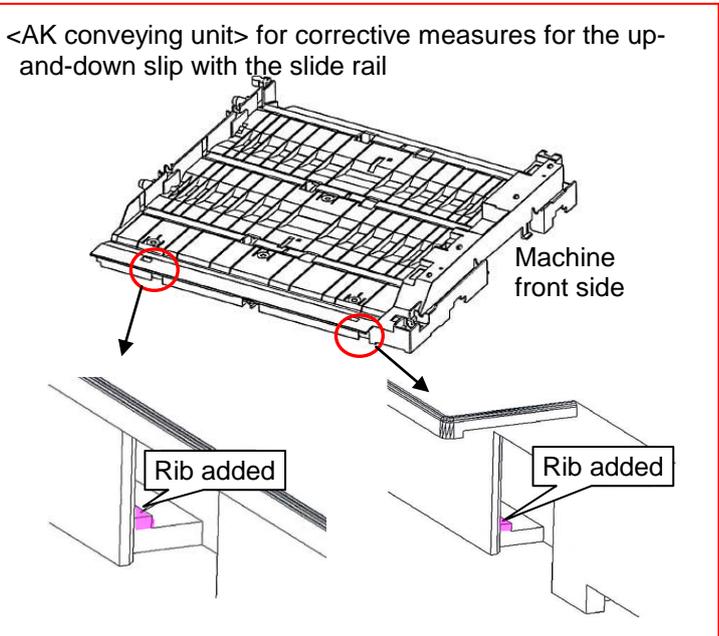
<AK conveying unit> for corrective measures for the up-and-down slip with the slide rail

Rib added

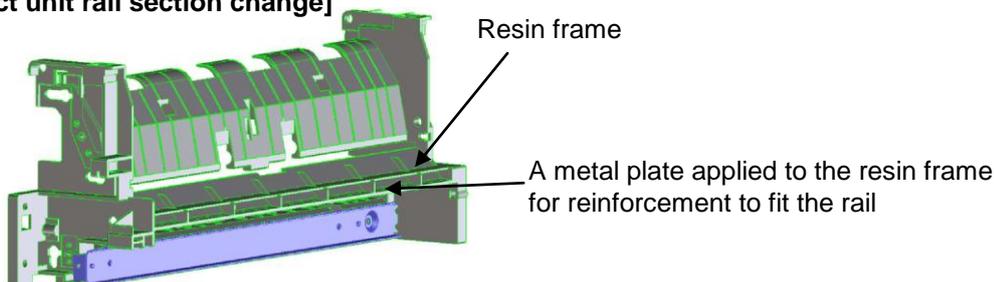
[Eject unit rail section change]

A metal plate applied to the resin frame for reinforcement to fit the rail

- 4) A metal plate is applied to the resin frame for reinforcement of the eject unit rail section and the rail is fitted on it.
(*The parts number remains unchanged after this change)

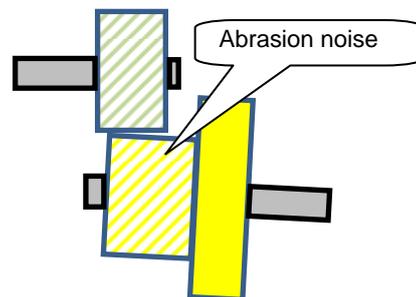
(Abnormal noise generated)

There is a gap between the gears and they are engaged at an angle

Once loosen 3 of the screws fixing the fuser drive unit and again fasten them in order to reduce the vibration in between the fuser drive joint gear and the joint gear at the fuser unit side

1. Loosen 3 of the gears fixing the fuser drive unit after removing the feed circuit board 1 assembly. (Refer to the page 1-5-8 Drive section of the service manual)
2. Fasten 3 of the gears for the fuser drive unit after confirming the fuser drive unit is well positioned at the main machine frame to eliminate the backlash at the gear engagement

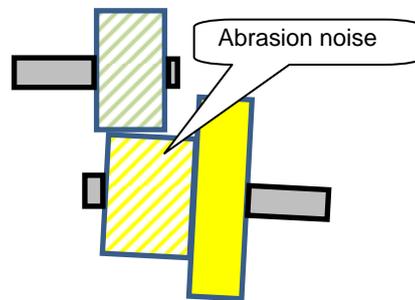
(Abnormal noise generated)

<Cause of occurrence>

There is a gap between the gears and they are engaged at an angle

Once loosen 3 of the screws fixing the fuser drive unit and again fasten them in order to reduce the vibration in between the fuser drive joint gear and the joint gear at the fuser unit side

- Loosen 3 of the gears fixing the fuser drive unit after removing the feed circuit board 1 assembly. (Refer to the page 1-5-8 Drive section of the service manual)
- Fasten 3 of the gears for the fuser drive unit after confirming the fuser drive unit is well positioned at the main machine frame to eliminate the backlash at the gear engagement.
