Service Bulletin

Ref. No. **COM-0218 (B056)**

Subject	Note when releasing the paper jam/maintaining the machine (Prohibition of use of the flammable sprays and liquids)
Model	All models

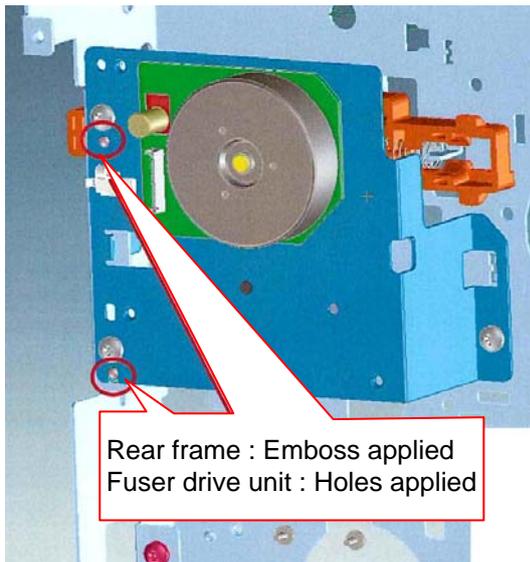
*The old type fuser drive unit is not physically compatible with the new type rear frame where the dowel is added.

Positioning embosses are added to prevent the fuser drive unit from being attached in angle.

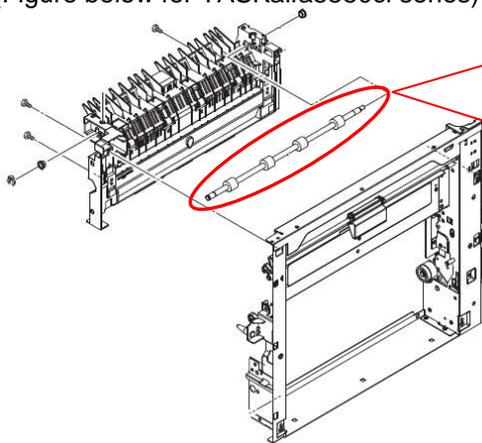
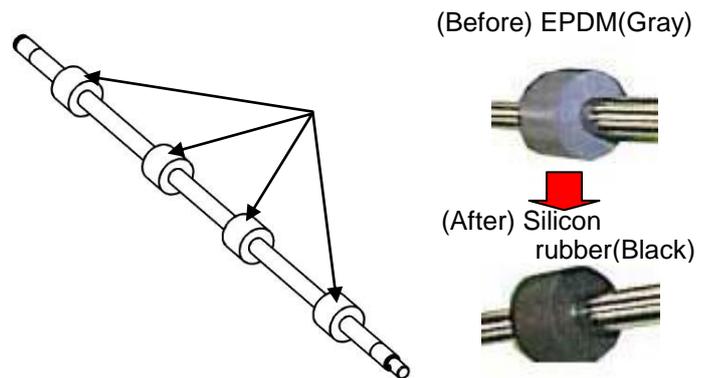
<Roller (No.5,8) rubber material change>

If the roller (No.5,8) at the conveying section reaches high temperature, the rubber roller is swelled due to the wax content of the toner and the inner diameter of the roller is expanded. Then, the rubber roller spins around against the shaft to cause the J440* jam (Duplex sensor 2 non arrival jam). Therefore, the following is changed.

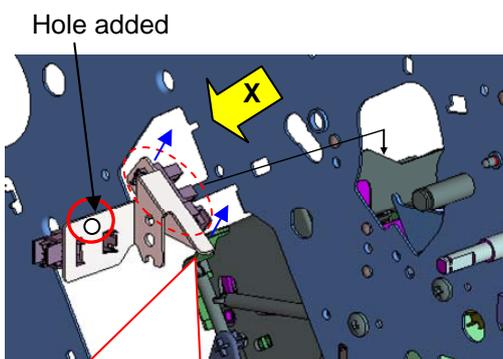
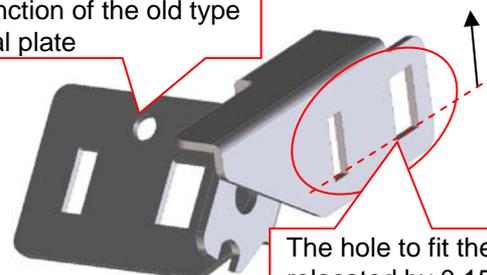
<Metal plate change> (Viewed from X)

The hole on the metal plate to fit the sensor is relocated upward in order to widen the upper eject roller

The hole to fit the sensor is relocated by 0.15mm upward

- 1) Change of the sensor fitting part that is parts not for field supply in order to widen the upper eject roller release (shifting by the distance as the current way of alignment)
- 2) The work to align the metal plate when fasten it with screw is discontinued after the above change

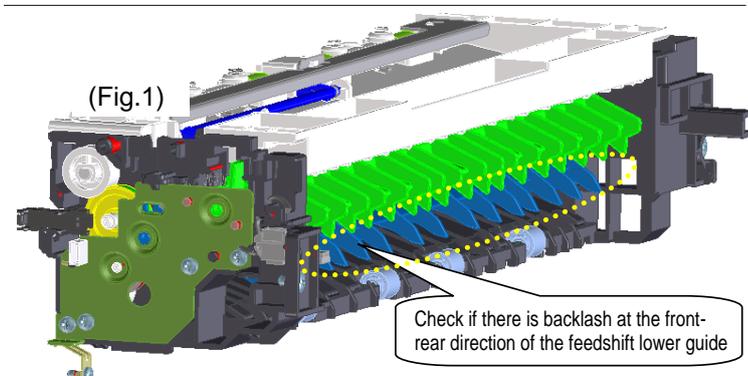
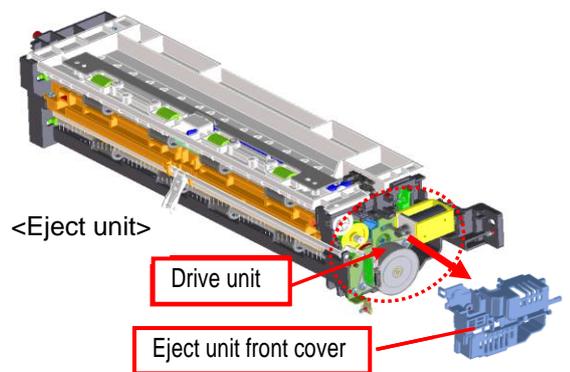
The feedshift lower guide fails in its motion since it does not have enough backlash to cause load at the motion.

The thrust backlash is reduced by thermal expansion and it makes load at the motion of the feedshift lower guide if the gap between the eject unit housing and the feedshift lower guide is small due to the dimensional variation of those parts.

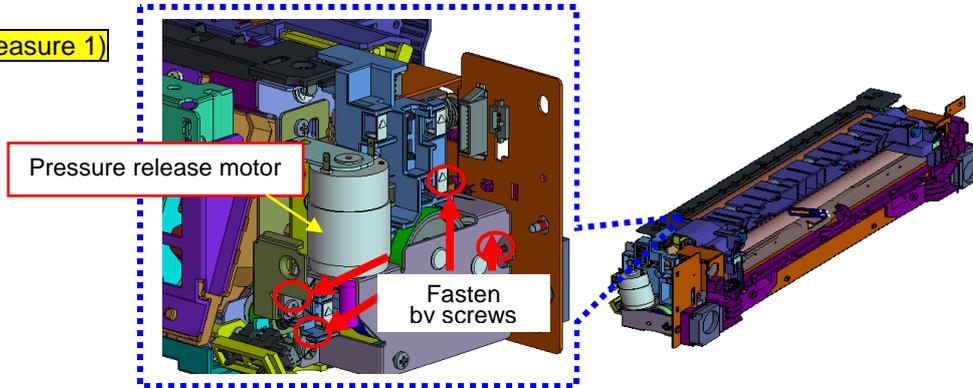
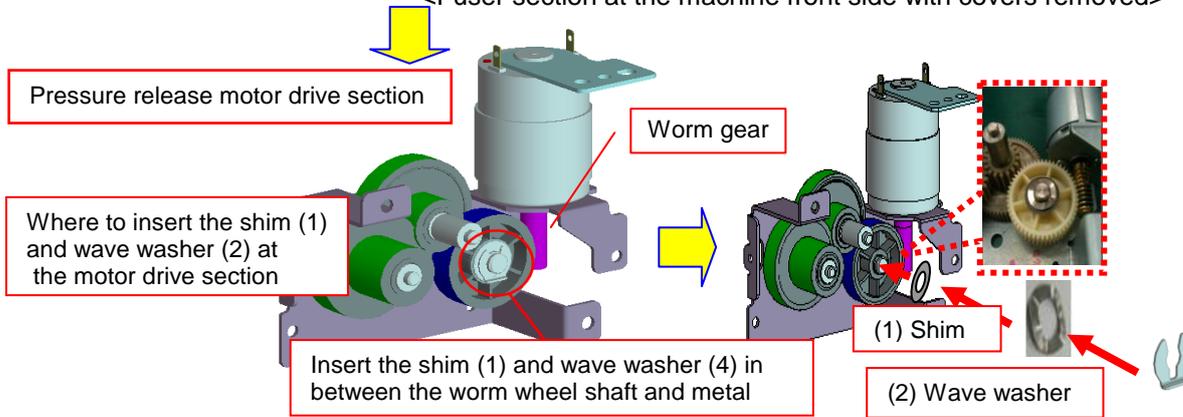
<Where to add the shim (1) and washer(2) to prevent the high-frequency vibration>

High-frequency vibration is generated by abrasion between the worm of the pressure release motor and the gear of the worm wheel and it cause the high sound.

(1) diameter	(2) diameter
Outer 13mm	Outer 11mm
Inner 6.2mm	Inner 6.4mm

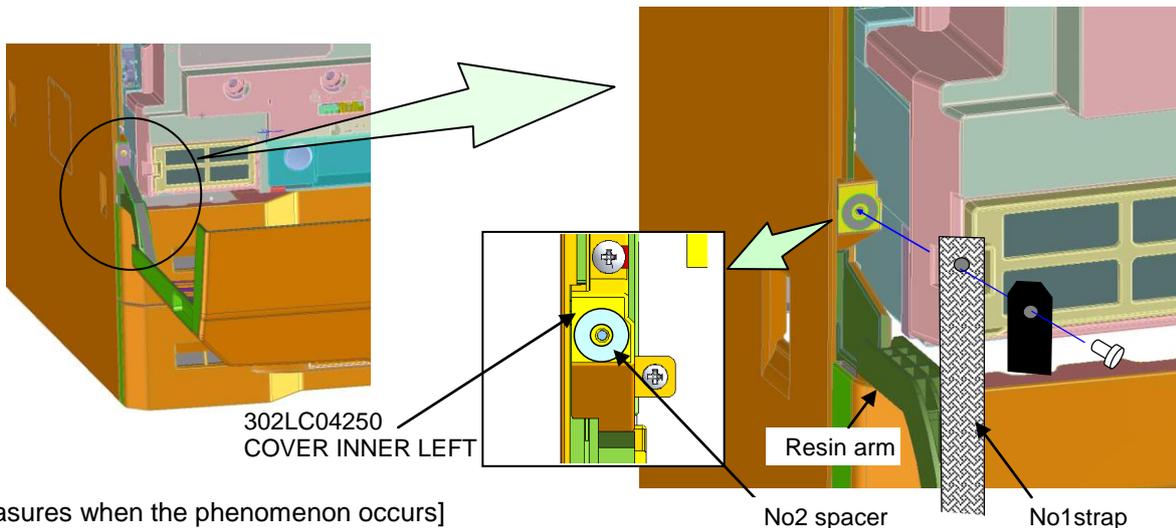
The resin part where screws are fixed may be influenced with oil content at the strap that holds the front cover and there may be damage like crack, break and dropout. The strap may come off if it is more damaged. Therefore, the following are changed.

(The left side of the machine cover may be more damaged depending on the material and shape of the parts)

1. The strap is degraded.
2. A spacer is added in between the strap and plastic cover (spacer affixed to cover) ···· 2 for front cover, 2 for main machine side

- 1) The machine left side among 4 of the screw points is most influenced depending on the material and shape of parts.
If the left side machine cover is damaged, replace with the parts below.
Machine left side cover: 302LC04250, COVER INNER LEFT
*The machine and front cover are connected with the resin arm and the front cover does not come off even if the strap comes off
- 2) Add the spacers to not only where damaged but to 4 of the screw points and replace the left and right side straps.
Clean the affixing point with alcohol before affixing the spacer.

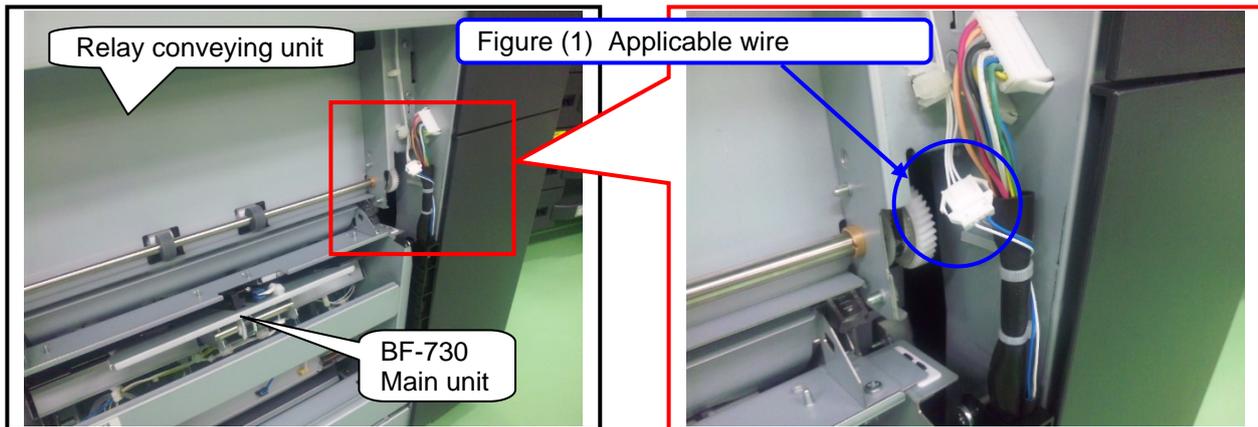
When releasing the BF-730 main unit, the wire connector ((1)in the figure below) may be disconnected and the JAM7700 (CF paper conveying sensor non arrival jam) may occur depending on the length and alignment of the wire connecting between the BF-730 main unit and the conveying switch in the relay conveying unit.

- 1) Check if the applicable wire connector is disconnected when the J7700(CF paper conveying sensor non arrival jam) occurs.
- Secure the margin for the wire length by taking off the wire from the wire saddle if there is no margin in the applicable wire length (Refer to the next page for the work content)
- 2) Check the applicable wire connector is not disconnected by releasing the BF-730 main unit several times after installing it at setup
- Take off the wire from the wire saddle to secure the margin for the wire length if the above check results prove the applicable wire connector is disconnected or the wire does not have the margin for length. (Refer to the next page for the work content)

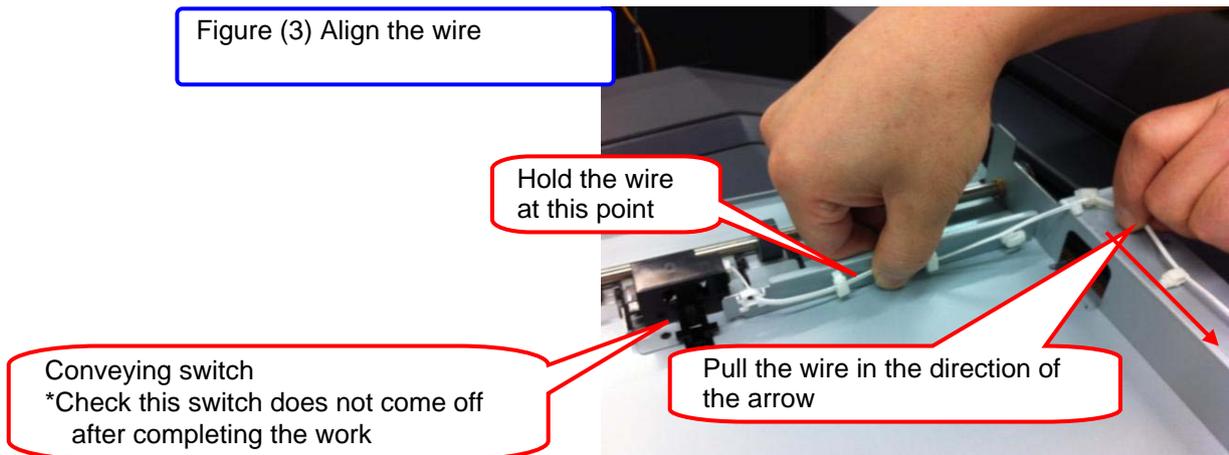
Figure (3) Align the wire

(B) Hold an end of the wire and pull the other end (Figure (3) below)

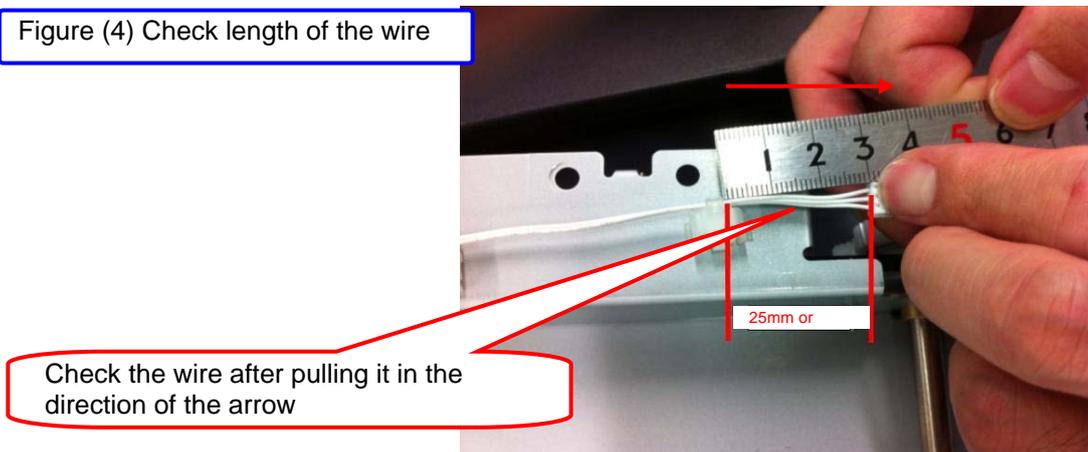
Figure (4) Check length of the wire

(C) The wire length is 25mm or more from the last point wire saddle. (Figure(4) below)

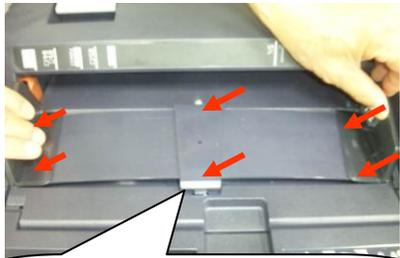
Cursor assembly: hooks come off

The paper width is detected depending on position of the cursor.
 If the hook comes off, it can not contract the terminal brush and can not detect the paper width.

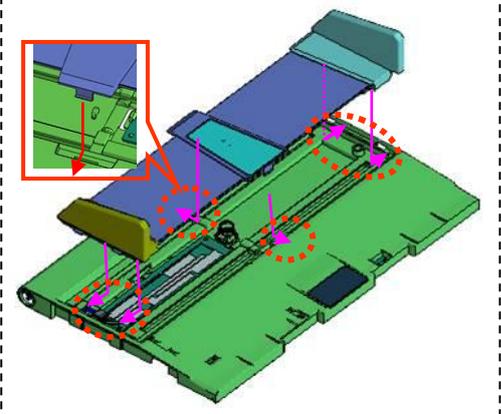
[Checkpoint]
 If the original size is not detected when setting up the one with old type packing, check if 6 of the hooks comes off as below.

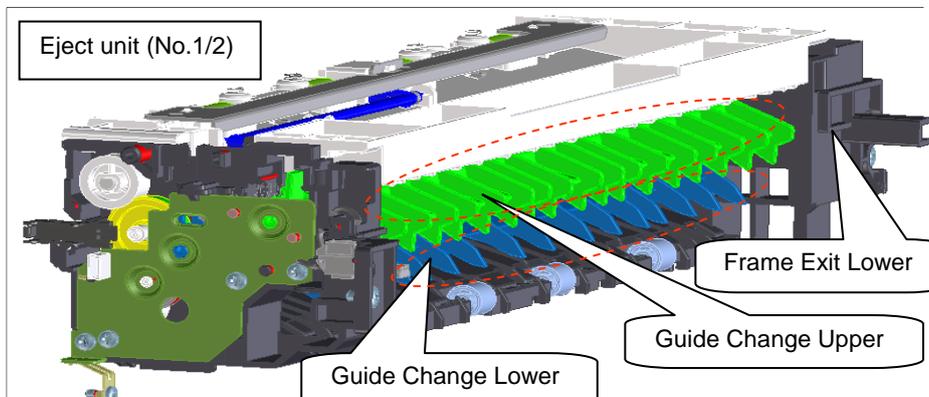
in order to prevent the upper/lower guide motion failure due to thermal expansion and to secure a forward-and-backward play.

b. Rear side shaft diameter: $5.95 \pm 0.03 \rightarrow 5.9 \pm 0.03\text{mm}$

c. Shaft length: $347.2 \pm 0.3 \rightarrow 346.4 \pm 0.3\text{mm}$ (not including length getting into the round hole on the frame)

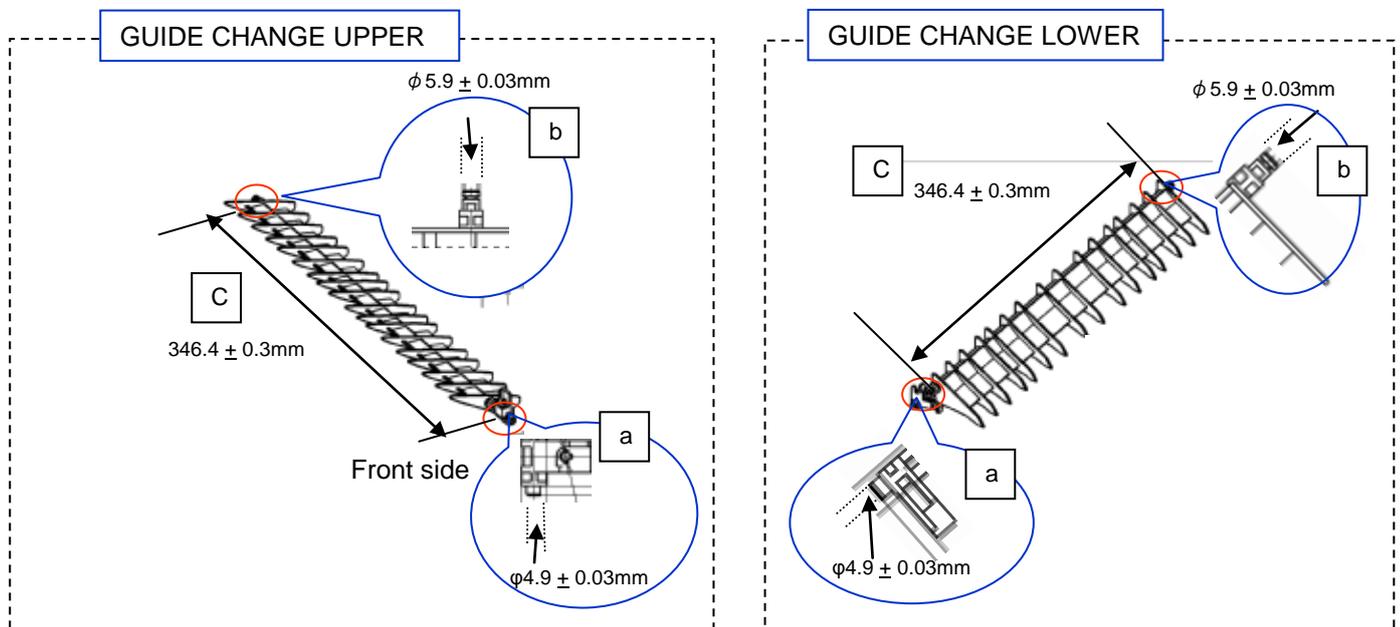
[Where changed]

The field measure was informed as per the service bulletin No. 2LC-0037 (Corrective measures for the jam due to the eject feedshift lower guide motion failure. The size of the upper and lower guide are changed as the permanent measure and the temporary measure parts of FILM for securing the gap is disused.

GUIDE CHANGE UPPER / GUIDE CHANGE LOWER : shaft diameter and length changed

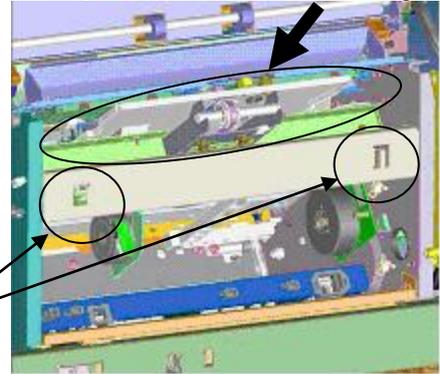
BF-730 right side surface Finishing tray

If setting the BF-730 right side surface facing down, the finishing tray contacts the floor. Therefore, bending is applied to the stay so that it contacts the floor first.

Bending is applied to the stay*

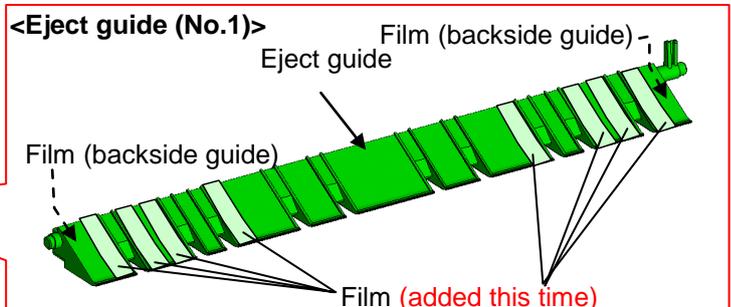
<Eject guide (No.1)>

The following is changed against the dog ear that may occur if paper curl part is caught up by the AK eject guide depending on the paper condition like downward curl when ejecting paper of low stiffness to the DF-790 tray C or DF-770 tray B.

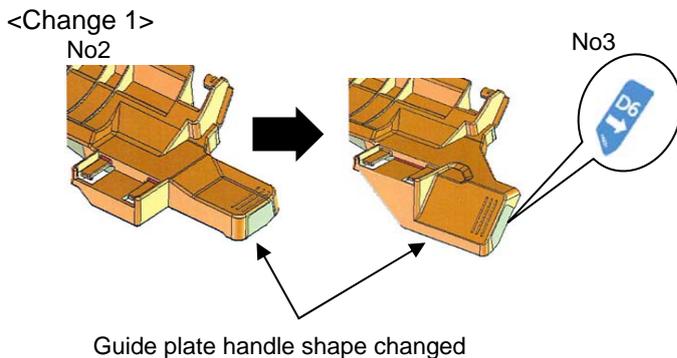
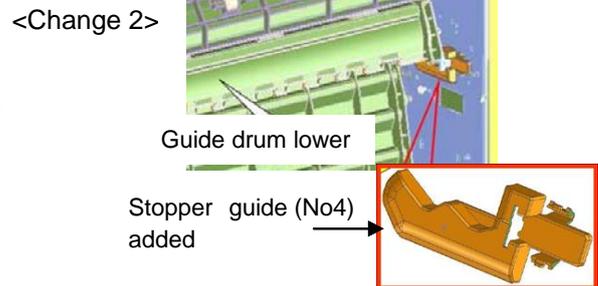
The eject guide support point may be broken if strongly closing the front cover while the eject guide (GUIDE DRUM LOWER) is open. Therefore, a stopper (Stopper Guide (No.4)) is added to the rear frame to reduce the load to the support point so that the impact to the eject guide (GUIDE DRUM LOWER) is absorbed at the rear frame. (The load to the support point is eliminated)

The new part No. is set up to supply a parts set of the countermeasure parts per the previous service bulletin No. 3NB-0010 (B378) and the countermeasure parts this time as the corrective measures for the eject guide damage.

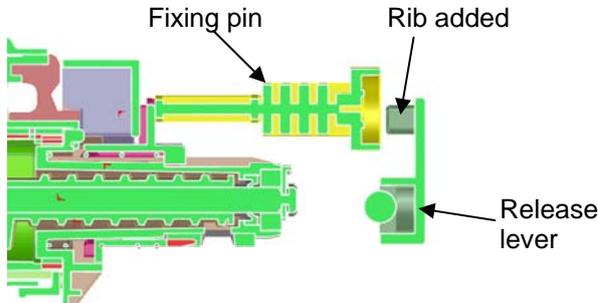
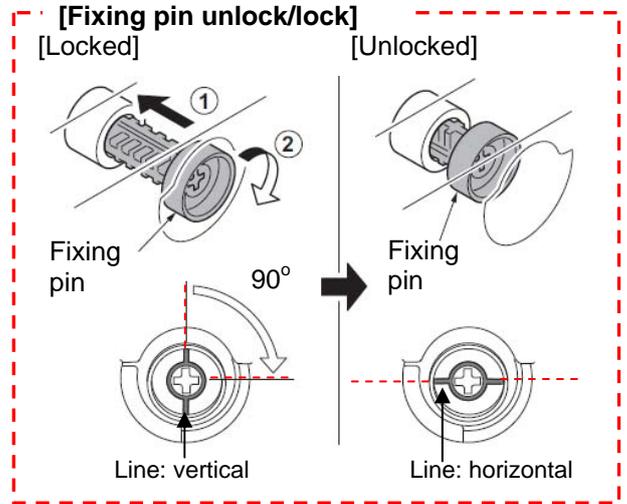
[Cross-section view]

If the fixing pin is incompletely pushed in, it may come out by vibration and it may make the lock state. Therefore, a rib is added to the release lever to prevent the pin from coming out.

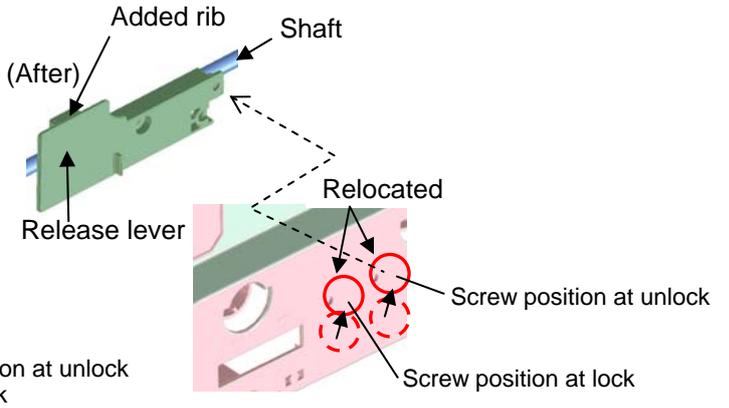
(Before)

Screw for the cover and NUT of the release lever
(Screw: M3x6 Tapping)

Screw for the cover, release lever and shaft
(Screw: M3x12 Tapping)

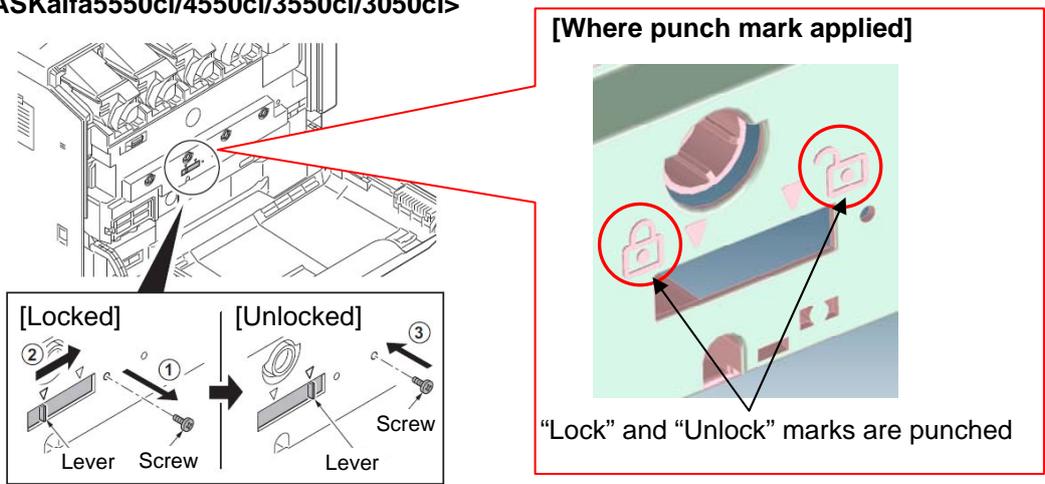
<TASKalfa5550ci/4550ci/3550ci/3050ci>

- If the developer powder waste vent shutter is not fixed enough, developer powder inside the developer unit is blocked at the waste vent to damage the developer unit.
- If the machine is transported after set-up, lock the developer powder waste vent. Otherwise, it affects image quality and cause the service call error.

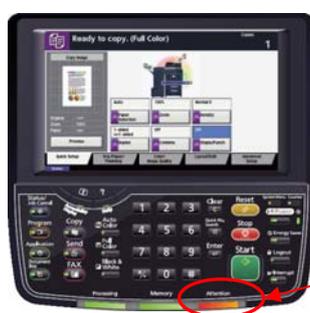
Attention lamp

The value of the R3 resistor on the LED board is changed from 160ohm to 68ohm to increase the Attention LED lamp intensity. (This is under study for the TASKalfa 7550ci/6550ci/8000i/6500i)

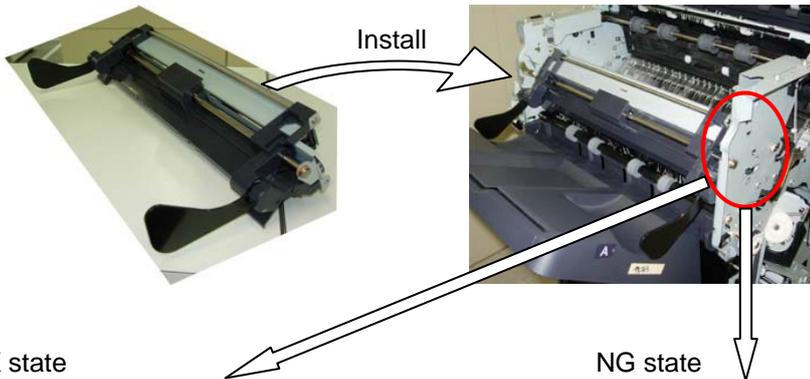
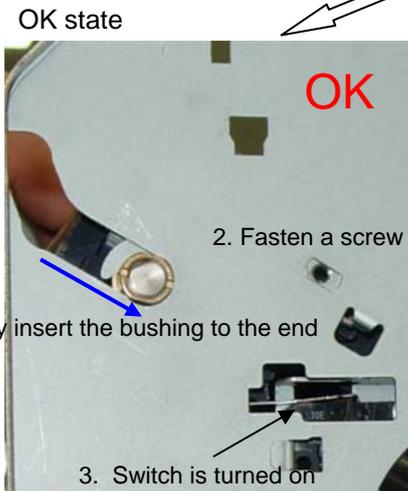
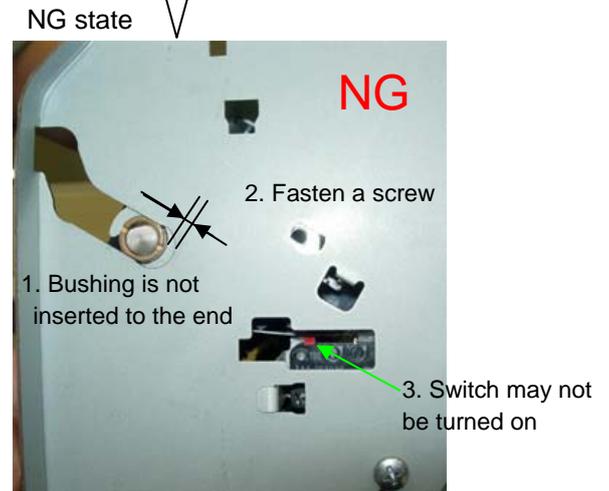
Main tray adjuster unit

The microswitch may not be turned on and the J0300 may appear in that the unit is not installed unless the bushing is deeply installed.

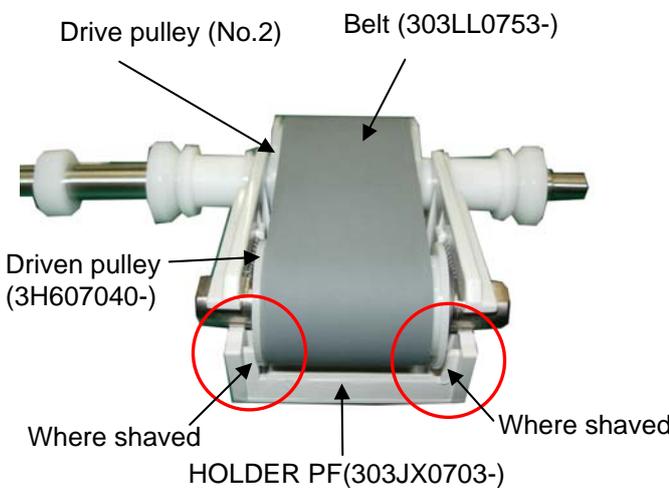
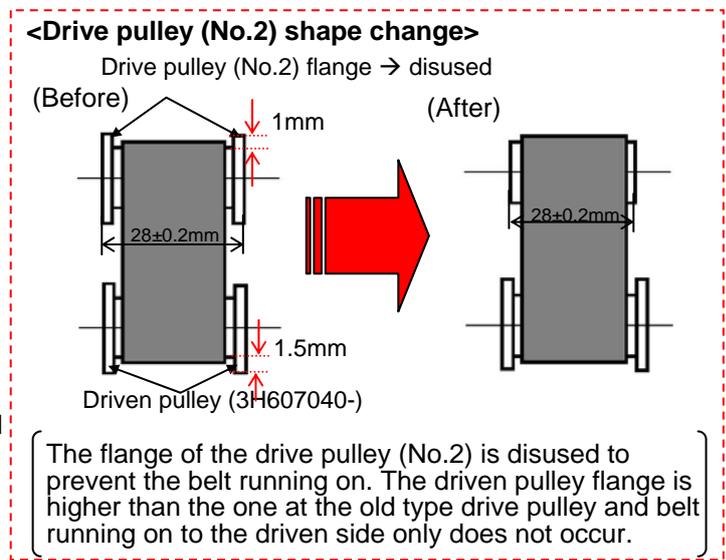
If the DP feed belt runs on to the flange at the edge of the drive pulley depending on the variation of the spring tension and parts dimension, it may further run on to the flange of the driven pulley later. Then, the belt edge may touch HOLDER PF(303JX0703-) and may be shaved to cause the J96xx jam. Therefore, the following is changed.

The shape of the drive pulley (No.2) is changed so that the belt does not run on to the flange at the edge of the drive pulley.

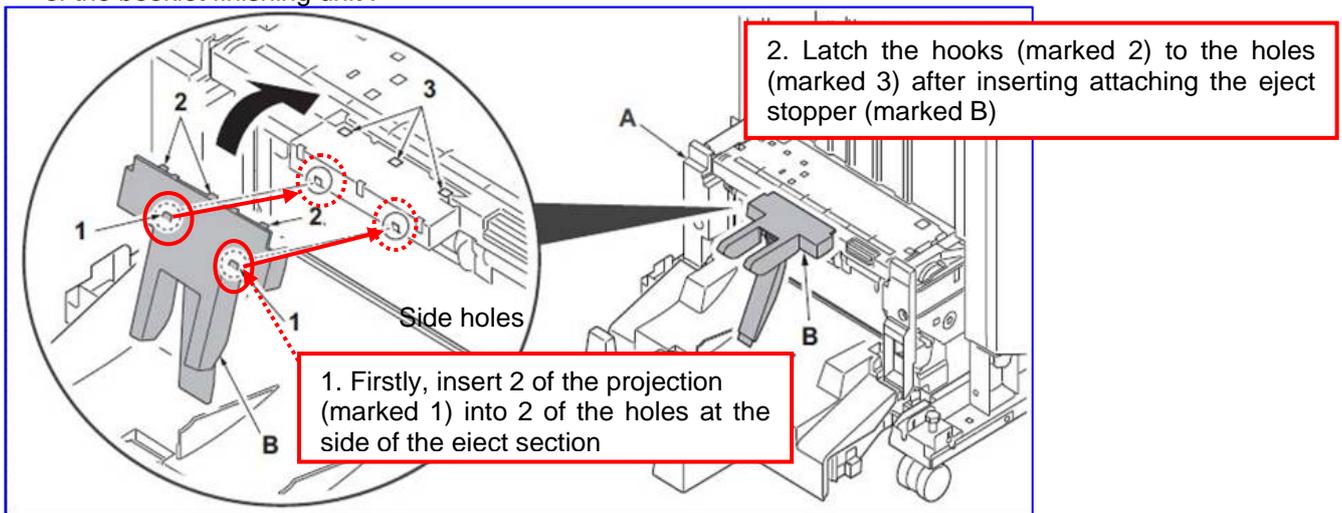
If 3 of the hooks (marked **2**) on the eject stopper (marked **B**) are inserted into 3 of the holes (marked **3**) at the top side while 2 of the projections (marked **1**) at the backside of the eject stopper **B** are not securely inserted into 2 of the holes on the side of the eject section of the booklet finishing unit (marked **A**) (for the BF-730), the hooks (marked **2**) may be broken and the eject stopper (marked **B**) may not be fixed.

Follow the procedures below when fitting the eject stopper (marked **B**) at setup of the booklet finishing unit (marked **A**) (BF-730).

1. Securely insert 2 of the projections (marked **1**) at the backside of the eject stopper (marked **B**) into 2 of the holes at the side of the eject section of the booklet finishing unit (marked **A**).
2. Latch the 3 of the hooks (marked **2**) on the eject stopper (marked **B**) to 3 of the holes (marked **3**) at the top side of the booklet finishing unit .

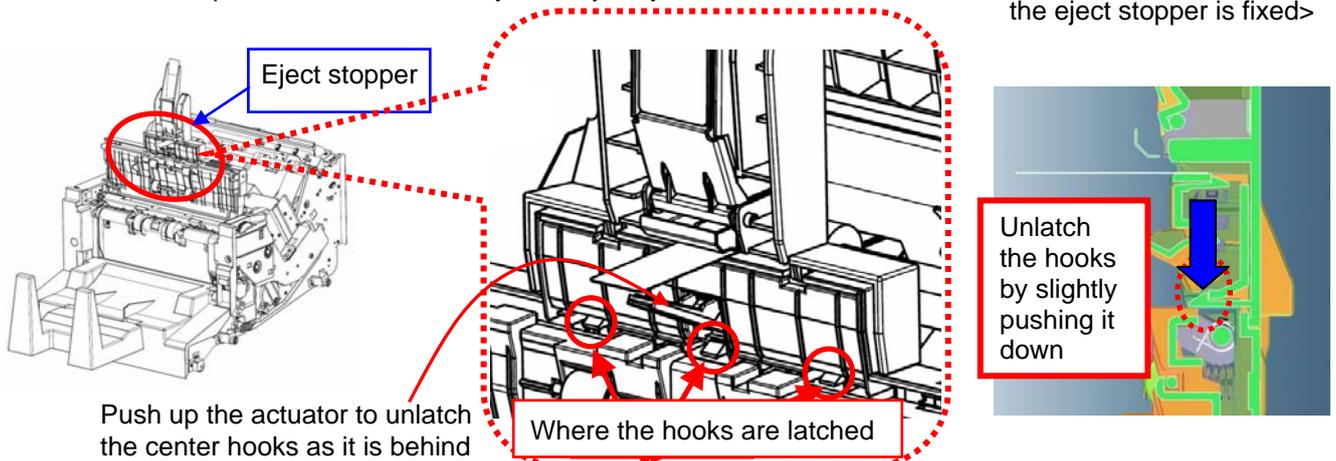
<Cross-section view for where the eject stopper is fixed>

The eject stopper (marked **B**) is fixed with latch of 3 of the hooks (marked **2**). Push down the hooks slightly to the direction of the blue arrow to detach the eject stopper.

*Take care not to push the hooks intensely or they may be broken.

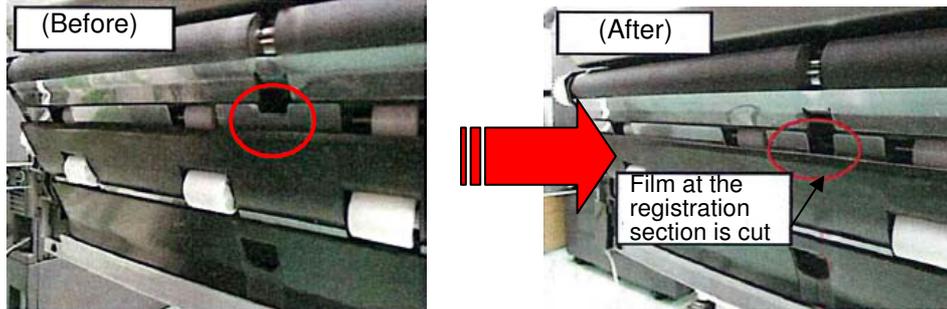
The shape of the film at the registration section is changed to improve the margin for the registration sensor detection.

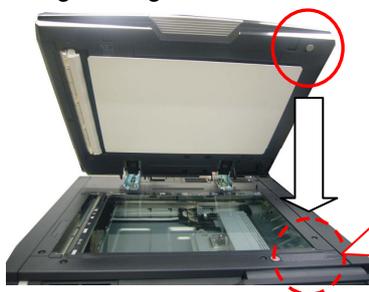
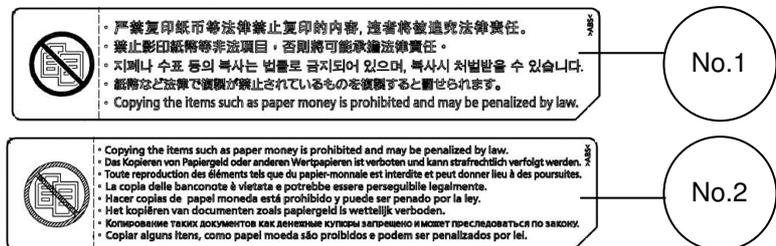
[Label affixed to ISU]

The material finish of the label affixed to the ISU is changed from lamination to texture to avoid scratches when opening/closing the DP.

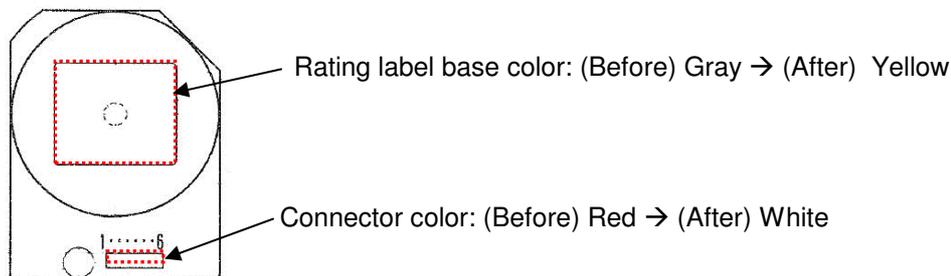
[PARTS MOTOR-ML W30 SP(No.1)]

The developing motor (No.1) rating is changed to 40W to 30W for parts procurement ease.

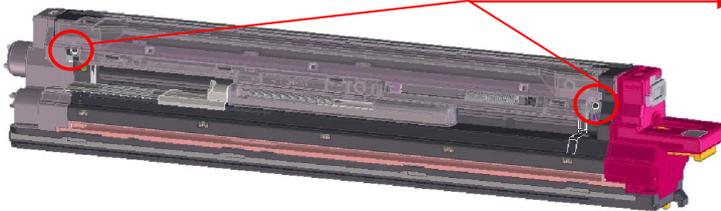
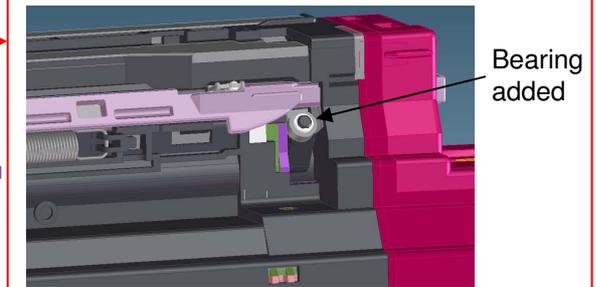
A bearing is added to the developer unit lever to reduce the developer unit lever push-in load.

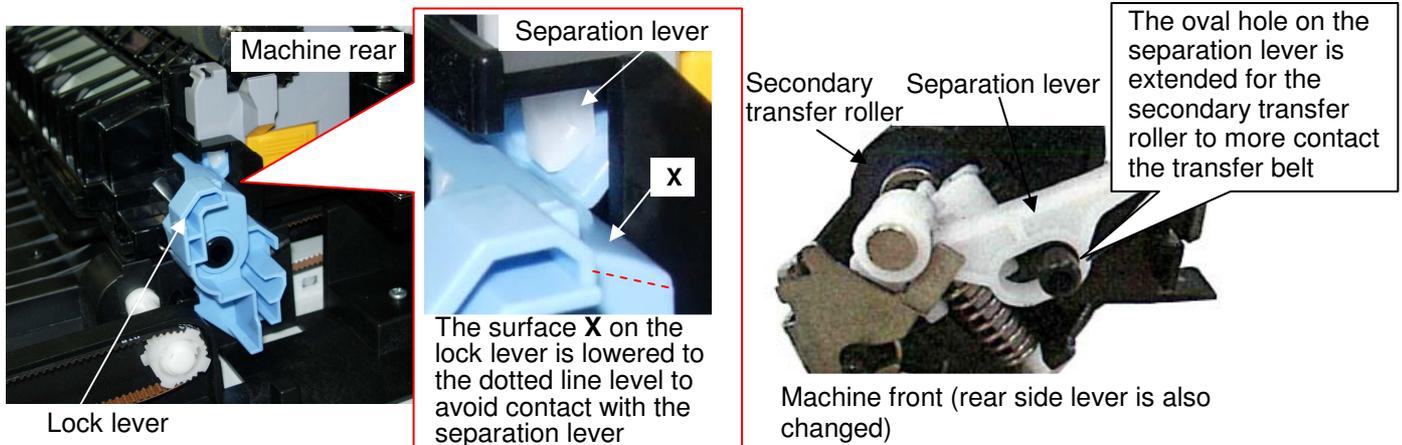
- 1) The shape of the lock lever is changed to avoid contact between the conveying unit lock lever and the secondary transfer separation lever when opening/closing the right cover.
- 2) The shape of the oval hole is changed to improve the margin for contact between the secondary transfer roller and the transfer belt.

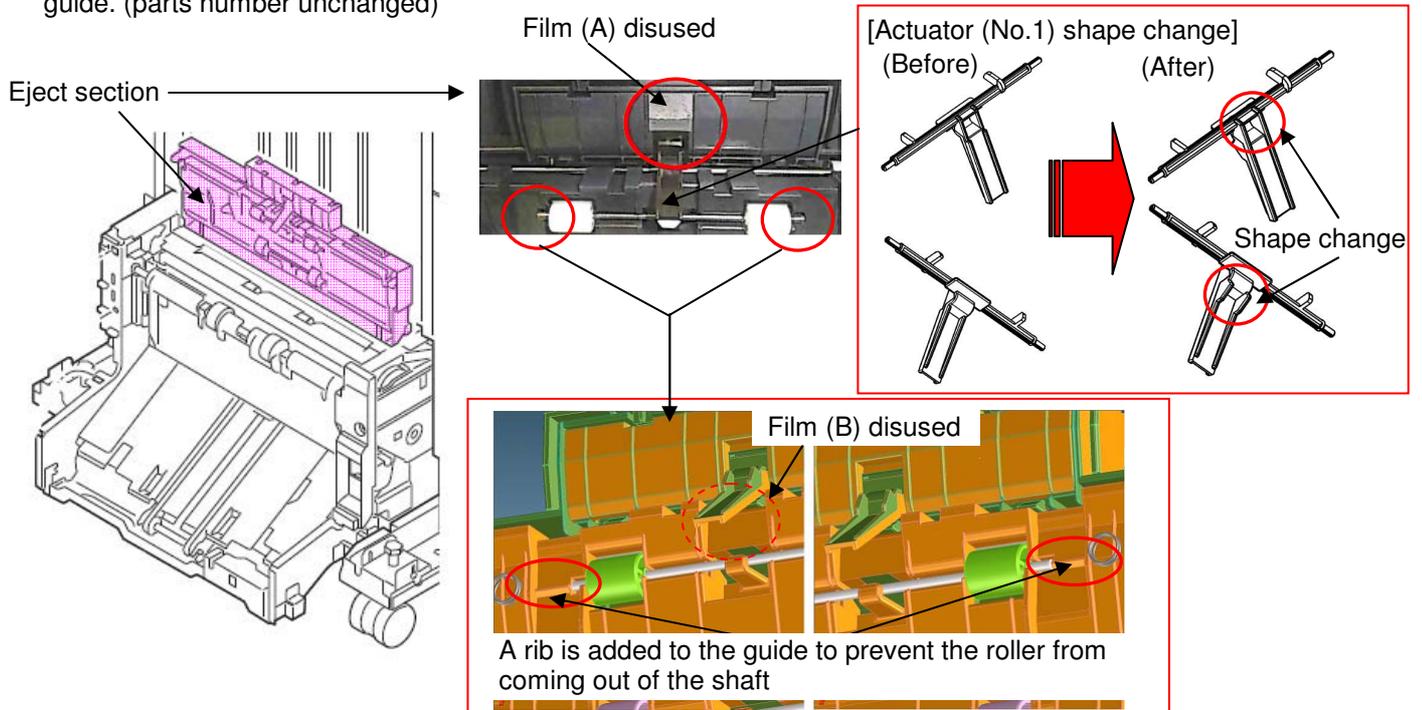
- 1) The film (A) that is affixed to limit the actuator angle is disused and the shape of the actuator (No.1) is changed.
- 2) The film (B) that is affixed to prevent the eject roller from coming out of the shaft and a rib is added to the guide. (parts number unchanged)

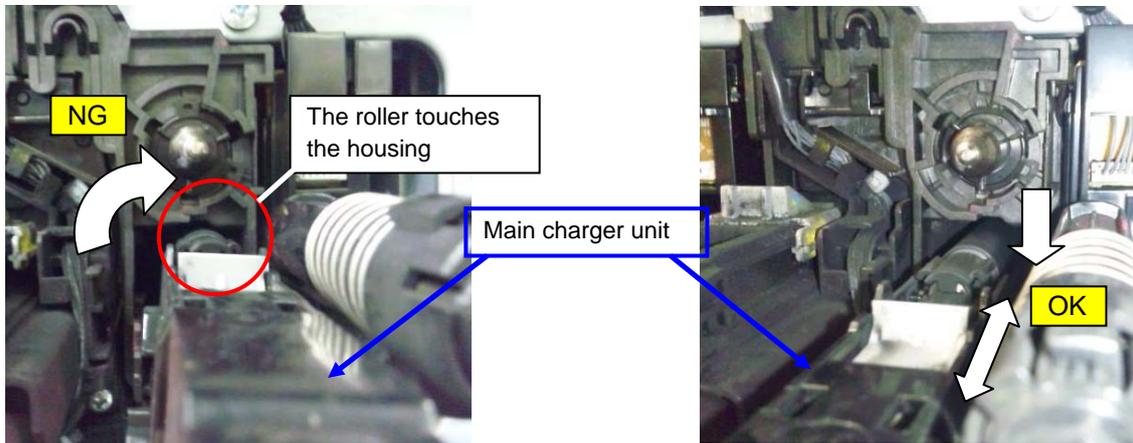
Do not lift up the main charge roller but pull it along the rail under the drum unit housing when detaching it.

When lifting up the main charge roller or tilt it toward the arrow as in the photo upper left, the main charge roller surface touches the drum unit housing and it is scratched and the drum surface potential comes to uneven to cause the uneven image in the 38mm main charge roller pitch.

Rib are added to the frame of the drum unit (No1 to 6) in order to prevent the backlash when detaching/attaching the MC roller unit.

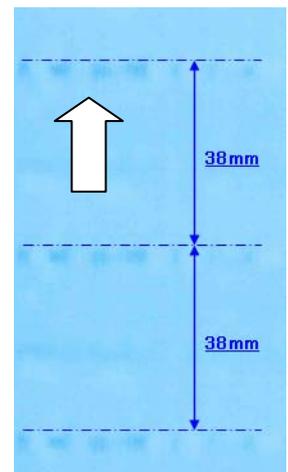
An uneven image appears in the main charge roller pitch of 38mm (Refer to the photo right) The density of the unevenness is dependent on the size and depth of the asperity

Replace with the main charger roller from other color drum to isolate the main charge roller factor when an uneven image in the 38mm interval appears.

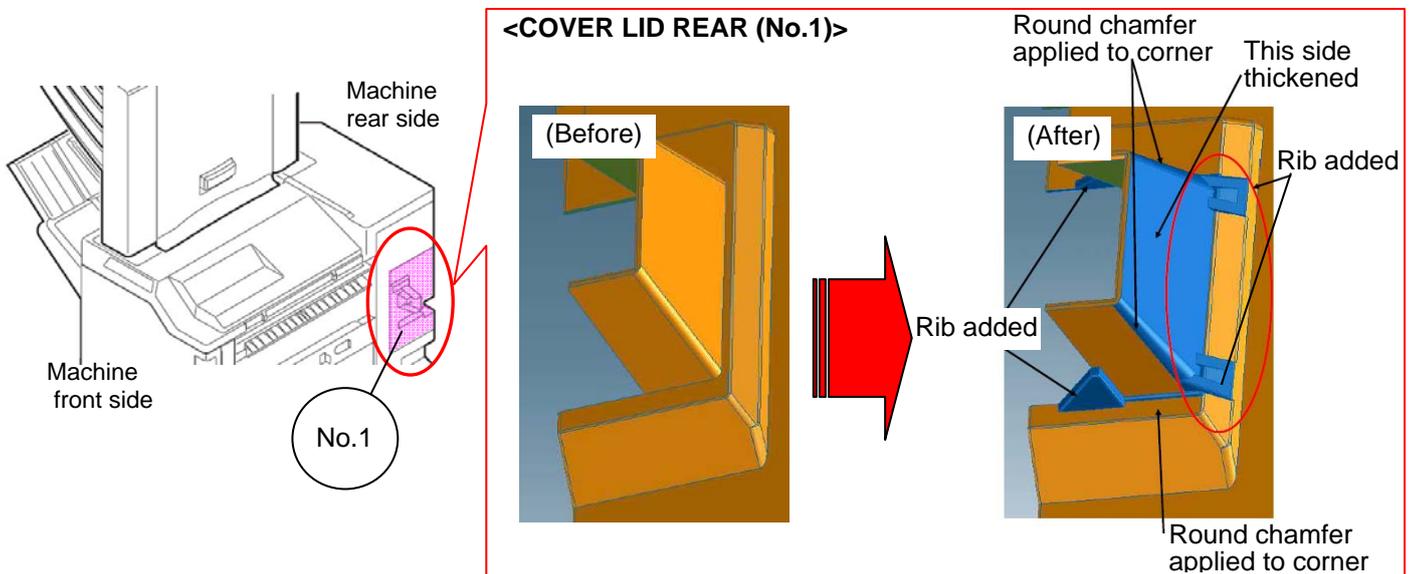
COVER LID REAR(No.1) at the rear side of the machine may be broken at an extreme shake and impact in transit. Therefore, the following are changed

The shape of COVER LID REAR(No.1) is changed for strengthening it.

KMC's Classification	<input type="checkbox"/> Entire Stock Rework	<input type="checkbox"/> In-Field modification at next visit
	<input checked="" type="checkbox"/> In-Field modification by case	<input type="checkbox"/> No modification necessary
Field Measure: Please replace with the new type part (No.1) if COVER LID REAR (No.1) is broken.		
Serial Nos. of Affected Machine: Planned from December 2011 production*		
*The above is the plan at the present moment. Please note that there is a possibility of change after giving this information.

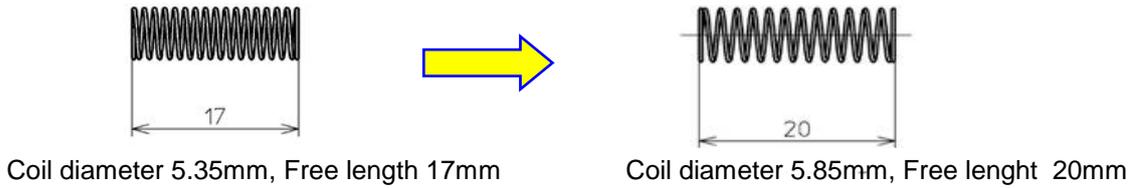
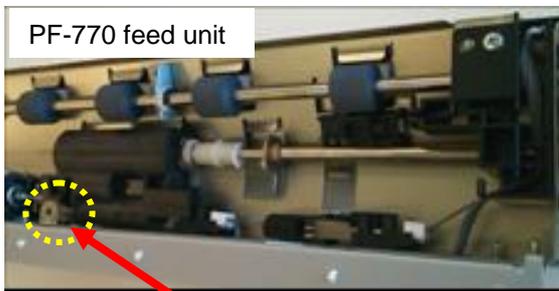
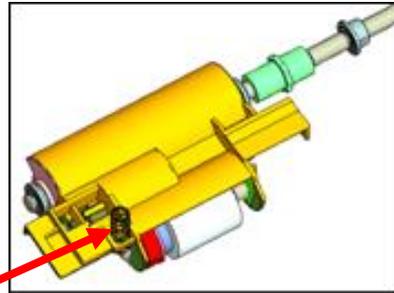
1. Insufficient conveying force of the pick-up roller
2. Insufficient projection of the Mylar sheet before the paper feed nip (too much gap with the feed roller)
3. Failure in the retard roller's positive rotation

The drive parts may touch the lower feed frame when the retard roller is driven depending on insert of the spring pin at the joint section, use at low temperature, wear of the feed and retard roller.

1. The spring tension for the pick-up roller increased: SPRING PICK UP 0.3N → 0.6N (No.2)
 (Before) Spring Pick Up Silver Tension 0.3N (After) Spring Pick Up Black Tension 0.6N

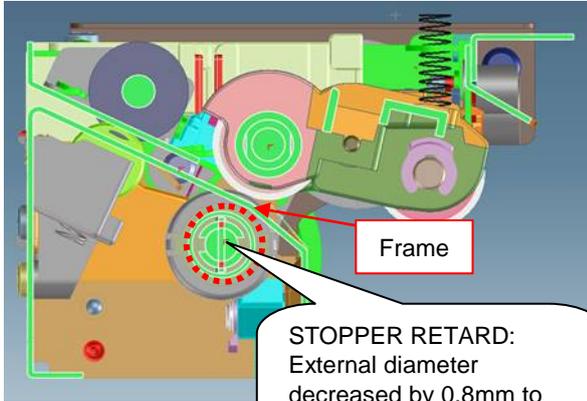
3. The shapes of the following 2 items are changed to prevent the drive parts from touching the lower feed frame
- 1) The external diameter of Stopper Retard is changed: 13.6 → 12.0mm diameter (thinned by 0.8mm)

STOPPER RETARD:
External diameter decreased by 0.8mm to prevent frame from touching after prolong use

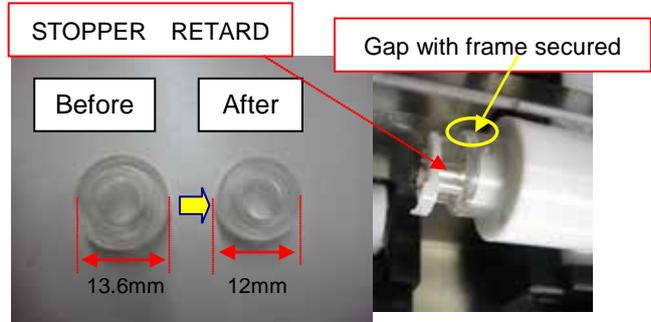
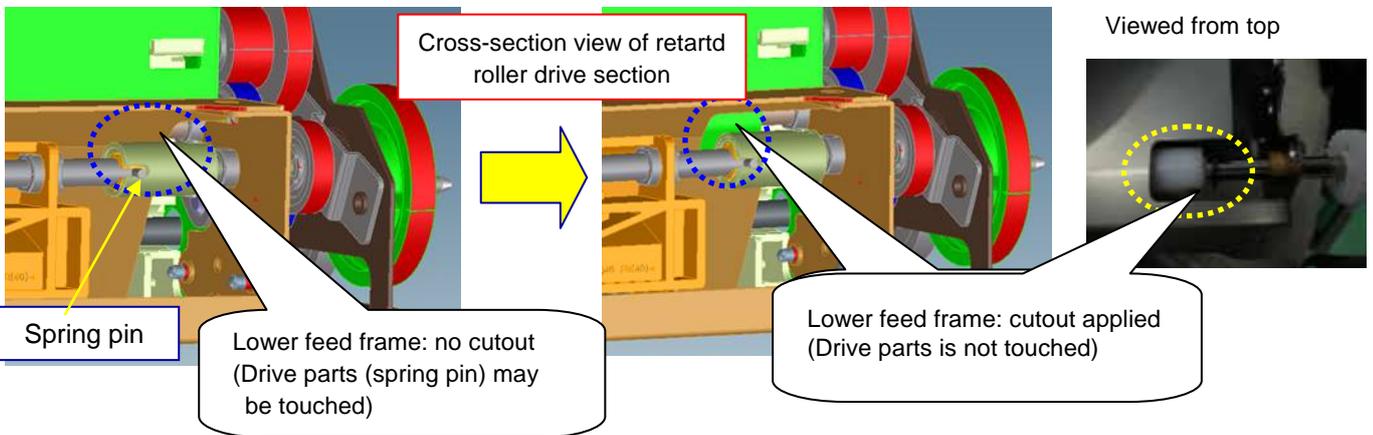
- 2) The shape of the lower feed frame is changed: Cutout is applied to the drive parts that may touch the neighboring frame

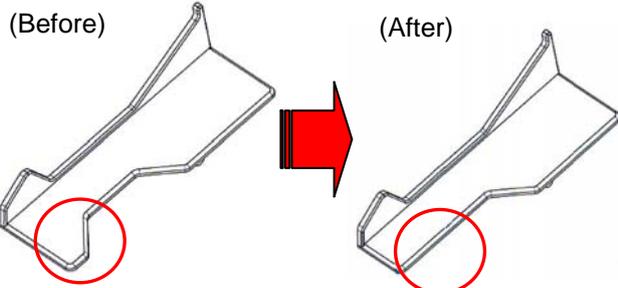
<CURSOR R MIDDLE TRAY (-->) (No.2)>

Paper may be caught by the finishing side cursor and the J6xxx jam (*1) may occur depending on the condition of the paper such as skew, downward curl and dog ear. Therefore, the following are changed.
 (Affected model on the phenomenon: TASKalfa5500i/4500i/3500i)

- 1) A part of the cursor where the paper is caught is cut.
- 2) The cursor not for field supply is set up for the service parts after the above change.

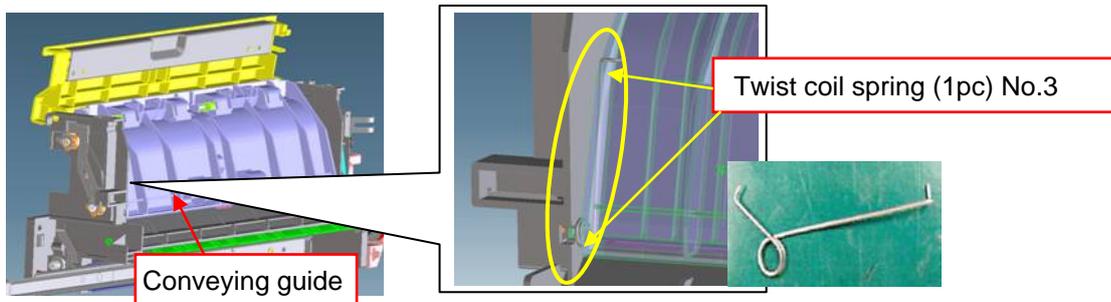
The twist coil spring (No.3) is added to the support point so that the conveying guide does not come off when opening the upper cover and it is usually closed.

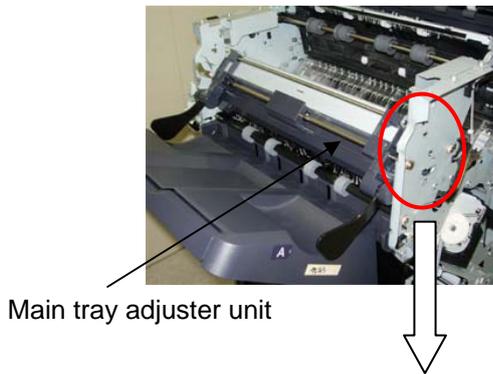
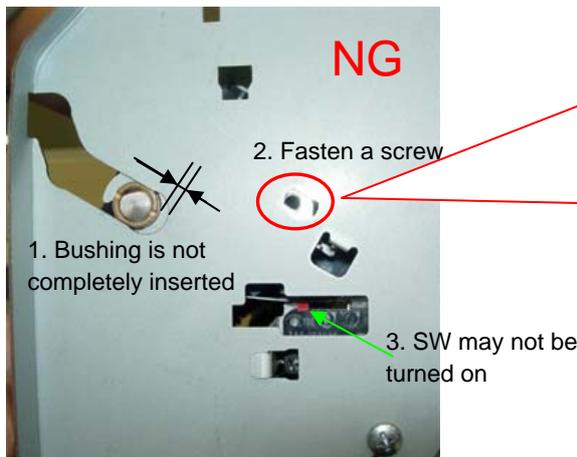
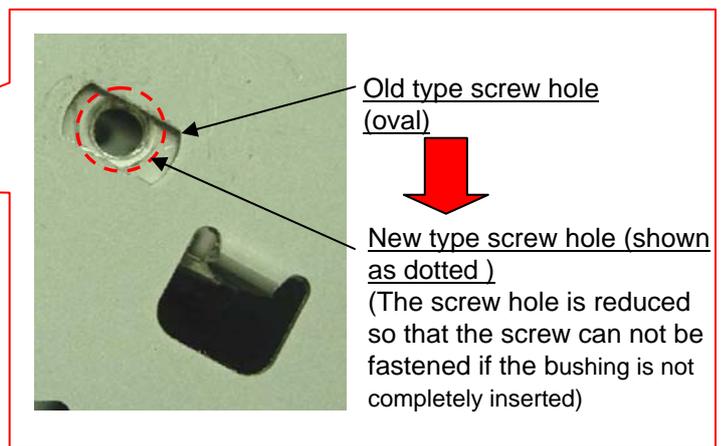
The shape of the screw hole is changed so that the screw can not be fastened unless the main tray adjuster section is securely installed.

KMC's Classification	<input type="checkbox"/> Entire Stock Rework	<input type="checkbox"/> In-Field modification at next visit
	<input checked="" type="checkbox"/> In-Field modification by case	<input type="checkbox"/> No modification necessary
Field Measure: Please securely insert the bushing all the way and fasten the screw when installing the main tray adjuster.		
Serial Nos. of Affected Machine: After using up the old stock

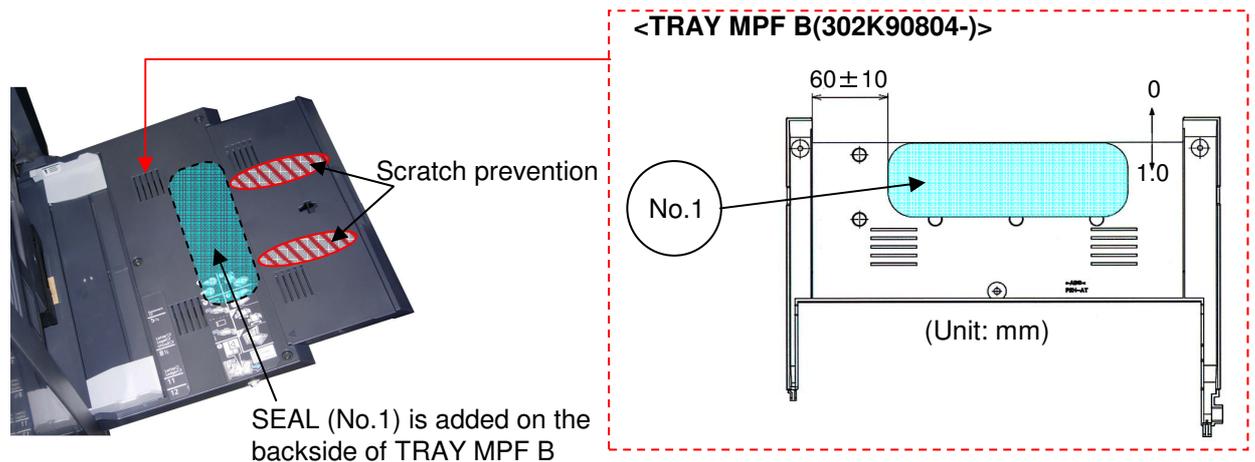
The seal (No.1) is added as below to prevent scratches when withdrawing the MPF sub tray.
