Service Bulletin

Ref. No. **COM-0218 (B056)**

Subject	Note when releasing the paper jam/maintaining the machine (Prohibition of use of the flammable sprays and liquids)
Model	All models

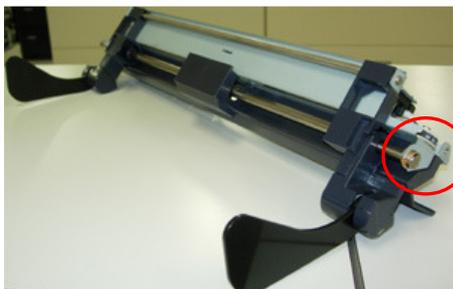
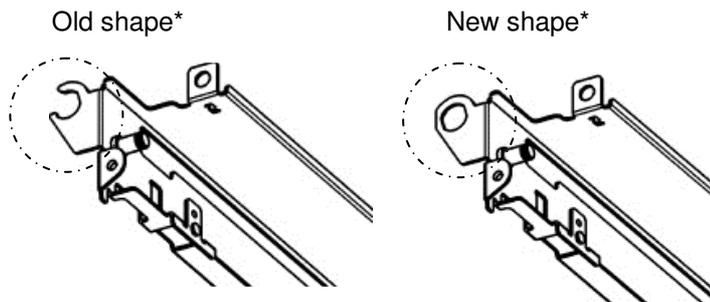
The shape of the hole is changed to strengthen the part on the main tray adjuster to fit the bushing.

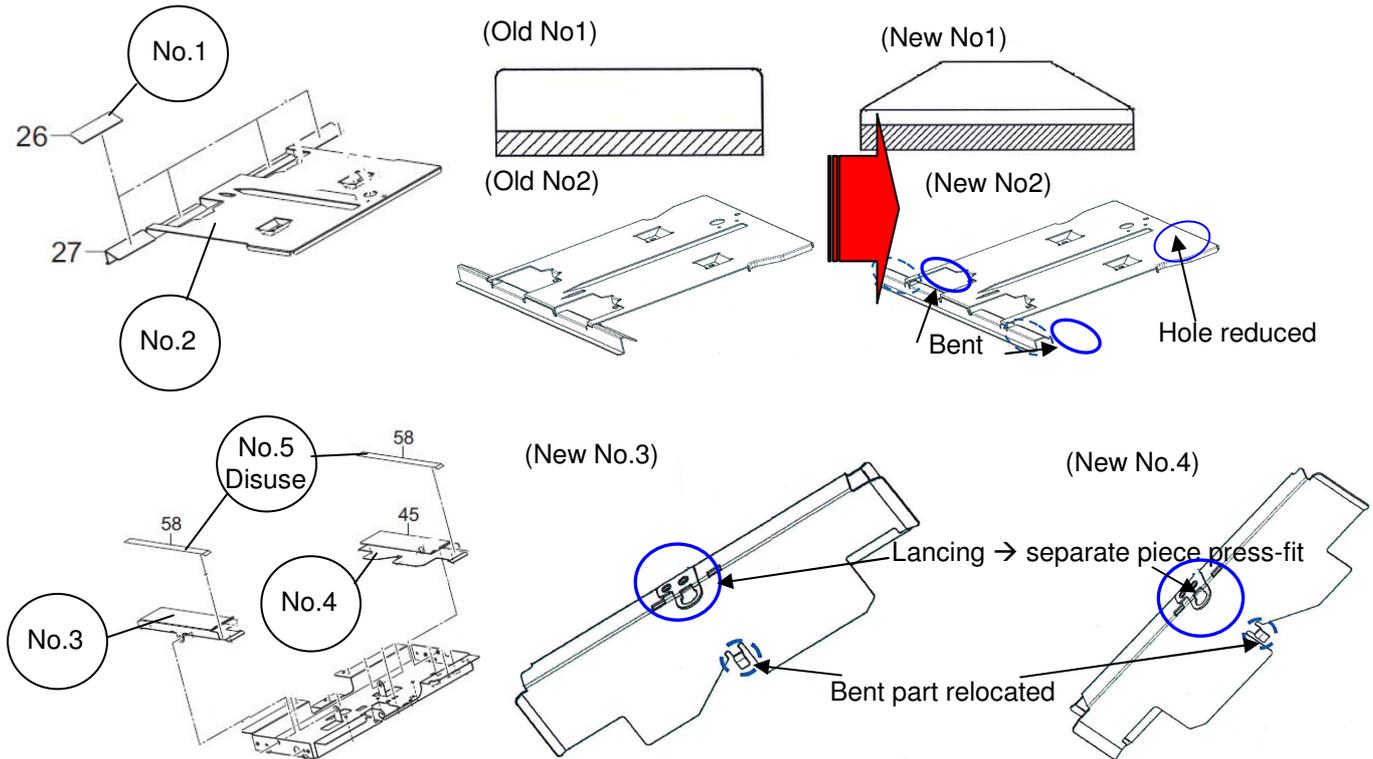
The shape of (No.1,2) is changed to prevent paper from being caught up.
 The shape of CURSOR FW FRONT/REAR(No.3,4) is changed and the sheet (No.5) is disused for assembly process improvement.

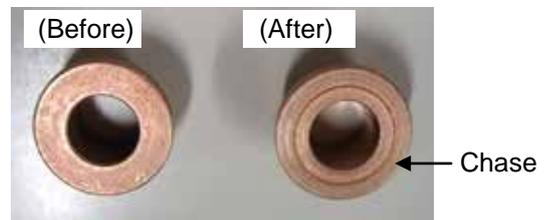
[Distinction of the old and new bushing]

If the bushing at the AK (bridge) eject section is shaved and the shaved debris get into the gap between the bushing and shaft, the load torque increases when driven and the shaft may fail to rotate to cause the Jam (*1) . Therefore, the following are changed.

- 1) The bushing is changed to one with newly conditioned oil smoother.
- 2) The bushing is set up for the service parts that used to be one not for field supply after this change.

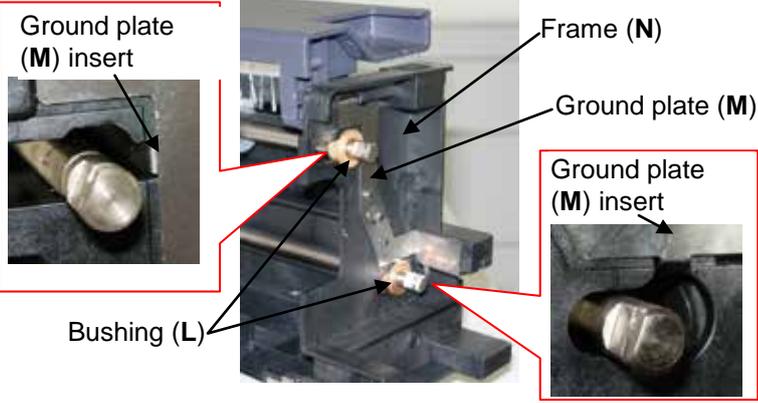
<p>Ground plate (M) insert</p> <p>Frame (N)</p> <p>Ground plate (M)</p> <p>Bushing (L)</p> <p>Ground plate (M) insert</p>

<p>Pulley (J)</p> <p>Ring stopper (I)</p> <p>Belt (K)</p> <p>Machine front side</p>
7	<p>Remove 2 of the bushings (L) and replace with the new bushings (No1)</p> <p>*The ground plate (M) is inserted in between the bushing (L) and frame (N). Take care not to deform it when removing and installing the bushing</p> <p>*If the roller is scratched, remove 3 of the bushings (L) and replace the roller. Then, install 3 each of the new bushings (No1) at the front and rear side of the machine</p>

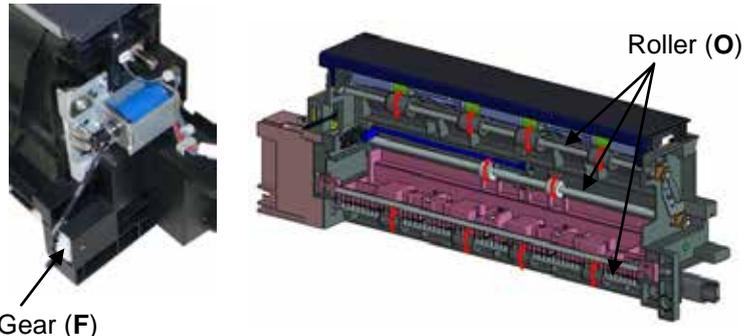
<p>Gear (F)</p> <p>Roller (O)</p>

8	<p>Reset the parts in the reverse manner of the above procedures.</p> <p>Confirm 3 of the rollers (O) rotate when manually rotating the gear (F) at the rear side of the machine.</p>

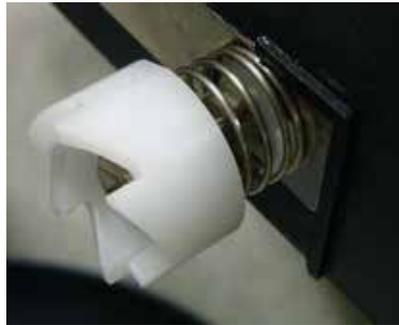
(OK)

Stop ring held in the spring inner diameter

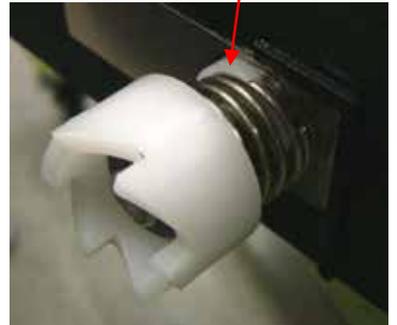
(NG)

Note) The abnormal sound may be heard from the conveying unit with the change to the bearing if the stop ring convex in the machine center is caught up by the spring.
Refer to the page 9 for treatment when the above phenomenon arises.

Stop ring convex

Stop ring convex caught up in between spring wires

Change the stop ring to the cut washer (No1) when the above phenomenon arises.

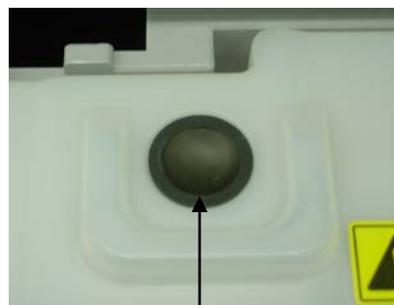
The rubber piece for the waste toner tank near-end detection may come off and the toner may leak. The following measures (change of the work with the tool, addition of the double-sided tape) have been implemented to prevent, however, please check the following for the machine before using the tool.

(*1) Slightly push the end of the rubber piece for the waste toner tank near-end detection by finger to check it not coming off or peeling off. If coming off or peeling off is found, replace with the waste toner tank that is the latest measured parts (Product*: Lot No.252R057 and after).

Slightly push the end of the rubber piece for the waste toner tank near-end detection by finger to check it not coming off or peeling off.

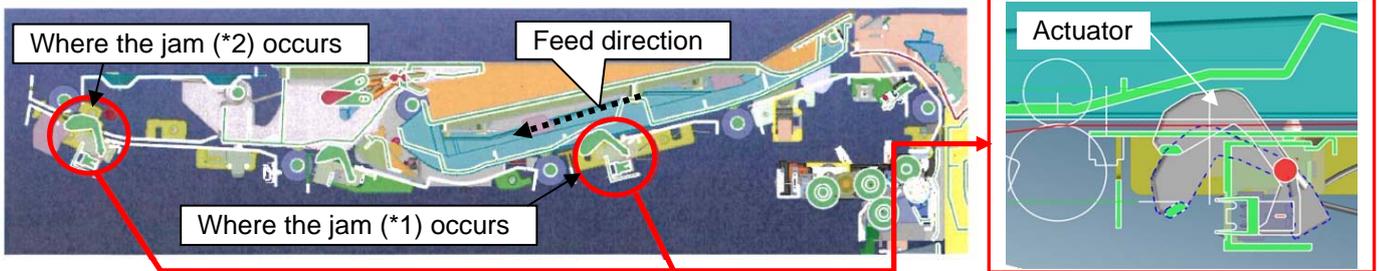
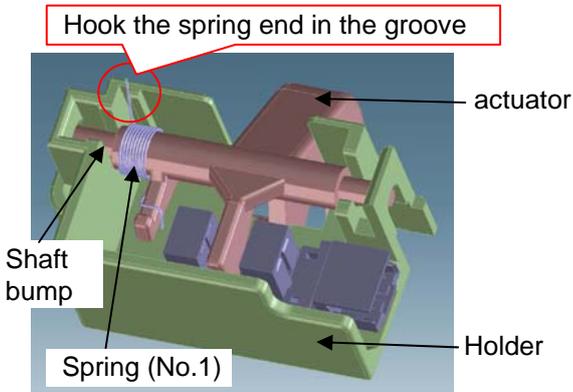
The spring is changed to prevent it from falling in the shaft bump and for the actuator to return faster.

- Spring width (Before) 4mm → (After) 3.3mm
- Coil inner diameter (Before) 6.54mm → (After) 5.6mm
- Spring tension (Before) 0.5N·mm → (After) 1.14±0.11N·mm

The old type spring falls in the actuator shaft bump. Then, there is no thrust backlash in the shaft and the spring tension is weak.

The actuator may return slowly.

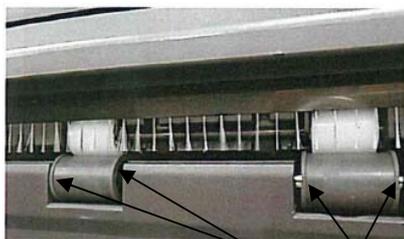
(Before)

The shape of the eject pulley is changed to the one without flange to reduce the marks of the AK (bridge) pulleys. The material of the pulley is changed from EPDM to Silicon rubber as the lateral spread from other rollers to prevent the swelling by toner.

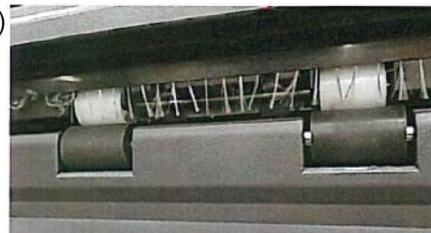
(After)

Flange disused

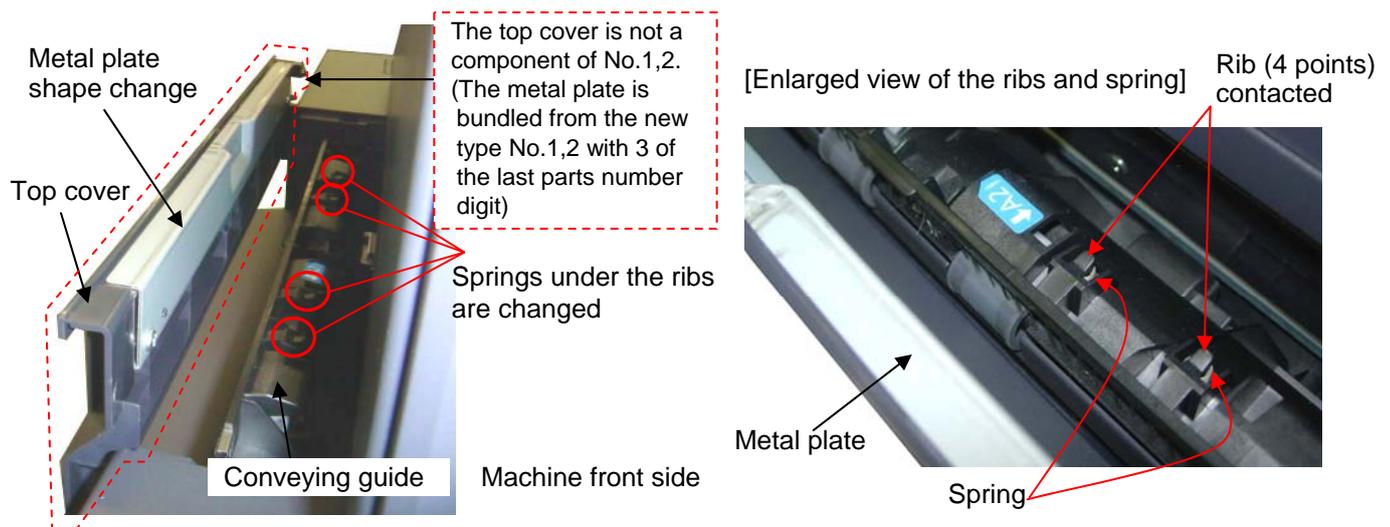
If the AK eject unit top cover is strongly closed, the metal plate on the interior side of the top cover contacts the ribs on the conveying guide and the ribs may be broken. Therefore, the following are changed.

- 1) Cutouts are applied to the metal plate on the interior side of the top cover to prevent the contact of the ribs on the conveying guide ---No.3
- 2) The tension for the springs (4 points) on the conveying guide is changed after the above change 1) since the pressing force to the top cover changes---No.4
- 3) The metal plate (No.3) and spring (No.4) are set up for the service parts that used to be not for field supply after the above changes 1) and 2)

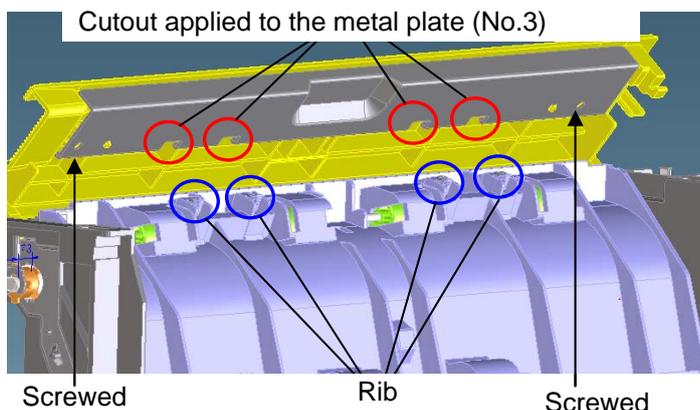
[Spring (No.4) change]

Before	After
Specified length	6.0mm	8.0mm
Free length	9.9mm	10.8mm
Load at specified length	2.0N	1.42N
Material	SUS304WPB	SWP-B
Color	Silver	Black

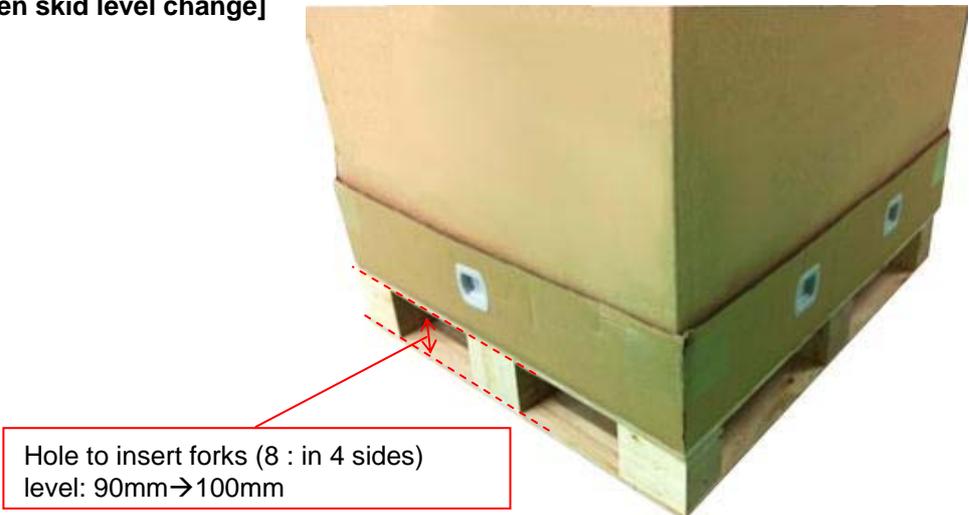
[Wooden skid level change]

The level of the holes on the wooden skid is changed from 90mm to 100mm for ease of inserting a fork of the hand pallet trucks. After this change, the slope level is changed from 90mm to 96.5mm.

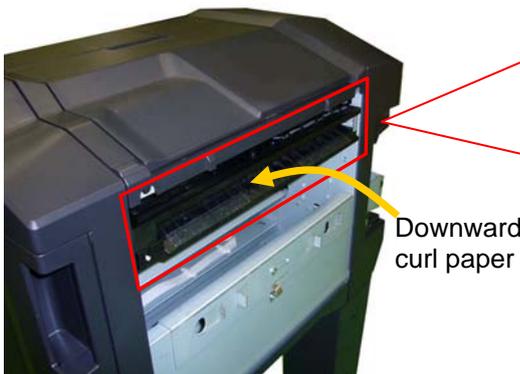
When the paper enters into the DF, the paper leading edge may be caught up by the ribs on the lower conveying guide depending on the paper condition like downward curl and the dog ear or the J610x/J611x jam may appear. Therefore, the following is changed.

The shape of the lower conveying guide (No.1) is changed and 2 pcs. of films are added to prevent the paper leading edge from being caught up.

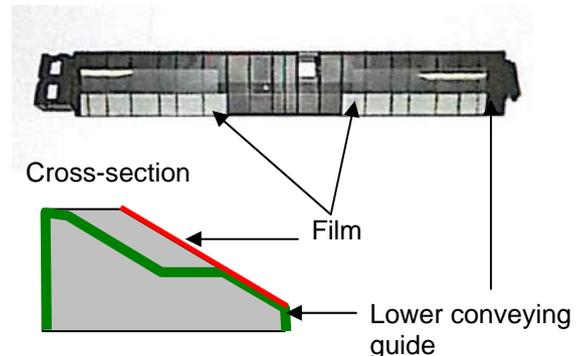
<New type Lower conveying guide (No.1)>

*1: The new type guide is supplied with 2 pcs. of the films affixed.

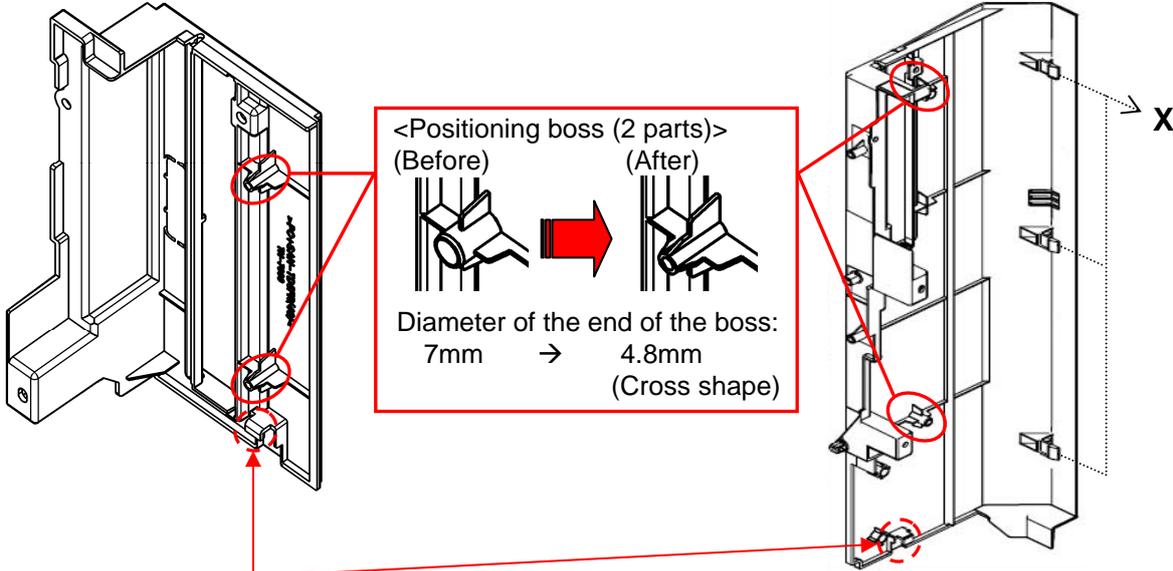
The label (No.1) is changed for common use of parts.

Hooks: Changing the margin to hang from 2.5mm to 1.0mm.

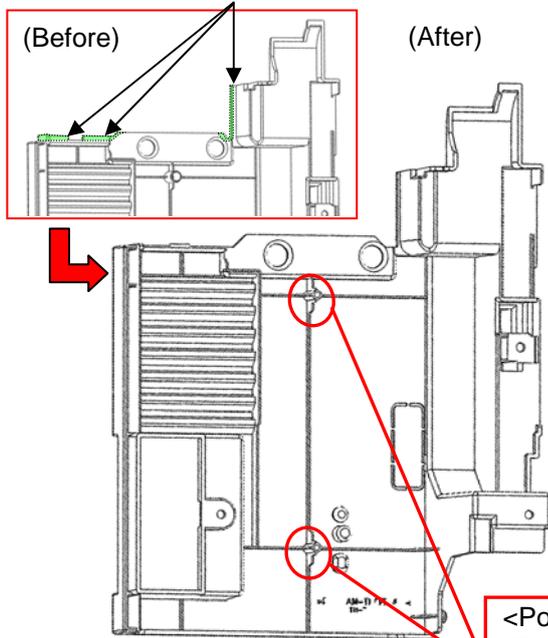
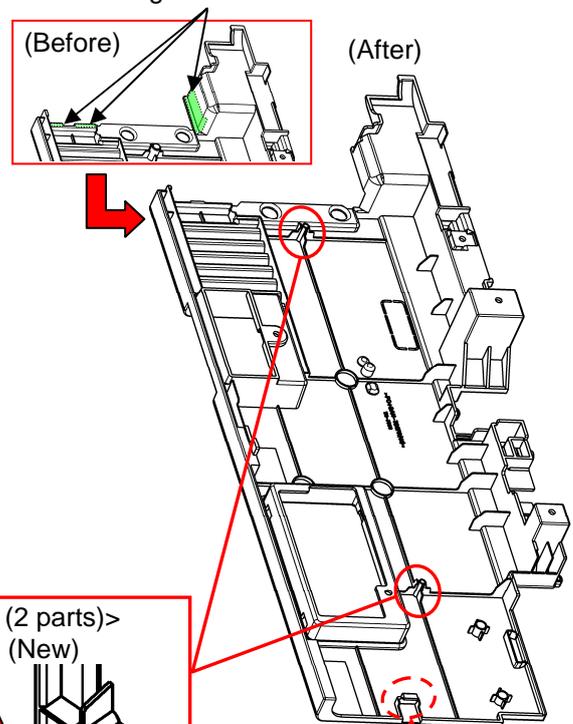
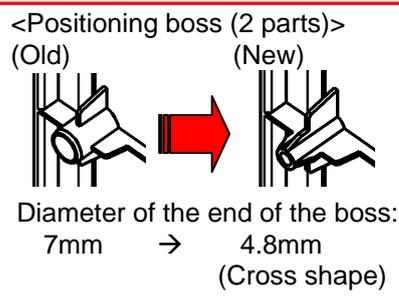
Cutting the overlap part with the right middle rear cover

Hook: Shortening the margin to hang the cut-out from 2.5mm to 1.0mm.

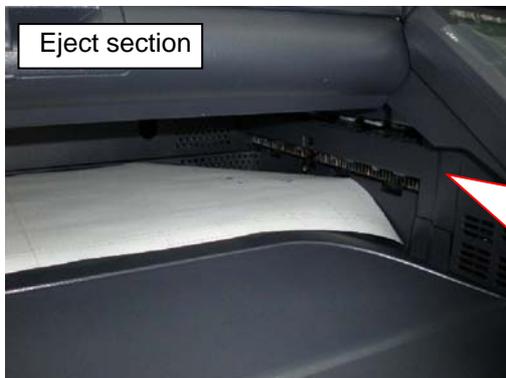
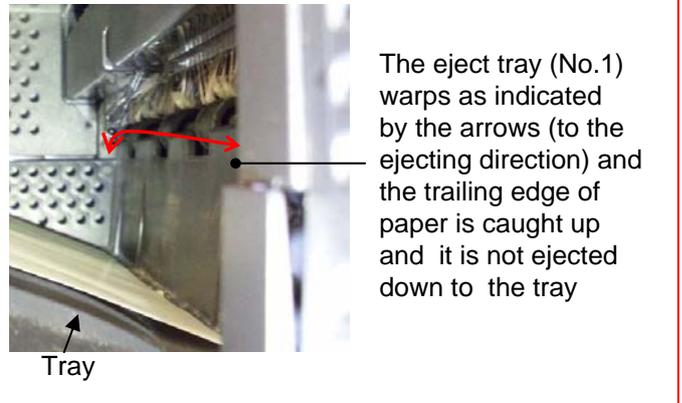
<Eject tray(No.1)>

The trailing edge of paper may be caught up at the warped part of the eject tray when it is ejected depending on paper type(*) if the eject tray (No1) is warped due to dimensional variation. Then, it may not be properly ejected to the eject tray to cause paper stock failure or paper full at early stage with the paper full sensor kept being activated. Therefore, the following are changed.

- 1) Molding condition of the eject tray (No.1) is change to limit the warp currently being 2mm to 1mm or less.
(This is equivalent to the new type parts (No.1) and white marking is applied to this. See the next page for detail)
- 2) The warp of the eject tray (No.1) is regulated.

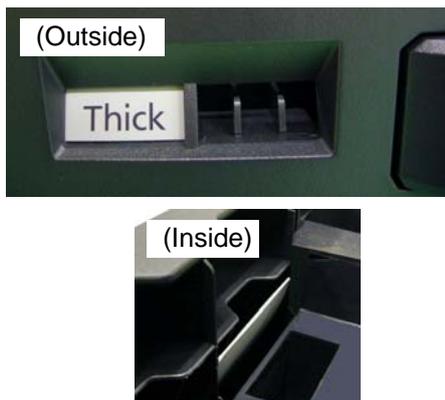
[Normal]

The paper size plate and media type plate of 2-fold type for the cassette may rise up at impact when loading and unloading the cassette. The plate is changed to 1 piece type that is separated from the 2-fold type. A positioning rib is added to the cassette cover to prevent the plate from being tilted after the change.

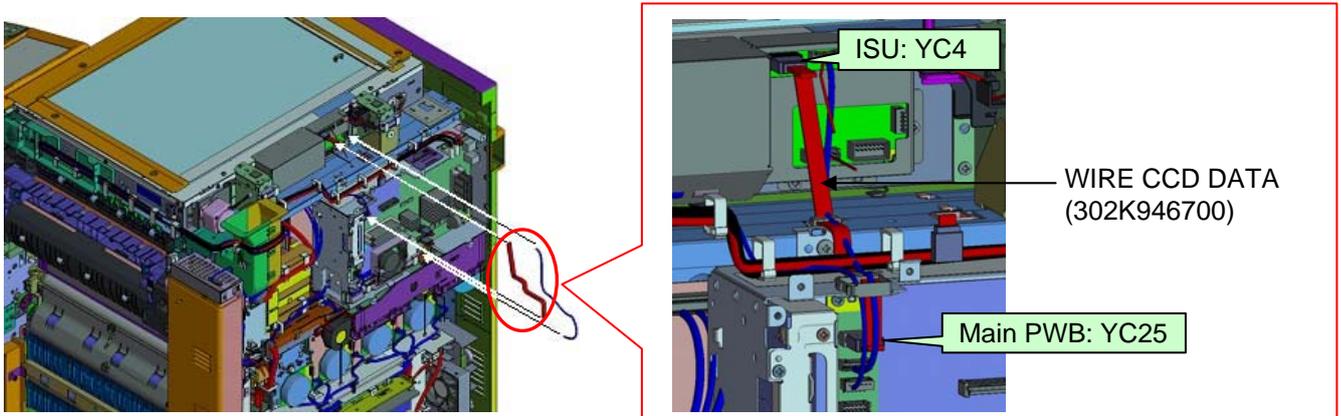
(1) Where to install WIRE CCD DATA(302K946700)

The SATA cable (No.1 to 3) may have contact failure or may be broken if the service call error below appears. Perform the corrective action below when it arises.

- 1) Check and perform the corrective action for each checkpoint as described in the service manual.
- 2) If the service call error still appears after the above action, the SATA cable may be broken and replace the applicable cable.

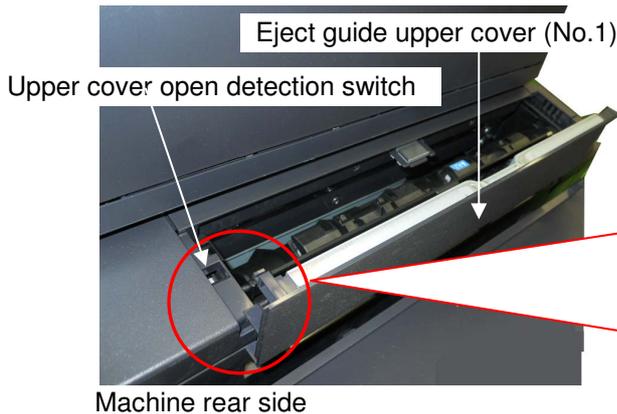
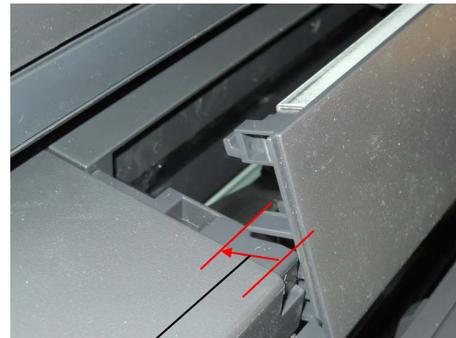
The shape of the upper cover (No.1) is changed as below to improve the switch sensing margin when opening/closing the AK eject unit upper cover.

Rib to push the switch on the eject guide upper cover (No.1) extended by 1mm

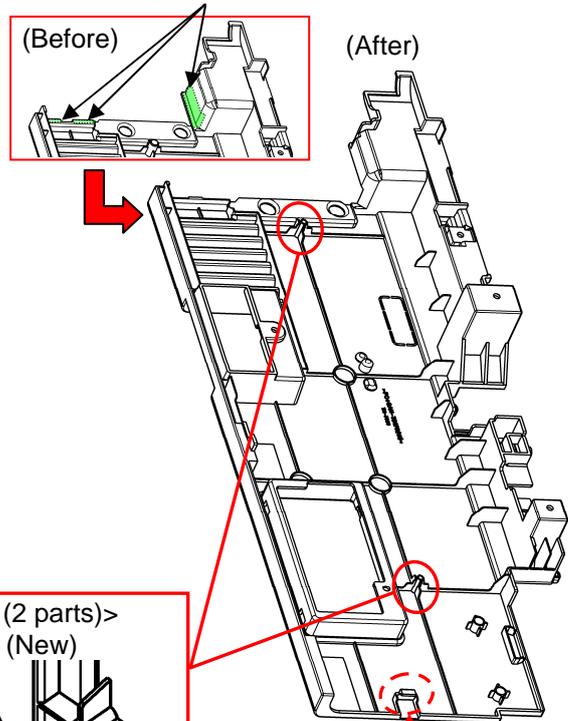
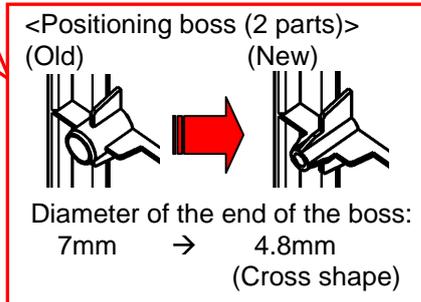
TASKalfa5550ci, TASKalfa4550ci, TASKalfa3550ci, TASKalfa3050ci

No.	Old Part No.	New Part No.	Description	Q'ty		Compati bility		Remarks
				Old	New	Old	New	
1	302LC93100 2LC93100	302LC93101 2LC93101	TR-8505	1	1	○	○

*Please use the new parts for the new development models.

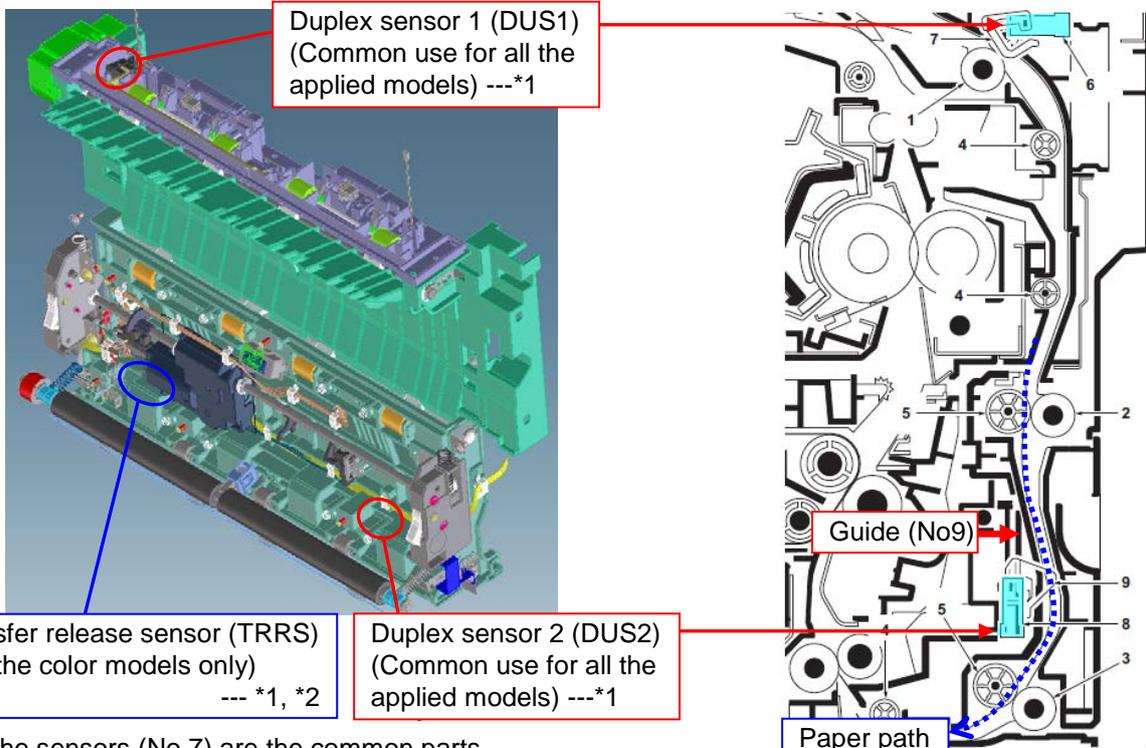
Ref. No. **PCI-0290 (B116)**

<Date> May 11, 2011

Subject	Parts Change Information
Model	TASKalfa255/FS-6025MFP, TASKalfa255b/FS-6025MFP/B, TASKalfa305/FS-6030MFP, TASKalfa255c/FS-C8025MFP, TASKalfa205c/FS-C8020MFP, TASKalfa305/FS-6030MFP, TASKalfa 5550ci, TASKalfa 4550ci, TASKalfa 3550ci, TASKalfa 3050ci, TASKalfa500ci, TASKalfa400ci, TASKalfa300ci, TASKalfa250ci, TASKalfa552ci, TASKalfa520i, TASKalfa420i, TASKalfa300i, TASKalfa550c, TASKalfa650c, TASKalfa750c, TASKalfa4814w, TASKalfa4815w, TASKalfa4816w, TASKalfa180, TASKalfa220, TASKalfa181, TASKalfa221, KM-3050, KM-4050*, KM-5050*, FS-9530DN*, FS-9130DN*, EP 510DN, KM-3035*, KM-4035*, KM-5035*, FS-9120DN*, FS-9120DN*, KM-2560*, KM-3060*, KM-2540*, KM-3040*, KM-4850w, KM-4830w*, KM-P4845w, KM-P4850w, KM-S4850w, FS-C8100DN+*, EP C320DN, FS-C8500DN, FS-3900DN*, FS-6950DN*, FS-4020DN*, FS-6970DN*, FS-4000DN, FS-3920DN*, FS-3925DN, FS-4025DN, FS-6975DN, FS-3140MFP, FS-3040MFP, FS-1800, FS-1800+, FS-3800*, FS-6700*, FS-6900, FS-1900*, FS-1920, FS-6950DN*, FS-3820N, FS-3830N*, FS-1200*, FS-C5030N*, FS-C5015N, FS-C5020N, FS-C5025N*, FS-C5016N*, DF-710, DF-720, DF-720(B), DF-760, DF-760(B), DF-470, JS-700, JS-700(B), JS-710, JS-720, JS-720(B), DP-710, PF-470, PF-471, PH-4A/PH-4B/PH-4C, PH-5A/5B/5C, Kyocera Mita Administration System, CARD READER HOLDER(B)

*Common with Chungho brand

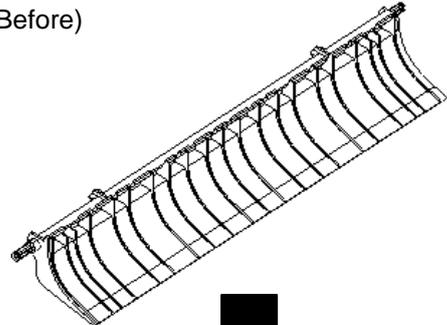
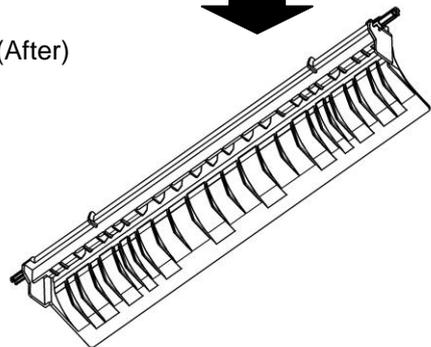
</div> <div style="border: 2px solid red; padding: 10px;"> <p>[LOWER GUIDE FEED IN (No.12): View from Y]</p> <div style="display: flex; flex-direction: column; align-items: center;"> <div style="text-align: center;"> <p>(Before)</p>

<p>Silver --> Black</p> </div> </div>
K	<p>Package A check box for "MT-730(B)" is added to the package case according to change of the product name.</p>
L	<p>PARTS PWB MAIN ASSY B SP (No.11) Upgraded the firmware. (VER. 3N0_9800.003.002)</p>
(-->) M	<p>LOWER GUIDE FEED IN (No.12) Changed the shape.</p> <div style="display: flex; align-items: center;"> <div style="margin-right: 20px;">

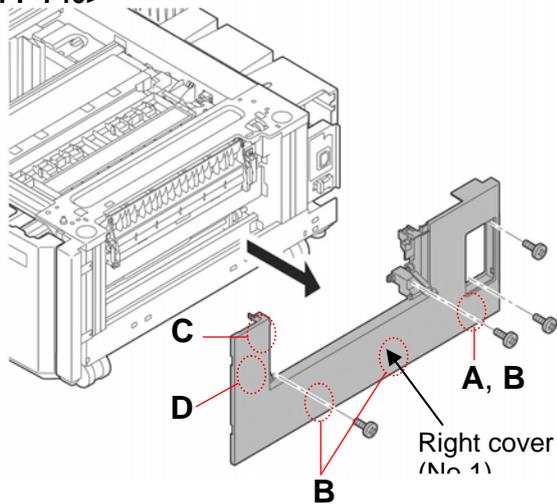
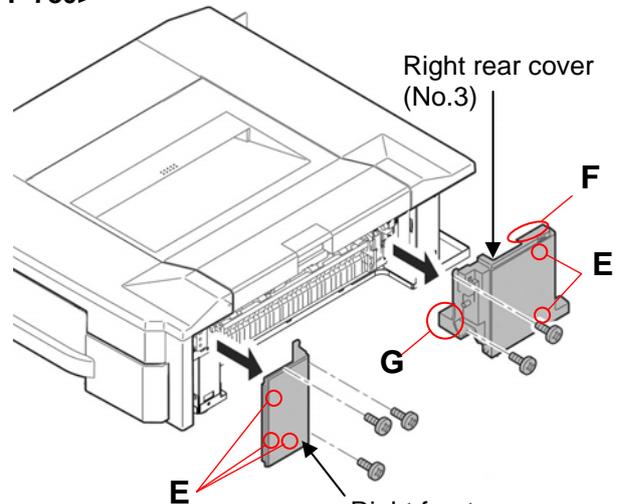
- 2) Added the triangle engraving that clearly indicates the positions of the hooks to the surface of the right front cover (No.2) and the right rear cover (No.3). ----- E
- 3) Cut the overlapping parts with the rear cover/intermediate roller unit on the right rear cover (No.3). --- F, G

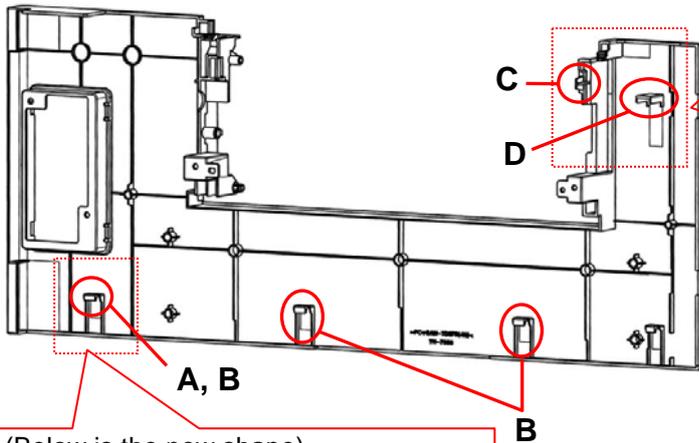
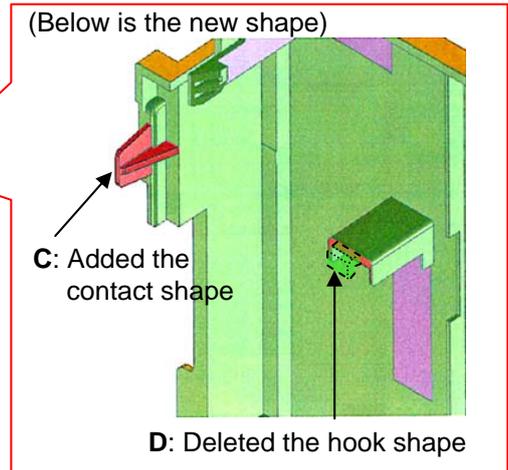
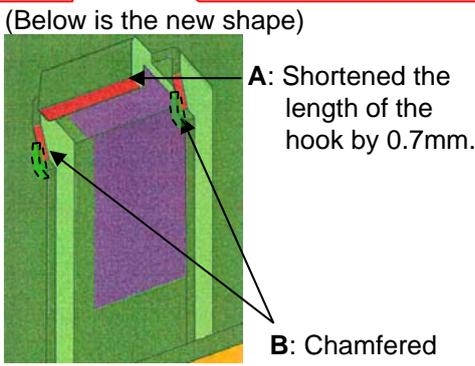
<Right cover (No.1)>

For easy detachment of the exterior cover when detaching the primary feed unit for PF-740/780 to replace the forwarding/paper feed/separation pulley at the periodic maintenance, etc, the following are changed.

- A: Shortened the length of the hook at the machine rear side by 0.7mm where the right cover rarely bends when detaching.
- B: Chamfered the corner of the rib at the both side of the hook for leading the hook to the main frame when attaching the right cover.
- C: Added the contact shape for preventing the bend of the right cover when attaching.
- D: Deleted the unnecessary hook shape for easy detachment.

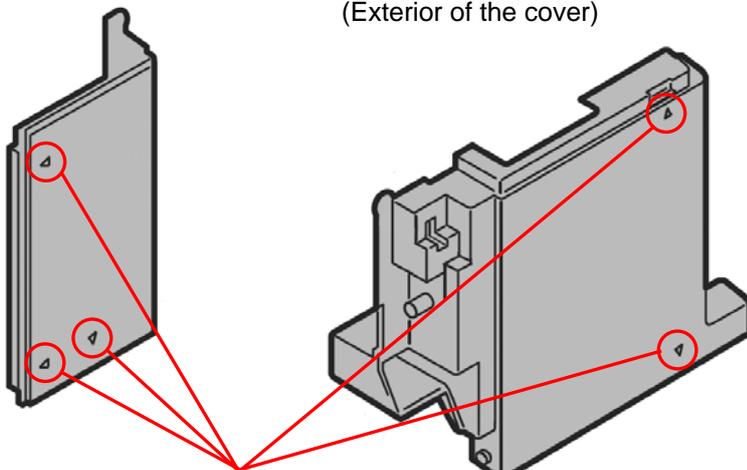
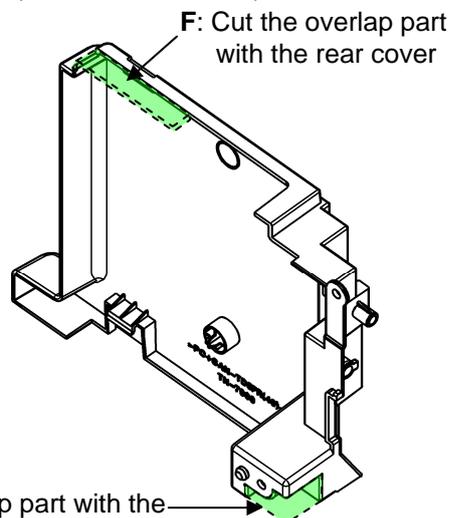
<Right front cover (No.2)>

E: Added the triangle engraving that clearly indicates the positions of the hook.

G: Cut the overlap part with the intermediate roller unit

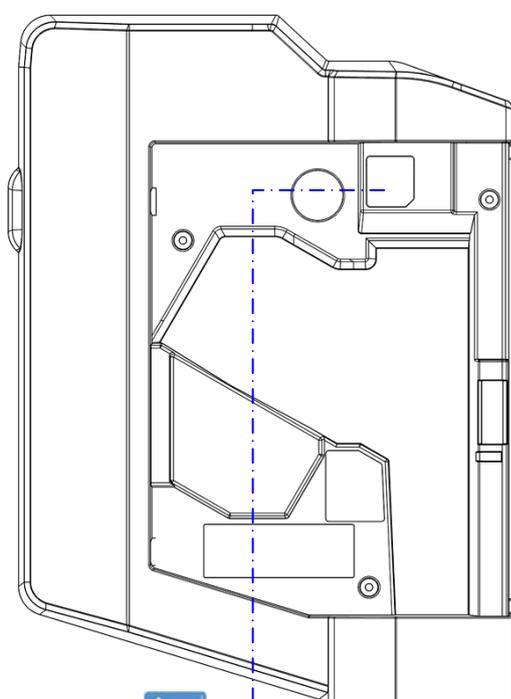
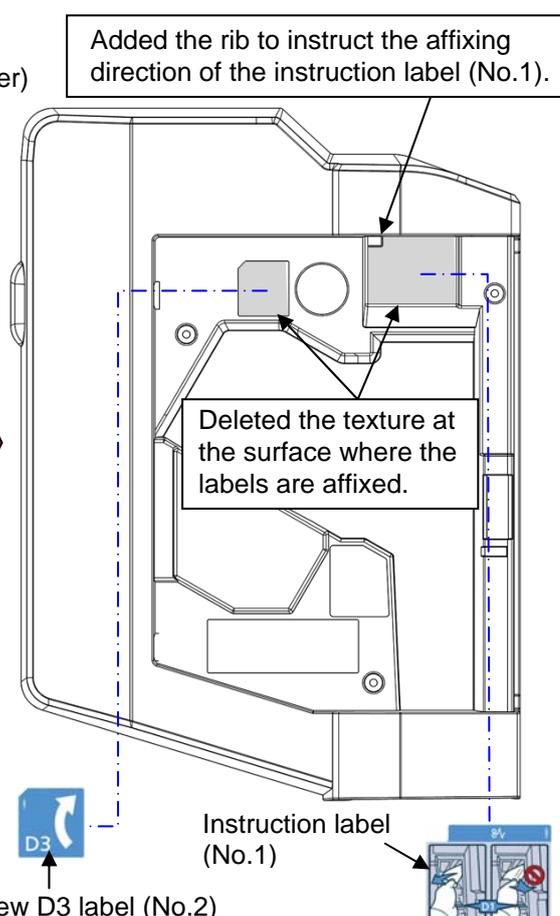
<DF inner cover (No.3)> --- For DF-770 only
(Before)

* New D3 label (No.2) is set up for the service parts according to this time change.

Old D3 label
(Not supplied as the individual parts.)

New D3 label (No.2)

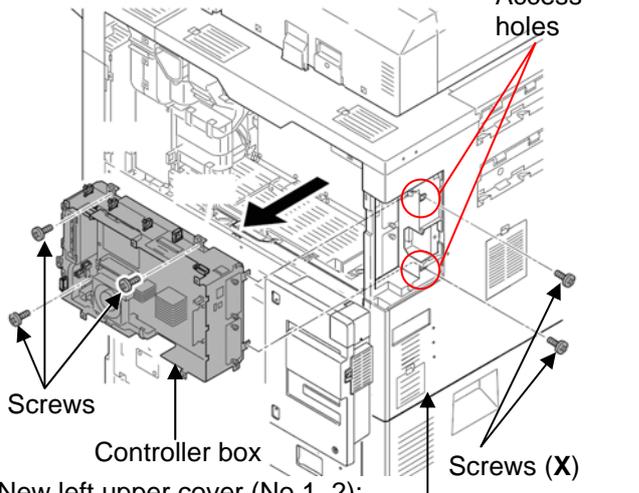
<p>Access holes</p> <p>Screws</p> <p>Controller box</p> <p>Screws (X)</p> <p>New left upper cover (No.1, 2): 2 screws (X in the above figure) securing the controller box can be removed in the state the cover secured in the main machine.</p>

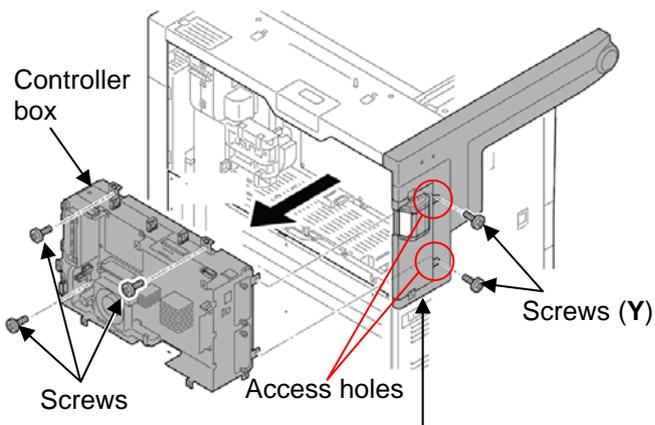
<p>Controller box</p> <p>Screws</p> <p>Access holes</p> <p>Screws (Y)</p> <p>New left upper cover (No.3): 2 screws (Y in the above figure) securing the controller box can be removed in the state the cover secured in the main machine.</p>

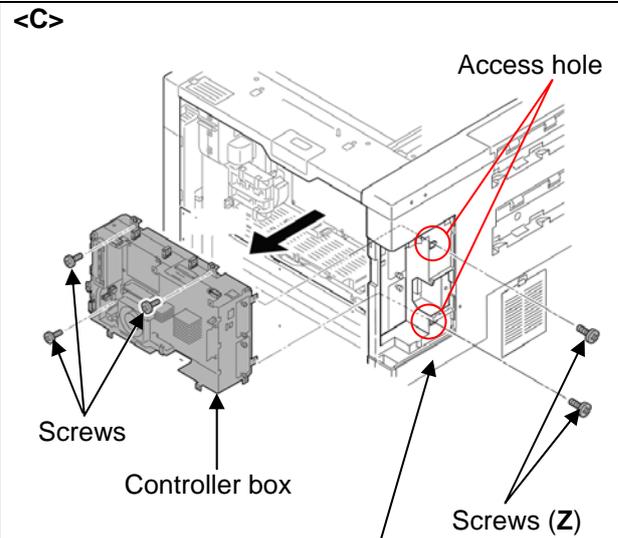
Left cover for installing AK-730 (No.4):
2 screws (Z in the above figure) securing the controller box can be removed in the state the left cover is secured at the main machine.
Accordingly, the DF connecting plate secured at the main machine left side beyond the left cover for installing AK-730 does not need to be removed.

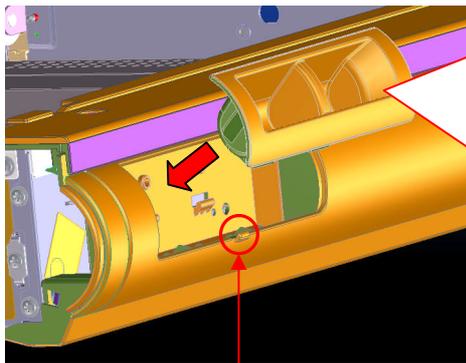
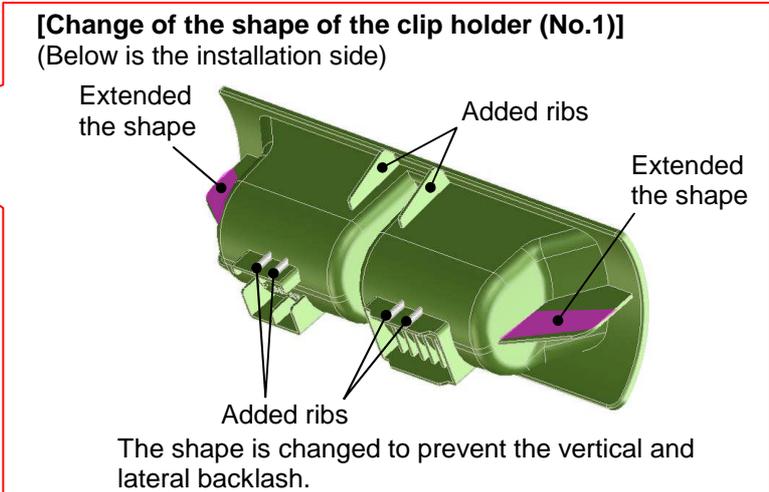
The shape of the clip holder (No.1) is changed as below for preventing the clip holder from coming off due to the vibration in transit, etc.

This convex part prevents the clip holder (No.1) from coming off before this change.

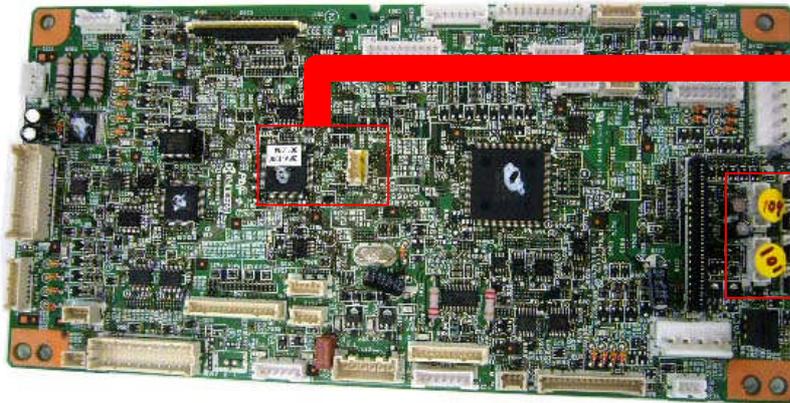
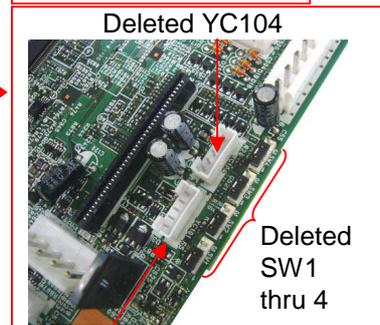
<Engine PWB (No.1)> (Below is the old part)

The unused circuits on the engine PWB (No.1) and the video PWB (No.2) are deleted.

Deleted YC105

Deleted YC104

Deleted SW1 thru 4

Deleted YC101

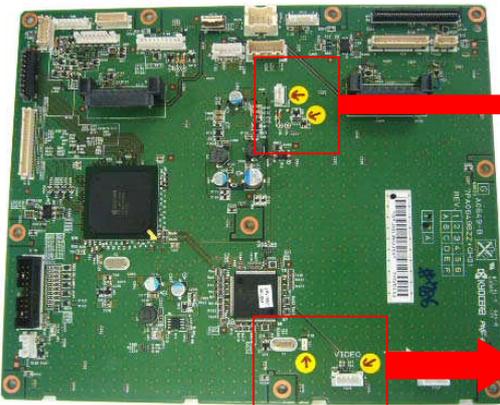
<Video PWB (No.2)> (Below is the old part)

Deleted YS1

Deleted YC18

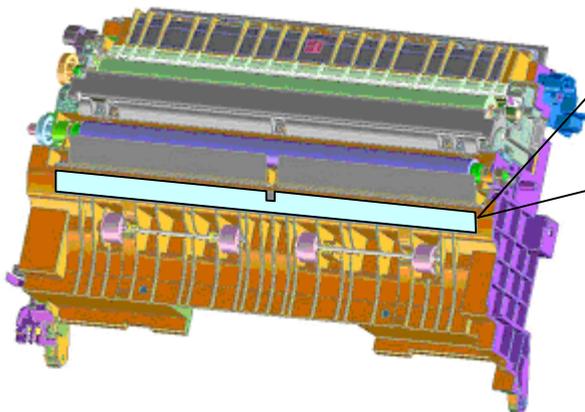
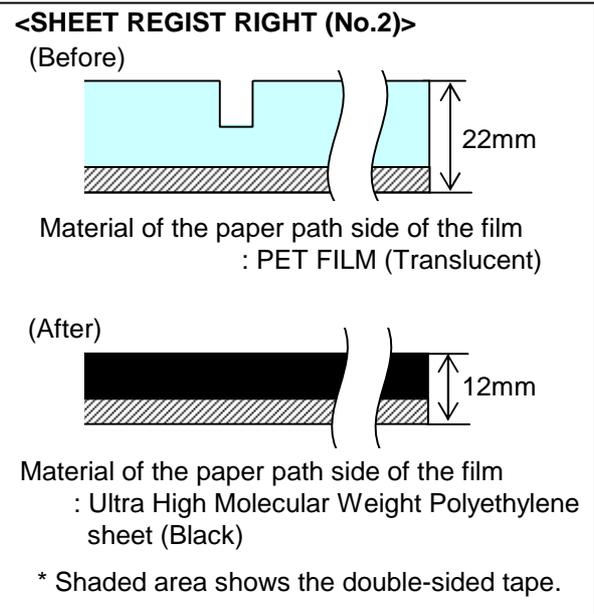
<Paper conveying unit (No.1)>

To reduce the amount of the paper dust on the paper surface after passing through the paper conveying section, the shape and material of SHEET REGIST RIGHT (No.2) affixed in front of the right register roller is changed as below.

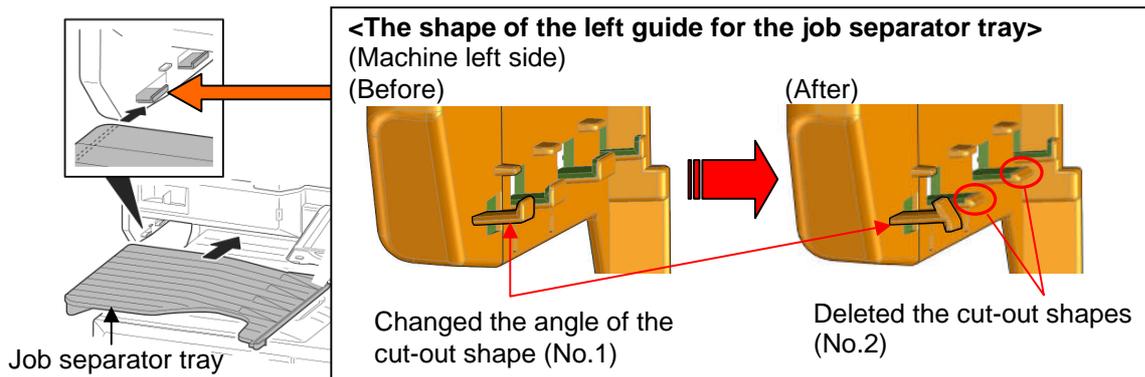
The shape of the left guide for the job separator tray is changed for improving the paper ejection ability when ejecting 11x17 inch size paper to the job separator tray.

- COVER ISU FRONT (No.1): Changed the angle of the cut-out shape of the left guide.
- COVER TRAY LEFT (No.2): Deleted 2 cut-out shapes of the left guide.

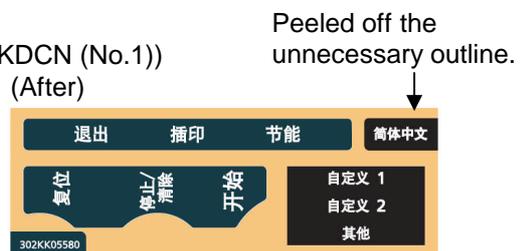
<Operation sheet (No.1 thru 3)> (Below is the sheet for KDCN (No.1))

The slit is added to the operation sheet (No.1 thru 3) so that it is supplied at the state the unnecessary outline is peeled off for the label separation ease.

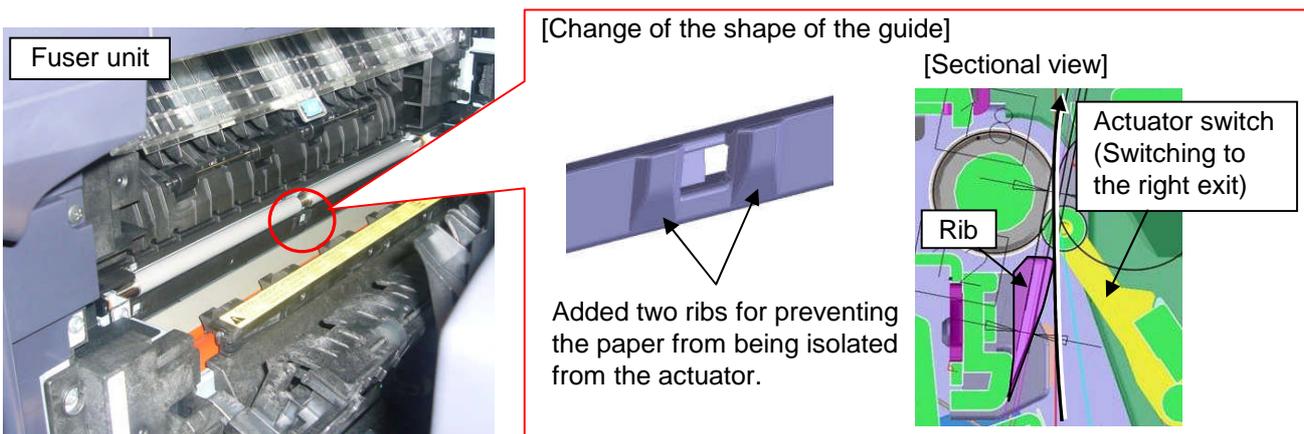
The JAM4311 (Duplex sensor 1 stay jam) may occur if operating the machine under the following condition.

The trailing edge of the paper having printed on the reverse side may curl and its center part may bend according to the paper properties (long grain or low stiffness fed widthwise) if the fuser heat roller has not yet expanded completely under the above condition.

Two ribs are added to the guide so that the paper touches the actuator switch without bending.

Field Measure: Please change the paper feeding direction to lengthwise as an emergency measure when the above phenomenon occurs. When the above phenomenon isn't cleared even if changing the paper feeding direction, please replace with the new fuser unit.

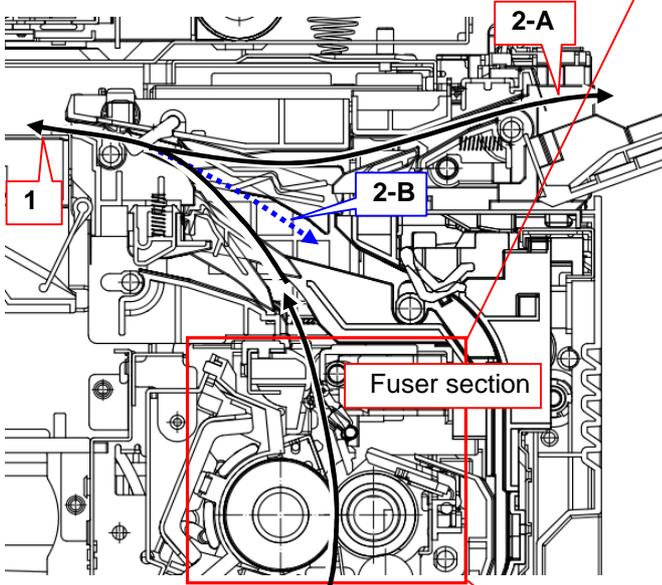
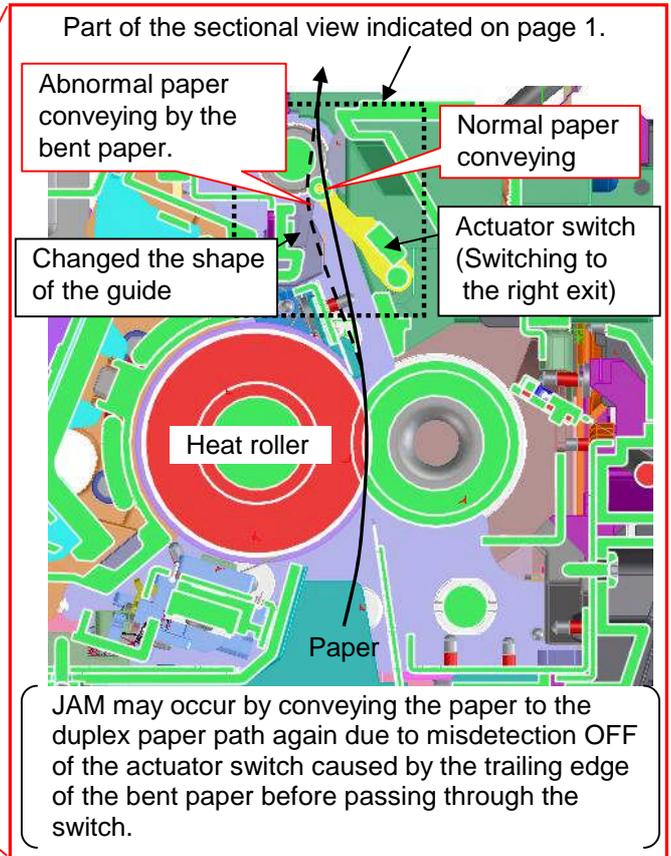
[Mechanism when JAM4311 occurs]

<Paper path of the reverse side from the fuser section to the exit section >

- Normal paper conveying: 1 --> 2-A (paper exit)
- Abnormal paper conveying when the actuator misdetects OFF due to the bent paper.: 1 --> 2-B

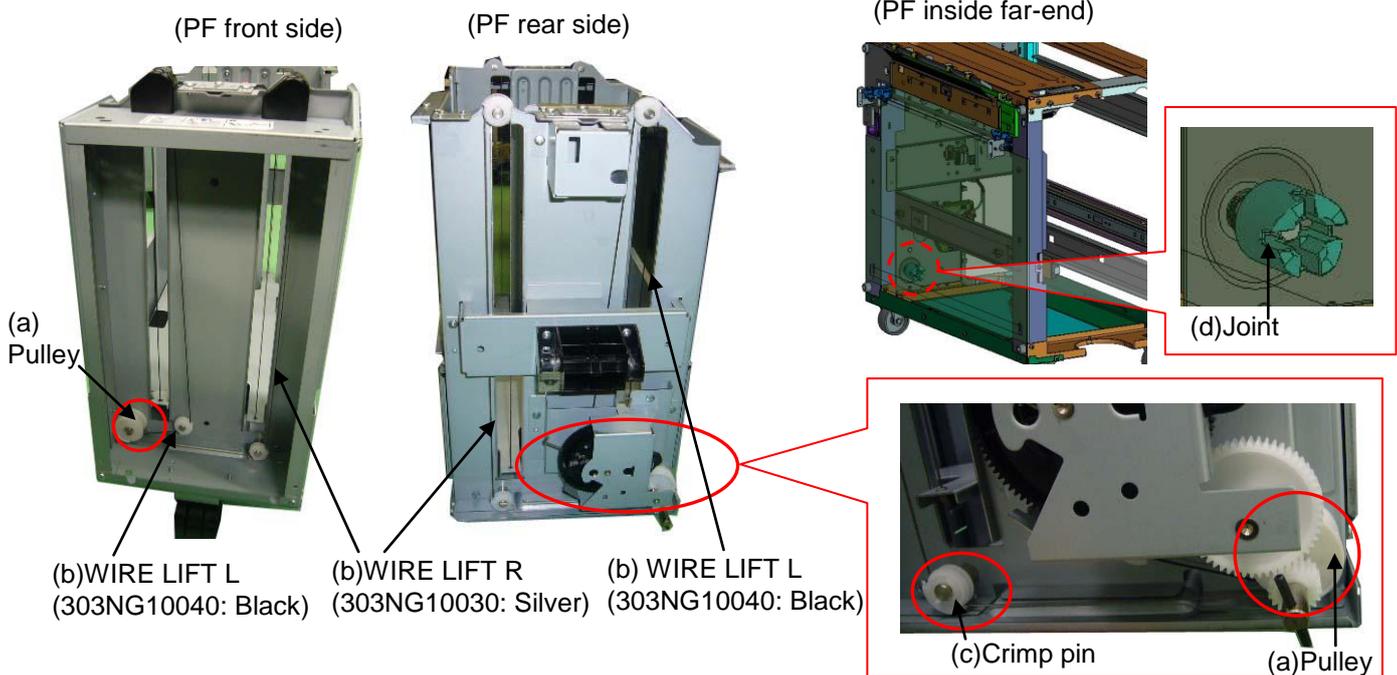
--> [Deck unit]

* The lift plate may rise obliquely if feeding the paper from PF-770 while improperly hooking the wire. As a result, the lift plate may over-rise by misdetection of the upper limit due to contacting of the lift plate with the square hole on the frame, and then (-->) (a) the pulley, (b) wire, (c) the crimp pin or (d) joint may be damaged. (When the pulley is damaged, the abnormal noise (damage noise) is heard and the C1050* service call error appears after damage.)
 *C1050: SD lift motor error (Side multi tray)

1) when the pulley (a) or wire (b) is damaged: Please replace with PARTS PULLEY LIFT ASSY SP(No3)		
2) when the crimp pin (c) at the PF rear side or the lift plate (TRAY PAPER: 303NG10010) is deformed: Please replace with the new paper deck unit (No.1 or No.2) (Please refer to the next page for details about the deformation of the lift plate.)

3) when the joint (d) is damage: Please replace the joint (Parts No: 303NG3102-)		
* Please refer to the next page and after for how to replace each of the parts.		
Serial Nos. of Affected Machine: (-->) Refer to page 15.
