Service Bulletin

Ref. No. **COM-0218 (B056)**

Subject	Note when releasing the paper jam/maintaining the machine (Prohibition of use of the flammable sprays and liquids)
Model	All models

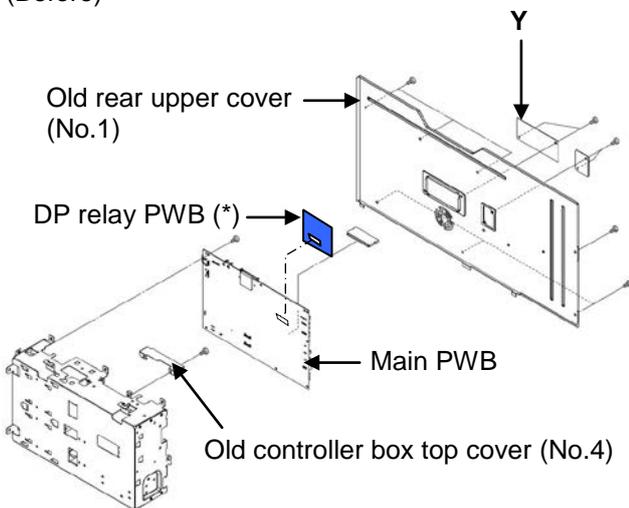
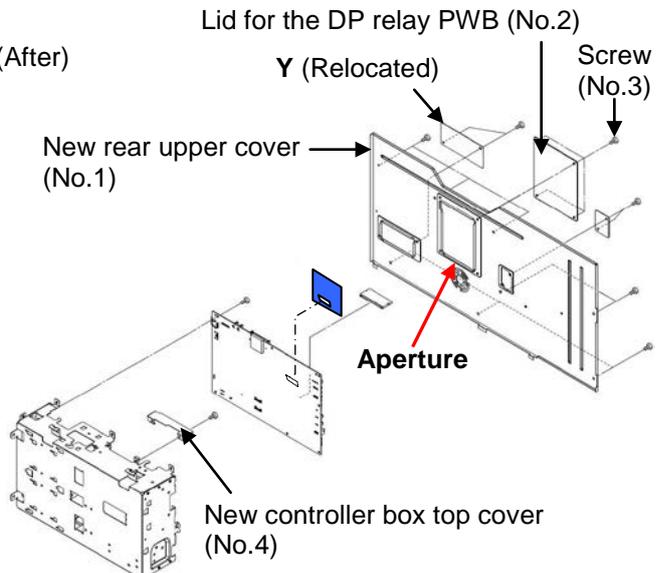
(*) The DP relay PWB is the bundled part in the DP-771.
It is attached to the main PWB in the main machine when setting up the DP.

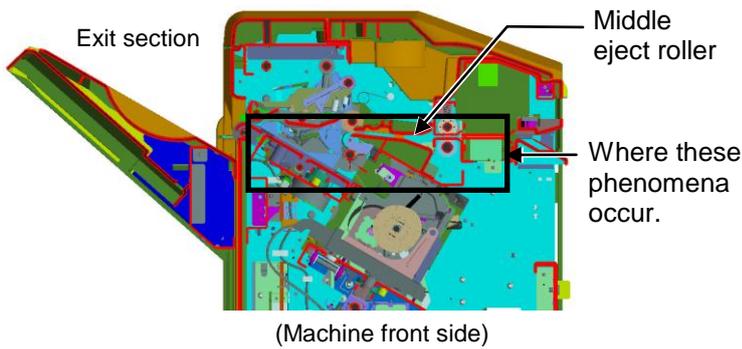
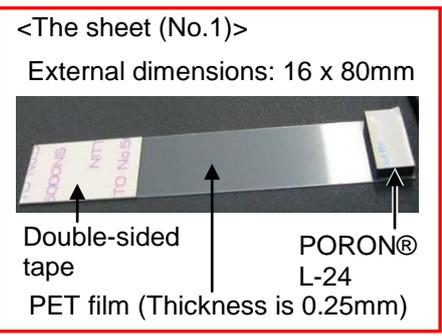
<Processing section> (Cross-section view)

2 sheets with the PORON® (No.1) are affixed on the leading edge of the lower conveying guide.
 (According to the above addition, the both ends of the paper hardly bend by giving stiffness to the paper and the downward paper curl is prevented.)

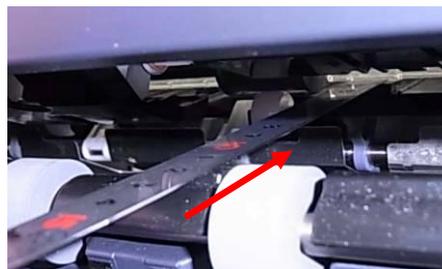
If the gap is less than 0.5mm, the PORON® may come off like the following NG figure. So, please check it and refit it.

*If there isn't enough gap, it affects paper conveying. Please retry affixing the sheets (No.1).

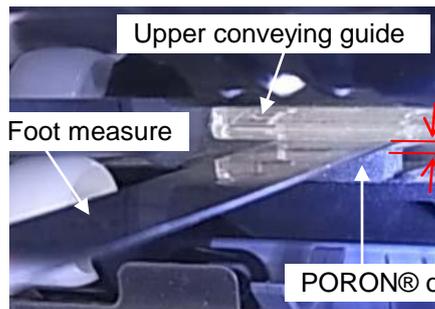
Check if the gap between the PORON® of the sheet (No.1) and the upper conveying guide is 0.5mm or more by inserting a ruler that is of 0.5mm thickness from the eject aperture.

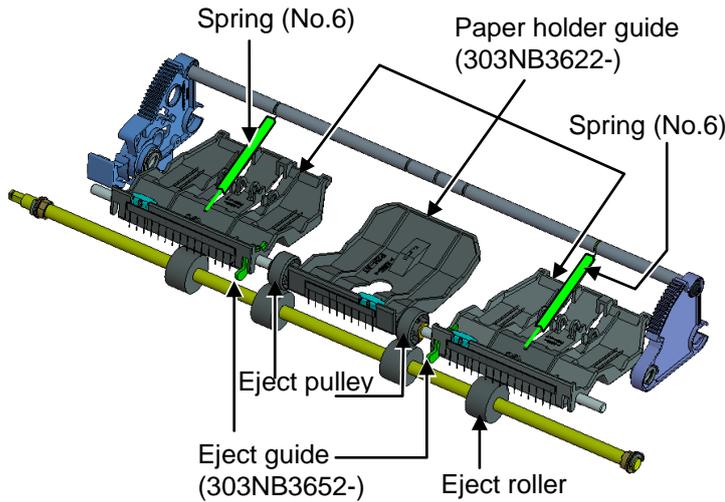
<Location of the spring (No.6)>

The tension of the spring (No.6) is increased that pulls up the paper holder guide to prevent bound of the paper holder guide

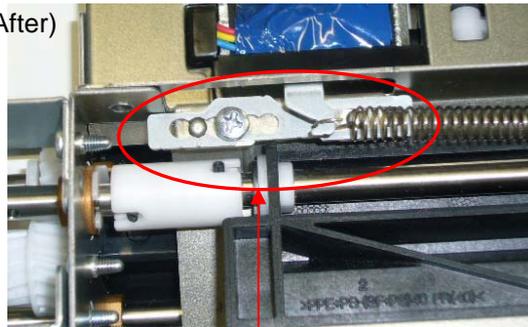
Changed the shape of the metal plate of the frame and added the adjusting plate so that the spring pressure becomes adjustable.

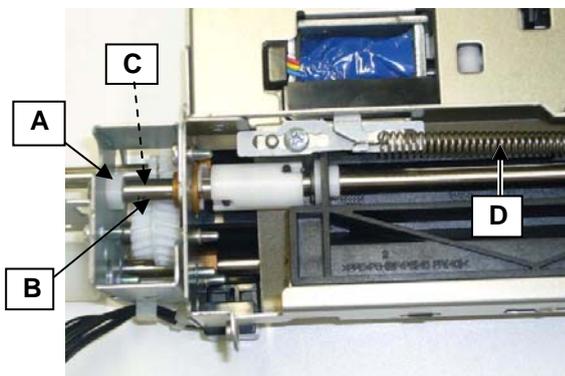
- A:** Changed the bush from Sinter to POM.
- B:** Changed the shape of the shaft.
- C:** Disused the gear.
- D:** Changed the spring. (New spring is silver with black marking.)

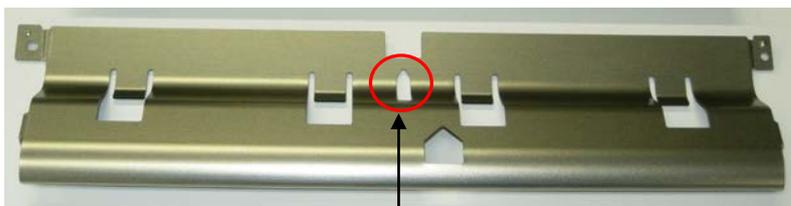
<Change of the shape of the middle feed plate>

Disused the hole according to disusing the actuator.

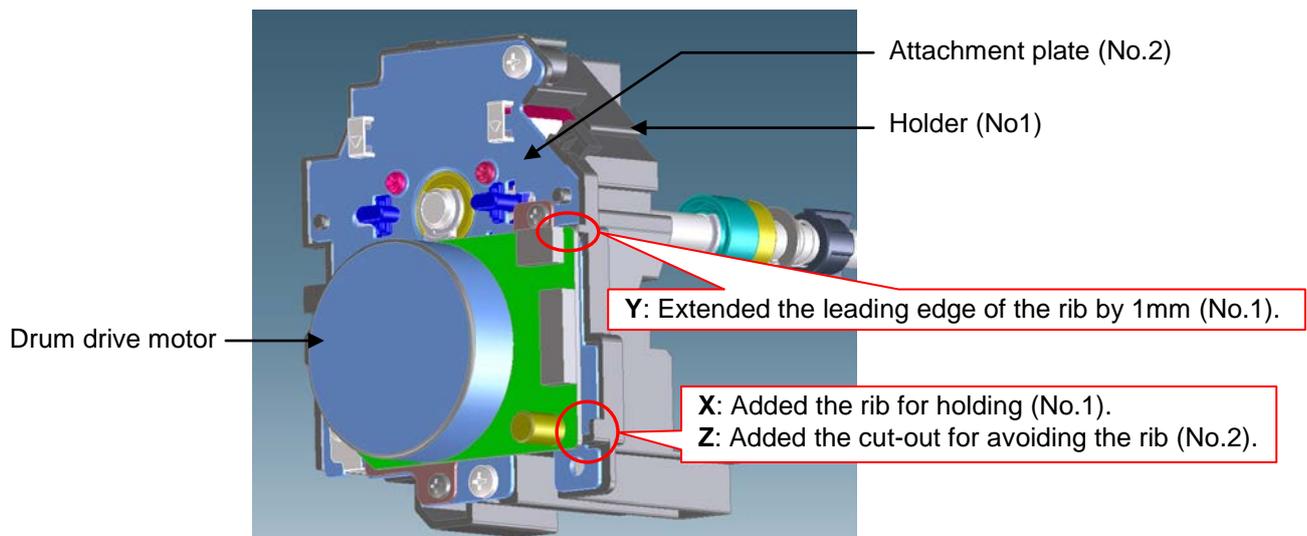
<New drum drive unit>

- The holder (No.1) of the drum drive unit is changed as below in order to strengthen the holding of the drum drive motor board.
 - The rib for holding (X in the figure below) is added.
 - The leading edge of the rib (Y) is extended by 1mm.
- Accordingly, the cut-out (Z) is added to the attachment plate (No.2) for avoiding the contact with the rib (X).

*2: Please replace the attachment plate (No.2) with the new parts at the same time if fitting the new holder of the drum drive unit (No.1) to the machine before change.

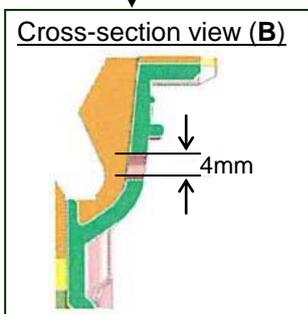
The shape and quantity of the hole in the duct for sucking the toner is changed for properly sucking the toner and reducing the amount of the toner ejection into the duct for sucking the toner.
(The q'ty of the hole is changed from 21 to 14.)

<1 hole at the left side>
Changed the shape.
(Vertical width is changed from 3mm to 4mm.)

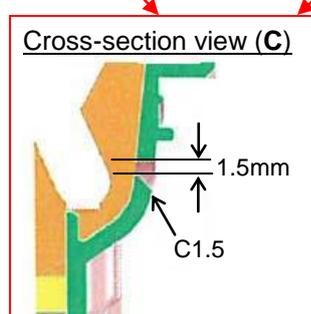
<Center section>
- Changed the q'ty of the hole from 15 to 8.
- Changed the shape.
(Width is changed from 8mm to 4mm.)

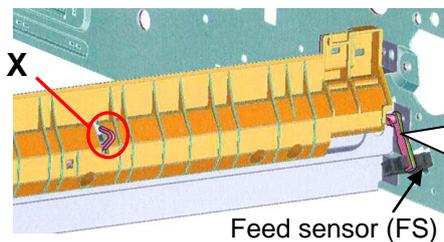
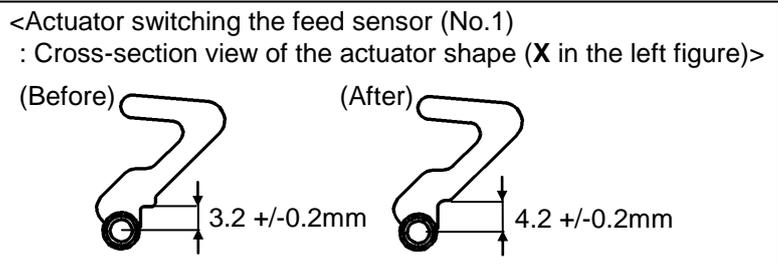
[Vertical paper conveying section]

The actuator shape (X in the below left figure) of the actuator switching the feed sensor (No.1) is changed for improving the margin of the feed sensor detection.

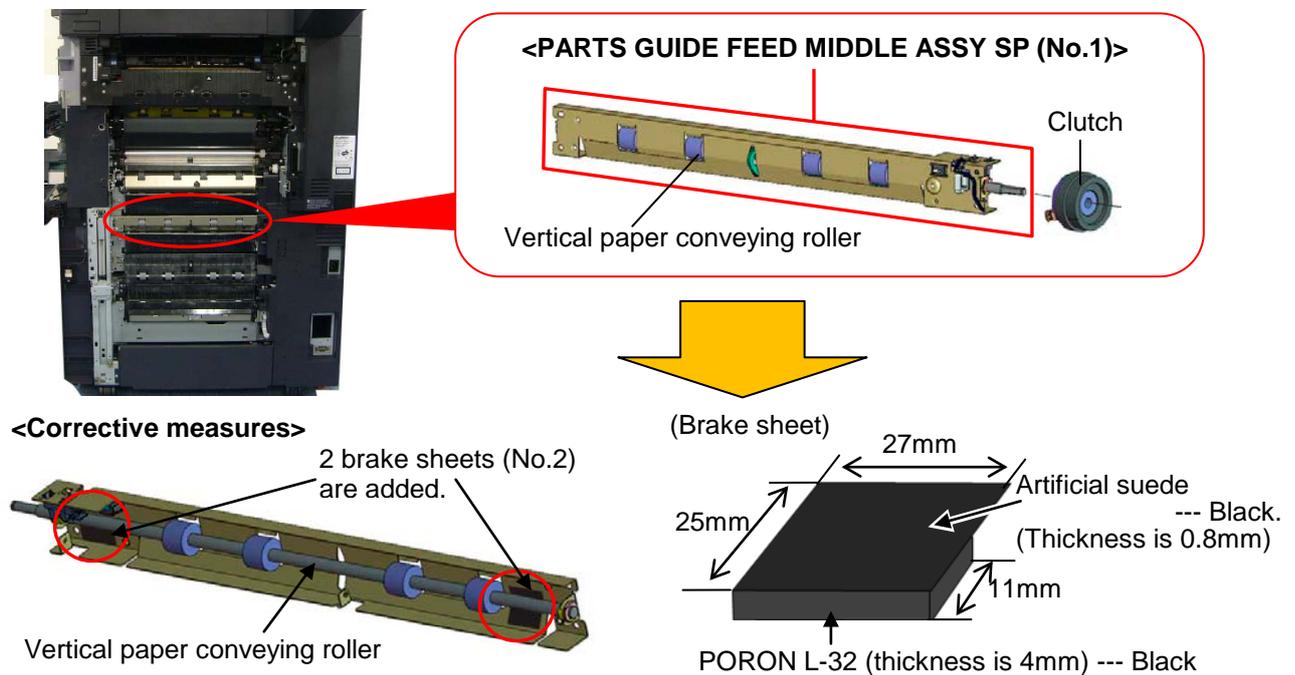
2 brake sheets (No.2) are added to the guide for the vertical paper conveying roller in order to increase the load of the vertical paper conveying roller.

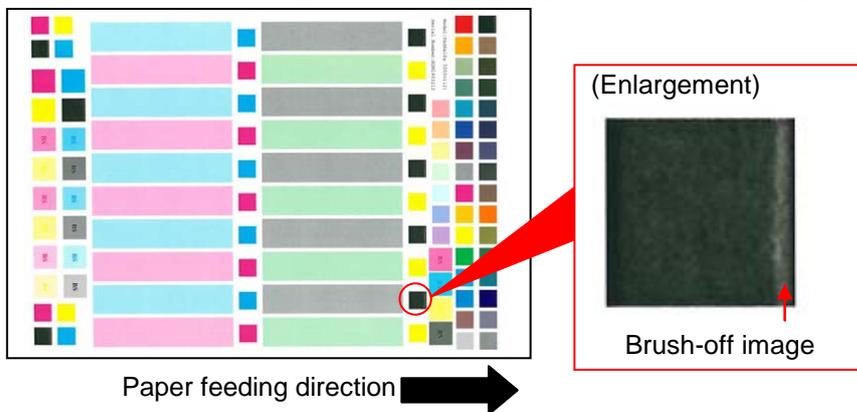
<Sample of brush-off image on the leading edge of the Bk solid image.>

(Note1) If installing the new developing unit in the machine (TASKalfa 3050ci only) having the older version of the firmware than the above, brush-off image may appear on the leading edge of the Bk solid image depending on the operational condition (low temperature and low humidity, low coverage print and frequent intermittent copy, etc.).

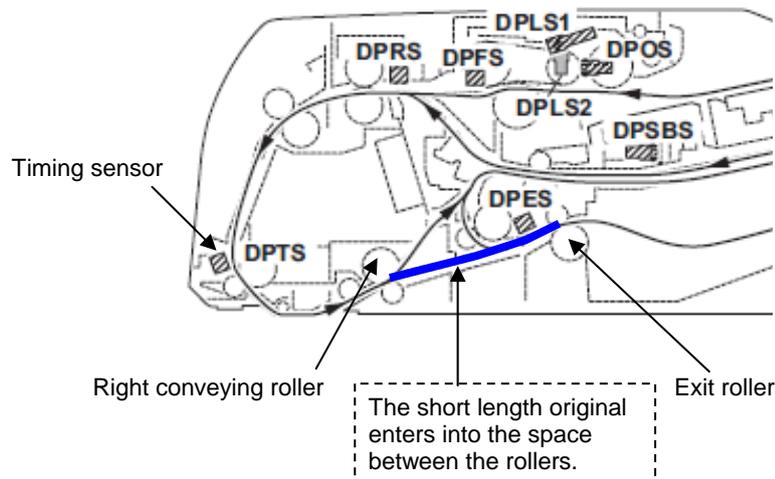
The length of detecting the jam by the timing sensor is changed 110mm to 130mm according to the distance between the rollers nipping the original because the short length original becomes irremovable by entering into the space between the right conveying roller and the exit roller and then the jam cannot be cleared.

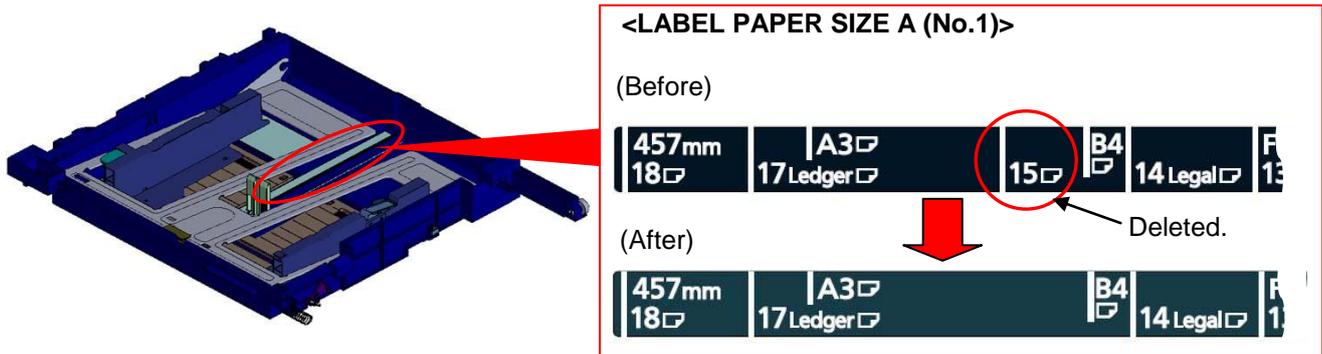
An indication of "15inch" not supported in the spec is deleted from the paper size label affixed on the cassette.

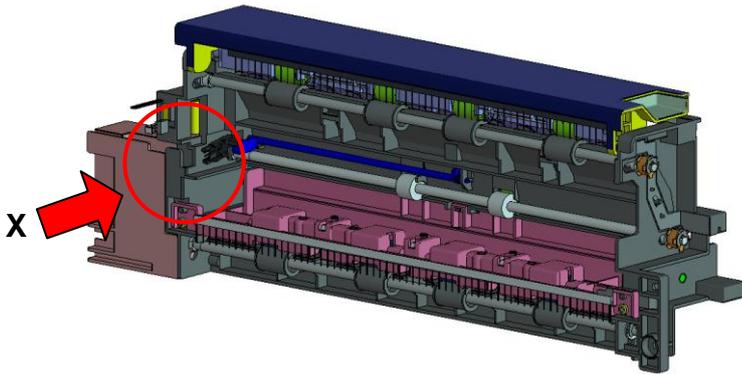
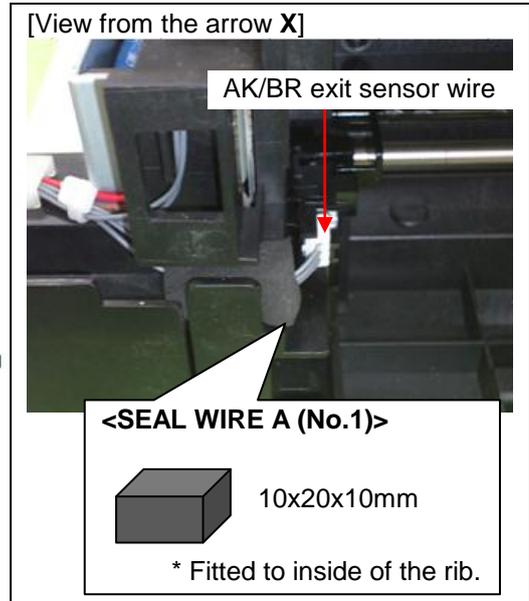
<AK/BR exit unit>

SEAL WIRE A (No.1) is added for improving the productivity of aligning the AK/BR exit sensor wire.

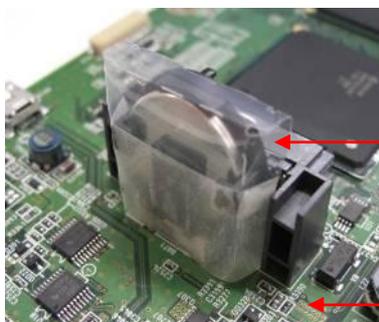
The protection film is affixed so that the metal parts do not contact the Lithium battery on the main PWB during assembling the machine at factory.

Added the protection film*.

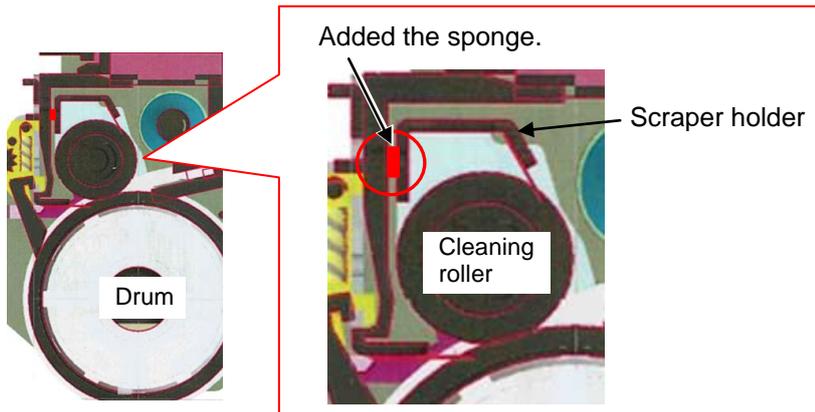
The sponge is added to the scraper holder for preventing the vibration of the cleaning roller.

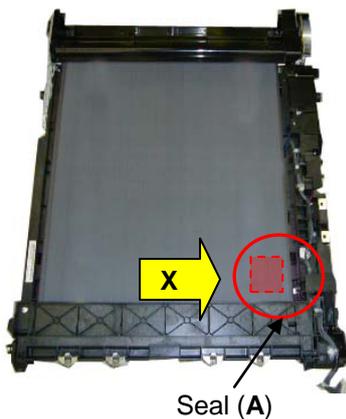
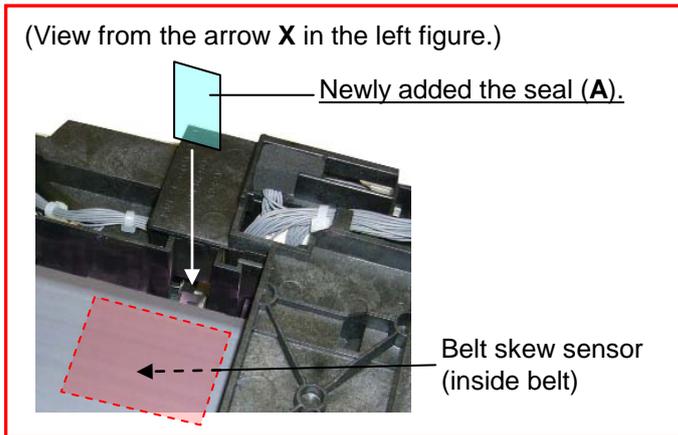
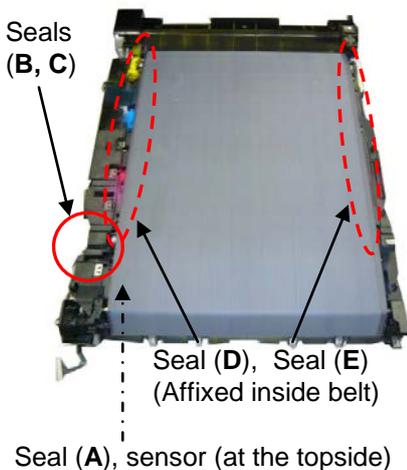
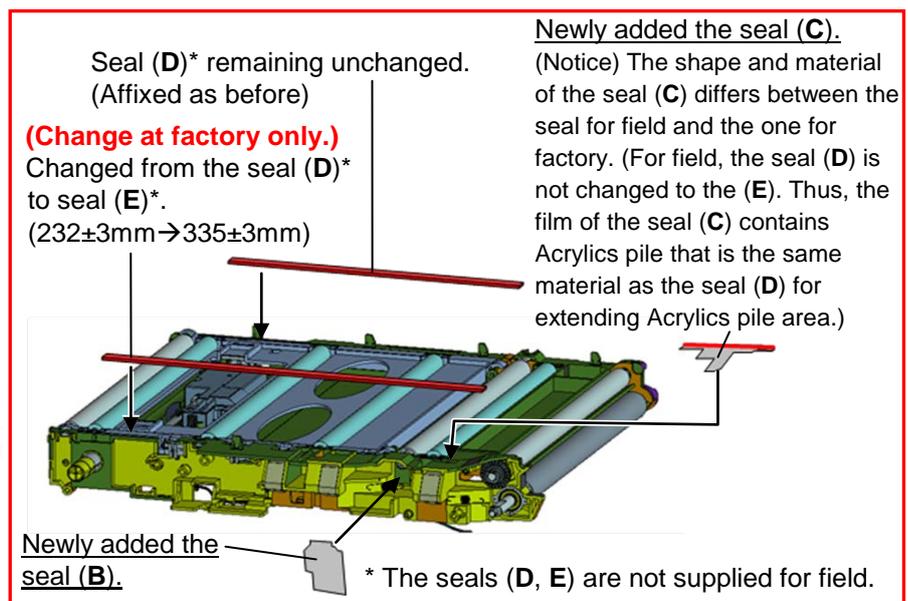
- 1) The seals are affixed for preventing the sensor in the intermediate transfer belt from the toner contamination.
- 2) Accordingly, the seal kit (No.3) is set up for the field measures.
- 3) The tape and spacer fixing the intermediate transfer belt unit for service are disused because they may contact the seals added in the above change 1). And, the leaflet bundled in the intermediate transfer belt unit for service is revised according to this change.

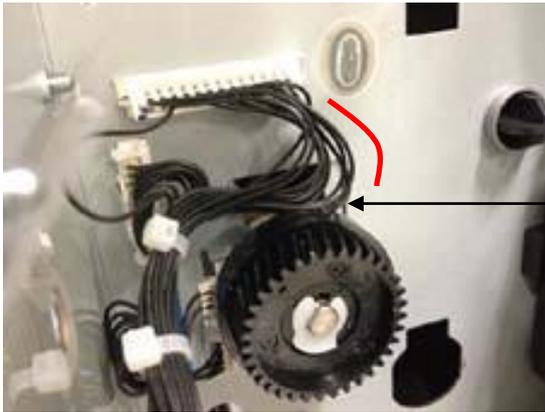
Please confirm the condition of wire alignment before attaching the feed drive unit (*1).
 If the wires are aligned as below, they may be damaged by the rotated clutch, and as a result, the machine operation may become abnormal.
 It may cause the phenomena (it will be mainly paper jam (-->) or the system error (*2)) relating to the middle conveying motor, paper conveying sensor and regist sensor.
 And, the abnormal image like the one in the next page may be also printed out depending on the condition.

Wires may partly contact the clutch if the wires are aligned near the clutch.

Please twist the wires together to bundle them so that the bundled wires are isolated from the applied clutch.

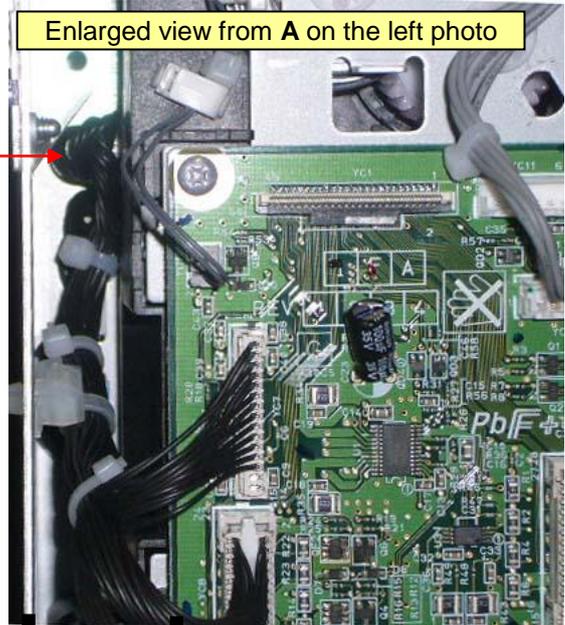
Lower left section of TASKalfa 4500i viewed from the rear side

The machine has already been applied to the field measures if it is confirmed between the side plate and the PWB that the wires are twisted through the gap.

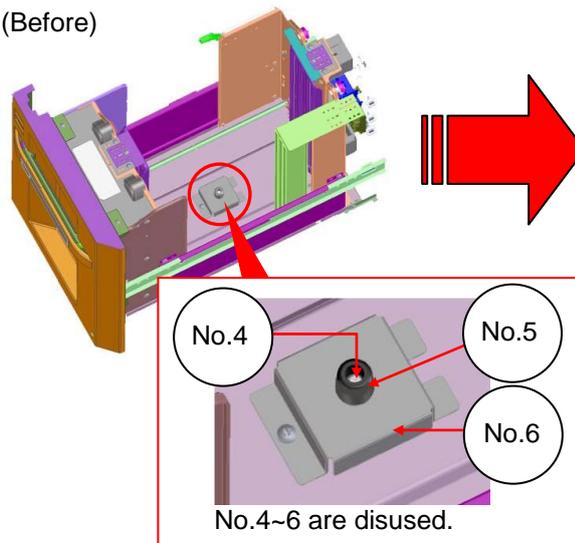
(Before)

If the paper deck with the stocked paper is drawn out, (-->) the tray is descending due to the paper's weight. Then, the crash sound between the tray bottom and the pedestal on the bottom plate may be heard and the pulley at the rear side of the machine and joint may be damaged. Thus, the following are changed to prevent them.

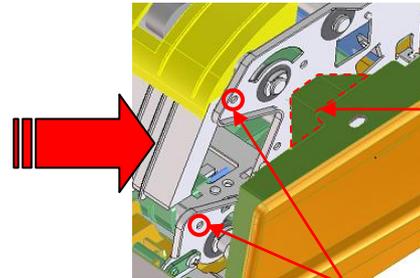
(After)

New COVER FRONT (No.2):
Added the bumper shape absorbing shock in transit. (It is the shape alternative to COVER FRONT FRAME (No.1).)

New FRAME FRONT (No.3):
The burr edge around the screw holes to fix COVER (No.1) is removed.
(Note) Please tighten 2 screws at the holes X where this change is applied this time when removing COVER (No.1) from the machine with the old FRAME.

*2: If COVER FRONT FRAME (No.1) is removed from the machine before this change due to damage, please retighten 2 screws at the holes X of the old FRAME FRONT to prevent the bare burr edge around the hole.

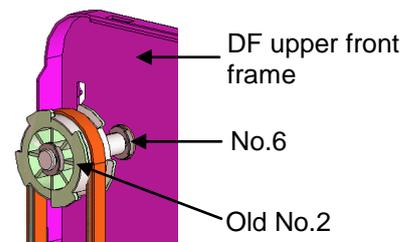
[View from Z] (Below is the old state)

While STOPPER 6 (No.6) had been attached as the spacer at the rear of the old pulley (No.2) at the DF upper front frame, it is removed according to adding STOPPER FRONT BELT (No.4) that keeps the space.

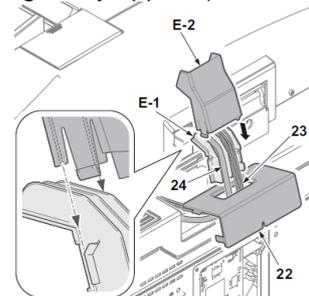
<Lower guide section> (Conveying rollers, actuator and conveying film are fitted)

(Before)

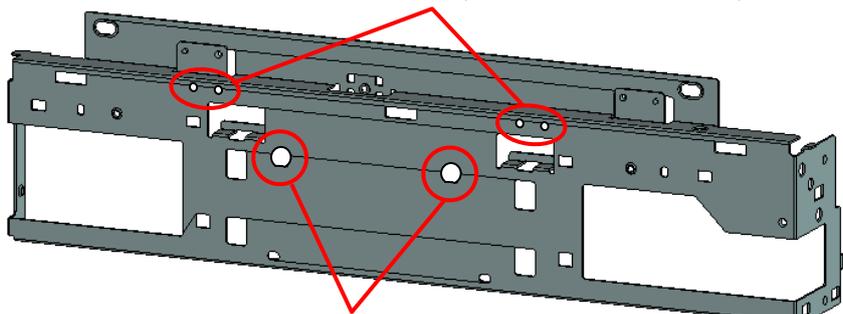
<FRAME FUSER UNIT (No.1)>

Added 4 round holes (its diameter is 2.72mm)

Added 2 holes

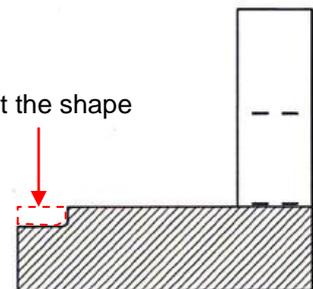
<SHEET COVER FRONT (No.2)>

Cut the shape

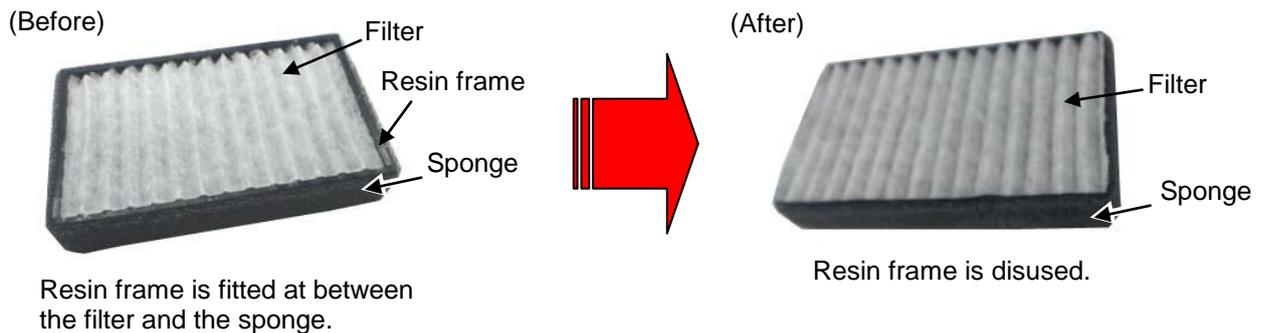
VOC filter (No.1) is changed as below for common use of the parts.

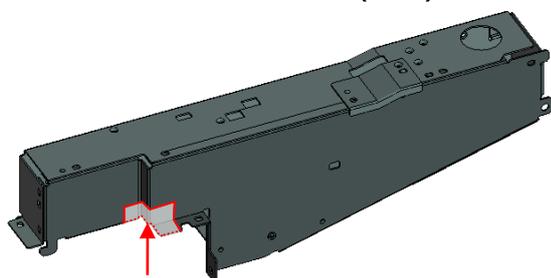
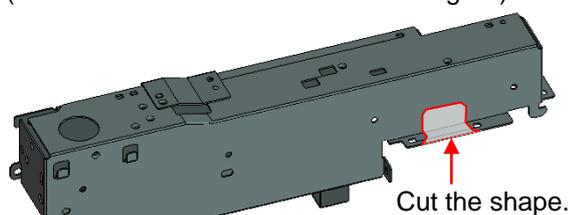
<MOUNT OPERATION ARM (No.5)>

Cut the shape

Cut the shape.

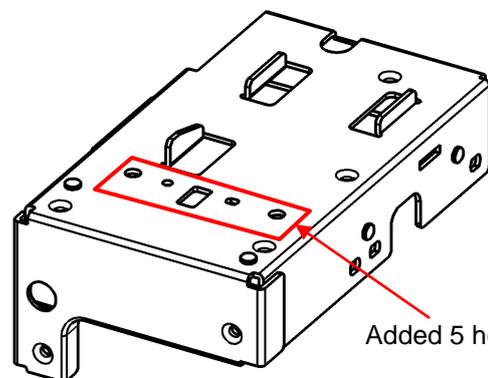
<RETAINER OPERATION ARM (No.6)>

Added 5 holes.

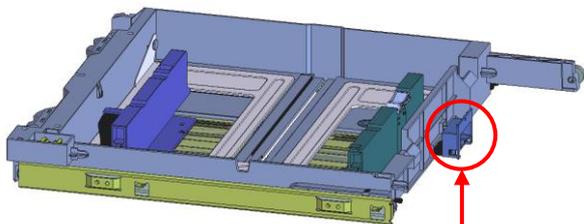
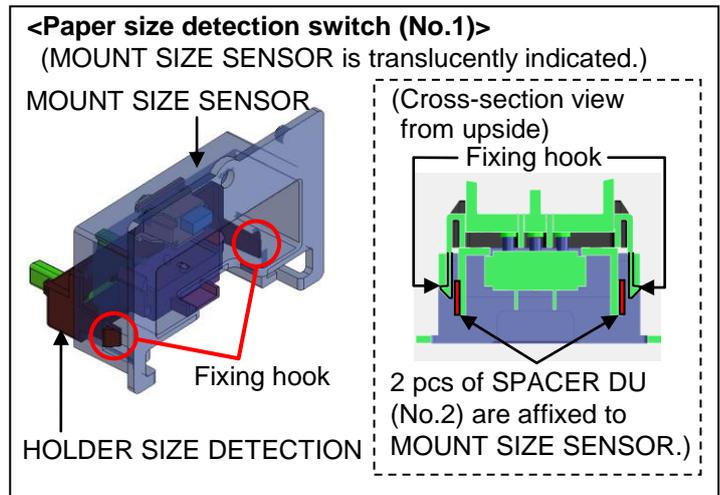
[Parts positioning of the cassette and the paper size detection switch (No.1)]
(View from the machine left rear side)

To improve the margin for fixing HOLDER SIZE DETECTION (302K90954_) against drop and shock in transit, 2 pcs of SPACER DU (No.2) are affixed to the inside of the HOLDER's fixing hook for preventing the fixing hook from deformation in outside direction.

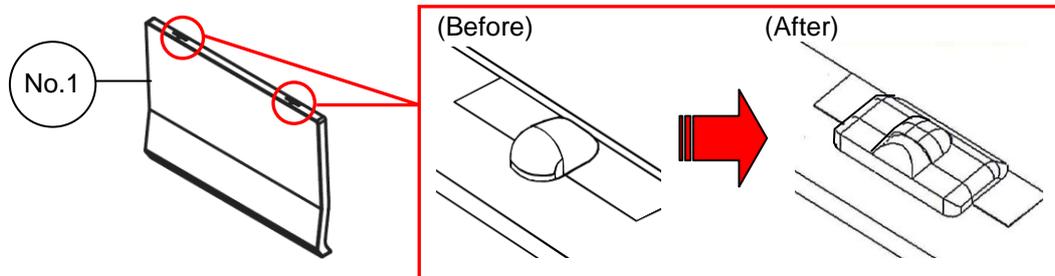
The shape of the protrusions on the upside of EMBLEM (No.1) is changed for common use of the parts.

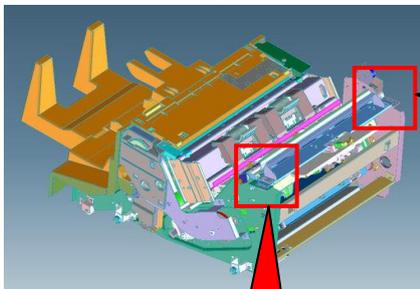
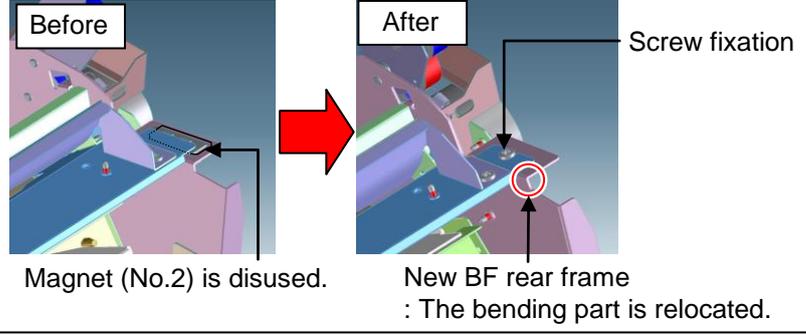
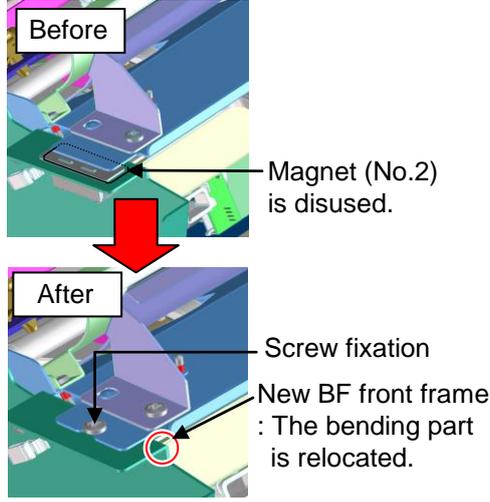
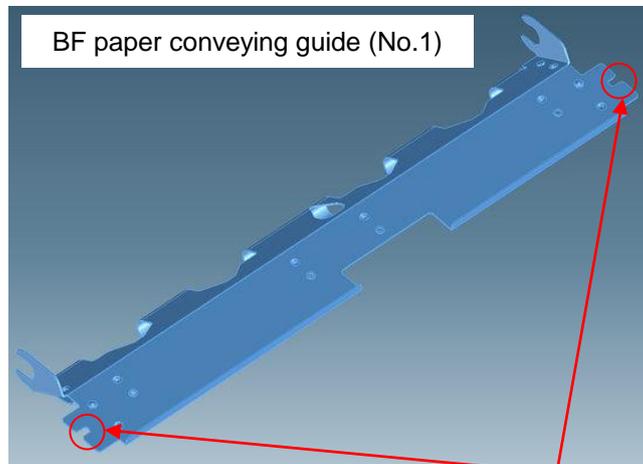
- 1) The cut-outs for tightening the screw are added to the front and rear edges of the BF paper conveying guide (No.1), and the guide's machine front and rear sides are fixed by the screws.
- 2) 2 magnets (No.2) are disused that fixed the old BF paper conveying guide's machine front and rear sides.
- 3) According to the above change 2), the bending parts of the BF front and rear frames that fit the magnets are relocated. (They are heightened by the magnet.)

Cut-outs are added to tighten the screw.

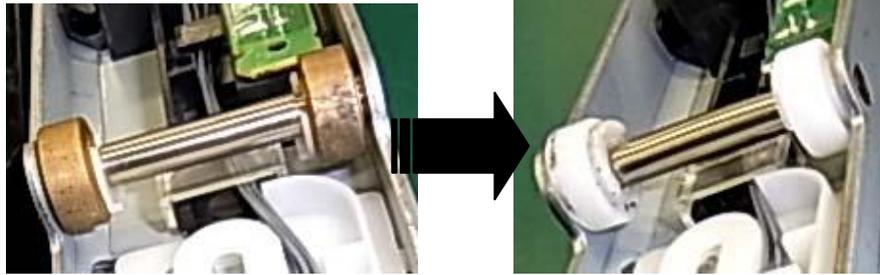
(Old pulleys (No.1) are copper color)

(New pulleys (No.1) are white)

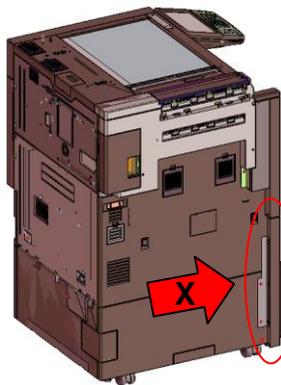
[Machine left side]

The shape of PLATE COVER JUNCTION (No.1) is changed from the L-shape to the U-shape for strengthening.

<Deformed PLATE(No.1)>
 (Circled part in red in the above figure)
 (View from upside) (Front side)

Photos indicate the lower connection cover coming off due to the deformation of PLATE.

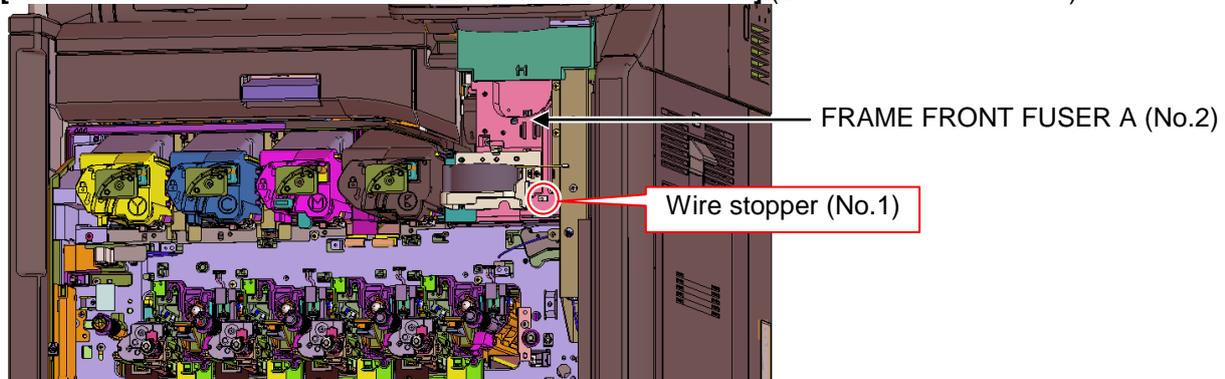
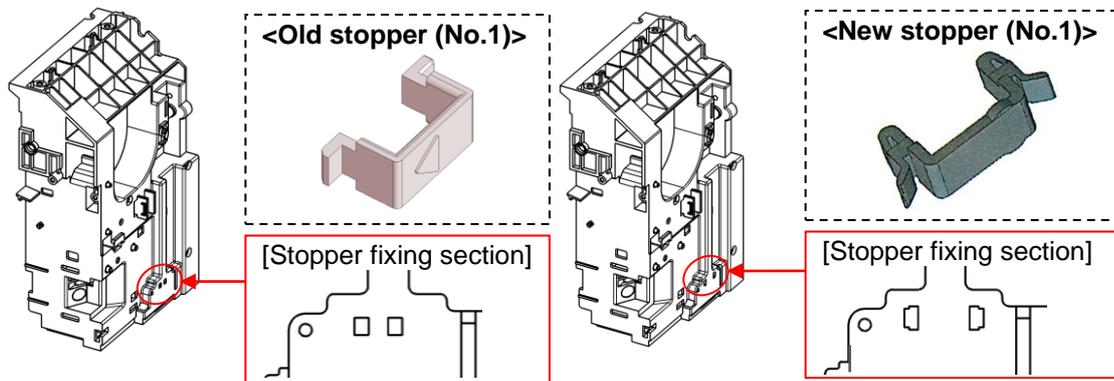
- 1) The wire stopper (No.1) is changed.
- 2) According to the above change, the shape of the stopper fixing section on FRAME FRONT FUSER A (No.2) is changed.

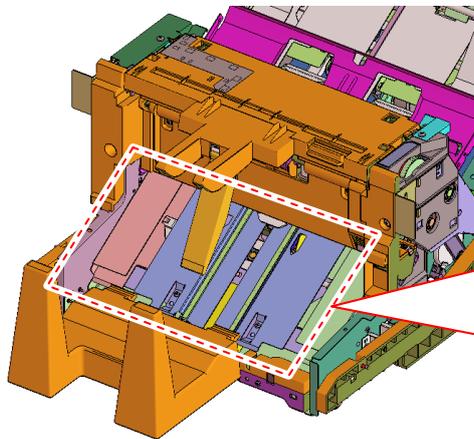
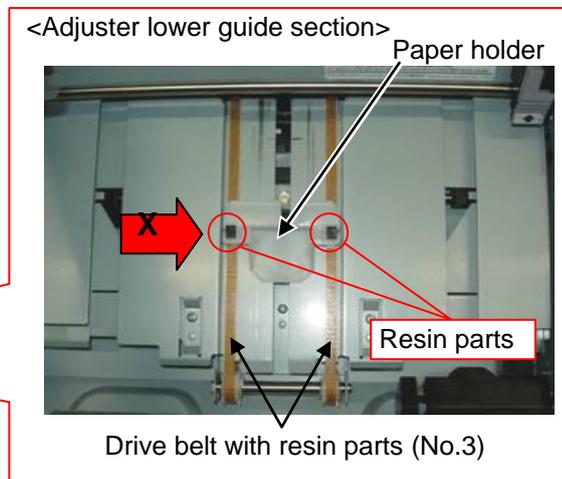
For simplifying the parts procurement, the paper holder drive belt is changed from the all-in-one type with the paper holder resin parts (No3) to the separate drive belt (No1) with the separate resin parts (No2). According to this change, the external color is changed. An attention is required when replacing the parts after this change and please refer to [Field Measure] below.

<Paper holder drive belt> (Viewed from X)
 (Before: All-in-one belt (No.3)) (After: Drive belt (No.1)+Resin parts (No.2))

* Fix the resin parts (No.2) to the belt cog side with the aperture of it facing the machine outside (if the aperture faces the inside, the paper holder can not be fixed).

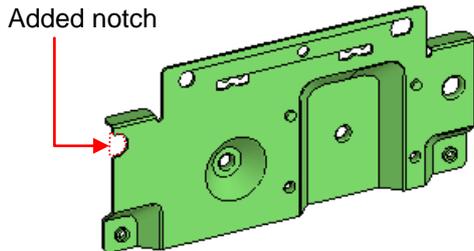
<New HOLDER PWB MIDDLE (No.1)>

- 1) HOLDER PWB MIDDLE (No.1): Notch is added.
- 2) HOLDER TONER DRIVE B (No.2): Round hole (4.8mm diameter) is added.

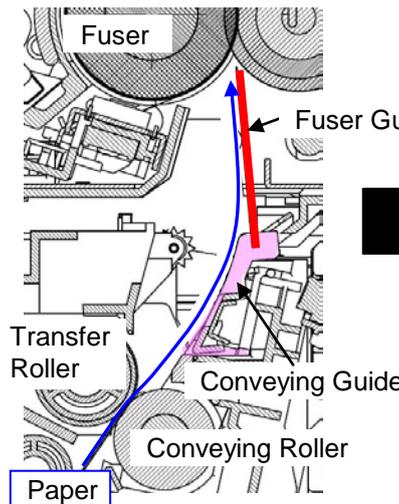
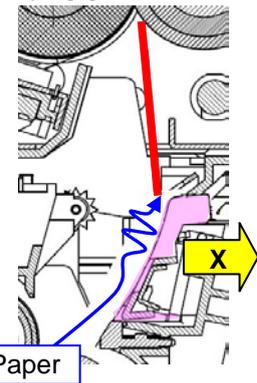
There may be a bump in between the conveying guide and fuser guide due to deformation (bending) of the conveying guide. Then, the leading edge of paper may be hit at the leading edge of the fuser guide to cause paper leading edge fold in Z-shape or J411x/J420x(*).

(Cross-section view) - Conveying guide deformed

If the conveying guide deforms and it moves toward the arrow X above, paper may be hit at the leading edge of the fuser guide

(Permanent Measures) The angle of bending of the metal plate (No.2) on the conveying guide is changed and the spacers (No.1) are disused.

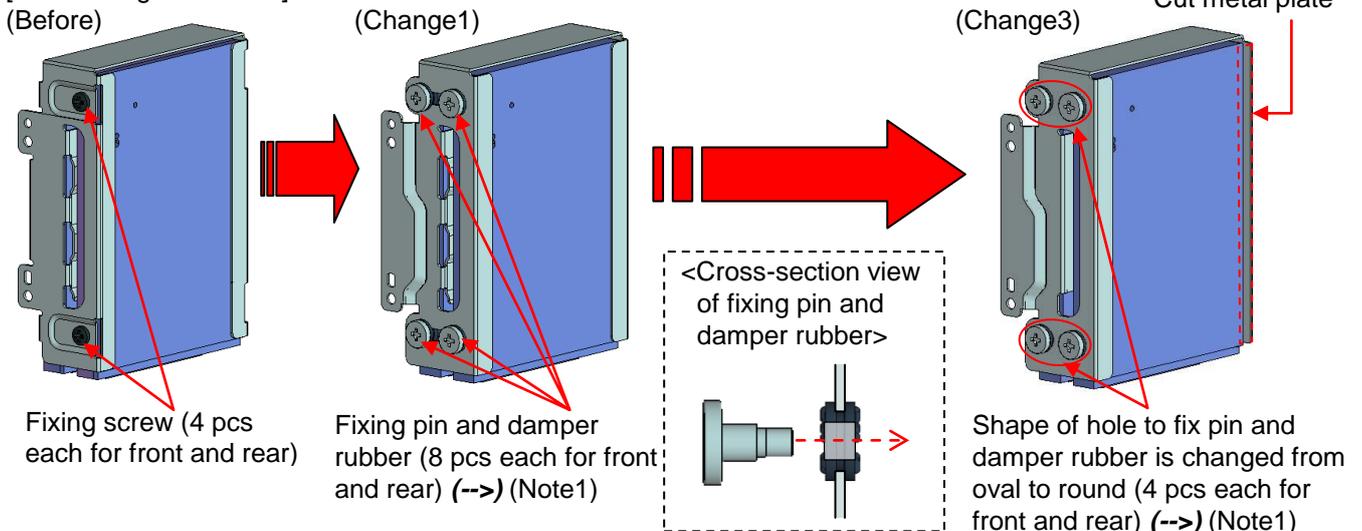
[HDD change transition]

HDD (302LC9316_/302LC9K16_/(-->)302LK9307_/302LH9307_/302MV9313_) may be damaged due to excess impact to it if vibration or impact is applied in transit of the main machine or the machine is moved during operation. Thus, the following are changed. (The service call error such as C0640 appears due to the HDD damage)

(-->) (Note1) 8 parts are secured by the pin and the damper rubber for TASKalfa 7550ci/6550ci/5550ci/4550ci/8000i/6500i like the above figure, and as for the other models, 4 parts are secured as in the same positions before the change.

<Content of changes> (Change1 and 2 below are the preventive measures for the HDD damage and Change3 is for further improvement to secure the margin)

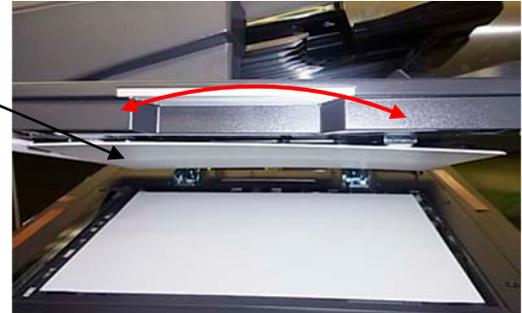
<NG> Center of the original mat is curved

KDC's Classification	<input type="checkbox"/> Entire Stock Rework	<input type="checkbox"/> In-Field modification at next visit
	<input checked="" type="checkbox"/> In-Field modification by case	<input type="checkbox"/> No modification necessary
Field Measure:	(Color models) Replace with the original mat with the regulation standard for the curve (new No.10) if the above phenomenon arises or affix the sponges (No.11-13) after cleaning the surface to affix them with alcohol. (Refer to Page 4, 5 for the alignment)	
	(BW models) No particular problems are expected.	
Serial Nos. of Affected Machine:	Refer to page 6-8.

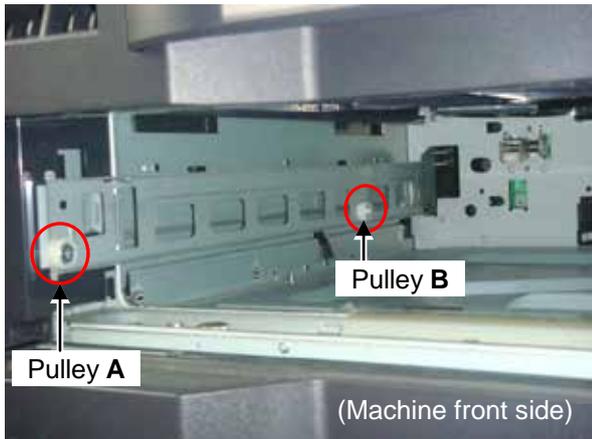
(Back side)

<SHEET CASSETTE A (No.20) x 2 sheets>

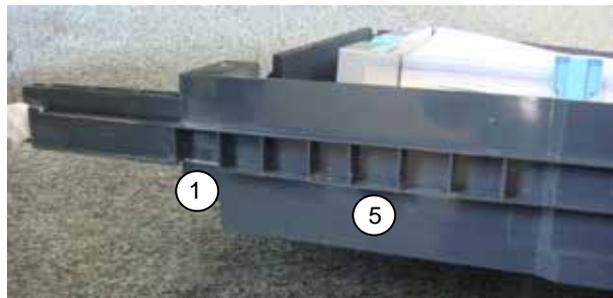
<SHEET CASSETTE B (No.21) x 2 sheets >

(Front side)

[FIG. 5 Paper Feed Section 1 (55/45 ppm)]

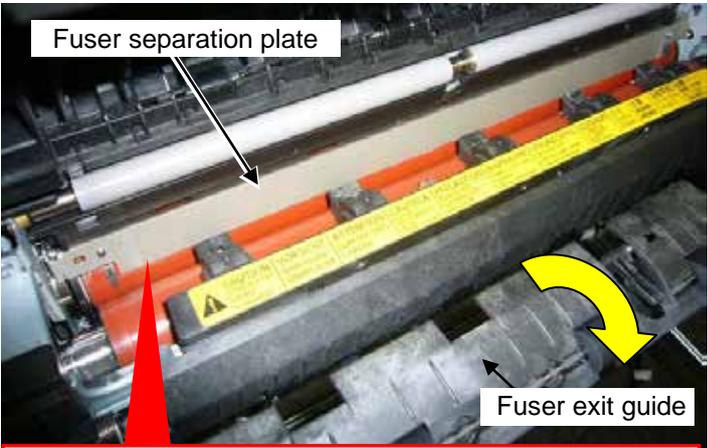
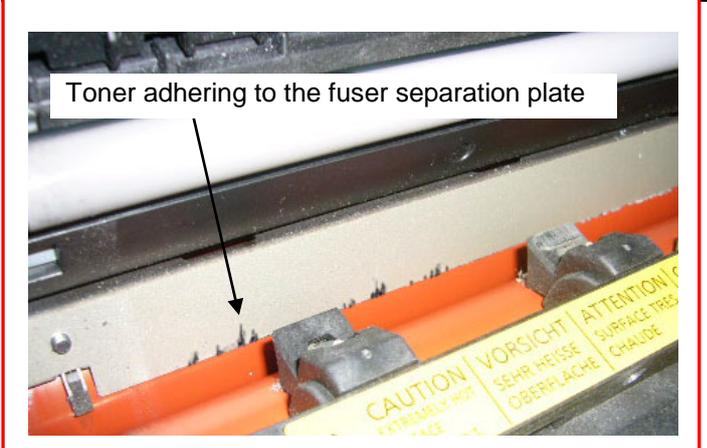
No.	Step	Detail
1	Prepare the cleaning paper.	Cut the thick A4/Letter size paper (200g or 80 lb cover paper) in half lengthwise.
2	Turn on the main switch to soften the toner adhering to the fuser separation plate by raising the temperature around the fuser separation plate. And then, set the low power mode time and sleep time to 10 minutes or more, and switch off the silent mode. Leave the machine for 5-10 minutes under the above state.	
3	Open the conveying cover and then open the fuser exit guide.

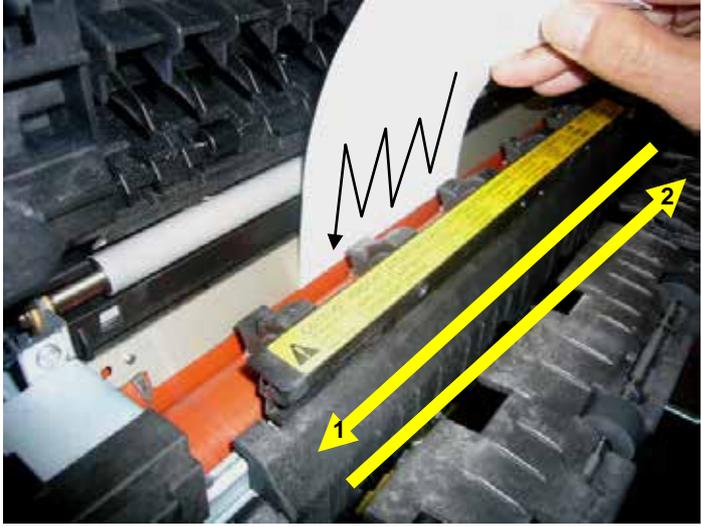
No.	Step	Detail
4	<p>Rub off the toner adhering to the fuser separation plate using the paper prepared at Step 1. (Clean the fuser separation plate from its end to the other end while gradually moving the paper.)</p> <p>Repeat the cleaning work going up and down 3 or 4 times until the leading end of the paper is not stained with the toner.</p>

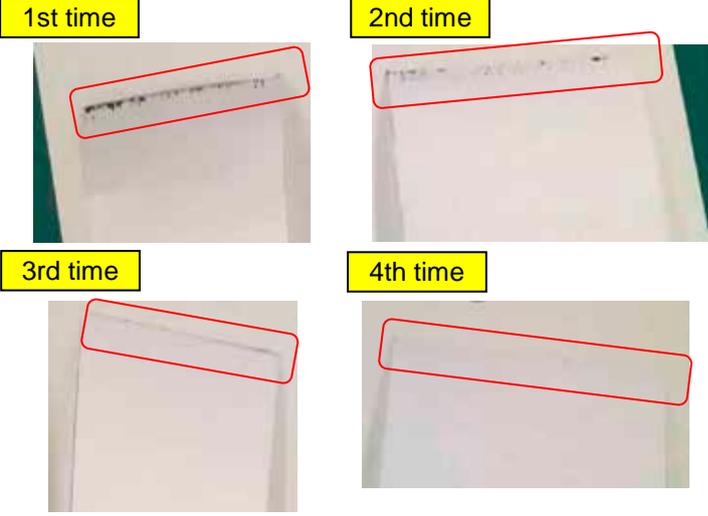
5	<p>Refer to the figures for the toner smudge on the paper's leading edge after the cleaning work from 1st time to 4th time.</p>
