Document Solutions

TASKalfa 3550ci Trouble Shooting Guide

Revision 2

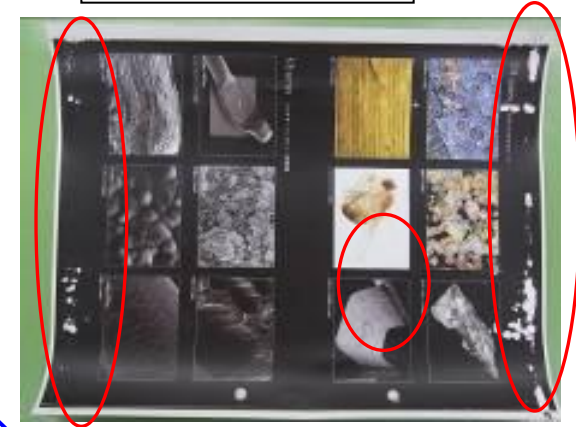
Image sample 1

It occurs notably in the composite solid part of image with many amounts of toner.

a. Take the measure or check along with the following flow chart.

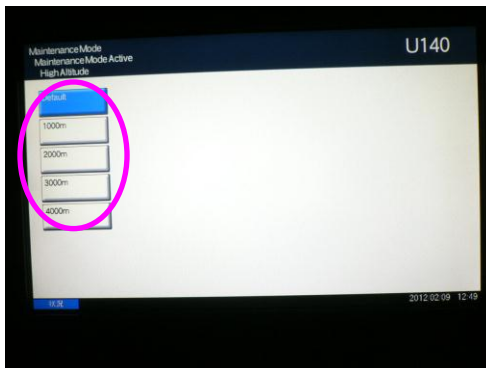
Image sample 1

- ◇ Leak at the solid part of image
Void image appears at the solid part.

1. If the solid part of image become void after printing U089 Color belt, go to next 2. *** If the horizontal line appears at the Halftone image part, replace the developing unit.**
2. Execute U140 → AC Calib → High Altitude
3. Select the high Altitude and find out the point which leak image does not appear.
*Avoid the setting far from actual altitude .
4. If the image will not be recovered, replace the developing unit.
5. Install the new firmware (**Plan to release at 2012 March**).

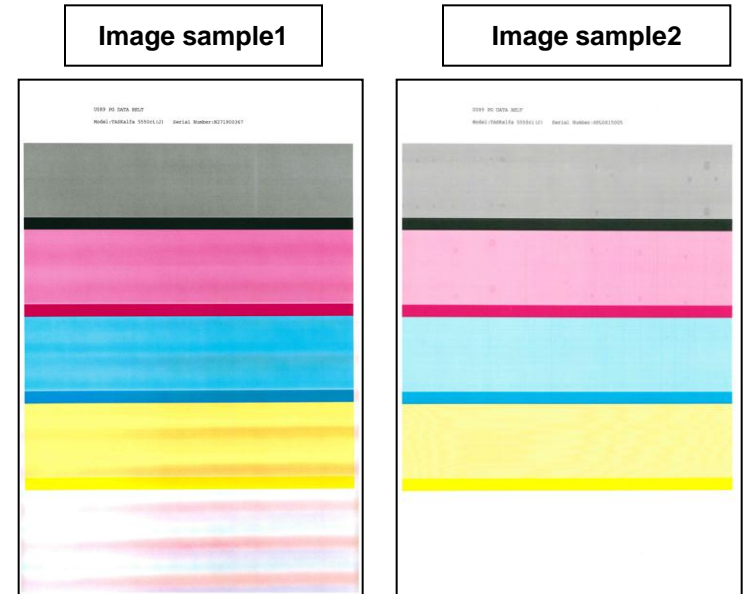
1. Background (Image sample 1)

Background (during continuous print)

- Version up the firmware to Upgrade Pack Ver. V3.07 and after,
- 1) Execute the calibration by U464.
 - 2) Execute the halftone auto adjustment by U410.

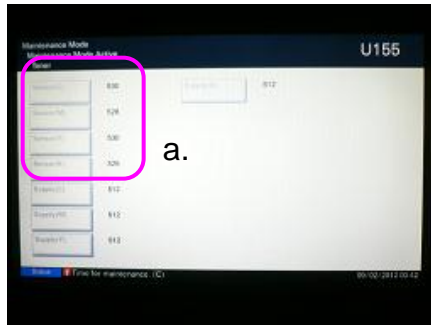
Image sample

2. Light image (refer to image sample)

Halftone image → Image density is lighter in a interval

- Check the toner sensor output by U155 Toner .
In case of higher than 542, supply the toner by U132 → Execute → Start.
- Firm up the engine firmware: **Use the Upgrade Pack Ver. V3.07and after.**
- Execute the calibration.
- If light image can not be solved by above (a.) to (b.) action.
Execute the developer refresh **One** times.
- If light image can not be solved by above (a.) to (d.) action.
Store the Maintenance Report into USB memory and replace the developing unit.

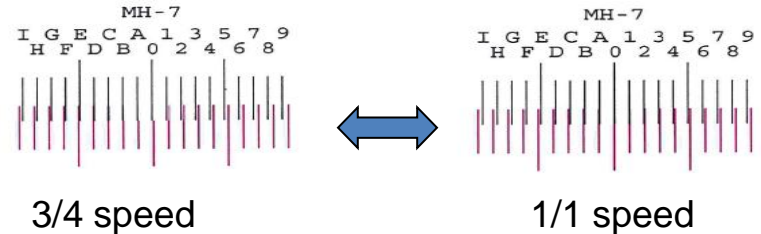
Image sample 1 (Enlarge of color registration adjust chart)

1. Main scanning direction color image shift (Image sample1)

A color shift of the main scanning direction occurs only at the time of 3 / 4 linear-velocity (Thick paper Heavy 1 setup) output.

- a. Replace the LSU of the color which has this fault.
(In the case of Oct. 2011 previous production machine)

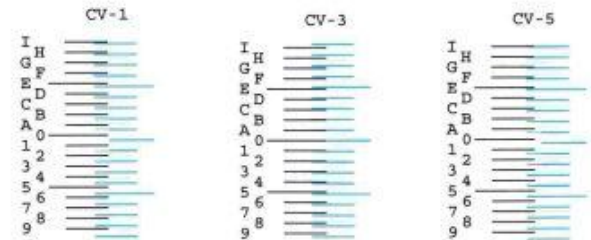
Image sample 3 (Enlarge of color registration adjust chart)

3. Sub scanning direction color image shift (Image sample 3)

- a. Replace the LSU of the color which has this fault.
(In the case of Oct. 2011 previous production machine)

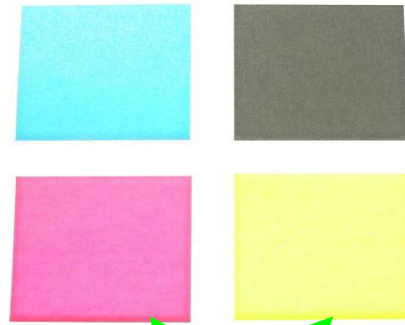
Thick density at bottom edge of solid image

The bottom end edge of the Solid image or the high density Halftone image is emphasized deeply.

- a. Firm up the engine firmware: **User the Upgrade Pack Ver. V3.03 and after**
- b. Increase +30bit for CMY at U464 "Target Value".
 - C: default 910 → 940 after changing
 - M: default 890 → 920 after changing
 - Y: default 910 → 940 after changing
- c. Execute U464 "Calibration"
- d. Check the image with above setting, if the result is not satisfied, use U464 "Edge Reduction" mode
- e. Execute the developer refresh twice
- f. Set U464 "Edge Reduction": ON

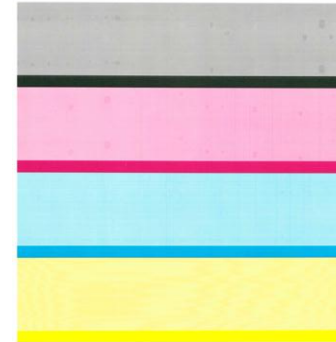
Image sample1

Color Belt image (OK image)

- Check there is no fault on image (sample1) which output by U089 Color Belt after executing the Calibration. → In case of fault on image, refer to the other trouble shooting.
- Repeat outputting the claimed image after executing the calibration, check the re-appearance of color change (Sample 2 output example)
- Upgrade the firmware most updated one
 - Execute calibration by U464, 2) Execute the U410 halftone auto adjustment.

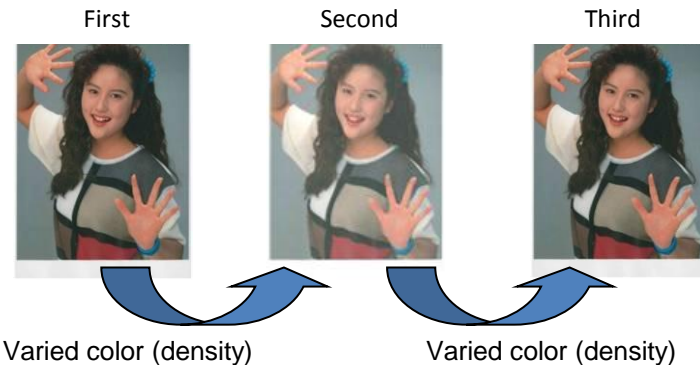
Image sample 2

3. Varied color image

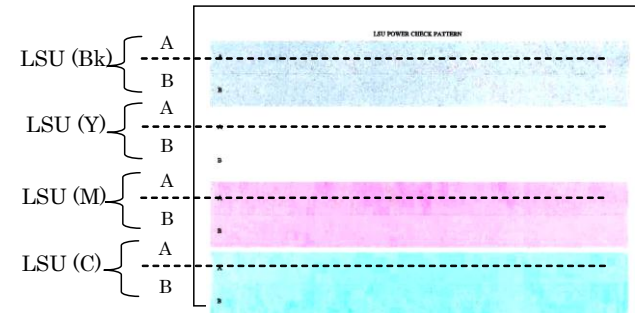
(Image file: LSU Power Check Pattern.capt)

A: density in full speed mode
B: density in half speed mode

1. Rewrite the LD1 and LD2 data for the applicable machine (Refer to [The procedure to replace the LSU]) (Applicable machine serial number: Refer to service bulletin.)
2. Replace the LSU for 8 of the machines instead of rewriting the LD1 and LD2 data (Refer to [The procedure to replace the LSU] on service bulletin) (Applicable machine serial number: Refer to service bulletin)

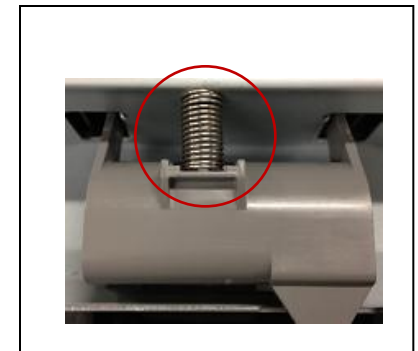
Fig.5 Check installation of SPRING RETARD

•As referring to Fig.5, check the installation condition of the Spring Retard whether it is misplaced or not.

h. If the problem is still not solved after performing above "g", replace the Primary Feed Unit.

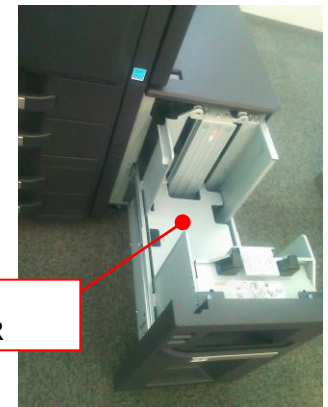
Fig. 1 JAM Paper

- d. If the TRAY PAPER for paper loading was assembled by slanting condition, there is possibility of JAM0545 occurring. In case of the problem, check it according to the next page "Inclination check and recovering procedure of PF-770 TRAY PAPER" and corrected.
(There is a possibility that J0545/0555/1305/1315 may occur.)

- a. If JAM paper or printout paper is like a Fig.1, replace the Roller of the Primary Feed. (Image sample 1)
- b. Replace with 303NG94011 PARTS FEED UNIT SP if the production of machine is before 2011 Dec.
- c. At replacement, check or clear the count number of U901 Paper Feeding Counter.
 - * The maintenance cycle for Primary Feed is 150K.*

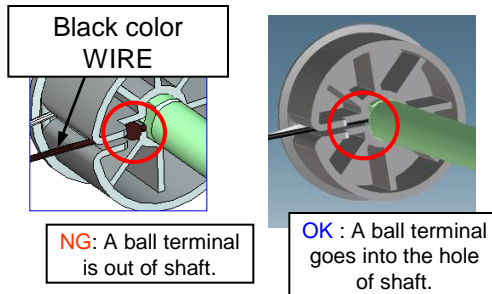
normal, it has a possibility that the ball is out of position as shown in the NG figure, re-assembly of the wire is necessary.

In the case of NG above item 2, it has a possibility that the ball is out of position at both of front and rear, re-assembly of a front and rear wire is necessary.

If above item 2 and 3 is NG, the following re-assembling is necessary.

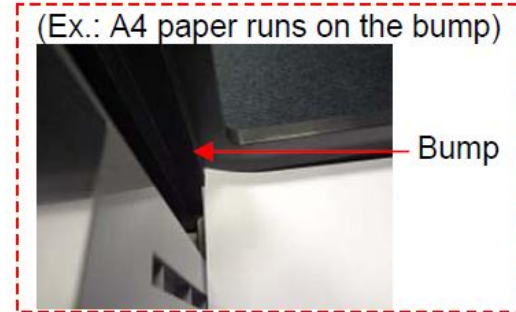
[With the sheet (No.1)]

When paper runs on, set paper correctly. Please adhesive the regulation sheet: PARTS SHEET STOPPER A4 SP(303NF94170) as needed.

*If paper seriously runs on, C1100/1110 may occur.

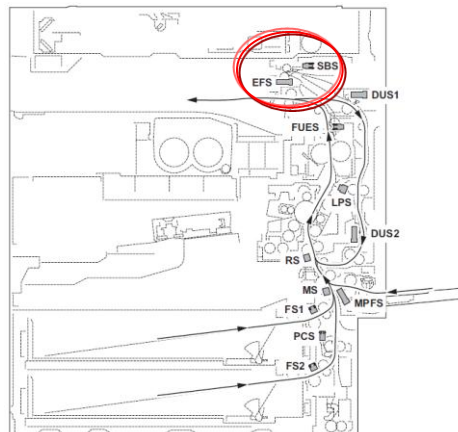
b. Paper jam occurs although paper is not damaged:

The possible cause is erroneous detection of the sensor. Please replace the sensor inside of the exit unit or the exit unit.

* Sensor: 7NXGP1A73LCH01(SENSOR OPT.); Exit unit: 302LH94271 (PARTS EXIT UNIT B SP)

* Change applied: Since April 2012 (As of the sensor alone, they were sorted out and handled from the March 2012 lot.)

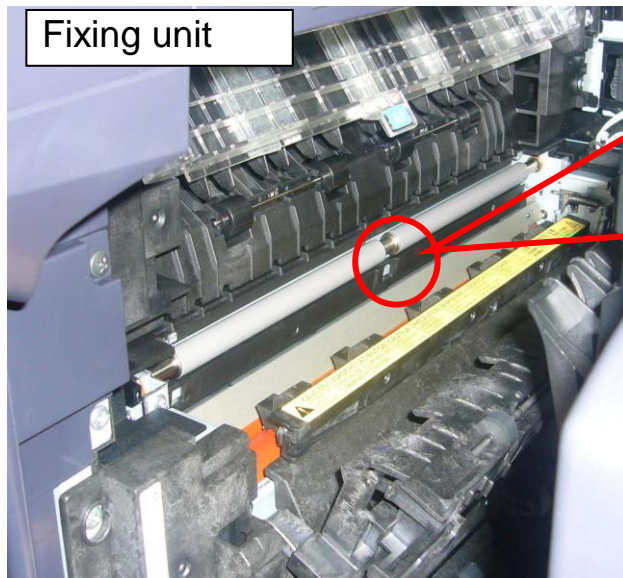
*SB:2LC-086 (C154)

The JAM4311 (Duplex sensor 1 stay jam) may occur if operating the machine under the following condition.

(Condition: The paper is ejected in the duplex mode to the right job separator at the state that the fuser unit is still cold after turning on the main power.)

Please exchange a fixing unit for the thing after the end 3.

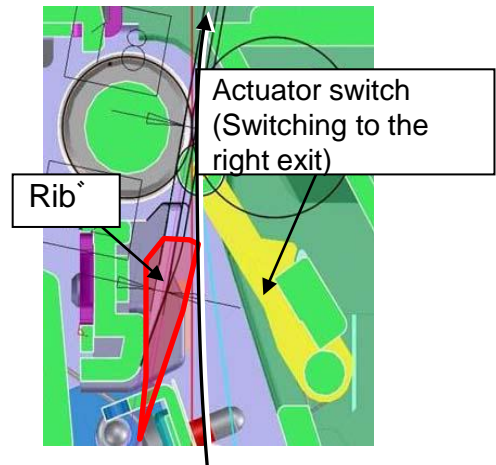
Change of the shape of the guide

Added two ribs for preventing the paper from being isolated from the actuator

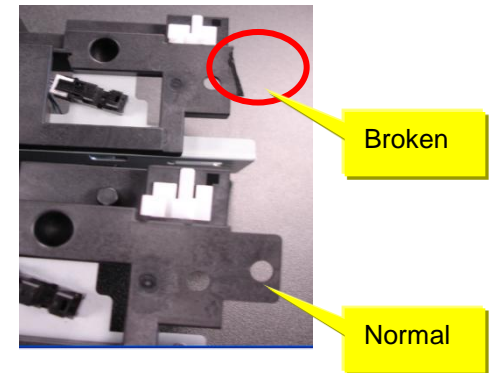
2. Check whether the positioning hole of the bridge drive unit is damaged.

→ If it is damaged, replace the AK drive unit (following item number.)

No.	Old	New item number	Parts name	Q'ty
1		303NB94200	PARTS DRIVE UNIT SP	1

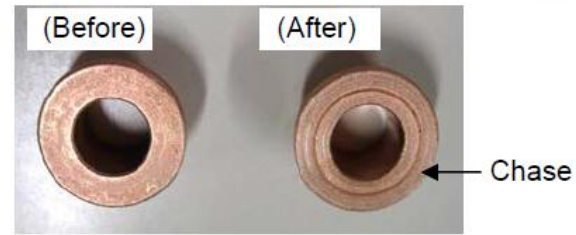
Fig 1

→ If it is old type shown in right fig, replace the bushing according to the replacement procedure (refer to the next page).

No	Old	New Item Number	Parts Name	Q'ty
1		302K324450 2K324450	BUSH 6	6

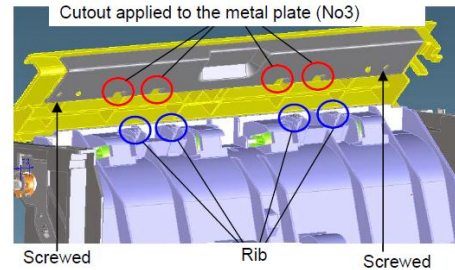
[Metal plate (No3) shape change]

10. Check whether the rib (blue color round mark on the right fig) of the conveying guide of the bridge exit unit is broken or not.

→ In case of breakage, replace the below part No.1 to 3 as referring to the service bulletin "2LC-0068(C076)

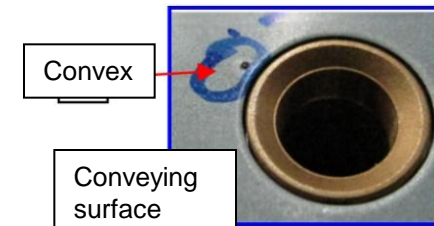
Paper is caught by the convex of welding part at the Punch unit upper guide conveying surface.

- b. If the serial number of unit is before below number, replace the Punch Unit.

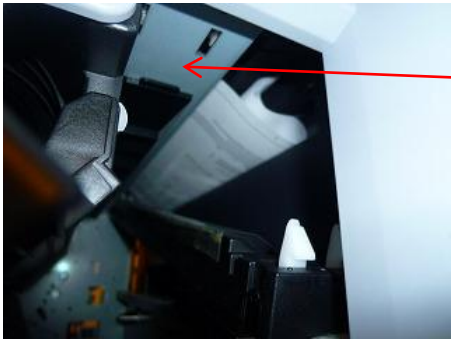
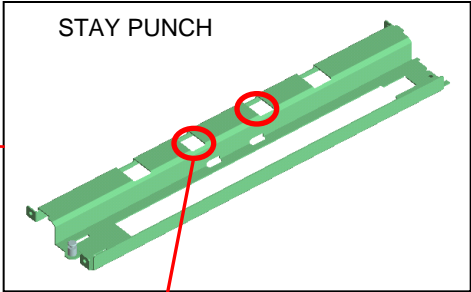
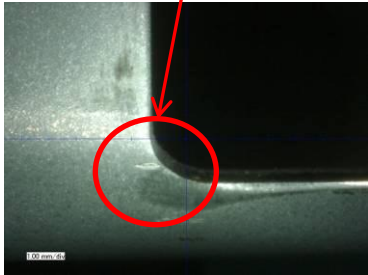
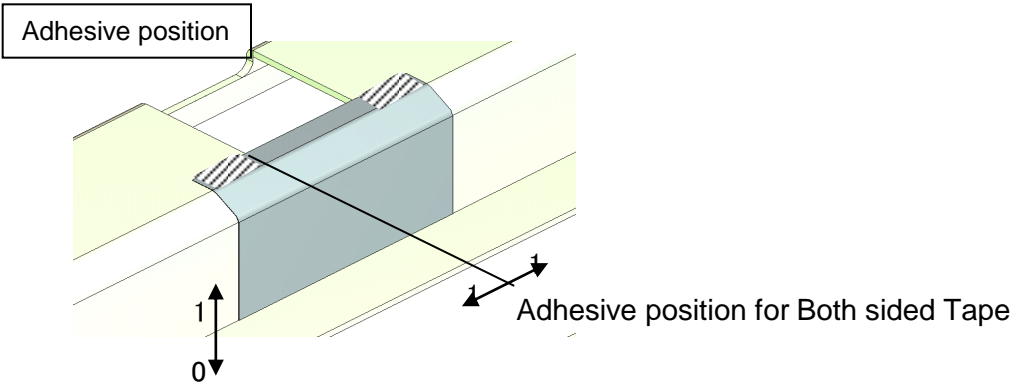
J6100 / J6110 (DF) (5/6)

4、 If the paper stop before the conveying-in roller and there is no damage on paper, check whether the paper is caught by the STAY PUNCH.

a. Add the PET Films on the middle part of cutout of the STAY PUNCH.

No	Old Parts Item	New Parts Items	Parts Name	Q'ty
1	303NB07140		SHEET ROLLER FEED	2

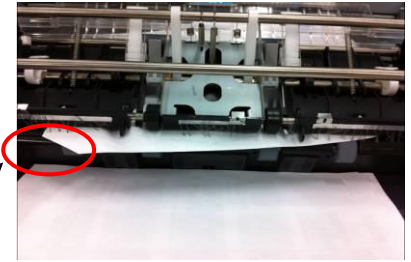
Image sample 1

1. Corner folding at paper leading edge or curling JAM (Image sample 1)

Corner folding

a. Replace the cursor.

- (a) Replace the cursor
- 303NB36031
- CURSOR L MIDDLE TRAY
- 303NB36041
- CURSOR R MIDDLE TRAY
- Affected from : 2012 Jan production

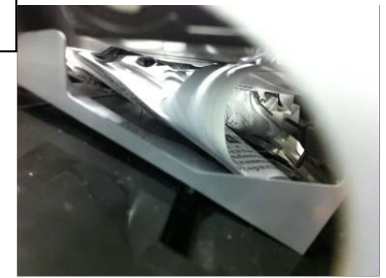
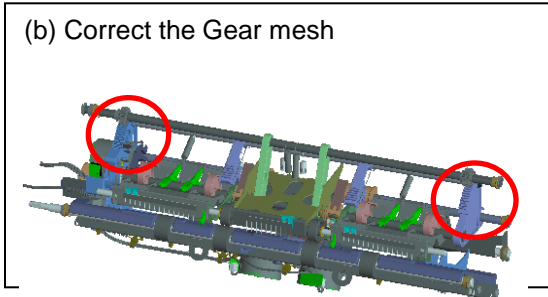
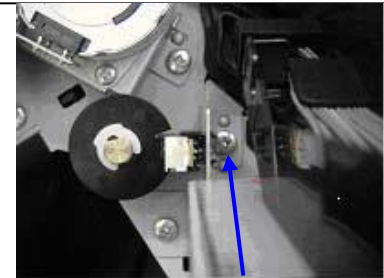
Image sample 2

2. Paper trail end folding JAM (Image sample 2)

(c) Place the MOUNT PI UPPER GUIDE

(b) Correct the Gear mesh

- (c) Replace the PI mount plate
- 303NB36321 MOUNT PI UPPER GUIDE
- Affected from : 2011 Oct. production

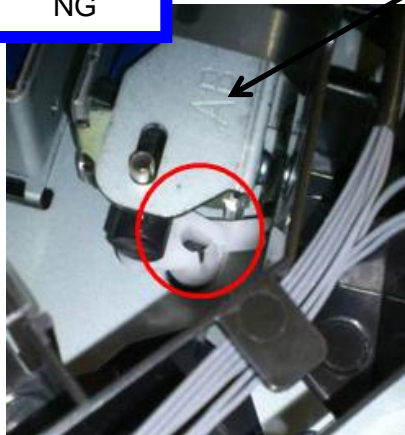
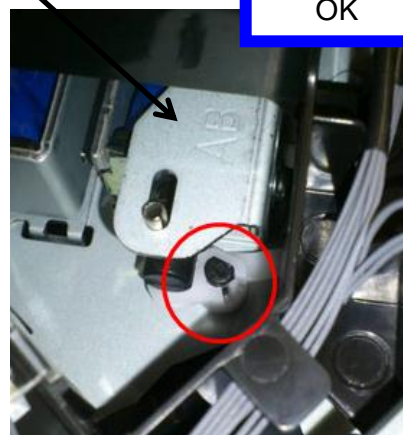
(b) Paper is fed to the direction2 instead of the direction1.

(a) Check the assembling condition of the Feedshift guide1.

Check the shaft of Feedshift guide 1 is firmly inserted into the lever of DF feedshift solenoid 1. In case of out of location, insert the shaft into level as shown in below photo.

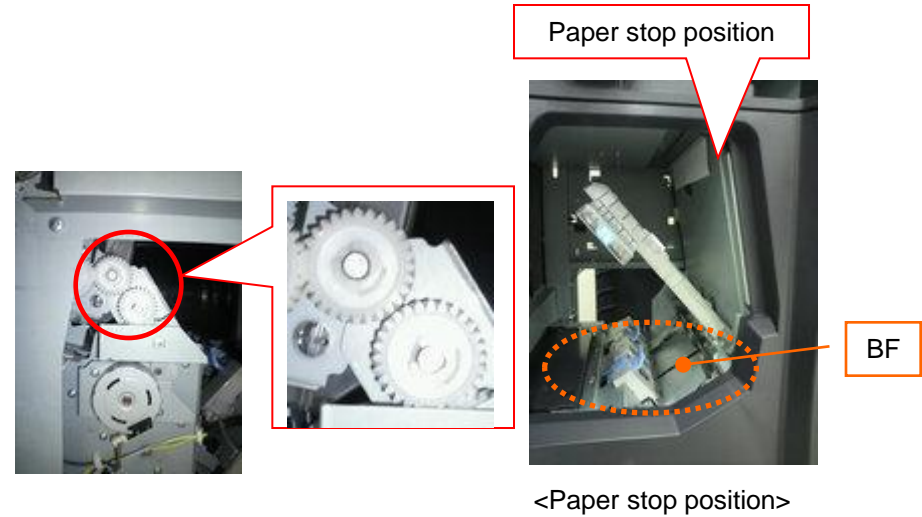
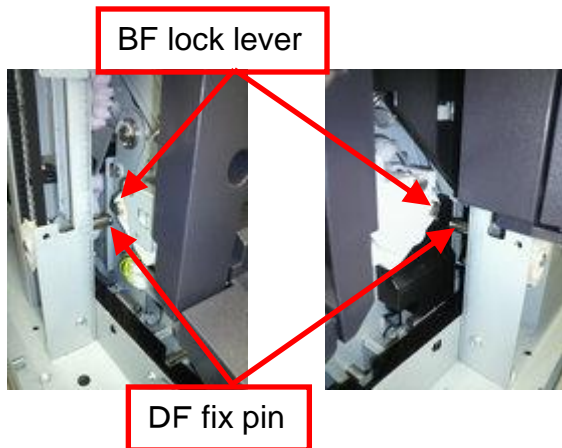
a. The JAM paper is stopped before reaching the BF.

b. Check whether the mesh of gears is not engaged or not after setting the BF into the DF.

→ If the gears are not engaged, replace the fulcrum pin (1) of BF lock lever, DF hook pin (2).

No.	Old	New Parts No	Parts name	Q'ty
1	303ND02280	303ND02281	FULCRUM PLATE RELEASE	2
2		303ND02360	PIN HOOK BOOKLET	2

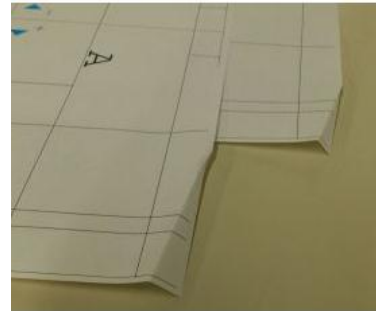
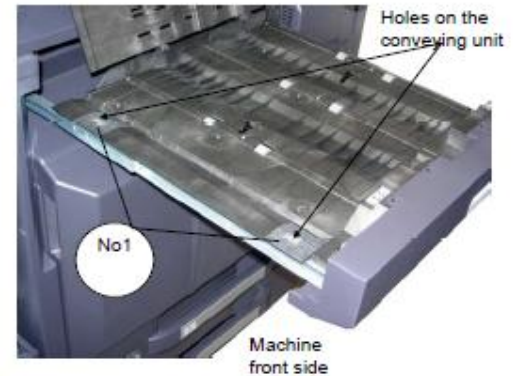
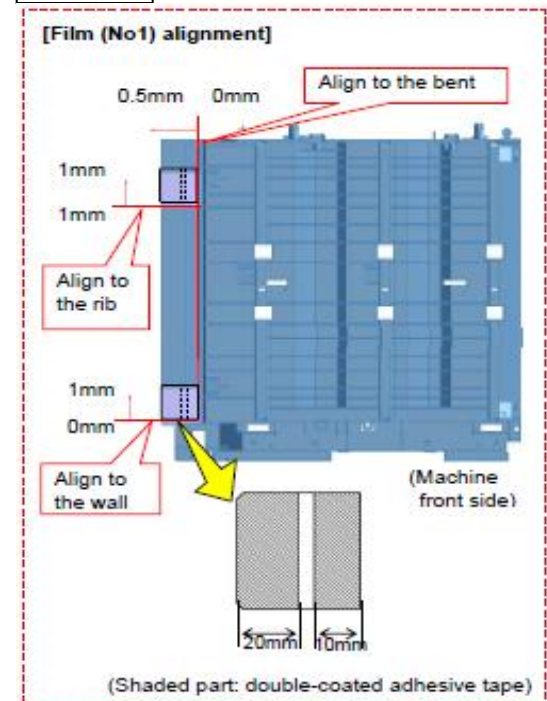
Sample1

If Corner Folding occurs at paper, check below item.

Affix the film (No.1) to the designated location at fig after cleaning where to affix it on the conveying unit. (Fig.2)

No.	Old	New Parts No	Parts name	Q'ty
1		302LF28820 2LF28820	SHEET RERAY LOWER	2

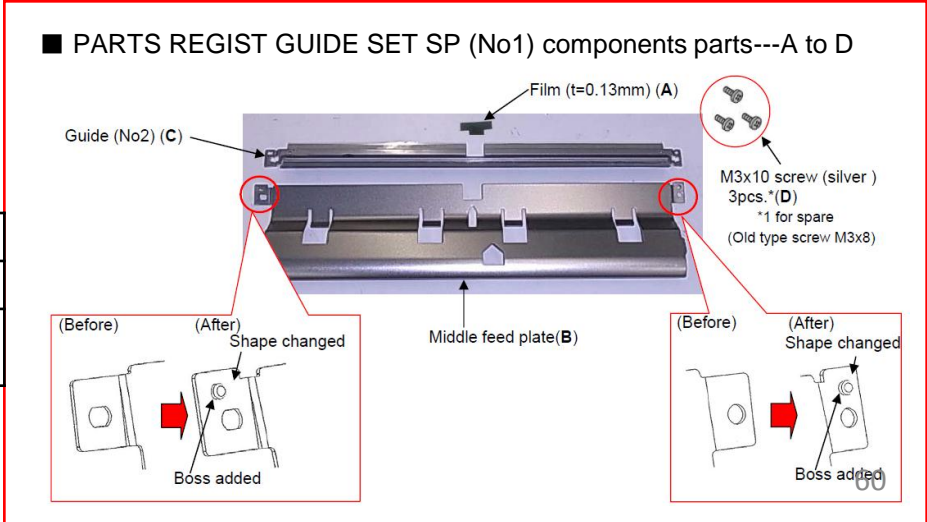
If the paper is above creasing condition, check whether modified guide below photo is equipped or not.

Add the modification guide (refer to next age for installation)

No.	Old Part No.	New Part No.	Description	Q'ty	
				Old	New
1	-----	302LC94690 2LC94690	PARTS REGIST GUIDE SET SP	-	1

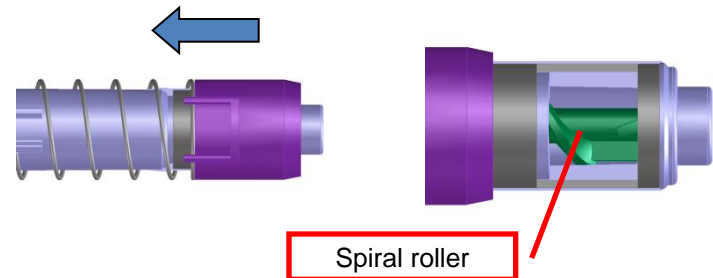
<Fig2 Check Spiral Roller Rotation

Check whether the spiral roller is rotating when turning the drum manually.

- a. Remove the DRUM unit from machine.
- b. Check the drum rotation (refer to Fig1)
In case of no rotation, replace the drum unit
→ skip to “e”.
- c. Check rotation of the drum spiral roller (refer to Fig2)
In case of no rotation, replace the drum unit,
→ skip to “e”.
- d. Replace the engine PCB.
- e. Check the Firmware version and version up to above FW
PACK V3.03.

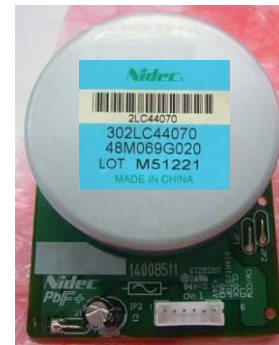
Old Drum Motor

- a. Check whether the poor connection for motor connector.
- b. Check whether the drum unit is locked.
- c. Replace the drum motor.

302LK94101 PARTS DRUM MOTOR SET SP

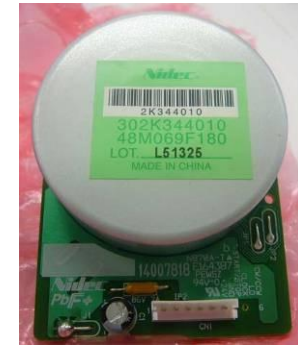
New Drum Motor

Affected production month: 2011 May 27th and after

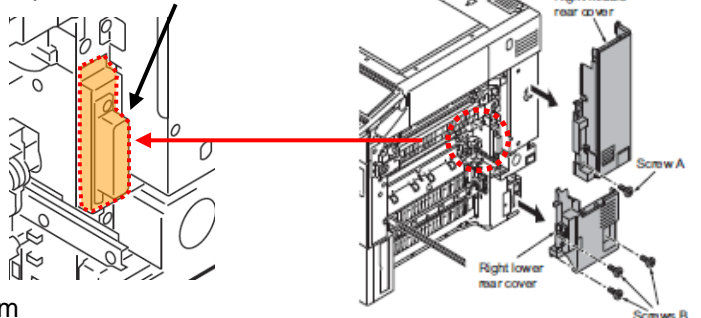
Fault on Drawer Connector

Replace Drawer Connector

Item 7YCC60M2199+H01 CONNECTOR

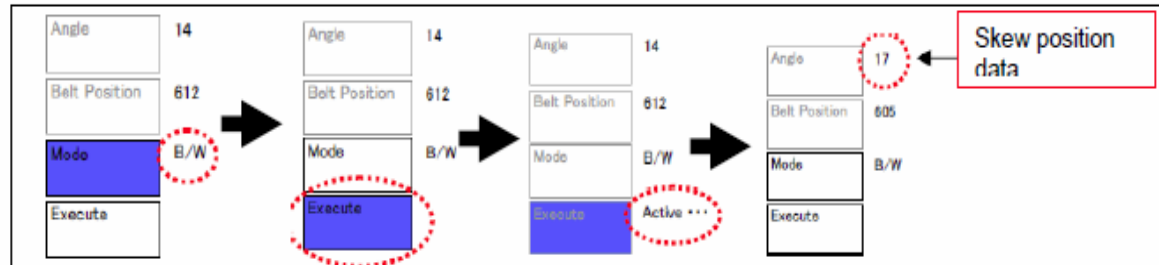
Middle Transfer belt Skew Feed

Angle: 6 to 26 = OK
 Angle: 5 or less, 27 or more = NG

- Version up the firmware with most updated one.
- Execute U469 Adjust Color Registration → “Belt Check”
- Set Mode “B/W” → select “Execute” → Press “Start” Key → Start detection (1 to 2 min)
- After disappearing the “Active” display, check the “Angle” display value.
- If “Angle” value is within 6 to 26, OK (To the next page), If below 5 or above 27, NG and go to below f.
- Detach the middle transfer unit and install.
- Execute U469 above b to e again.
- If NG at above g., replace the middle transfer belt unit.

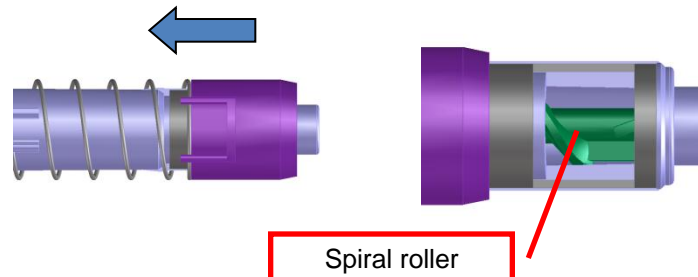
<Fig2 Check Spiral Roller Rotation

Check whether the spiral roller is rotating when turning the drum manually.

- a. Remove the DRUM unit from machine.
- b. Check the drum rotation (refer to Fig1)
In case of no rotation, replace the drum unit
- c. Check rotation of the drum spiral roller (refer to Fig2)
In case of no rotation, replace the drum unit.
- d. Check the poor connection of cleaning lamp connector.
- e. Replace the HVT PCB.
- f. Replace the engine PCB.

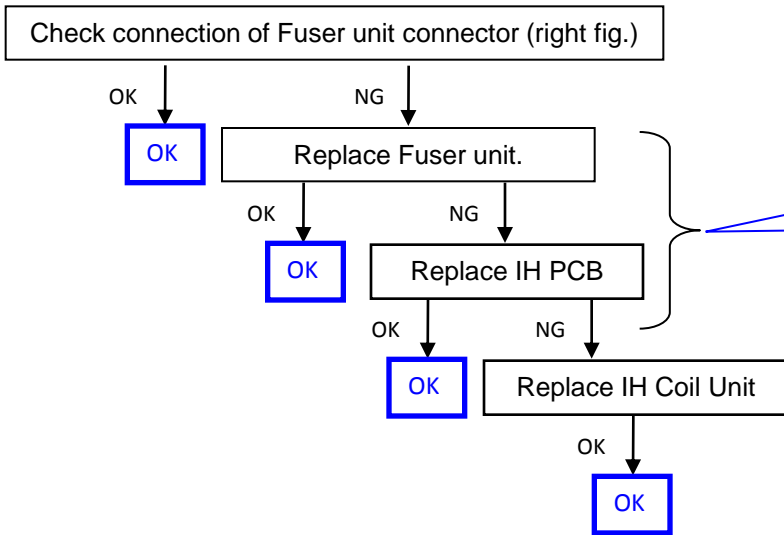
1.C6770

When C6770 occurs after cable of Fuser unit is shorted and broken, while the fuser unit is kept installing without replacing and replacing with new IH PCB first, IH PCB will be damaged. So, replace the IH PCB after replacing the Fuser unit.

Check the connector of Fuser Unit

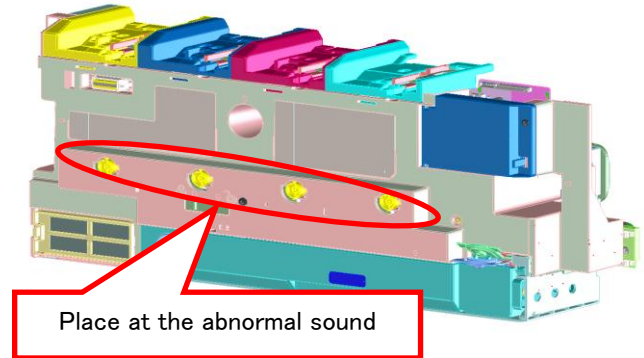
attention 1

**There is a possibility that DLP is LOCKing by jam in the developing powder outlet etc.
(It may be accompanied by C2101 and C7101)**

When pushing in the CASS LOCK release LEVER at the INNER UNIT, there is a case not to push in smoothly.
In that case, without pushing in by force, re-install the INNER UNIT while shifting it by right-hand side and fix.
If it pushes into INNER UNIT forcefully, the lock release cannot be done normally, C2101, C7101, and unusual sound occur again and DLP UNIT may damage.

- a. Replace the DLP UNIT .
- b. Re-assemble it as referring to below attention 1.

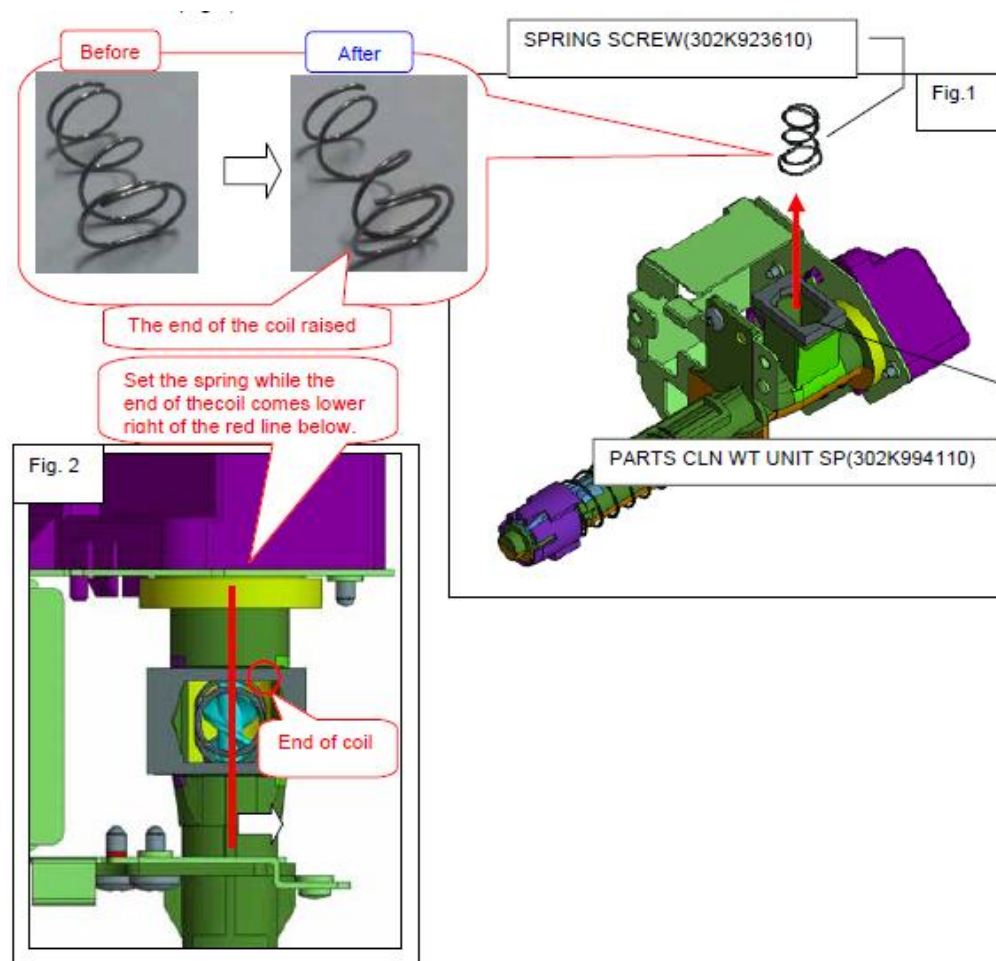
1.Abnormal sound for the middle transfer belt conveying

- Remove the PARTS CLN WT UNIT(302K994110) (Fig.1)
- Remove the spring inside of the nozzle. SPRING SCREW(302K923610) (Fig.1)
- Place the last one turn of the spring at the end of coil over the previous turn.
- Reseat the spring while taking care of the direction of the spring (the end of the coil comes to lower right of the red line below (Fig.2)

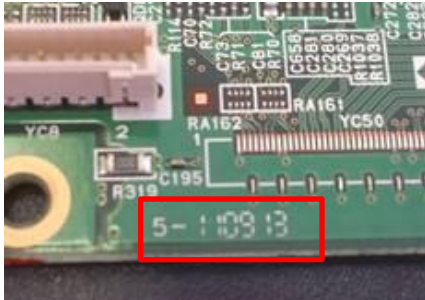
NG

The fault on present condition cannot be specified due to the through hole disconnection on the base plate of engine PCB.
(It is the feature that it works without any problem after immediate power supply, but the problem occurs after contious usage.)

Check the silk prints at screw hole of lower middle part on the Engine PCB
Affected Engine PCB Lot:110913

Replace the engine PCB

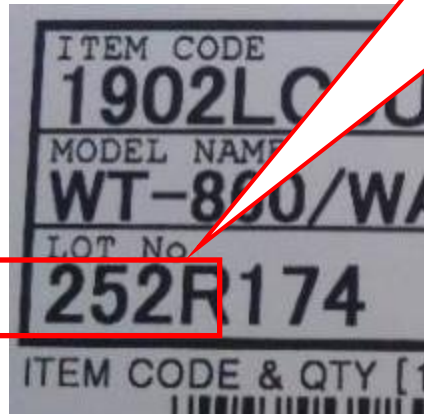
Fig.A

1st digit: production year
2nd digit: production
In this case, 2012 May. production

* In case of the top 2digits is "25" (2012 May. production) or before, perform the checking mentioning at right.

- a. When Lot No. of the waste toner bottle is "25" (refer to fig. A) and before, check it as referring to the fig. B.
- b. When there are any faults such as peeling and poor adhesion, replace with another waste toner bottle.

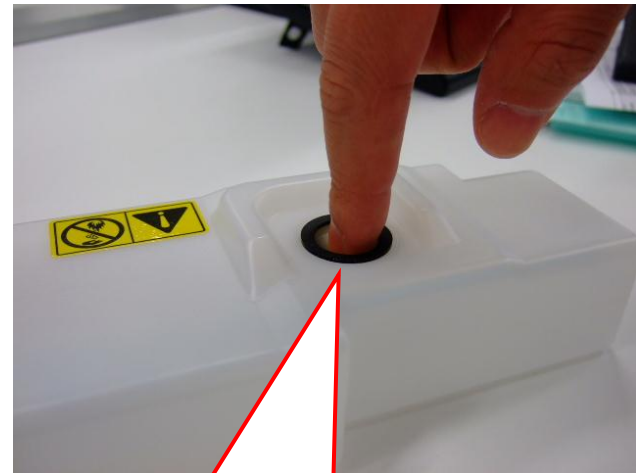
Fig.B

Push it lightly by a fingertip and check peeling and adhesion.

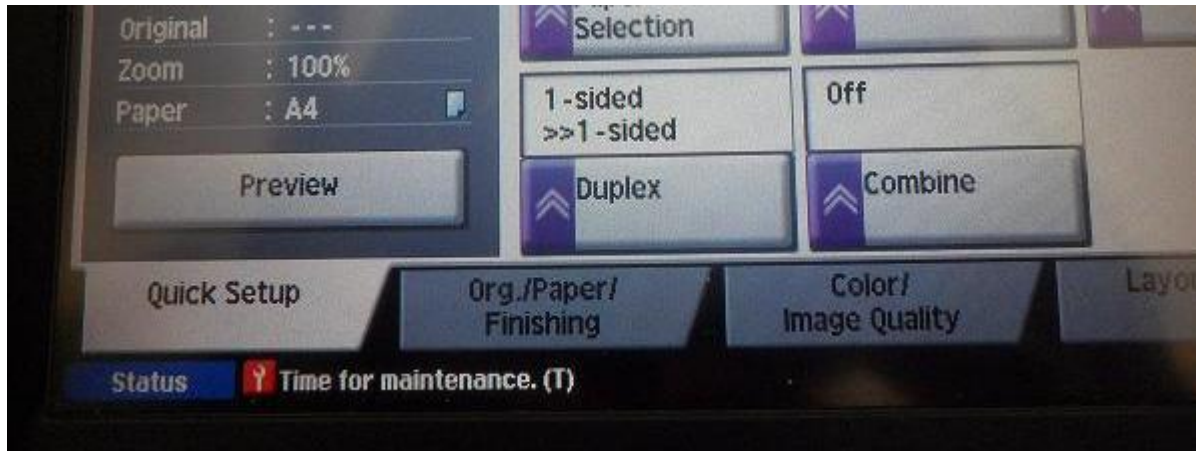
When "Time for maintenance.(T)" was displayed on a status bar (refer to attachment picture), please take the following measure.

- a. Performs resetting partial operation control in Sim.906.
- b. Set up the present time from a system menu.
- c. When can not canceled above, please exchange Main PCB.
