Service Bulletin

Ref. No. **COM-0218 (B056)**

Subject	Note when releasing the paper jam/maintaining the machine (Prohibition of use of the flammable sprays and liquids)
Model	All models

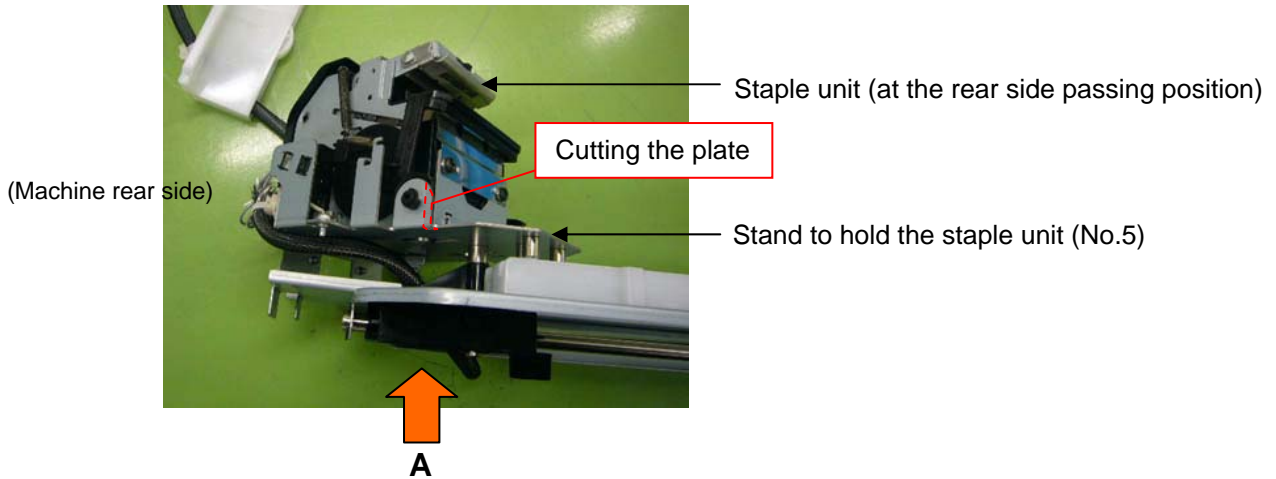
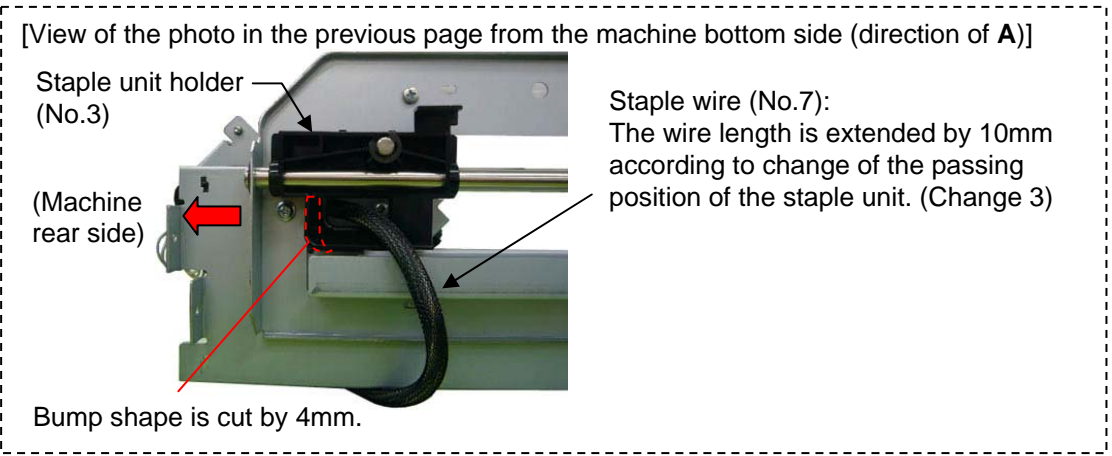
<Staple unit slide section at the machine rear side> (Below is the old shape)

[Change 2 Avoiding the contact with the staple unit that is at the new migrating position]

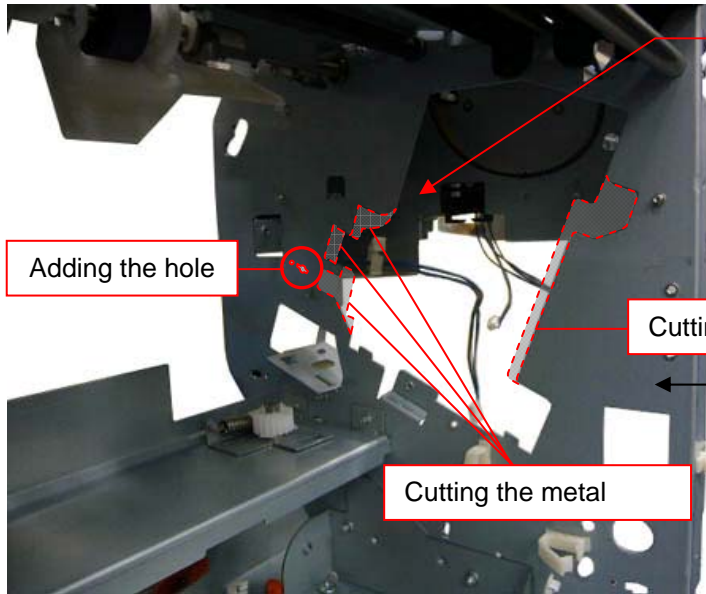
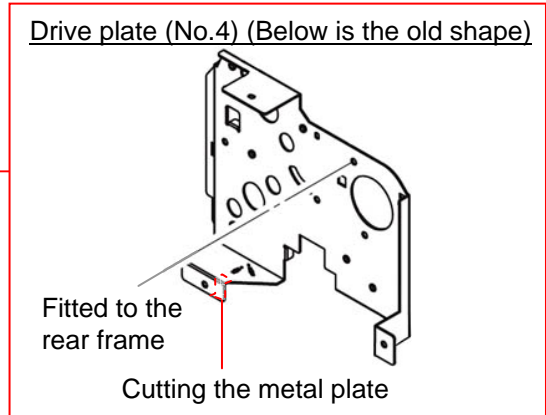
<Slide section of the staple unit at the machine rear side>
(Below is the new rear frame.)

Cutting the metal

New rear frame
(It is not supplied in the field)
: - The hole for migrating the staple unit is expanded. (Change 2)
- The hole for fitting the RDHS wire alignment part (No.9) is added. (Change 3)

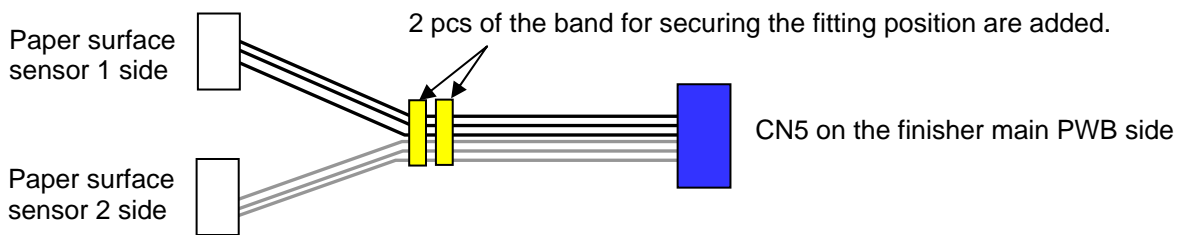
<New RDHS wire (No.6): It is the wire to connect the paper surface sensor 1/2 to the finisher main PWB (CN5)>

[Change of the wire length of the RDHS wire]
- The wire of the paper surface sensor 1 side (black): (Before) 370mm --> (After) 400m

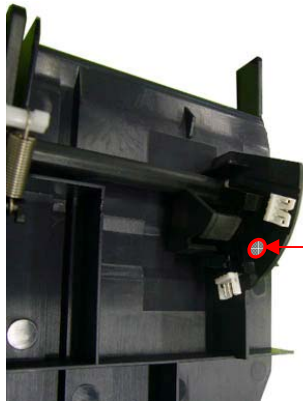
<The paper surface sensor 1/2 fitting section on the paper feed left guide (No.8) at the machine rear side>

The hole for fitting the RDHS wire alignment part (No.10) is

Wire alignment part (No.9):
Both of the wires (black/gray) of the paper surface sensor1/2 side of the new RDHS wire (No.6) pass through it.

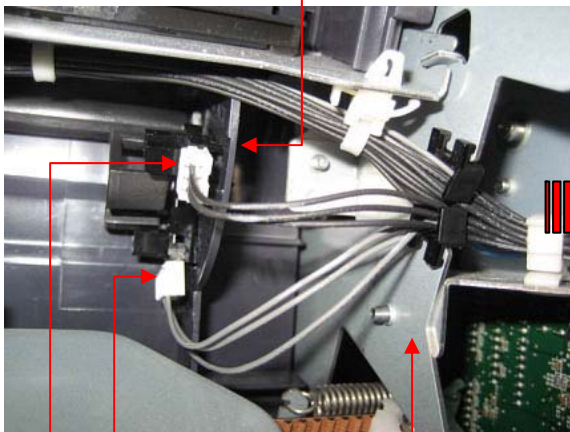
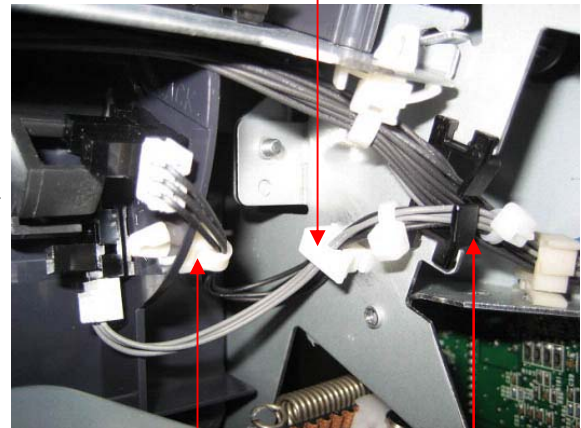
<Change of the wire alignment of the RDHS wire (No.6)>

(Old wire alignment) Old paper feed left guide (No.8) (New wire alignment)

Old rear frame

Old RDHS wire (No.6)
: The wire of the paper surface sensor 2 side (Gray)

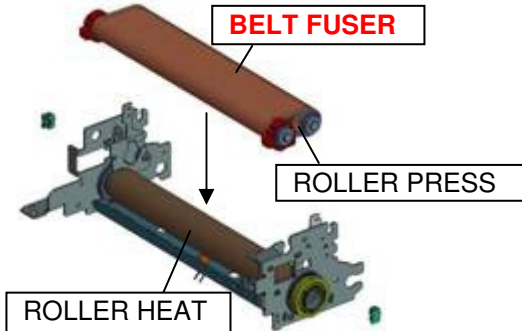
For strengthening BAELT FUSER in the fuser unit (FK-570), the belt surface finish is added before fitting the guide preventing meandering of BELT FUSER According to this change, the shape remains unchanged.

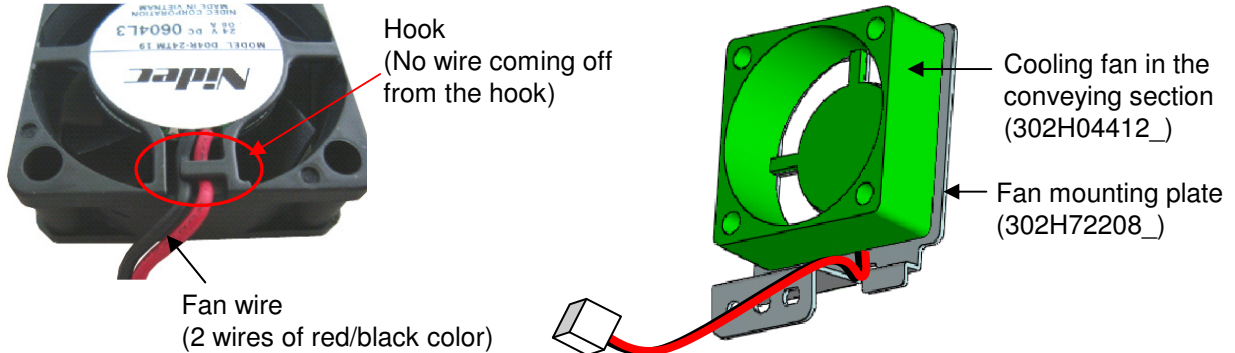
(Photo in below is the fitting side to the fan mounting plate of the cooling fan)

- 1) Check if the wire (2 wires of red/black color) of the cooling fan stays at the hook inside and is not pinched up between the cooling fan and the cooling fan mounting plate.

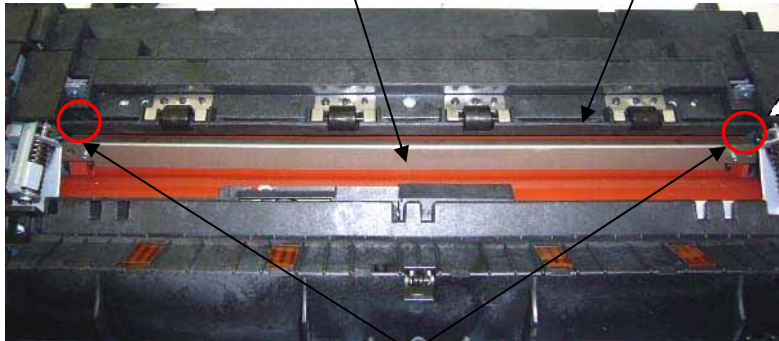
<Fuser unit> Fuser separation plate Fuser guide (No.13)

The position adding the ribs

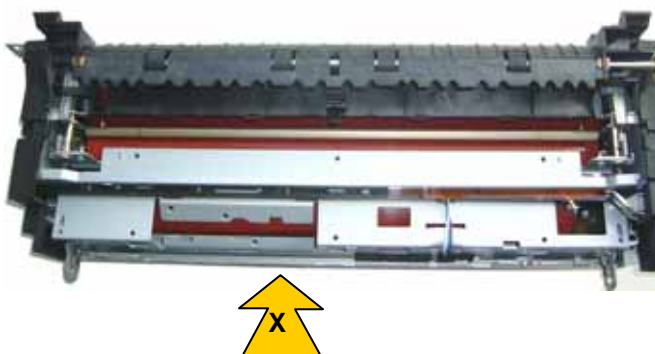
4. Check if there is paper.

(It is possible to check if the paper is wrapped around the fuser roller by viewing from X in the figure below.)
If the paper can be removed, securely remove so that the paper piece does not remain.

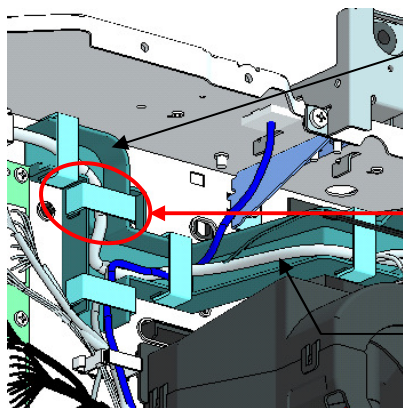
Deleting 1 pce of HOLDER WIRE A (No.1)
(Parts List: Fig.28-28)

For improving the assembly process, 1pce of HOLDER WIRE A (No.1) that aligns WIRE TRANSFER JOINT/WIRE TRANSFER EXIT is deleted.

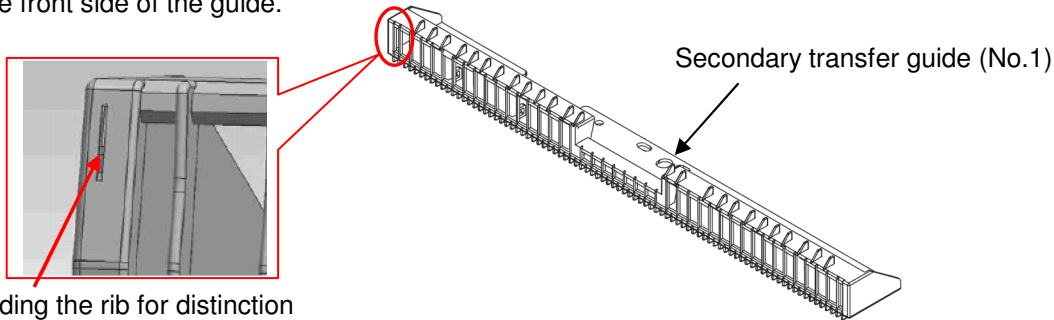
The rib on the secondary transfer guide (No.1) is thickened for common use of the parts. The parts number remains unchanged according to this change. However, the rib for distinction is added to the machine front side of the guide.

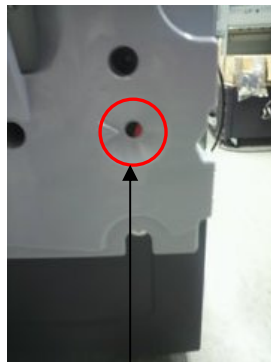
Red color is partly visible.

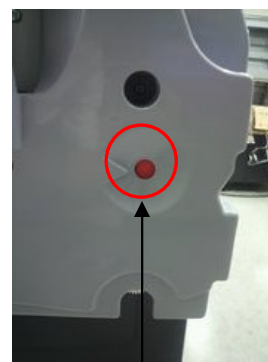
All of red color is visible

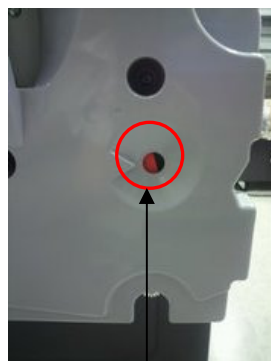
Red color is partly visible.

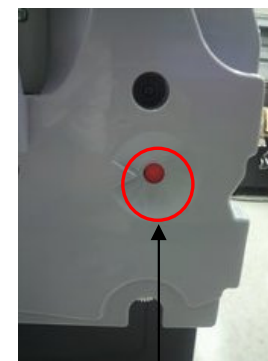
All of red color is visible

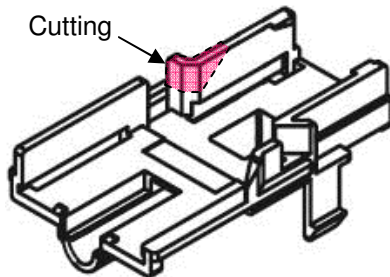
[PIPE DLP UP (No.1)]

Edge of PIPE DLP UP (No.1) is partly cut for common use of the parts.

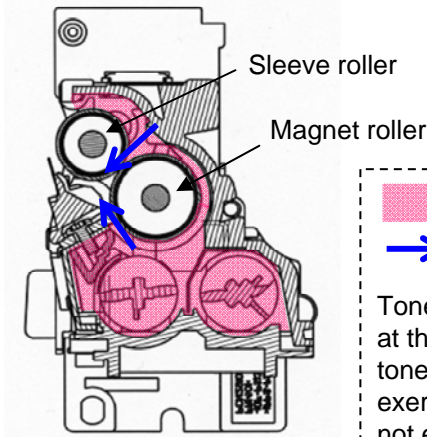
(Cross section figure of the normal Bk developer unit viewed from the machine front side)

Developer housing: Diameter of the hole at the both sides of the developer housing is widened from 3mm to 6mm to reduce the toner scatter from the inside of the developer unit to the magnet cover by lowering the internal pressure of the edge section of the developer unit. (According to this change, the amount of the toner scatter from diameter 6mm hole of the developer housing increases. However, there is the developer filter in the upper part of the 6mm hole and the filter partly removes the scattered toner.)

: Section where the internal pressure of the developer unit is exerted.
 : Direction of the toner scatter
 Toner scatter is reduced by especially lowering the internal pressure at the both ends where the toner is frequently scattered because the toner is scattered from the section where the internal pressure is exerted to the side of the sleeve/magnet roller where the pressure is not exerted.

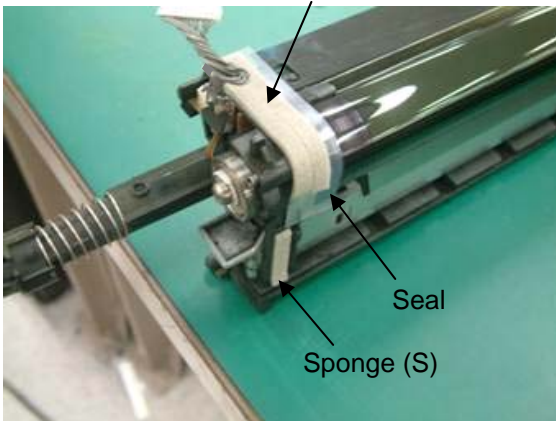
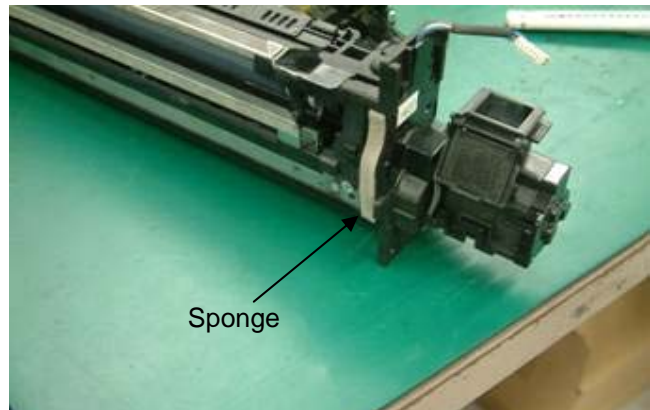
Sponge (L)

(-->) *Image failure may appear if the sponge and seal are not affixed in the correct position. Therefore, affix them correctly according to the procedures.

(e.g.) If the seal affixed together with the sponge (L) shifts inside to the right as in the photo of drum unit below, it gets in between the DS pulley* and drum to cause the faint image.

Please separately order the seal kit (No.3) and affix the sponge and seal to the new drum unit when replacing the drum unit in the machine that installs the Bk developer unit for preventing the toner smudge.

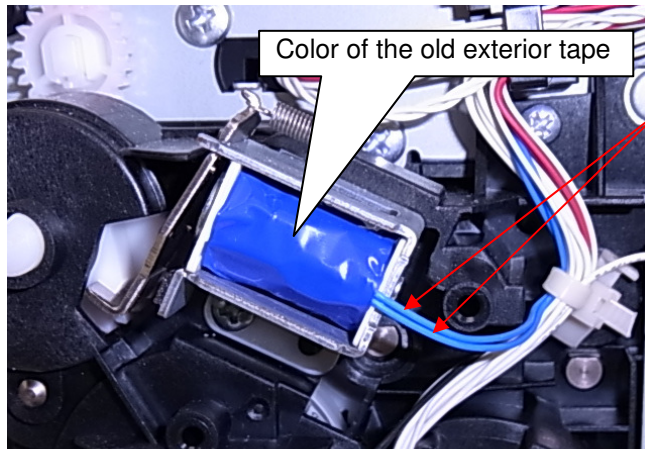
(Below is old No.11)

In order to enable to visually check the presence of the gap between two wires of the solenoid (Coating color of the wire is blue) that are aligned under the exterior tape, color of the exterior tape of the solenoid is changed from blue to white. (Visual check becomes possible because the blue coating of the wire of the solenoid can be seen through the new exterior tape that is white.)

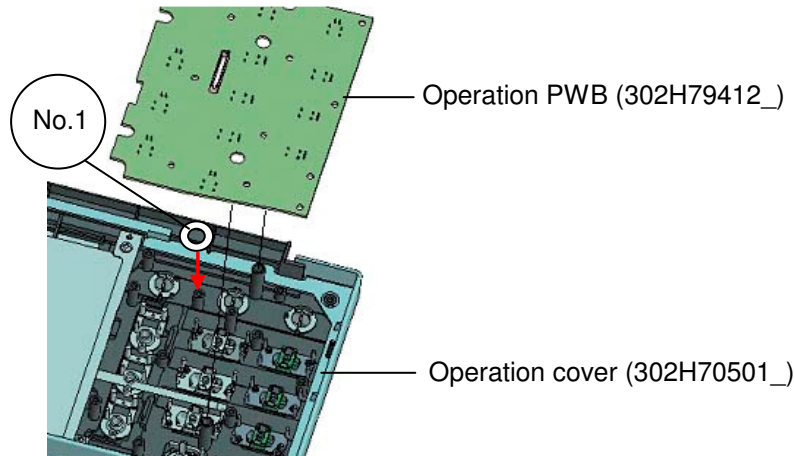
SPACER USB (No.1) is added to secure the clearance margin for the operation cover with the operation PWB.

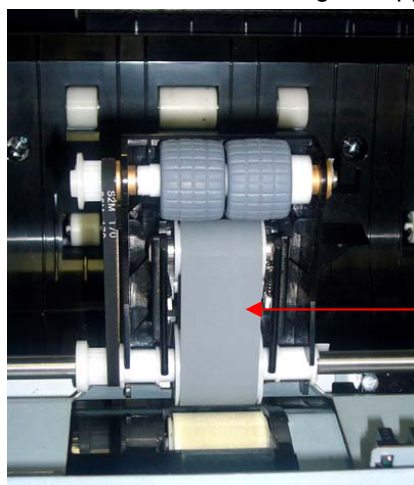
DP original feed belt (No.2)

As the result, the DP original feed belt may rarely drift when feeding the original at DP depending on the variation of the parts, and it may cause the paper jam (JAM70/71/72). Therefore, following are changed.

No.	Old Part No.	New Part No.	Description	Q'ty		Com pat i bi lity		Remarks
				Old	New	Old	New	
1	303JX94080 3JX94080	303JX94081 3JX94081	PF ASS'Y SP	1	1	X	O	DP-700
2	303LL07530 3LL07530	303LL07531 3LL07531	+BELT PF	1	1	X	O

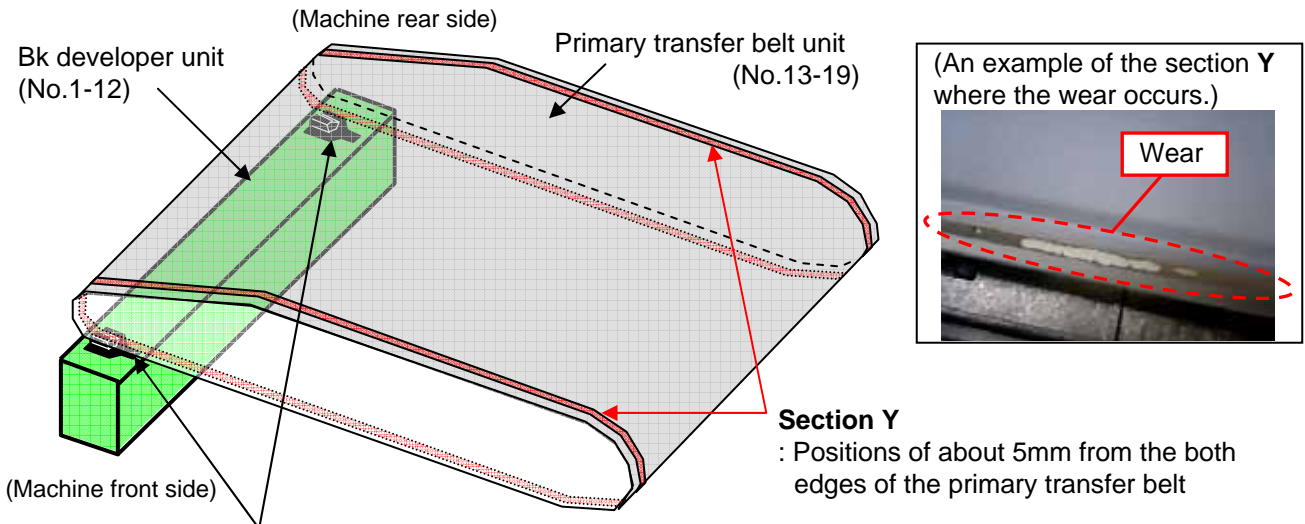
<Seal (X: 20) on the topside of the Bk developer unit>

The affixing position of the seal (X in the figure below: No. 20) on the topside of the Bk developer unit was changed before (Note 1) as the countermeasure against the primary transfer belt side scratches. (*1)
Following is changed to reduce the wear at the positions (Section Y) of about 5 mm from the both edges of the primary transfer belt.

(*1) When the section Y at the primary transfer belt is worn down due to increase of the friction resistance between the primary transfer belt and the seal under the influence of the operation environment (high temperature/high humidity), the following phenomena may occur.

- White steaks or black streaks from the cleaning failure because of the scratched dust getting into the developer unit and the drum unit.
- Image failure from tear of the primary transfer belt because of the scratches going further to tear.

Material/Color: Seal planted nylon fiber/Black

Material/Color: Fujiron (Teflon felt) (Dark)

Material of the seal (X: No.20) on the topside of the Bk developer unit is changed to the one with lower friction resistance than before to reduce the wear of the section Y of the primary transfer belt.

Material of the seal: (Before) Seal planted nylon fiber (Black) --> (After) Fujiron (Teflon felt) (Dark brown)

1. Peel off the seal (**X**) on the topside of the Bk developer unit (Old No.1-12), and affix the new seals (**X**: New No.20) to the machine front/rear side of the Bk developer unit after cleaning the affixing part with alcohol. (Please refer to the attached leaflet for the alignment.)
2. Replace with the new primary transfer belt (No.13-19).
(New seals (**X**) in the above 1 should not be separately procured because the new primary transfer belt unit bundles 2 pcs of the new seal (**X**.)

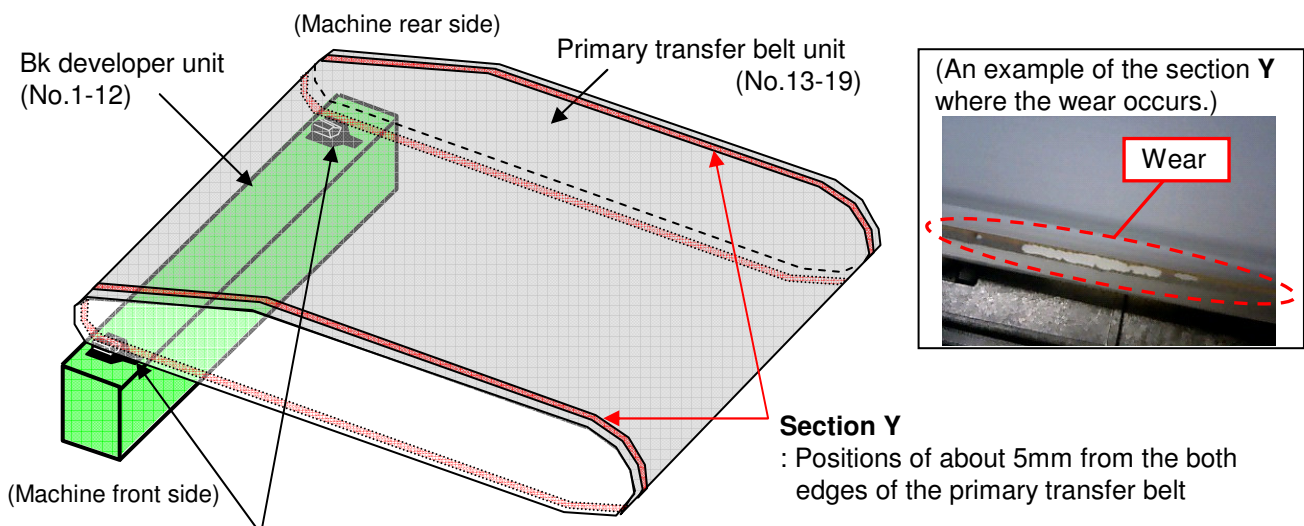
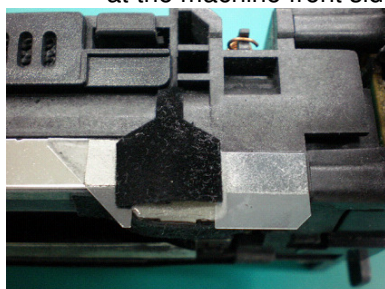
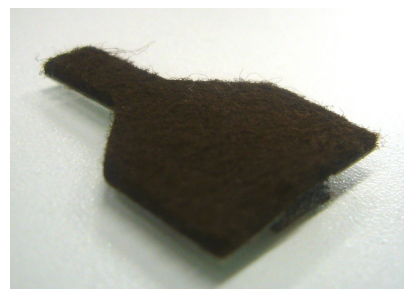
<Seal (X: 20) on the topside of the Bk developer unit>

The affixing position of the seal (X in the figure below: No. 20) on the topside of the Bk developer unit was changed before (Note 1) as the countermeasure against the primary transfer belt side scratches. (*1)
Following is changed to reduce the wear at the positions (Section Y) of about 5 mm from the both edges of the primary transfer belt.

(*1) When the section Y at the primary transfer belt is worn down due to increase of the friction resistance between the primary transfer belt and the seal under the influence of the operation environment (high temperature/high humidity), the following phenomena may occur.

- White steaks or black streaks from the cleaning failure because of the scratched dust getting into the developer unit and the drum unit.
- Image failure from tear of the primary transfer belt because of the scratches going further to tear.

Material/Color: Seal planted nylon fiber/Black

Material/Color: Fujiron (Teflon felt) (Dark brown)

Material of the seal (X: No.20) on the topside of the Bk developer unit is changed to the one with lower friction resistance than before to reduce the wear of the section Y of the primary transfer belt.

Material of the seal: (Before) Seal planted nylon fiber (Black) --> (After) Fujiron (Teflon felt) (Dark brown)

2. Replace with the new primary transfer belt (No.13-19). (New seals (X) in the above 1 should not be separately procured because the new primary transfer belt unit bundles 2 pcs of the new seal (X .)					
And, please draw out the primary transfer belt before detaching/reinstalling the Bk developer unit.					
Serial Nos. of Affected Machine: (-->)					
TASKalfa500ci	KME	Consip 17	KMHG	Other spec	
	QHW1303116	QHW1303291	QLA1300033	Next production	
TASKalfa400ci	KME	KMTW	KMSG	KMHG	KTST
	QJA1305350	QGG1300041	QFG1300116	QKZ1300054	QMM1300136
	Other spec				
	Next production				
TASKalfa300ci	KME	UTAX/TA	KMTW	KTST	Other spec
	QJE1307986	QER1302081	QGF1300112	QMN1300162	Next production
TASKalfa250ci	KME	UTAX/TA	KMTW	KMSG	PHILIPINE
	QJK1335583	QEQ1313032	QGE1300097	QFE1300294	QLU1300059
	Other spec				
	Next production				
TASKalfa552ci	Next production				
<Serial number of the developing unit>					
No.1/2: KBT1322119-		No.3/4: KKZ1301557-		No.5/6: KUQ1275407-

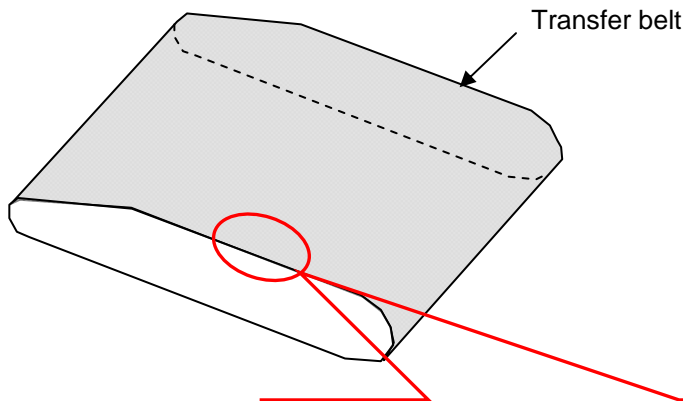
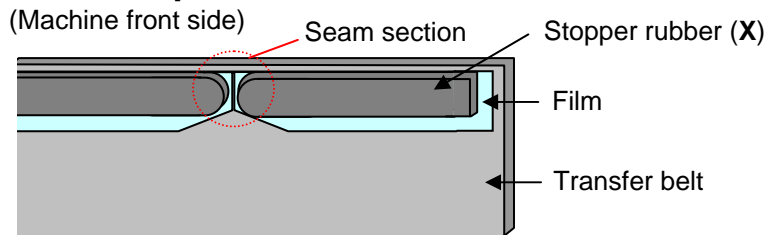
<Where to affix the stopper rubber (X)>

Following phenomena may occur with peel-off of the stopper rubber for the primary transfer belt side slipping during the machine drive from the seam in case adhesive force of the double-side tape comes to weak that affixes the stopper rubber (marked **X** in the figure below) at the inner side edge of the primary transfer belt depending on the operating environment of high temperature and high humidity.

- Image failure with tear of the transfer belt after the rubber runs over the edge of the drive roller
- Abnormal noise and jam (JAM31) with lock-up of the transfer belt drive after the rubber rolls up along the driver roller and gear

*The stopper rubber is first affixed on the film with the double-side tape and then they are affixed on the inner edge of the primary transfer belt. In case adhesive force of the double-side tape in between the film and rubber comes to weak, the stopper rubber may peel off at the seam section. Then, seam section of the stopper rubber is fixed with glue to prevent it from peeling off. (The transfer belt edge at the machine rear side has also the stopper rubber and film as in the above figure)

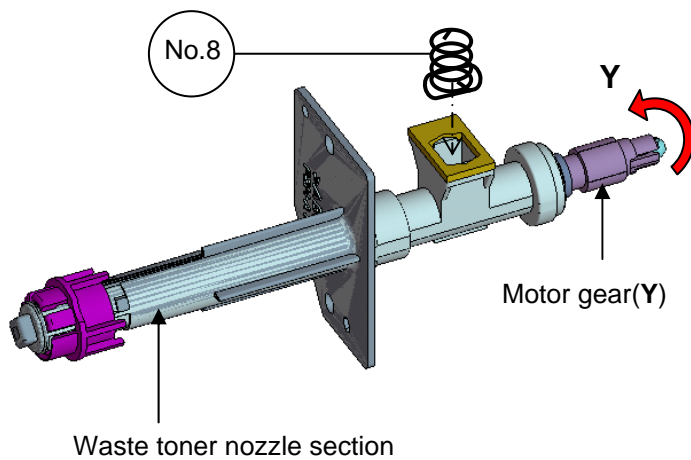
<Check2> The motor gear (D) that is at rear of the waste toner nozzle section can rotate toward the arrow Y without caught up.

* The lower end of the spring may be caught up in the mixer screw inside the waste toner nozzle if the upper end of the spring is in the right side area.

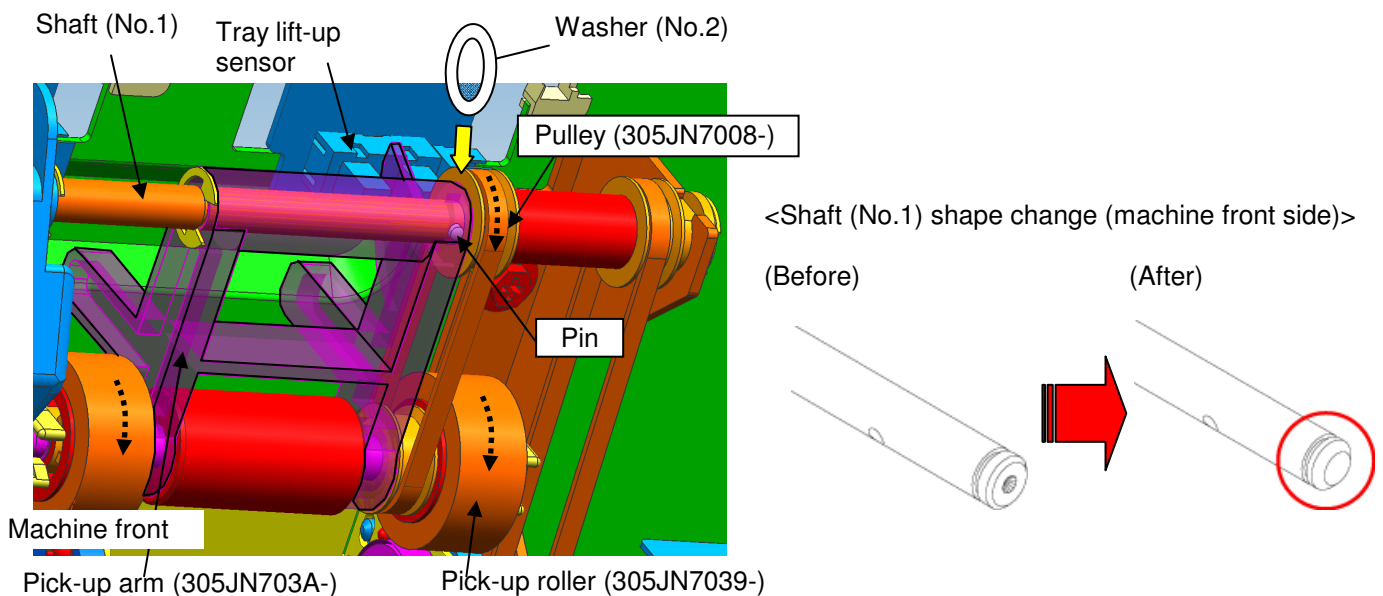
- 1) Pin hole angle on the shaft (No.1) is changed to prevent backlash of the shaft (No.1) and pick-up arm when the pick-up roller rotates
- 2) Shape of the shaft (No.1) is changed for distinction of the old and new shaft according to the above change.
- 3) Washer (No.2) is added in between the pick-up arm and pulley to reduce load to the pick-up arm and shaft (No.1) when the pulley rotates

No.	Old Part No.	New Part No.	Description	Q'ty		Compati bility		Remarks
				Old	New	Old	New	
1	305JN72QK0 5JN72QK0	305JN72QK1 5JN72QK1	SHAFT-PICK-LCF-S-F677	1	1	○	○	
2	-----	305JN707Q0 5JN707Q0	WASHER-6R2X9R5XR25-PL	-	1	○	○

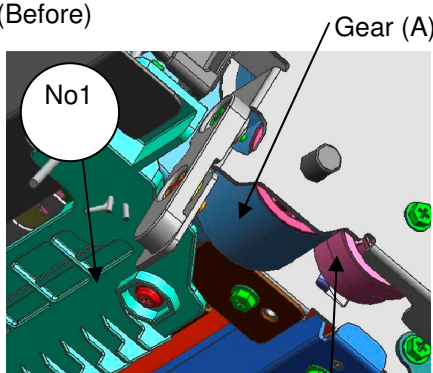
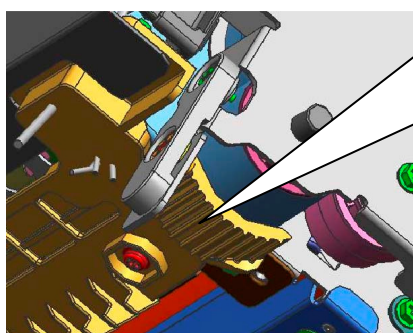
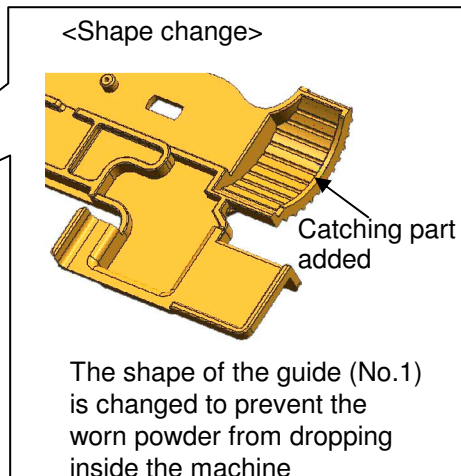
<Change of the Guide Shape>

Change of the gear was informed per the service bulletin No.5JN-0030(A208) to improve the abrasion resistance of the fuser drive gear and the shape of the guide (No.1) is changed for further improvement to prevent the worn powder from dropping inside the machine. Adhesion of the worn powder to other units does not affect the image failure and abnormal sound, etc.

When GEAR-8H30-8(305JN7218-) is worn, the worn powder is brought to the gear (A) to prevent it from dropping inside the machine

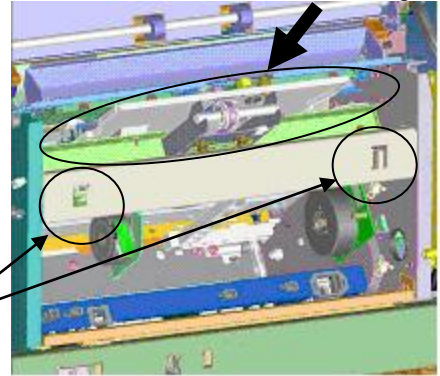
N00053242

KMC's Classification	<input type="checkbox"/> Entire Stock Rework	<input type="checkbox"/> In-Field modification at next visit
	<input checked="" type="checkbox"/> In-Field modification by case	<input type="checkbox"/> No modification necessary
Field Measure:		
Please check the state of the wire alignment/wire coating of WIRE DU at the machine front side for the machine with the record of disassembling and reassembling the conveying unit. If the wire coating is damaged, please wrap the insulation tape to the damaged part or replace WIRE DU to the new parts according to the state of the wire and correct the wire alignment to the normal state. (Please refer to the next page for the parts number of WIRE DU and the wire alignment.)

Ref. No. **2H7-0077 (A356)**

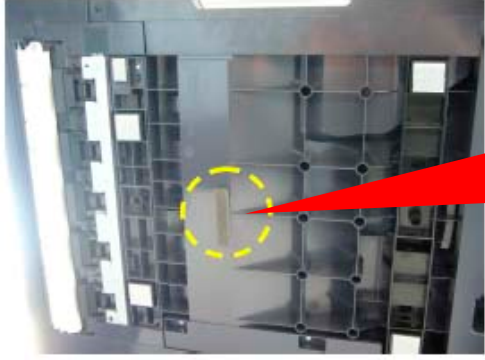
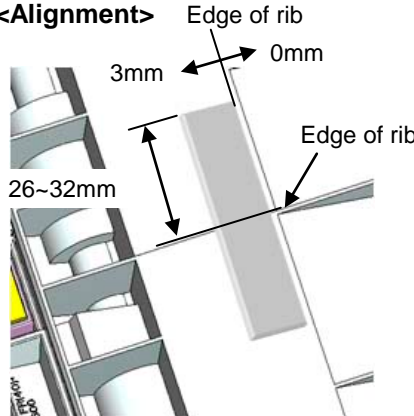
<Sponge (No.11)>

[Alignment of sponge]--- Color models only

Edge of rib
 3mm
 0mm
 26~32mm
 Edge of rib

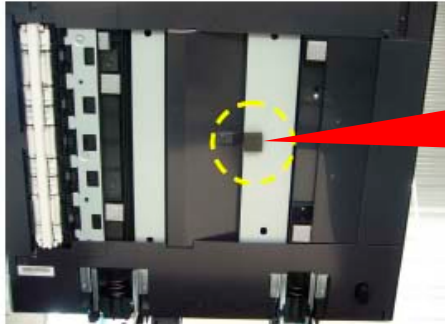
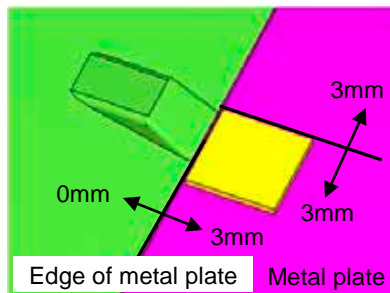
<Sponge (No.12)>

0mm
 3mm
 3mm
 3mm
 Edge of metal plate
 Metal plate

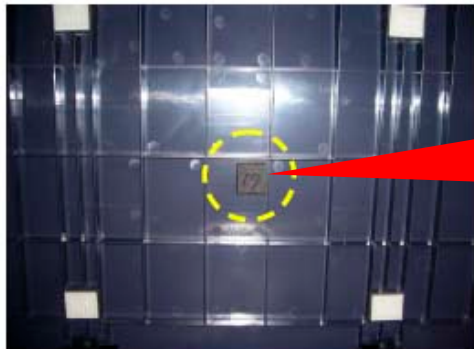
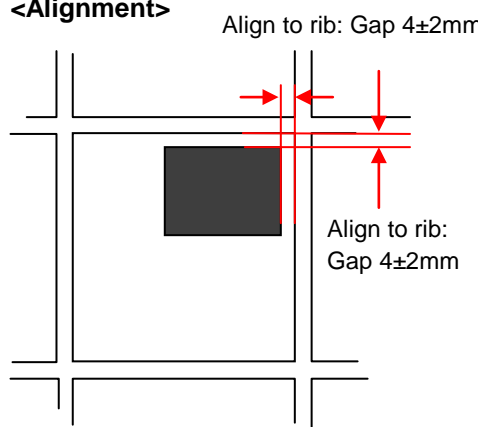
<Sponge (No.13)>

Align to rib: Gap 4±2mm
 Align to rib: Gap 4±2mm

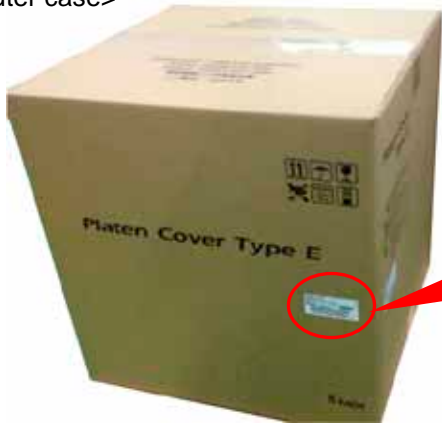
<Outer case>

A marking is added to the barcode label on the outer case bundling the new original mat regulating the curves.

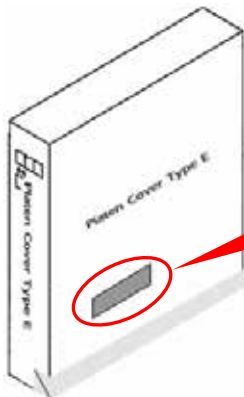
<Individual case>

The marking is added to the barcode label on the outer case bundling the new original mat regulating the curves.

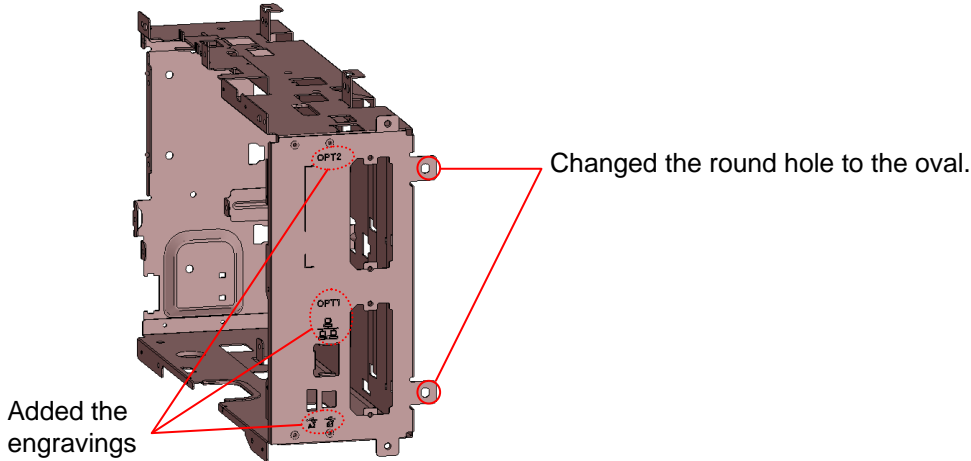
<New SHIELD BOX (No.1)> (Following is the machine left side)

The shape of SHIELD BOX (No.1) is changed for common use of the parts.

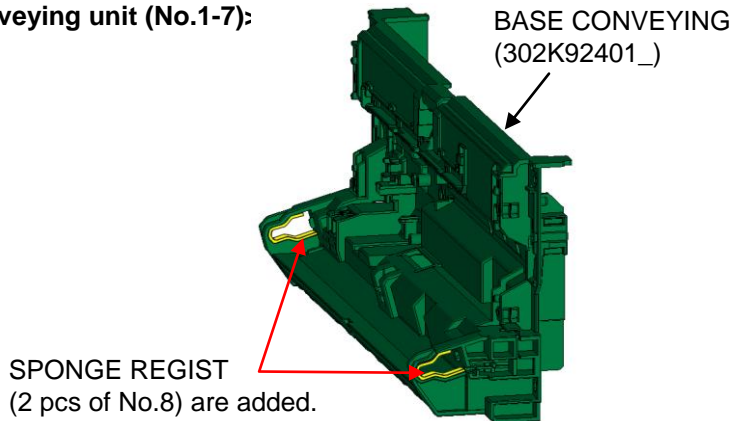
<Conveying unit (No.1-7):

- 1) Conveying unit (No.1-7): Added SPONGE REGIST (2 pcs of No.8).
- 2) Drum unit (No.9-11): Added the seals. (The seals are not supplied to field as individual parts.)
- 3) Intermediate transfer unit (No.12, 13): Added the seal. (The seal is not supplied to field as individual parts.)
- 4) FILM FRAME UPPER CL (No.14): Changed the shape.
- 5) FILM FRAME UPPER BK (No.15): Changed the shape.

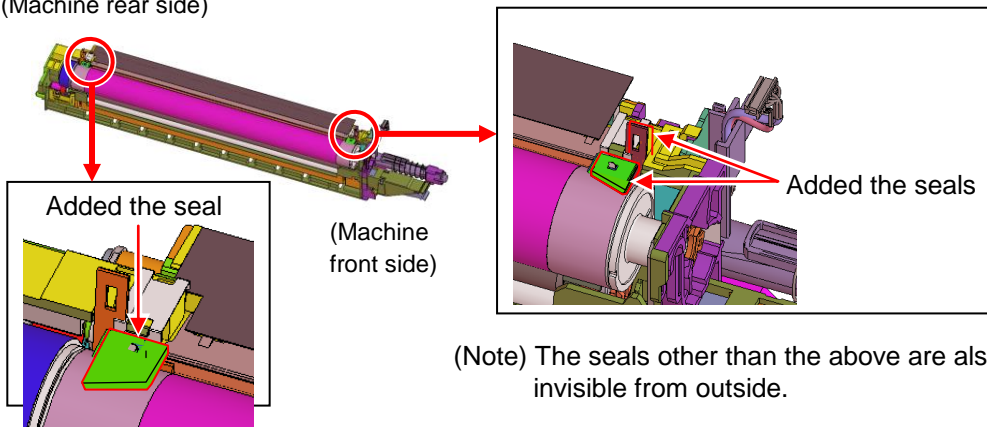
<Drum unit (No.9-11)> (TASKalfa 5550ci/4550ci/3550ci/3050ci, FS-C8650DN, FS-C8600DN only)
 (Machine rear side)

(Note) The seals other than the above are also added while they are invisible from outside.

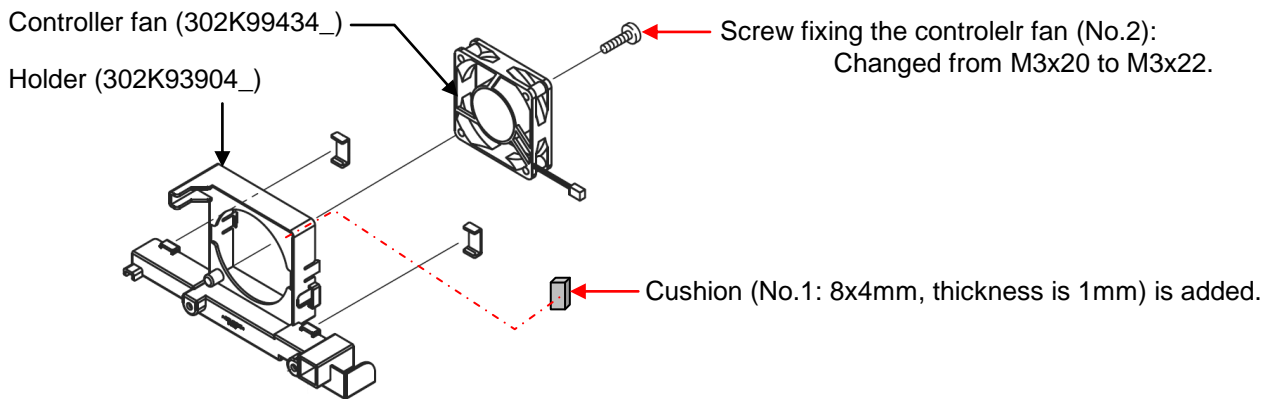
Followings are changed for improving the margin of fixation of the controller fan (302K99434_).

- 1) Added the cushion (No.1) to where the controller fan is fitted on the holder (302K93904_).
- 2) Changed the screw fixing the controller fan (No.2) from M3x20 to M3x22.

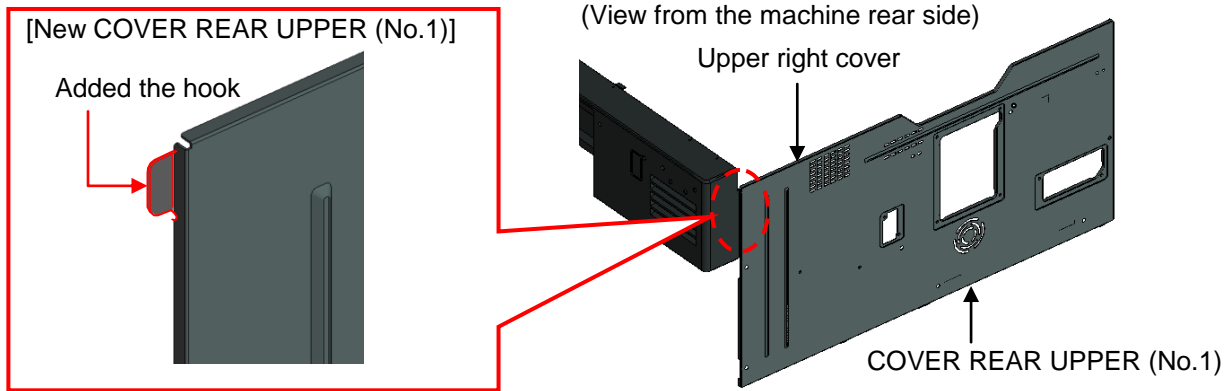
The hook to the upper right cover is added to COVER REAR UPPER (No.1) for improving the surface level of the exterior covers depending on the parts variation.

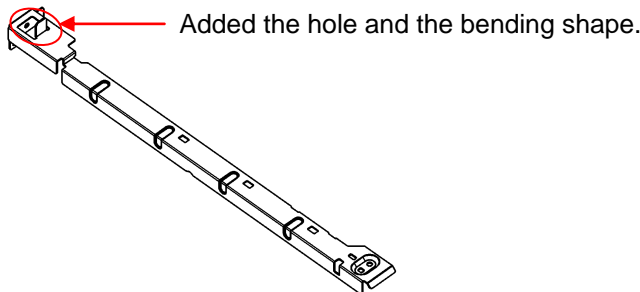
<New RAIL HF LOWER(No.1)>

The shape of RAIL HF LOWER (No.1) for the optional paper feeder and the large capacity feeder is changed as below for common use of the parts.

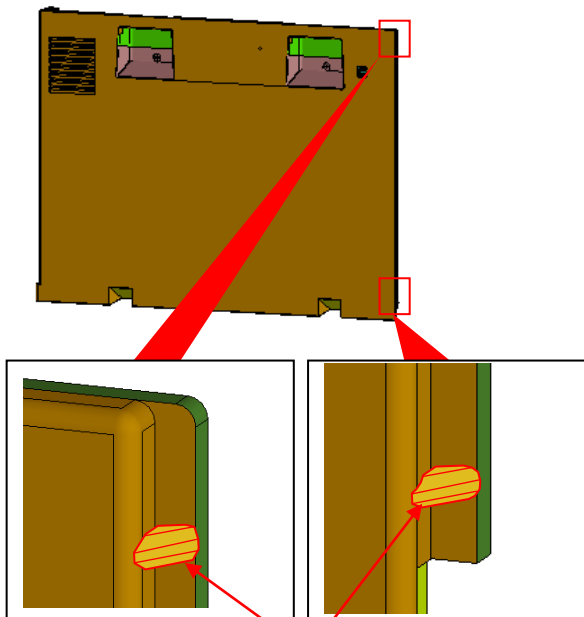
<COVER LEFT UPPER (No.3)>

Added the ribs

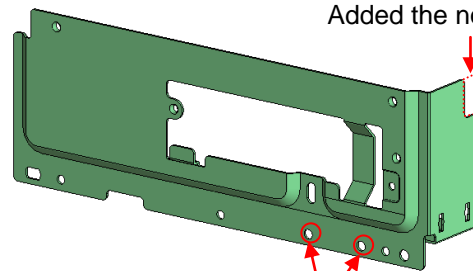
<New MOUNT OPTION(No.2)>

Added the notch

Added 2 round holes
 diameter is 4.5mm)

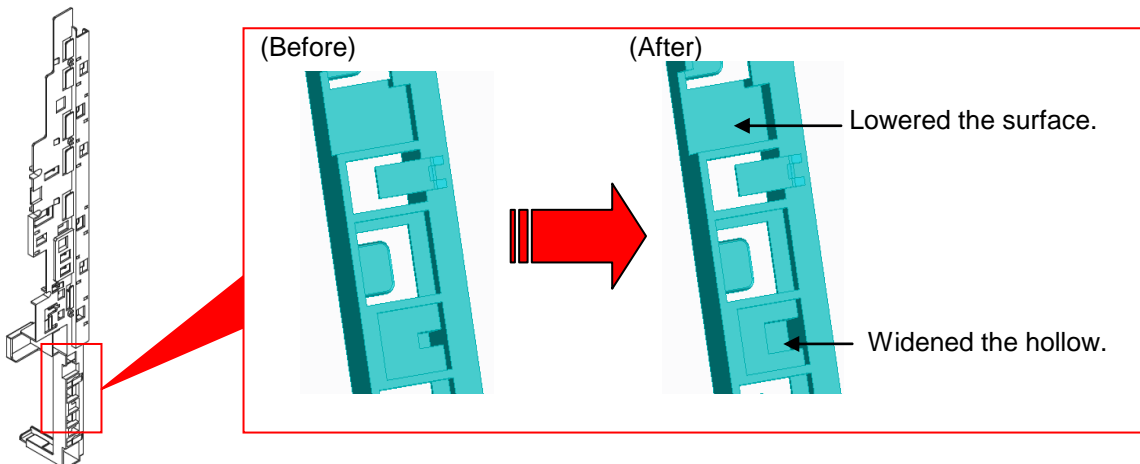
<HOLDER CORD RIGHT (No.1)>

The shape of HOLDER CORD RIGHT (No.1) is changed for common use of the parts.
