TASKalfa 6550ci/7550ci Trouble Shooting Guide

Revision 2

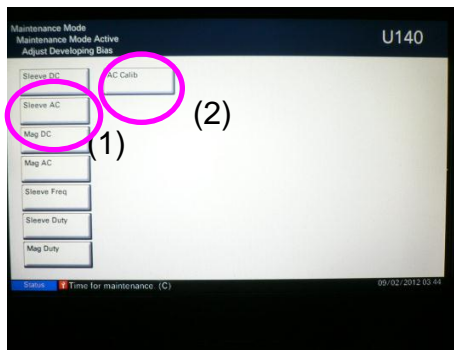
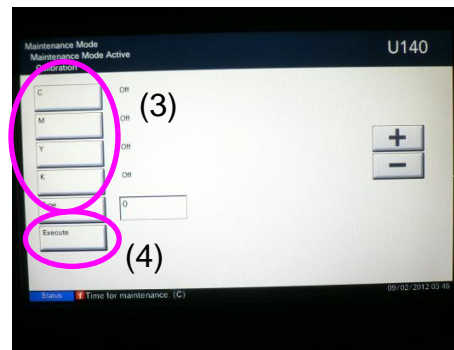
Image sample 1

Leak Image

1. If the solid part of image become void after printing U089 Color belt, go to next 2. *** If the horizontal line appears at the Halftone image part, replace the developing unit.**
2. Check AC value (1) of U140 Sleeve AC.
3. U140 → Execute AC Calib(2) → Set “CMYK” (4 colors) Off to On(3) → Execute(4) → Start
4. Check whether the value of U140 Sleeve AC (3) becomes lower and the image is recovered.
5. If the image will not be recovered, replace the developing unit.
6. Install the new firmware (**Upgrade Pack Ver. V3.06**).

- ◇ Leak at the solid part of image
Void image appears at the solid part.

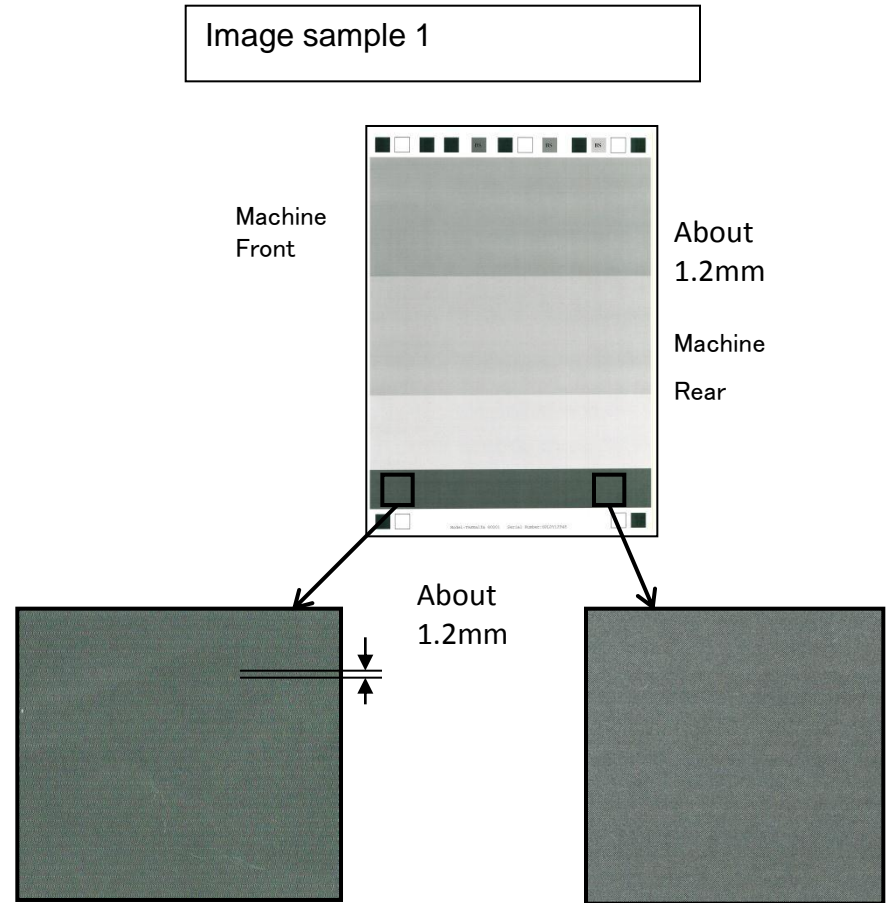
1.2mm interval horizontal streaks occur at the gray image in the paper conveying direction and the right-angled direction.

- For 7550ci, replace the LSU.
- For 6550ci, exchange the location of BK and Y of the LSU.

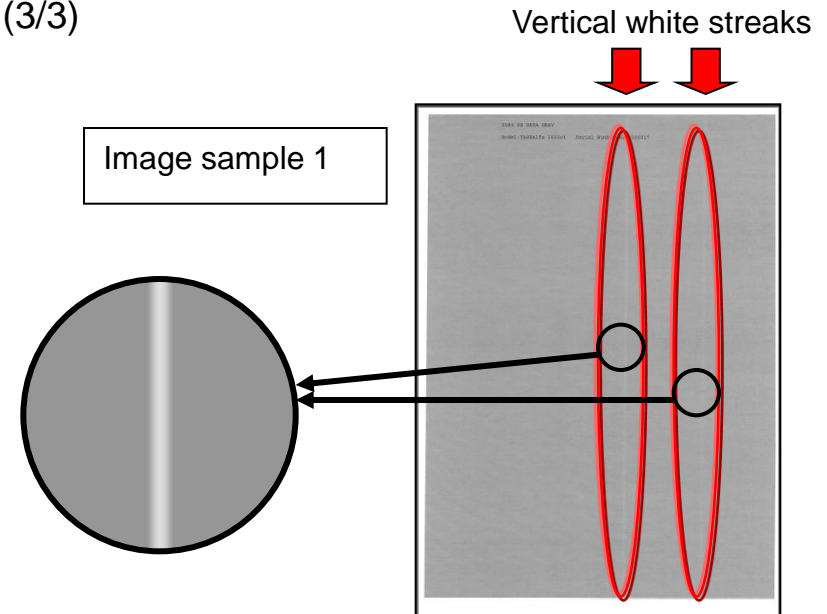
1. Vertical White streaks (Image sample 1)

→ Laser Scanner Cleaning

b. If it is not recovered, or appearing again soon,
clean the inside of machine.

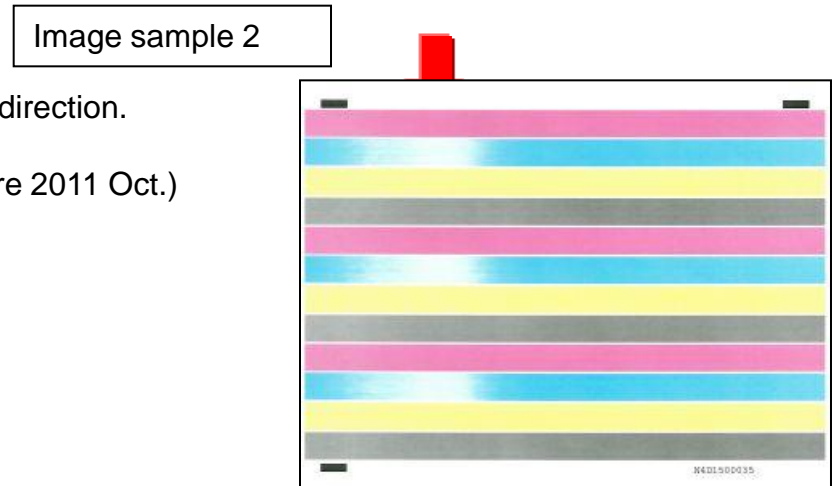
2. Vertical White lines (void image) (Image sample 2)

The void image appears by wide width in the paper conveying direction.

a. Replace the LSU. (In case of the machine is produced before 2011 Oct.)

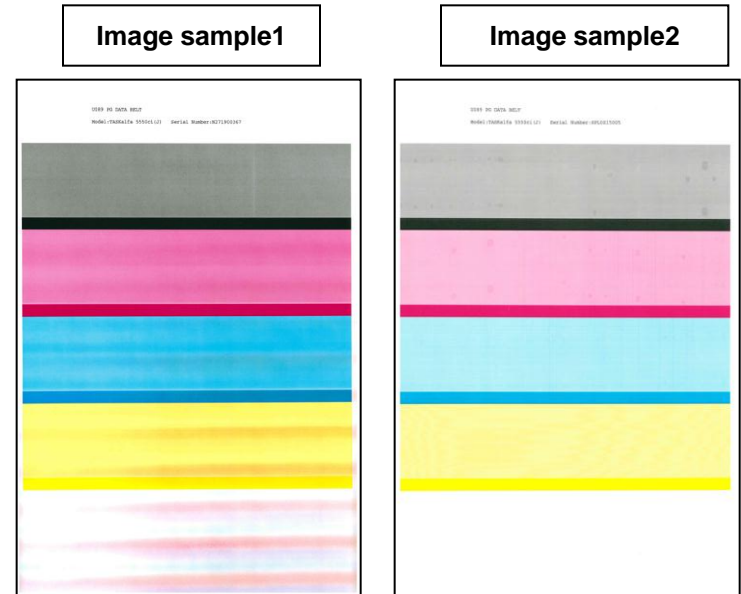
1. Background (Image sample 1)

Background (during continuous print)

OK Image (after calibration)

- Version up the firmware to Upgrade Pack Ver. V3.07 and after,
- 1) Execute the calibration by U464.
 - 2) Execute the halftone auto adjustment by U410.

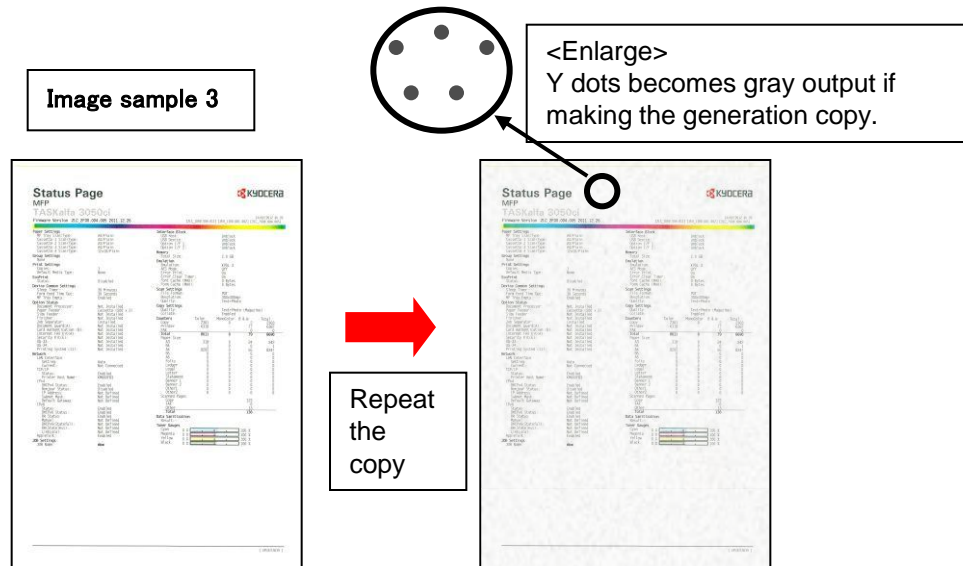
If it repeats the copy with own print put original (generation copy), the background image appears at the base of paper.

- a. Perform the engine firmware update.

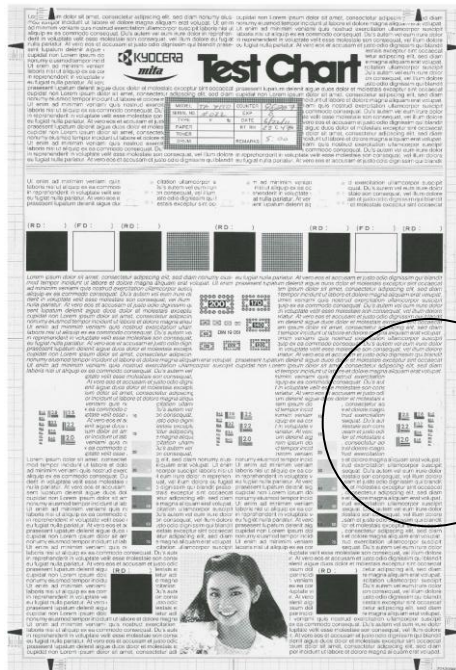
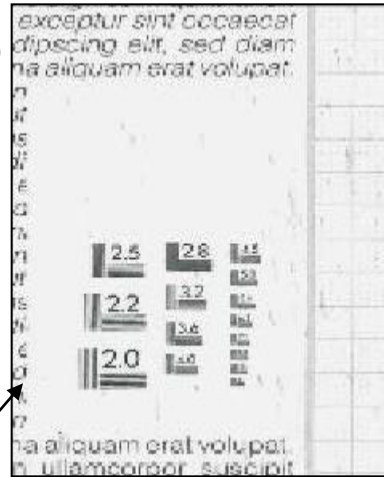
Sample 1

When scattering toner being accumulated into the collection duct, suction capability of toner by the fan declines, collection of toner may not be enough amount and the dirt of toner may accumulate on the image developing section, and toner stain on the image of below A/B, and lower part of toner container and inside of the front cover may occur. At the PM maintenance or occurring the following phenomenon, make sure to clean the machine according to the following procedure.

A) Toner stain image by accumulating toner in each section

- Image smudges by toner accumulating upper surface of drum and developing unit. (sample 1)
- Image smudges by paper feeding pulley which has toner stain at feeding paper from upper cassette .

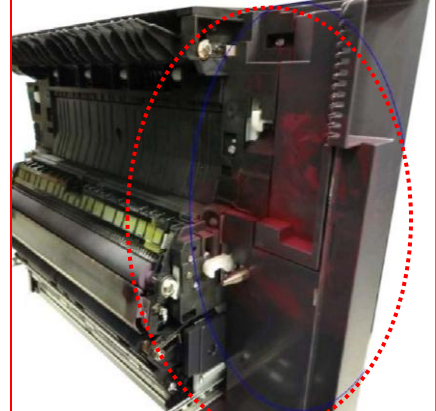
Toner stain on the conveying unit

→ Perform “2.Clean toner stain at inside of machine”.

→ Please use the PARTS SEAL SET SP, and replace the New Inner Unit.

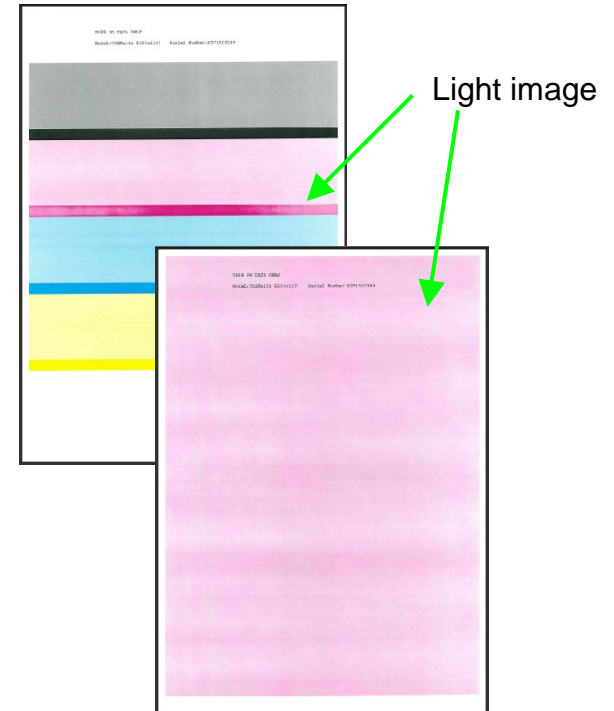
Image sample

1. Light image (refer to image sample)

Halftone image → Image density is lighter in a interval

- Check the toner sensor output by U155 Toner .
In case of higher than 542, supply the toner by U132 → Execute → Start.
- Firm up the engine firmware: **Use the Upgrade Pack Ver. V3.07 and after.**
- Execute the calibration.
- If light image can not be solved by above (a.) to (b.) action.
Execute the developer refresh **One** times.
- If light image can not be solved by above (a.) to (d.) action.
Store the Maintenance Report into USB memory and replace the developing unit.

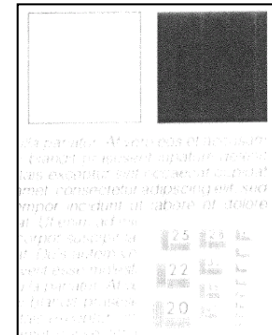
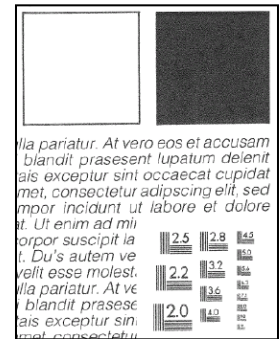
Image sample (copy)

2. Light image (ID sensor)

- Replace the ISU_LENS UNIT (PARTS IMAGE SCANNER L SP : 302K993082)
(6550ci/7550ci : PARTS IMAGE SCANNER H ASSY SP : 302K993032)
- Execute the scanner auto adjustment.
 - Place the designated adjustment original (Part No.: 7505000005) on the contact glass.
 - Select "Target" on U411 Scanner Auto Adjustment
 - Select "Auto" and press the start key.
 - Select "Table (Chart1)".
 - Select "ALL" for items to be executed.
 - Press the start key and start the auto adjustment.

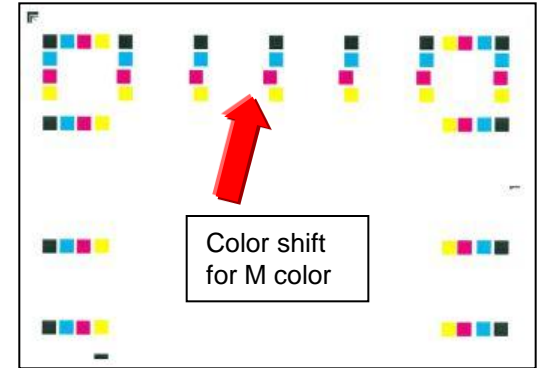
Image sample 1

1. Main scanning direction color image shift (Image sample 1)

a. Replace the LSU of the color which has this fault.

(In the case of Oct. 2011 previous production machine)

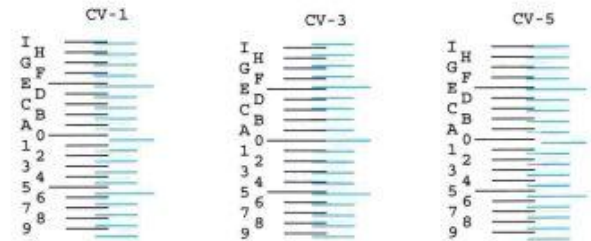
Image sample 2 (Enlarge of color registration adjust chart)

2. Sub scanning direction color image shift (Image sample 2)

A large amount of difference in the central part and both ends occurs at the sub scanning direction color shift.

a. Replace the LSU of the color which has this fault.

(In the case of Oct. 2011 previous production machine)

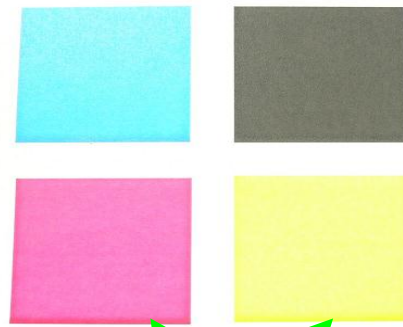
Thick density at bottom edge of solid image

1. Thick density at bottom edge of solid

The bottom end edge of the Solid image or the high density Halftone image is emphasized deeply.

- Firm up the engine firmware: **User the Upgrade Pack Ver. V3.03 and after**
- Increase +30bit for CMY at U464 "Target Value".
 - C: default 910 → 940 after changing
 - M: default 890 → 920 after changing
 - Y: default 910 → 940 after changing
- Execute U464 "Calibration"
- Check the image with above setting, if the result is not satisfied, use U464 "Edge Reduction" mode
- Execute the developer refresh twice
- Set U464 "Edge Reduction": ON

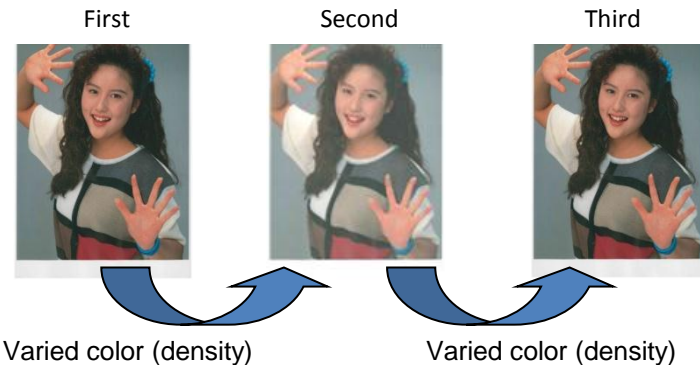
Image sample 2

3. Varied color image

- Check there is no fault on image (sample1) which output by U089 Color Belt after executing the Calibration. → In case of fault on image, refer to the other trouble shooting.
- Repeat outputting the claimed image after executing the calibration, check the re-appearance of color change (Sample 2 output example)
- Upgrade the firmware most updated one
 - Execute calibration by U464, 2) Execute the U410 half-tone auto adjustment.
- Perform above b, check the effectiveness.

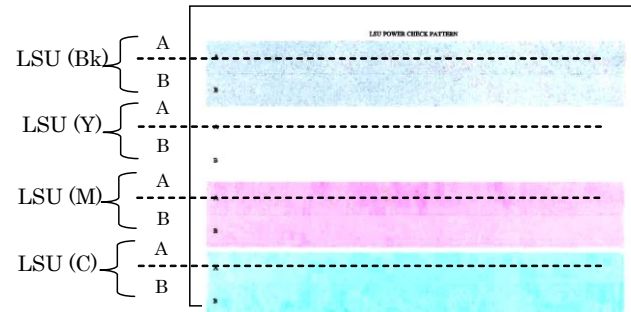
(Image file: LSU Power Check Pattern.capt)

A: density in full speed mode
B: density in half speed mode

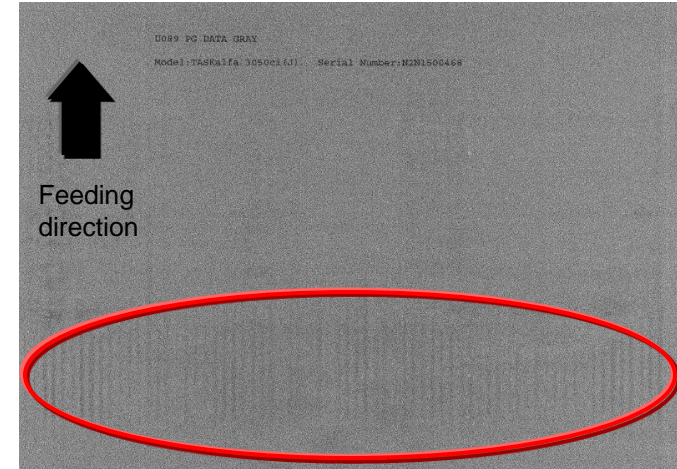
Due to paper, the rubbing track caused by the separation guide or separation appears at the bottom part image such a halftone.

1. Remove the conveying guide after losing 2 screws.

3. Attach the static eliminating sheet at below metal part and return it the original position.

Note: Do not over from a hole so that the edge and a hole of sheet metal is aligned and there is free from creasing

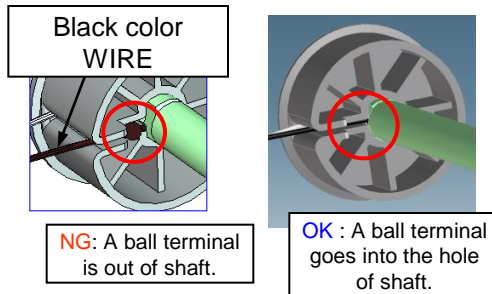
normal, it has a possibility that the ball is out of position as shown in the NG figure, re-assembly of the wire is necessary.

In the case of NG above item 2, it has a possibility that the ball is out of position at both of front and rear, re-assembly of a front and rear wire is necessary.

* As shown in the right figure, make it a ball terminal go into the hole of SHAFT within PULLEY LIFT WIRE DRUM at the time of re-assembly. Be cautions especially at the time of the assembly of a black wire.

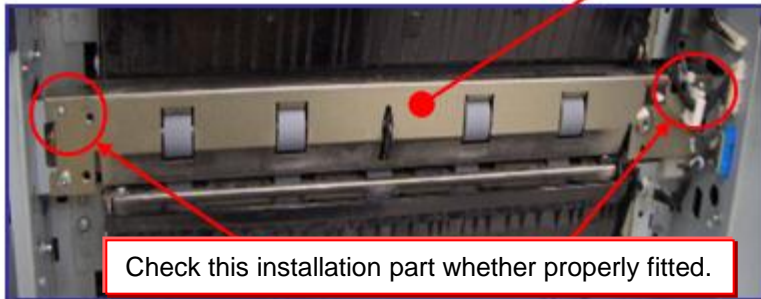
Check this installation part whether properly fitted.

- a. Check whether installing 302K994130 PARTS GUIDE FEED MIDDLE ASSY SP is proper.
→ The unit is not set properly, reinstall it.
- b. Check whether 302K994430 PARTS ROLLER FEED LOW SP is rotating without power on the clutch.
* refer to the procedure-1
→ If the clutch is rotating, change the clutch cable wiring treatment. * refer to the procedure-2
- c. If JAM is not solved after changing the clutch cable wiring, replace the 302K994130 PARTS GUIDE FEED MIDDLE ASSY SP unit.

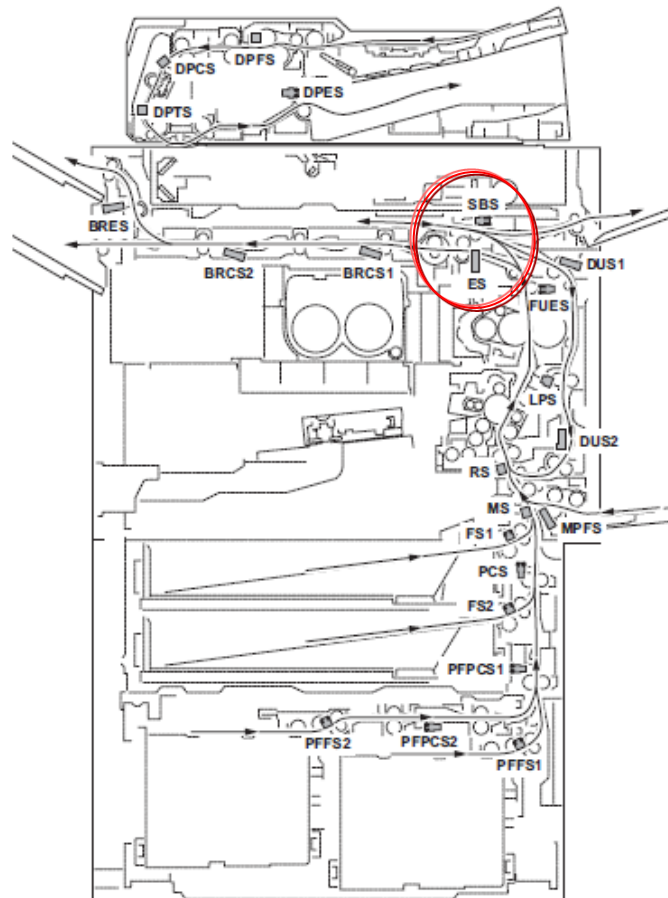
1. In case of JAM at the shift guide of the exit unit part, take the following measure.

When the entire paper is not damaged at JAM.

Since there is a possibility of incorrect detection of the sensor, please replace the sensor in the inside of the eject unit, or the eject unit.

* Sensor : 7NXGP1A73LCH01(SENSOR OPT.) Eject unit : 302LH94271 (PARTS EXIT UNIT B SP)

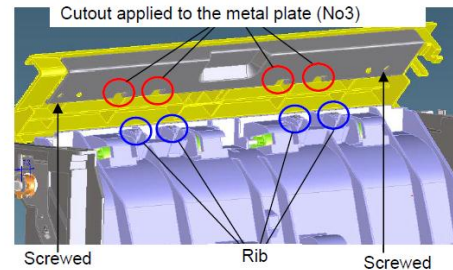
[Metal plate (No3) shape change]

5. Check whether the rib (blue color round mark on the right fig) of the conveying guide of the bridge exit unit is broken or not.

→ In case of breakage, replace the below part No.1 to 3 as referring to the service bulletin "2LC-0068(C076)

Refer to the service bulletin: 2LC-0068(C076)

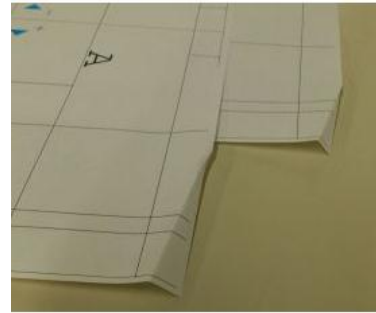
Sample1

If J6100/J6110 occurs, check the following item 1 to 3.

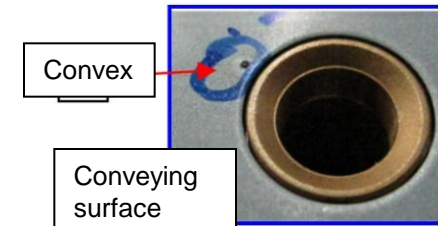
3. Check whether the paper corner folding or scratching occurs at the Punch unit (Sample1, Sample2)

Paper is caught by the convex of welding part at the Punch unit upper guide conveying surface.

- a. Upgrade the firmware (as set.)
 3NB_9200.004.007 and after
 3NK_9A00.003.004 and after

- b. If the serial number of unit is before below number, replace the Punch Unit.

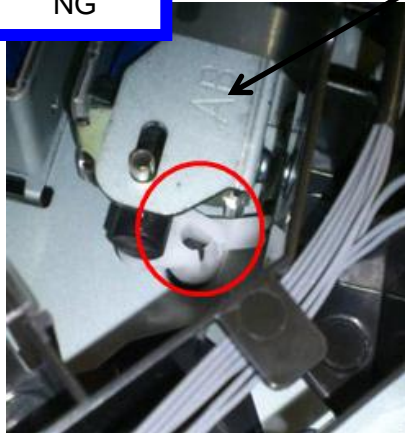
NG

Check the shaft of Feedshift guide 1 is firmly inserted into the lever of DF feedshift solenoid 1. In case of out of location, insert the shaft into level as shown in below photo.

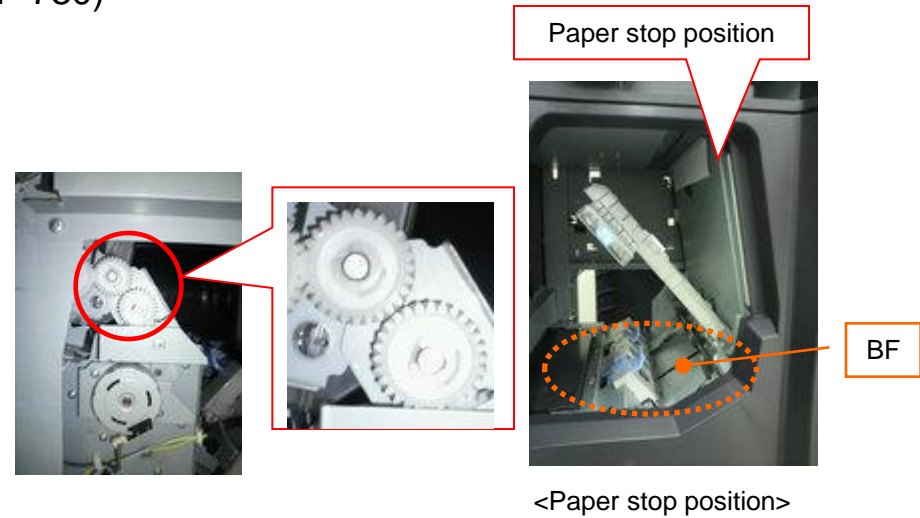
a. The JAM paper is stopped before reaching the BF.

b. Check whether the mesh of gears is not engaged or not after setting the BF into the DF.

→ If the gears are not engaged, replace the fulcrum pin (1) of BF lock lever, DF hook pin (2).

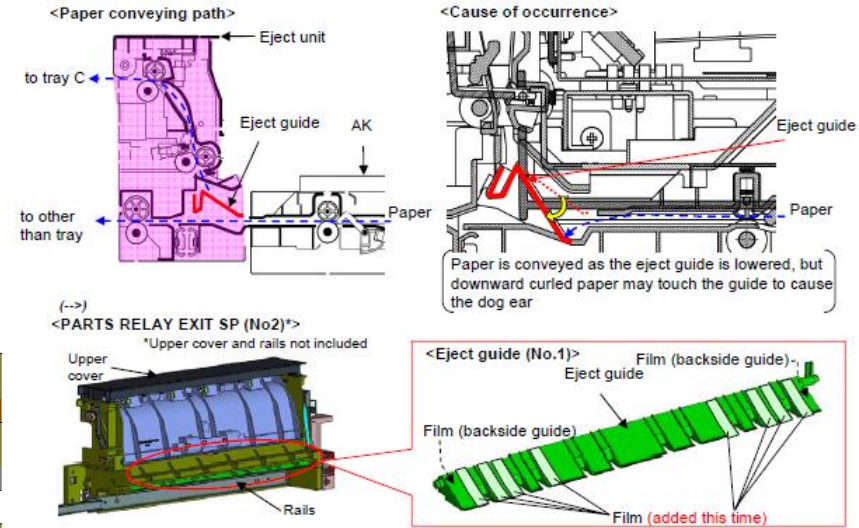
2. If it occurs at ejecting paper to upper tray (at DF-770 install: B tray eject/ at DF-790 installed: C tray eject), replace with new guide (No.1) which is affixed the films or the Relay exit unit (No,2).

Refer to the service bulletin : 2K9-0007(B393)

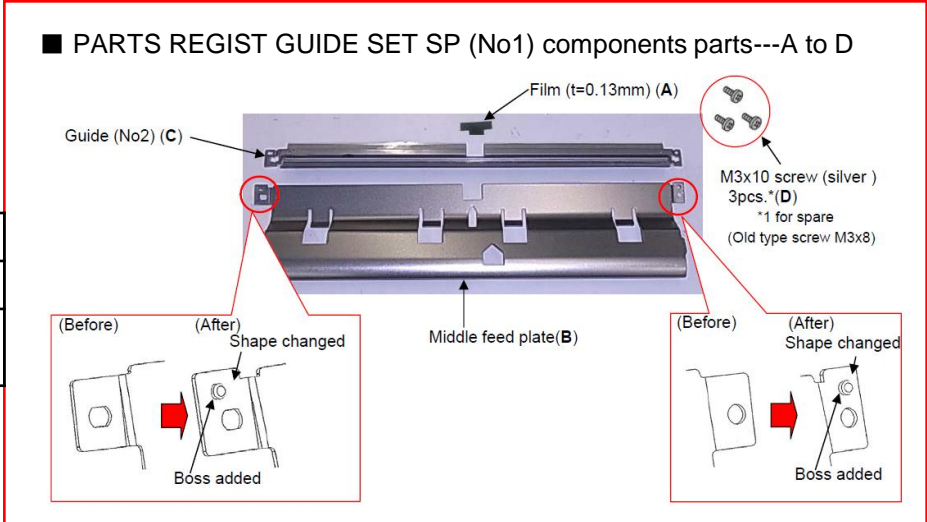
If the paper is above creasing condition, check whether modified guide below photo is equipped or not.

Add the modification guide (refer to next age for installation)

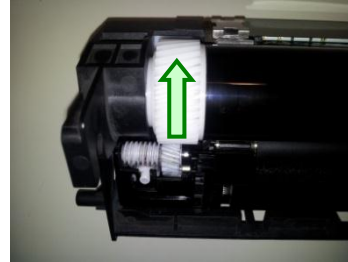
<Fig1 Check Drum Rotation>
Turn it below direction.

- a. Remove the DRUM unit from machine.
- b. Check the drum rotation (refer to Fig1)
In case of no rotation, replace the drum unit
→ skip to “e”.
- c. Check rotation of the drum spiral roller (refer to Fig2)
In case of no rotation, replace the drum unit,
→ skip to “e”.
- d. Replace the engine PCB.
- e. Check the Firmware version and version up to above FW
PACK V3.03.

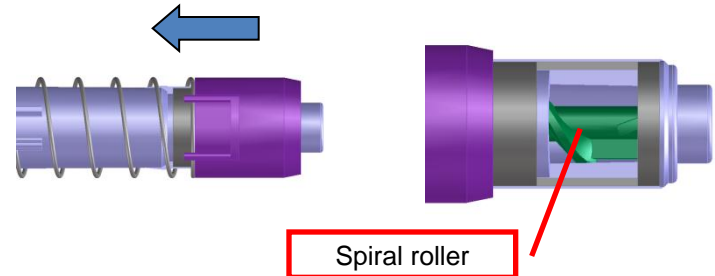
<Fig2 Check Spiral Roller Rotation

Check whether the spiral roller is rotating when turning the drum manually.

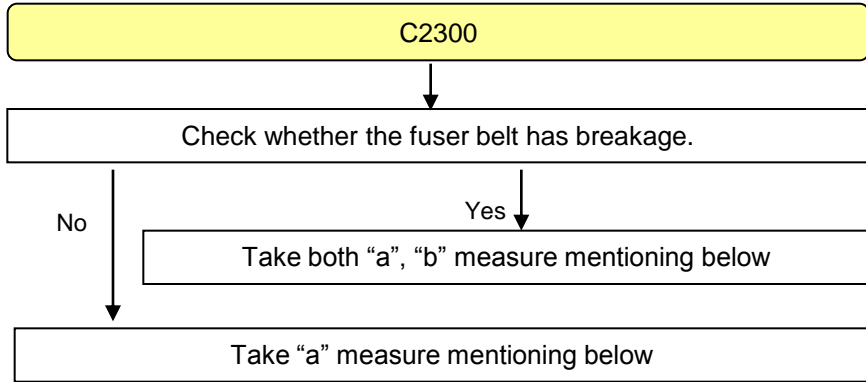
C2300 (Fuser Motor Error)

If C2300 occurs, take the following measure "a", "b" according to the following.

a. When replacing the fuser unit, it exchanges for the fuser unit applicable to the end of the right figure.

b. Check the machine's serial number whether its number is before taking the measure (use the jig to adjust the fuser position plate) during the production.

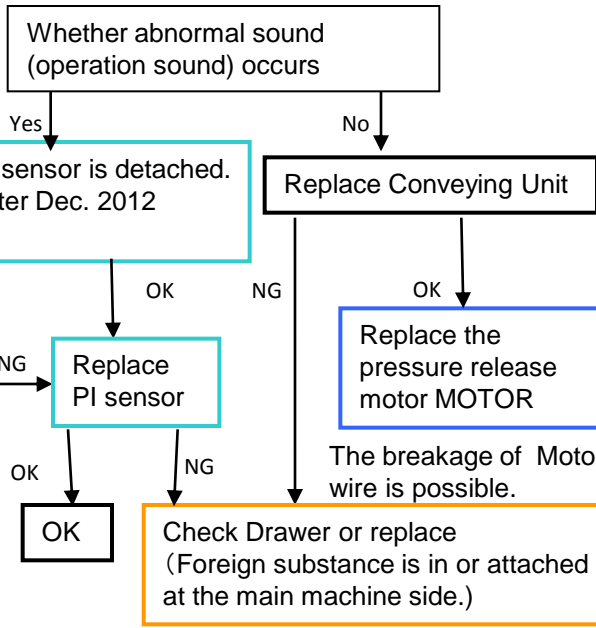
Fault on Drawer Connector

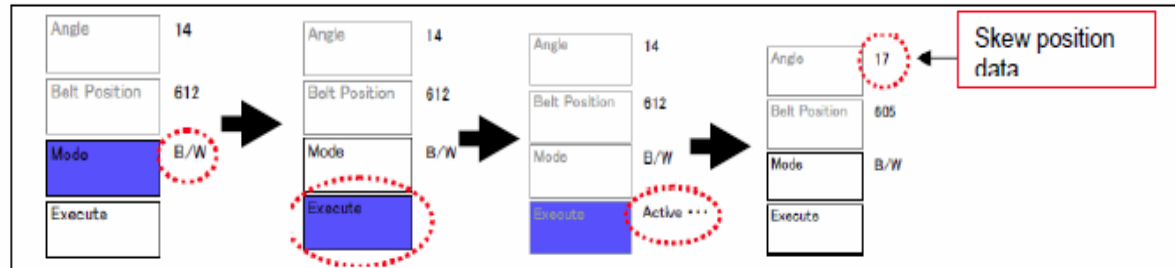
<Judgment>

Angle: 6 to 26 = OK
 Angle: 5 or less, 27 or more = NG

- Version up the firmware with most updated one.
- Execute U469 Adjust Color Registration → “Belt Check”
- Set Mode “B/W” → select “Execute” → Press “Start” Key → Start detection (1 to 2 min)
- After disappearing the “Active” display, check the “Angle” display value.
- If “Angle” value is within 6 to 26, OK (To the next page), If below 5 or above 27, NG and go to below f.
- Detach the middle transfer unit and install.
- Execute U469 above b to e again.
- If NG at above g., replace the middle transfer belt unit.

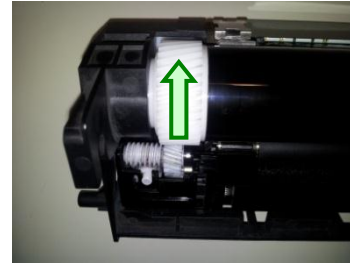
<Fig1 Check Drum Rotation>
Turn it below direction.

- a. Remove the DRUM unit from machine.
- b. Check the drum rotation (refer to Fig1)
In case of no rotation, replace the drum unit
- c. Check rotation of the drum spiral roller (refer to Fig2)
In case of no rotation, replace the drum unit.
- d. Check the poor connection of cleaning lamp connector.
- e. Replace the HVT PCB.
- f. Replace the engine PCB.

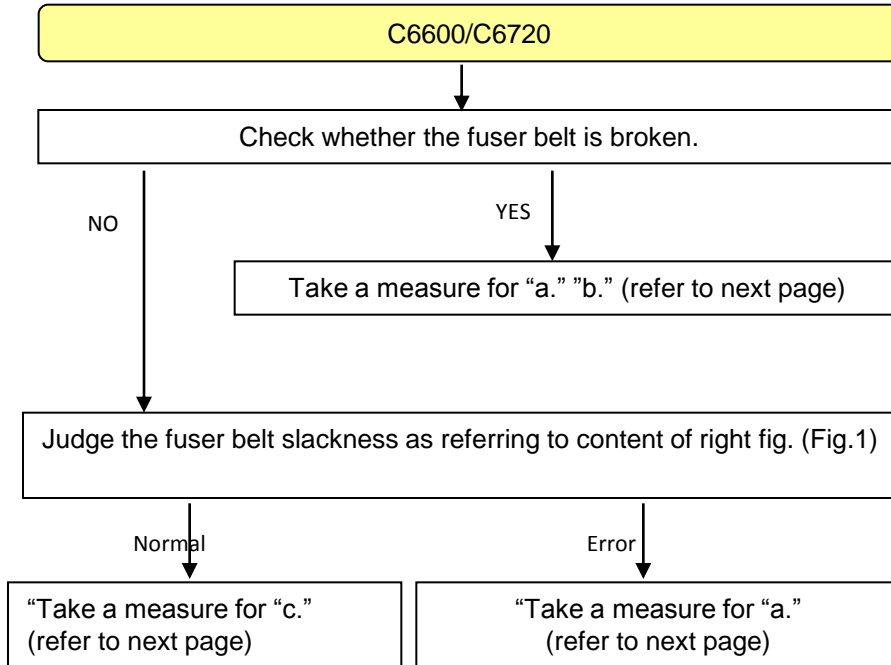
Fig 1

Procedure the check the fuser belt slacking condition

■ If the bearing is broken, the slackness of belt tension becomes large and above clearance is increased.

If C6600/C6720 occurs, according to the below checking procedure, find the solution for a to c.

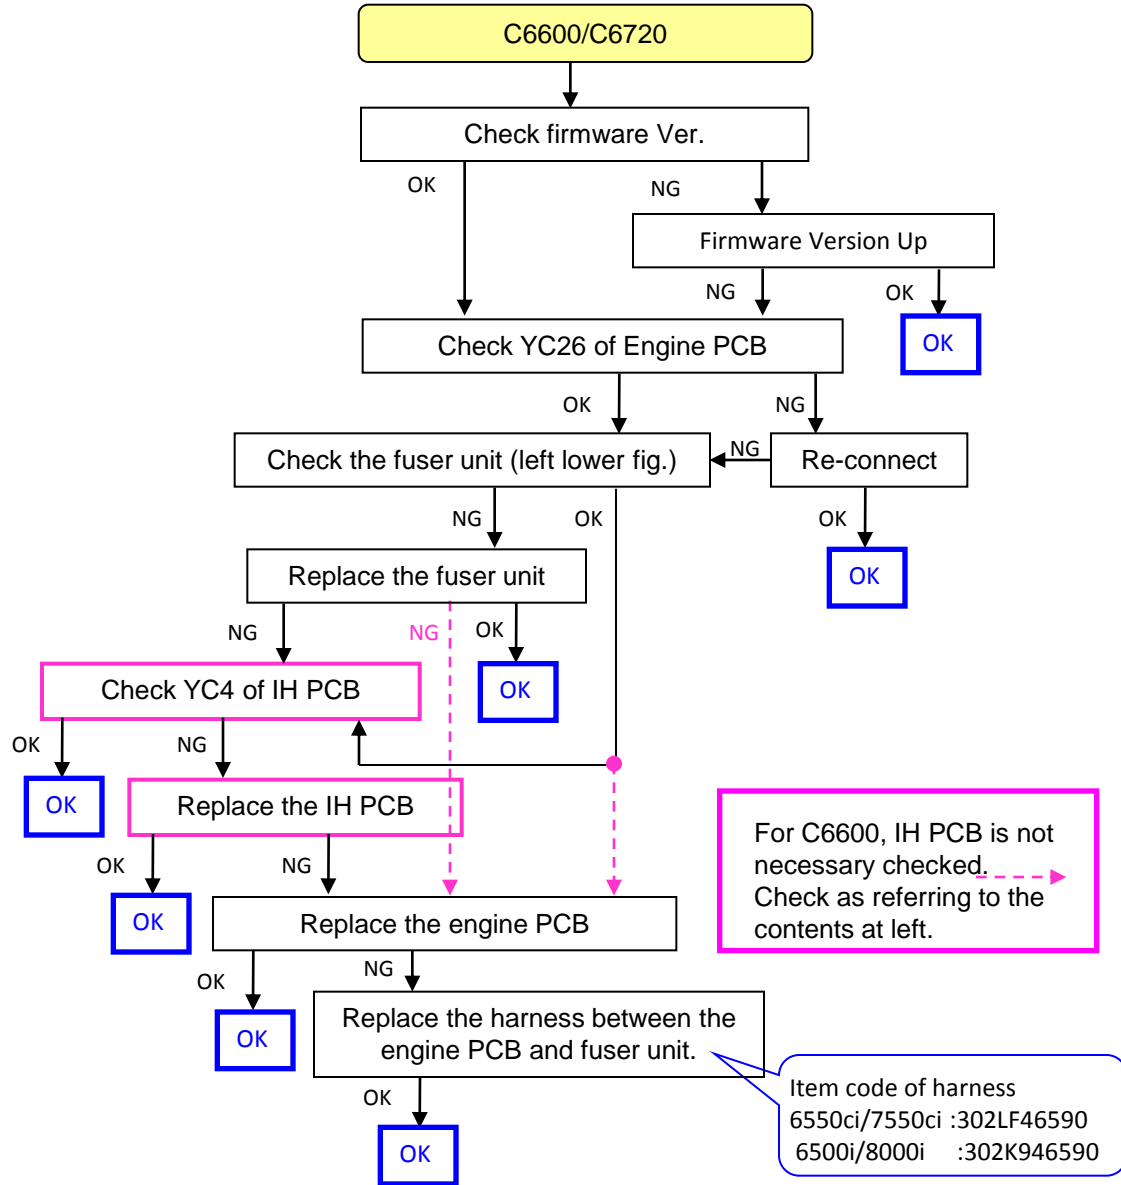
No1: FILM FUSER ADJUST (302K902C30)

Check firmware Ver (engine)
 6550ci/7550ci : 2K9_1000.004.006
 6500i/8000i : 2LF_1000.003.006
 Whether it is after above version.

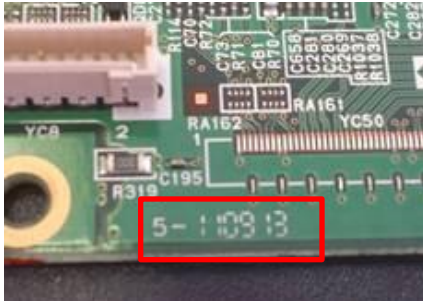
302K980152 PWB ENGINE ASSY WITH SOFTWARE SP

The fault on present condition cannot be specified due to the through hole disconnection on the base plate of engine PCB.
(It is the feature that it works without any problem after immediate power supply, but the problem occurs after contious usage.)

Replace the engine
PCB

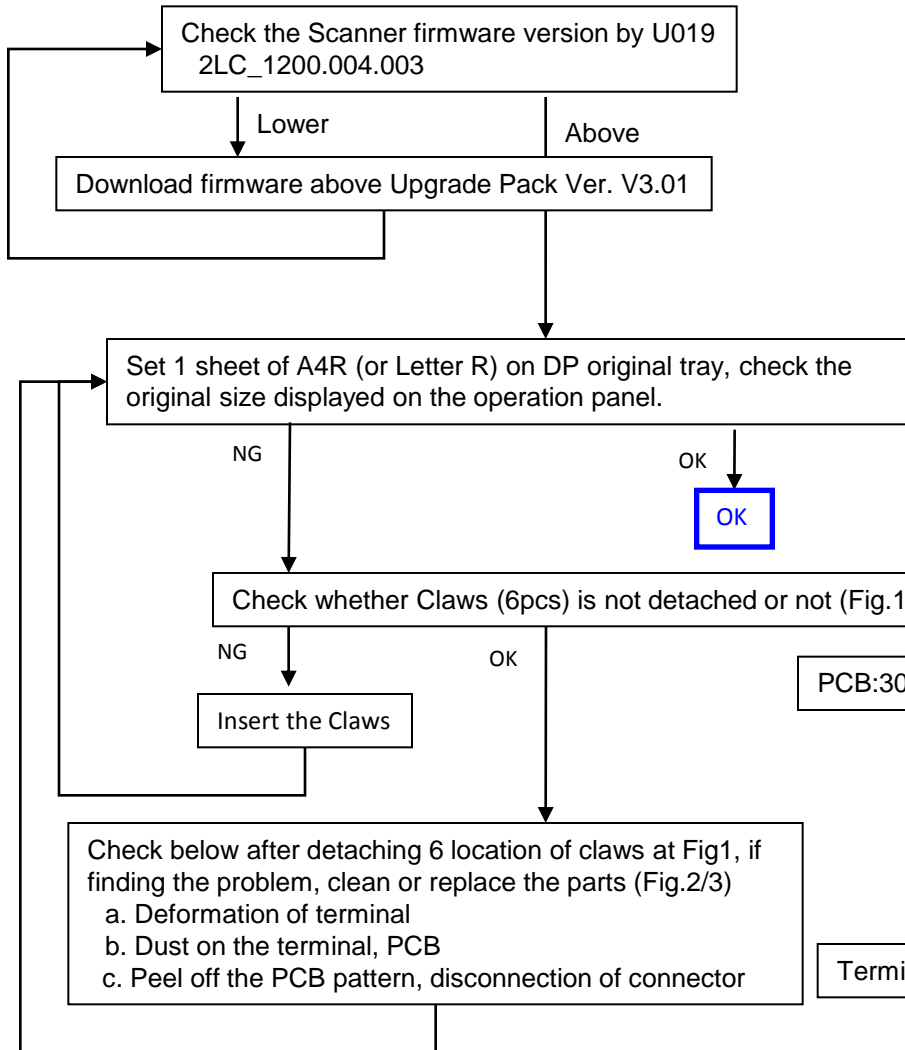
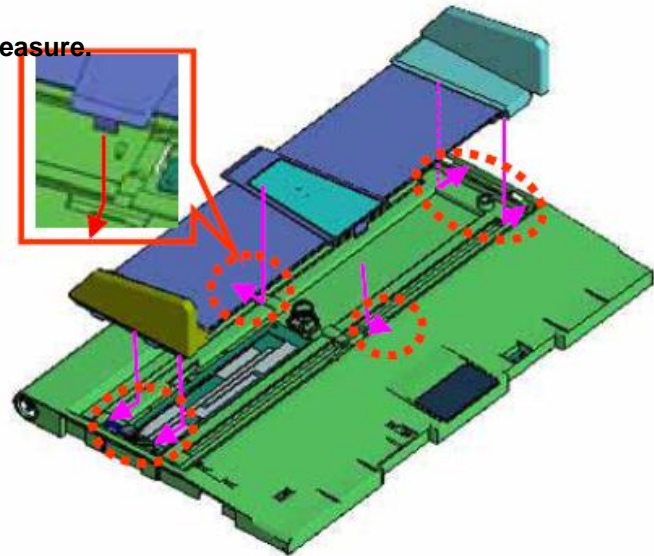
Fig.1

1.DP Size Detection Error

When the size detection error occurs at DP, check below item and take measure.

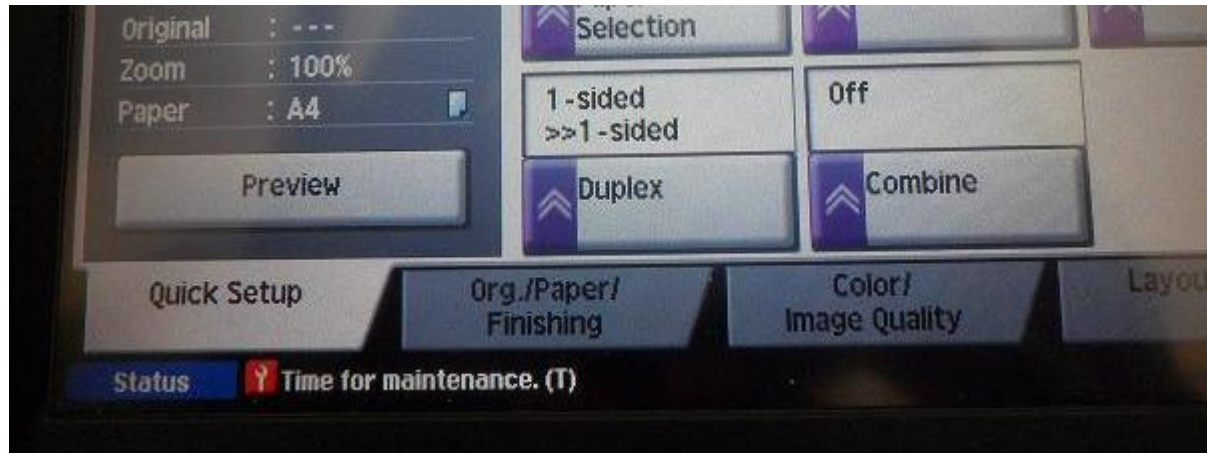
When "Time for maintenance.(T)" was displayed on a status bar (refer to attachment picture), please take the following measure.

- a. Performs resetting partial operation control in Sim.906.
- b. Set up the present time from a system menu.
- c. When can not canceled above, please exchange Main PCB.
