Process improvement for UCOS feeder.

Important Technical Information

<u>UCOS Feeder</u>	Specifications	
	Firmware	
	General Recommendations	
	Resources	
<u>Technical Issues</u>	<u>Wedge Lever Damage</u>	
	<u>Feed Belts Damage</u>	
	<u>Discharge Belt Damage</u>	
	<u>Paper Guides Mechanical Alignment</u>	
	<u>Paper Guides Damage</u>	
	<u>Prepared lever is Loosen</u>	
	<u>Black Envelope Detection</u>	
<u>Troubleshooting</u>	<u>Envelope Jamming, misfeeding</u>	
	<u>Print position offset</u>	
	<u>Spring Pinch Damage</u>	
	<u>Prepared Lever</u>	
	<u>Not Feeding Envelopes</u>	
	<u>Power</u>	
	<u>Magnetic Catch</u>	
<u>RSPL</u>	<u>Recently added</u>	
	<u>Lock-Parts, Rollers-Catches-Bracket</u>	
	<u>Fuser-Drive Assy, p/n: 45192101</u>	
	<u>RSPL</u>	
<u>Troubleshooting</u>	<u>Envelope Jamming, misfeeding</u>	
	<u>Spring Pinch Damage</u>

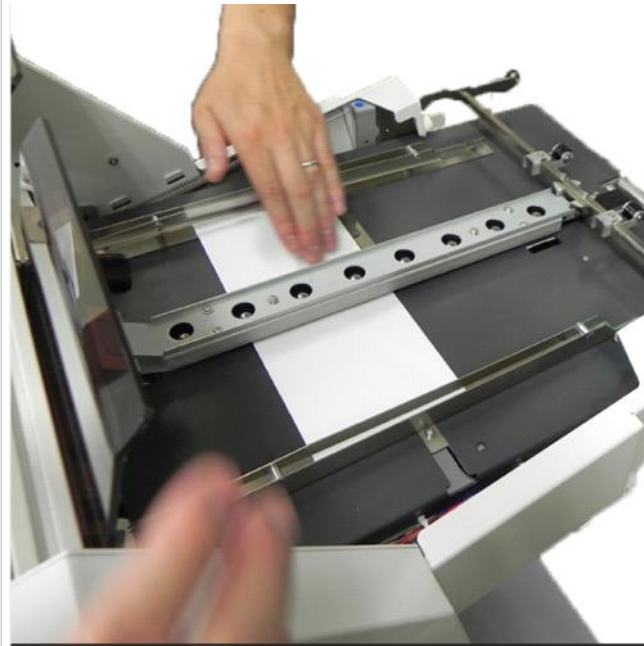
Paper Guides set to match Com#10 width.
Note: See Operators Manual for details

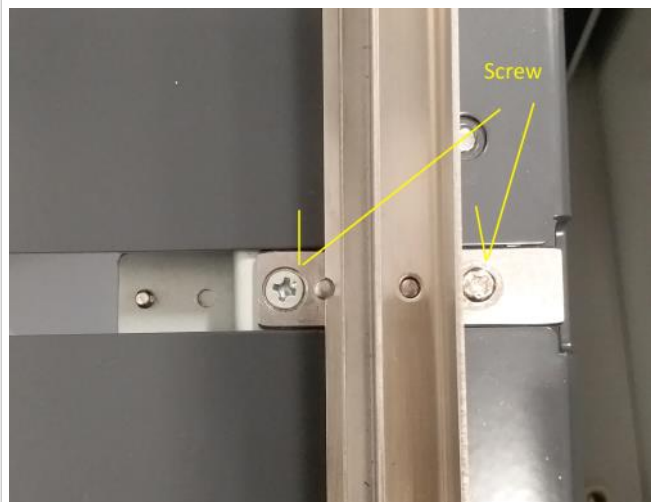
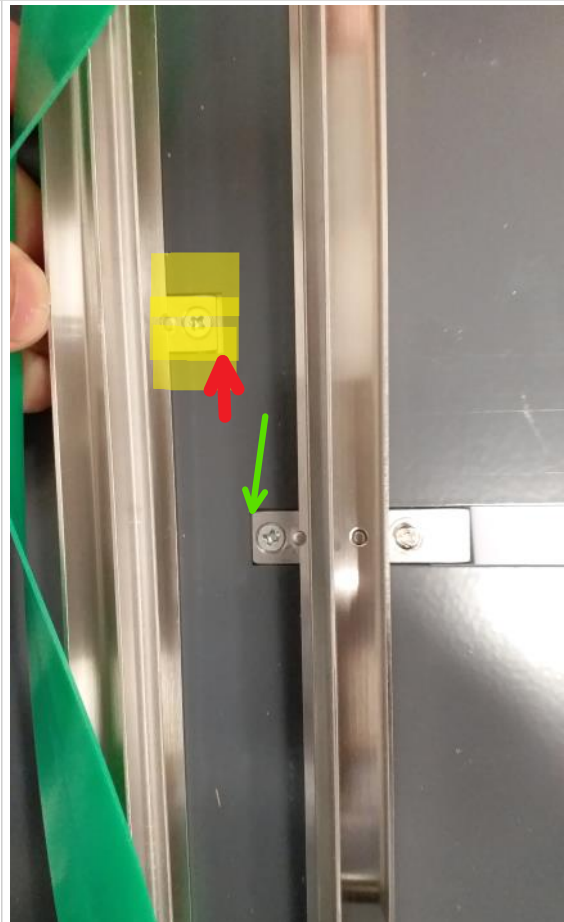
Paper Guide is attached to slider

Paper Guides fully retracted. Back paper guide (LHS) is off centered. There is a gap between the slider and the slot on the feeding table (Red Arrow)

Picture above shows both front (RHS) and back (LHS) paper guides. Back paper guide is off center (Red arrow). Both guides can be centered by adjusting the slotted bracket.

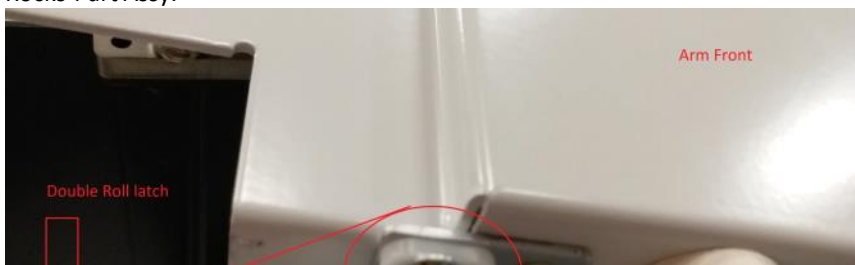
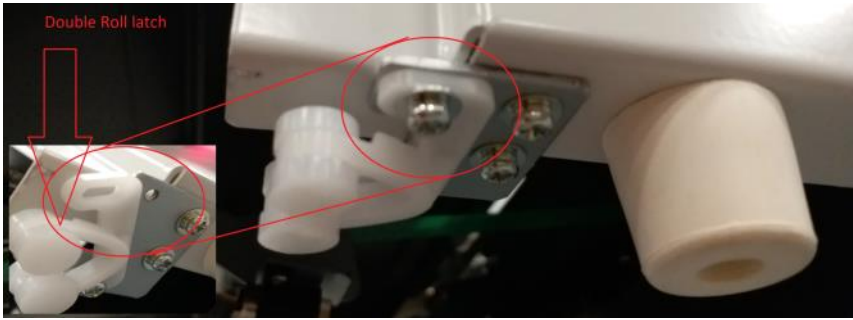
Rocks-Part Assy.

- a. The Rock Parts-Assy comes with a double roller catch with spear Strike (See picture attached). The spear strike is slotted and the position can be adjusted and this can be changed the separation of the feeder and the printer. The change is minimal, but is a couple of cases, this made a difference in the performance of feeder (both envelope detection and feeding). Normal position is

- the printer. The change is minimal, but in a couple of cases, this made a difference in the performance of feeder (both envelope detection and feeding). Normal position is with screw in the middle.
- b. Make sure the Double roller catch bracket is not bent or damaged, I had one case where feeder was pushed too hard and this bracket was deformed. If not in bad shape, it can be bent back; Not recommended though.

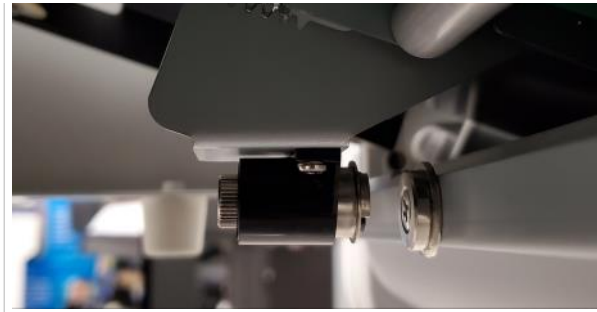
Prepared lever actuated (Feeder previously attached to printer). **See warning notes below**

Warning Notes

Please, **gently actuate the Prepared lever, only a slight force is necessary** to actuate the mechanism that moves the magnetic catch to a latch position, and the Paper presence sensor remains actuated.

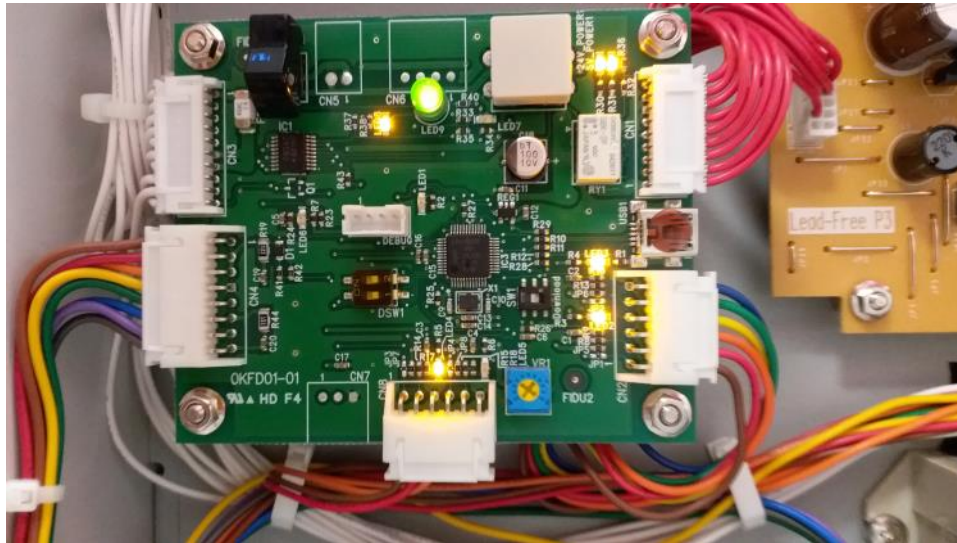
Old Style controller Bd.

Amber LEDs show status of all envelope sensors, 5 VDC and 24 VDC as well.
Firmware can be updated to version 1.06

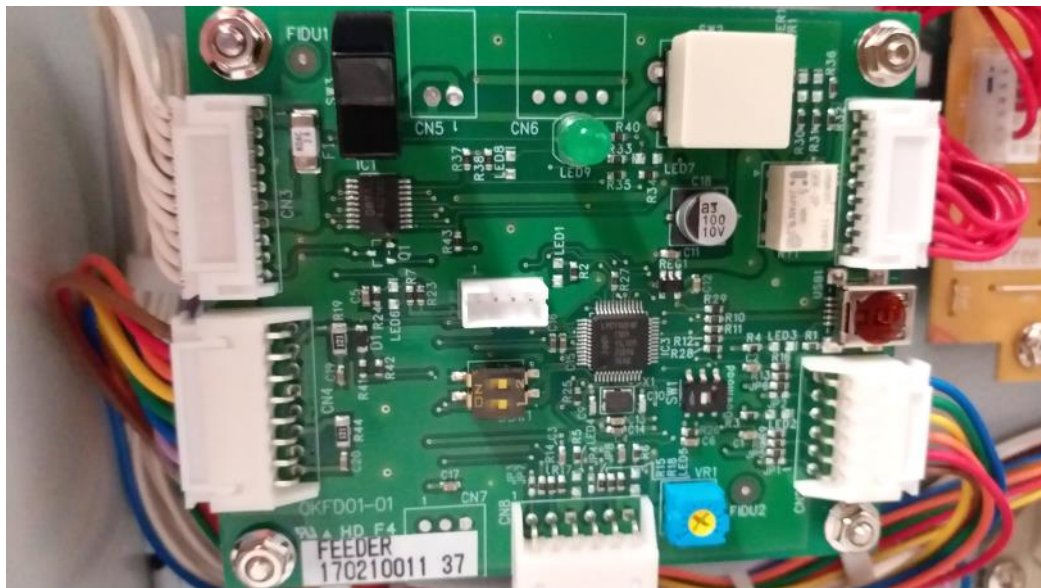
New Style Controller Bd., for all production envelope feeders
No Amber LEDs on it.

Device no longer recognized / mounted by MS Windows when connected to USB port

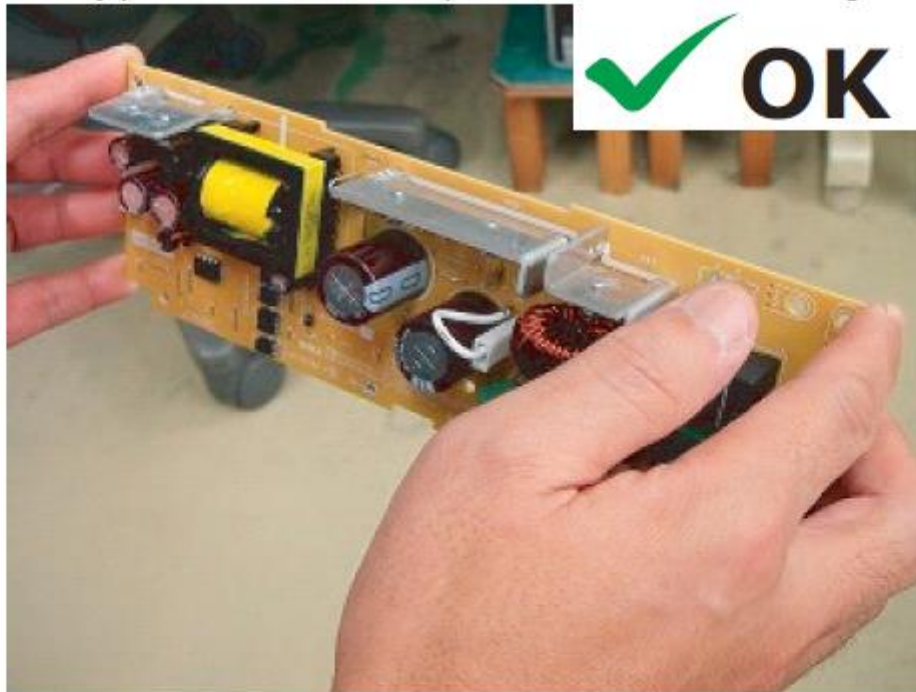
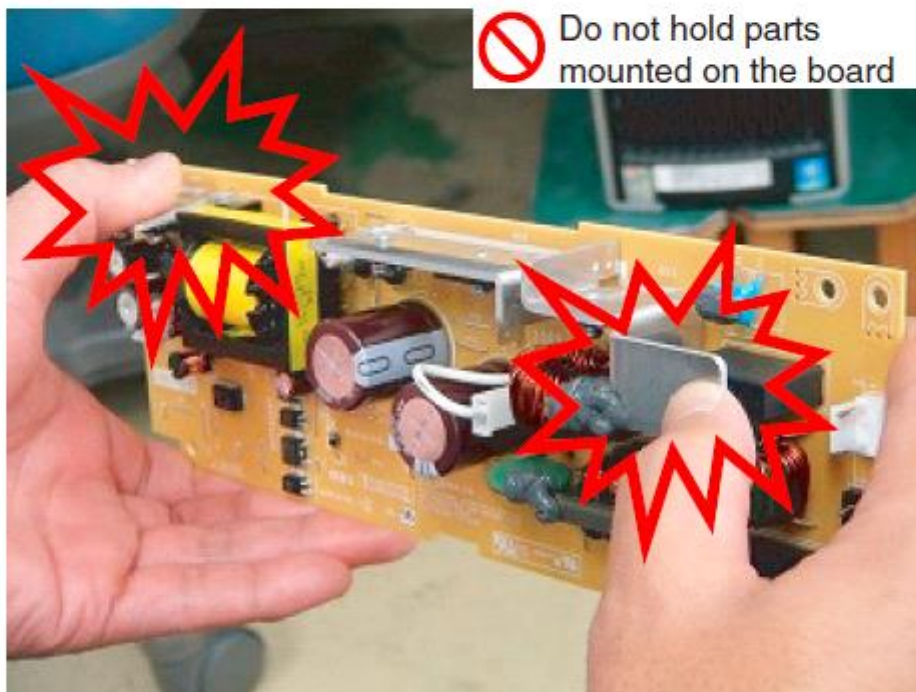
Note!: for the risk of destruction

1. Do not hold any parts mounted on the power board when removing the board.

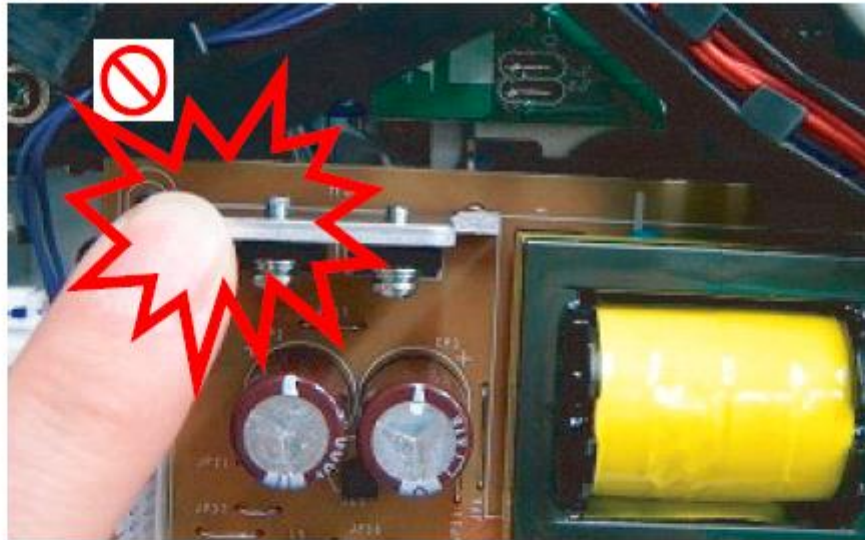
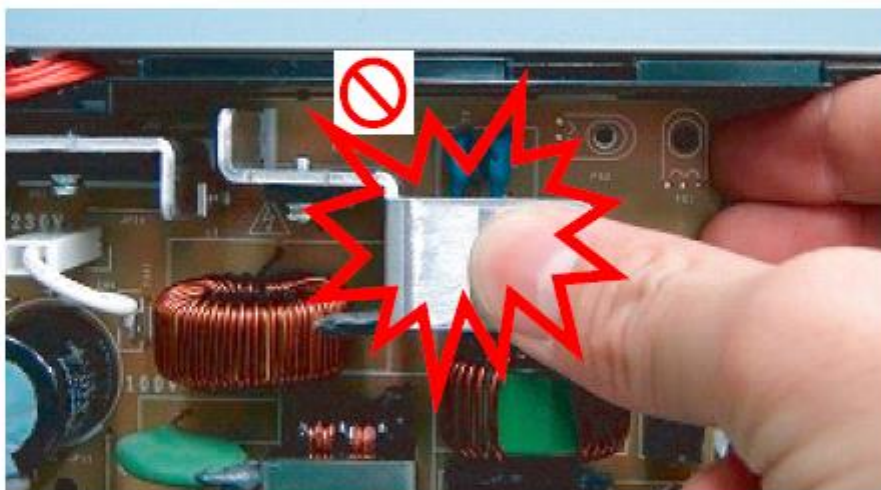
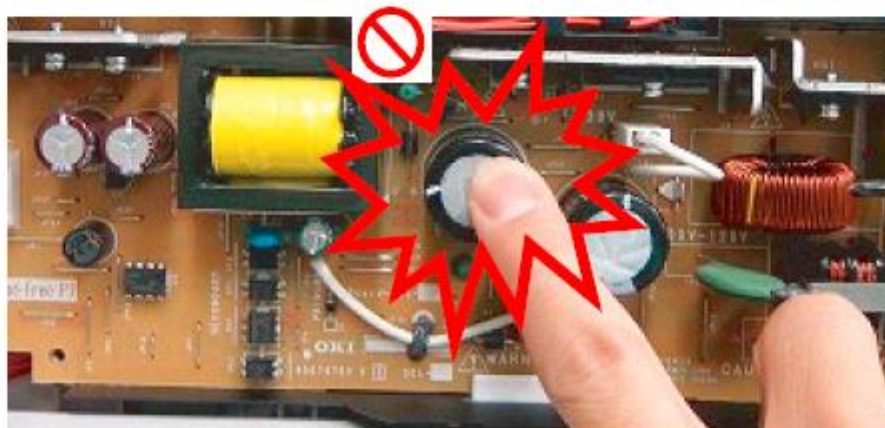
2. Do not push the parts mounted on the parts or push them against another object such as a table.

3. Pushing parts causes terminal peeling on the back side.
