Troubleshooting Guide

imageRUNNER ADVANCE

C5560 III Series

New Arrival Information

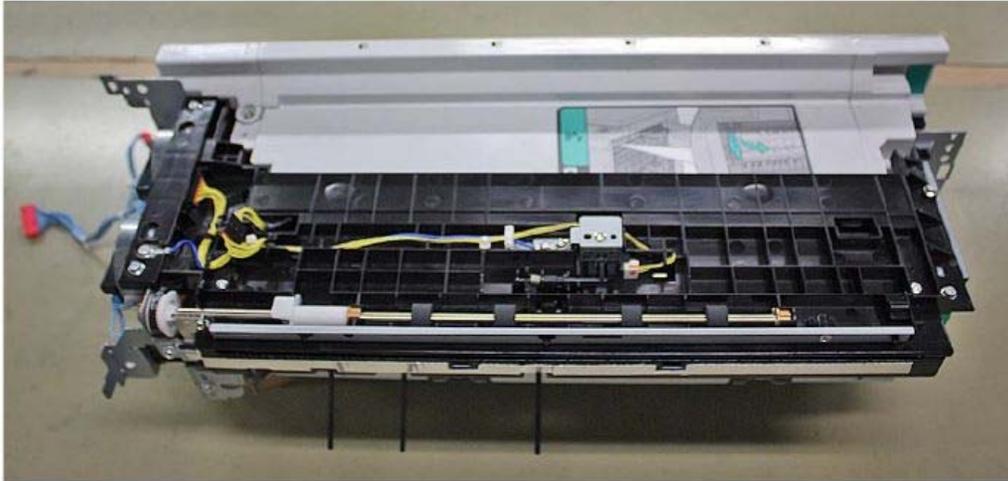
This causes the reverse sensor flag to dislodge when clearing jams in the reversing area.

1. By referring to the Service Manual, remove the 2nd / 3rd Paper Delivery Assembly from the device and place it on a stable area.

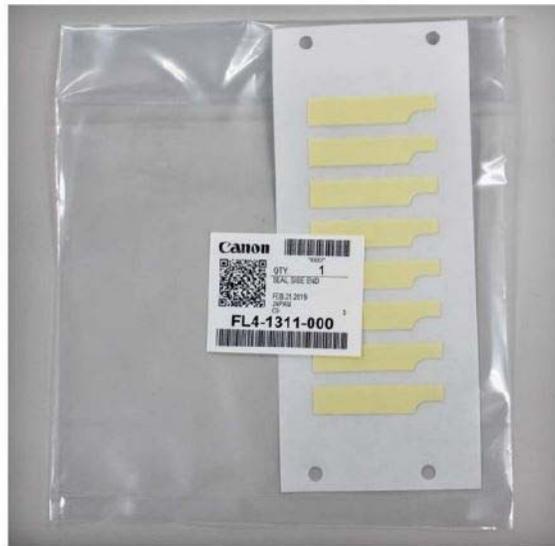
This issue is caused by a buildup of developer material on the outer edges of the developer roller. This buildup is what creates the streaks on the front and rear margins of paper wider than 305mm (12 inches).

To prevent this issue from happening, order the newly setup Side End Seal (FL4-1311-000) and follow the procedure in the **SERVICING PROCEDURE** section.

When the Side End Seal (FL4-1311-000) is ordered, one (1) package contains eight (8) seals.
