# Troubleshooting Guide

## imagePRESS C800 Series

July 16, 2019  
Canon U.S.A., Inc.

# New Arrival Information

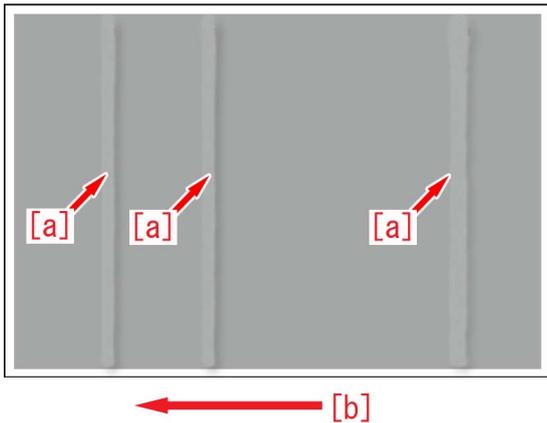
Horizontal lines [a] may appear randomly on a Bk half-tone image after leaving the machine for a long time. The arrow [b] indicates the direction of feeding.

1) Go to Service Mode (Lv2) > Mode List > COPIER > Function > MISC-P >, select ITB-ROT and press "OK" button.

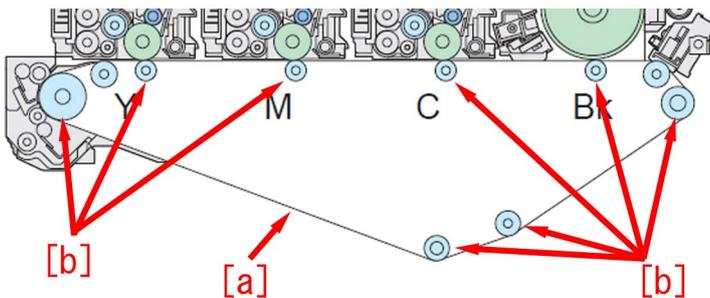
If a machine is left untouched for a long time, ITB[a] and 8 rollers[b] inside ITB are in contact each other for a long time, and this condition curls ITB.

The curled part makes tiny space between ITB and the secondary transfer roller, therefore discharge phenomenon may be generated.

If discharge phenomenon is generated, toner on ITB scatters, disarranges the image and this results in the above mentioned symptom.

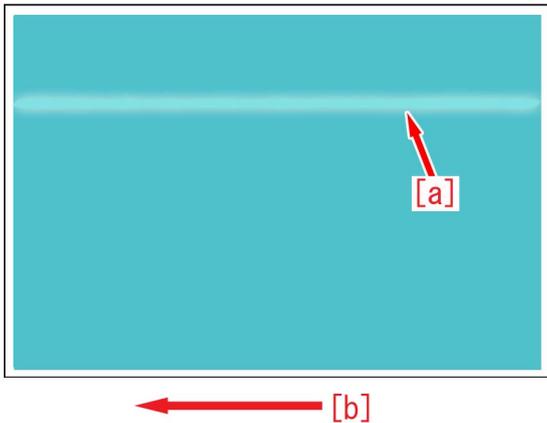
When a low-duty image is output continuously, a line [a] may appear on the output image (faulty toner coating on the developing sleeve).

The arrow [b] indicates the direction of feeding.

1) In Service Mode (Level 2) > Mode List > COPIER > Function > CLEANING > "DVS-CLNx," select a color having shown the symptom. Then press "OK."

Executing this Service Mode causes the developing sleeve to rotate, thereby removing the toner clump.

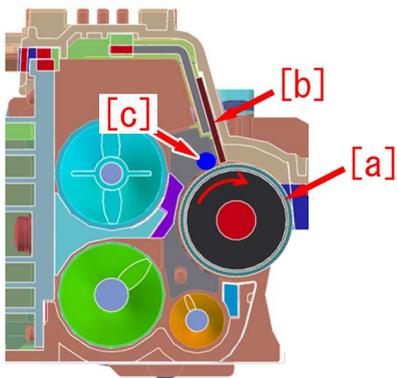
When a low-duty image is output continuously, toner consumption is not high. Accordingly, toner may stagnate between the developing sleeve [a] and the blade [b], possibly resulting in a clump [c].

Due to such toner clump, the developing sleeve cannot be coated evenly with the toner. In that case, the above symptom occurs.

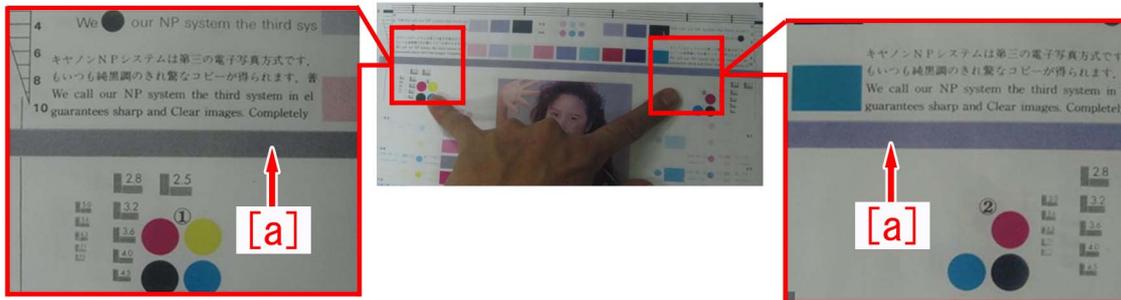
Hue difference [a] between front side and rear side may occur due to condensation.

The above symptom occurs due to condensation on dustproof glass when the device is placed in a low temperature/high humidity environment and then when the temperature rises drastically.

Opening the front door during drastic temperature change makes the humidity inside the device to go up, making the symptom to occur easily.

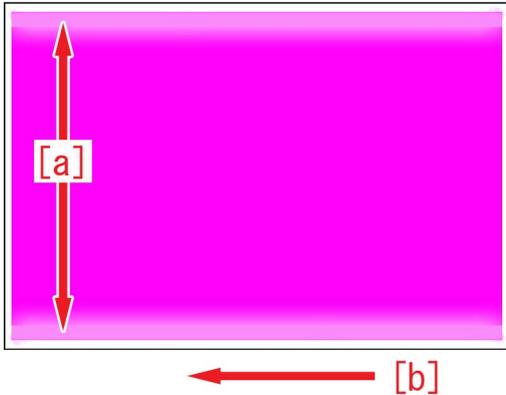
If a high density image is output after a large amount of output of low density images in a low humidity environment, the density along the edge on the front or rear side may come out light [a].

The arrow [b] indicates the direction of feeding.

In low humidity environments, transfer performance deteriorates comparing to other environments attributed to high triboelectricity of toner.

A large amount of output of low density images consumes only a small amount of toner, and so the toner deteriorates and results in poor transfer.

The contacting pressure along the edges of primary transfer area is lower than that on the center. This is why the transfer performance deteriorates along the edge.

When the above mentioned three conditions are met at a time, the density of high density area comes out light and that brings the symptom.

1) Select Settings/Registration > Adjustment/Maintenance > Maintenance > Clean Inside Main Unit, and press "Start" button. The cleaning takes about 1 min.

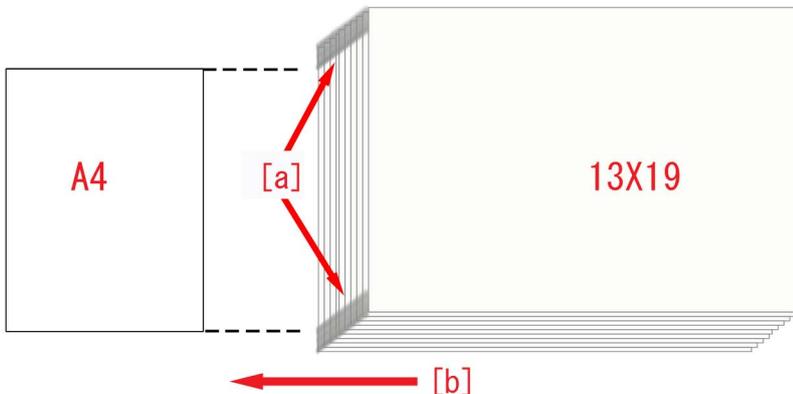
After 20,000 sheets or more of a certain size of paper passed, if a wider size of paper passes, the part where the former paper did not pass at the leading edge of the latter paper may get soiled [a].  
The arrow [b] indicates the direction of feeding.

The whole surface of the drum is covered with a slight amount of toner that is impossible to be removed completely even with the fogging removal potential.

1) Select Settings/Registration > Adjustment/Maintenance > Maintenance > Clean Roller, and press "Start" button.  
The cleaning takes about 30 seconds.

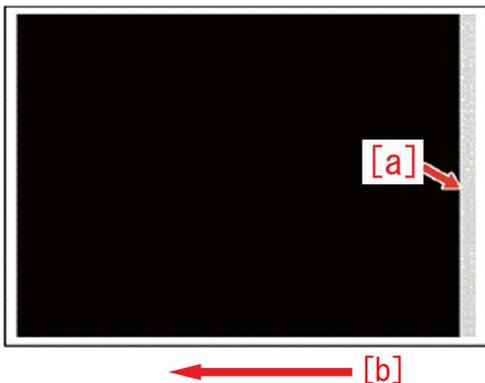
When a thick coated paper is used under a low humidity environment, image blanking [a] may occur at the trailing edge of paper. The arrow [b] indicates the direction of feeding.

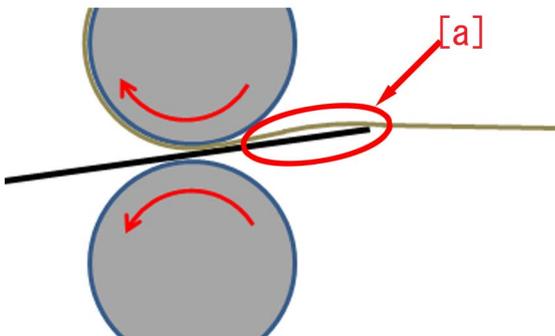
A tiny space [a] may be formed between the trailing edge of paper just in front of the nip of the secondary transfer roller and ITB. If electricity is discharged in this space, polarity of toner on ITB changes and the toner will not be transferred onto the paper. This results in the above mentioned symptom.

This symptom is likely to occur when a rigid and thick coated paper is used under a low humidity environment where the set value of the secondary transfer voltage is high.

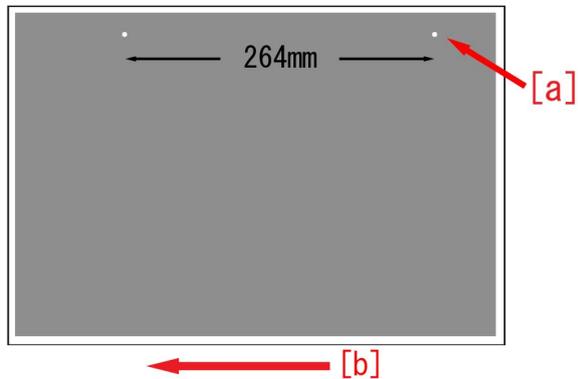
White spots [a] with 264mm intervals may appear on a Bk halftone image.  
The arrow [b] indicates the direction of feeding.

The above mentioned symptom occurs when the drum of the drum unit (Bk) gets soiled.

1) Refer to the service manual "Parts Replacement and Cleaning > Image Formation System > Removing the Drum Unit (Bk) > Procedure" to remove the Drum Unit (Bk).

2) Clean the drum [1] with lint-free paper moistened with alcohol, then take a new sheet of lint-free paper and wipe the moisture off with it without moistening the paper.

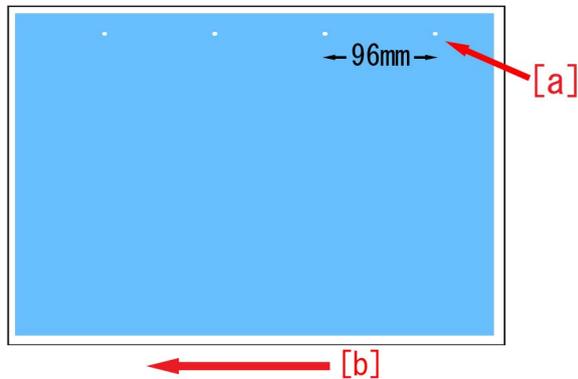
White spots [a] with 96mm intervals may appear on a halftone image of a color other than Bk.  
The arrow [b] indicates the direction of feeding.

The above mentioned symptom occurs when the Drum of the process unit (CL) whose color is corresponding to the halftone color gets soiled.

1) Refer to the service manual "Parts Replacement and Cleaning > Image Formation System > Removing the Process Unit (Y)/(M)/(C) > Procedure" to remove the Process Unit (CL).

3) Clean the drum [1] with lint-free paper moistened with alcohol, then take a new sheet of lint-free paper and wipe the moisture off with it without moistening the paper.

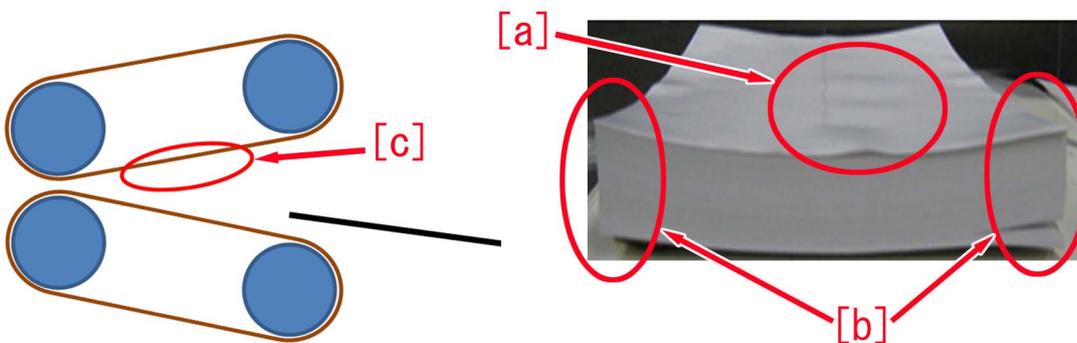
## Smearred image occurs with paper that had been left in a low humidity environment

If a coated paper 150gsm or less or a plain paper 100gsm or less that had been left in a low humidity environment is used, uneven density [a] as if scratched in the center of a Bk halftoned image or disordered image [b] on the front and rear edges near the trailing edge of the sheet may occur.

A sheaf of paper that had been left in a low humidity environment is dried unevenly and the paper deforms.

If the paper deforms as its center part is bloated [a], the paper is fed with the deformed part close to the fixing belt [c] and uneven density as is rubbed appears.

If the trailing edge of the paper deforms upward [b], the paper is fed with the deformed part rubbing the fixing belt [c] and a disordered image appears.

Improving a state of preservation of paper may be effective in resolving a trouble in some cases.

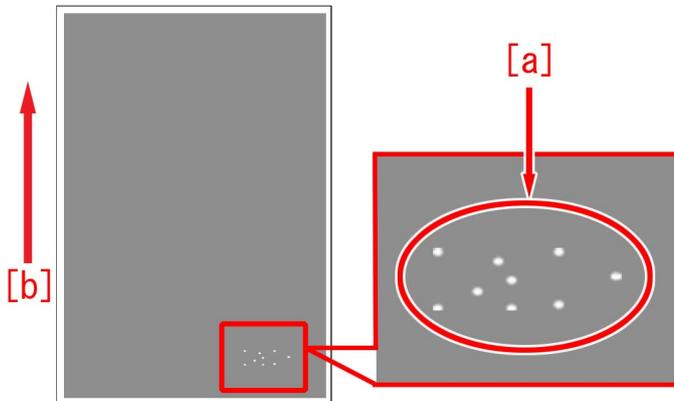
# White spots appear in halftone image when paper left in low humidity environment is used

When paper left in a low humidity environment is used, white spots [a] may appear in a halftone image. The arrow [b] indicates the feed direction.

If dry paper having been left in a low humidity environment frequently rubs against the secondary transfer inlet upper guide, the guide is electrically charged.

Explain to a customer that unused or remaining paper should be stored by being covered with wrapping paper in a place avoiding direct sunlight.

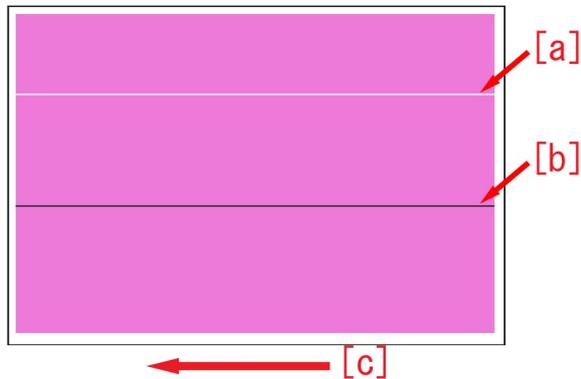
A sharp white line [a] or black line [b] may appear on a halftone image other than Bk color. The arrow [c] indicates the direction of feeding.

The above mentioned symptom occurs when the charging roller of the process unit (CL) whose color is corresponding to the halftone color gets soiled.

1) Select Settings/Registration > Adjustment/Maintenance > Maintenance > Clean Inside Main Unit, and press "Start" button. The cleaning takes about 1 min.

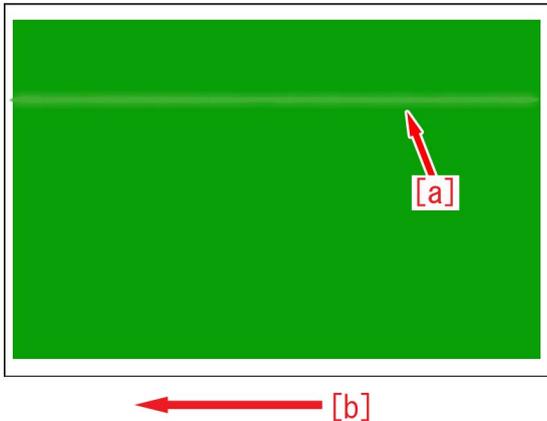
Streaks on high density image (red/green) due to the dust on the primary transfer roller

If some endurance time of the primary transfer roller has elapsed, rubber constituent can ooze on the surface by current application.

After passing many sheets in a low humidity environment with high primary transfer voltage, if it changes to a high humidity environment under which dust is more likely to attach on the roller, it increases the chance of having the symptom.

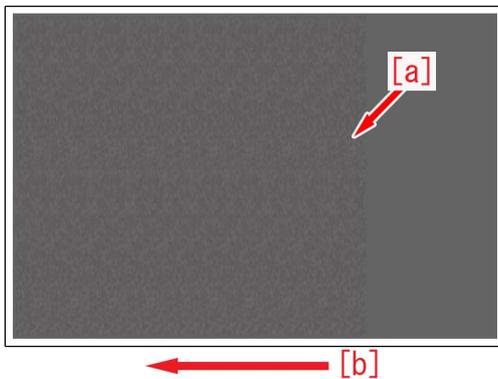
Coarse image [a] may occur from the leading edge to around 100mm from the trailing edge of paper with a Bk halftone image under high temperature and high humidity environment.

The arrow [b] indicates the feed direction.

While the trailing edge of the paper passes through the registration roller, if the same paper is slipped slightly at the nip of the secondary transfer roller, the behavior of paper becomes unstable.

Under high temperature and high humidity environment, if the speed of the registration roller is higher than that of the secondary transfer roller and the paper is fed in a sort of pushing manner, the behavior of the paper becomes unstable and likely to have the symptom.

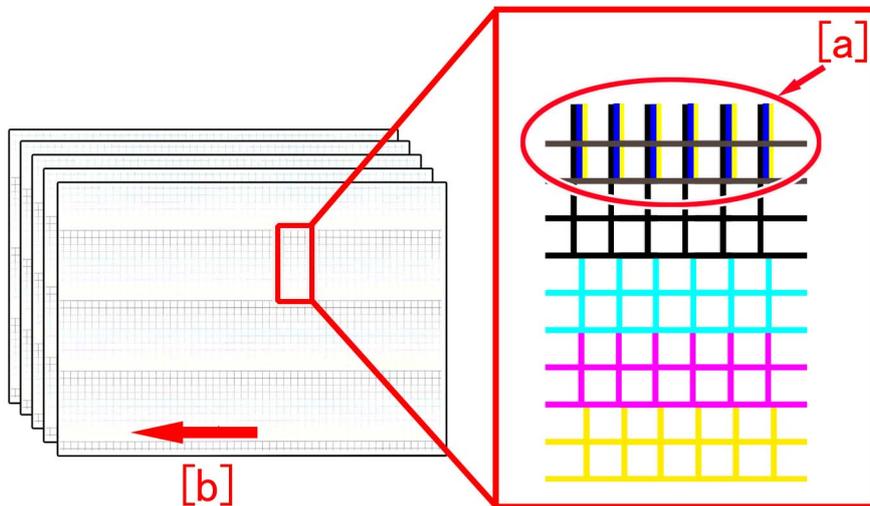
When the temperature inside a machine suddenly changes, color displacement [a] may occur in the vertical scanning direction (feed direction).

The arrow [b] indicates the feed direction.

Depending on the temperature, components in the vicinity of the laser scanner slightly shrink due to heat.

When the temperature inside a machine suddenly changes, a larger difference occurs between the degree of actual shrinkage and the degree of shrinkage estimated based on the detected temperature. This causes the laser beam to be applied to a deviated position on the drum, resulting in the symptom.

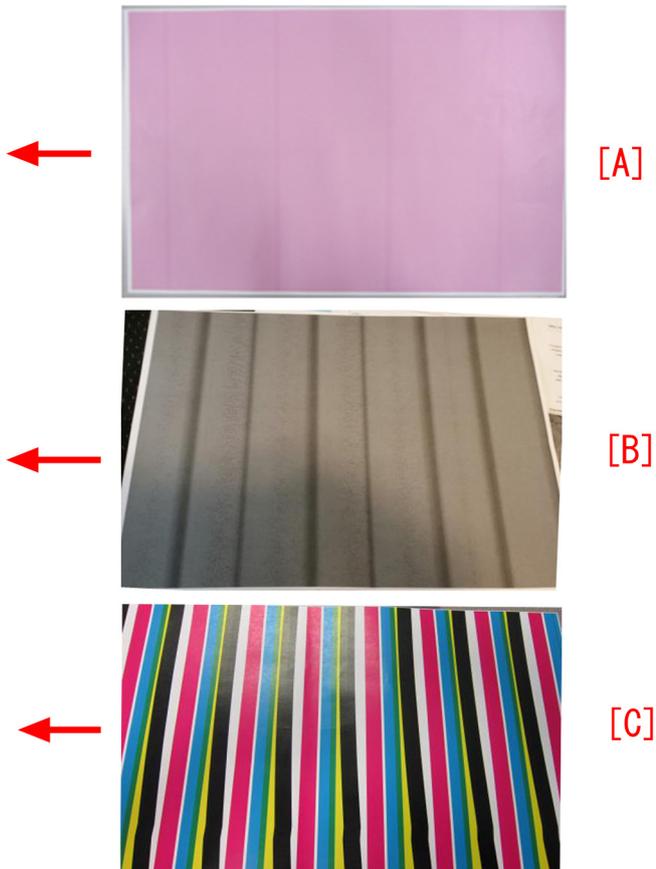
In the machines prior to the Countermeasure cut-in serial number in factory described below Image failure such as uneven pitch at around 120 mm intervals [A] or 60 mm intervals [B] in paper feed direction, or color displacement [C] may occur. Also one of E012-0500 / 0502 / 0503 may occur after the occurrence of the image failure.

- E012-0500 : ITB Drive Motor drive detection error
- E012-0502 : ITB speed detection error
- E012-0503 : ITB speed detection error

When encoder support plate [1] for ITB unit is deformed to the direction of arrows [A] or [B], the encoder sensors [2] attached the encoder support plate may come into contact with encoder [3]. The encoder shaves the surface of the encoder sensors due to this contact, and the accumulation of shaving chips in the slit of the encode sensors causes detective failure and then it results in the above symptom.

When the symptom occurs, correct a part or replace the intermediate transfer belt drive unit with new one in the following procedures.

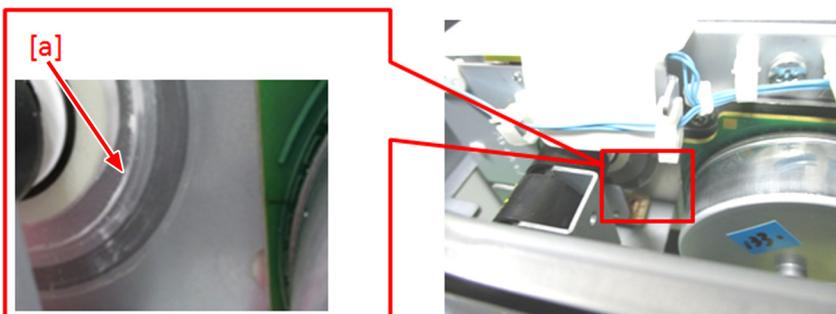
- 3) Check if the surface of ITB encoder has shaving chips of encode sensors. [a] is the portion where shaving chips sticks to.
- 3-a) If there are shaving chips on the surface of ITB encoder, go to Step 4)
- 3-b) If there are not shaving chips on the surface of ITB encoder, go to Step 10) to check another fact because it is different from this cause.

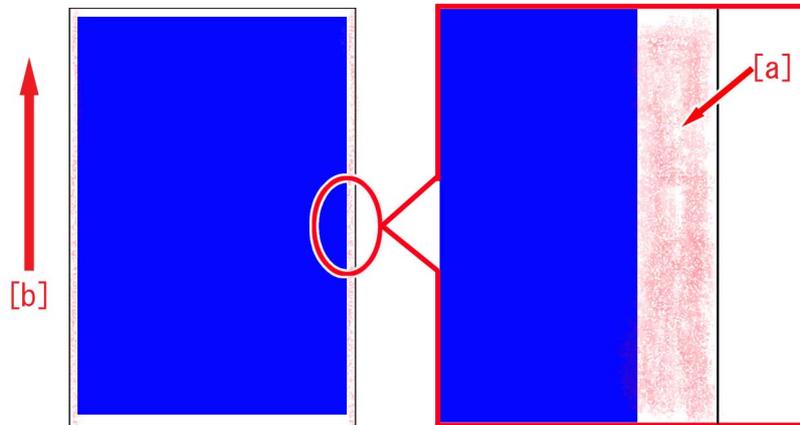
Toner stain [a] may occur in the strip areas of 2.5mm width from the edge of the front /rear sides of 13x19 paper in the use under a low humidity environment.

It does not occur with 12x18 or SRA3 paper.

The arrow [b] indicates the direction of feeding.

The ends of the drum cleaning blade continue to contact with the drum without toner, so that it gets abraded with progression of endurance time.

As toner passes through the abraded part, the charging roller gets soiled with toner and generates charging failure.

Excess toner attaches on the part with charging failure and this causes the above mentioned symptom.

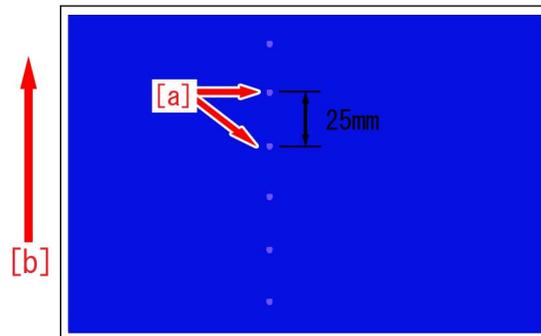
The symptom can be easily seen especially on high density images of heavy coated paper.

[b] shows the paper feed direction.

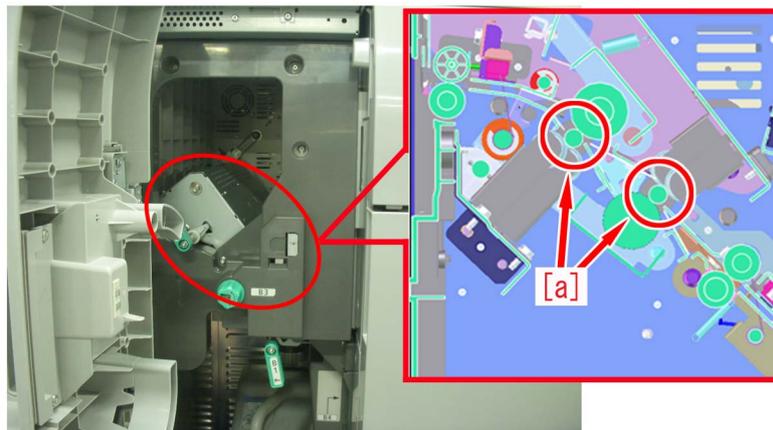
The above symptom occurs when dust and foreign objects are attached to the decurler rollers [a] where the decurler adjustment rollers face.

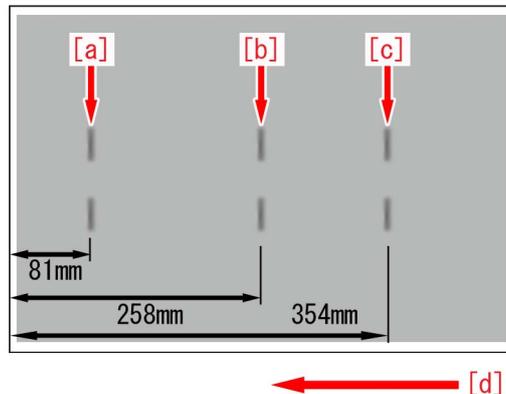
If paper is picked up from the cassette 1 or 2 under a high humidity environment, roller marks may appear in the area at 81mm[a]/258mm[b]/354mm[c] from the leading edge of the first page of halftone image.

Roller marks in the area at 354mm[c] may appear only when paper is picked up from the cassette 2.

The arrow [d] indicates the feed direction.

After print started, the first sheet of paper stands by at the registration assembly.

The symptom is more likely to be generated under a high humidity environment as the force of electrostatic attraction between paper and toner is weakened.

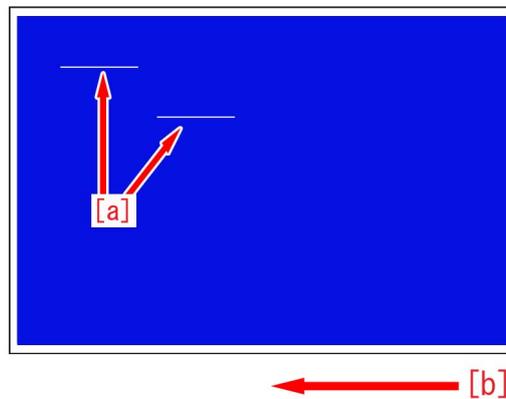
When 2-sided heavy coated paper with high-density image is fed, scratches [a] may appear on the first side. [b] shows the feed direction.

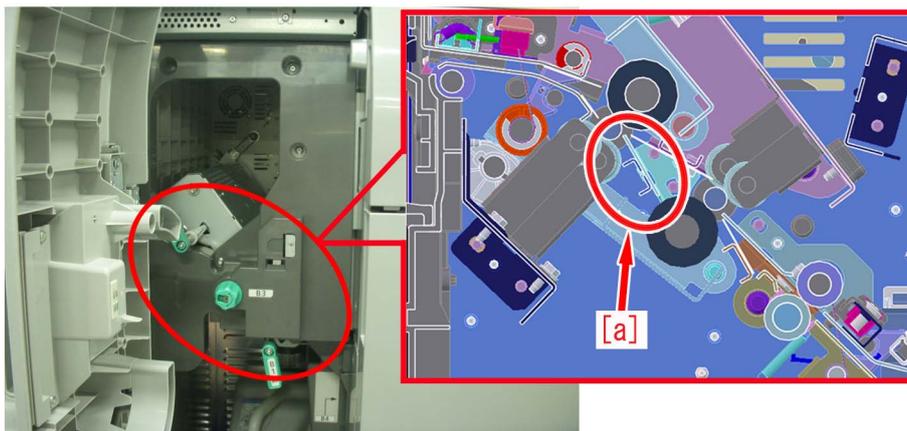
The above symptom occurs when the first side of 2-sided heavy coated paper scrapes against foreign objects including paper dust accumulated on the guide [a] of the decurler unit.

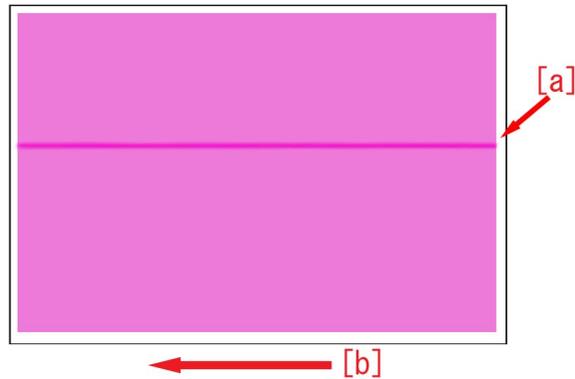
In high humidity environment, dark vertical line under 5mm in width [a] may appear on halftone image. [b] is the feeding direction.

Wax component contained in toner may attach to drum when pressed by drum cleaning blade.

When moisture gets on the area where wax is attached in high humidity environment, less amount of electricity is charged in such area. The above-mentioned symptom occurs due to the difference in the amount of electricity charged between the areas where wax is attached and where it is not attached.

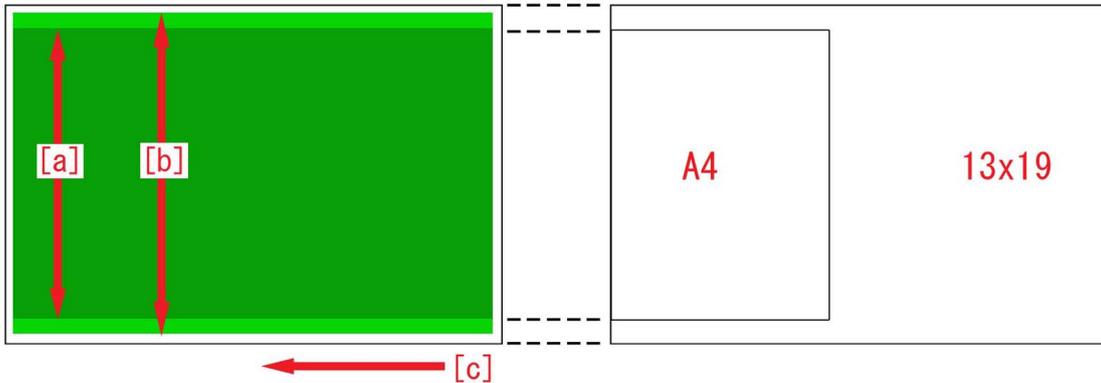
After 200,000 sheets or more of a certain width[a] of paper is fed, if a broader width[b] of paper is fed with a high density image, the symptom where the color comes out lighter in the areas at the both outer sides of the width of the former paper[a] may occur. The arrow [c] indicates the feed direction.

The below figure shows an instance that A4 and 13 x 19 are fed.

The resistance in the area of ITB where paper passed consecutively becomes higher, so that toner transfers from the drum to ITB easier.

1. Have the customer log in from System Management Mode in user mode.
2. Go to Preferences > Paper Settings > Paper Type Management Settings, select an appropriate paper type from among the list, press "Duplicate" button and then "OK" button.

7. Select Cyan and Black in the adjust primary transfer voltage screen, press "-" button thrice and if the corrected value[a] is confirmed to be "-3", then press "OK".  
The range of setting is from "-10" to "+10" ("0" by default). Changing this value changes the primary transfer voltage.

8. Output the image having shown the symptom, and check that the symptom does not occur. If the symptom no longer occurs, the work is completed.  
If the symptom does not show an improvement, go back to the step 2) and change the value of Black by one at a time down to "-5".
9. If the symptom still persists, revert the changed value in the step 2) to what it was and replace ITB.

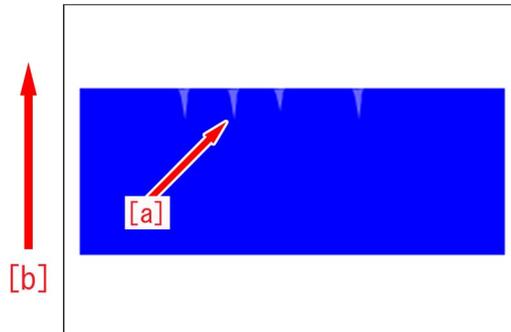
In the leading edge of high density image area, 3-5 mm width uneven gloss (Rain drop mark)[a] may appear in feeding direction with about 10mm in length.[b] is the feeding direction.

Water vapor from paper tends to stay more in the area with weak fixing nip pressure than in the area with high pressure. When the remained water vapor moves around on the paper, it causes uneven fixing leading to the above symptom. Coated paper tends to have poor air flow making water vapor in the area with weak fixing nip pressure not distribute and stay. This causes the symptom to easily occur.

1. Have the customer log in to System Management Mode in user mode.
2. Go to Preferences > Paper Settings > Paper Type Management Settings, select an appropriate paper type from the list. Press "Duplicate" and then "OK".

7. Press "-" button for gloss. Make sure the correction value [a] is set to "-1" and press "OK". The setting range is from "-2" to "+2". (Default: 0) Changing the value causes fixing temperature to change accordingly.

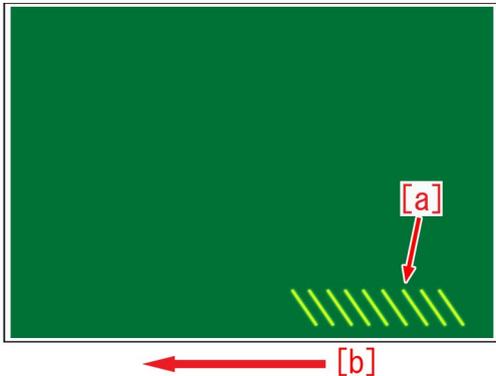
When printing several sheets of the high-density solid image after consecutive printing of the low-density image, skewed uneven density at 23mm intervals [a] may occur.

[b] indicates the feed direction.

Consecutive printing of the low-density image deteriorates the developer and worsens its fluidity.

Since the worsened fluidity of developer causes the unevenness in developer stirring on the developing sleeve, printing several sheets of the high-density solid image consecutively causes the above-mentioned symptom.

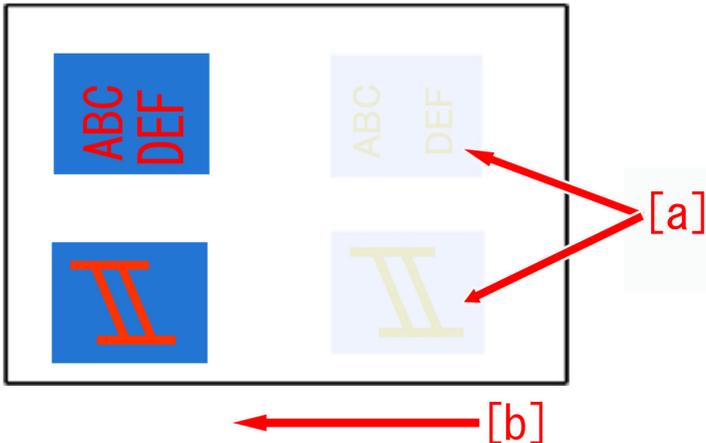
When outputting an image of high density on a heavy paper consecutively in double-sided mode in a low humidity environment, double image [a] may occur on the second side.

"[b] indicates the feed direction."

When outputting on a heavy paper in double-sided mode consecutively in a low humidity, the secondary transfer current increases and more electric charge amount is applied on toner.

If the cleaning after the secondary transfer failed to adequately remove the toner with more electric charge from the intermediate transfer belt, the residual toner will attach onto the second side and result in the aforementioned symptom.

- 4) Change the value of <Adjust ITB Image Cleaning> to "-10" and press "OK".  
The setting range is between "-10" and "+10". ("0" by default)

7) In <Adjust Secondary Transfer Voltage> press [-] key for the Back Side ten times, check if the corrected value [a] has become "-10" and press "OK" after confirmation.

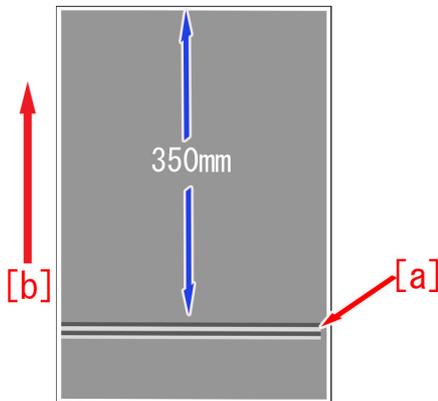
When outputting consecutively in black mode on a paper of 150gsm or less, uneven image density [a] at a regular intervals of 4.5 mm may occur around 350 mm from the leading edge of the paper.

[b] indicates the feed direction.

When the secondary transfer outer roller attaches on and detaches from the ITB, the speed of the ITB changes and the aforementioned symptom occurs.

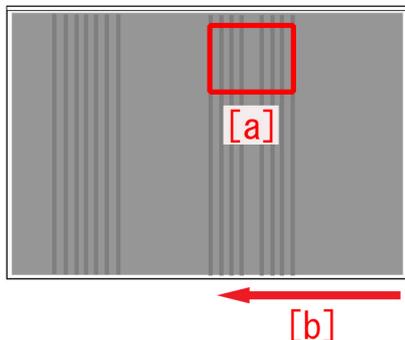
When using papers of 150gsm or less, outputting consecutively, uneven density [a] at a regular intervals of 4.3 mm may occur. This phenomenon is more noticeable in Black and White mode.

[b] indicates the feed direction.

1) Change Service Mode (Level 2) > Mode List > COPIER > Option > IMG-TR > BK- 4C-SW to "1".

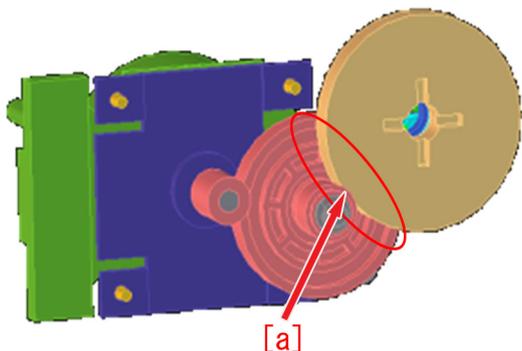
The meshing [a] between the ITB idler stepped gear in the ITB drive assembly and the ITB drive gear may fail, this brings a rotary irregularity and results in the above mentioned symptom.

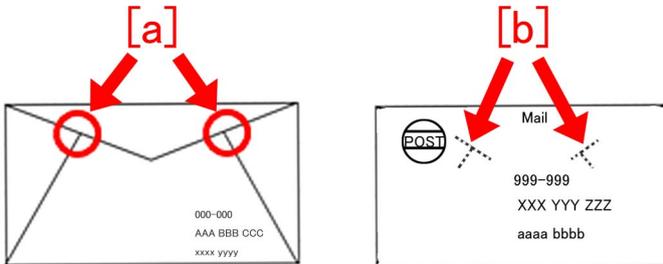
When envelopes pass the fixing assembly, the load is centralized on the overlapping points [a] on the reverse side of envelop. Therefore an image having partial white spots may be output due to the occurrence of worn-out fixing belt surface or shaved rubber of fixing roller surface. If the fixing pressure is greater, the overlapping points [a] may make impresses [b] on the front of envelop depending of the type of envelop.

As the measure of the above-mentioned symptoms, MN-CONT is graded up to v30.52 and D-CON is graded up to v30.31 for the following 2 controls.

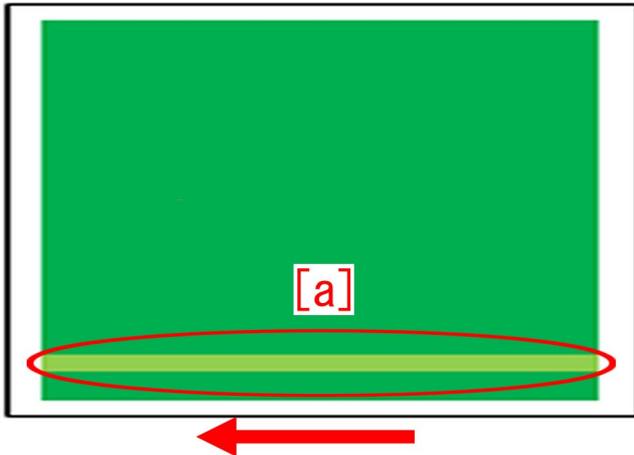
On the main body whose Countermeasure Cut-in Serial Numbers in Factory is earlier than the following number, non-glossy streaks [a] image may occur with high gloss media or heavy media (200g or more). The arrow indicates the paper feed direction.

As a countermeasure against the aforementioned symptom, replace the separation plate with the thinner type that reduces scuffing of the tape even when a high gloss or heavy media is passed through.

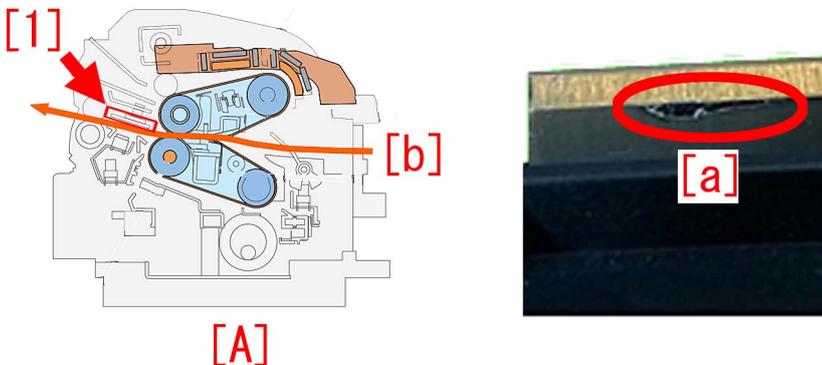
The separation plate [1] in the fixing assembly [A] comes in thick and thin types. The tape affixed to the thicker separation plate [1] comes off [a] from scuffing, then the fed paper comes in contact with the peeled off tape and leads to the above mentioned symptom.

The arrow [b] indicates the paper feeding path.

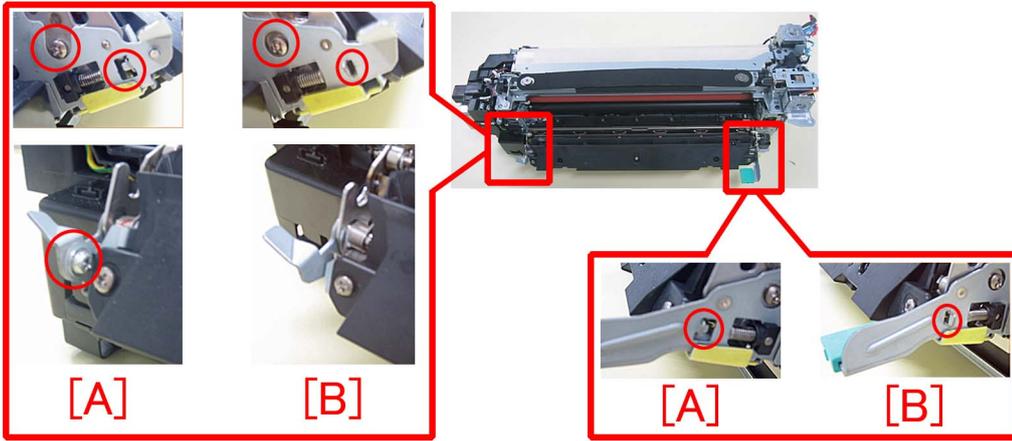
If the shape of the inner paper delivery assembly is as shown in the photo [A], replacing the fixing separation unit only is possible. The photo [B] shows the shape of the old type inner paper delivery assembly.

Check to see if the inner paper delivery assembly is the new type or the previous type, if it is the new type follow the procedure A, and if it is the previous type, then follow B.

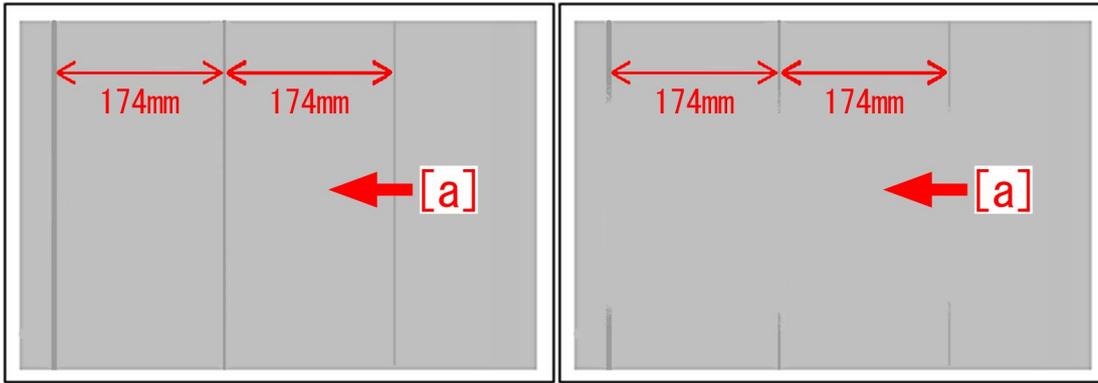
- 14) Close the inner paper delivery assembly and install the fixing assembly.  
15) Take some prints and check the image. If the image appears normal, the work is finished.  
16) A streaks with 174mm regular intervals may rarely occur. (The arrow [a] indicates the paper feed direction.)  
In that case, from User mode go to Settings/Registration > Preferences > Paper Settings > Paper Type Management Settings, select the paper type with which the streaks occurs, press the change button of "Adjust Fixing Speed" in [Details/Edit] to adjust the fixing speed towards the positive direction.

If the streaks appear on images even after adjusting the fixing speed, replace the fixing separation unit with the thick type (FM1-R469-000).

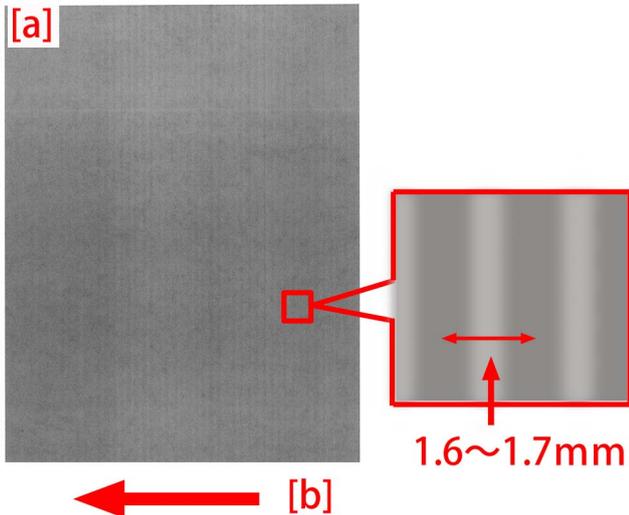
From 1.6mm to 1.7mm pitch uneven density [a] may appear in main scanning direction on the second sheet or later when coated sheets whose basis weight is 200gsm or more are continuously output. The symptom is prominently seen on a black halftone image. The arrow [b] indicates the direction of feeding.

Because the paper feeding speed of fixing assembly is faster than the speed of secondary transfer unit, the media will be pulled between the secondary transfer unit and the fixing assembly. Therefore, the vibration of fixing idler gear is transferred to the scanner and that results in the above symptom.

When the above symptom occurs, adjust the fixing speed to minus side for every sheet in the management setting for media type in user mode.

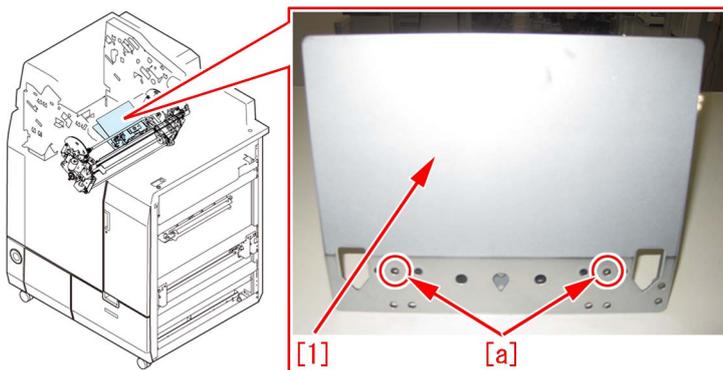
The stack of sheets loaded on the height tray assembly is fed by sub gripper assembly and then transferred to the main gripper assembly. The marks caused by friction are put on the first and last pages of glued stacked of sheets due to the edges of round holes [a] of mini gripper [1] being located at the upper and lower sides of main gripper assembly when transferring.

If the above-mentioned symptom occurs, prepare the sheet kit (4Y8-3138-000) to affix the sheet on the mini gripper being located on the upper and lower sides of main gripper assembly.

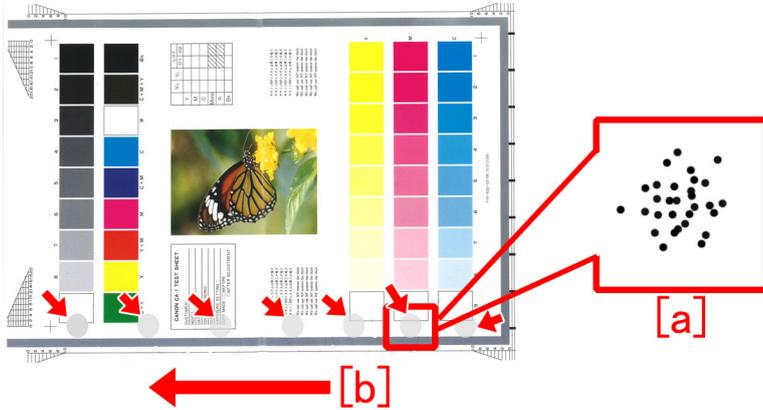
When printing with the machines manufactured before the following serial numbers, soiled image (black dots) [a] may occur at the edge of papers (front or rear side) in 37mm intervals.

The arrow [b] indicates the feed direction.

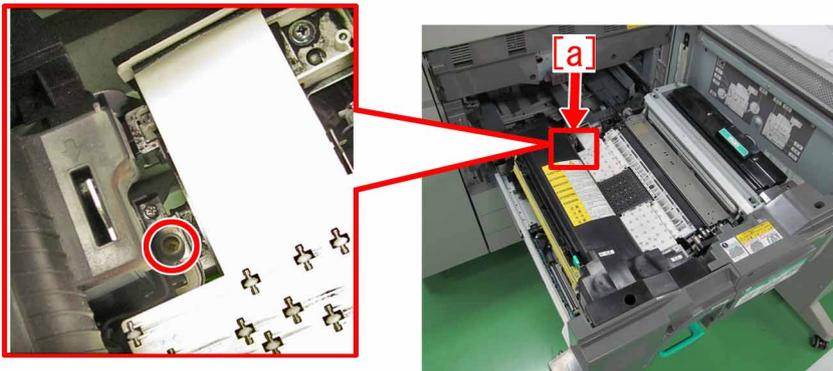
When installing a fixing assembly to a fixing feed unit, 3 screws are to be used and the first screw has to be fixed on the positioning hole [a] before installing other screws. When screws are not installed in this order, a fixing assembly may be not installed in correct position. In such case, the gear mesh between a fixing drive idler gear and a fixing idler gear become insufficient. As a result, gear vibration increases to cause aforementioned symptom.

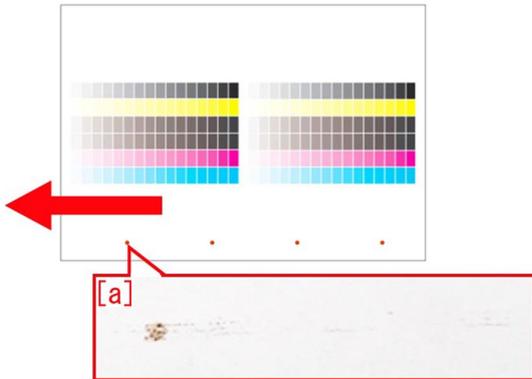
In the machines prior to the countermeasure cut-in serial number in factory described below, brown smear (76.3mm pitch or 62.8mm pitch smear of rice grain size) [a] may be occurred.

Shown in arrow is feeding direction.

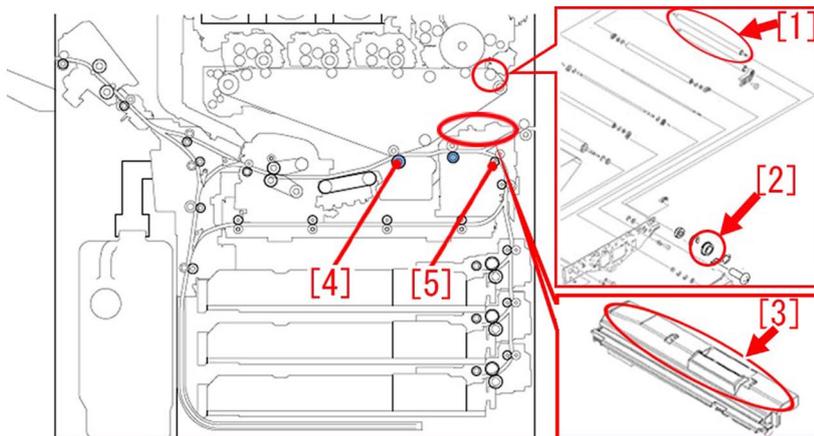
Bushing [2] attached on idler roller A [1] of I.TB. frame assembly may be shaved, and the shaved powder scatters and drop on the upper cover surface [3] of the registration assembly. When removing paper jam etc., this shaved powder may adhere on secondary transfer outer roller [4] or pre-registration roller [5] and be transferred on papers to cause the above symptom.

When the aforementioned symptom is occurred, prepare a new type of ball bearings (XG9-0780-000) x2pcs, E-rings (XD9-0137-010) x2pcs and super lube grease (FY9-6005), and follow the steps below to replace the parts.

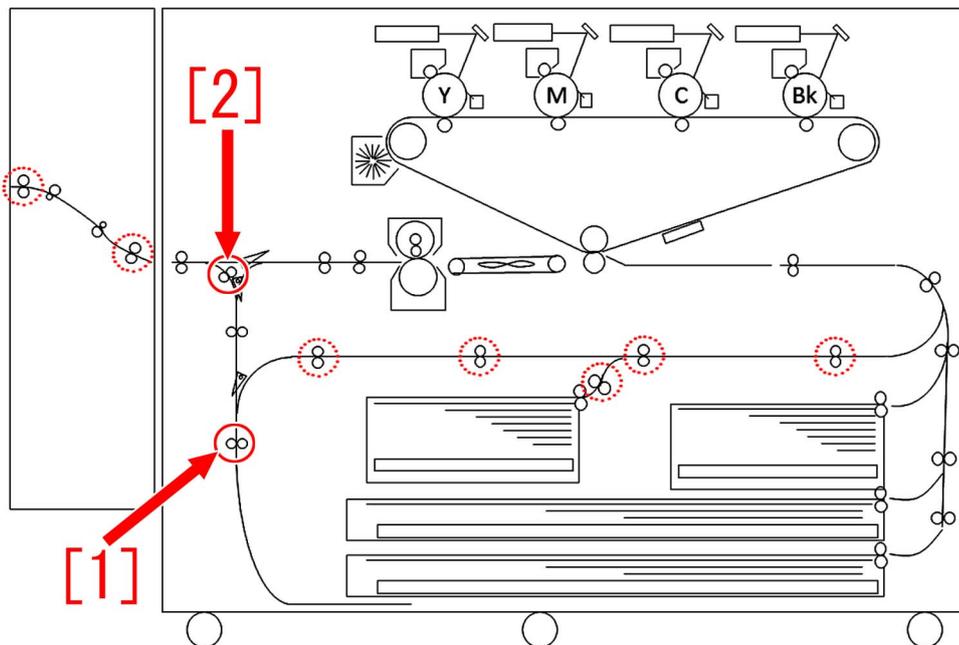
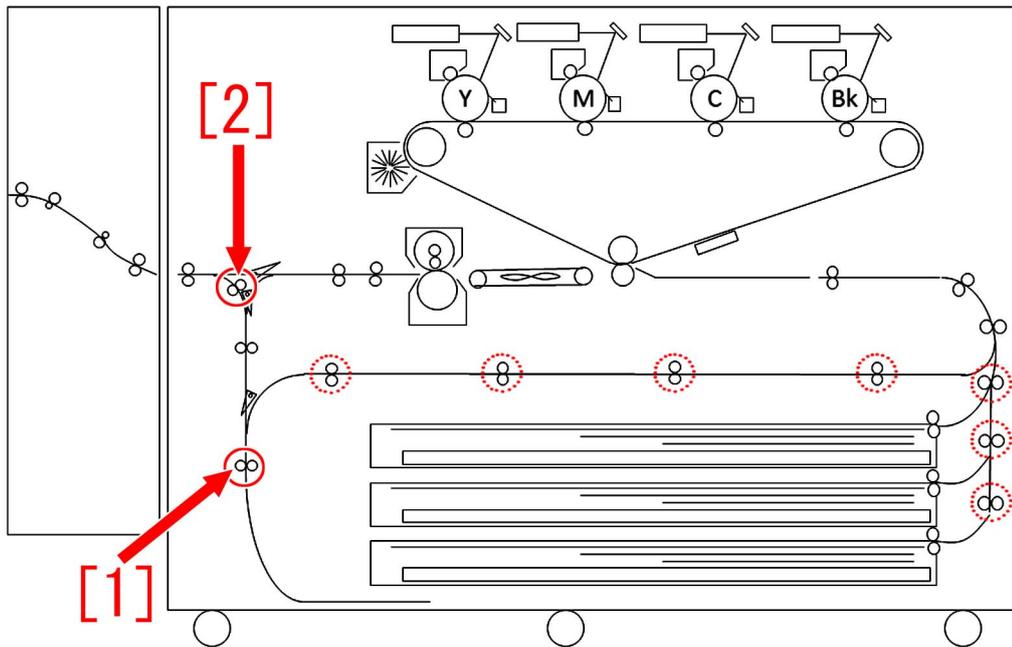
[Reference] This symptom occurs with the bushing of the lower reverse roller [1] and the bushing of the front delivery roller [2]. The same bushing is used in the rollers circled in the dotted line, but the issue due to shaved bushing does not occur.

When the symptom occurs, prepare the new type reverse driven roller set (FM1-P168-000) and grease (Hanarl). The reverse driven roller set is used when replacing the lower reverse roller [1] and the front delivery roller [2] shown in the figure under [Cause], and the grease (Hanarl) needs to be applied before being replaced.

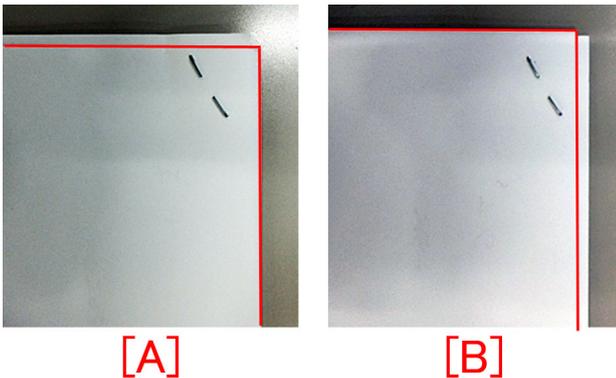
Misalignment of the last sheet occurs on the outer side of the set as shown in the photo [A] or on the inner side of the set as shown in the photo [B].

[Reference] The specification of staple misalignment is within 2 mm

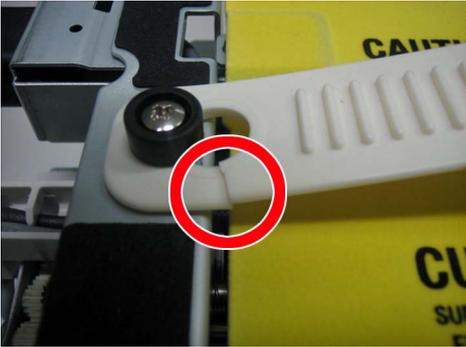
[Reference] The image below shows the similar symptom occurred on the fixing assembly of an iR-ADV 6275 series.

Aged deterioration of the nylon part of the handle belt induces cracks and this leads to breakage.

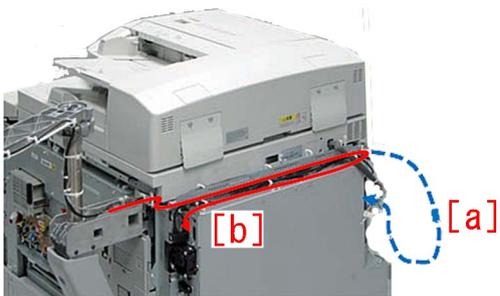
A faulty connection of cable from the upright control panel assembly to the connector of main body causes blowout of the fuse on the relay PCB assembly. That results in the above-mentioned symptom.

Especially when it is a printer model, when viewed from the back, the connector located the right side which is for reader is unused. Therefore the cable connector potentially is connected with the unused connector mistakenly. (See the below figure. The dashed line [a] shows an example of wrong wiring.) The solid line [b] of the following figure shows a proper wiring. Connect the cable to the connector located left side, when viewed from the back.

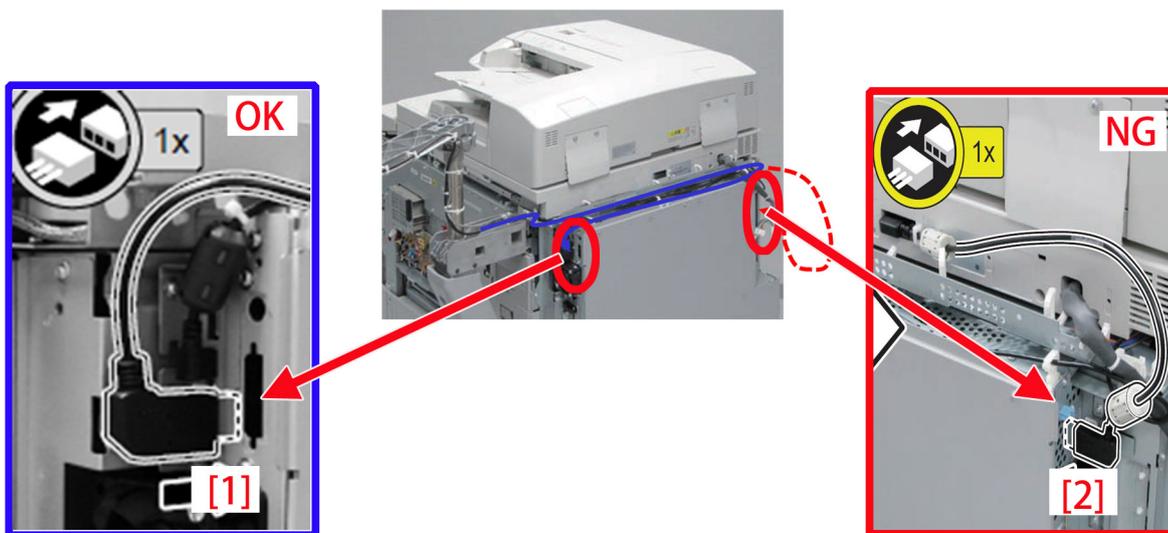
When the fuse of the relay PCB is blown out, the above mentioned symptom occurs.

[CAUTION] The connector [2] on the right side is to be connected with the reader communication cable. Keep in mind that this connector is left unconnected with a printer model.

- 1) Turn the main power of the main body off and insert the cable of the control panel to the connector on the left side.
- 2) Start the main body and confirm that a phenomenon does not occur.  
If the symptom does not improve, go to the step 3).
- 3) Measure the fuse (FU2) [1] of the relay PCB [A] with a tester.

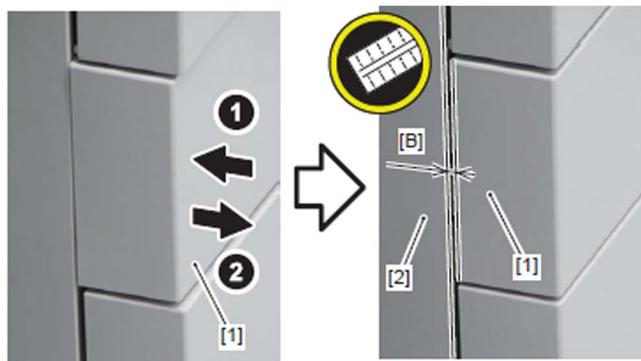
Misalignment after cassette side registration adjustment between the cassette front cover and the position to which the pull-in guide should be adjusted causes the above symptom.

Preparatorily, measure the gap [B] between the cover on the rear side [2].

In case of semi-closed, push the cassette [1] further first and then measure the gap [B] between the cover on the rear side [2].

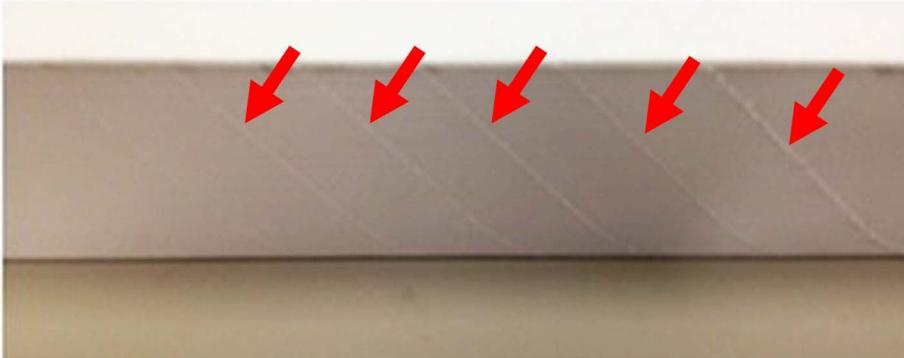
In the machines prior to the Countermeasure cut-in serial number in factory described below lines may occur on the trimming side of the books.

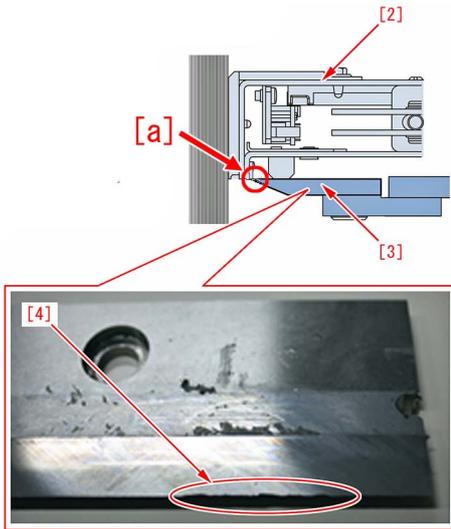
If the stack of sheets are trimmed in a state where the pressing plate [2] is lowered, the trimming blade [3] contacts with the pressing plate [2] [a], and the nicked trimming blade [4] occurs. As a result, the above-mentioned symptom occurs.

If the trimming blade is found to be nicked, prepare the new cutter unit (4Y8-3057-000), the reinforcement kit (4Y8-3099-000) and the super lube grease (FY9-6005-000). And replace the trimming blade and attach the reinforcement kit by following the procedures.
