# Troubleshooting Guide

## imagePRESS C800 Series

July 16, 2019  
Canon U.S.A., Inc.

# New Arrival Information

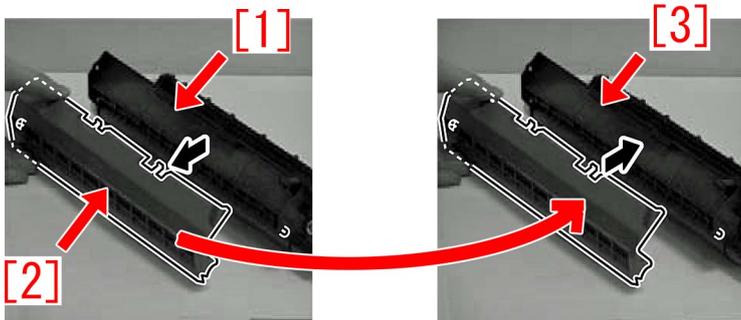
When to replace the transfer cleaning unit, it is required to detach the heat absorbing cover [2] from the old unit [1] and attach the said cover to the new unit [3].

However in service operation a mistake of forgetting to attach the heat absorbing cover occurs from time to time. If the device is used without attaching the heat absorbing cover, waste toner inside the transfer cleaning unit will cake from the heat, and this brings failure in toner circulation. Replacing the transfer cleaning unit may be required as a result.

In replacing the transfer cleaning unit referring to the service manual, attach the heat absorbing cover removed from the old unit [1] to the new transfer cleaning unit.

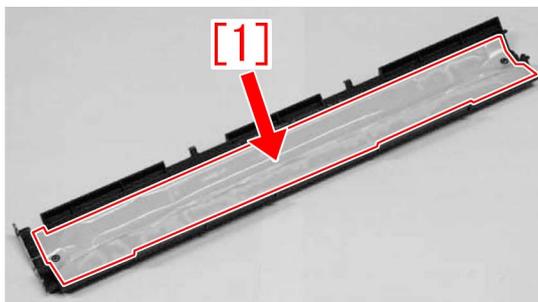
- Do not damage the heat absorbing material [1] attached inside the heat absorbing cover. In case the heat absorbing material [1] is damaged, do not use the same heat absorbing cover.
- Do not leave the detached heat absorbing cover under a high temperature environment of 50 degrees C or more. The shape of the heat absorbing cover may be deformed and become unable to be reused.

If needed, prepare the heat cover (FM1-M165-000) that is newly assigned as service part, detach the heat absorbing cover from the heat cover (FM1-M165-000) and attach it to the transfer cleaning unit.

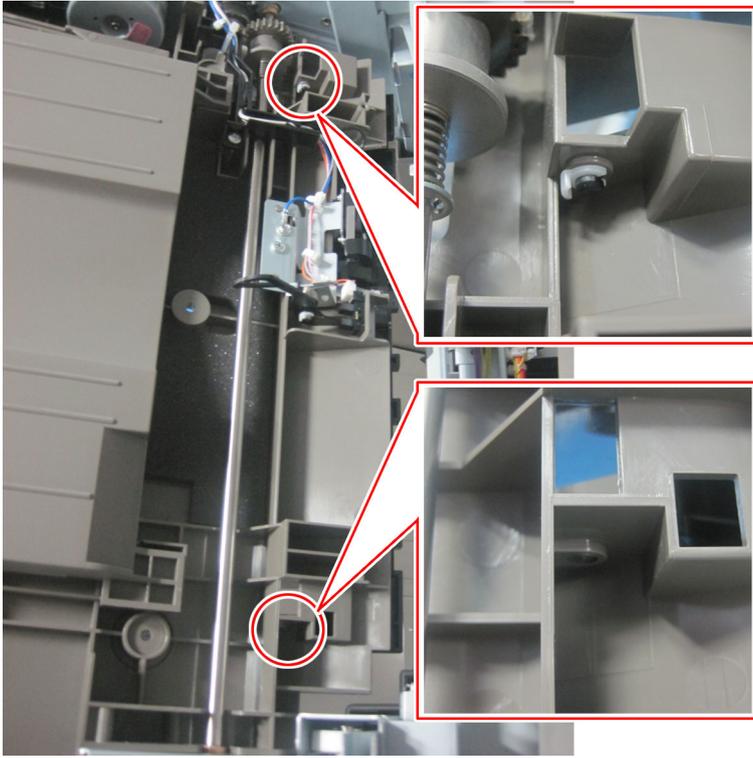
[Caution] Make sure to check that the safety cover[1] is located over the lever of Tray1 closing detect switch[2]. If it is located different position, the Tray 1 closing detect switch[2] does not work correctly.

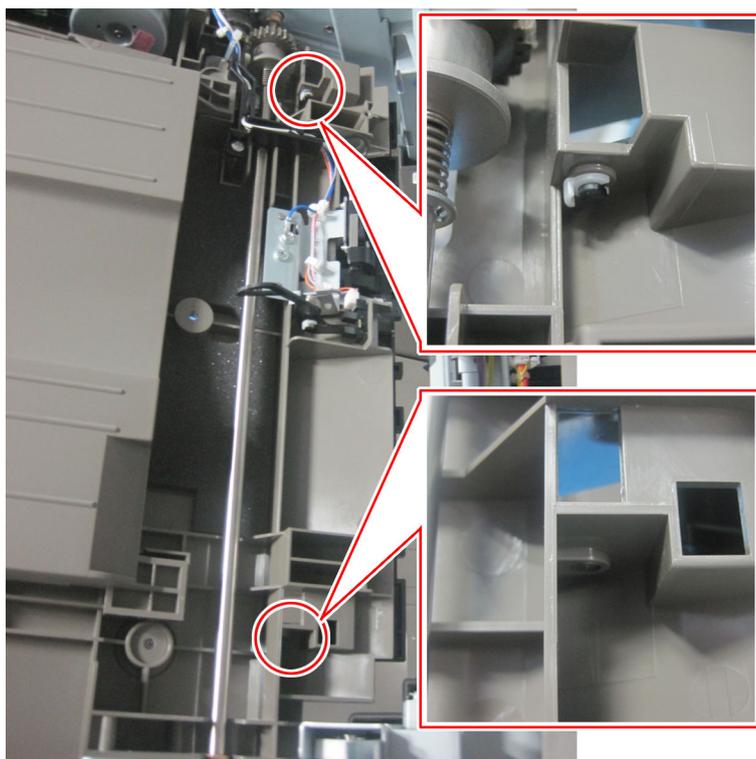
[Caution] Make sure to check that the rib [1] of safety cover is located over the lever of Tray 1 closing detect switch[2]. If it is located different position, the Tray 1 closing detect switch does not work correctly.

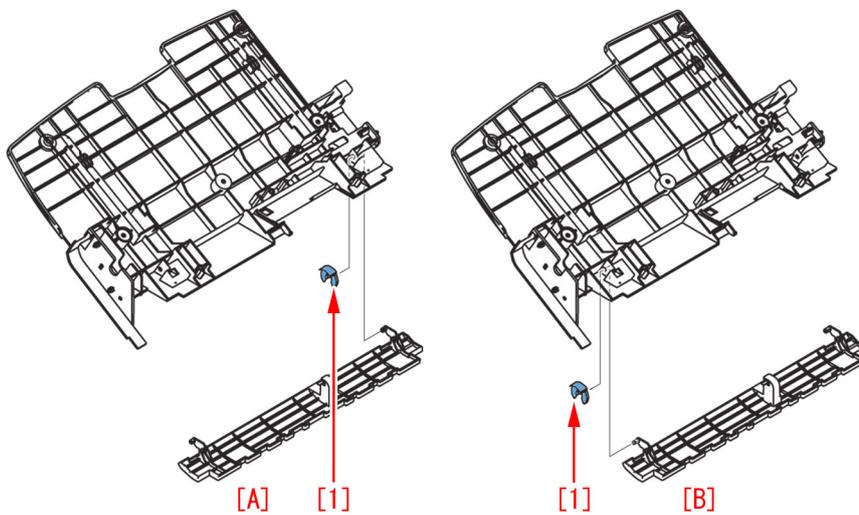
[Caution] When the safety cover is replaced with new type one, the attachment position of the clip [1] shifts to the front side. Please note that. Fig.[A] shows old type and Fig.[B] shows new type.

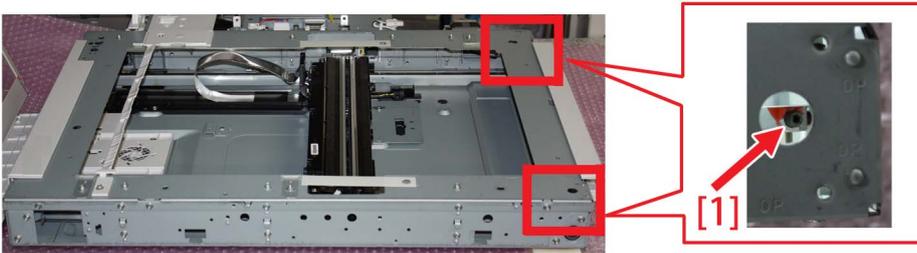
This symptom is due to the loosening of the screw [1] (x 4) for fixing the drive pulleys. 2 screws are attached per a pulley.

When the above mentioned symptom has occurred, further tighten the screw set for fixing the drive pulleys (4 x screw). As the looseness of the screw that emits an abnormal noise is minor, it is treated with retightening.

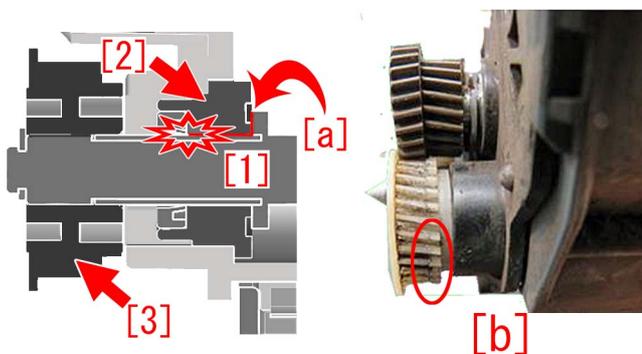
If inappropriate service work is conducted when removing the I.T.B. frame assembly and standing it with the gear of the transfer cleaner assembly facing the floor, toner leaks into the bushing of the transfer cleaning screw [a]. In this case, rubbing between the screw shaft [1] and bushing [2] makes the toner adhere to cause the increase in rotational load. Therefore, abrasion of the transfer cleaning screw gear [3] and the gear disengagement [b] occur to cause the above-mentioned symptom.

When the above-mentioned symptom occurs, check the transfer cleaning screw gear of the transfer cleaner assembly, and if the abrasion is found, replace with the new-type transfer cleaner assembly (FM1-C653-010).

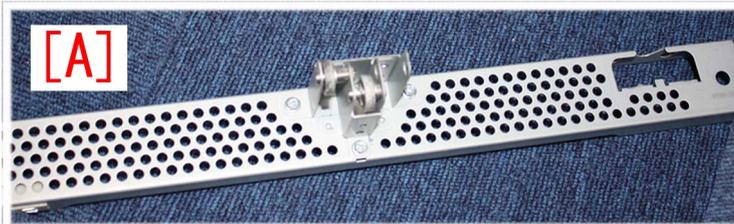
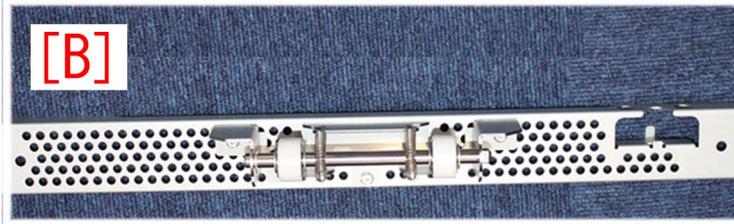
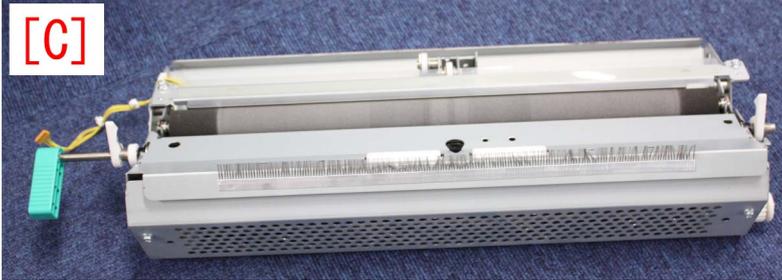
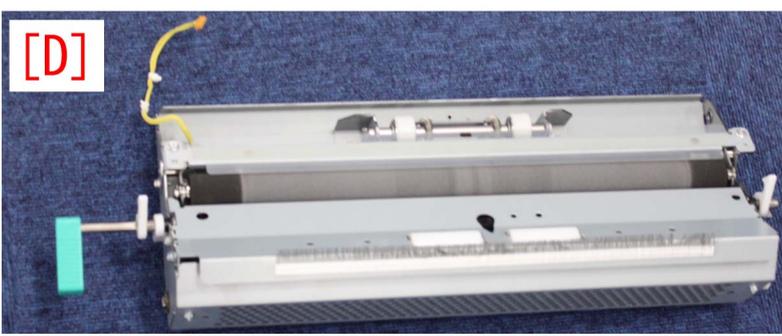
The new type lower back-up crossmember unit and rotation frame have a resistance to abrasion from the change of its shape to make the contacting surface larger. The following picture [A] shows the former type of the lower back-up crossmember unit for iPR C800 series and [B], the new type. The picture [C] shows the former type of the rotation frame assembly and [D], the new type.

When the symptom has occurred, prepare and replace with the new type lower back-up crossmember unit and the rotation frame assembly.

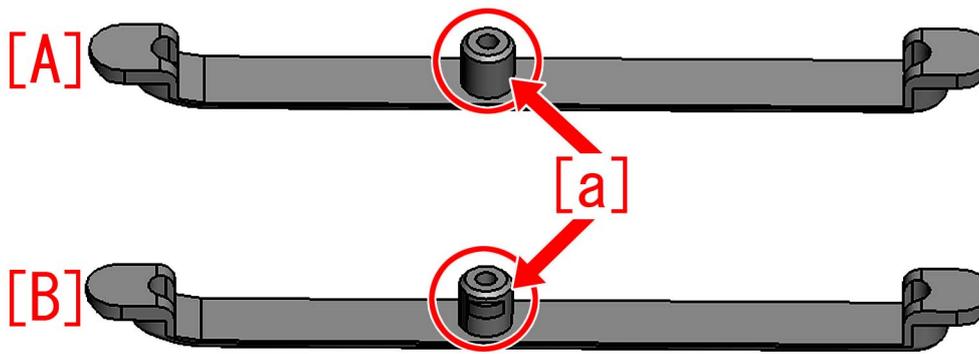
[Reference]The illustration below[A] shows the old type reverse guide rib, and [B] shows the new type. The shape of [a] has been changed.

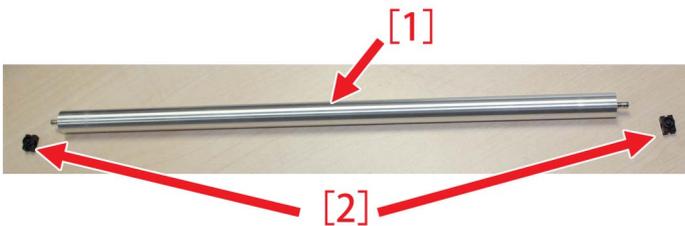
After some endurance time has elapsed, the bushing [2] of the inner delivery upper roller [1] is chipped and the chips accumulate between the bushing and the shaft, which deteriorates the sliding performance of the inner delivery upper roller and comes out as rotation failure. As a result, paper is fed insufficiently and ends in a jam.

When the symptom has occurred, prepare the new type inner delivery upper roller FC8-2080-010 and a new bushing FC5-2598-000 and replace with them at a time following the procedure below.

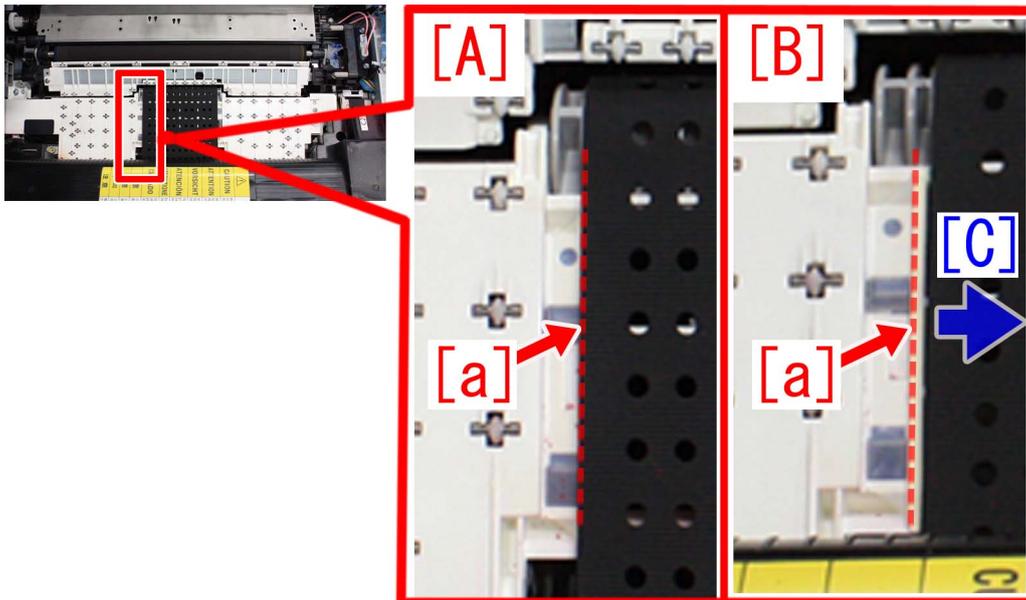
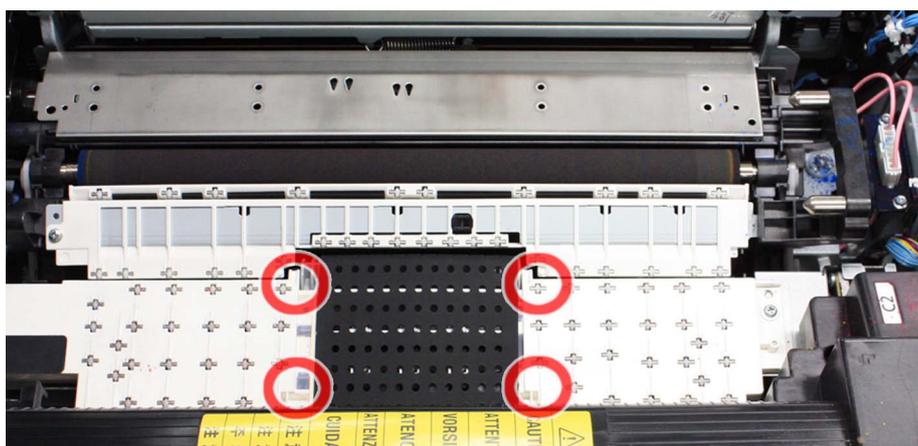
The cause is misalignment of the four portions (indicated by red circles) of the pre-fixing feed shaft support in the pre-fixing paper feed assembly. Due to this misalignment, the belt is gradually displaced and the suction force of the belt is reduced. As the suction force is reduced, it becomes difficult to transfer small-size paper (such as a postcard) particularly, by keeping it pulled to the belt. This may result in the jam.

When the symptom occurs, prepare the countermeasure washer (XD1-1104-135), and add it by following the procedure below. By installing the washer (XD1-1104-135) to one portion [a] of the four portions of the pre-fixing feed shaft support, the misalignment of the belt is improved.

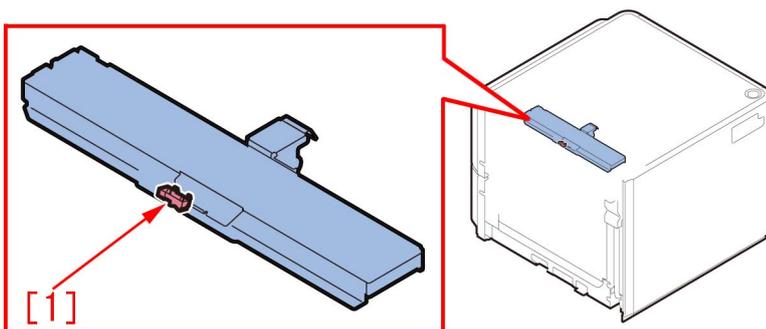
The deck pull-out sensor [1] of the pickup unit may incorrectly detect the reflected light of the adjacent deck pull-out roller feeder guide as paper, resulting in the above-mentioned symptom.

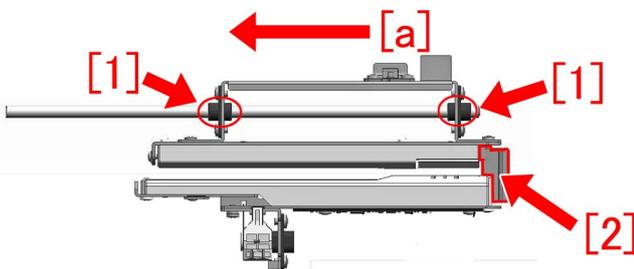
When the sliding load from the sliding part [1] inside the side registration sensor assembly is great, the side registration sensor assembly drive motor steps out and the position of the support [2] is displaced towards the front side of the product [a]. In the said condition, the paper contacts the support [2], would be skewed in delivery and may result in the aforementioned symptom.

When the above mentioned symptom frequents, prepare and replace with the new type side registration sensor assembly for each product referring to the service manual.

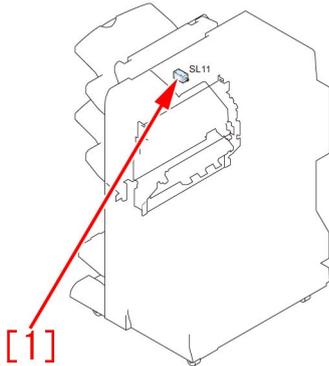
When pull in current value of the solenoid was insufficient and the installed position of estrangement solenoid unit (SL11) [1] was inappropriate, nip pressure of the postcard feeding rollers may be insufficient. This may lead to the above mentioned phenomenon.

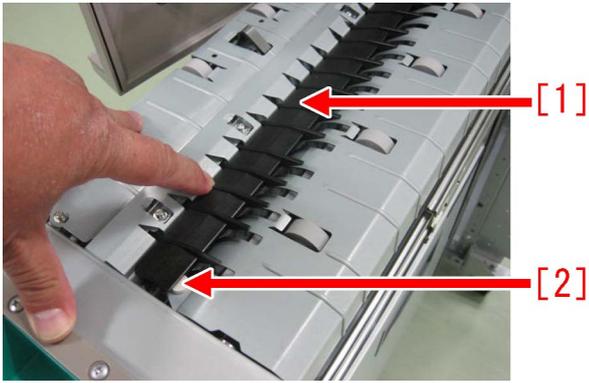
- 2) Press the folding/straight flapper [1] lightly with a finger and check if it is stuck to the spacer [2]. If the folding/straight flapper and the spacer are stuck together, proceed to the step 3). If not, look for another cause.

Follow the steps below and check if the spacer [1] is stuck to the folding/straight flapper [2]. If it is stuck, prepare the 2 new type spacers (FL1-6535-000) and replace with them.

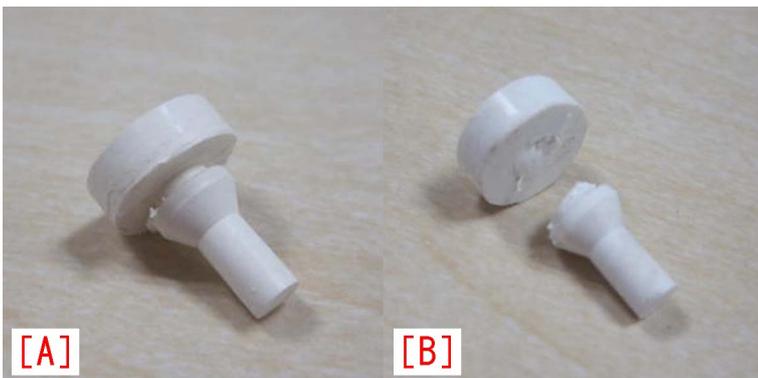
The photo below shows the normal spacer [A] and the broken spacer [B].

[Note] When removing the spacers, be sure not to break it as when the spacer breaks and falls inside the machine, jam and error may occur.

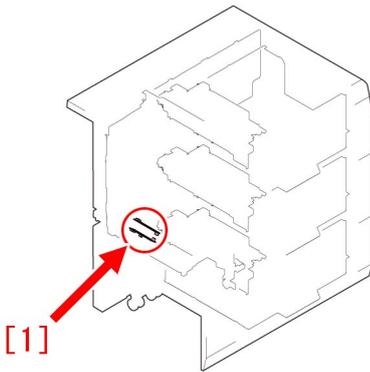
If one feeding sheet is wrongly detected as two sheets or over, due to inconsistent sensor adjustment value of the double feed sensor assembly (FM4-3471-000) [1], the above-mentioned symptom occurs.

If the above-mentioned symptom occurs, prepare the new-type double feed sensor assembly (FM4-3471-010) with the adjustment value changed, and perform replacement by referring to "Installing the Paper Deck Double Feeding Detection Kit" in Installation Procedure of Service Manual.

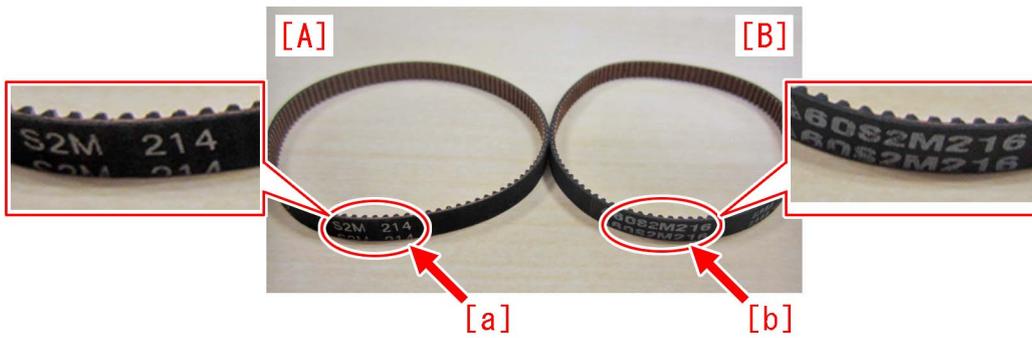
[Note] When replacing to the paper delivery drive assembly (L), be sure to also replace the timing belt [B] at the same time that is included in the set. 110F jam occurs when using the old type timing belt [A] as the number of teeth of the new type is different from the old type originally attached to the engine.

In the photo below, [A] is the old type and [B] is the new type.

The old type [A] has "S2M 214" [a] printed on it. The new type [B] has "60S2M216" [b] printed on it.

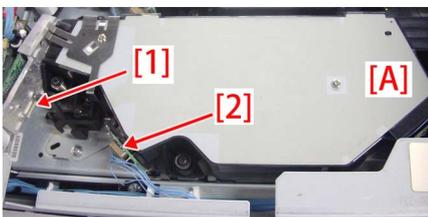
The symptom occurs on a machine with System Software Version earlier than xxxx when either the connector on J3 [1] of the laser driver PCB or the connector on J1 [2] of the APC PCB is disconnected in the laser scanner unit [A].

1) Check the connector on J3 of the laser driver PCB and the connector on J1 of the APC PCB in the laser scanner unit of a color that corresponds to the occurring error code. Check whether these connectors are disconnected. If the connectors are not disconnected, check other factors (disconnection of cable and PCB etc.)

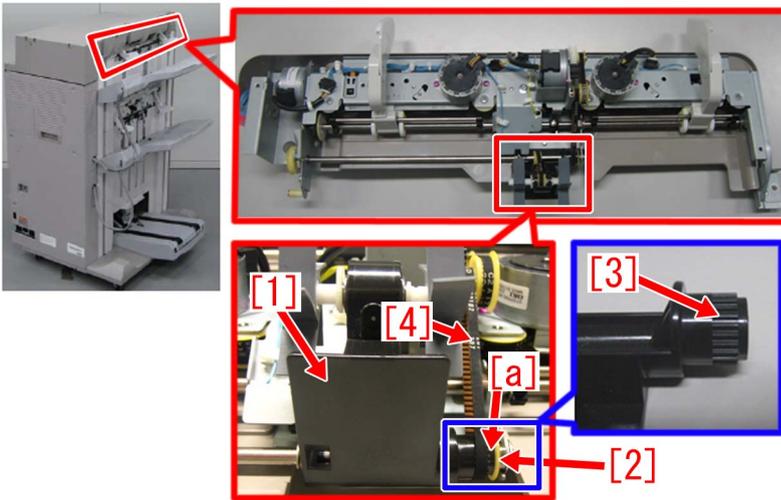
The gap [a] between the paddle holder (upper) [1] and the pulley [2] may be set wide within dimensional tolerance. If this gap becomes wider, the drive timing belt [4] falls off the gear [3] of the paddle holder (upper) and down the gap between the paddle holder (upper) and the pulley, this disables the rotation of the paddle and results in the aforementioned symptom.

Add a washer (FS5-6488-000) following to the procedure below

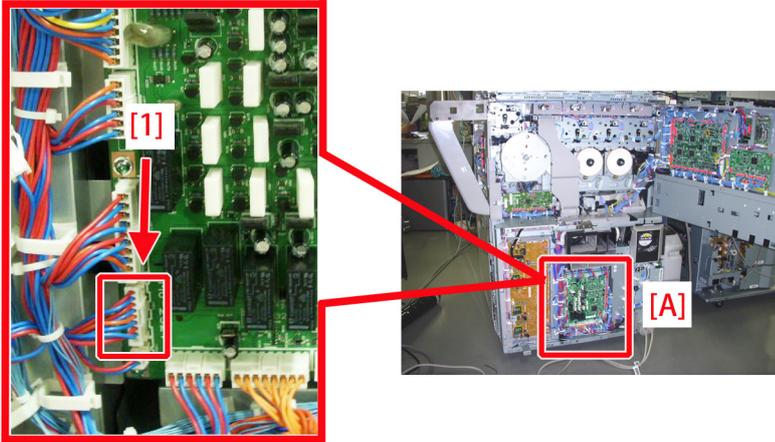
When the connector [1] of Relay PCB [A] J1814 comes off, the above mentioned symptom occurs.

- 1) Modify the connector of Relay PCB J1814.
  - 2) Start the main body and confirm that a phenomenon does not occur.
- If the symptom does not improve, check other causes.

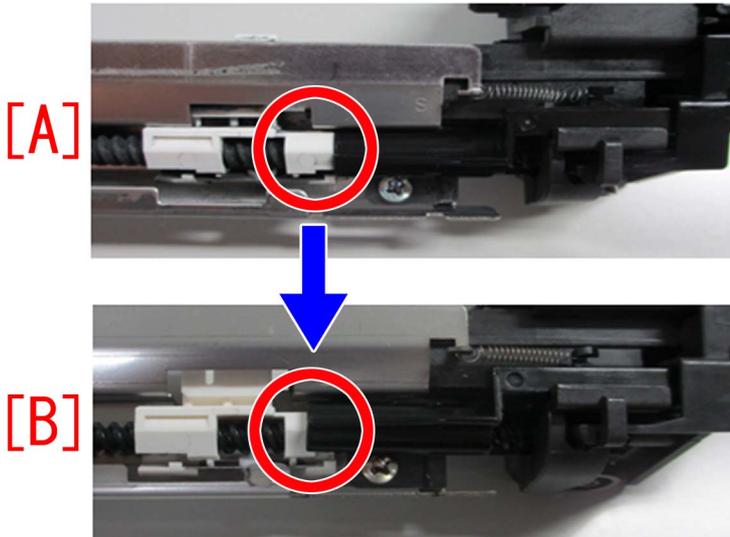
If a strong shock is applied to the machine during transport, the home position sensing flag may run on the felt holder. This prevents the end of the flag from reaching the sensor, causing the symptom. Photo [A] shows the normal state, and Photo [B] shows the home position sensing flag running on the felt holder.

When the symptom occurs during installation, perform the steps in the following procedure.

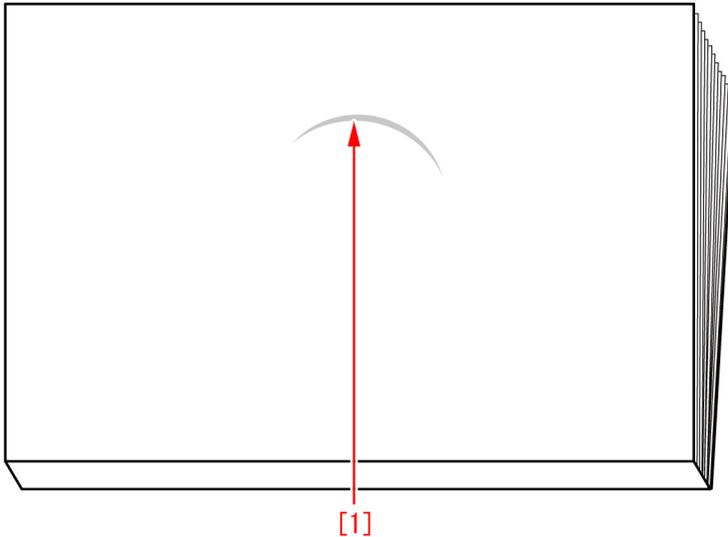
In the machines prior to the Countermeasure cut-in serial number in factory described below Front cover of booklet may be stained [1] when bookbinding outputting. Or E5B5-xx07/ E5B5-xx13 errors may occur.

- E5B5-xx07... Inlet path sensor (S92T/S92L) error of perfect binder
- E5B5-xx13... Registration sensor (S88T/S88L) error of perfect binder.

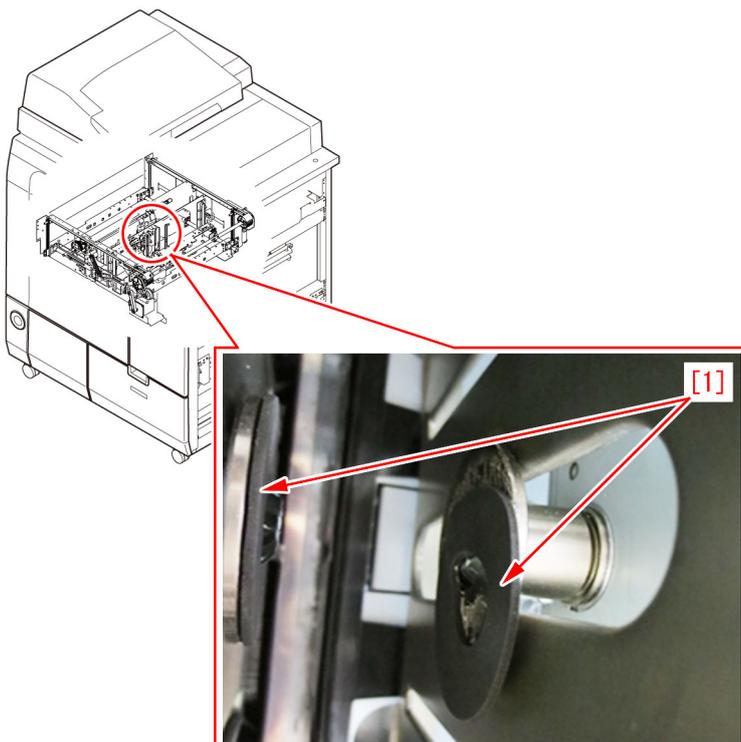
Rotation sheet [1] of stack rotation assembly may peel off or be displaced. It causes stain of front cover of booklet because adhesive agent on the rotation sheet adheres on the front cover in bound or the operation failure of stack rotation assembly. That results in the above symptom or errors.

Prepare 2 sheets of the rotation sheet, and check the condition of the stack rotation assembly. When the rotation sheet is peeling, re-stick the new type rotation sheet following the steps below. Clean the surface to be stuck with lint-free paper moistened with alcohol before the sticking. (There are 2 rotation sheets, check them and replace the peeling sheet.)

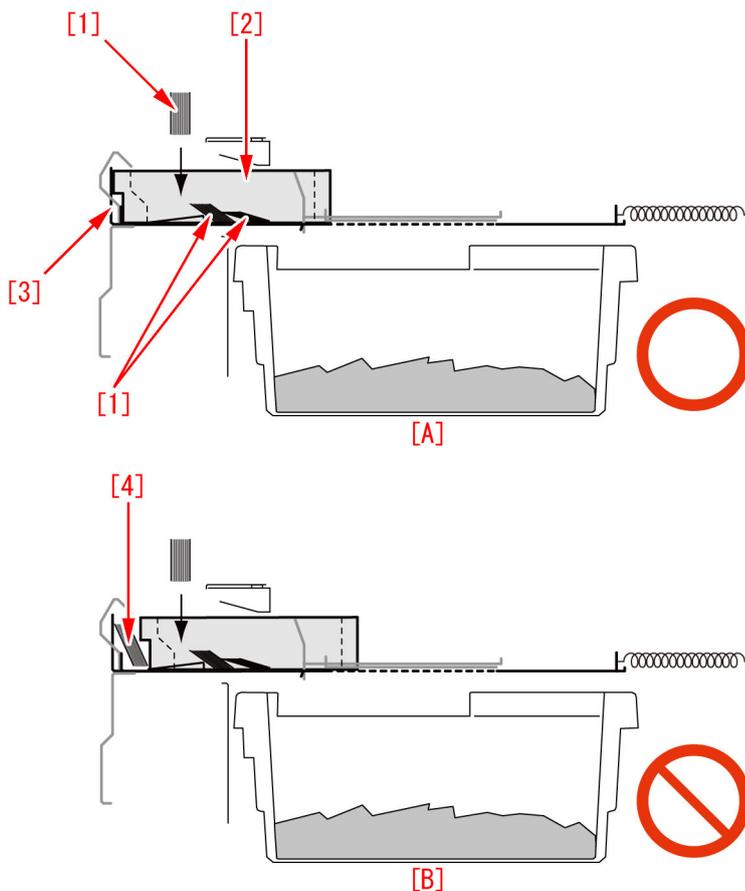
Normally, waste paper [1] generated at the time of trimming goes into the waste paper buffer [2]. When waste paper goes into the gap [4] between the waste paper buffer [2] and shutter [3] due to some factors, the shutter will be deformed if the operation is continued as it is. The above symptom occurs because the deformation of shutter disables to lock the sub-buffer. The following figure [A] indicates the normal drop position of the waste paper. The following figure [B] indicates the state that the waste paper goes into the gap between the waste paper buffer [2] and shutter.

When the above symptom occurs, prepare the new type shutter (FLO-0749-000) and sheet (4A3-2553-000) to replace with them following the procedure below. The following procedure describes from the steps after separating Perfect Binder from the main body. Even error is not displayed, there is a possibility of the deformation of shutter. Check if there is a deformation of shutter executing below step 1) at the time of periodical checking or so, if possible. When the deformation is found, replace the shutter with new type shutter.

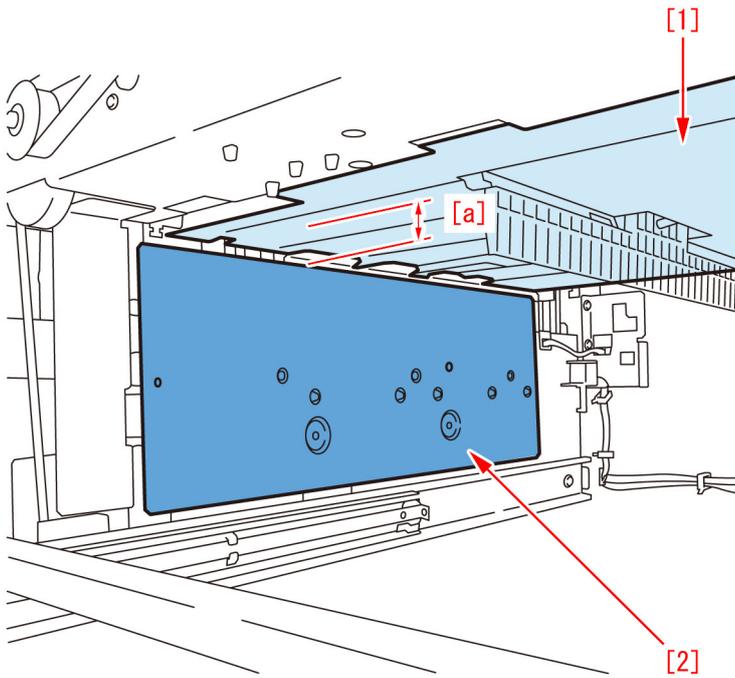
When the gap [a] is 9 mm or more, the shutter is not deformed. Other causes may be possible.

When the gap [a] is less than 9 mm, the shutter is deformed. Proceed to step 2).

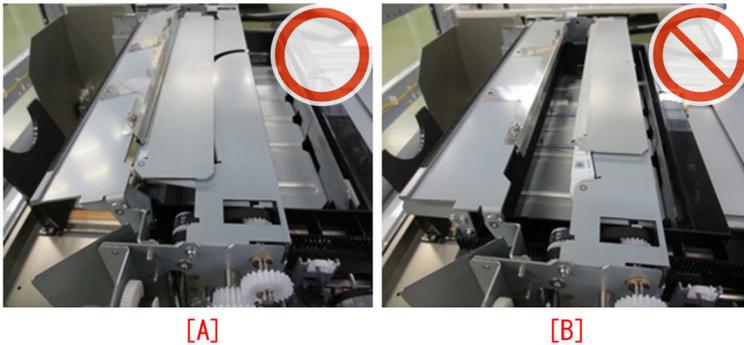
3-4) Press PSW1 to shift the dust catch assembly to the locked position. Confirm that the hook arm of dust catch assembly is locked in this state. Photo [A] shows normal state that the assembly is locked. Photo [B] shows unlocked state.

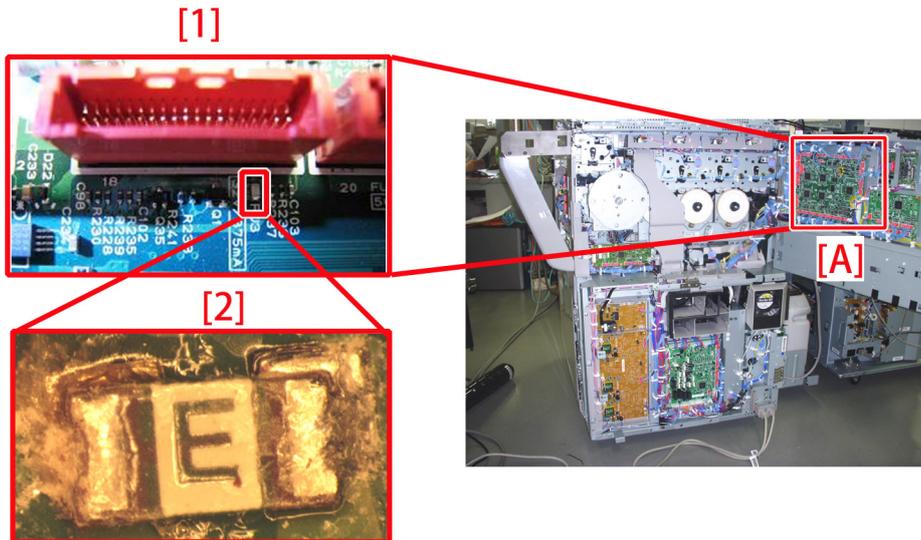
The aforementioned symptom occurs due to that the fuse (FU3) [2] does not conduct electricity that is beneath the connector (J1240) [1] of the DC controller I/F PCB [A] because of the poor weld.

1) Prepare the new DC controller I/F PCB (FM0-2916-010) and replace with it.

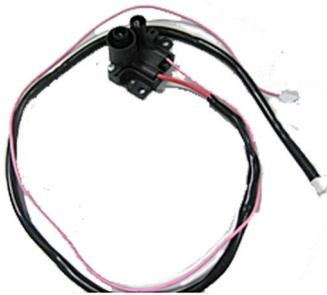
During the production of the mold part of the primary H.V. connector assembly, material used to remove burr may remain in some cases. Such material absorbs water in a high humidity environment. As a result, the surface resistance of the mold part decreases and causes a current leak, leading to the above symptom.

When the symptom keeps occurring, prepare the new type primary H.V. connector assembly (FM3-9890-010) [1] and replace the old one.

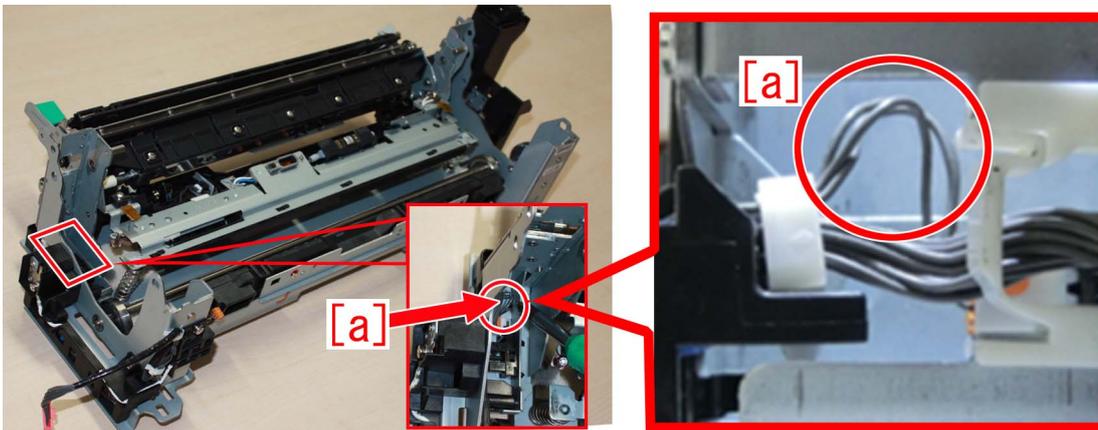
Lower belt unit cable connected to pressure release sensor (PS73) of fixing base assembly is lengthy. When handling the lower belt unit cable, if it is pushed up widely [a] toward the lower plate of the lower belt assembly, the plate of the lower belt assembly and the lower belt unit cable interfere with each other when attaching and detaching the lower belt assembly, and it causes the coating to come off and short-circuit, and the above symptom occurs.

When the symptom occurs, check the condition of the lower belt unit cable. If it is short-circuited with plate, take measures below in accordance with the symptom.

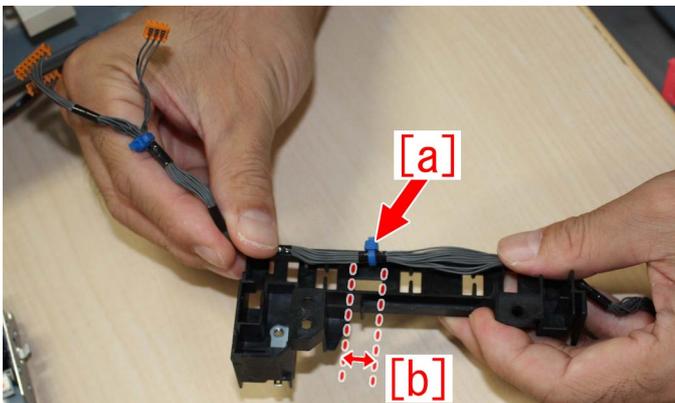
- When attaching the new lower belt unit cable, make sure that the cable band [a] in the center enters within the window of the front cable guide [b].

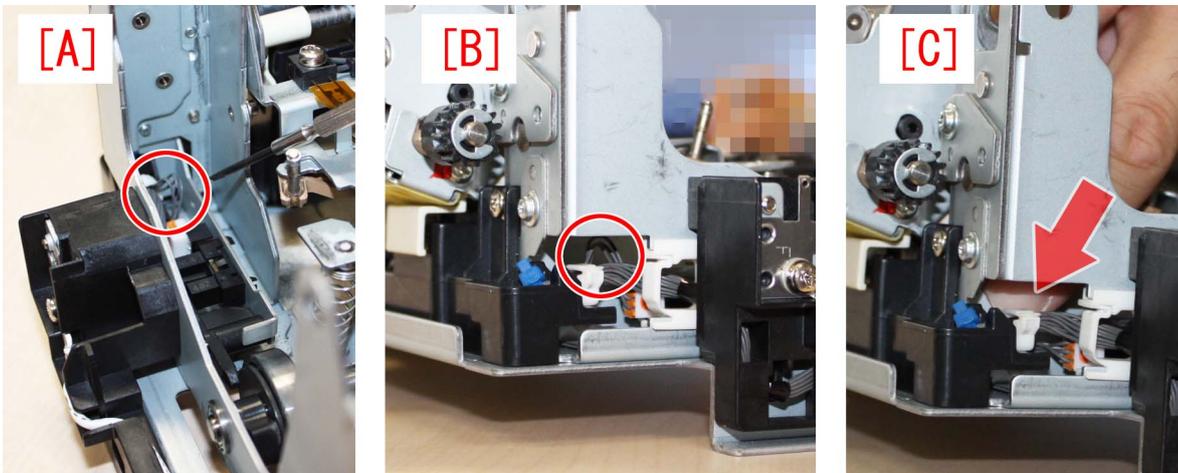
- After attaching all the parts, press the extra length of the lower belt unit cable (photo [A] and [B]) with a finger shown as the photo [C]. Make sure that the connector of pressure release sensor (PS73) is not displaced or protruded.

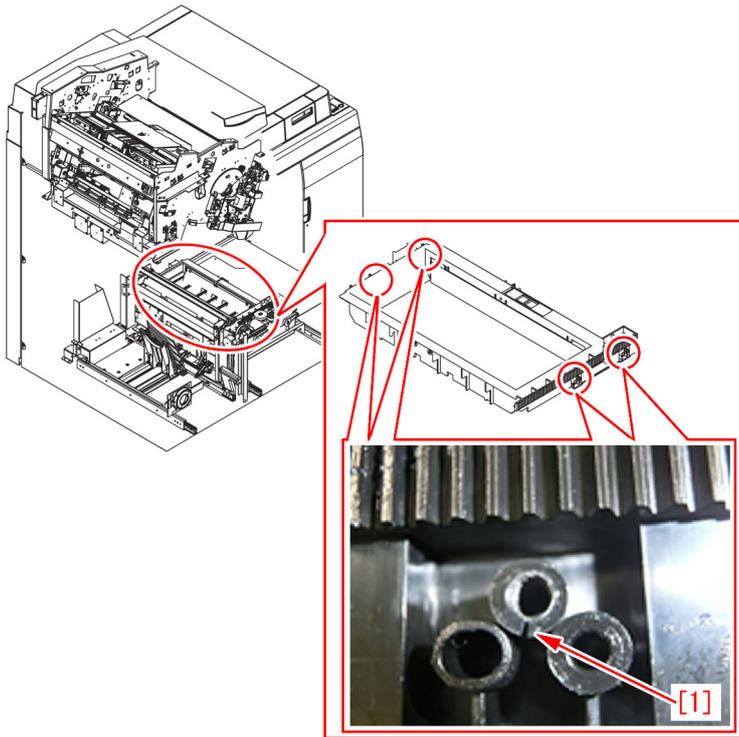
The mount portions [1] of the Dust Buffer Unit may be damaged due to low strength, and the Dust Buffer Unit cannot operate properly. As a result, the symptom occurs.

If the symptom occurs, prepare the new type Dust Buffer Unit (FM4-0478-020). By following the procedure below, replace the Dust Buffer Unit with this new type. Note that the following description starts from the step in which Perfect Binder is disconnected from the Main Body of MFP.

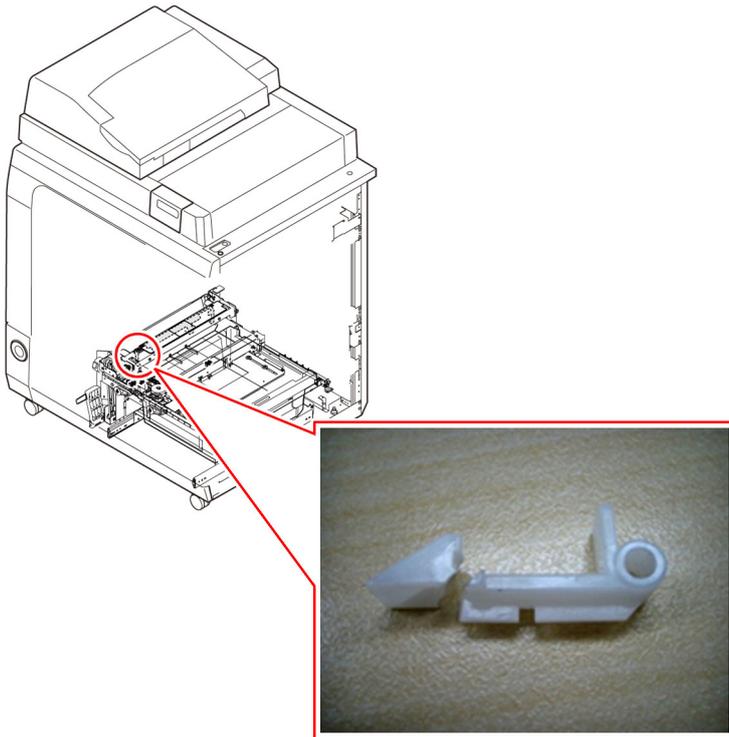
The Hook arm of the shutter unit gets fractured and trim waste processing operation does not run properly. As a result, the symptom occurs.

When the above mentioned symptom has occurred, prepare and replace with the new type Hook arm (4A3-2391-010) following the procedure below. The procedure below starts from the step after disconnected Perfect binder from the copier main body.

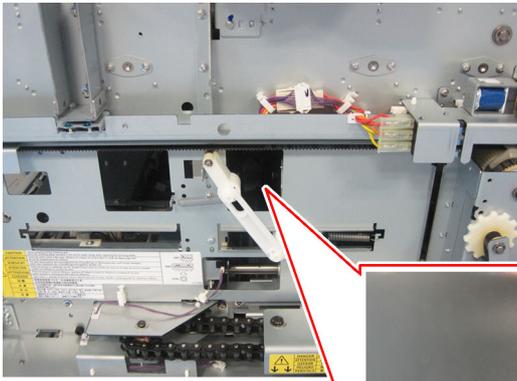
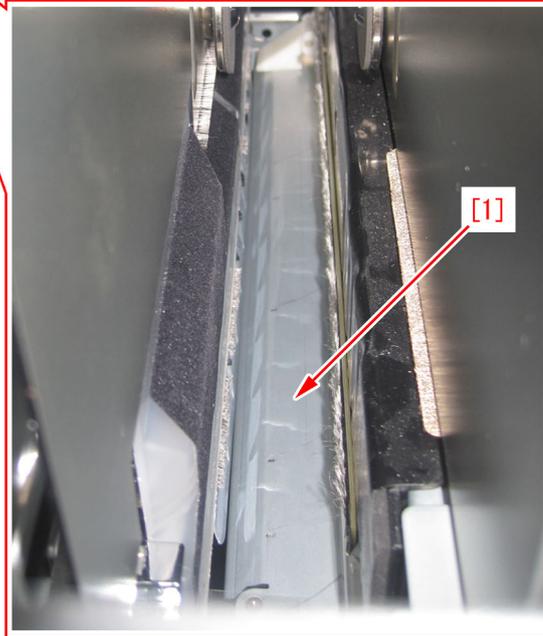
1-9) Repeat the step 1-8) for several times and check if the metal plate [1] of the Dust buffer is seen from the gap on the stack rotation assembly.  
 If the metal plate is not seen, then the Hook arm may be fractured. Go to the step 2).  
 If the metal plate is seen, then the Hook arm is not fractured. The error results from another cause. Reassemble the parts in reverse order of the step 1-7).

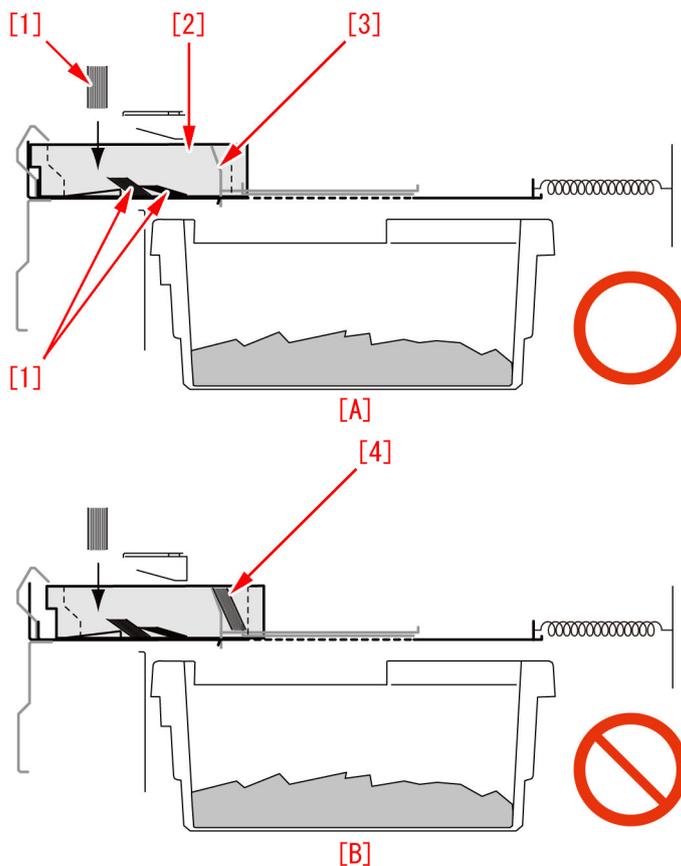
Waste paper [1], generated upon trimming, normally falls into the waste paper buffer [2]. In some cases, the waste paper [1] may go into the space [4] between the waste paper buffer and the waste stopper [3]. If the waste paper goes in the space, the frictional resistance increases at the front of the waste stopper. This prevents proper operation, resulting in the symptom.

Figure [A] below shows paper waste that has properly fallen. Figure [B] shows the state in which waste paper has gone into the space between the waste paper buffer and the waste stopper.

When the above mentioned symptom has occurred, prepare and replace with the Dust Stopper Unit (FM1-D248-000) following the procedure below. The procedure below starts from the step after disconnected Perfect binder from the copier main body.

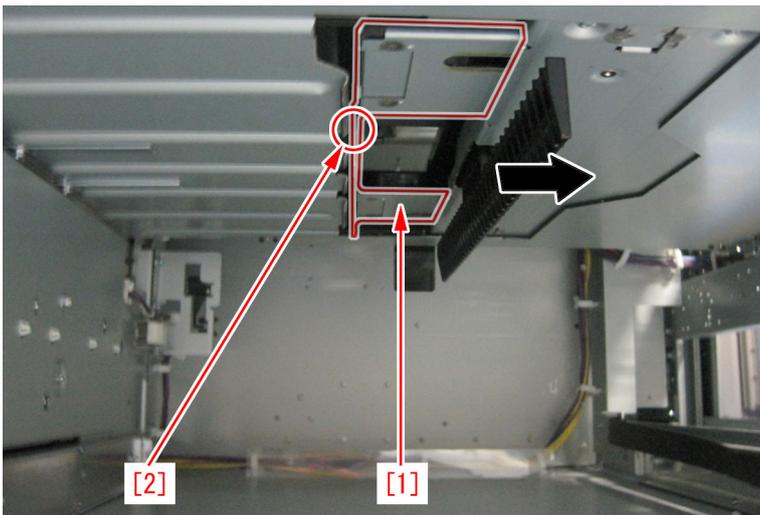
If the Waste stopper moves without problems, other factors may be a cause. Install the parts by reversing the procedure from step 1-6).

If the movement of the Waste stopper is not good, go to step 2).

1-10) Put a hand into the area where the Waste paper unit is housed. Hold the center edge [2] of the Waste stopper [1], and move it in the direction indicated by the arrow.

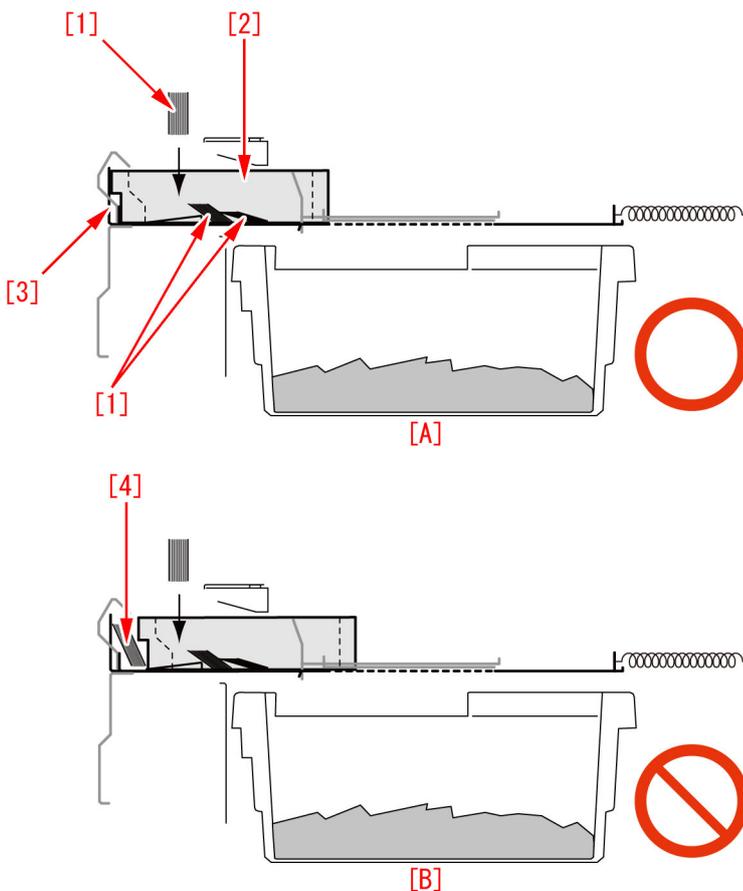
Normally, waste paper [1] generated at the time of trimming goes into the waste paper buffer [2]. When waste paper goes into the gap [4] between the waste paper buffer [2] and shutter [3] due to some factors, the shutter will be deformed if the operation is continued as it is. The above symptom occurs because the deformation of shutter disables to lock the sub-buffer. The following figure [A] indicates the normal drop position of the waste paper. The following figure [B] indicates the state that the waste paper goes into the gap between the waste paper buffer [2] and shutter.

When the above symptom occurs, prepare the new type shutter (FLO-0749-000) and sheet (4A3-2553-000) to replace with them following the procedure below. The following procedure describes from the steps after separating Perfect Binder from the main body. Even error is not displayed, there is a possibility of the deformation of shutter. Check if there is a deformation of shutter executing below step 1) at the time of periodical checking or so, if possible. When the deformation is found, replace the shutter with new type shutter.

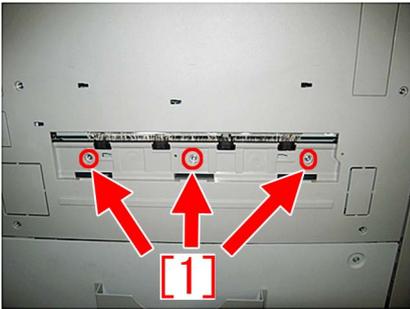
When to fix the left upper cover of the device, if the screws [1] are tighten while the cover is pressed hardly, the metal plate of the decurler is deformed and the positions of the backup rollers are deviated, and this leads to the above mentioned symptom.

When the aforementioned symptom has occurred, perform the work following the procedure.

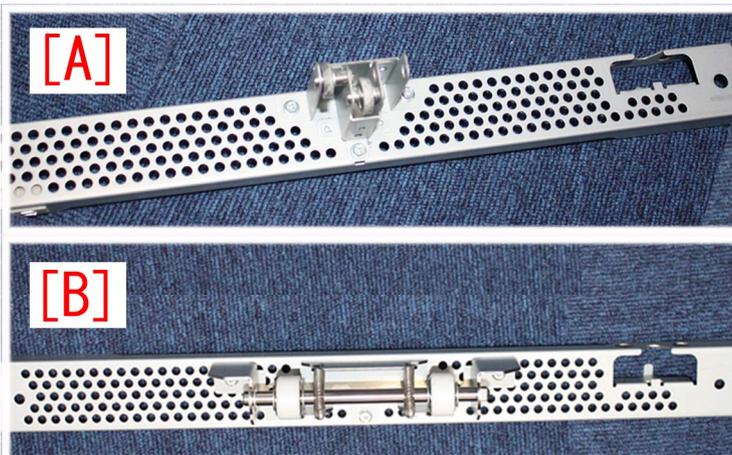
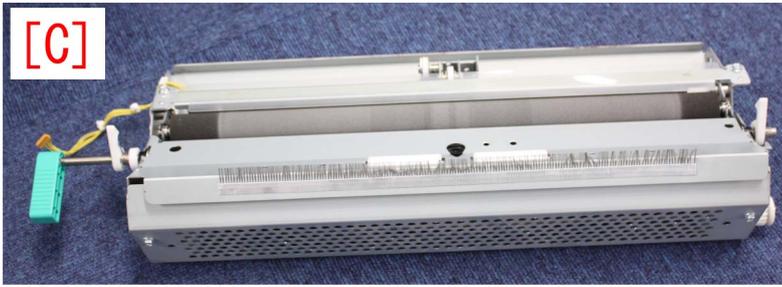
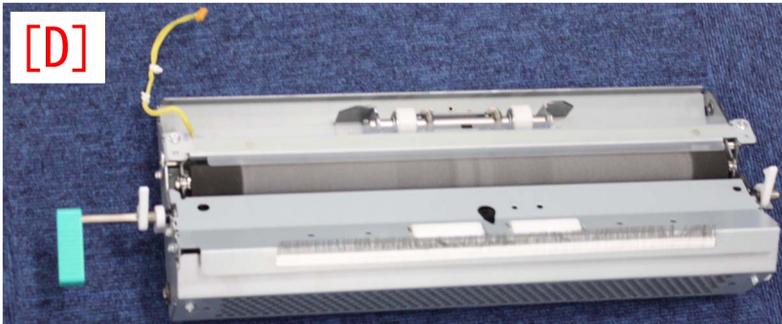
The new type lower back-up crossmember unit and rotation frame have a resistance to abrasion from the change of its shape to make the contacting surface larger. The following picture [A] shows the former type of the lower back-up crossmember unit and [B], the new type.

The picture [C] shows the former type of the rotation frame assembly and [D], the new type.

If the part has already been replaced with the new type, go to the step B.).

If the part has not been replaced with the new type, go to the step 2).

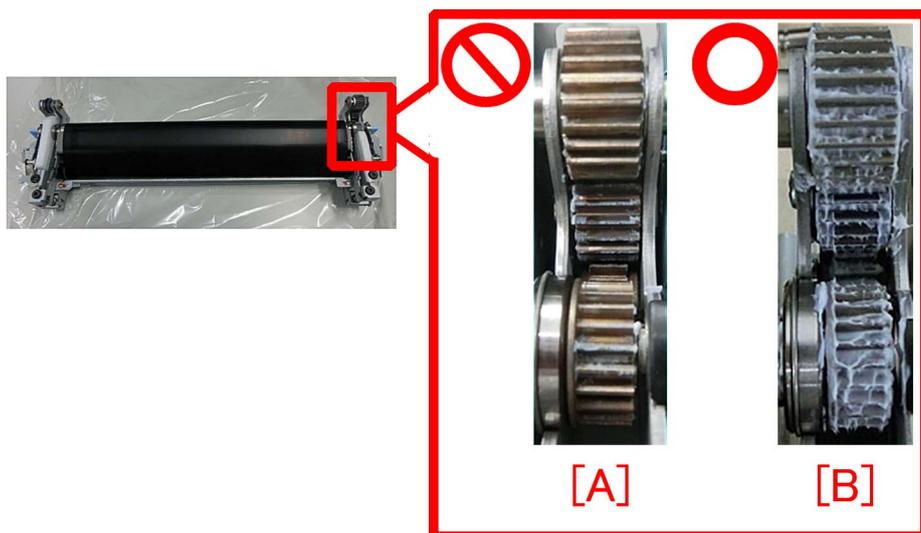
[A] shows the state where insufficient grease is applied, and [B] shows the state where proper amount of grease is applied.

If the amount of grease is insufficient, go to the step 2). If the proper amount of grease is applied, carry on replacement.

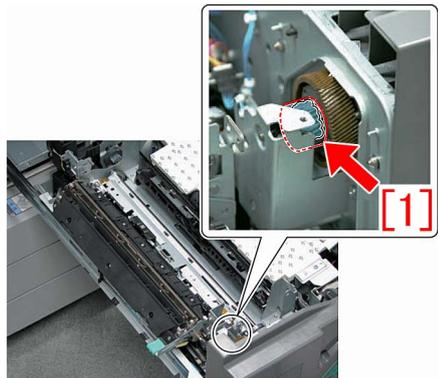
When the life of the fixing belt unit advances, the greases applied to 27T gear in the fixing drive unit and 31T gear in the fixing belt unit deteriorate. Also abnormal noise (noise of meshing failure of tooth) during operation or E004-0203 may occur when the gear is worn out due to the deterioration of the greases.

Clean 27T gear [1] and reapply grease by following the step A).

If any damage was observed on teeth of gears, replace the gears by following the step B).

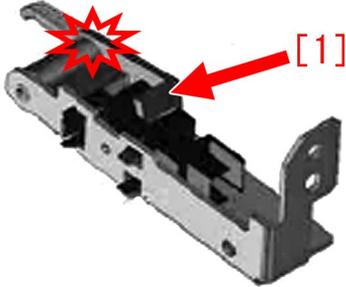
With the sensor flag rotation portion of the pressure release sensor unit with reduced sliding performance, the arm of the sensor flag [1] becomes unable to come back to the original position by its own weight after the detection and detection release behavior fails, and this leads to the aforementioned symptom.

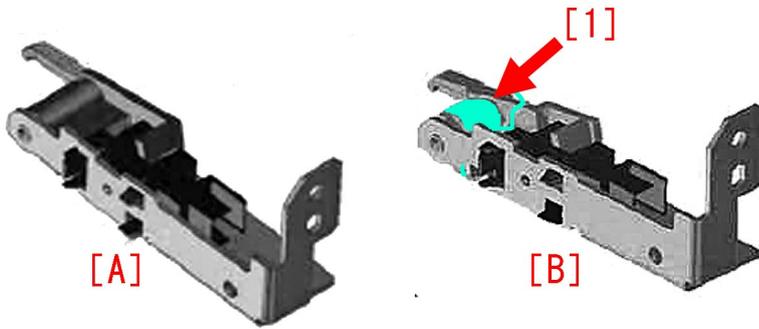
[Reference] A spring [1] is added to the sensor flag of the new type pressure release sensor unit [B] and the sliding performance of the sensor flag rotation portion is improved comparing to the previous type part [A].
