# Troubleshooting Guide

## imagePRESS C800 Series

July 16, 2019  
Canon U.S.A., Inc.

# New Arrival Information

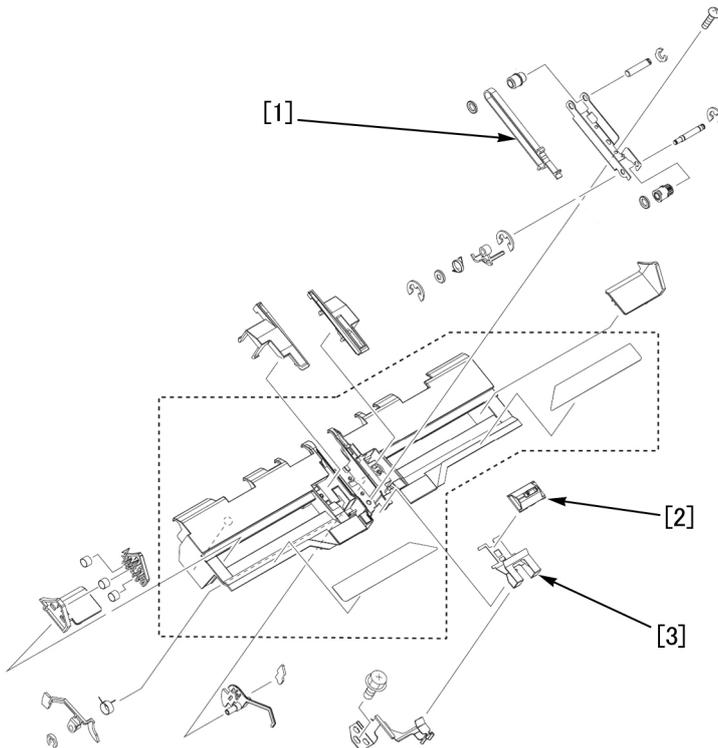
If the claws attached to the cogged timing belt (FC5-3553-000) are detached due to the insufficient strength, the back end assist button (FC5-4715-000) and the back end assist plate (4F8-0088-000) are also detached, and the printed paper cannot be output, which may cause E514-8001 error.

As a result, if any one of the above parts is changed, all the 3 parts need to be changed simultaneously.

If changing any one of the timing belt [1], the back end assist button [2] and the back end assist plate [3], prepare the timing belt set (4Y8-3107-000), which is composed of the new-type parts, and replace the 3 parts simultaneously by following the steps below.

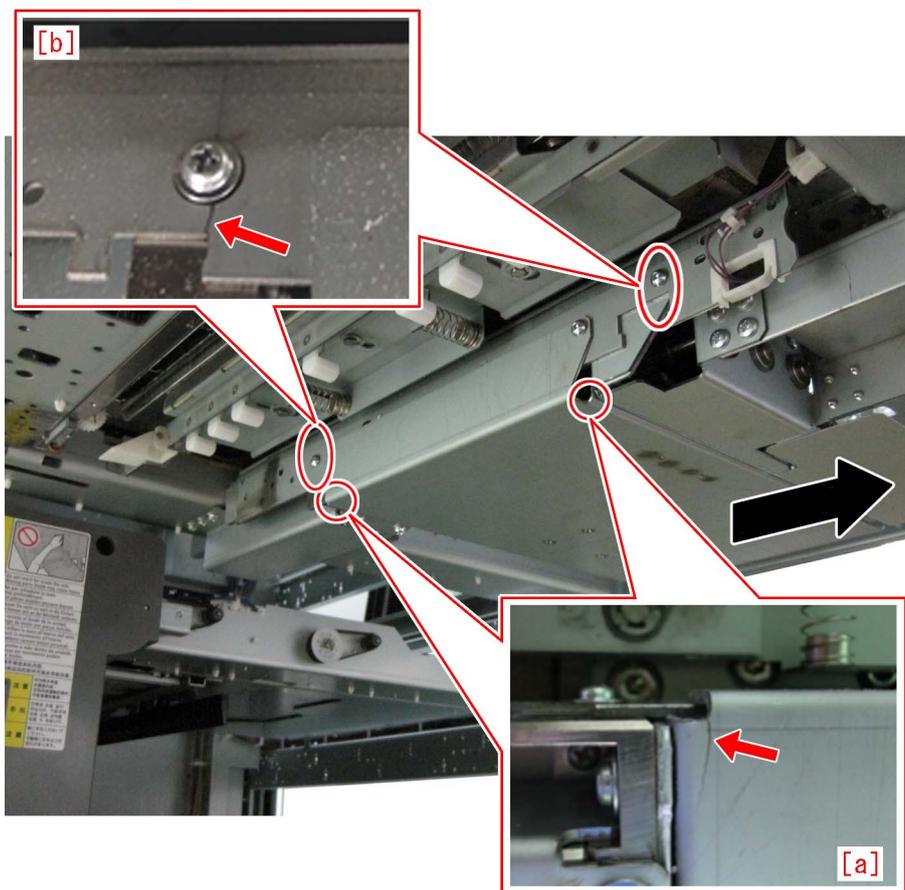
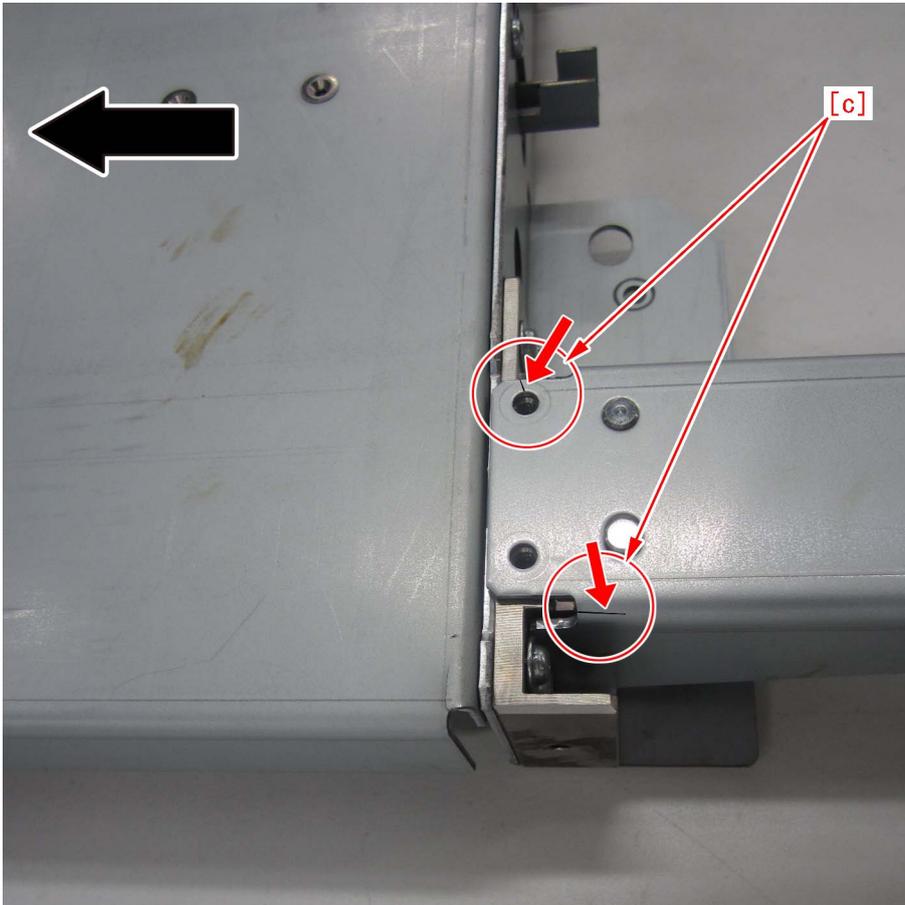
Figure [a] shows the broken section of the trimming drive assembly.

Figure [b] shows the broken section of the peripheral component of the trimming drive assembly.

Figure [c] shows the broken section of the rear stay.

If the above-mentioned symptom occurs, pull out the trimming assembly to check the broken sections. Replace the parts corresponding to the broken sections. The replacing parts are all the service parts used only for the service work.

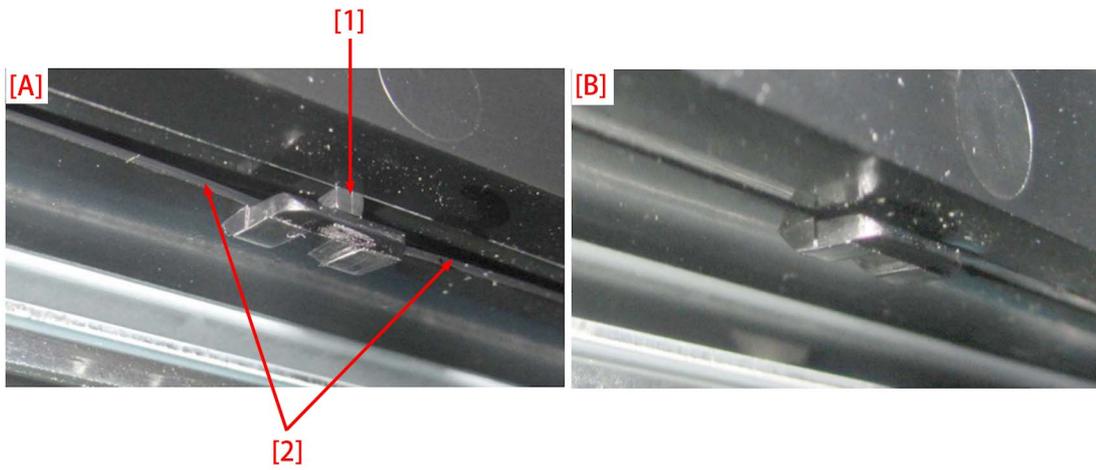
The boss [1] is seen when the claw is only half seated [A]. Also there is a gap [2] between its counterpart.

If the boss is not seen and no gap left between the counterpart, then the claw is seated fine [B].

2) Check the seating of the 5 claws [1] at the contact of the paper cooling lower left duct and the paper cooling lower right duct, and if any claw is not seated properly, then push it in the direction of the arrow [2] to lock it.

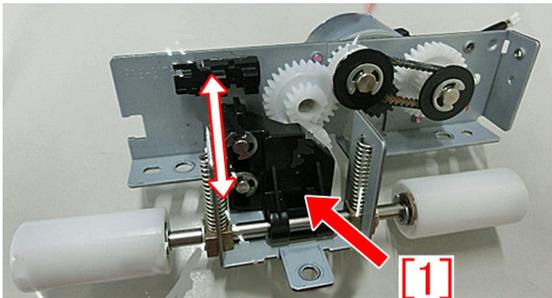
While the feed roller shaft is moving up and down to detect home position, if the estrangement rack [1] that holds the feed roller shaft inclines, the load from sliding increases and the feed roller shaft becomes unable to go back to home position, and this brings the aforementioned symptom.

When the above-mentioned symptom occurs, perform the work either A) Replacing the upper feeder assembly with the new type or B) Applying the grease to the feed assembly.

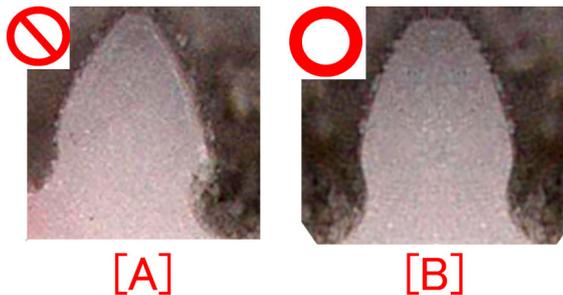
B-5) Visually, check the condition of the teeth marked in the step B-4).

If chipped/shaved teeth are observed, shift the phase of the gear position by rotating by 180 degrees at angle.

The picture [A] shows a shaved gear tooth in a triangle shape. The picture [B], a gear tooth in the normal shape.

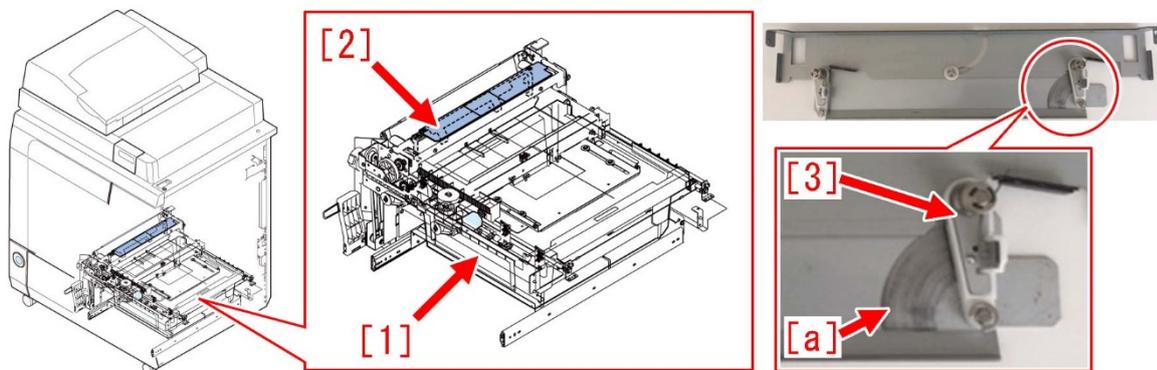
As the life of the dust buffer [2] in dust collecting area [1] advances, the surface [a] that comes in contact with the arm [3] gets shaved. This causes sliding failure of the dust buffer, resulting in the above symptom.

When the above symptom occurs, prepare some lint-free paper and alcohol, and clean the dust buffer in the following procedure. [Note] When bringing down the trimming assembly, be sure to do so with two people.

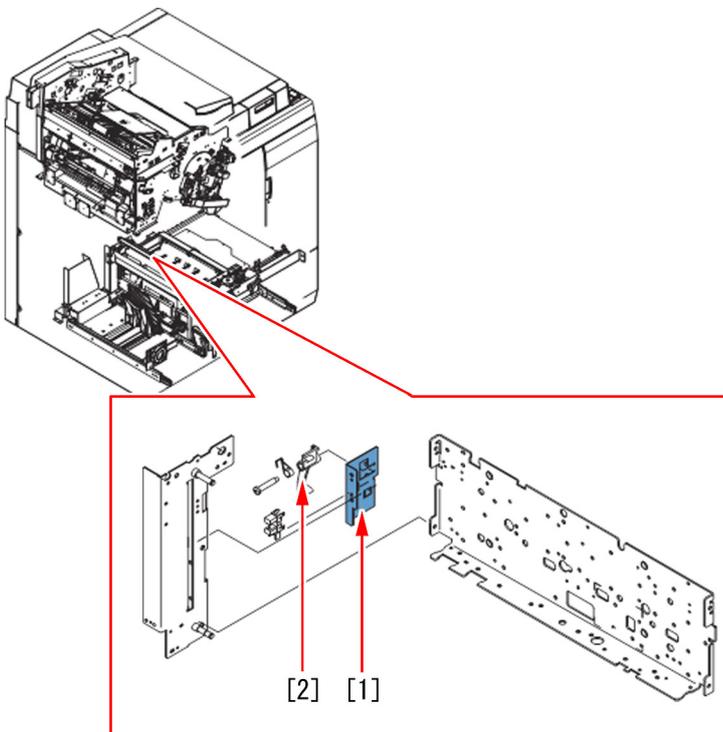
If the waste paper box is housed roughly, the bracket [1] that fixes the sensor to detect open/close state of the waste paper box gets deformed. Because of this, the waste paper box open/close detection sensor flag [2] stops to operate normally, and this leads to the aforementioned symptom.

If the symptom occurs, prepare the new type detection sensor bracket(FE4-9766-000). By following the procedure below, replace the detection sensor bracket with this new type. Note that the following description starts from the step in which Perfect Binder is disconnected from the Main Body of MFP.

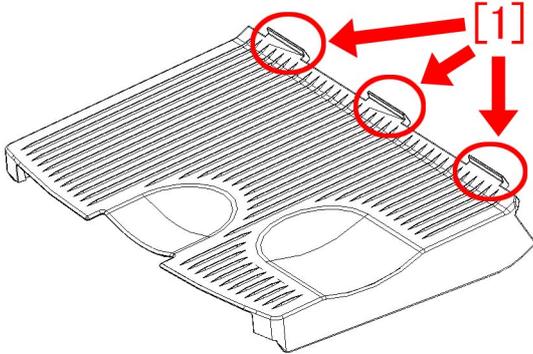
The copy tray hooks (claws) [1] may break on an engine whose serial number is earlier than the following countermeasure cut-in serial numbers in factory.

An overloading of output paper overcomes the designed strength of copy tray, and this induces the above mentioned symptom. The said symptom would not occur in the use where the stack volume in the tray is within the specification.

When the aforementioned symptom has occurred, replace the copy tray 1 [1] with new type which changed shape of the hooks (claws) and enhanced strength against weight.

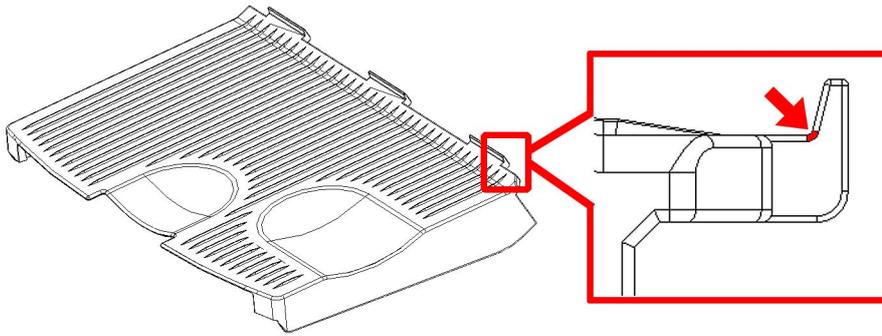
Figure [A] is the previous copy tray 1 and [B], the new type copy tray 1.

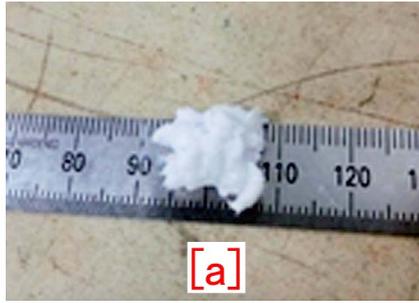
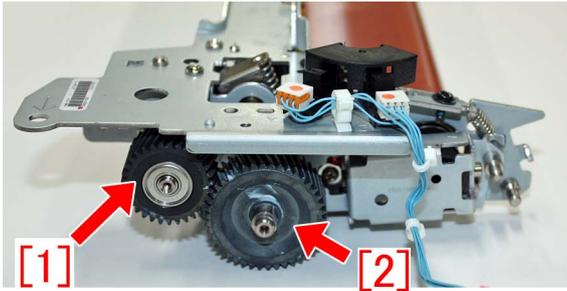
- The 2 bearings attached to the old type 31T gear whose color is black will be redundant after the replacement.
- The new type 31T gear (FL1-0579-000) [2] is brass colored and integrated with the bearings.

### a) Replacement of 31T gear and 37T/42T gear in the fixing belt unit

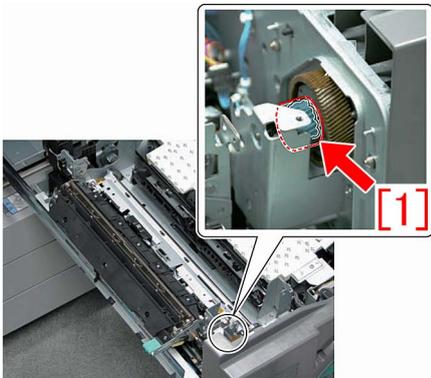
In addition, check the status of 27T gear, which is the counterpart of 31T gear, located inside the fixing drive unit. If any damage was observed on its teeth, replace the 27T gear to new one at the same time.

Refer to the issued Service Information (F01476) and perform cleaning and grease application for 27T gear [1]. If necessary, replace with a new 27T gear [1].
