# Troubleshooting Guide

## imagePRESS C850 Series

July 16, 2019  
Canon U.S.A., Inc.

Please be advised of the release of Troubleshooting Guide for imagePRESS C850 Series.  
Troubleshooting Guide is a booklet compiled from FAQs issued by Canon Inc.

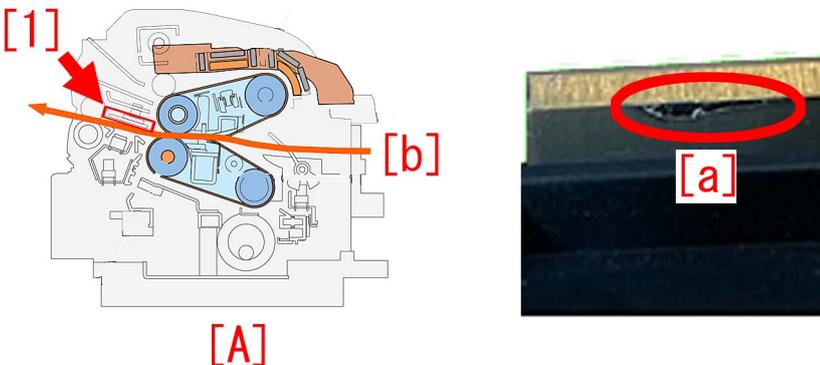
The separation plate [1] in the fixing assembly [A] comes in thick and thin types. The tape affixed to the thicker separation plate [1] comes off [a] from scuffing, then the fed paper comes in contact with the peeled off tape and leads to the above mentioned symptom.

The arrow [b] indicates the paper feeding path.

As a countermeasure against the aforementioned symptom, replace the separation plate with the thinner type that reduces scuffing of the tape even when a high gloss or heavy media is passed through.

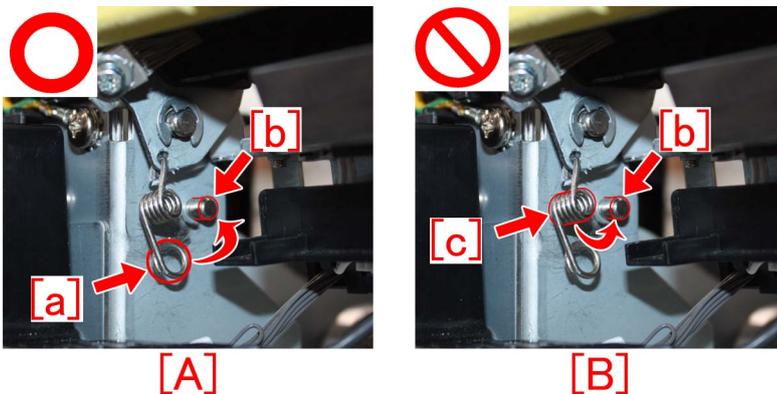
[Note] To attach the spring, put the looped end [a] in the boss [b]. Do not put the looped portion at the center [c] in the boss [b]. The photo [A] indicates the proper way to attach the spring and [B], an erroneous way to attach the spring.

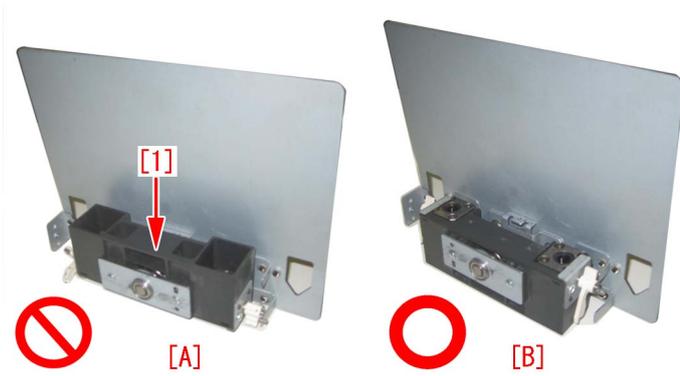
[Attention] Make sure that the position of unit [1] being the side of mini gripper is correct and then put the mini gripper. Photo [A] shows upside-down position of the unit on the side of mini gripper. Photo [B] shows the correct position.

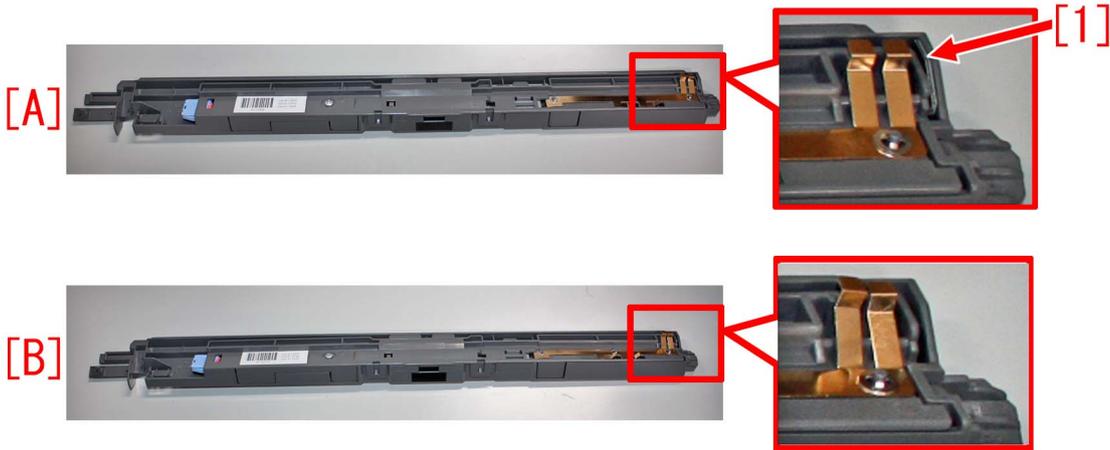
When a sensor holder of a black patch sensor unit [1] is deformed by heat, it touches the central part of ITB belt [2] to cause toner friction, resulting in the above-mentioned symptom. Since the toners C[3], M[4] and Y[5] exist at the upper stream side of the black patch sensor unit [1], the above symptom occurs with all colors except Bk[6].

The new type of black patch sensor unit [A] has a spacer [1] to prevent deformation. Photo [B] shows the old type.

When the above symptom is seen, prepare a new type of black patch sensor unit (FM0-4955-010) and replace it by referring the service manual "4. Parts Replacement and Cleaning" > "Image Formation System" > "Removing the Drum Patch Sensor Unit (Bk)" to replace the part.

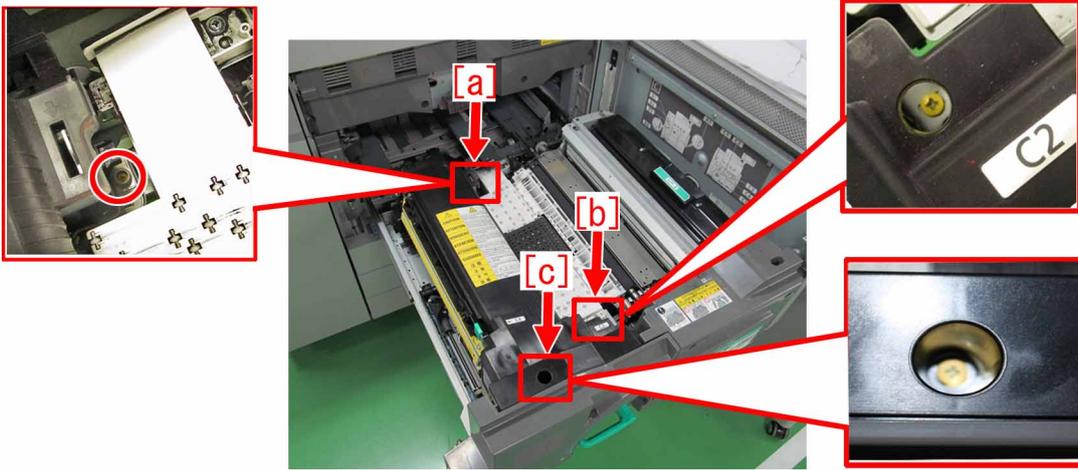
When installing a fixing assembly to a fixing feed unit, 3 screws are to be used and the first screw has to be fixed on the positioning hole [a] before installing other screws. When screws are not installed in this order, a fixing assembly may be not installed in correct position. In such case, the gear mesh between a fixing drive idler gear and a fixing idler gear become insufficient. As a result, gear vibration increases to cause aforementioned symptom.

- 1) Refer to the service manual to open the front cover and draw out a fixing feed unit.
- 2) Loosen the 3 pcs of yellow screws [a] [b] [c], which are fixing a Fixing Assembly. Then install the screws again, in the order of [a] (screw this on first), [b] and [c], firmly

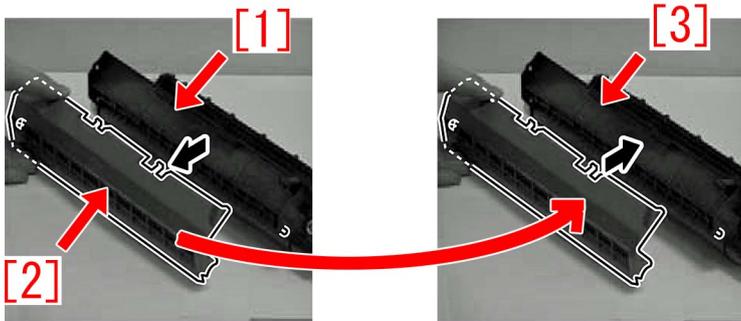
When to replace the transfer cleaning unit, it is required to detach the heat absorbing cover [2] from the old unit [1] and attach the said cover to the new unit [3].

However in service operation a mistake of forgetting to attach the heat absorbing cover occurs from time to time. If the device is used without attaching the heat absorbing cover, waste toner inside the transfer cleaning unit will cake from the heat, and this brings failure in toner circulation. Replacing the transfer cleaning unit may be required as a result.

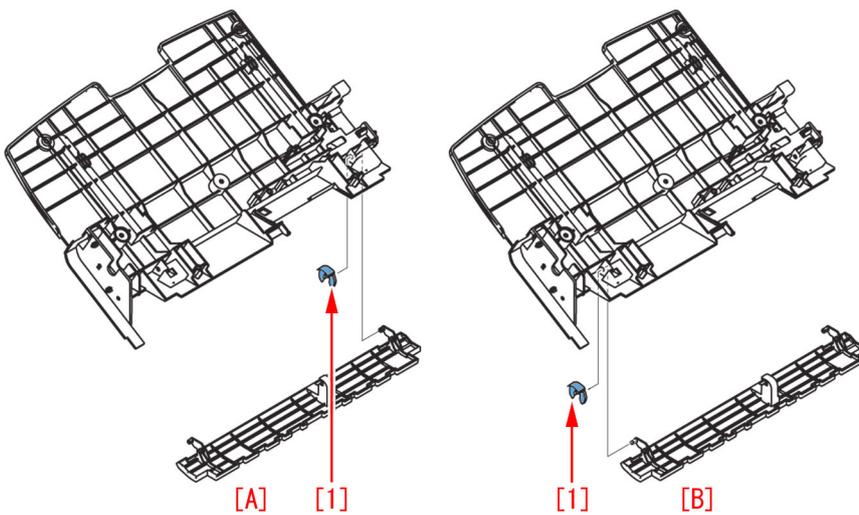
[Caution] When the safety cover is replaced with new type one, the attachment position of the clip [1] shifts to the front side. Please note that. Fig.[A] shows old type and Fig.[B] shows new type.

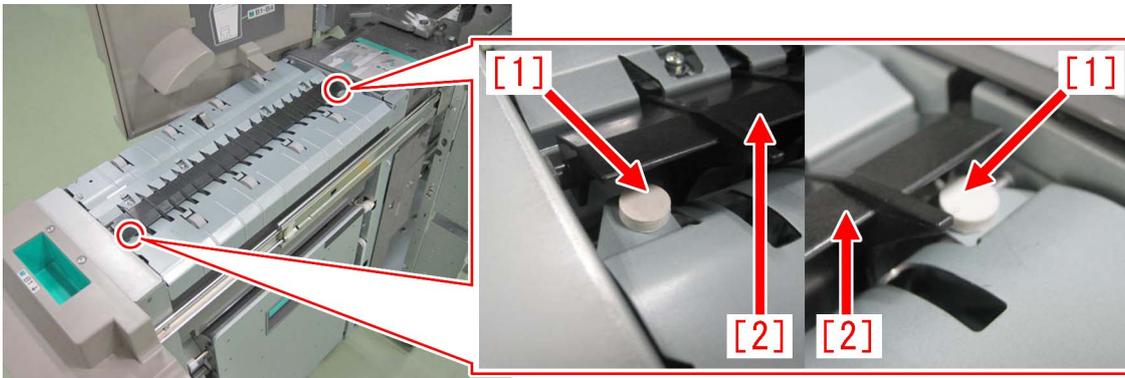
As the spacer [1] gets softened and its surface gets sticky, the folding/straight flapper [2] sticks to it, causing the above symptom to occur.

Follow the steps below and check if the spacer [1] is stuck to the folding/straight flapper [2]. If it is stuck, prepare the 2 new type spacers (FL1-6535-000) and replace with them.

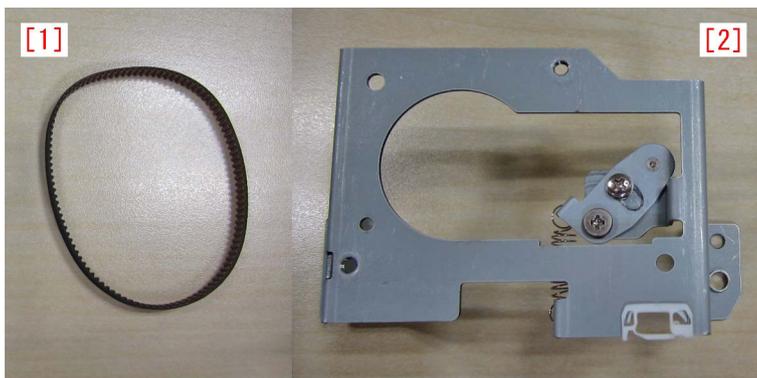
The timing belt [2] in the operation feed motor (M26) [1] is designed to keep its tension and prevent from being loose by having the tensioner [3] pressed in the direction of the arrow. This tensioning method is "unfixed type". However, the pressing power of the tensioner [3] in the unfixed type is insufficient in some cases and when the operation feed motor (M26) [1] drives rapidly a meshing failure occurs on the timing belt because of power, resulting in the above symptom.

When the above symptom occurs, prepare and replace the paper delivery drive set (L) (4Y8-3156-000).

The paper delivery drive set (L) (4Y8-3156-000) contains the following 2 items.

- Timing belt [1]
- Paper delivery drive assembly (L) [2]

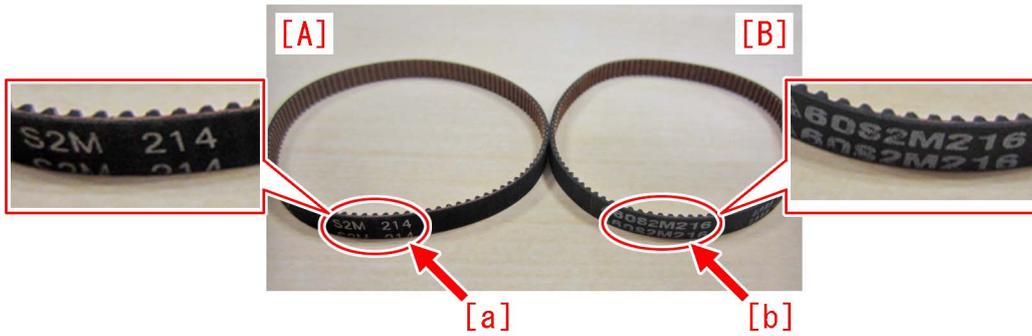
[Note] When replacing to the paper delivery drive assembly (L), be sure to also replace the timing belt [B] at the same time that is included in the set. 110F jam occurs when using the old type timing belt [A] as the number of teeth of the new type is different from the old type originally attached to the engine.

In the photo below, [A] is the old type and [B] is the new type.

The old type [A] has "S2M 214" [a] printed on it. The new type [B] has "60S2M216" [b] printed on it.

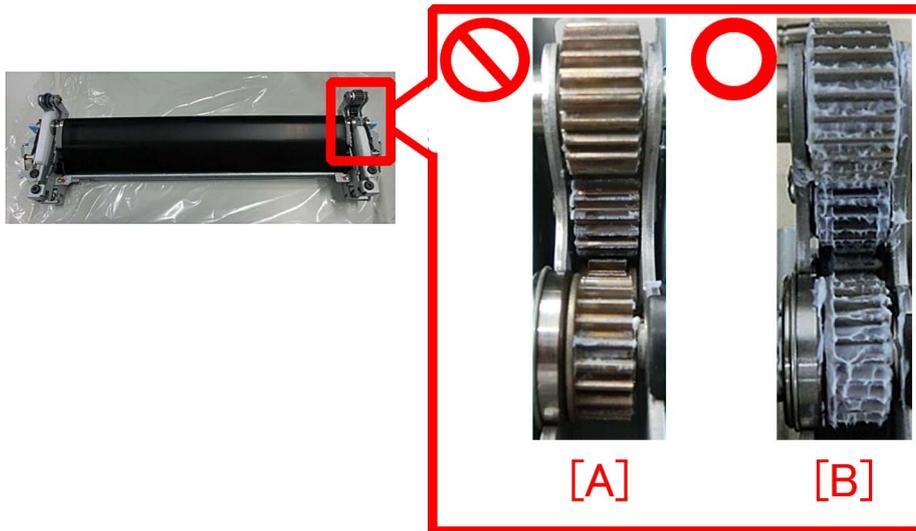
When an amount of grease applied is insufficient, gears may wear out, and additionally, the bearing may be displaced because of the following symptoms.

[A] shows the state where insufficient grease is applied, and [B] shows the state where proper amount of grease is applied.

If the amount of grease is insufficient, go to the step 2). If the proper amount of grease is applied, carry on replacement.

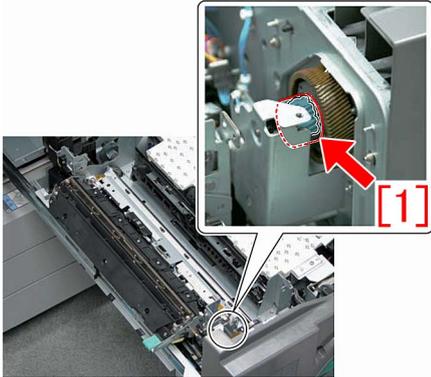
When the life of the fixing belt unit advances, the greases applied to 27T gear in the fixing drive unit and 31T gear in the fixing belt unit deteriorate. Also abnormal noise (noise of meshing failure of tooth) during operation or E004-0203 may occur when the gear is worn out due to the deterioration of the greases.

Clean 27T gear [1] and reapply grease by following the step A).

If any damage was observed on teeth of gears, replace the gears by following the step B).

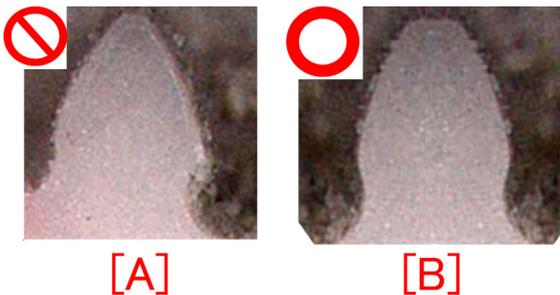
B-5) Visually, check the condition of the teeth marked in the step B-4).

The picture [A] shows a shaved gear tooth in a triangle shape. The picture [B], a gear tooth in the normal shape.

If chipped/shaved teeth are observed, shift the phase of the gear position by rotating by 180 degrees at angle.

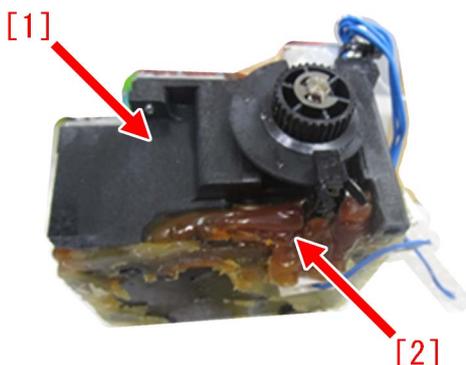
Trimming performance of the trimming blade goes down and trimming failure [a] occurs.

-E5B7-0001/-0002: Error in Glue Vat Shift Motor (M32) of Perfect Binder

-E5B8-8001: The Glue Vat Roller Rotation Sensor (S59) could not detect rotation of the Glue Vat Roller when it was driven.

Replace the trimming blade and the heater (Glue vat unit) in accordance with the designated work interval described in Service Manual.

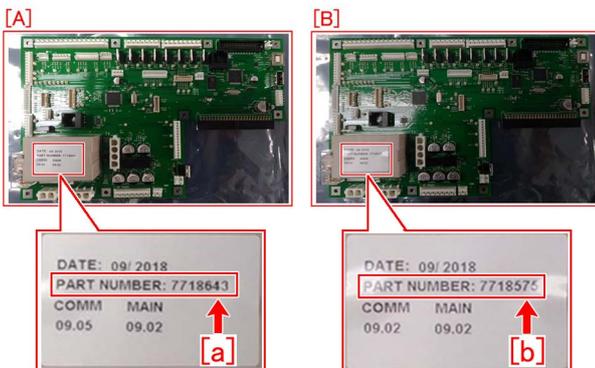
The new/old type of MAIN CONTROLLER PCB ASS'Y could be identified by the PART NUMBER [a] [b] printed on a label on a PCB.

- New type [A]: 7718643[a]
- Old type [B]: 7718575[b]

When the above mentioned failure is observed, replace with the new type MAIN CONTROLLER PCB ASS'Y( FC3-7449-000)[A], which has its Bootloader firmware modified.

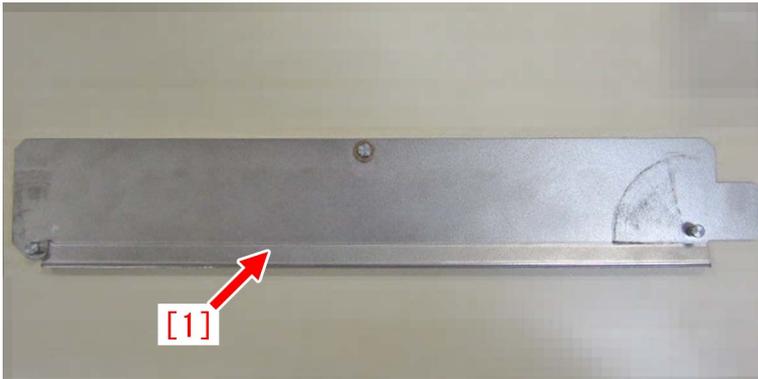
As the life of the dust buffer [2] in dust collecting area [1] advances, the surface [a] that comes in contact with the arm [3] gets shaved. This causes sliding failure of the dust buffer, resulting in the above symptom.

14) Moisten the lint-free paper with alcohol and clean the front side and back side of the sub buffer [1].

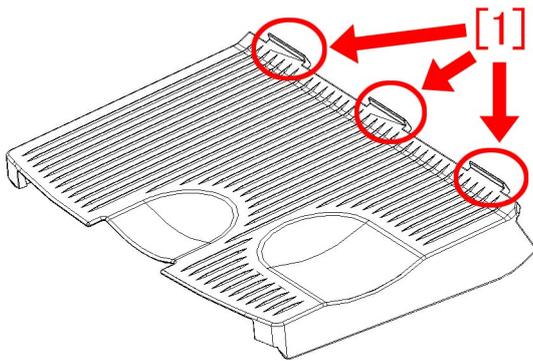
The copy tray hooks (claws) [1] may break on an engine whose serial number is earlier than the following countermeasure cut-in serial numbers in factory.

An overloading of output paper overcomes the designed strength of copy tray, and this induces the above mentioned symptom. The said symptom would not occur in the use where the stack volume in the tray is within the specification.

When the aforementioned symptom has occurred, replace the copy tray 1 [1] with new type which changed shape of the hooks (claws) and enhanced strength against weight.

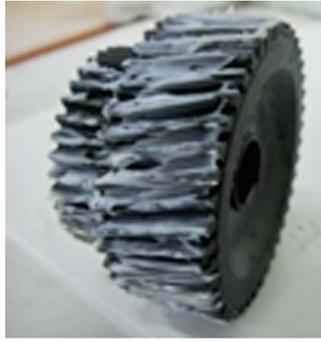
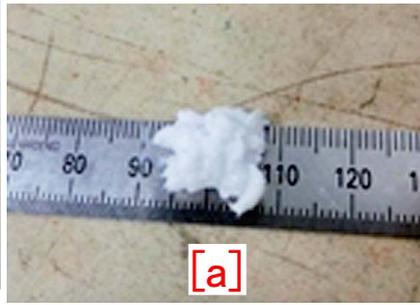
When grease applied on fixing belt unit was deteriorated or the applied amount was insufficient, gears may wear out. Therefore, follow the instructions below carefully when replacing the fixing belt unit with a new one.

- 4) Apply grease on entire circumference of the prepared 31T gear and 37T/42T gear, before replacing the 31T gear [1] and 37T/42T gear [2]. Apply 1.3g grease [a] for each gear.

- The 2 bearings attached to the old type 31T gear whose color is black will be redundant after the replacement.
- The new type 31T gear (FL1-0579-000) [2] is brass colored and integrated with the bearings.
