708P91370
April 2017

Xerox® VersaLink® B7025/B7030/B7035 Multifunction Printer Service Manual

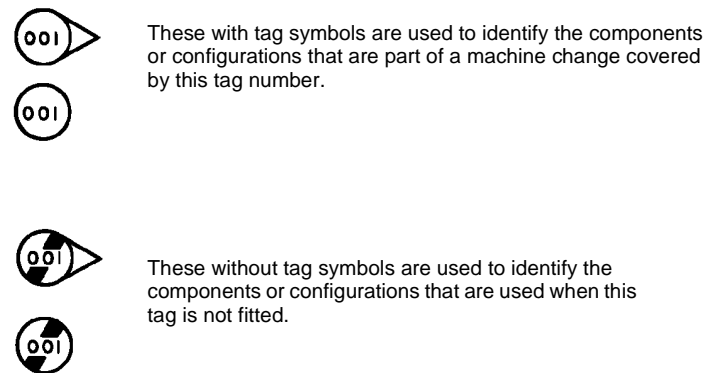
Y-1-0419-A

Figure 1 shows the Mod/Tag identification symbols.

Figure 1 Mod/Tag identification symbols

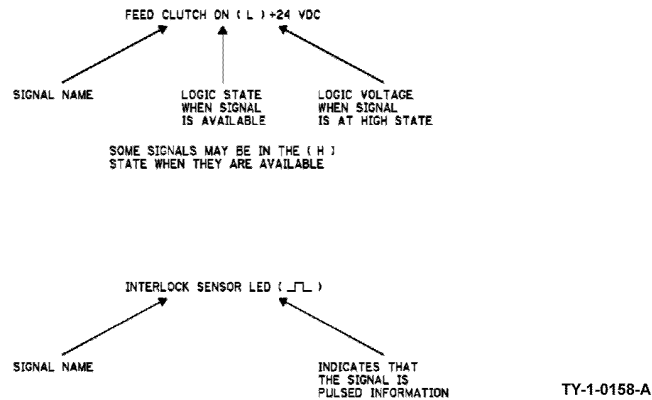
Figure 1 shows the signal nomenclature used in the BSDs.

Figure 1 Signal nomenclature

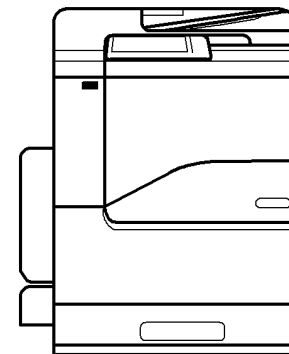
Y-1-0475-A

Figure 1 Desktop machine

- Xerox® VersaLink® B7025 desktop, Figure 1.

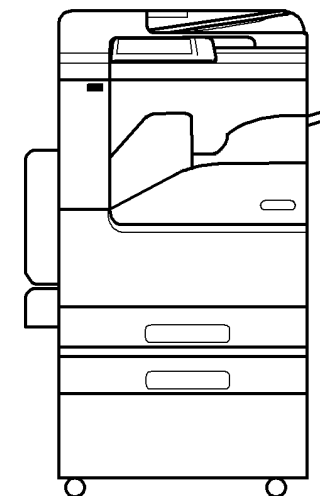
Y-1-0476-A

Figure 2 Machine with integrated finisher and 1TM

- Xerox® VersaLink® B7030 with integrated finisher and 1TM, Figure 2.
- Xerox® VersaLink® B7035 with office finisher LX and 3TM, Figure 3.
- Xerox® VersaLink® B7035 with office finisher LX, booklet maker, HCF and TTM, Figure 4.

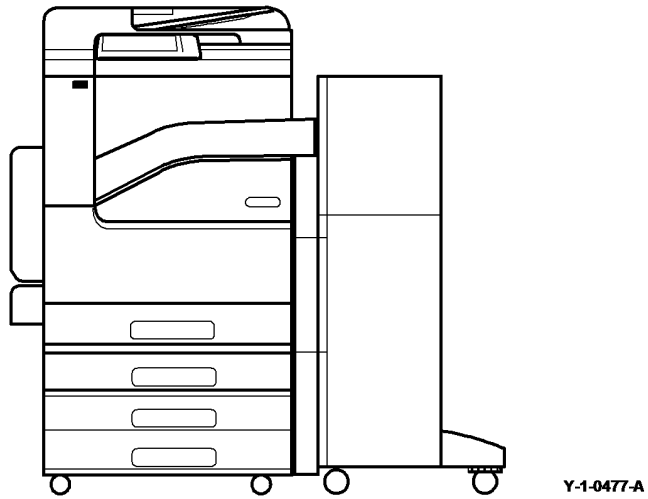
Figure 3 Machine with office finisher LX and 3TM

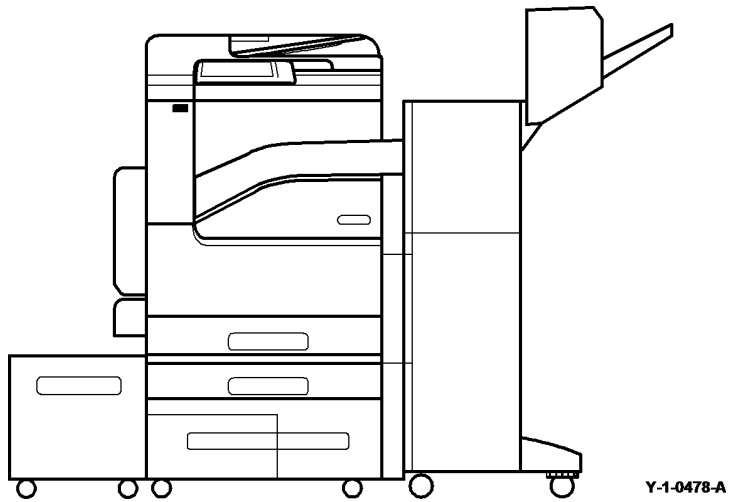
Figure 4 Machine with office finisher LX, booklet maker, HCF and TTM

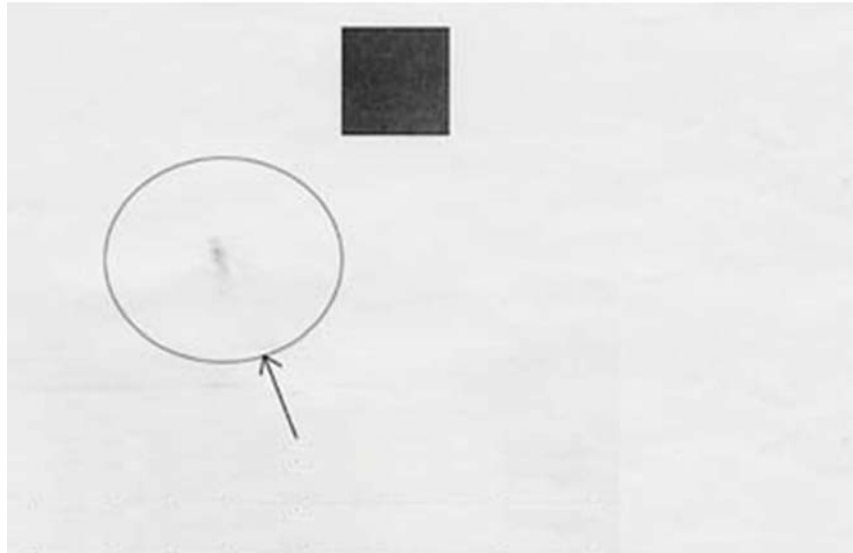
Y-1-0420-A

Smearred toner spills that are long and narrow. Refer to [Figure 1](#).

Figure 1 Example

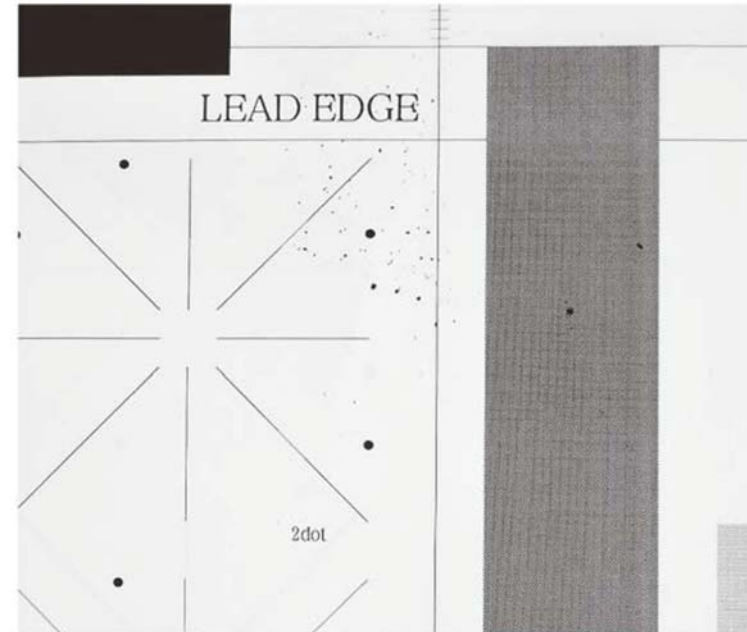
Y-1-0421-A

Many uneven black spots on the paper. Refer to [Figure 1](#).

Figure 1 Example

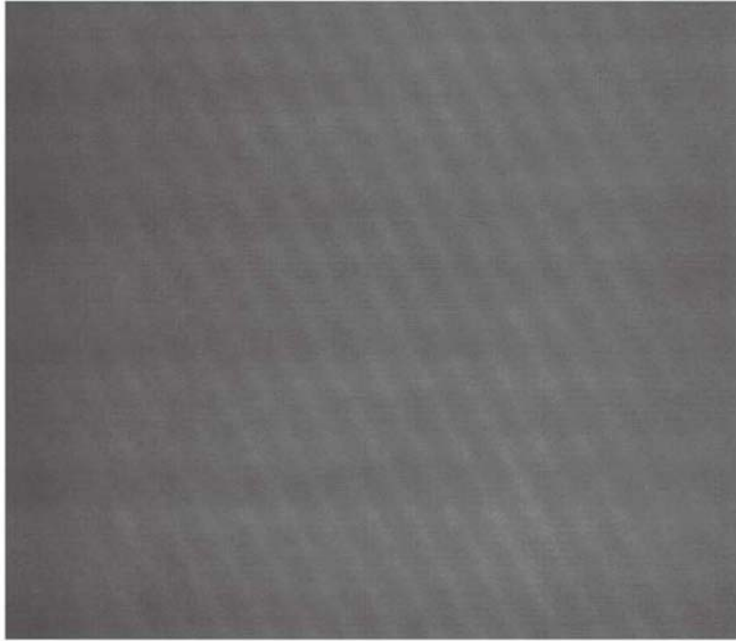
Y-1-0422-A

Multiple parallel halftone shades of bands in the process direction. Refer to [Figure 1](#).

Figure 1 Example

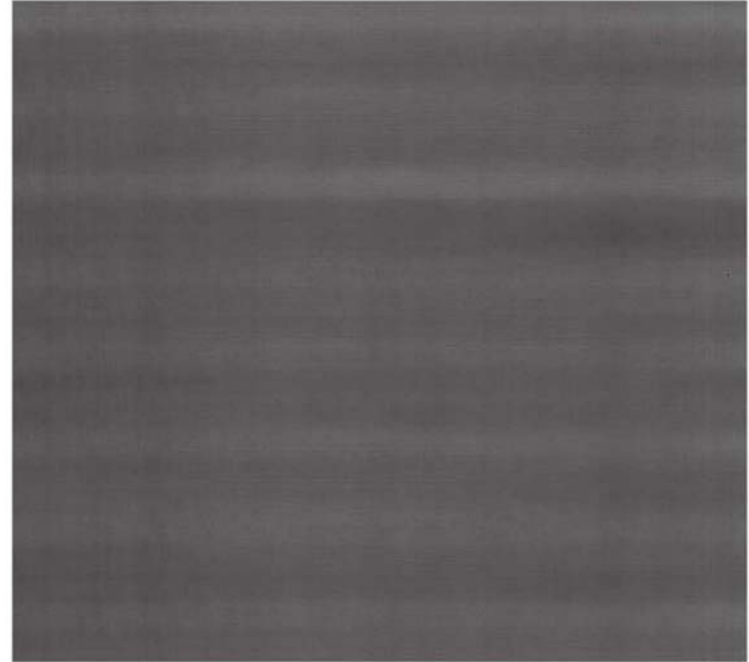
Y-1-0423-A

Shades of 32mm or 16mm pitch in the process direction. Refer to [Figure 1](#).

Figure 1 Example

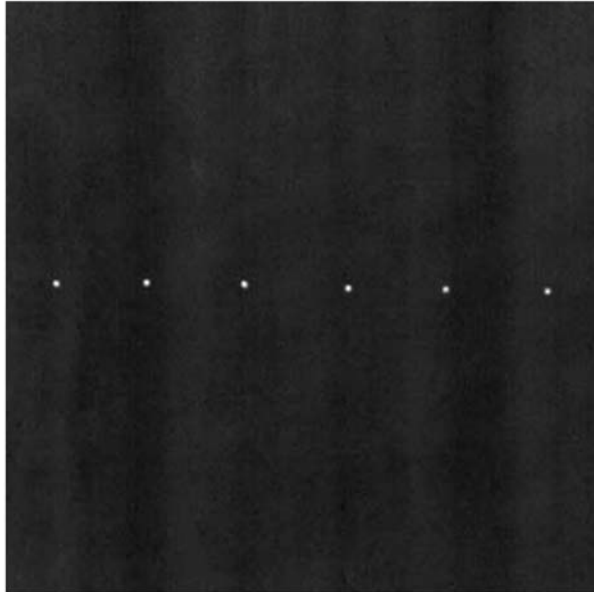
Y-1-0424-A

Regular, same shape and pitch blank areas (spots, streaks or bands). Refer to [Figure 1](#).

Figure 1 Example

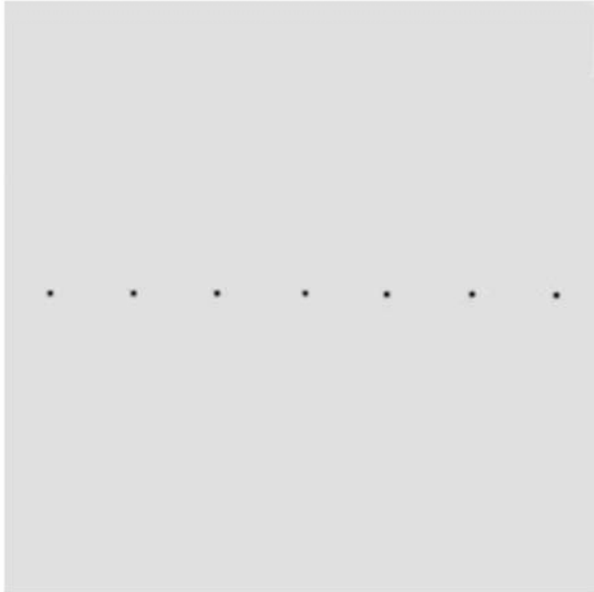
Y-1-0425-A

Regular, same pitch toner contamination in the process direction. Refer to [Figure 1](#).

Figure 1 Example

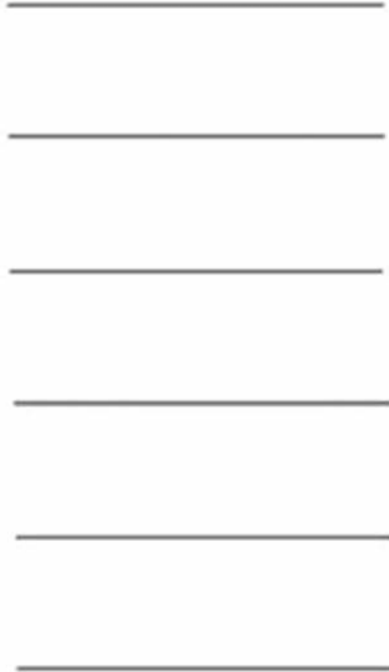
Y-1-0426-A

Regular pitch toner contamination in the process direction. Refer to [Figure 1](#).

Figure 1 Example

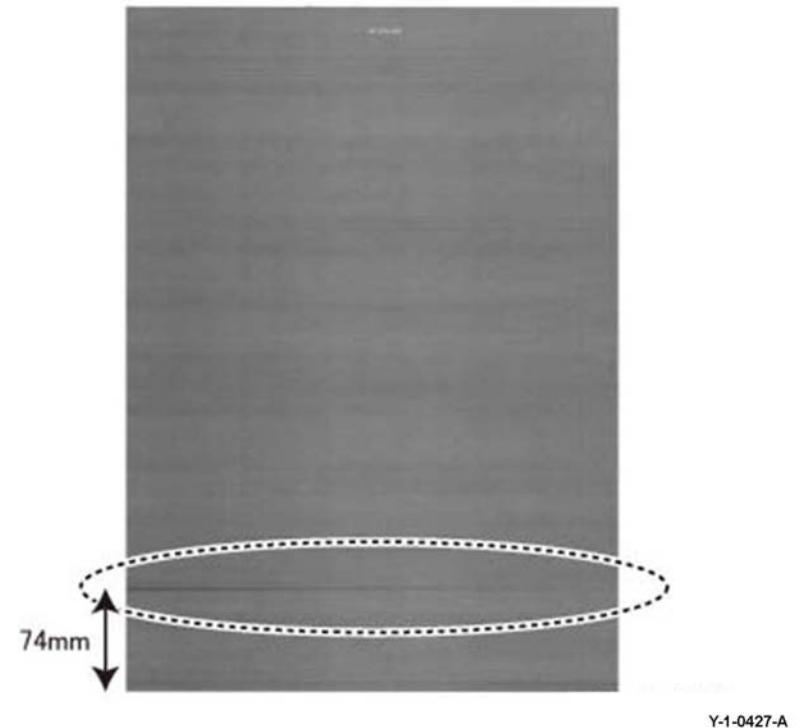
Same symptom as smear, but occurs only when heavyweight paper is used. Refer to **Figure 1**.

Figure 1 Example

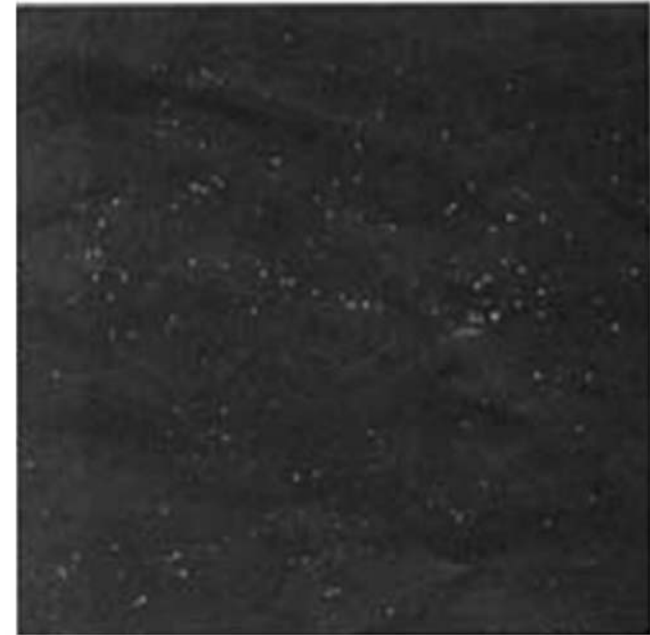
Y-1-0428-A

Blank areas spread irregularly over the whole page. Refer to [Figure 1](#).

Figure 1 Example

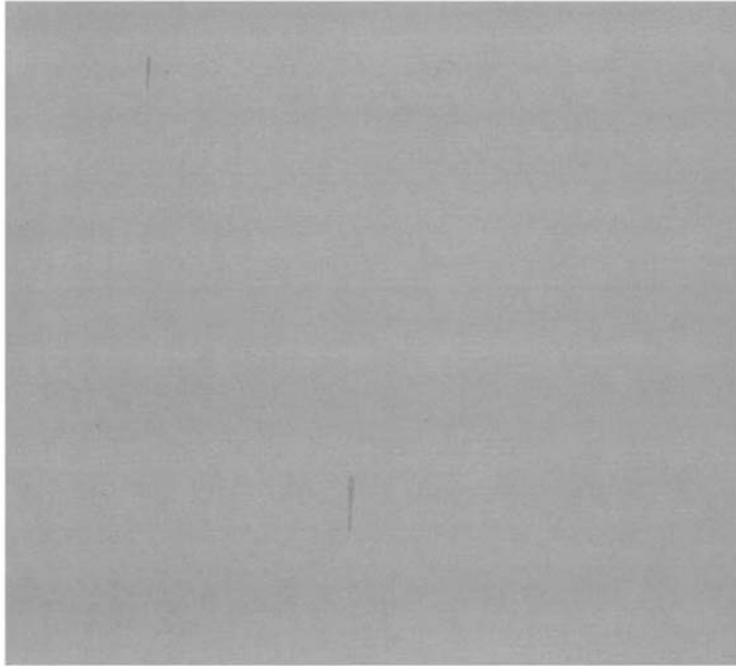
Y-1-0429-A

A long thin line in the process direction. The length can range from 2mm (0.08 inch) to over 10cm (4 inches). This occurs in solids or halftones, it does not occur in the background. Refer to [Figure 1](#).

Figure 1 Example

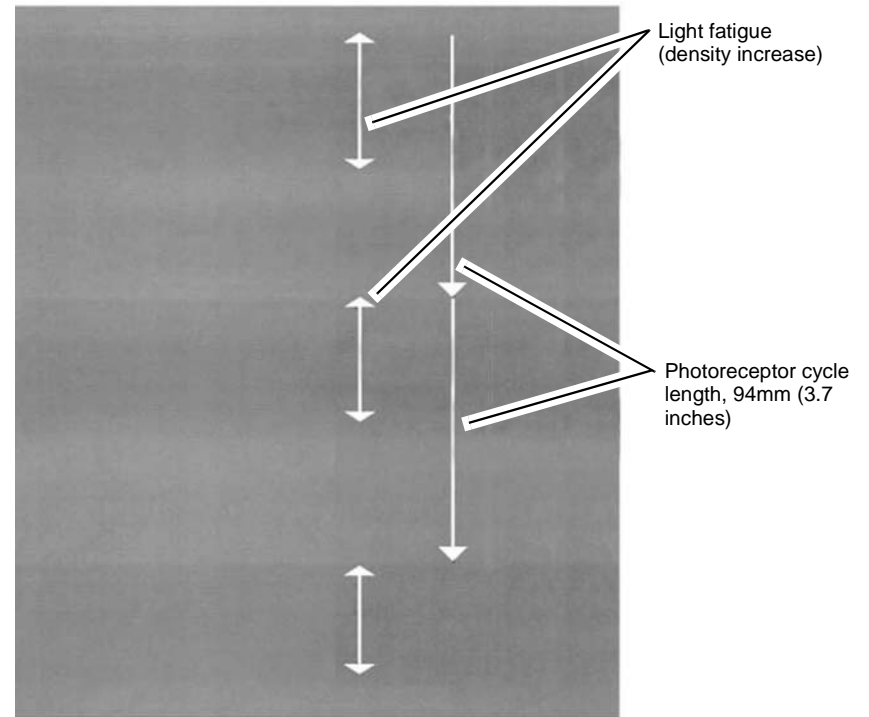
Y-1-0430-A

Drum pitch, 94.2mm (3.7 inches) shade occurs in halftones. Refer to [Figure 1](#).

Figure 1 Example

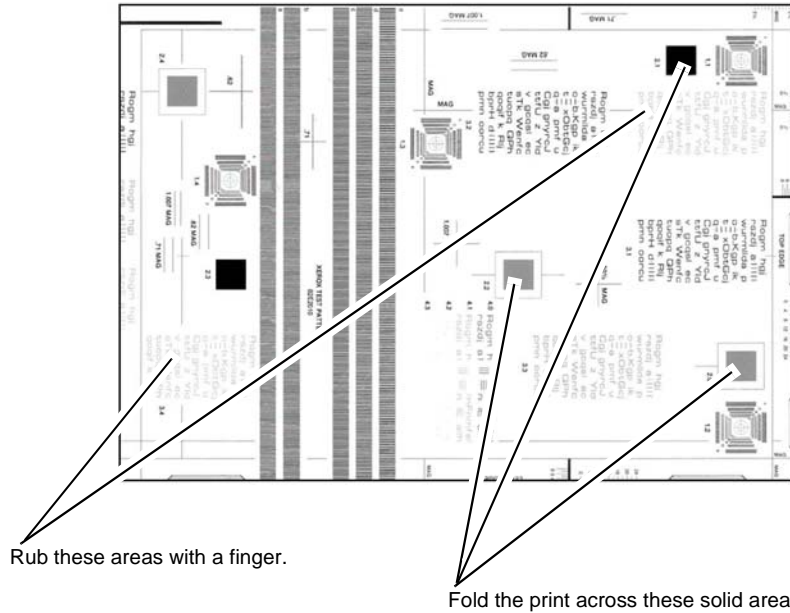
Y-1-0434-A

Figure 1 Test pattern

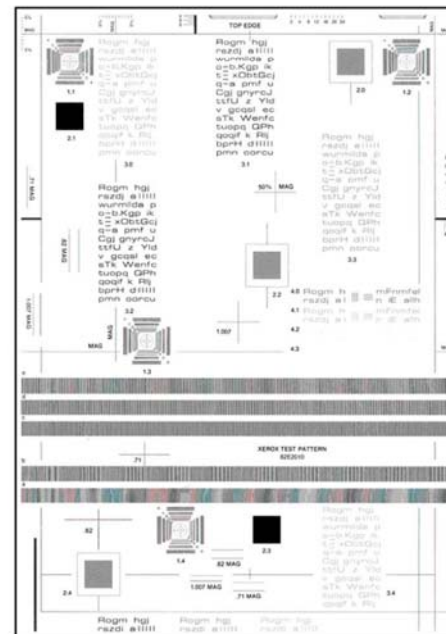
Y-1-0435-A

Figure 1 Test pattern

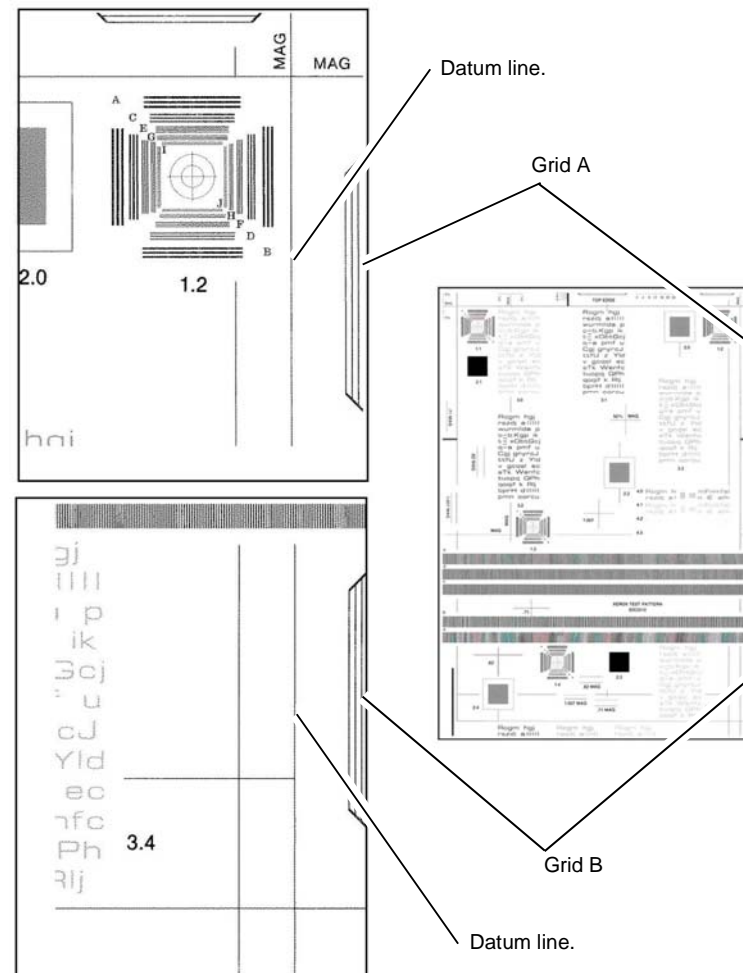
Y-1-0438-A

NOTE: Grid A and grid B are small areas of parallel lines 1mm apart.

Figure 1 Copy and scan skew measurement

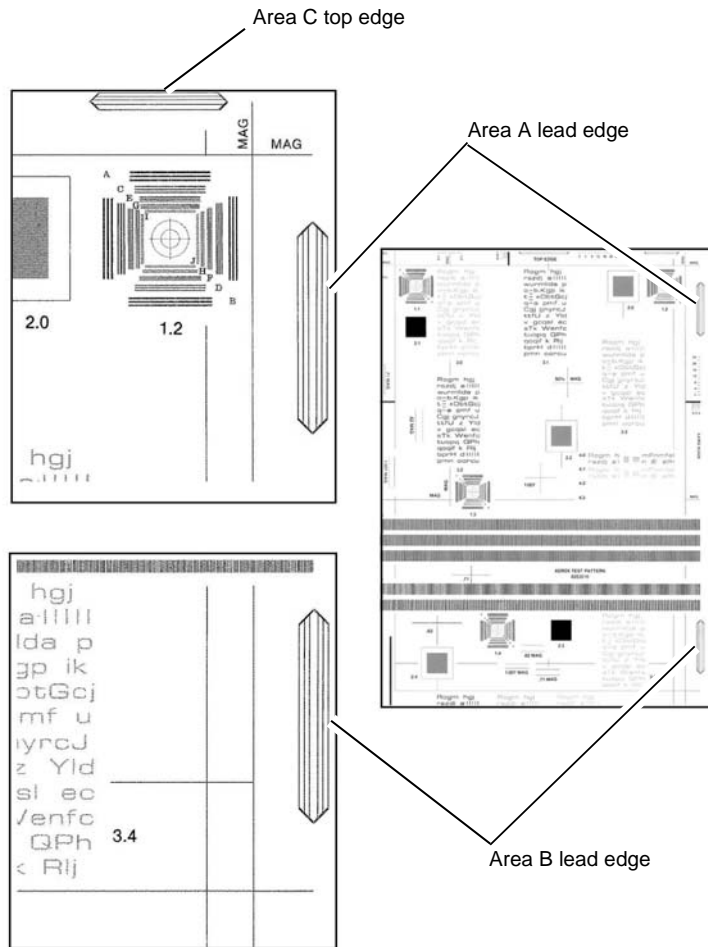
Y-1-0439-A

Figure 1 Registration measurement

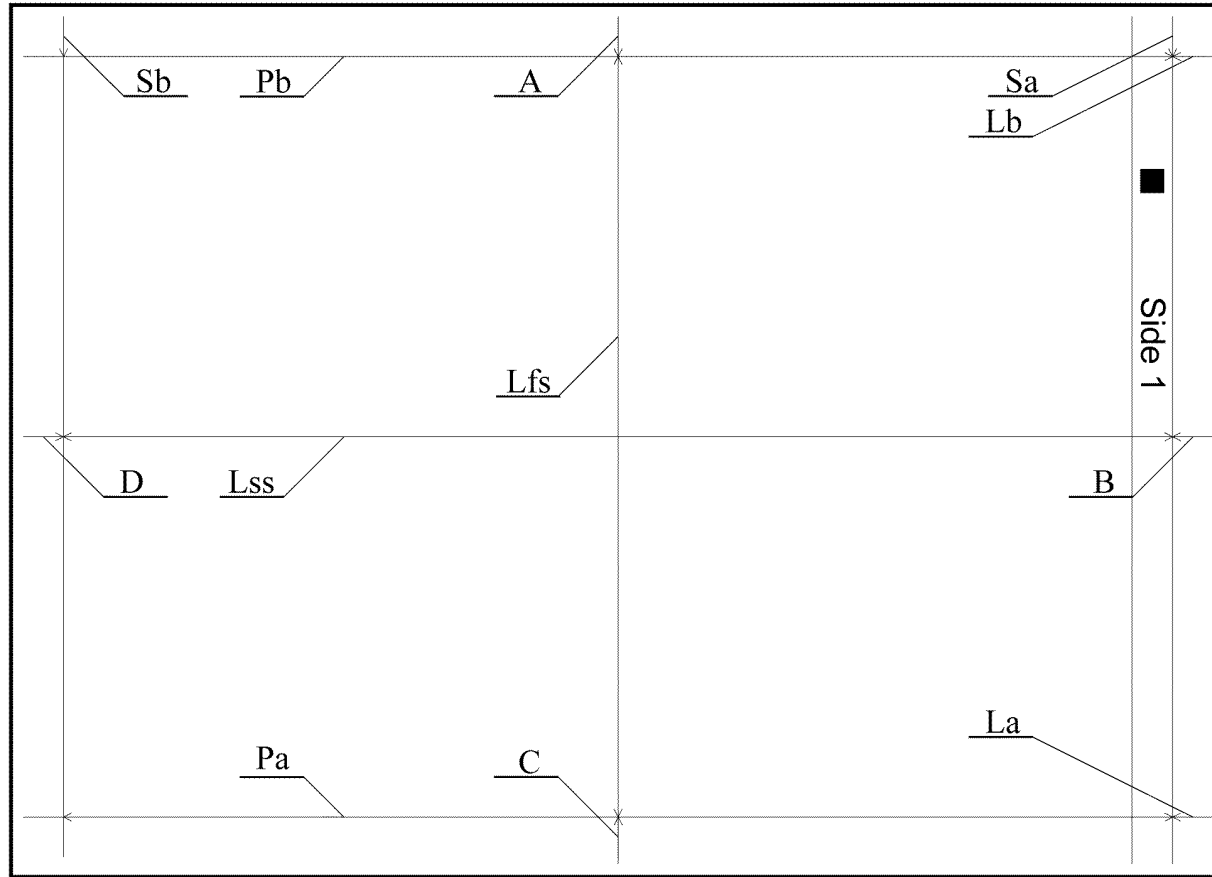
Y-1-0560-A

Figure 1 Test pattern side 1

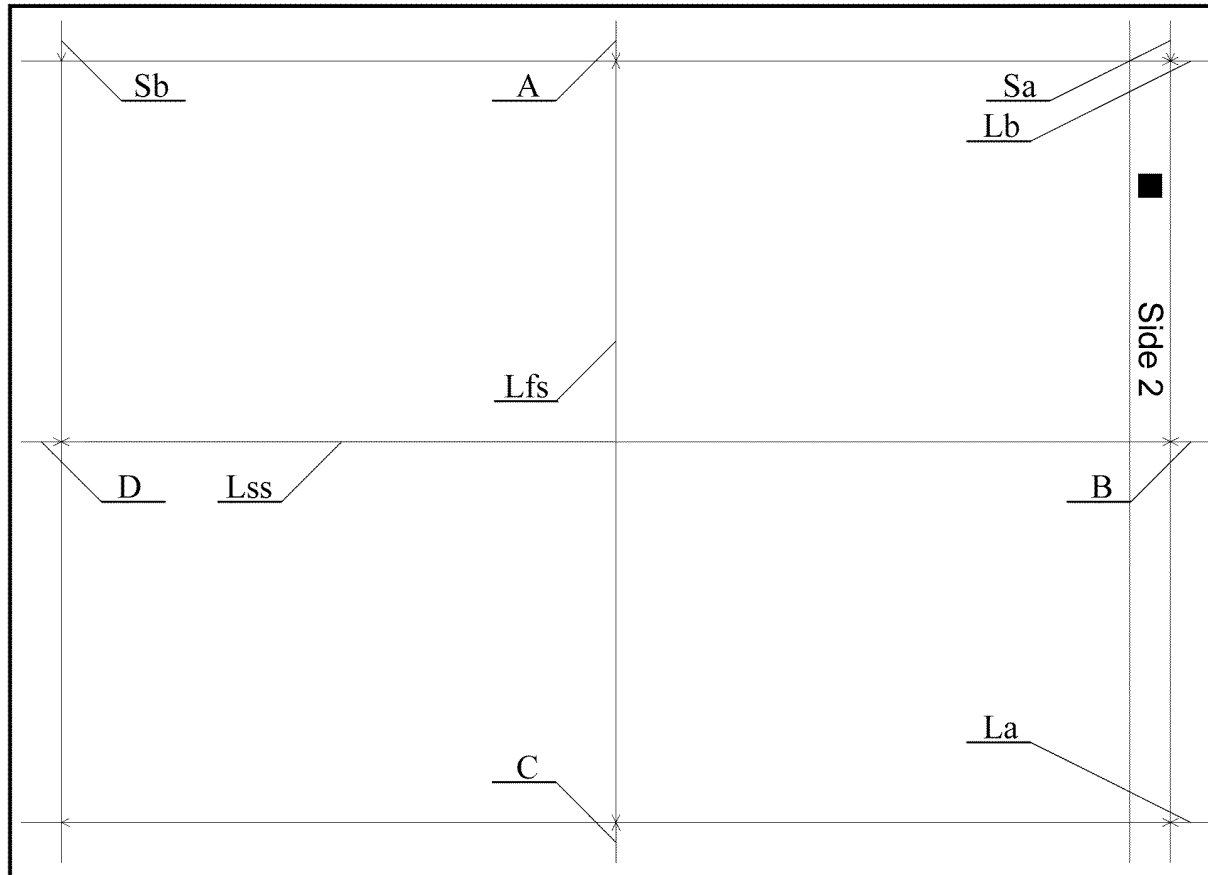
Y-1-0561-A

Figure 2 Test pattern side 2

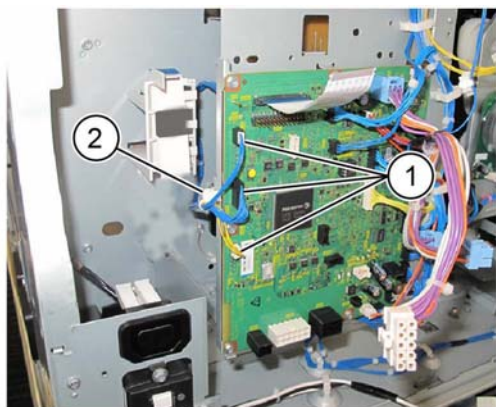
Y-1-0001-A

1. Remove the upper rear cover, REP 28.5.
2. Remove the lower rear cover, REP 28.6.
3. Remove the ESS PWB chassis assembly, REP 3.2.
4. Remove the LVPS assembly, REP 1.4.
5. Disconnect three connectors (1), then release the harness from the clamp (2), Figure 2.

Figure 2 Connectors

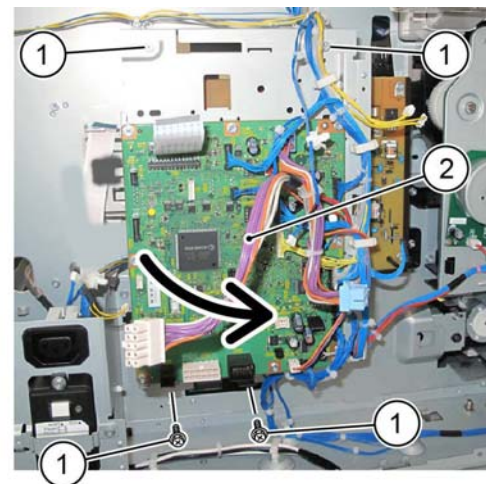
Y-1-0002-A

- b. Move the drive PWB assembly (2) in the direction of the arrow.

Figure 3 Preparation

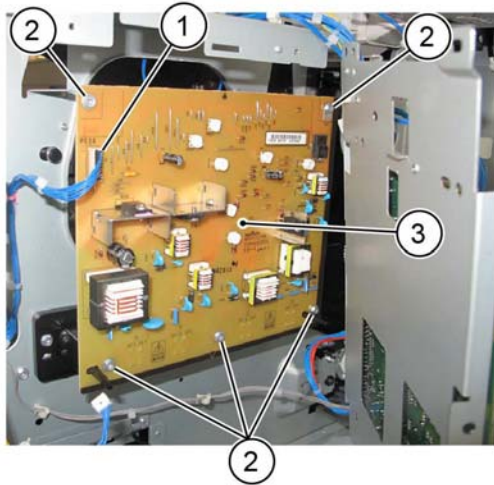
7. Remove the HVPS, [Figure 4](#):
 - a. Disconnect the connector (1).
 - b. Remove five screws (2).
 - c. Remove the HVPS (3).

Figure 4 HVPS Removal

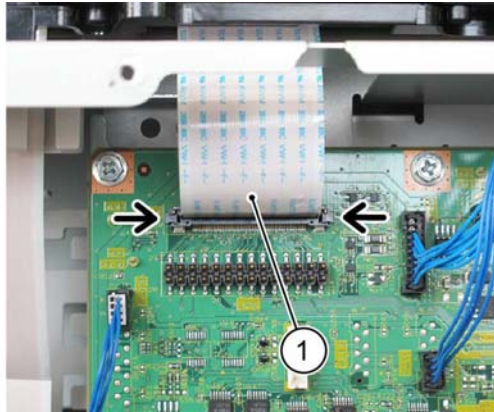
4. Carefully disconnect the ribbon cable (1) by releasing the side clips, [Figure 2](#).

Figure 2 Ribbon cable

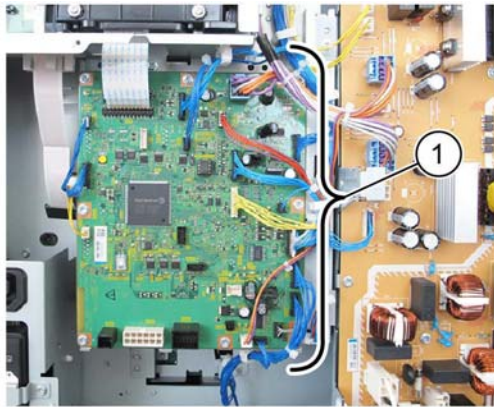
5. Disconnect all connectors from the drive PWB (1), [Figure 3](#).

Figure 3 Connectors

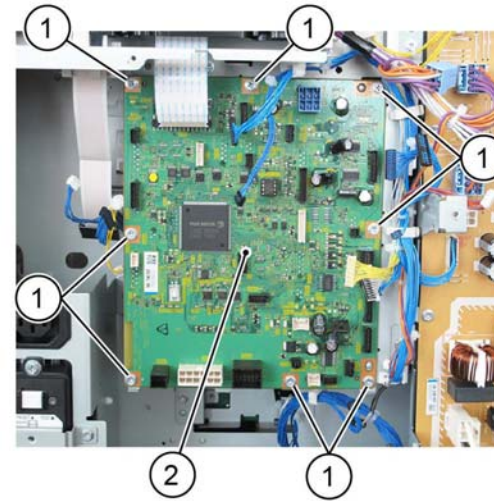
Y-1-0006-A

6. Remove 8 screws (1), then the drive PWB (2), [Figure 4](#).

Figure 4 Drive PWB removal

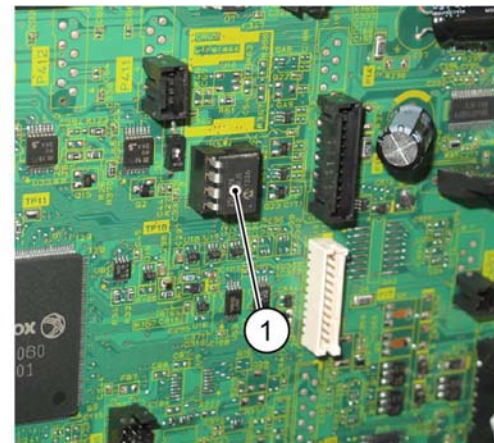
Y-1-0007-A

1. The replacement is the reverse of the removal procedure.
2. If a new drive PWB is to be installed, remove the EEPROM (1) from the old drive PWB, then install it onto the new drive PWB, [Figure 5](#).

Figure 5 EEPROM

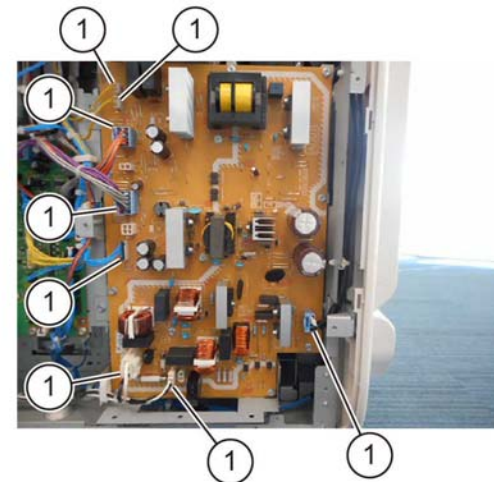
Y-1-0008-A

1. Remove the upper rear cover, REP 28.5.
2. Remove the lower rear cover, REP 28.6.
3. Disconnect all connectors from the LVPS, Figure 2.

Figure 2 Connectors

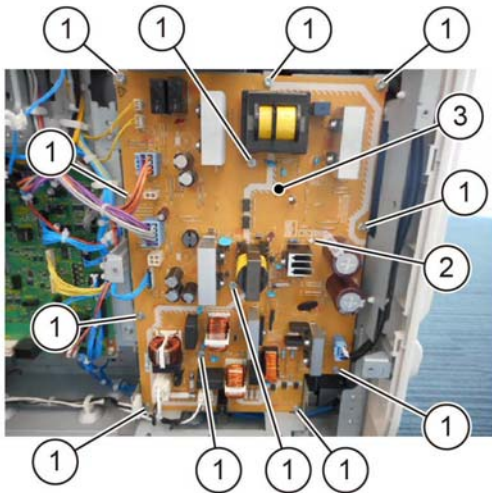
4. Remove the LVPS, **Figure 3**:
 - a. Remove 12 screws (1).
 - b. Release the stand off (2), then remove the LVPS (3).

Figure 3 LVPS removal

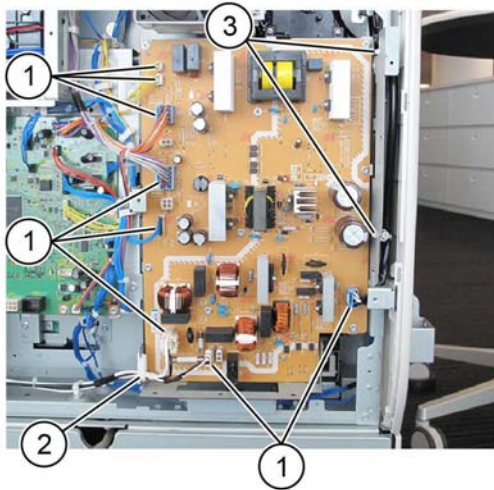
Y-1-0011-A

3. Prepare to remove the LVPS assembly, [Figure 2](#):
 - a. Disconnect eight connectors (1).
 - b. Release the harness from the clamp (2).
 - c. Remove both harness clamps (3) from the frame.

Figure 2 Preparation

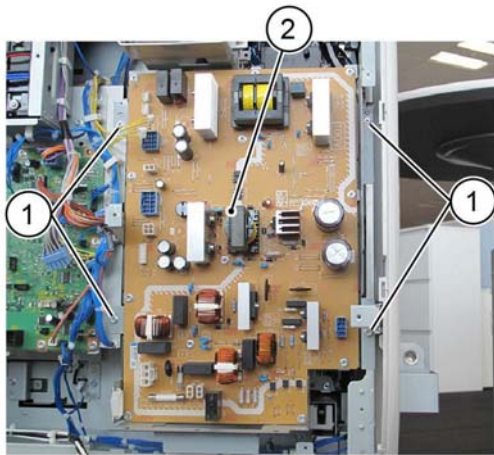
Y-1-0012-A

4. Remove four screws (1), then the LVPS assembly (2), [Figure 3](#).

Figure 3 LVPS removal

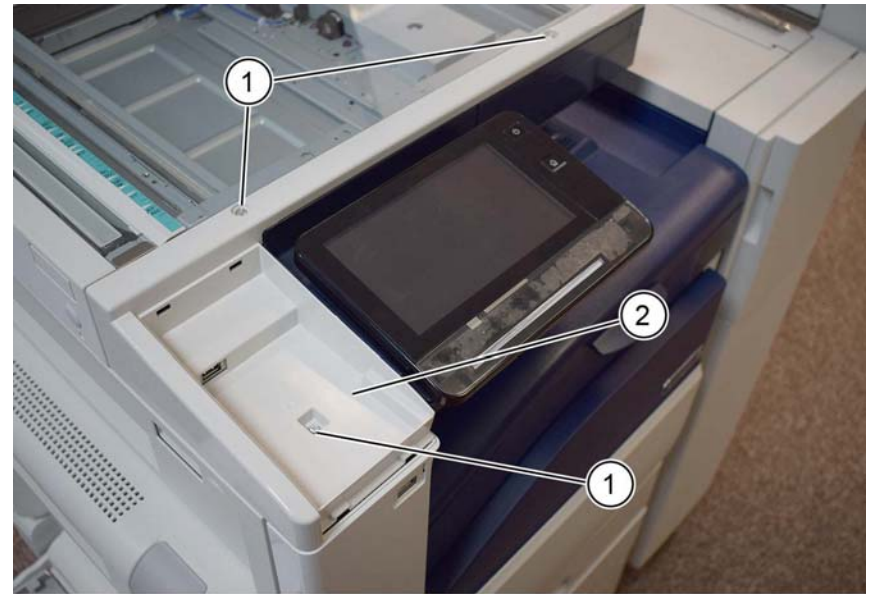
Y-1-0515-A

4. Remove the upper cover, [Figure 1](#):
 - a. Remove 3 screws (1).
 - b. Remove the upper cover (2).

Figure 1 Upper cover

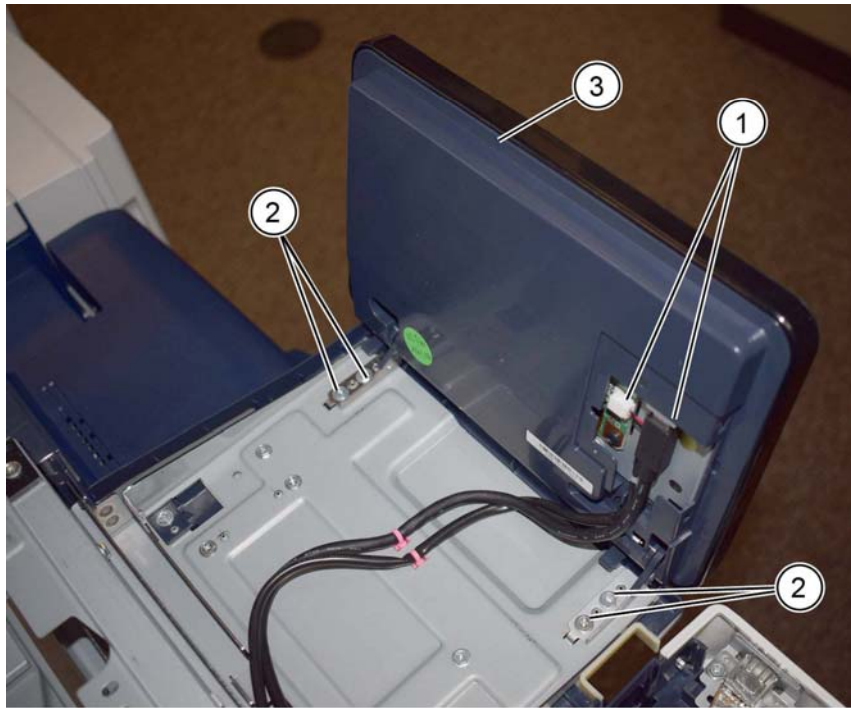
Y-1-0516-A

7. Remove the UI assembly, [Figure 2](#):
 - a. Disconnect both connectors (1).
 - b. Remove 4 screws (2), then the UI assembly (3).

Figure 2 UI assembly removal

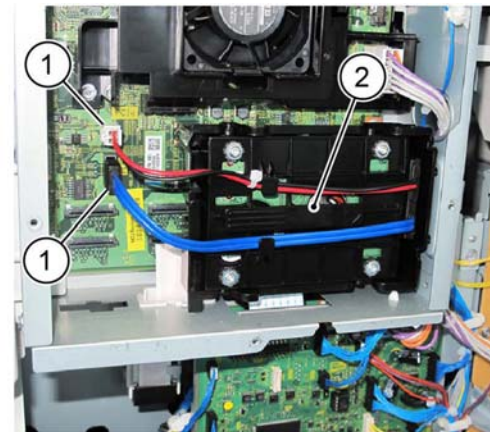
Y-1-0018-A

3. If the machine has an HDD assembly installed, remove the HDD assembly, [Figure 2](#):
 - a. Disconnect the connectors (1).
 - b. Remove the HDD assembly (2).

Figure 2 HDD removal

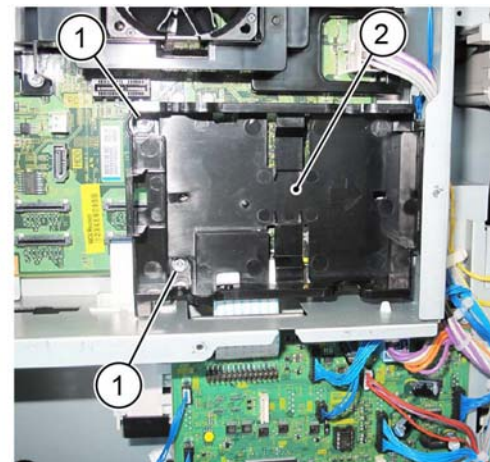
Y-1-0019-A

4. If the machine had an HDD assembly installed, remove both screws (1), then the HDD bracket (2), [Figure 3](#).

Figure 3 HDD bracket removal

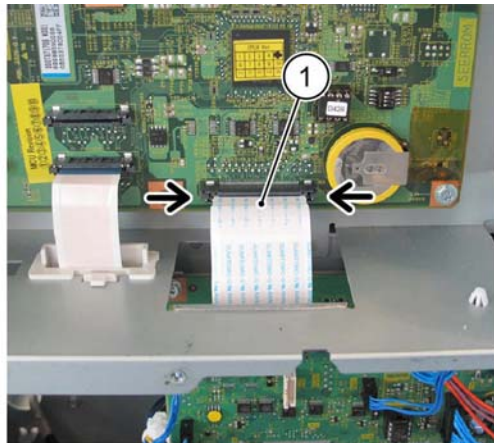
Y-1-0020-A

5. Carefully disconnect the ribbon cable (1) by releasing the side clips, [Figure 4](#).

Figure 4 Ribbon cable

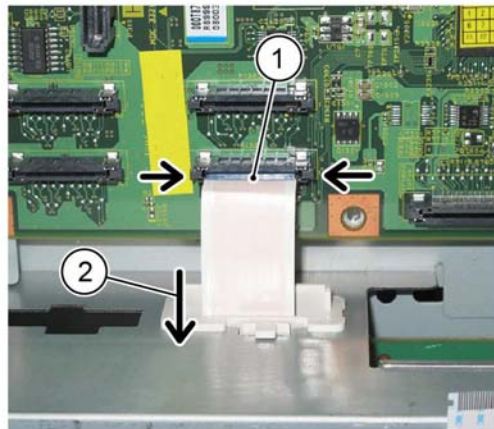
Y-1-0021-A

6. Disconnect the FFC cable, [Figure 5](#):
 - a. Carefully disconnect the FFC cable (1) by releasing the side clips.
 - b. Pull down the FFC cable (2).

Figure 5 FFC cable

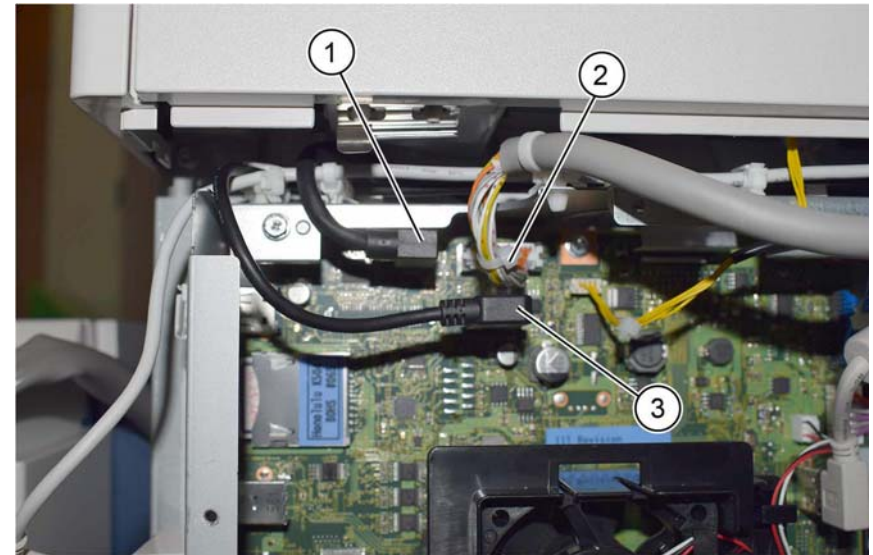
Y-1-0022-A

7. Disconnect the USB, DADF I/F and UI cables, [Figure 6](#):
 - a. Disconnect the USB cable (1).
 - b. Disconnect the DADF I/F cable. (2).
 - c. Disconnect the UI cable (3).

Figure 6 Cables

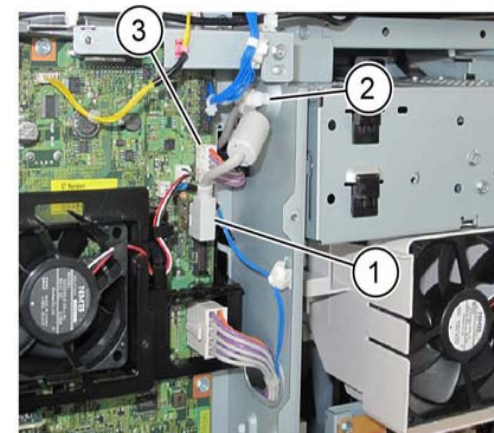
Y-1-0023-A

8. If the machine has a fax installed, disconnect the connection between the connector and the USB cable, [Figure 7](#):
 - a. Disconnect the USB cable (1).
 - b. Release the USB cable clamp (2).
 - c. Disconnect the connector (3).

Figure 7 USB cable

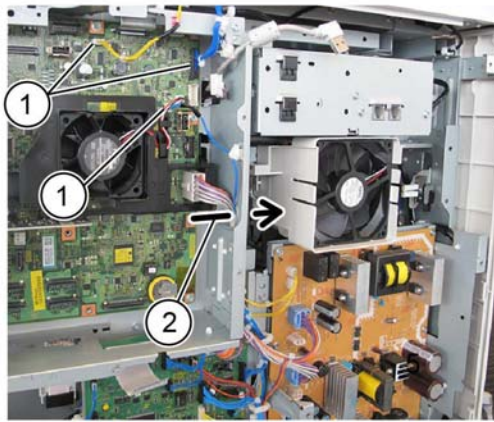
Y-1-0024-A

9. Disconnect the connectors, **Figure 8**:
 - a. Disconnect the three connectors (1), then release the associated harness clamps.
 - b. Pull the harness through the hole in the chassis (2).

Figure 8 Connectors

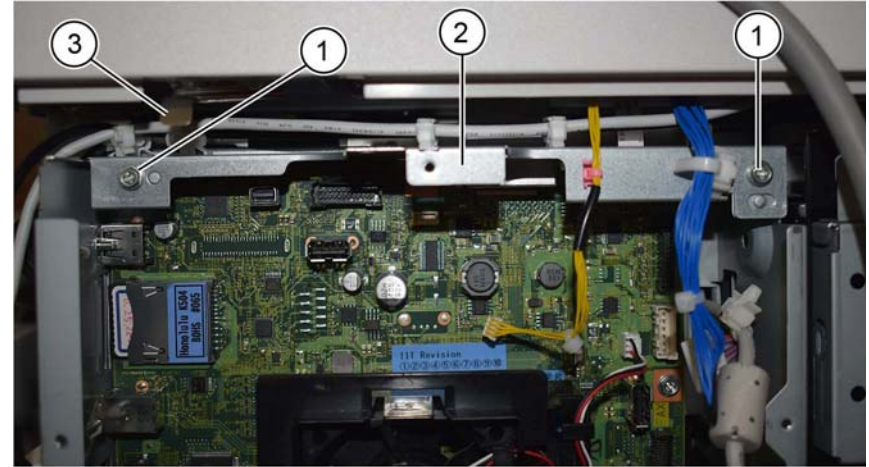
Y-1-0025-A

Take not to damage or dislodge the rear cover ground clip (3) when removing the ESS upper panel.

10. Remove the ESS upper panel, **Figure 9**.
 - a. Remove both screws (1).
 - b. Remove the ESS upper panel (2).
 - c. Release all remaining harness clamps from the ESS upper panel.

Figure 9 ESS upper panel removal

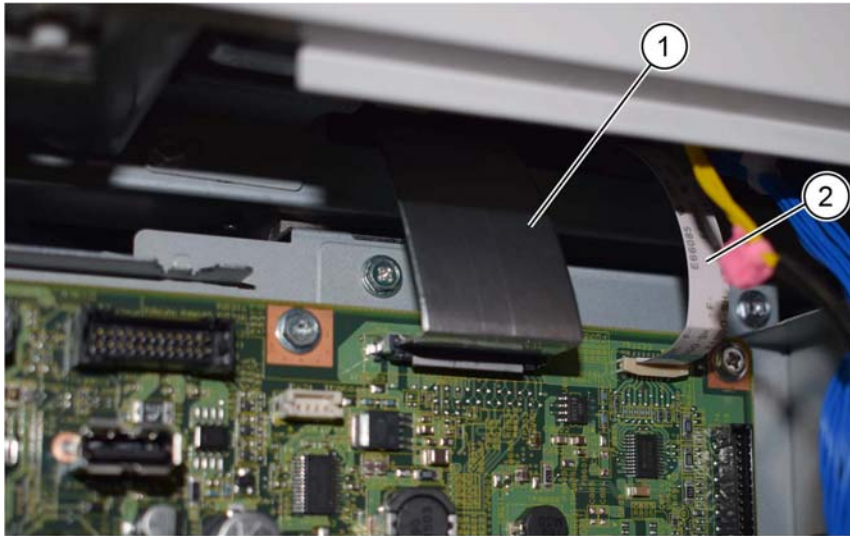
Y-1-0026-A

The FFC LED cable is secured by a clamp. Carefully lift both ends of the cable clamp simultaneously to release the cable.

11. Carefully disconnect the CCD ribbon cable (1) and the FFC LED cable (2), Figure 10.

Figure 10 Cables

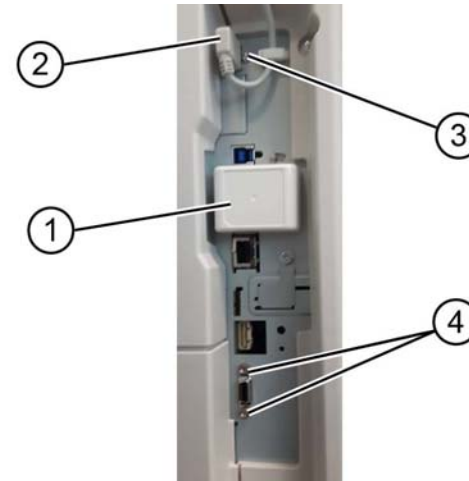
Y-1-0533-A

12. Disconnect the connectors and fittings from side of ESS PWB, Figure 11.
- If fitted, remove the wireless dongle (1).
 - Disconnect the USB cable (2).
 - Remove screw for the USB connector (3).
 - Remove screws for the D-type connector (4).

Figure 11 ESS PWB side connectors

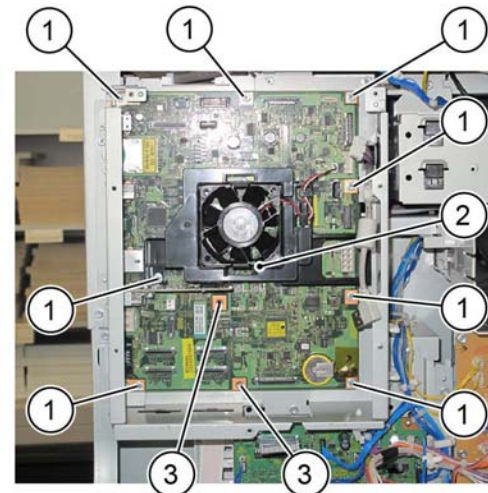
Y-1-0027-A

13. Remove the ESS PWB, Figure 12:
- Remove eight screws (1).
 - Remove the ESS fan (2).
 - For machines without an HDD, remove both screws (3).

Figure 12 ESS PWB removal

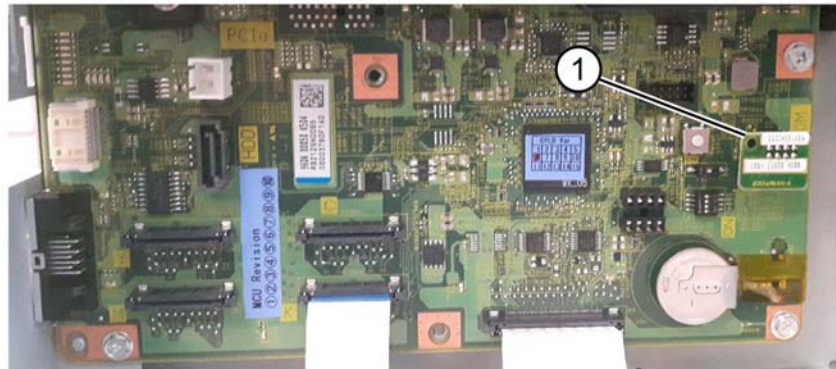
Y-1-0029-A

Take care when removing and reinstalling the SEEPROM. The pins are easily damaged.

- a. Remove the SEEPROM (1) from the old ESS PWB, then install it onto the new ESS PWB, [Figure 13](#).

Figure 13 SEEPROM

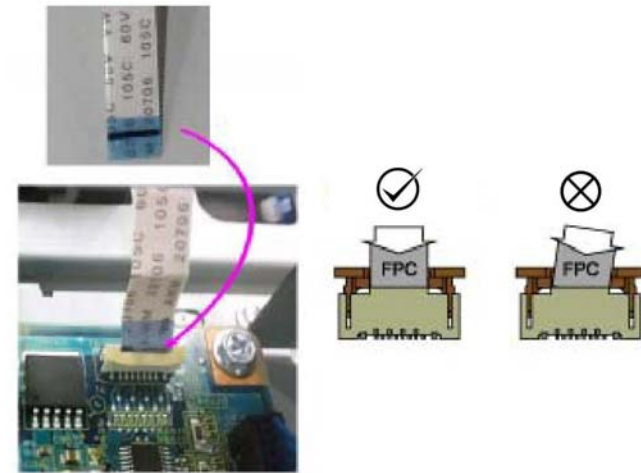
Y-1-0030-A

4. Be aware that when connecting the FFC LED cable, [Figure 14](#):
 - a. The black lines serve as a guide for whether the FFC LED cable is inserted correctly. Insert the connector so that the back lines are parallel.

NOTE: The black lines remain visible even after the FFC connector is inserted.

Figure 14 FFC LED cable

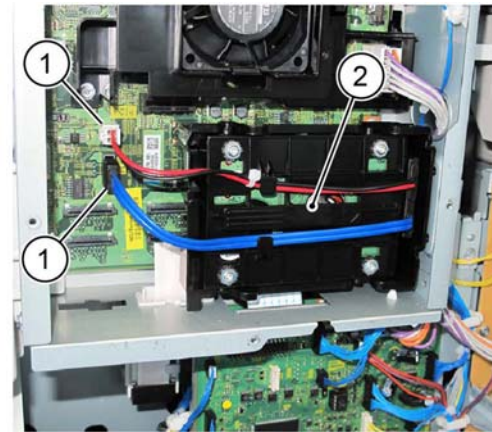
Y-1-0519-A

5. If the machine has an HDD assembly installed, remove the HDD assembly, [Figure 2](#):
 - a. Disconnect the connectors (1).
 - b. Remove the HDD assembly (2).

Figure 2 HDD removal

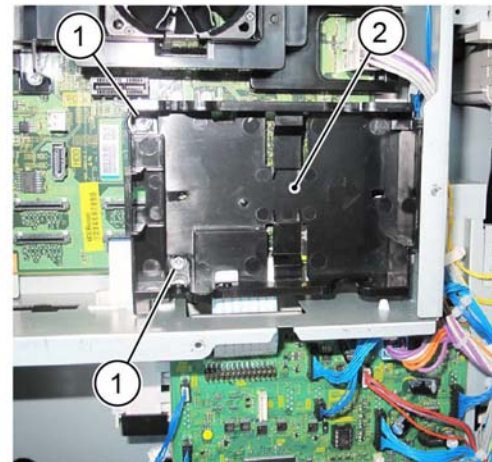
Y-1-0520-A

6. If the machine had an HDD assembly installed, remove both screws (1), then the HDD bracket (2), [Figure 3](#).

Figure 3 HDD bracket removal

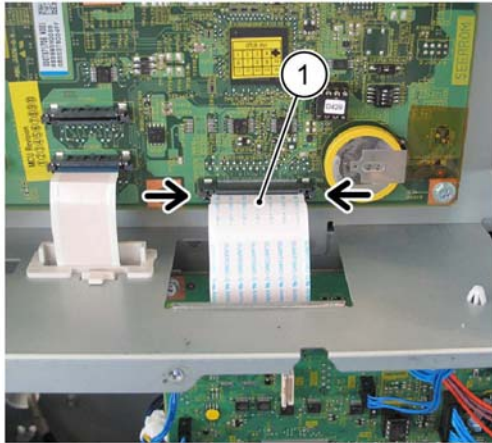
Y-1-0521-A

7. Carefully disconnect the ribbon cable (1) by releasing the side clips, [Figure 4](#).

Figure 4 Ribbon cable

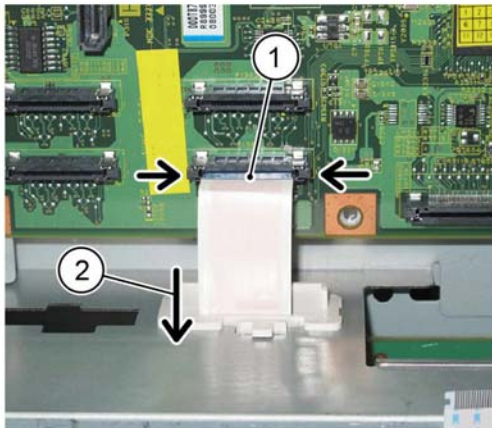
Y-1-0522-A

8. Disconnect the FFC cable, [Figure 5](#):
- Carefully disconnect the FFC cable (1) by releasing the side clips.
 - Pull down the FFC cable (2).

Figure 5 FFC cable

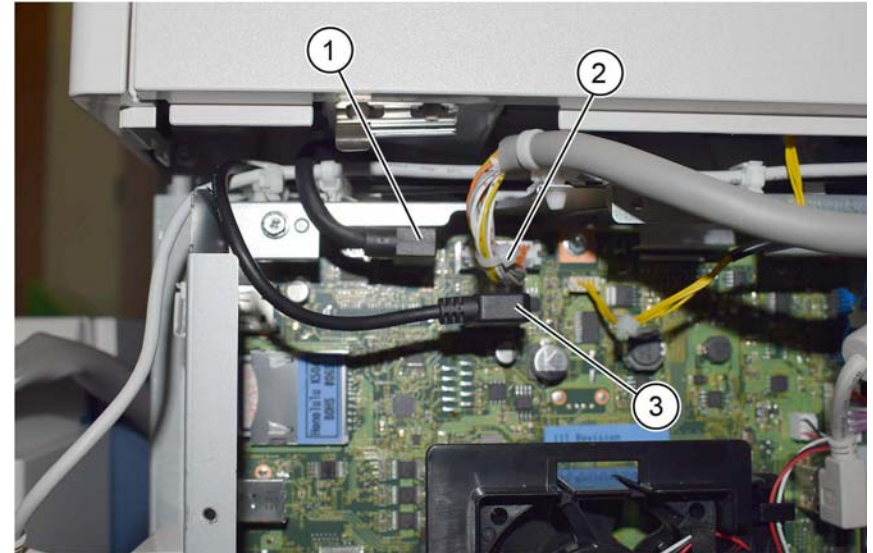
Y-1-0523-A

9. Disconnect the USB, DADF I/F and UI cables, [Figure 6](#):
- Disconnect the USB cable (1).
 - Disconnect the DADF I/F cable. (2).
 - Disconnect the UI cable (3).

Figure 6 Cables

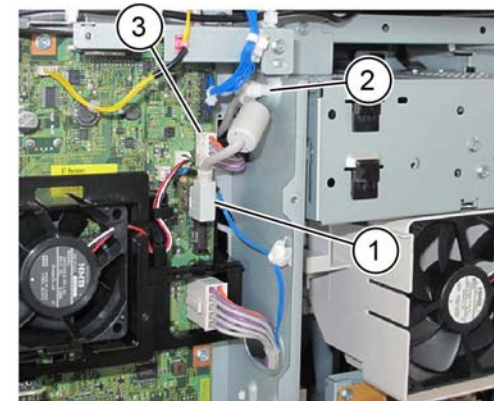
Y-1-0524-A

10. Disconnect the connection between the connector and the USB Cable, [Figure 7](#):
- Disconnect the USB cable (1).
 - Release the USB cable clamp (2).
 - Disconnect the connector (3).

Figure 7 USB cable

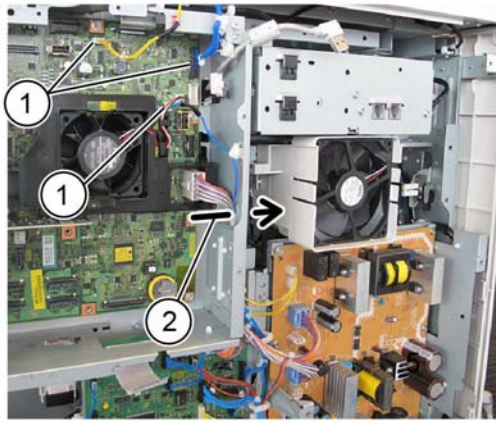
Y-1-0525-A

11. Disconnect the connectors, **Figure 8**:
 - a. Disconnect the three connectors (1), then release the associated harness clamps.
 - b. Pull the harness through the hole in the chassis (2).

Figure 8 Connectors

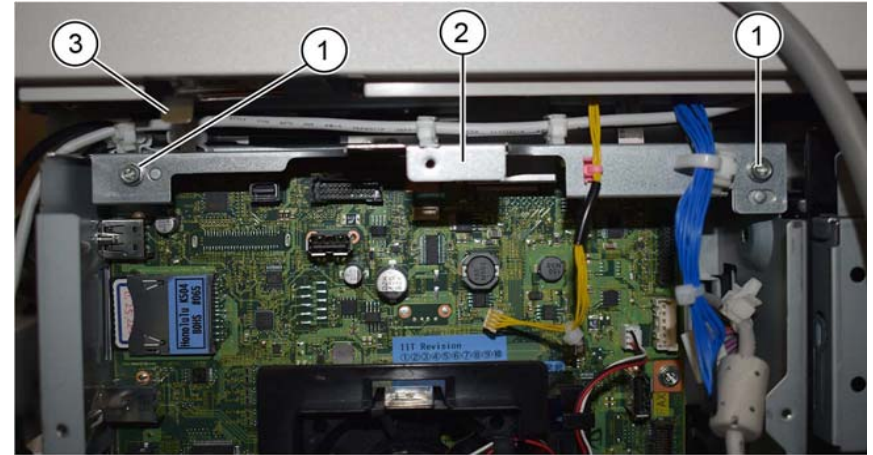
Y-1-0526-A

Take not to damage or dislodge the rear cover ground clip (3) when removing the ESS upper panel.

12. Remove the ESS upper panel, **Figure 9**:
 - a. Remove both screws (1).
 - b. Remove the ESS upper panel (2).
 - c. Release all remaining harness clamps from the ESS upper panel.

Figure 9 ESS upper panel removal
