708P91370
April 2017

Xerox® VersaLink® B7025/B7030/B7035 Multifunction Printer Service Manual

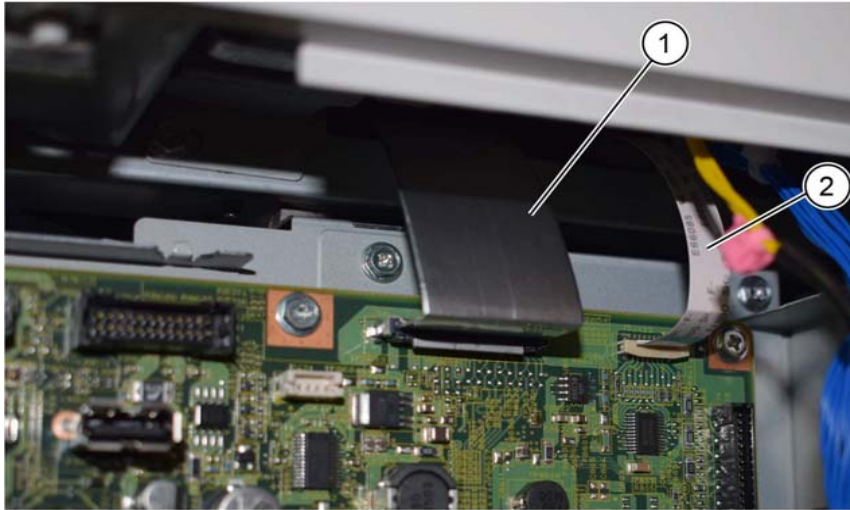
Y-1-0527-A

The FFC LED cable is secured by a clamp. Carefully lift both ends of the cable clamp simultaneously to release the cable.

13. Carefully disconnect the CCD ribbon cable (1) and the FFC LED cable (2), Figure 10.

Figure 10 Cables

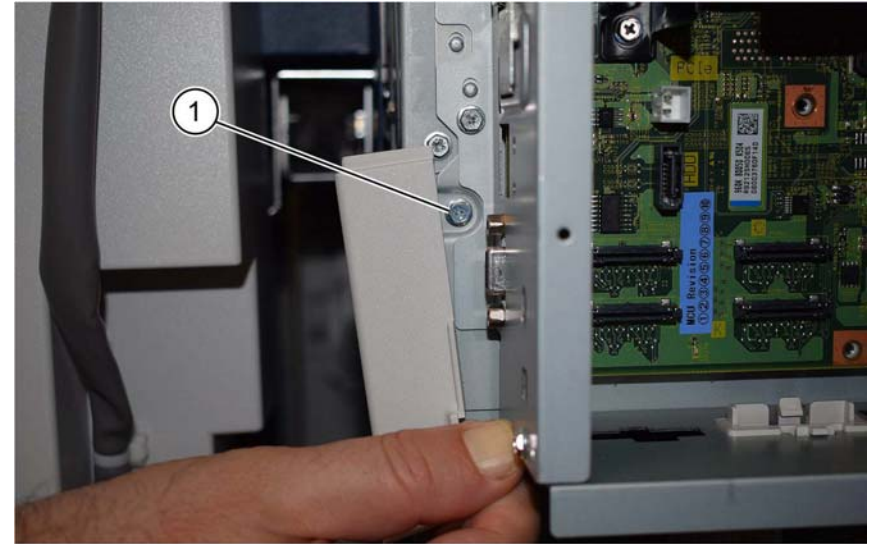
Y-1-0528-A

14. Carefully flex the corner of the right cover away from the machine, then remove the screw (1), Figure 11.

Figure 11 Lower right screw

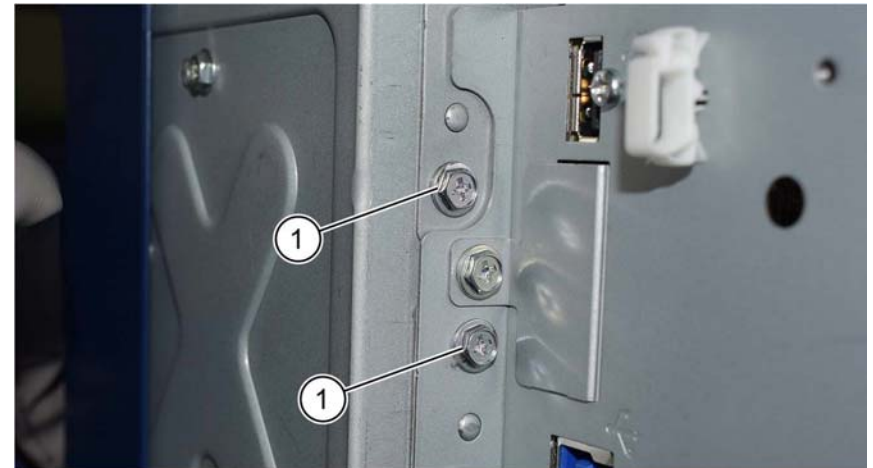
Y-1-0529-A

15. Remove two screws (1), Figure 12.

Figure 12 Upper right screws

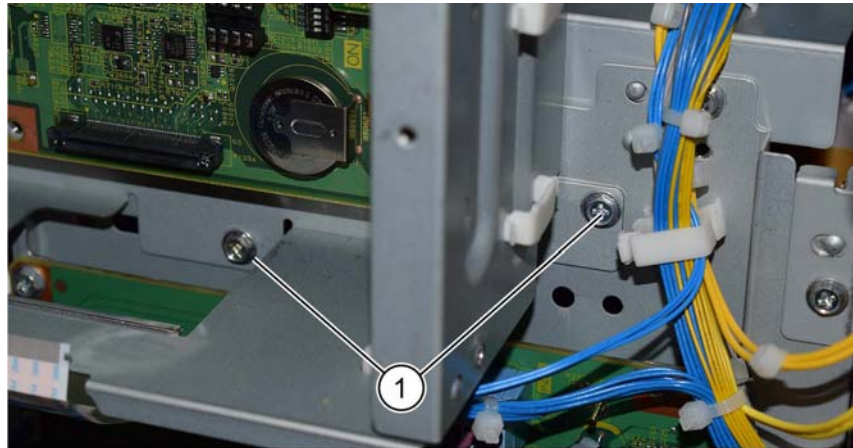
Y-1-0530-A

16. Remove two screws (1), Figure 13.

Figure 13 Lower left screws

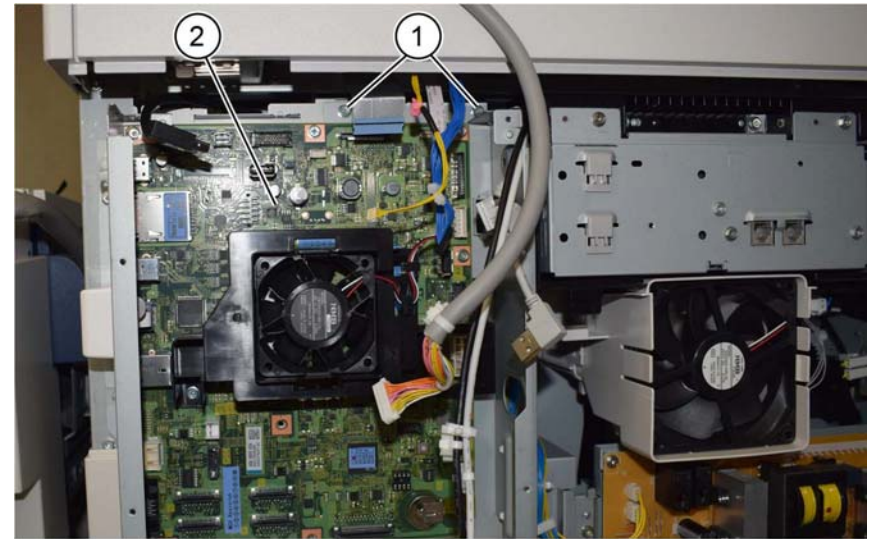
Y-1-0531-A

For machines with a fax, the USB cable and connector are still secured by the clamp. Do not forcibly pull the ESS PWB chassis assembly.

17. Remove two screws (1), then the ESS PWB chassis assembly (2), Figure 14:

Figure 14 ESS PWB chassis assembly removal

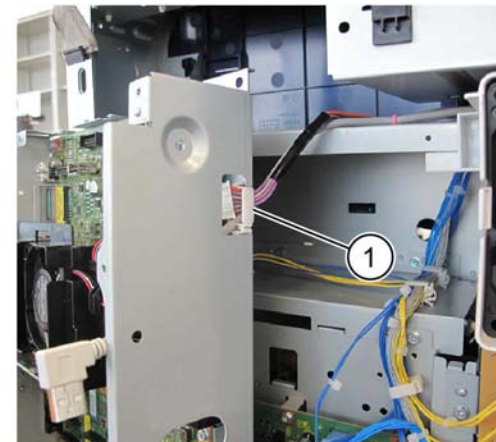
Y-1-0532-A

18. If the machine has a fax installed, release the USB cable and connector from the clamp (1), Figure 15.

Figure 15 USB cable and connector

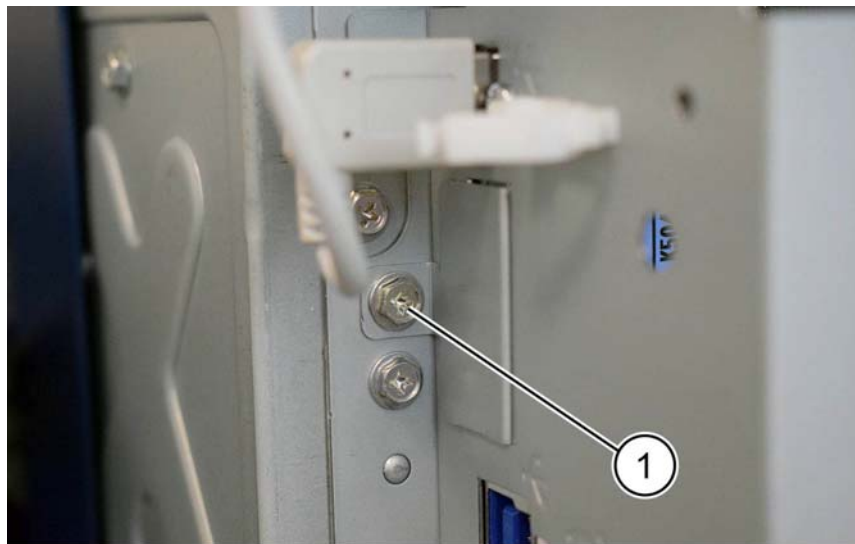
Y-1-0555-A

1. Remove the upper rear cover, [REP 28.5](#).
2. Remove the lower rear cover, [REP 28.6](#).
3. Remove the RH top cover, [PL 28.06 Item 2](#).
4. Remove the RH rear cover, [PL 28.06 Item 3](#).
5. Remove one screw (1), then the SD card cover, [Figure 1](#).

Figure 1 SD card cover removal

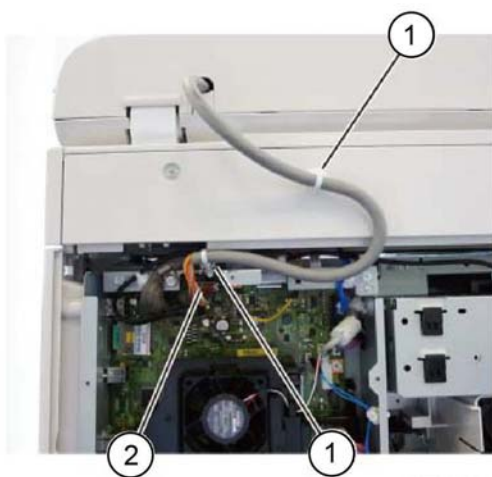
Y-1-0031-A

1. If a new DADF is to be installed, if possible, record the current software level by either:
 - Printing the configuration report, [GP 14](#).
 - From the user interface Home screen, touch Device, then About. Scroll down to view the Software Version.
2. Remove the upper rear cover, [REP 28.5](#).
3. Disconnect the cable clamps (1), then the connector (2), [Figure 1](#).

Figure 1 Connector

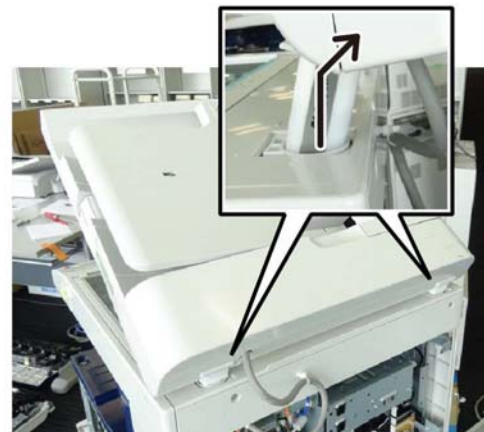
Y-1-0032-A

4. Remove the DADF, [Figure 2](#).

Figure 2 DADF removal

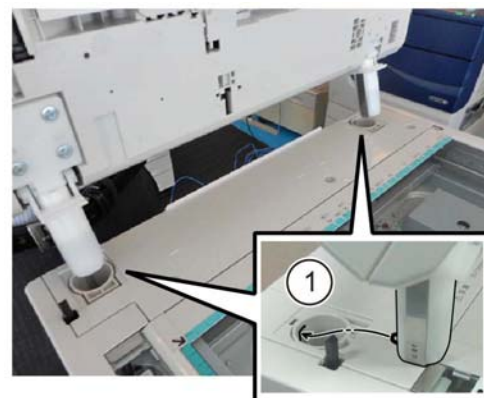
Y-1-0033-A

1. The replacement is the reverse of the removal procedure.
2. Install the DADF by inserting the tabs of the counter balance into the grooves of the installation holes (1), [Figure 3](#).

Figure 3 DADF replacement

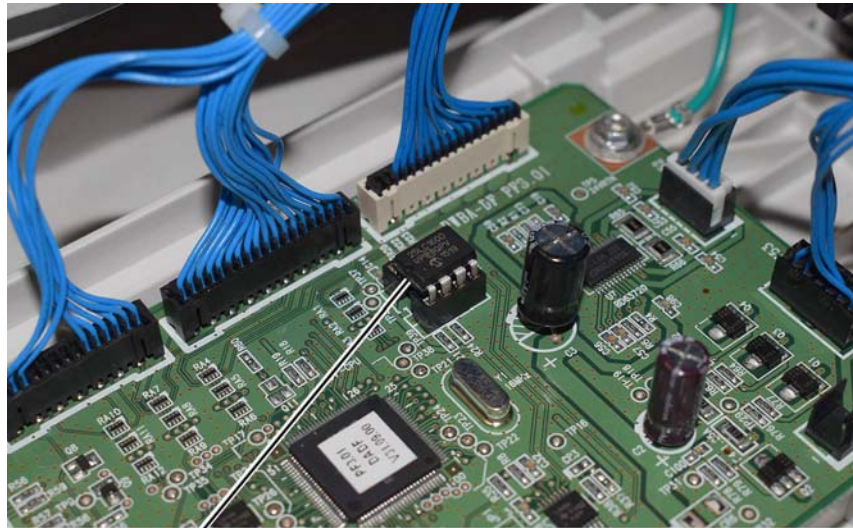
Y-1-0550-A

Take care when removing and reinstalling the SEEPROM. The pins are easily damaged.

- Remove the SEEPROM (1) from the old DADF PWB, then install it onto the new DADF PWB, [Figure 4](#).

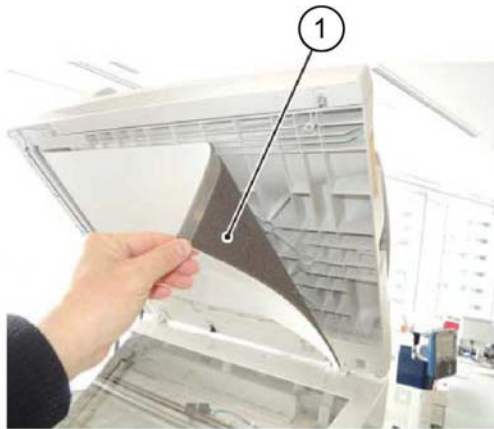
Y-1-0034-A

NOTE: The DADF document cushion is attached with double sided adhesive tape.

1. Peel off the DADF document cushion, [Figure 1](#).

Figure 1 Document cushion removal

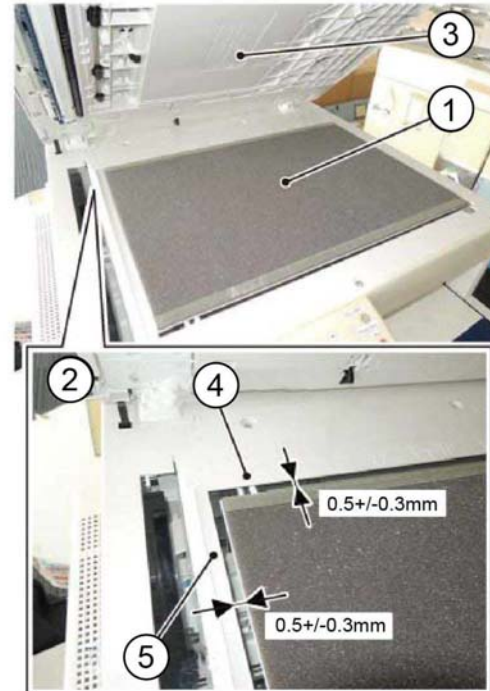
Y-1-0035-A

1. Attach the new DADF document cushion, [Figure 2](#):
 - a. Place the DADF document cushion (1) on the document glass.
 - b. Set the gaps (2) between the document cushion and the document guide (4) and the registration guide (5).
 - c. Slowly lower the DADF to adhere the DADF document cushion (3).

Figure 2 Document cushion installation

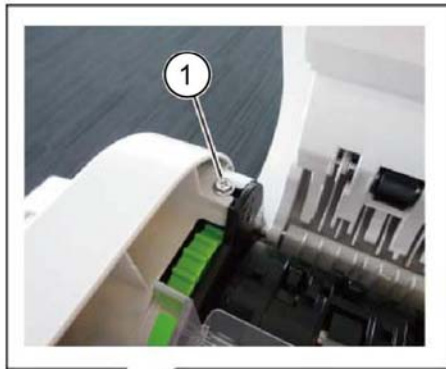
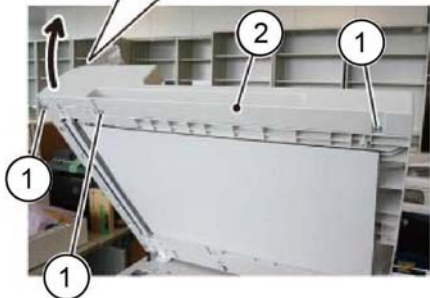
Y-1-0036-A

1. Open the upper feeder assembly.
2. Open the DADF.
3. Remove the DADF front cover, [Figure 1](#):
 - a. Remove four screws (1).
 - b. Remove the DADF front cover in the direction of the arrow.

Figure 1 Front cover removal

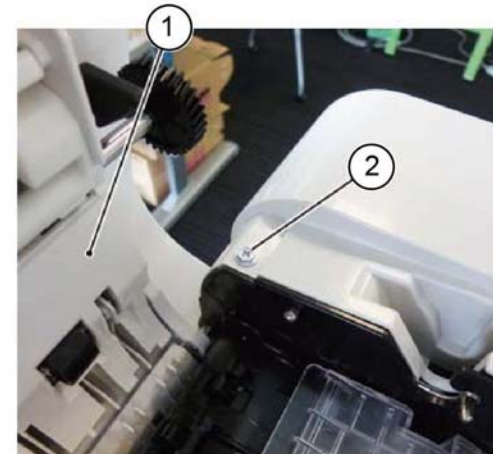
Y-1-0037-A

1. Remove the left screw that secures the DADF rear cover, [Figure 1](#):
 - a. Open the upper feeder assembly (1).
 - b. Remove the left screw (2).

Figure 1 Left screw removal

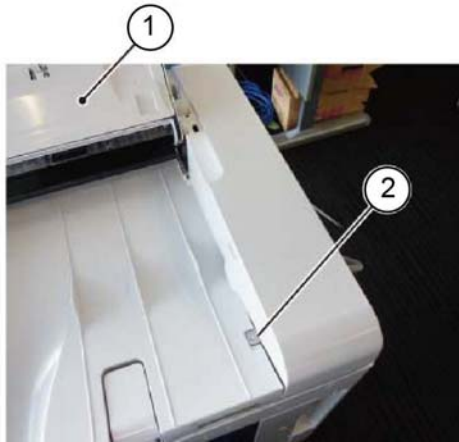
Y-1-0038-A

2. Remove the right screw that secures the DADF rear cover, [Figure 2](#):
 - a. Raise the document tray (1).
 - b. Remove the right screw (2).

Figure 2 Right screw removal

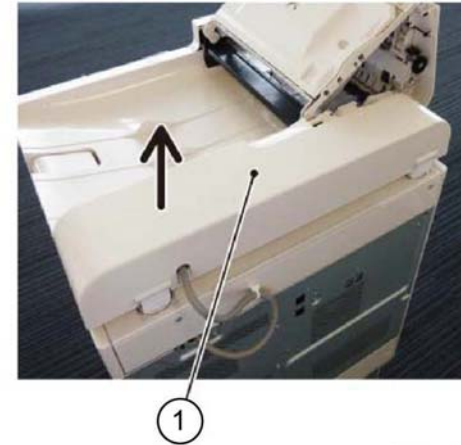
Y-1-0040-A

4. Remove the DADF rear cover in the direction of the arrow, [Figure 4](#).

Figure 4 Rear cover removal

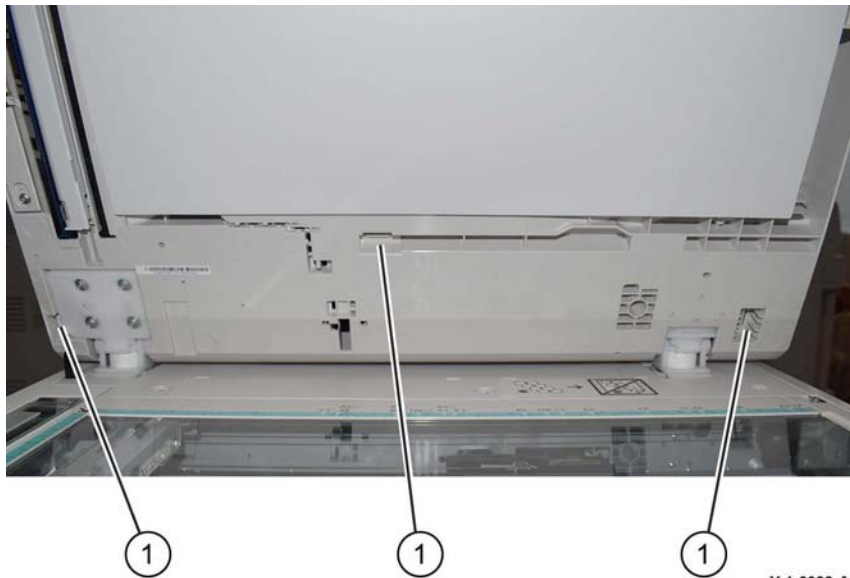
Y-1-0039-A

3. Release the three hooks (1) that secure the DADF rear cover, [Figure 3](#).

Figure 3 Hooks

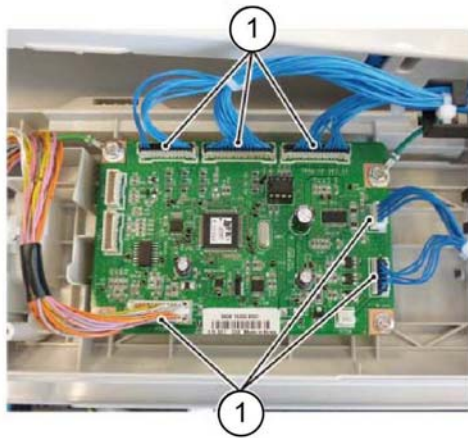
Figure 2 Connectors

1. If possible, record the current software level by either:
 - Printing the configuration report, [GP 14](#).
 - From the user interface Home screen, touch Device, then About. Scroll down to view the Software Version.
2. Remove the DADF rear cover, [REP 5.4](#).
3. Disconnect six connectors (1), [Figure 2](#).

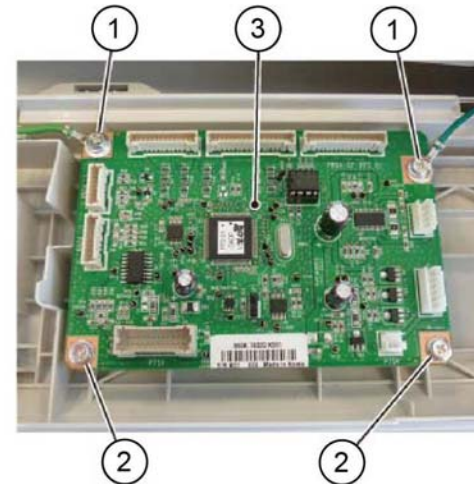
Figure 3 DADF PWB removal

4. Remove the DADF PWB, [Figure 3](#):
 - a. Disconnect the two screws with ground wires (1).
 - b. Remove the other two screws (2).
 - c. Remove the DADF PWB (3).

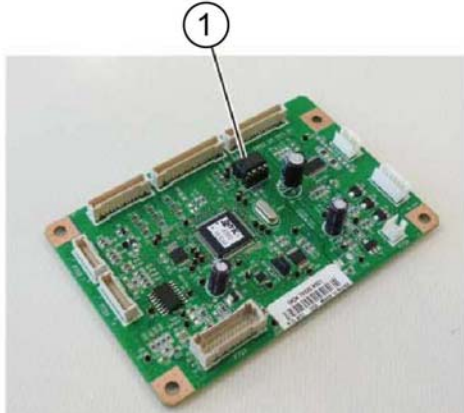
Figure 4 SEEPROM

2. Remove the SEEPROM (1) from the old DADF PWB, then install it onto the new DADF PWB, [Figure 4](#).

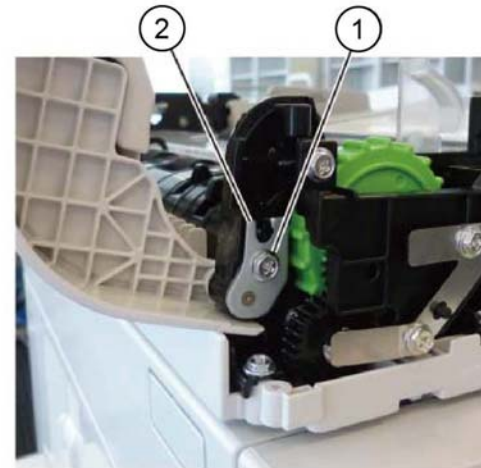
Figure 1 Front hinge bracket removal

1. Remove the DADF front cover, [REP 5.3](#).
2. Remove the DADF rear cover, [REP 5.4](#).
3. Remove the front hinge bracket, [Figure 1](#):
 - a. Remove the screw (1).
 - b. Remove the front hinge bracket (2).

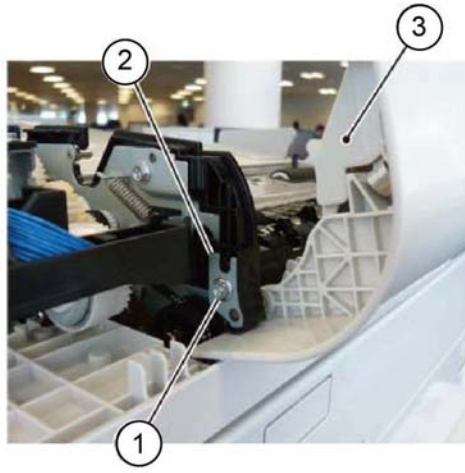
Figure 2 Upper feeder assembly removal

4. Remove the upper feeder assembly, [Figure 2](#):
 - a. Remove the screw (1).
 - b. Remove the rear hinge bracket (2).
 - c. Remove the upper feeder assembly (3).

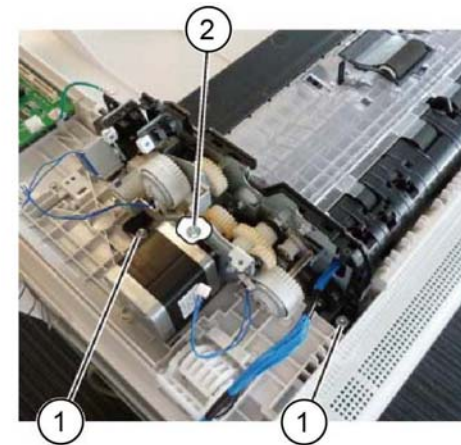
Figure 1 Screw removal

1. Remove the DADF front cover, [REP 5.3](#).
2. Remove the DADF rear cover, [REP 5.4](#).
3. Remove the upper feeder assembly, [REP 5.6](#).
4. Remove the document tray, [REP 5.14](#).
5. Remove the harness guide and wire harness, [REP 5.11](#).
6. Remove two screws (1) that secure the DADF feeder assembly at the rear, [Figure 1](#).

NOTE: On some machines, the DADF feeder assembly may be secured by a third screw (2).

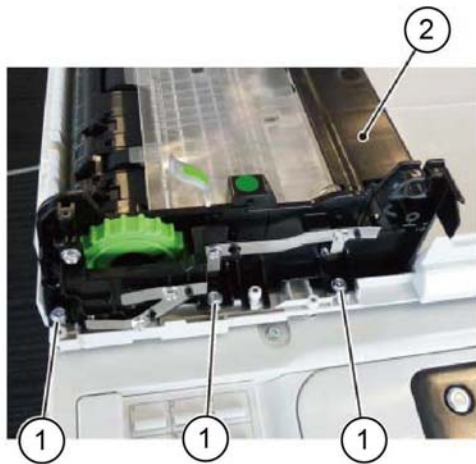
Figure 2 DADF feeder assembly removal

7. Remove the DADF feeder assembly, [Figure 2](#):
 - a. Remove three screws (1).
 - b. Remove the DADF feeder assembly (2).

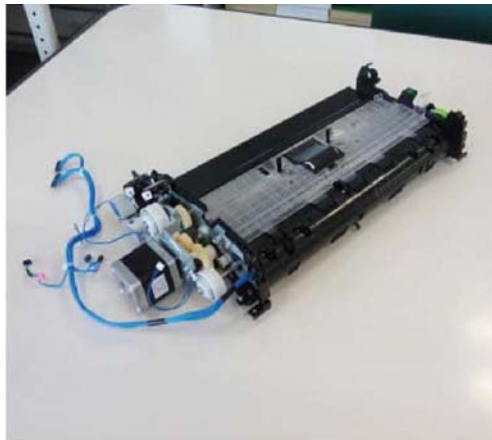
Figure 3 Removed feeder assembly

NOTE: The removed DADF feeder assembly is shown in [Figure 3](#).

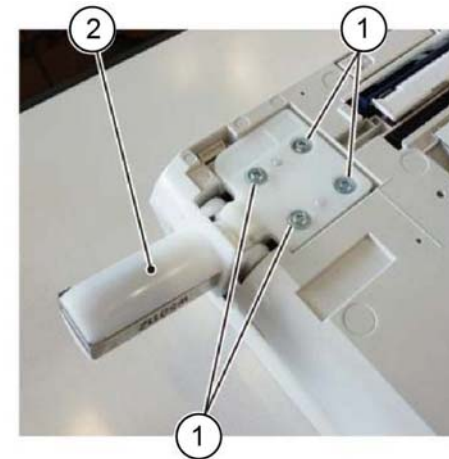
Figure 1 Counter balance removal

1. Remove the DADF, [REP 5.1](#).
2. Turn the DADF upside down.
3. Remove the left counter balance, [Figure 1](#):
 - a. Remove four screws (1).
 - b. Remove the left counter balance (2).

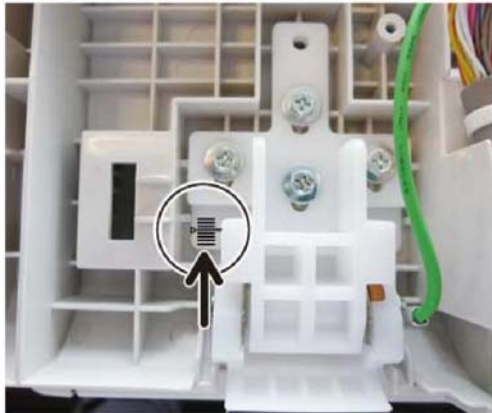
Figure 1 Position

1. Remove the DADF rear cover, [REP 5.4](#).
2. Remove the DADF, [REP 5.1](#).
3. Record the position of right counter balance, [Figure 1](#).

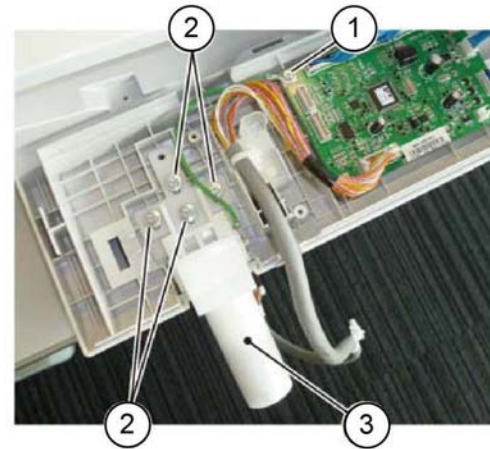
Figure 2 Counter balance removal

4. Remove the right counter balance, [Figure 2](#):
 - a. Disconnect the ground wire (1).
 - b. Remove four screws (2).
 - c. Remove the right counter balance (3).

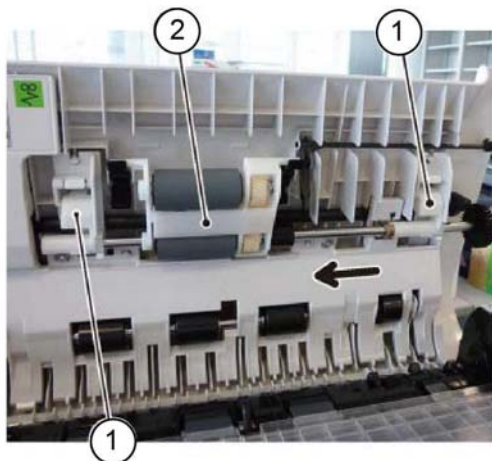
Figure 1 Assembly removal

1. Open the upper feeder assembly.
2. Remove the feed roll nudger roll assembly, [Figure 1](#):
 - a. Release the hooks (1) of the feed front/rear handle.
 - b. Move the feed/nudger roll assembly (2) in the direction of the arrow, then remove it.

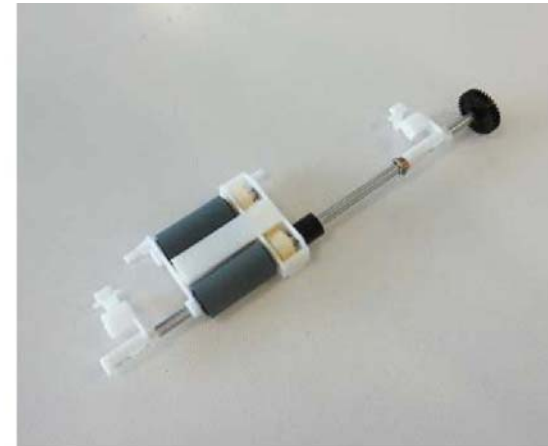
Figure 2 Removed feed/nudger roll assembly

NOTE: The removed feed/nudger roll assembly is shown in [Figure 2](#).

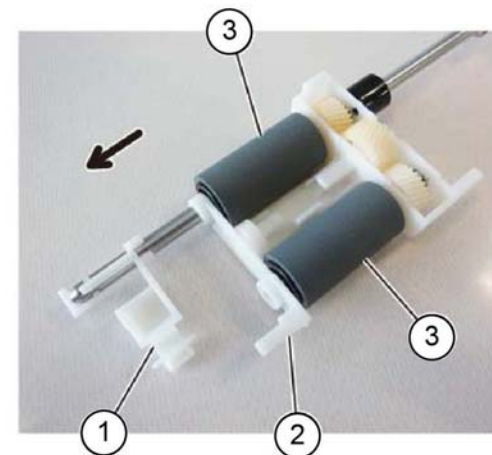
Figure 3 Roll assembly removal

3. Remove the roll assemblies, [Figure 3](#):
 - a. Release the hook to remove the feed front handle (1).
 - b. Release the hook to remove the nudger CRU housing (2).
 - c. Remove the roll assemblies (3).

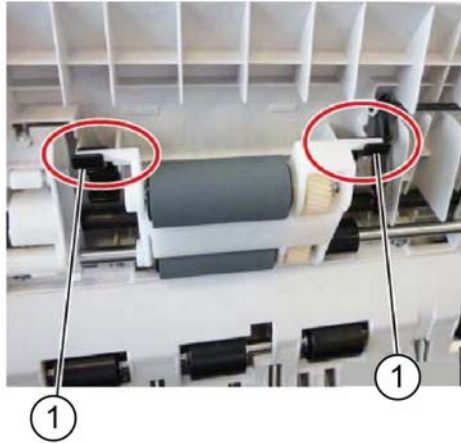
Figure 4 Set link alignment

1. The replacement is the reverse of the removal procedure.
2. Install the new roll assemblies so that they rotate in a clockwise direction.
3. Ensure the feed/nudger roll assembly is installed to correctly align with the front and rear set links (1), [Figure 4](#).

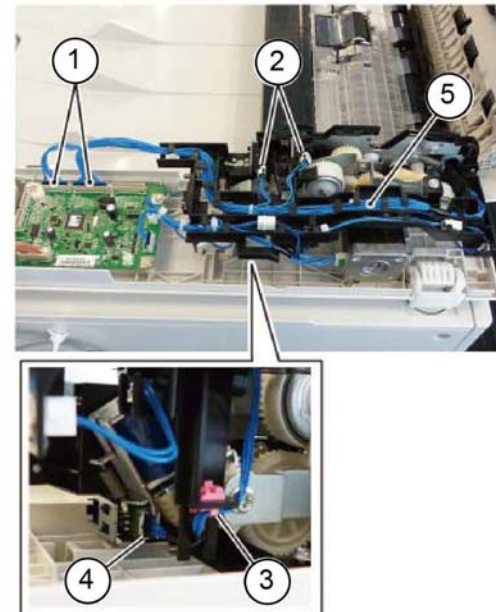
Figure 1 Harness removal

1. Remove the DADF front cover, [REP 5.3](#).
2. Remove the DADF rear cover, [REP 5.4](#).
3. Remove the document tray, [REP 5.14](#).
4. Remove the harness from the harness guide, [Figure 1](#):
 - a. Disconnect two connectors (1).
 - b. Disconnect the sensor connectors (2).
 - c. Remove the harness retainer (3) from the guide.
 - d. Disconnect the sensor connector (4).
 - e. Remove the harness (5) from the harness guide.

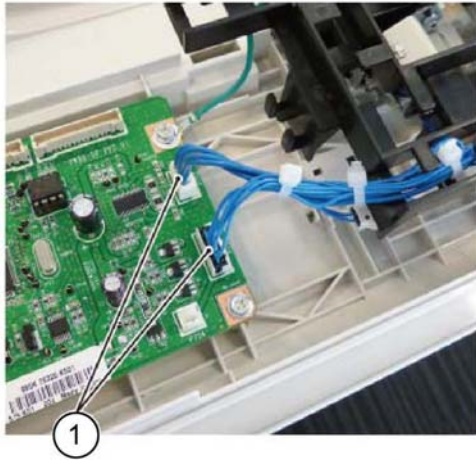
Figure 2 DADF PWB connectors

5. Disconnect the DADF PWB connectors (1), [Figure 2](#).

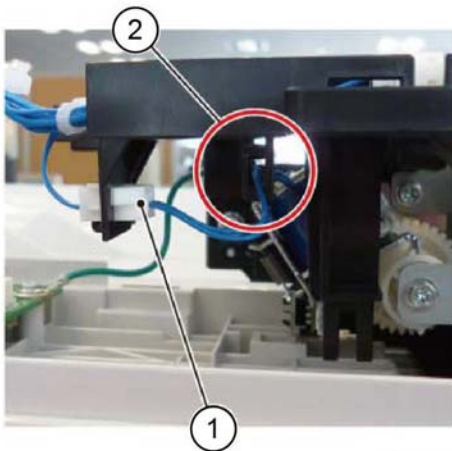
Figure 3 Solenoid harness

6. Disconnect the solenoid, [Figure 3](#):
- Disconnect the connector (1).
 - Remove the harness from the harness guide (2).

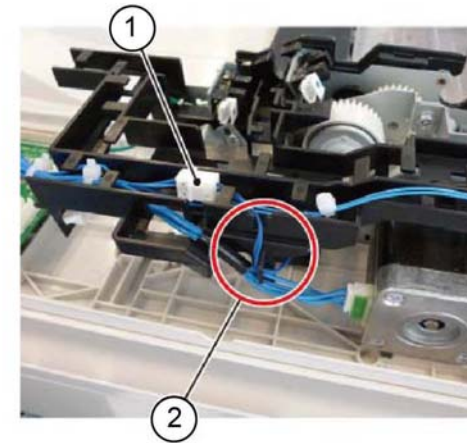
Figure 4 DADF feed clutch harness

7. Disconnect the DADF feed clutch, [Figure 4](#):
- Disconnect the connector (1).
 - Remove the harness from the harness guide (2).

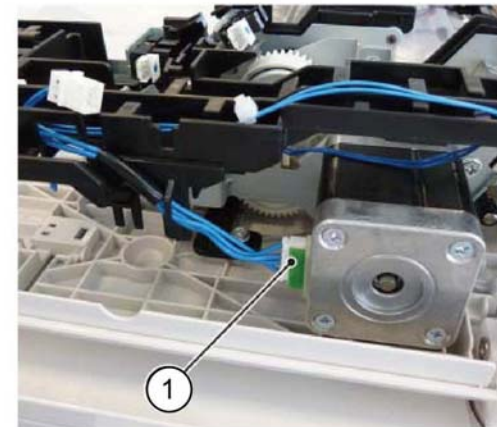
Figure 5 DADF feed motor assembly connector

8. Disconnect the DADF feed motor assembly connector (1), [Figure 5](#).

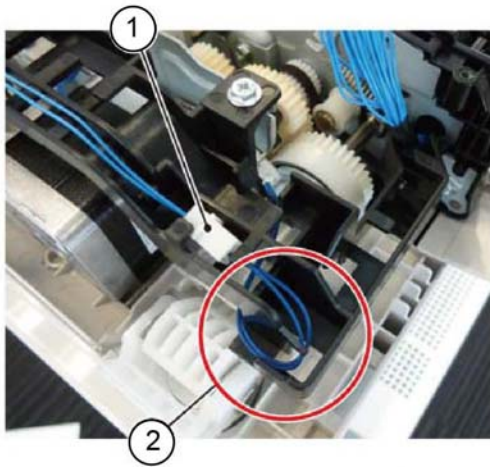
Figure 6 DADF T/A clutch connector

9. Disconnect the DADF T/A clutch, [Figure 6](#):
 - a. Disconnect the connector (1).
 - b. Remove the harness from the harness guide (2).

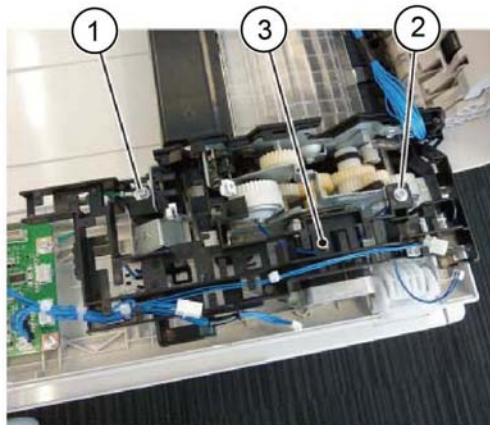
Figure 7 Harness guide removal

10. Remove the harness guide and wire harness, [Figure 7](#):
 - a. Disconnect the ground wire (1).
 - b. Remove the screw (2).
 - c. Remove the harness guide and wire harness (3).

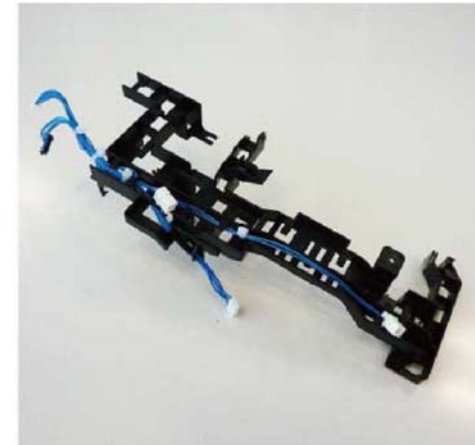
Figure 8 Removed harness guide

NOTE: The removed harness guide and wire harness is shown in [Figure 8](#).

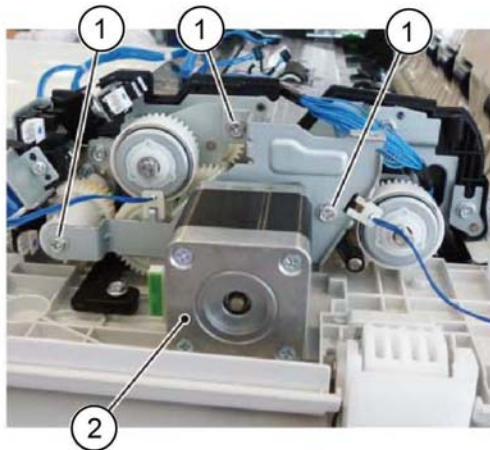
Figure 1 Feed motor assembly removal

1. Remove the DADF front cover, [REP 5.3](#).
2. Remove the DADF rear cover, [REP 5.4](#).
3. Remove the document tray, [REP 5.14](#).
4. Remove the harness guide and wire harness, [REP 5.11](#).
5. Remove the DADF feed motor assembly, [Figure 1](#):
 - a. Remove three screws (1).
 - b. Remove the DADF feed motor assembly (2).

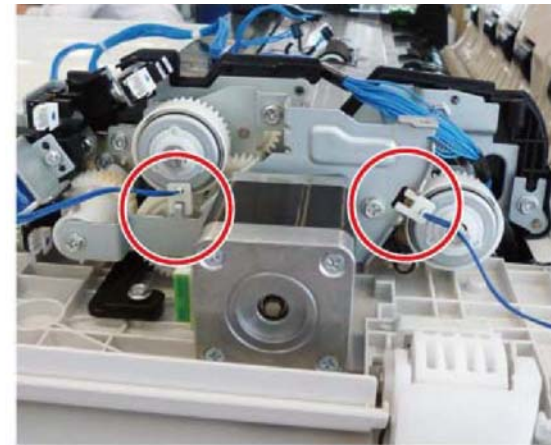
Figure 2 Alignment

1. The replacement is the reverse of the removal procedure.
2. Ensure the DADF feed motor assembly is correctly aligned with the DADF feed clutch and the DADF T/A clutch, [Figure 2](#).

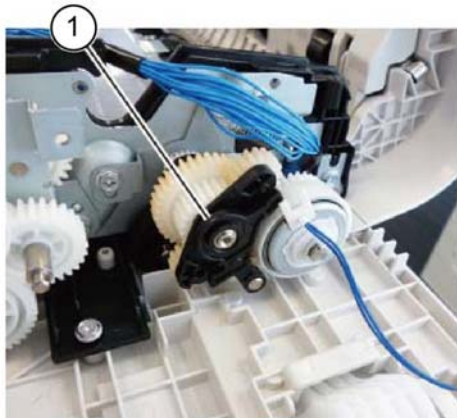
Figure 1 Stopper link removal

1. Remove the DADF front cover, [REP 5.3](#).
2. Remove the DADF rear cover, [REP 5.4](#).
3. Remove the document tray, [REP 5.14](#).
4. Remove the harness guide and wire harness, [REP 5.11](#).
5. Remove the DADF feed motor assembly, [REP 5.12](#).
6. Remove the stopper link, [Figure 1](#).

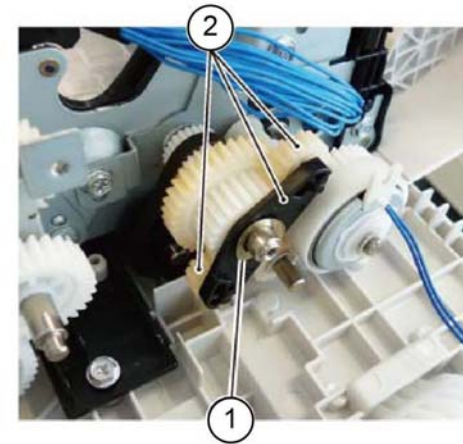
Figure 2 Idler gear bracket removal

7. Remove the idler gear bracket, [Figure 2](#):
 - a. Remove the washer (1).
 - b. Remove two gears, then the idler gear bracket (2).

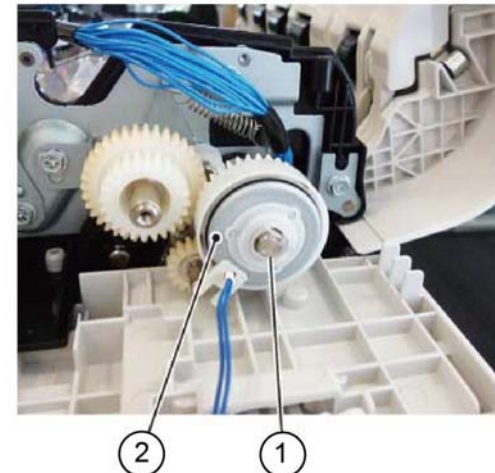
Figure 3 T/A clutch removal

8. Remove the DADF T/A clutch, [Figure 3](#):
 - a. Remove the E-clip (1).
 - b. Remove the DADF T/A clutch (2).

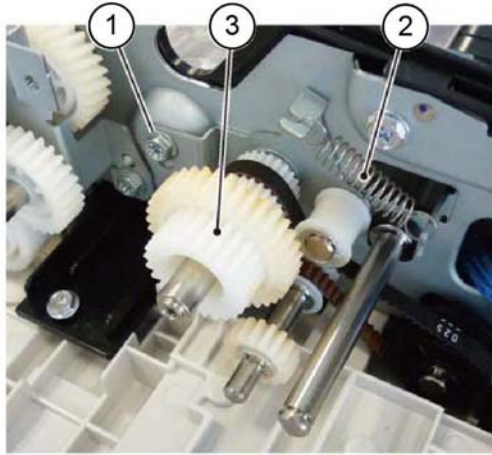
Figure 4 Gear pulley removal

9. Remove the gear pulley, [Figure 4](#):
 - a. Loosen the screw (1).
 - b. Remove the tension spring (2).
 - c. Remove the gear pulley (3).

1. The replacement is the reverse of the removal procedure.
2. Ensure the belt is fully tensioned before tightening the screw, refer to [Figure 4](#).

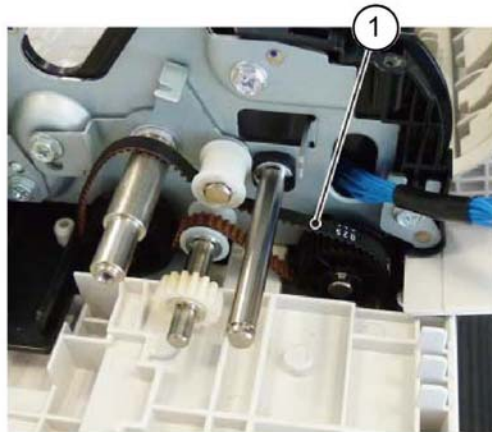
Figure 5 Drive belt removal

10. Remove the DADF drive belt (1), [Figure 5](#).

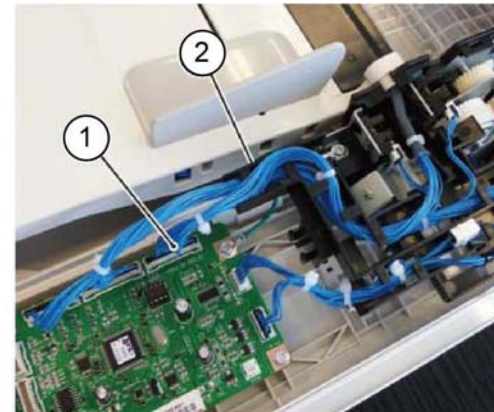
Figure 1 Harness removal

1. Remove the DADF front cover, [REP 5.3](#).
2. Remove the DADF rear cover, [REP 5.4](#).
3. Remove the document tray harness, [Figure 1](#):
 - a. Disconnect the connector (1).
 - b. Remove the harness from the harness guide (2).

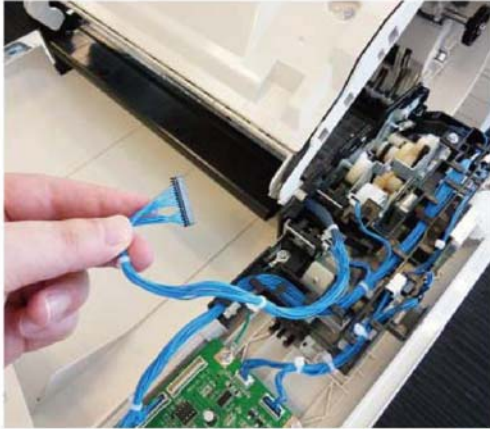
Figure 2 Removed harness

NOTE: The removed harness is shown in [Figure 2](#).

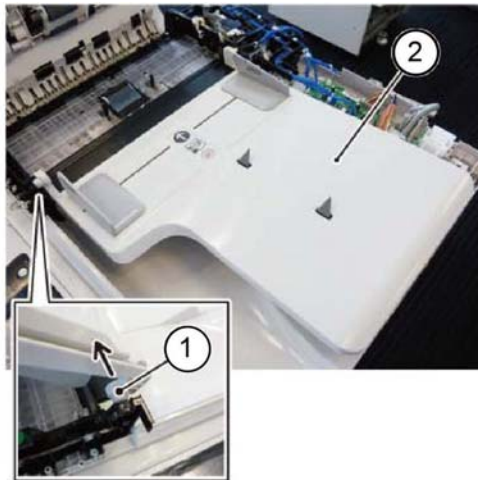
Figure 3 Document tray removal

4. Remove the document tray, [Figure 3](#):
 - a. At the front, squeeze the boss (1) in the direction of the arrow, then remove it from the hole.
 - b. Remove the document tray (2).

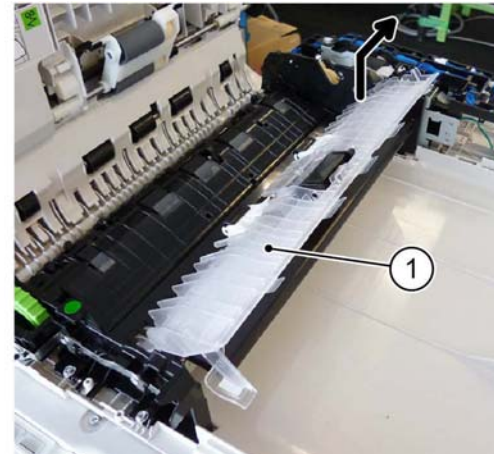
Figure 1 Retard chute assembly removal

1. Remove the DADF front cover, [REP 5.3](#).
2. Remove the DADF rear cover, [REP 5.4](#).
3. Remove the document tray, [REP 5.14](#).
4. Open the retard chute assembly.
5. Remove the retard chute assembly in the direction of the arrow, [Figure 1](#).

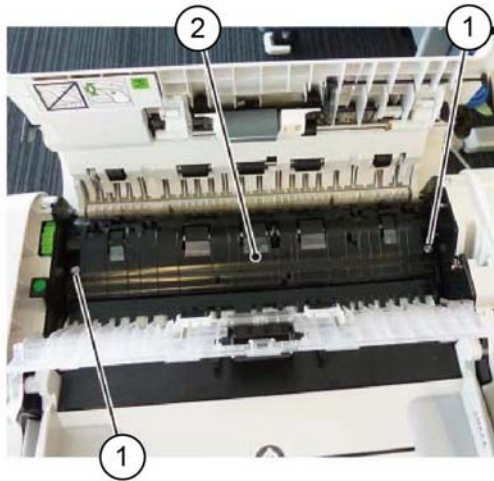
Figure 1 Invert chute assembly removal

1. Open the upper feeder assembly, [PL 5.10 Item 10](#).
2. Open the retard chute assembly, [PL 5.45 Item 2](#).
3. Remove the invert chute assembly, [Figure 1](#):
 - a. Remove two screws (1).
 - b. Remove the invert chute assembly (2).

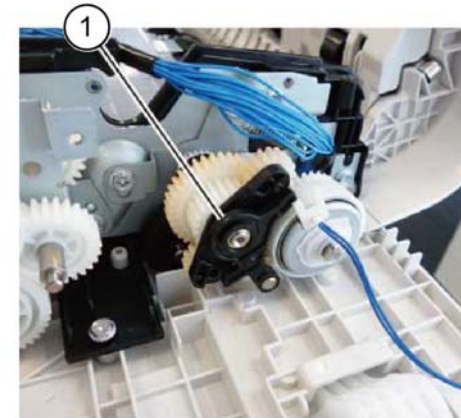
Figure 1 Stopper link removal

1. Remove the DADF front cover, [REP 5.3](#).
2. Remove the DADF rear cover, [REP 5.4](#).
3. Remove the upper feeder assembly, [REP 5.6](#).
4. Remove the invert chute assembly, [REP 5.16](#).
5. Remove the document tray, [REP 5.14](#).
6. Remove the harness guide and wire harness, [REP 5.11](#).
7. Remove the DADF feed motor assembly, [REP 5.12](#).
8. Remove the stopper link, [Figure 1](#).

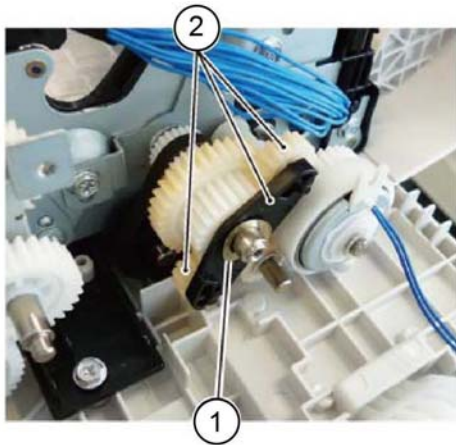
Figure 2 Idler gear bracket removal

9. Remove the idler gear bracket, [Figure 2](#):
 - a. Remove the washer (1).
 - b. Remove two gears, then the idler gear bracket (2).

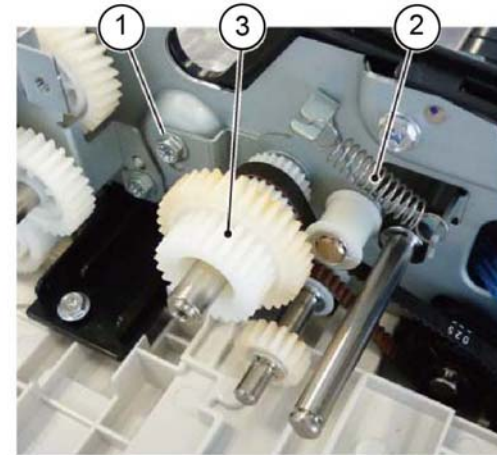
Figure 4 Gear pulley removal

11. Remove the gear pulley, [Figure 4](#):
 - a. Loosen the screw (1).
 - b. Remove the tension spring (2).
 - c. Remove the gear pulley (3).

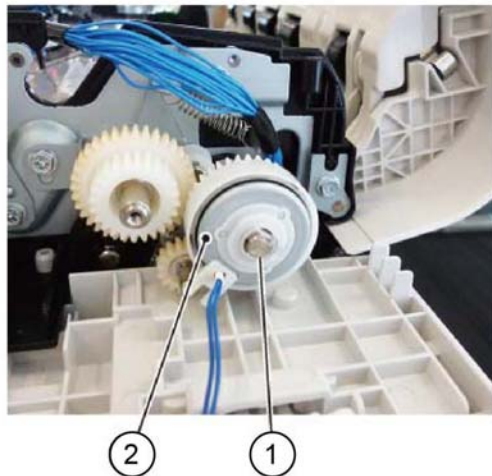
Figure 3 T/A clutch removal

10. Remove the DADF T/A clutch, [Figure 3](#):
 - a. Remove the E-clip (1).
 - b. Remove the DADF T/A clutch (2).

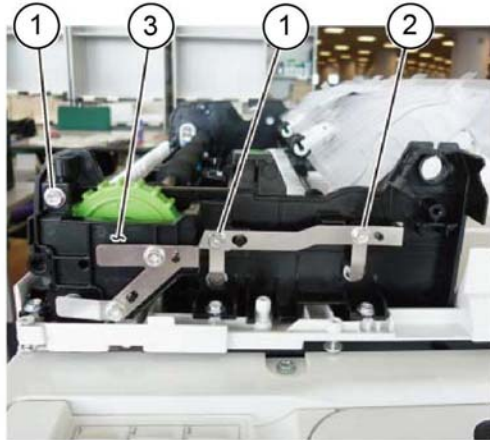
Figure 5 Front bracket removal

12. Remove the front bracket and ground roll plate, Figure 5:
 - a. Remove two screws (1).
 - b. Loosen the screw (2).
 - c. Remove the front bracket and ground roll plate (3).

Do not lose the gear on the rear of the front bracket. Refer to Figure 6.

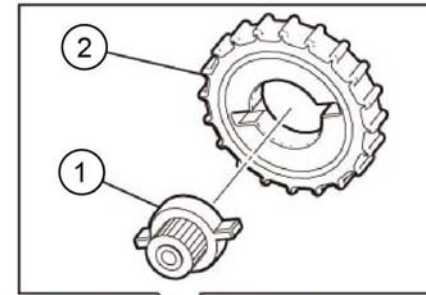
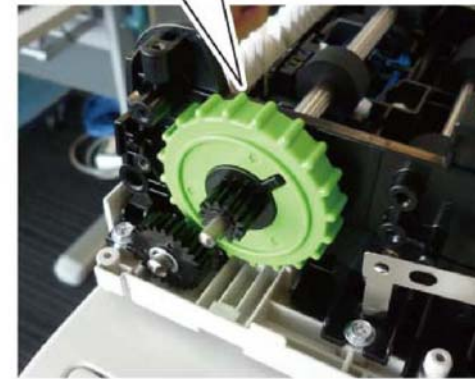
Figure 7 Knob

13. Remove the knob, Figure 7:
 - a. Remove the gear (1).
 - b. Remove handle knob (2).

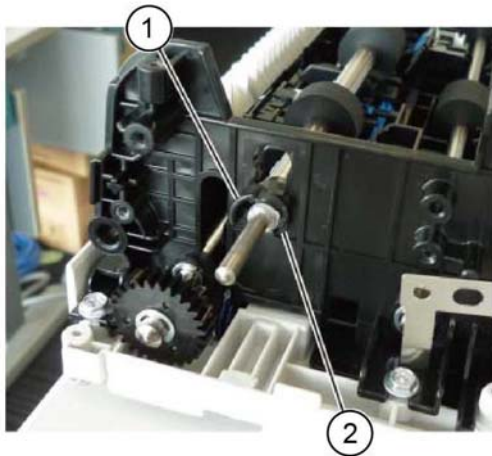
Figure 8 Bearing removal

14. Remove the front bearing, [Figure 8](#):

- a. Remove the KL-clip (1).
- b. Remove the bearing (2).

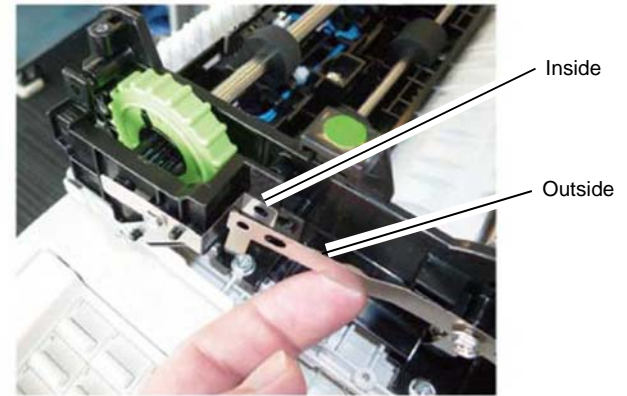
Figure 10 Ground plate installation

1. The replacement is the reverse of the removal procedure.
2. Install the front bracket and ground roll plate as shown in [Figure 10](#).

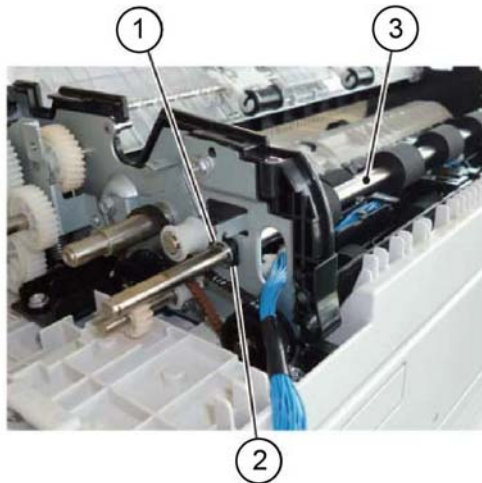
Figure 9 Takeaway roll removal

15. Remove the rear bearing, then the DADF takeaway roll, [Figure 9](#):

- a. Remove the E-clip (1).
- b. Remove the bearing (2).
- c. Remove the DADF takeaway roll (3).

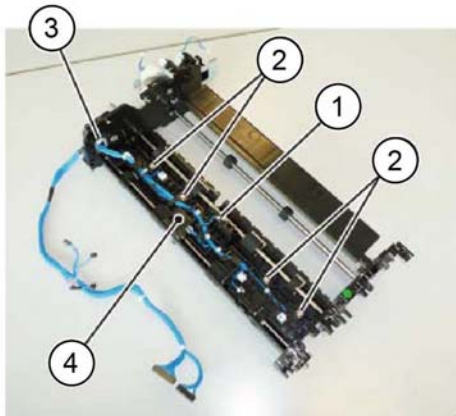
Figure 1 Sensor bracket assembly removal

1. Remove the DADF front cover, [REP 5.3](#)
2. Remove the DADF rear cover, [REP 5.4](#).
3. Remove the document tray, [REP 5.14](#).
4. Remove the harness guide and wire harness, [REP 5.11](#).
5. Remove the upper feeder assembly, [REP 5.6](#).
6. Remove the DADF feeder assembly, [REP 5.7](#).
7. Remove the retard chute assembly, [REP 5.15](#).
8. Remove the invert chute assembly, [REP 5.16](#).
9. Remove the DADF feed motor assembly, [REP 5.12](#).
10. Remove the DADF takeaway roll, [REP 5.17](#).
11. Remove the sensor bracket assembly, [Figure 1](#):
 - a. Disconnect the connector (1).
 - b. Remove four screws (2).
 - c. Remove the wire harness (3) through the hole.
 - d. Remove the sensor bracket assembly (4).

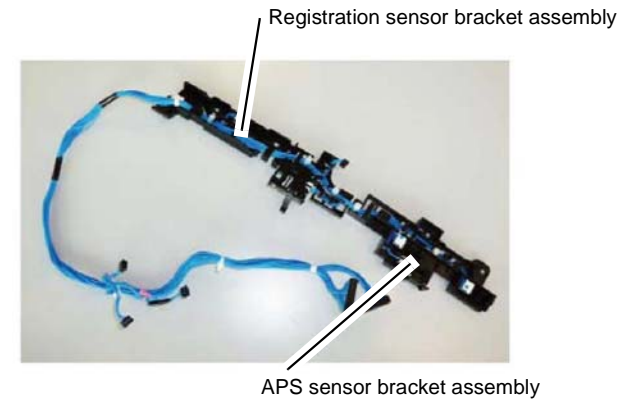
Figure 2 Removed sensor bracket assembly

NOTE: The removed sensor bracket assembly is shown in [Figure 2](#).

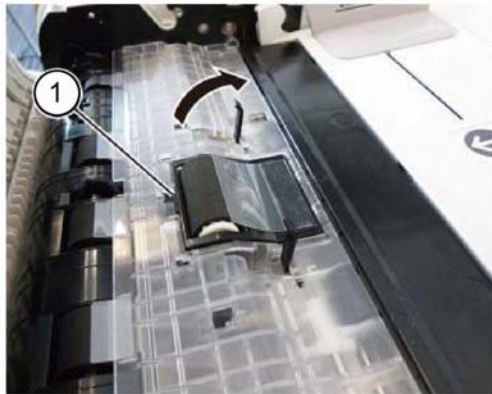
Figure 1 Retard CRU cover assembly

1. Open the upper feeder assembly.
2. Release the hook (1), then open the retard CRU cover assembly in the direction of the arrow, [Figure 1](#).

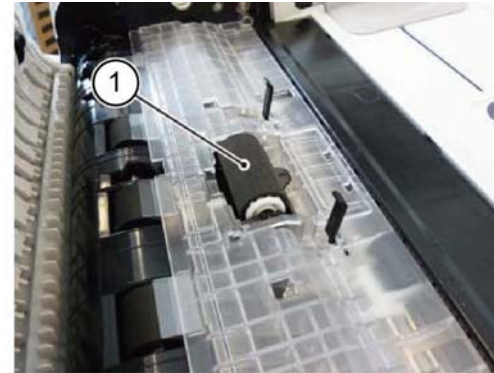
Figure 2 Retard roll assembly removal

3. Remove the retard roll assembly (1), [Figure 2](#).

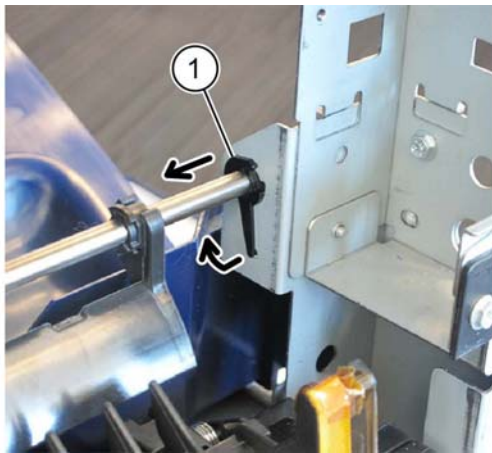
Figure 1 Bearing

1. Remove the exit 2 transport assembly, refer to [REP 10.2](#).
2. Remove the exit front cover, [PL 28.05 Item 10](#).
3. Remove the fusing fan duct assembly, [REP 10.4](#).
4. Move the bearing (1) toward the front, [Figure 1](#).

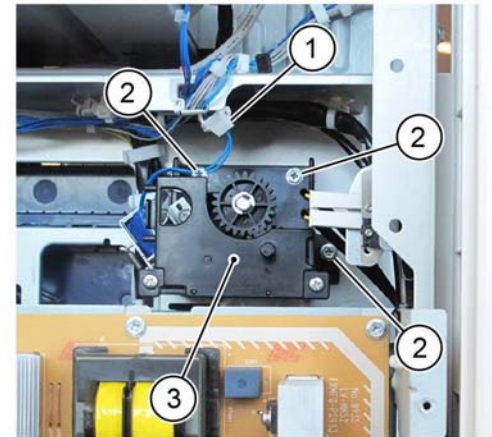
Figure 2 Exit 1 OCT assembly removal

5. Remove the exit 1 OCT assembly toward the rear, [Figure 2](#):
 - a. Disconnect the connector (1).
 - b. Remove three screws (2).
 - c. Remove the exit 1 OCT assembly (3) toward the rear.

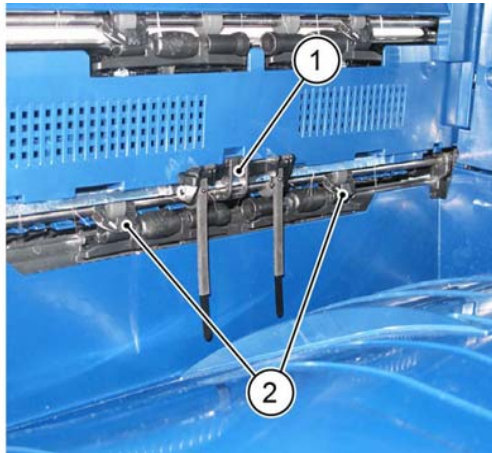
Figure 1 Weight assembly removal

1. Disengage the hooks, then remove the paper exit 1 weight assembly, (1), [Figure 1](#).

NOTE: Take note of the orientation of the paper guides (2).

1. The replacement is the reverse of the removal procedure.
2. Ensure the paper guides are orientated correctly, refer to [Figure 1](#).

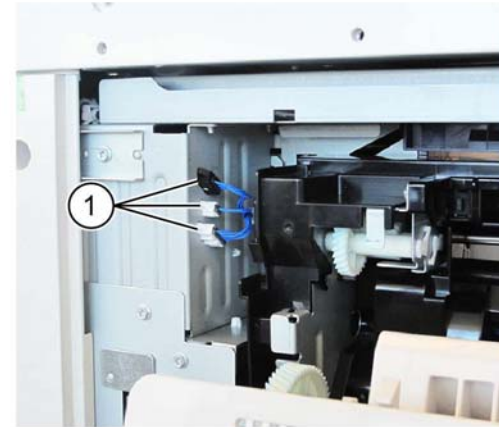
Figure 2 Connectors

7. Disconnect three connectors (1), [Figure 2](#).

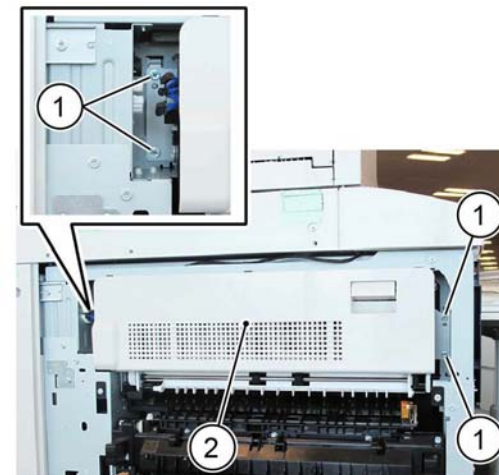
Figure 3 Transport assembly removal

8. Close the exit 2 transport assembly.
9. Remove the exit 2 transport assembly, [Figure 3](#):
 - a. Remove four screws (1).
 - b. Remove the exit 2 transport assembly (2).

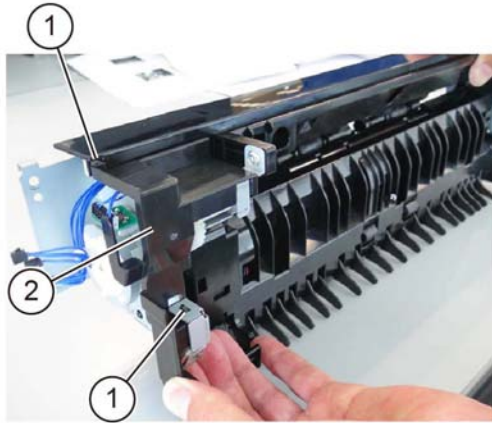
Figure 4 Rear cover removal

10. Disengage two hooks (1), then remove the rear cover (2), [Figure 4](#).

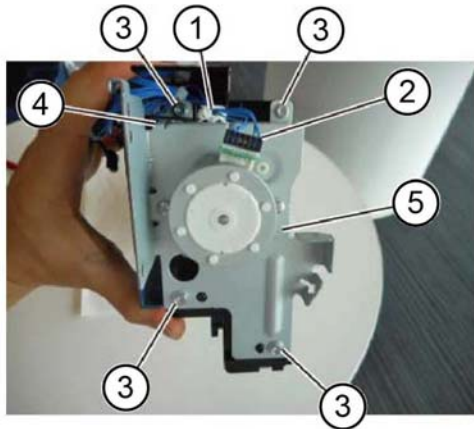
Figure 5 Motor removal

11. Remove the rear bracket and exit 2 motor, [Figure 5](#):
 - a. Release the clamp, then remove the harness (1).
 - b. Disconnect the connector (2).
 - c. Remove four screws (3).
 - d. Disengage the hook (4),
 - e. Remove the rear bracket and exit 2 motor (5).

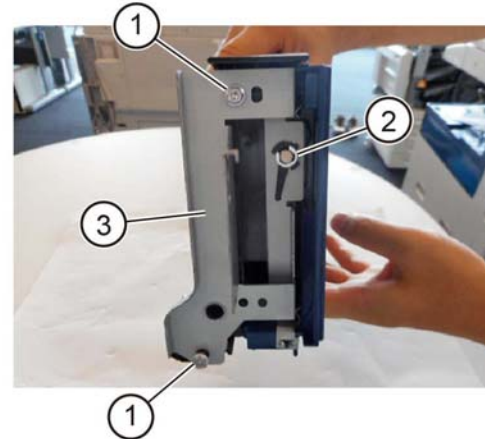
Figure 6 Front bracket removal

12. Remove the front bracket, [Figure 6](#):
 - a. Remove two screws (1).
 - b. Remove the E-clip (2).
 - c. Remove the front bracket (3).

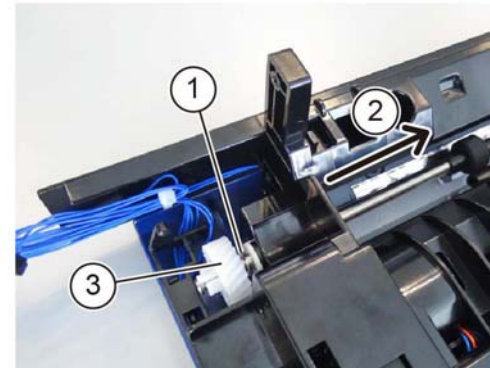
Figure 7 Helical gear removal

13. Remove the helical gear, [Figure 7](#):
 - a. Remove the E-clip (1).
 - b. Move the exit roll in the direction of the arrow (2).
 - c. Disengage the hook to remove the helical gear (3).
