708P91370
April 2017

Xerox® VersaLink® B7025/B7030/B7035 Multifunction Printer Service Manual

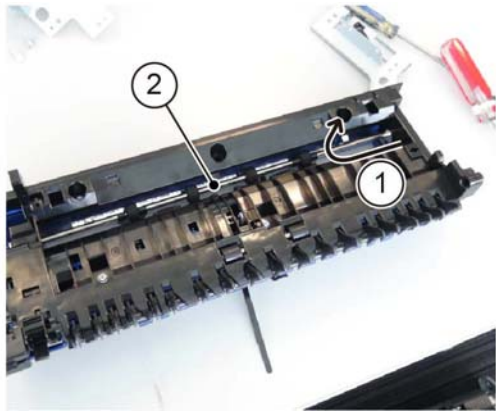
Figure 8 Exit 2 roll removal

14. Remove the exit 2 roll, [Figure 8](#):
 - a. Move, then release the exit roll in the direction of the arrow (1).
 - b. Remove the exit roll (2).

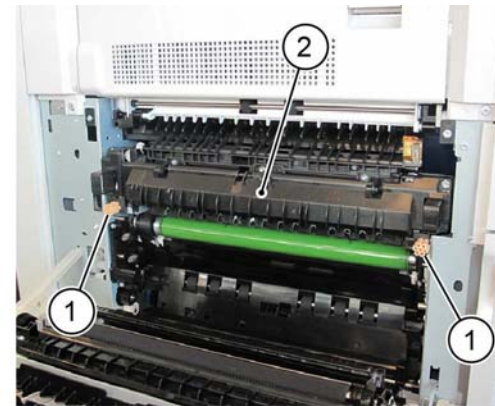
Figure 1 Fuser removal

1. Open the LH transport assembly.
2. Remove the fuser, [Figure 1](#):
 - a. Loosen two screws (1).
 - b. Remove the fuser(2).

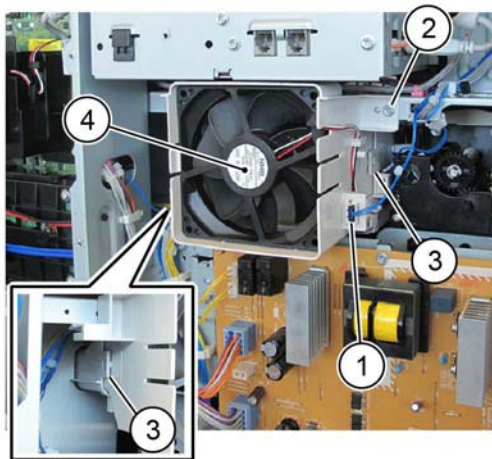
Figure 1 Fuser rear duct A removal

1. Remove the upper rear cover, [REP 28.5](#).
2. Remove the fuser rear duct A, [Figure 1](#):
 - a. Disconnect the connector (1).
 - b. Remove the screw (2).
 - c. Disengage the right and left hooks (3), then remove the fuser rear duct A (4).

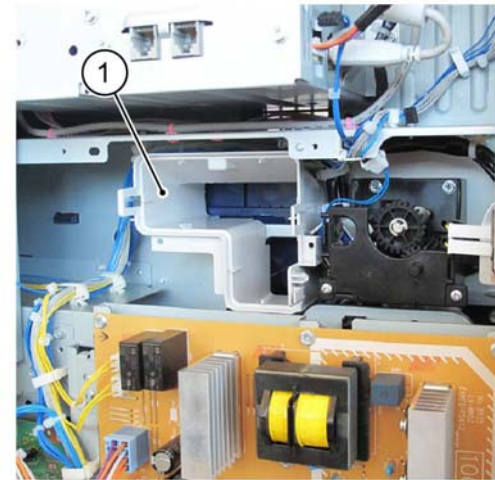
Figure 2 Fuser rear duct B removal

3. Remove the fuser rear duct B (1), [Figure 2](#).

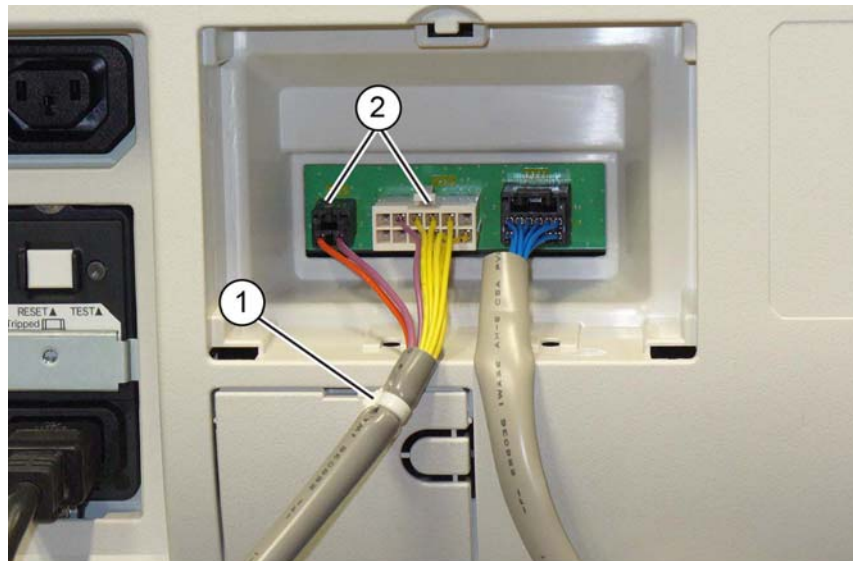
Figure 1 Connectors

1. Remove the STM cover, [PL 28.06](#) Item 1.
2. Disconnect the integrated office finisher harnesses, [Figure 1](#):
 - a. Release the cable clamp (1).
 - b. Disconnect two connectors (2).

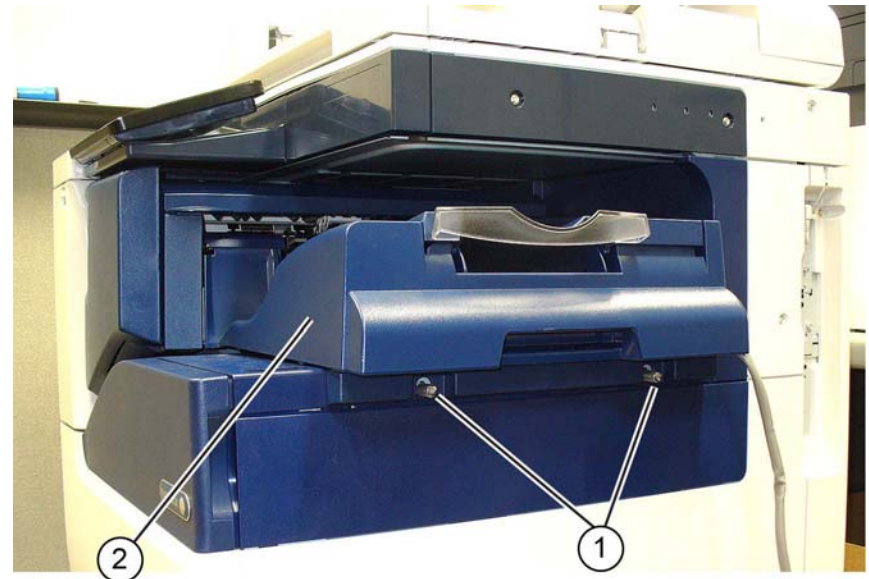
Figure 2 Finisher removal

3. Remove the integrated office finisher, [Figure 2](#):
 - a. Remove two thumbscrews (1).
 - b. Remove the integrated office finisher (2) towards the front of the machine.

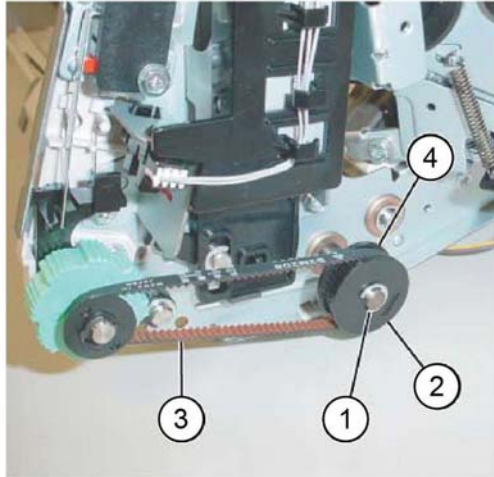
Figure 1 Front pulley removal

1. Remove the integrated office finisher, REP 12.1.
2. Remove the compiler assembly, REP 12.19.
3. Remove the front pulley, Figure 1:
 - a. Remove the E-clip (1).
 - b. Remove the flange (2).
 - c. Disengage the front paddle belt (3) from the front pulley.
 - d. Remove the front pulley (4).

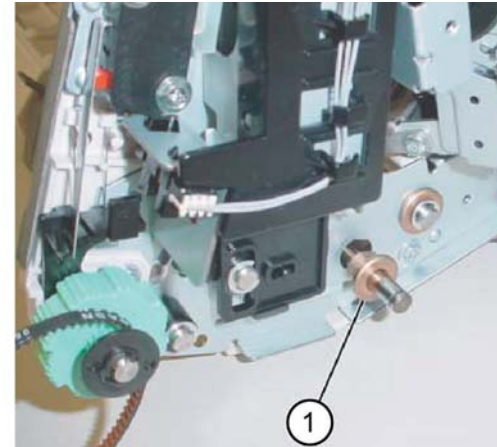
Figure 2 Front bearing removal

4. Remove the front bearing (1), Figure 2:

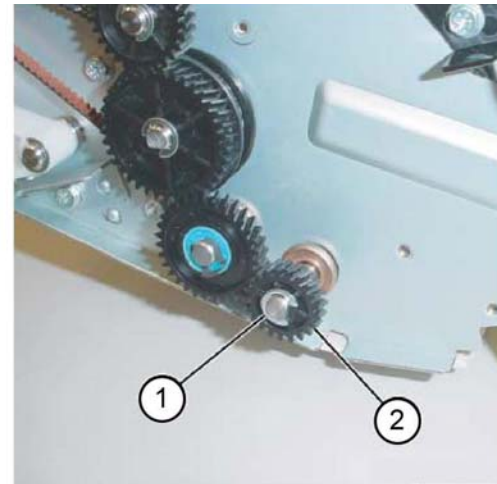
Figure 3 Rear gear removal

5. Remove the rear gear, Figure 3.
 - a. Remove the E-clip (1).
 - b. Remove the rear gear (2).

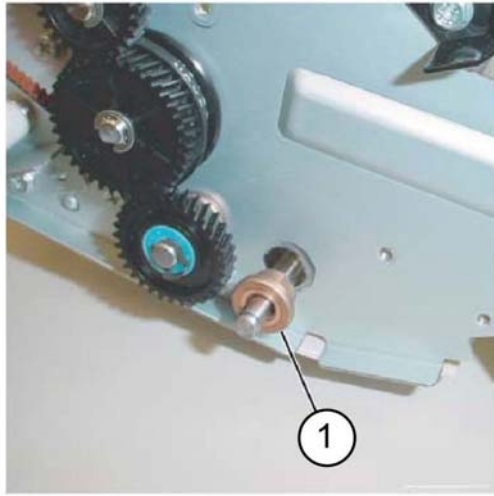
Figure 4 Rear bearing removal

6. Remove the rear bearing (1), [Figure 4](#).

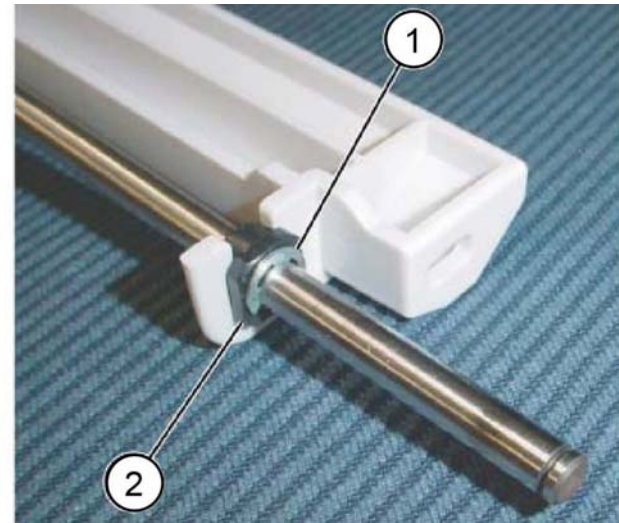
Figure 6 Bearing removal

8. Remove the bearing, [Figure 6](#):
- Remove the E-clip (1).
 - Remove the bearing (2).

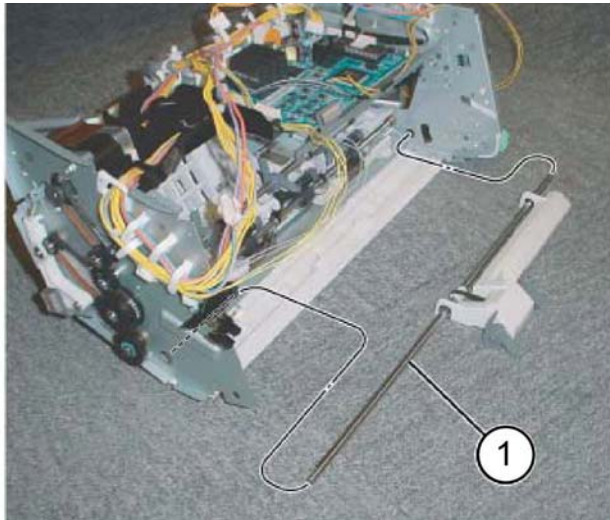
Figure 5 Paddle link assembly removal

7. Remove the paddle link assembly (1), [Figure 5](#).

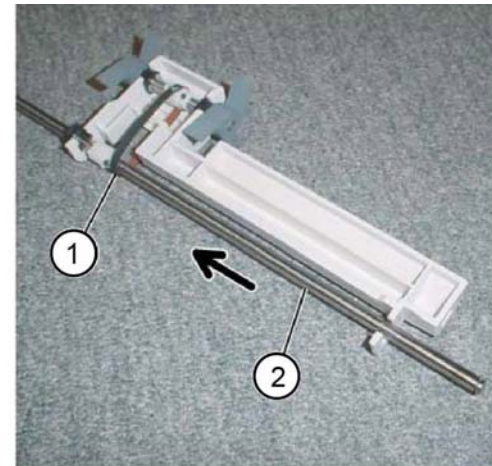
Figure 7 Shaft assembly removal

9. Remove the shaft assembly, [Figure 7](#):
- Remove the paddle belt (1) from the pulley.
 - Remove the shaft assembly (2) in the direction of the arrow.

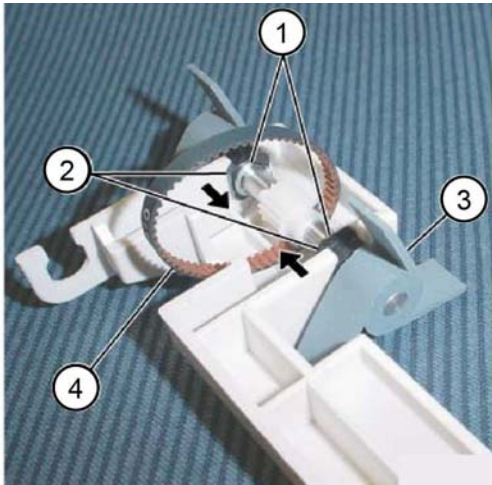
Figure 8 Rear paddle belt removal

10. Remove the paddle belt, **Figure 8**:
 - a. Remove two E-clips (1).
 - b. Move the two bearings (2) in the direction of the arrow.
 - c. Remove the sub paddle shaft assembly (3).
 - d. Remove the rear paddle belt (4).

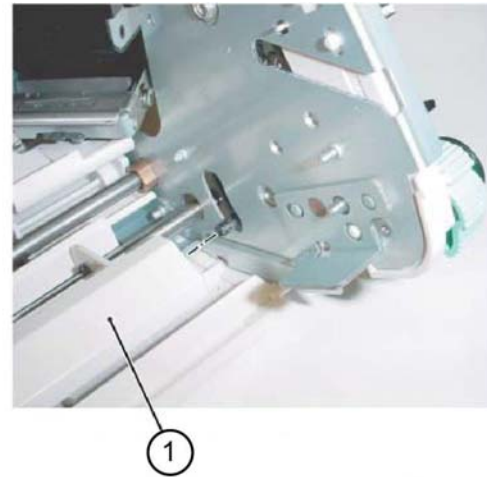
Figure 9 Paddle link assembly installation

1. The replacement is the reverse of the removal procedure.
2. Install the paddle link assembly (1) as shown in **Figure 9**.

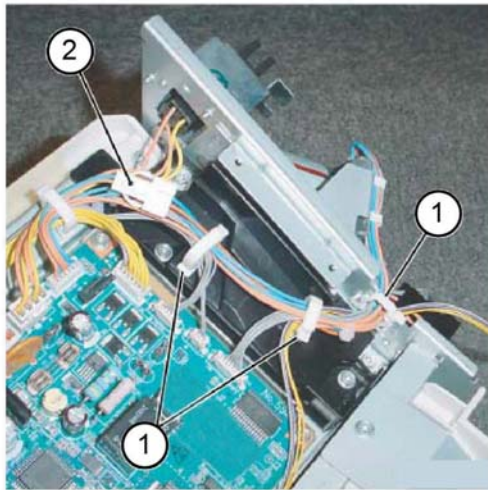
Figure 1 Connector

1. Remove the integrated office finisher, [REP 12.1](#).
2. Remove the front inner cover, [PL 12.05 Item 6](#).
3. Turn over the integrated office finisher.
4. Remove the bottom cover, [PL 12.06 Item 1](#).
5. Disconnect the connector, [Figure 1](#):
 - a. Release the harness from the three clamps (1).
 - b. Disconnect the connector (2).

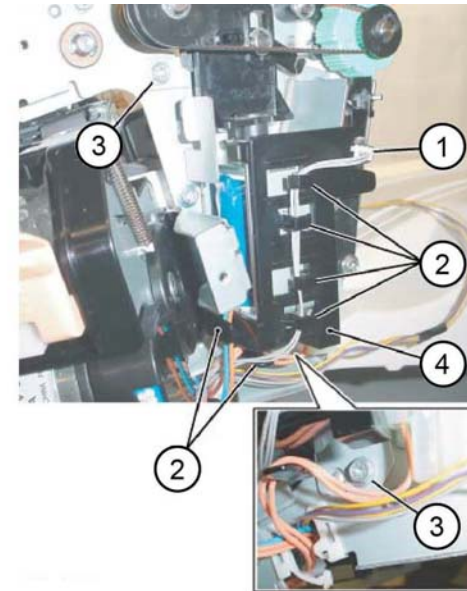
Figure 2 Sub paddle solenoid assembly removal

6. Turn over the integrated office finisher.
7. Remove the sub paddle solenoid assembly, [Figure 2](#):
 - a. Disconnect the connector (1).
 - b. Release the harness from the retainers (2).
 - c. Remove two screws (3).
 - d. Remove the sub paddle solenoid assembly (4).

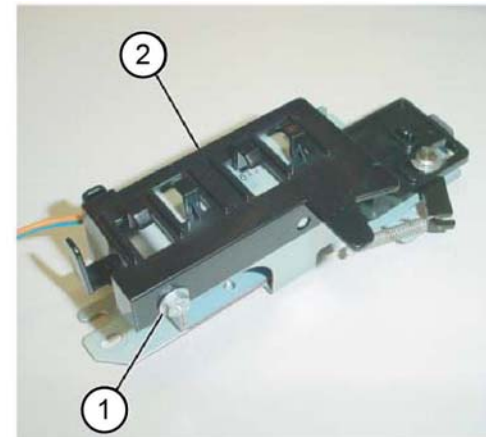
Figure 3 Support removal

8. Remove the support, [Figure 3](#):
 - a. Remove the screw (1).
 - b. Remove the support (2).

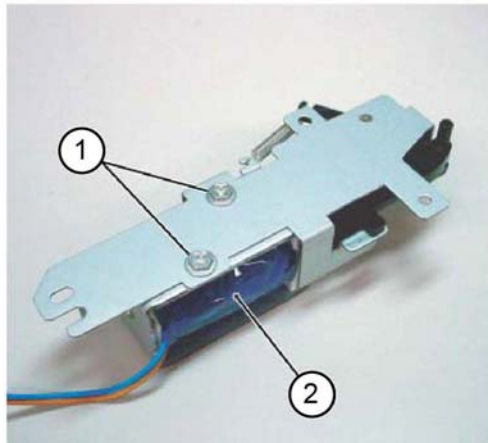
Figure 4 Sub paddle solenoid removal

9. Remove the sub paddle solenoid, [Figure 4](#):
 - a. Remove two screws (1).
 - b. Remove the sub paddle solenoid (2).

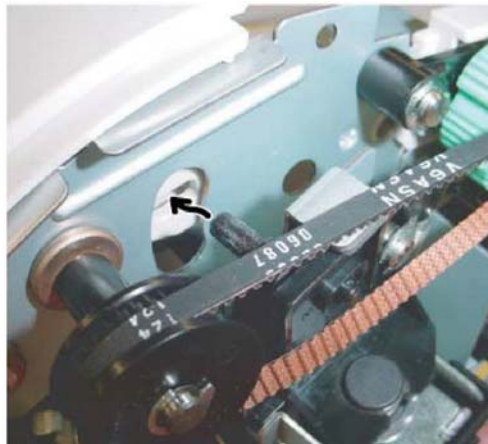
Figure 5 Sub paddle assembly installation

1. The replacement is the reverse of the removal procedure.
2. Install the sub paddle assembly as shown in [Figure 5](#).

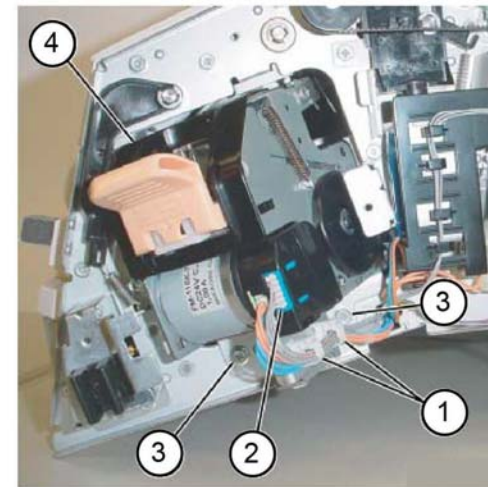
Figure 1 Stapler assembly removal

1. Switch off the power and disconnect the power cord.
2. Remove the integrated office finisher, [REP 12.1](#).
3. Remove the front inner cover, [PL 12.05 Item 6](#).
4. Remove the stapler assembly, [Figure 1](#):
 - a. Remove the clamps (1).
 - b. Disconnect the connectors (2).
 - c. Remove two screws (3).
 - d. Remove the stapler assembly (4).

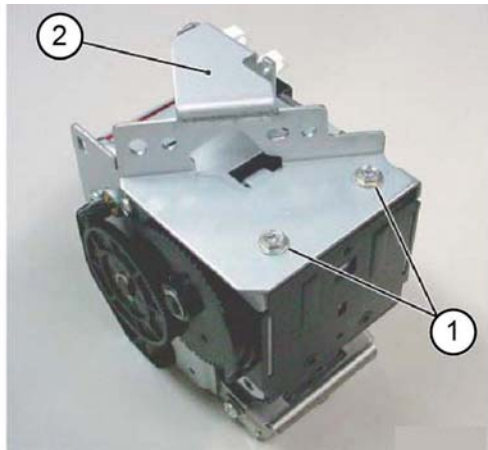
Figure 2 Bracket removal

5. Remove the bracket from the stapler assembly, [Figure 2](#):
 - a. Remove two screws (1).
 - b. Remove the bracket (2).

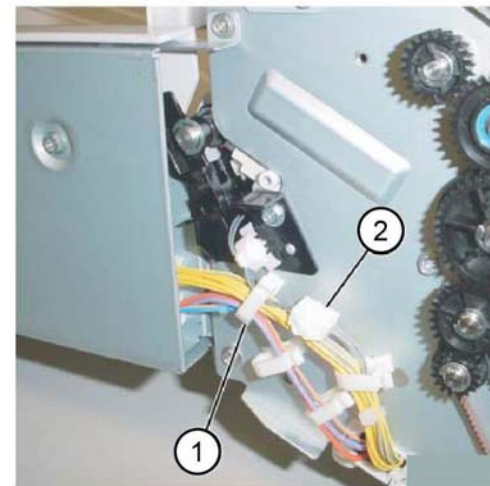
Figure 1 Connector

1. Remove the integrated office finisher, [REP 12.1](#).
2. Remove the rear cover, [PL 12.05 Item 14](#).
3. Disconnect the connector, [Figure 1](#):
 - a. Release the harness from the clamps (1).
 - b. Disconnect the connector (2).

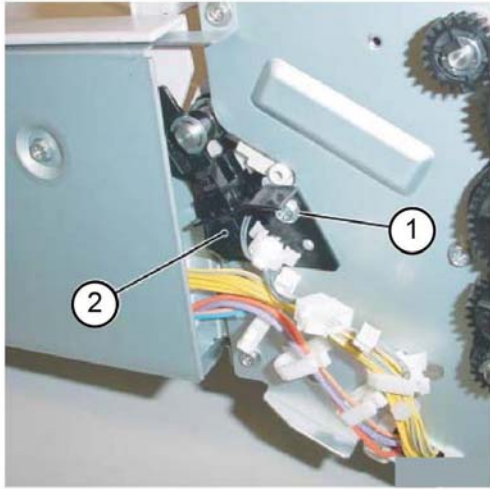
Figure 2 Set clamp home sensor assembly removal

4. Remove the set clamp home sensor assembly, **Figure 2**:
 - a. Remove the screw (1).
 - b. Remove the set clamp home sensor assembly (2).

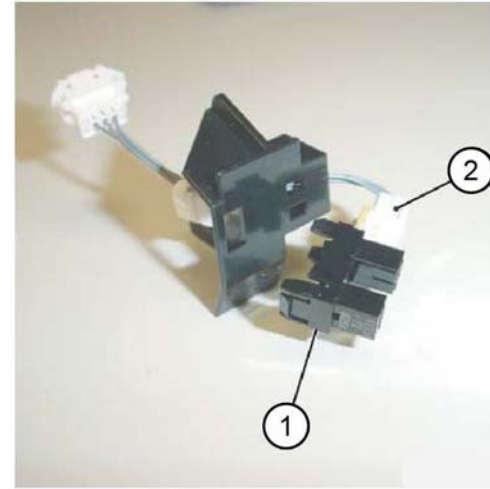
Figure 3 Set clamp home sensor removal

5. Remove the set clamp home sensor, **Figure 3**:
 - a. Remove the set clamp home sensor (1) from the bracket.
 - b. Disconnect the connector (2).

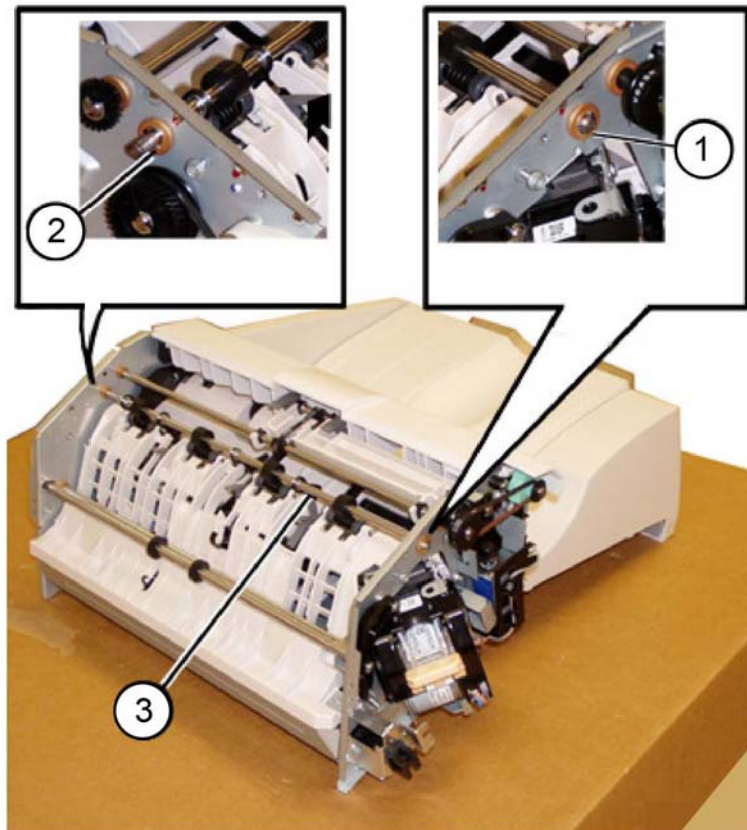
Figure 1 Exit roll assembly removal

1. Remove the upper chute assembly, [REP 12.13](#).
2. Remove the exit roll assembly, [Figure 1](#):
 - a. Remove the E-ring, then the bearing (1).
 - b. Remove the E-ring, then the bearing (2).
 - c. Remove the exit roll assembly (3).

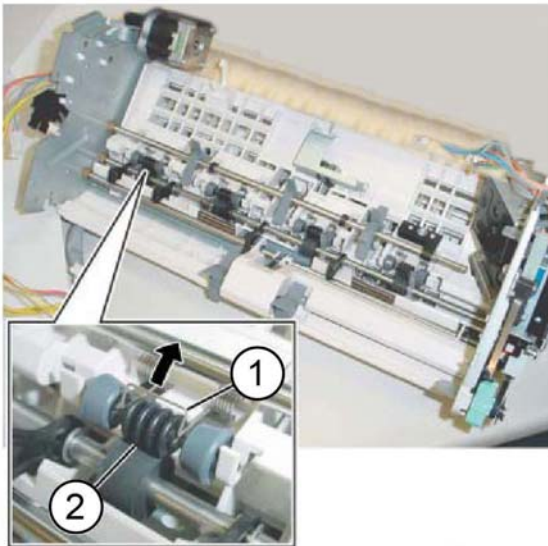
Figure 1 Nip rolls removal

1. Remove the integrated office finisher, [REP 12.1](#).
2. Remove the compiler assembly, [REP 12.19](#).
3. Remove the pinch roll, [Figure 1](#):
 - a. Raise the four springs (1) in the direction of the arrow.
 - b. Remove the four nip rolls (2).

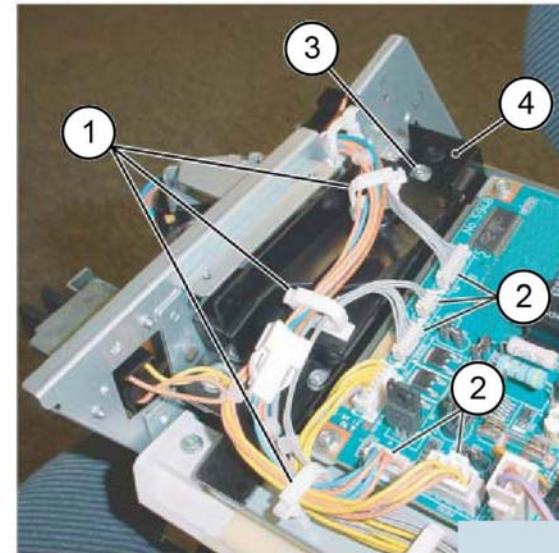
Figure 1 Connector bracket removal

1. Remove the integrated office finisher, [REP 12.1](#).
2. Turn over the integrated office finisher.
3. Remove the bottom cover, [PL 12.06 Item 1](#).
4. Remove the connector bracket, [Figure 1](#):
 - a. Release the harness from the three clamps (1).
 - b. Disconnect the connectors (2).
 - c. Remove two screws (3).
 - d. Remove the connector bracket (4).

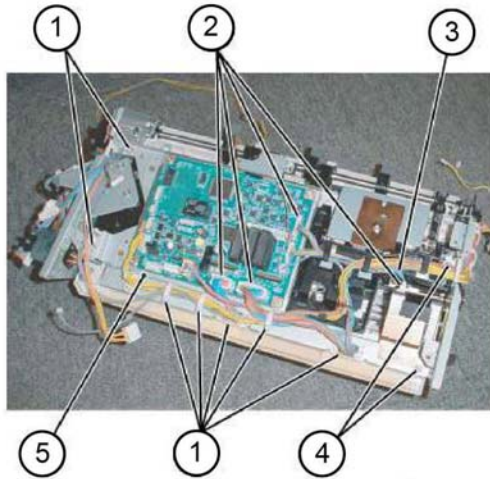
Figure 2 Bottom plate removal

5. Remove the bottom plate, [Figure 2](#):
 - a. Release the harness from the 5 clamps (1).
 - b. Disconnect eight connectors (2).
 - c. Remove the harness from the retainers (3).
 - d. Remove four screws (4).
 - e. Remove the bottom plate (5).

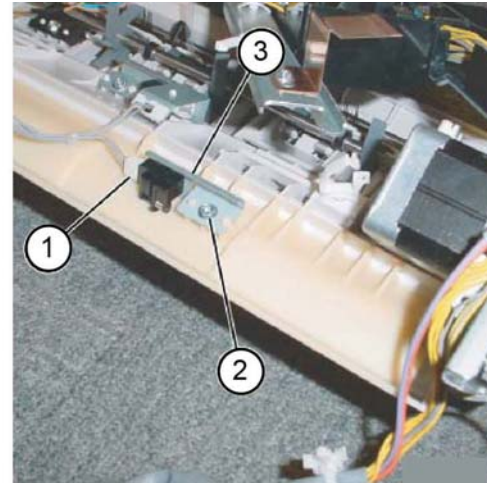
Figure 3 Finisher entrance sensor assembly removal

6. Remove the finisher entrance sensor assembly, [Figure 3](#):
 - a. Disconnect the connector (1).
 - b. Remove the self-tapping screw (2).
 - c. Remove the finisher entrance sensor assembly (3).

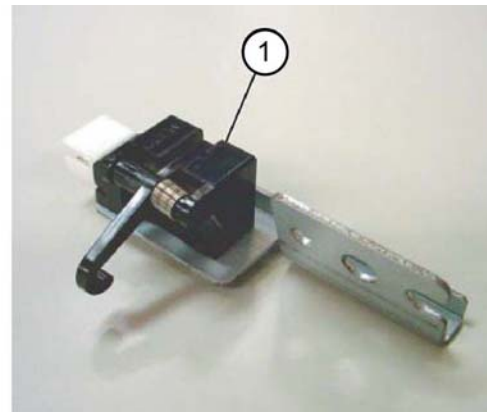
Figure 4 Finisher entry sensor removal

7. Remove the finisher entry sensor (1) from the bracket, [Figure 4](#).

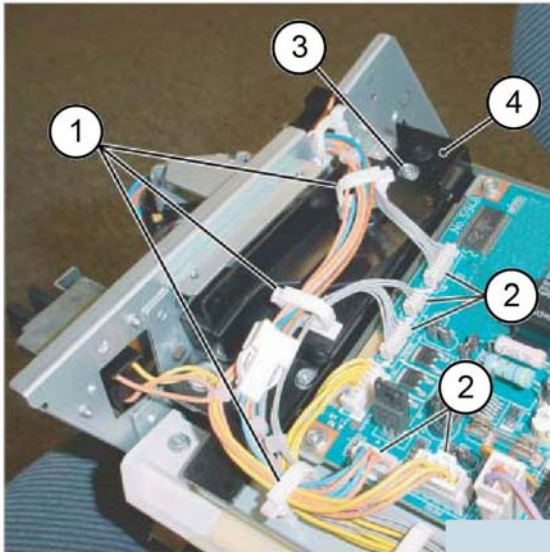
Figure 1 Connector bracket removal

1. Remove the integrated office finisher, [REP 12.1](#).
2. Turn over the integrated office finisher.
3. Remove the bottom cover, [PL 12.06 Item 1](#).
4. Remove the connector bracket, [Figure 1](#):
 - a. Release the harness from the three clamps (1).
 - b. Disconnect five 5 connectors (2).
 - c. Remove two screws (3).
 - d. Remove the connector bracket (4).

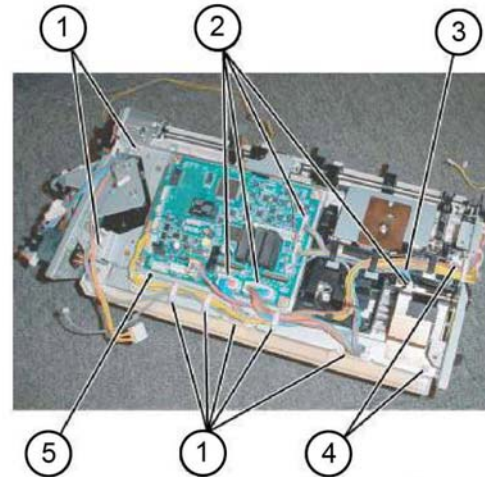
Figure 2 Bottom plate removal

5. Remove the bottom plate, [Figure 2](#):
 - a. Release the harness from the five clamps (1).
 - b. Disconnect eight connectors (2).
 - c. Release the harness from the retainers (3).
 - d. Remove four screws (4).
 - e. Remove the bottom plate (5).

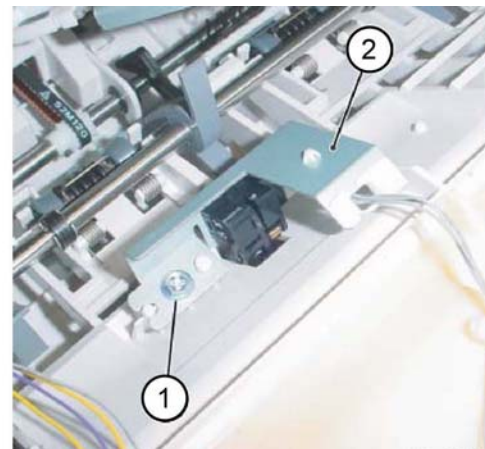
Figure 3 Compiler exit sensor assembly removal

6. Remove the compiler exit sensor assembly, [Figure 3](#):
 - a. Remove the screw (1).
 - b. Remove the compiler exit sensor assembly (2).

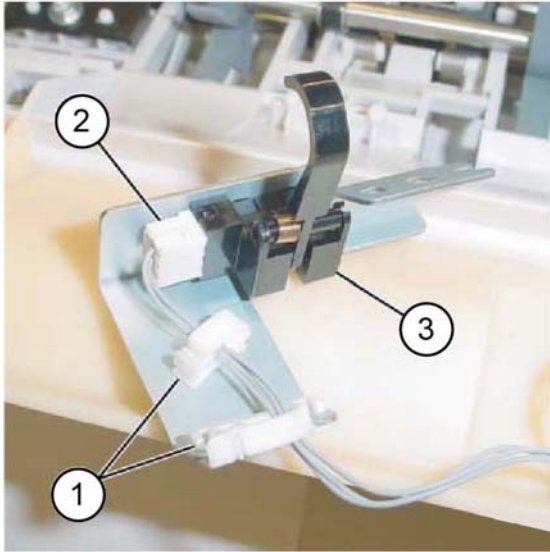
Figure 4 Compiler exit sensor removal

7. Remove the compiler exit sensor, [Figure 4](#):
 - a. Release the harness from the two clamps (1).
 - b. Disconnect the connector (2).
 - c. Remove the compiler exit sensor (3).

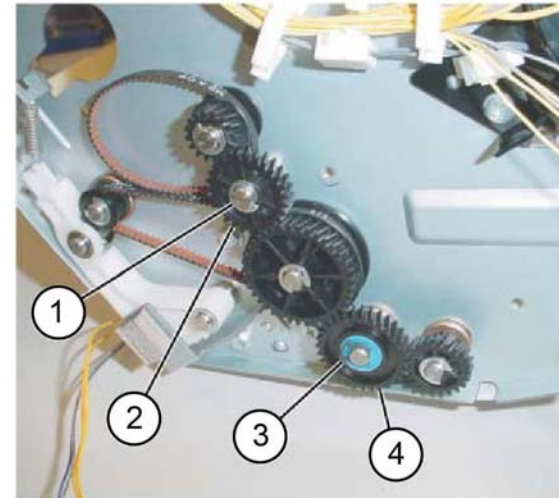
Figure 1 Gear removal

1. Remove the integrated office finisher, [REP 12.1](#).
2. Remove the compiler assembly, [REP 12.19](#).
3. Remove the gear, [Figure 1](#):
 - a. Remove the E-clip (1).
 - b. Remove the gear (2).
 - c. Remove the KL-clip (3).
 - d. Remove the gear (4).

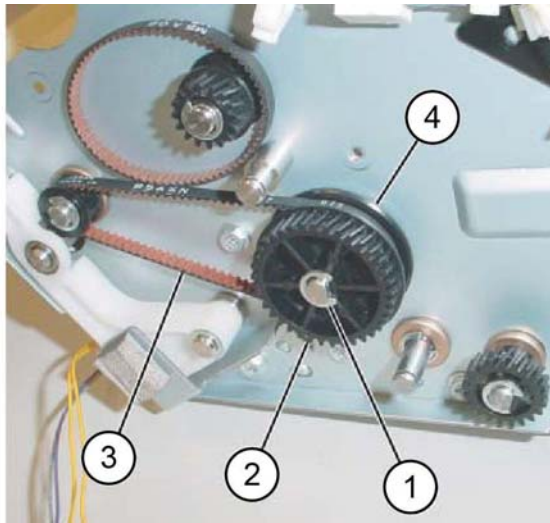
Figure 2 Gear pulley removal

4. Remove the gear pulley, [Figure 2](#):
 - a. Remove the E-clip (1).
 - b. Remove the gear (2).
 - c. Remove the flange (3).

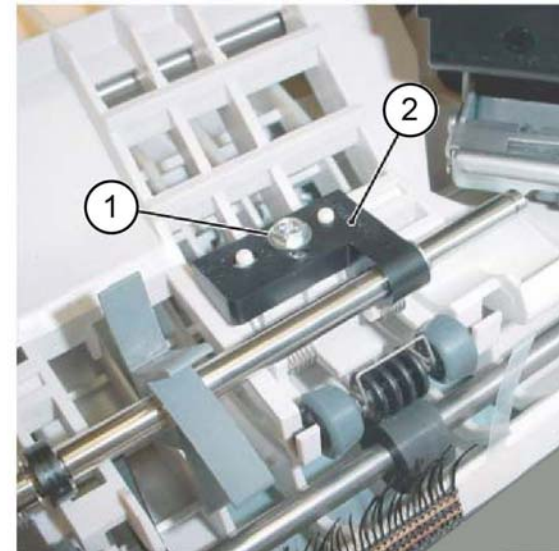
Figure 4 Support bearing removal

6. Remove the support bearing from the entrance lower chute assembly, [Figure 4](#):
 - a. Remove the self-tapping screw (1).
 - b. Remove the support bearing (2).

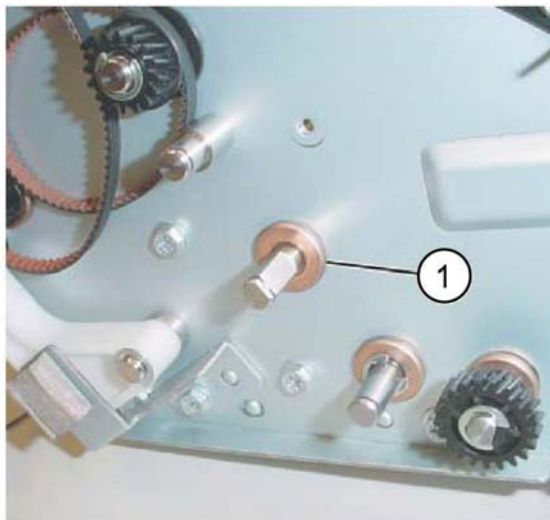
Figure 3 Bearing removal

5. Remove the bearing, [Figure 3](#).

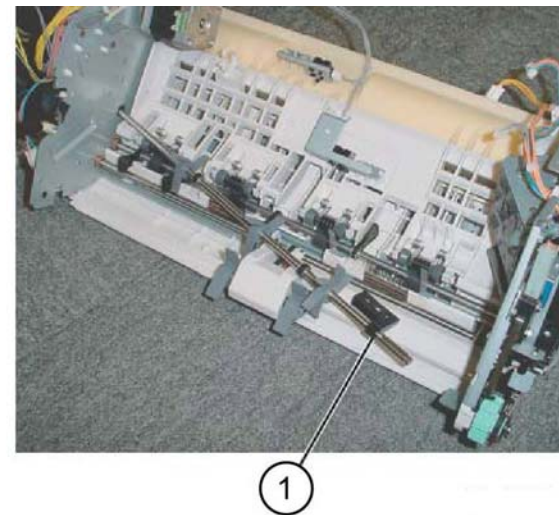
Figure 5 Main paddle shaft assembly removal

7. Remove the main paddle shaft assembly, [Figure 5](#).

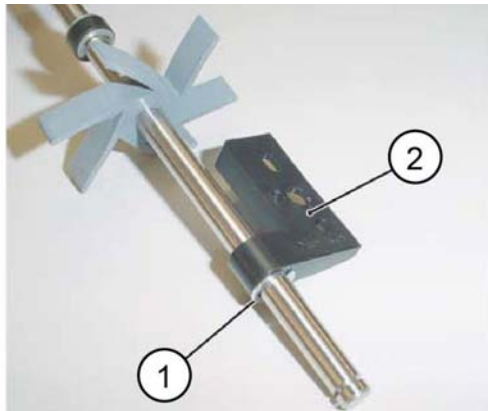
Figure 6 Support bearing removal

8. Remove the support bearing from the main paddle shaft assembly, [Figure 6](#):
 - a. Remove the E-clip (1).
 - b. Remove the support bearing (2).

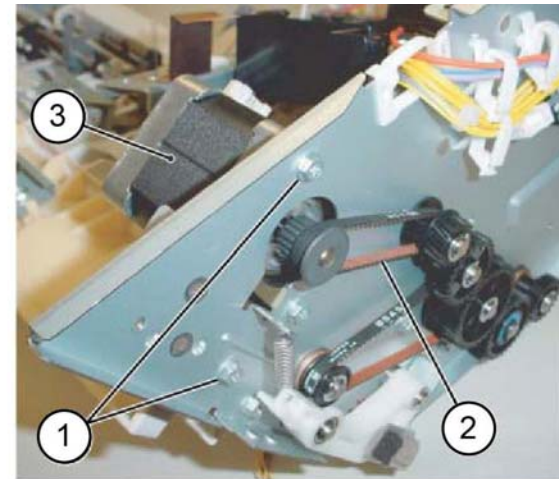
Figure 1 Transport motor removal

1. Remove the stapler assembly, refer to [REP 12.4](#).
2. Turn over the integrated office finisher.
3. Remove the transport motor, [Figure 1](#):
 - a. Remove two screws (1).
 - b. Remove the belt (2) from the pulley.
 - c. Remove the transport motor (3).

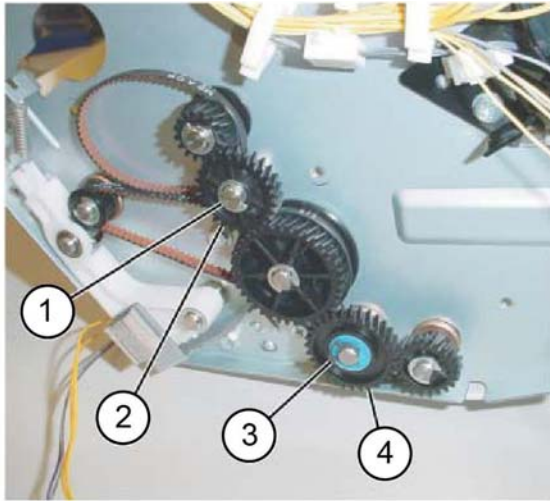
Figure 2 Gear removal

4. Remove the gear, [Figure 2](#):
 - a. Remove the E-clip (1).
 - b. Remove the gear (2).
 - c. Remove the KL-clip (3).
 - d. Remove the gear (4).

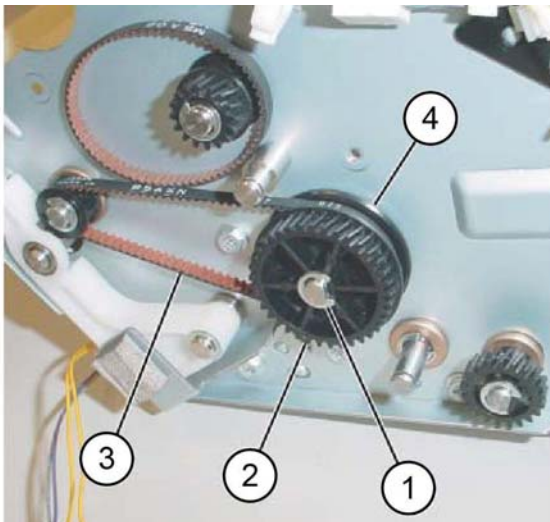
Figure 3 Gear pulley removal

5. Remove the gear pulley, [Figure 3](#):
 - a. Remove the E-clip (1).
 - b. Remove the gear (2).
 - c. Remove the belt (3) from the pulley.
 - d. Remove the flange (4).

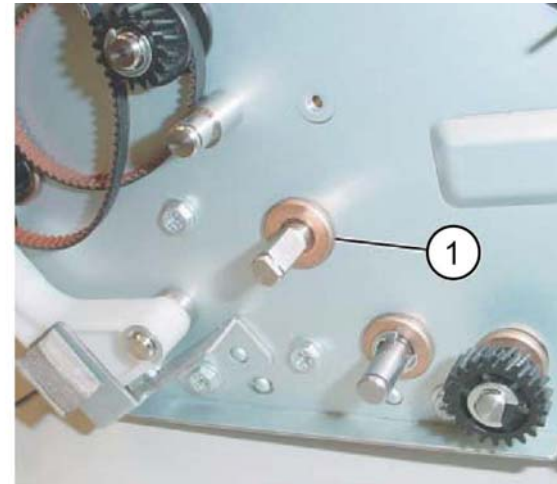
Figure 4 Bearing removal

6. Remove the bearing, [Figure 4](#).

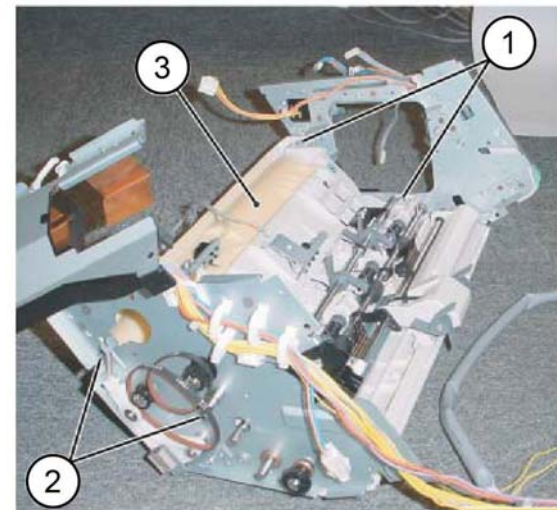
Figure 5 Entrance lower chute assembly removal

7. Remove the entrance lower chute assembly, [Figure 5](#):
 - a. Remove two screws (1).
 - b. Loosen two screws (2).
 - c. Remove the entrance lower chute assembly (3).

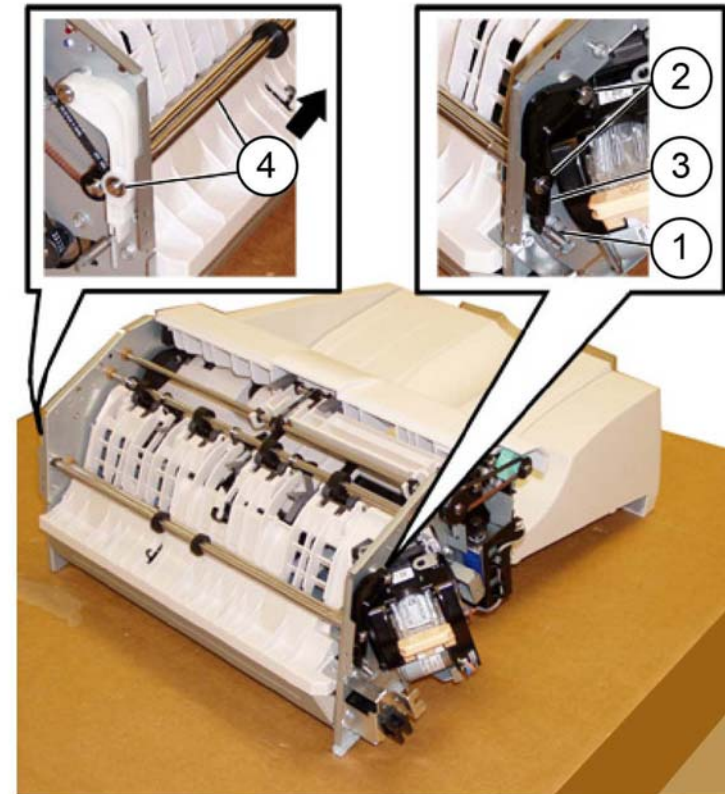
Figure 1 Roll removal

1. Remove the upper chute assembly, [REP 12.13](#).
2. Remove the entry roll, [Figure 1](#):
 - a. Disconnect the spring (1).
 - b. Remove two E-clips (2).
 - c. Remove the arm (3).
 - d. Slide the shaft (4) out of the bearing in the arm.

NOTE: Capture the bearing.

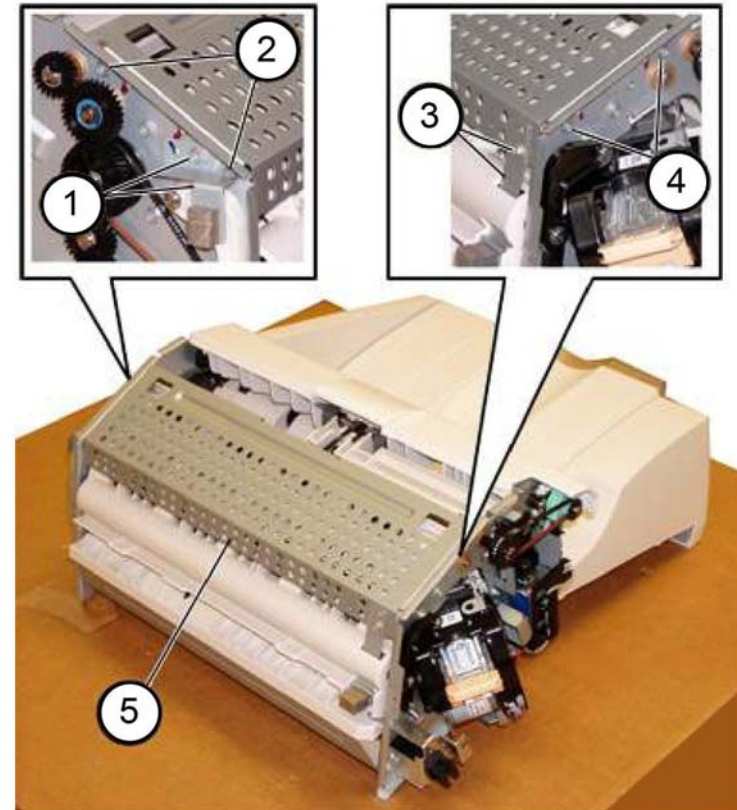
Figure 1 Upper frame section removal

1. Remove the integrated office finisher, [REP 12.1](#).
2. Remove the front inner cover, [PL 12.05 Item 6](#).
3. Remove the rear cover, [PL 12.05 Item 14](#).
4. Remove the left cover, [PL 12.06 Item 4](#).
5. Remove the upper frame section, [Figure 1](#):
 - a. Remove the screw, then the bracket (1).
 - b. Remove two screws (2).
 - c. Remove the screw, then the bracket (3).
 - d. Remove two screws (4).
 - e. Remove the upper frame section (5).

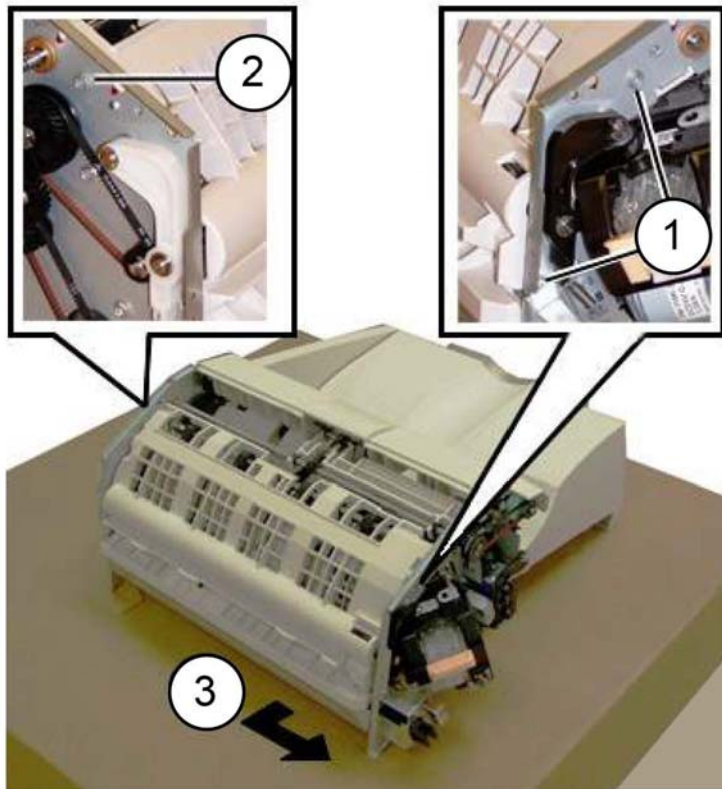
Figure 2 Upper chute assembly removal

NOTE: The screws do not thread into the upper chute. They are used like pins to secure the upper chute in place.

- a. Remove two screws (1).
- b. Remove the screw (2).
- c. Carefully remove the upper chute assembly (3).

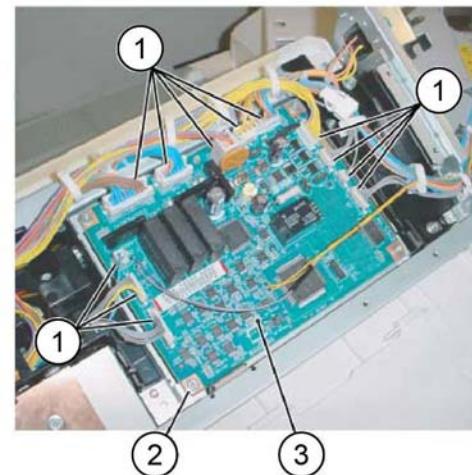
Figure 1 Finisher PWB removal

1. If possible, record the current software level by either:
 - Printing the configuration report, [GP 14](#).
 - From the user interface Home screen, touch Device, then About. Scroll down to view the Software Version.
2. Remove the integrated office finisher, [REP 12.1](#).
3. Turn over the integrated office finisher.
4. Remove the bottom cover, [PL 12.06 Item 1](#).
5. Remove the finisher PWB, [Figure 1](#):
 - a. Disconnect 12 connectors (1).
 - b. Remove four screws (2).
 - c. Remove the finisher PWB (3).

1. The replacement is the reverse of the removal procedure.
2. Check the machine's current software level against the software level recorded prior to installation of the new finisher PWB. If necessary, reload the software, [GP 4](#).

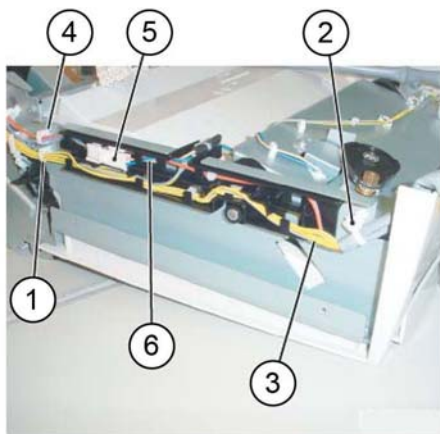
Figure 1 Connector

1. Remove the integrated office finisher, [REP 12.1](#).
2. Remove the front inner cover, [PL 12.05 Item 6](#).
3. Remove the rear cover, [PL 12.05 Item 14](#).
4. Turn over the integrated office finisher.
5. Remove the bottom cover, [PL 12.06 Item 1](#).
6. Remove the tray cover, [PL 12.06 Item 3](#).
7. Disconnect the connector, [Figure 1](#):
 - a. Release the clamp (1).
 - b. Remove the clamp (2).
 - c. Release the harness (3) from the retainer.
 - d. Release the clamp (4).
 - e. Disconnect the connector (5).
 - f. Release the harness (6) from the retainer.

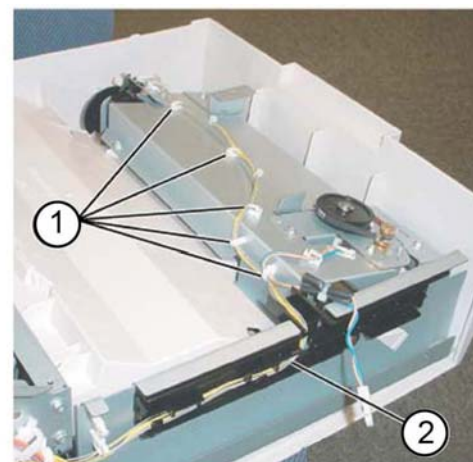
Figure 2 Harness release

8. Release the wiring, [Figure 2](#):
 - a. Release five clamps (1).
 - b. Release the harness (2) from the retainers.

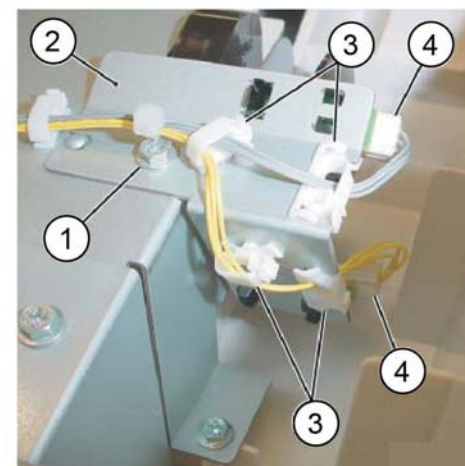
Figure 3 Stacker sensor assembly removal

9. Remove the stacker sensor assembly, [Figure 3](#):
 - a. Remove the screw (1).
 - b. Remove the stacker sensor assembly (2).
 - c. Release the four clamps (3).
 - d. Disconnect two connectors (4).

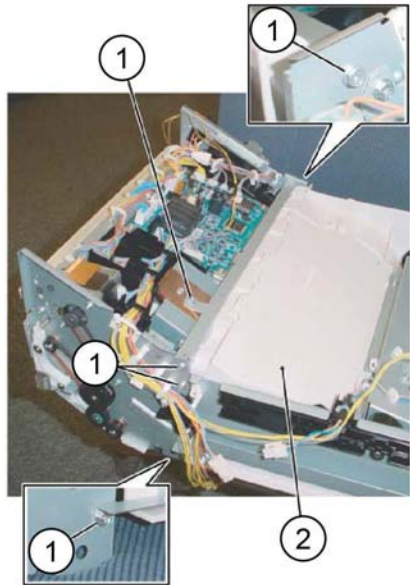
Figure 4 Stacker tray assembly removal

10. Remove the stacker tray assembly, [Figure 4](#):
 - a. Remove five screws (1).
 - b. Remove the stacker tray assembly (2).

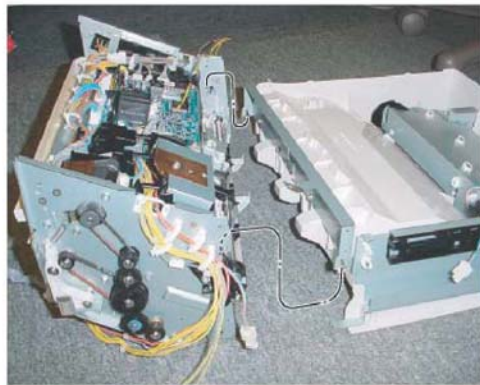
Figure 5 Stacker tray assembly installation

1. The replacement is the reverse of the removal procedure.
2. Install the stacker tray assembly and integrated office finisher as shown in [Figure 5](#).

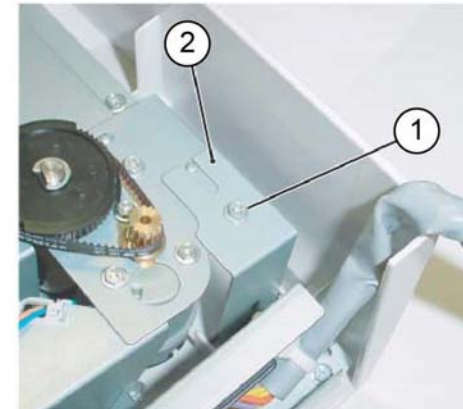
Figure 1 Rear bracket removal

1. Remove the integrated office finisher, [REP 12.1](#).
2. Remove the rear cover, [PL 12.05 Item 14](#).
3. Turn over the integrated office finisher.
4. Remove the tray cover, [PL 12.06 Item 3](#).
5. Remove the rear bracket, [Figure 1](#):
 - a. Remove the screw (1).
 - b. Remove the bracket (2).

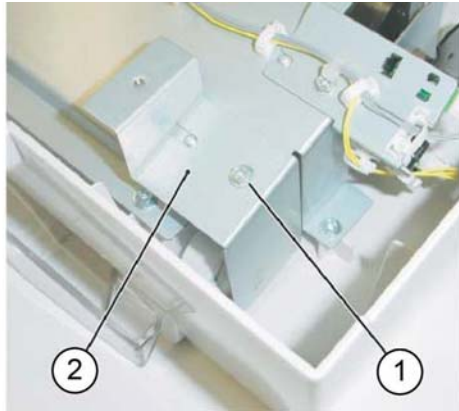
Figure 2 Front bracket removal

6. Remove the front bracket, **Figure 2:**

- a. Remove the screw (1).
- b. Remove the bracket (2).

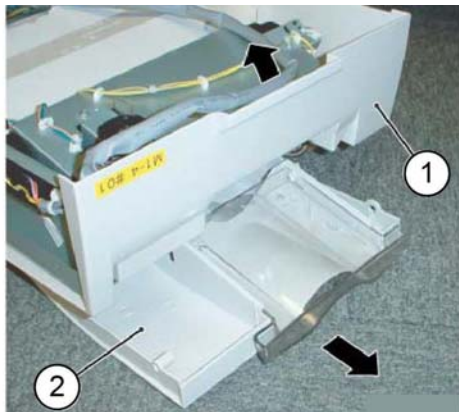
Figure 3 Top tray removal

7. Remove the top tray, **Figure 3:**

- a. Raise the integrated office finisher slightly in the direction of the arrow (1).
- b. Remove the top tray (2).

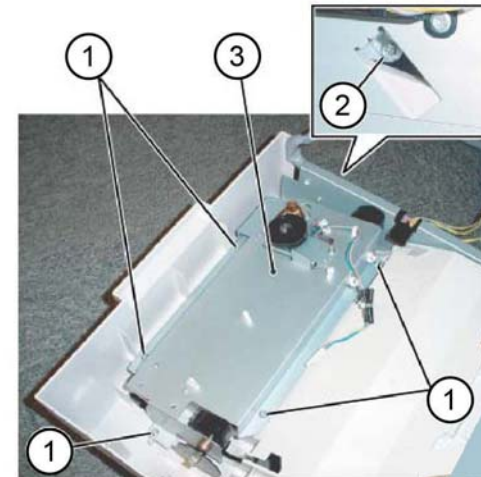
Figure 5 Stacker assembly removal

9. Remove the stacker assembly, **Figure 5:**

- a. Remove five self-tapping screws (1).
- b. Remove the screw (2).
- c. Remove the stacker assembly (3).

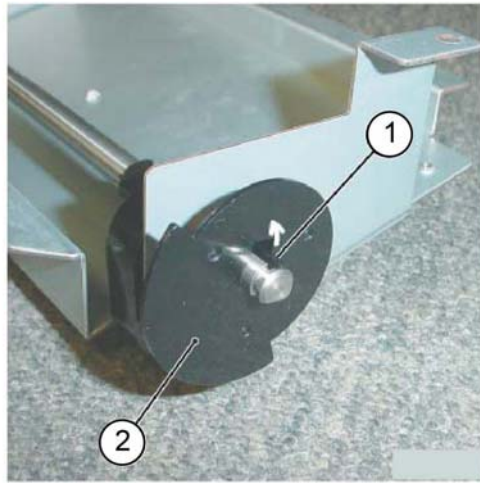
Figure 6 Actuator removal

10. Unhook (1), then remove the actuator (2), [Figure 6](#).

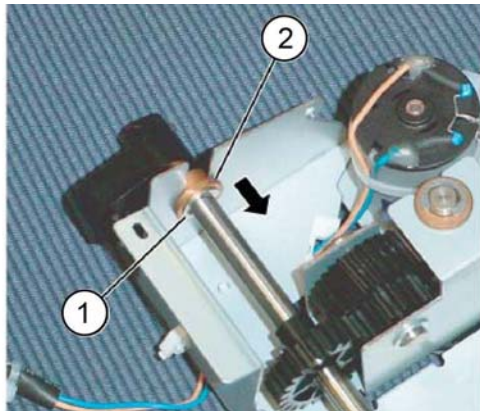
11. Prepare to remove the stacker shaft assembly, [Figure 7](#):
- Remove the E-clip (1).
 - Move the bearing (2) in the direction of the arrow.

Figure 7 Preparation

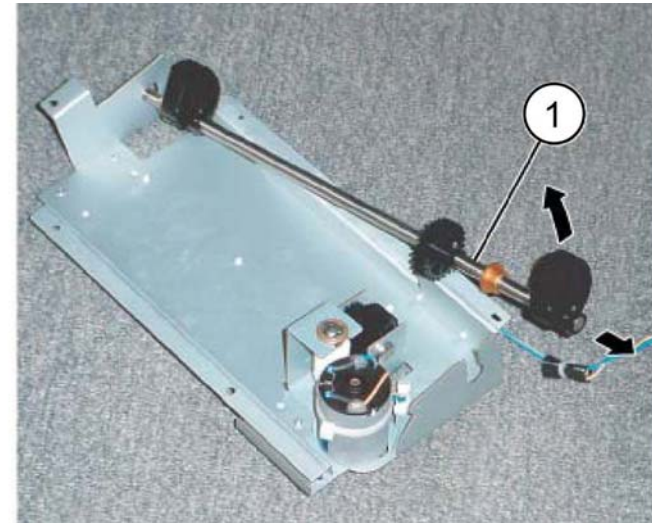
12. Remove the stacker shaft assembly in the direction of the arrow, [Figure 8](#).

Figure 8 Stacker shaft assembly removal

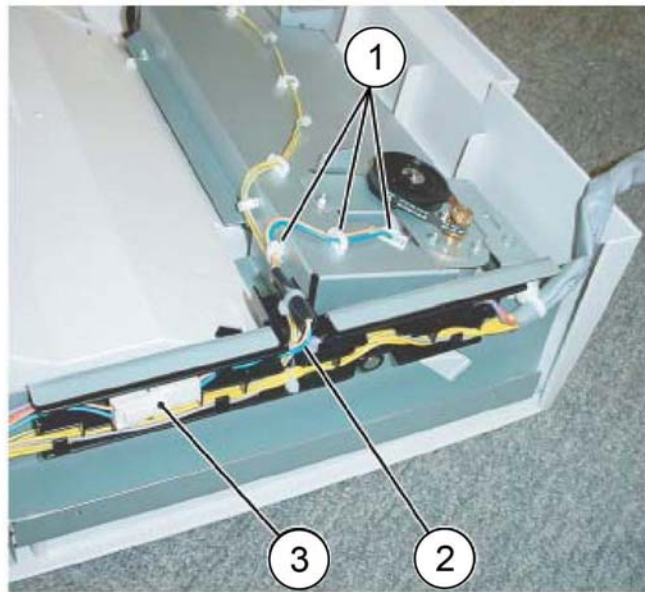
Y-1-0294-A

1. Remove the integrated office finisher, [REP 12.1](#).
2. Remove the rear cover, [PL 12.05 Item 14](#).
3. Turn over the integrated office finisher.
4. Remove the tray cover, [PL 12.06 Item 3](#).
5. Disconnect the connector, [Figure 1](#):
 - a. Release the harness from the three clamps (1).
 - b. Release the harness from the retainer (2).
 - c. Disconnect the connector (3).

Figure 1 Connector

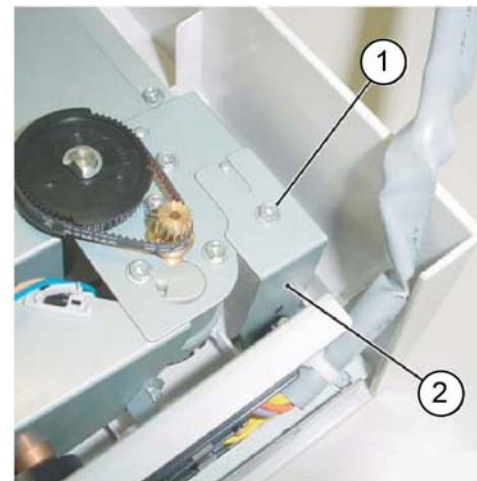
Y-1-0295-A

6. Remove the bracket, [Figure 2](#):
 - a. Remove the screw (1).
 - b. Remove the bracket (2).

Figure 2 Bracket removal

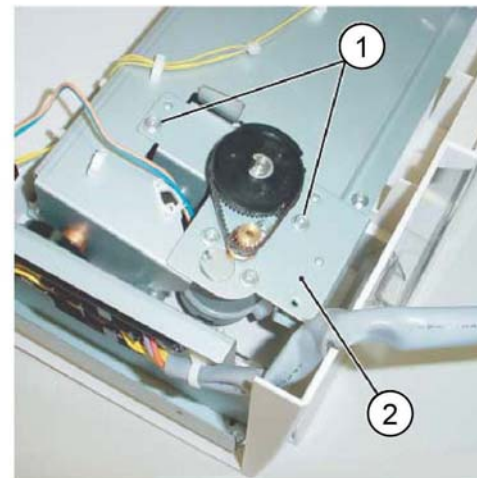
Y-1-0296-A

7. Remove the stacker motor assembly, [Figure 3](#):
 - a. Remove two screws (1).
 - b. Remove the stacker motor assembly (2).

Figure 3 Stacker motor assembly removal

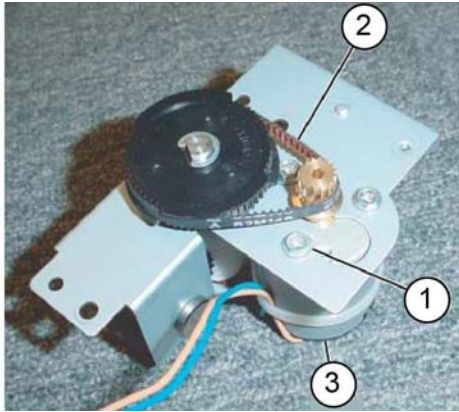
8. Remove the stacker motor, [Figure 4](#):
 - a. Remove three crews (1).
 - b. Remove the belt (2) from the pulley.
 - c. Remove the stacker motor (3).

Figure 4 Stacker motor removal

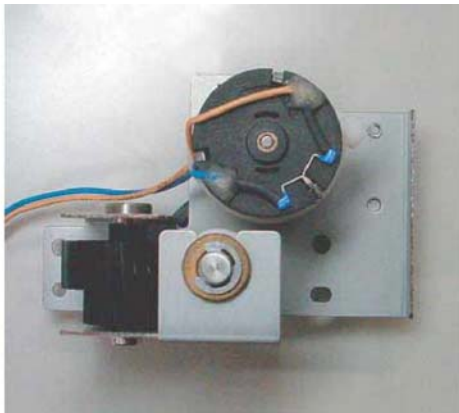
1. The replacement is the reverse of the removal procedure.
2. Install the stacker motor as shown in [Figure 5](#).

Figure 5 Stacker motor installation

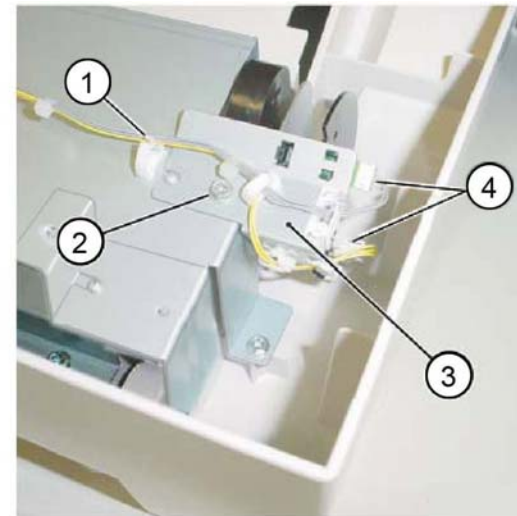
Y-1-0299-A

1. Remove the integrated office finisher, [REP 12.1](#).
2. Remove the rear cover, [PL 12.05 Item 14](#).
3. Turn over the integrated office finisher.
4. Remove the tray cover, [PL 12.06 Item 3](#).
5. Remove the stacker sensor assembly, [Figure 1](#):
 - a. Release the harness from the lamp (1).
 - b. Remove the screw (2).
 - c. Remove the stacker sensor assembly (3).
 - d. Disconnect the sensor connector (4), then remove the sensor from the bracket.

Figure 1 Stacker sensor assembly removal
