708P91370
April 2017

Xerox® VersaLink® B7025/B7030/B7035 Multifunction Printer Service Manual

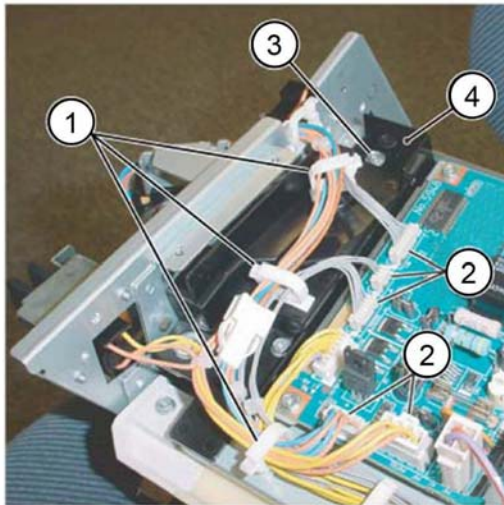
Y-1-0300-A

1. Remove the integrated office finisher, [REP 12.1](#).
2. Remove the front inner cover, [PL 12.05 Item 6](#).
3. Remove the rear cover, [PL 12.05 Item 14](#).
4. Turn over the integrated office finisher.
5. Remove the bottom cover. [PL 12.06 Item 1](#).
6. Remove the tray cover, [PL 12.06 Item 3](#).
7. Remove the connector bracket, [Figure 1](#):
 - a. Release the harness from the three clamps (1).
 - b. Disconnect five connectors (2).
 - c. Remove two screws (3).
 - d. Remove the connector bracket (4).

Figure 1 Connector bracket removal

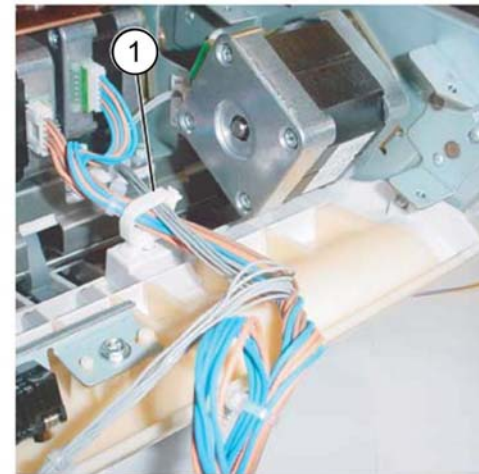
Y-1-0302-A

9. Release the harness from the clamp, [Figure 3](#).

Figure 3 Harness release

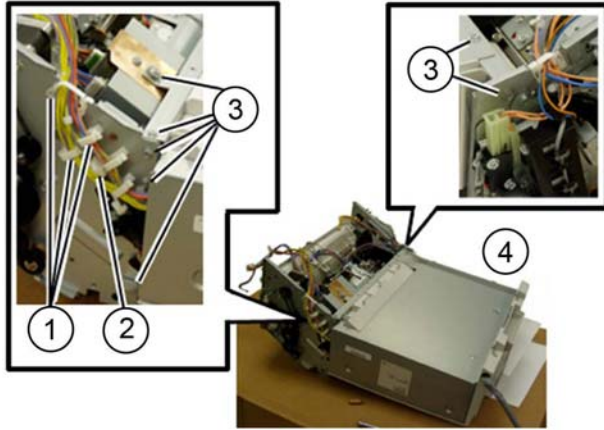
10. Remove the stacker tray, [Figure 4](#):
 - a. Release the harness from the five clamps (1).
 - b. Disconnect the connector (2).
 - c. Remove seven screws (3).
 - d. Remove the stacker tray (4).

Figure 4 Stacker tray removal

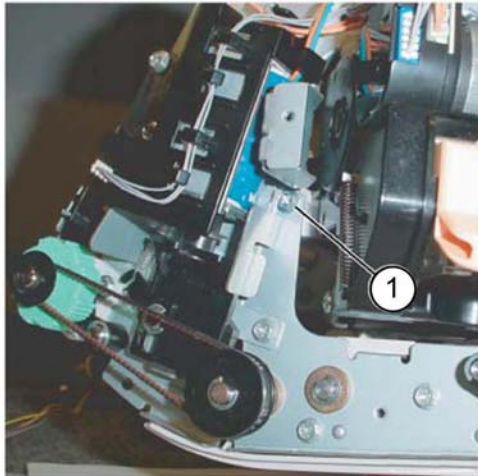
11. Remove the front self-tapping screw (1), [Figure 5](#).

Figure 5 Front screw removal

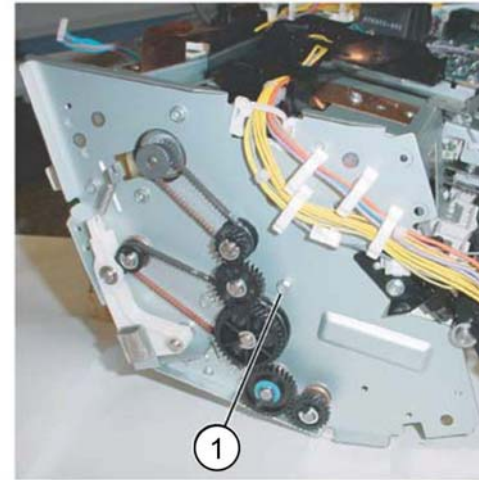
Y-1-0305-A

12. Remove the rear screw (1), [Figure 6](#).

Figure 6 Rear screw removal

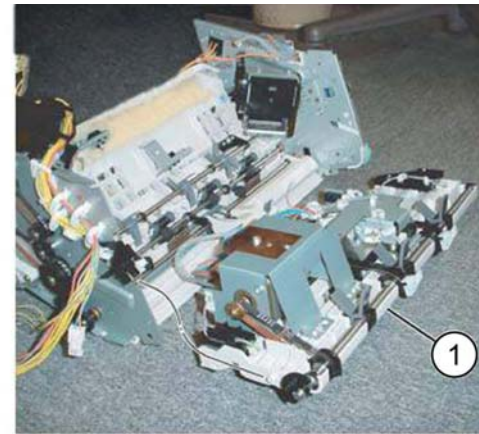
Y-1-0306-A

13. Remove the compiler assembly (1), [Figure 7](#).

Figure 7 Compiler assembly removal

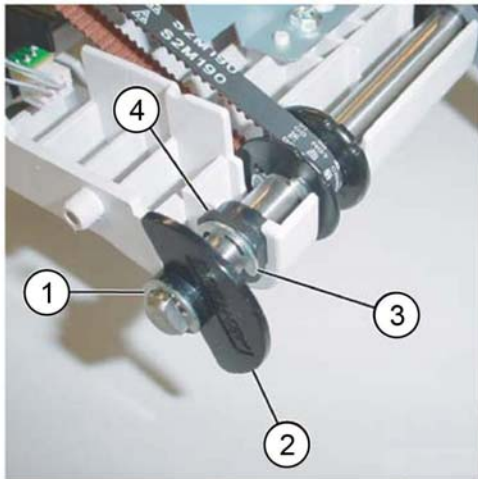
Y-1-0307-A

1. Remove the compiler assembly, REP 12.19.
2. Remove the eject shaft assembly, REP 12.24.
3. Remove the actuator and the bearing, Figure 1:
 - a. Remove the E-clip (1).
 - b. Remove the actuator (2).
 - c. Remove E-clip (3).
 - d. Remove the bearing (4).

Figure 1 Actuator and bearing removal

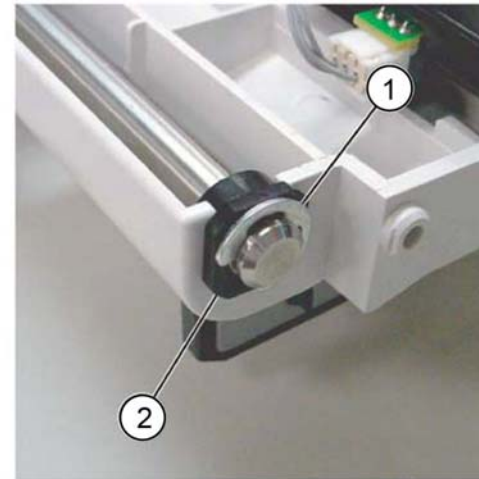
Y-1-0308-A

4. Remove the bearing, Figure 2:
 - a. Remove the E-clip (1).
 - b. Remove the bearing (2).

Figure 2 Bearing removal

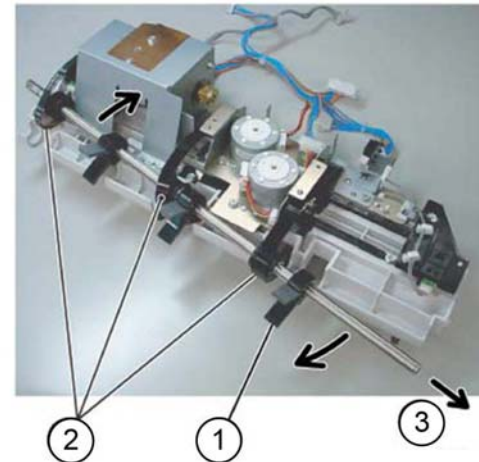
Y-1-0309-A

5. Remove the set clamp shaft, Figure 3:
 - a. Move the set clamp shaft (1) in the direction of the arrow.
 - b. Remove the three belts (2) from the pulleys.
 - c. Remove the set clamp shaft in the direction of the arrow (3).

Figure 3 Set clamp shaft removal

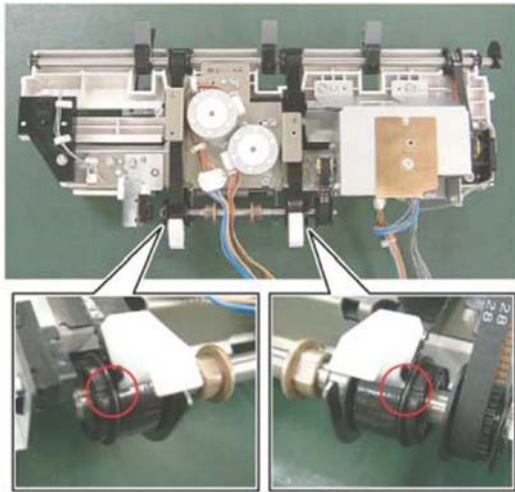
Y-1-0310-A

1. The replacement is the reverse of the removal procedure.
2. Ensure the eject belt is aligned with the marks on the pulleys, [Figure 4](#).

Figure 4 Eject belt installation

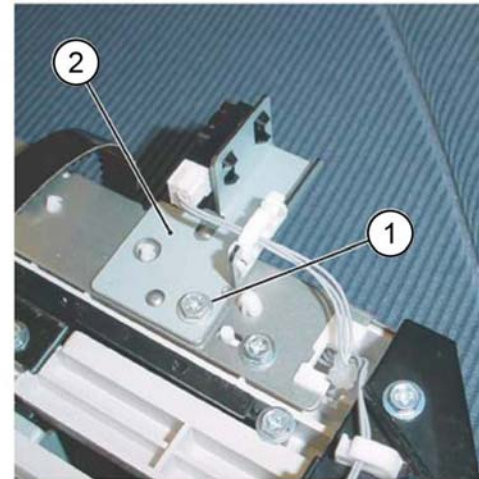
Y-1-0311-A

1. Remove the compiler assembly, [REP 12.19](#).
2. Remove the front/rear tamper motor assembly, [REP 12.25](#).
3. Move the eject home sensor assembly, [Figure 1](#):
 - a. Remove the screw (1).
 - b. Move the eject home sensor assembly (2).

Figure 1 Eject home sensor assembly

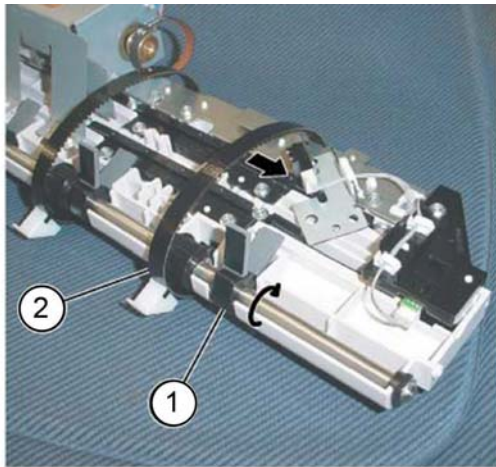
4. Remove the eject belt, [Figure 2](#):
 - a. Move the blades of the set clamp shaft (1) in the direction of the arrow.
 - b. Remove the eject belt (2) in the direction of the arrow.

Figure 2 Eject belt removal

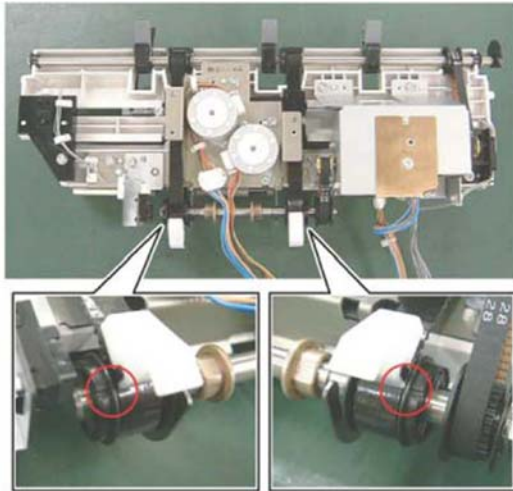
Y-1-0312-A

1. The replacement is the reverse of the removal procedure.
2. Ensure the eject belt is aligned with the marks on the pulleys, [Figure 3](#).

Figure 3 Eject belt installation

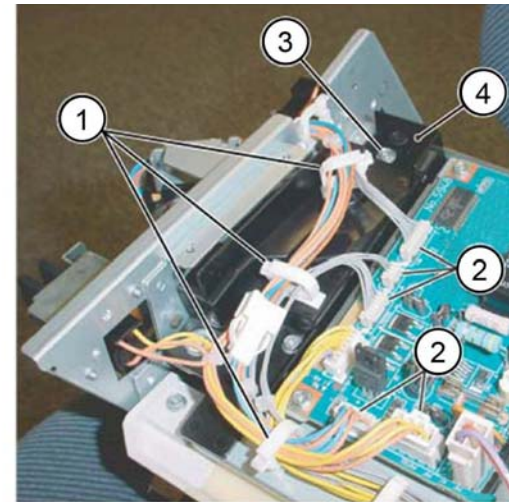
Y-1-0314-A

1. Remove the integrated office finisher, [REP 12.1](#).
2. Remove the front inner cover, [PL 12.05 Item 6](#).
3. Remove the rear cover, [PL 12.05 Item 14](#).
4. Turn over the integrated office finisher.
5. Remove the bottom cover, [PL 12.06 Item 1](#).
6. Remove the connector bracket, [Figure 1](#):
 - a. Release the harness from the three clamps (1).
 - b. Disconnect five connectors (2).
 - c. Remove two screws (3).
 - d. Remove the connector bracket (4).

Figure 1 Connector bracket removal

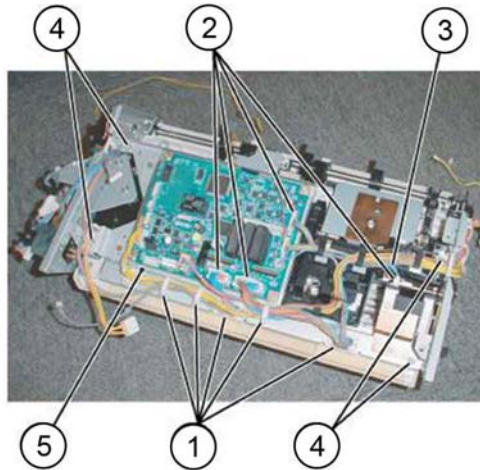
7. Remove the bottom plate, [Figure 2](#):
 - a. Release the harness from the five clamps (1).
 - b. Disconnect eight connectors (2).
 - c. Release the harness from the retainer (3).
 - d. Remove four screws (4).
 - e. Remove the bottom plate (5).

Figure 2 Bottom plate removal

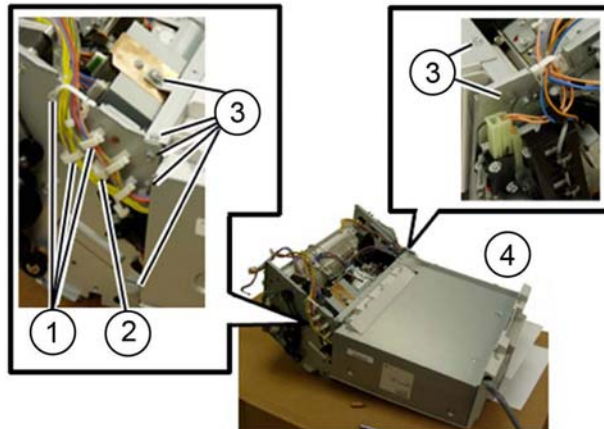
8. Remove the stacker tray, [Figure 3](#):
 - a. Release the harness from the five clamps (1).
 - b. Disconnect the connector (2).
 - c. Remove seven screws (3).
 - d. Remove the stacker tray (4).

Figure 3 Stacker tray removal

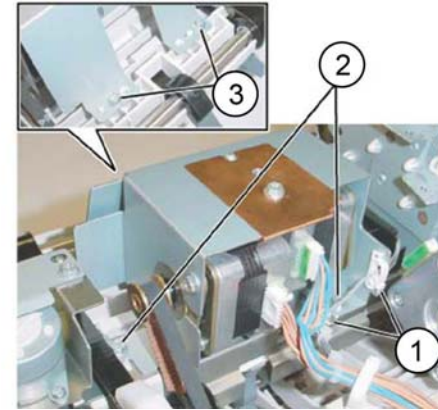
Y-1-0317-A

9. Remove the screws securing the eject/set clamp motor assembly, [Figure 4](#):
 - a. Release the harness from both clamps (1).
 - b. Remove both screws (2).
 - c. Remove both self-tapping screws (3).

Figure 4 Screw removal

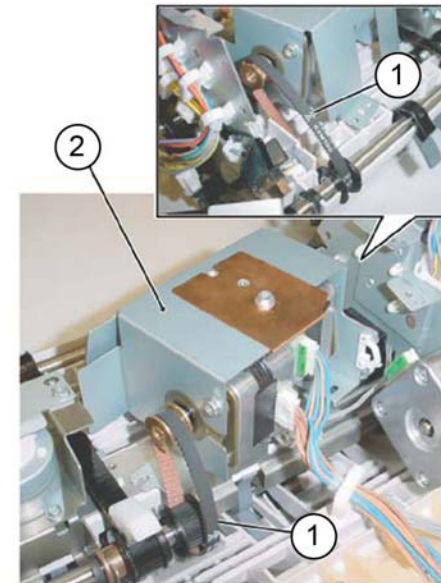
Y-1-0318-A

10. Remove the eject/set clamp motor assembly, [Figure 5](#):
 - a. Remove both belts (1) from the Pulleys.
 - b. Remove the eject/set clamp motor assembly (2).

Figure 5 Eject/set clamp motor assembly removal

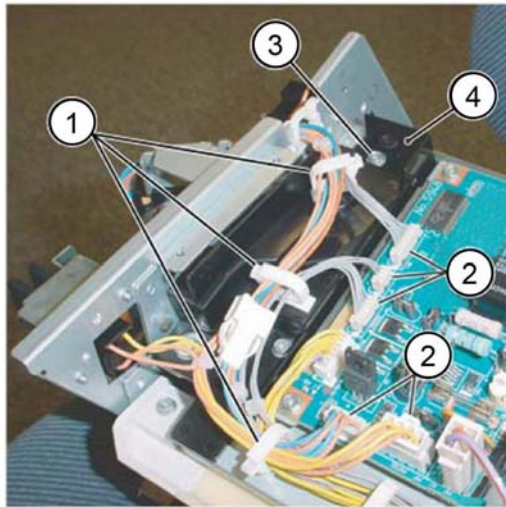
Y-1-0319-A

1. Remove the integrated office finisher, [REP 12.1](#).
2. Remove the front inner cover, [PL 12.05 Item 6](#).
3. Remove the rear cover, [PL 12.05 Item 14](#).
4. Turn over the integrated office finisher.
5. Remove the bottom cover, [PL 12.06 Item 1](#).
6. Remove the connector bracket, [Figure 1](#):
 - a. Release the harness from the three clamps (1).
 - b. Disconnect the connectors (2).
 - c. Remove two screws (3).
 - d. Remove the connector bracket (4).

Figure 1 Connector bracket removal

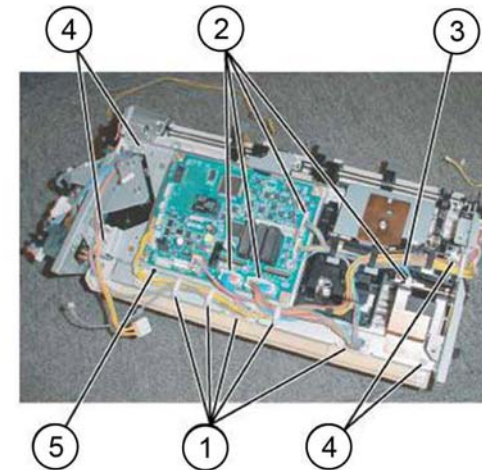
Y-1-0320-A

7. Remove the bottom plate, [Figure 2](#):
 - a. Release the harness from the 5 clamps (1).
 - b. Disconnect eight connectors (2).
 - c. Remove the harness from the retainers (3).
 - d. Remove four screws (4).

- e. Remove the bottom plate (5).

Figure 2 Bottom plate removal

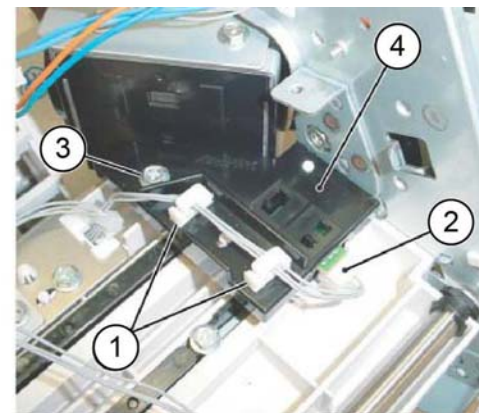
Y-1-0321-A

8. Remove the rear tamper home sensor assembly, [Figure 3](#):
 - a. Release the harness from both clamps (1).
 - b. Remove the self-tapping screw (2).
 - c. Move the rear tamper home sensor assembly (3) in order to disconnect the connector.

Figure 3 Rear tamper home sensor assembly removal

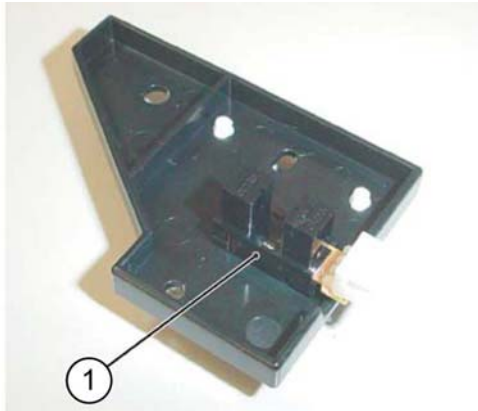
9. Remove the rear tamper home sensor (1) from the bracket, [Figure 4](#).

Figure 4 Rear tamper home sensor removal

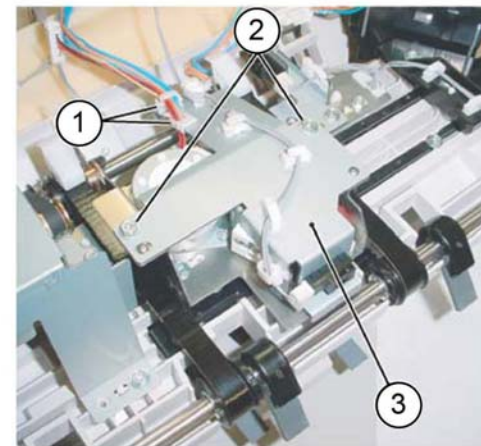
Y-1-0323-A

1. Remove the compiler assembly, [REP 12.19](#).
2. Remove the bracket assembly, [Figure 1](#):
 - a. Release the harness from the two clamps (1).
 - b. Remove two screws (2).
 - c. Remove the bracket assembly (3).

Figure 1 Bracket assembly removal

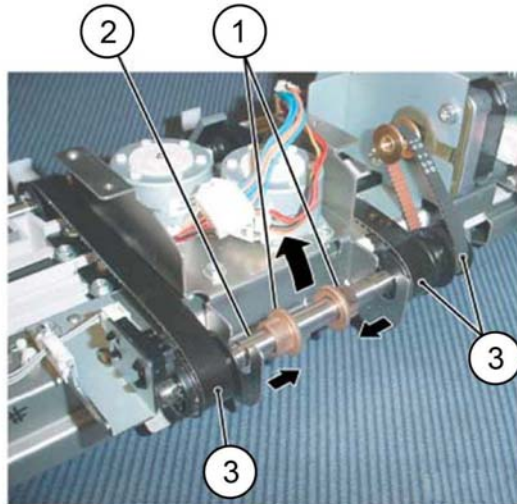
Y-1-0325-A

4. Remove the eject shaft from the front/rear tamper motor assembly, [Figure 3](#):
 - a. Move the bearings (1) in the direction of the arrow.
 - b. Remove the eject shaft (2) in the direction of the arrow.
 - c. Remove the belts (3) from the pulley.

Figure 3 Eject shaft removal

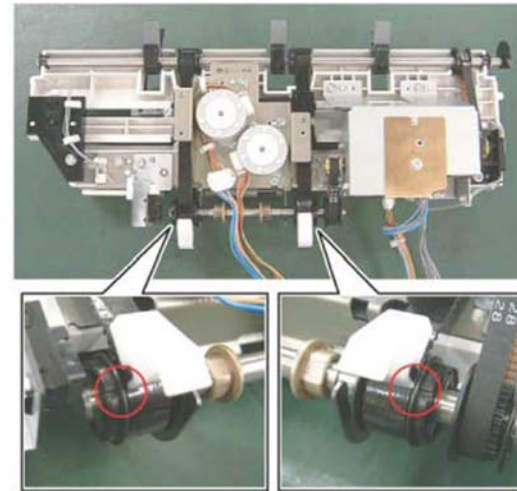
Y-1-0326-A

1. The replacement is the reverse of the removal procedure.
2. Ensure the eject belt is aligned with the marks on the pulleys, [Figure 4](#).

Figure 4 Eject belt installation

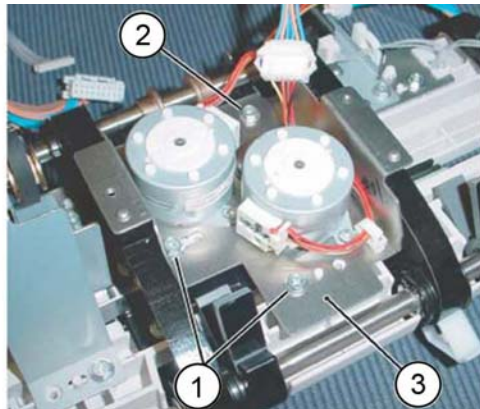
Y-1-0327-A

1. Remove the compiler assembly, [REP 12.19](#).
2. Remove the eject shaft assembly, [REP 12.24](#).
3. Remove the front/rear tamper motor assembly, [Figure 1](#):
 - a. Remove two self-tapping screws (1).
 - b. Remove the screw (2).
 - c. Remove the front/rear tamper motor assembly (3).

Figure 1 Tamper motor assembly removal

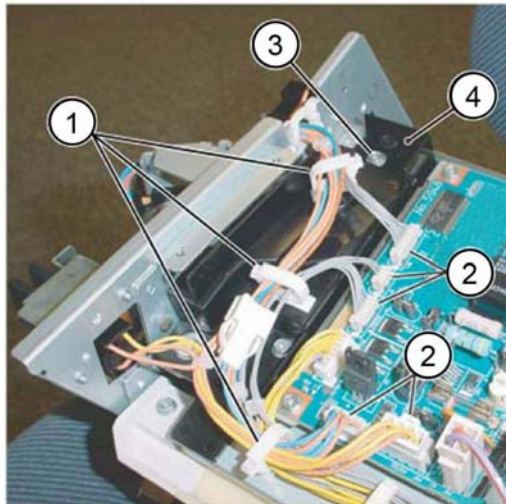
Y-1-0329-A

1. Remove the integrated office finisher, [REP 12.1](#).
2. Remove the front inner cover, [PL 12.05 Item 6](#).
3. Remove the rear cover, [PL 12.05 Item 14](#).
4. Turn over the integrated office finisher.
5. Remove the bottom cover, [PL 12.06 Item 1](#).
6. Remove the connector bracket, [Figure 1](#):
 - a. Release the harness from the three clamps (1).
 - b. Disconnect the connectors (2).
 - c. Remove two screws (3).
 - d. Remove the connector bracket (4).

Figure 1 Connector bracket removal

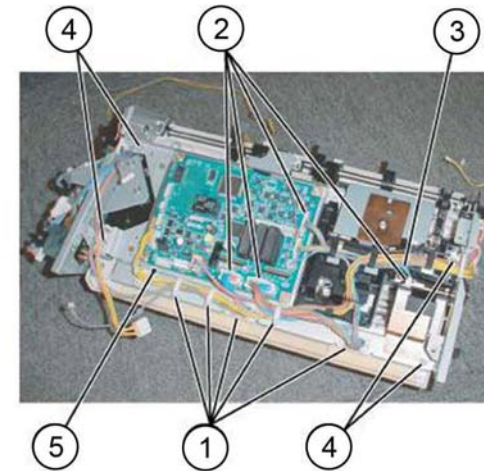
Y-1-0330-A

7. Remove the bottom plate, [Figure 2](#):
 - a. Release the harness from the 5 clamps (1).
 - b. Disconnect eight connectors (2).
 - c. Remove the harness from the retainers (3).
 - d. Remove four screws (4).
 - e. Remove the bottom plate (5).

Figure 2 Bottom plate removal

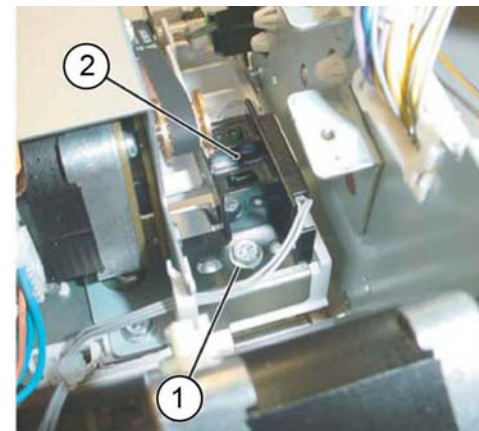
Y-1-0331-A

8. Remove the front tamper home sensor assembly, [Figure 3](#):
 - a. Remove the screw (1).
 - b. Remove the front tamper home sensor assembly (2).

Figure 3 Front tamper home sensor assembly removal

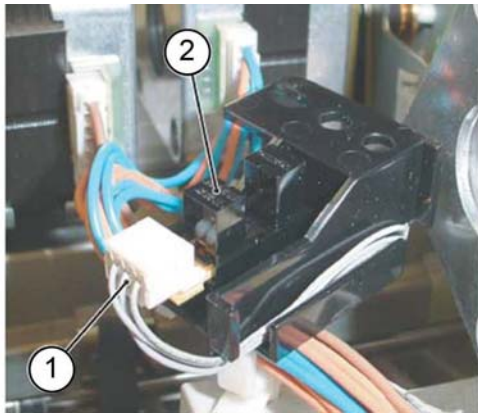
Y-1-0332-A

9. Remove the front tamper home sensor, [Figure 4](#):
 - a. Disconnect the connector (1).
 - b. Remove the front tamper home sensor (2).

Figure 4 Front tamper home sensor removal

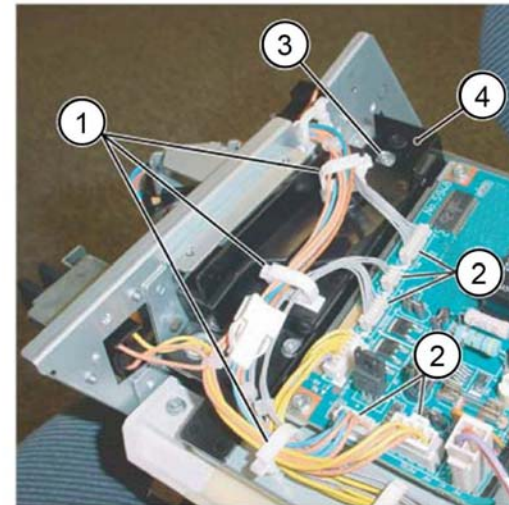
Y-1-0333-A

1. Remove the integrated office finisher, [REP 12.1](#).
2. Remove the front inner cover, [PL 12.05 Item 6](#).
3. Remove the rear cover, [PL 12.05 Item 14](#).
4. Turn over the integrated office finisher.
5. Remove the bottom cover, [PL 12.06 Item 1](#).
6. Remove the connector bracket, [Figure 1](#):
 - a. Release the harness from the three clamps (1).
 - b. Disconnect the connectors (2).
 - c. Remove two screws (3).
 - d. Remove the connector bracket (4).

Figure 1 Connector bracket removal

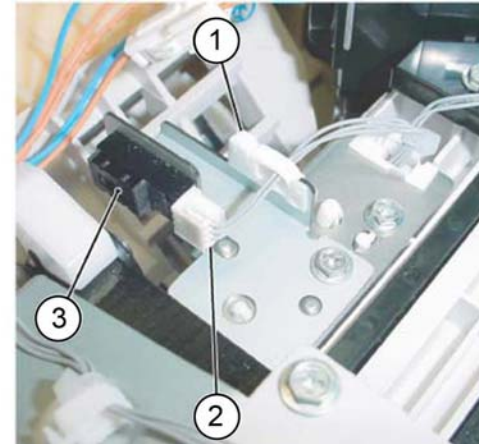
Y-1-0335-A

8. Remove the eject home sensor, **Figure 3**:
 - a. Release the harness from the clamp (1).
 - b. Disconnect the connector (2).
 - c. Remove the eject home sensor (3) from the bracket.

Figure 3 Eject home sensor removal

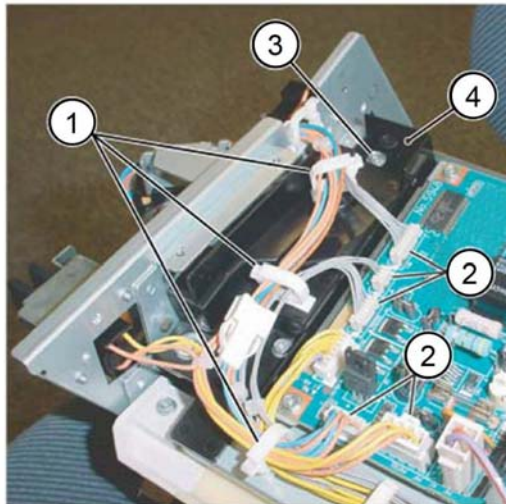
Y-1-0337-A

1. Remove the integrated office finisher, [REP 12.1](#).
2. Remove the front inner cover, [PL 12.05 Item 6](#).
3. Remove the rear cover, [PL 12.05 Item 14](#).
4. Turn over the integrated office finisher.
5. Remove the bottom cover, [PL 12.06 Item 1](#).
6. Remove the connector bracket, [Figure 1](#):
 - a. Release the harness from the three clamps (1).
 - b. Disconnect the connectors (2).
 - c. Remove two screws (3).
 - d. Remove the connector bracket (4).

Figure 1 Connector bracket removal

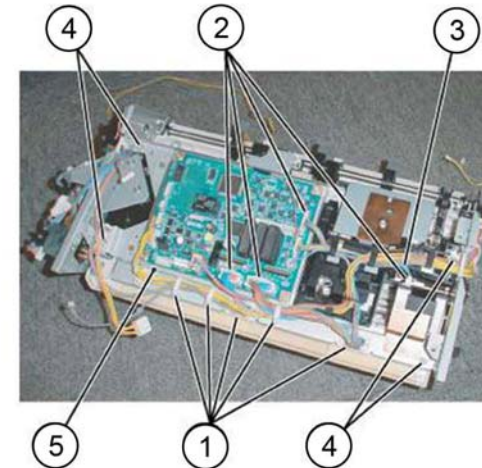
Y-1-0336-A

7. Remove the bottom plate, [Figure 2](#):
 - a. Release the harness from the 5 clamps (1).
 - b. Disconnect eight connectors (2).
 - c. Remove the harness from the retainers (3).
 - d. Remove four screws (4).
 - e. Remove the bottom plate (5).

Figure 2 Bottom plate removal

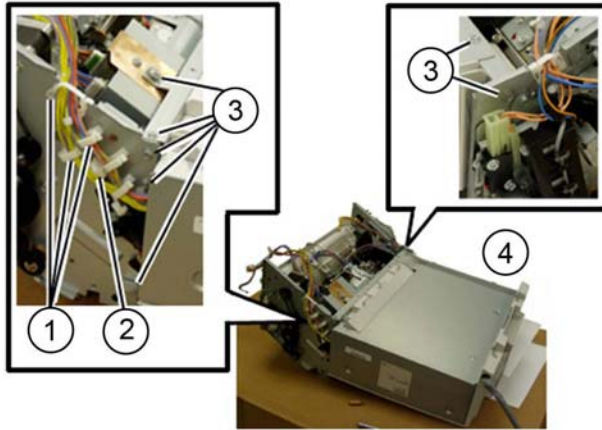
Y-1-0338-A

8. Remove the stacker tray, **Figure 3**:
 - a. Release the harness from the five clamps (1).
 - b. Disconnect the connector (2).
 - c. Remove seven screws (3).
 - d. Remove the stacker tray (4).

Figure 3 Stacker tray removal

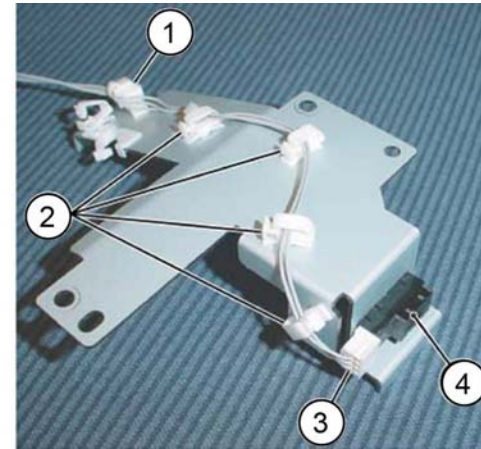
Y-1-0340-A

10. Remove the stack height sensor, **Figure 5**:
 - a. Remove the clamp (1).
 - b. Release the harness from the clamps (2).
 - c. Disconnect the connector (3).
 - d. Remove the stack height sensor (4) from the bracket.

Figure 5 Stack height sensor removal

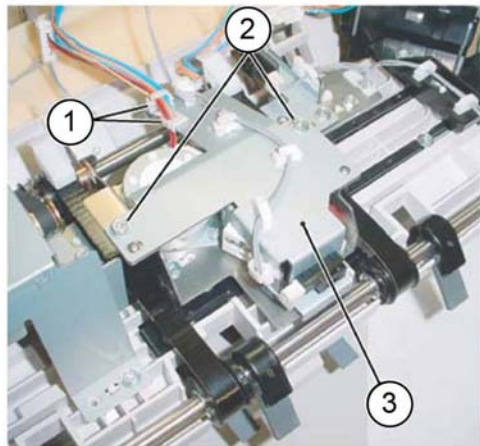
9. Remove the bracket assembly, **Figure 4**:
 - a. Release the harness from both clamps (1).
 - b. Remove two screws (2).
 - c. Remove the bracket assembly (3).

Figure 4 Bracket assembly removal

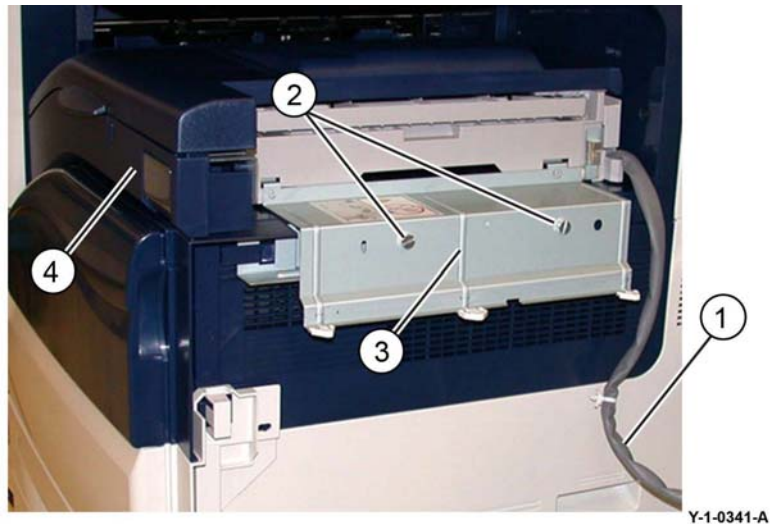
1. Undock the finisher, [REP 13.5](#).
2. Remove the H-transport assembly, [Figure 1](#):
 - a. Disconnect the harness (1).
 - b. Remove two screws (2).
 - c. Remove the docking plate (3).
 - d. Remove the H-transport (4).

Figure 1 H-transport removal

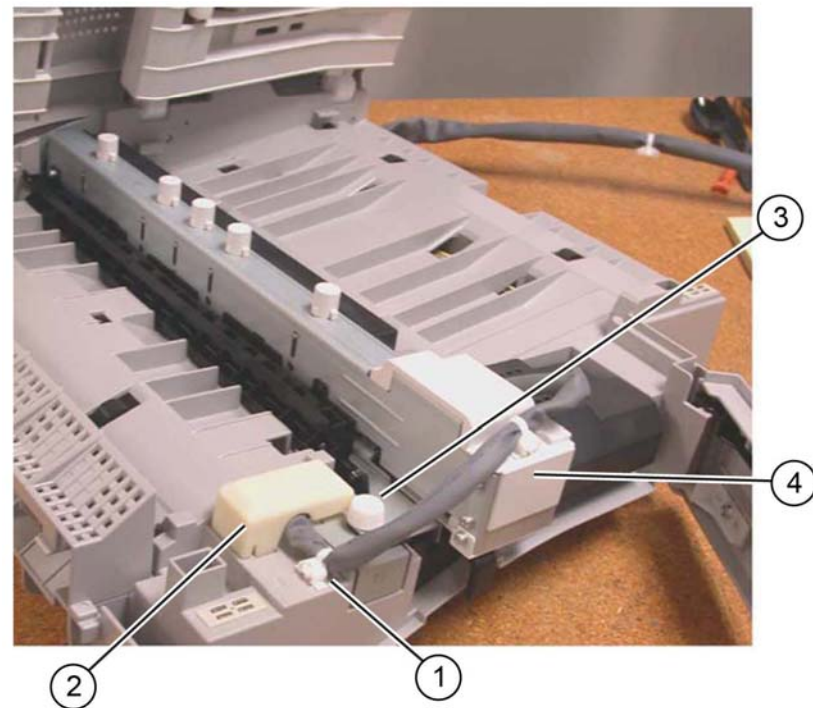
NOTE: For clarity, the H-transport is shown removed from the machine in [Figure 1](#).

1. Hold open the H-transport top cover.
2. Open the H-transport front cover.
3. Remove the hole punch assembly, [Figure 1](#):
 - a. Release the cable clamp (1).
 - b. Remove the connector cover (2), then disconnect the connector.
 - c. Remove the thumbscrew (3).
 - d. Remove the hole punch assembly (4).

Figure 1 Hole punch assembly removal

1. Insert the hole punch assembly rear locating pin into the H-transport frame.
2. The replacement is the reverse of the removal procedure.
3. Perform [ADJ 13.1](#) Finisher LX Hole Punch Position.

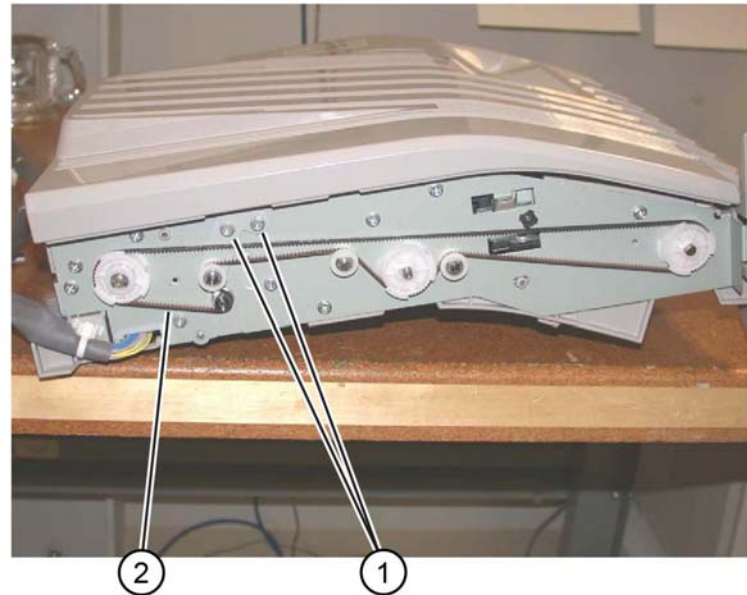
Y-1-0343-A

1. Remove the H-transport assembly, [REP 13.1](#).
2. Remove the H-transport rear cover, [PL 13.06](#) Item 9.
3. Remove the H-transport belt, [Figure 1](#):
 - a. Loosen two screws to release the belt tension (1).
 - b. Remove the belt (2).

Figure 1 H-transport belt removal

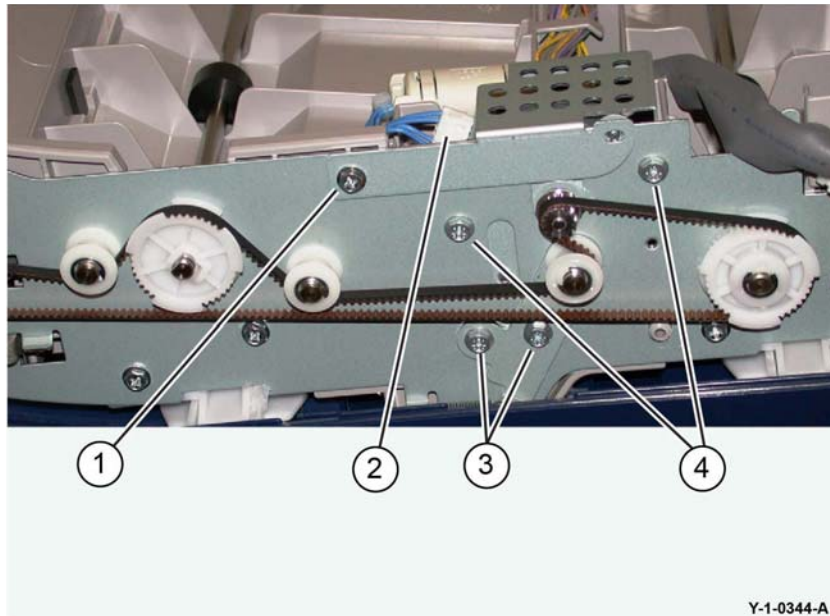
1. Remove the H-transport assembly, [REP 13.1](#).
2. Remove the H-transport rear cover, [PL 13.06 Item 9](#).
3. Place the H-transport top down on a work surface.
4. Remove the H-transport motor, [Figure 1](#):
 - a. Remove the screw, then the shield (1).
 - b. Disconnect the connector (2).
 - c. Loosen two screws to release the belt tension (3).
 - d. Remove two screws (3), then remove the H-transport motor.

Figure 1 H-transport motor removal

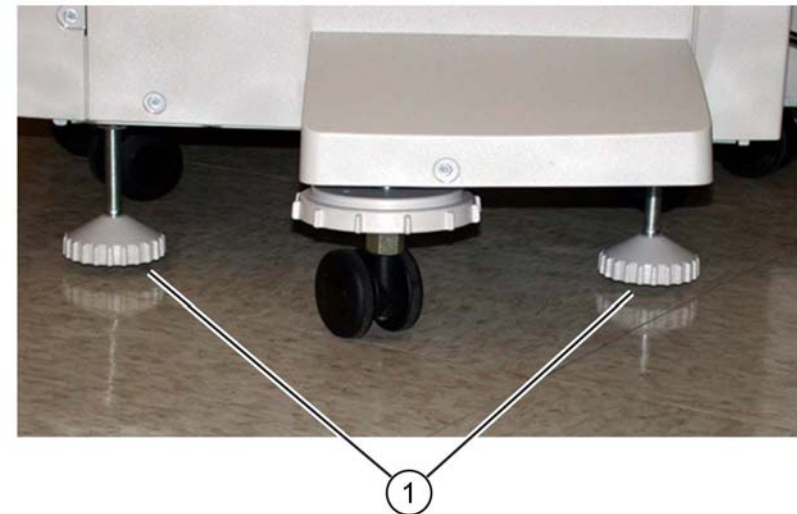
Y-1-0345-A

2. Raise the feet (1) to free the finisher, [Figure 1](#).

Figure 1 Finisher feet

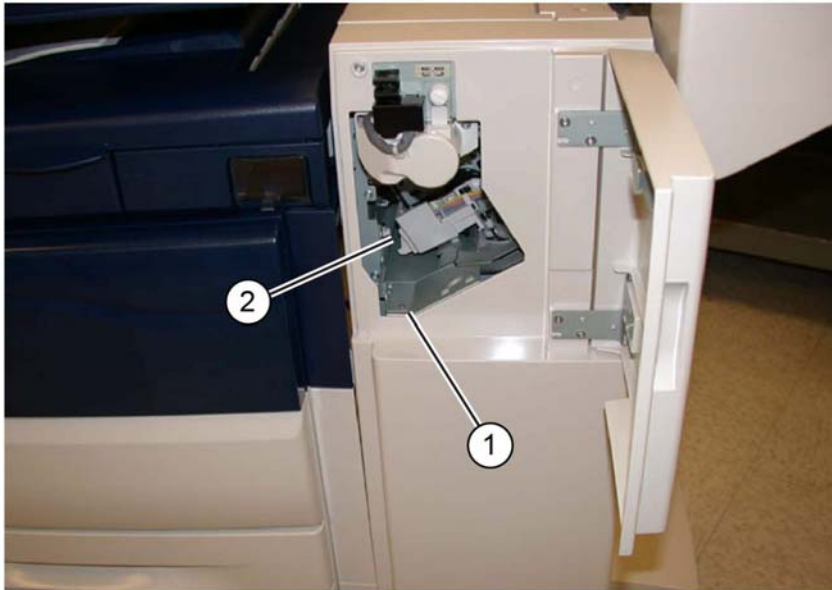
Y-1-0346-A

4. Undock the finisher, [Figure 2](#):
 - a. Remove the screw (1).
 - b. Pull the docking plate lever (2) forwards to detach the finisher.

Figure 2 Finisher undocking

1. Align the machine docking bracket with the cut outs in the finisher docking bracket.
2. Mate the finisher to the machine until it latches.
3. Check that the finisher is firmly latched to the machine.
4. Perform the remainder of the replacement procedure in reverse of the removal procedure.

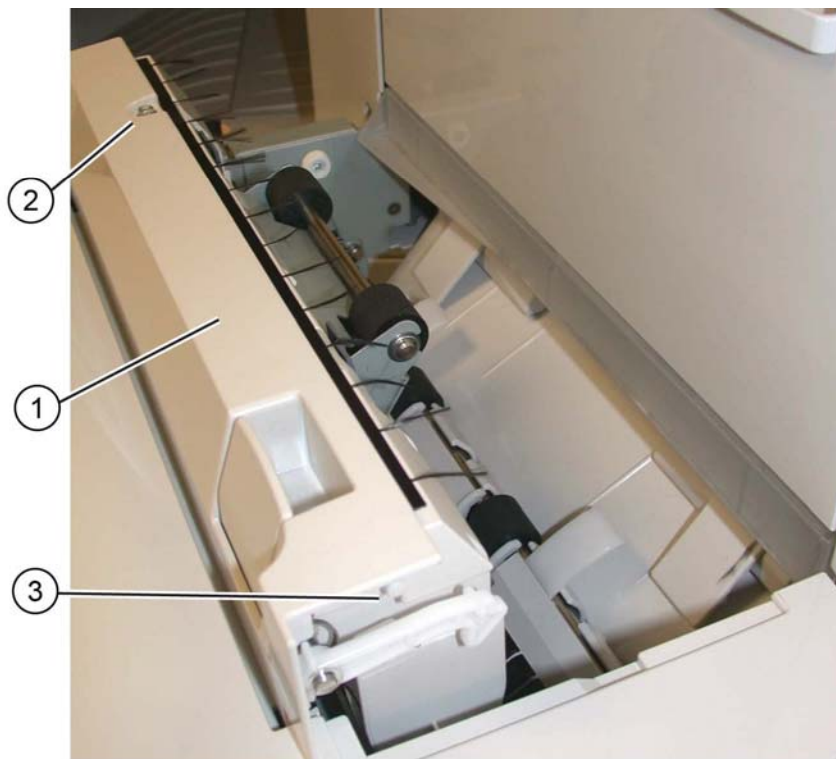
Y-1-0347-A

1. Remove the eject cover, [Figure 1](#):
 - a. Unlatch the eject cover (1), then move it to the left.
 - b. Remove the retaining screw (2).
 - c. Push the latch (3) through the hole in the cover.
 - d. Remove the cover by moving it to the left.

Figure 1 Eject cover removal

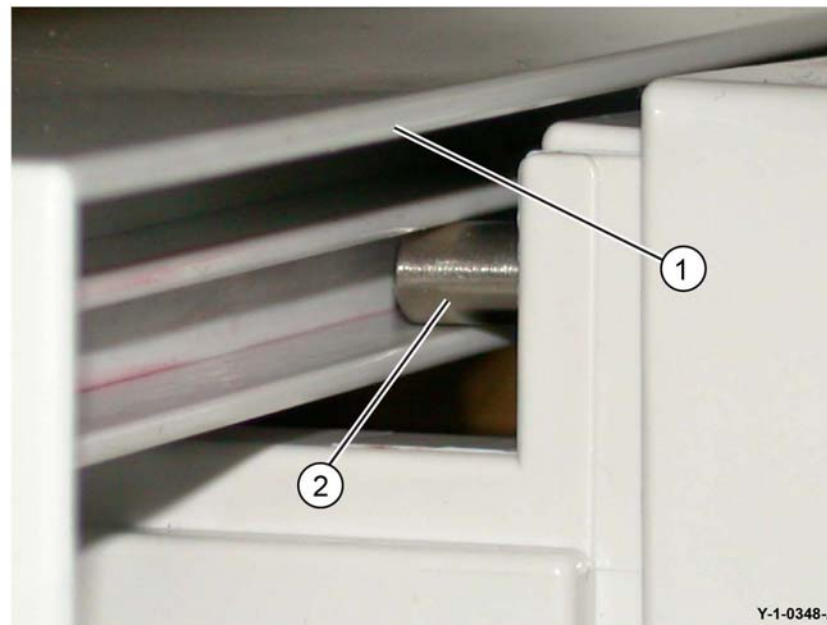
Y-1-0348-A

1. Align the eject cover (1) with the pins (2) on both sides, then slide it to the right, [Figure 2](#).

NOTE: The left side of the cover will be captured by the pins and cannot be lifted up.

Figure 2 Eject cover alignment

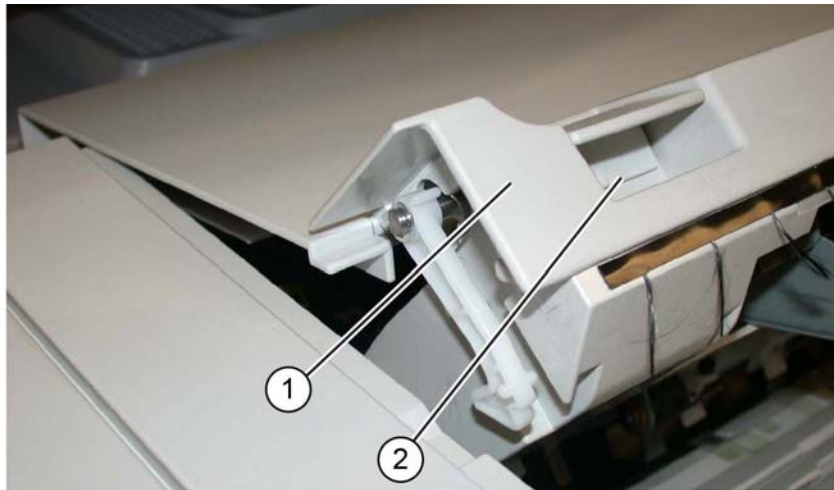
Y-1-0349-A

2. Position the eject cover (1) so that the latch (2) is inserted in the hole, [Figure 3](#).

NOTE: The Latch must be outside the hole.

Figure 3 Inserting the Latch

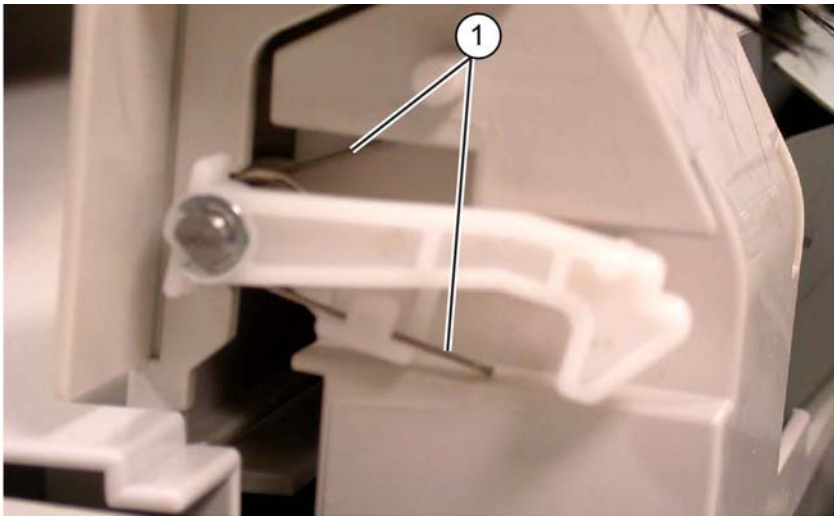
Y-1-0350-A

3. Position the latch spring (1) as shown, [Figure 4](#).

Figure 4 Latch spring position

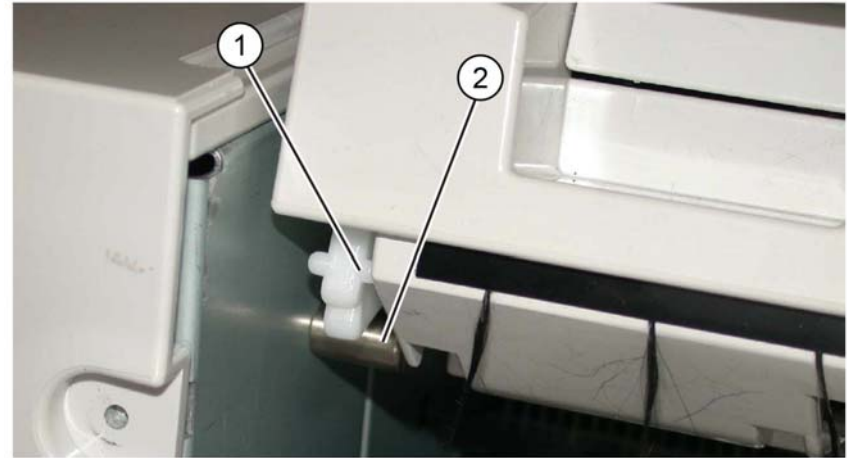
Y-1-0351-A

4. Position the latch hook (1) and latch pin (2) are positioned as shown, [Figure 5](#).

Figure 5 Latch hook and latch pin positioning

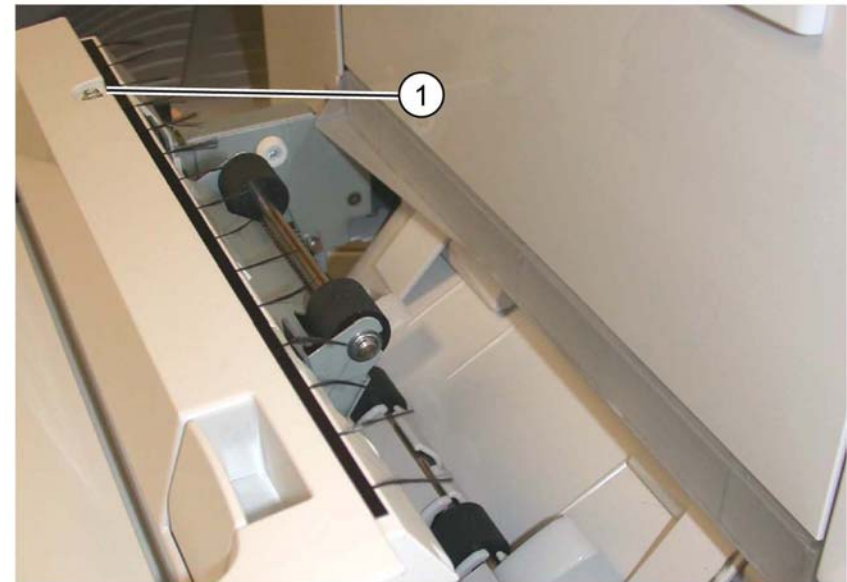
Y-1-0352-A

5. Install the retaining screw (1), [Figure 6](#).

Figure 6 Retaining screw

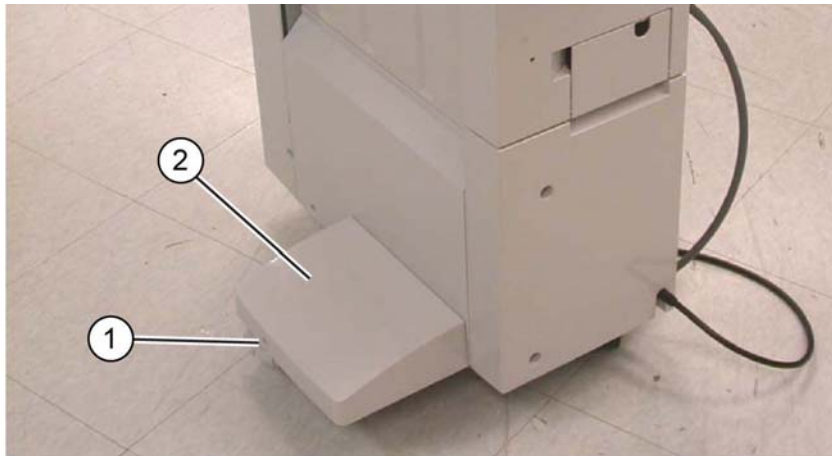
Y-1-0353-A

1. Remove the screw (1), then the foot cover (2), [Figure 1](#).

Figure 1 Foot cover removal

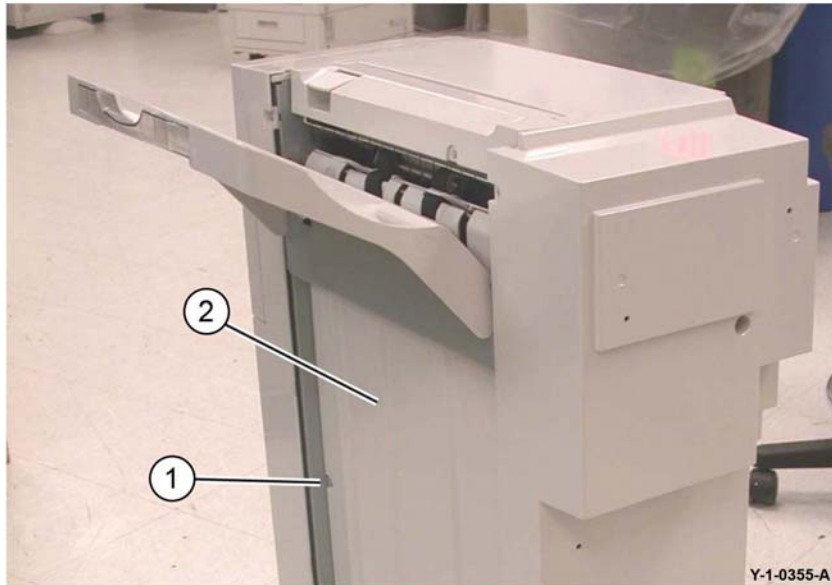
1. Remove the stacker tray, [REP 13.20](#).
2. Remove the stacker lower cover, [REP 13.11](#).
3. Remove six screws (1), then the stacker upper cover (2), [Figure 1](#).

Figure 1 Stacker upper cover removal

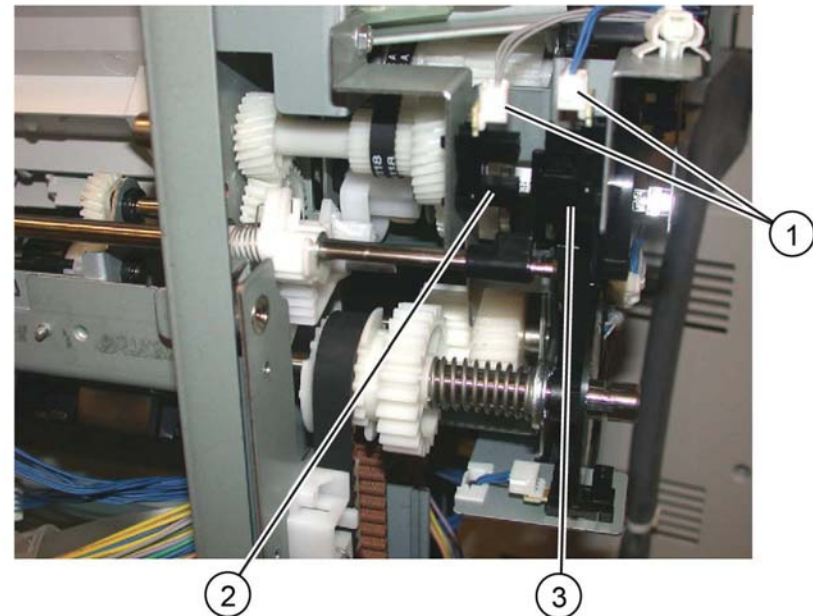
1. Remove the rear upper cover, [REP 13.7](#).
2. Remove the relevant stack height sensor, [Figure 1](#):
 - a. Disconnect the relevant connector (1).
 - b. Remove either stack height sensor 1 (2) or stack height sensor 2 (3).

Figure 1 Sensor removal

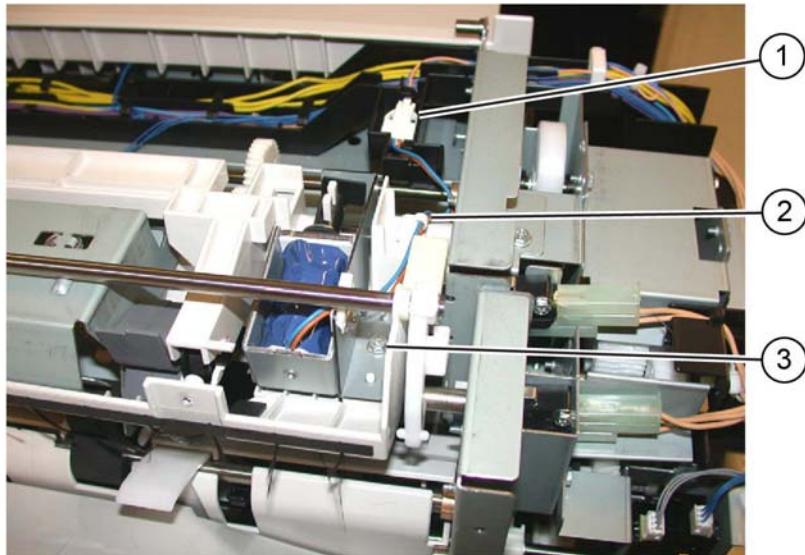
Y-1-0357-A

1. Remove the eject cover, [REP 13.9](#).
2. Remove the sub paddle solenoid assembly, [Figure 1](#):
 - a. Disconnect the connector (1).
 - b. Release the harness from the clamps (2).
 - c. Remove the screw (3), then the sub paddle solenoid assembly.

Figure 1 Sub paddle solenoid assembly removal

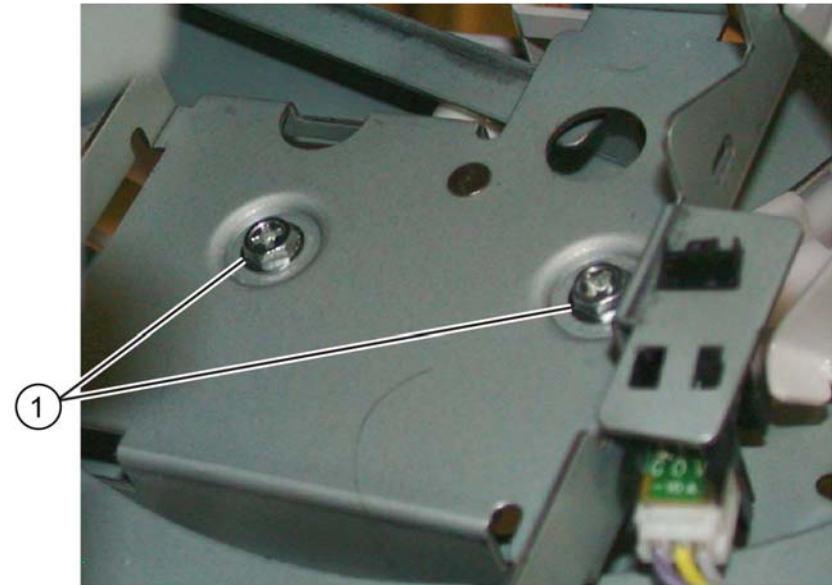
Y-1-0410-A

1. Remove the finisher stapler assembly, [REP 13.16](#).
2. Remove two screws (1), [Figure 1](#).

Figure 1 Screw removal

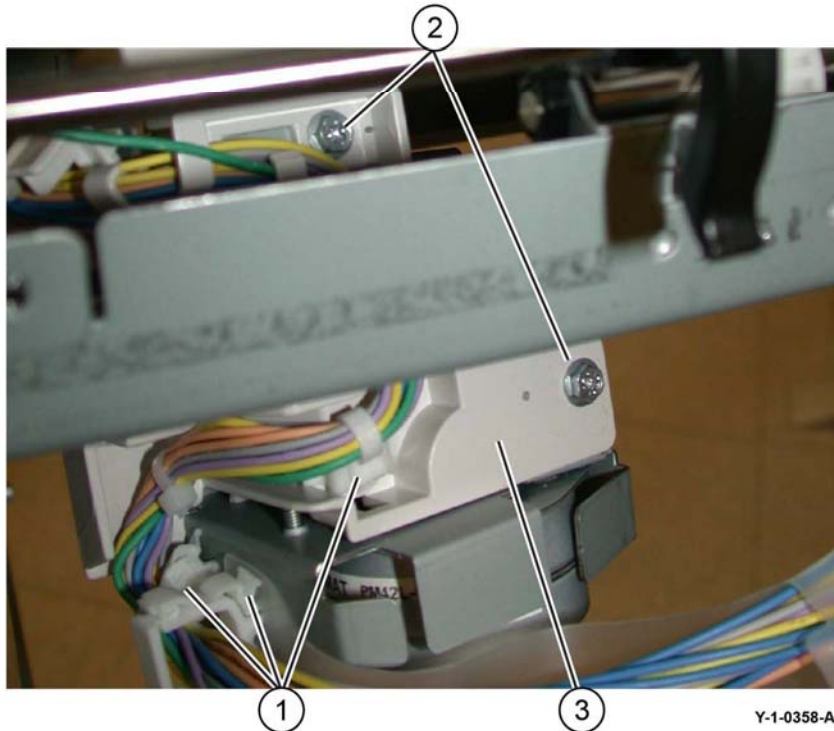
Y-1-0358-A

3. Remove the wire guide, **Figure 2**:
 - a. Pull out the cable clamps (1), then remove the wires from the wire guide.
 - b. Remove two screws (2).
 - c. Remove the wire guide (3).

Figure 2 Wire guide removal

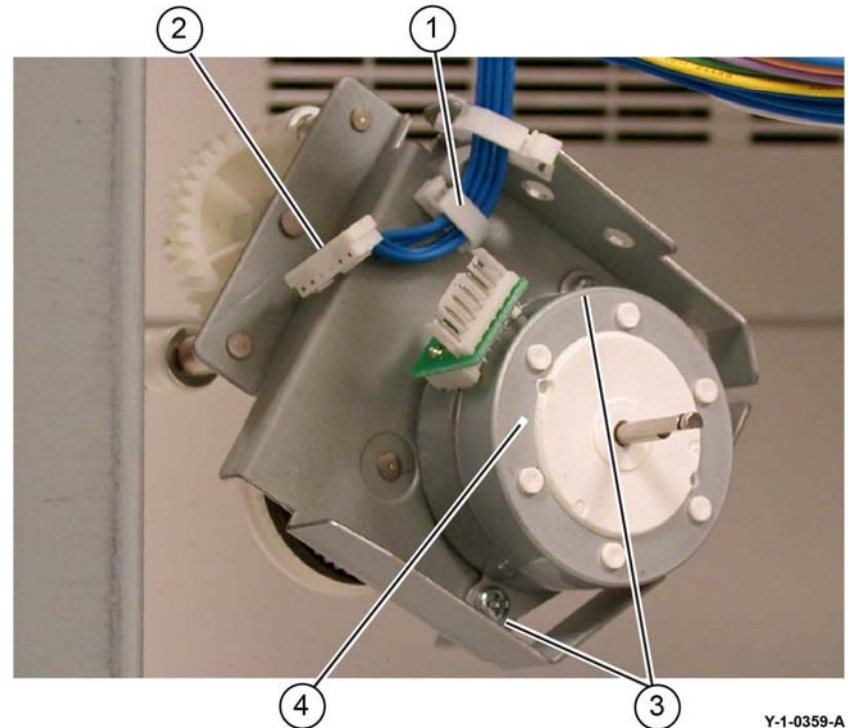
Y-1-0359-A

4. Remove the stapler motor, **Figure 3**:
 - a. Release the wires from the cable clamp (1).
 - b. Disconnect the connector (2).
 - c. Remove two screws (3).
 - d. Remove the stapler motor (4).

Figure 3 Stapler motor removal

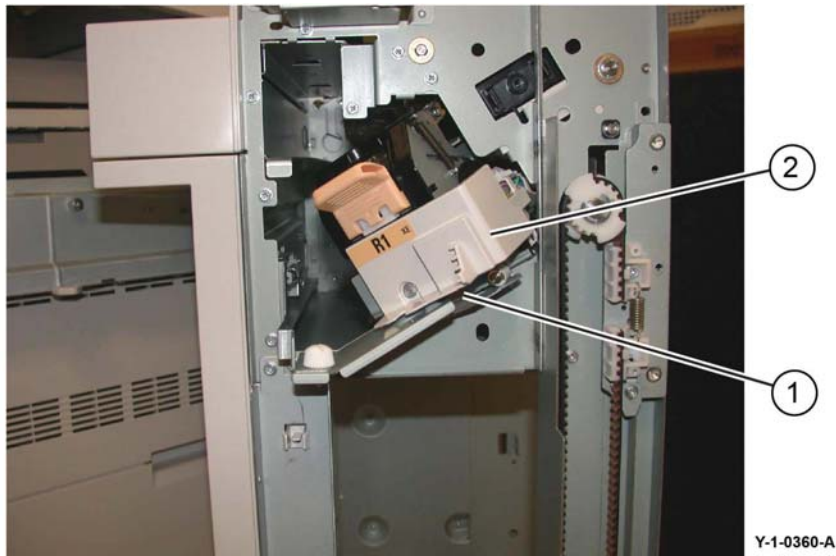
1. Remove the creaser knife assembly, [REP 13.18](#).
2. Remove the front cover assembly, [REP 13.6](#).
3. Remove the stapler cover, [Figure 1](#):
 - a. Remove the screw (1).
 - b. Remove the stapler cover (2).

Figure 1 Stapler cover removal
