708P91370
April 2017

Xerox® VersaLink® B7025/B7030/B7035 Multifunction Printer Service Manual

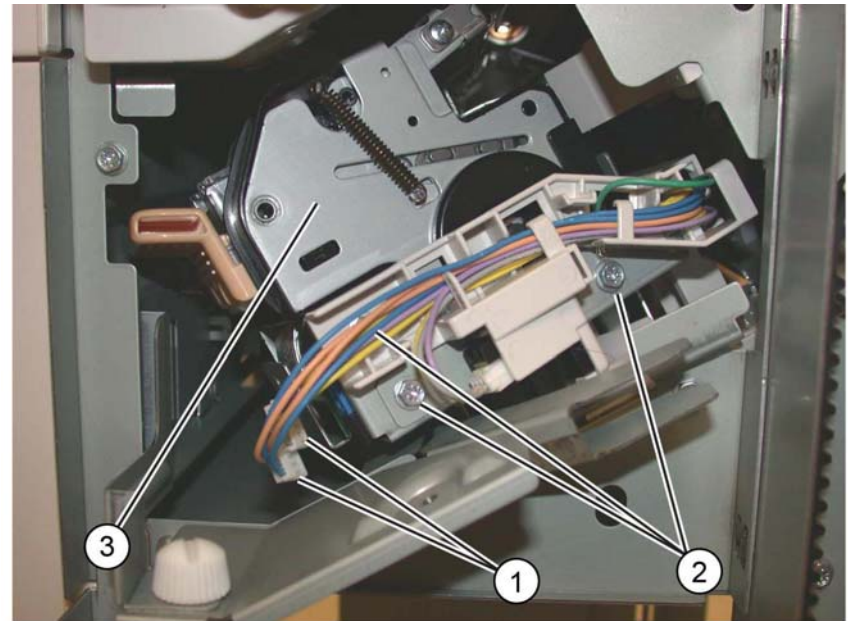
Y-1-0361-A

4. Remove the finisher stapler assembly, [Figure 2](#):
 - a. Disconnect the connectors (1).
 - b. Remove three screws (2).
 - c. Remove the finisher stapler assembly (3).

Figure 2 Finisher stapler assembly removal

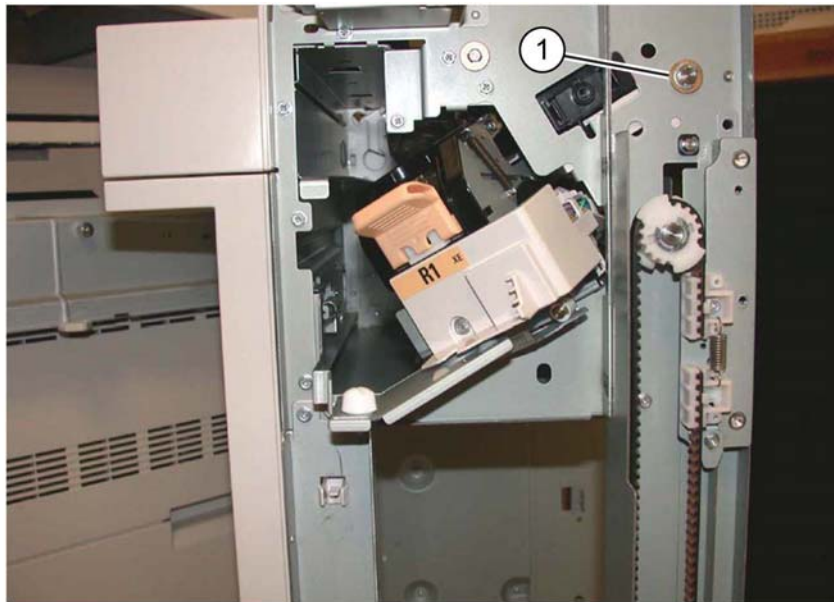
Y-1-0362-A

1. Undock the finisher, [REP 13.5](#).
2. Remove the front cover, [REP 13.6](#).
3. Remove the rear upper cover, [REP 13.7](#).
4. Remove the foot cover, [REP 13.10](#).
5. Remove the stacker lower cover, [REP 13.11](#).
6. Remove the stacker tray, [REP 13.20](#).
7. Remove the stacker upper cover, [REP 13.12](#).
8. Remove the eject cover, [REP 13.9](#).
9. Remove the E-ring and brass bearing from the front of the shaft (1), [Figure 1](#).

Figure 1 E-ring and bearing removal

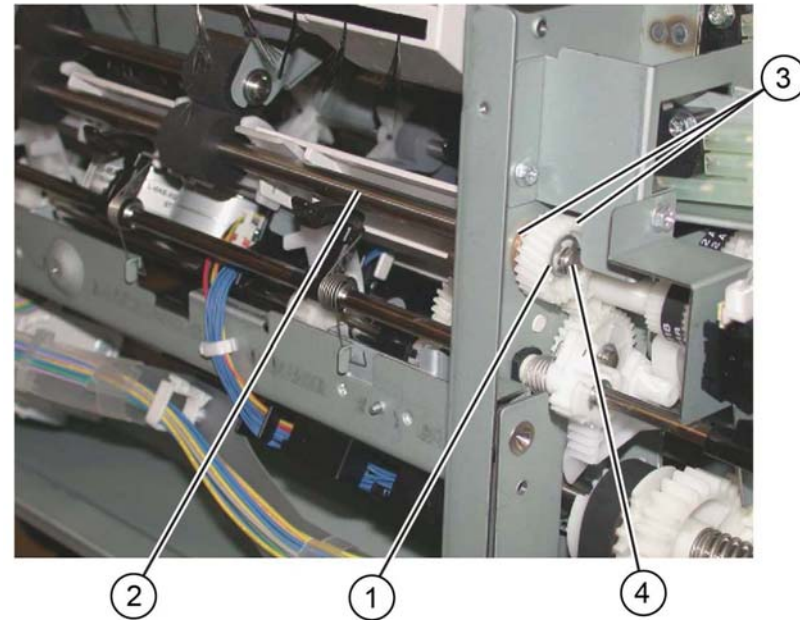
Y-1-0363-A

10. Remove the eject roll shaft, [Figure 2](#):
 - a. Remove the E-ring (1).
 - b. Slide the eject roller shaft (2) toward the front.
 - c. Remove the gear and brass bushing (3).
 - d. Remove the eject roll shaft (4) from the finisher.

Figure 2 Eject roll shaft removal

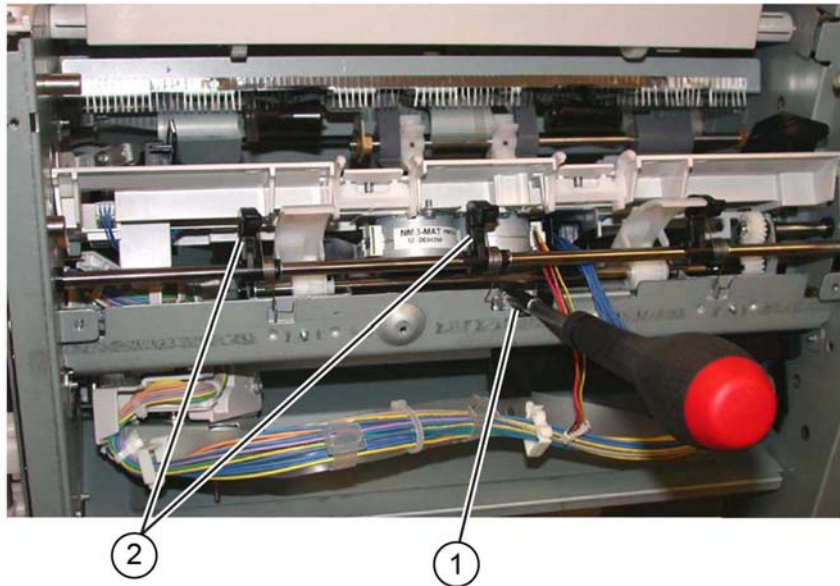
Y-1-0364-A

11. Remove the compiler tray screw (1), [Figure 3](#).

NOTE: Note the position of the set clamp holders (2).

Figure 3 Compiler tray screw removal

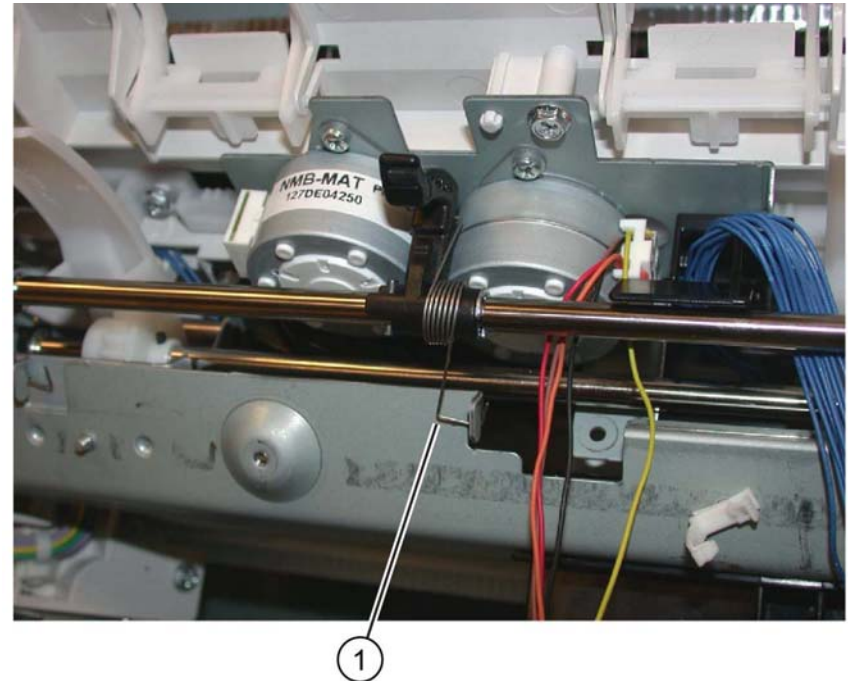
Y-1-0365-A

12. Disengage the three springs (1) from the set clamp holders, [Figure 4](#).

Figure 4 Set clamp holder springs

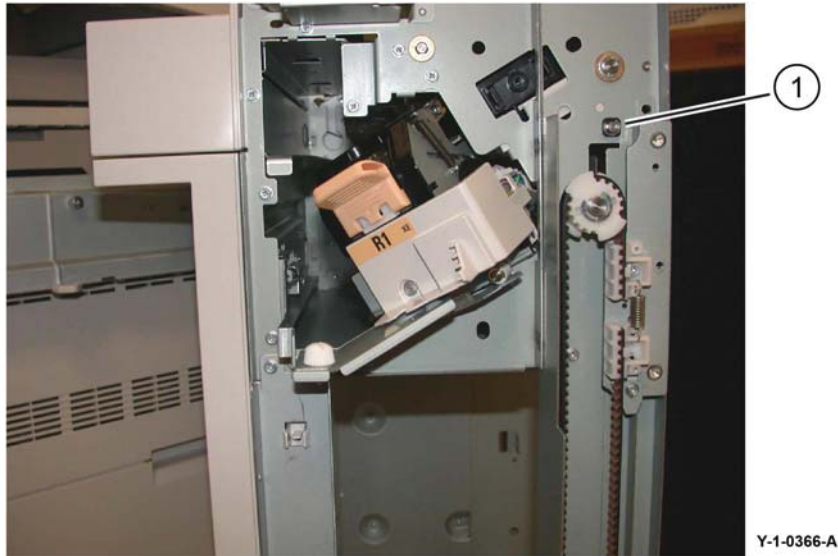
Y-1-0366-A

13. Remove the front E-ring and the bushing (1) from the set clamp shaft assembly, [Figure 5](#).

Figure 5 Front E-ring removal

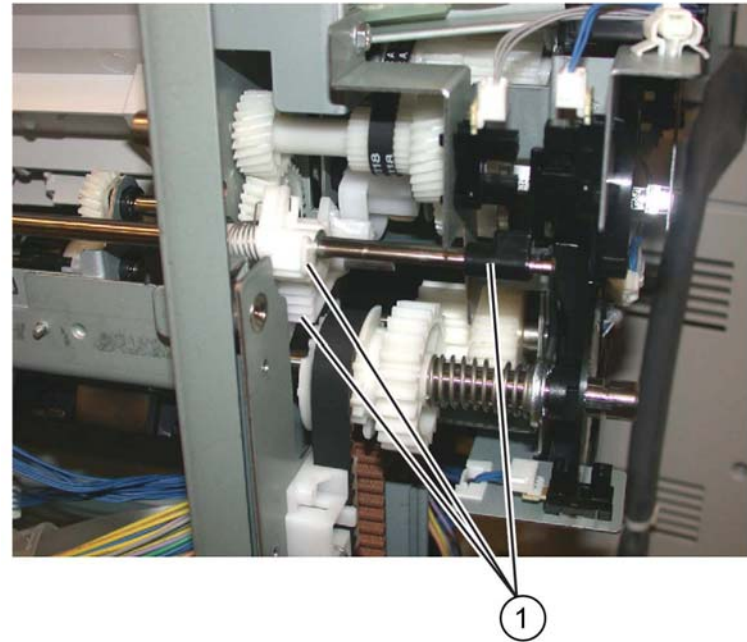
Y-1-0367-A

NOTE: Note the position and orientation of the set clamp shaft gear and the cam gear that it engages (1). When installing the set clamp shaft, these gears must engage in the same manner, [Figure 6](#).

Figure 6 Gear orientation

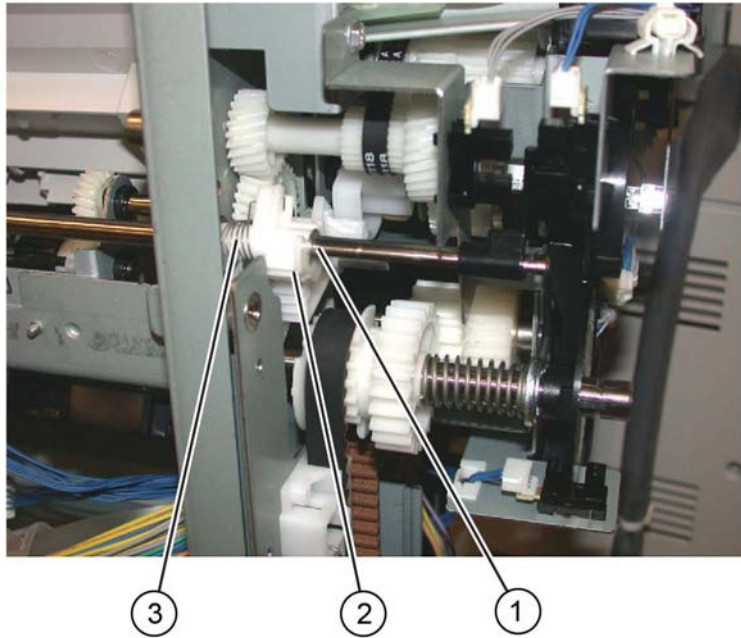
Y-1-0368-A

14. Prepare to remove the set clamp shaft, **Figure 7**:
 - a. Remove the rear E-ring (1) from the set clamp shaft
 - b. Slide the gear (2) away from the frame.
 - c. Disconnect the spring (3) from the gear.

Figure 7 Prepare to remove the set clamp shaft

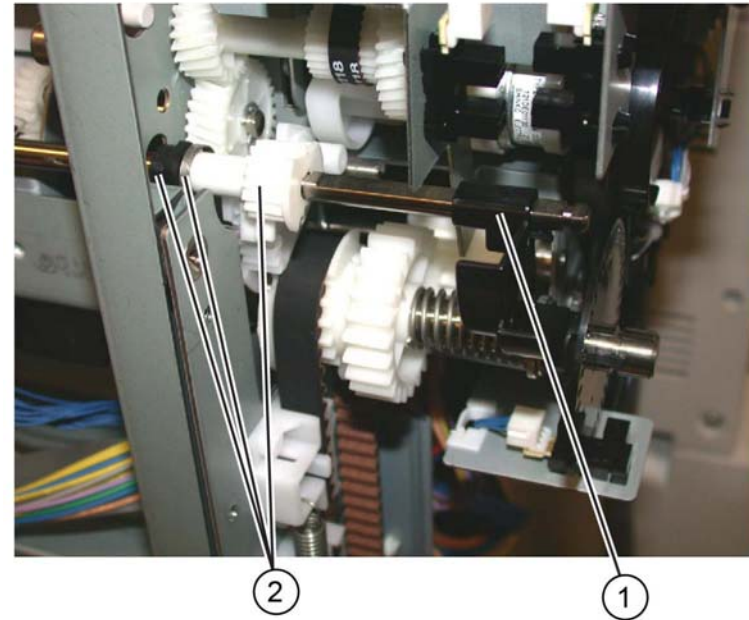
15. Slide the gear, spring and the bushing away from the frame, **Figure 8**:
 - a. Unlock, then remove the flag (1).
 - b. Slide the gear, spring and the bushing (2) away from the frame.

Figure 8 Flag removal

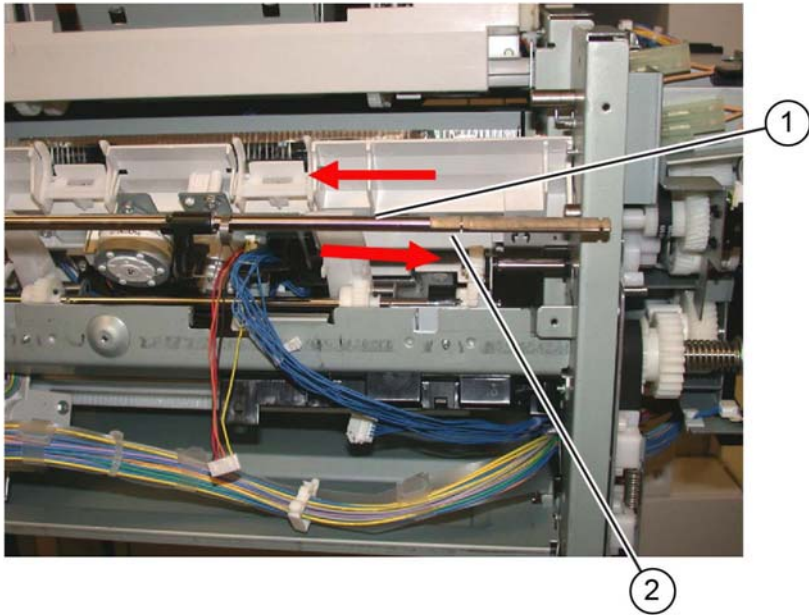
16. Remove the set clamp shaft, [Figure 9](#):
 - a. Slide the shaft toward the front (1).
 - b. Slide the shaft toward the rear, then remove (2).

Figure 9 Set clamp shaft removal

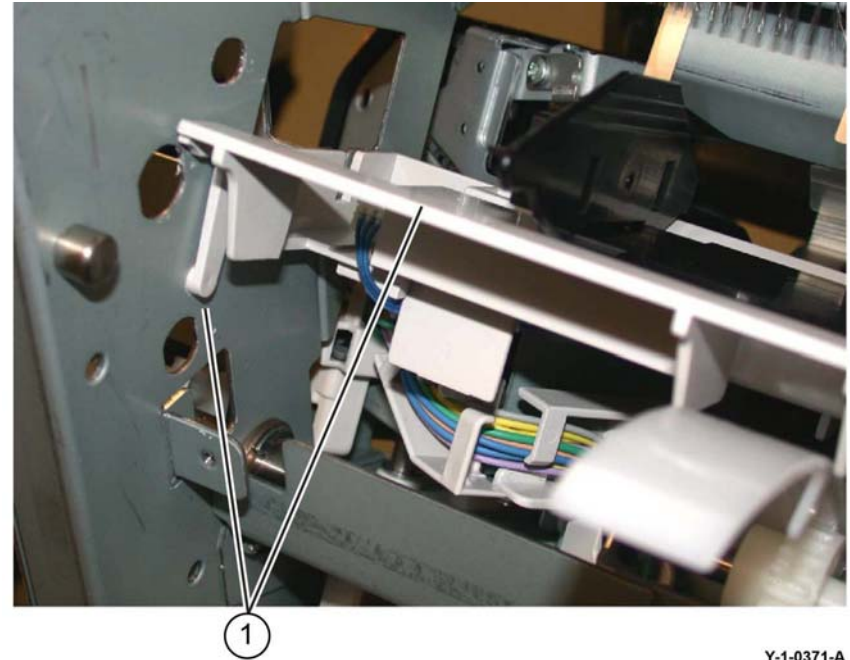
17. Remove the compiler tray assembly (1), [Figure 10](#).

Figure 10 Compiler tray assembly removal

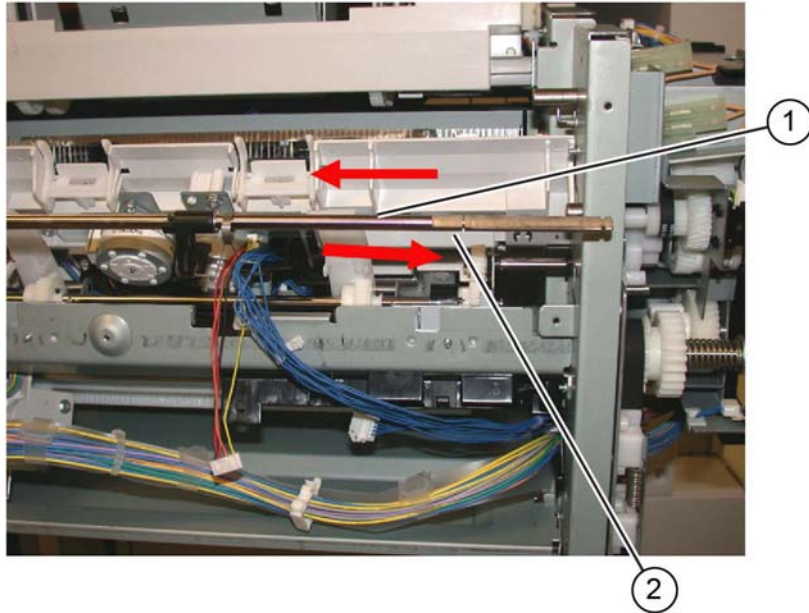
1. Route the harness through the wire guides and connect the proper connectors to the no paper sensor, tamper home sensors and tamper motors.
2. Place the compiler tray assembly into position.
3. Install the set clamp shaft front end into the front frame, **Figure 11**:
 - a. Insert the front end of the shaft into the front frame (1).
 - b. Slide the shaft toward the front until the rear end of the shaft can be inserted into the rear frame (2).

Figure 11 Set clamp shaft installation

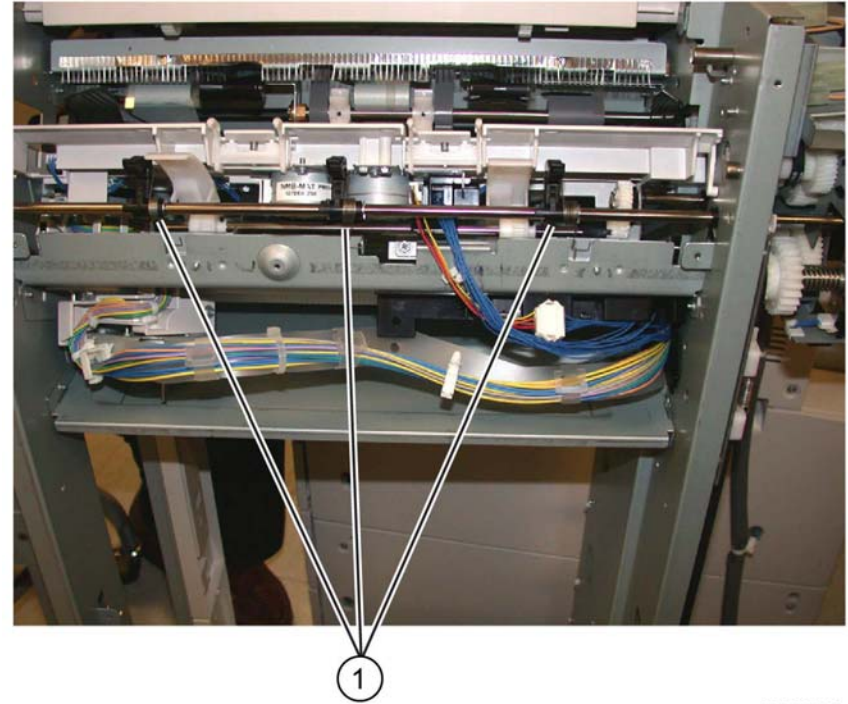
4. Slide the three set clamp holders with springs (1) into the correct location on the shaft, **Figure 12**.

Figure 12 Preparing to install the holder springs

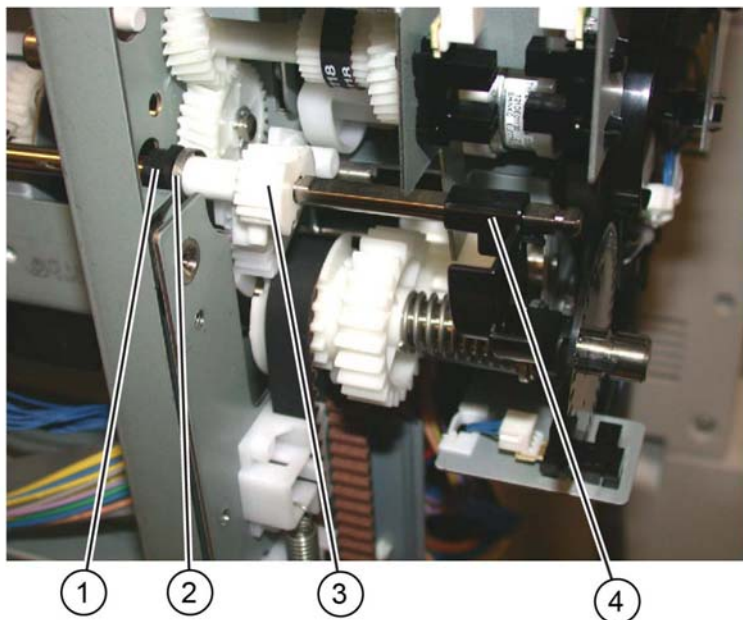
5. Install the bushing, spring and gear onto the rear end of the set clamp shaft, **Figure 13**:
 - a. Install the bushing (1).
 - b. Install the spring (2).
 - c. Install the gear (3).
 - d. Install the stack height sensor flag (4) onto the rear end of the shaft as shown.

Figure 13 Bushing, spring and gear installation

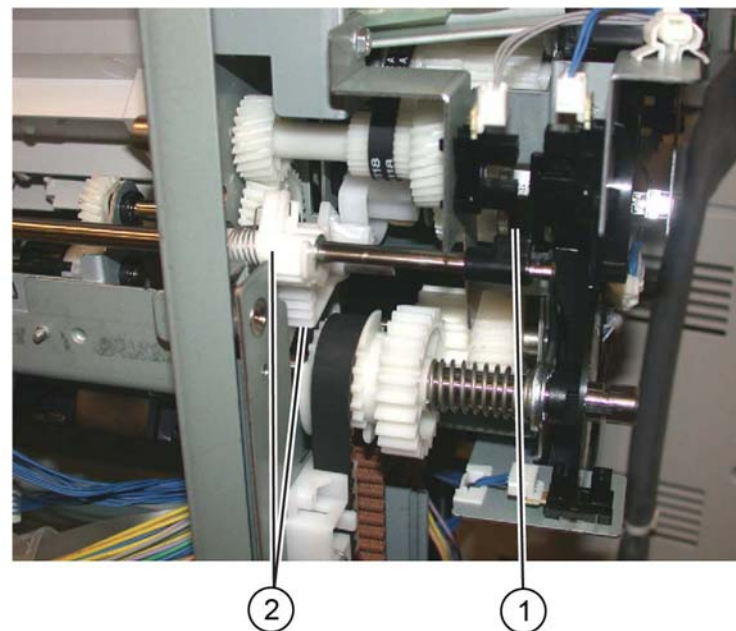
6. Rotate the set clamp shaft until the stack height sensor flag (1) is in the correct position, then correctly align both gears (2), **Figure 14**.

Figure 14 Sensor flag and gear alignment

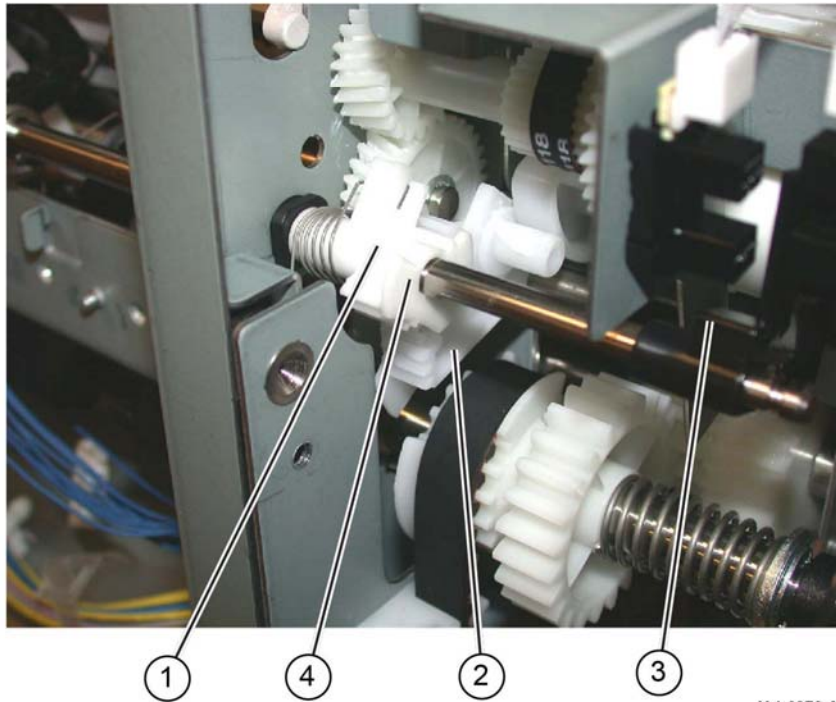
8. Ensure that the shaft gear (1), pinion gear (2) and the stack height sensor flag (3) are position as shown in [Figure 15](#), then install the E-ring (4).

Figure 15 Gears and stack height sensor flag

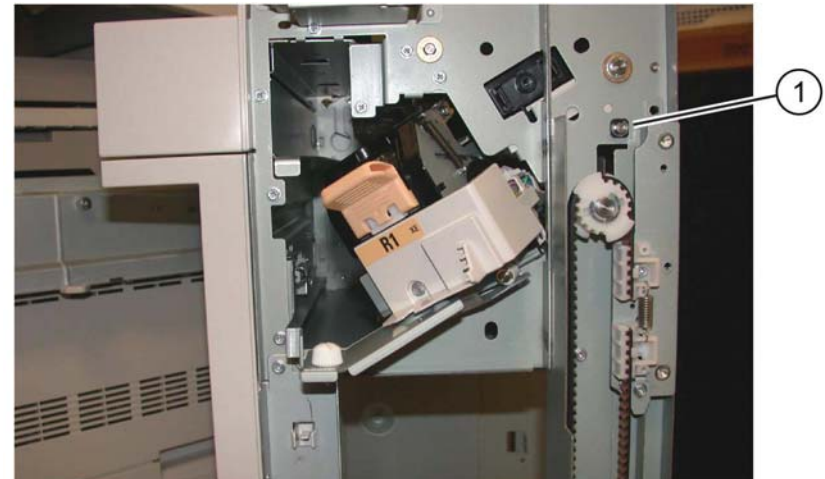
9. Install the bushing onto the front end of the set clamp shaft, then install the E-ring (1), [Figure 16](#).

Figure 16 Bushing and E-ring

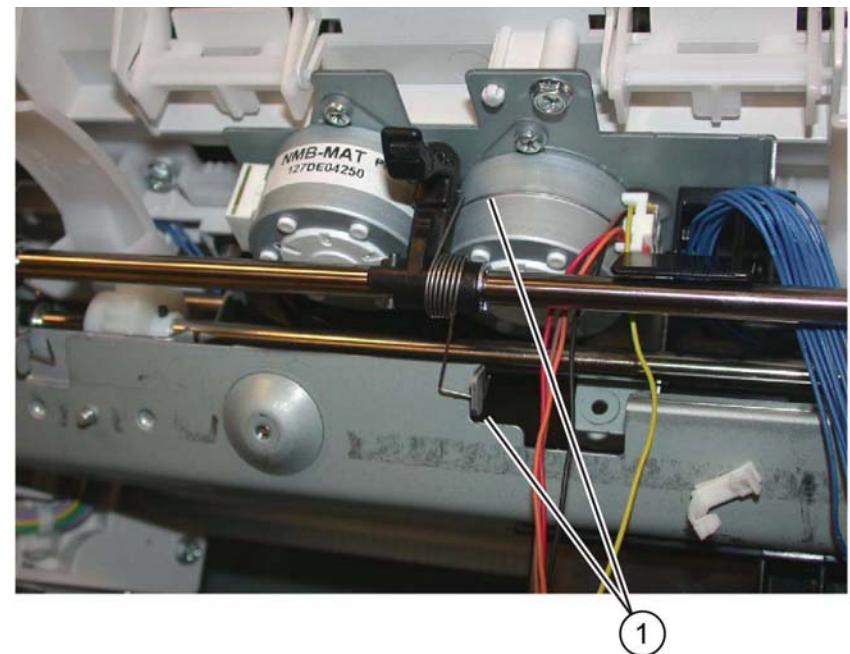
10. Ensure that the set clamp holder springs (1) are connected, [Figure 17](#).

Figure 17 Set clamp holder springs

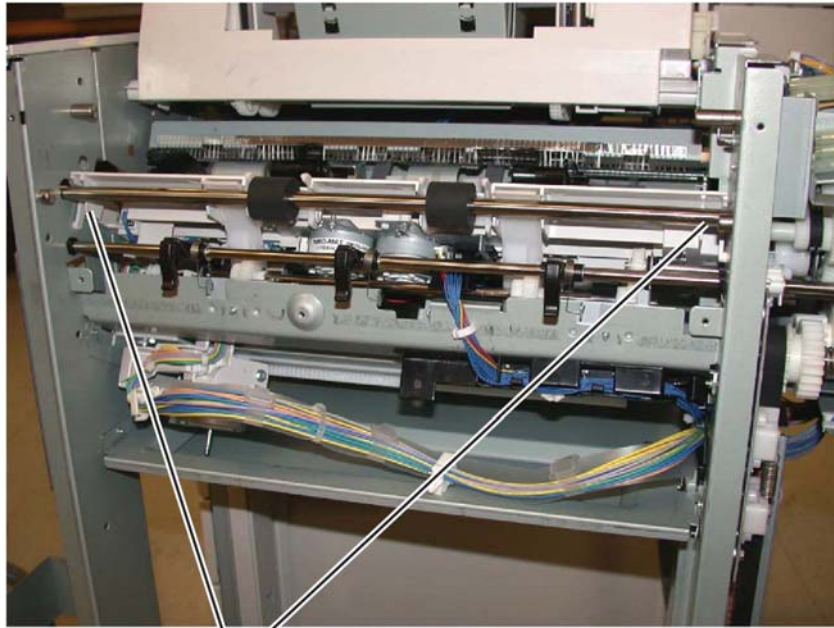
11. Install the eject roll shaft (1) into position in the front and rear frame, [Figure 18](#).

Figure 18 Eject roll shaft installation

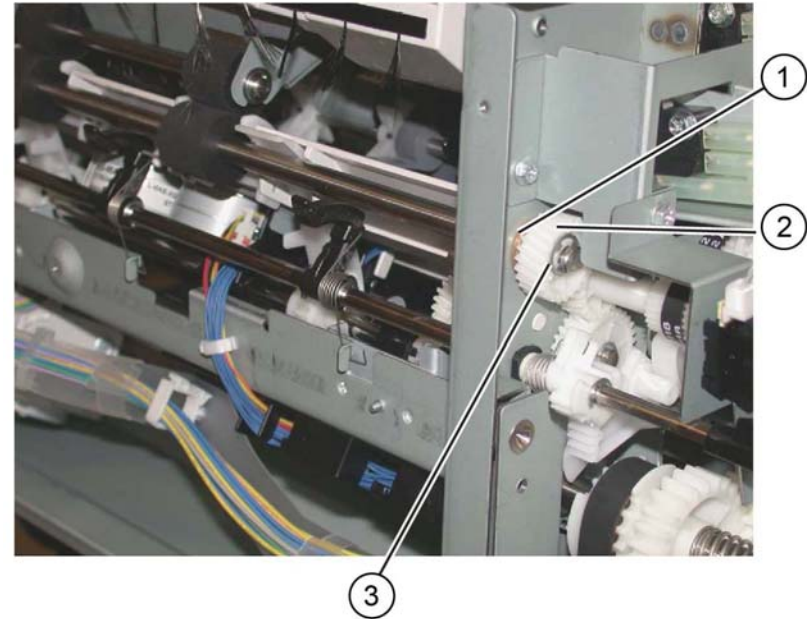
12. Install the brass bearing (1), gear (2) and E-ring (3) onto the rear of the eject roll shaft, [Figure 19](#).

Figure 19 Eject roll shaft rear components

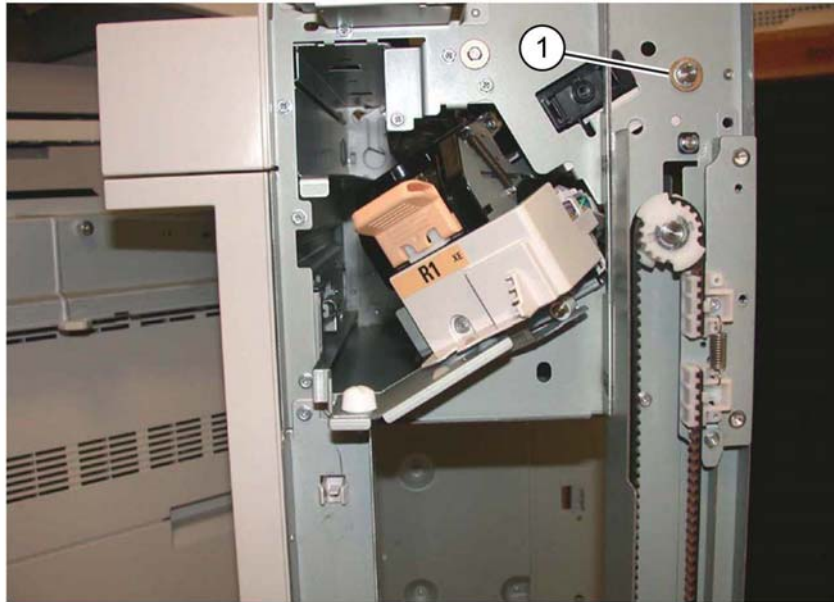
13. Install the brass bearing and E-ring onto the front of the eject roll shaft (1), [Figure 20](#).

Figure 20 Eject roll shaft front components

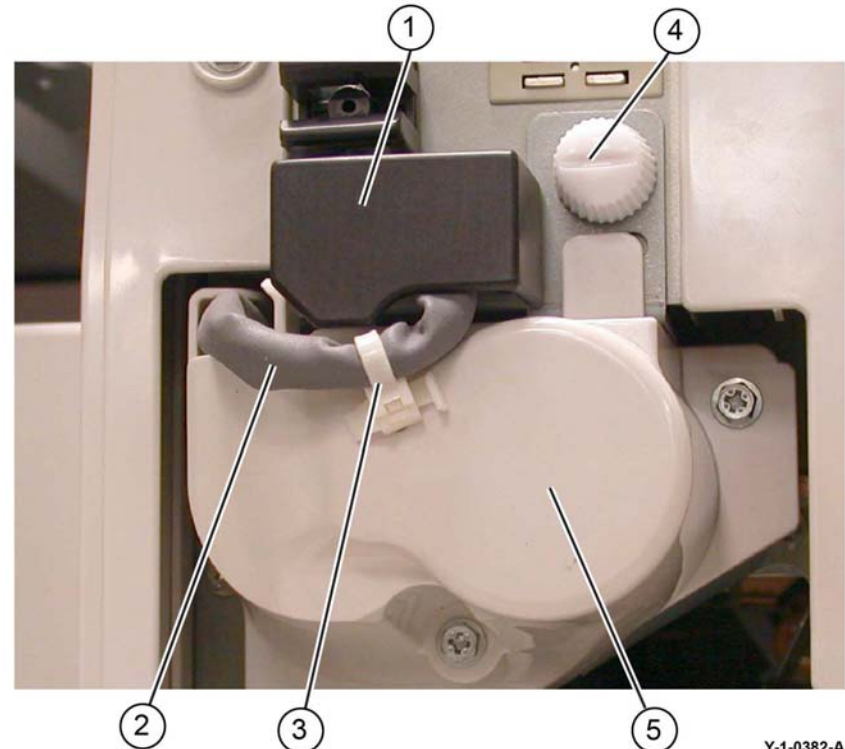
NOTE: . Pull out the cable tie (3) to obtain additional slack in the cable.

- Remove the thumbscrew (4).
- Pull out the crease assembly (5).

Figure 1 Crease assembly removal

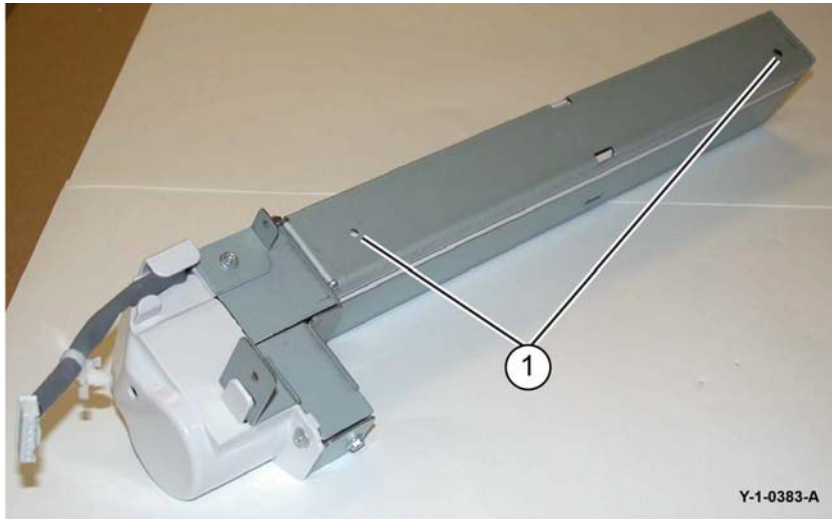
1. The replacement is the reverse of the removal procedure.
2. Ensure the locating pins (1) are correctly engaged, [Figure 2](#).

Figure 2 Crease assembly

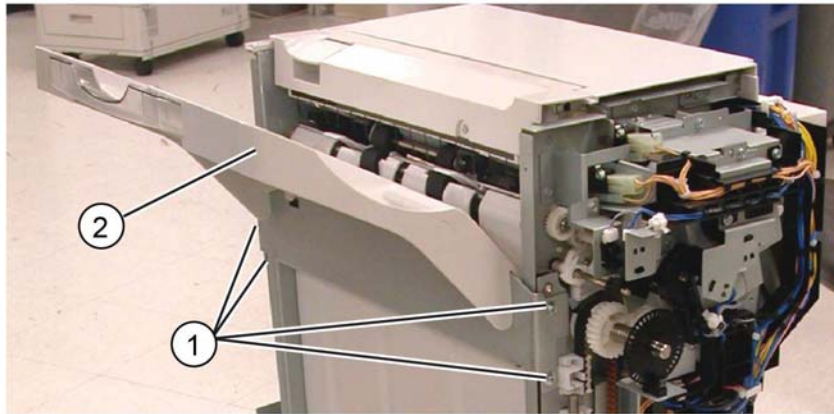
1. If installed, remove the booklet maker assembly, [REP 13.31](#).
2. Remove the front cover assembly, [REP 13.6](#).
3. Remove the rear upper cover, [REP 13.7](#).
4. Remove the stacker tray, [Figure 1](#):
 - a. Remove four screws (1).
 - b. Remove the stacker tray (2).

Figure 1 Stacker tray removal

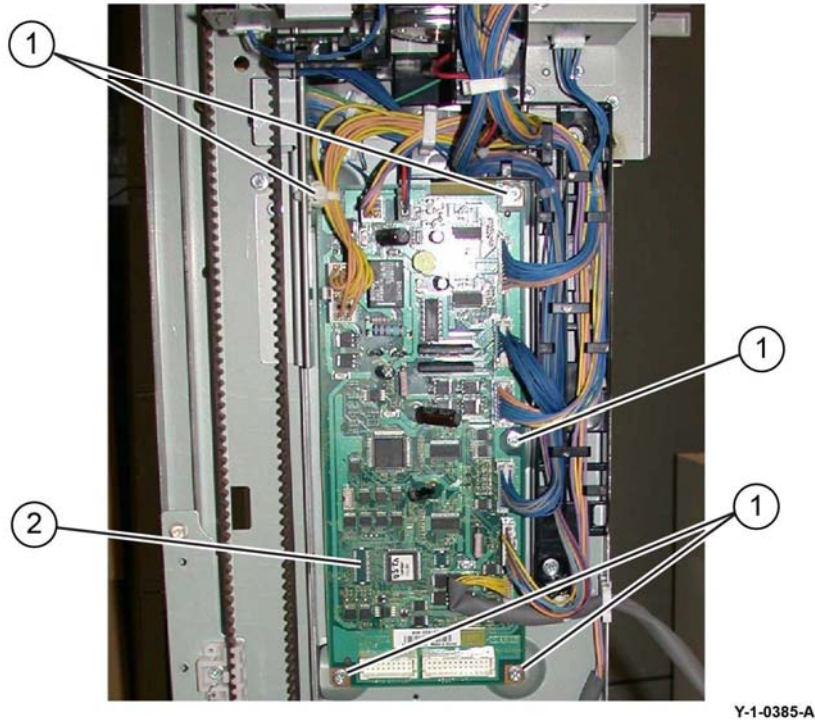
3. Remove the finisher PWB, [Figure 1](#):
 - a. Disconnect the all connectors from the finisher PWB.
 - b. Remove the five screws (1).
 - c. Remove the finisher PWB (2).

Figure 1 Finisher PWB removal

1. The replacement is the reverse of the removal procedure.
2. Check the machines current software level against the software level recorded prior to installation of the new finisher PWB. If necessary, reload the software, [GP 4](#).

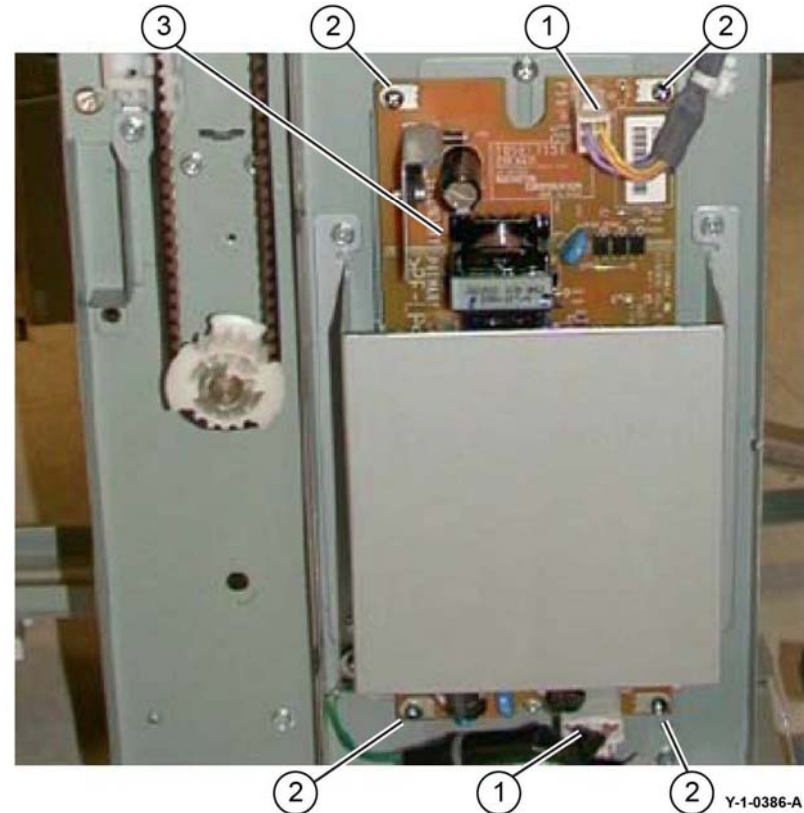
1. Remove the rear lower cover, [REP 13.8](#).
2. Remove the finisher LVPS, [Figure 1](#):
 - a. Disconnect both Connectors (1).
 - b. Remove four screws (2).
 - c. Remove the finisher LVPS (3).

Figure 1 Finisher LVPS removal

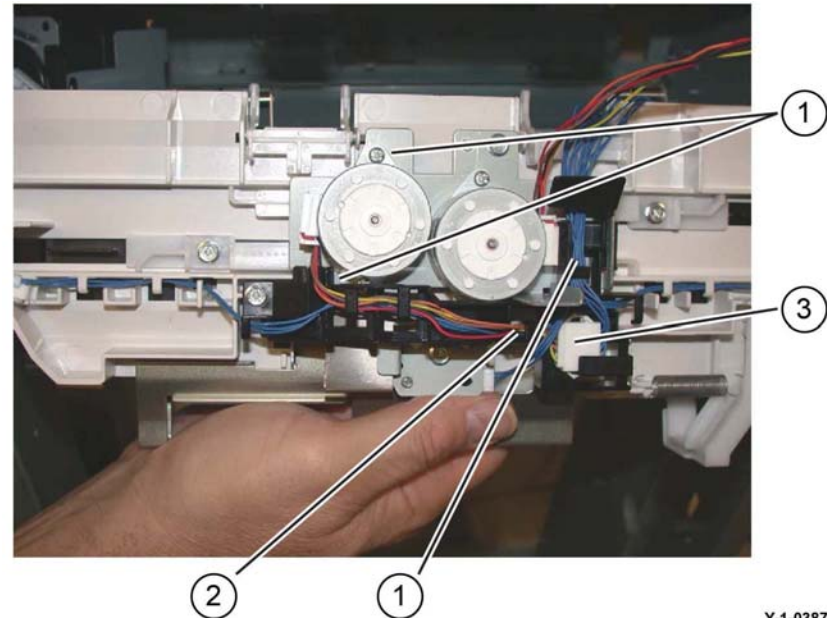
1. Remove the compiler tray, [REP 13.17](#).
2. Place the compiler tray upside down on a work surface.
3. Remove the tamper motor, [Figure 1](#):
 - a. Release the harness (1) from the harness guide.
 - b. Remove the screw (2), then the harness guide.
 - c. Disconnect the tamper motor connector (3).
 - d. Remove both screws, then the relevant tamper motor (4).

Figure 1 Tamper motor removal

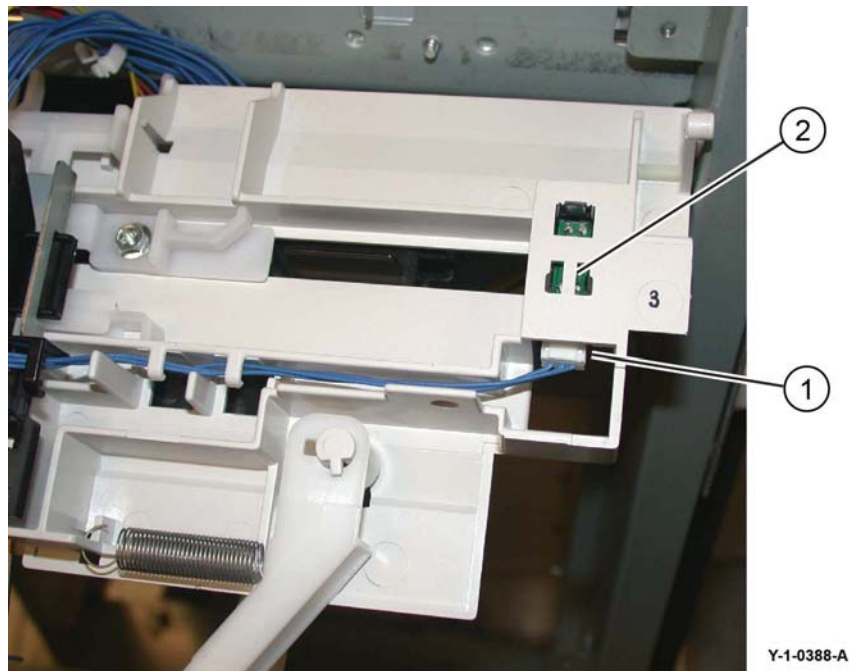
1. Remove the compiler tray assembly, [REP 13.17](#).
2. Place the compiler tray upside down on a work surface.
3. Remove the front or rear tamper home sensor, [Figure 1](#):
 - a. Disconnect the connector (1).
 - b. Remove the front or rear tamper home sensor (2).

NOTE: The removal of the rear tamper home sensor is shown in [Figure 1](#).

Figure 1 Tamper home sensor removal

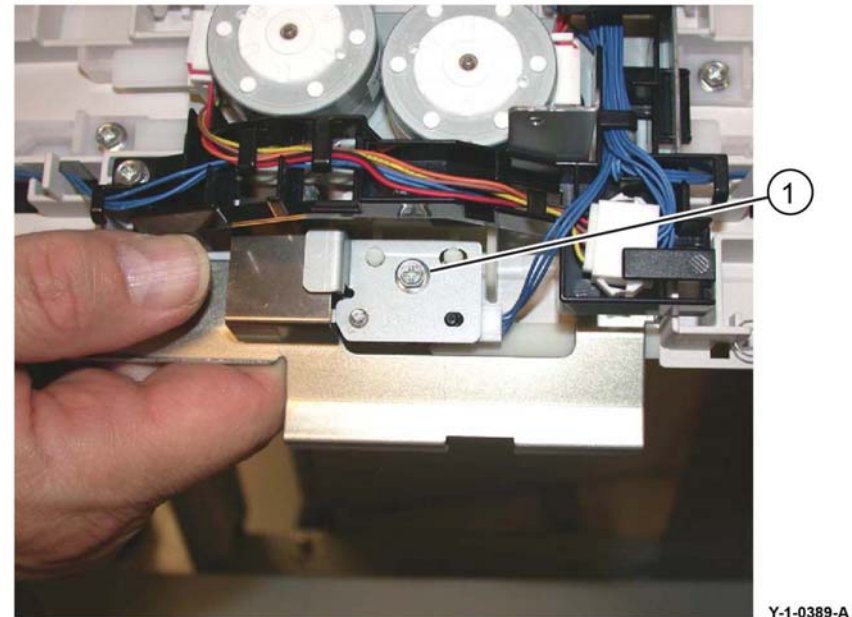
1. Remove the compiler tray assembly, [REP 13.17](#).
2. Place the compiler tray upside down on a work surface.
3. Remove the screw (1) that secures the bracket, [Figure 1](#).

Figure 1 Bracket removal

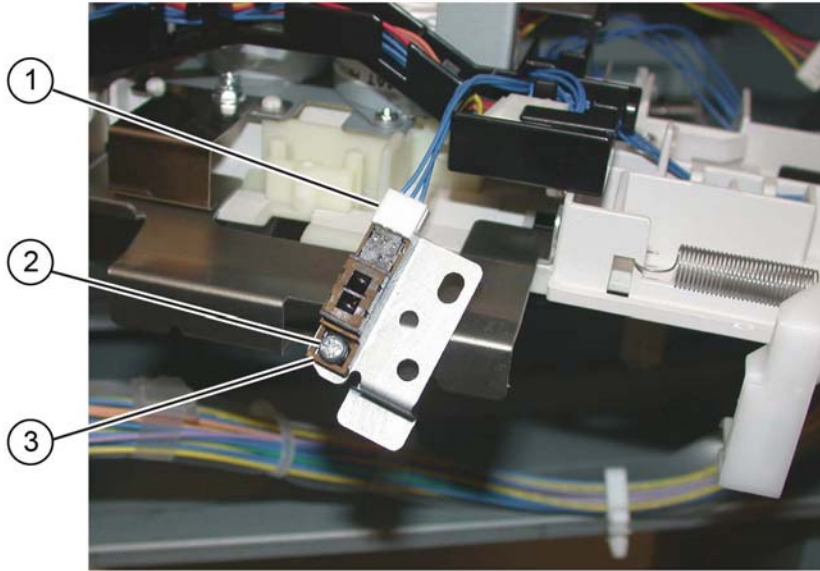
4. Remove the compiler no paper sensor, [Figure 2](#):
 - a. Disconnect the connector (1).
 - b. Remove the screw (2).
 - c. Remove the compiler tray no paper sensor (3).

Figure 2 Compiler tray no paper sensor removal

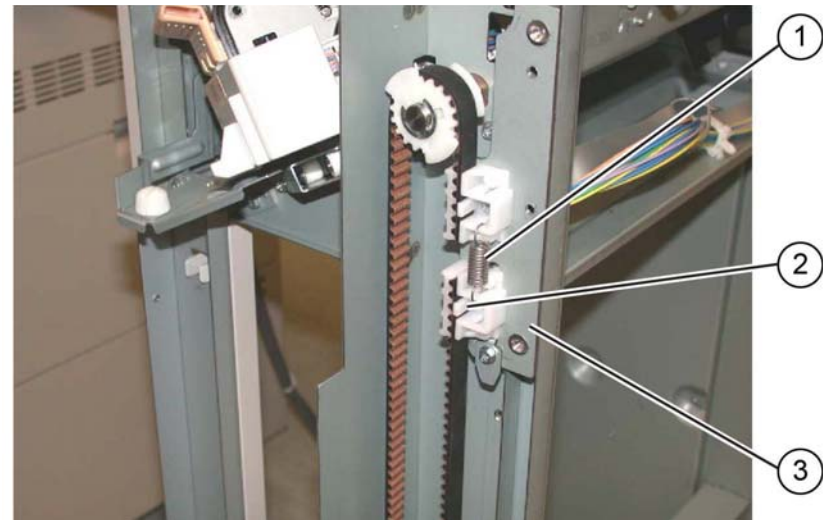
1. Enter dC330, code 12-060 stacker motor up, to fully raise the stacker tray.
2. Remove the finisher front cover, [REP 13.6](#).
3. Remove the rear upper cover, [REP 13.7](#).
4. Remove the rear lower cover, [REP 13.8](#).
5. Remove the stacker tray, [REP 13.20](#).
6. Removing the carriage assembly, [Figure 1](#):
 - a. Disconnect, then remove the spring (1).
 - b. Use a flat bladed screwdriver to release the belt clamp latch (2).aside and
 - c. Remove the stacker belt and carriage assembly.

NOTE: . The carriage bearings (2 each assembly) are not fastened to the shafts. Ensure the bearings are retained when the carriage assembly is removed.

Figure 1 Carriage assembly removal

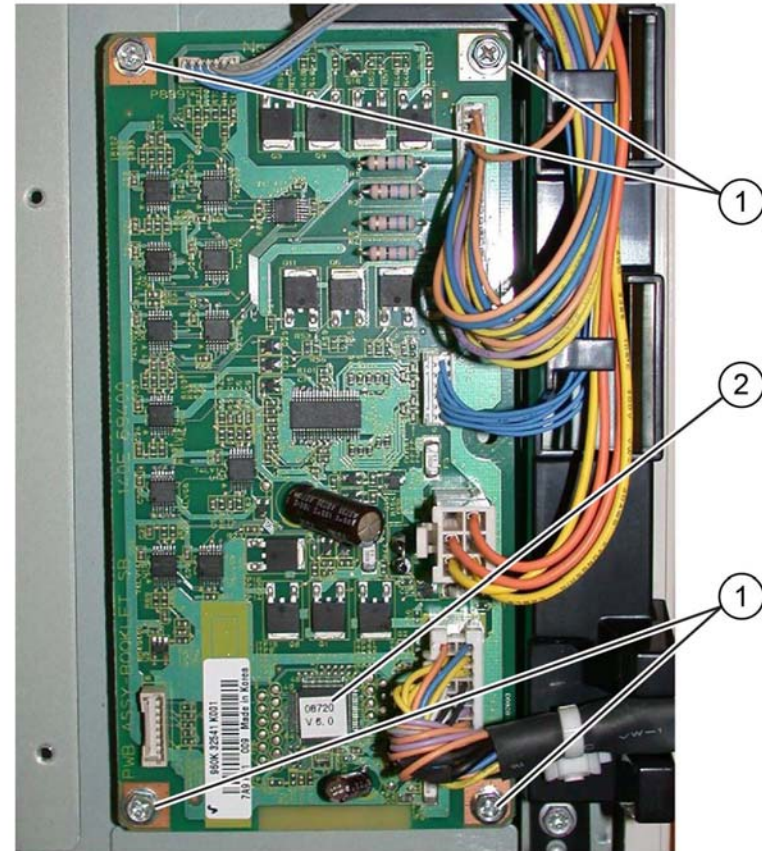
1. Remove the booklet PWB cover, [REP 13.35](#).
2. Remove the booklet PWB, [Figure 1](#):
 - a. Disconnect all connectors from the booklet PWB.
 - b. Remove four screws (1).
 - c. Remove the booklet PWB (2).

Figure 1 Booklet PWB removal

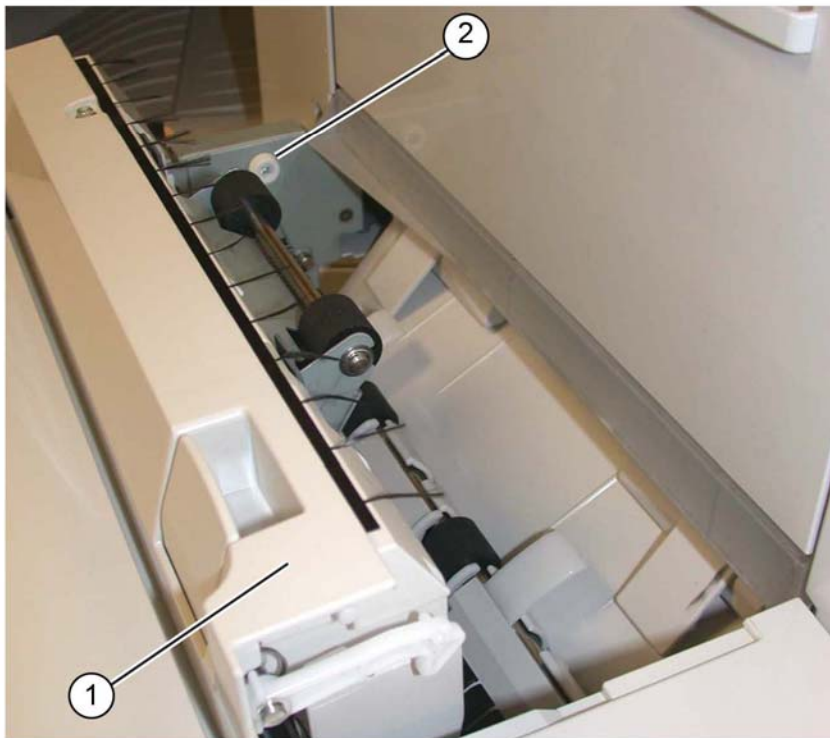
1. Prepare to remove the booklet maker assembly, [Figure 1](#):
 - a. Unlatch the eject cover (1), then move it all the way to the left.
 - b. Remove the front and rear thumbscrews (2).

Figure 1 Preparation

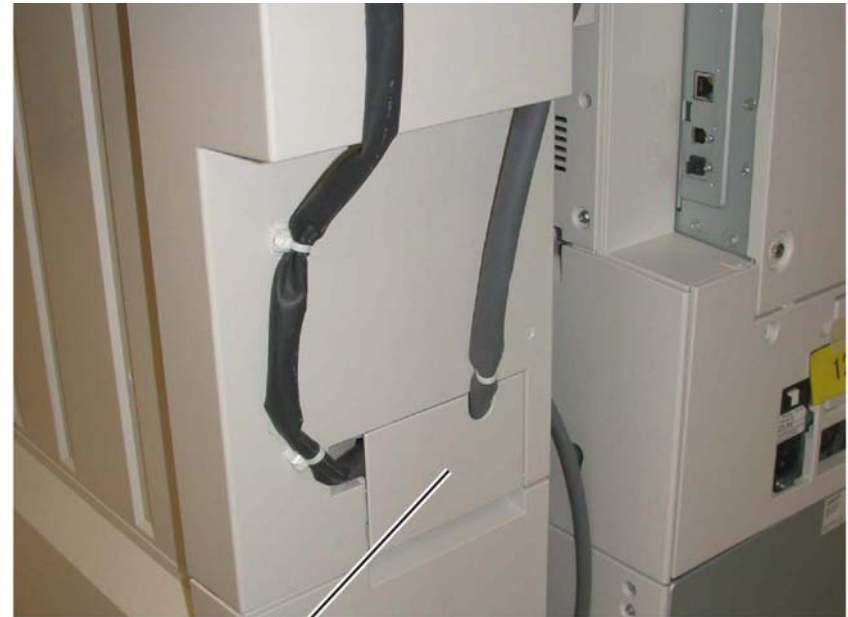
2. Remove the connector cover (1), [Figure 2](#).

Figure 2 Connector cover

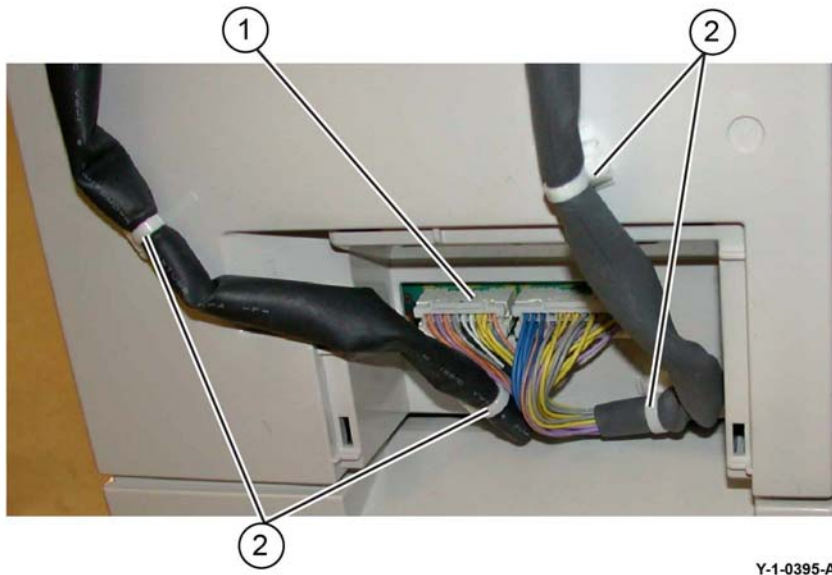
3. Disconnect the booklet maker assembly from the finisher, **Figure 3**:
 - a. Disconnect the connector (1).
 - b. Pull out the four cable ties (2).

Figure 3 Booklet maker assembly disconnection

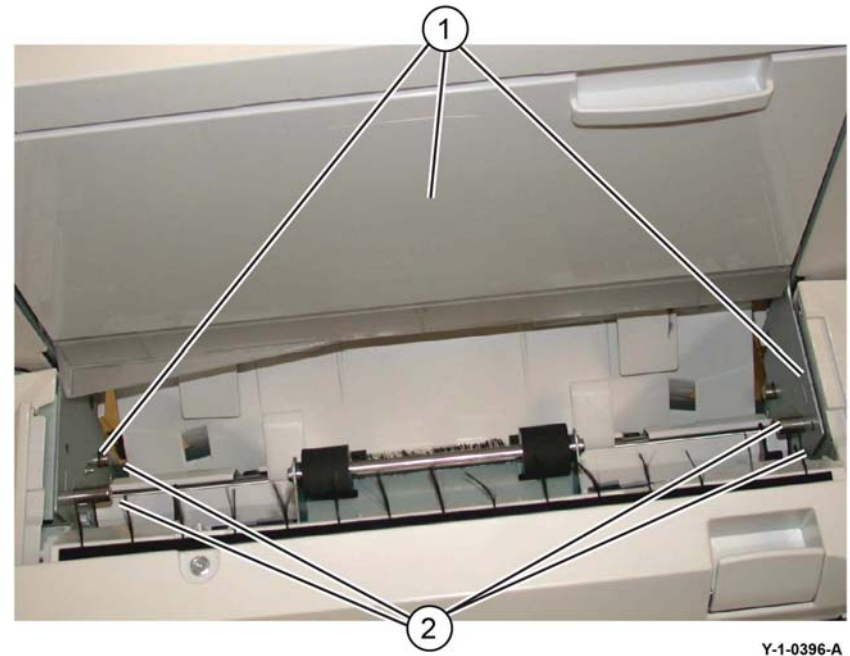
4. Lift the booklet maker assembly (1) off the four locating pins (4), then remove, **Figure 4**.

Figure 4 Booklet maker assembly removal

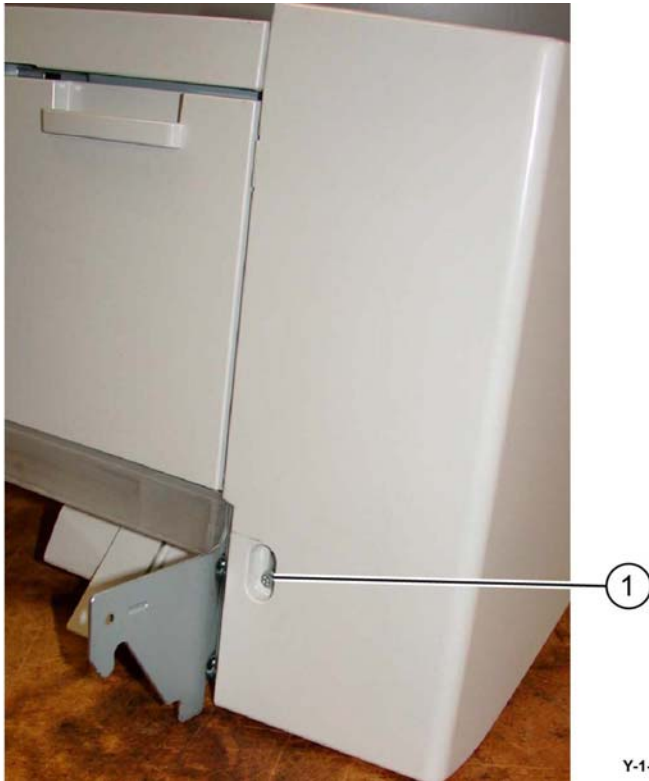
1. Remove the booklet maker assembly from the finisher, [REP 13.31](#).
2. Remove the screw (1), [Figure 1](#).

Figure 1 Screw removal

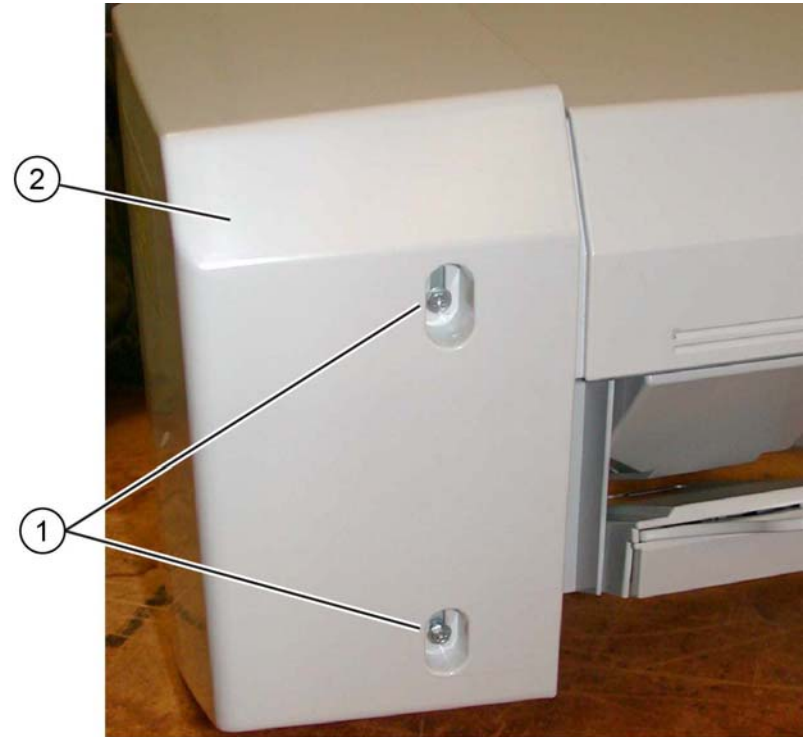
3. Remove two screws (1), then the booklet front cover (2), [Figure 2](#).

Figure 2 Booklet front cover removal

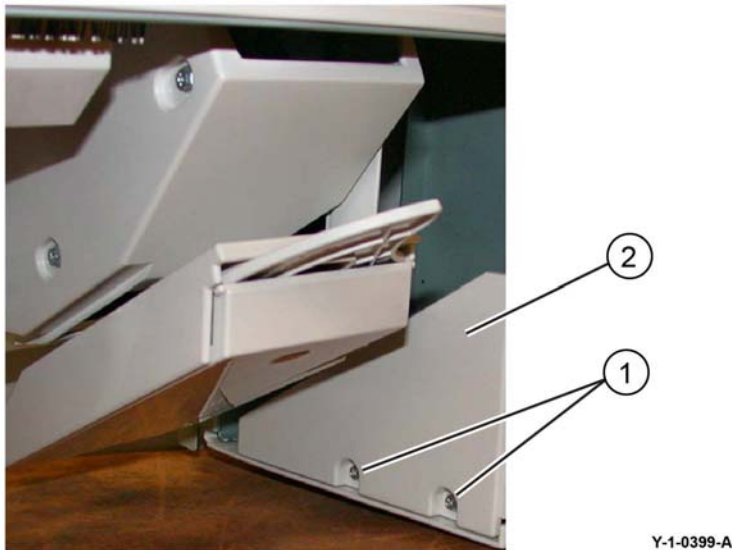
1. Remove the booklet maker assembly from the finisher, [REP 13.31](#).
2. Remove the booklet PWB cover, [REP 13.35](#).
3. Prepare to remove the booklet rear cover, [Figure 1](#):
 - a. Remove both self-tapping screws (1).
 - b. Remove the booklet side cover (2).

Figure 1 Preparation
