708P91370
April 2017

Xerox® VersaLink® B7025/B7030/B7035 Multifunction Printer Service Manual

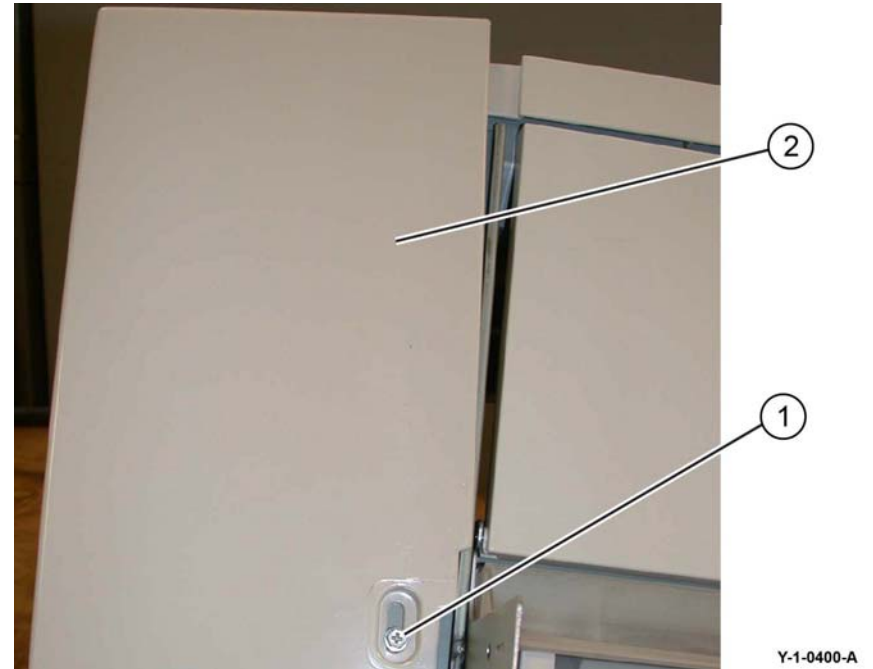
4. Remove the screw (1), then the booklet rear cover (2), [Figure 2](#).

Figure 2 Booklet rear cover removal

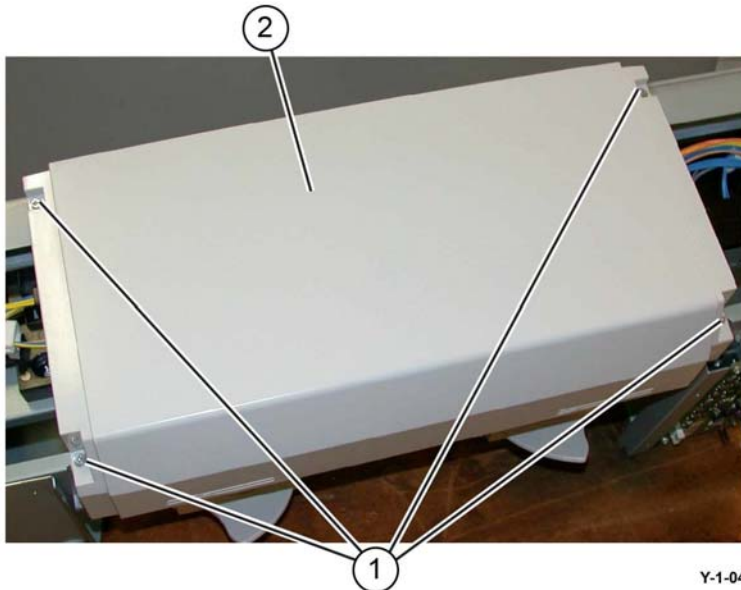
1. Remove the booklet front cover, [REP 13.32](#).
2. Remove the booklet rear cover, [REP 13.33](#).
3. Remove the booklet top cover, [Figure 1](#):
 - a. Remove four screws (1).
 - b. Remove the booklet top cover (2).

Figure 1 Booklet top cover removal

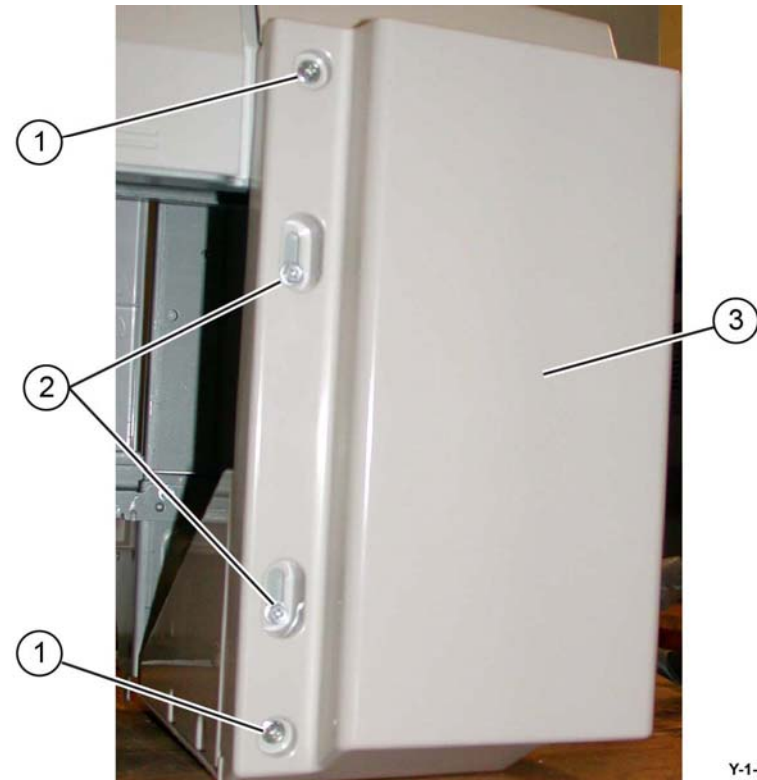
1. Remove the booklet PWB cover, [Figure 1](#):
 - a. Remove both self-tapping screws (1).
 - b. Remove both screws (2).
 - c. Remove the booklet PWB cover (3).

Figure 1 Booklet PWB cover removal

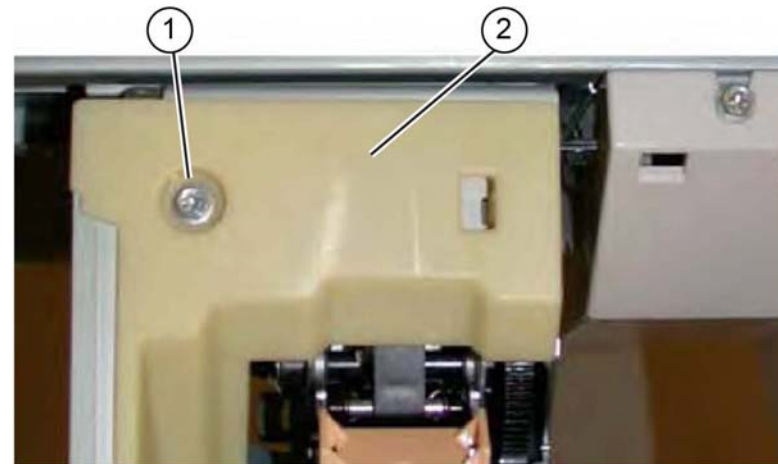
1. Remove the booklet maker from the finisher, [REP 13.31](#).
2. Remove the stapler guide, [Figure 1](#):
 - a. Remove the screw (1).
 - b. Remove the stapler guide (2).

Figure 1 Stapler guide removal

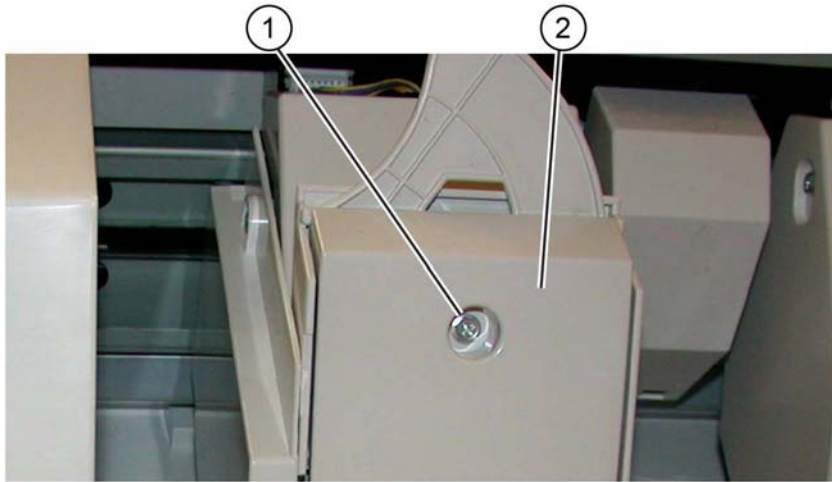
3. Remove the stapler lower cover, **Figure 2**:
 - a. Remove the screw (1).
 - b. Remove the stapler lower cover (2).

Figure 2 Stapler lower cover removal

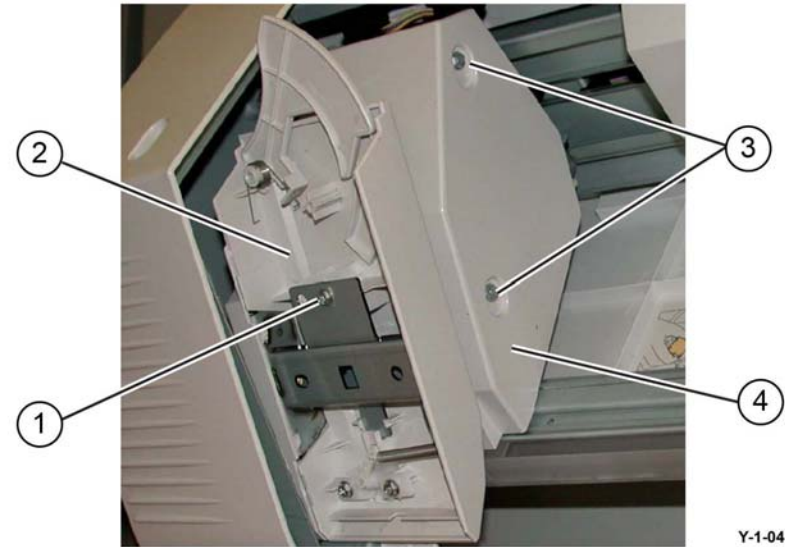
4. Prepare to remove the stapler, **Figure 3**:
 - a. Remove the screw (1).
 - b. Remove the chute (2).
 - c. Remove both screws (3).
 - d. Remove the stapler rear cover (4).

Figure 3 Preparation

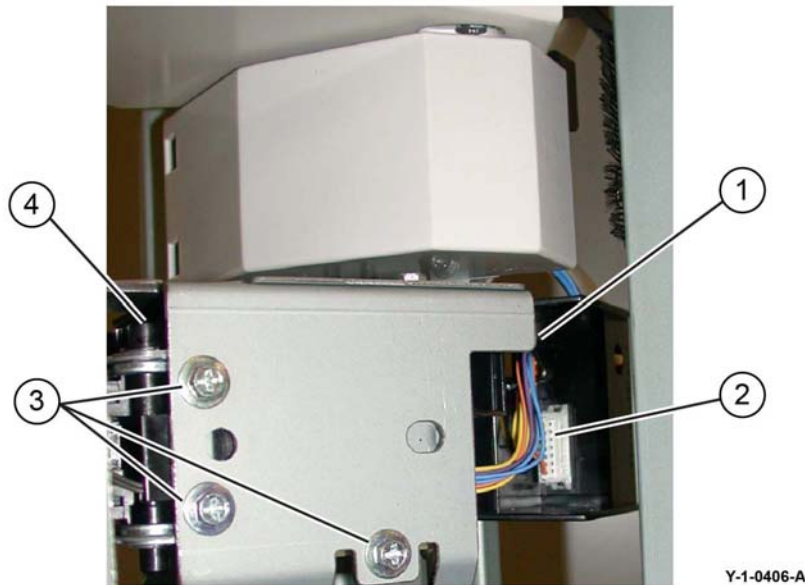
5. Remove the stapler, **Figure 4**:
 - a. Release the harness from the clamp (1).
 - b. Disconnect the connector (2).
 - c. Remove three screws (3).
 - d. Remove the stapler (4).

Figure 4 Stapler removal

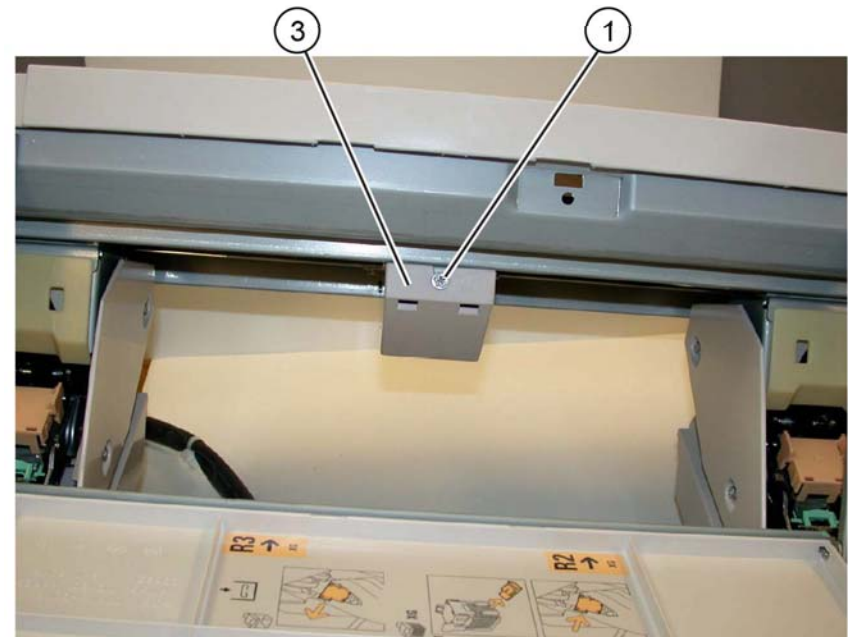
1. Remove the booklet maker assembly, **REP 13.31**.
2. Remove the cover for the booklet stapler move motor, **Figure 1**:
 - a. Remove the screw (1).
 - b. Remove the cover (2).

Figure 1 Cover removal

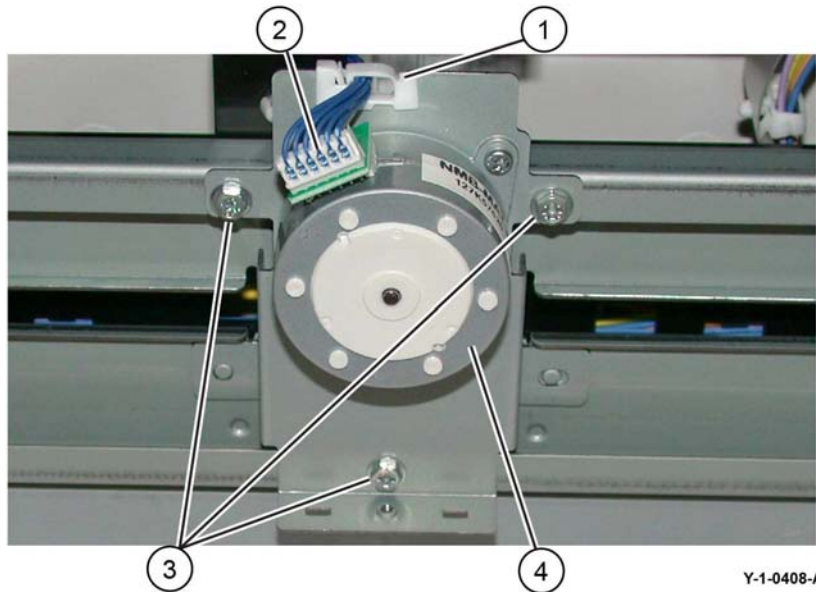
Figure 2 Booklet stapler move motor removal

3. Remove the booklet stapler move motor, [Figure 2](#):
 - a. Release the harness from the clamp (1).
 - b. Disconnect the connector (2).
 - c. Remove three screws (3).
 - d. Remove the booklet stapler move motor (4).

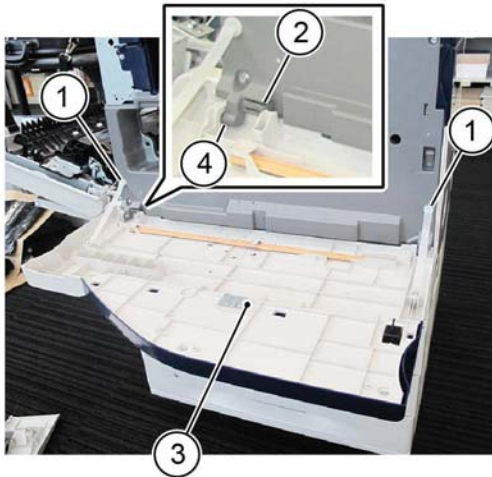
Figure 1 Front cover removal

1. Open the front cover.
2. Remove the front cover, [Figure 1](#):
 - a. Rotate the two straps (1) 90 degrees, then disconnect.
 - b. Press the stopper (2), then move the front cover (3) to the left. Remove the front cover from the boss (4).

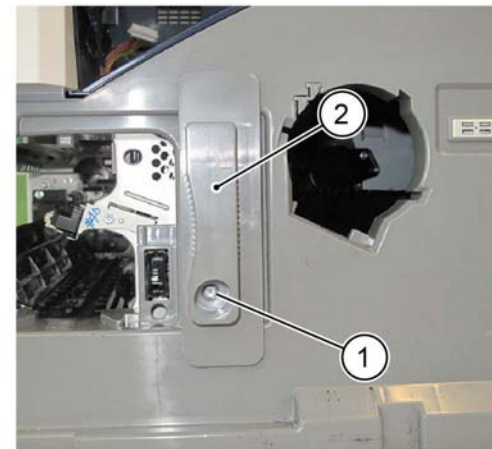
Figure 1 CRU handle and bearing removal

1. As necessary, remove the:
 - Integrated finisher, [REP 12.1](#).
 - Office finisher LX, [REP 13.5](#).
 - Horizontal transport, [REP 13.1](#).
2. Remove the drum cartridge, [REP 90.4](#).
3. Remove the front cover, [REP 28.1](#).
4. Pull out, then remove the toner cartridge, [PL 90.05 Item 1](#).
5. Remove the CRU handle and handle bearing as an assembly, [Figure 1](#):
 - a. Remove the screw (1).
 - b. Remove the CRU handle and handle bearing (2).

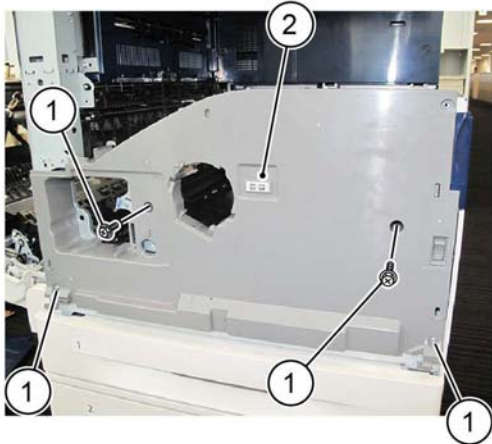
Figure 2 Inner cover removal

7. Remove the inner cover, [Figure 2](#):
 - a. Remove four screws (1).
 - b. Remove the inner cover (2).

NOTE: It will be necessary to carefully bend the top edge of the right cover to release a tab on the top right of the inner cover.

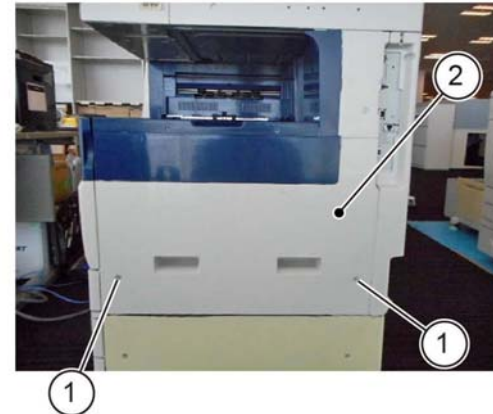
Figure 1 Right cover removal

1. If a finisher LX is installed, undock the finisher LX, [REP 13.5](#).
2. If a finisher LX is installed, remove the vertical infill covers, [PL 13.40](#).
3. Open the front cover.
4. Pull out tray 1.
5. Remove the right cover, [Figure 1](#):
 - a. Remove two screws (1).
 - b. Remove the right cover (2).

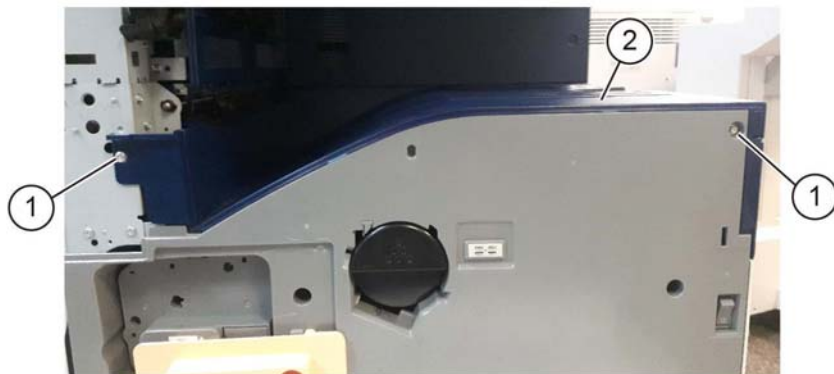
Figure 1 Top cover removal

1. As necessary, remove the:
 - Integrated finisher, REP 12.1.
 - Office finisher LX, REP 13.5.
 - Horizontal transport, REP 13.1.
2. Open the front cover.
3. Remove the pillar left cover, PL 28.05 Item 13.
4. Remove the exit front cover, PL 28.05 Item 10.
5. If an office finisher LX was installed, remove the components that follow:
 - a. Upper adjust cover, PL 13.10 Item 18 and lower adjust cover, PL 13.10 Item 19.
 - b. Docking plate, PL 13.05 Item 3.
 - c. Docking bracket, PL 13.05 Item 7.
6. Remove the top cover, Figure 1:
 - a. Remove two screws (1).
 - b. Remove the top cover (2).

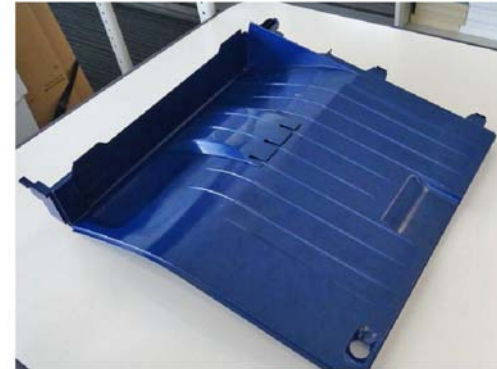
Figure 2 Removed top cover

NOTE: The removed top cover is shown in Figure 2.

1. The replacement is the reverse of the removal procedure.
2. When installing the top cover, align the bosses on the rear of the top cover with the mounting holes.

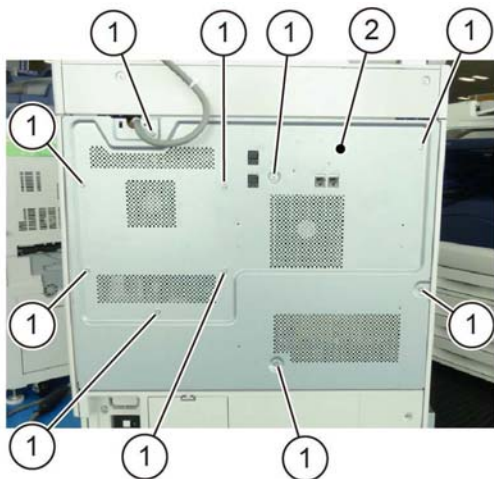
Figure 1 Upper rear cover removal

1. Remove the upper rear cover, [Figure 1](#):
 - a. Remove ten screws (1).
 - b. Remove the upper rear cover (2).

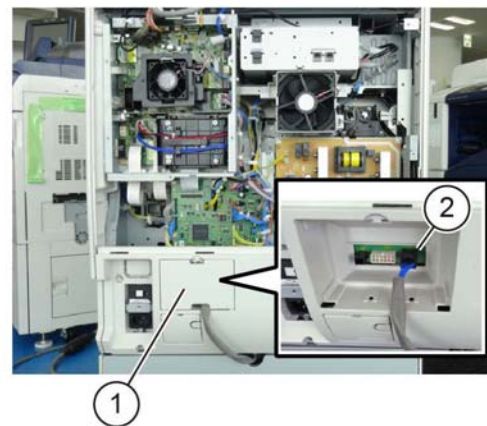
Figure 1 Connector

1. Remove the upper rear cover, [REP 28.5](#).
2. Remove the cover (1), disconnect all connectors (2), [Figure 1](#).

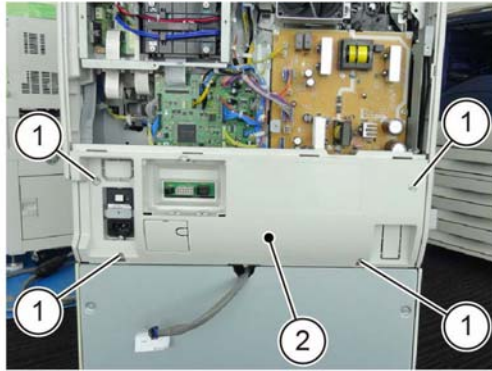
Figure 2 Lower rear cover removal

3. Remove the lower rear cover, **Figure 2**:
 - a. Remove four screws (1).
 - b. Remove the lower rear cover (2).

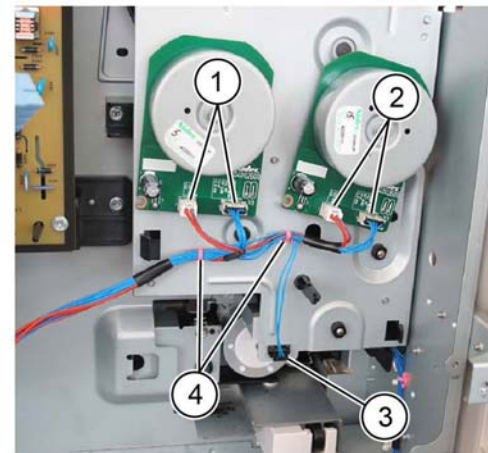
Figure 2 Harnesses

6. Remove the wire harness secured on the drive assembly, [Figure 2](#):
 - a. Disconnect the connectors (1).
 - b. Disconnect the connectors (2).
 - c. Disconnect the connector (3).
 - d. Remove the clamp band (4).

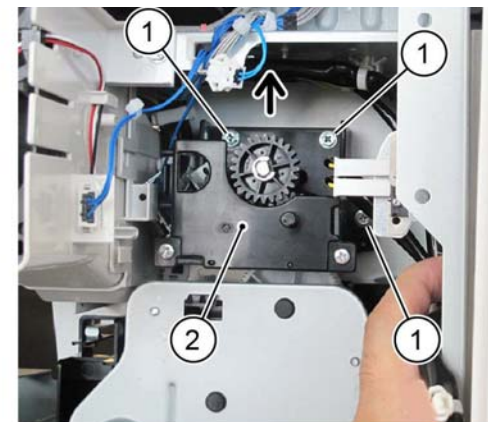
Figure 3 Exit 1 transport assembly

7. Move the exit 1 transport assembly, [Figure 3](#):
 - a. Remove three screws (1).
 - b. Move the exit 1 transport assembly (2) upward.

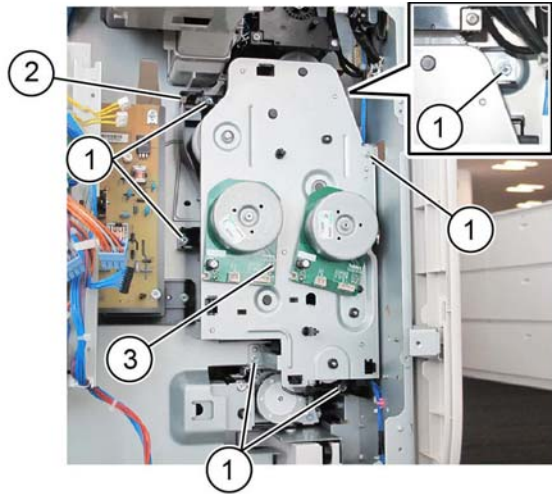
Figure 4 Drive assembly removal

8. Remove the drive assembly, [Figure 4](#):
 - a. Remove six screws (1).
 - b. Release the latch (2), then remove the drive assembly (3).

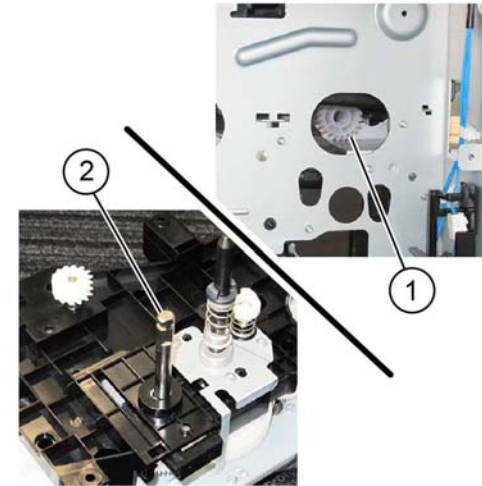
Figure 5 Gear alignment

1. The replacement is the reverse of the removal procedure.
2. When installing the drive assembly, align the gear (1) with the flat on the shaft (2), [Figure 5](#).

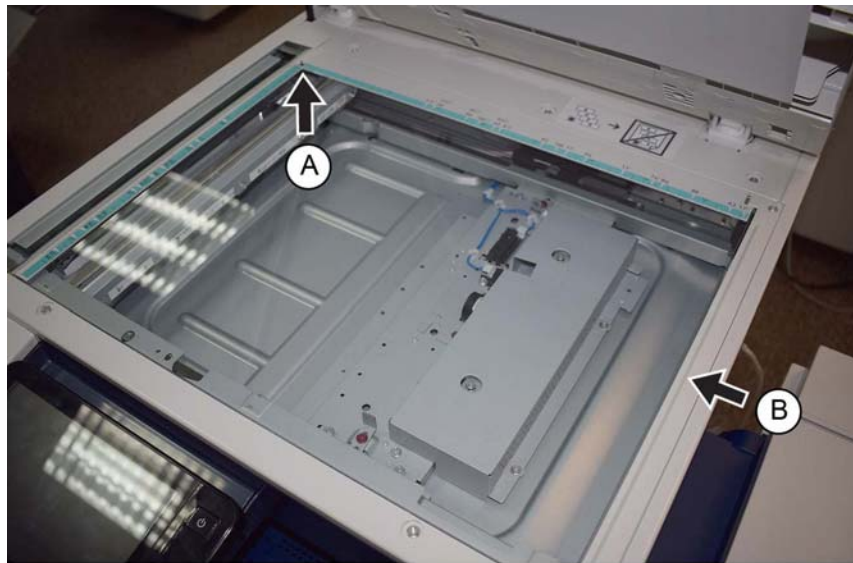
Figure 1 Alignment

1. The replacement is the reverse of the removal procedure.
2. Before tightening the two screws, align the document glass in the direction of arrow A and the right plate in the direction of arrow B, [Figure 1](#).

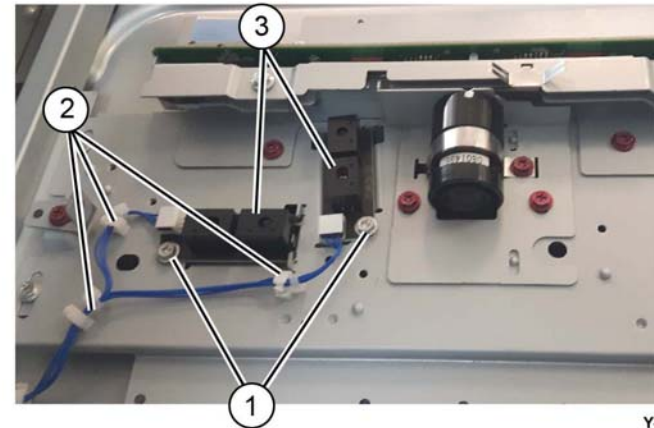
Figure 1 APS sensors

1. Remove the document glass, [REP 60.1](#).
2. Remove the lens cover assembly, [PL 60.10 Item 12](#).
3. Move the APS sensor, [Figure 1](#).
 - a. Remove two screws (1).
 - b. Release the harness from the retainers (2).
 - c. Move the APS sensors (3).

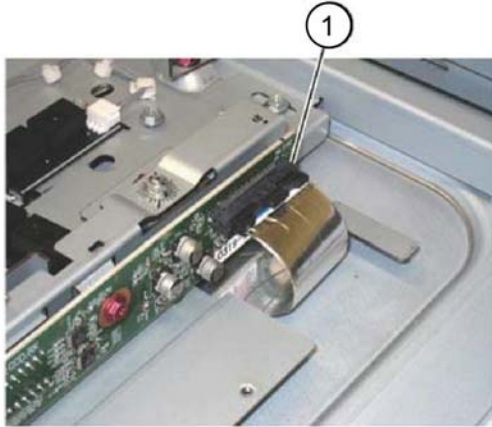
Figure 2 FFC CCD ribbon cable

4. Release the hooks, then disconnect the FFC CCD ribbon cable, [Figure 2](#).

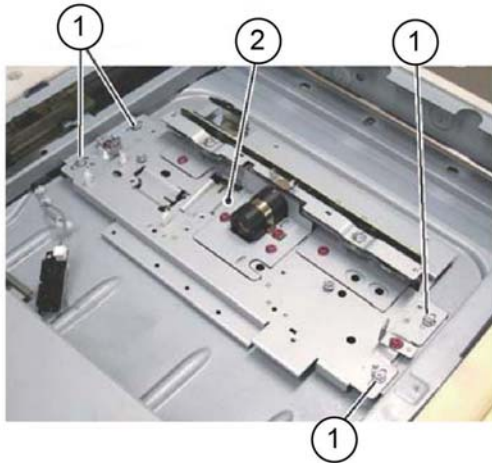
Figure 3 CCD lens assembly removal

5. Remove the CCD lens assembly, [Figure 3](#):
 - a. Remove four screws (1).
 - b. Remove the CCD lens assembly (2).

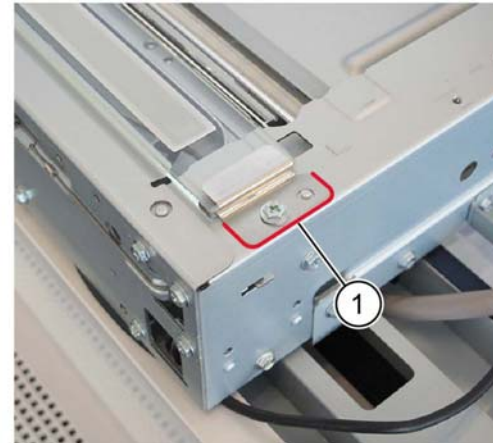
Figure 1 Front glass support

5. Take note of the installation position of the front glass support (1), Figure 1.

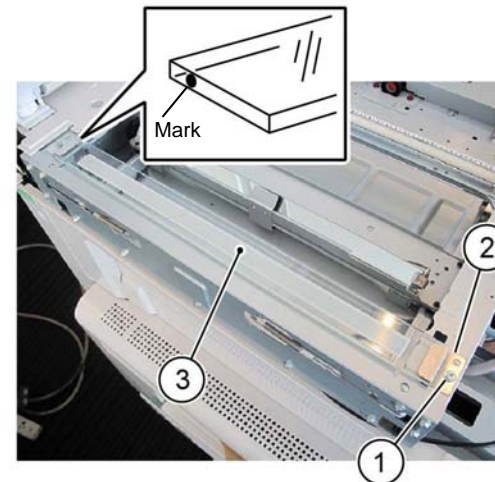
Figure 2 CVT glass removal

6. Remove the CVT glass, Figure 2:
 - a. Remove the screw (1).
 - b. Remove the front glass support (2).
 - c. Remove the CVT glass (3).

NOTE: The CVT glass must be reinstalled with the mark toward the rear of the machine. Refer to Figure 2.

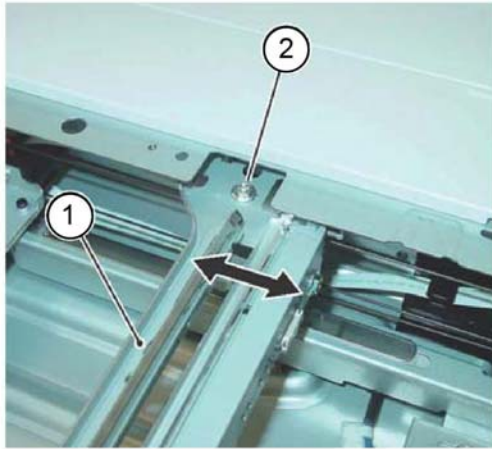
Figure 3 Cable detachment

7. Detach the carriage cable from the full rate carriage, [Figure 3](#):
 - a. Move the full rate carriage (1) to the cutout in the frame.
 - b. Remove the screw (2).

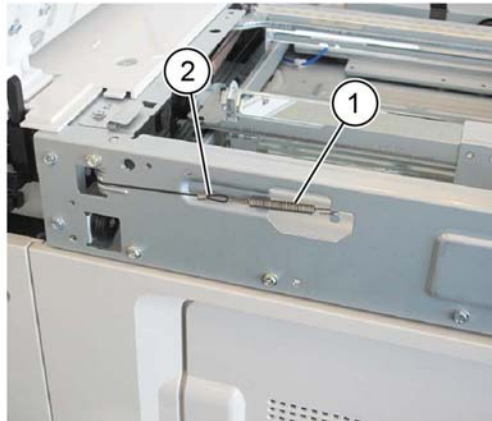
Figure 4 Preparation

8. Prepare to remove the carriage cable, [Figure 4](#):
 - a. Unhook the extension spring (1) from the frame.
 - b. Detach the cable (2) from the extension spring.

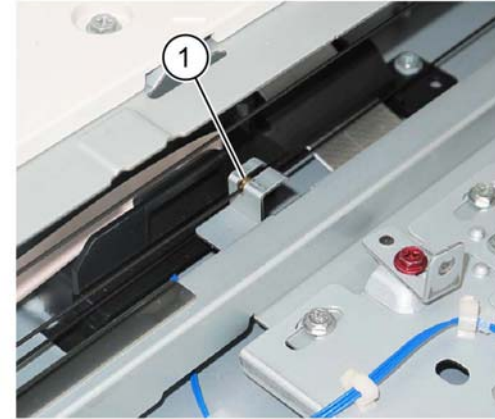
Figure 5 Cable removal

9. Remove the anchor ball (1) from the notch in the frame, then remove the carriage cable, [Figure 5](#).

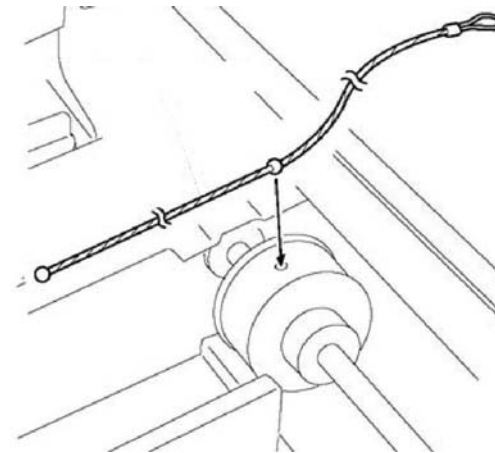
Figure 6 Anchor ball

1. Insert the anchor ball of the carriage cable into the groove in the capstan, [Figure 6](#).

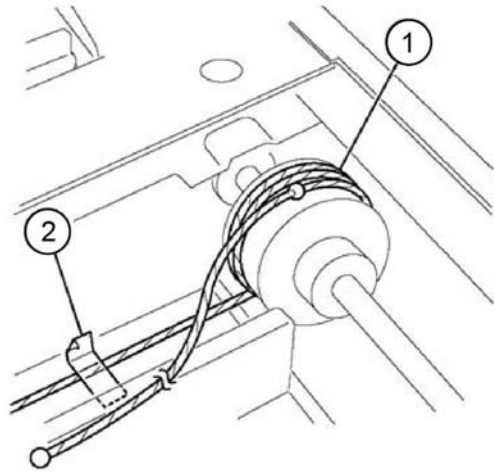
Figure 7 Capstan winding (1)

2. Wind the extension spring loop end of the carriage cable around the capstan, **Figure 7**:
 - a. Wind the cable (1) 2.5 turns.
 - b. Use adhesive tape (2) to affix the extension spring loop end of the cable to the frame.

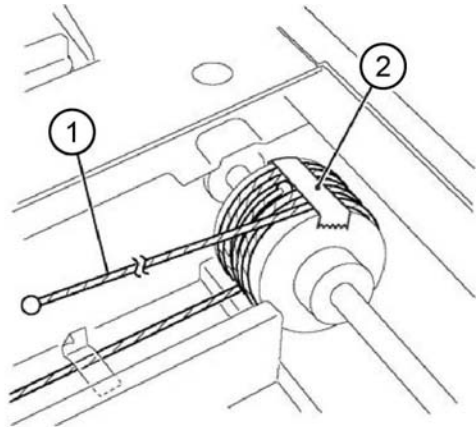
Figure 8 Capstan winding (2)

3. Wind the end-ball end of the carriage cable around the capstan, **Figure 8**:
 - a. Wind the cable (1) 3 turns.
 - b. Use adhesive tape (2) to affix the cable to the capstan.

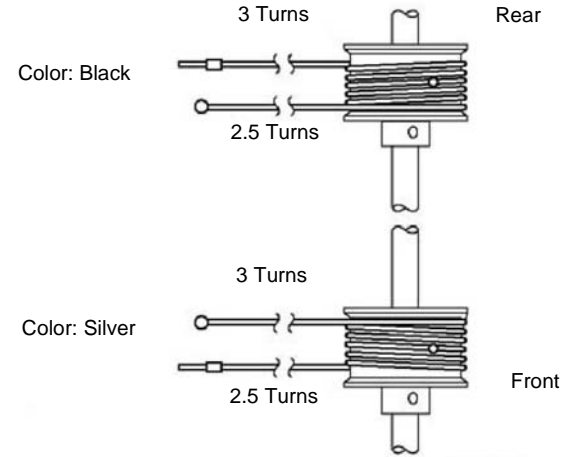
Figure 9 Cable arrangement

4. **Figure 9** shows the correct arrangement of the cables, front and rear.

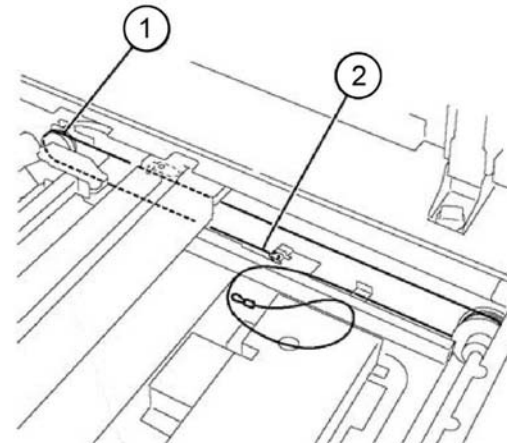
Figure 10 End-ball end installation

5. Install the end-ball end of the carriage cable, **Figure 10**:
 - a. Wrap the cable on the pulley at the front of the half rate carriage (1).
 - b. Put the end-ball in the notch in the frame (2).

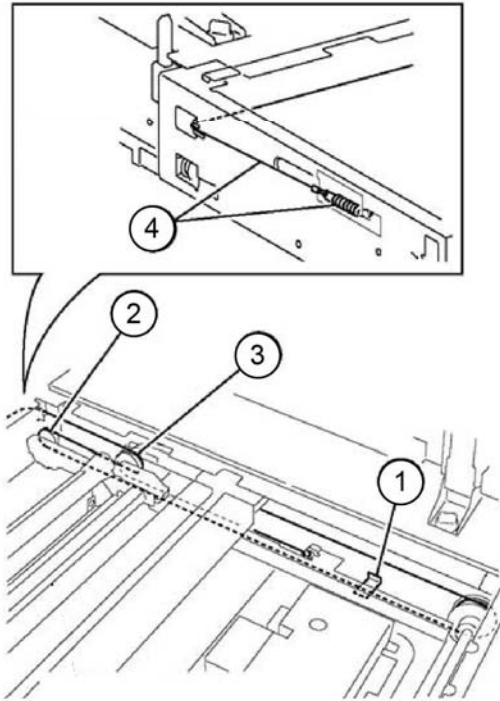
Figure 11 Spring attachment

6. Attach the extension spring hanger end of the carriage cable, [Figure 11](#):
 - a. Remove the tape (1) that secures the cable.
 - b. Wrap the cable on the pulley (2).
 - c. Wrap the cable on the pulley at the rear of the half rate carriage (3).
 - d. Attach the extension spring on the cable and hook it to the Frame (4).

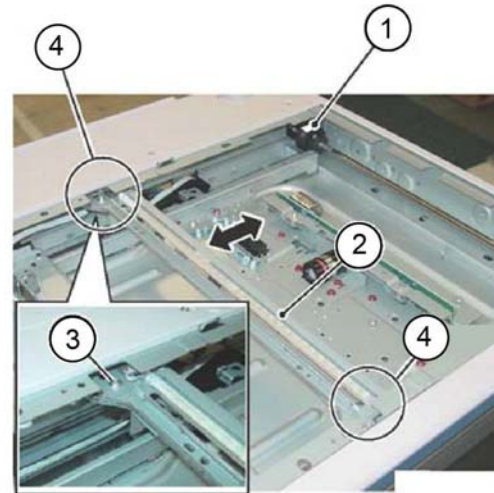
Figure 12 Full rate carriage attachment

7. Loosely attach the cable to the full rate carriage, [Figure 12](#):
 - a. Remove the tape (1).
 - b. Move the full rate carriage (2) to the cutout (4) in the frame.
 - c. Loosely attach the cable to the full rate carriage (3).

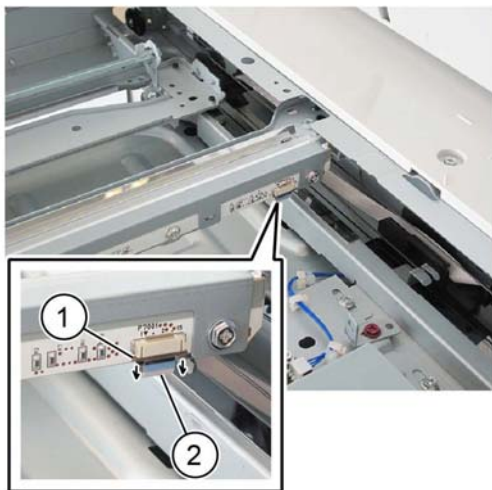
Figure 1 FFC LED cable assembly

1. Open the DADF.
2. Remove the document glass, [REP 60.1](#)
3. Move the full rate carriage to the cutouts in the frame.
4. Disconnect the FFC LED cable assembly, [Figure 1](#):
 - a. Move the connector housing catch (2) in the direction of the arrows.
 - b. Disconnect the FFC LED cable assembly.

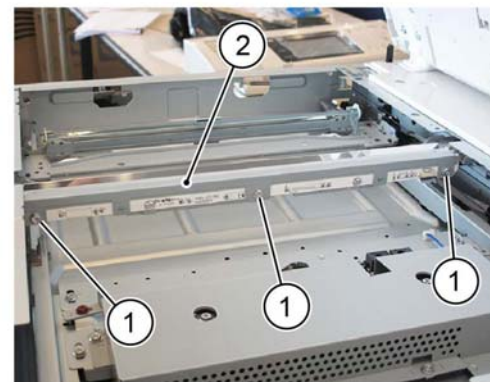
Figure 2 LED bracket removal

5. Remove the LED bracket, [Figure 2](#):
 - a. Remove three screws (1).
 - b. Remove the LED bracket (2).

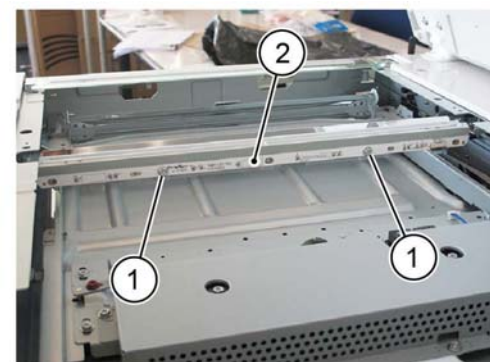
Figure 3 Lamp assembly removal

6. Remove the lamp assembly, [Figure 3](#):
 - a. Remove two screws (1).
 - b. Remove the lamp assembly (2).

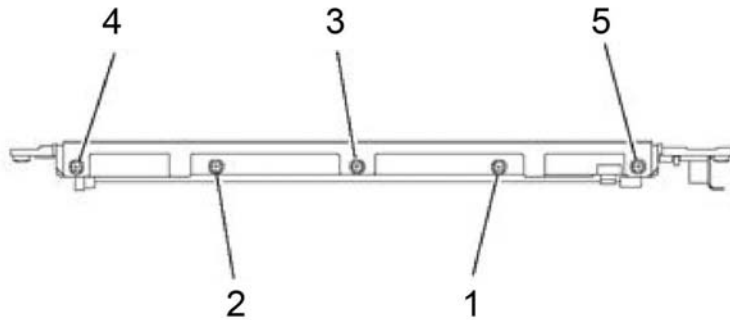
Figure 4 Screws

1. The replacement is the reverse of the removal procedure.
2. When installing the lamp assembly, first tighten screw (1), then screw (2), [Figure 4](#).
3. When installing the LED bracket, first tighten screw (3), then screw (4), then screw (5), [Figure 4](#).

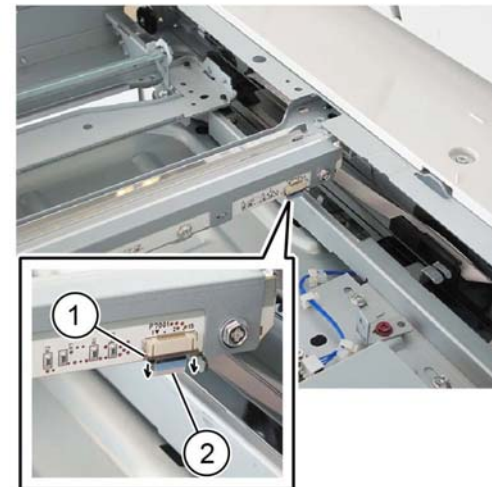
Figure 1 FFC LED cable assembly

1. Remove the DADF, [REP 5.1](#).
2. Remove the upper rear cover, [REP 28.5](#).
3. Disconnect the FFC LED cable assembly, [Figure 1](#):
 - a. Move the connector housing catch (2) in the direction of the arrows.
 - b. Disconnect the FFC LED cable assembly (1).

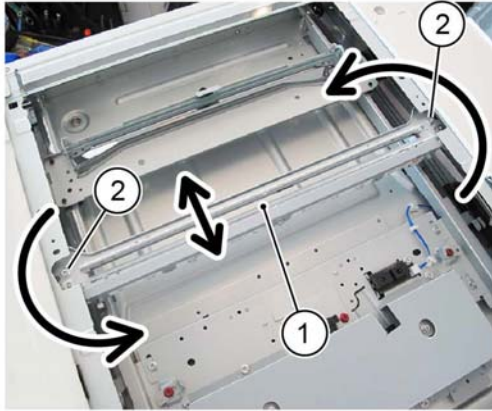
Figure 2 Full rate carriage removal

Be careful when lifting out the full rate carriage. It is still connected to the FFC cable and cannot be fully removed from the scanner assembly.

4. Lift out the full rate carriage from the scanner assembly, **Figure 2**:
 - a. Move the full rate carriage (1) to the cutouts in the frame.
 - b. Remove two screws (2).
 - c. Carefully lift out the full rate carriage.

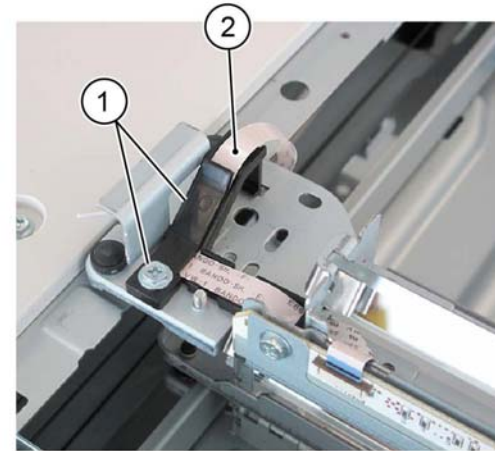
Figure 3 Cable assembly disconnection (1)

5. Turn the full rate carriage upside down.
6. Disconnect the FFC LED cable assembly from the full rate carriage, **Figure 3**:
 - a. Remove the screw, then remove the plate (1).
 - b. Disconnect the FFC LED cable assembly (2).

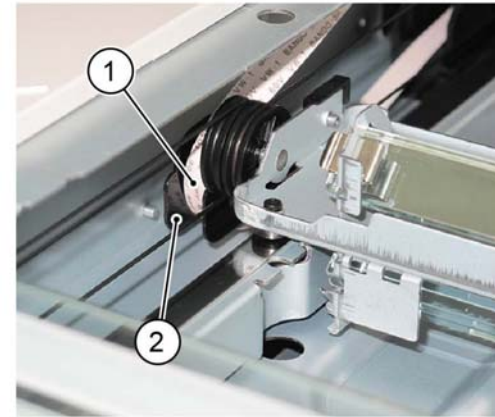
Figure 4 Harness guide

7. Disconnect the FFC LED cable assembly (1) from the half rate carriage harness guide (2), **Figure 4**.

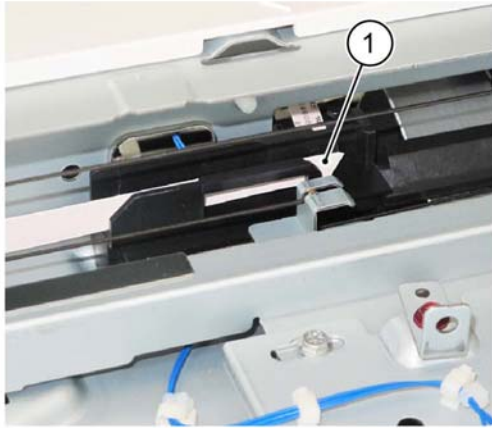
Figure 5 Cable assembly disconnection (2)

8. Disconnect the FFC LED cable assembly from the guide, [Figure 5](#).

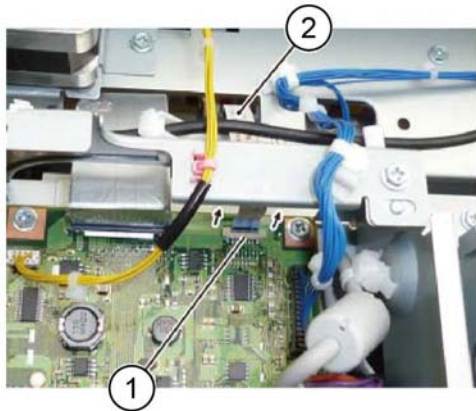
Figure 6 Cable assembly disconnection (3)

9. Disconnect the FFC LED cable assembly from the ESS chassis assembly, [Figure 6](#):
 - a. Move the connector housing catch (1) in the direction of the arrow.
 - b. Disconnect the FFC LED cable assembly (2).

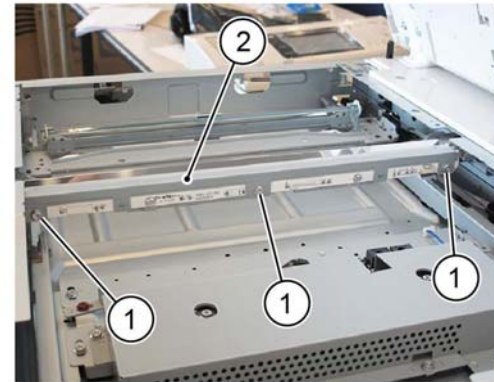
1. Remove the DADF, [REP 5.1](#).
2. Remove the document glass, [REP 60.1](#).
3. Move the full rate carriage to the cutouts in the frame.
4. Remove the LED bracket, [Figure 1](#):
 - a. Remove three screws (1).
 - b. Remove the LED bracket (2).

Figure 1 LED bracket removal

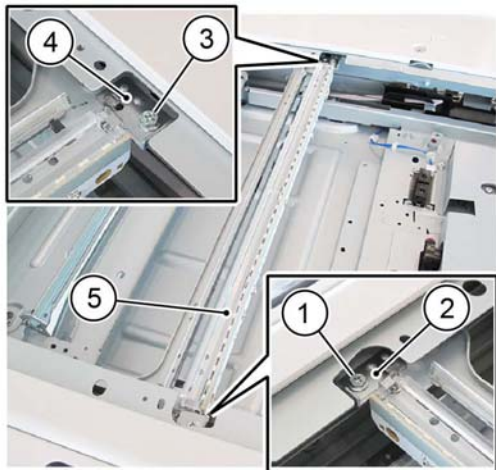
5. Remove the light guide, **Figure 2**:
 - a. Remove the screw (1).
 - b. Remove the spring guide (2).
 - c. Remove the screw (3).
 - d. Remove the spring guide (4).
 - e. Remove the light guide (5).

Figure 2 Light guide removal

1. The replacement is the reverse of the removal procedure.
2. When installing the light guide, insert the boss into the locating hole in the full rate carriage.

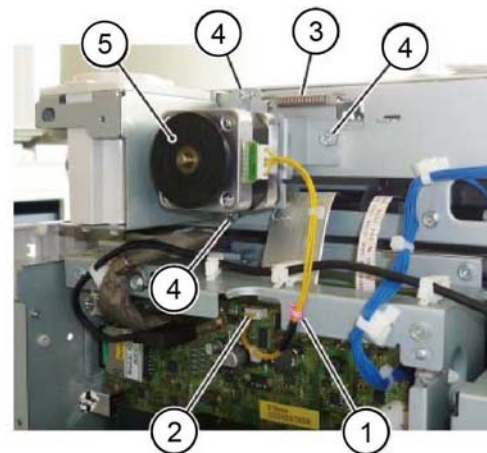
1. Remove the DADF, **REP 5.1**.
2. Remove the IIT rear cover, **PL 60.05 Item 4**.
3. Remove the IIT top cover, **PL 60.05 Item 3**.
4. Remove the IIT scan motor assembly, **Figure 1**:
 - a. Release the cable clamp (1).
 - b. Disconnect the connector (2).
 - c. Remove the extension spring (3).
 - d. Remove three screws (4).
 - e. Remove the IIT scan motor assembly (5).

Figure 1 IIT scan motor assembly removal

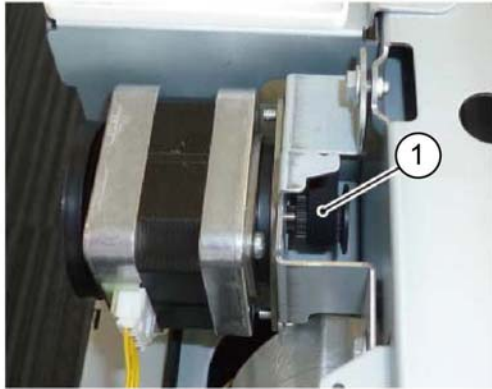
1. The replacement is the reverse of the removal procedure.
2. Attach the timing belt (1) to the IIT scan motor pulley, [Figure 2](#).

Figure 2 Timing belt

3. Be aware of the steps that follow when reinstalling the IIT scan motor assembly:
 - a. Attach the extension spring.
 - b. Loosely install the IIT scan motor assembly and timing belt.
 - c. Ensure that the timing belt is correctly attached to the carriage.
 - d. Fully tighten the screws that secure the IIT scan motor assembly.
4. After installing the IIT scan motor assembly, check that the full rate carriage moves smoothly.

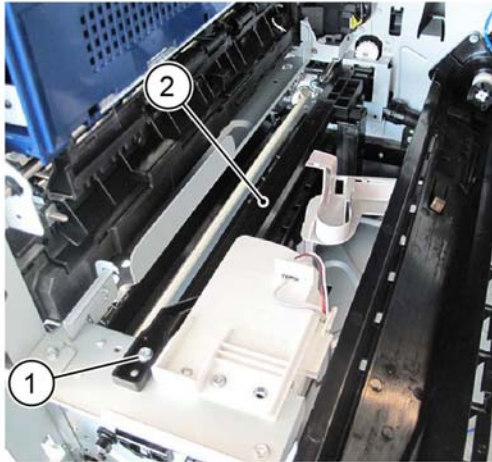
4. Remove the CRU upper guide assembly, [Figure 2](#).
 - a. Remove the screw (1).
 - b. Remove the CRU upper guide assembly. (2).

Figure 2 CRU upper guide assembly removal

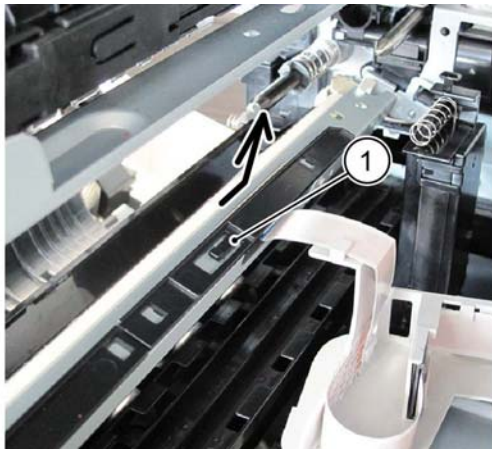
5. Pull up the tab (1), move the CRU guide toward the rear, then remove it, [Figure 3](#).

Figure 3 CRU guide removal

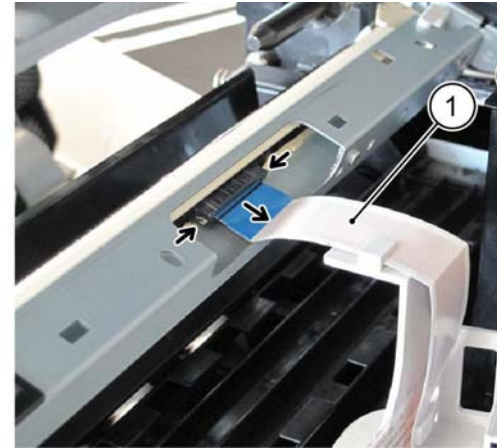
6. Release the catches in the direction of the arrows, then disconnect the FFC cable (1), [Figure 4](#).

Figure 4 FFC cable

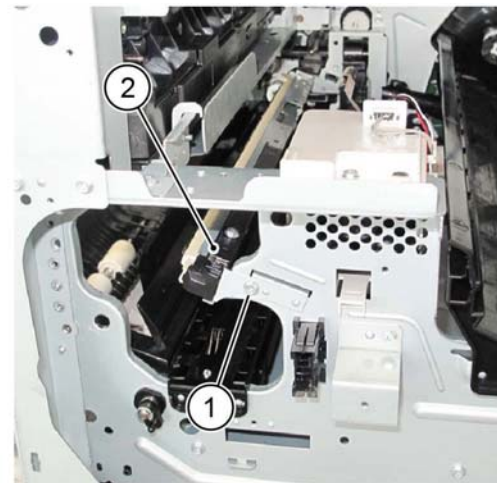
7. Remove the print head assembly, [Figure 5](#).
 - a. Remove the screw (1).
 - b. Remove the print head assembly (2).

Figure 5 Print head assembly removal

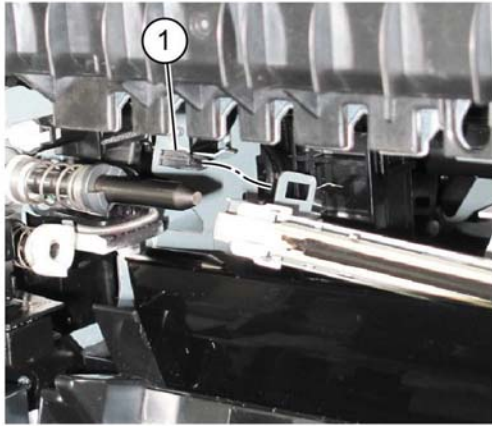
1. The replacement is the reverse of the removal procedure.
2. When installing the print head assembly, fit the frame hole into the block (1), [Figure 6](#).

Figure 6 Block

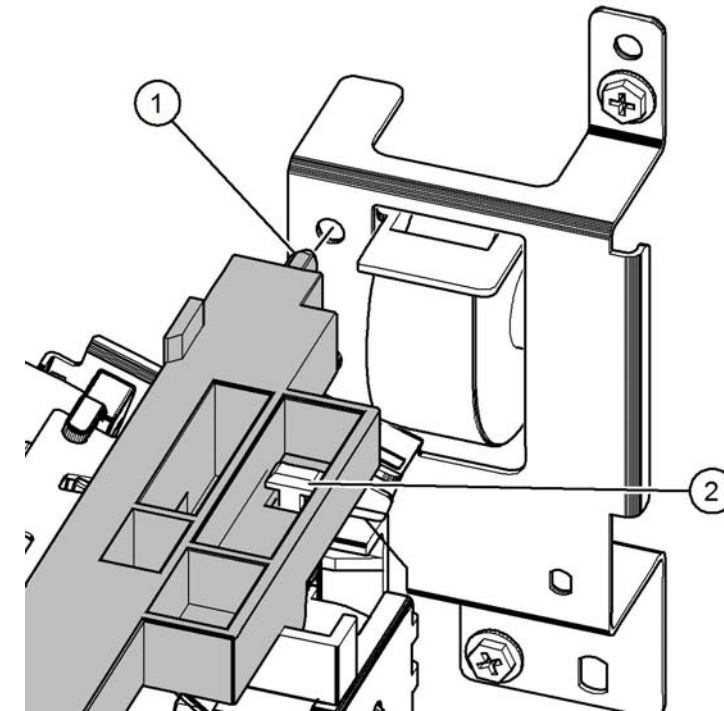
Figure 7 Boss

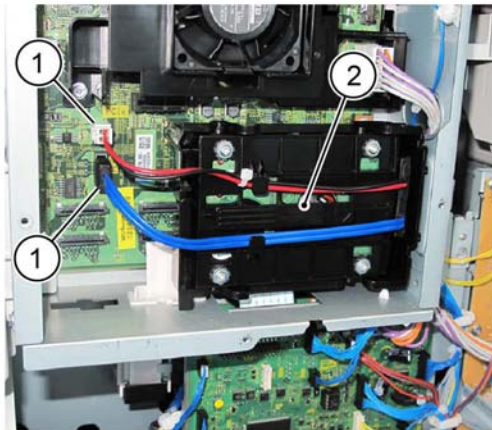
1. Remove the upper rear cover, [REP 28.5](#).
2. Remove the lower rear cover, [REP 28.6](#).
3. If the machine has an HDD assembly installed, remove the HDD assembly, [Figure 2](#):
 - a. Disconnect the connectors (1).
 - b. Remove the HDD assembly (2).

Figure 2 HDD removal

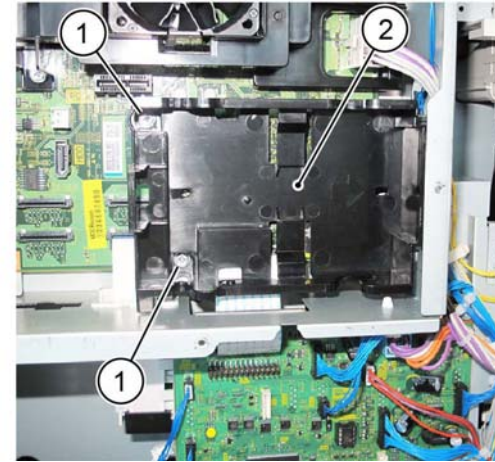
4. If the machine had an HDD assembly installed, remove both screws (1), then the HDD bracket (2), [Figure 3](#).

Figure 3 HDD bracket removal

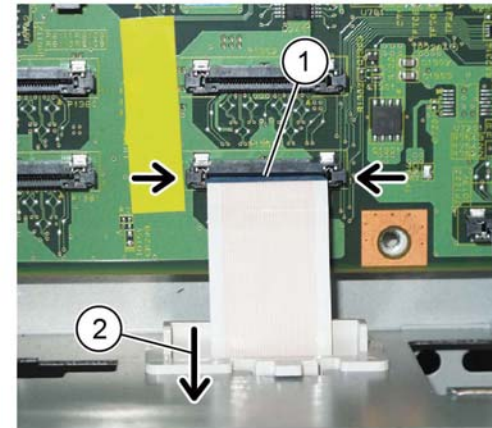
5. Disconnect the FFC cable, [Figure 4](#):
 - a. Carefully disconnect the FFC cable (1) by releasing the side clips.
 - b. Pull down the FFC cable (2).

Figure 4 FFC cable

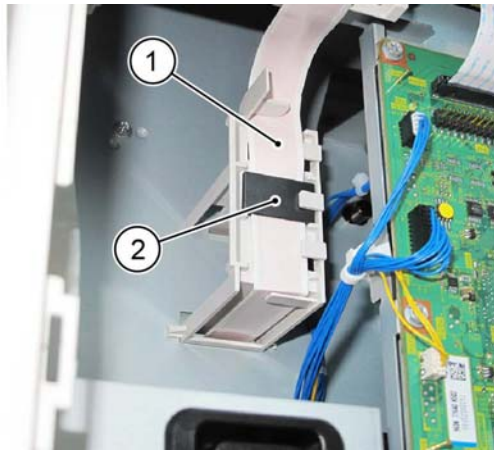
6. Release the FFC cable, [Figure 5](#):
 - a. Release FFC cable from the FFC guide-R (1).
 - b. Remove the ferrite core (2).

Figure 5 Guide release

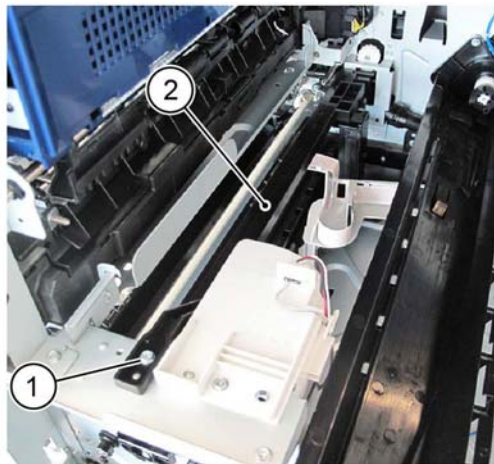
7. Remove the inner cover, [REP 28.2](#).
8. Remove the CRU upper guide assembly, [Figure 6](#):
 - a. Remove the screw (1).
 - b. Remove the CRU upper guide assembly (2).

Figure 6 CRU upper guide removal

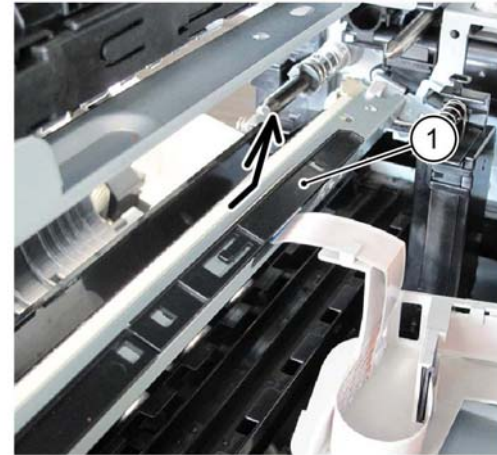
9. Pull up the center tab (1), move the CRU guide toward the rear, then remove it, [Figure 7](#).

Figure 7 CRU guide removal

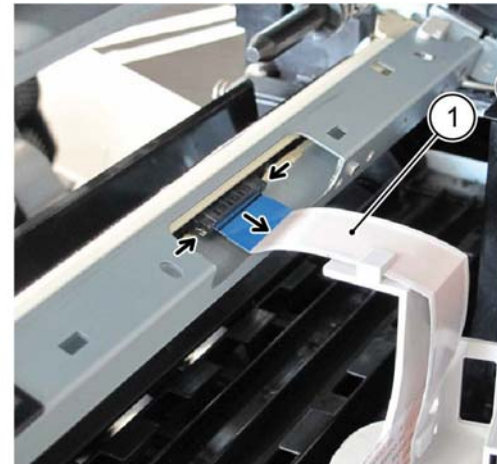
10. Carefully disconnect the FFC cable (1) by releasing the side clips, [Figure 8](#).

Figure 8 FFC Cable

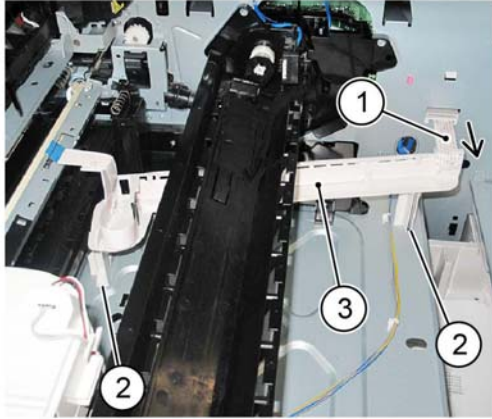
11. Remove the harness assembly, **Figure 9**:
 - a. Pull the FFC cable (1) toward the inside of the machine.
 - b. Disengage the hooks (2) on the foot, then remove the harness assembly (3).

Figure 9 Assembly removal

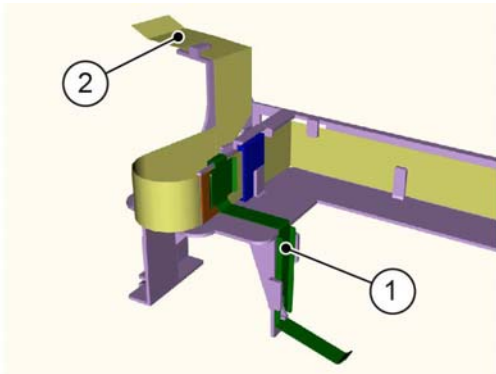
12. Remove the FFC cable, **Figure 10**:
 - a. Remove the FFC conductor (1).
 - b. Remove the FFC cable (2).

Figure 10 FFC cable removal

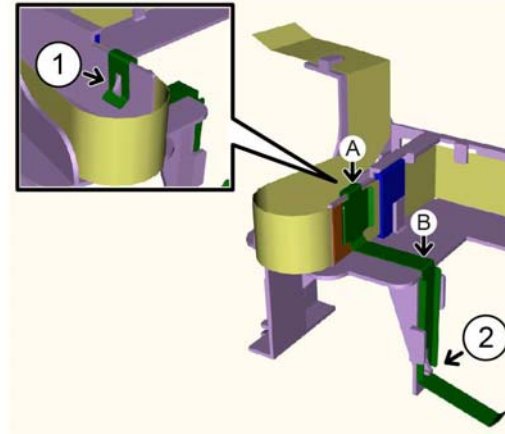
1. The replacement is the reverse of the removal procedure.
2. Connect the FFC cable as shown in **Figure 11**.
 - a. Push section A of the spring and hook it to the tab (1) of the guide.
 - b. Push section B of the spring and hook it to the tab (2) of the guide.

Figure 11 Cable replacement

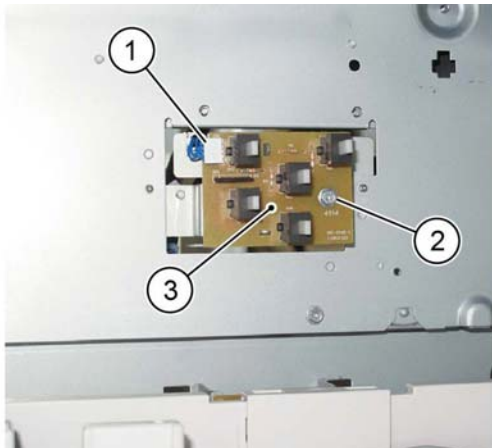
1. Remove tray 1.
2. Remove the tray 1 size sensor, [Figure 1](#):
 - a. Disconnect the connector (1).
 - b. Remove the screw (2).
 - c. Remove the tray 1 size sensor (3).

Figure 1 Tray 1 size sensor removal

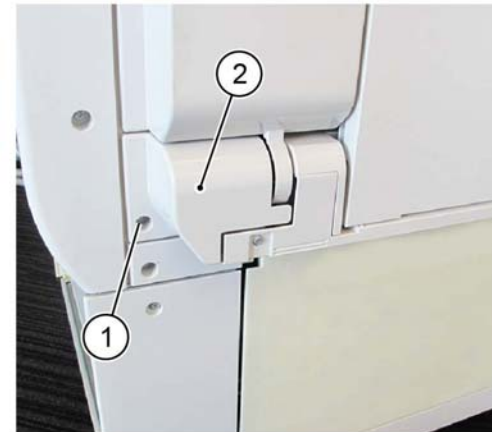
1. Remove the hinge rear cover, [Figure 1](#):
 - a. Remove the screw (1).
 - b. Remove the hinge rear cover (2).

Figure 1 Hinge rear cover removal
