708P91370
April 2017

Xerox® VersaLink® B7025/B7030/B7035 Multifunction Printer Service Manual

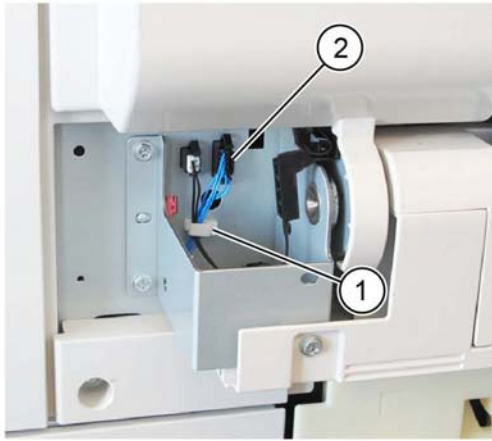
2. Disconnect the connector, **Figure 2:**
 - a. Release the harness from the clamp (1).
 - b. Disconnect the connector (2).

Figure 2 Harness release

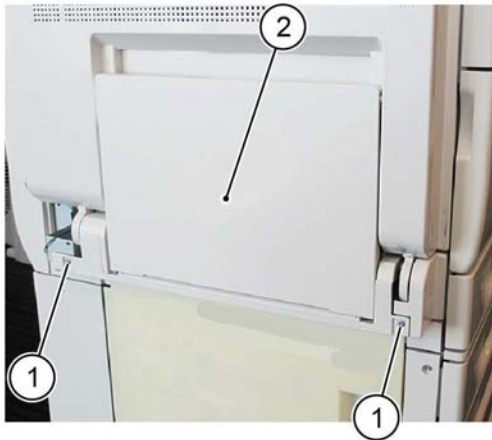
3. Remove the bypass tray, **Figure 3:**
 - a. Remove two screws (1).
 - b. Remove the bypass tray (2).

Figure 3 Bypass tray removal

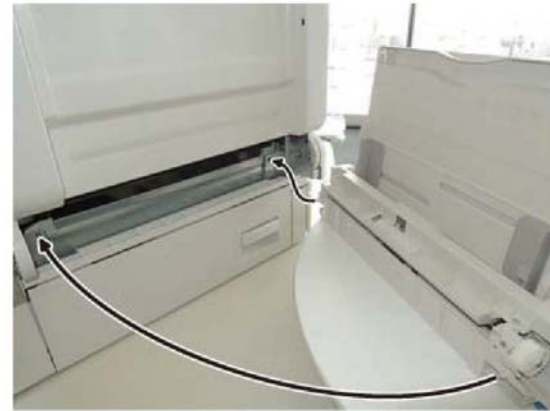
1. The replacement is the reverse of the removal procedure.
2. When installing the bypass tray, insert the two bypass tray bosses into the holes in the frame, **Figure 4.**

Figure 4 Replacement

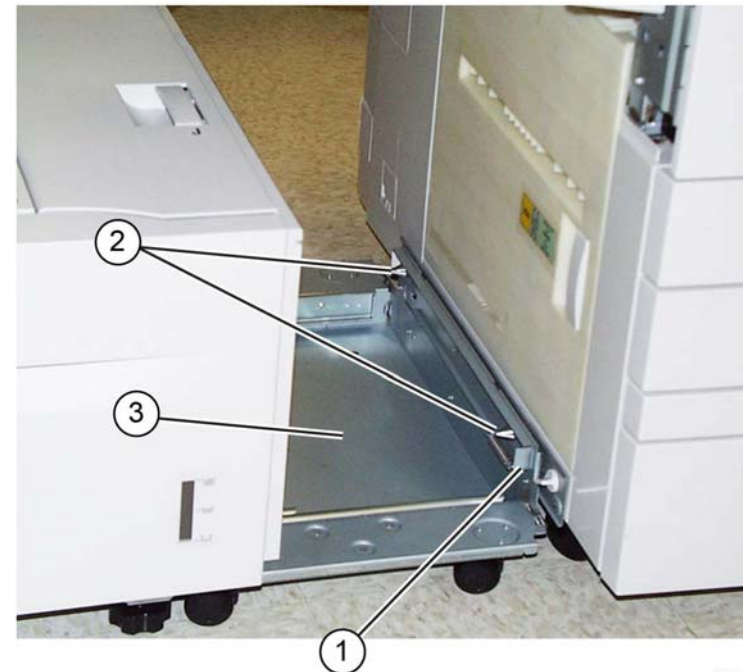
1. Disconnect the HCF power cable from the machine.
2. Pull the HCF away from the machine.
3. Release the docking latch spring lever (1) on the right side of the docking base, [Figure 1](#).

Figure 1 Docking base

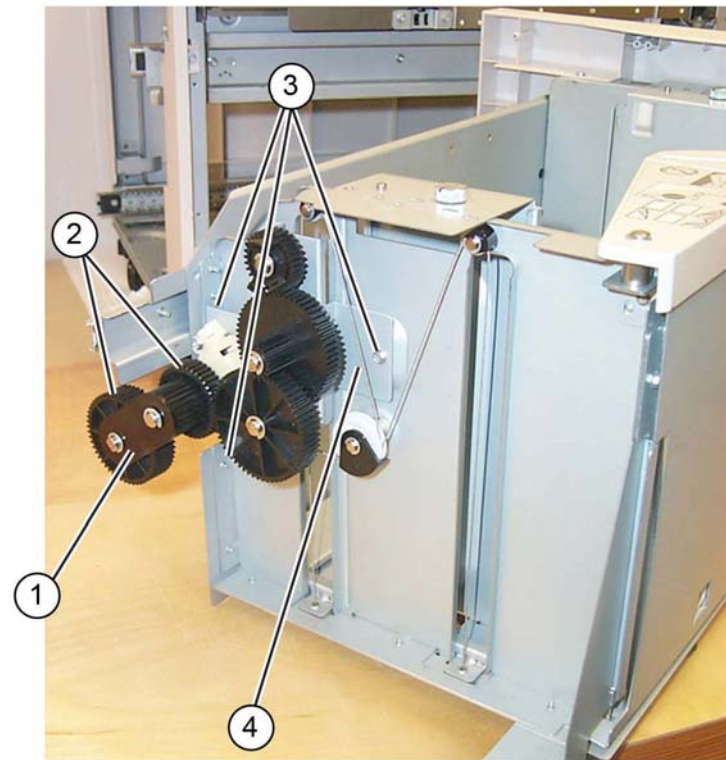
1. Remove the HCF tray, [REP 70.3](#).
2. Remove the gear bracket assembly, [Figure 1](#):
 - a. Remove the oval shaped plate (1).
 - b. Remove two gears (2).
 - c. Remove three screws (3).
 - d. Remove the gear bracket assembly (4).

Figure 1 Gear bracket assembly

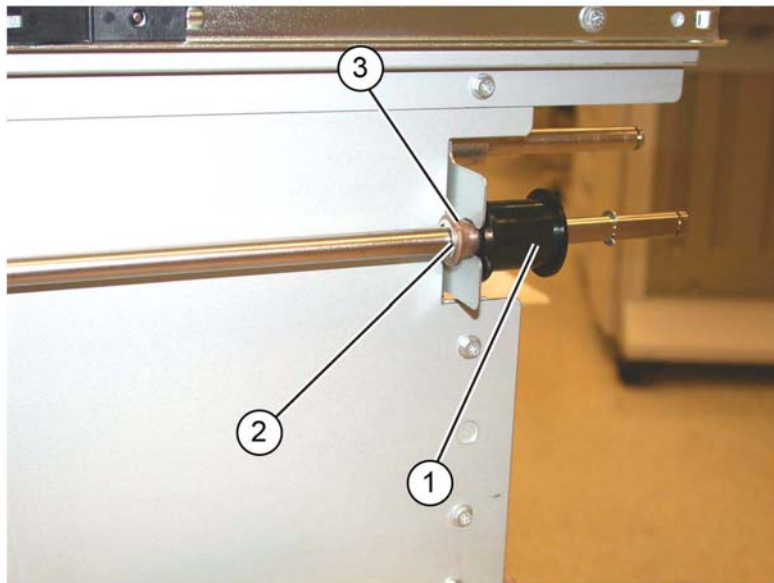
3. Free movement of the tray cable pulley (1), [Figure 2](#):
 - a. Remove the E-ring (2).
 - b. Slide the bushing (3) away from the frame.

Figure 2 Tray cable pulley

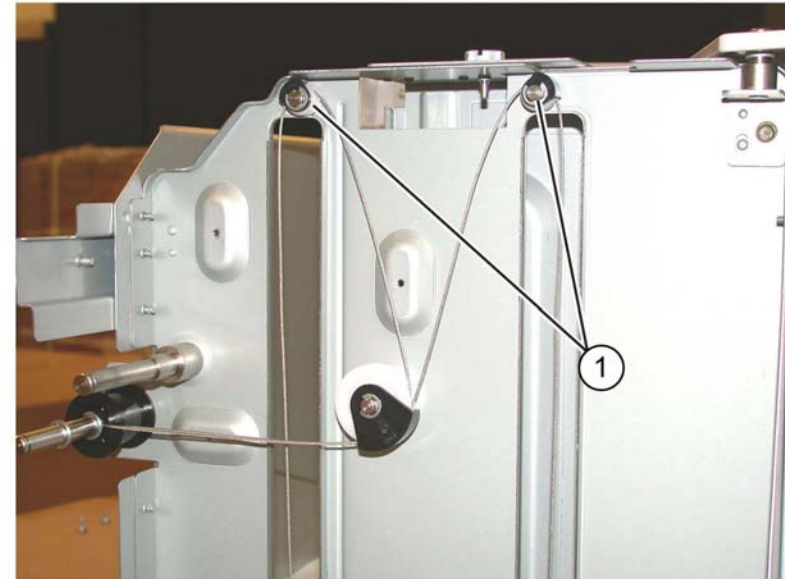
4. Prepare to remove the tray rear cables. Remove two E-rings, wire guides and pulleys (1), [Figure 3](#).

Figure 3 Preparation

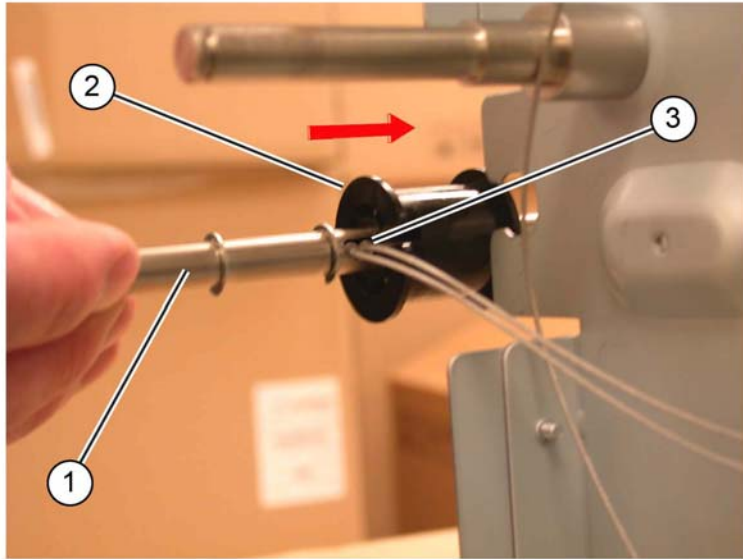
5. When both cables are slack, disengage the lift shaft (1) from the frame. Then slide the tray cable pulley (2) to the front of the lift shaft to release the rear lift cable ends (3) that are trapped in the pocket underneath the tray cable pulley, [Figure 4](#).

Figure 4 Releasing the cable ends

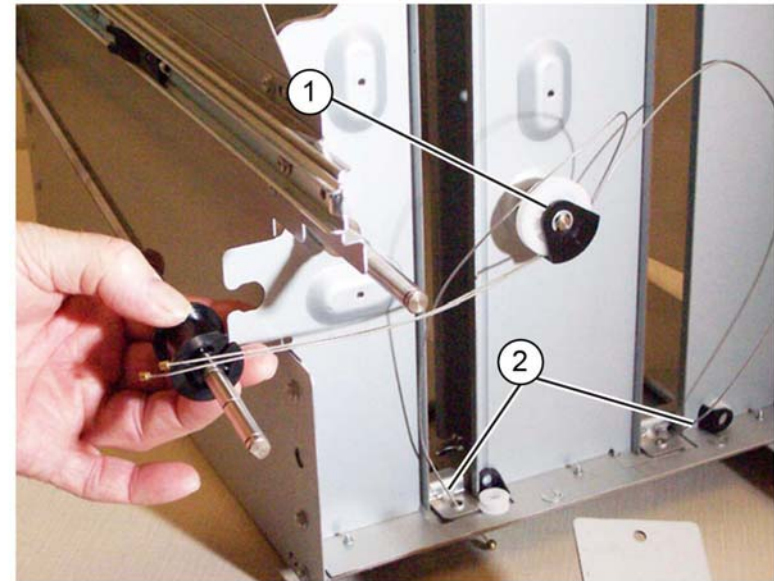
6. Remove the rear tray cables, [Figure 5](#):
 - a. Remove the E-ring, wire guide and pulley (1).
 - b. Remove the cables (2).

Figure 5 Rear cables removal

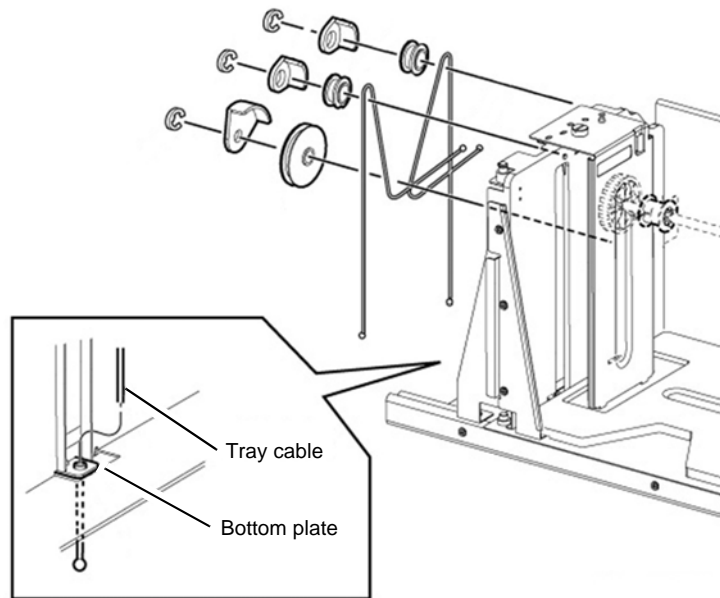
The replacement is the reverse of the removal procedure. Refer to [Figure 6](#).

Figure 6 Replacement

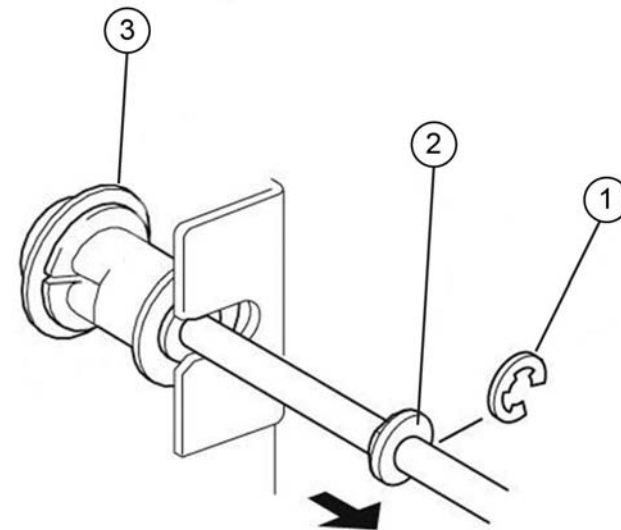
1. Remove the HCF tray front cover, [PL 70.50 Item 7](#).
2. Free movement of the front tray cable pulley, [Figure 1](#).
 - a. Remove the E-ring (1) on the lift shaft.
 - b. Slide the bearing (2) to the rear on the lift shaft.
 - c. Front tray cable pulley (3).

Figure 1 Tray cable pulley

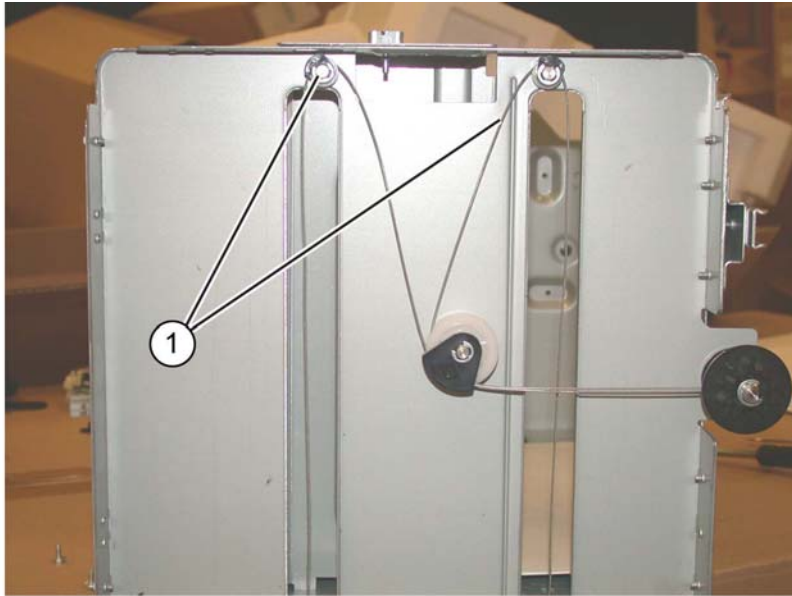
3. Prepare to remove the tray front cables. Remove two E-rings, wire guides and pulleys (1) from the front of the HCF tray, [Figure 2](#).
4. When both cables are slack, disengage the lift shaft from the frame, Then slide the tray cable pulley to the front of the lift shaft to release the rear lift cable ends that are trapped in the pocket underneath the tray cable pulley, [Figure 3](#).

Figure 2 Preparation

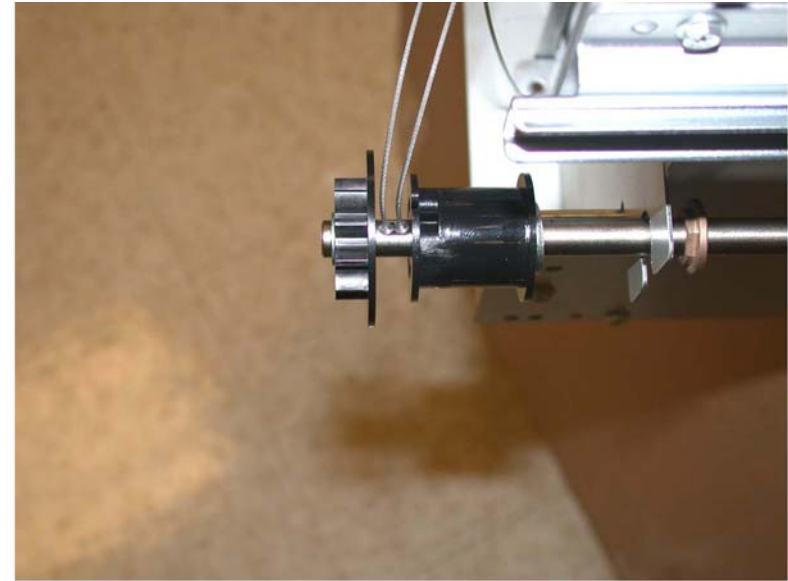
Figure 3 Releasing the cable ends

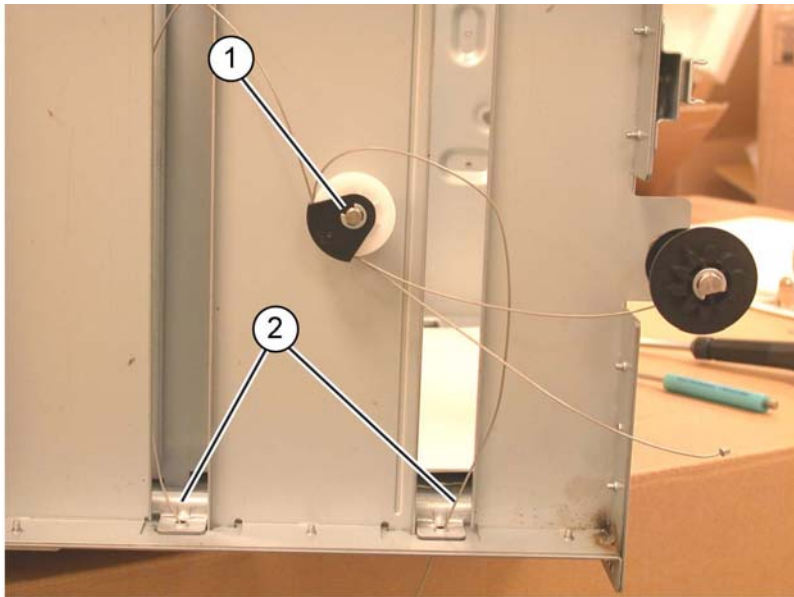
5. Remove the front tray cables, [Figure 4](#):
 - a. Remove the E-ring, wire guide and pulley (1).
 - b. Remove the cables (2).

Figure 4 Front cables removal

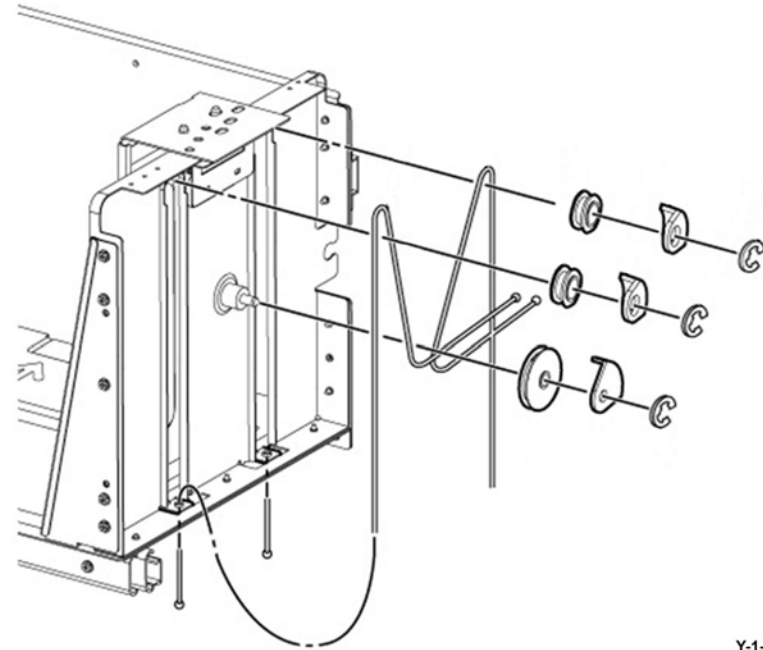
1. The replacement is the reverse of the removal procedure. Refer to [Figure 5](#).

Figure 5 Replacement

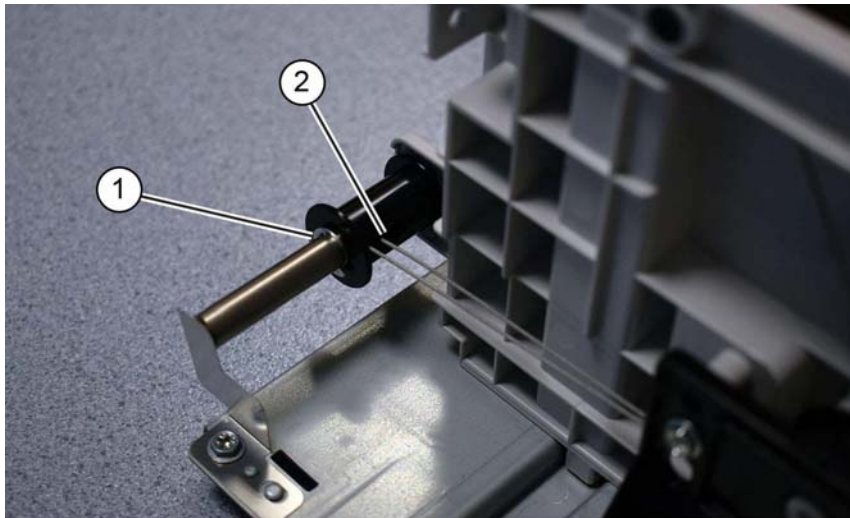
1. Remove the paper from tray 3.
2. Fully pull out tray 3. Remove the paper from tray 3. Lift out tray 3.
3. Remove the tray 3 front cover, [PL 70.65 Item 18](#).
4. Release the front lift cables, [Figure 1](#):
 - a. Remove the E-clip (1).
 - b. Release the front lift cables (2).

Figure 1 Front cables

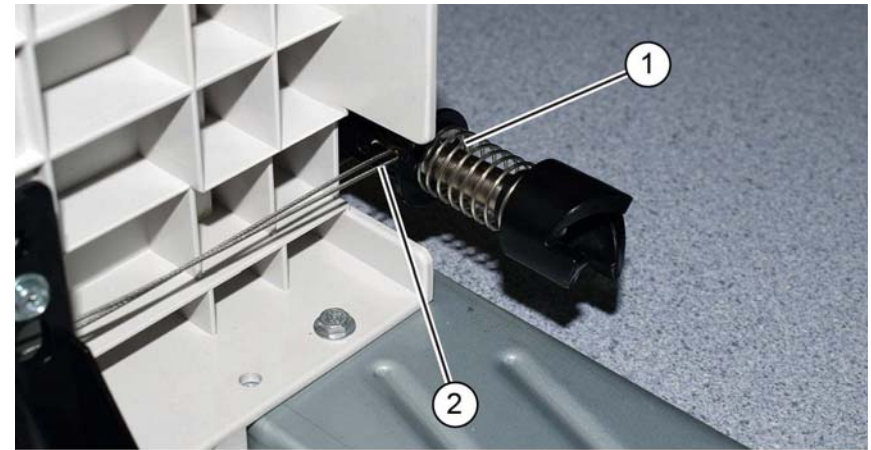
5. Release the rear lift cables, [Figure 2](#):
 - a. Pull the spring away from the pulley, then remove the E-clip (1).
 - b. Release the rear lift cables (2).

Figure 2 Rear cables

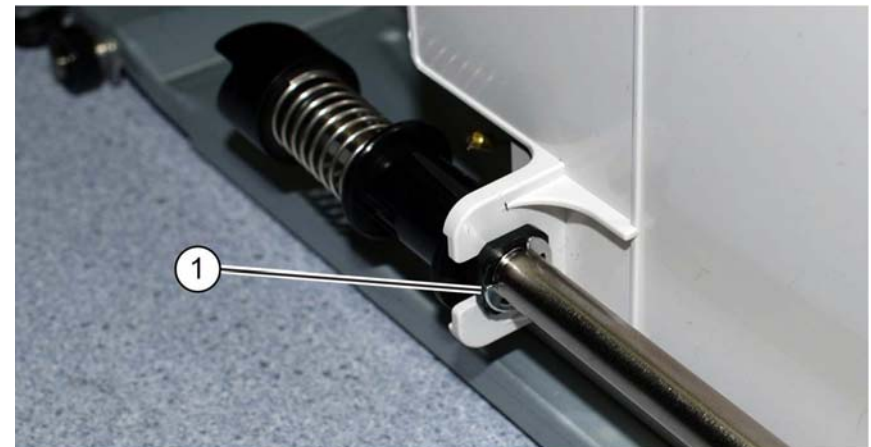
6. Remove the E-clip (1), [Figure 3](#):

Figure 3 Rear E-clip

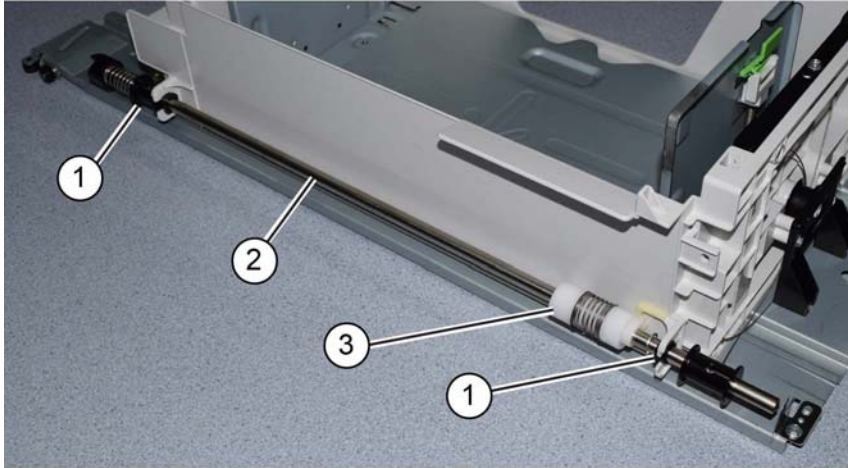
Figure 4 Lift shaft removal

The lift shaft brake, item 3 in Figure 4, is secured on the lift shaft by a pin. Do not lose the pin when the lift shaft is removed.

7. Remove the lift shaft, Figure 4:
 - a. Release the front and rear bearings (1).
 - b. Remove the lift shaft (2).

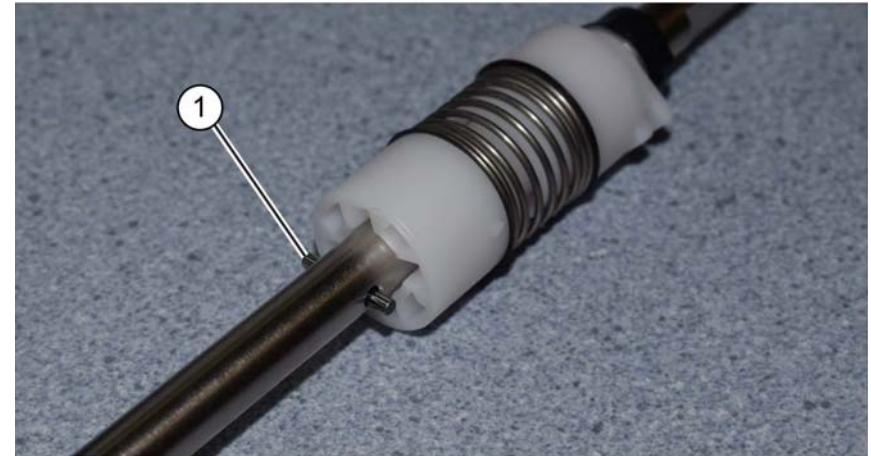
Figure 5 Pin

2. Ensure the brake securing pin (1) is installed correctly, Figure 5.

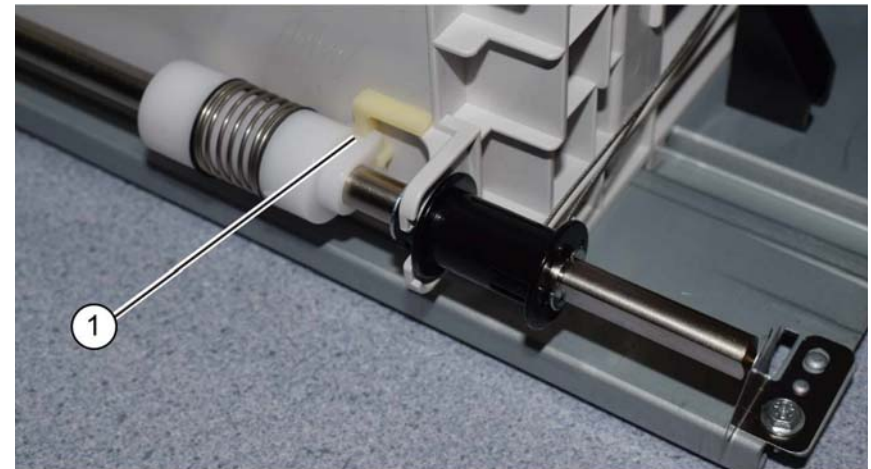
Figure 6 Brake

3. Ensure the brake (1) is correctly positioned against the tray frame, Figure 6.

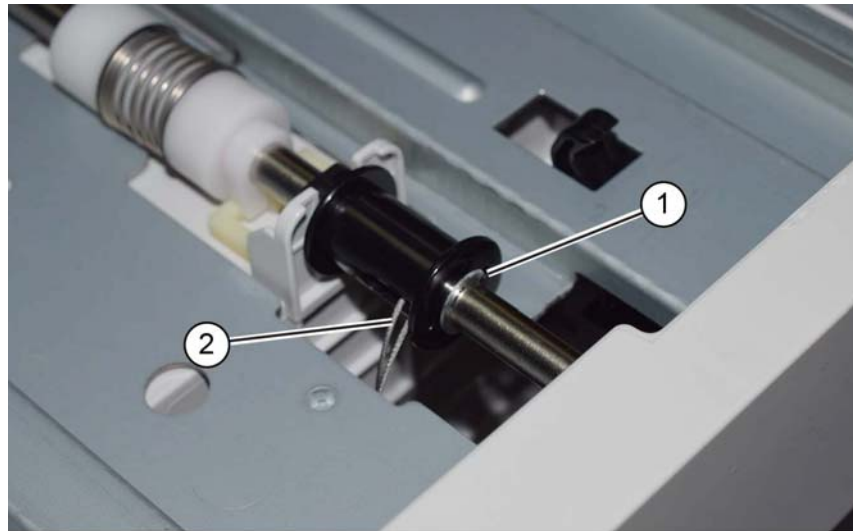
Figure 1 Front cables

1. Fully pull out tray 4. Remove the paper from tray 4. Lift out tray 4.
2. Remove the tray 4 transport assembly, [PL 80.70 Item 11](#).
3. Remove the tray 4 front cover, [PL 70.65 Item 3](#).
4. Turn tray 4 upside down.
5. Release the front lift cables, [Figure 1](#):
 - a. Remove the E-clip (1).
 - b. Release the front lift cables (2).

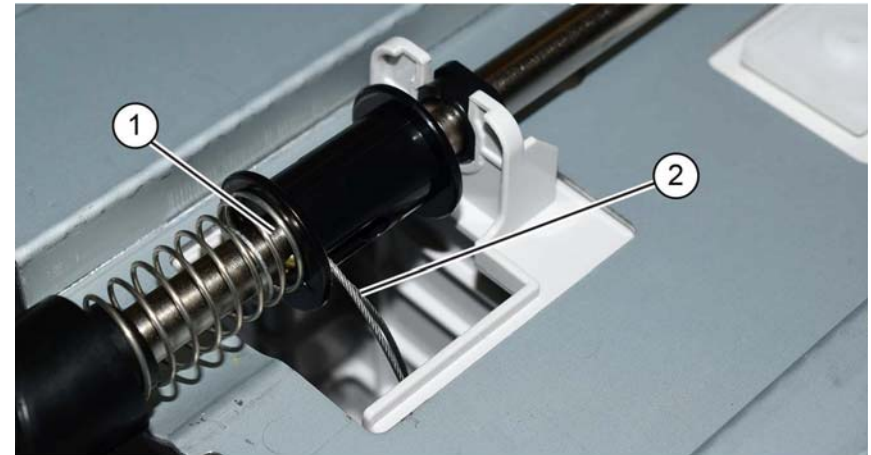
Figure 2 Rear cables

6. Release the rear lift cables, [Figure 2](#):
 - a. Pull the spring away from the pulley, then remove the E-clip (1).
 - b. Release the rear lift cables (2).

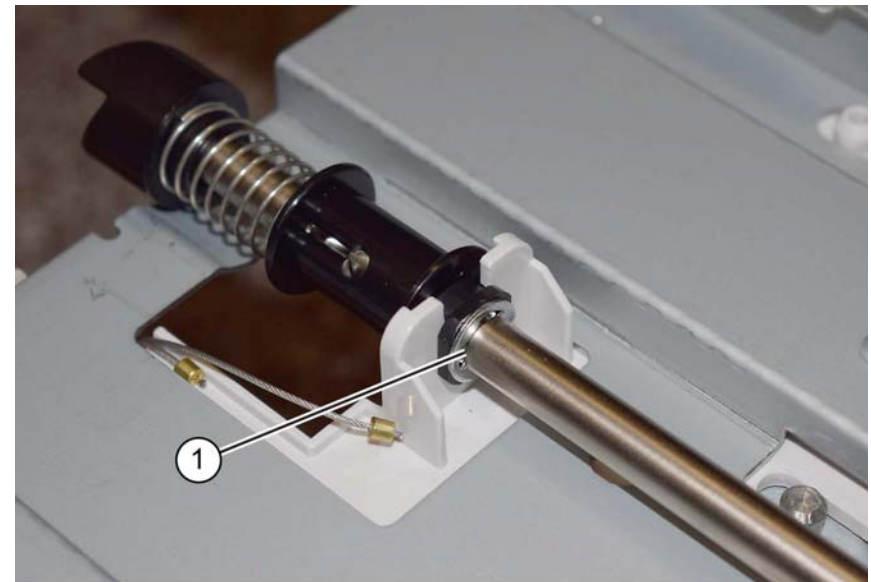
Figure 3 Rear E-clip

7. Remove the E-clip (1), [Figure 3](#):

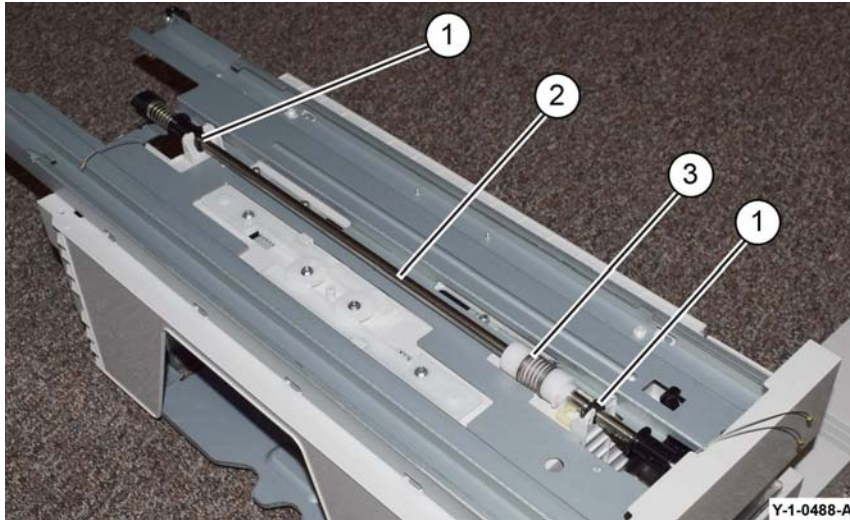
Figure 4 Lift shaft removal

The lift shaft brake, item 3 in Figure 4, is secured on the lift shaft by a pin. Do not lose the pin when the lift shaft is removed.

8. Remove the lift shaft, Figure 4:
 - a. Release the front and rear bearings (1).
 - b. Remove the lift shaft (2).

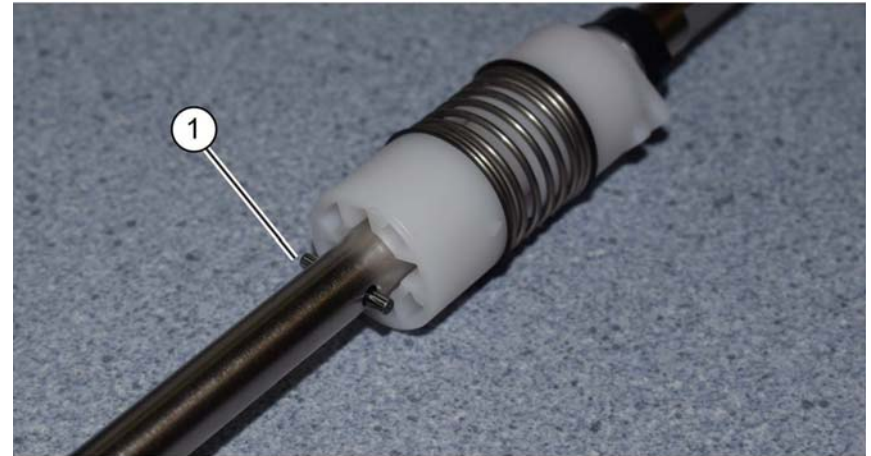
Figure 5 Pin

2. Ensure the brake securing pin (1) is installed correctly, Figure 5.

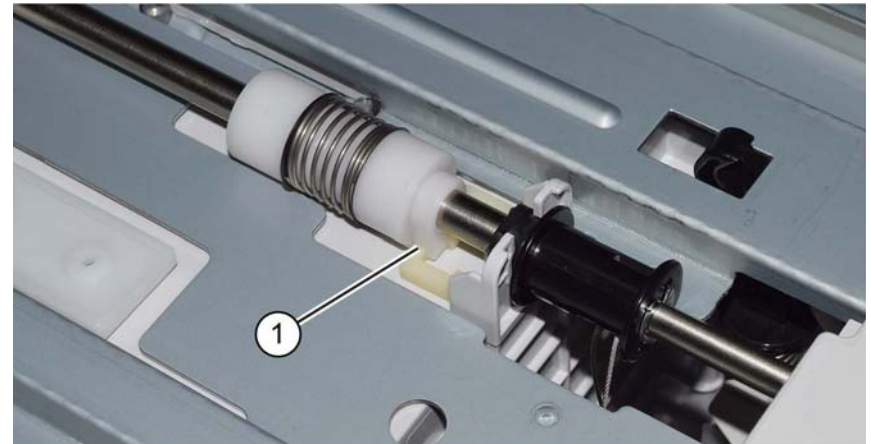
Figure 6 Brake

3. Ensure the brake (1) is correctly positioned against the tray frame, Figure 6.

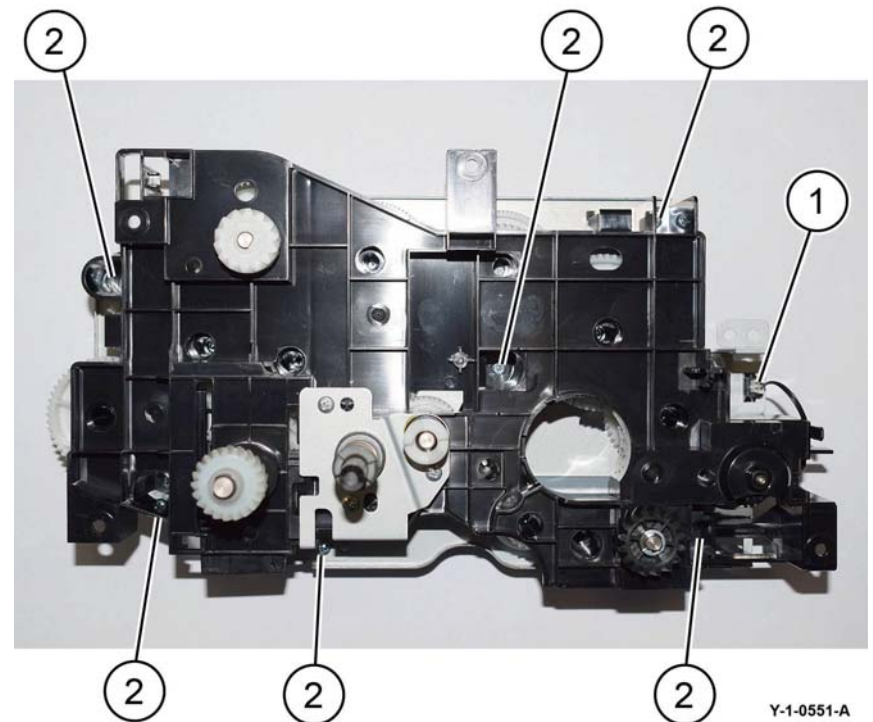
Figure 1 Preparation

1. Remove the drive assembly, [REP 40.1](#).
2. Prepare to split the drive assembly, [Figure 1](#):
 - a. Disconnect the inline connector (1).
 - b. Remove six screws (2).

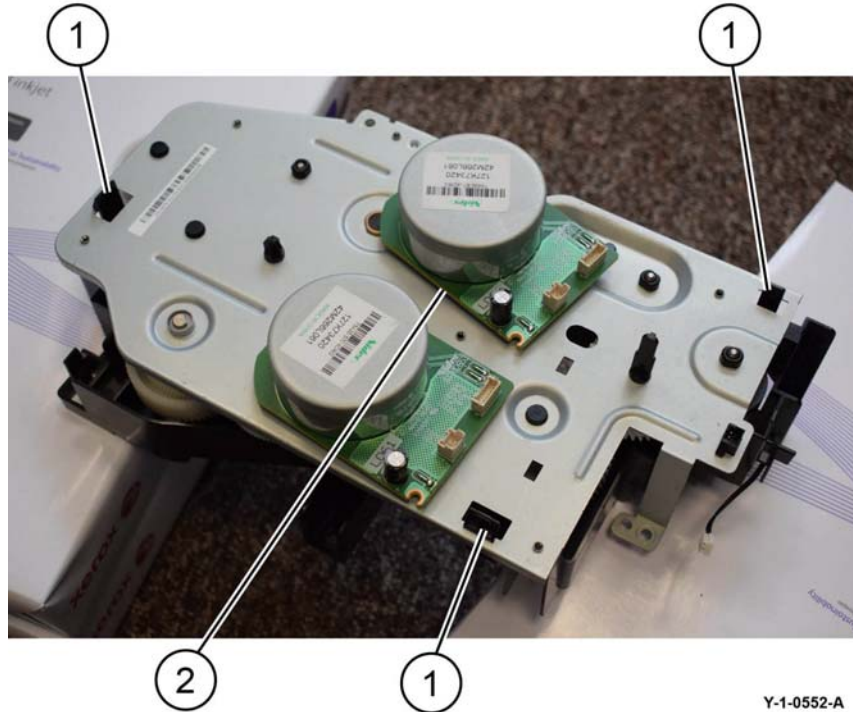
Figure 2 Clips

3. Place the drive assembly, metal drive plate face up, on four reams of paper (two stacks of two). Remove the metal drive plate, [Figure 2](#):
 - a. Release the three clips (1).
 - b. Very carefully, lift off the metal drive plate (2).

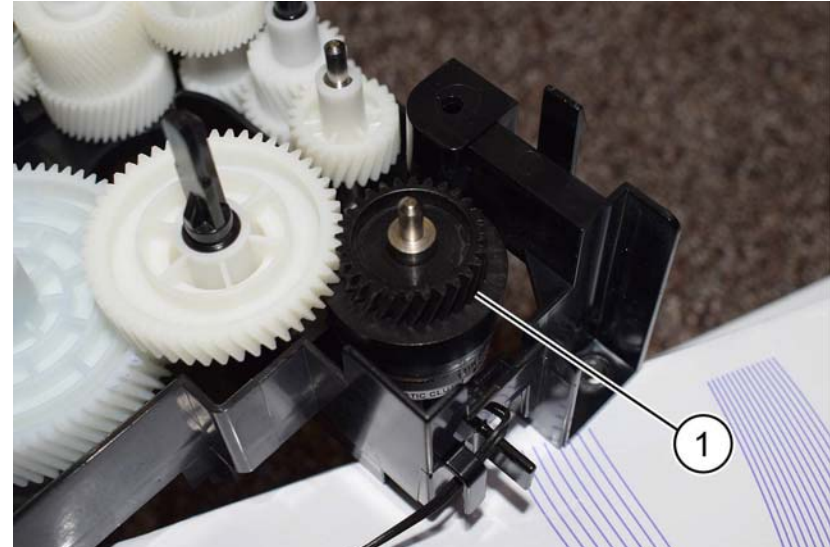
Figure 3 Clutch removal

4. Remove the takeaway clutch (1) or lock bearing, [PL 40.10 Item 4](#) as necessary, [Figure 3](#).

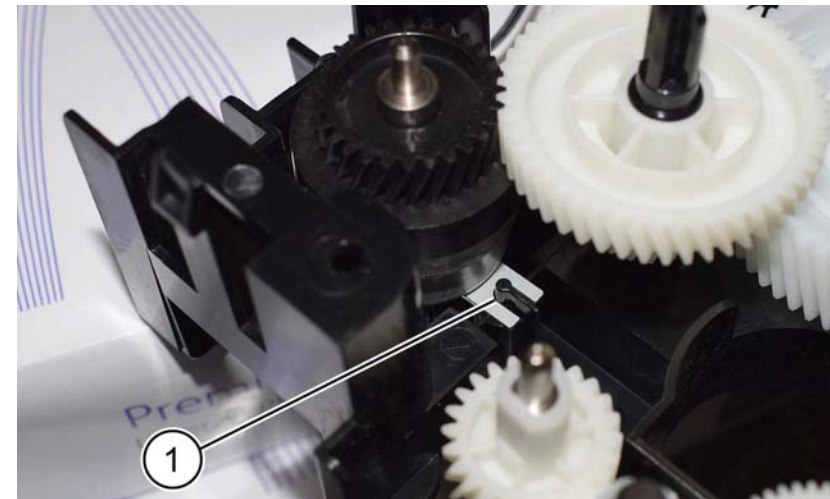
Figure 4 Clutch replacement

1. The replacement is the reverse of the removal procedure.
2. When installing the new takeaway clutch. Ensure that the two fingered bracket on the clutch is correctly positioned over the moulded peg (1) on the drive assembly, [Figure 4](#).

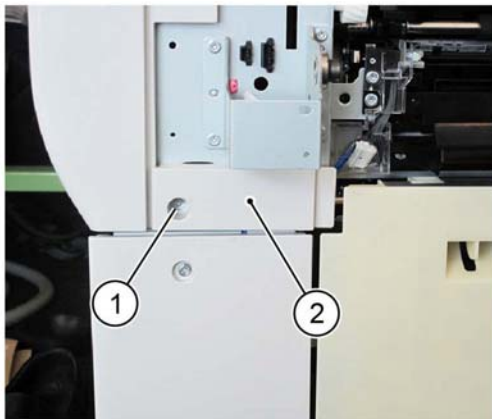
Figure 1 Bypass tray R cover removal

1. Pull out tray 1.
2. Open the LH transport assembly.
3. Remove the bypass tray, [REP 70.2](#).
4. Remove the bypass tray R cover, [Figure 1](#):
 - a. Remove the screw (1).
 - b. Remove the bypass tray R cover (2).

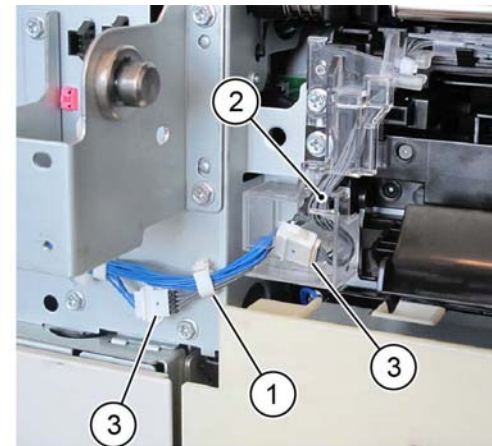
Figure 2 Connectors

5. Disconnect the connectors, [Figure 2](#):
 - a. Release the harness from the retainer (1).
 - b. Release the harness from the harness holder (2).
 - c. Disconnect two connector (3).

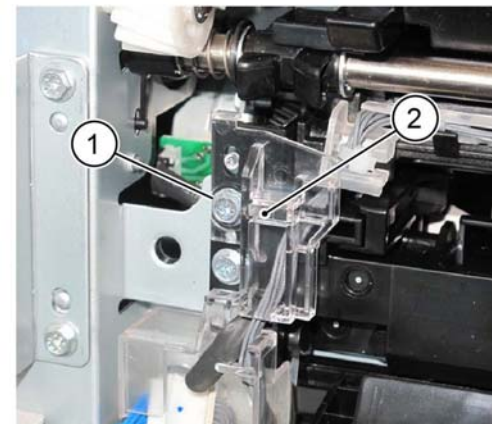
Figure 3 Harness holder removal

6. Remove the harness holder, [Figure 3](#):
 - a. Remove the screw (1).
 - b. Remove the harness holder (2).

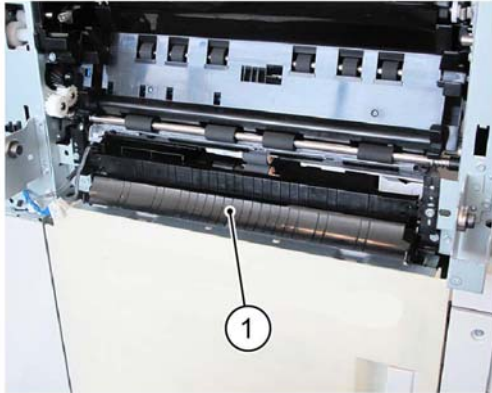
Figure 4 Feed out chute removal

7. Remove the feed out chute (1), [Figure 4](#).

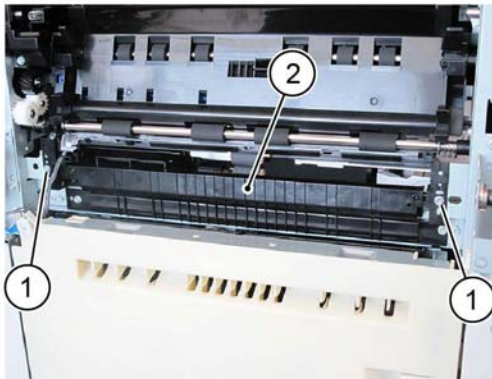
Figure 5 Tray 1 feeder assembly removal

8. Remove the tray 1 feeder assembly, [Figure 5](#):
 - a. Remove two screws (1).
 - b. Remove the tray 1 feeder assembly (2).

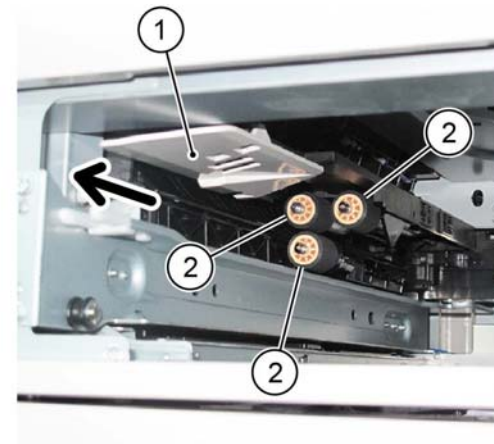
Figure 1 Roll removal

1. Pull out tray 1.
2. Remove the tray 1 feed, retard and nudger rolls, [Figure 1](#):
 - a. Slide the chute (1) forwards.
 - b. Release the clip, then remove the tray 1 feed, retard and nudger rolls (2).

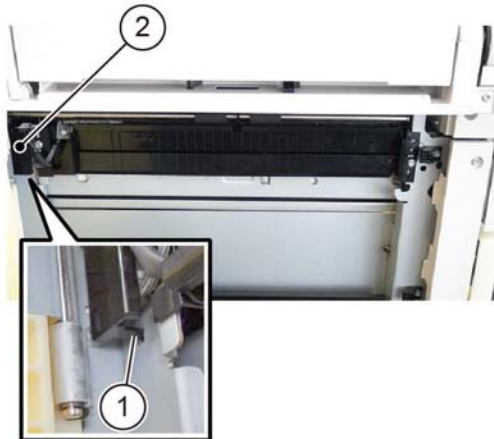
Figure 1 ESD cover removal

1. Pull out tray 2. Remove the paper.
2. Remove tray 2.
3. Open the left cover assembly, [PL 70.15 Item 12](#).
4. Remove the ESD cover, [Figure 1](#):
 - a. Disengage the hook (1).
 - b. Remove the ESD cover (2).

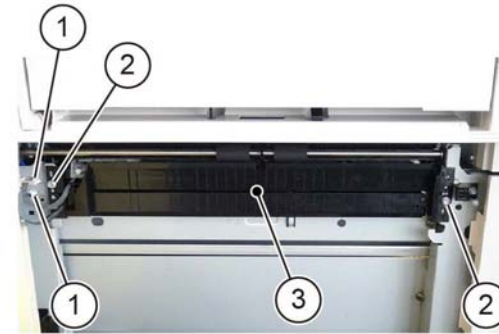
Figure 2 Tray 2 feeder assembly removal

5. Remove the tray 2 feeder assembly, [Figure 2](#):
 - a. Disconnect the connectors (1).
 - b. Remove two screws (2).
 - c. Remove the tray 2 feeder assembly (3).

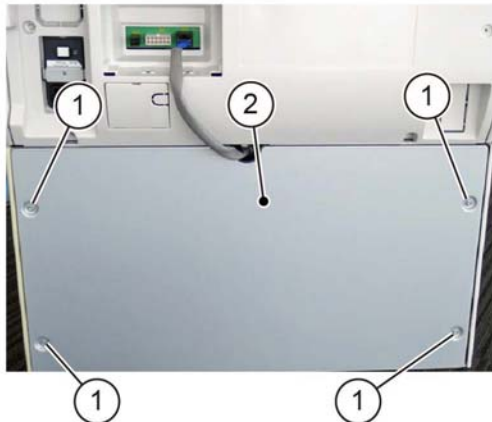
Figure 2 Rear cover removal

1. Remove the rear cover, [Figure 1](#):
 - a. Remove four screws (1).
 - b. Remove the rear cover (2).

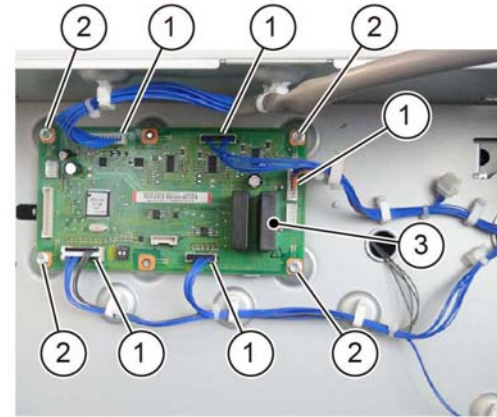
Figure 3 1TM PWB removal

2. Remove the 1TM PWB, [Figure 2](#):
 - a. Disconnect five connectors (1).
 - b. Remove four screws (2).
 - c. Remove the 1TM PWB (3).

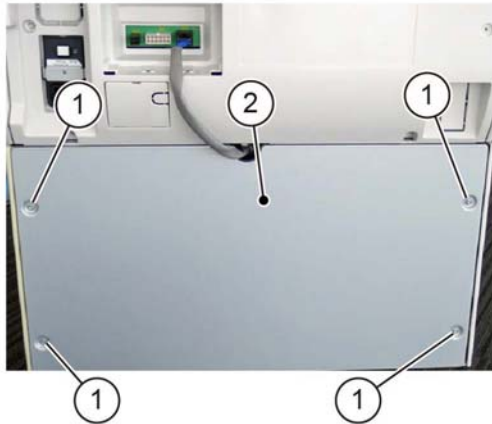
Figure 1 Rear cover removal

1. Remove the rear cover, [Figure 1](#):
 - a. Remove four screws (1).
 - b. Remove the rear cover (2).

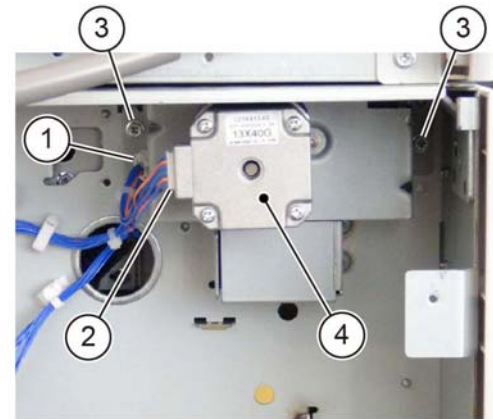
Figure 2 1TM takeaway motor removal

2. Remove the 1TM takeaway motor, [Figure 2](#):
 - a. Release the clamp (1).
 - b. Disconnect the connector (2).
 - c. Remove two screws (3).
 - d. Remove the 1TM takeaway motor (4).

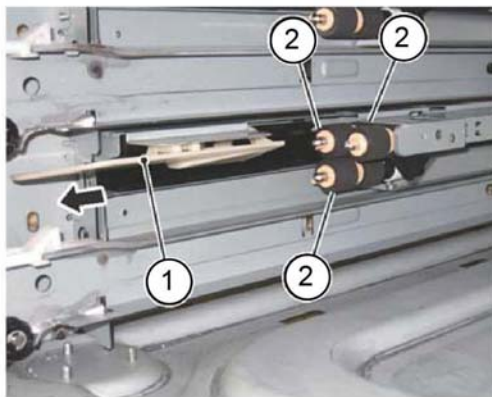
Figure 1 Roll removal

1. Pull out tray 1 and tray 2. Remove the paper.
2. Remove tray 1 and tray 2.
3. Open the left cover assembly, [PL 70.15 Item 12](#).
4. Remove the tray 2 feed, retard and nudger rolls (1TM), [Figure 1](#):
 - a. Slide the chute (1) forwards.
 - b. Release the clip, then remove the tray 2 feed, retard and nudger rolls (2).

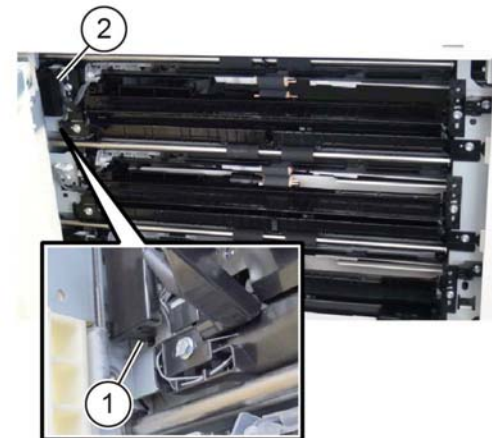
Figure 1 ESD cover removal

1. Pull out tray 2. Remove the paper.
2. Remove tray 2.
3. Open the left cover assembly, [PL 70.20 Item 11](#).
4. Remove the ESD cover, [Figure 1](#):
 - a. Disengage the hook (1).
 - b. Remove the ESD cover (2).

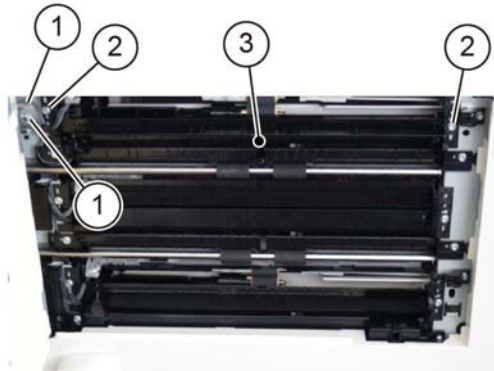
Figure 2 Tray 2 feeder assembly removal

5. Remove the tray 2 feeder assembly, [Figure 2](#):
 - a. Disconnect two connectors (1).
 - b. Remove two screws (2).
 - c. Remove the tray 2 feeder assembly (3).

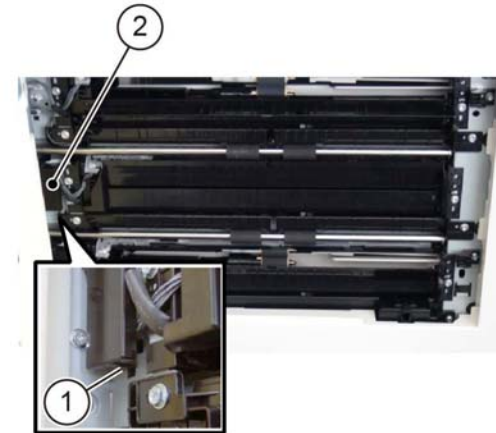
Figure 1 ESD cover removal

1. Pull out tray 3. Remove the paper.
2. Remove tray 3.
3. Open the left cover assembly, [PL 70.20 Item 11](#).
4. Remove the ESD cover, [Figure 1](#):
 - a. Disengage the hook (1).
 - b. Remove the ESD cover (2).

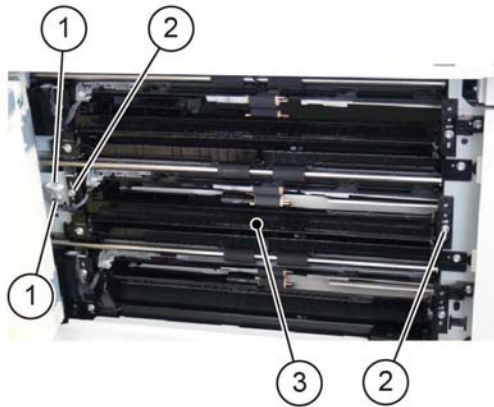
Figure 2 Tray 3 feeder assembly removal

5. Remove the tray 3 feeder assembly, [Figure 2](#):
 - a. Disconnect two connectors (1).
 - b. Remove two screws (2).
 - c. Remove the tray 3 feeder assembly (3).

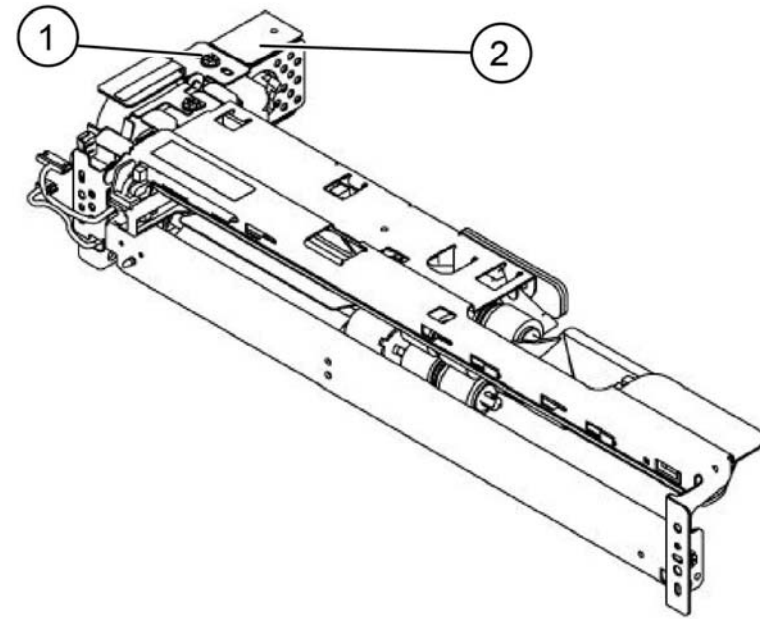
Figure 3 FDR 2T cover removal

6. Remove the FDR 2T cover from the tray 3 feeder assembly, [Figure 3](#).
 - a. Remove the screw (1).
 - b. Remove the FDR 2T cover (2). Retain the cover for installation onto the new tray 3 feeder assembly.

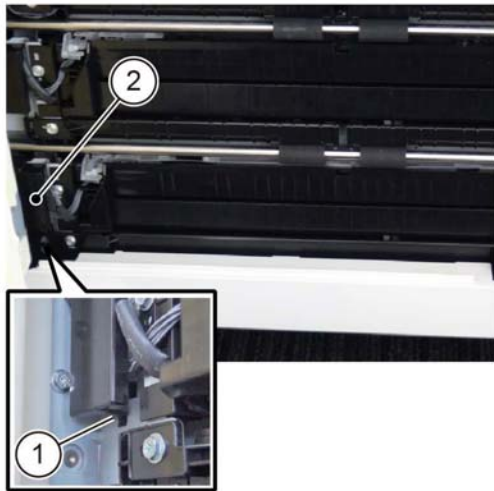
Figure 1 ESD cover removal

1. Pull out tray 4. Remove the paper.
2. Remove tray 4.
3. Open the left cover assembly, [PL 70.20 Item 11](#).
4. Remove the ESD cover, [Figure 1](#):
 - a. Disengage the hook (1)
 - b. Remove the ESD cover (2).

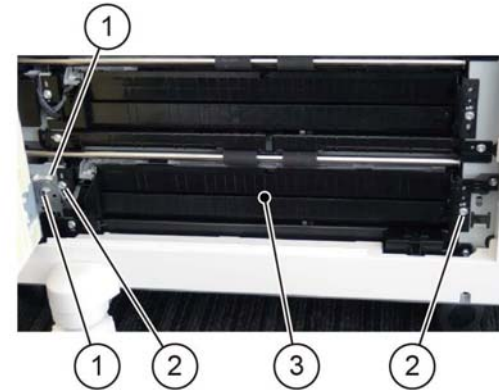
Figure 2 Tray 4 feeder assembly removal

5. Remove the tray 4 feeder assembly, [Figure 2](#):
 - a. Disconnect two connectors (1).
 - b. Remove two screws (2).
 - c. Remove the tray 4 feeder assembly (3).

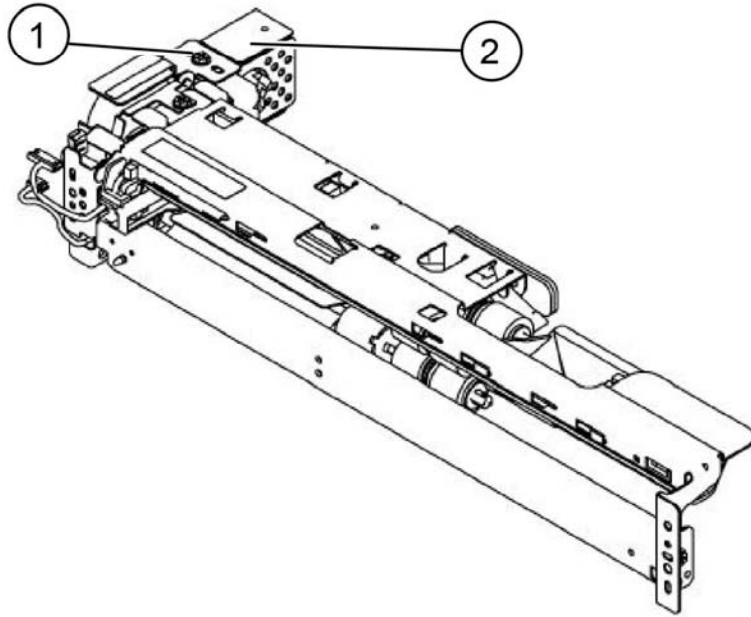
Figure 3 FDR 2T cover removal

6. Remove the FDR 2T cover from the tray 4 feeder assembly, [Figure 3](#).
 - a. Remove the screw (1).
 - b. Remove the FDR 2T cover (2). Retain the cover for installation onto the new tray 4 feeder assembly.

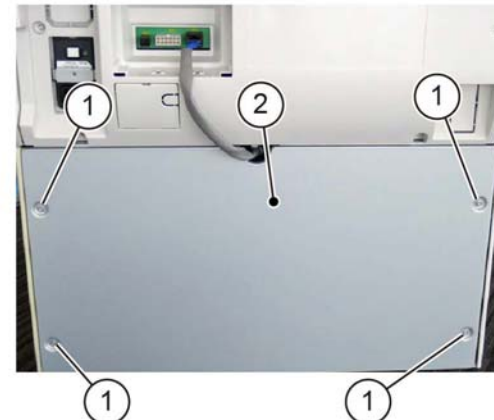
Figure 2 Rear cover removal

1. Remove the rear cover, [Figure 1](#):
 - a. Remove four screws (1).
 - b. Remove the rear cover (2).

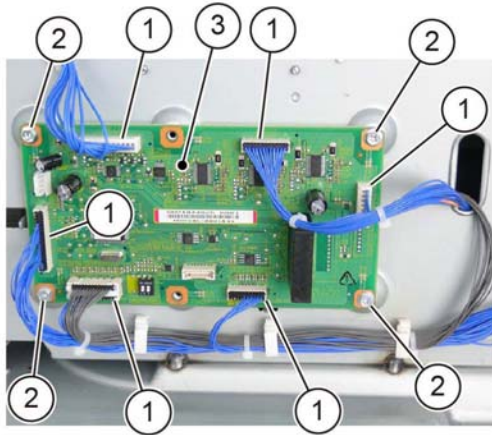
Figure 3 3TM PWB removal

2. Remove the 3TM PWB, [Figure 2](#):
 - a. Disconnect six connectors (1).
 - b. Remove four screws (2).
 - c. Remove the 3TM PWB (3).

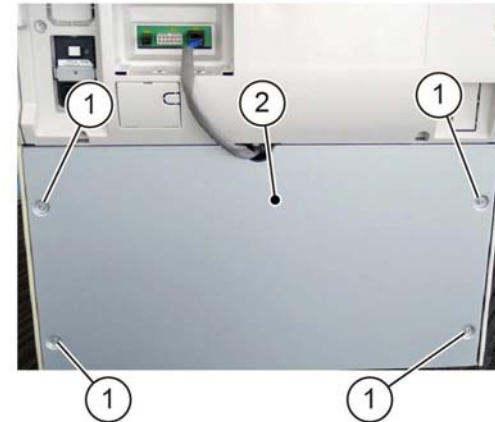
Figure 1 Rear cover removal

1. Remove the rear cover, [Figure 1](#):
 - a. Remove four screws (1).
 - b. Remove the rear cover.

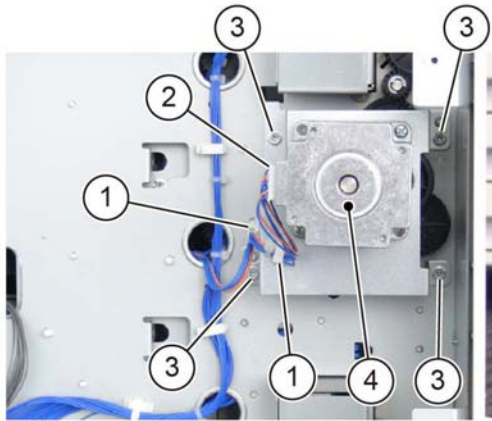
Figure 2 3TM takeaway motor removal

2. Remove the 3TM takeaway motor, [Figure 2](#):
 - a. Release the clamp (1).
 - b. Disconnect the connector (2).
 - c. Remove four screws (3).
 - d. Remove the 3TM takeaway motor (4).

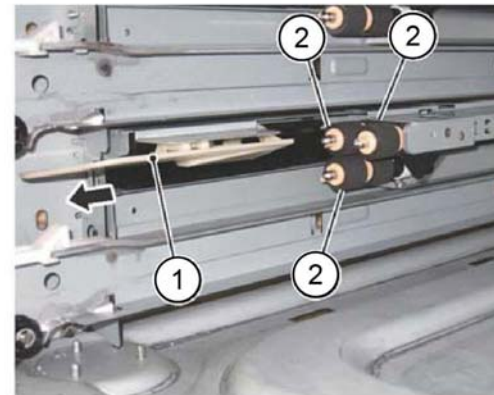
Figure 1 Roll removal

1. Pull out trays 2, 3 and 4. Remove the paper.
2. Remove trays 2, 3 and 4.
3. Open the left cover assembly, [PL 70.20 Item 11](#).
4. Remove the tray 2, 3 or 4 feed, retard and nudger rolls, [Figure 1](#):
 - a. Slide the chute (1) forwards.
 - b. Release the clip, then remove the tray 2, 3 or 4 feed, retard and nudger rolls (2).

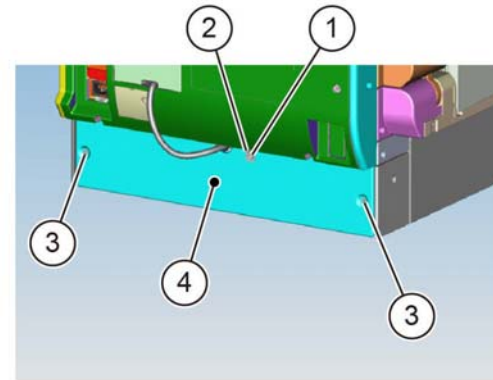
Figure 2 Rear cover removal

1. Enter [dC131](#). Record the value of NVM location 742-003.
2. Remove the rear cover, [Figure 2](#):
 - a. Remove the docking screw (1).
 - b. Remove the docking bracket (2).
 - c. Remove two screws (3).
 - d. Remove the rear cover (4).

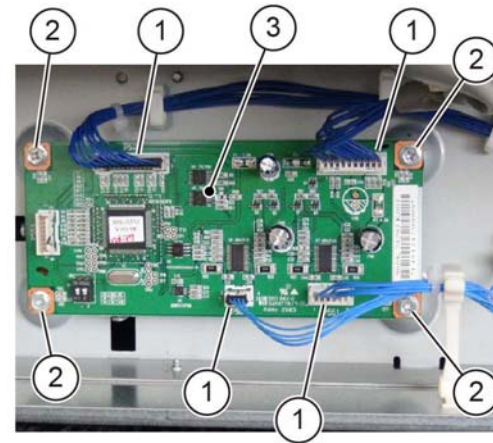
Figure 3 STM PWB Removal

3. Remove the STM PWB, [Figure 3](#):
 - a. Disconnect four connectors (1).
 - b. Remove four screws (2).
 - c. Remove the STM PWB (3).

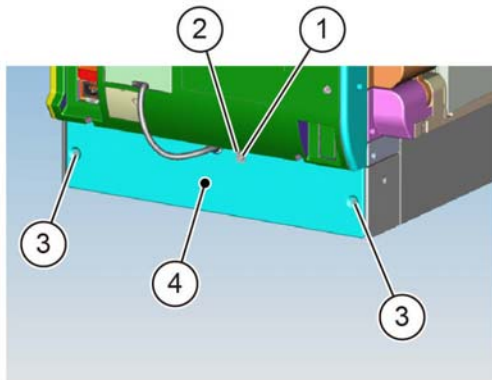
Figure 1 Rear cover removal

1. Remove the rear cover, [Figure 2](#):
 - a. Remove the docking screw (1).
 - b. Remove the docking bracket (2).
 - c. Remove two screws (3).
 - d. Remove the rear cover (4).
