708P91370
April 2017

Xerox® VersaLink® B7025/B7030/B7035 Multifunction Printer Service Manual

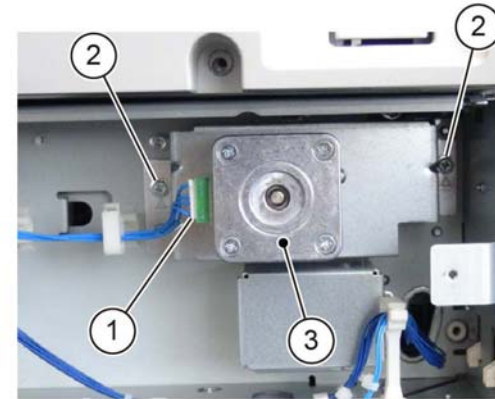
Figure 2 STM takeaway motor removal

2. Remove the STM takeaway motor, [Figure 2](#):
 - a. Disconnect the connector (1).
 - b. Remove two screws (2).
 - c. Remove the STM takeaway motor (3).

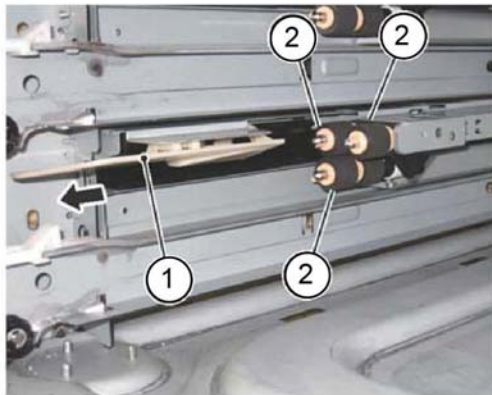
Figure 1 Roll removal

1. Pull out tray 1 and tray 2. Remove the paper.
2. Remove tray 1 and tray 2.
3. Open the left cover assembly, [PL 70.25 Item 2](#).
4. Remove the tray 2 feed, retard and nudger rolls (1TM), [Figure 1](#):
 - a. Slide the chute (1) forwards.
 - b. Release the clip, then remove the tray 2 feed, retard and nudger rolls (2).

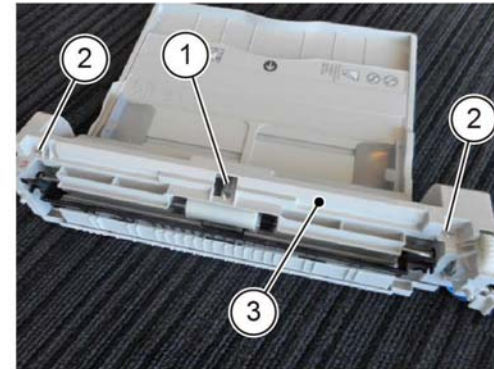
Figure 1 Upper frame removal

1. Remove the bypass tray, [REP 70.2](#).
2. Remove the upper frame, [Figure 1](#):
 - a. Remove the spring (1).
 - b. Remove two crews (2).
 - c. Remove the upper frame (3).

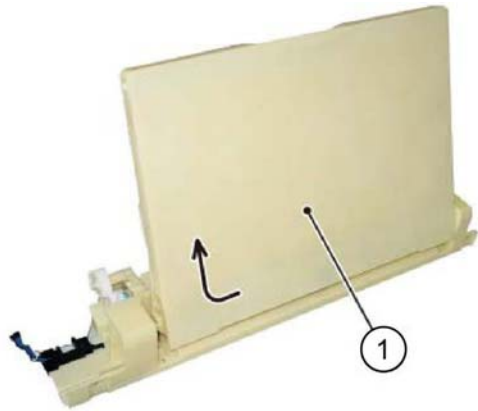
Figure 2 Tray assembly removal

3. Remove the bypass tray assembly in the direction of the arrow, [Figure 2](#).

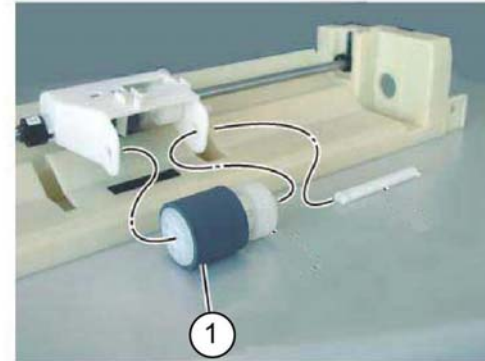
Figure 4 Nudger roll removal

5. Remove the bypass tray nudger roll (1), [Figure 4](#).

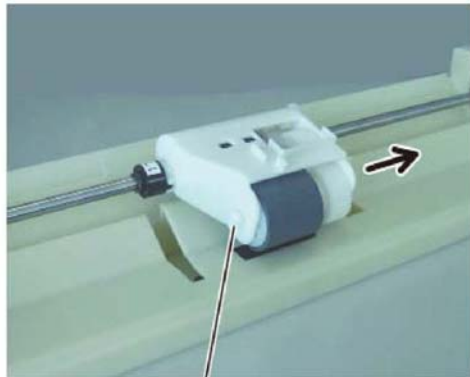
Figure 3 Shaft removal

4. Release the shaft, then remove the shaft in the direction of the arrow, [Figure 3](#).

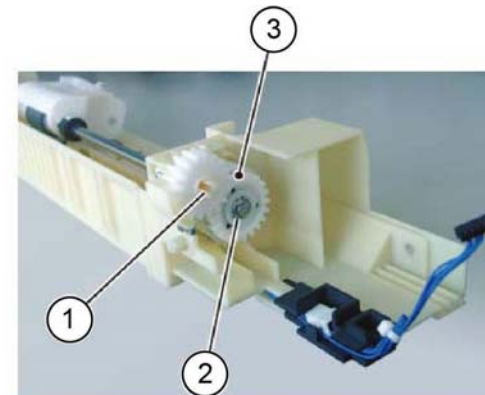
Figure 5 Feed clutch removal

6. Remove the bypass tray feed clutch, [Figure 5](#):
- Release the hook, then remove the gear (1).
 - Remove the E-clip (2).
 - Remove the bypass tray feed clutch from the shaft (3).

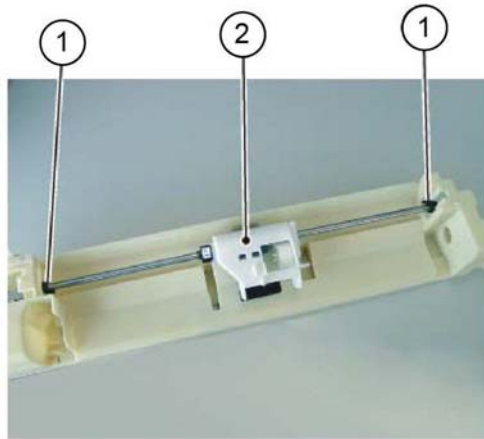
Figure 6 Feed roll assembly removal

7. Remove the bypass tray feed roll assembly, [Figure 6](#):
 - a. Remove two E-Clips (1).
 - b. Remove the bypass tray feed roll assembly (2).

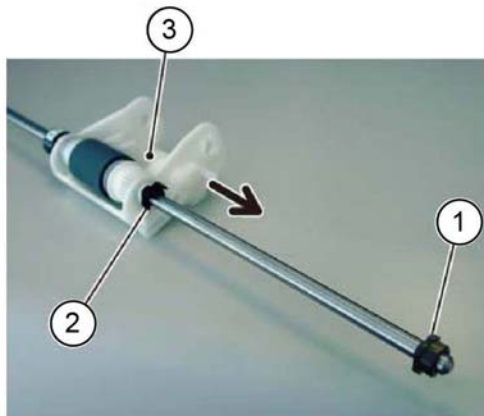
Figure 7 Shaft

8. Move the housing, [Figure 7](#):
 - a. Remove the bearing (1).
 - b. Remove the E-clip (2).
 - c. Move the housing, in the direction of the arrow, to the end of the shaft.

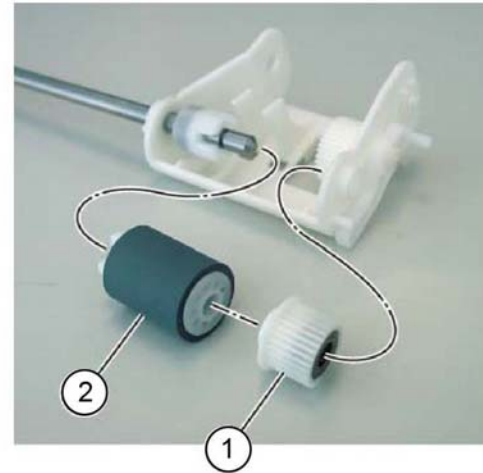
Figure 8 Feed roll removal

9. Remove the bypass tray feed roll, [Figure 8](#):
 - a. Remove the gear (1).
 - b. Remove the bypass tray feed roll (2).

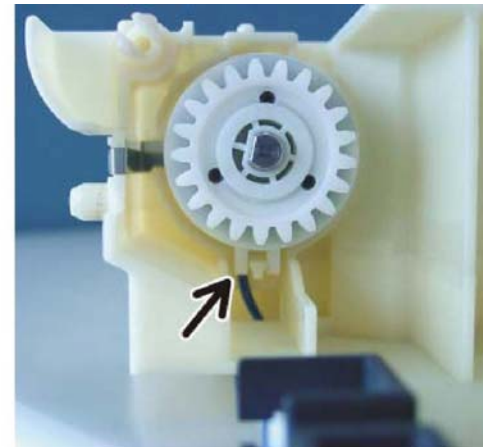
Figure 9 Feed clutch alignment

1. The replacement is the reverse of the removal procedure.
2. When installing the bypass tray feed clutch, align the cutout of the bypass tray feed clutch with the tab, [Figure 9](#).

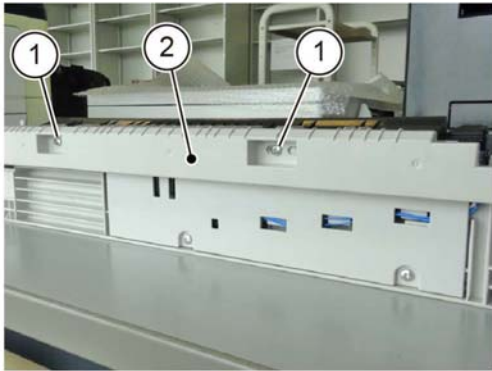
Figure 1 Low chute removal

1. Remove the bypass tray, REP 70.2.
2. Remove the bypass tray low chute, Figure 1:
 - a. Remove two screws (1).
 - b. Remove the bypass tray low chute (2).

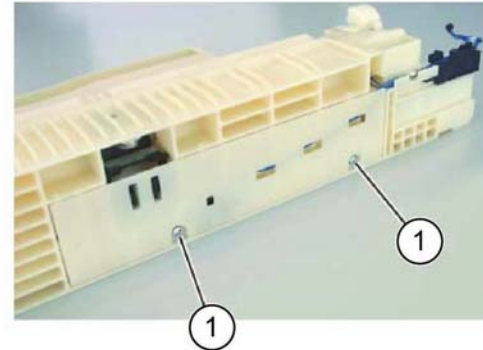
Figure 2 Bypass tray lower cover

3. Remove two screws (1) that secure the bypass tray lower cover at the bottom of the bypass tray, Figure 2.

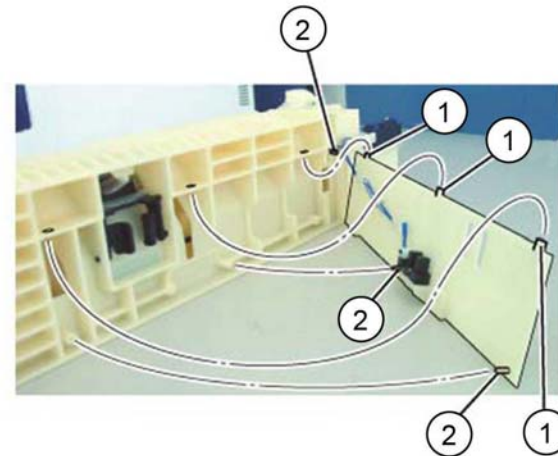
Figure 3 Bypass tray lower cover removal

4. Release three hooks (1) and three bosses (2) from the installation holes to open the bypass tray lower cover, Figure 3.

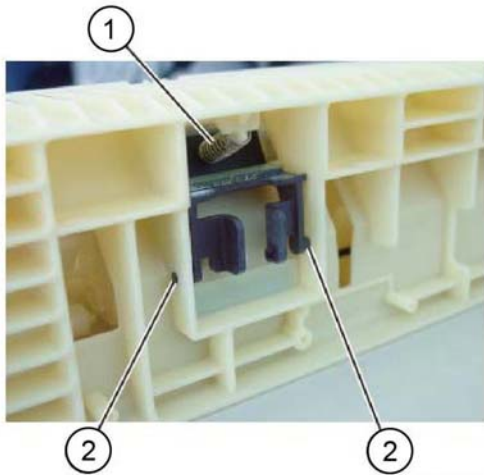
Figure 4 Retard pad removal

5. Remove the bypass tray retard pad, [Figure 4](#).
 - a. Remove the spring (1).
 - b. Release the bosses (2), then remove the bypass tray retard pad.

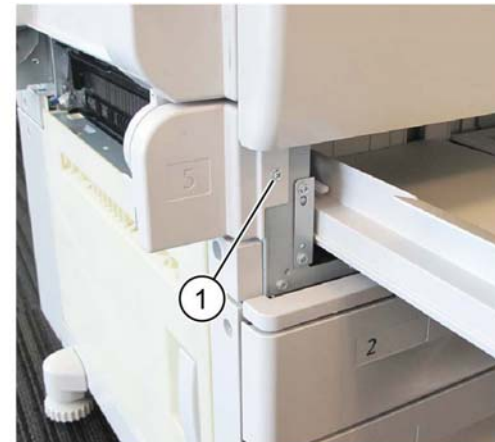
Figure 1 Hinge front cover

1. Remove the bypass tray, [REP 70.2](#).
2. Pull out tray 1. Remove the screw (1) that secures the hinge front cover, [Figure 1](#).

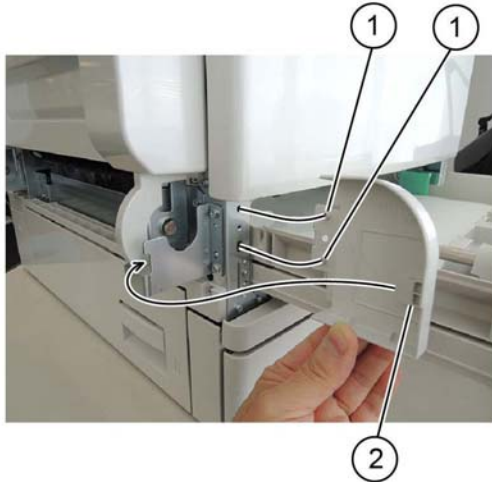
Figure 2 Hinge front cover removal

3. Pull out the bossed (1) from the mounting holes. Release the hook (2), then remove the hinge front cover, [Figure 2](#).

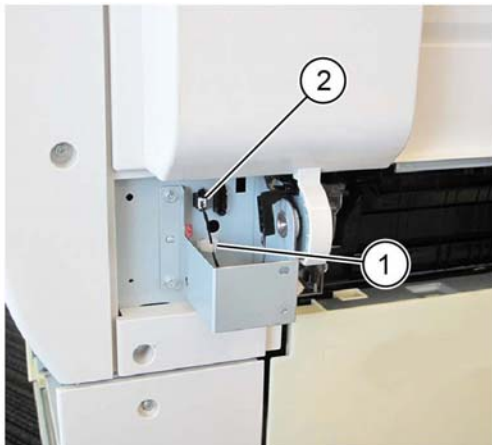
Figure 3 Connector

4. Disconnect the connector, [Figure 3](#):
 - a. Release the harness from the retainer (1).
 - b. Disconnect the connector (2).

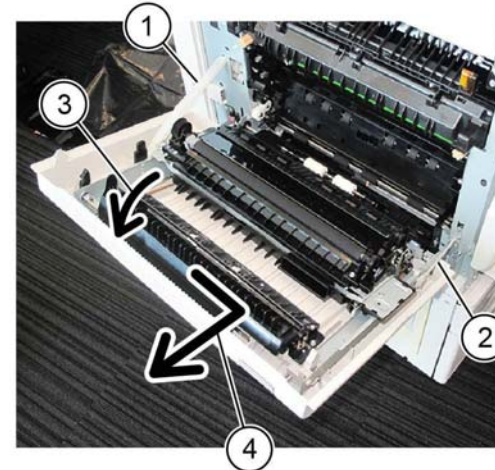
Figure 4 LH cover removal

5. Remove the L/H cover, [Figure 4](#):
 - a. Open the LH cover.
 - b. Rotate by 90 degrees, then disconnect the rear support (1).
 - c. Rotate by 90 degrees, then disconnect the front support (2).
 - d. Hold the L/H cover (3) open at 90 degrees.
 - e. Remove the L/H cover in the direction of the arrow (4).

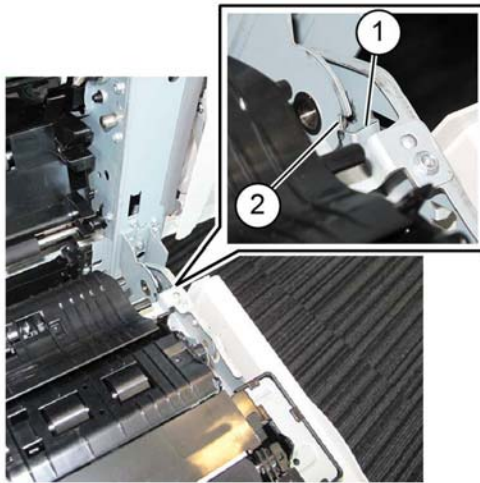
Figure 5 Alignment

1. The replacement is the reverse of the removal procedure.
2. Align the tab on the LH cover front frame with the cutout on the bypass tray front frame assembly then move the LH cover backwards, [Figure 5](#).

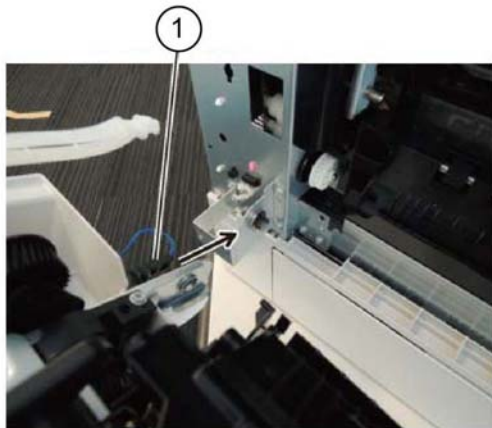
Figure 6 Harness guide

When reinstalled the LH cover, do not let the rear harness guide (1) contact the bracket. Refer to [Figure 6](#).

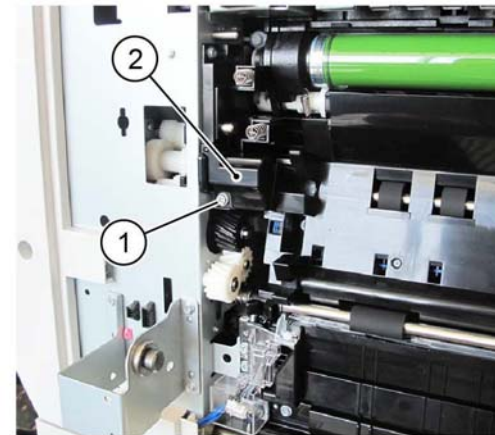
Figure 1 Connector cover removal

1. Remove the bypass tray, [REP 70.2](#).
2. Remove the L/H cover, [REP 80.18](#).
3. Remove the connector cover, [Figure 1](#):
 - a. Remove the screw (1).
 - b. Remove the connector cover (2).

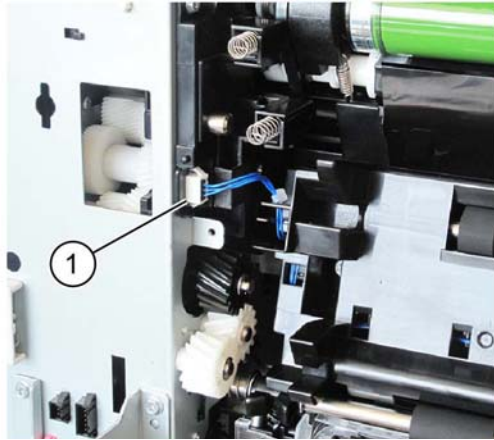
Figure 2 Connector

4. Disconnect the connector, [Figure 2](#).

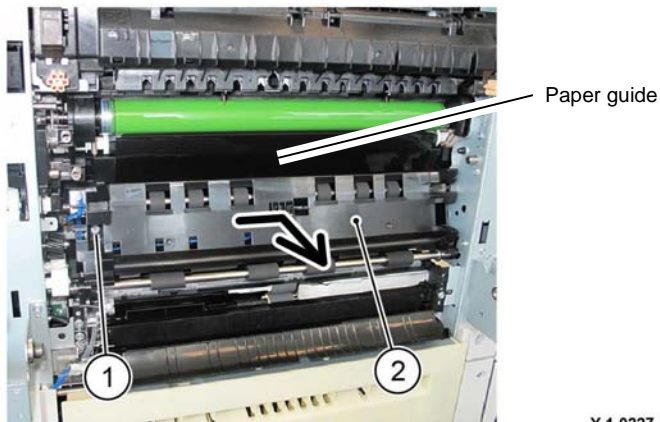
Figure 3 Registration transport assembly removal

Take care not to damage the paper guide when removing the registration transport assembly. Damage to the paper guide may result in paper jams.

- b. Move the registration transport assembly (2) in the direction of the arrow to remove.

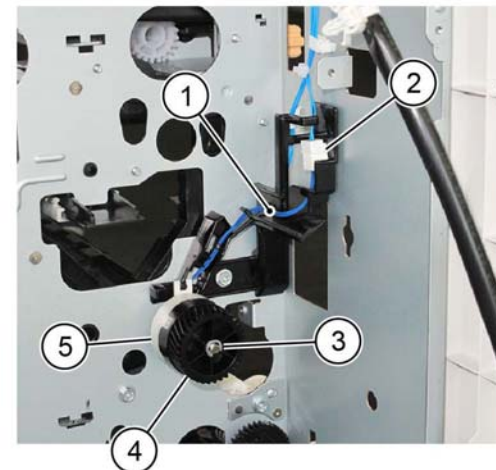
Figure 1 Registration clutch assembly removal

1. Remove the drum cartridge, [REP 90.4](#).
2. Remove the front cover, [REP 28.1](#).
3. Remove the inner cover, [REP 28.2](#).
4. Remove the bypass tray, [REP 70.2](#).
5. Remove the LH cover, [REP 80.18](#).
6. Remove the registration transport assembly, [REP 80.19](#).
7. Remove the drive assembly, [REP 40.1](#).
8. Remove the registration clutch assembly, [Figure 1](#):
 - a. Release the harness from the guide (1).
 - b. Disconnect the connector (2).
 - c. Remove the E-clip (3).
 - d. Remove the registration clutch gear (4).
 - e. Remove the registration clutch assembly (5).

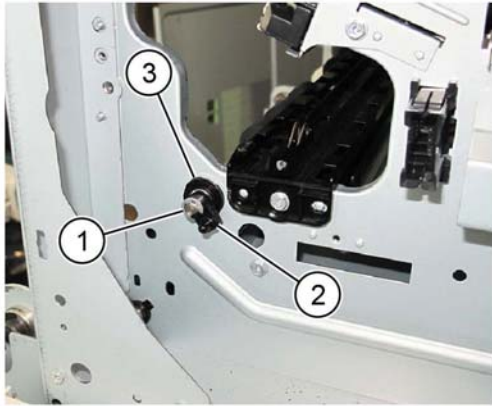
Figure 2 Front bearing removal

9. Remove the front bearing, [Figure 2](#):
 - a. Remove the E-clip (1).
 - b. Remove the registration coupling (2).
 - c. Remove the bearing (3).

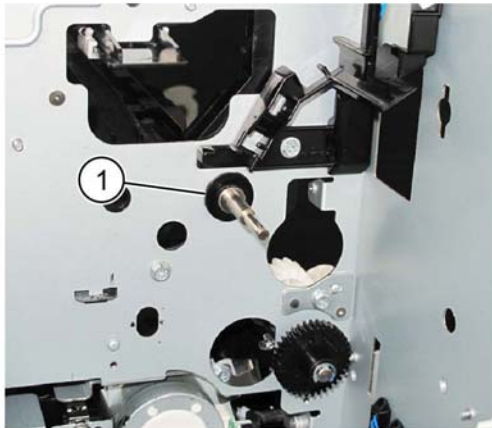
Figure 3 Rear bearing removal

10. Remove the rear bearing, [Figure 3](#).

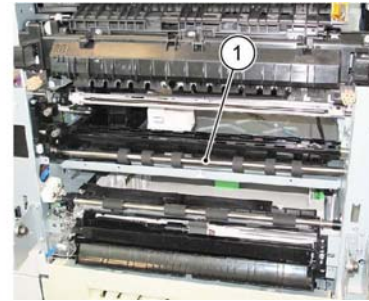
Figure 4 Registration roll removal

11. Remove the registration roll, [Figure 4](#).

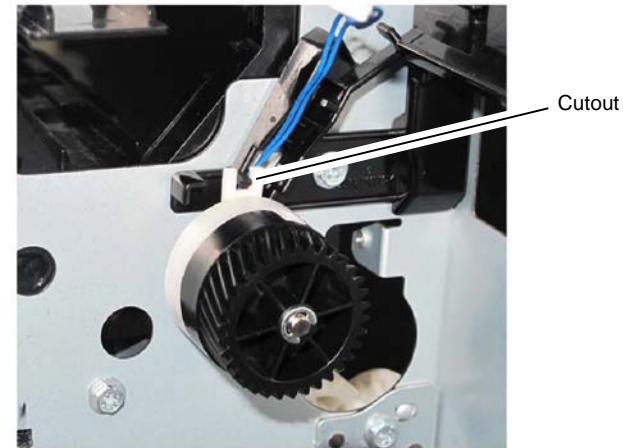
Figure 5 Alignment

1. The replacement is the reverse of the removal procedure.
2. When installing the registration clutch assembly, align the cutout with the harness guide tab, [Figure 5](#).

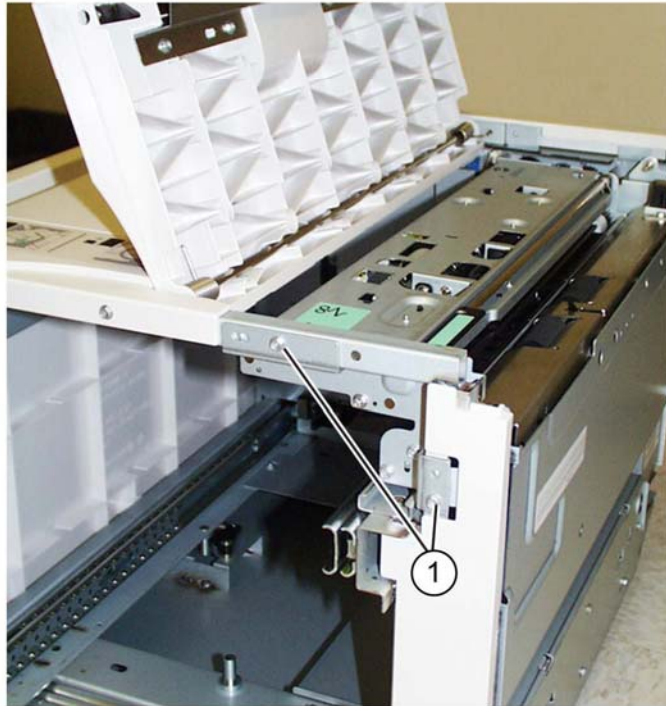
Figure 1 Feeder securing screws

1. Move the HCF away from the machine.
2. Open the feeder top cover, [PL 70.55 Item 7](#).
3. Remove two screws (1) that secure the HCF feeder to the rail, [Figure 1](#).

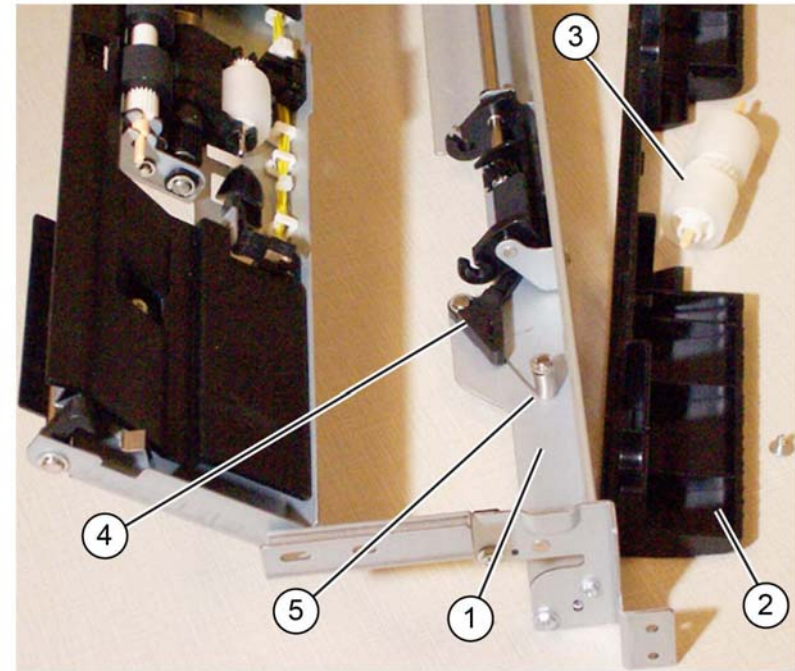
Figure 1 Retard lever spring

NOTE: Note how the spring extension fits into the lever.

- f. Remove the retard lever spring (5).

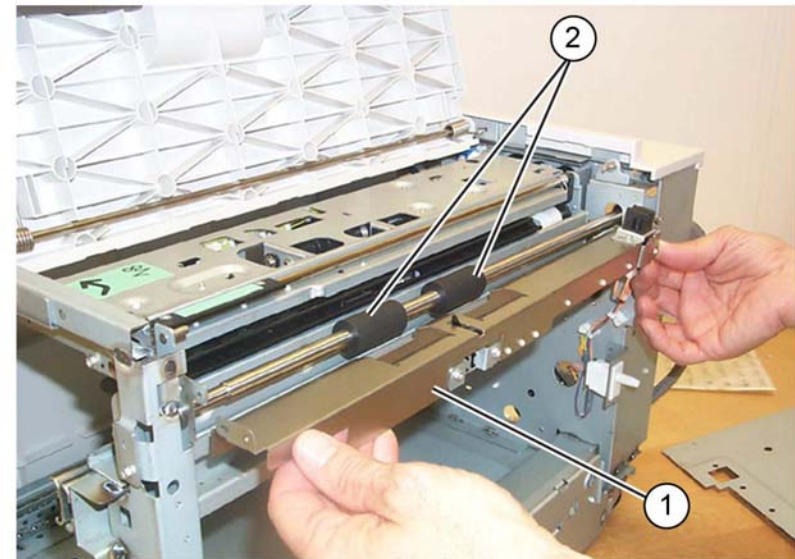
Figure 1 Lower chute removal

1. Remove the HCF feed motor, [REP 80.27](#).
2. Remove the takeaway roll, [Figure 1](#):
 - a. Remove two screws, then the lower chute (1).
 - b. Slide the takeaway roll (2) to the rear until the front end is released, then lower the roll to remove.

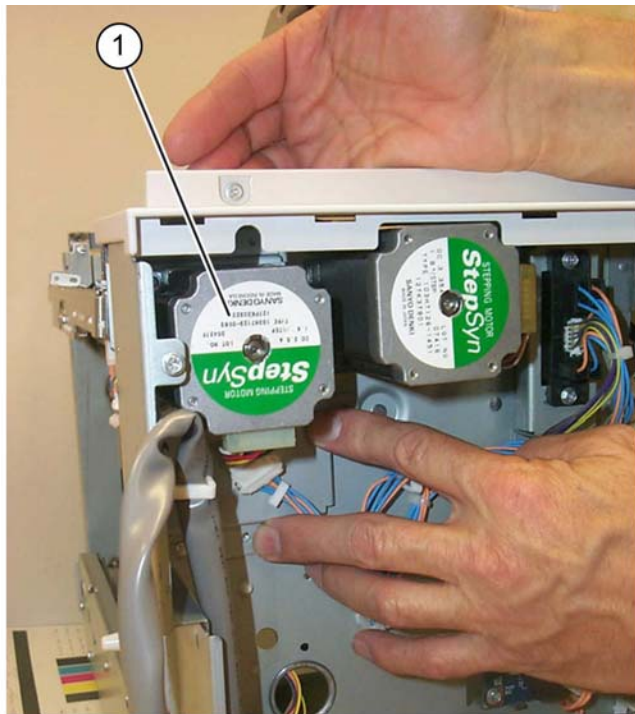
Figure 1 HCF feed/lift motor removal

NOTE: Be careful when removing the motor as it is meshed to a hidden gear.

4. While supporting the motor with one hand, remove two screws then the HCF feed/lift motor (1), [Figure 1](#).

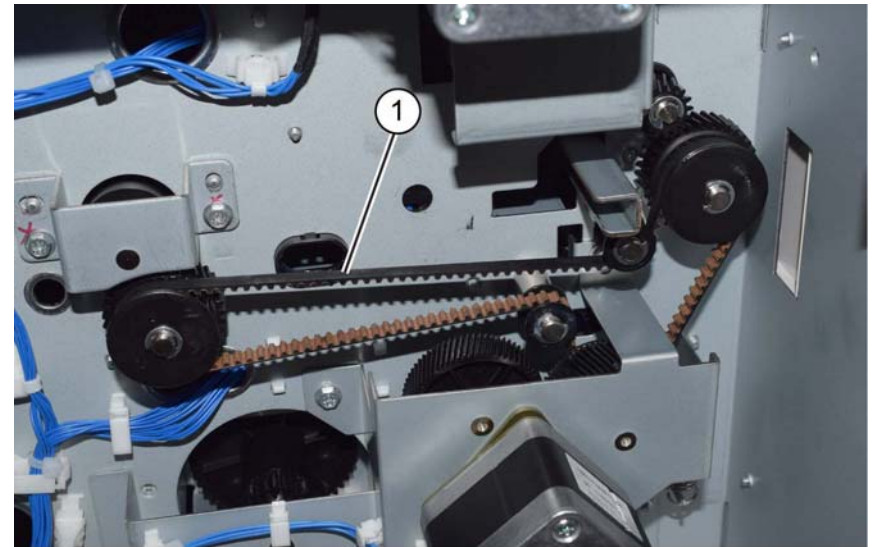
Figure 1 Belt installation

1. The replacement is the reverse of the removal procedure.
2. Ensure that the drive belt (1) is installed as shown in [Figure 1](#).

1. The replacement is the reverse of the removal procedure.
2. Ensure that the drive belt is correctly installed, refer to [REP 80.28](#).

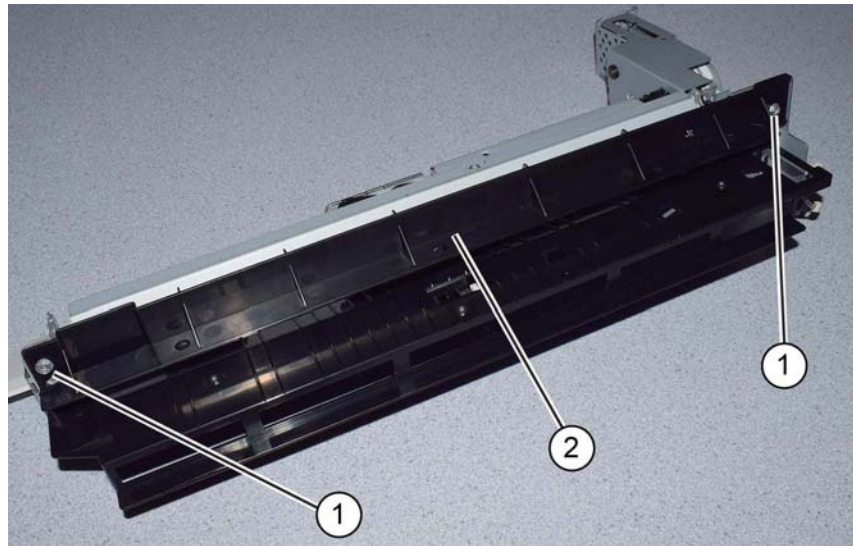
Figure 1 Lower feed chute removal

1. Remove the tray 4 feeder assembly, [REP 80.35](#).
2. Turn the tray 4 feeder assembly upside down.
3. Remove the lower feed chute, [Figure 1](#):
 - a. Remove two screws (1).
 - b. Remove the lower feed chute (2).

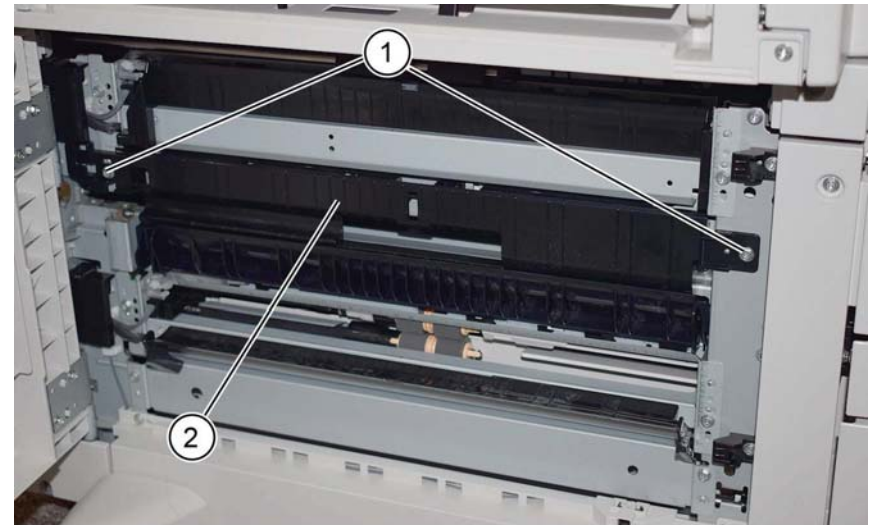
Figure 1 TTM chute removal

1. Remove the lower (tray 3 and 4) takeaway roll, [REP 80.41](#).
2. Remove the TTM chute, [Figure 1](#):
 - a. Remove two screws (1).
 - b. Move the TTM chute (2) towards the rear, then remove the TTM chute.

NOTE: The TTM chute is secured in the centre by a clip feature.

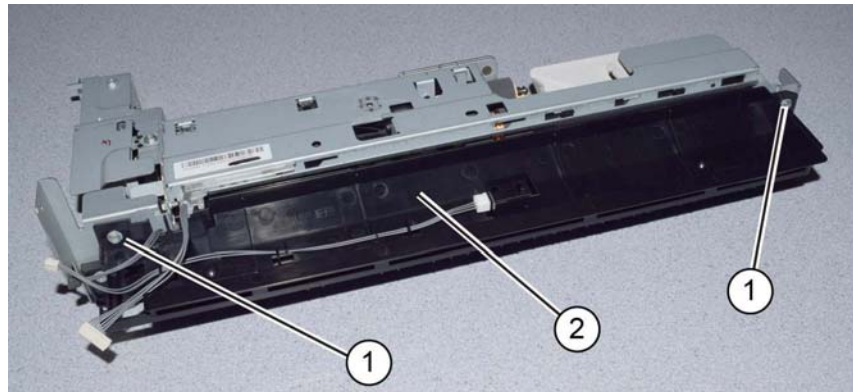
Figure 1 Upper feed chute removal

1. Remove the tray 4 feeder assembly, [REP 80.35](#).
2. Remove the upper feed chute, [Figure 1](#):
 - a. Remove two screws (1).
 - b. Remove the lower feed chute (2).

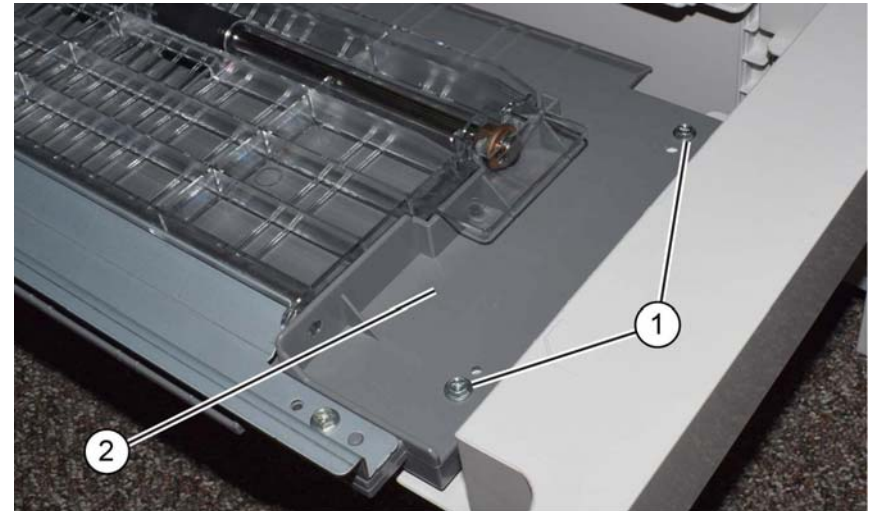
Figure 1 Transport assembly removal

Ensure that the tray 4 transport assembly, [PL 80.70 Item 11](#) is supported when removing the tray 4 assembly.

1. Fully pull out tray 4. Lift out the tray 4 assembly, [PL 70.65 Item 1](#).
2. Remove the tray 4 transport assembly from the tray 4 assembly, [Figure 1](#):
 - a. Remove two screws (1).
 - b. Remove the tray 4 transport assembly (2).

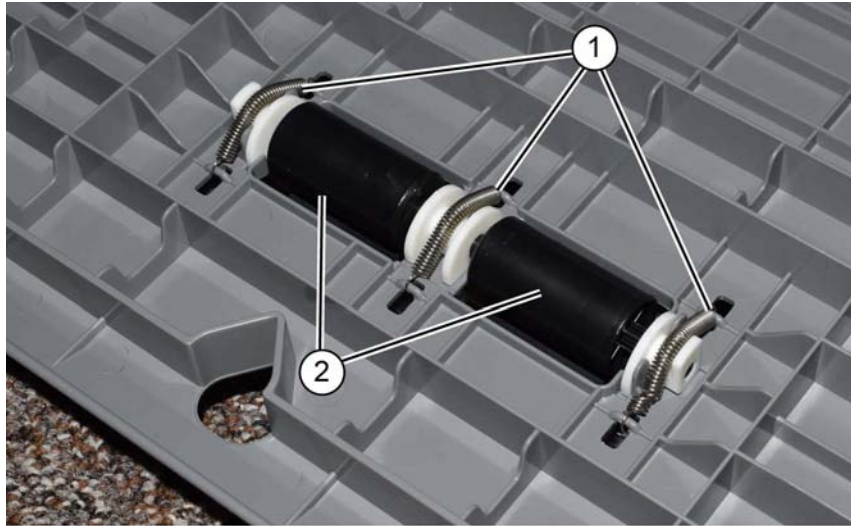
3. Release the springs (1), then remove the nip rolls (2), [Figure 2](#).

Figure 2 Nip rolls removal

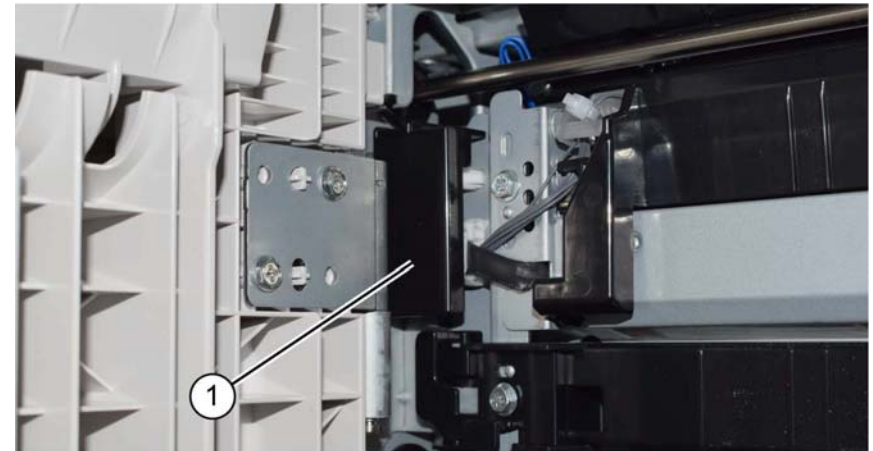
1. Pull out tray 2. Remove the paper.
2. Remove tray 2.
3. Open the left cover assembly, [PL 70.70 Item 7](#).
4. Remove the ESD cover (1), [Figure 1](#):

Figure 1 ESD cover removal

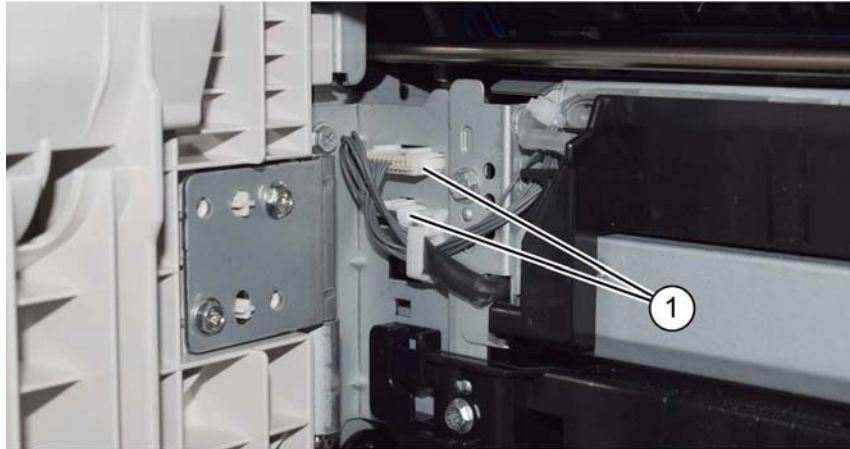
5. Disconnect 2 connectors (1), [Figure 2](#).

Figure 2 Connectors

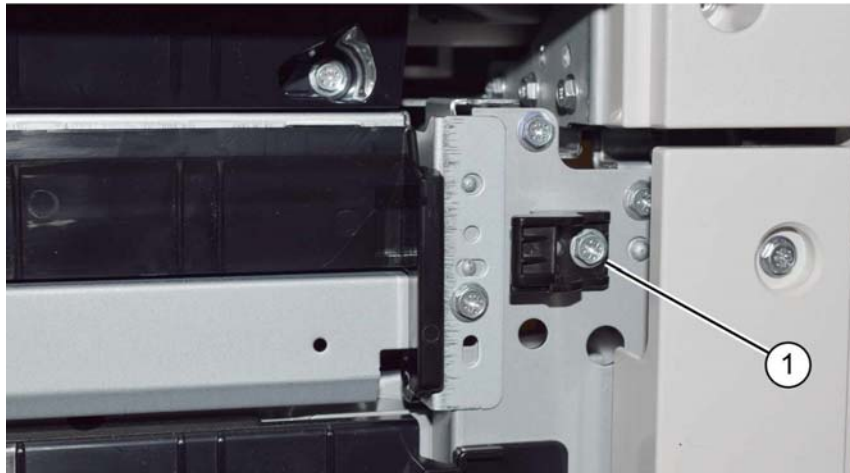
6. Remove the upper door catch (1), [Figure 3](#).

Figure 3 Door catch

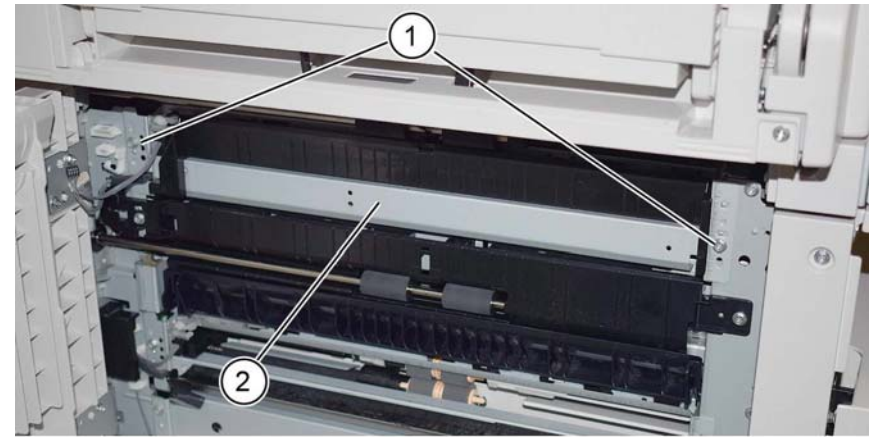
7. Remove the tray 2 feeder assembly, [Figure 4](#):
 - a. Remove two screws (1).
 - b. Remove the tray 2 feeder assembly (2).

Figure 4 Tray 2 feeder assembly removal

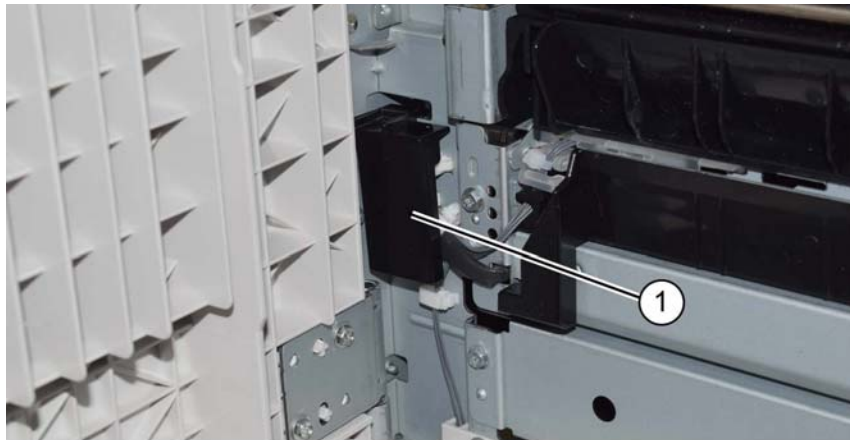
1. Pull out tray 3. Remove the paper.
2. Lift out tray 3.
3. Open the left cover assembly, [PL 70.70 Item 7](#).
4. Remove the ESD cover (1) [Figure 1](#):

Figure 1 ESD cover removal

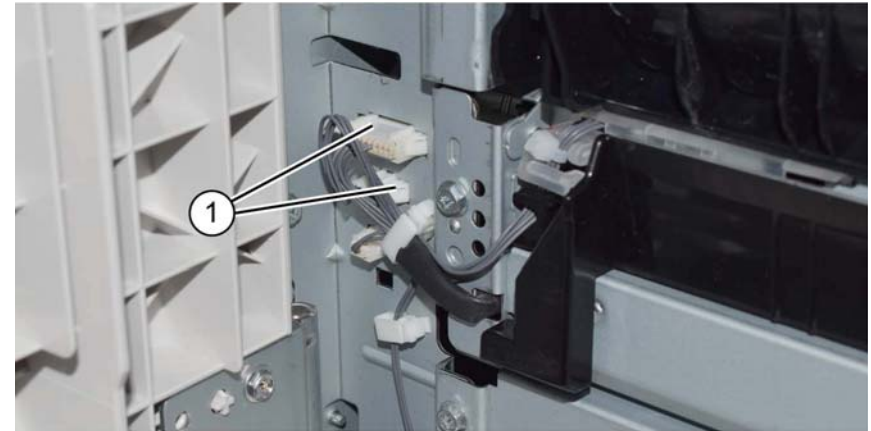
5. Disconnect 2 connectors (1), [Figure 2](#).

Figure 2 Connectors

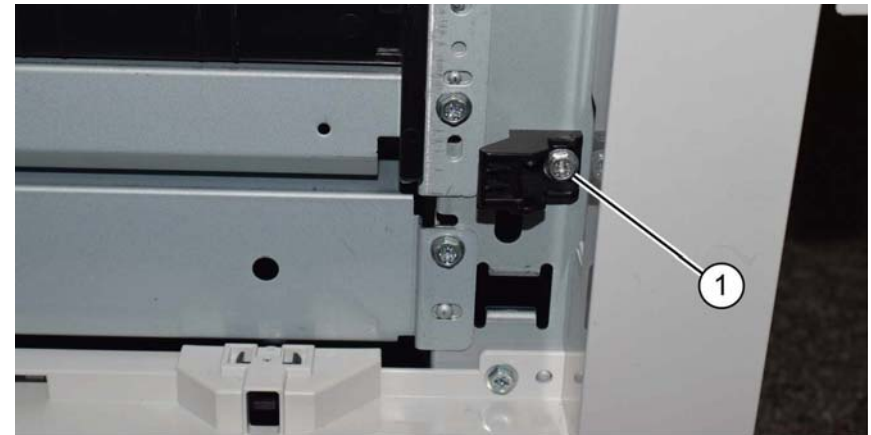
6. Remove the lower door catch (1), [Figure 3](#).

Figure 3 Door catch

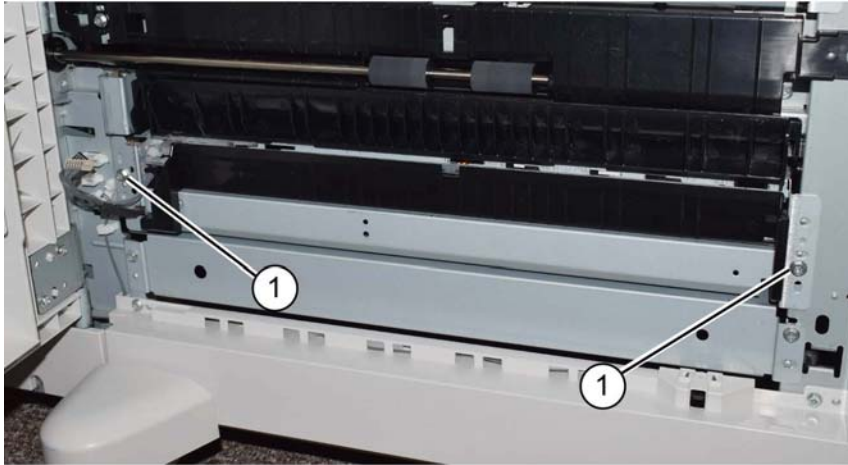
7. Remove two screws (1), [Figure 4](#):

Figure 4 Tray 3 feeder assembly left side fittings

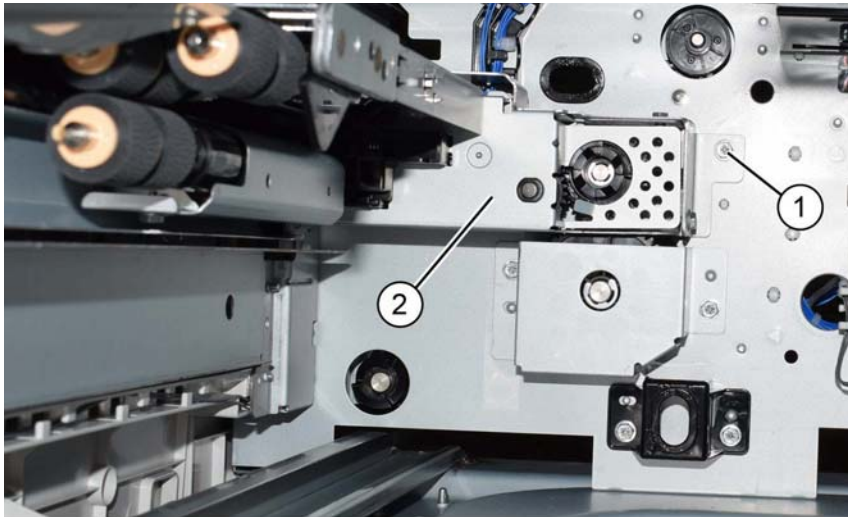
8. Remove the complete tray 3 feeder assembly including bracket, [Figure 5](#).
- Remove the screw (1).
 - Remove the tray 3 feeder assembly (2).

Figure 5 Tray 3 feeder assembly removal

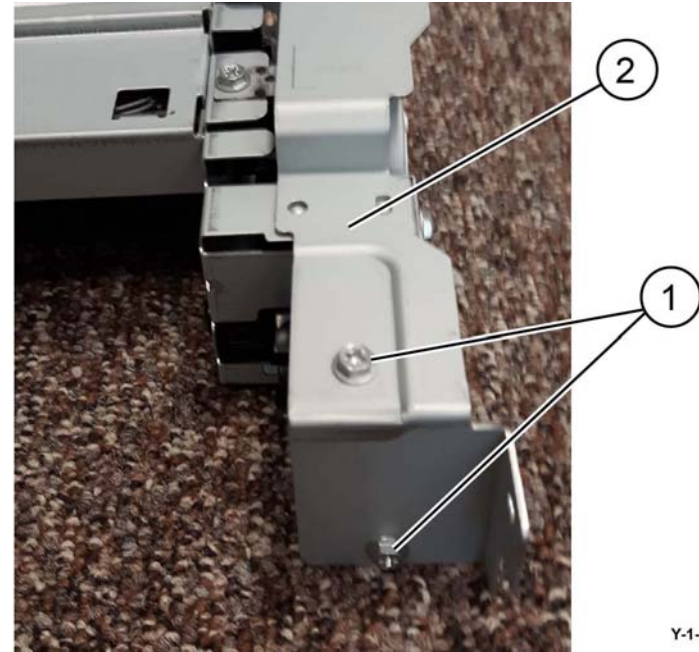
9. Remove the feeder cover from the tray 3 feeder assembly, [Figure 6](#).
- Remove two screws(1).
 - Remove the feeder cover (2). Retain the cover for installation onto the new tray 3 feeder assembly.

Figure 6 Feeder cover removal

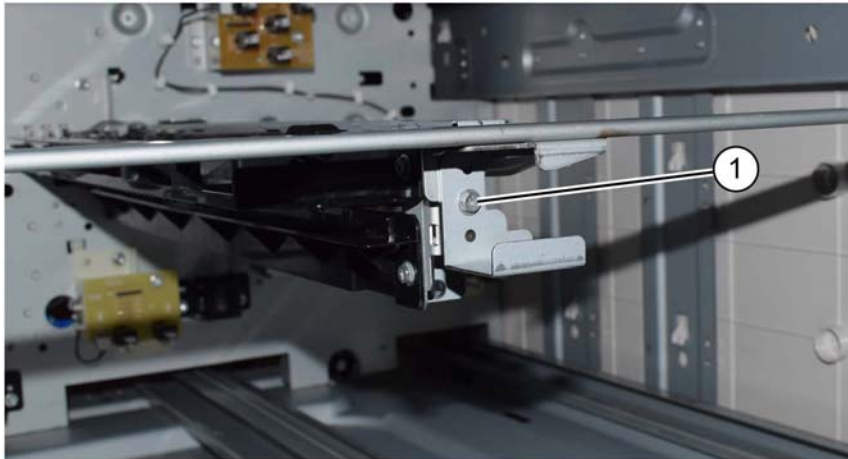
1. Pull out tray 2, 3 and 4. Remove the paper.
2. Lift out tray 3 and 4. Remove tray 2.
3. Remove the support bracket (1), [Figure 1](#).

Figure 1 Support bracket removal

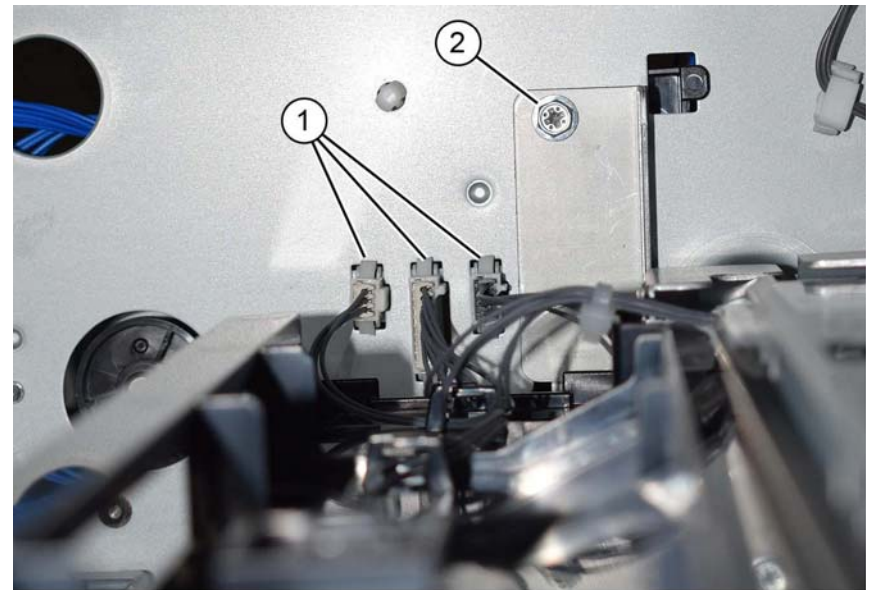
4. Prepare to remove the tray 4 feeder assembly, [Figure 2](#):
 - a. Disconnect 3 connectors (1).
 - b. Remove the screw (2).

Figure 2 Preparation

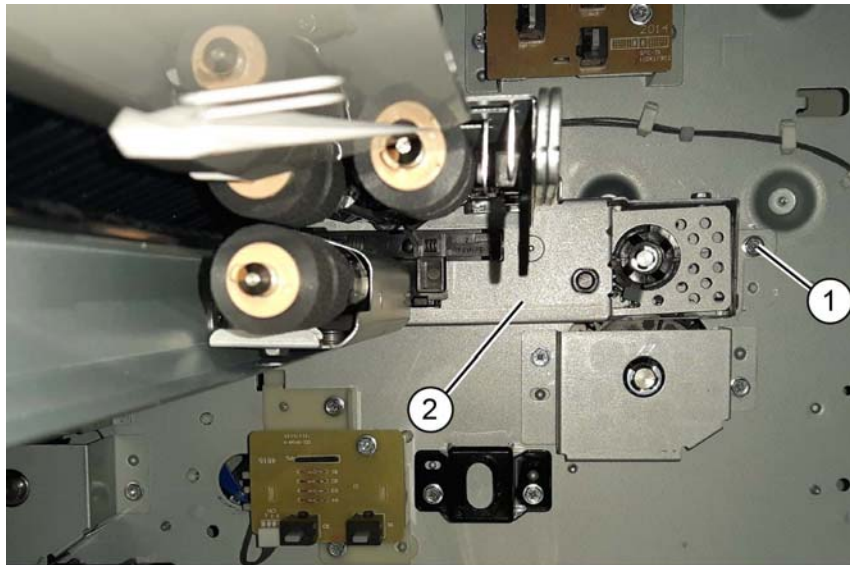
5. Remove the tray 4 feeder assembly, [Figure 3](#):
 - a. Remove the screw (1).
 - b. Remove the tray 4 feeder assembly (2).

Figure 3 Tray 4 feeder assembly removal

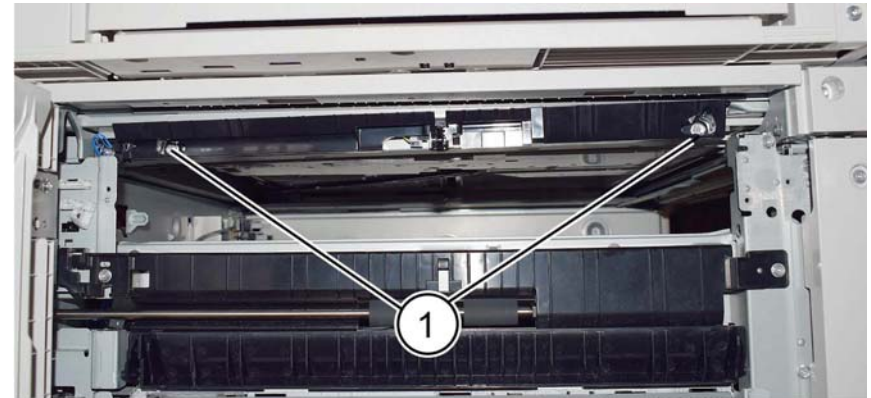
1. Remove the upper (tray 2) takeaway roll, [REP 80.41](#).
2. Remove two screws (1), [Figure 1](#).

Figure 1 Screw removal

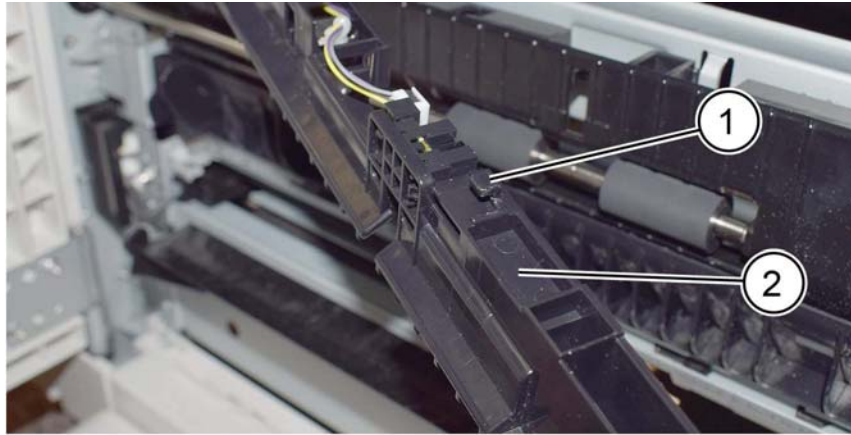
3. Remove the takeaway chute, [Figure 2](#):
 - a. Move the takeaway chute to the rear to release the hook (1).
 - b. Disconnect the connector at the rear of the takeaway chute.
 - c. Remove the takeaway chute (2).

Figure 2 Takeaway chute removal

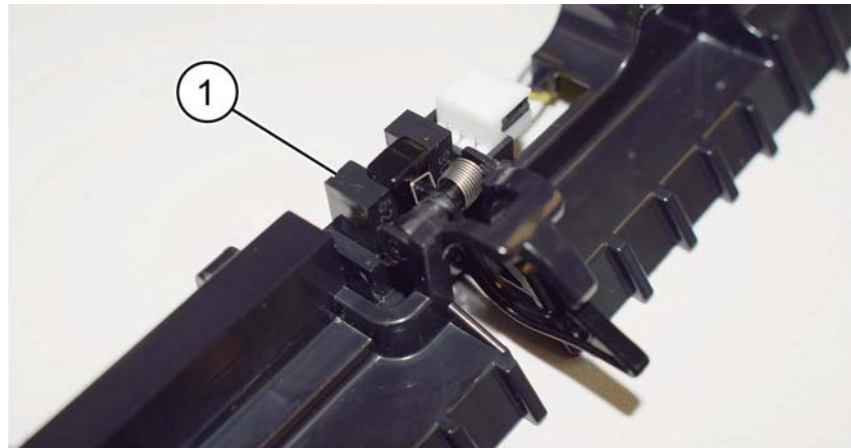
4. Remove the tray 2 feed out sensor (1), [Figure 3](#).

Figure 3 Sensor removal

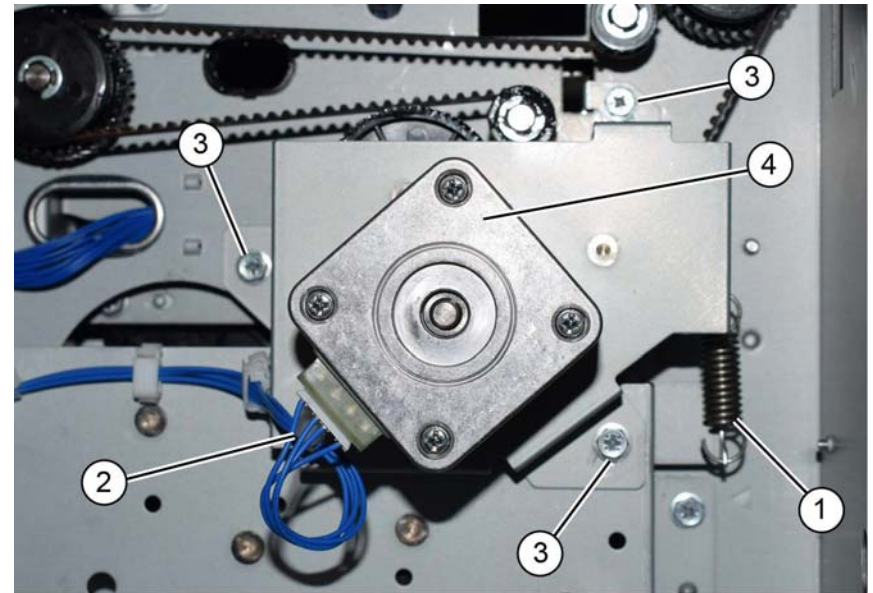
1. Remove the TTM rear cover, [PL 70.95 Item 8](#).
2. Remove the takeaway motor 2 assembly, [Figure 1](#):
 - a. Unhook the spring (1).
 - b. Disconnect the PJ and release the harness (2).
 - c. Remove three screws (3).
 - d. Remove the takeaway motor 2 assembly (4).

Figure 1 Motor assembly removal

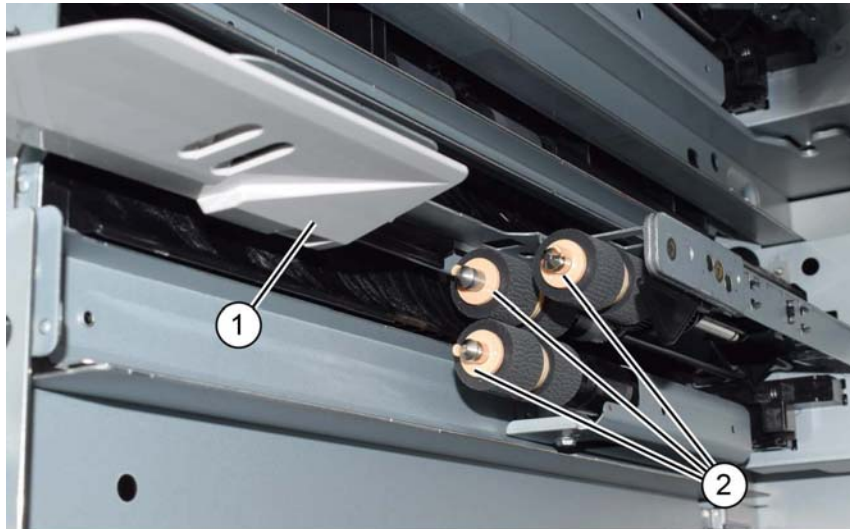
1. Pull out trays 2, 3 and 4. Remove the paper.
2. Remove trays 2, 3 and 4.
3. Open the left cover assembly, [PL 70.70 Item 7](#).
4. Remove the tray 2 or 3 feed, retard and nudger rolls, [Figure 1](#):
 - a. Slide the chute (1) forwards.
 - b. Release the clip, then remove the tray 2 or 3 feed, retard and nudger rolls (2).

Figure 1 Roll removal

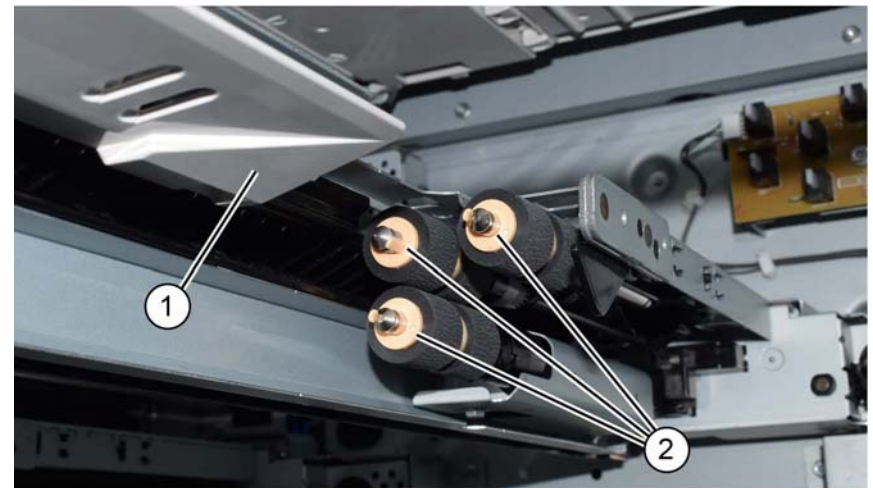
1. Pull out trays 2, 3 and 4. Remove the paper.
2. Remove trays 2, 3 and 4.
3. Open the left cover assembly, [PL 70.70 Item 7](#).
4. Remove the tray 4 feed, retard and nudger rolls, [Figure 1](#):
 - a. Slide the chute (1) forwards.
 - b. Release the clip, then remove the tray 4 feed, retard and nudger rolls (2).

Figure 1 Roll removal

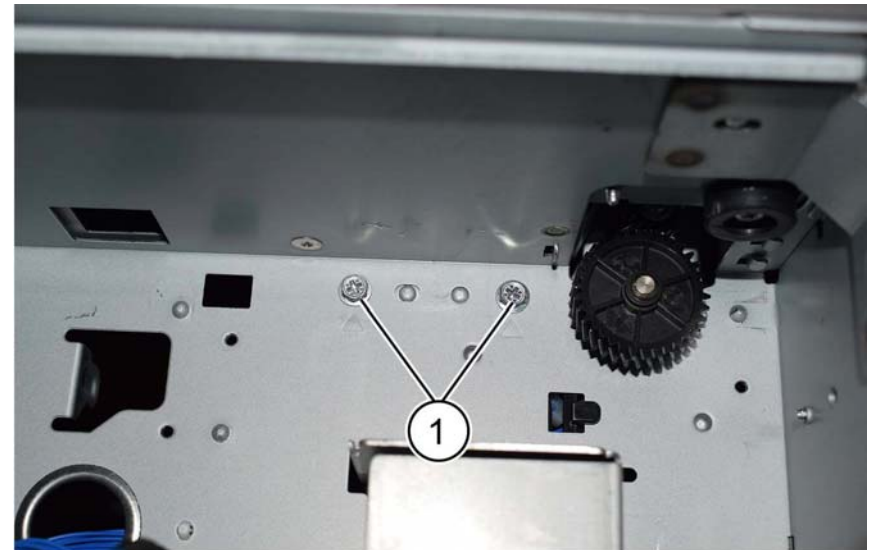
1. Pull out trays 2, 3 and 4. Remove the paper.
2. Remove trays 2, 3 and 4.
3. Remove the tray 2 feeder assembly, [REP 80.33](#).
4. Remove the rear cover, [PL 70.95 Item 8](#).
5. Remove the takeaway motor assembly, [PL 70.85 Item 1](#).
6. Remove two rear screws (1), [Figure 1](#).

Figure 1 Rear screw removal

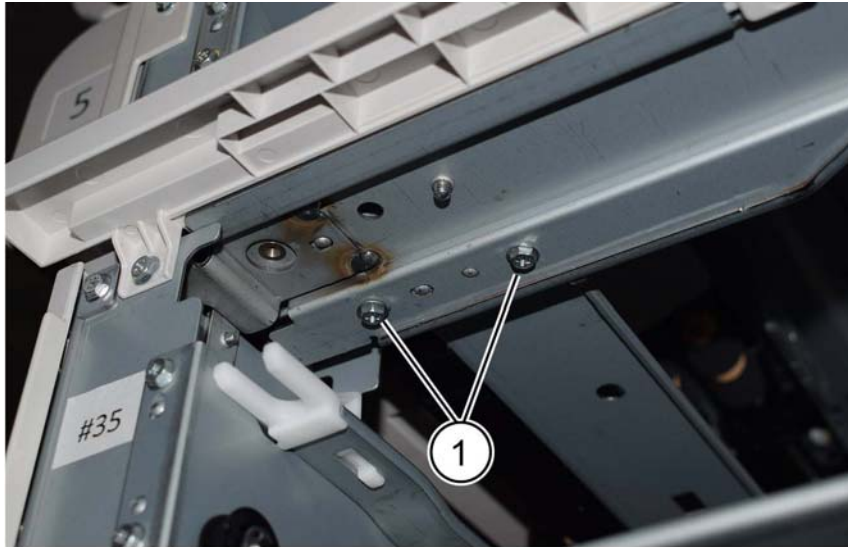
7. Remove two front screws (1), [Figure 2](#).

Figure 2 Front screw removal
