708P91370
April 2017

Xerox® VersaLink® B7025/B7030/B7035 Multifunction Printer Service Manual

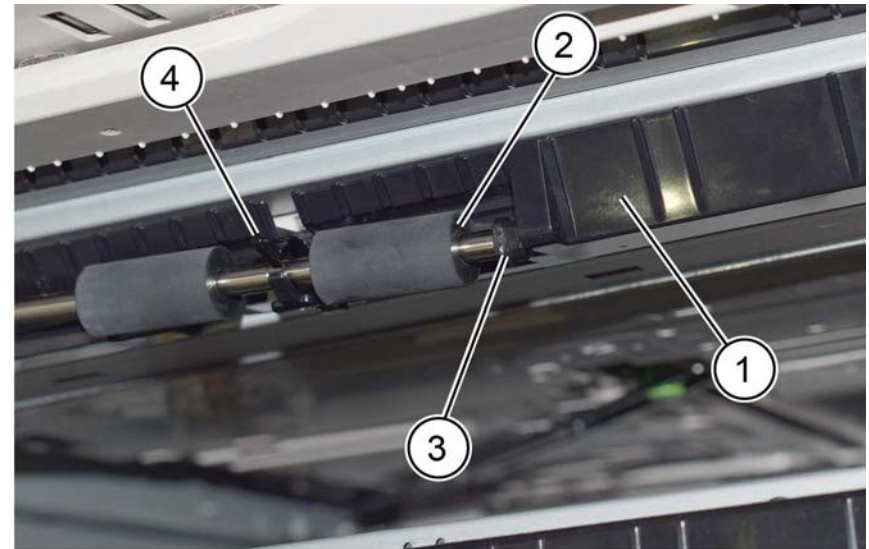
8. Move the takeaway chute assembly (1) to the right, then release the front of the takeaway roll (2) from the chute, [Figure 3](#).

NOTE: Do not lose the front plastic bearing (3).

Figure 3 Front bearing release

Take care not to damage the tray 2 feed out sensor actuator (4) when releasing or removing the takeaway roll.

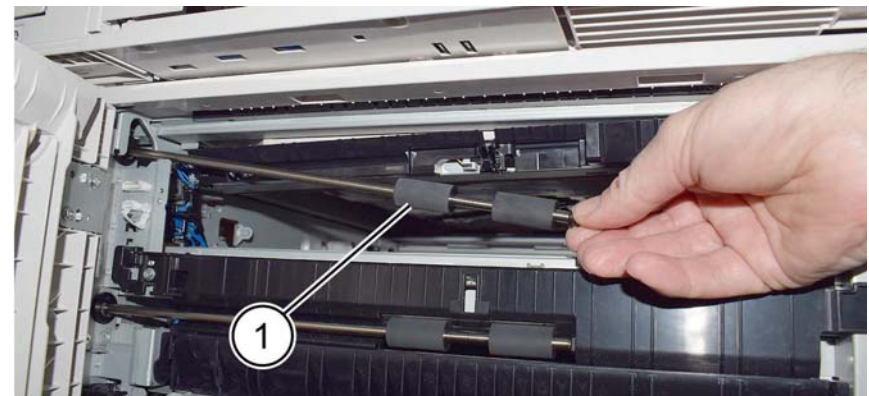
9. Remove the takeaway roll (1), [Figure 4](#).

Figure 4 Takeaway roll removal

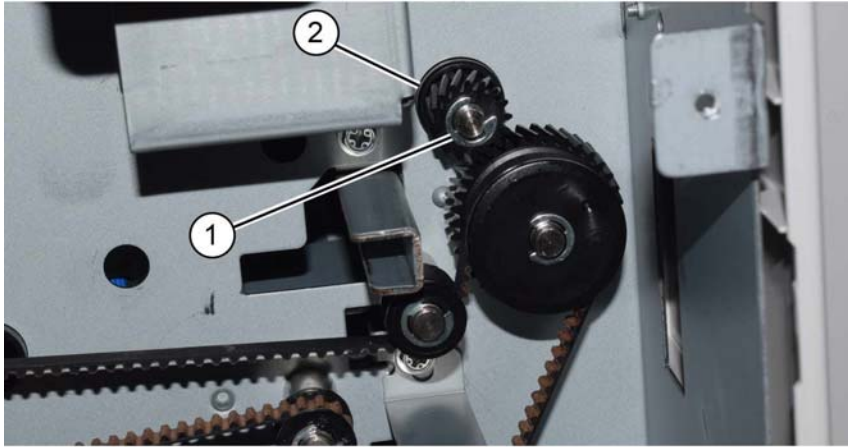
1. Remove the rear cover, PL PL 70.95 Item 8.
2. Open the left cover assembly, PL 70.70 Item 7.
3. Remove the E-clip (1), then the gear (2), Figure 5.

Figure 5 Gear removal

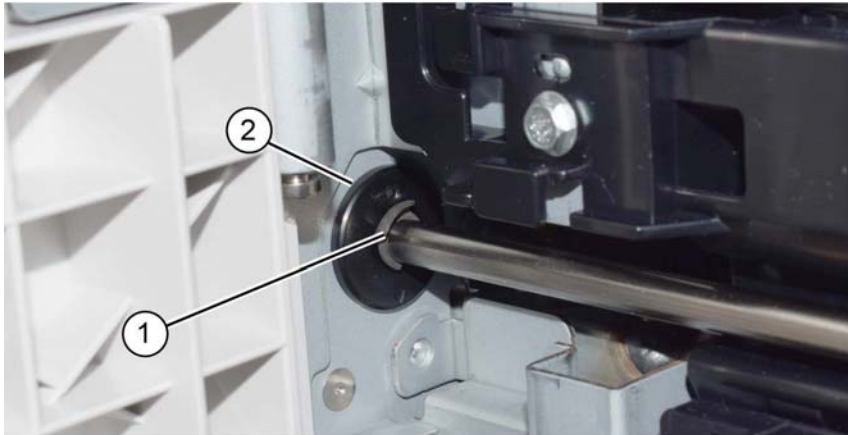
4. Remove the KL-clip (1), then the release the bearing (2), Figure 6.

Figure 6 KL-clip removal

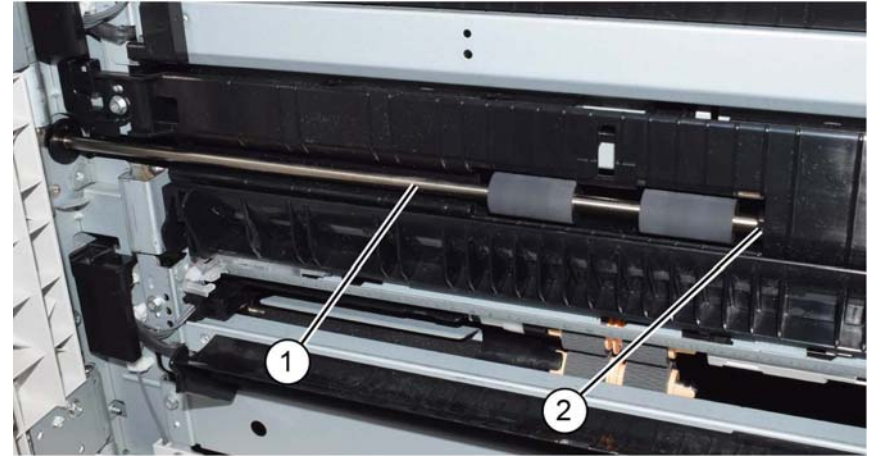
5. Remove the lower takeaway roll (1) and bearing (2), Figure 7.

Figure 7 Roll removal

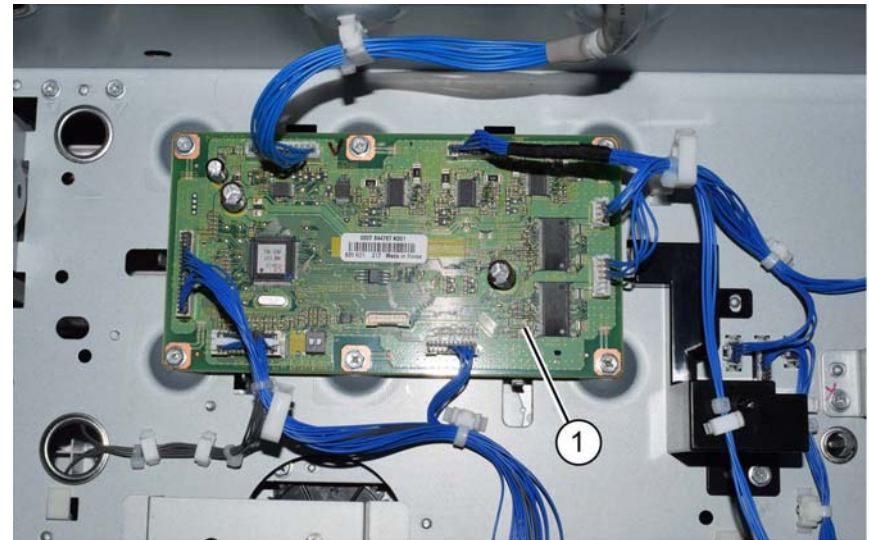
1. Remove the TTM rear cover, [PL 70.95 Item 8](#).
2. Remove the TTM PWB, [Figure 2](#):
 - a. Disconnect seven connectors.
 - b. Remove six screws.
 - c. Remove the TTM PWB (1).

Figure 2 TTM PWB removal

1. The replacement is the reverse of the removal procedure.
2. If a new TTM PWB is installed, change the value of NVM ID 742-205 to 2.

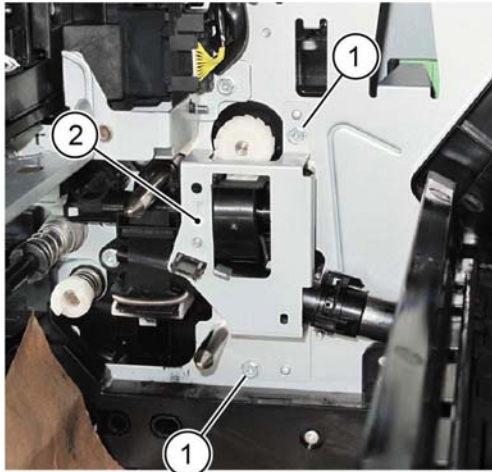
1. Remove the drum cartridge, [REP 90.4](#).
2. Remove the front cover, [REP 28.1](#).
3. Remove the inner cover, [REP 28.2](#).
4. Remove the print head assembly, [REP 60.8](#).
5. Remove the AC housing assembly, [REP 90.6](#).
6. Remove the bracket assembly, [Figure 1](#):
 - a. Remove two screws (1).
 - b. Remove the bracket assembly (2).

Figure 1 Bracket assembly removal

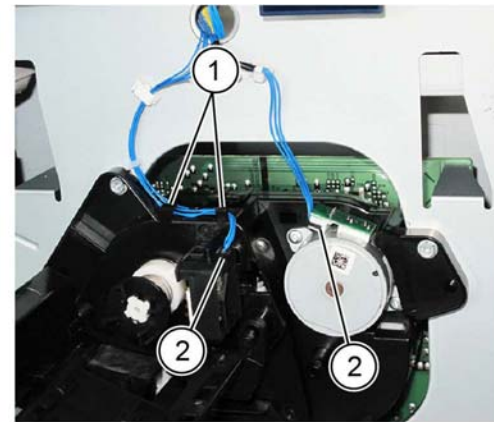
7. Prepare to remove the dispenser pipe unit, [Figure 2](#):
 - a. Release the wire harness (1).
 - b. Disconnect the connectors (2).

Figure 2 Preparation

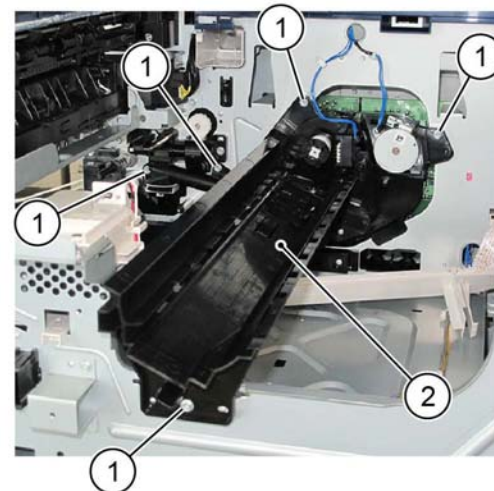
8. Remove the dispenser pipe unit, [Figure 3](#).
 - a. Remove five screws (1).
 - b. Remove the dispenser pipe unit (2).

Figure 3 Dispenser pipe unit removal

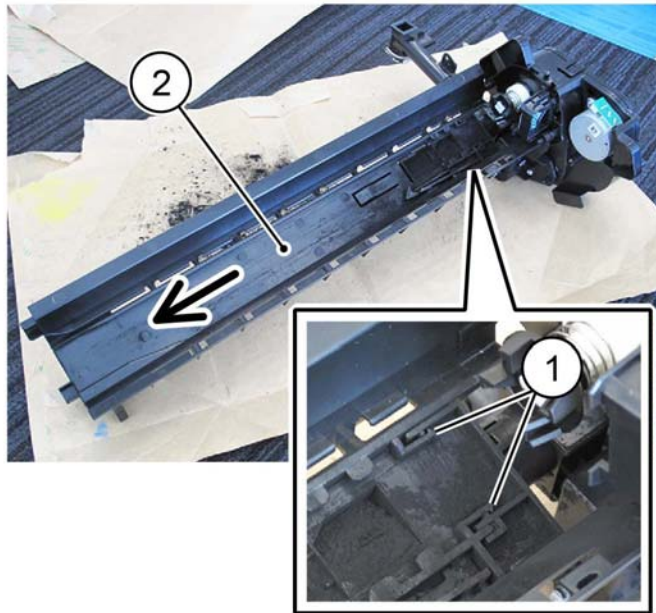
1. Remove the drum cartridge, [REP 90.4](#).
2. Remove the front cover, [REP 28.1](#).
3. Remove the inner cover, [REP 28.2](#).
4. Remove the print head assembly, [REP 60.8](#).
5. Remove the AC housing assembly, [REP 90.6](#).
6. Remove the dispenser pipe unit, [REP 90.1](#).
7. Disengage two hooks (1), then remove the cartridge guide from the dispenser pipe assembly, [Figure 1](#).

Figure 1 Dispenser pipe assembly removal

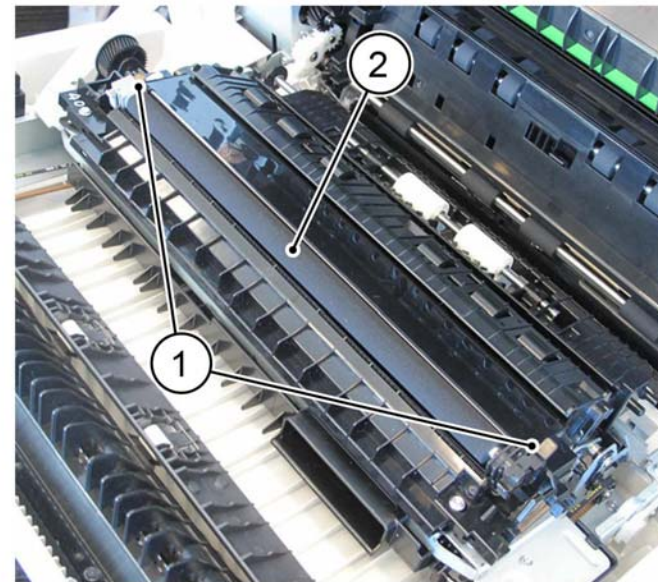
1. Open the LH transport assembly, [PL 80.45 Item 1](#).
2. Disengage the hooks (1) on front and rear, then remove the BTR assembly (2), [Figure 1](#).

Figure 1 BTR assembly removal

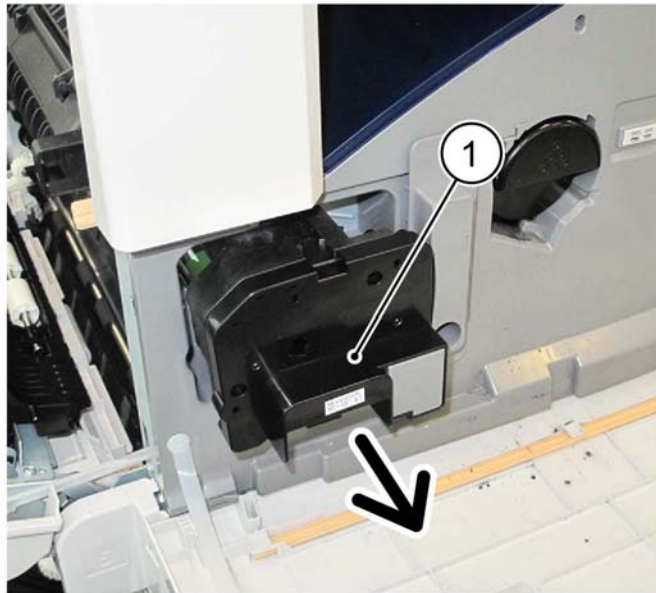
1. Open the front cover.
2. Open the LH transport assembly, [PL 80.45 Item 1](#).
3. Raise the latch (1), then remove the drum cartridge, [Figure 1](#).

Figure 1 Drum cartridge removal

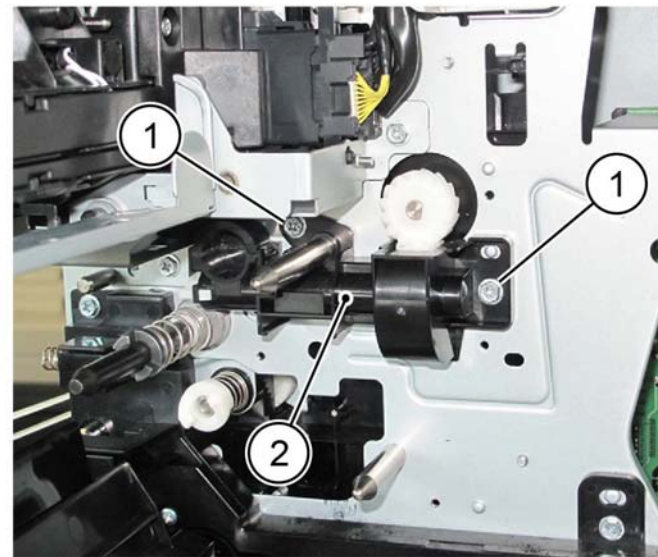
1. Remove the drum cartridge, [REP 90.4](#).
2. Remove the front cover, [REP 28.1](#).
3. Remove the inner cover, [REP 28.2](#).
4. Remove the print head assembly, [REP 60.8](#).
5. Remove the AC housing assembly, [REP 90.6](#).
6. Remove the dispenser pipe unit, [REP 90.1](#).
7. Remove the reclaim pipe assembly, [Figure 1](#):
 - a. Remove two screws (1).
 - b. Remove the reclaim pipe assembly (2).

Figure 1 Reclaim pipe assembly removal

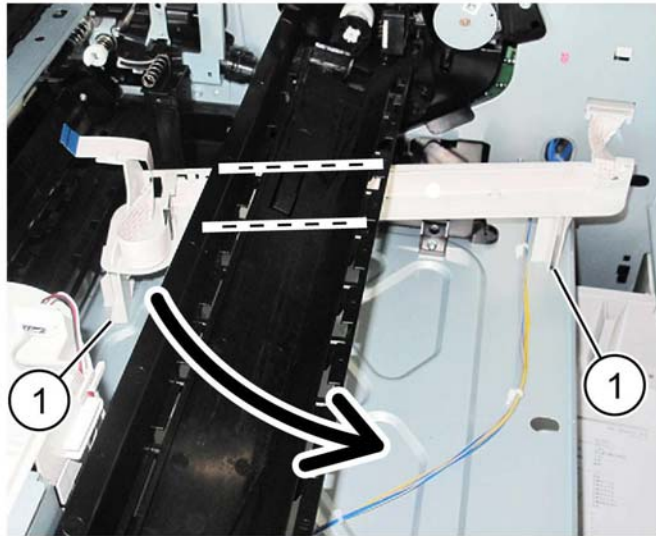
1. Remove the drum cartridge, [REP 90.4](#).
2. Remove the front cover, [REP 28.1](#).
3. Remove the inner cover, [REP 28.2](#).
4. Remove the print head assembly, [REP 60.8](#).
5. Move the harness assembly, [Figure 1](#):
 - a. Disengage the hooks (1).
 - b. Move the harness assembly in the direction of the arrow.

Figure 1 Harness assembly

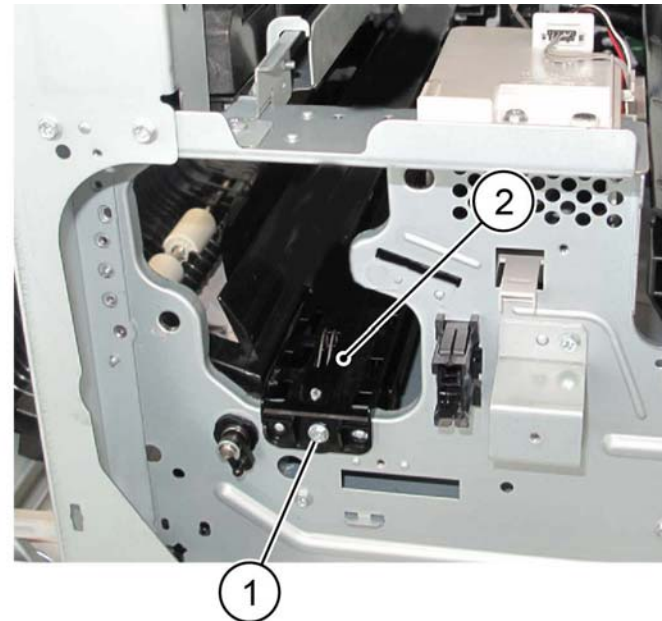
6. Remove the lower guide assembly, [Figure 2](#):
 - a. Remove the screw (1).
 - b. Remove the lower guide assembly (2).

Figure 2 Lower guide assembly removal

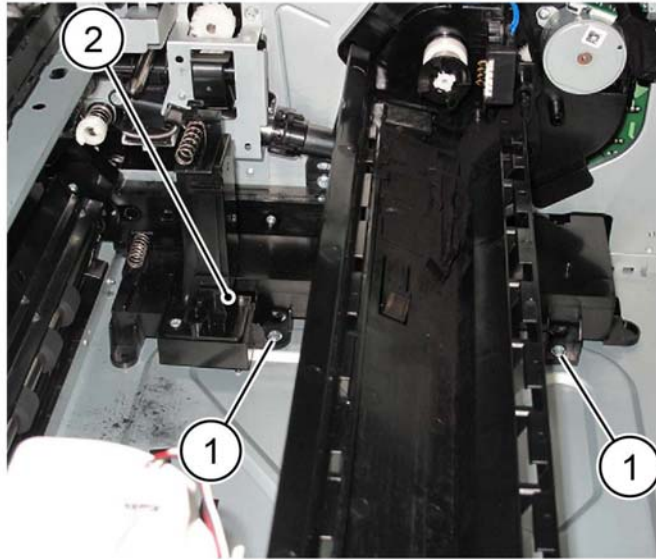
7. Remove the AC housing assembly, [Figure 3](#):
 - a. Remove two screws (1).
 - b. Remove the AC housing assembly (2).

Figure 3 AC housing assembly removal

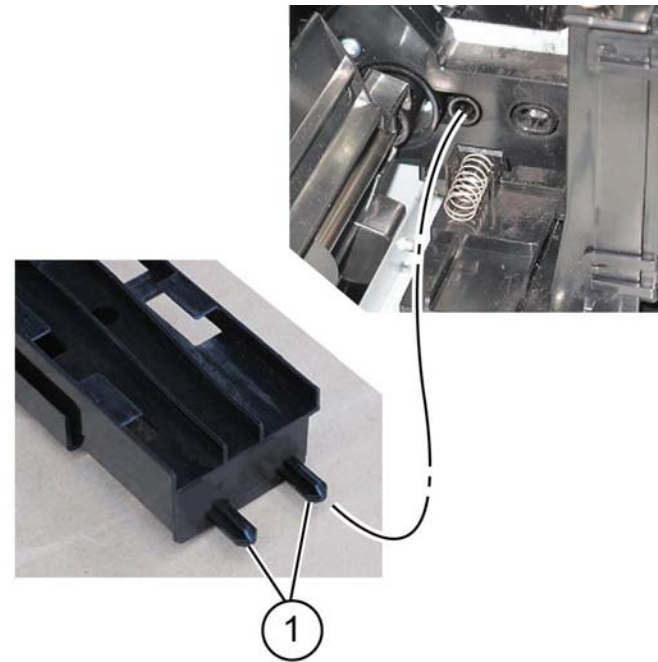
1. The replacement is the reverse of the removal procedure.
2. When installing the lower guide assembly, align the bosses (1) with the holes, [Figure 4](#).

Figure 4 Alignment

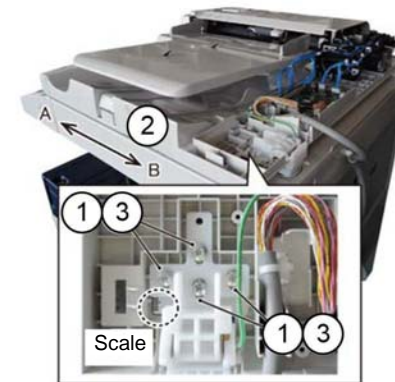
1. Remove the DADF rear cover, [REP 5.4](#).
2. Adjust the position of the DADF by moving the DADF in direction A or B, [Figure 1](#):
 - a. Loosen four screws (1).
 - b. Move the DADF in direction A or B (2):
 - DADF moved in direction A (clockwise) is shown in [Figure 2](#).
 - DADF moved in direction B (counter-clockwise) is shown in [Figure 3](#).

NOTE: Each mark on the scale represents movement of 1mm (0.04 inch).

- c. Tighten four screws (3).

Figure 1 Skew adjustment

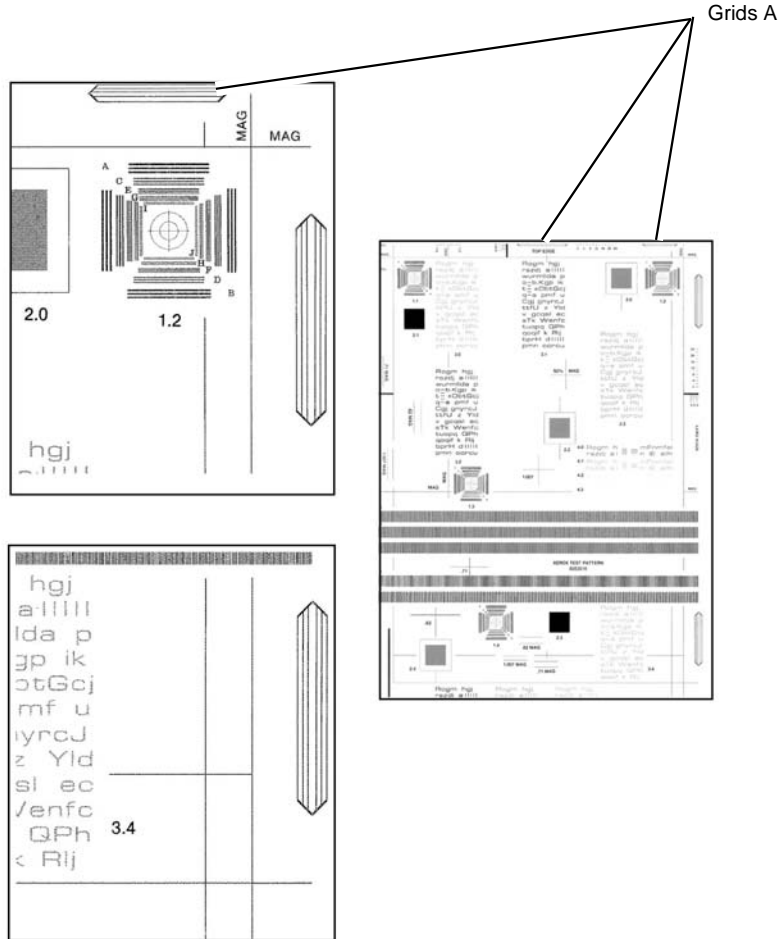
Figure 1 Test pattern

NOTE: Grid A and grid B of test patterns 82E2010, 82E2020 are small areas of parallel lines 1mm apart. These can be used to directly measure the registration displacement.

NOTE: An increment of 1 in NVM = 0.1mm (0.04 inch).

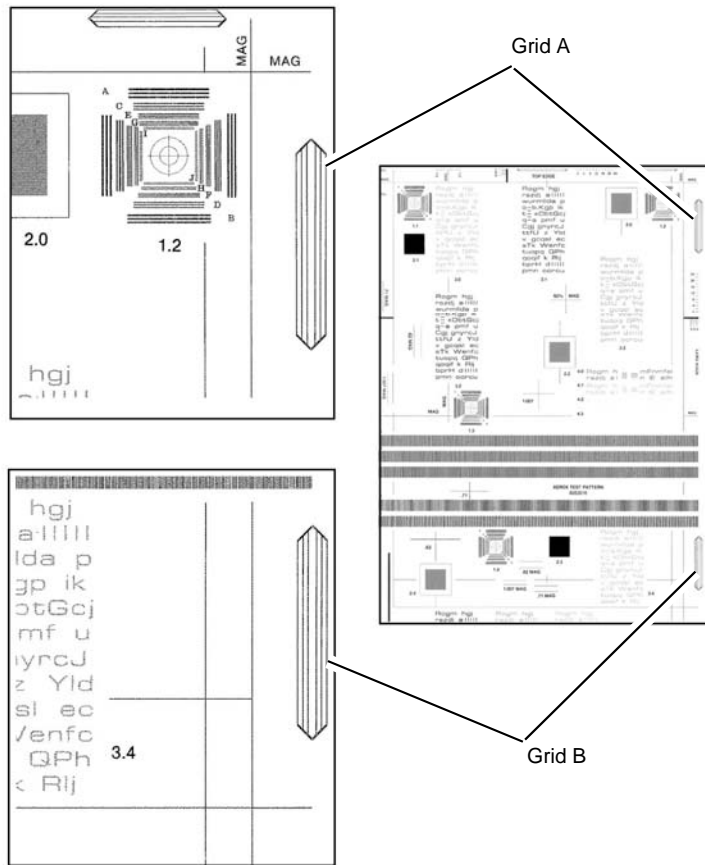
Figure 1 Test pattern

NOTE: Grid A and grid B of test patterns 82E2010, 82E2020 are small areas of parallel lines 1mm apart. These can be used to directly measure the registration displacement.

NOTE: If there is a difference between measurements at A and B, refer to IQS 5 Skew.

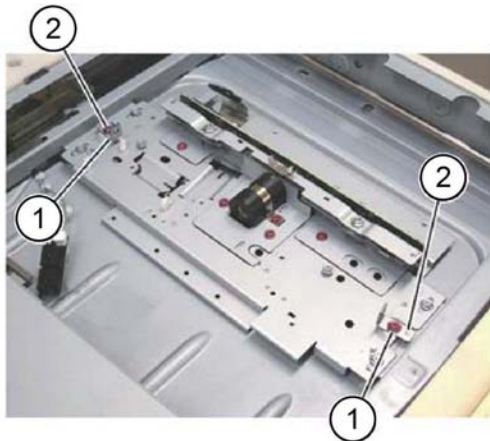
Figure 1 Alignment pins

3. Remove the alignment pins from the lens assembly, Figure 1:
 - a. Remove two screws (1).
 - b. Remove the alignment pins (2).

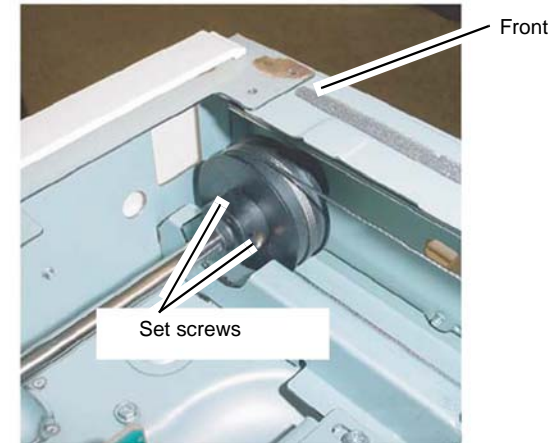
Figure 2 Front set screws

4. Check that the pulley at the front side is firmly secured. If the pulley is loose, tighten both set screws, Figure 2.

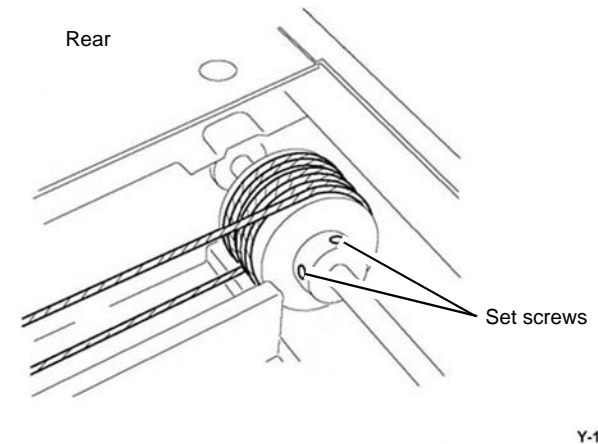
Figure 3 Rear set screws

5. Loosen the two set screws that secure the pulley at the rear, Figure 3.

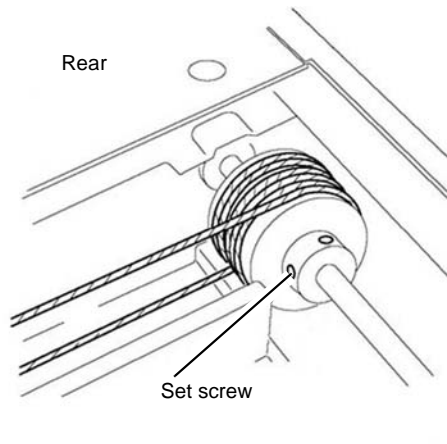
Figure 5 First rear set screw

7. Tighten one of the rear set screws, [Figure 5](#).
NOTE: The second set screw will not be accessible at this time.

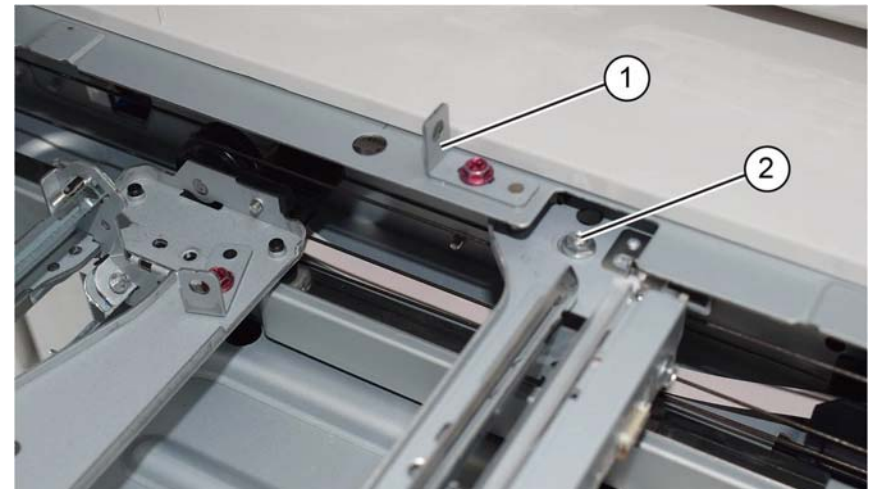
Figure 6 Carriage setting

8. Secure the rear cable to the full rate carriage, [Figure 6](#):
 - a. Remove the alignment pin from the front of the half rate carriage. Install the alignment pin (1) to the rear of the full rate carriage.
 - b. Tighten the rear cable securing screw (5).

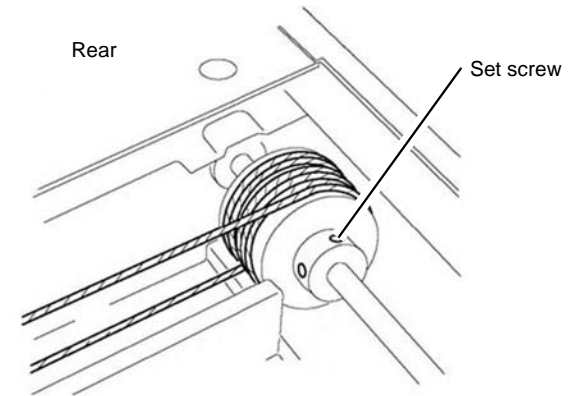
Figure 7 Second rear set screw

9. Remove both alignment pins.
10. Tighten the other rear set screw, [Figure 7](#).

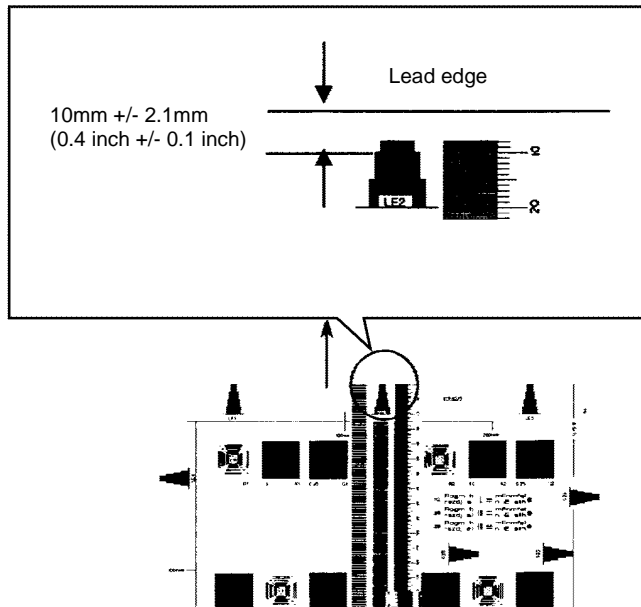
Figure 1 IIT lead edge registration

1. Ensure that the IOT lead edge registration is correct. Refer to [dC126 System Registration](#).
2. Make two, 100% copies of test pattern 82E8220 from the document glass.
3. On the 2nd copy, check that the distance from the lead edge to the top of Step 3 on the LE2 scale is 10mm +/- 2.1mm (0.4 inch +/- 0.1 inch), [Figure 1](#).

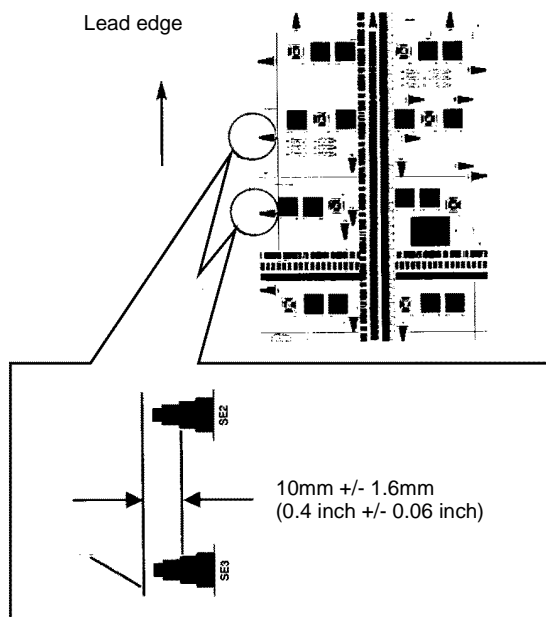
Figure 1 IIT side edge registration

1. Ensure that the IOT side registration is correct. Refer to [dC126 System Registration](#).
2. Make two, 100% copies of test pattern 82E8220 from the document glass.
3. On the 2nd copy, check that the distance from the lead edge to the top of Step 3 on the SE2 and SE3 scales is 10mm +/- 1.6mm (0.4 inch +/- 0.06 inch), [Figure 1](#).

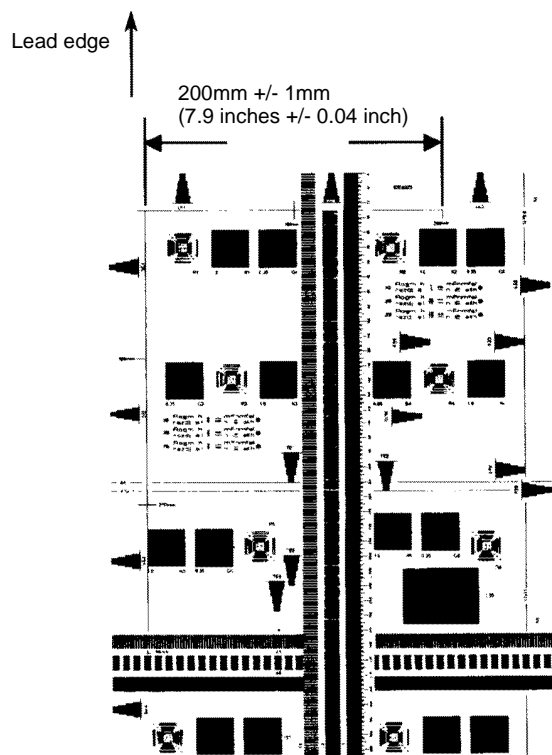
Figure 1 Cross process direction magnification

1. Make two, 100% copies of test pattern 82E8220 from the document glass.
2. Check the 2nd copy:
 - a. To check the cross process direction magnification: measure the 200mm line running from near LE1 to near LE3. Check that the dimension is 200mm +/- 1mm (7.9 inches +/- 0.04 inch). Refer to [Figure 1](#).

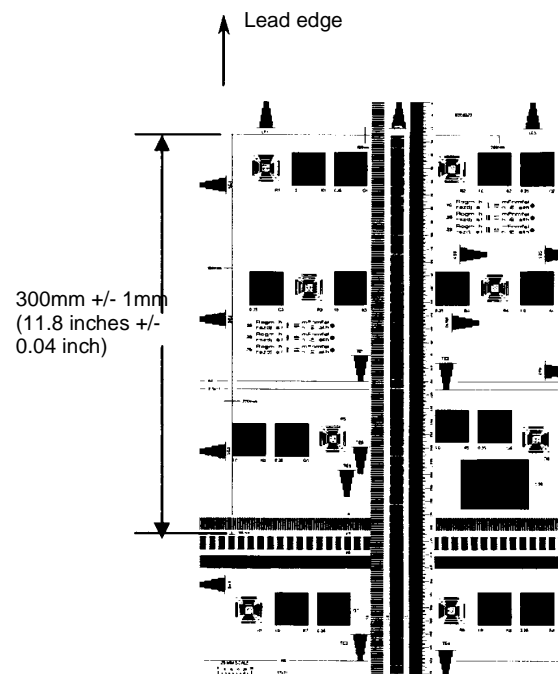
Figure 2 In process direction magnification

- b. To check the in process direction magnification: measure the 300mm line running from near LE1 to the trail edge of the 1.8lp ladder. Check that the dimension is 300mm +/- 1mm (11.8 inches +/- 0.04 inch). Refer to [Figure 2](#).

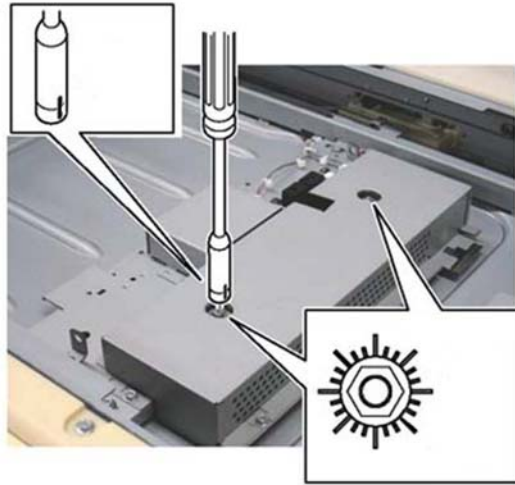
Figure 1 Nut adjustment

1. The result screen will show the information depicted in [Table 1](#):
 - Front nut refers to the nut at the front of the CCD lens assembly, refer to [Figure 1](#).
 - Rear nut refers to the nut at the rear of the CCD lens assembly, refer to [Figure 1](#).
 - + Refers to clockwise rotation.
 - - Refers to counter-clockwise rotation.
 - Numeral: refers to the adjustment angle (degrees).Using the content of [Table 1](#) as an example:
 - The front nut must be rotated 90 degrees clockwise.
 - The rear nut must be rotated 260 degrees counter clockwise.**NOTE:** If the value is abnormally high, for example 990, it may be due to the light path being blocked. Perform [ADJ 60.5 Optics Cleaning Procedure](#), then repeat the Check.
2. Rotate each nut the required amount.

NOTE: It may be necessary to mark the nut runner to track the rotation.

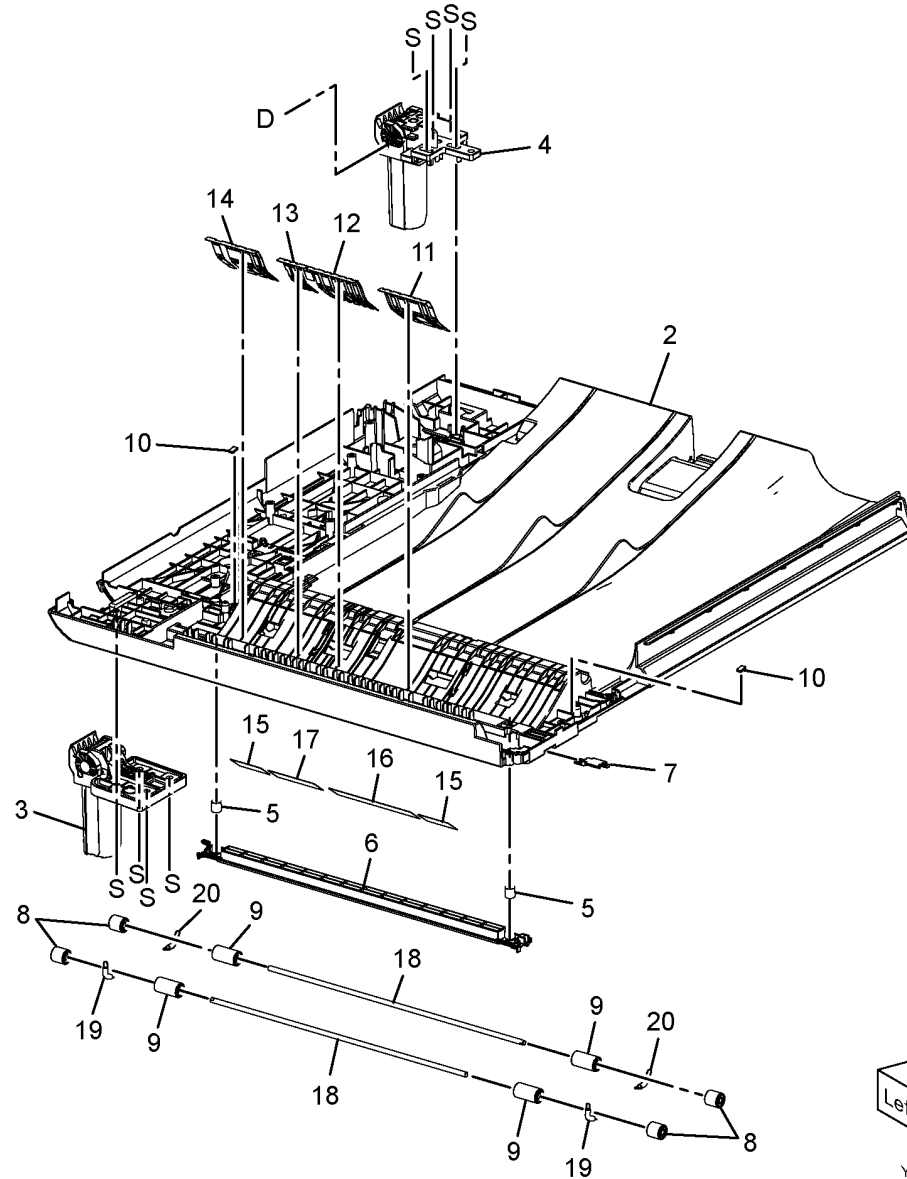
PL 5.20 Upper Feeder

Item	Part	Description
1	-	Upper feeder assembly (Not Spared)
2	-	DADF feeder assembly (P/O PL 5.20 Item 1)
3	-	Feed roll nudger roll assembly (REF: PL 5.25)
4	-	Upper feeder cover (P/O PL 5.20 Item 1)
5	-	Pinch roller takeaway (P/O PL 5.20 Item 1)
6	-	Bracket (P/O PL 5.20 Item 1)
7	-	Jam label (P/O PL 5.20 Item 1)
8	-	Ground plate (P/O PL 5.20 Item 1)
9	-	Exit spring (P/O PL 5.20 Item 1)
10	011K04261	Handle lever
11	120E34245	Actuator (document sensor)
12	-	Actuator stopper (P/O PL 5.20 Item 1)
13	-	Spring (P/O PL 5.20 Item 1)
14	-	Link set (P/O PL 5.20 Item 1)
15	-	TA spring (P/O PL 5.20 Item 1)
16	-	Shaft (P/O PL 5.20 Item 5)
17	-	Nip roll (P/O PL 5.20 Item 5)
18	-	Nip roll (P/O PL 5.20 Item 5)
19	-	Interlock seal assembly (P/O PL 5.20 Item 1)

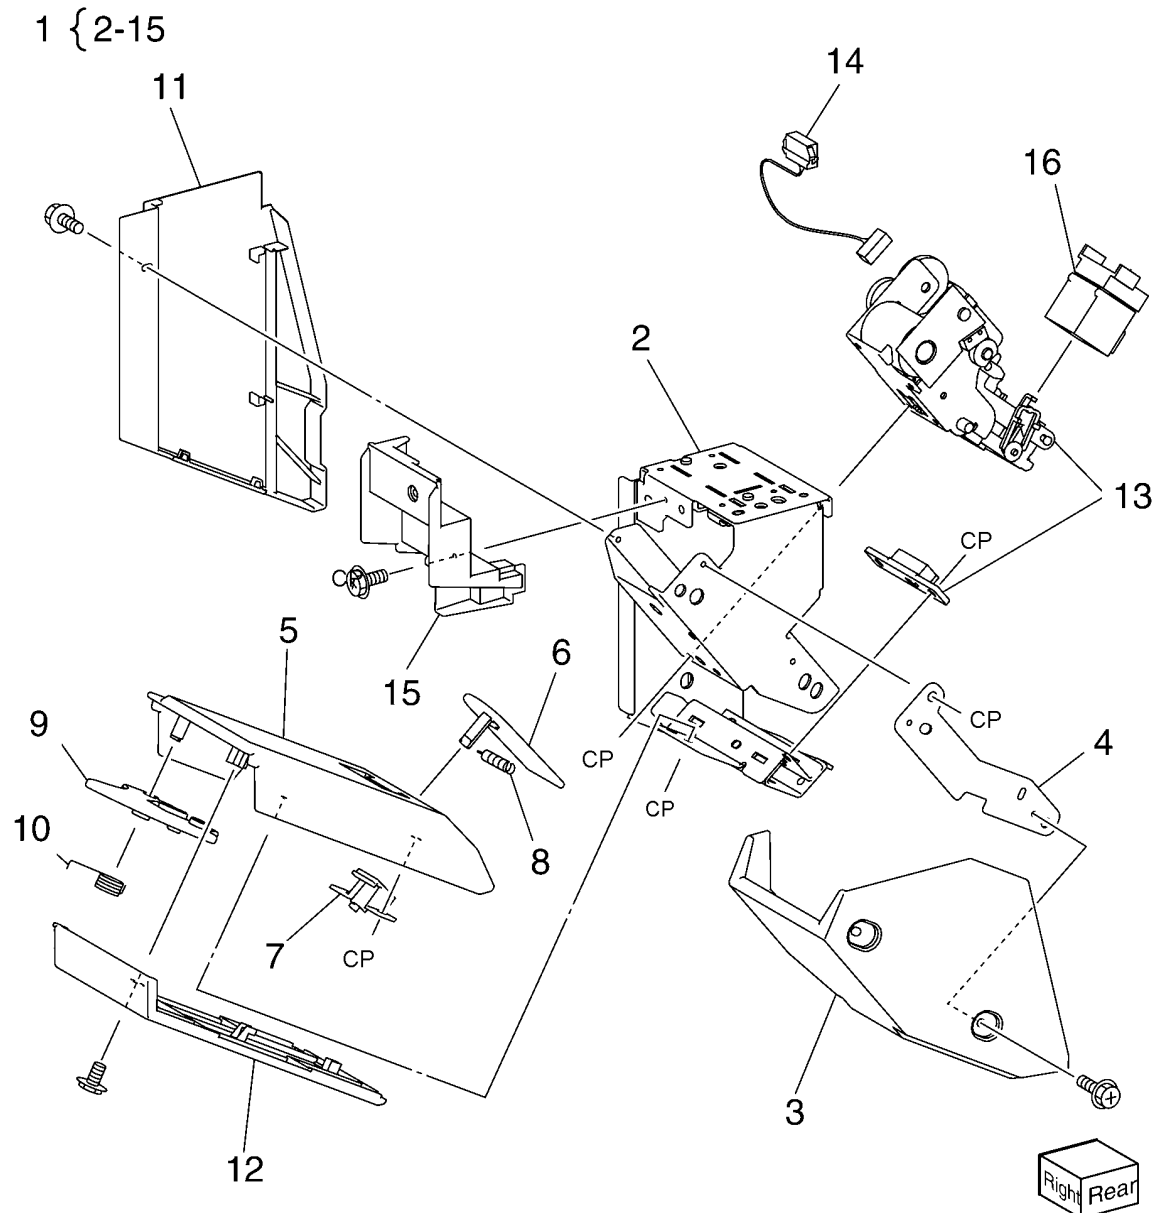
PL 13.65 Office Finisher LX Booklet Rear Stapler Assembly

Item	Part	Description
1	029K92501	Booklet rear stapler assembly
2	-	Bracket (P/O PL 13.65 Item 1)
3	-	Rear cover (P/O PL 13.65 Item 1)
4	-	Bracket (P/O PL 13.65 Item 1)
5	-	Chute (P/O PL 13.65 Item 1)
6	-	Sub chute (P/O PL 13.65 Item 1)
7	-	Support (P/O PL 13.65 Item 1)
8	-	Spring (P/O PL 13.65 Item 1)
9	-	Sub chute (P/O PL 13.65 Item 1)
10	-	Spring (P/O PL 13.65 Item 1)
11	-	Front cover (P/O PL 13.65 Item 1)
12	-	Lower cover (P/O PL 13.65 Item 1)
13	-	Booklet stapler assembly (P/O PL 13.65 Item 1) (REP 13.37)
14	-	Wire harness (P/O PL 13.65 Item 1)
15	-	Guide (P/O PL 13.65 Item 1)
16	008R12964	Booklet staple cassette assembly

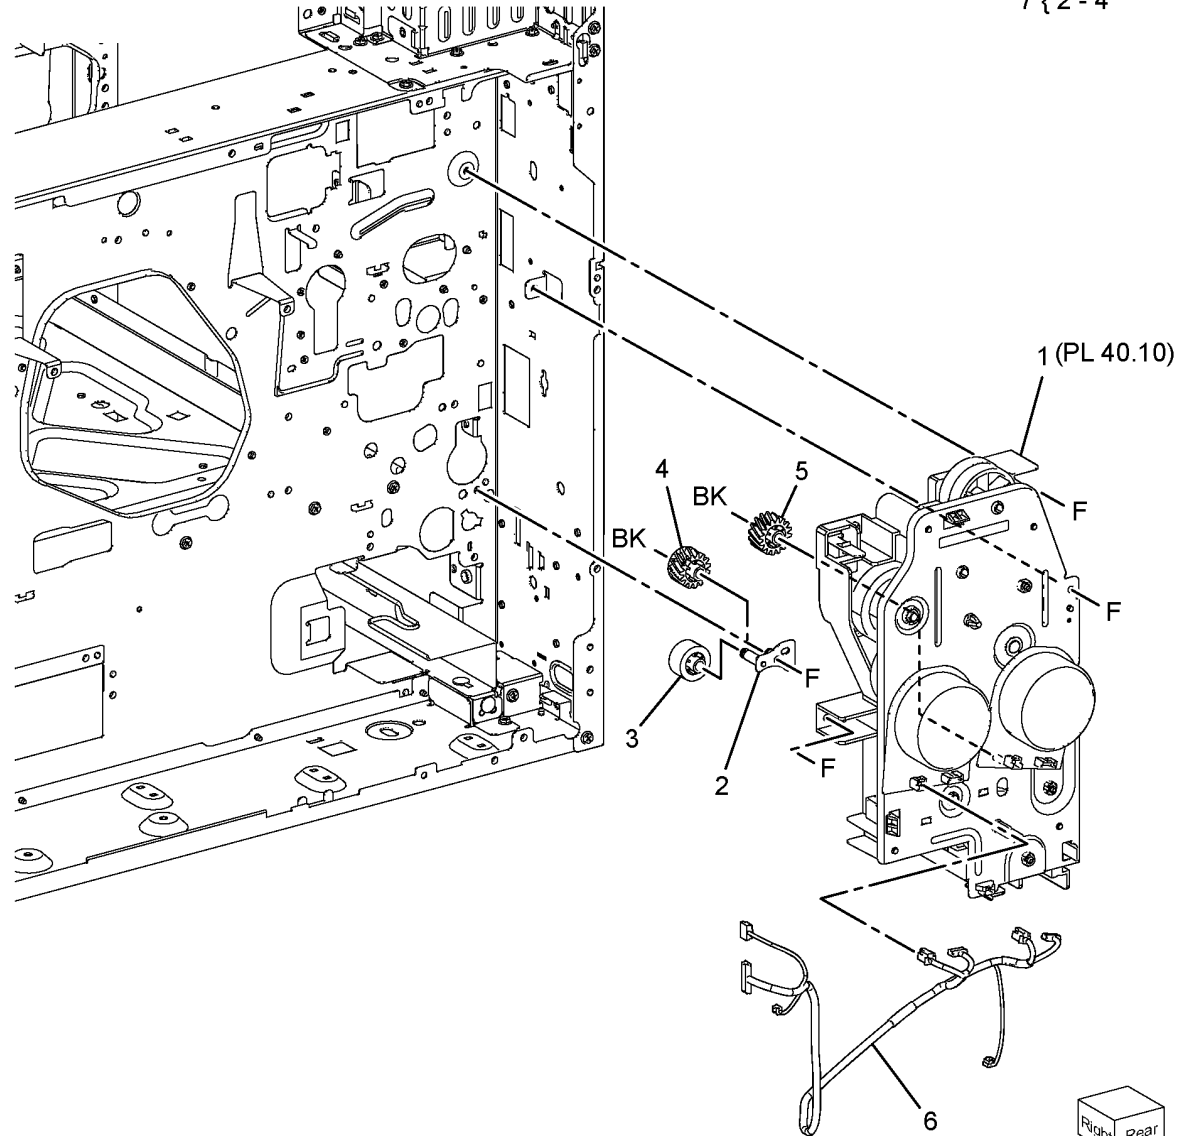
PL 40.10 Drive Component

Item	Part	Description
1	127K73052	Main motor (MOT42-003), drum motor (MOT42-002)
2	-	Not used
3	-	Motor plate assembly (Not Spared)
4	413W11660	Lock bearing (REP 70.12)
5	121K56550	Takeaway clutch (CL77-001) (REP 70.12)
6	-	Connector (Not Spared)
7	-	Drive assembly (REF: PL 40.05 Item 1)

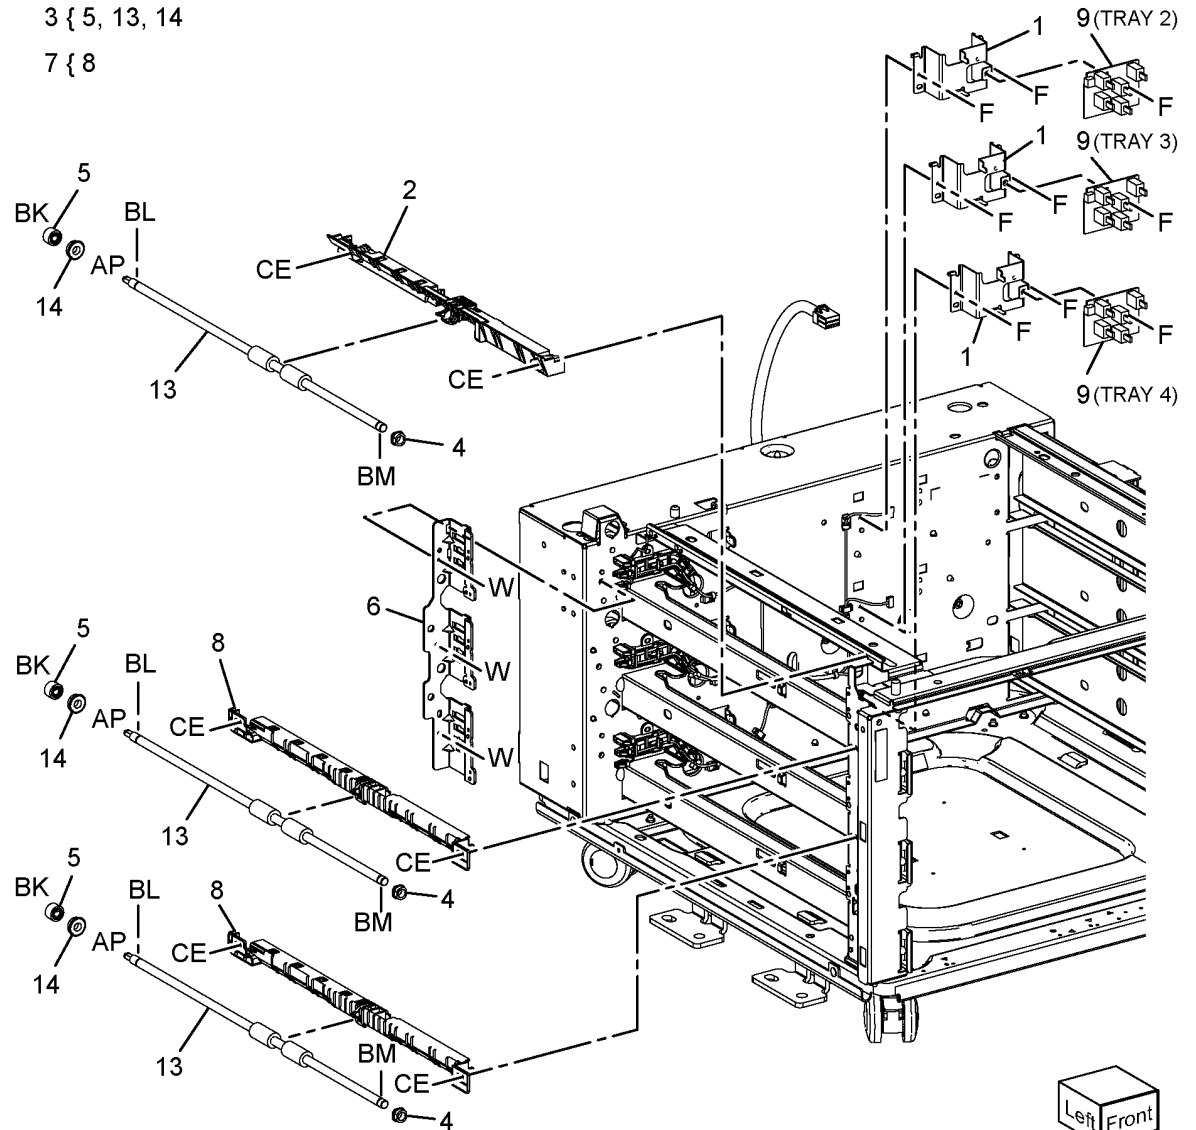
PL 70.22 3TM (3 of 4)

Item	Part	Description
1	-	Sensor bracket (Not Spared)
2	054K55730	Takeaway chute
3	859K03850	Takeaway roll assembly
4	013E46870	Bearing
5	-	Gear 16T (P/O PL 70.22 Item 3)
6	-	Bracket (Not Spared)
7	-	Feed chute assembly (Not Spared)
8	054E58810	Exit chute
9	110K17950	Tray 2 paper size sensor/tray 3 paper size sensor/tray 4 paper size sensor
10	-	Not used
11	-	Not used
12	-	Not used
13	-	Takeaway roll (P/O PL 70.22 Item 3)
14	-	Bearing (P/O PL 70.22 Item 3)

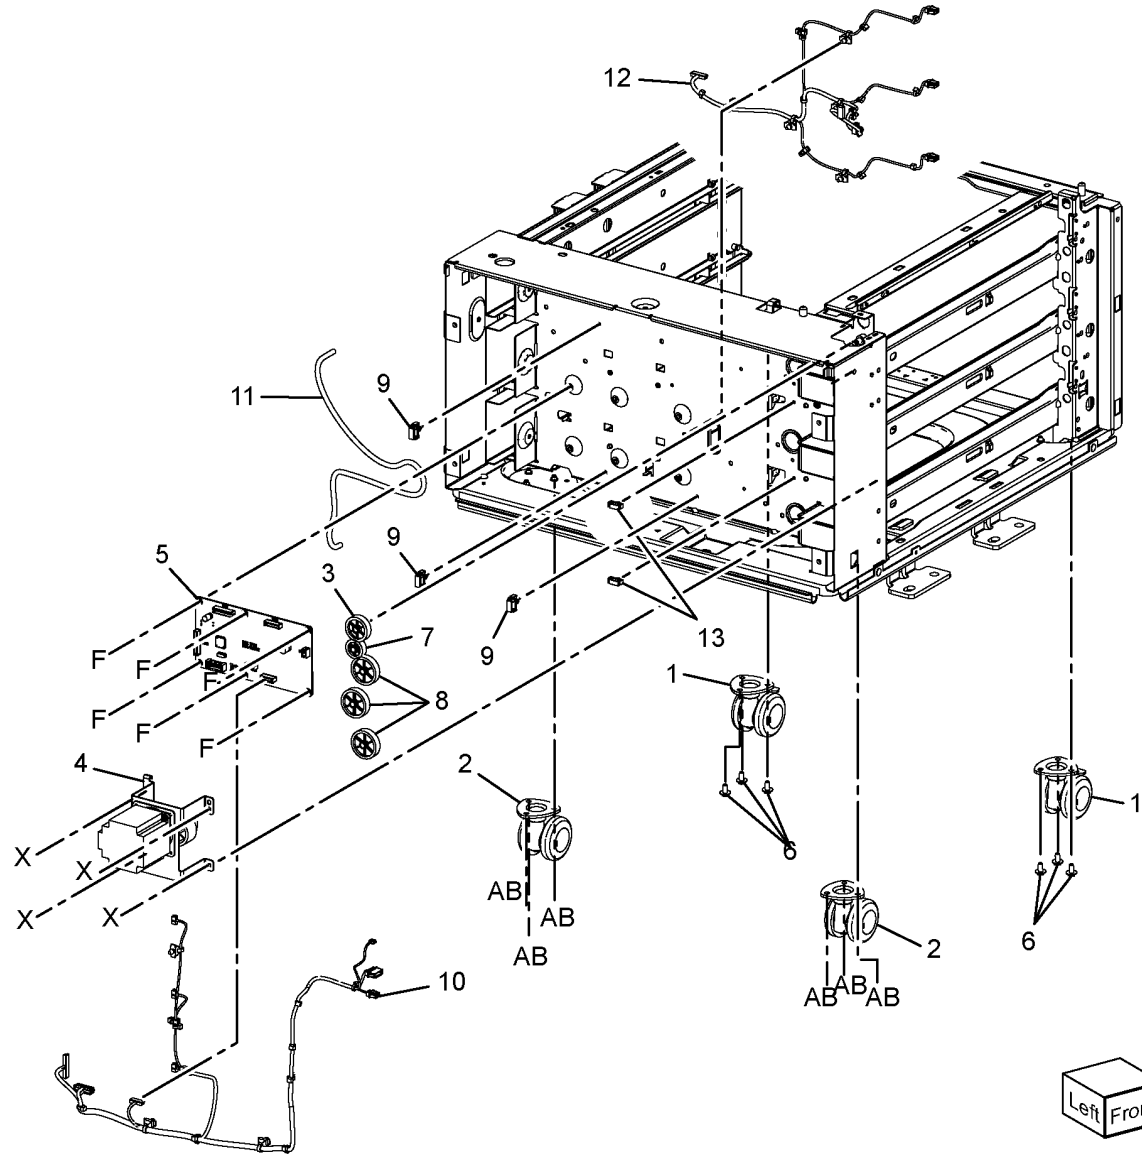
PL 70.23 3TM (4 of 4)

Item	Part	Description
1	417W41349	Front caster
2	417W41449	Rear caster
3	807E20700	Gear 34T
4	127K72691	Takeaway motor (MOT77-033) (REP 80.11)
5	960K85441	3TM PWB (REP 80.10)
6	-	Screw (Not Spared)
7	807E20710	Gear 26T
8	807E20720	Gear 39T
9	920W01211	Locking clamp
10	952K20130	Harness
11	-	Harness (Not Spared)
12	-	Harness (Not Spared)
13	920W01210	Locking clamp

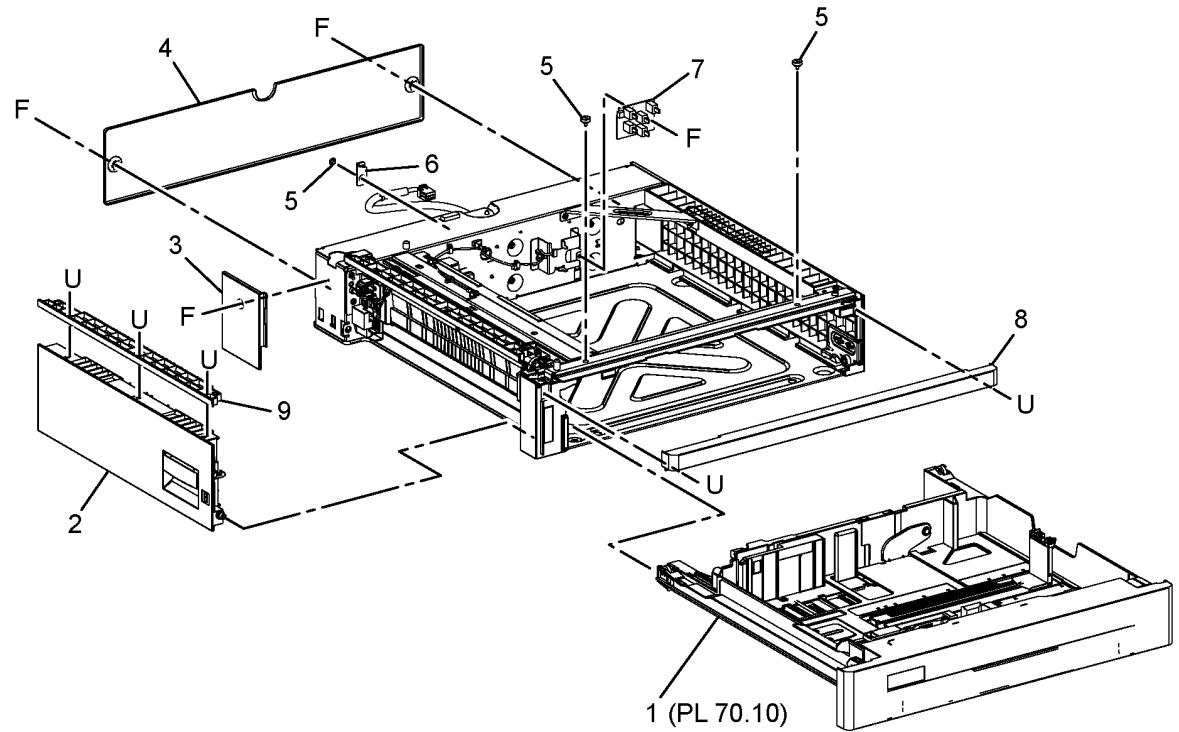
PL 70.25 STM (1 of 4)

Item	Part	Description
1	-	A3 tray assembly (REF: PL 70.10)
2	-	Left cover assembly (Not Spared)
3	-	Left cover (Not Spared)
4	-	Rear cover (Not Spared)
5	-	Docking screw (Not Spared)
6	-	Docking bracket (Not Spared)
7	110K17950	Paper size sensor
8	-	MA top cover (Not Spared)
9	-	Chute (Not Spared)

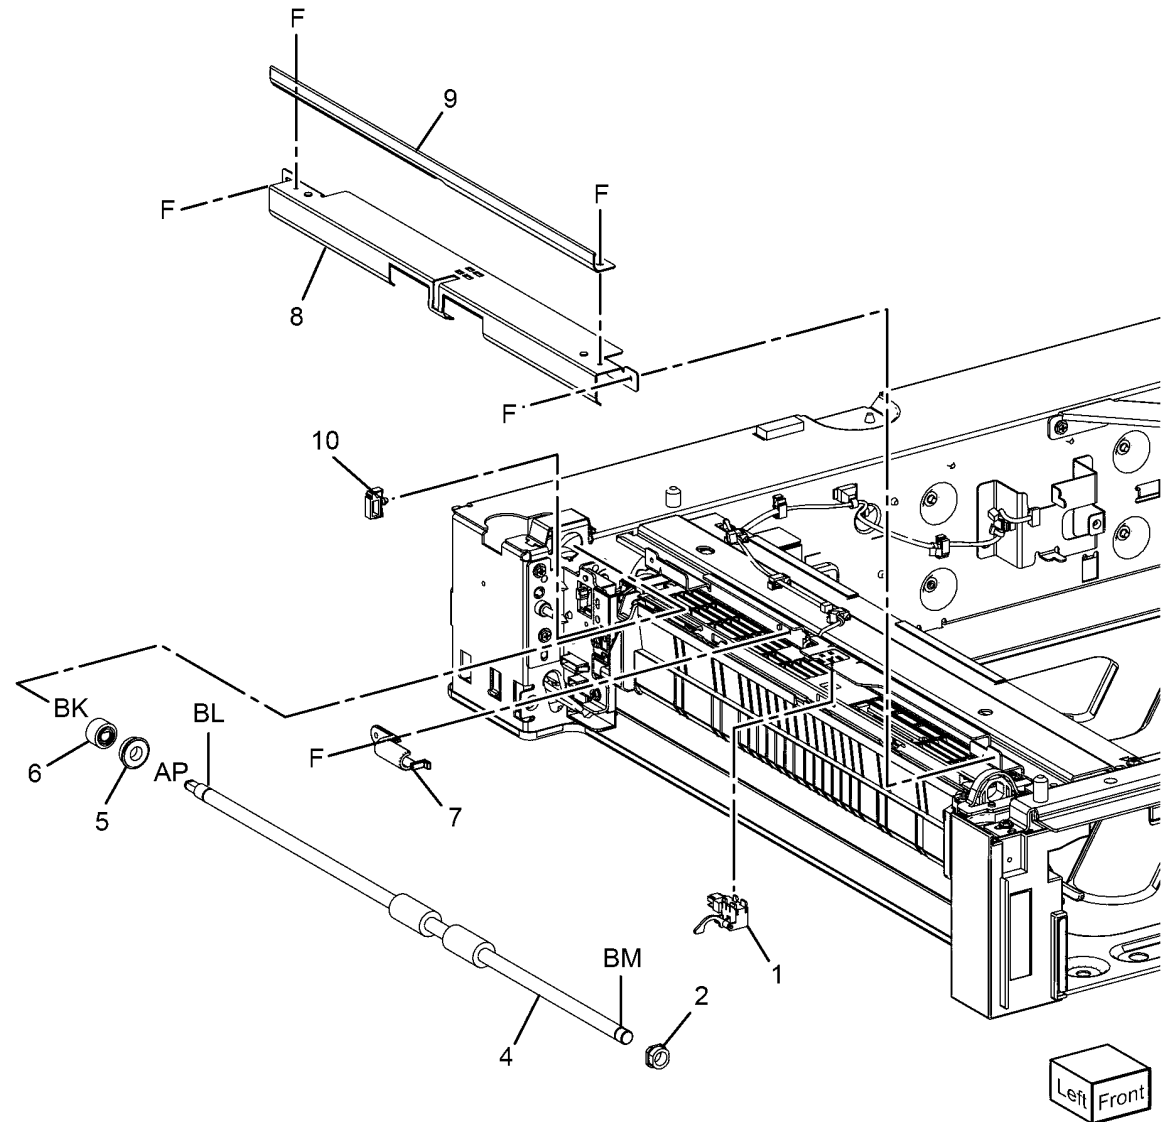
PL 70.26 STM (2 of 4)

Item	Part	Description
1	130K64121	Tray 2 feed out sensor (Q72-103)
2	413W11860	Bearing
3	059K86600	Takeaway roll assembly
4	-	Roller assembly (P/O PL 70.26 Item 3)
5	-	Bearing (P/O PL 70.26 Item 3)
6	-	Gear 16T (P/O PL 70.26 Item 3)
7	-	LH harness guide (Not Spared)
8	-	Takeaway chute (Not Spared)
9	-	Exit chute (Not Spared)
10	920W01209	Locking clamp
