708P91370
April 2017

Xerox® VersaLink® B7025/B7030/B7035 Multifunction Printer Service Manual

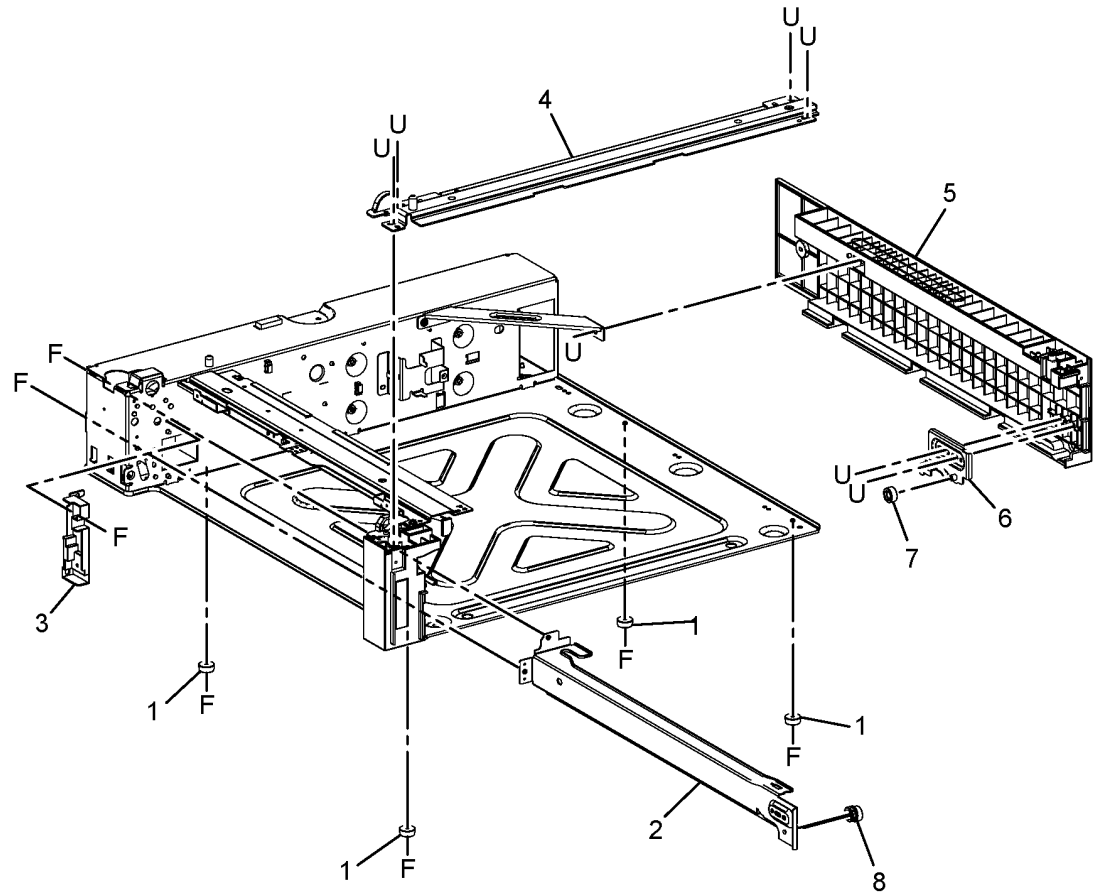
PL 70.27 STM (3 of 4)

Item	Part	Description
1	–	Foot (Not Spared)
2	–	Left rail assembly (Not Spared)
3	–	Harness guide (Not Spared)
4	–	Top front frame assembly (Not Spared)
5	–	RH guide (Not Spared)
6	–	Right rail assembly (Not Spared)
7	059E08410	Front right roller
8	059E03500	Front left roller

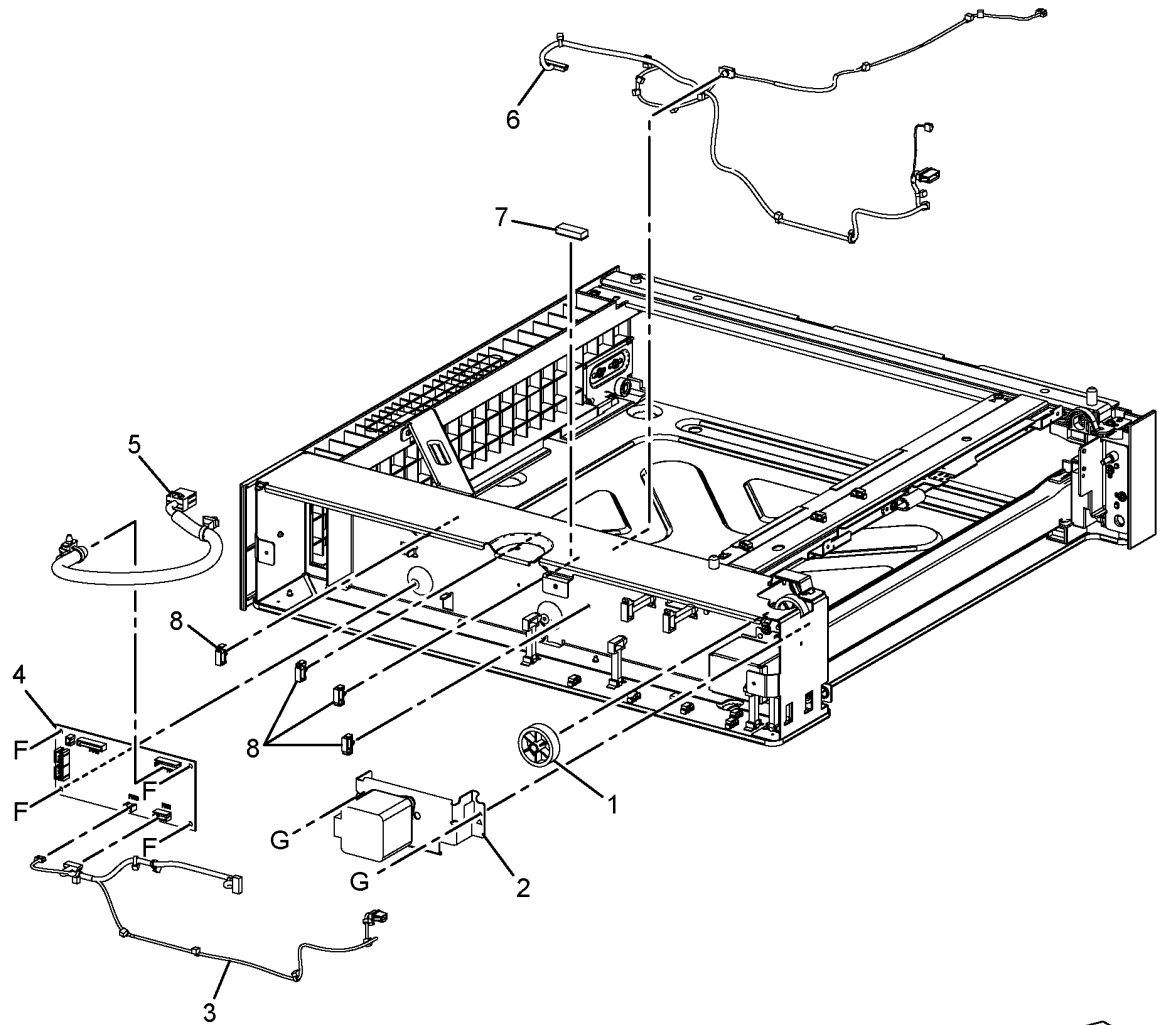
PL 70.28 STM (4 of 4)

Item	Part	Description
1	807E45050	Gear 65/20
2	049K28360	Takeaway motor (MOT77-033) (REP 80.14)
3	952K15720	Harness
4	607K04440	STM PWB (REP 80.13)
5	952K15700	Harness
6	952K15710	Harness
7	-	Gasket shield (Not Spared)
8	920W01210	Locking clamp

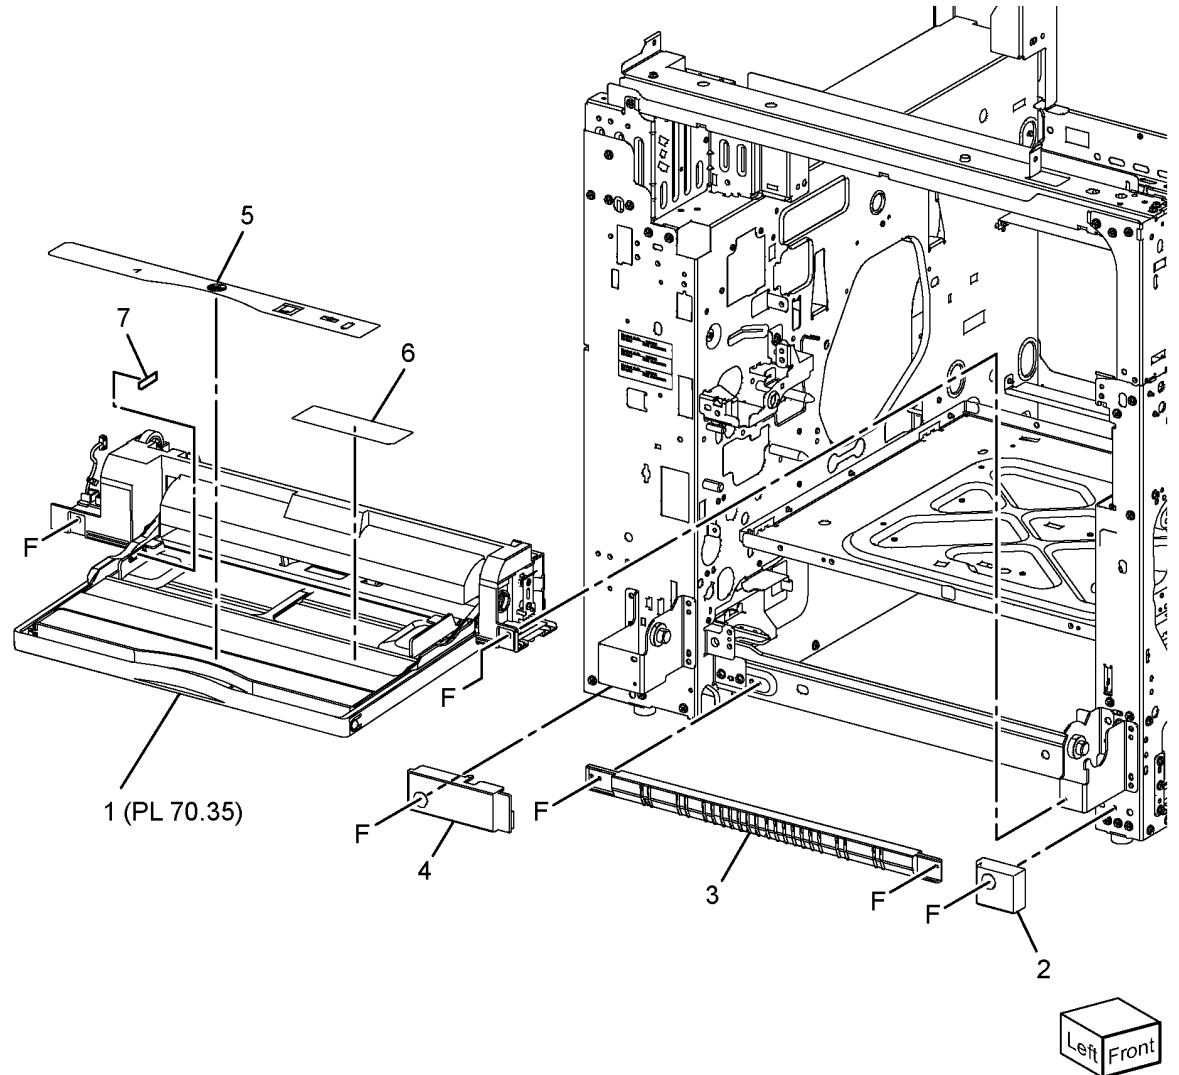
PL 70.30 Bypass Tray

Item	Part	Description	
1	-	Bypass tray (REF: PL 70.35) (REP 70.2)	8 { 1, 5 - 7
2	-	Bypass tray front cover (Not Spared)	
3	-	TM exit chute (Not Spared)	
4	-	Bypass tray right cover (Not Spared)	
5	-	Bypass tray instruction label (P/O PL 70.30 Item 8)	
6	-	Bypass tray size label (P/O PL 70.30 Item 8)	
7	-	Max label (P/O PL 70.30 Item 8)	
8	607K01961	Bypass tray kit

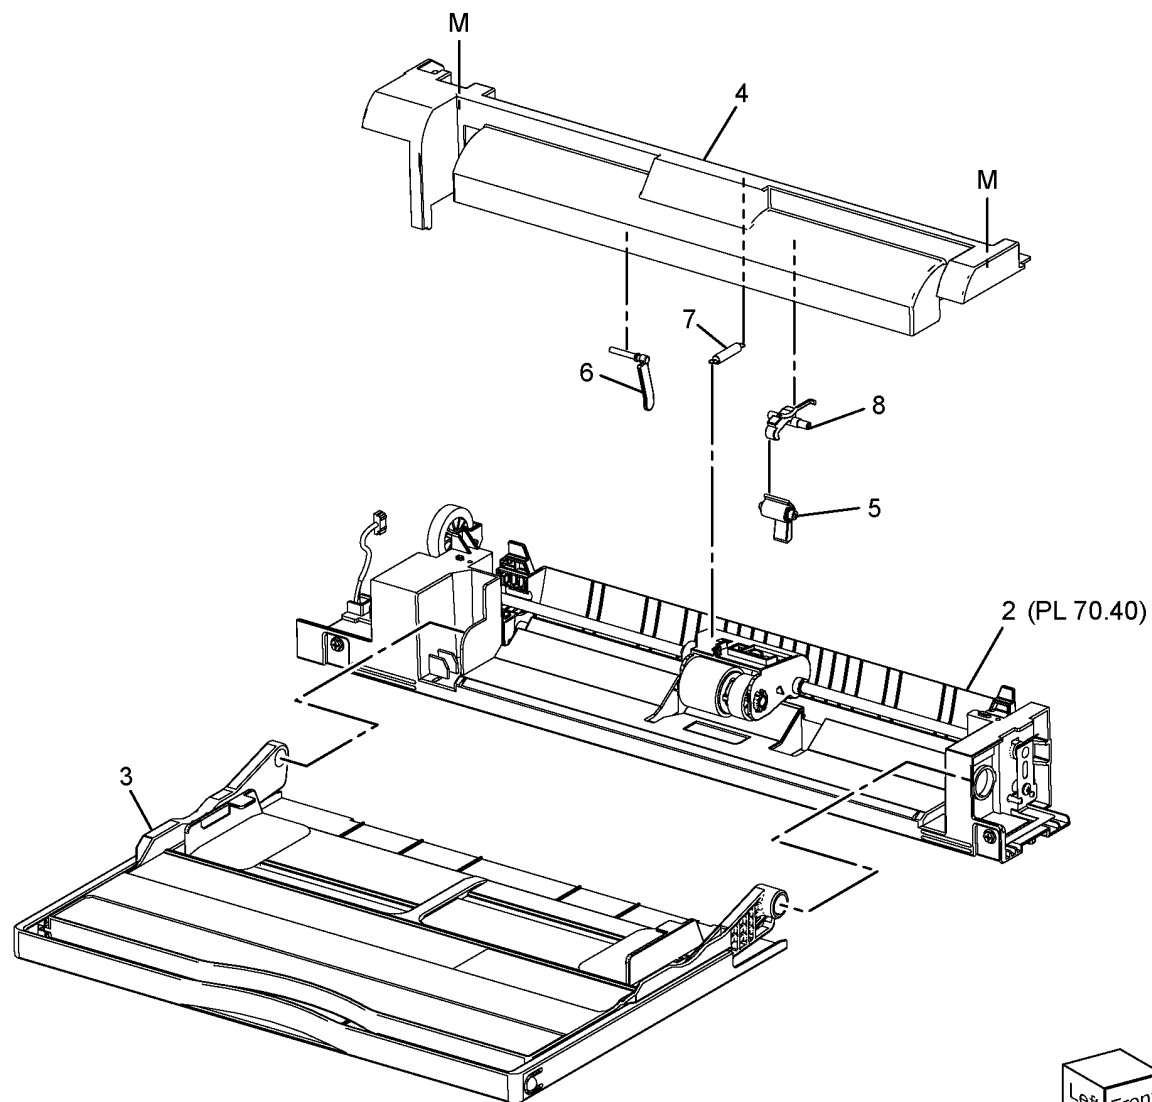
PL 70.35 Bypass Tray Components

Item	Part	Description
1	-	Bypass tray feeder assembly (Not Spared)
2	-	Bypass tray lower feeder assembly (REF: PL 70.40)
3	-	Bypass tray assembly (P/O PL 70.35 Item 1)
4	-	Upper frame (P/O PL 70.35 Item 1)
5	-	Paper stopper (P/O PL 70.35 Item 1)
6	-	No paper sensor actuator (P/O PL 70.35 Item 1)
7	-	Spring (P/O PL 70.35 Item 1)
8	-	Paper lock stopper (P/O PL 70.35 Item 1)

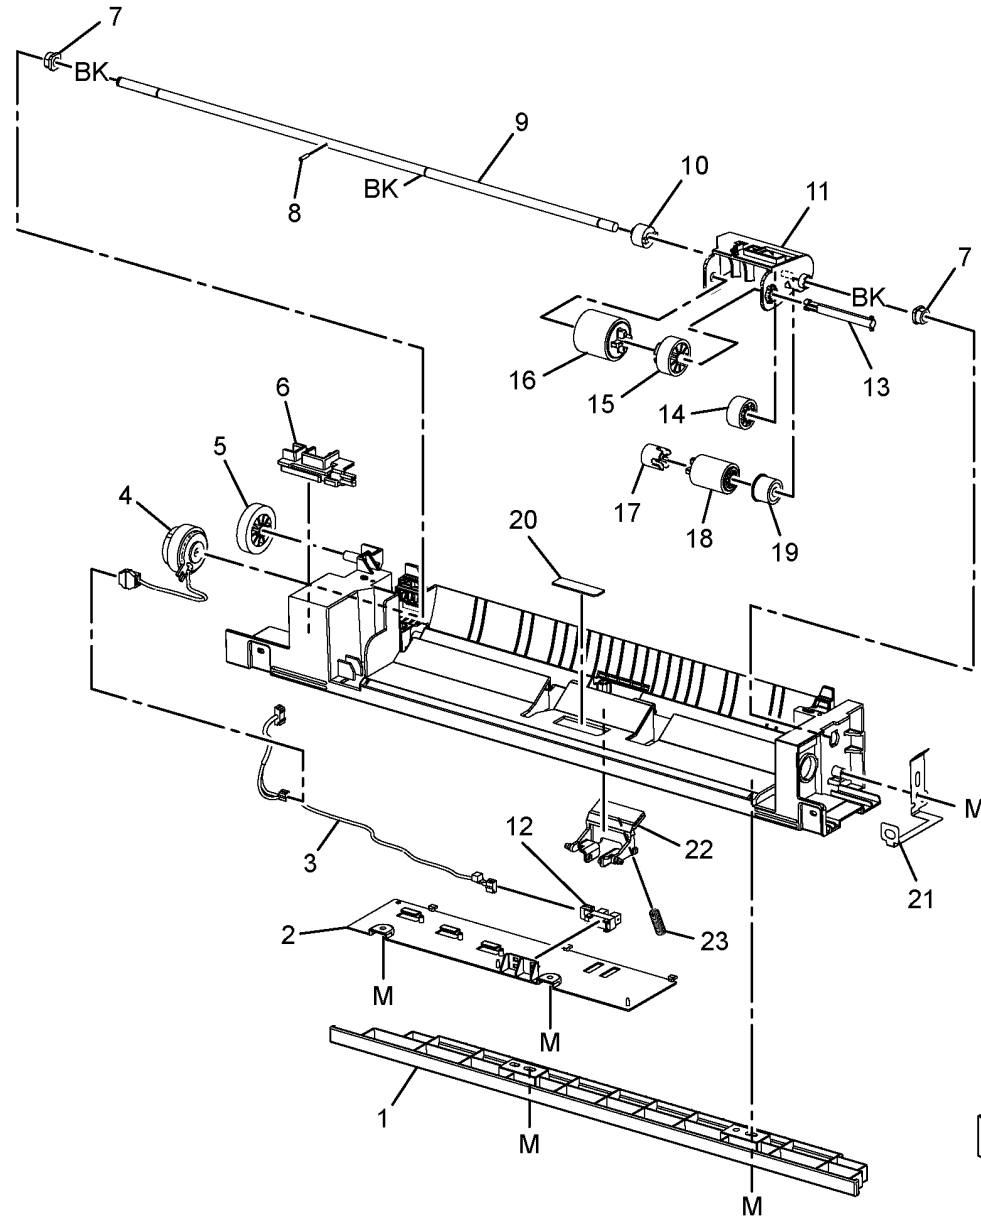
PL 70.40 Bypass Tray Lower Feeder

Item	Part	Description
1	-	Bypass tray low chute (Not Spared)
2	-	Lower cover (Not Spared)
3	-	Bypass tray harness assembly (Not Spared)
4	121K56480	Bypass tray feed clutch (CL75-001)
5	-	Drive gear 22T (Not Spared)
6	-	Connector cover (Not Spared)
7	-	Bearing (Not Spared)
8	-	Pin (Not Spared)
9	-	Shaft (Not Spared)
10	-	Friction clutch assembly (Not Spared)
11	-	Nudger holder (Not Spared)
12	930W00123	Bypass tray no paper sensor (Q75-100)
13	-	Shaft (Not Spared)
14	-	Idler gear 37T (Not Spared)
15	-	Nudger gear 46T (Not Spared)
16	022K78481	Bypass tray nudger roll (See NOTE) (REP 80.16)
17	-	One way clutch (Not Spared)
18	022K77450	Feed roll (REP 80.16)
19	-	Feed gear 30T (Not Spared)
20	-	Pad (Not Spared)
21	-	Earth plate (Not Spared)
22	019K12820	Retard pad (See NOTE) (REP 80.17)
23	-	Spring (Not Spared)

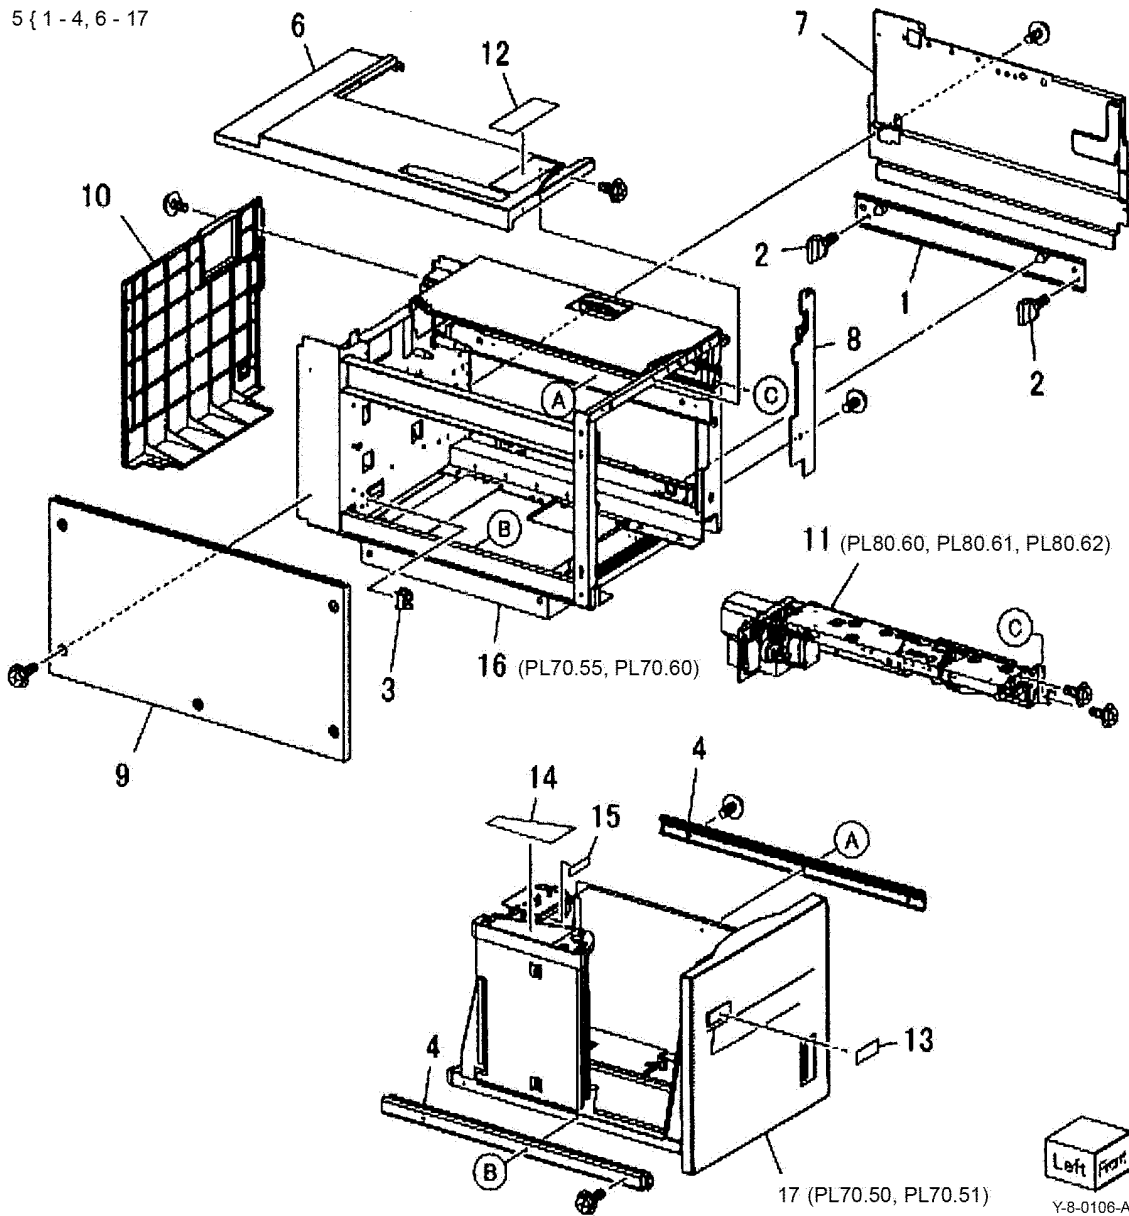
PL 70.45 HCF Assembly

Item	Part	Description
1	-	Docking plate (Not Spared)
2	003K91881	Knob
3	130K55590	HCF tray in sensor (Q78-204)
4	801K15701	Tray rail
5	050K51976	HCF Tray 6 (REP 70.3, REP 70.4)
6	-	Left top cover (Not Spared)
7	-	Right cover (Not Spared)
8	-	Front right cover (Not Spared)
9	-	Left cover (Not Spared)
10	-	Rear cover (Not Spared)
11	-	HCF feeder (Not Spared) (REP 80.21)
12	-	Label (top) (Not Spared)
13	-	Label (tray number) (Not Spared)
14	-	Label (size) (Not Spared)
15	-	Label (end) (Not Spared)
16	-	Frame assembly (Not Spared)
17	-	HCF Tray (P/O PL 70.45 Item 5)

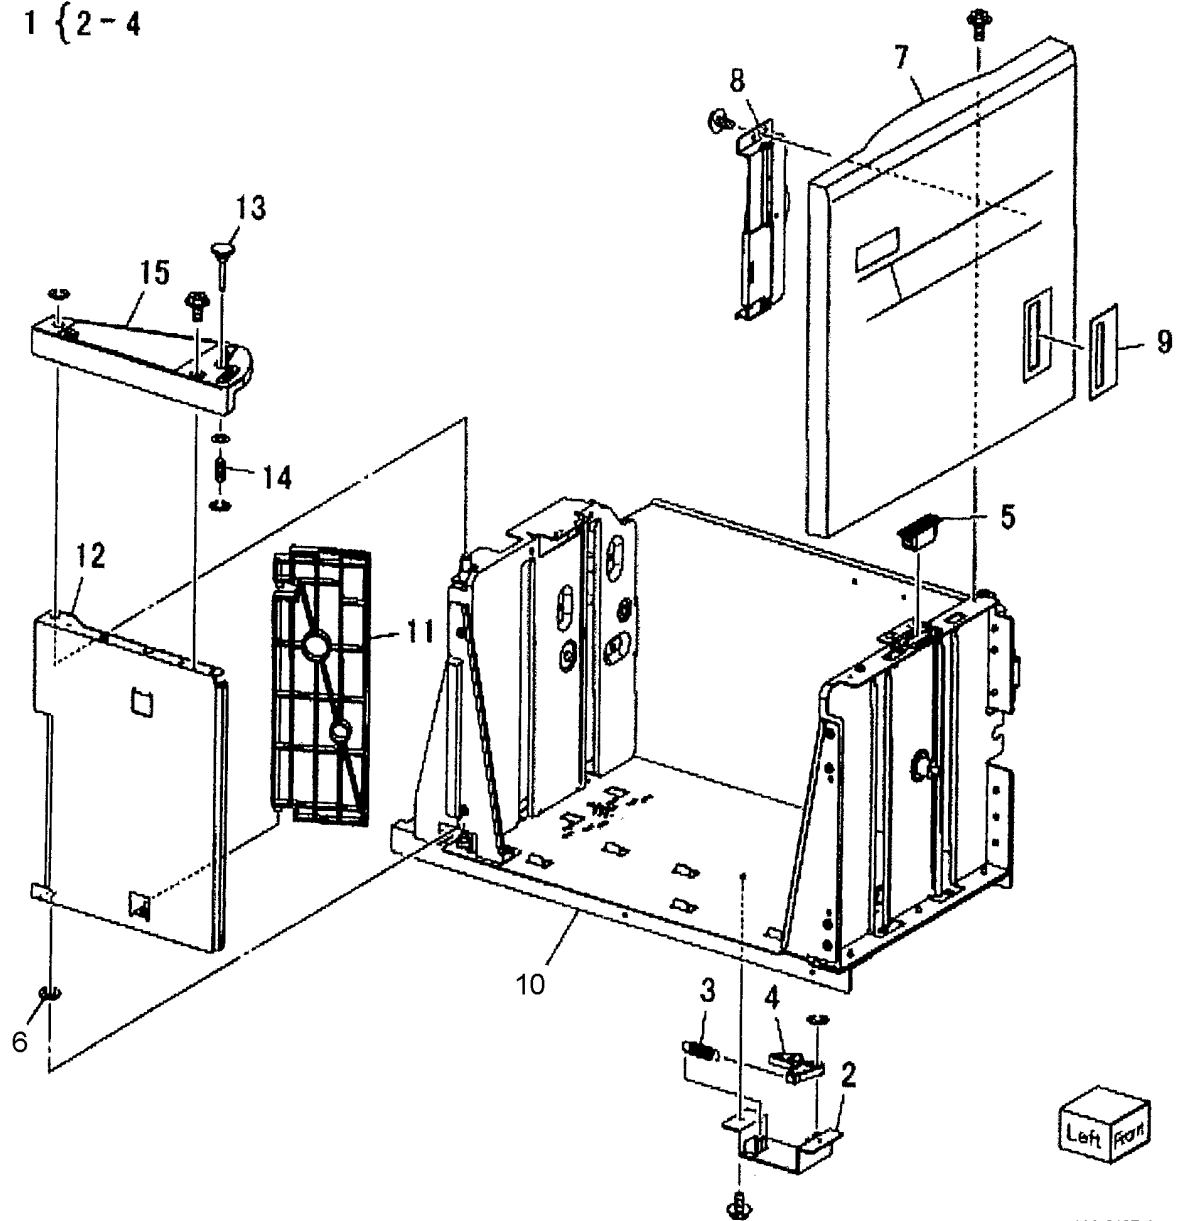
PL 70.50 HCF (1 of 2)

Item	Part	Description
1	003K13592	Tray latch assembly
2	-	Bracket (P/O PL 70.50 Item 1)
3	-	Spring (P/O PL 70.50 Item 1)
4	-	Latch lever (P/O PL 70.50 Item 1)
5	-	Magnet (P/O PL 70.45 Item 5)
6	-	Wave washer (P/O PL 70.45 Item 5)
7	-	Front cover (P/O PL 70.45 Item 5)
8	-	Gear bracket (P/O PL 70.45 Item 5)
9	-	Label (Gauge) (P/O PL 70.45 Item 5)
10	-	Frame (P/O PL 70.45 Item 5)
11	-	Plate (P/O PL 70.45 Item 5)
12	-	Bracket (P/O PL 70.45 Item 5)
13	-	Pin (P/O PL 70.45 Item 5)
14	-	Spring (P/O PL 70.45 Item 5)
15	-	Top plate (P/O PL 70.45 Item 5)

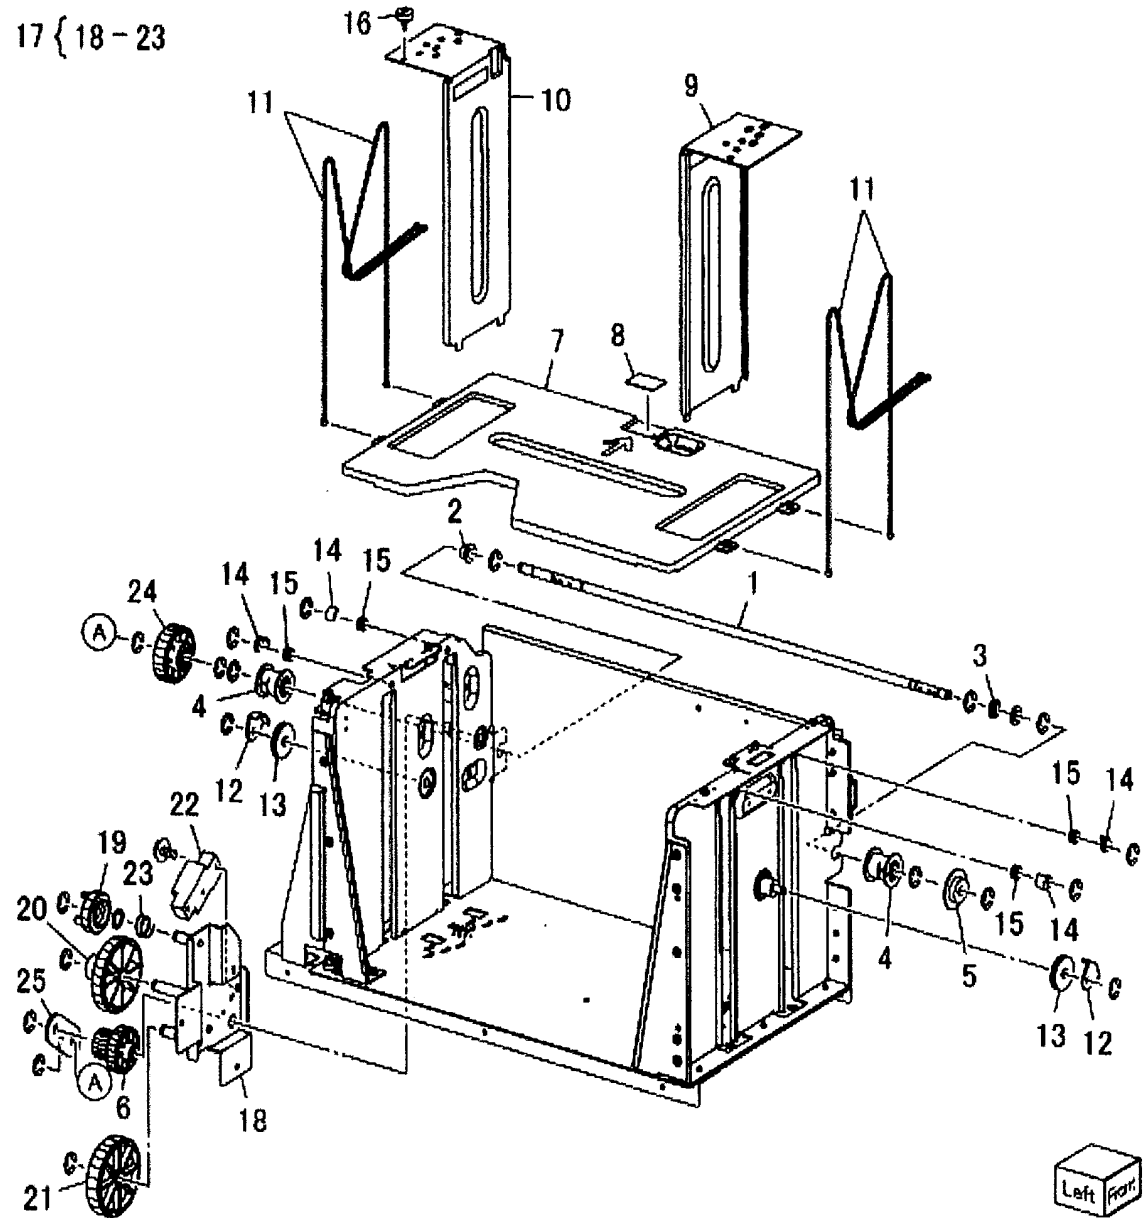
PL 70.51 HCF (2 of 2)

Item	Part	Description
1	-	Lift shaft (P/O PL 70.45 Item 5)
2	-	Bearing (P/O PL 70.45 Item 5)
3	-	Bearing (P/O PL 70.45 Item 5)
4	020E37620	Tray cable pulley
5	-	Gear (P/O PL 70.45 Item 5)
6	-	Gear (P/O PL 70.45 Item 5)
7	-	Bottom plate (P/O PL 70.45 Item 5)
8	019E58620	Pad
9	-	Front side guide (P/O PL 70.45 Item 5)
10	-	Rear side guide (P/O PL 70.45 Item 5)
11	604K19981	Rear cables (REP 70.5)/front cables (REP 70.6)
12	032E22410	Wire guide (L)
13	-	Pulley (P/O PL 70.45 Item 5)
14	-	Wire guide (S) (P/O PL 70.45 Item 5)
15	-	Pulley (P/O PL 70.45 Item 5)
16	-	Screw (P/O PL 70.45 Item 5)
17	015K65532	Gear bracket assembly
18	-	Gear bracket (P/O PL 70.51 Item 17)
19	-	Contact gear (P/O PL 70.51 Item 17)
20	-	Gear (P/O PL 70.51 Item 17)
21	-	Gear (P/O PL 70.51 Item 17)
22	-	Brake (P/O PL 70.51 Item 17)
23	-	Spring (P/O PL 70.51 Item 17)
24	807E04500	Lift gear
25	-	Plate (P/O PL 70.45 Item 5)

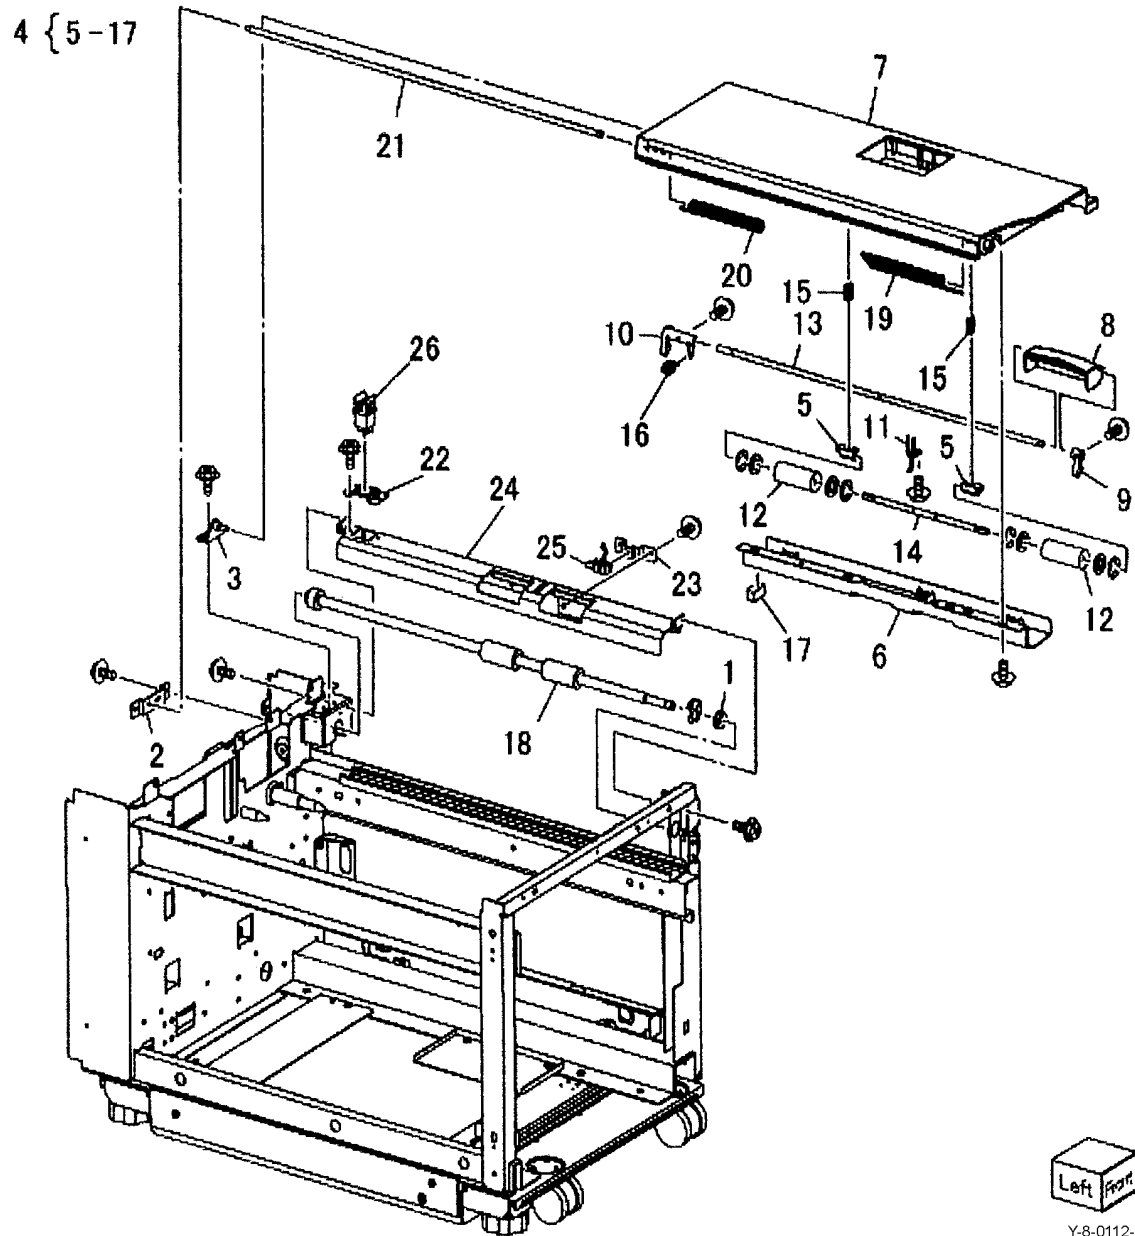
PL 70.55 HCF Top Cover Assembly

Item	Part	Description
1	013E17100	Bearing
2	-	Bracket (Not Spared)
3	-	Pivot bracket (Not Spared)
4	-	Top cover assembly (Not Spared)
5	-	Bearing (P/O PL 70.55 Item 4)
6	-	Upper chute (P/O PL 70.55 Item 4)
7	-	Top cover (P/O PL 70.55 Item 4)
8	-	Knob (P/O PL 70.55 Item 4)
9	-	Latch (P/O PL 70.55 Item 4)
10	-	Latch (P/O PL 70.55 Item 4)
11	-	Spring (P/O PL 70.55 Item 4)
12	059E01430	Nip roll
13	-	Shaft (P/O PL 70.55 Item 4)
14	-	Shaft (P/O PL 70.55 Item 4)
15	-	Spring (P/O PL 70.55 Item 4)
16	-	Spring (P/O PL 70.55 Item 4)
17	-	Gasket (P/O PL 70.55 Item 4)
18	059K36260	Takeaway roll (REP 80.26)
19	-	Spring (left) (P/O PL 70.45 Item 16)
20	-	Spring (right) (P/O PL 70.45 Item 16)
21	-	Pivot shaft (P/O PL 70.45 Item 16)
22	-	Bracket (P/O PL 70.45 Item 5)
23	-	Bracket (P/O PL 70.45 Item 16)
24	-	Lower chute (P/O PL 70.45 Item 16)
25	130K88150	HCF feed out sensor (Q78-101)
26	110E94770	Top cover interlock switch

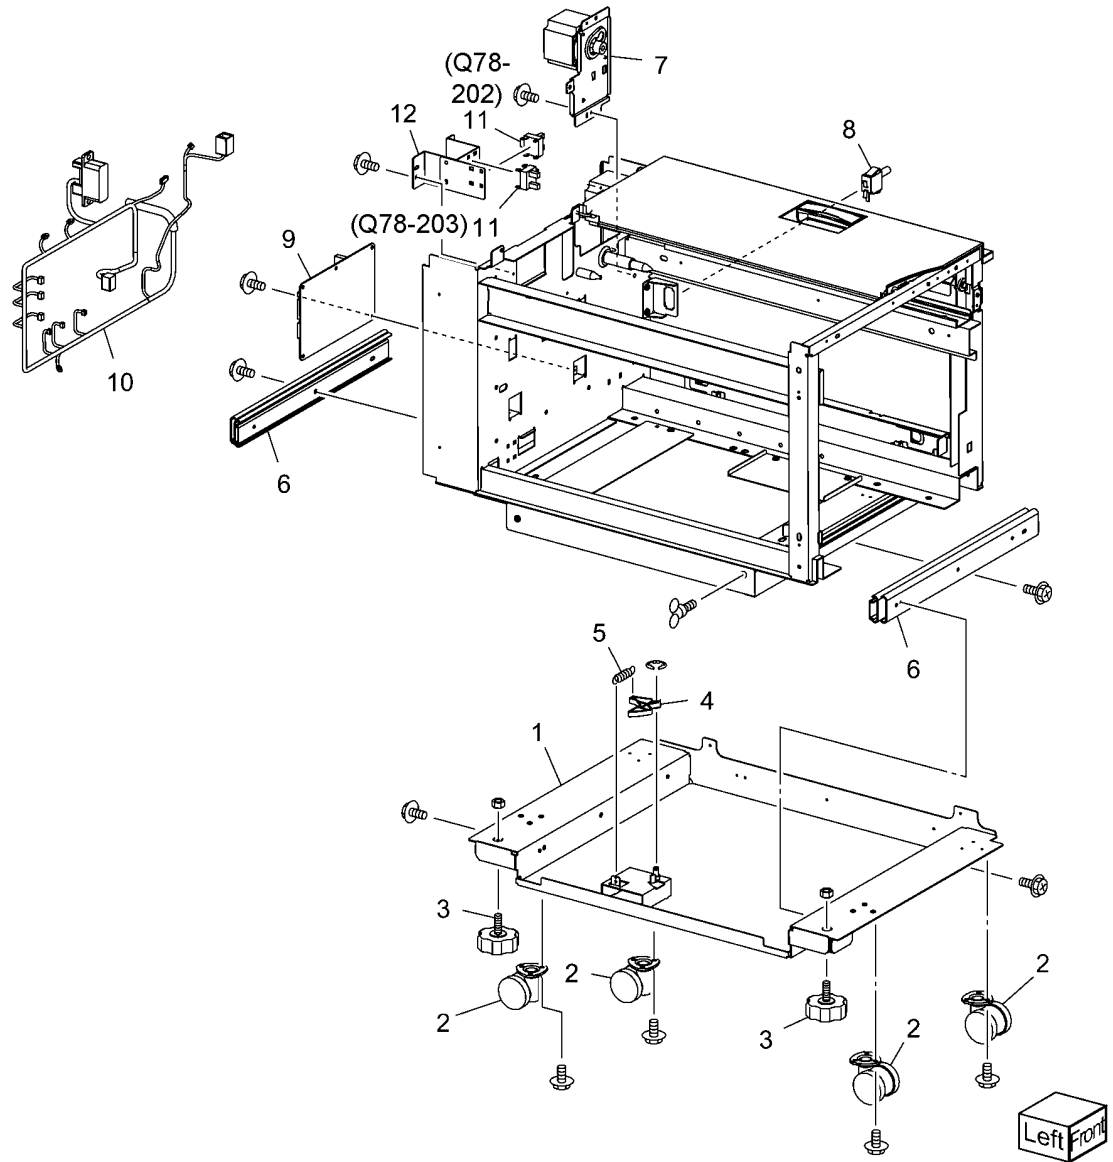
PL 70.60 HCF Electrical and Rails

Item	Part	Description
1	-	Plate (Not Spared)
2	017E92820	Caster (REP 70.7)
3	-	Foot (Not Spared)
4	-	Latch lever (Not Spared)
5	-	Spring (Not Spared)
6	801K15690	Rail
7	127K47152	Takeaway motor (MOT78-093)
8	-	HCF side out switch (S78-301) (Not Spared)
9	960K31492	HCF PWB (REP 70.8)
10	-	Wire Harness (P/O PL 70.45 Item 16)
11	130K55590	HCF size sensor A (Q78-202)/HCF size sensor B (Q78-203)
12	-	Bracket (P/O PL 70.45 Item 5)

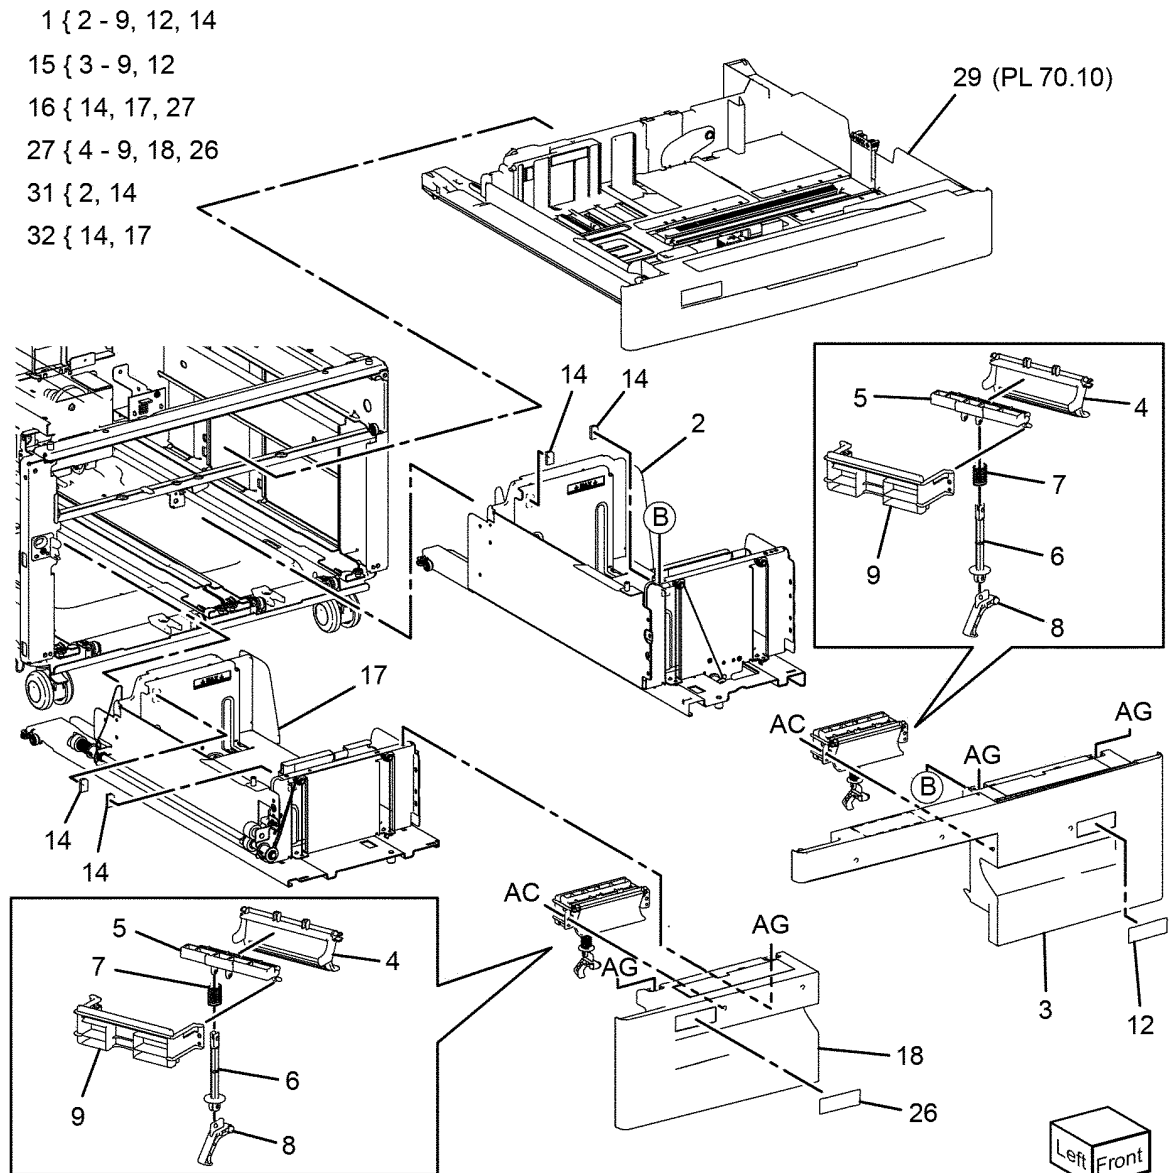
PL 70.65 TTM (1 of 3)

Item	Part	Description	
1	-	Tray 4 assembly (Not Spared)	1 { 2 - 9, 12, 14
2	-	Tray 4 (P/O PL 70.65 Item 31)	15 { 3 - 9, 12
3	-	Tray 4 cover (P/O PL 70.65 Item 15)	16 { 14, 17, 27
4	-	Lever (P/O PL 70.65 Item 27)	27 { 4 - 9, 18, 26
5	-	Link (P/O PL 70.65 Item 15)	31 { 2, 14
6	-	Link (P/O PL 70.65 Item 15)	32 { 14, 17
7	-	Spring (P/O PL 70.65 Item 15)	
8	-	Latch (P/O PL 70.65 Item 15)	
9	-	Cover (P/O PL 70.65 Item 15)	
10	-	Not used	
11	-	Not used	
12	-	Label (P/O PL 70.65 Item 15)	
13	-	Not used	
14	819E04150	Pad	
15	607K08830	Tray 4 cover assembly	
16	-	Tray 3 assembly	
17	-	Tray 3 (P/O PL 70.65 Item 32)	
18	-	Tray 3 cover (P/O PL 70.65 Item 27)	
19	-	Not used	
20	-	Not used	
21	-	Not used	
22	-	Not used	
23	-	Not used	
24	-	Not used	
25	-	Not used	
26	-	Label (P/O PL 70.65 Item 27)	
27	607K08820	Tray 3 cover assembly	
28	-	Not used	
29	-	Tray 2 assembly (REF: PL 70.10)	
30	-	Not used	
31	050K73143	Tray 4 kit	
32	050K73163	Tray 3 kit

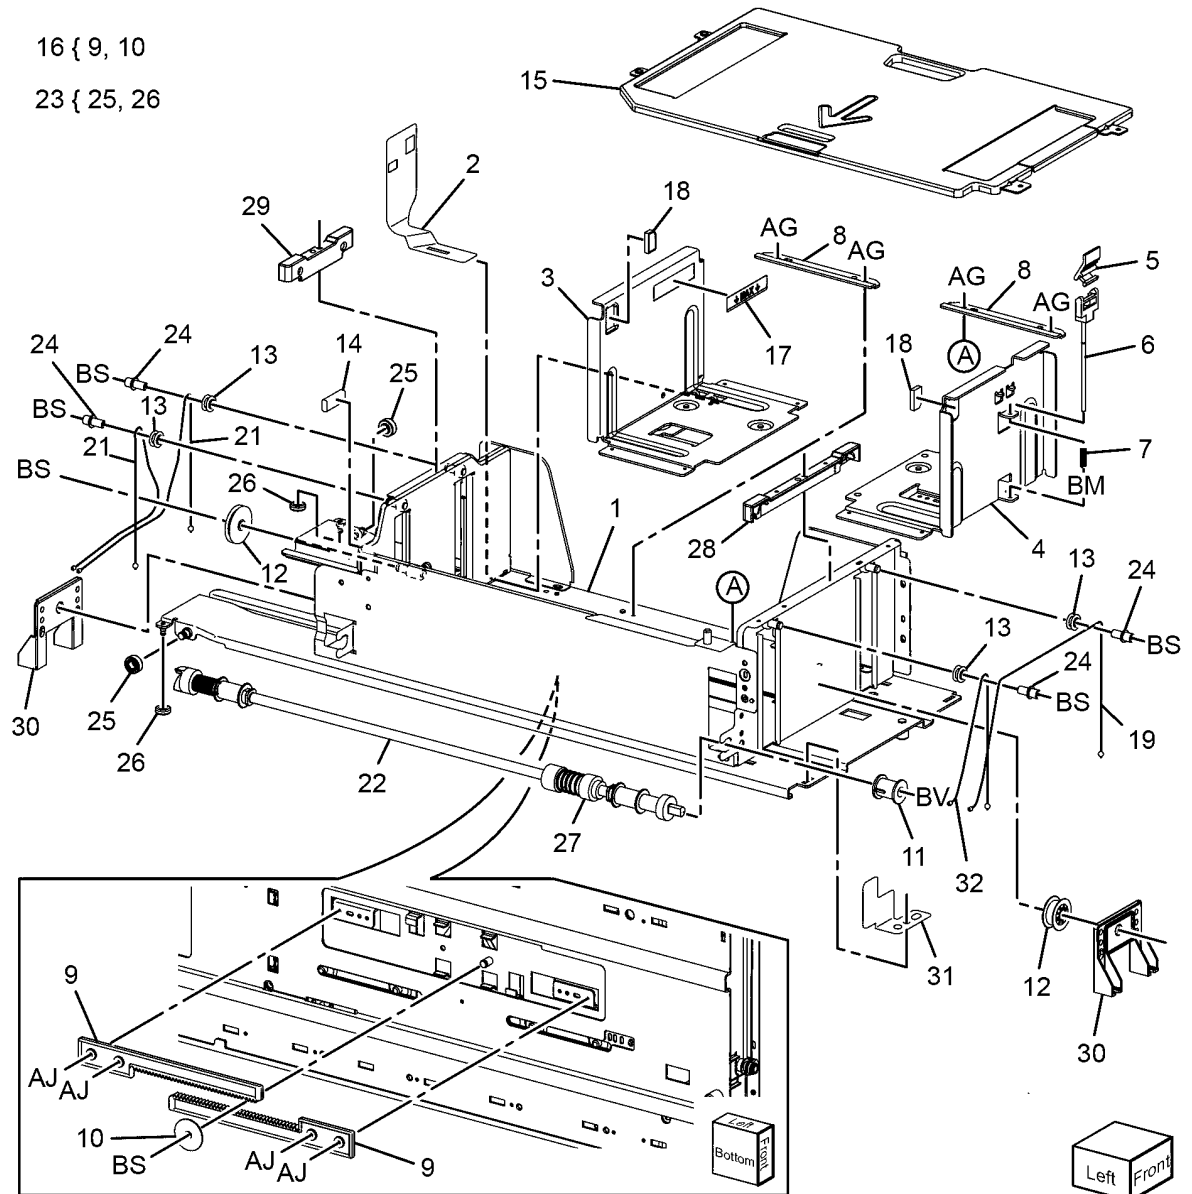
PL 70.66 TTM (2 of 3)

Item	Part	Description
1	-	Tray 3 cassette assembly (Not Spared)
2	-	Size actuator (Not Spared)
3	-	Side rear guide (Not Spared)
4	-	Side front guide (Not Spared)
5	-	Knob (Not Spared)
6	-	Knob assembly (Not Spared)
7	-	Spring (Not Spared)
8	-	Bracket (Not Spared)
9	-	Rack gear (P/O PL 70.66 Item 16)
10	807E32730	Pinion
11	-	Pulley (Not Spared)
12	-	Pulley (Not Spared)
13	-	Pulley (Not Spared)
14	-	Gasket (Not Spared)
15	-	Bottom plate (Not Spared)
16	604K68260	Rack gear and pinion kit
17	-	Label (Max) (Not Spared)
18	819E04150	Pad
19	-	Front lift cable (long) (Not Spared)
20	-	Not used
21	-	Rear lift cable (Not Spared)
22	006K35290	Lift shaft (REP 70.9)
23	604K68160	Roller kit
24	-	PL shaft (Not Spared)
25	-	Side roller (P/O PL 70.66 Item 23)
26	-	Lower roller (P/O PL 70.66 Item 23)
27	019K17181	Brake assembly (REP 70.9)
28	-	Guide - WF (Not Spared)
29	-	Guide - W (Not Spared)
30	-	Guide - WL (Not Spared)
31	-	Spring (Not Spared)

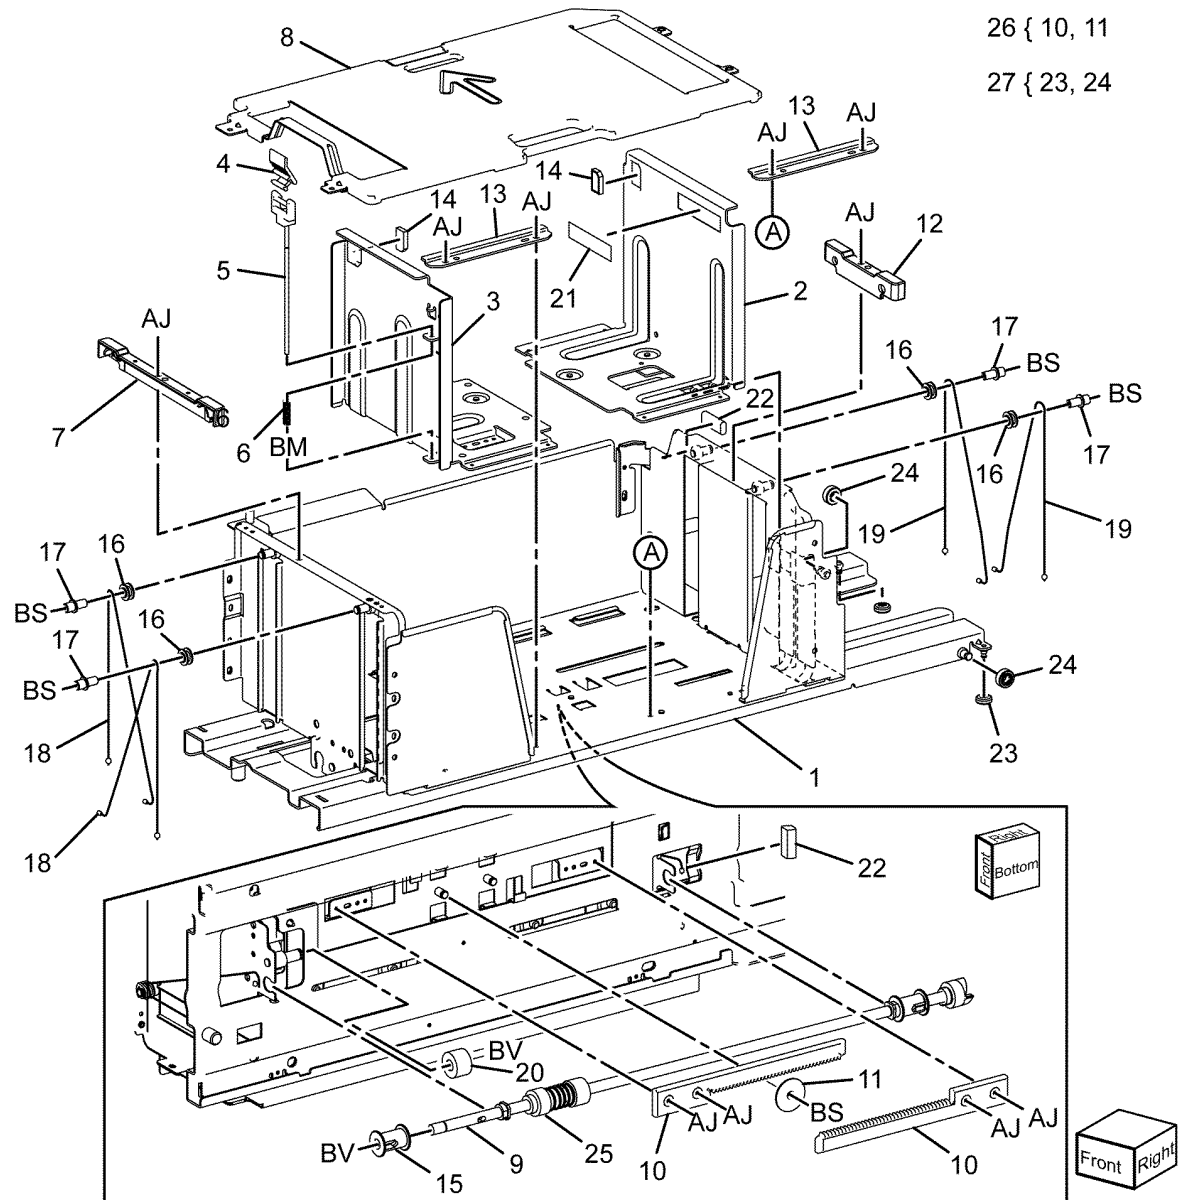
PL 70.67 TTM (3 of 3)

Item	Part	Description
1	-	Tray 4 cassette assembly (Not Spared)
2	-	Side rear guide (Not Spared)
3	-	Side front guide (Not Spared)
4	-	Knob (Not Spared)
5	-	Knob assembly (Not Spared)
6	-	Spring (Not Spared)
7	-	Guide - WF (Not Spared)
8	-	Bottom plate (Not Spared)
9	006K35290	Lift shaft (REP 70.10)
10	-	Rack gear (P/O PL 70.67 Item 26)
11	-	Pinion (P/O PL 70.67 Item 26)
12	-	Guide - W (Not Spared)
13	-	Bracket (Not Spared)
14	819E04150	Pad (REP 70.10)
15	-	Pulley (Not Spared)
16	-	Pulley (Not Spared)
17	-	Shaft - PL (Not Spared)
18	-	Front lift cable (Not Spared)
19	-	Rear lift cable (Not Spared)
20	-	Size actuator (Not Spared)
21	-	Label (Not Spared)
22	-	Gasket (Not Spared)
23	-	Lower roller (P/O PL 70.67 Item 27)
24	-	Side roller (P/O PL 70.67 Item 27)
25	019K17181	Brake assembly
26	604K68260	Rack gear and pinion kit
27	604K68160	Roller kit

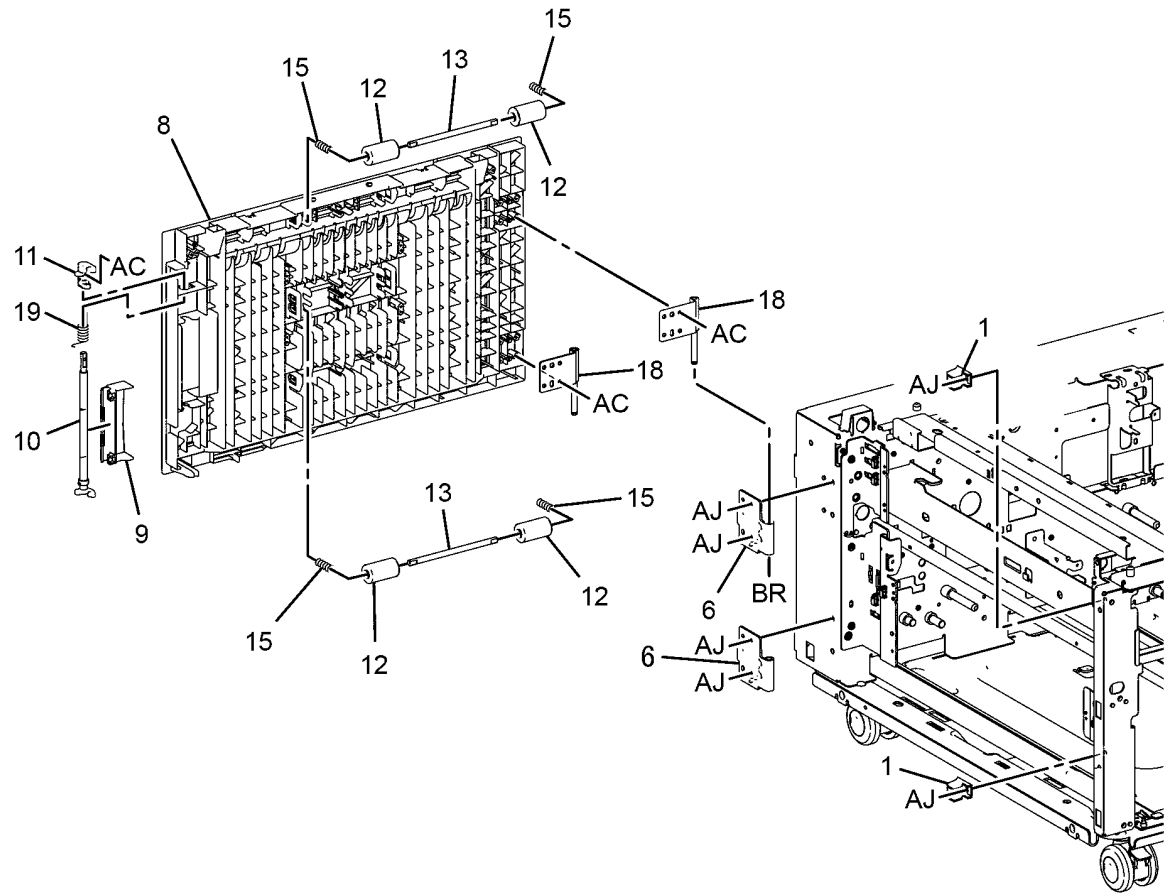
Item	Part	Description
1	-	Door catch (Not Spared)
2	-	Not used
3	-	Not used
4	-	Not used
5	-	Not used
6	-	Hinge frame bracket (Not Spared)
7	948K03890	Left cover assembly
8	-	Left cover (P/O PL 70.70 Item 7)
9	-	Handle (P/O PL 70.70 Item 7)
10	-	Latch (P/O PL 70.70 Item 7)
11	-	Hook (P/O PL 70.70 Item 7)
12	059E99241	Nip roll
13	-	Nip spring (P/O PL 70.70 Item 7)
14	-	Not used
15	-	Pinch spring (P/O PL 70.70 Item 7)
16	-	Not used
17	-	Not used
18	-	Hinge bracket assembly (P/O PL 70.70 Item 7)
19	-	Spring (P/O PL 70.70 Item 7)

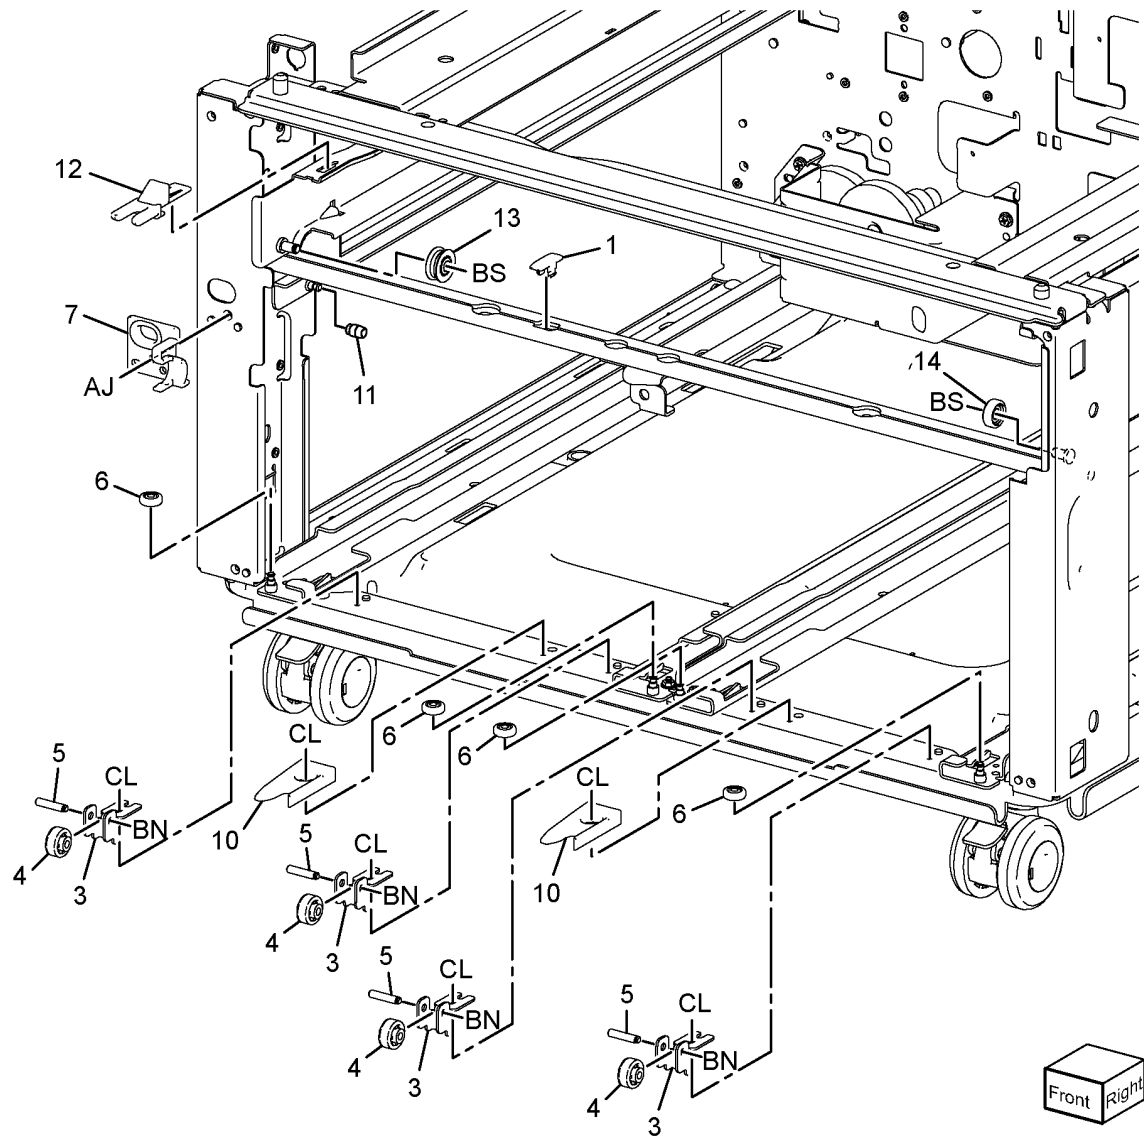
PL 70.75 TTM Front Support

Item	Part	Description
1	-	Spacer (Not Spared)
2	-	Roller assembly (Not Spared)
3	-	Stopper bracket (P/O PL 70.75 Item 2)
4	-	Roller (P/O PL 70.75 Item 2)
5	-	Shaft (P/O PL 70.75 Item 2)
6	059E05060	Upper roller
7	-	Tray stop (Not Spared)
8	-	Not used
9	-	Not used
10	803E09020	Stopper
11	059E05131	Roller
12	003E75432	Tray stop
13	059E03500	Front left roller
14	059E08410	Front right roller
