708P91370
April 2017

Xerox® VersaLink® B7025/B7030/B7035 Multifunction Printer Service Manual

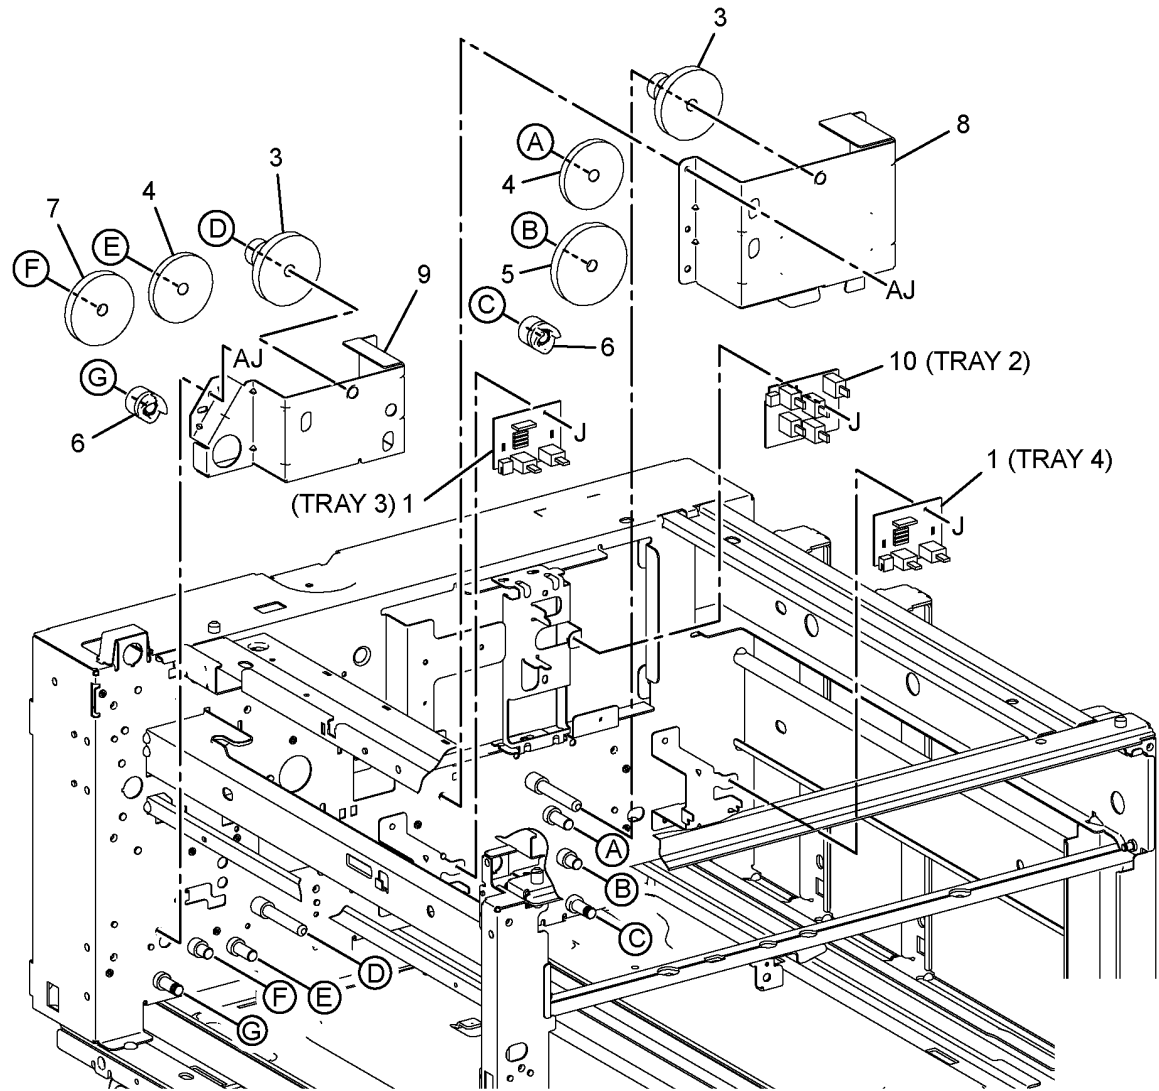
PL 70.80 TTM Size Sensing

Item	Part	Description
1	110K15040	Paper size sensor
2	-	Not used
3	-	Gear 17/50T (Not Spared)
4	-	Gear 16/48T (Not Spared)
5	-	Gear 57T (Not Spared)
6	-	Gear 18T (Not Spared)
7	-	Gear 51T (Not Spared)
8	-	Bracket (Not Spared)
9	-	Bracket (Not Spared)
10	110K11680	Tray 2 paper size sensor

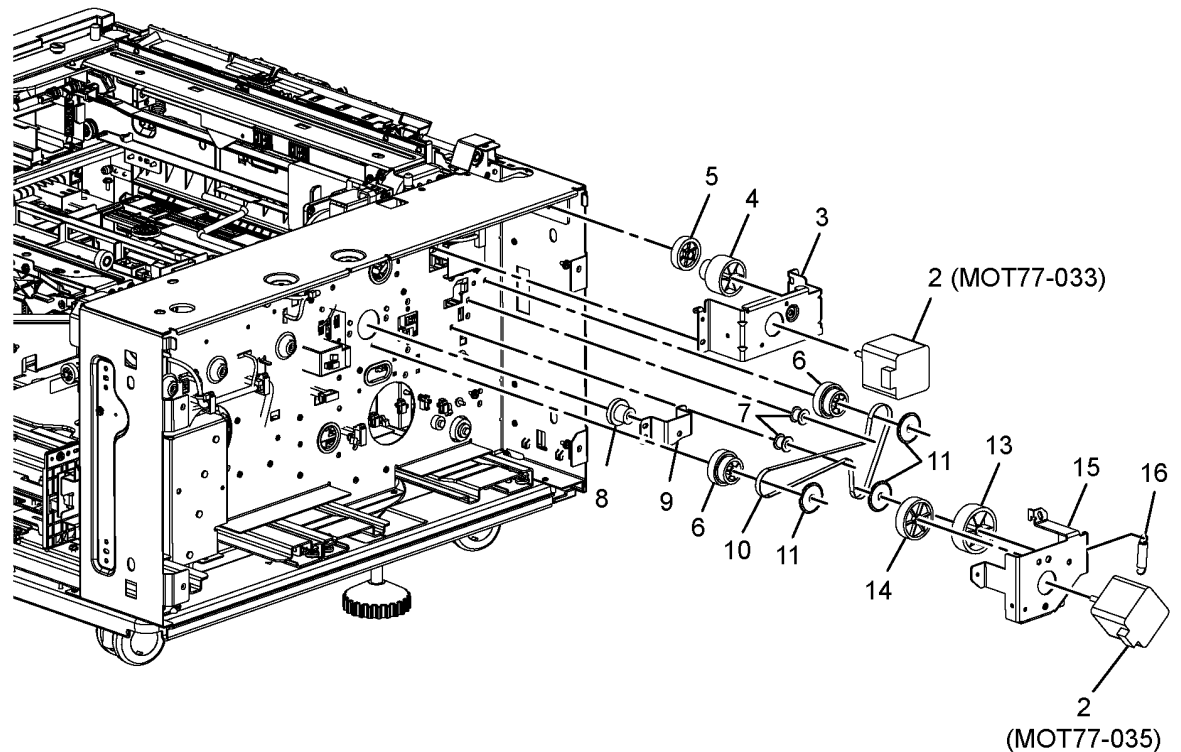
PL 70.85 TTM Drive Components

Item	Part	Description
1	127K75990	Takeaway motor 1 assembly
2	-	Takeaway motor 1 (MOT77-033) (P/O PL 70.85 Item 1)/takeaway motor 2 (MOT77-035) (P/O PL 70.85 Item 12)
3	-	Motor bracket (P/O PL 70.85 Item 1)
4	-	Gear M2 (P/O PL 70.85 Item 1)
5	-	Gear 34T (Not Spared)
6	-	Gear 26T (Not Spared)
7	-	Roller (Not Spared)
8	807E35860	Transfer gear (REP 80.40)
9	-	Trans bracket assembly (Not Spared)
10	023E28900	Drive belt (REP 80.28)
11	-	Collar - 2 (P/O PL 70.85 Item 12)
12	127K76000	Takeaway motor 2 assembly (REP 80.37)
13	-	Gear 81T (P/O PL 70.85 Item 12)
14	-	Gear 70T (P/O PL 70.85 Item 12)
15	-	Motor bracket (P/O PL 70.85 Item 12)
16	-	Spring (Not Spared)

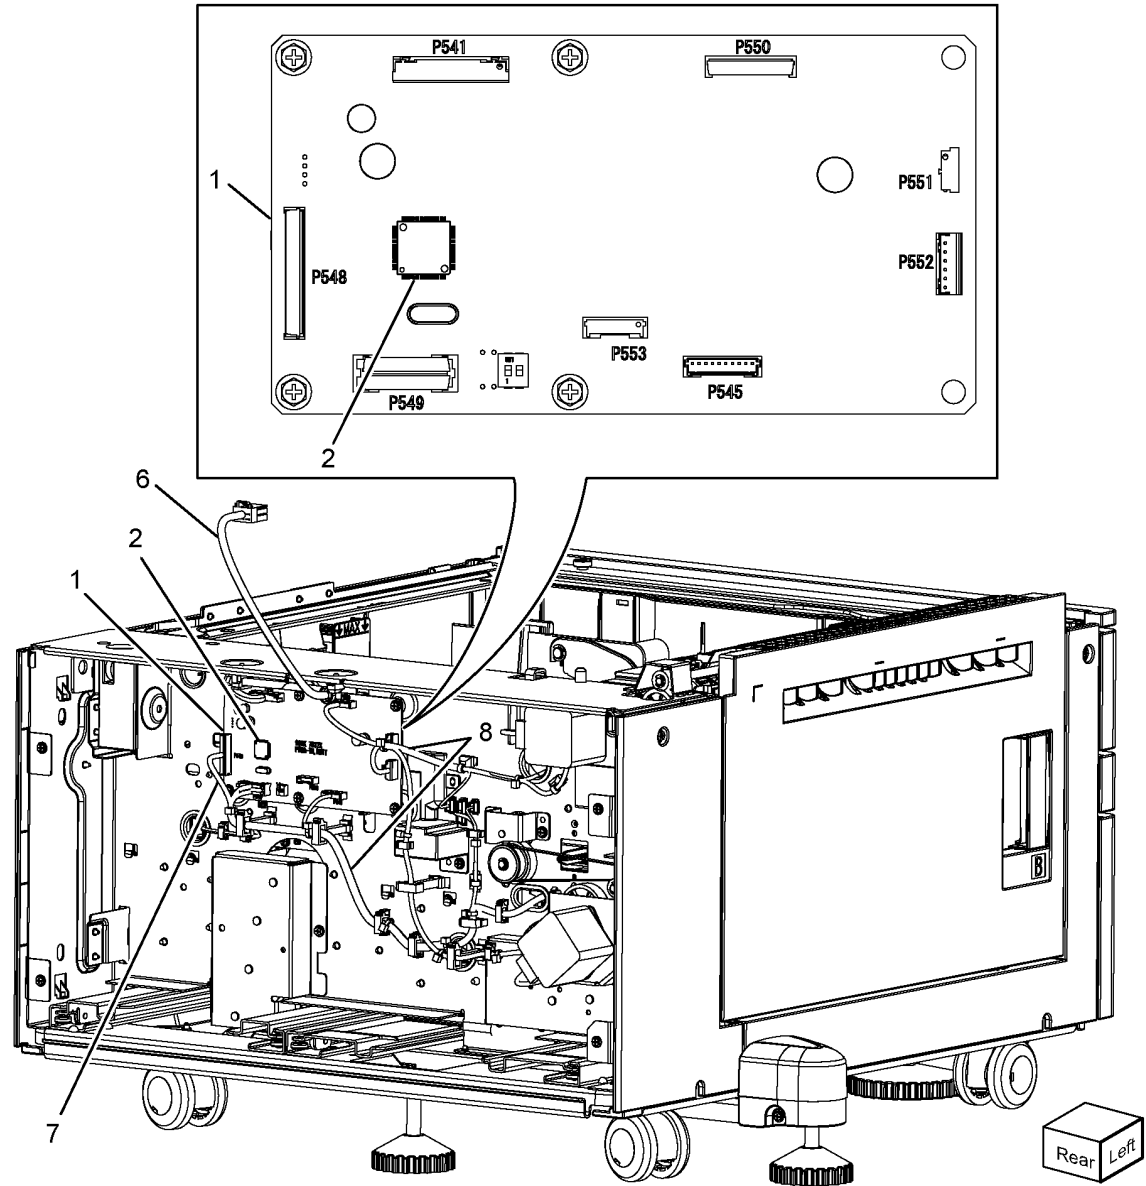
PL 70.90 TTM Electrical

Item	Part	Description
1	960K85452	TTM PWB
2	-	Flash CPU (Not Spared)
3	-	Not used
4	-	Not used
5	-	Not used
6	952K20150	IOT harness
7	952K20160	Sensor harness assembly
8	952K20170	Motor harness assembly

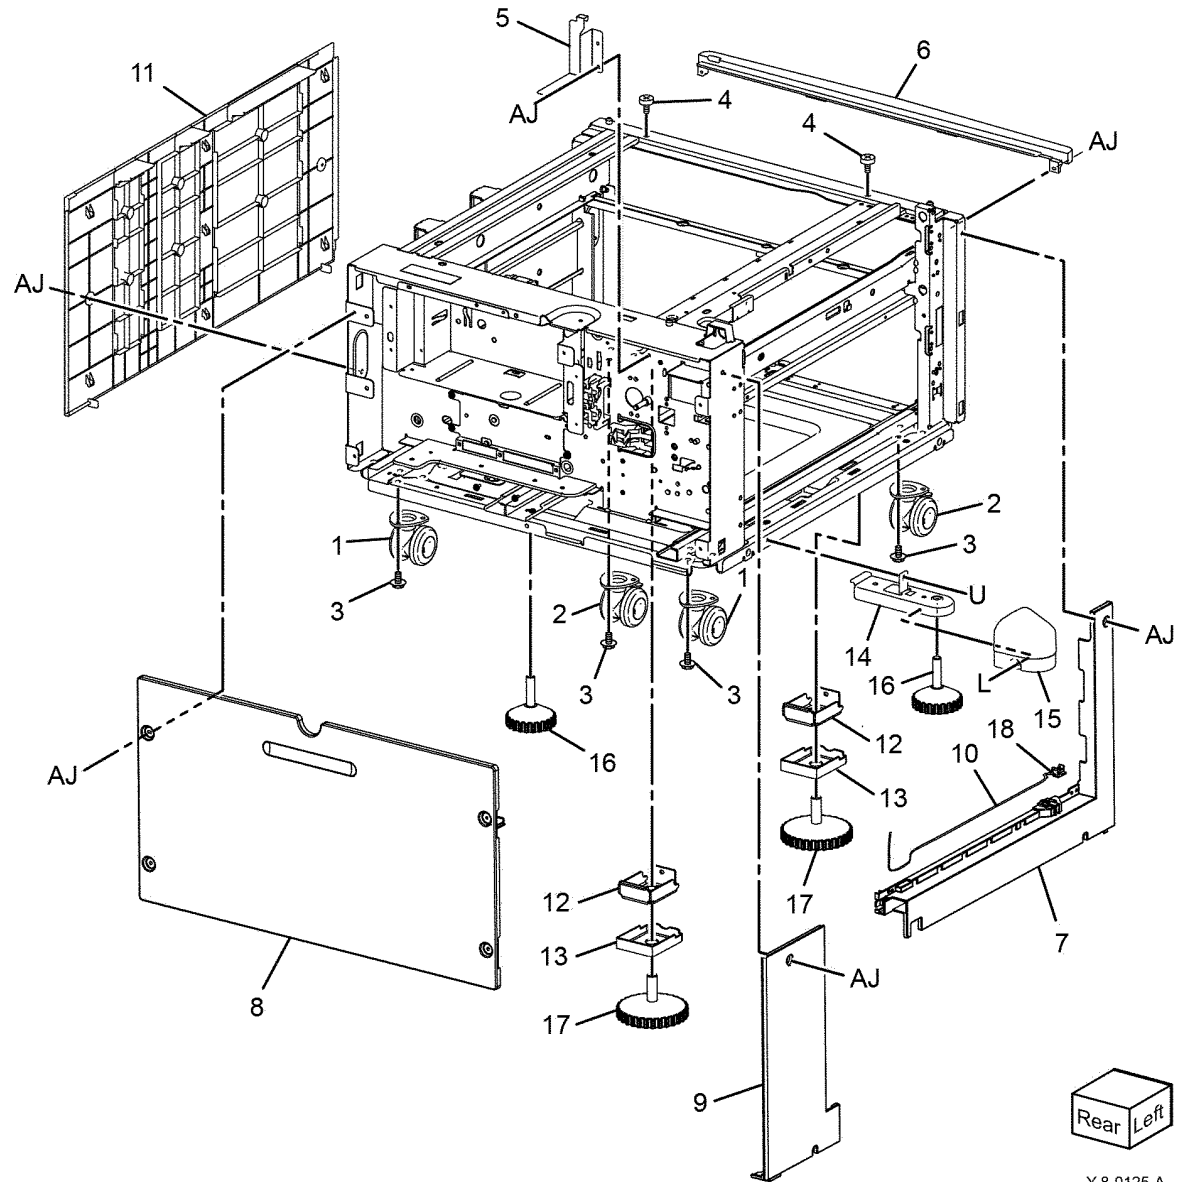
PL 70.95 TTM Castors

Item	Part	Description
1	417W41449	Caster
2	417W41349	Locking caster
3	-	Screw (Not Spared)
4	-	Docking screw (Not Spared)
5	-	Docking bracket (Not Spared)
6	-	Top cover (Not Spared)
7	-	Left front cover (Not Spared)
8	-	Rear cover (Not Spared)
9	-	Left rear cover (Not Spared)
10	-	Harness (Not Spared)
11	-	Right cover (Not Spared)
12	-	Front foot bracket (Not Spared)
13	-	Front foot cover (Not Spared)
14	-	Left foot bracket (Not Spared)
15	-	Foot cover (Not Spared)
16	017K94910	Foot assembly adjuster
17	017K96680	Front foot assembly adjuster
18	110E11580	TM left hand interlock switch (77-306)

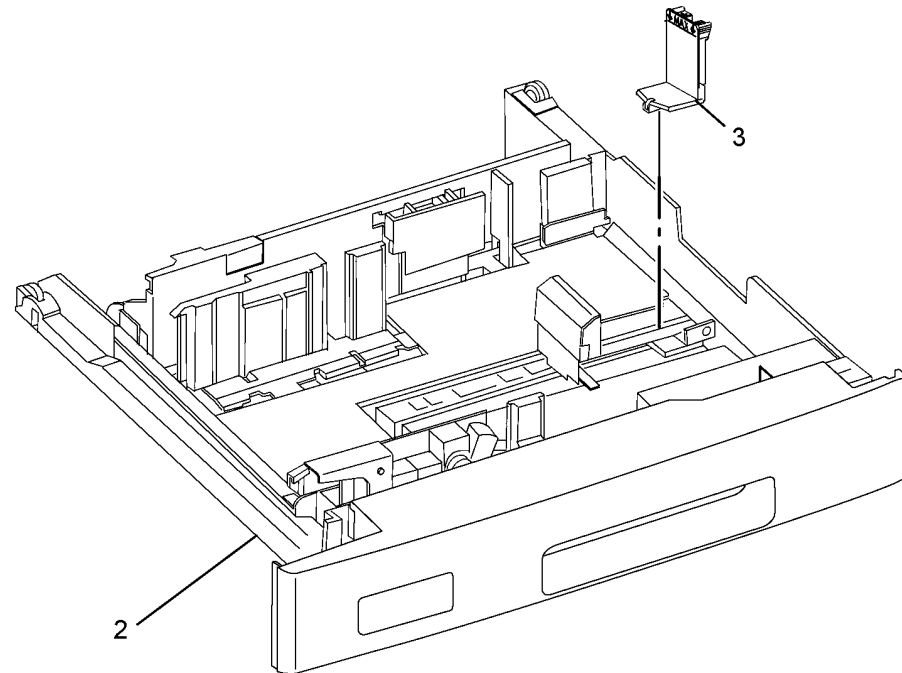
PL 70.100 Envelope Tray

Item	Part	Description
1	050K76610	Envelope tray assembly
2	–	Envelope tray
3	038E44700	End guide

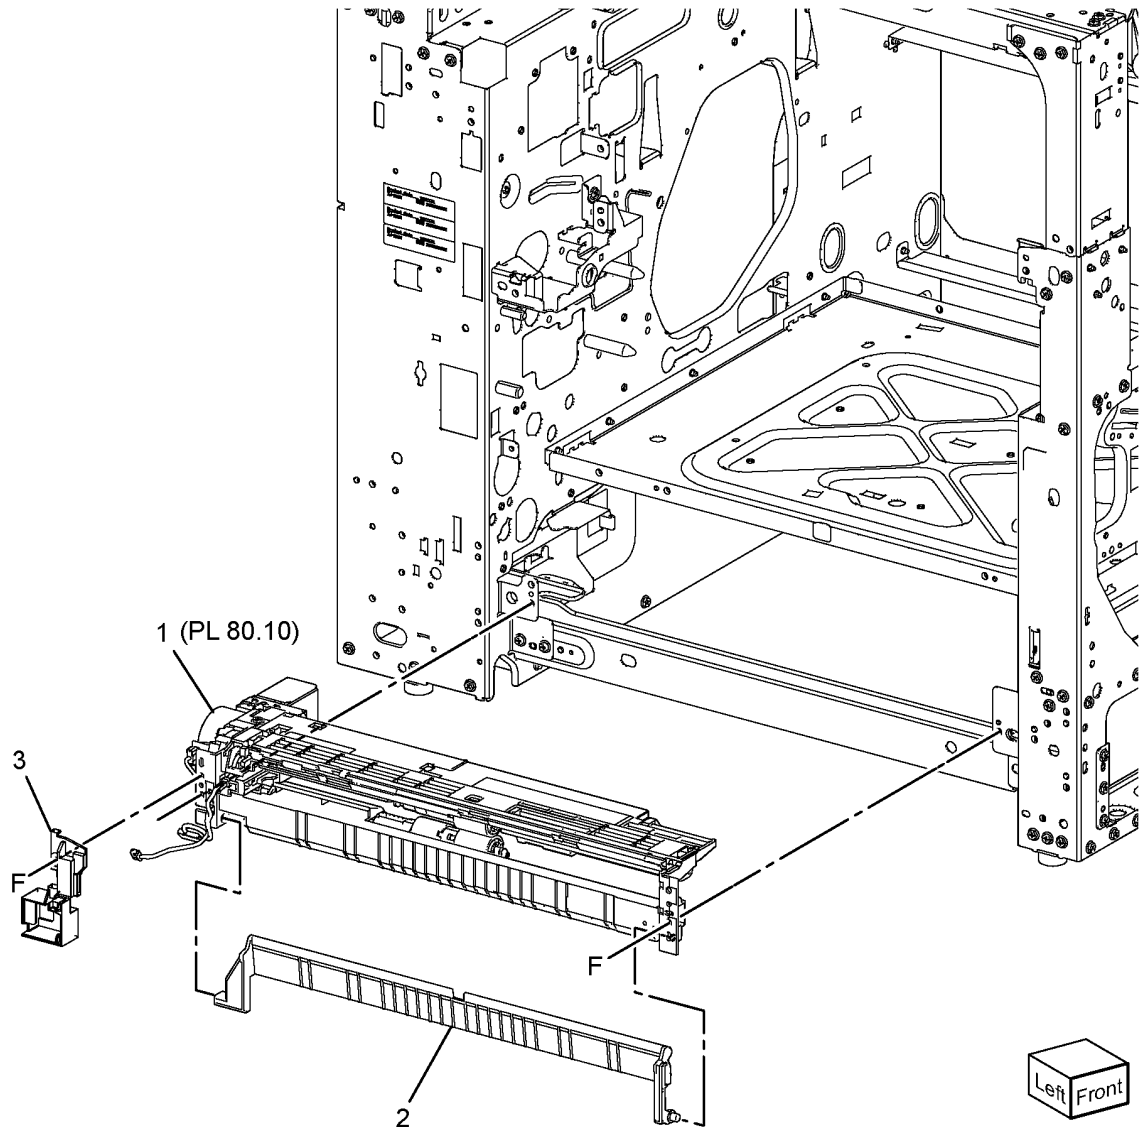
PL 80.05 Tray 1 Feeder

Item	Part	Description
1	859K08541	Tray 1 feeder assembly (REF: PL 80.10, PL 80.11) (See NOTE) (REP 80.1)
2	054E33803	Feed out chute
3	-	Harness holder (Not Spared)

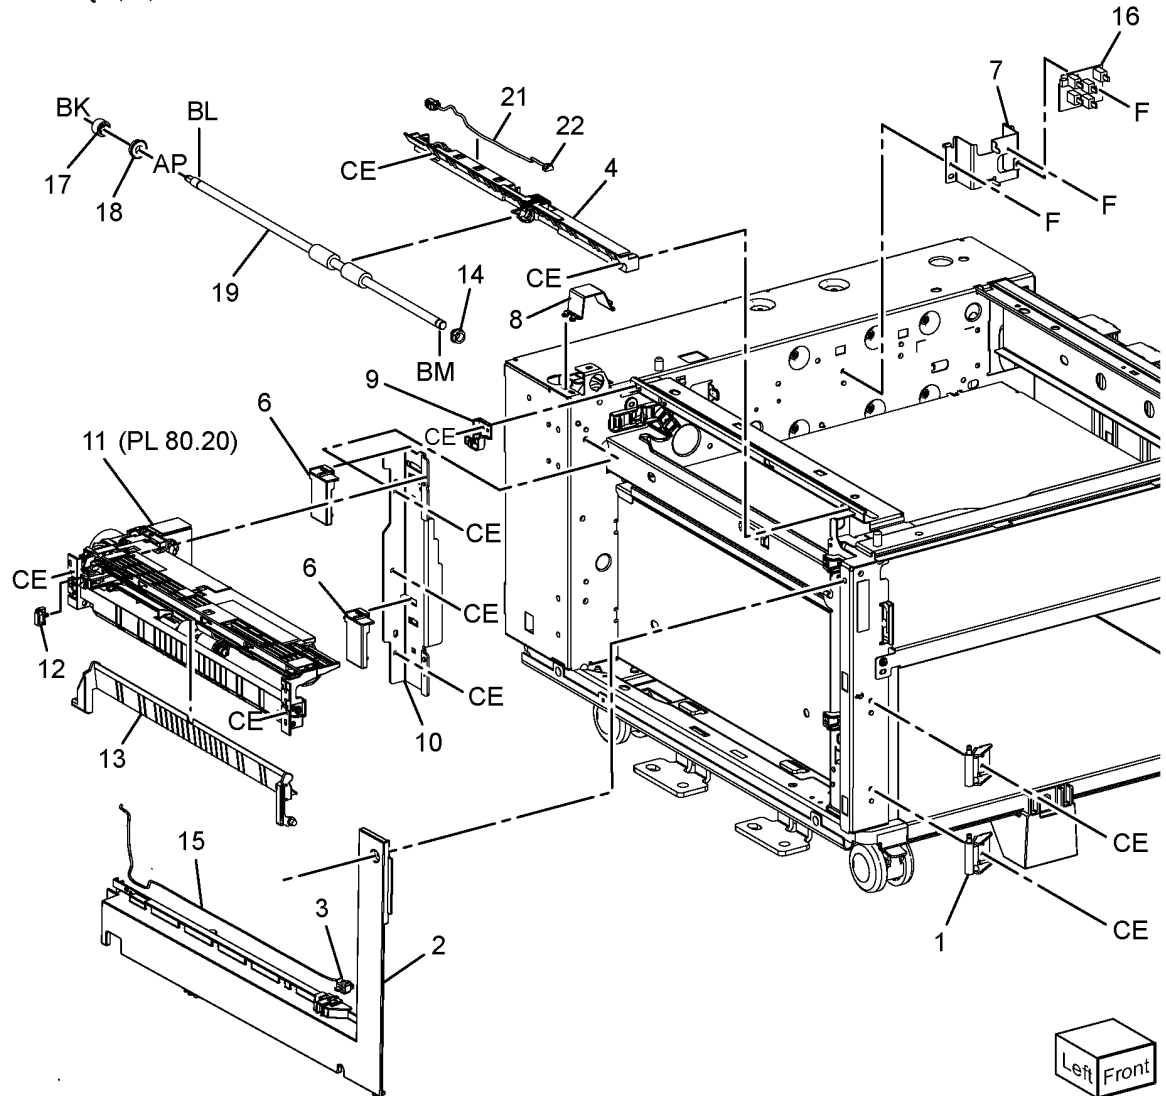
PL 80.15 1TM Feeder

Item	Part	Description
1	-	Hinge bracket (Not Spared)
2	-	Left front cover (P/O PL 80.15 Item 20)
3	110E11580	TM left hand interlock switch (S77-306) (P/O PL 80.15 Item 20)
4	-	Exit chute
5	859K03850	Takeaway roll assembly
6	-	ESD cover (Not Spared)
7	-	Sensor bracket (Not Spared)
8	-	Cover bracket (Not Spared)
9	-	Left guide (Not Spared)
10	-	Bracket (Not Spared)
11	859K09730	Feeder assembly (REF: PL 80.20, PL 80.25) (see NOTE) (REP 80.3)
12	920W01210	Locking clamp
13	054E33803	Feed chute
14	013E46870	Bearing
15	-	Harness assembly (P/O PL 80.15 Item 20)
16	110K17950	Tray 2 paper size sensor
17	-	Gear 16T (P/O PL 80.15 Item 5)
18	-	Ball bearing (P/O PL 80.15 Item 5)
19	-	Takeaway roll (P/O PL 80.15 Item 5)
20	-	Left front cover assembly
21	-	Feed out sensor harness
22	-	Tray 2 feed out sensor (Q72-103)

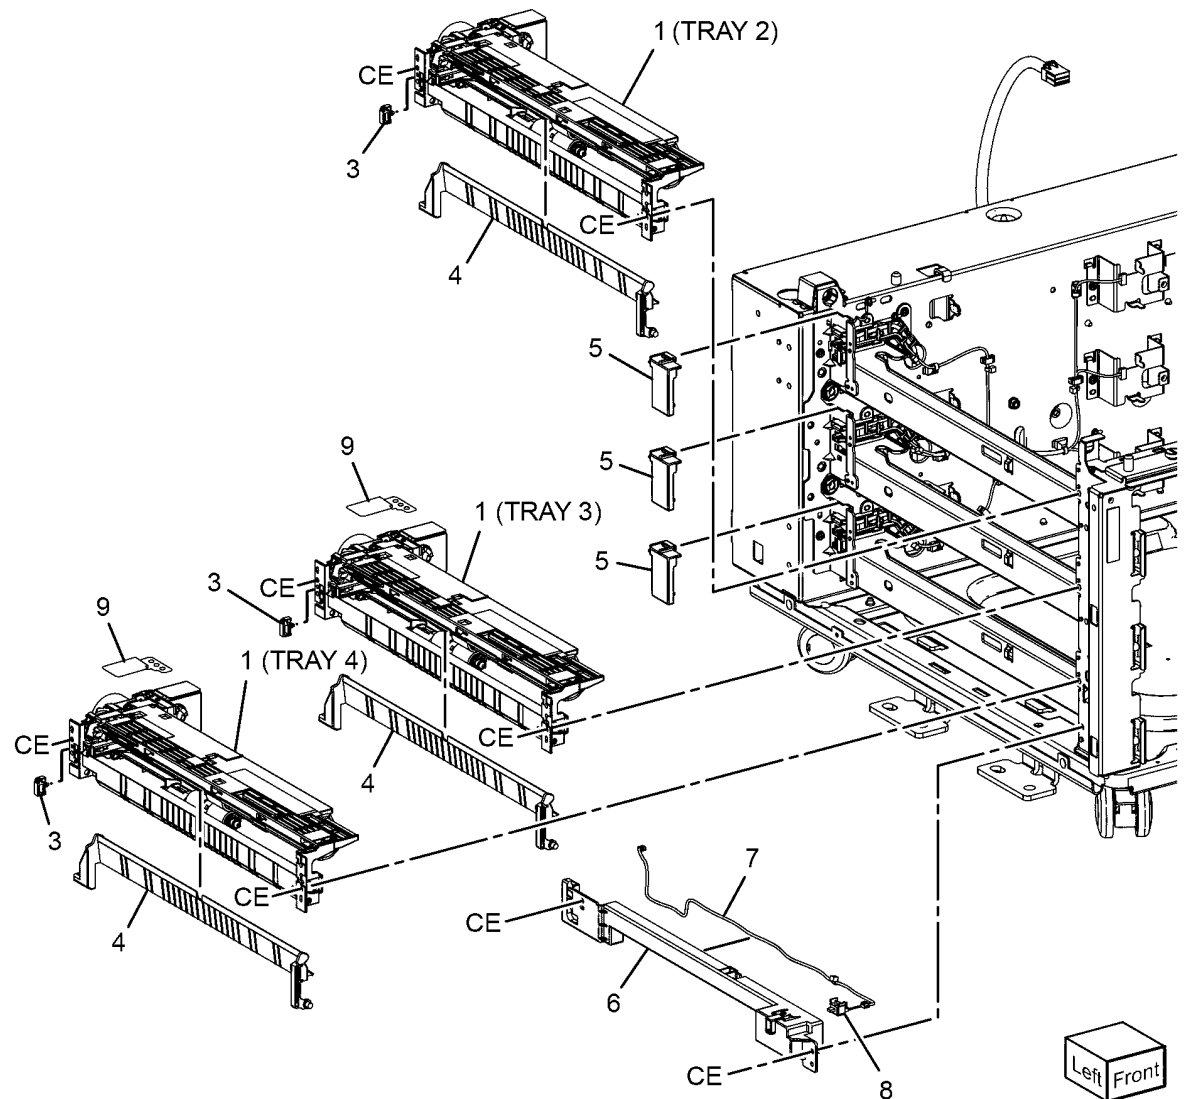
PL 80.30 3TM Feeders

Item	Part	Description
1	859K09730	Tray 2/3/4 feeder assembly (REF: PL 80.20, PL 80.25) (See NOTE) (tray 2 - REP 80.7, tray 3 - REP 80.8, tray 4 - REP 80.9)
2	-	Not used
3	920W01209	Locking clamp
4	054E33803	Feed chute
5	-	ESD cover (Not Spared)
6	-	IL cover assembly (Not Spared)
7	-	IL harness assembly (Not Spared)
8	110E11580	TM left hand interlock switch (S77-306)
9	-	FDR 2T cover (Not Spared)

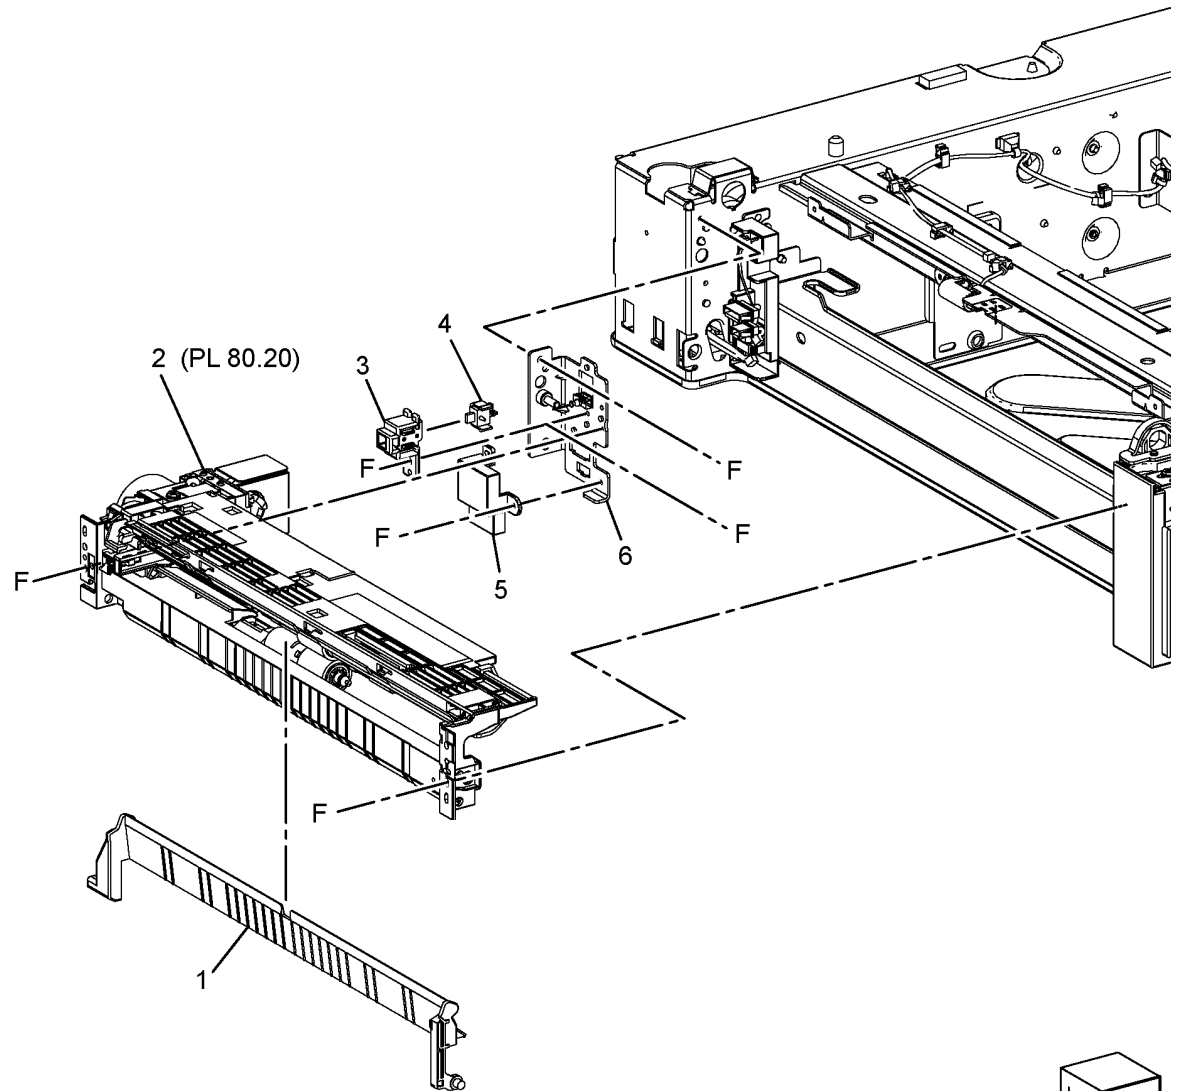
PL 80.35 STM Feeder

Item	Part	Description
1	054E33803	Feed chute
2	859K09730	Tray 2 feeder assembly (See NOTE)
3	–	IL cover (Not Spared)
4	110E12220	TM left hand interlock switch (S77-306)
5	–	ESD STM cover (Not Spared)
6	–	Latch bracket assembly (Not Spared)

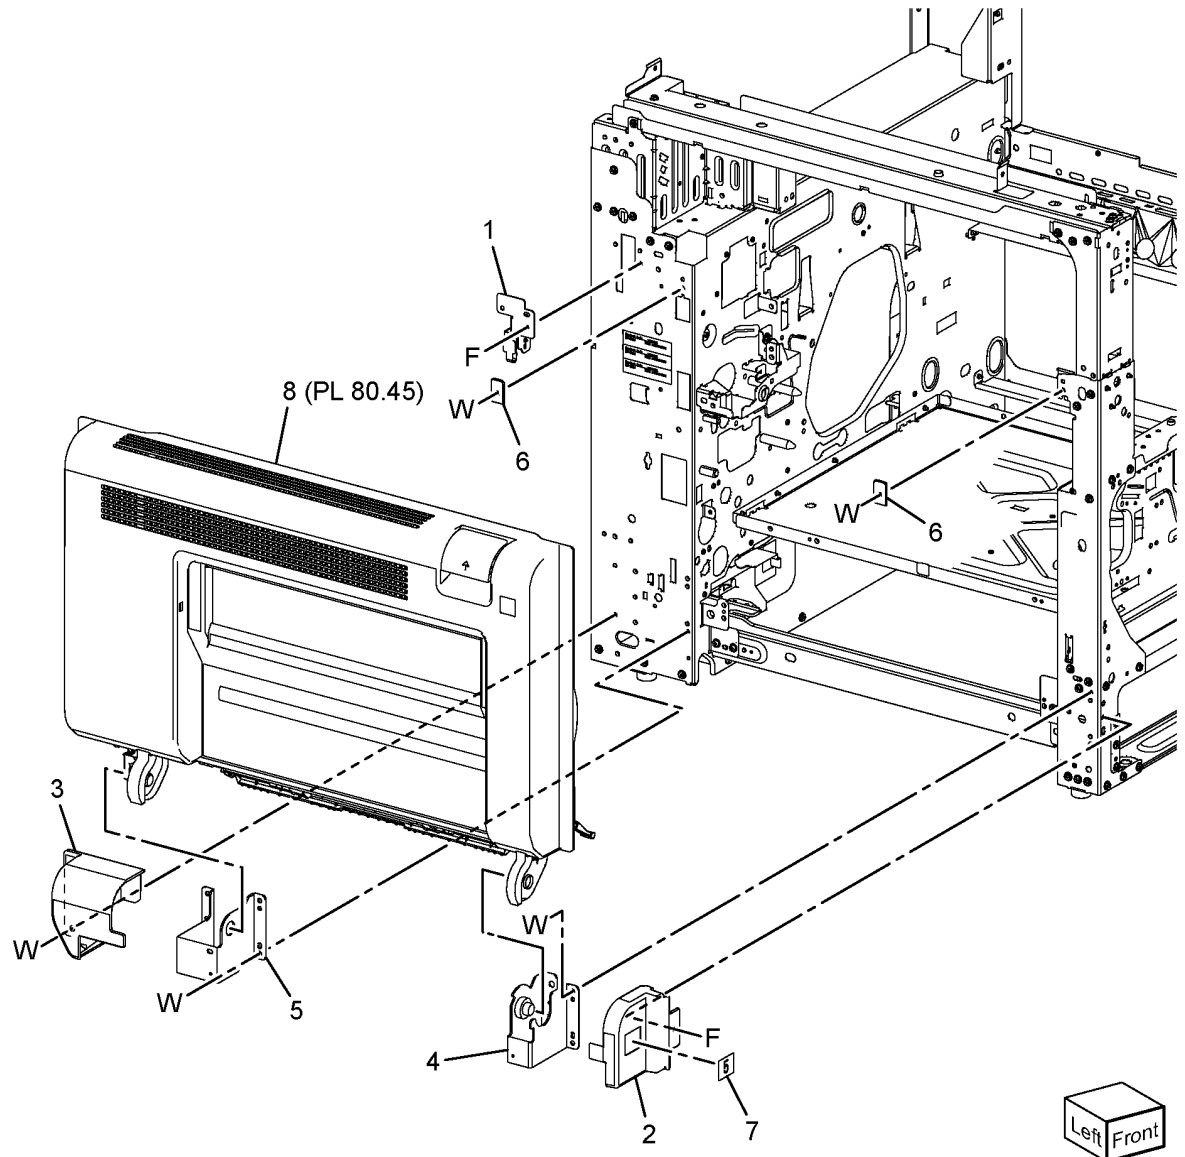
Y-8-0038-A

PL 80.40 LH Transport Components

Item	Part	Description
1	110K18072	Left hand high cover switch (S77-302)
2	-	Front hinge cover (Not Spared)
3	-	Rear hinge cover (Not Spared)
4	-	Bypass tray front frame assembly (Not Spared)
5	-	Bypass tray rear frame assembly (Not Spared)
6	-	Latch guide (Not Spared)
7	-	Number label (5) (Not Spared)
8	859K05131	L/H cover (REP 80.18)

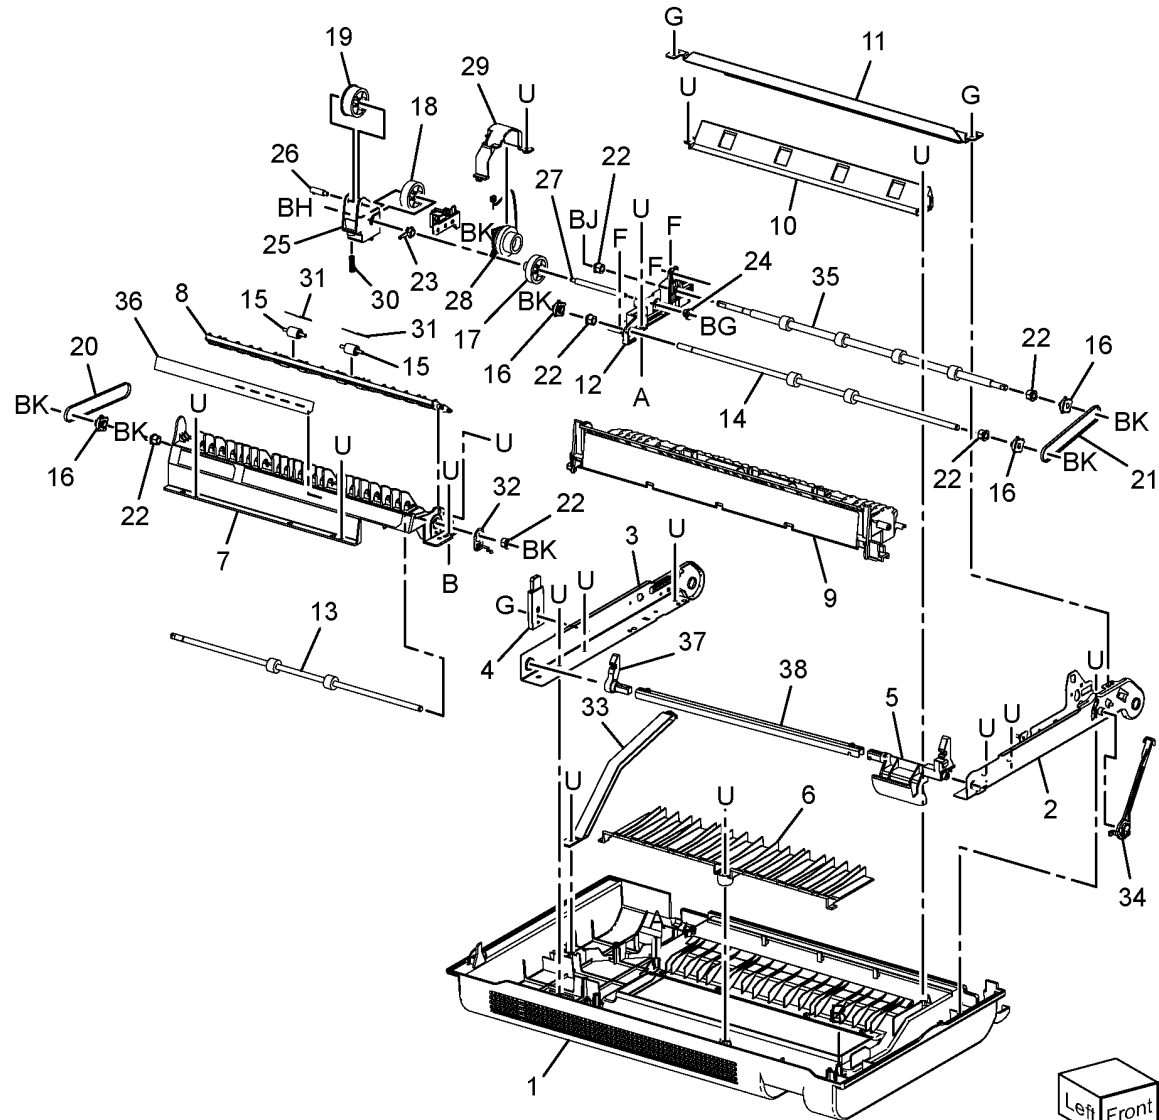
Y-8-0040-A

PL 80.50 Duplex LH Cover Component

Item	Part	Description
1	-	Left cover (Not Spared)
2	-	Front frame (Not Spared)
3	-	Rear frame (Not Spared)
4	-	Fusing plate (Not Spared)
5	011E28351	Lever latch front mat
6	-	Duplex cover chute (Not Spared)
7	-	LH cover duplex chute (Not Spared)
8	-	LH low chute (Not Spared)
9	-	TA pinch chute assembly (Not Spared)
10	-	Duplex out chute (Not Spared)
11	-	Plate tie TA (Not Spared)
12	-	Gear bracket (Not Spared)
13	-	Duplex 1 roll (Not Spared)
14	-	Duplex 2 roll (Not Spared)
15	-	Duplex nip roll (Not Spared)
16	-	Pulley (Not Spared)
17	-	Gear (Not Spared)
18	-	Gear (Not Spared)
19	-	Swing gear (Not Spared)
20	-	Belt (Not Spared)
21	-	Belt (Not Spared)
22	-	Bearing (Not Spared)
23	-	Bearing (Not Spared)
24	-	Bearing (Not Spared)
25	-	Swing bracket (Not Spared)
26	-	Swing shaft (Not Spared)
27	-	Clutch shaft (Not Spared)
28	121K56560	Duplex clutch (CL77-003)
29	-	Clutch cover (Not Spared)
30	-	Spring (Not Spared)
31	-	Pinch spring (Not Spared)

32	-	Ground plate (Not Spared)
33	869E14461	LH rear support
34	868E48840	LH front support
35	-	Duplex 3 roll (Not Spared)
36	-	Label (Not Spared)
37	011E29140	Rear latch lever
38	-	Plate latch (Not Spared)

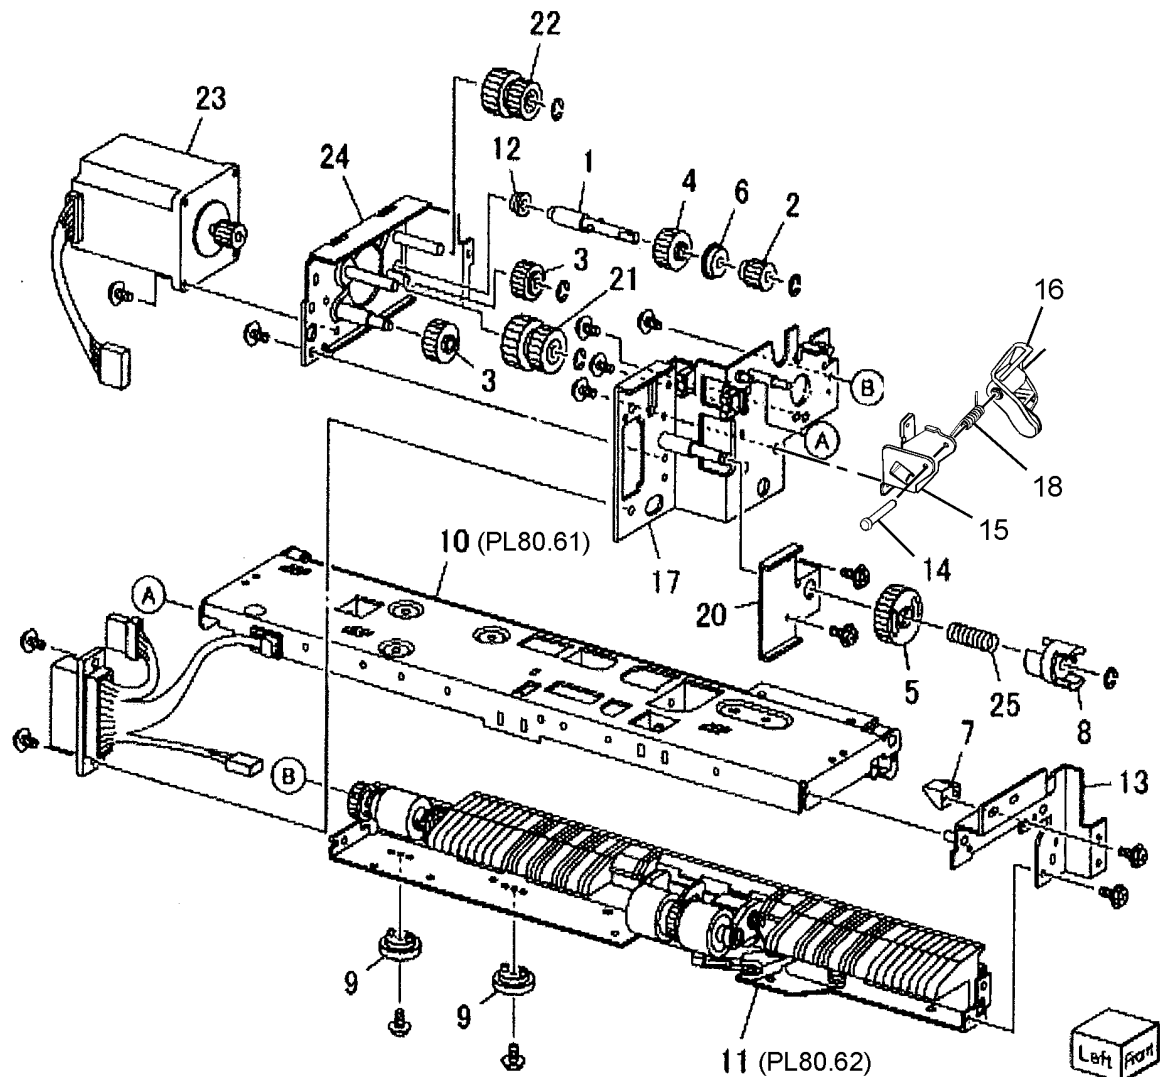
Y-8-0109-A

PL 80.60 HCF Feeder (1 of 3)

Item	Part	Description
1	-	Shaft (P/O PL 70.45 Item 11)
2	007E78760	Gear 19T
3	007E78770	Gear 25T
4	007E78780	Gear 25T
5	007E78790	Gear 40T
6	013E25530	Bearing
7	-	Block (P/O PL 70.45 Item 11)
8	-	Spacer (P/O PL 70.45 Item 11)
9	019E56470	Holder
10	-	Upper feeder assembly (P/O PL 70.45 Item 11)
11	-	Lower feeder assembly (P/O PL 70.45 Item 11)
12	413W66250	Ball bearing
13	-	Front frame (P/O PL 70.45 Item 11)
14	-	Pin (P/O PL 70.45 Item 11)
15	-	Down bracket (P/O PL 70.45 Item 11)
16	-	Link bracket (P/O PL 70.45 Item 11)
17	-	Rear frame (P/O PL 70.45 Item 11)
18	-	Tension spring (P/O PL 70.45 Item 11)
19	-	Lift/Motor frame (P/O PL 70.45 Item 11)
20	-	Bracket (P/O PL 80.60 Item 19)
21	007K88520	Gear 23T/27T
22	007K88530	Gear 31T/36T
23	127K37901	HCF feed/lift motor (MOT78-003) (REP 80.27)
24	-	Plate (P/O PL 80.60 Item 19)
25	-	Spring (P/O PL 70.45 Item 11)

19 { 20 - 24

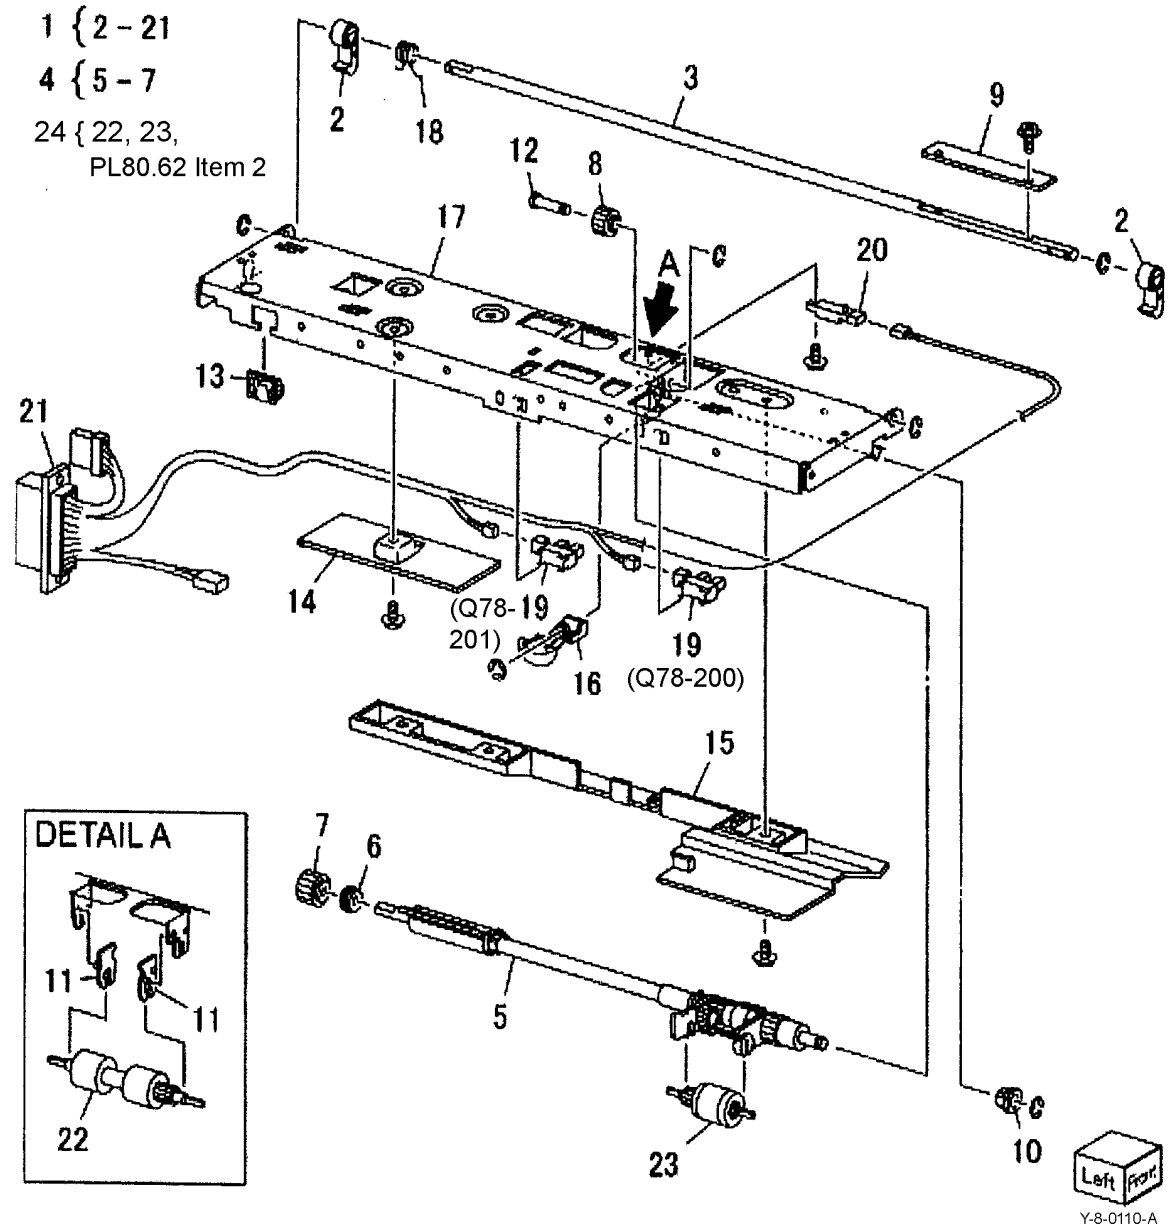
PL 80.61 HCF Feeder (2 of 3)

Item	Part	Description
1	-	Upper feeder assembly (P/O PL 70.45 Item 11)
2	003E59570	Latch
3	-	Shaft latch (P/O PL 80.61 Item 3)
4	006K23124	Feed shaft assembly (REP 80.23, REP 80.25)
5	-	Feed shaft (P/O PL 80.61 Item 4)
6	413W66250	Ball bearing
7	-	Gear 20T (P/O PL 80.61 Item 4)
8	007E78180	Feed gear 25T
9	-	Lever (P/O PL 80.61 Item 1)
10	-	Bearing (P/O PL 80.61 Item 1)
11	-	Spacer (P/O PL 80.61 Item 1)
12	-	Pin drive (P/O PL 80.61 Item 1)
13	-	Guide (P/O PL 80.61 Item 1)
14	-	Rear upper chute (P/O PL 80.61 Item 1)
15	-	Upper chute (P/O PL 80.61 Item 1)
16	120E21900	Actuator
17	-	Upper frame (P/O PL 80.61 Item 1)
18	-	Spring (P/O PL 80.61 Item 1)
19	930W00112	HCF no paper sensor (Q78-200)/ HCF level sensor (78-201)
20	-	HCF Pre feed sensor (Q78-100) (P/O PL 80.61 Item 1)
21	-	Wire harness (P/O PL 80.61 Item 1)
22	-	Feed roll (P/O PL 80.61 Item 24)
23	-	Nudger roll (P/O PL 80.61 Item 24)
24	604K23660	Feed roller kit (REP 80.22)

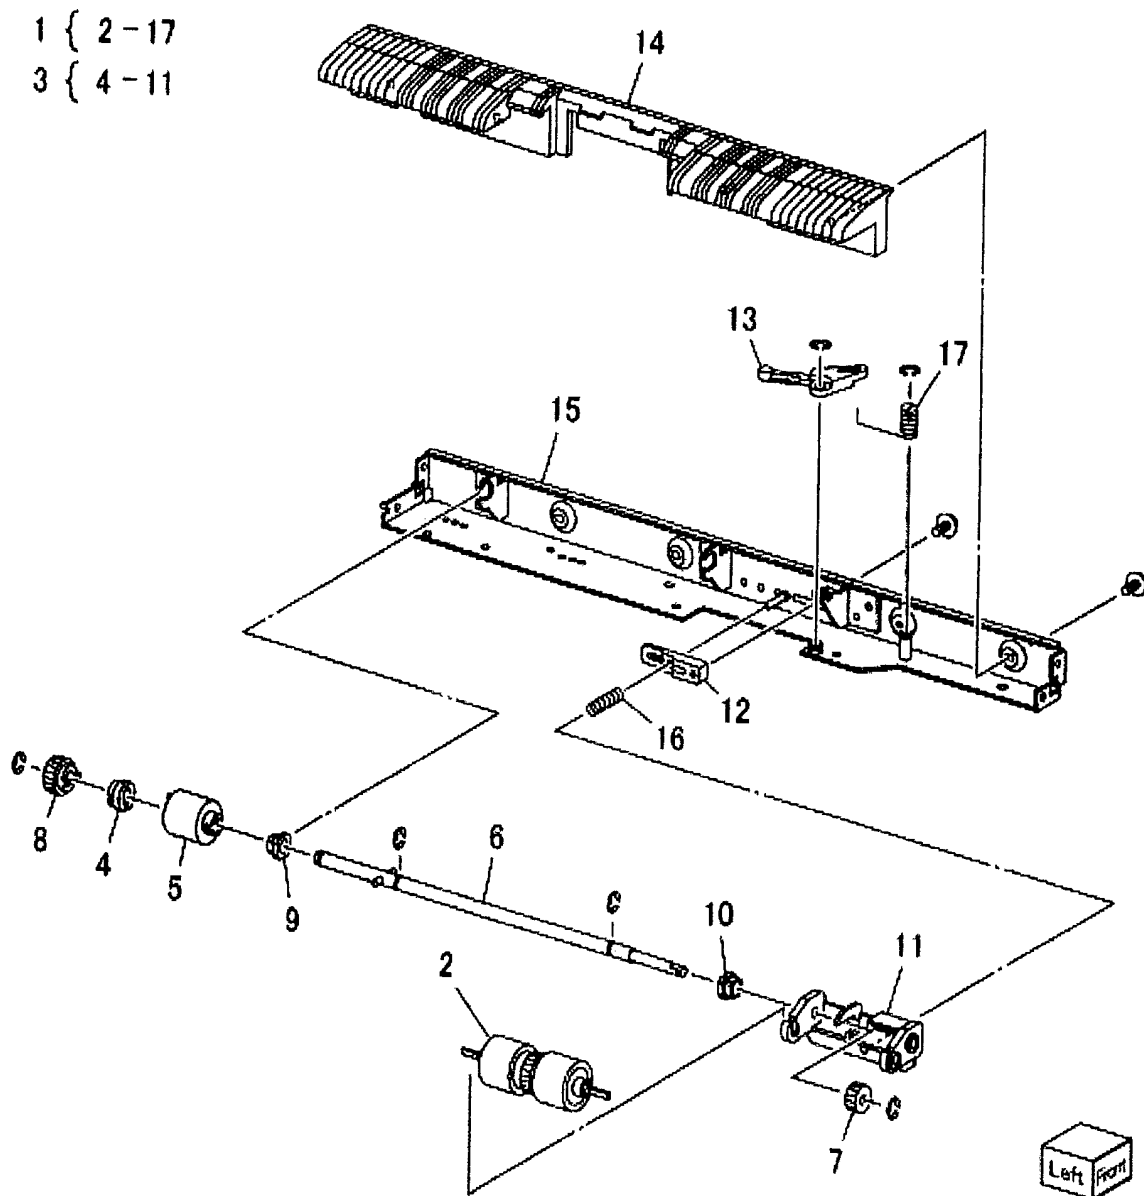
Y-8-0111-A

PL 80.62 HCF Feeder (3 of 3)

Item	Part	Description
1	-	Lower feed assembly (Not Spared)
2	-	Retard roll (P/O PL 80.61 Item 24)
3	-	Retard shaft assembly (P/O PL 80.62 Item 1)
4	-	Collar (P/O PL 80.62 Item 3)
5	005K06701	Friction clutch
6	-	Shaft (P/O PL 80.62 Item 3)
7	007E78170	Gear 15T
8	007E89760	Gear 22T
9	013E23600	Bearing
10	013E23610	Bearing
11	-	Retard bracket (P/O PL 80.62 Item 3)
12	-	Slide (P/O PL 80.62 Item 1)
13	-	Lever (P/O PL 80.62 Item 1)
14	-	Lower chute (P/O PL 80.62 Item 1)
15	-	Lower frame (P/O PL 80.62 Item 1)
16	-	Spring (P/O PL 80.62 Item 1)
17	-	Spring (P/O PL 80.62 Item 1) (REP 80.24)

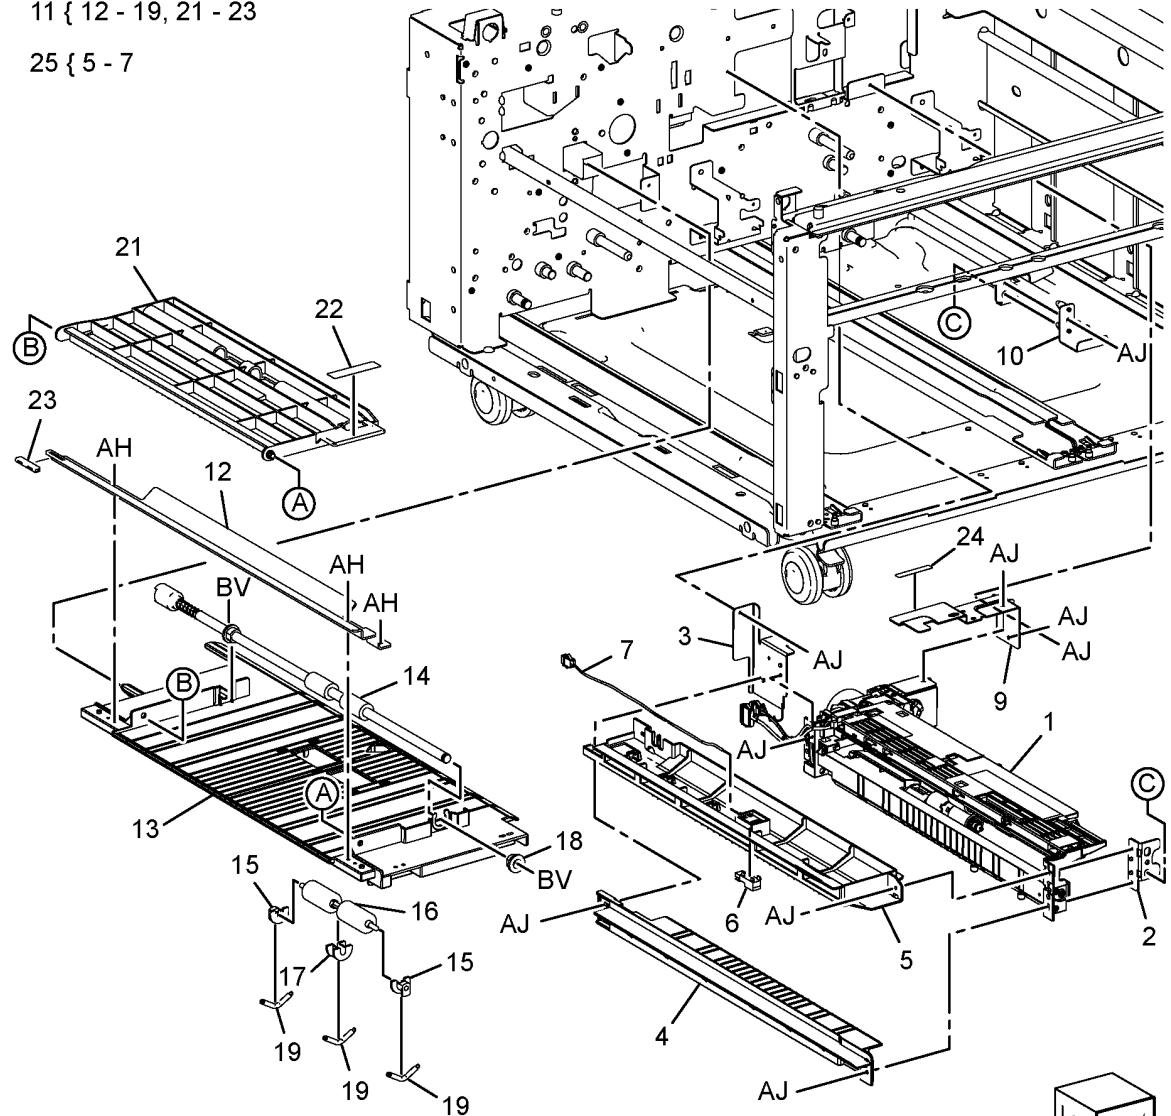
Y-8-0118-A

PL 80.70 TTM Tray 4 Feeder

Item	Part	Description
1	859K00482	Tray 4 feeder assembly (REF: PL 80.20, PL 80.25) (See NOTE) (REP 80.35)
2	-	Bracket (Not Spared)
3	-	Bracket (Not Spared)
4	054E57341	Lower feed chute (REP 80.29)
5	-	Upper feed chute (P/O PL 80.70 Item 25) (REP 80.31)
6	930W00212	Tray 4 feed out sensor
7	-	Wire harness (P/O PL 80.70 Item 25)
8	-	Not used
9	-	Feeder cover (Not Spared)
10	-	Support bracket (Not Spared)
11	-	Tray 4 transport assembly (Not Spared)
12	-	Transport rail (P/O PL 80.70 Item 11)
13	-	Lower chute (P/O PL 80.70 Item 11)
14	-	Transport roll assembly (P/O PL 80.70 Item 11)
15	-	Bearing (P/O PL 80.70 Item 11)
16	059E98860	Nip roll (REP 80.32)
17	-	Bearing (P/O PL 80.70 Item 11)
18	-	Bearing (P/O PL 80.70 Item 11)
19	-	Spring (P/O PL 80.70 Item 11)
20	-	Not used
21	-	Upper chute (P/O PL 80.70 Item 11)
22	-	Label (P/O PL 80.70 Item 11)
23	-	Spacer (P/O PL 80.70 Item 11)
24	-	Label (Not Spared)
25	054K54480	Upper chute assembly

11 { 12 - 19, 21 - 23
25 { 5 - 7

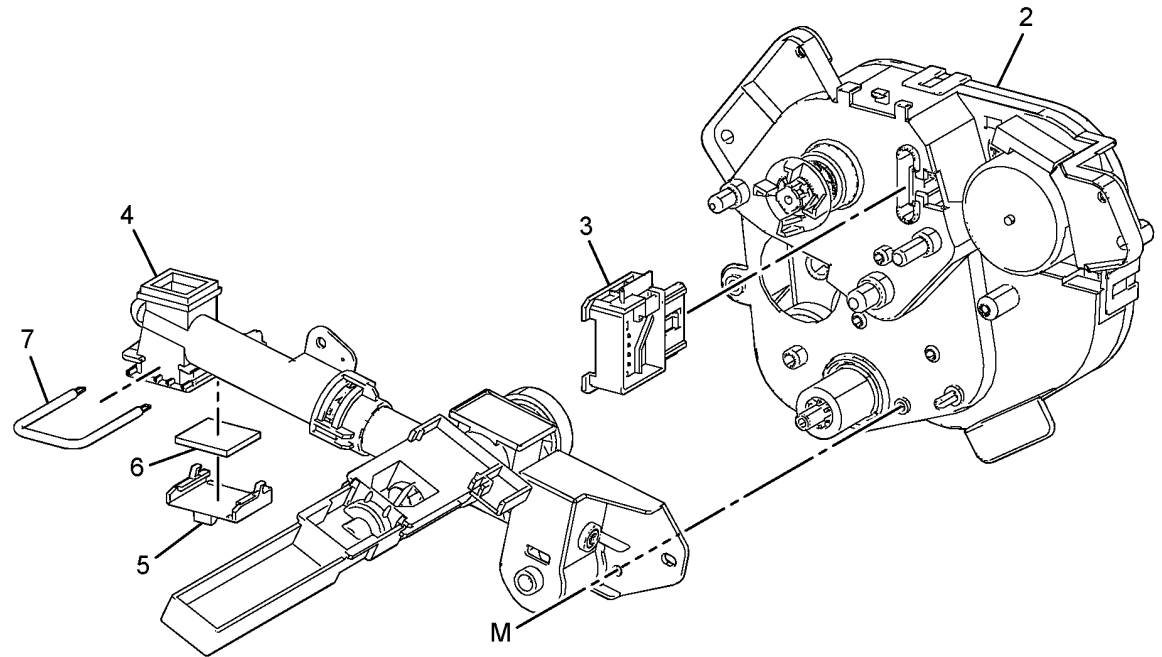
Y-8-0002-A

PL 90.10 Dispenser Component

Item	Part	Description	
1	-	Dispenser drive assembly (Not Spared)	1 { 2, 3
2	-	Toner dispense drive (P/O PL 90.10 Item 1)	8 { 4 - 7
3	-	Toner CRUM connector (P/O PL 90.10 Item 1)	
4	-	Pipe assembly (P/O PL 90.10 Item 8)	
5	-	Shutter (P/O PL 90.10 Item 8)	
6	-	Seal (P/O PL 90.10 Item 8)	
7	-	Spring (P/O PL 90.10 Item 8)	
8	-	Pipe assembly (Not Spared)
